WEAKLEY COUNTY, TENNESSEE

ADA EVALUATION

Architectural and Site Findings with Recommendations

TLM Associates, Inc

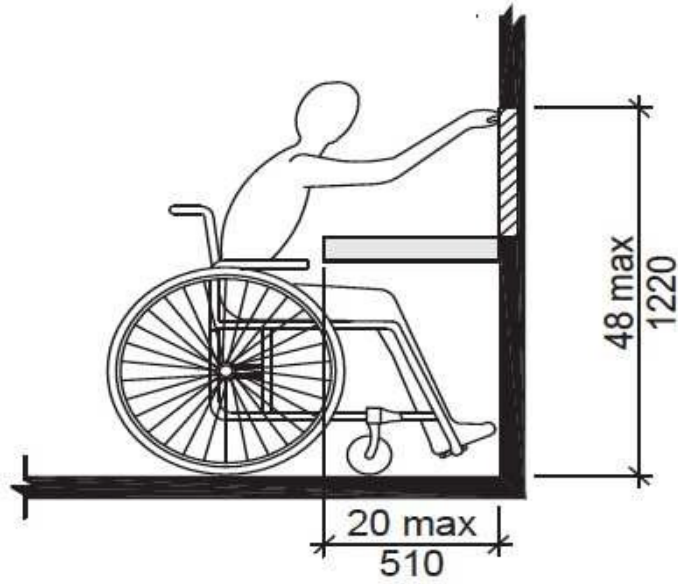
As Built: The clear floor space only allows for a forward approach and the soap dispenser is out of reach range at 51" AFF.

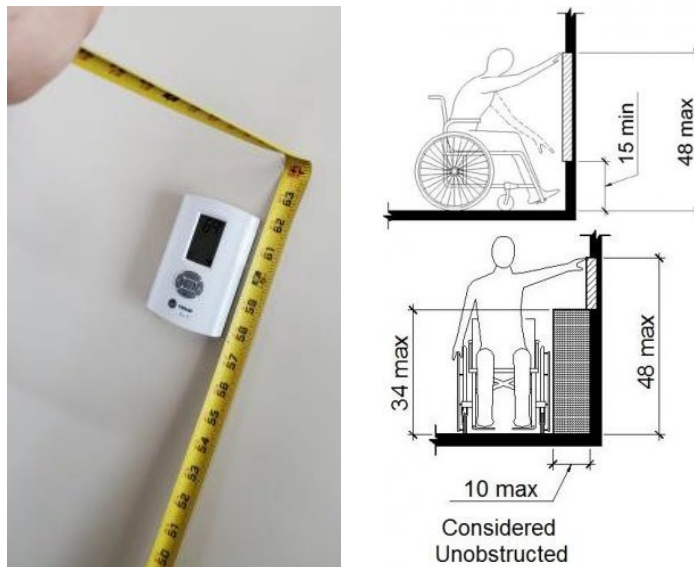
As Built: The thermostat is not positioned correctly for either a side or front approach.

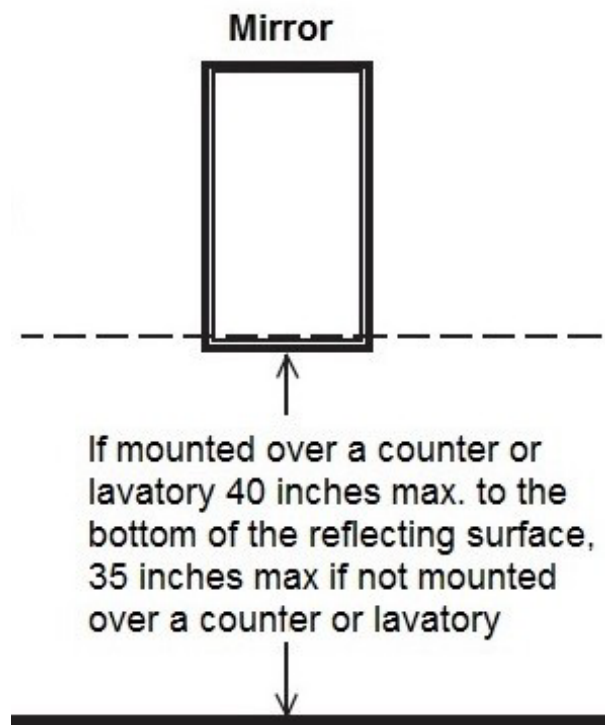
As Built: The mirror is mounted too high.

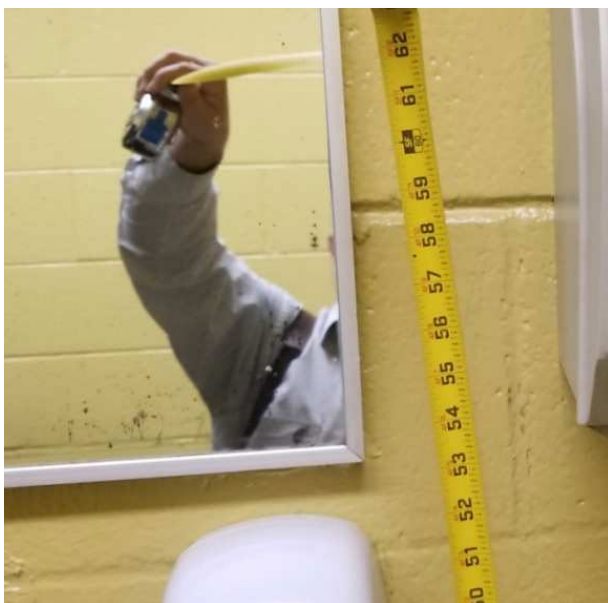
As Built: The mirror is mounted too high at 53”.

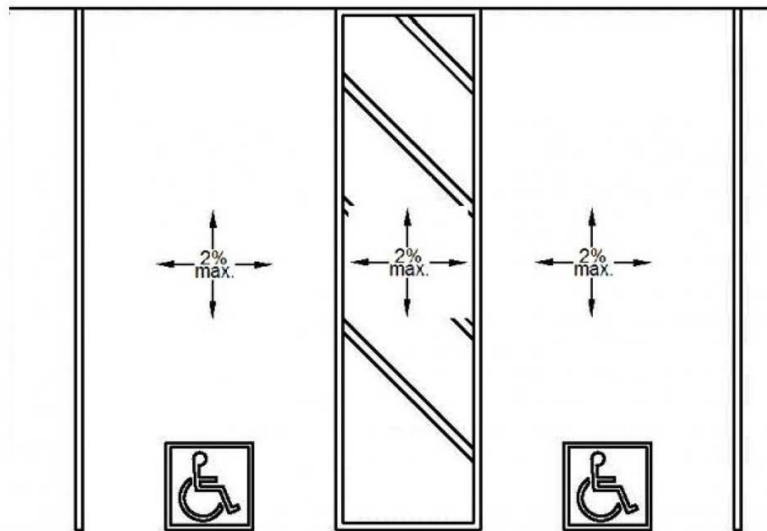
As Built: The cross slopes (narrow dimension) and/or running slopes (long dimension) of the accessible stall varies up to 3.5% across and 5.5% running slope in both spaces.

The running slope and the cross slope in an accessible parking stall and the access aisle must not exceed 2%.

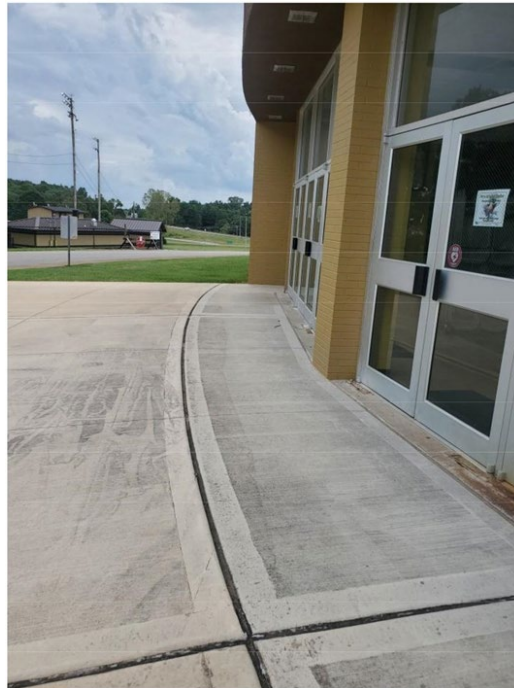
As Built: The cross slope of the pedestrian access route varies from 2.2 to 3.1%

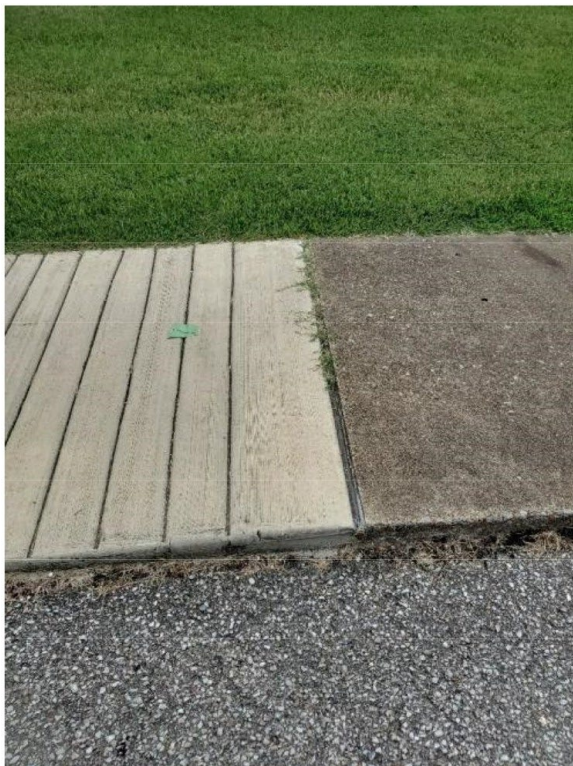
As Built: The concrete expansion joint is spaced greater than a 1/2 inch.

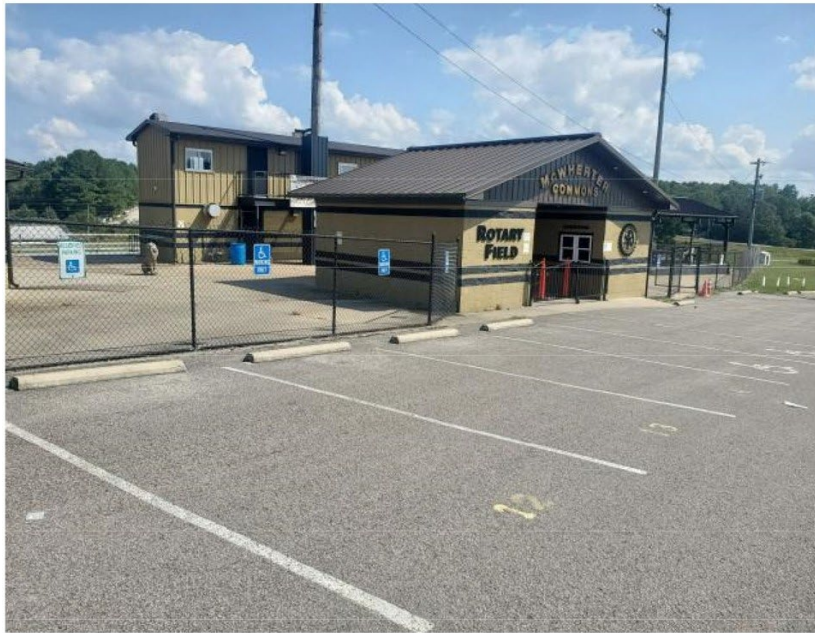
As Built: The access aisle is missing at the accessible parking stall.

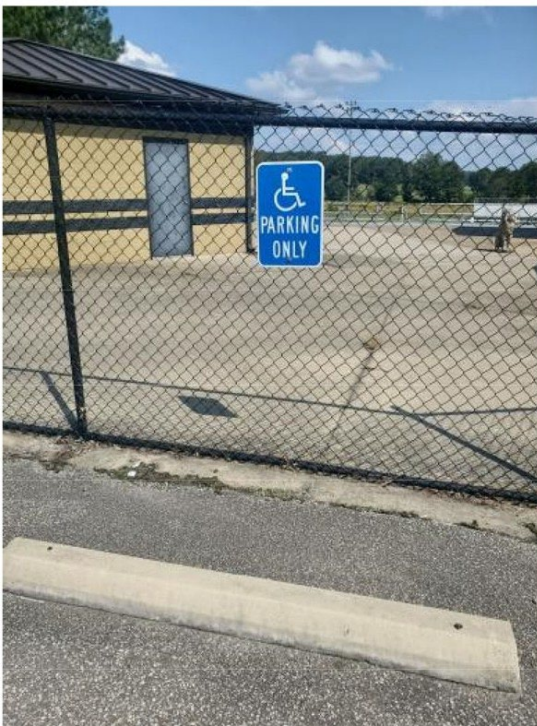
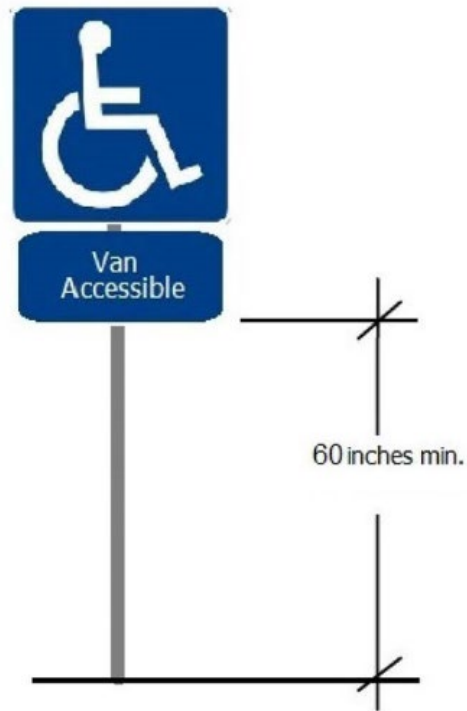
As Built: The parking sign is mounted at 3.5' which is too low.

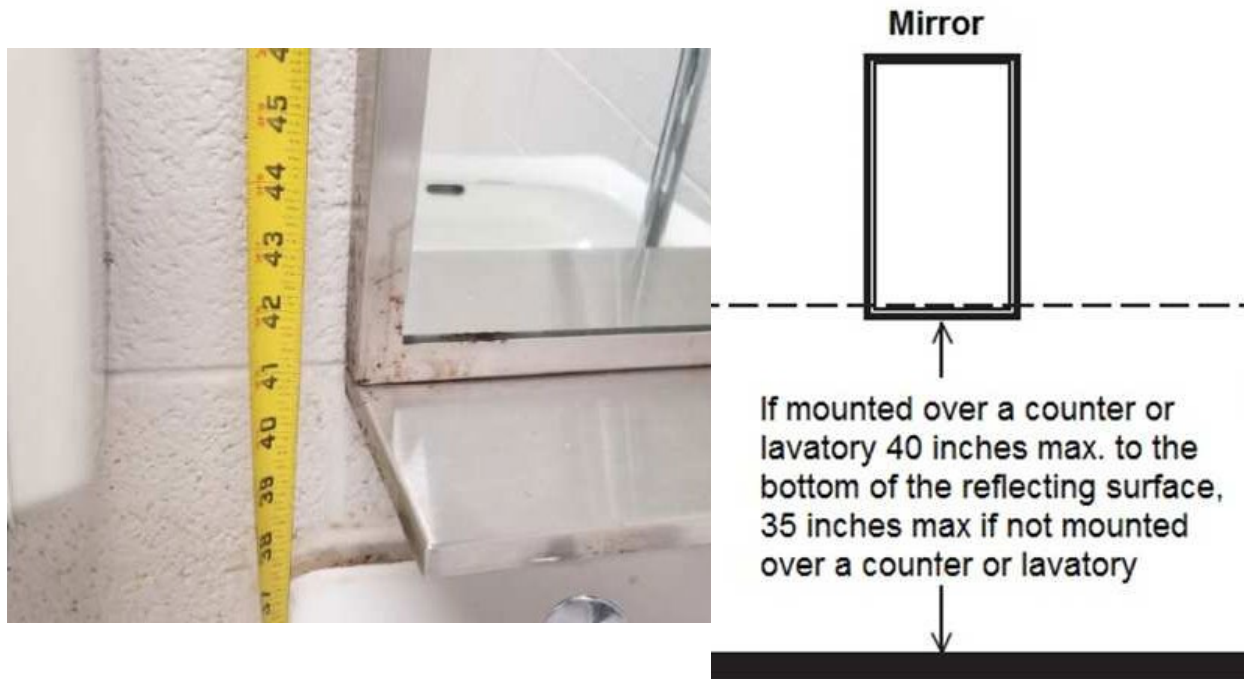
As Built: The mirror is mounted at 41.5" to reflecting surface, which is too high. Mirrors must have the bottom edge of the reflecting surface a maximum of 40 inches above the floor if above a sink or counter. Mirrors not located above lavatories or countertops shall be installed with the bottom edge of the reflecting surface 35 inches maximum above the finish floor or ground.

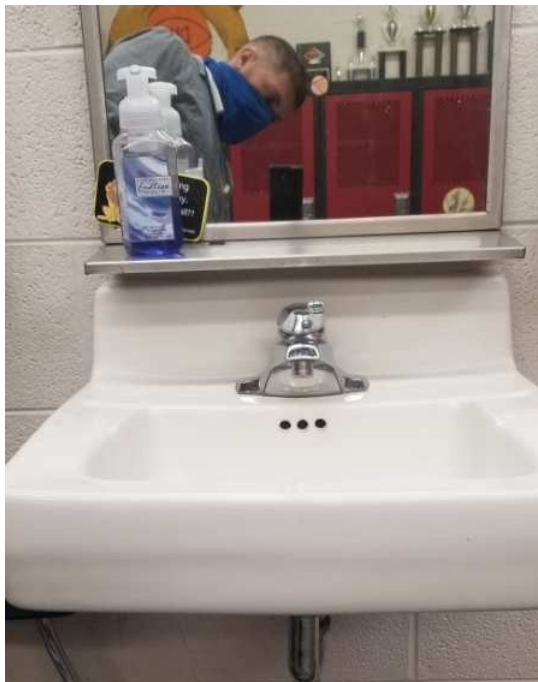
As Built: The water and drain pipes under the lavatory are not adequately insulated.

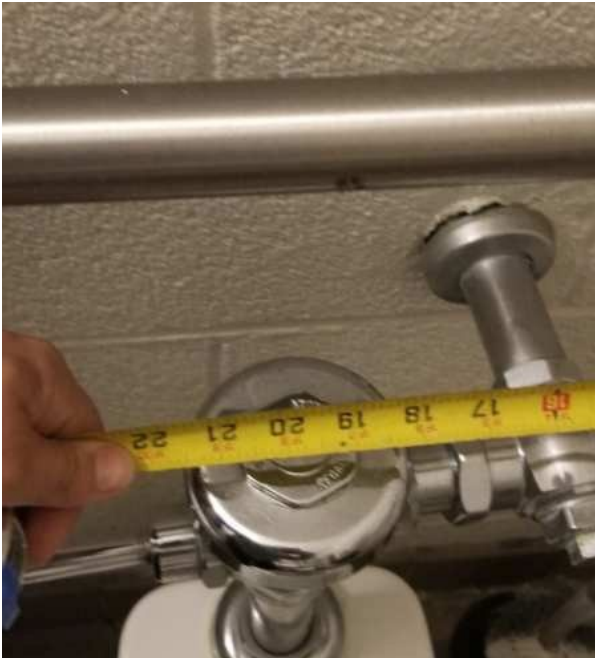
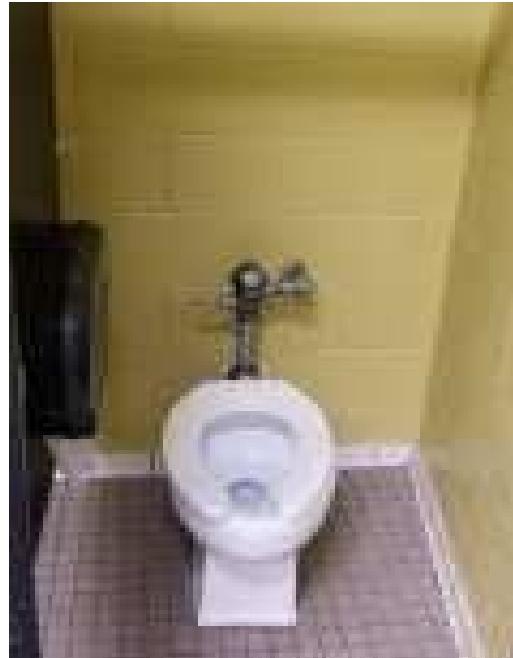
As Built: The toilet is 20" from the wall which is not located within the range allowed from the side wall or partition. The centerline of the toilet must be 16 to 18 inches from the side wall.

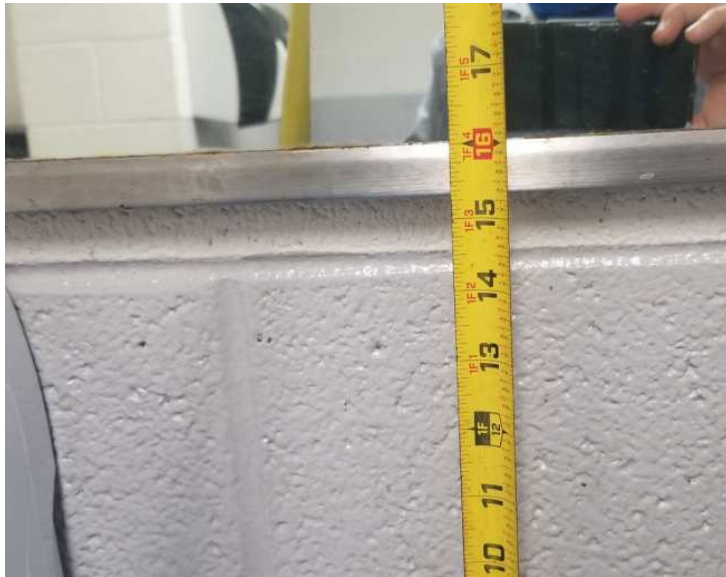
As Built: The mirror is mounted at 52" AFF which is too high.

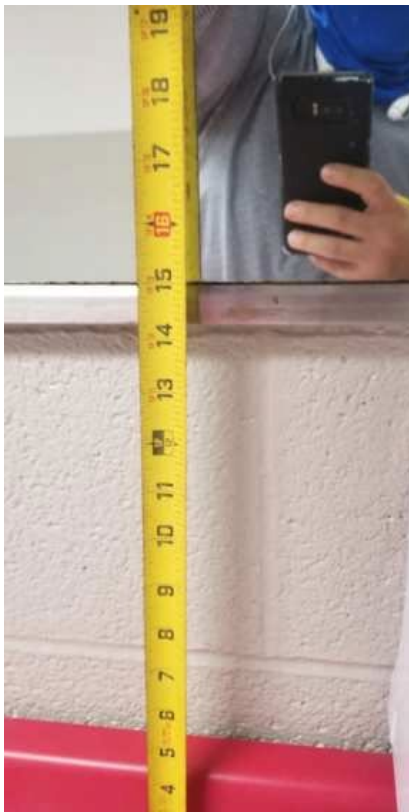
As Built: The mirror is mounted at 51" AFF which is too high.

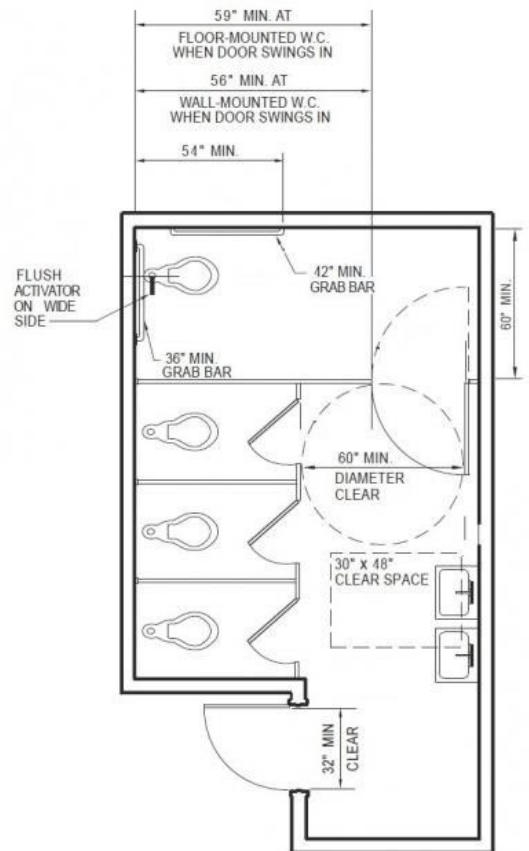
As Built: Compartment door on wrong side, Flush handle on wrong side, side grab bar at 55.5" from wall. The stall does not have the required minimum clear floor space or maneuvering clearances for the toilet. Grab bars are missing and/or incorrectly installed, accessories, such as toilet seat covers, toilet paper holders, and garbage cans are either too high, without clear floor space or both.

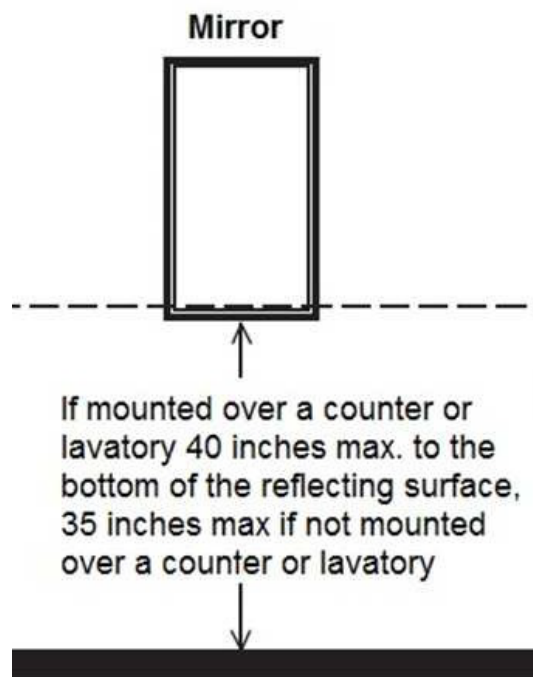
As Built: The mirror is mounted at 51" AFF which is too high.

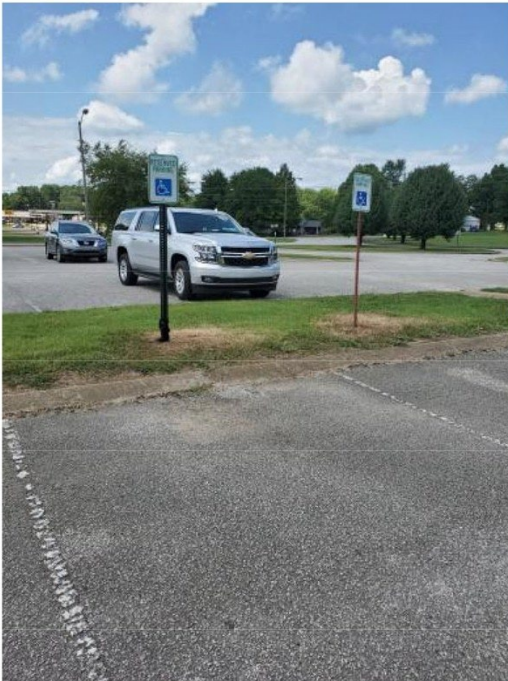
As Built: The parking sign is mounted too low.

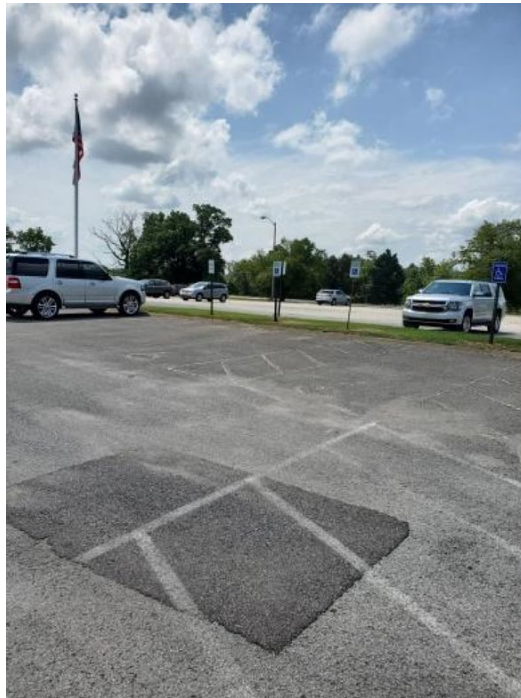
As Built: The striping and markings for the accessible parking stall, loading/unloading access aisle are dilapidated and in need of repair and/or maintenance.

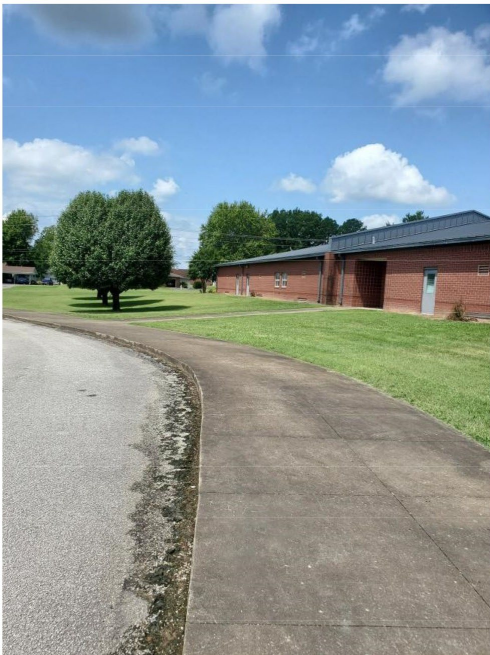
As Built: The accessible route on the site contains running slopes at 8.6% which is greater than the 5% max and has not been constructed as a ramp (i.e. handrails, wheel guides, etc.).

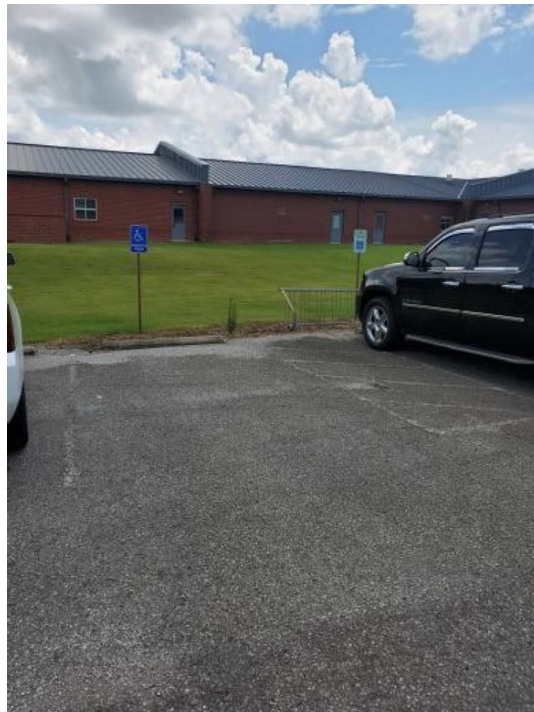
As Built: The striping and markings for the accessible parking stall, loading/unloading access aisle are dilapidated and in need of repair and/or maintenance.

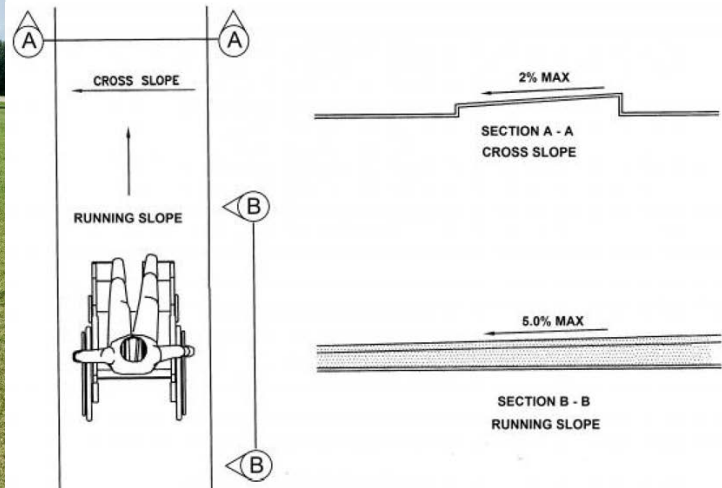
As Built: Six 5' panels of sidewalk approaching entrance exceed 2%, varies up to 2.6%.

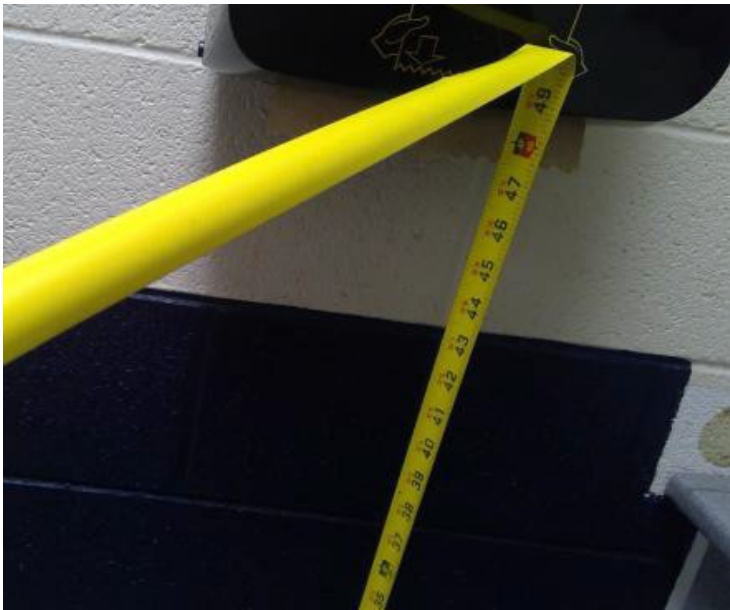
As Built: The paper towel dispenser is not positioned correctly for either a side or front approach.

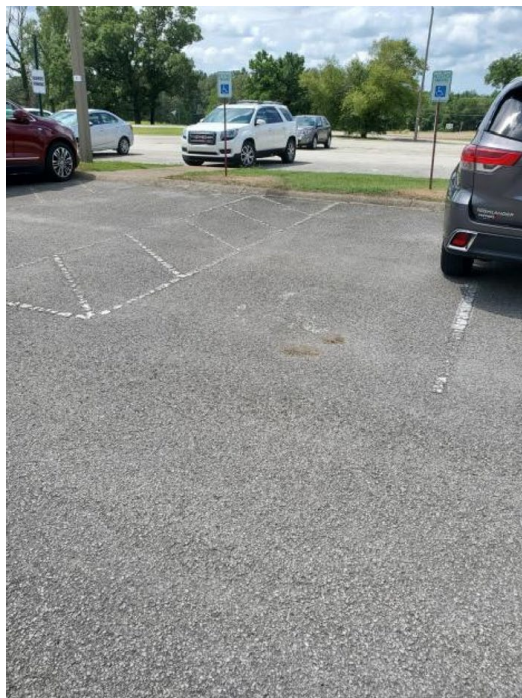
As Built: The striping and markings for the accessible parking stall, loading/unloading access aisle are dilapidated and in need of repair and/or maintenance. Spaces are compliant.

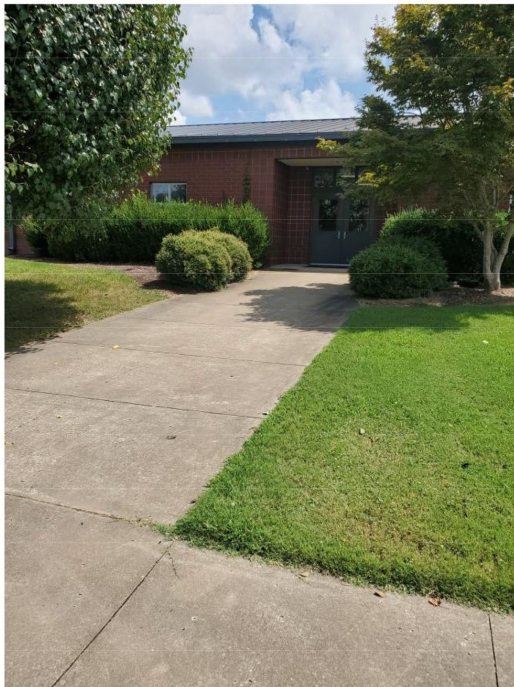
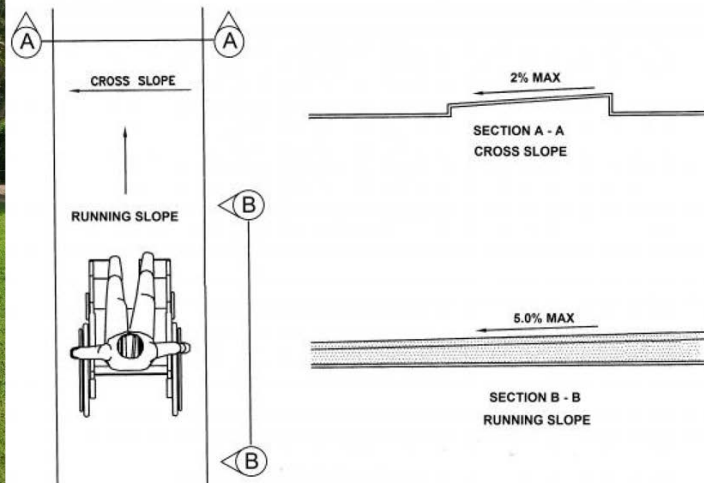
As Built: The accessible route on the site contains running slopes greater than 5% and has not been constructed as a ramp (i.e. handrails, wheel guides, etc.).

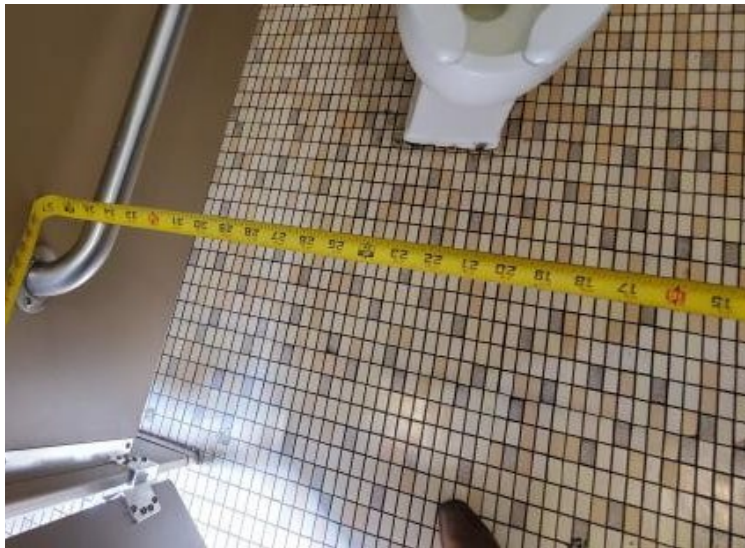
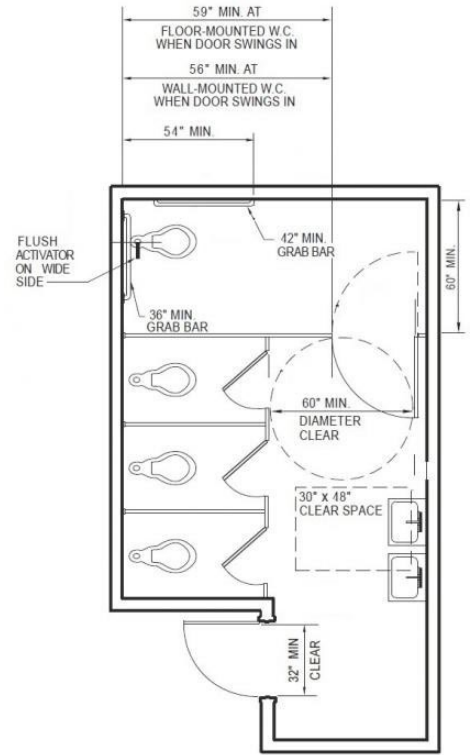
As Built: The toilet compartment does not have the required minimum clear floor space or maneuvering clearances for the toilet.

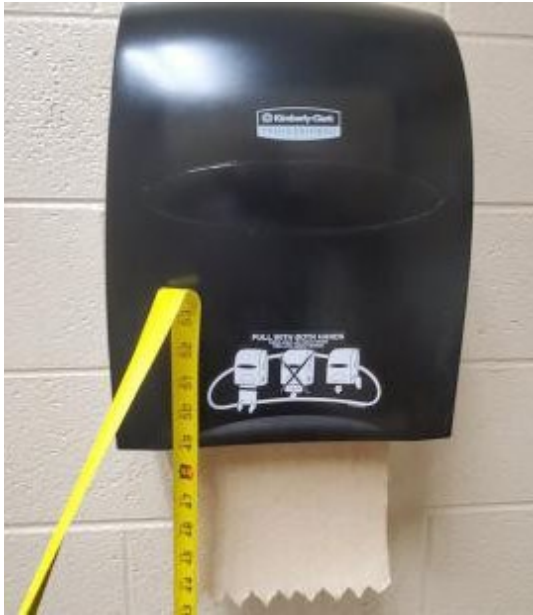
As Built: The paper towel dispenser is not positioned correctly for either a side or front approach.

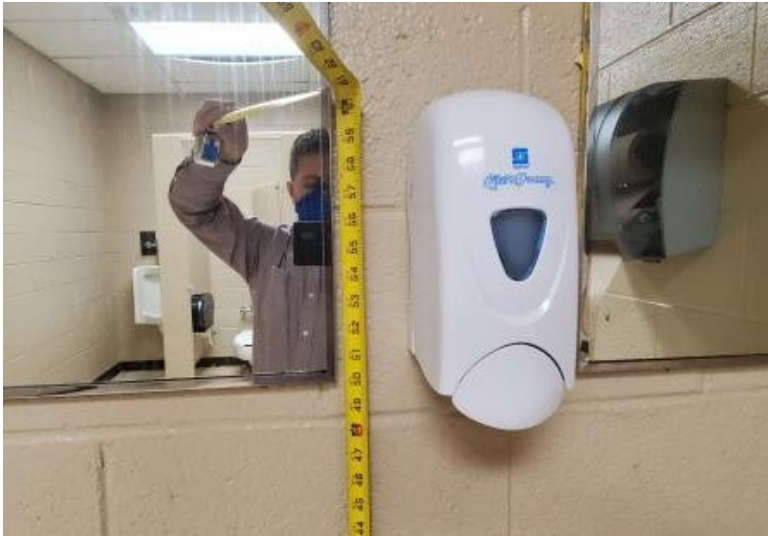
As Built: The soap dispenser is not positioned correctly for either a side or front approach.

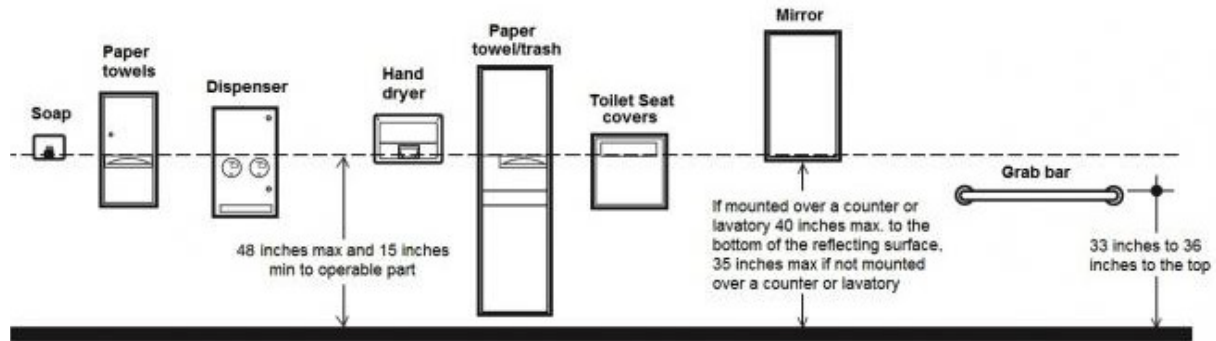
As Built: The paper towel dispenser's operation mechanism is too high off the floor. Dispensers must have all operable parts a maximum of 48 inches above the floor.

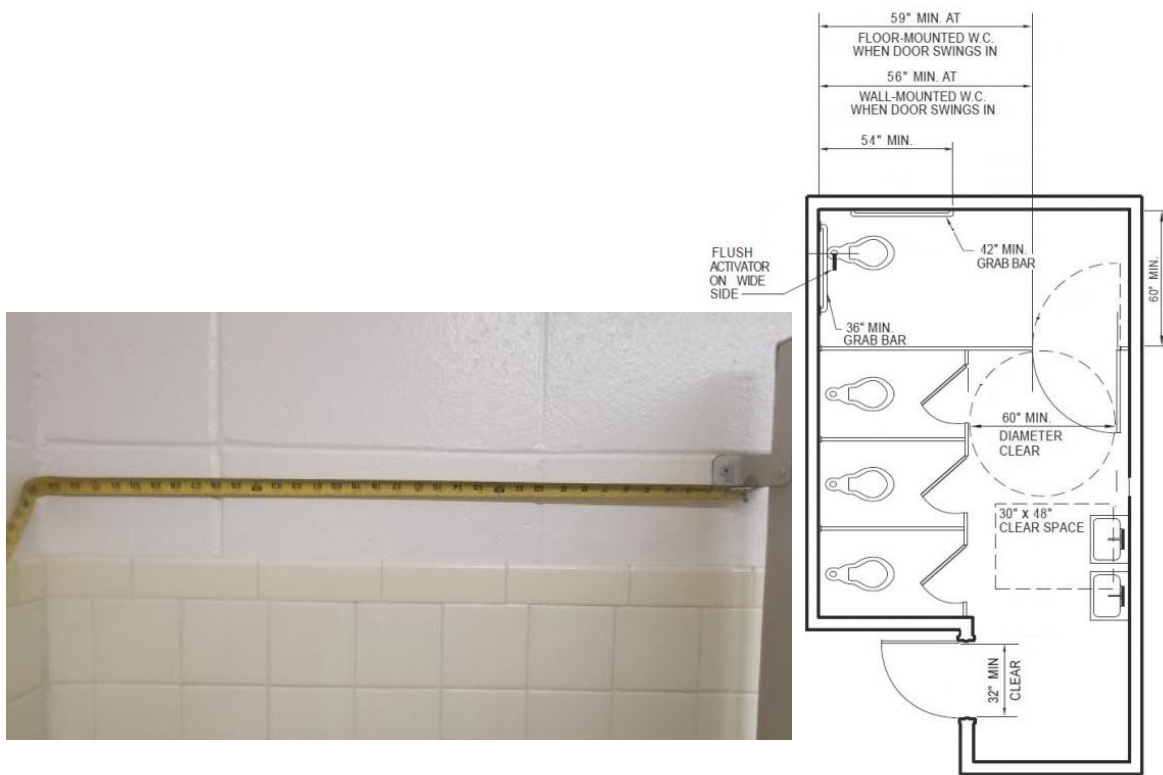
As Built: The toilet compartment does not have the required minimum clear floor space or maneuvering clearances for the toilet. The toilet compartment does not meet required minimum width and depth dimensions. Grab bars are missing. Toilet flush handle is on wrong side.

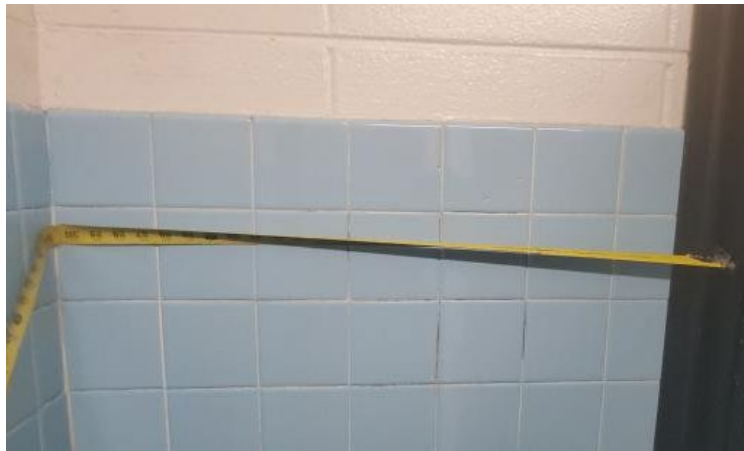
As Built: The toilet compartment does not have the required minimum clear floor space or maneuvering clearances for the toilet. The toilet compartment does not meet required minimum width and depth dimensions. Grab bars are missing. Toilet flush handle is on wrong side.

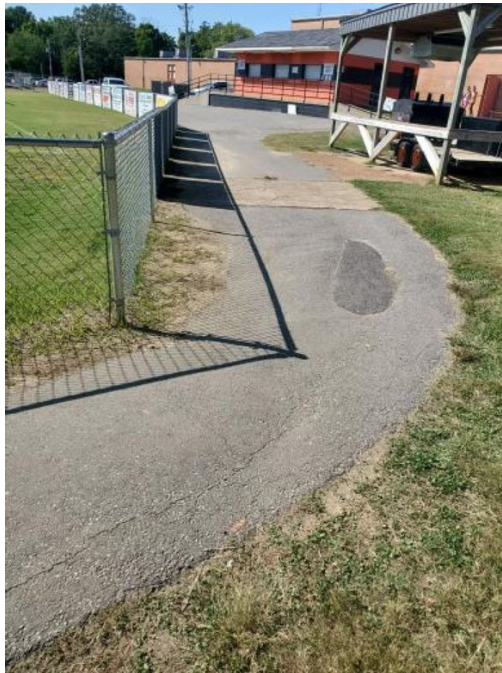
As Built: There is excessive cracking and settling with patched, mounded asphalt.

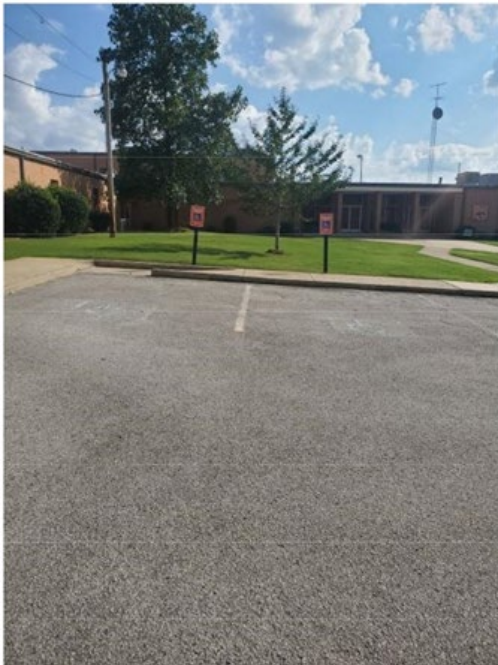
As Built: There are two spaces provided with no access aisles.

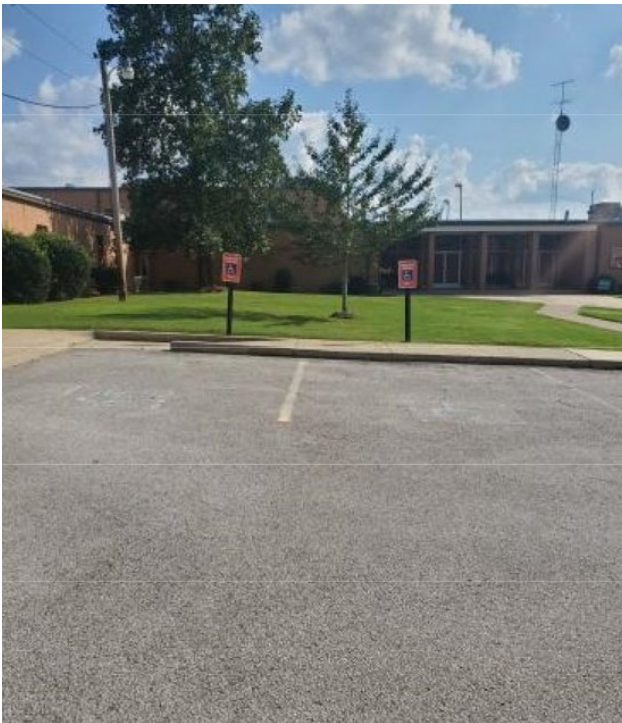
As Built: The parking sign is mounted too low.

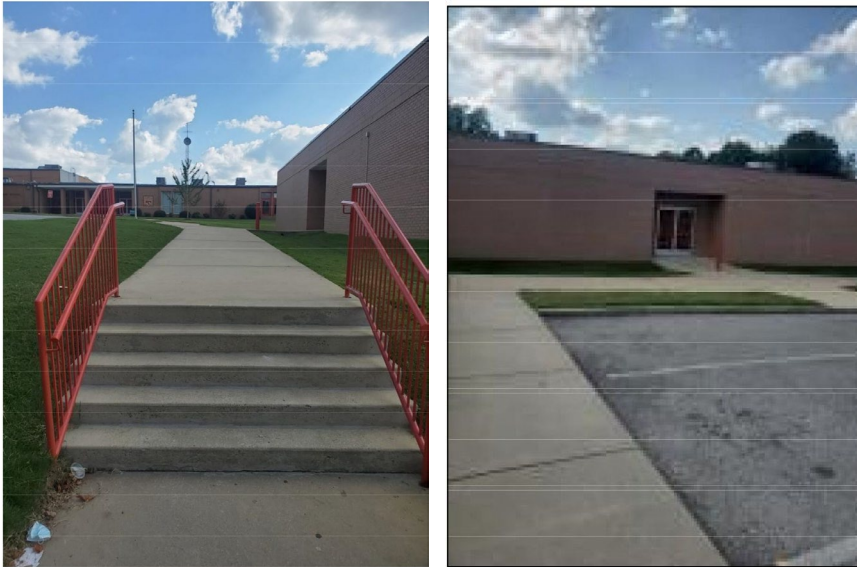
As Built: From the steps at street crossing to the side entrance of the high school to flagpole, running slope exceeds 5% and cross slope exceeds 2% on various panels. The grade of the pedestrian access route is too steep.

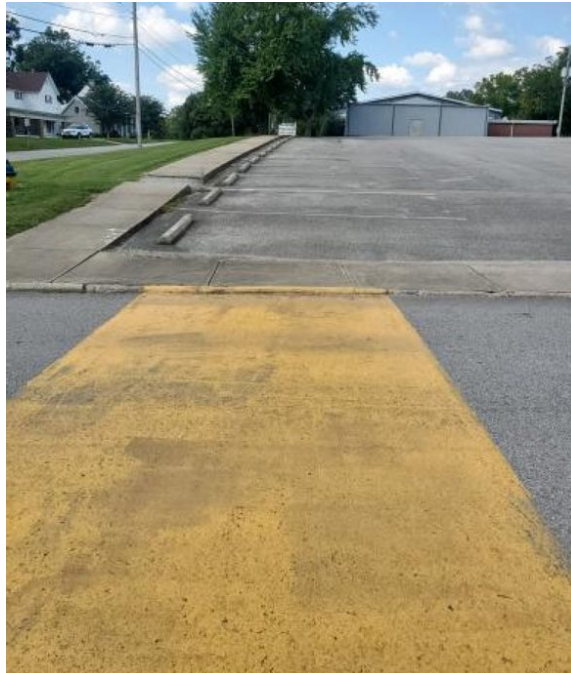
As Built: There is no pedestrian access route at the street crossing.

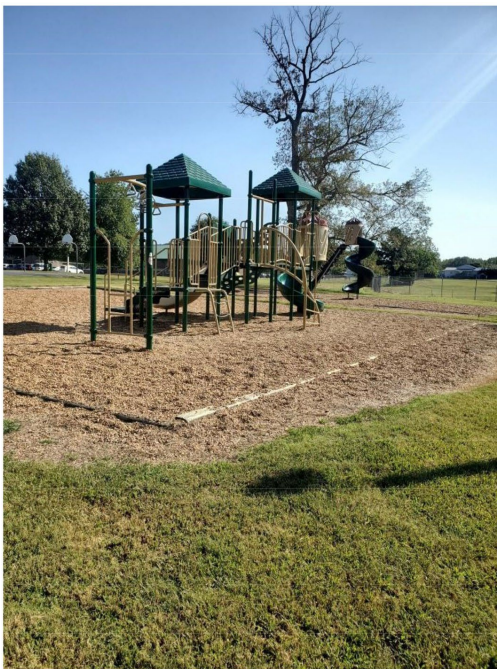
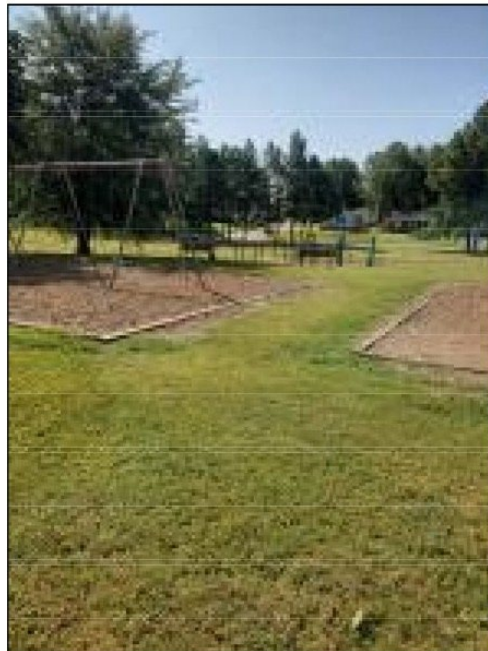
As Built: All playground components are inside wood borders filled with pea gravel. No route between components, benches, etc. No ground level play components. The ground level play component(s) are not on an accessible route.

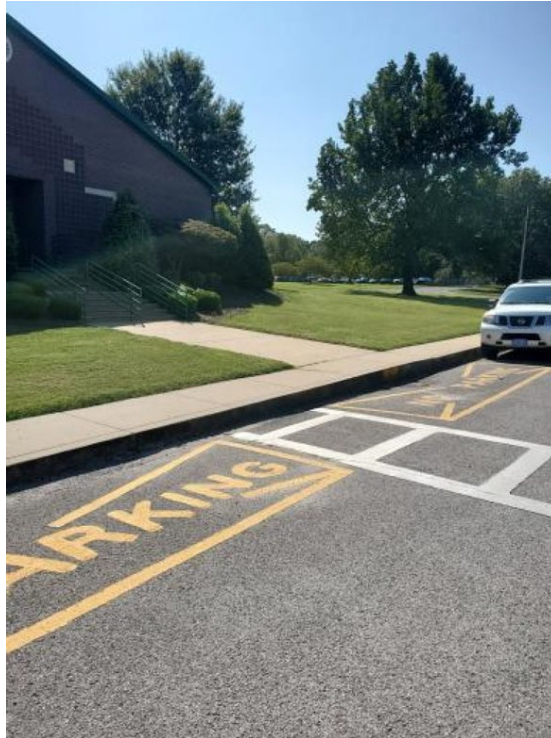
As Built: There is no pedestrian access route at the street crossing.

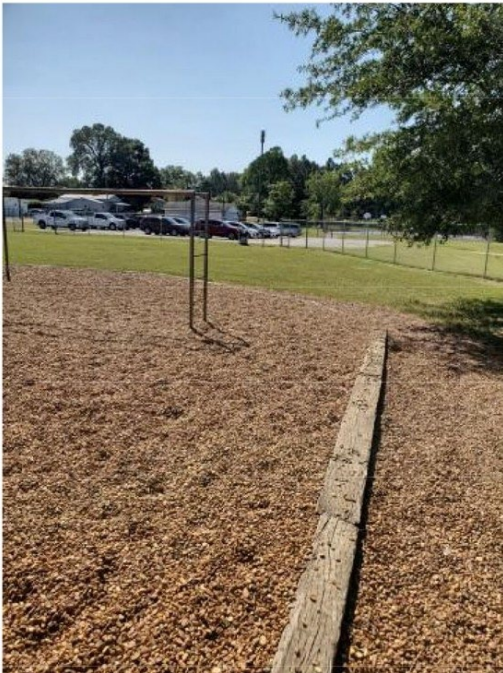
As Built: All playground equipment is enclosed in a pea gravel filled wooden box that is elevated with no ramp entry.

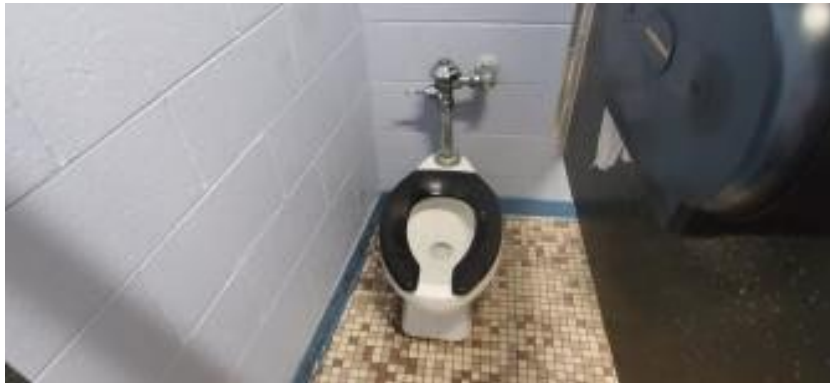
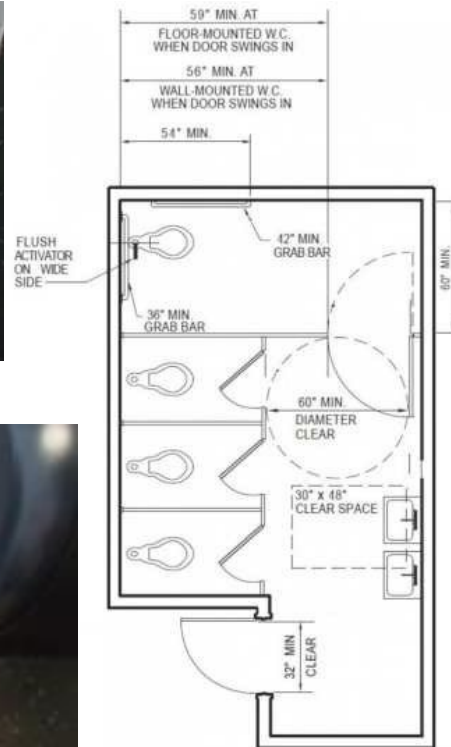
As Built: The toilet compartment does not have the required minimum clear floor space or maneuvering clearances for the toilet. The toilet flush handle is on wrong side. Toilet not within 16-18" from wall. No Grab bars are installed.

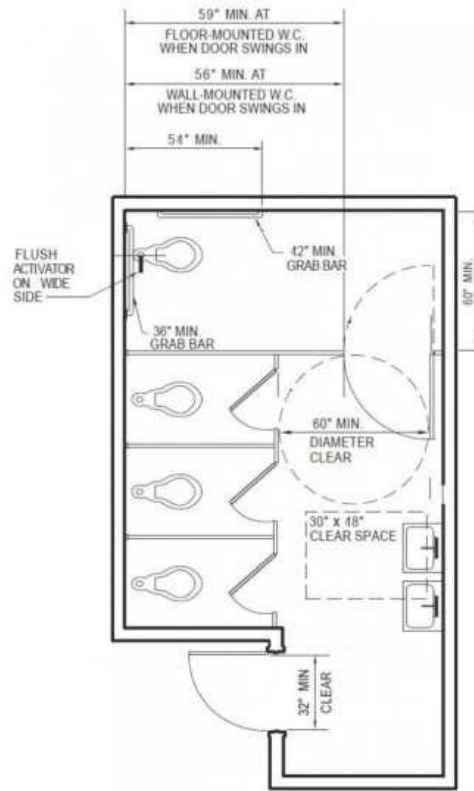
As Built: The toilet compartment does not have the required minimum clear floor space or maneuvering clearances for the toilet. The toilet flush handle is on wrong side. Toilet not within 16-18" from wall. No grab bars are installed.

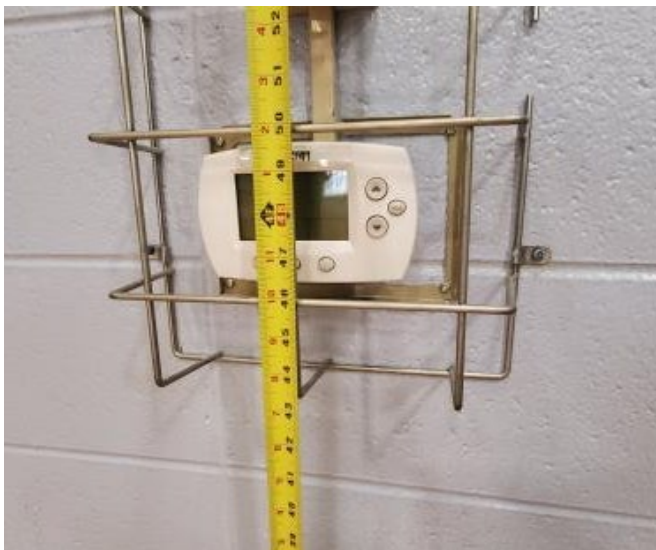
As Built: The thermostat is not positioned correctly for either a side or front approach.

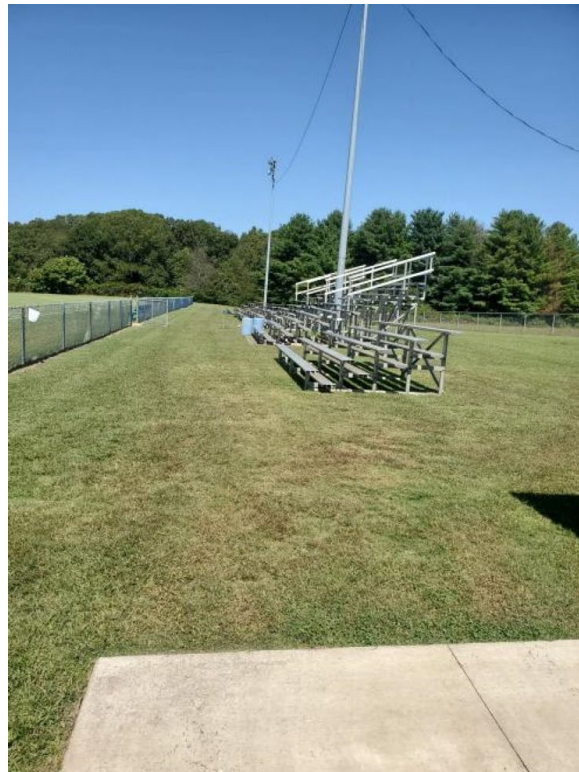
As Built: The outdoor seating area is not on an accessible route.

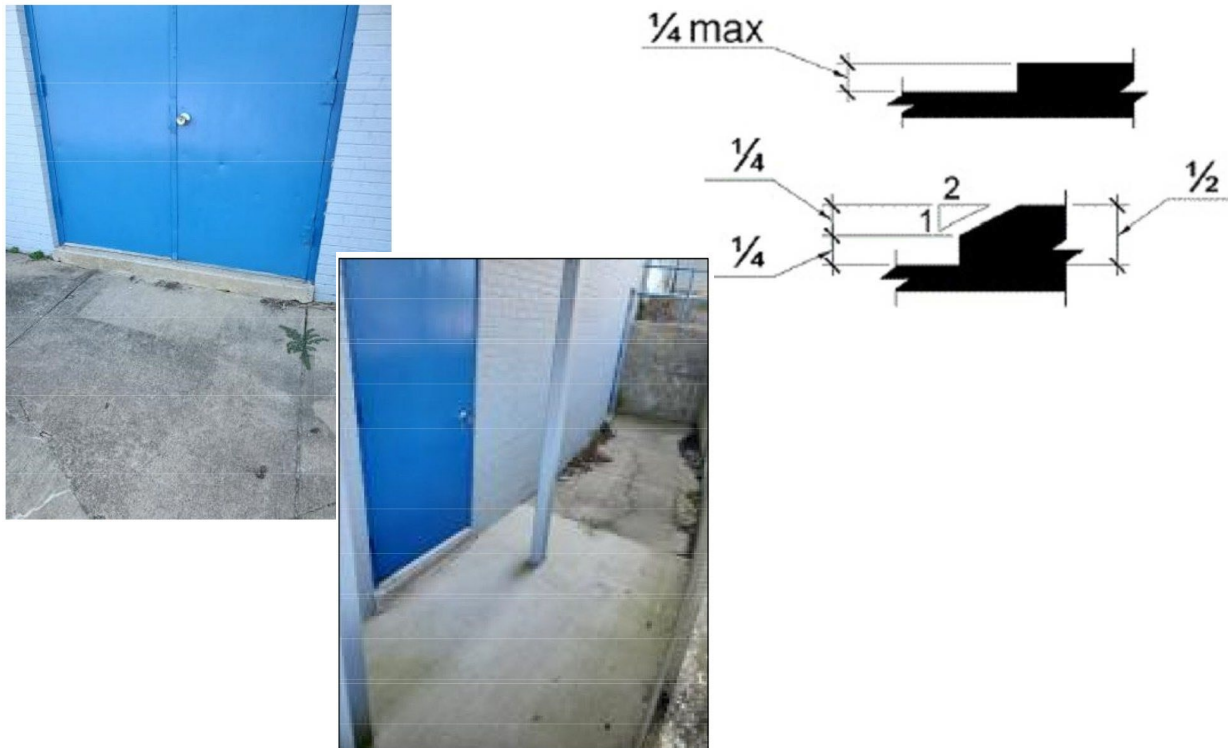
As Built: Most exterior doors have a step down to the sidewalk. It appears all classroom exterior doors as well as other areas are not accessible.

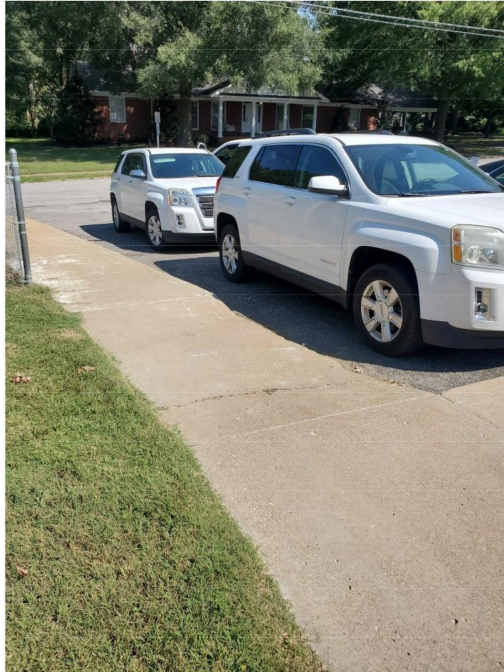
As Built: Vehicles block the curb ramp. The ramp flares exceed 10%. No turn radius is provided. Flare is cracked with vertical discontinuity greater than 1/4".

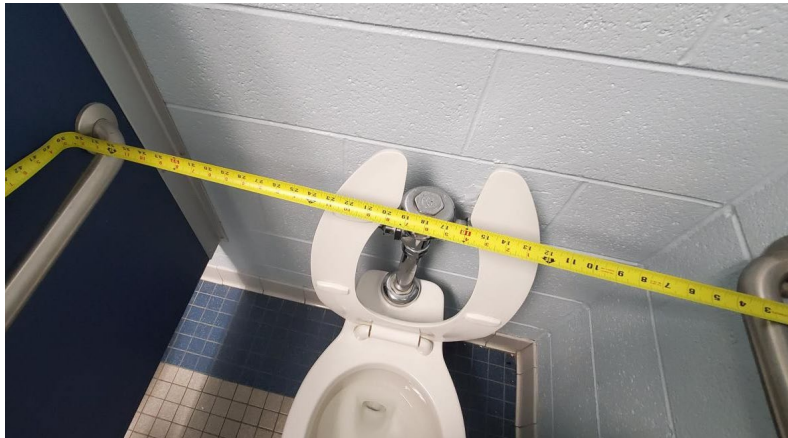
As Built: The toilet compartment does not have the required minimum clear floor space or maneuvering clearances for the toilet. Side grab bar installed incorrectly and rear grab bar missing.

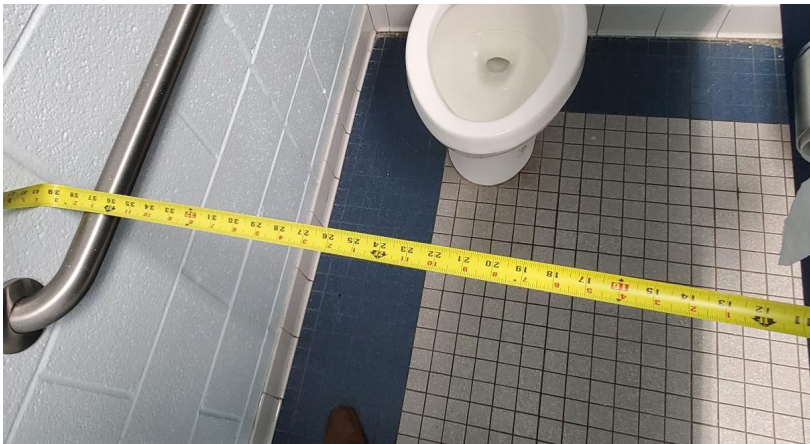
As Built: The toilet compartment does not have the required minimum clear floor space or maneuvering clearances for the toilet. Side grab bar installed incorrectly and rear grab bar missing.
