WEAKLEY COUNTY, TENNESSEE

ADA EVALUATION

Architectural and Site Findings with Recommendations

TLM Associates, Inc

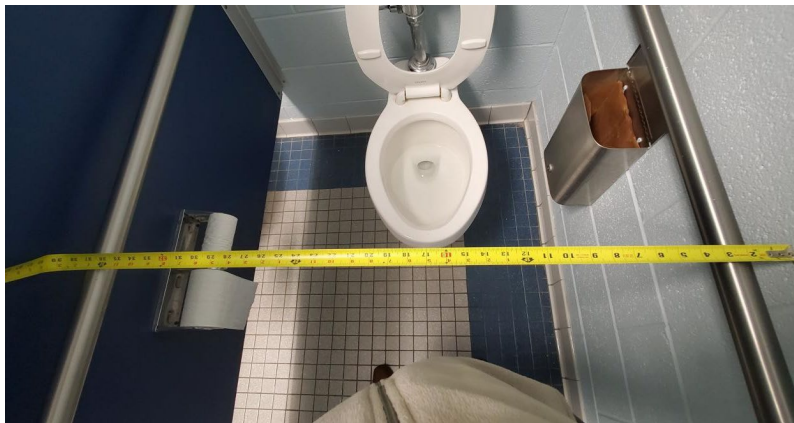
As Built: The toilet compartment does not have the required minimum clear floor space or maneuvering clearances for the toilet. Side grab bar installed incorrectly and rear grab bar missing.

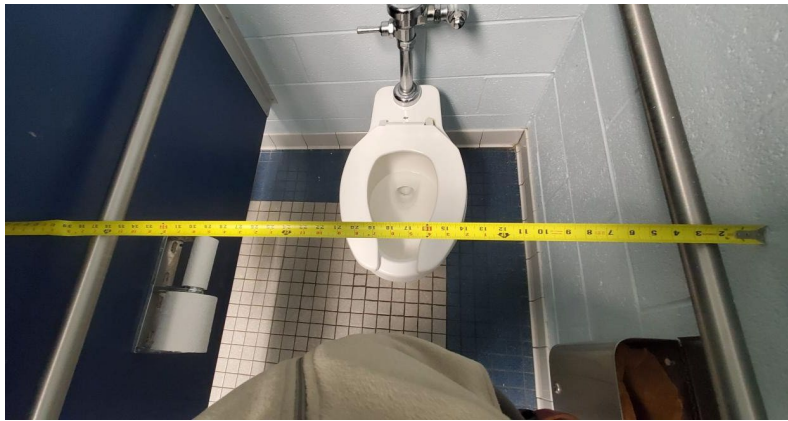
As Built: The toilet compartment does not have the required minimum clear floor space or maneuvering clearances for the toilet. Side grab bar installed incorrectly and rear grab bar missing.

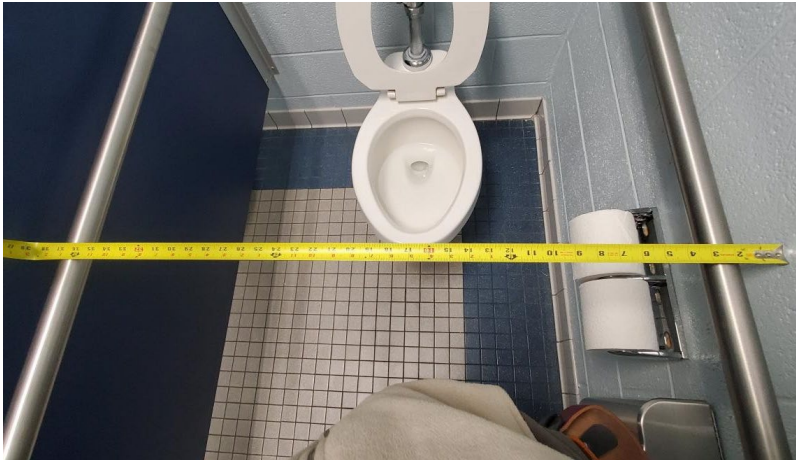
As Built: The toilet compartment does not have the required minimum clear floor space or maneuvering clearances for the toilet. Side grab bar installed incorrectly and rear grab bar missing.

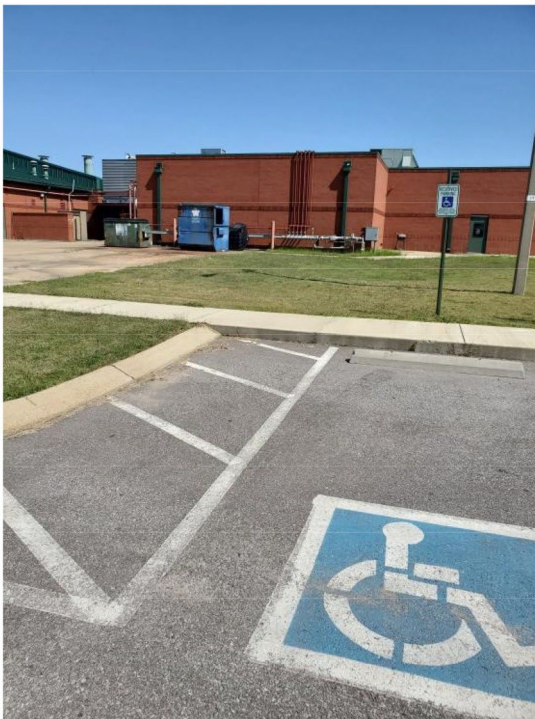
As Built: The access aisle contains abrupt edges and surface irregularities over a 1/4 inch.

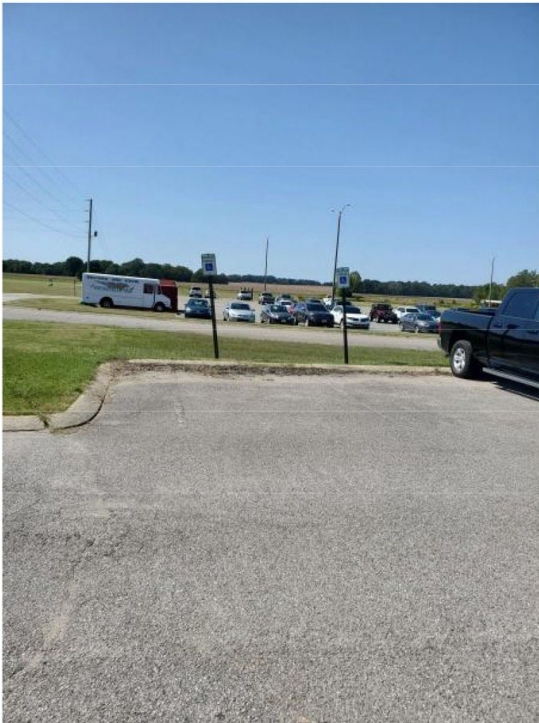
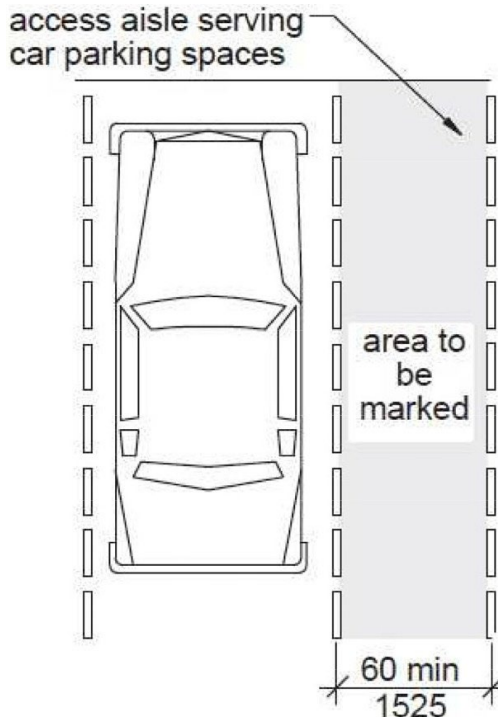
As Built: There are 4 signed spaces, 2 on one row, across from entrance and 2 two rows over. The access aisle is missing at the accessible parking stall.

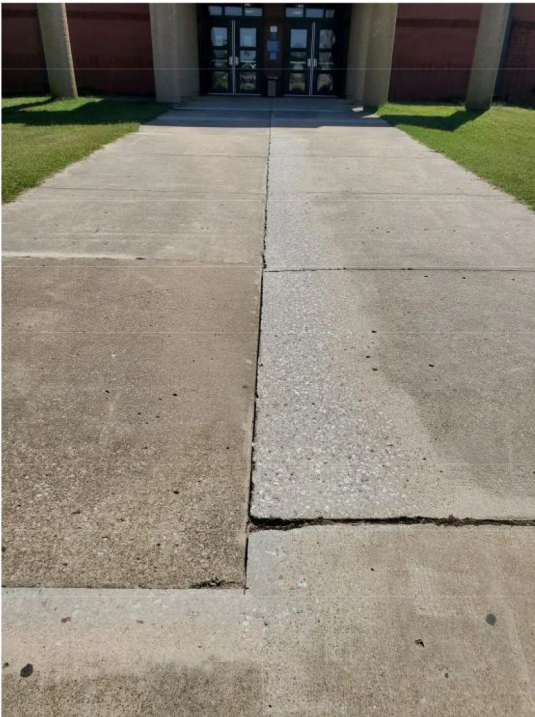
As Built: The surface of the pedestrian access route has openings greater than 1/2 inch.

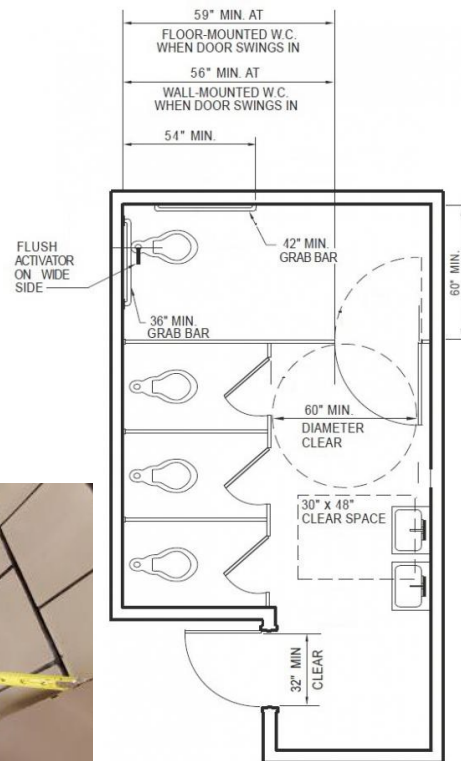
As Built: The stall does not have the required minimum clear floor space or maneuvering clearances for the toilet, grab bars are missing and/or incorrectly installed, flush handle on wrong side.

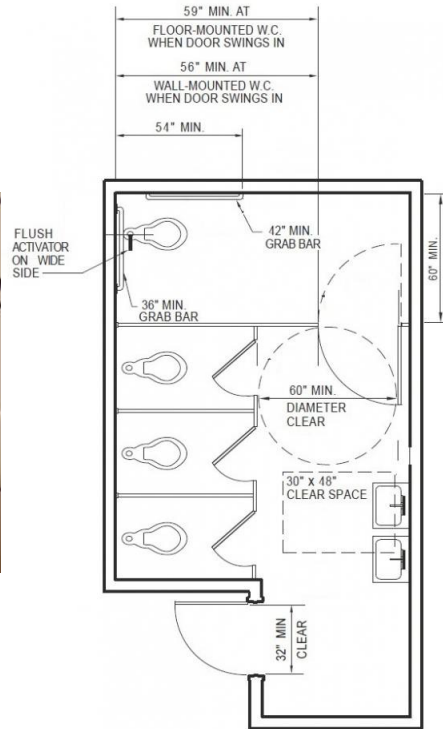
As Built: The stall does not have the required minimum clear floor space or maneuvering clearances for the toilet, grab bars are missing and/or incorrectly installed, flush handle on wrong side.

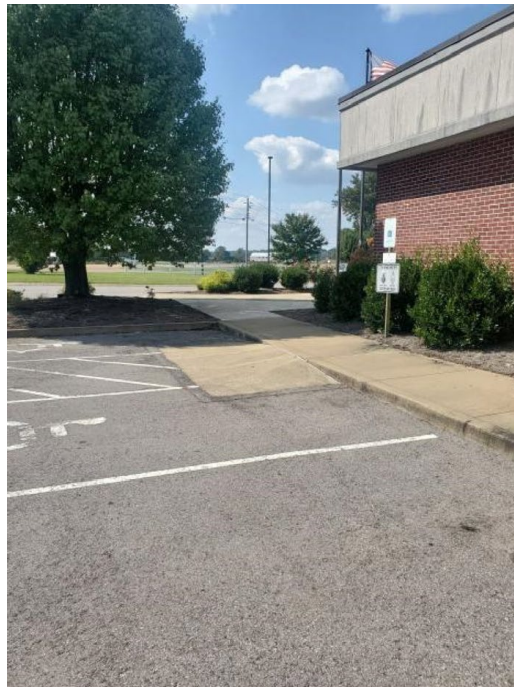
As Built: The ramp projects into a prohibited area.

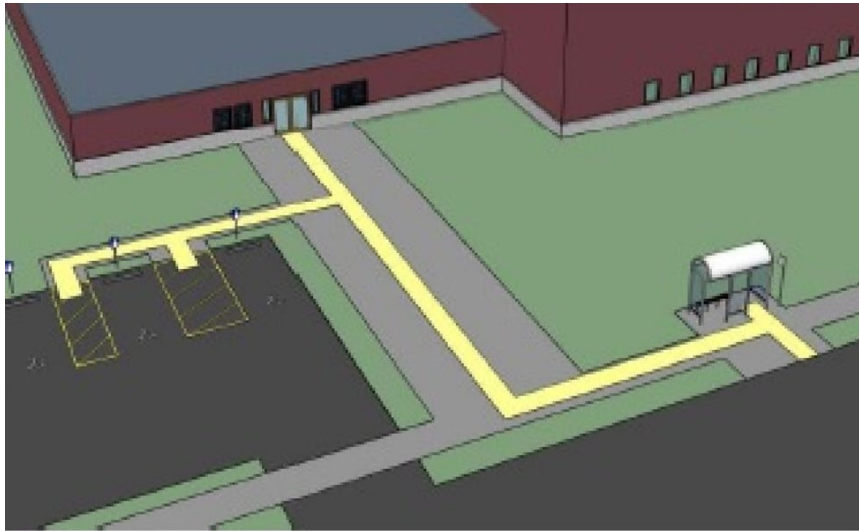
As Built: The accessible parking space is not located on the shortest accessible route to the building.

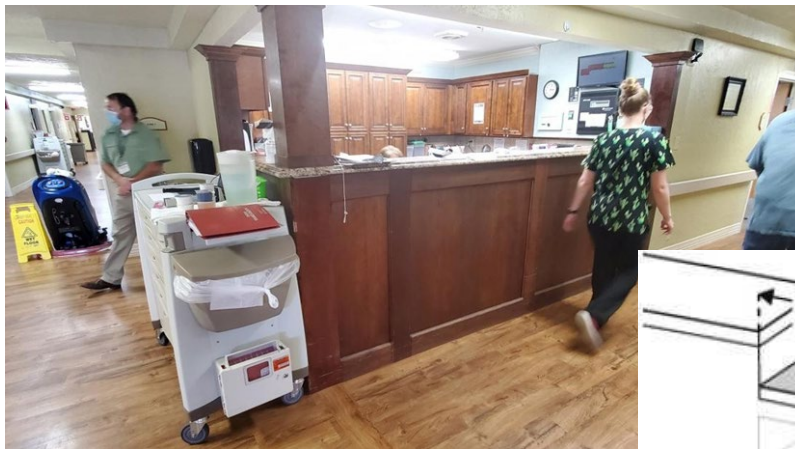
As Built: The counter is too high.

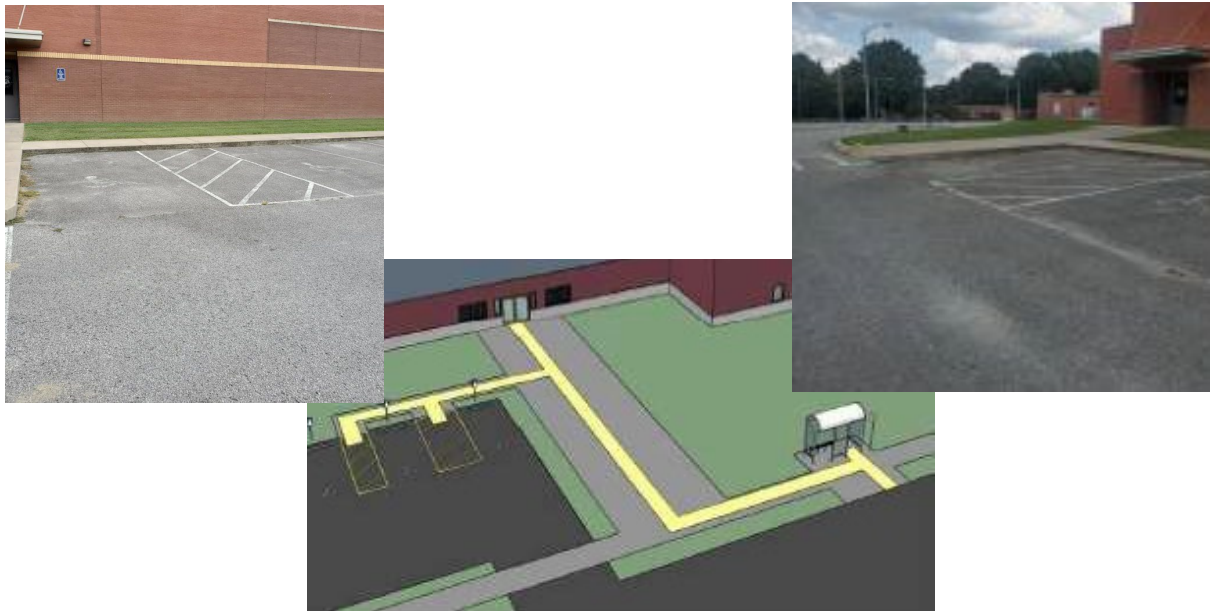
As Built: The accessible parking is not located on an accessible route of travel to the accessible building entrance. There is no curb ramp provided at access aisle. Users must get into traffic to access nearby ramp.

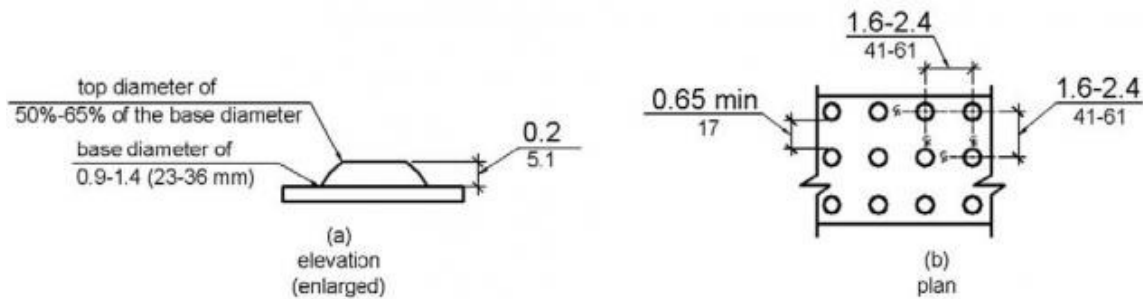
As Built: The detectable warning is missing at the curb ramp.

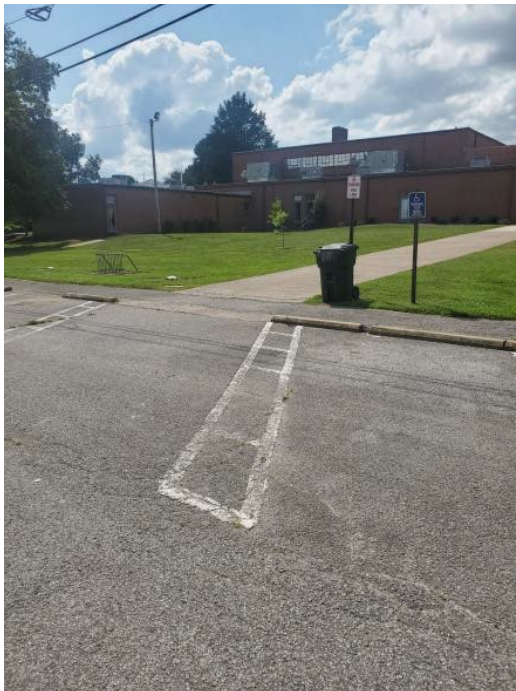
As Built: The access aisle is not a minimum of 5 feet wide.
