WEAKLEY COUNTY, TENNESSEE

ADA EVALUATION

Architectural and Site Findings with Recommendations

TLM Associates, Inc

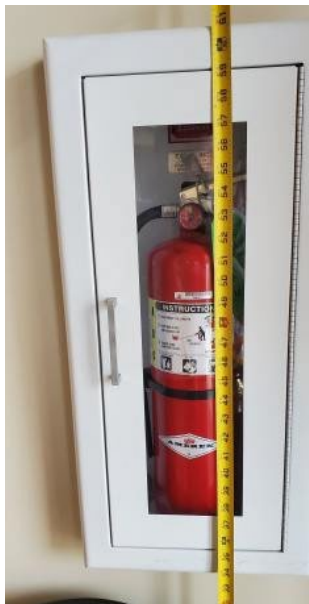
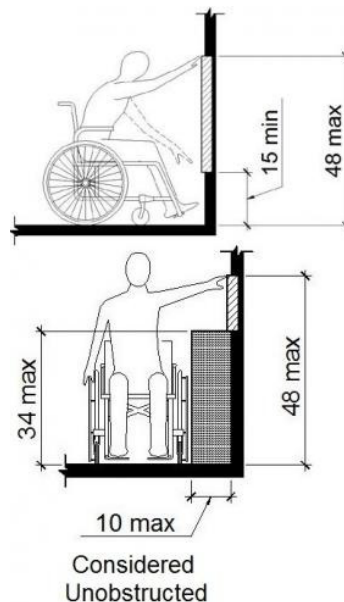
Finding: 1

As Built: The Fire Extinguisher is not positioned correctly for either a side or front approach.

Citation: 2010 ADAS Section: 308.2.1

Lower the Fire Extinguisher so the handle is at 48" max AFF.

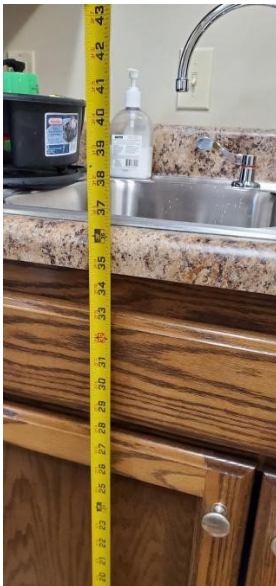
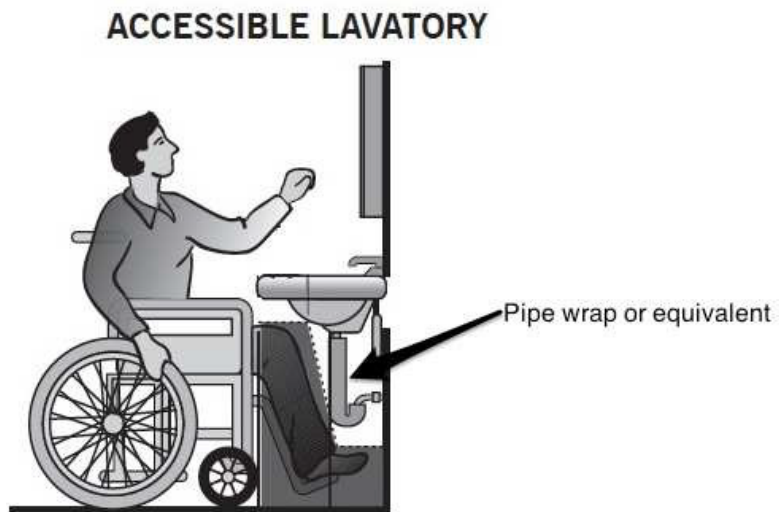
As Built: The top of the sink is 36", which is too high. Sinks that are required to be accessible shall be a minimum 17 inches in horizontal depth and mounted with the rim or counter edge no higher than 34 inches above the finished floor.

Citation: 2010 ADAS Section: 606.3

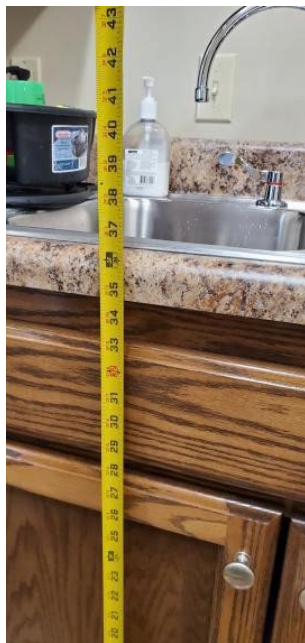
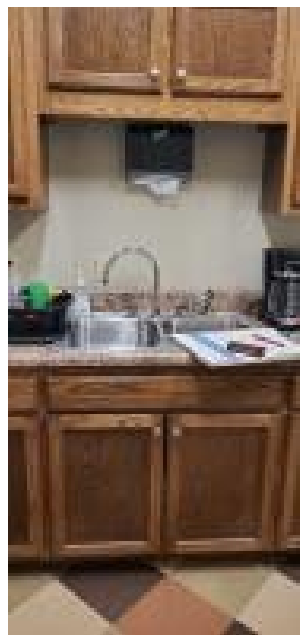
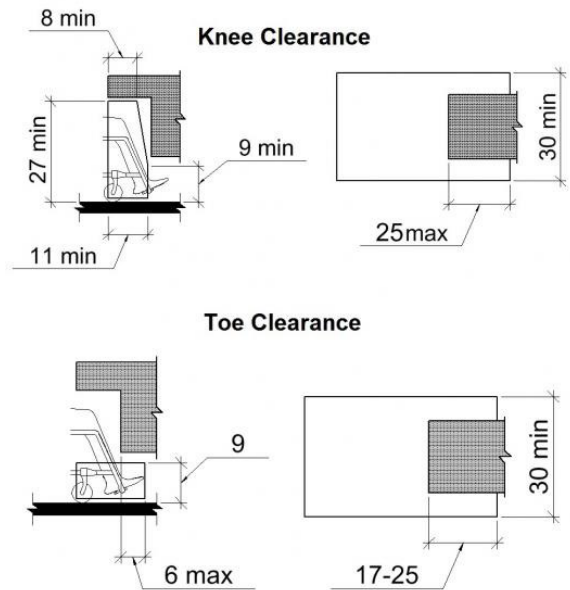
As Built: Knee and toe clearance have not been provided at the sink. The knee clearance shall be 11 inches deep minimum at 9 inches above the finish floor or ground, and 8 inches deep minimum at 27 inches above the finish floor or ground. The toe clearance is the space under the sink between the finish floor or ground and 9 inches above the finish floor 30 inches wide minimum.

Citation: 2010 ADAS Section 606.2

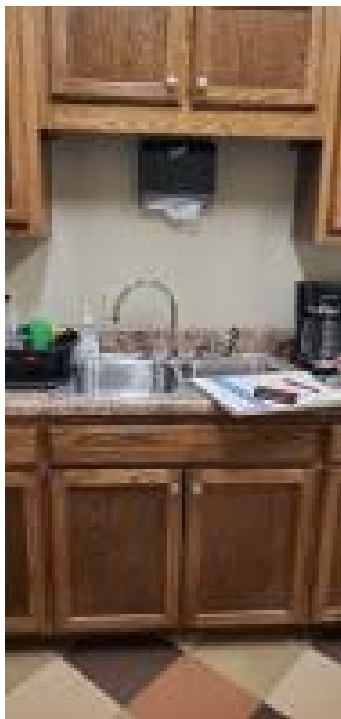
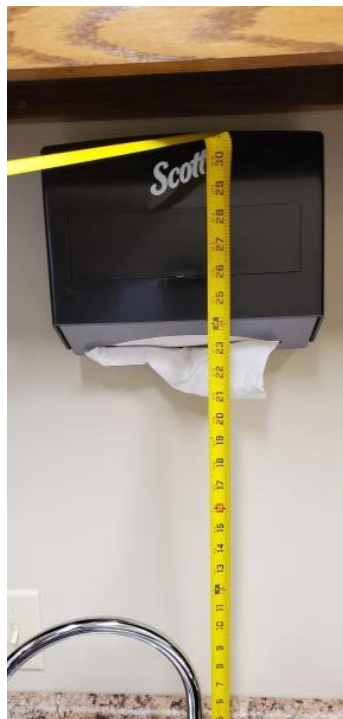
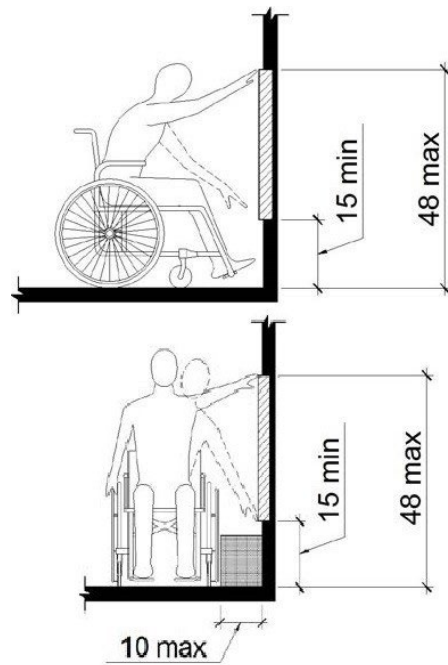
As Built: The Paper Towel is positioned 60" AFF, which is too high for either a side or front approach.

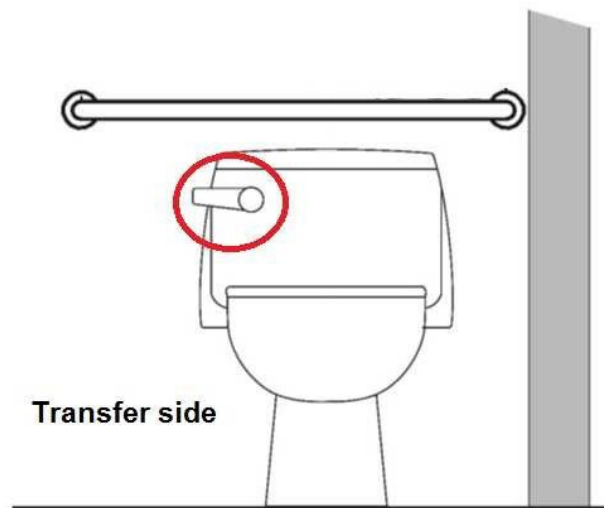
As Built: The flush handle is located on the wrong side of the toilet.

Controls shall be operable with one hand and shall not require tight grasping, pinching or twisting. Controls for the flush valves shall be mounted on the wide side of toilet areas, no more than 48 inches above the floor.

Remove and reinstall toilet hardware for handle to be on accessible side.

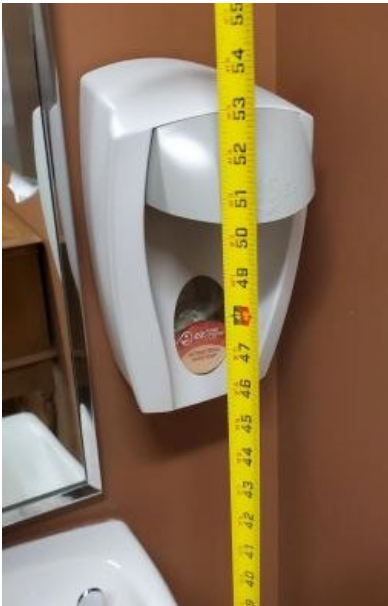
As Built: The clear floor space only allows for a forward approach and the soap dispenser is out of reach range at 51" AFF.

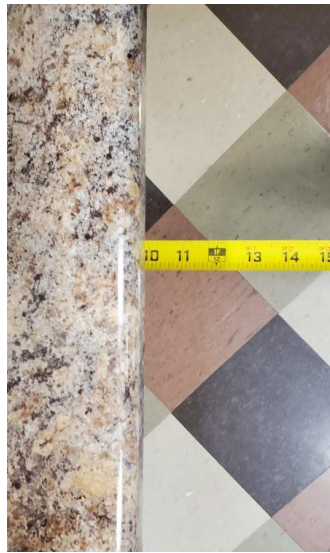
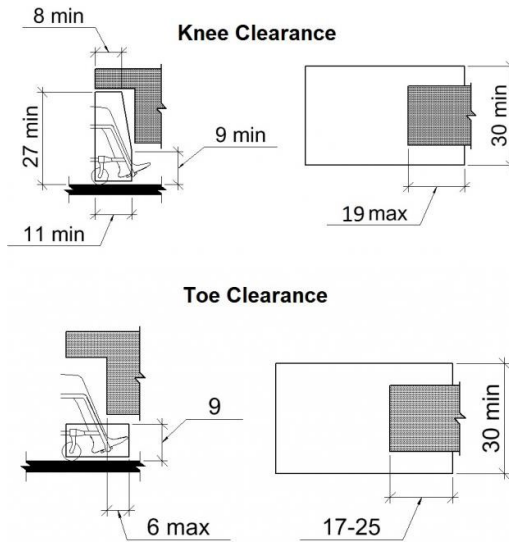
As Built: Compliant knee and/or toe space is not provided. Space under an element between the finish floor or ground and 9 inches above the finish floor or ground shall be considered toe clearance. Toe clearance shall extend 25 inches maximum and 17 inches minimum under an element. Space extending greater than 6 inches beyond the available knee clearance at 9 inches above the finish floor or ground shall not be considered toe clearance. Toe clearance shall be 30 inches wide minimum. Space under an element between 9 inches and 27 inches above the finish floor or ground shall be considered knee clearance. Knee clearance shall extend 25 inches maximum under an element at 9 inches above the finish floor or ground. Knee clearance shall be 11 inches deep minimum at 9 inches above the finish floor or ground, and 8 inches deep minimum at 27 inches above the finish floor or ground. Knee clearance shall be 30 inches wide minimum

Citation: 2010 ADAS Section 306.1

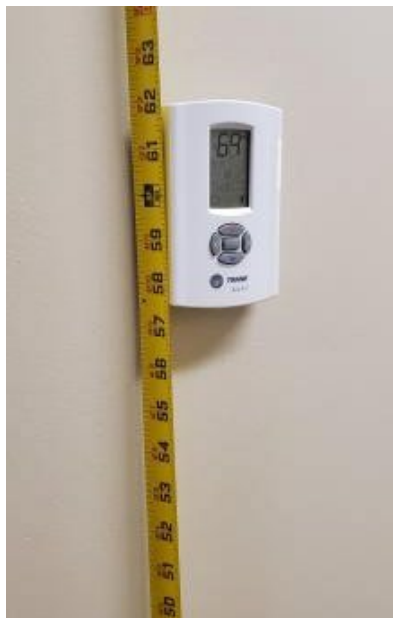
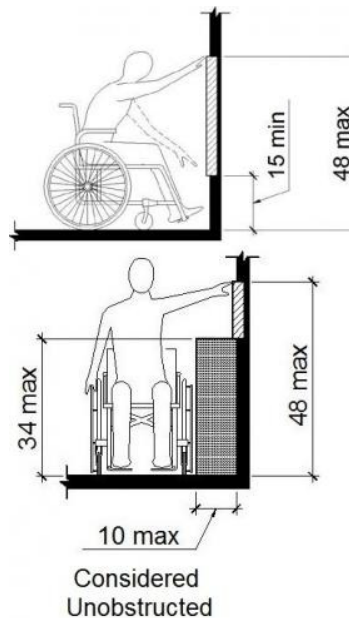
As Built: The thermostat is not positioned correctly for either a side or front approach.

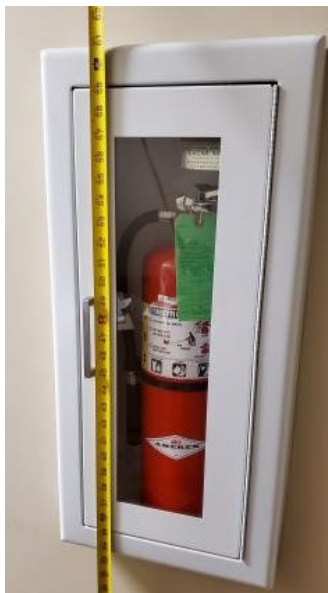
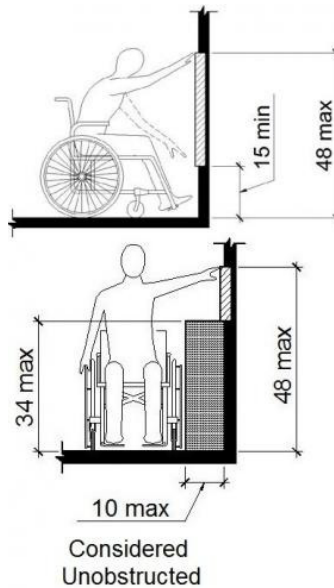
As Built: The fire extinguisher is not positioned correctly for either a side or front approach.

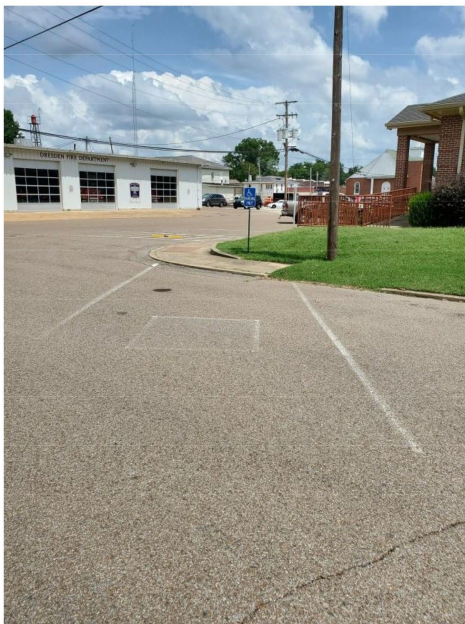
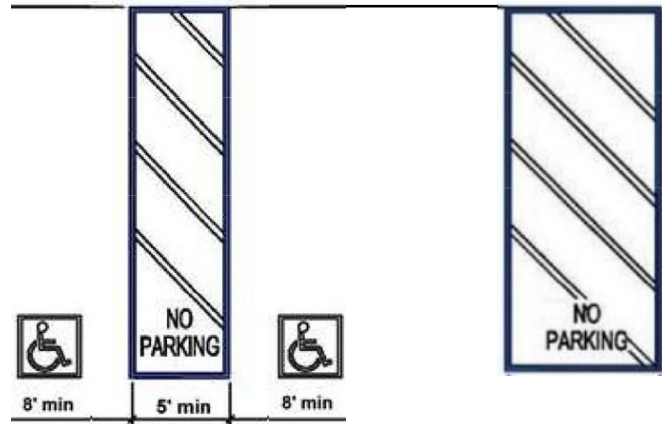
As Built: There is no access aisle at one space. The sign at this space is too short. Space is 10'-7" wide, 2.2% cross and running slope. The access aisle is missing at the accessible parking stall.

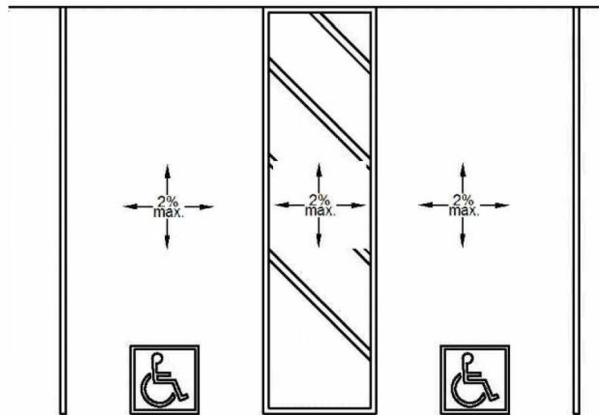
As Built: The running slope (long dimension) of the accessible parking stall varies 2.6-3%, which exceeds 2%.

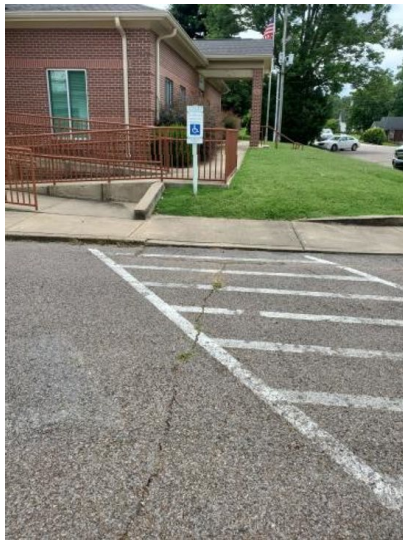
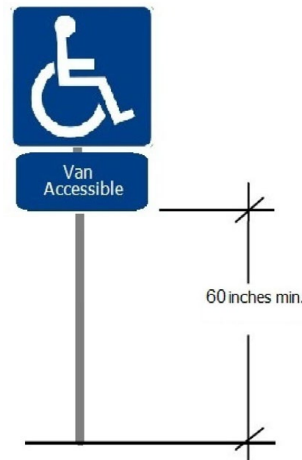
As Built: The parking sign is mounted at 4', which is too low.

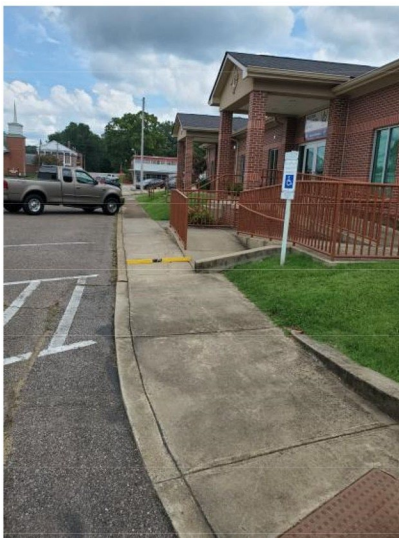
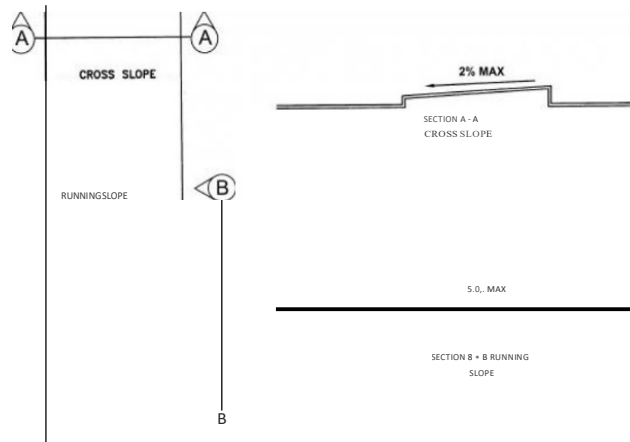
As Built: The accessible path of travel between the building entrance and the accessible parking contains cross slopes that vary up to 5.4%, which is greater than the 2% max slope.

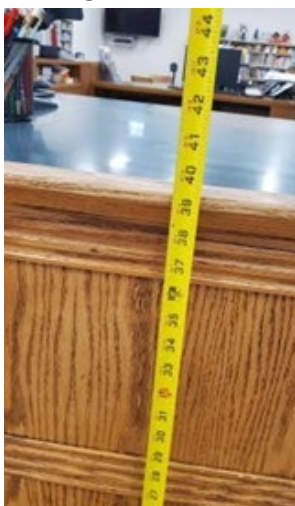
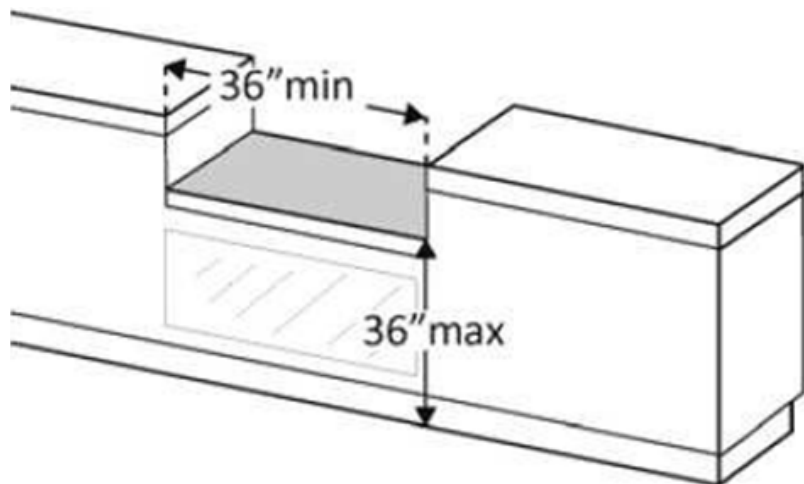
As Built: The transaction counter is too high.

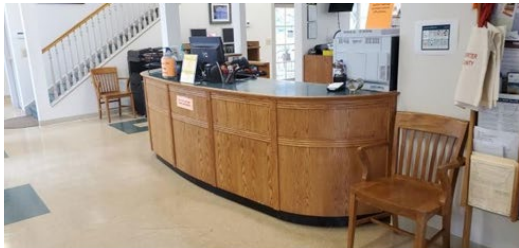
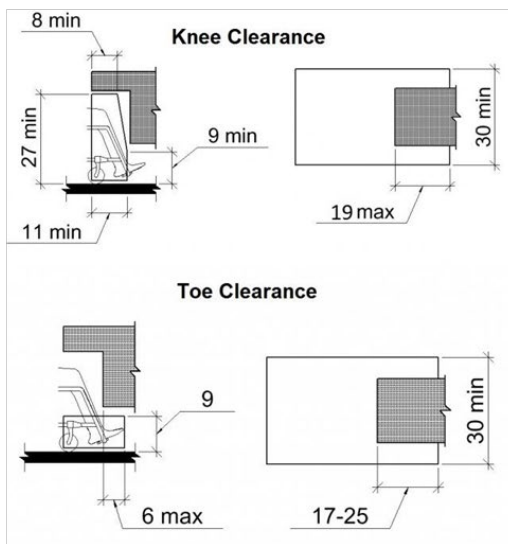
As Built: Compliant knee and/or toe space is not provided. Space under an element between the finish floor or ground and 9 inches above the finish floor or ground shall be considered toe clearance. Toe clearance shall extend 25 inches maximum and 17 inches minimum under an element. Space extending greater than 6 inches beyond the available knee clearance at 9 inches above the finish floor or ground shall not be considered toe clearance. Toe clearance shall be 30 inches wide minimum.

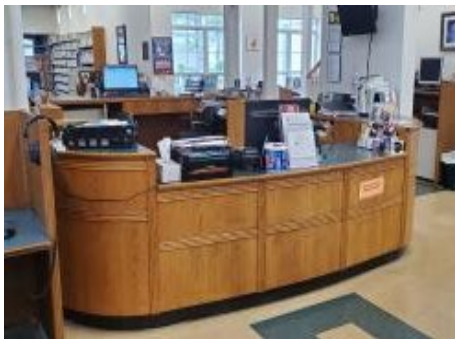
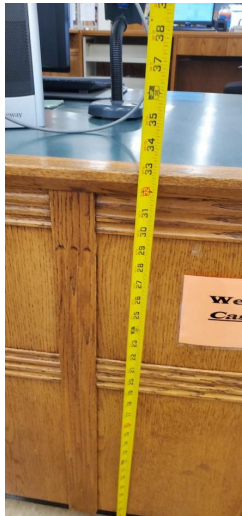
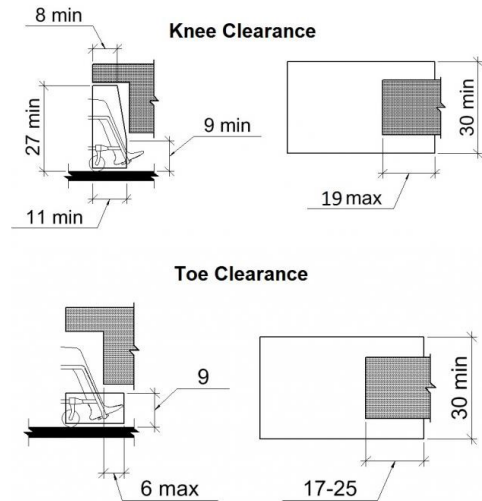
As Built: Compliant knee and/or toe space is not provided.

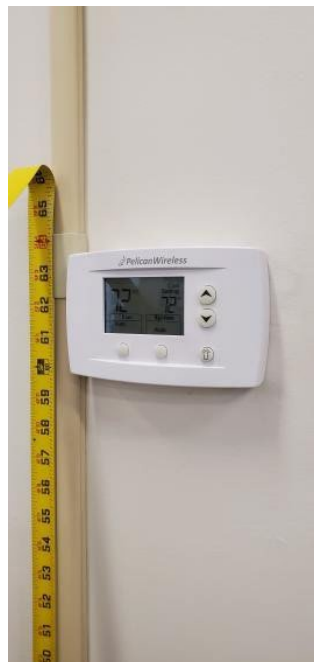
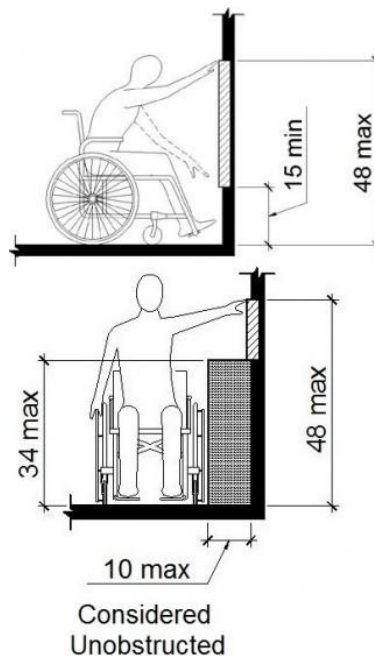
As Built: The thermostat is not positioned correctly for either a side or front approach.

Lower thermostat for all operable components to be 48" max AFF.

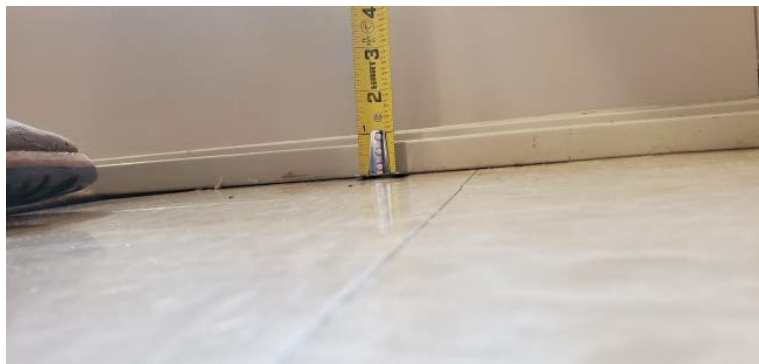
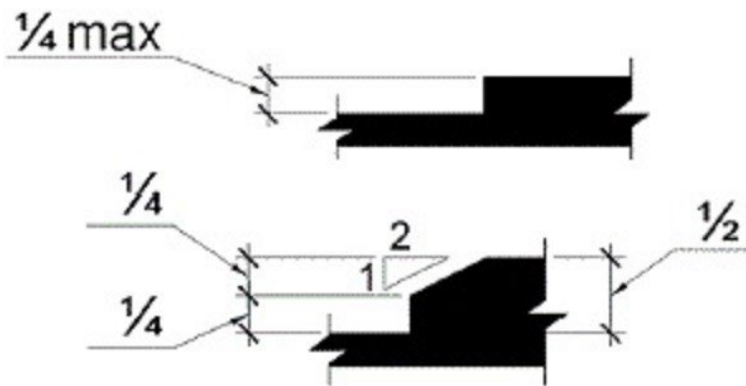
As Built: The threshold is greater than 1/2 inch high.

Citation: 2010 ADAS Section 404.2.5

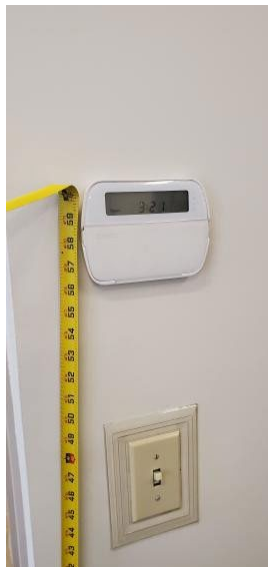
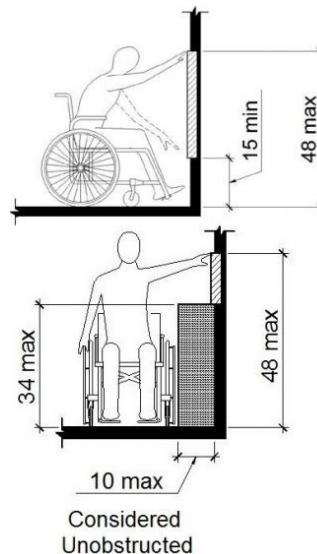
As Built: The thermostat is not positioned correctly for either a side or front approach.

Where a clear floor or ground space allows a parallel or front approach and the side reach is unobstructed, the high side reach shall be 48 inches maximum above the finish floor or ground and the low side reach shall be 15 inches minimum above the finish floor or ground.

Lower the thermostat for all operable components to 48" max AFF.

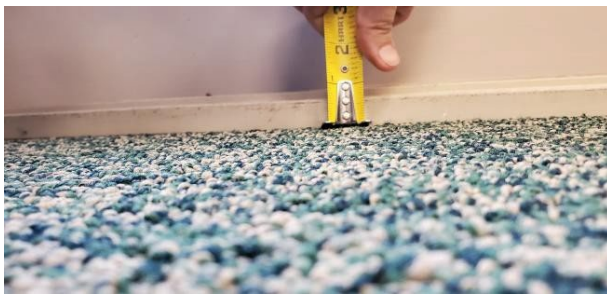
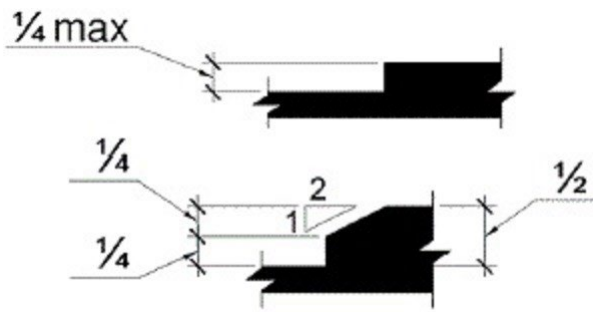
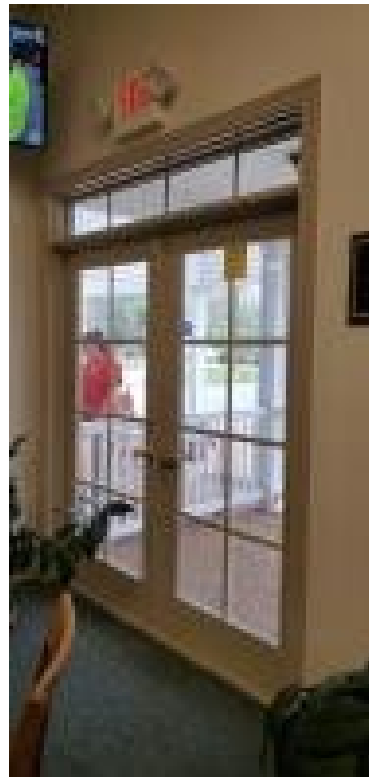
As Built: The threshold is greater than 1/2 inch high.

The threshold at a doorway shall be no higher than 1/2 inch. Changes in level between 1/4 inch and 1/2 inch must be beveled at 1:2 or less. 1/4 inch is the maximum vertical rise.

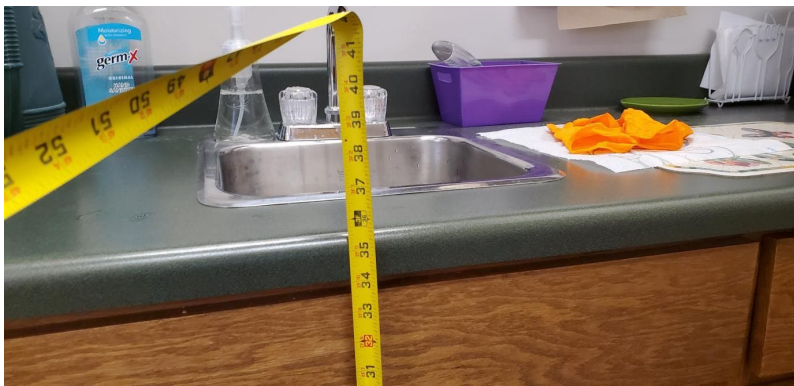
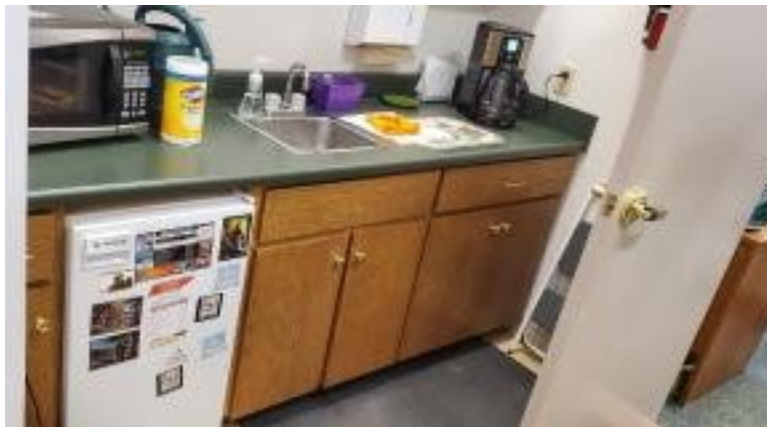
As Built: The top of the sink is too high.

Sinks that are required to be accessible shall be a minimum 17 inches in horizontal depth and mounted with the rim or counter edge no higher than 34 inches above the finished floor.

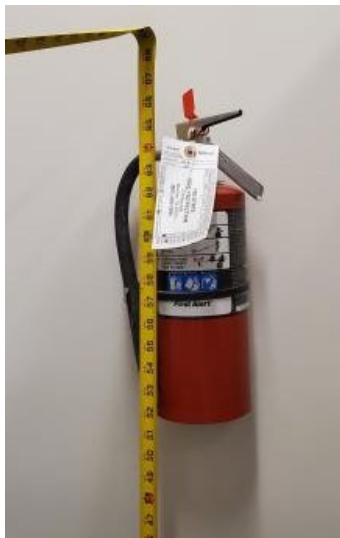
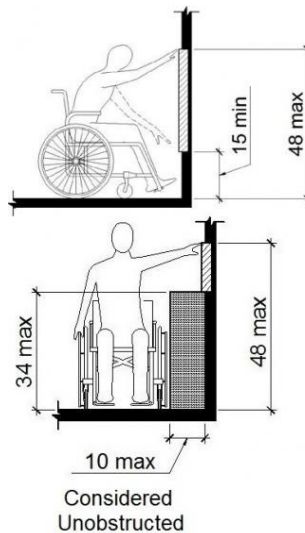
As Built: The fire extinguisher is not positioned correctly for either a side or front approach.

Where a clear floor or ground space allows a parallel or front approach and the side reach is unobstructed, the high side reach shall be 48 inches maximum above the finish floor or ground and the low side reach shall be 15 inches minimum above the finish floor or ground.

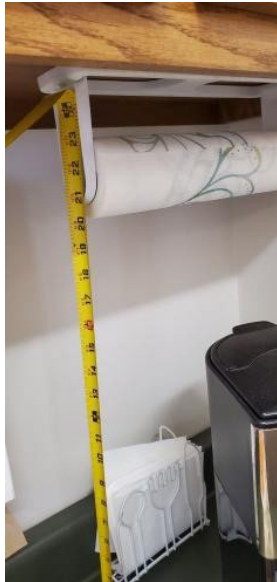
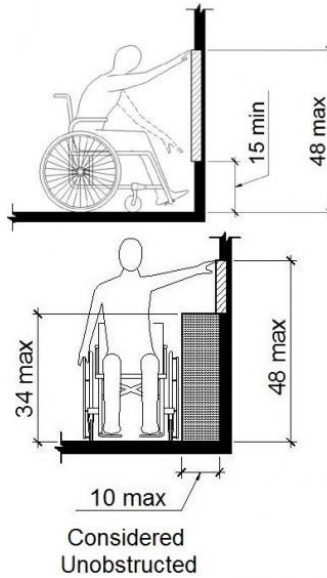
As Built: The paper towel dispenser is not positioned correctly for either a side or front approach.

Where a clear floor or ground space allows a parallel or front approach and the side reach is unobstructed, the high side reach shall be 48 inches maximum above the finish floor or ground and the low side reach shall be 15 inches minimum above the finish floor or ground.

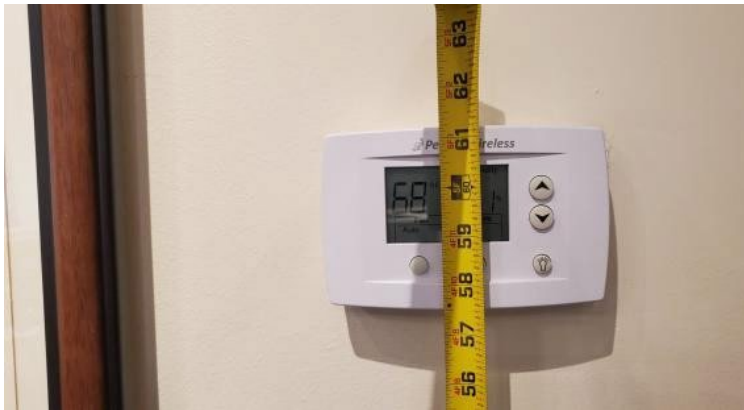
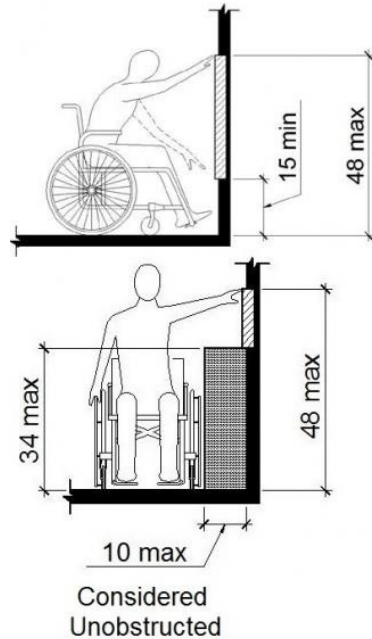
As Built: The Thermostat is not positioned correctly for either side or front approach.

Where a clear floor or ground space allows a parallel or front approach and the side reach is unobstructed, the high side reach shall be 48 inches maximum above the finish floor or ground and the low side reach shall be 15 inches minimum above the finish floor or ground.

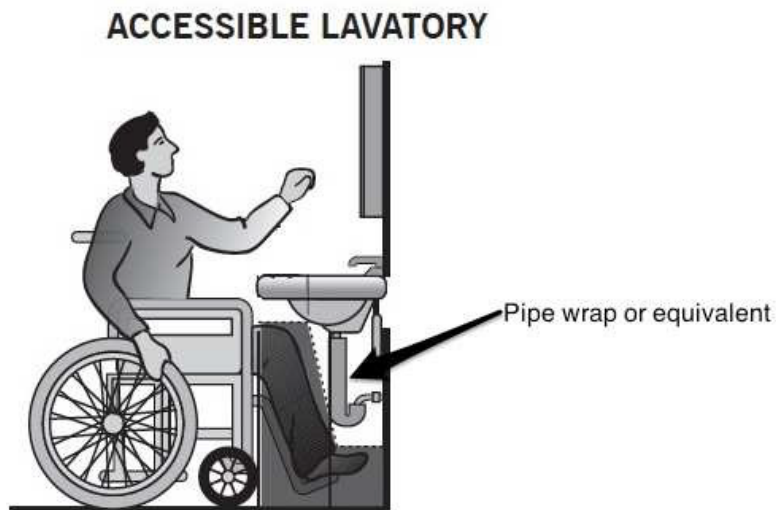
As Built: The water and drain pipes under the lavatory are not adequately insulated.

Water supply and drain pipes under lavatories and sinks shall be insulated or otherwise configured to protect against contact. There shall be no sharp or abrasive surfaces under lavatories and sinks.

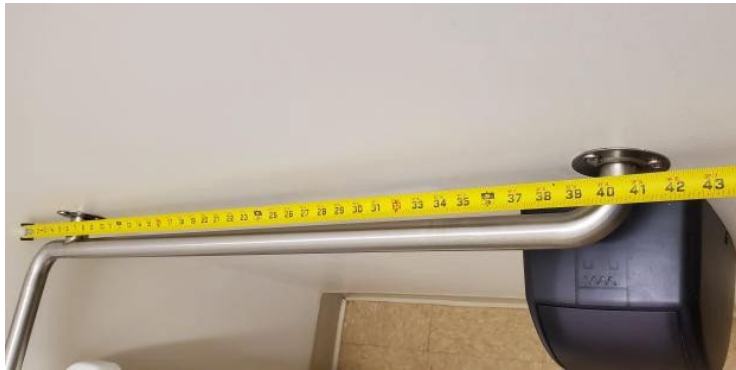
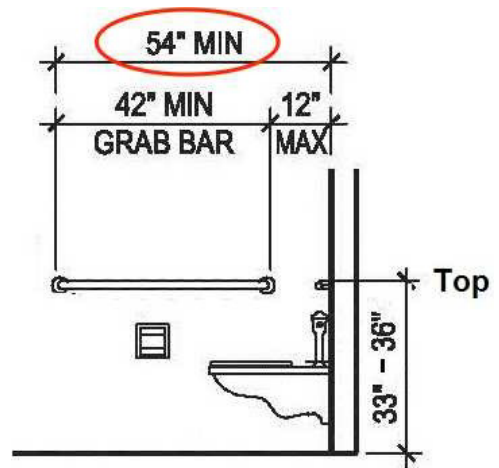
As Built: The side grab bar does not extend far enough from the rear wall.

The side grab bar must extend at least 54 inches minimum beyond the rear wall and start a maximum of 12 inches from the rear wall. A 42 inch grab bar installed the maximum distance from the rear wall (12 inches) will leave the leading end 54 inches from the rear wall.

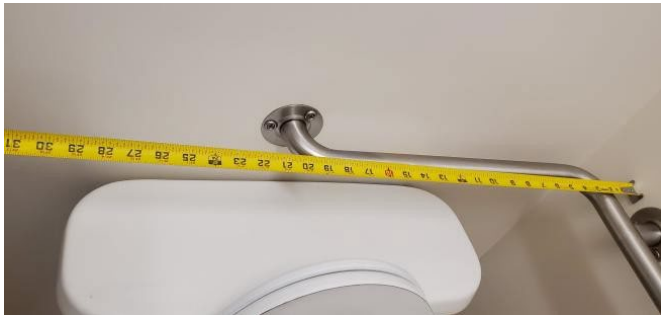
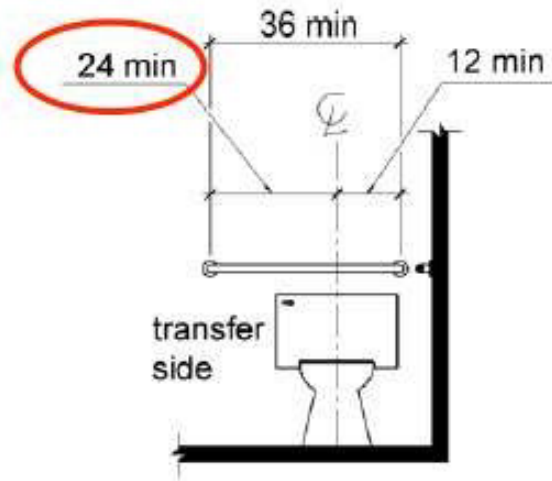
As Built: The rear grab bar does not extend adequately past the toilet on the wide side.

The rear grab bar must be a minimum of 36 inches long and extend from the centerline of the toilet 12 inches minimum on wall side and 24 inches minimum on the wide side.

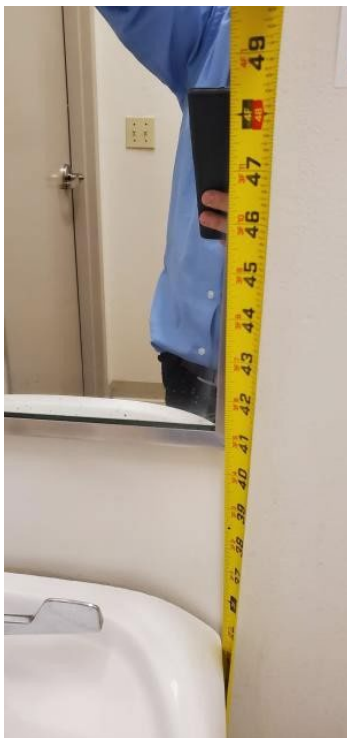
As Built: The mirror is mounted too high.

Mirrors must have the bottom edge of the reflecting surface a maximum of 40 inches above the floor if above a sink or counter. Mirrors not located above lavatories or countertops shall be installed with the bottom edge of the reflecting surface 35 inches maximum above the finish floor or ground.

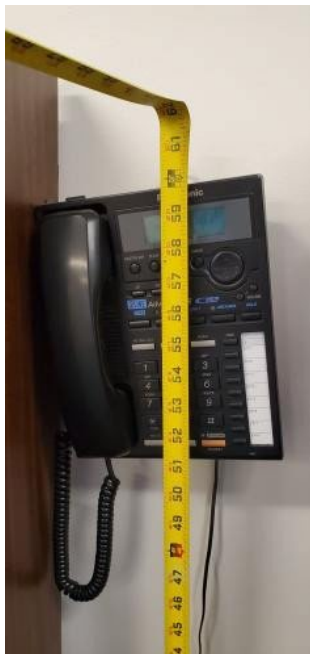
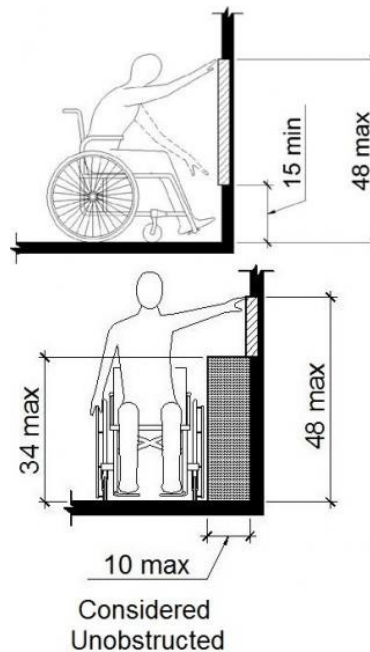
As Built: The telephone is not positioned correctly for either a side or front approach.

Where a clear floor or ground space allows a parallel or front approach and the side reach is unobstructed, the high side reach shall be 48 inches maximum above the finish floor or ground and the low side reach shall be 15 inches minimum above the finish floor or ground.

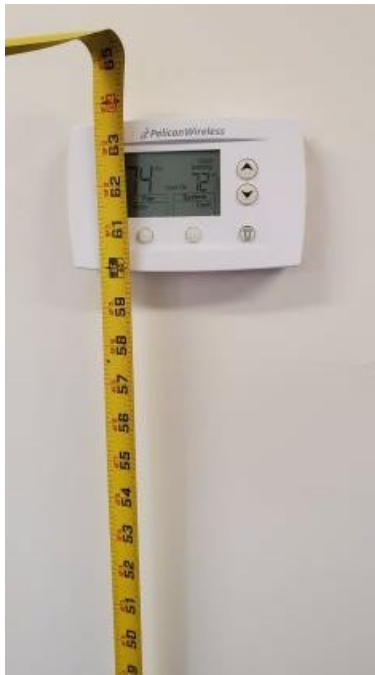
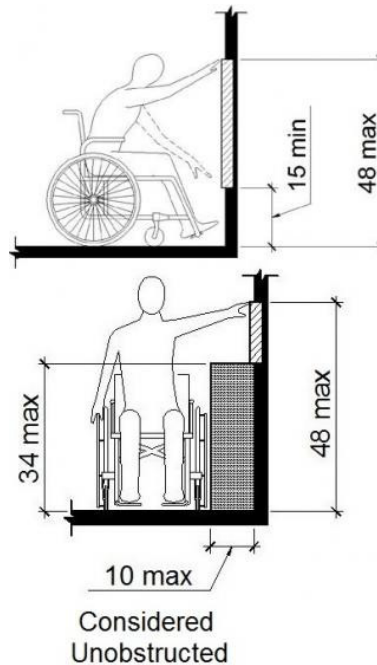
As Built: The thermostat is not positioned correctly for either a side or front approach.

Where a clear floor or ground space allows a parallel or front approach and the side reach is unobstructed, the high side reach shall be 48 inches maximum above the finish floor or ground and the low side reach shall be 15 inches minimum above the finish floor or ground.

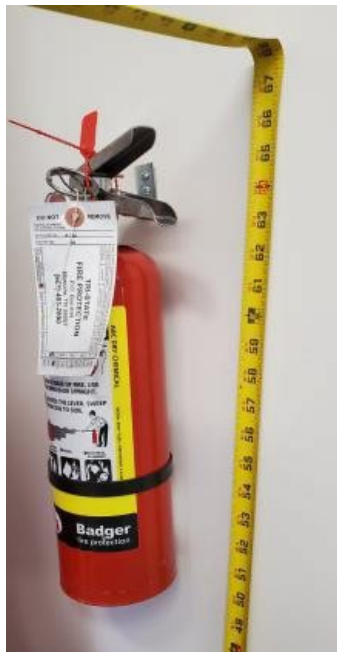
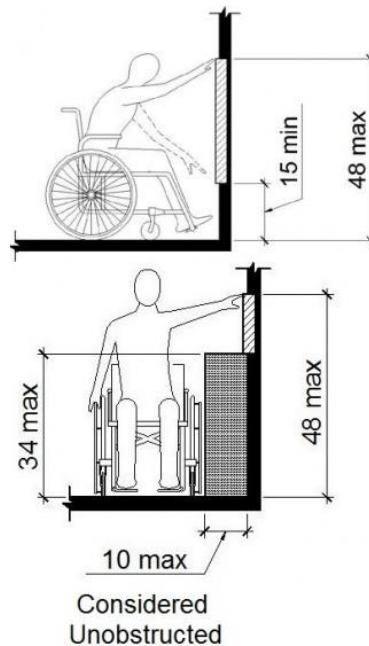
As Built: The fire extinguisher is not positioned correctly for either a side or front approach.

Where a clear floor or ground space allows a parallel or front approach and the side reach is unobstructed, the high side reach shall be 48 inches maximum above the finish floor or ground and the low side reach shall be 15 inches minimum above the finish floor or ground.

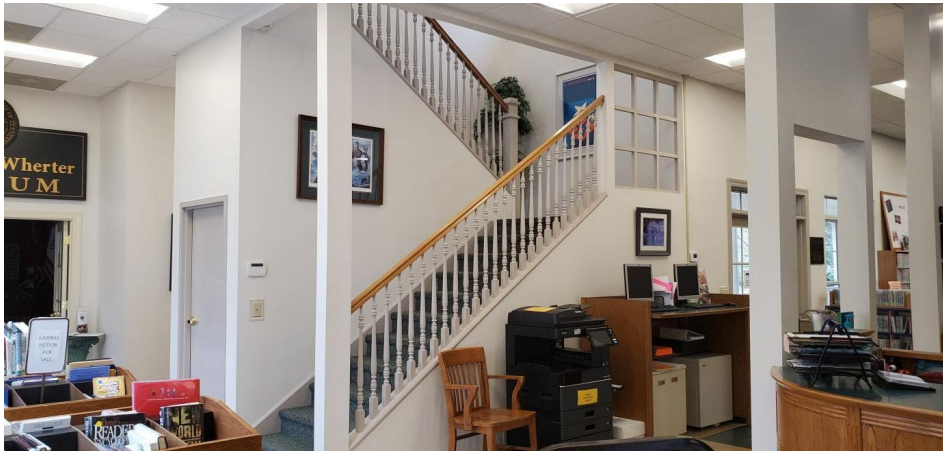
As Built: At least one accessible route (i.e. elevator, ramp, or platform lift) shall connect each story and mezzanine in multi-story buildings and facilities. The following buildings and facilities do not require vertical access:

In private buildings or facilities that are less than three stories or that have less than 3000 square feet per story, an accessible route shall not be required to connect stories provided that the building or facility is not a shopping center, a shopping mall, the professional office of a health care provider, a terminal, depot or other station used for specified public transportation, an airport passenger terminal, or another type of facility as determined by the Attorney General.

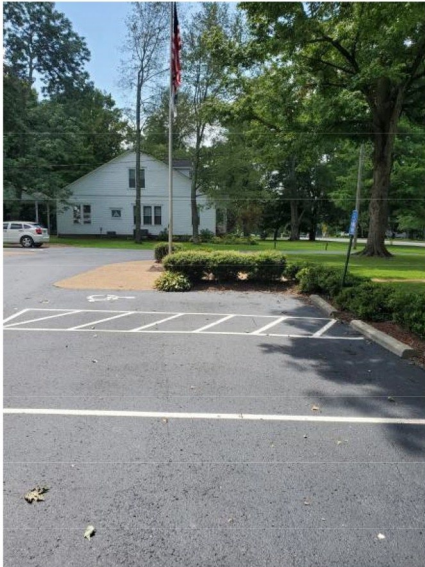
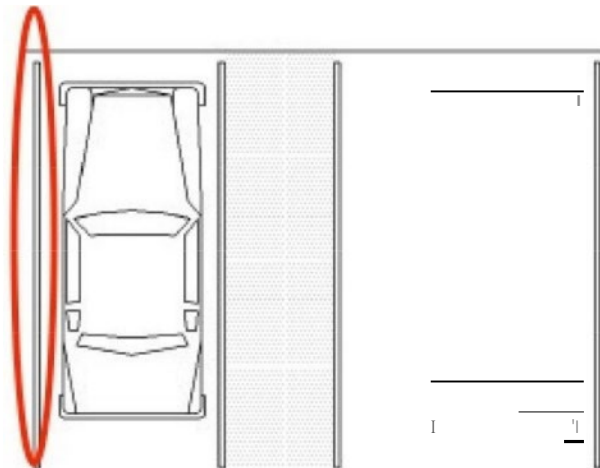
As Built: The stripe is missing at the left side of the left parking stall which identifies its border.

Citation: 2010 ADAS Section 502.2

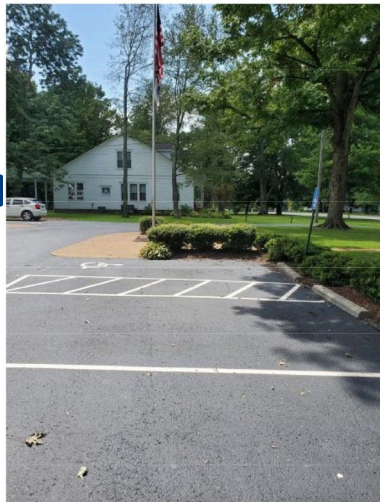
As Built: The parking sign is mounted too low.

Citation: 2010 ADAS Section 502.6

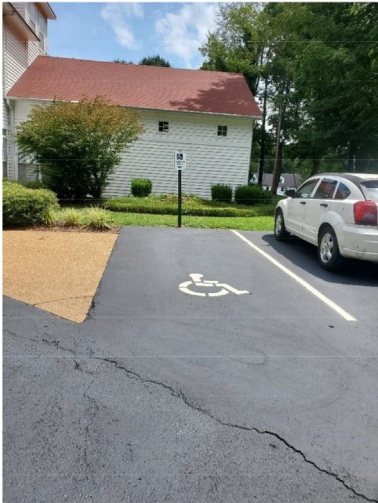
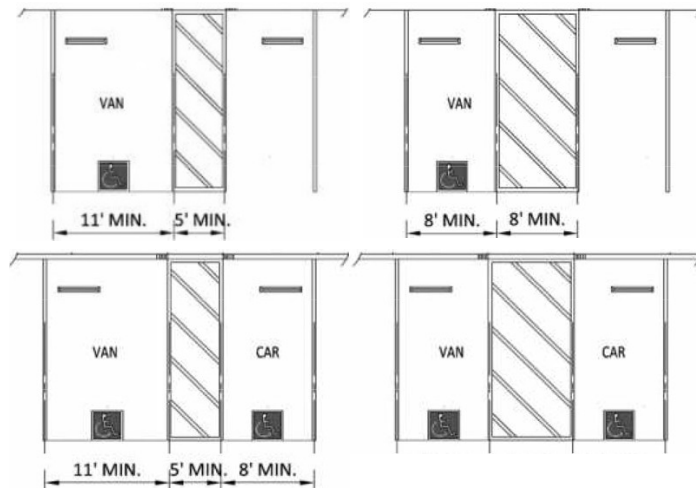
As Built: The accessible parking stall is only 9' wide. There is no access aisle, no van sign and the cross slope of the space is 2.9%

The Parking space must meet one of the acceptable layouts in the diagram above.

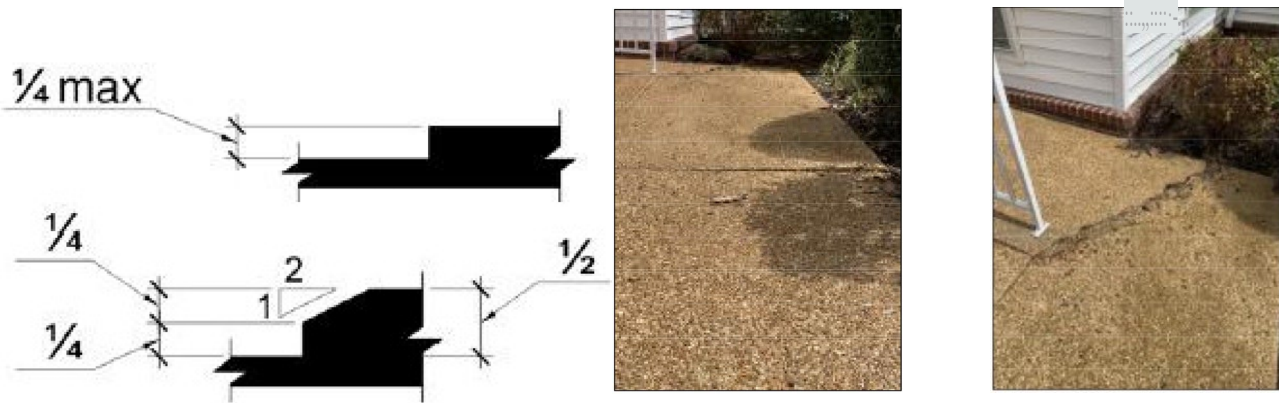
As Built: The walkway contains abrupt vertical edges and/or variations over a 1/4 inch.

1/4 inch is the maximum vertical rise. Changes in level between 1/4 inch and 1/2 inch must be beveled at 1:2 or less. Changes in level greater than 1/2 inch must be by way of a ramp.

Level or replace walkways as required.

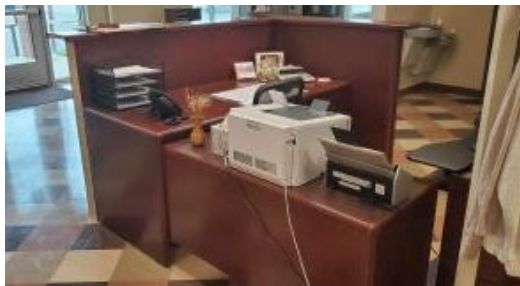
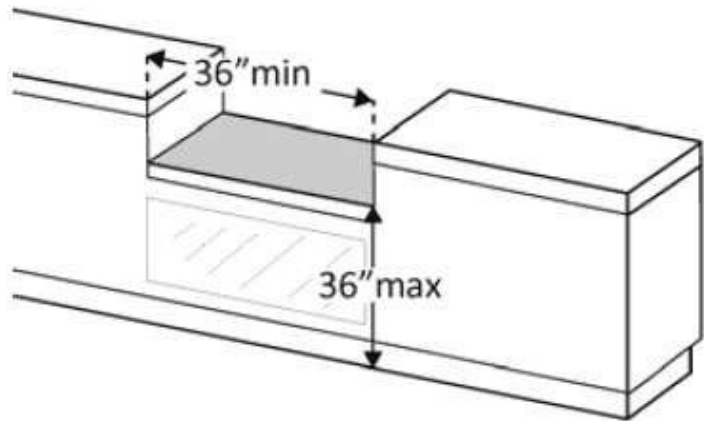
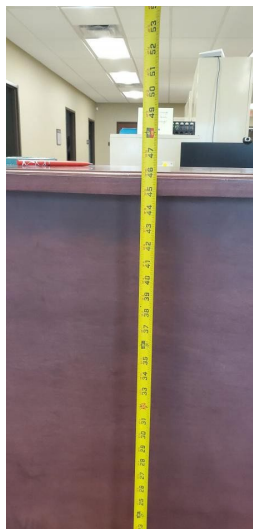
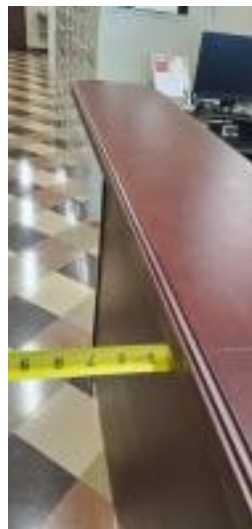
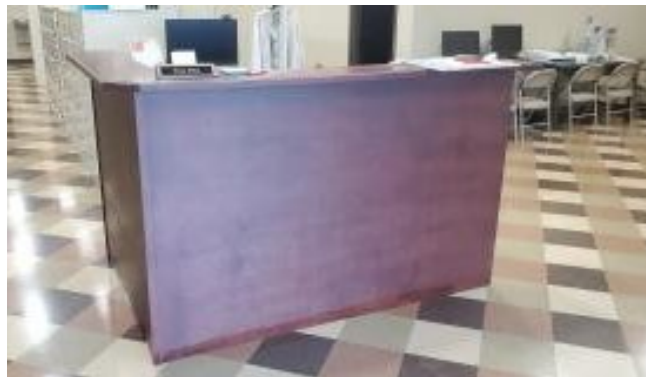
As Built: The transaction counter is too high.

A portion of the counter surface that is 36 inches long minimum and 36 inches high maximum above the finish floor shall be provided. Knee and toe space must be provided for a forward approach. A 30 inch by 48 inch clear floor space on an accessible route must be provided for either a forward or parallel approach.

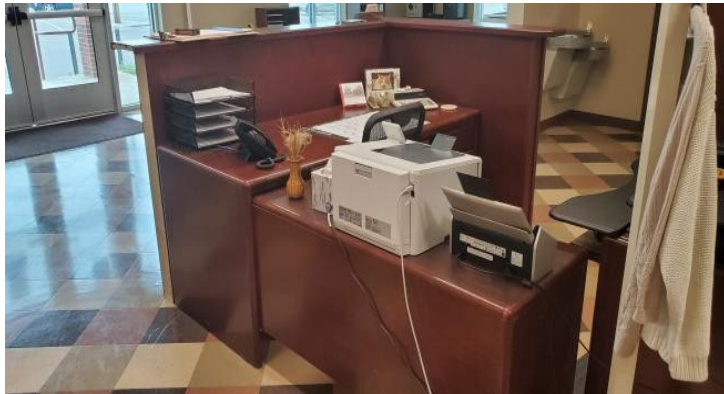
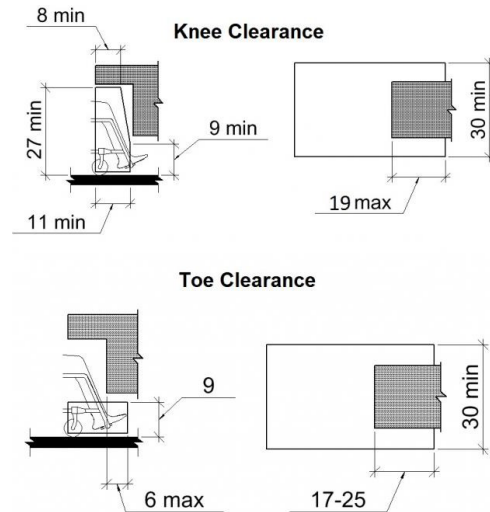
As Built: Compliant knee and/or toe space is not provided.

Space under an element between the finish floor or ground and 9 inches above the finish floor or ground shall be considered toe clearance. Toe clearance shall extend 25 inches maximum and 17 inches minimum under an element. Space extending greater than 6 inches beyond the available knee clearance at 9 inches above the finish floor or ground shall not be considered toe clearance. Toe clearance shall be 30 inches wide minimum.

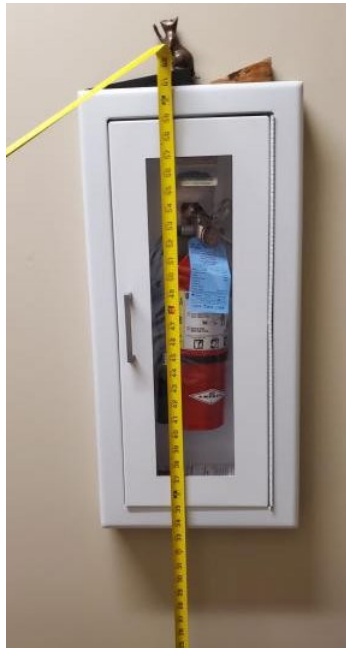
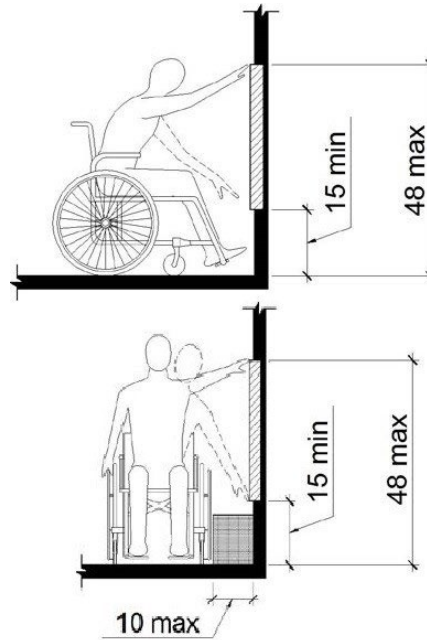
As Built: The Fire Extinguisher is positioned too high for either a side or front approach.

Where a clear floor or ground space allows a parallel approach to an element and the side reach is unobstructed, the high side reach shall be 48 inches maximum and the low side reach shall be 15 inches minimum above the finish floor or ground.

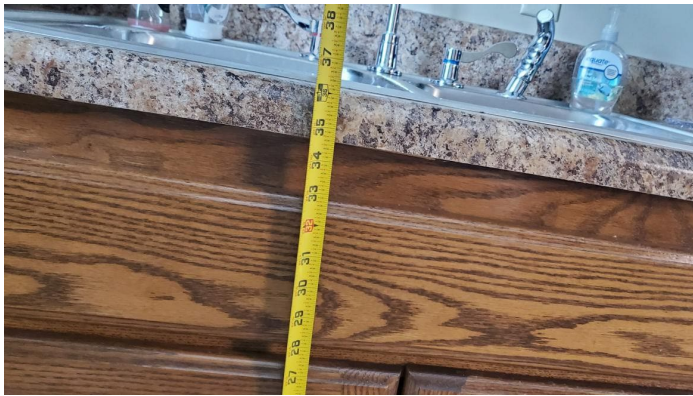
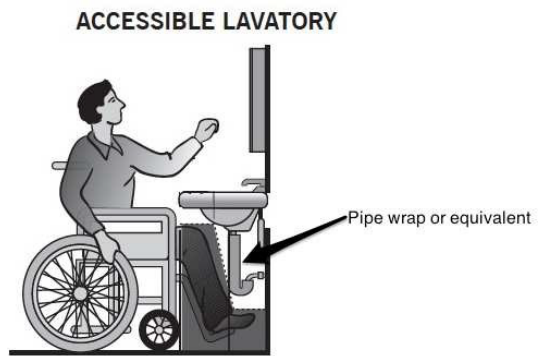
As Built: The top of the sink is too high.

Sinks that are required to be accessible shall be a minimum 17 inches in horizontal depth and mounted with the rim or counter edge no higher than 34 inches above the finished floor.

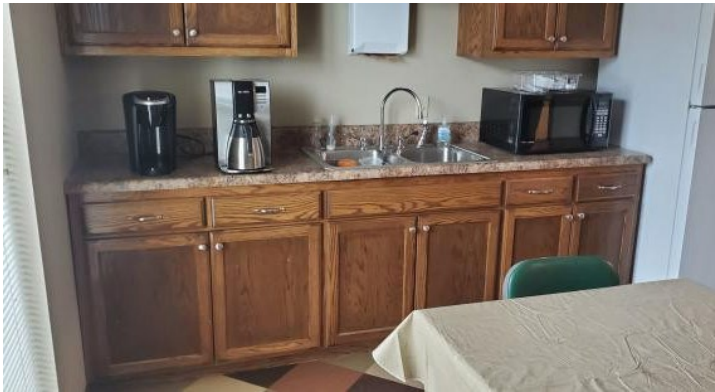
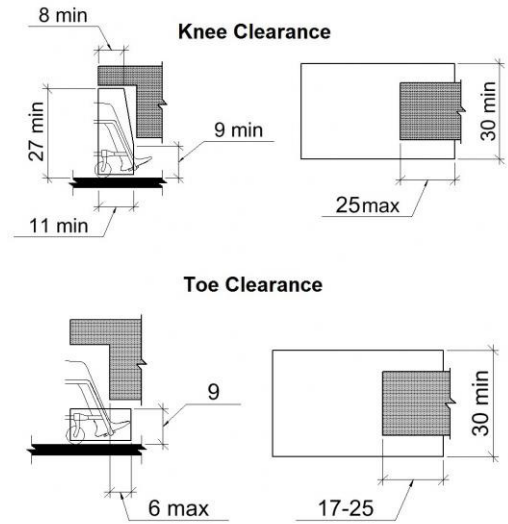
As Built: Knee and toe clearance have not been provided at the sink.

The knee clearance shall be 11 inches deep minimum at 9 inches above the finish floor or ground, and 8 inches deep minimum at 27 inches above the finish floor or ground.
