WEAKLEY COUNTY, TENNESSEE

ADA EVALUATION

Architectural and Site Findings with Recommendations

TLM Associates, Inc

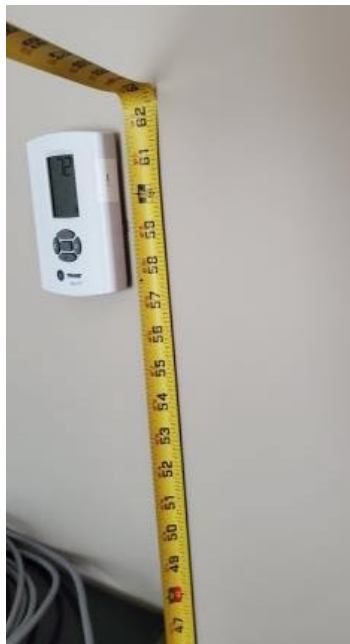
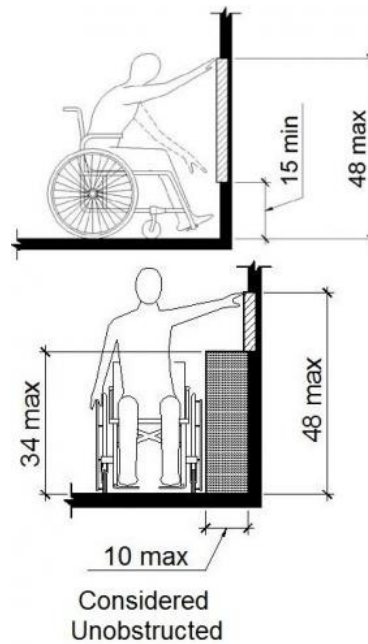
As Built: The thermostat is not positioned correctly for either a side or front approach.

Where a clear floor or ground space allows a parallel or front approach and the side reach is unobstructed, the high side reach shall be 48 inches maximum above the finish floor or ground and the low side reach shall be 15 inches minimum above the finish floor or ground.

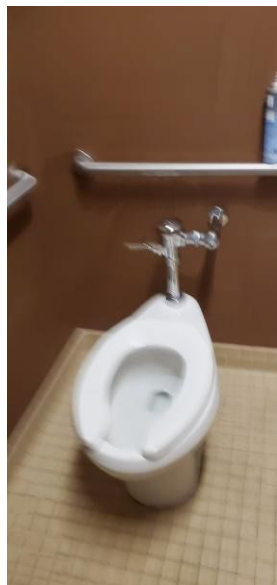
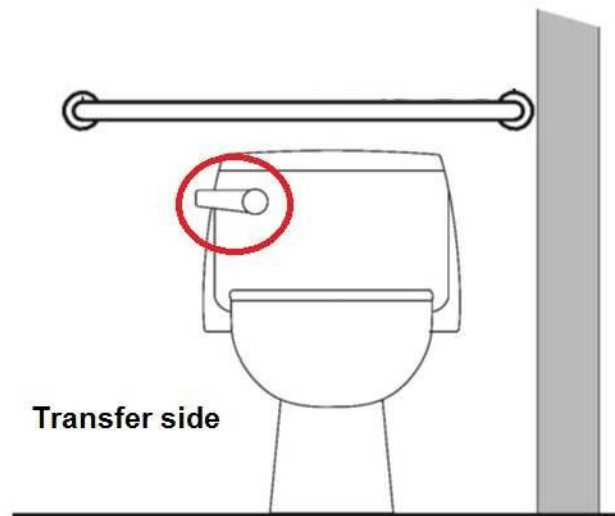
As Built: The flush handle is located on the wrong side of the toilet.

Controls shall be operable with one hand and shall not require tight grasping, pinching or twisting. Controls for the flush valves shall be mounted on the wide side of toilet areas, no more than 48 inches above the floor.

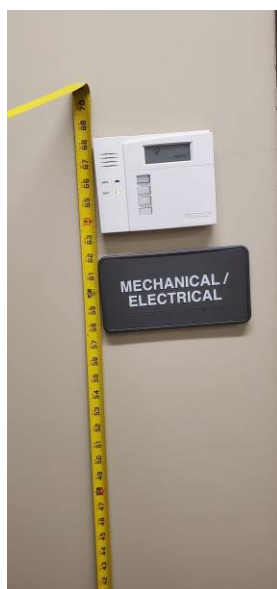
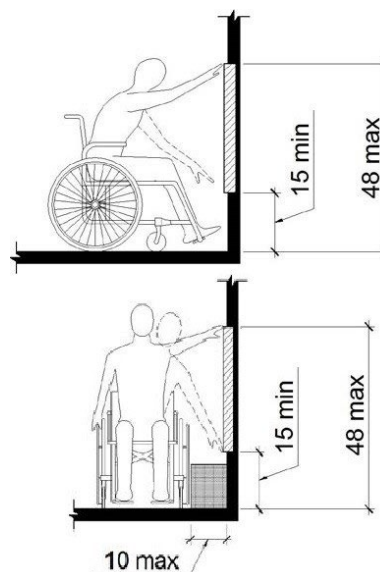
As Built: The Alarm Pad is positioned too high for either a side or front approach.

Where a clear floor or ground space allows a parallel approach to an element and the side reach is unobstructed, the high side reach shall be 48 inches maximum and the low side reach shall be 15 inches minimum above the finish floor or ground.

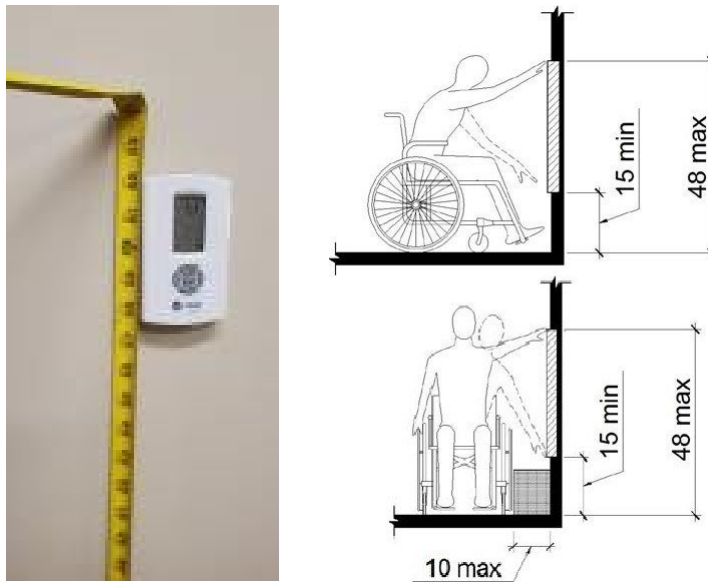
As Built: The thermostat is positioned too high for either a side or front approach.

Where a clear floor or ground space allows a parallel approach to an element and the side reach is unobstructed, the high side reach shall be 48 inches maximum and the low side reach shall be 15 inches minimum above the finish floor or ground.

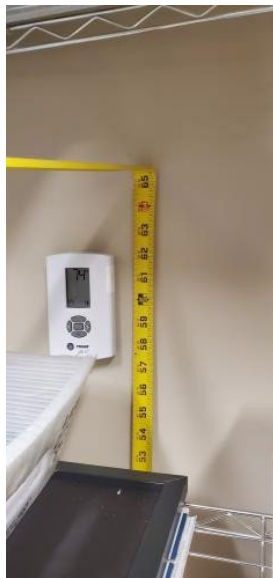
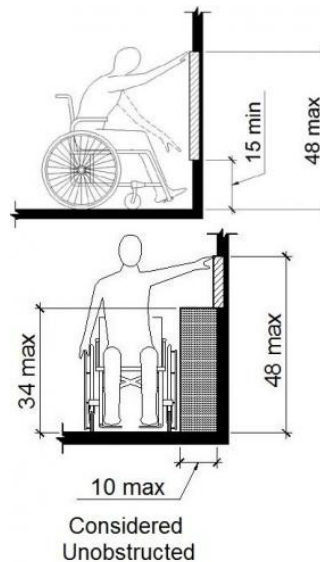
As Built: The thermostat is not positioned correctly for either a side or front approach.

Where a clear floor or ground space allows a parallel or front approach and the side reach is unobstructed, the high side reach shall be 48 inches maximum above the finish floor or ground and the low side reach shall be 15 inches minimum above the finish floor or ground.

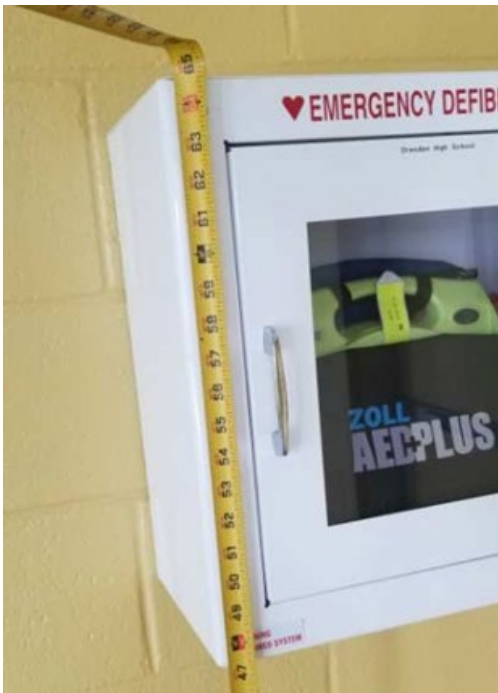
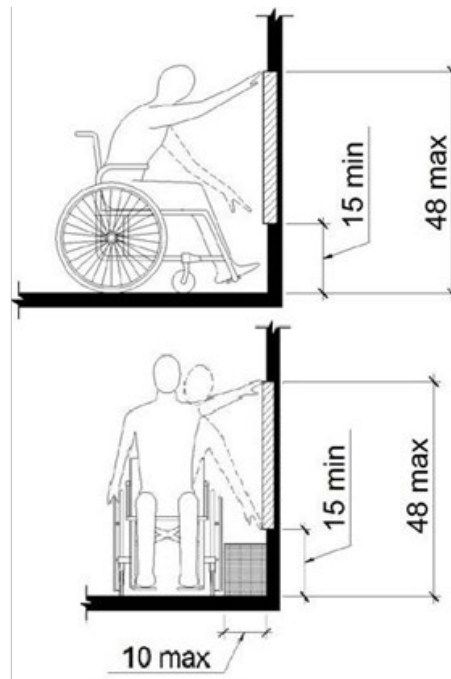
As Built: The defibrillator is positioned too high for either a side or front approach. The defibrillator handle is at 55" AFF.

Where a clear floor or ground space allows a parallel approach to an element and the side reach is unobstructed, the high side reach shall be 48 inches maximum and the low side reach shall be 15 inches minimum above the finish floor or ground.

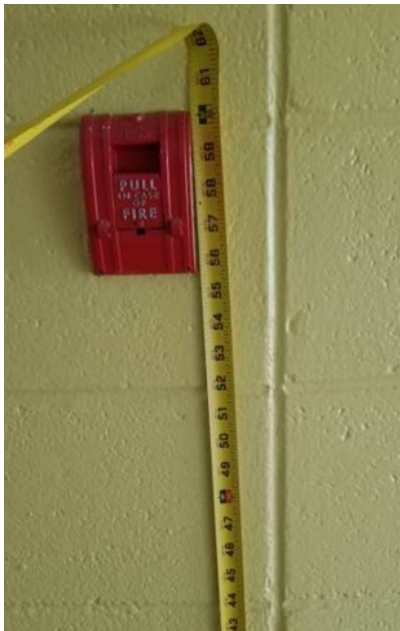
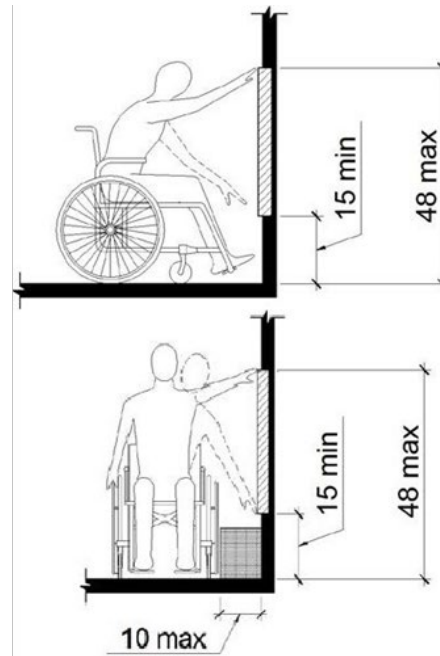
As Built: The Fire Alarm Pull is positioned too high for either a side or front approach. The fire alarm pull is at 60".

Where a clear floor or ground space allows a parallel approach to an element and the side reach is unobstructed, the high side reach shall be 48 inches maximum and the low side reach shall be 15 inches minimum above the finish floor or ground.

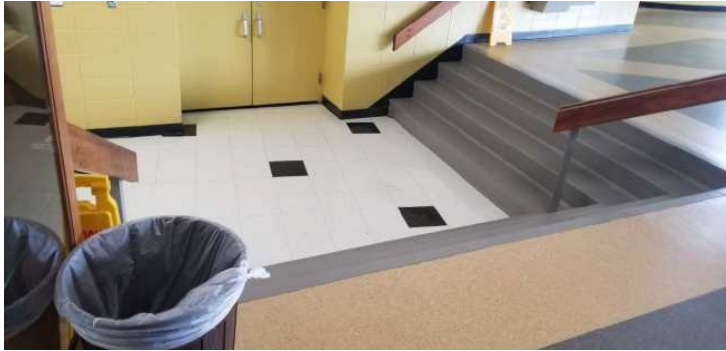
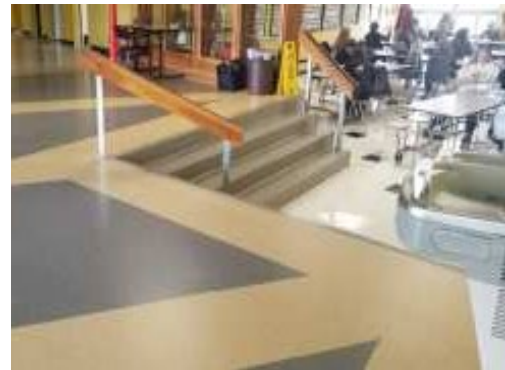
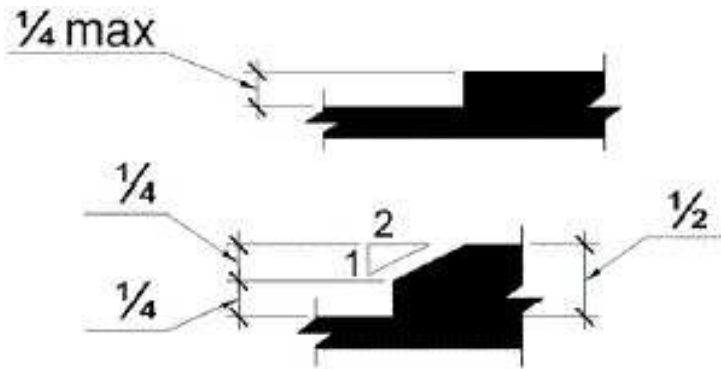
As Built: The cafeteria is only accessible through the gymnasium. There is a change in level greater than 1/4 inch. 1/4 inch is the maximum vertical rise. Changes in level between 1/4 inch and 1/2 inch must be beveled at 1:2 or less. Changes in level greater than 1/2 inch must be by way of a ramp.

Citation: 2010 ADAS Section 303.3

Add a wheelchair lift on wall side.

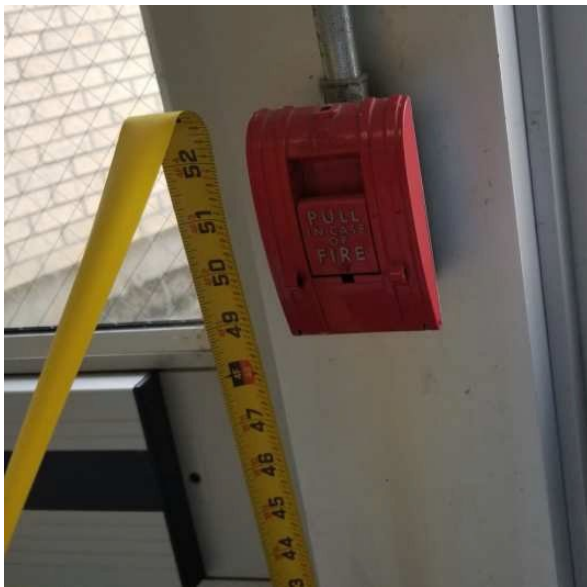
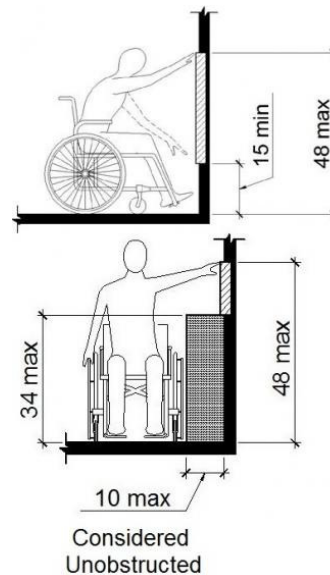
As Built: The Fire alarm pull is at 51" AFF. The fire alarm pull is not positioned correctly for either a side or front approach.

Where a clear floor or ground space allows a parallel or front approach and the side reach is unobstructed, the high side reach shall be 48 inches maximum above the finish floor or ground and the low side reach shall be 15 inches minimum above the finish floor or ground.

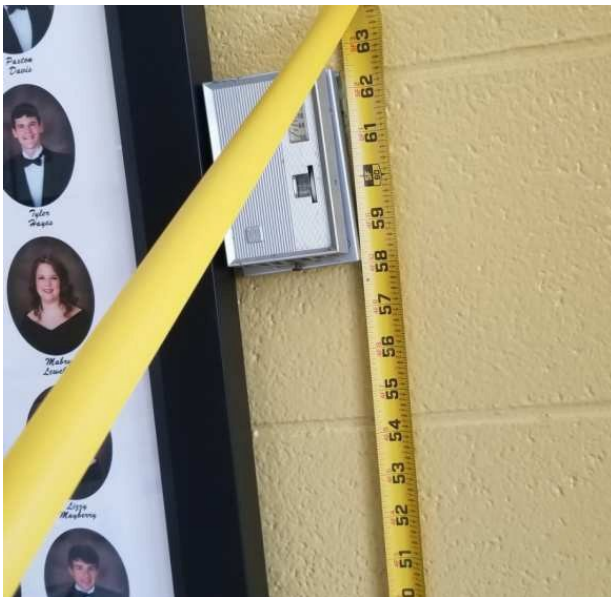
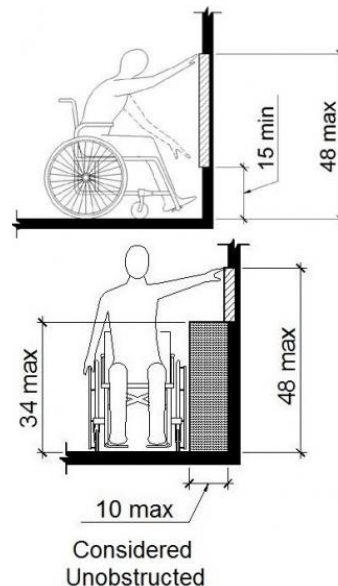
As Built: The Thermostat is at 60" AFF. The thermostat is not positioned correctly for either a side or front approach.

Where a clear floor or ground space allows a parallel or front approach and the side reach is unobstructed, the high side reach shall be 48 inches maximum above the finish floor or ground and the low side reach shall be 15 inches minimum above the finish floor or ground.

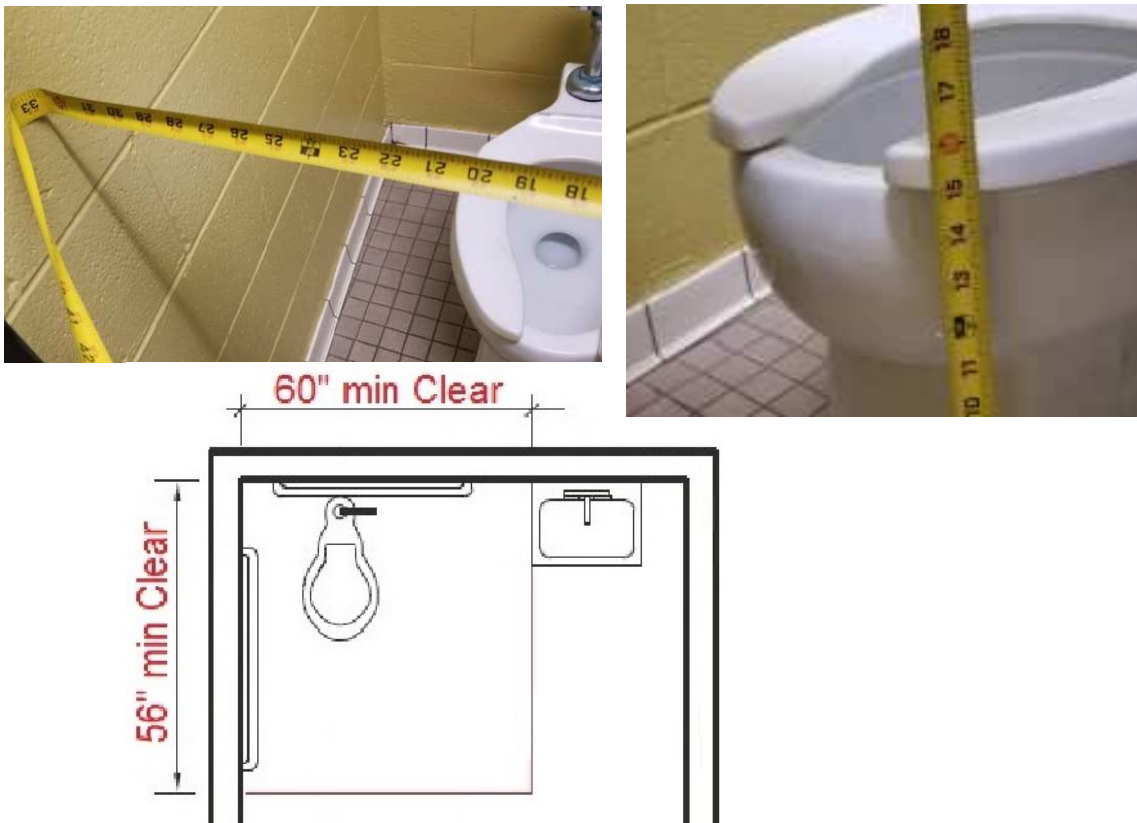
As Built: The Compartment width is 33" and the toilet seat is 16". The clear floor space around the toilet is obstructed by adjacent toilet compartment.

The required clearance around the water closet shall be permitted to overlap the water closet, associated grab bars, dispensers, clear floor space and clearances required at other fixtures, and the turning space.

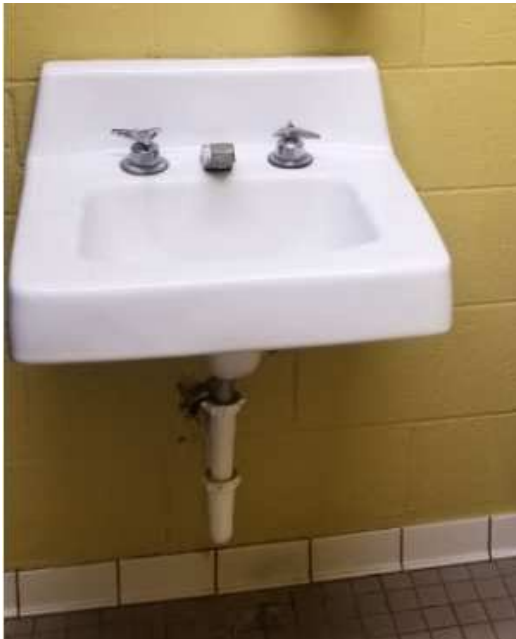
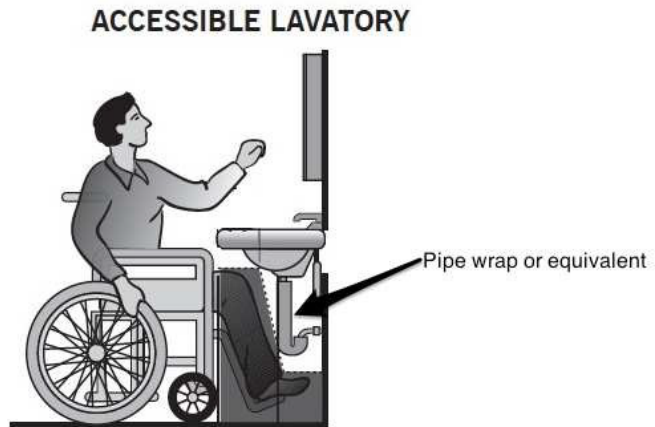
As Built: There is no pipe insulation provided. The water and drain pipes under the lavatory are not adequately insulated.

Water supply and drain pipes under lavatories and sinks shall be insulated or otherwise configured to protect against contact. There shall be no sharp or abrasive surfaces under lavatories and sinks.

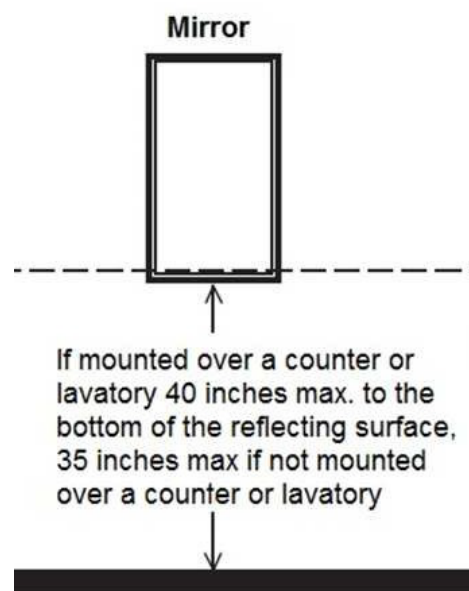
As Built: The mirror is mounted too high at 53”.

Mirrors must have the bottom edge of the reflecting surface a maximum of 40 inches above the floor if above a sink or counter. Mirrors not located above lavatories or countertops shall be installed with the bottom edge of the reflecting surface 35 inches maximum above the finish floor or ground.

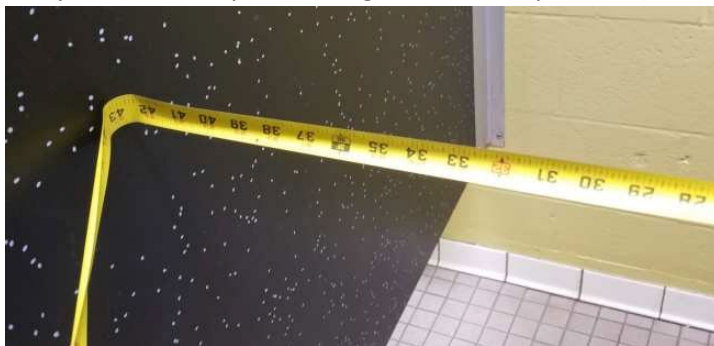
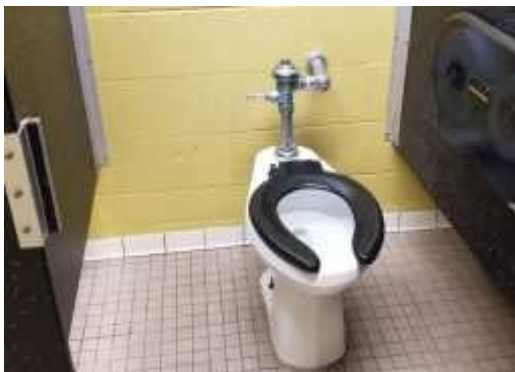
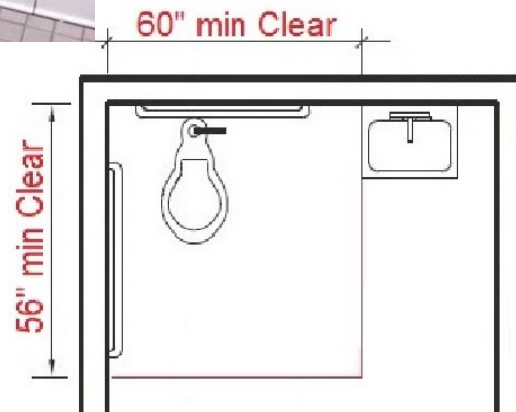
As Built: The clear floor space around the toilet is obstructed by the toilet partition. No fixtures are allowed in the clear floor space required for the toilet.

The required clearance around the water closet shall be permitted to overlap the water closet, associated grab bars, dispensers, sanitary napkin disposal units, coat hooks, shelves, accessible routes, clear floor space and clearances required at other fixtures, and the turning space. No other fixtures or obstructions shall be located within the required water closet clearance.

Remove urinal to left of compartment, repair and patch wall, install new toilet partitions, door, coat hook, and grab bars to comply with minimum ADA compartment requirements and extend ADA compartment

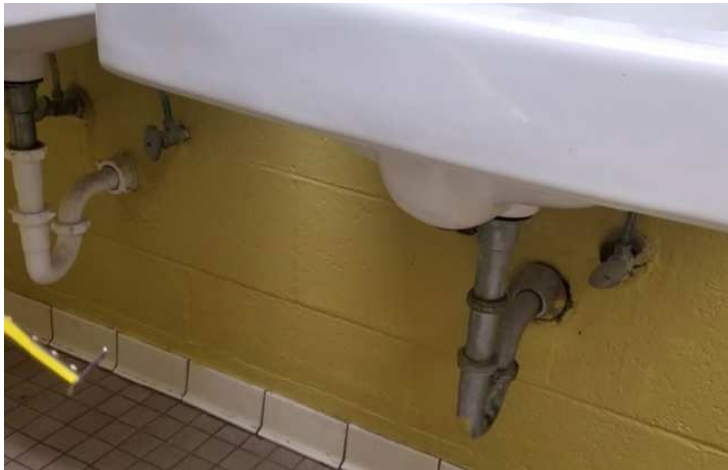
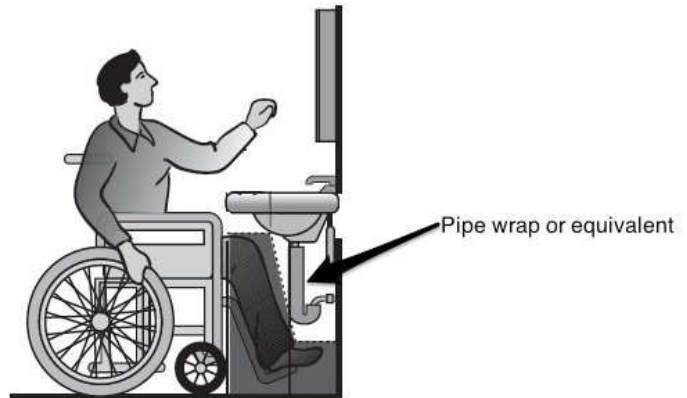
ACCESSIBLE LAVATORY

As Built: There is no pipe insulation provided. Water supply and drain pipes under lavatories and sinks shall be insulated or otherwise configured to protect against contact. There shall be no sharp or abrasive surfaces under lavatories and sinks.

Citation: 2010 ADAS Section 606.5

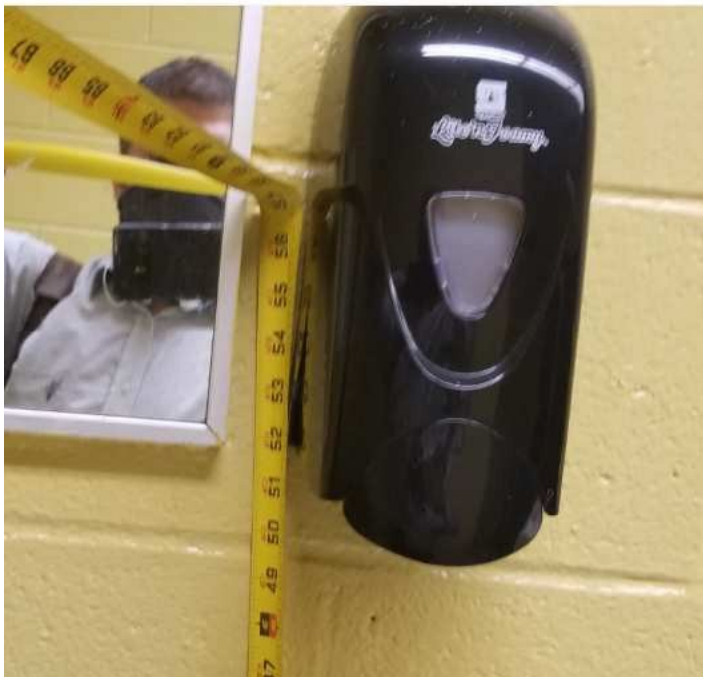
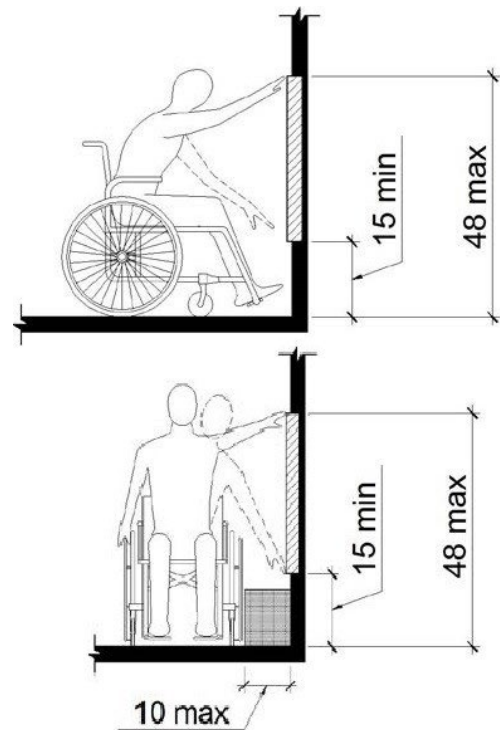
As Built: The soap dispenser push release is at 50". Where a clear floor or ground space allows a parallel approach to an element and the side reach is unobstructed, the high side reach shall be 48 inches maximum and the low side reach shall be 15 inches minimum above the finish floor or ground.

Where a forward reach is unobstructed, the high forward reach shall be 48 inches maximum and the low forward reach shall be 15 inches minimum above the finish floor or ground.

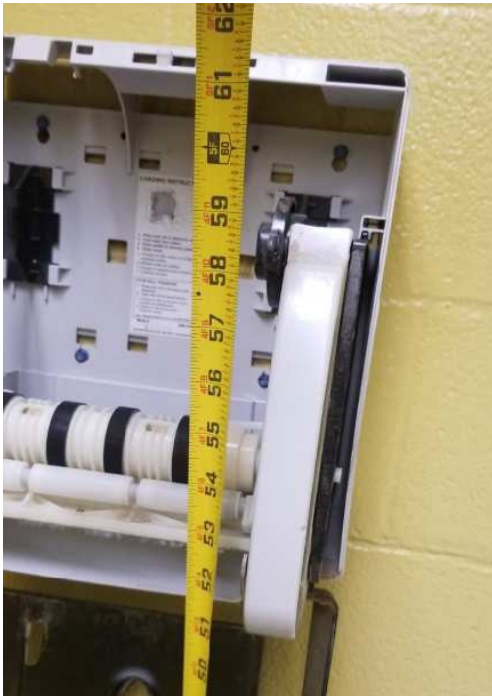
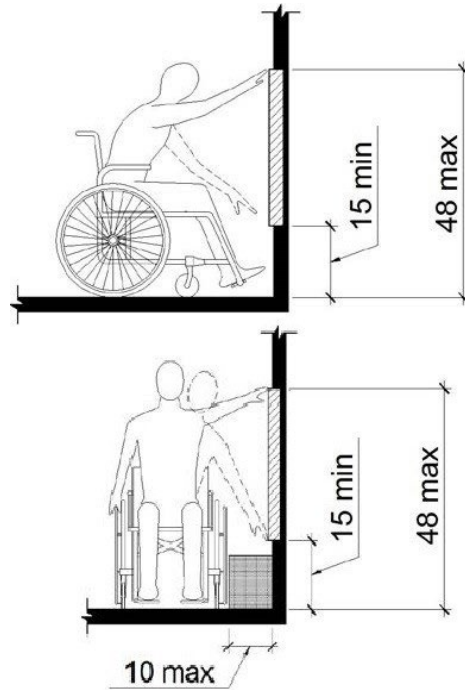
As Built: The paper towel dispenser is at 52" AFF, which is too high for either a side or front approach. Where a clear floor or ground space allows a parallel approach to an element and the side reach is unobstructed, the high side reach shall be 48 inches maximum and the low side reach shall be 15 inches minimum above the finish floor or ground.

Where a forward reach is unobstructed, the high forward reach shall be 48 inches maximum and the low forward reach shall be 15 inches minimum above the finish floor or ground.

3 (Moderate): Should be completed as soon as possible, but there may be other items that will provide greater access to persons with disabilities. (Includes findings that have a high financial impact on the entity in relationship to the degree of access provided).

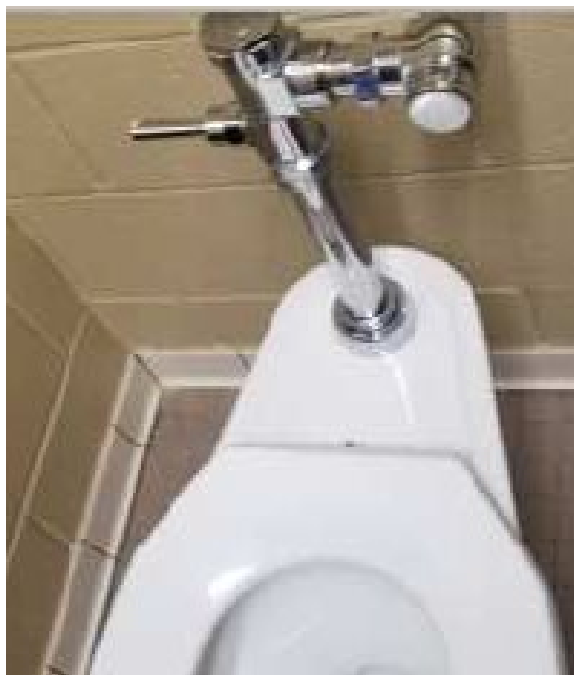
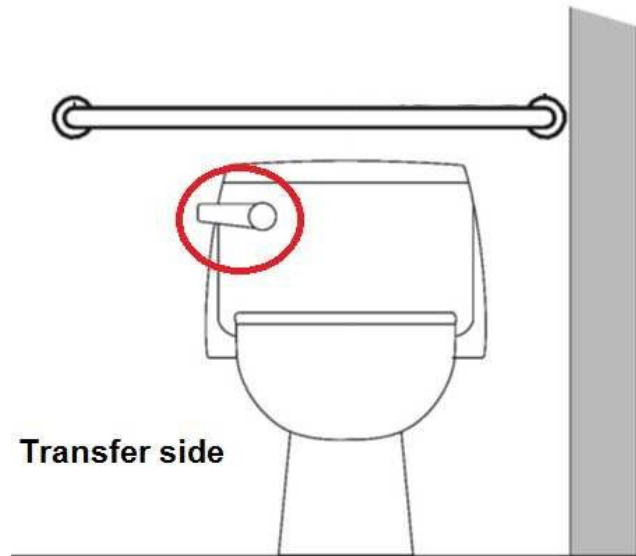
As Built: The flush handle is located on the wrong side of the toilet.

Controls shall be operable with one hand and shall not require tight grasping, pinching or twisting. Controls for the flush valves shall be mounted on the wide side of toilet areas, no more than 48 inches above the floor

3 (Moderate): Should be completed as soon as possible, but there may be other items that will provide greater access to persons with disabilities. (Includes findings that have a high financial impact on the entity in relationship to the degree of access provided).

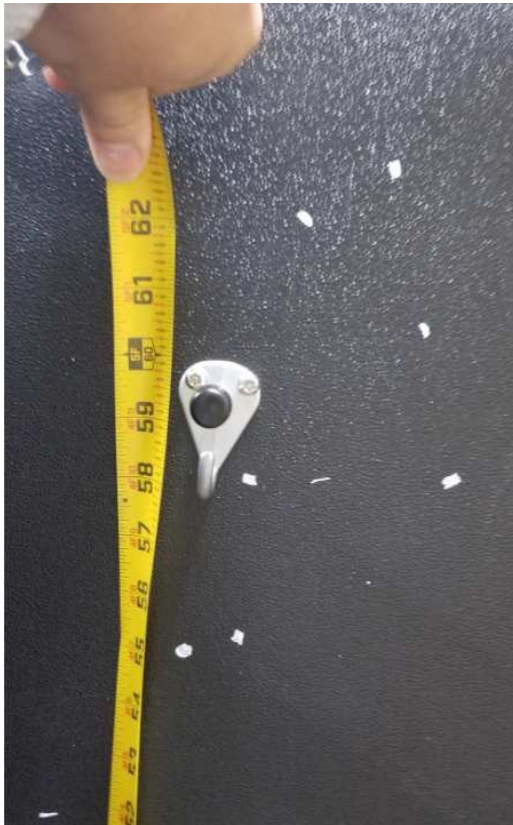
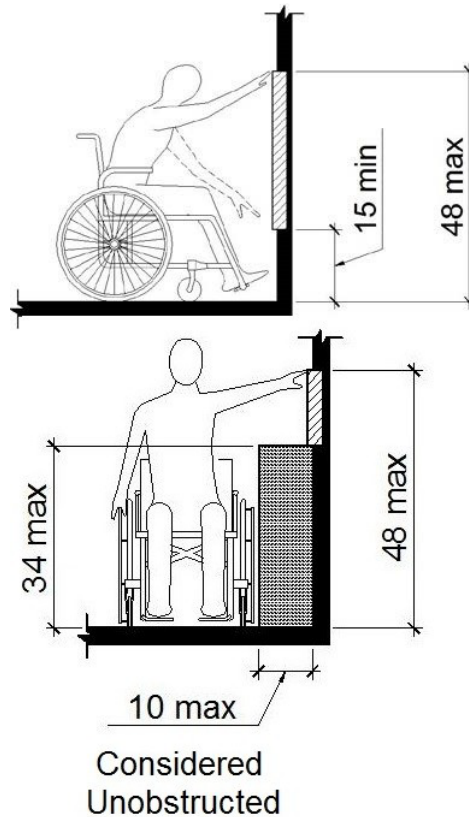
As Built: The coat hook is installed greater than 48 inches above the finished floor.

Where a forward reach is unobstructed, the high forward reach shall be 48 inches maximum above the finished floor.

3 (Moderate): Should be completed as soon as possible, but there may be other items that will provide greater access to persons with disabilities. (Includes findings that have a high financial impact on the entity in relationship to the degree of access provided).

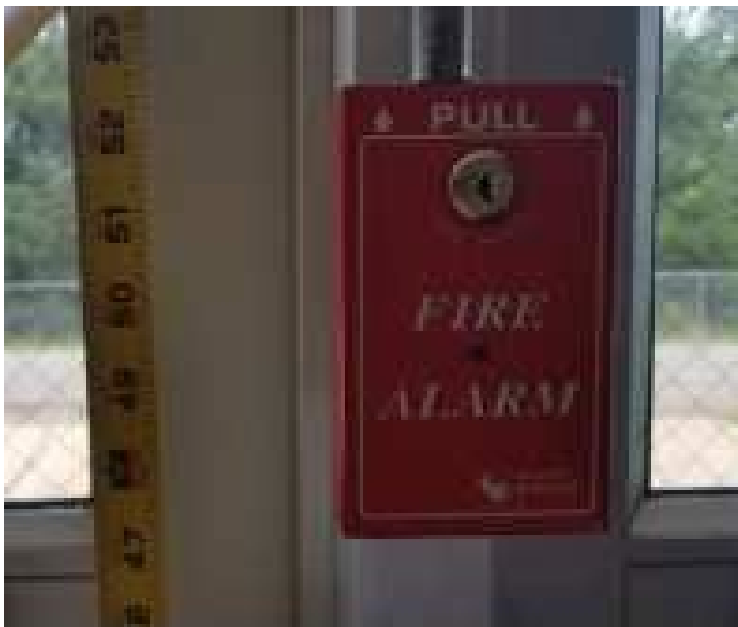
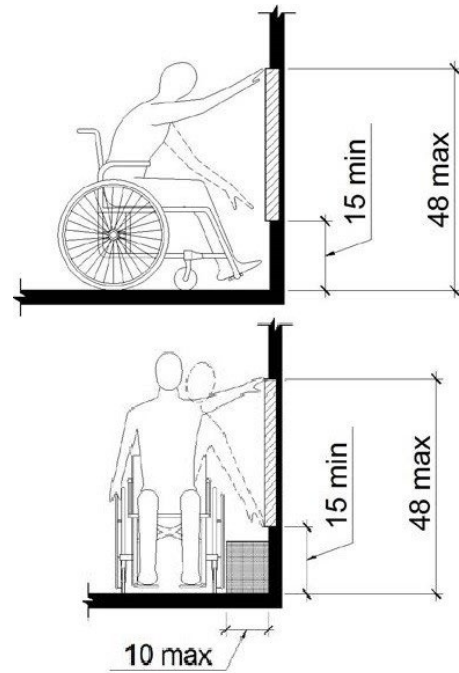
As Built: The Fire Alarm pull is positioned at 3 qty – 60" to fire alarm pull which is too high for either a side or front approach. Where a clear floor or ground space allows a parallel approach to an element and the side reach is unobstructed, the high side reach shall be 48 inches maximum and the low side reach shall be 15 inches minimum above the finish floor or ground.

Where a forward reach is unobstructed, the high forward reach shall be 48 inches maximum and the low forward reach shall be 15 inches minimum above the finish floor or ground.

3 (Moderate): Should be completed as soon as possible, but there may be other items that will provide greater access to persons with disabilities. (Includes findings that have a high financial impact on the entity in relationship to the degree of access provided).

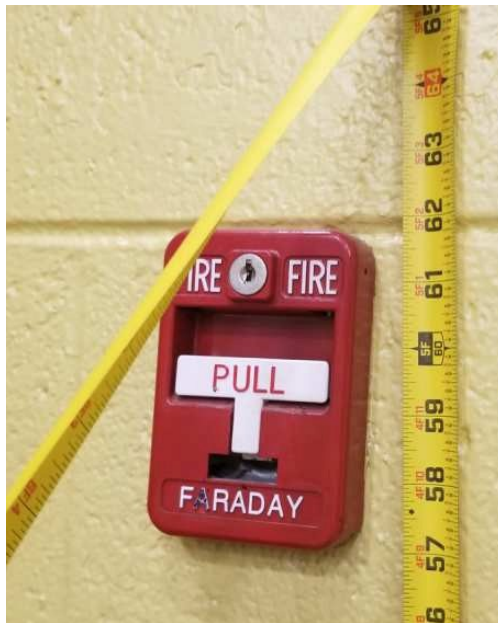
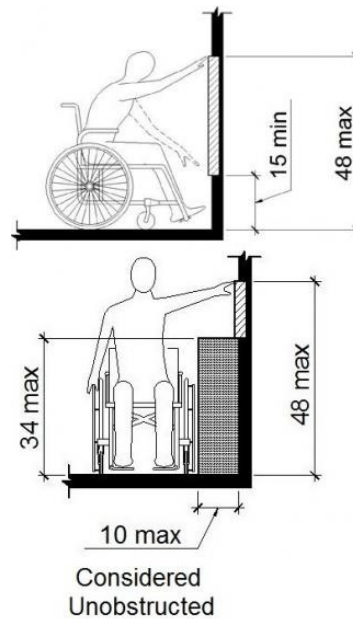
As Built: The fire alarm pull is not positioned correctly for either a side or front approach.

Where a clear floor or ground space allows a parallel or front approach and the side reach is unobstructed, the high side reach shall be 48 inches maximum above the finish floor or ground and the low side reach shall be 15 inches minimum above the finish floor or ground.

3 (Moderate): Should be completed as soon as possible, but there may be other items that will provide greater access to persons with disabilities. (Includes findings that have a high financial impact on the entity in relationship to the degree of access provided).

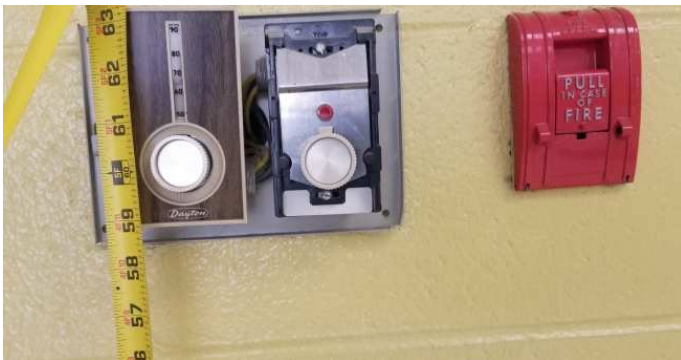
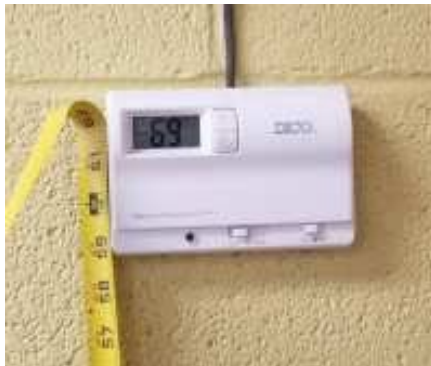
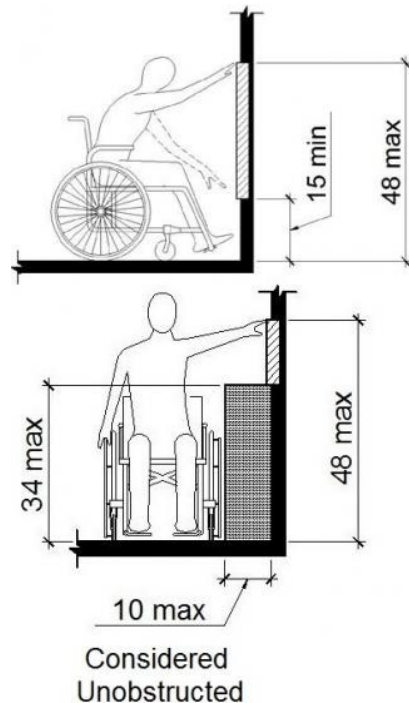
As Built: The thermostats are not positioned correctly for either a side or front approach.

Where a clear floor or ground space allows a parallel or front approach and the side reach is unobstructed, the high side reach shall be 48 inches maximum above the finish floor or ground and the low side reach shall be 15 inches minimum above the finish floor or ground.

3 (Moderate): Should be completed as soon as possible, but there may be other items that will provide greater access to persons with disabilities. (Includes findings that have a high financial impact on the entity in relationship to the degree of access provided).

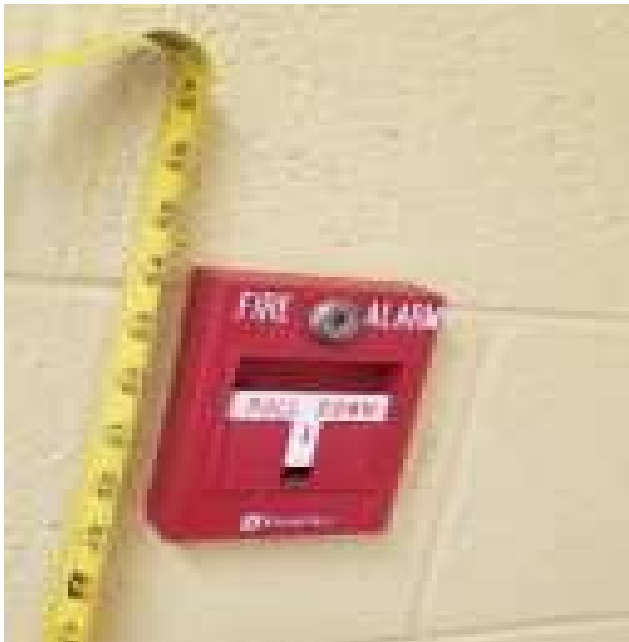
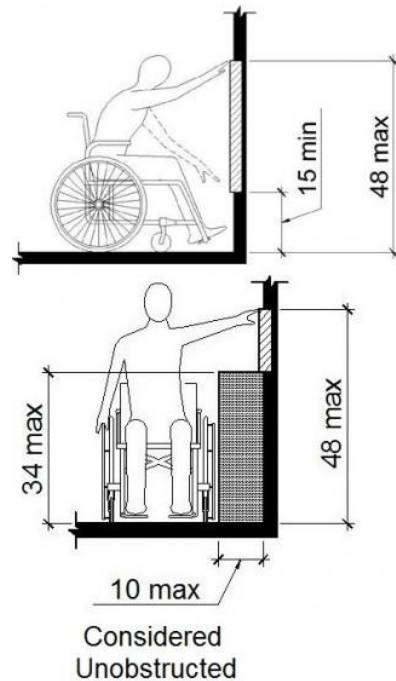
As Built: The Fire Alarm Pull is not positioned correctly for either a side or front approach.

Where a clear floor or ground space allows a parallel or front approach and the side reach is unobstructed, the high side reach shall be 48 inches maximum above the finish floor or ground and the low side reach shall be 15 inches minimum above the finish floor or ground.

3 (Moderate): Should be completed as soon as possible, but there may be other items that will provide greater access to persons with disabilities. (Includes findings that have a high financial impact on the entity in relationship to the degree of access provided).

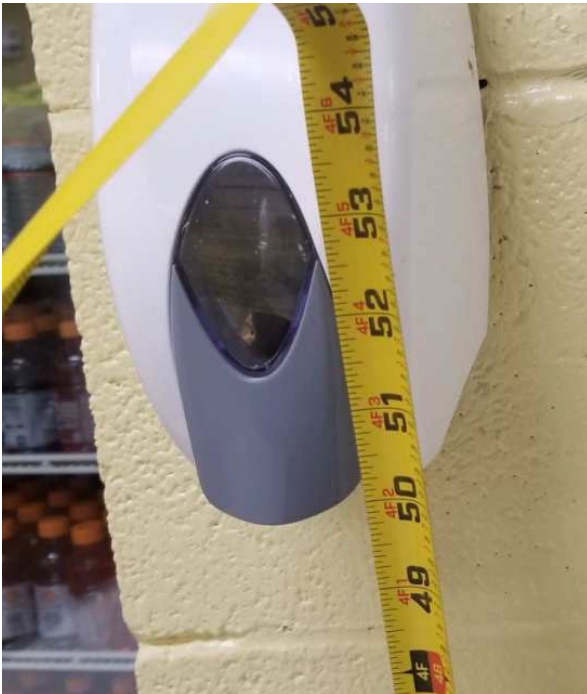
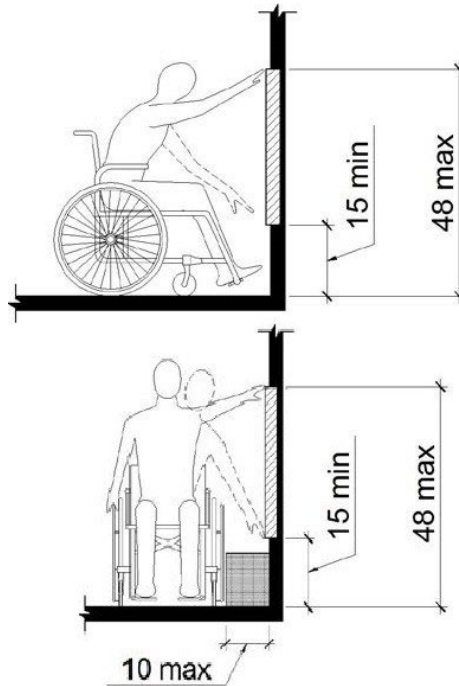
As Built: The soap dispenser is positioned too high for either a side or front approach.

Where a clear floor or ground space allows a parallel approach to an element and the side reach is unobstructed, the high side reach shall be 48 inches maximum and the low side reach shall be 15 inches minimum above the finish floor or ground.

3 (Moderate): Should be completed as soon as possible, but there may be other items that will provide greater access to persons with disabilities. (Includes findings that have a high financial impact on the entity in relationship to the degree of access provided).

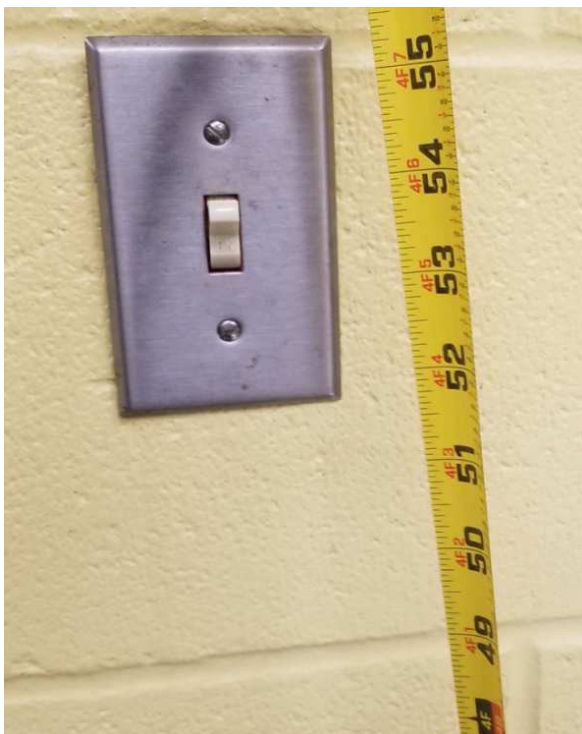
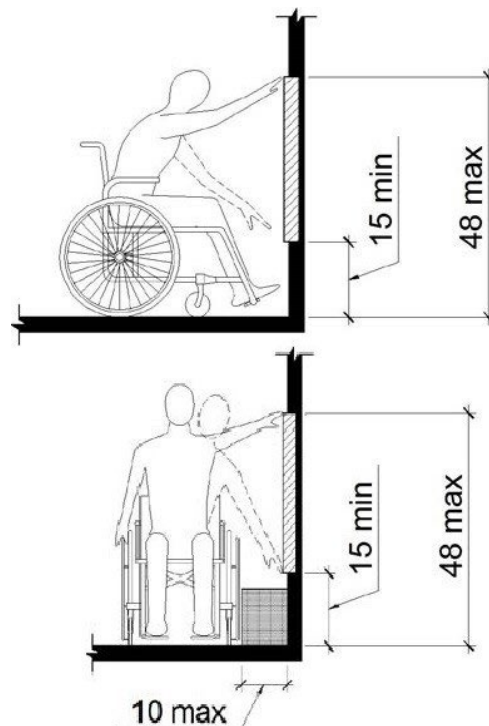
As Built: The light switch is at 53". The receptacle/switch is not positioned correctly for either a side or front approach.

Where a clear floor or ground space allows a parallel or front approach to a switch or receptacle and the side reach is unobstructed, the high side reach shall be 48 inches maximum above the finish floor or ground and the low side reach shall be 15 inches minimum above the finish floor or ground.

3 (Moderate): Should be completed as soon as possible, but there may be other items that will provide greater access to persons with disabilities. (Includes findings that have a high financial impact on the entity in relationship to the degree of access provided).

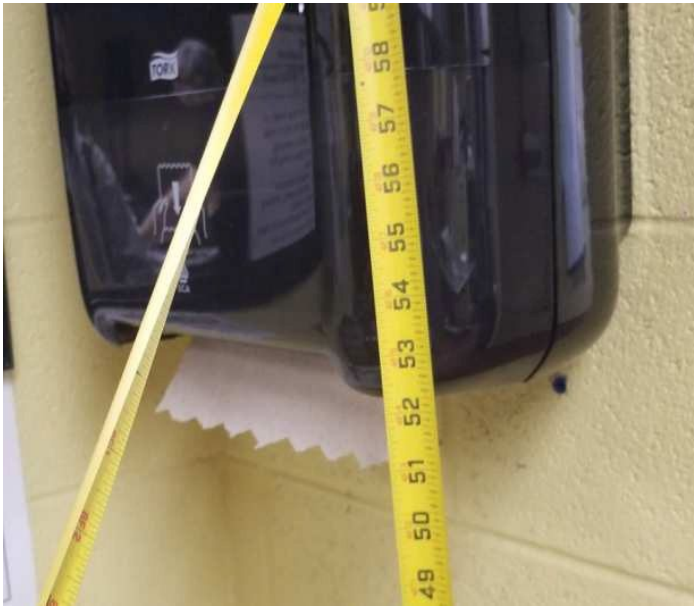
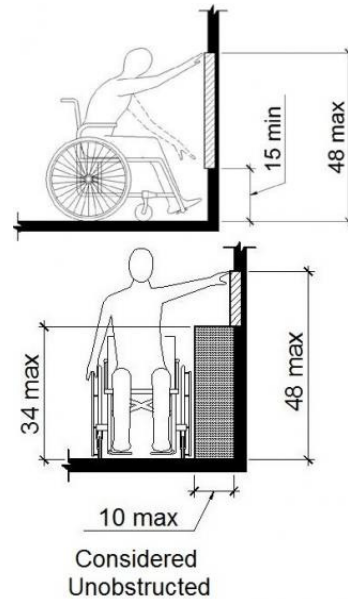
As Built: The paper towel dispenser is at 53" which is not positioned correctly for either a side or front approach.

Where a clear floor or ground space allows a parallel or front approach and the side reach is unobstructed, the high side reach shall be 48 inches maximum above the finish floor or ground and the low side reach shall be 15 inches minimum above the finish floor or ground.

3 (Moderate): Should be completed as soon as possible, but there may be other items that will provide greater access to persons with disabilities. (Includes findings that have a high financial impact on the entity in relationship to the degree of access provided).

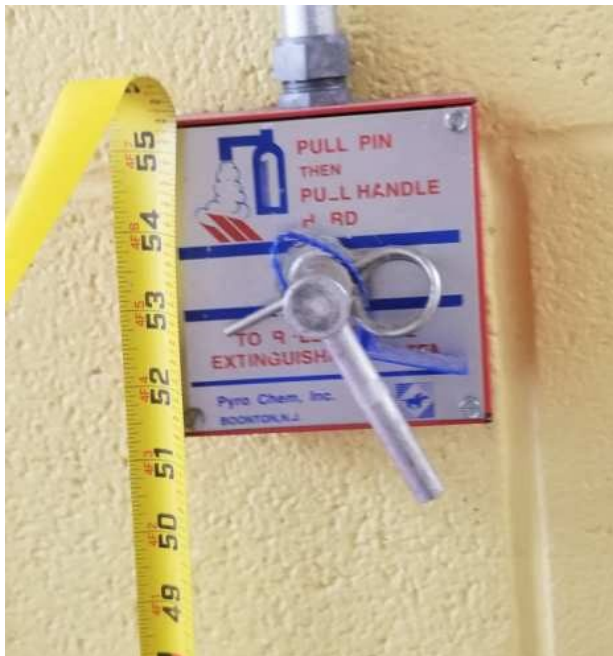
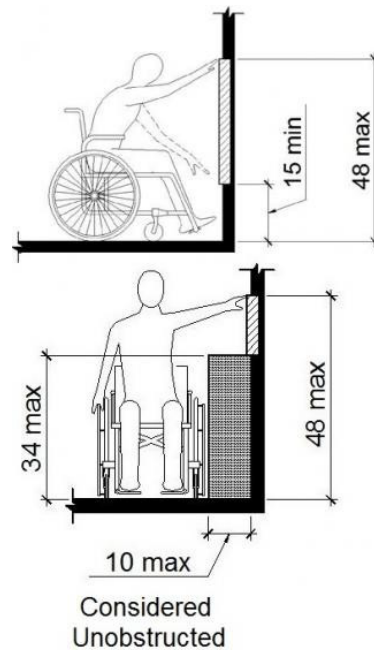
As Built: Ansul System extinguisher lever at 53" and is not positioned correctly for either a side or front approach.

Where a clear floor or ground space allows a parallel or front approach and the side reach is unobstructed, the high side reach shall be 48 inches maximum above the finish floor or ground and the low side reach shall be 15 inches minimum above the finish floor or ground.

3 (Moderate): Should be completed as soon as possible, but there may be other items that will provide greater access to persons with disabilities. (Includes findings that have a high financial impact on the entity in relationship to the degree of access provided).

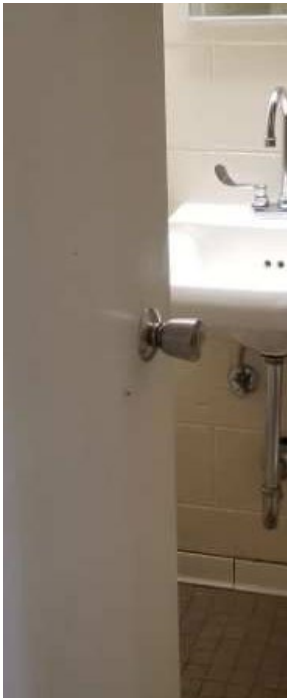
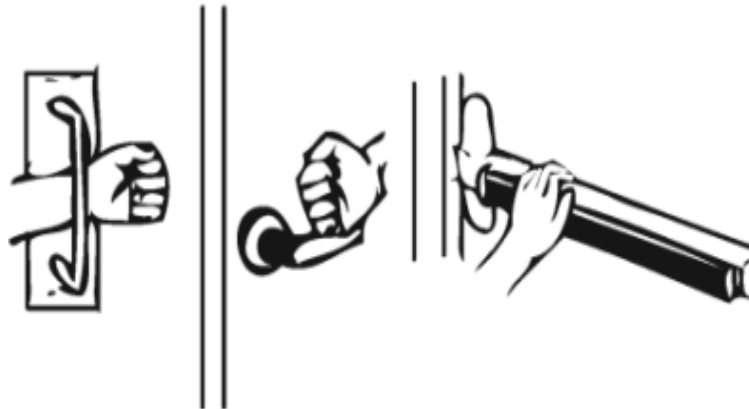
As Built: The door/gate operating hardware is a round knob, which is not accessible.

Hand-activated door/gate opening hardware, handles, pulls, latches, locks, and other operating devices on accessible doors shall have a shape that is easy to grasp with one hand and does not require tight grasping, tight pinching or twisting of the wrist to operate. Hardware shall be 34 inches minimum and 48 inches maximum above the finish floor or ground.

3 (Moderate): Should be completed as soon as possible, but there may be other items that will provide greater access to persons with disabilities. (Includes findings that have a high financial impact on the entity in relationship to the degree of access provided).

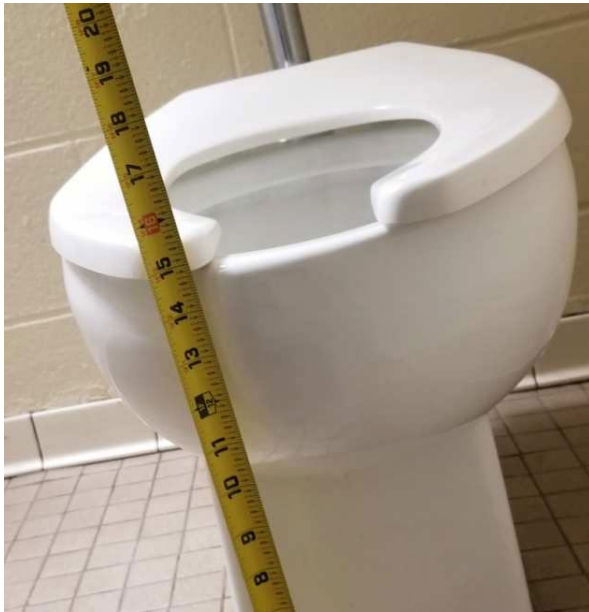
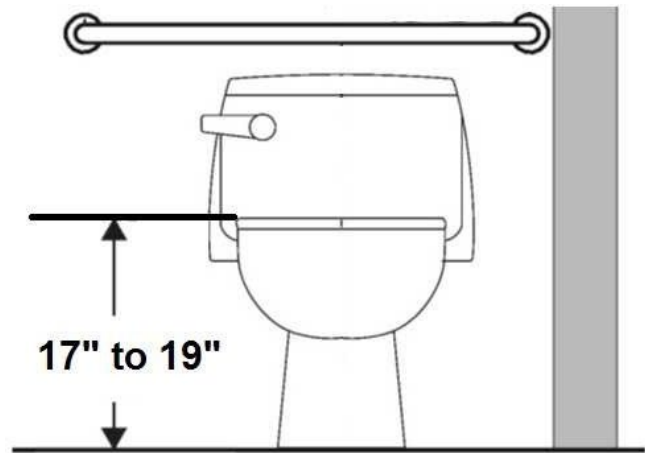
As Built: The toilet seat is located 15.5" off the floor.

The height of accessible water closets shall be a minimum of 17 inches and a maximum of 19 inches measured to the top of the toilet seat. The seat itself shall be a maximum of 2 inch high.

3 (Moderate): Should be completed as soon as possible, but there may be other items that will provide greater access to persons with disabilities. (Includes findings that have a high financial impact on the entity in relationship to the degree of access provided).

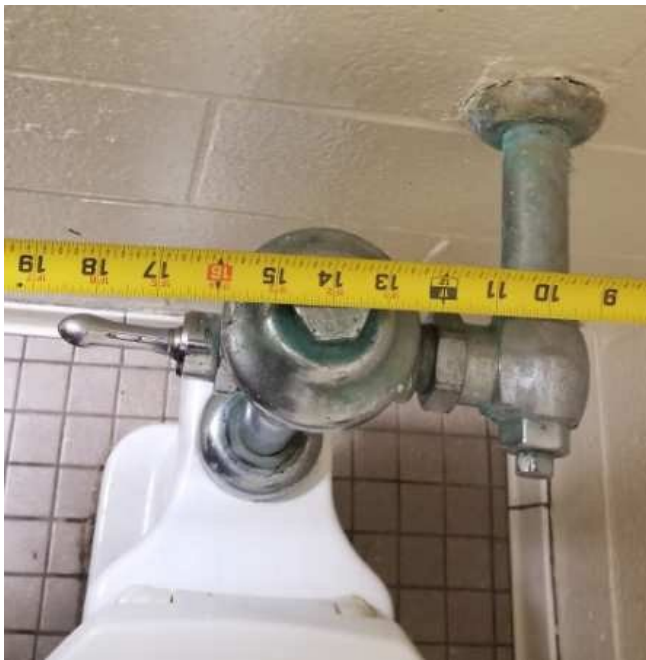
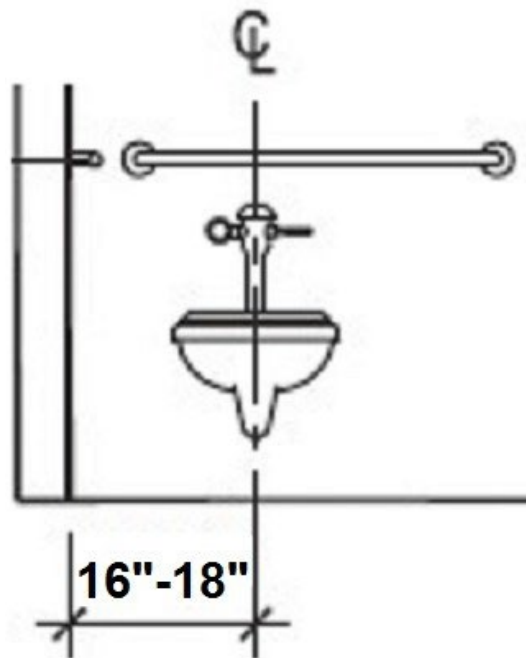
As Built: The toilet is not located within the range allowed from the side wall or partition. The centerline of the toilet must be 16 to 18 inches from the side wall and it is at 14".

Citation: 2010 ADAS Section 604.2

3 (Moderate): Should be completed as soon as possible, but there may be other items that will provide greater access to persons with disabilities. (Includes findings that have a high financial impact on the entity in relationship to the degree of access provided).
