WEAKLEY COUNTY, TENNESSEE

ADA EVALUATION

Architectural and Site Findings with Recommendations

TLM Associates, Inc

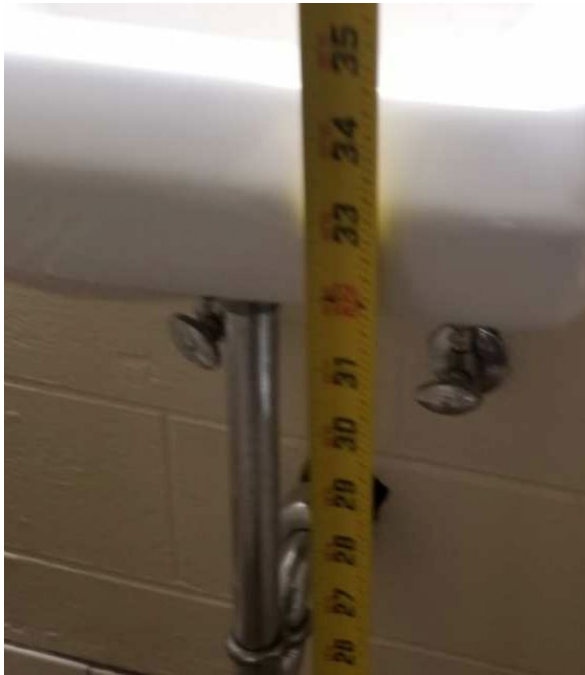
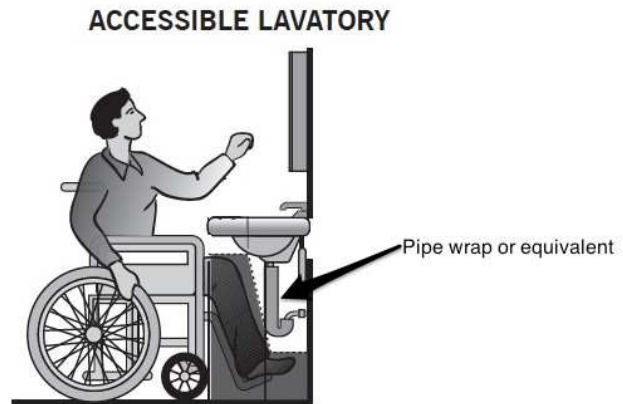
As Built: The water and drain pipes under the lavatory are not adequately insulated.

Water supply and drain pipes under lavatories and sinks shall be insulated or otherwise configured to protect against contact. There shall be no sharp or abrasive surfaces under lavatories and sinks.

3 (Moderate): Should be completed as soon as possible, but there may be other items that will provide greater access to persons with disabilities. (Includes findings that have a high financial impact on the entity in relationship to the degree of access provided).

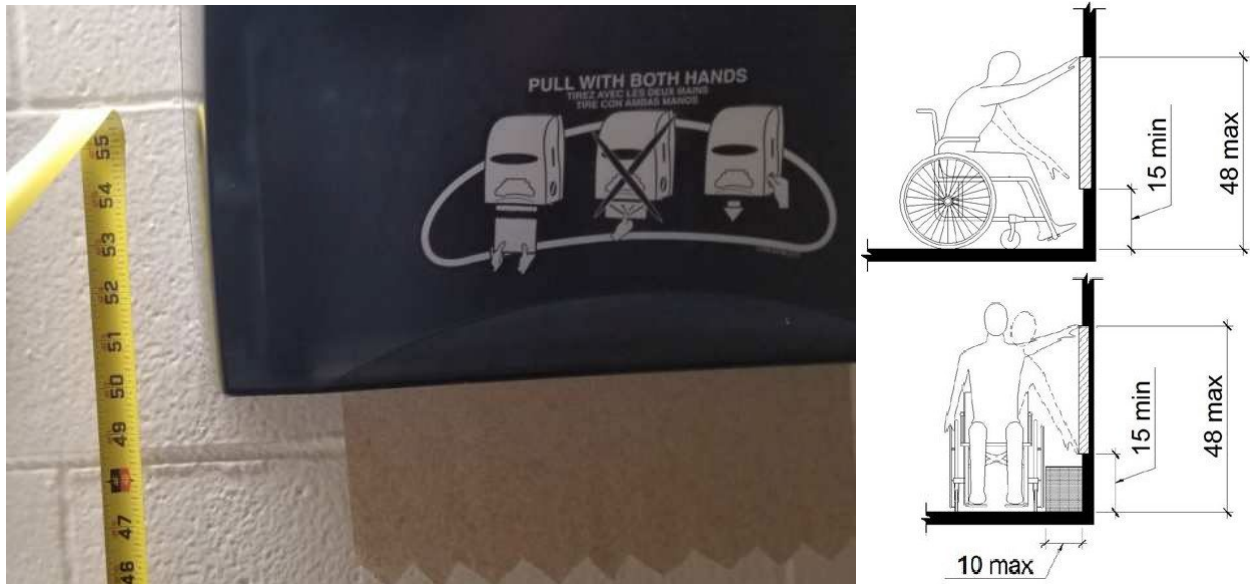
As Built: The paper towel dispenser is positioned too high for either a side or front approach.

Where a clear floor or ground space allows a parallel approach to an element and the side reach is unobstructed, the high side reach shall be 48 inches maximum and the low side reach shall be 15 inches minimum above the finish floor or ground.

3 (Moderate): Should be completed as soon as possible, but there may be other items that will provide greater access to persons with disabilities. (Includes findings that have a high financial impact on the entity in relationship to the degree of access provided).

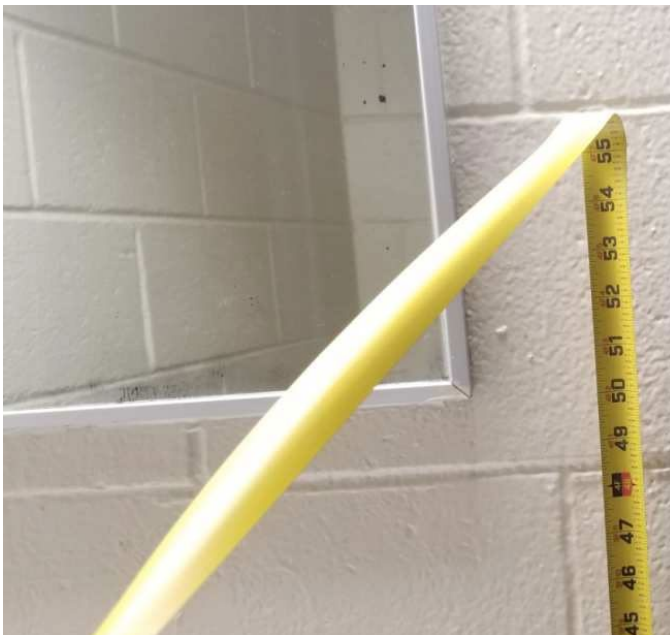
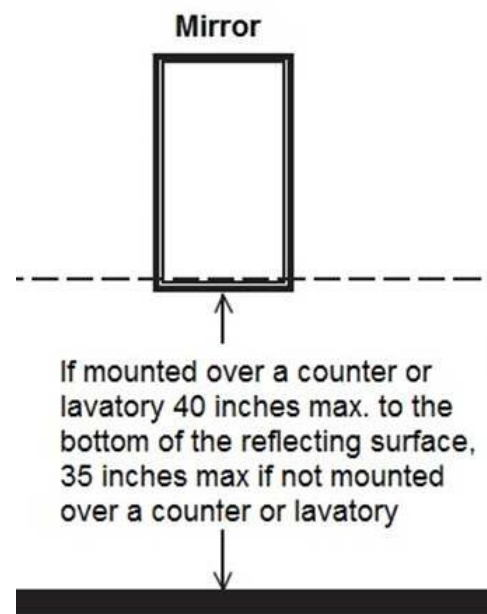
As Built: The mirror is mounted at 50.5" which is too high.

Mirrors must have the bottom edge of the reflecting surface a maximum of 40 inches above the floor if above a sink or counter. Mirrors not located above lavatories or countertops shall be installed with the bottom edge of the reflecting surface 35 inches maximum above the finish floor or ground.

3 (Moderate): Should be completed as soon as possible, but there may be other items that will provide greater access to persons with disabilities. (Includes findings that have a high financial impact on the entity in relationship to the degree of access provided).

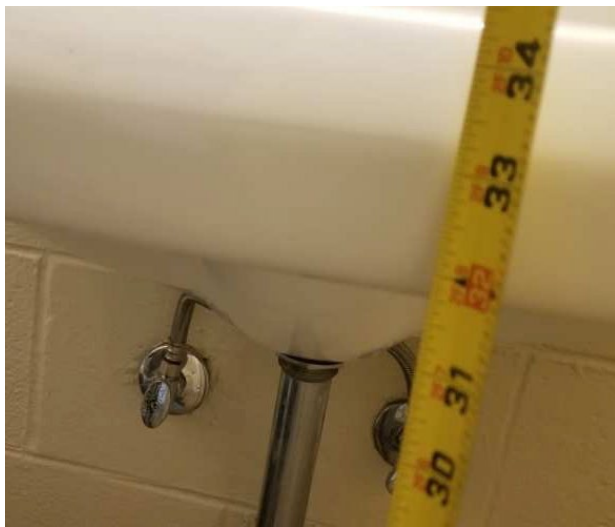
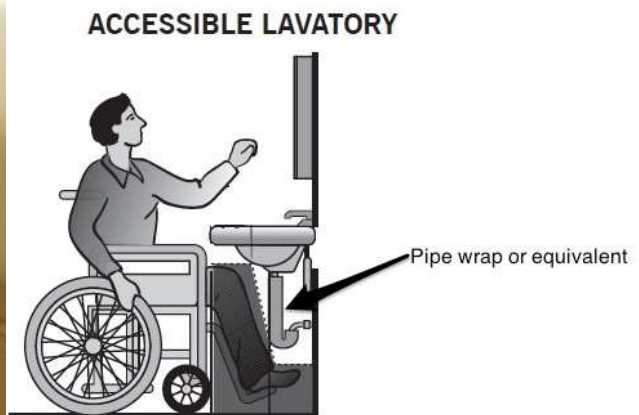
As Built: The water and drain pipes under the lavatory are not adequately insulated.

Water supply and drain pipes under lavatories and sinks shall be insulated or otherwise configured to protect against contact. There shall be no sharp or abrasive surfaces under lavatories and sinks.

3 (Moderate): Should be completed as soon as possible, but there may be other items that will provide greater access to persons with disabilities. (Includes findings that have a high financial impact on the entity in relationship to the degree of access provided).

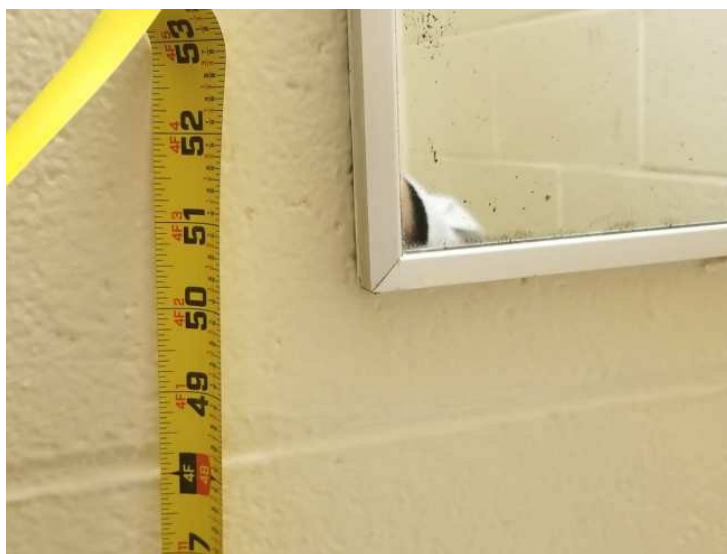
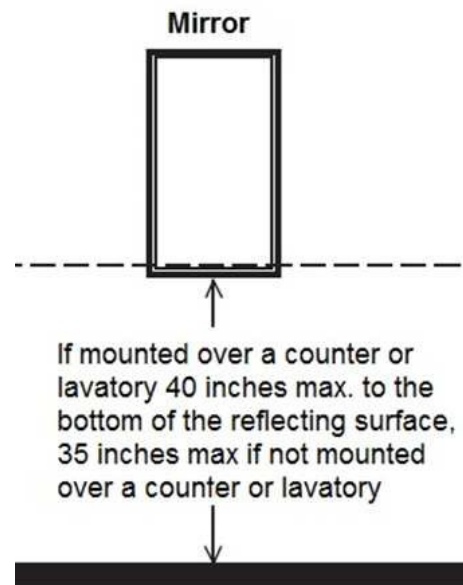
As Built: The mirror is mounted at 50.5" which is too high.

Mirrors must have the bottom edge of the reflecting surface a maximum of 40 inches above the floor if above a sink or counter. Mirrors not located above lavatories or countertops shall be installed with the bottom edge of the reflecting surface 35 inches maximum above the finish floor or ground.

3 (Moderate): Should be completed as soon as possible, but there may be other items that will provide greater access to persons with disabilities. (Includes findings that have a high financial impact on the entity in relationship to the degree of access provided).

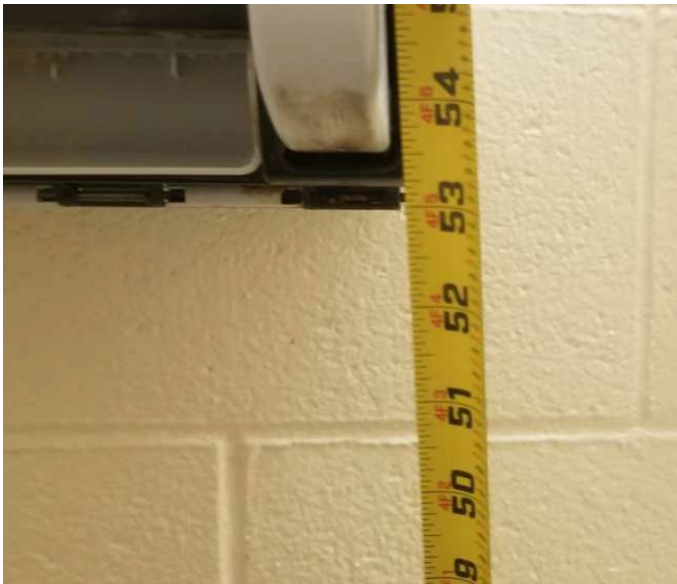
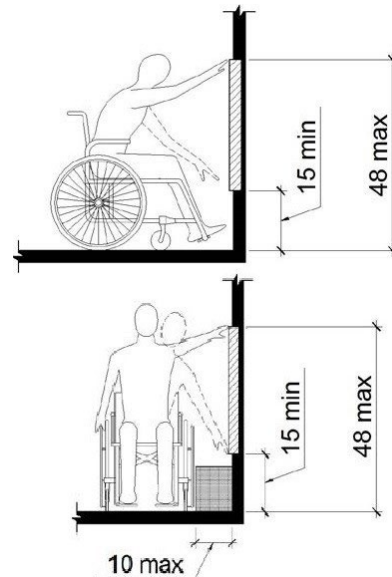
As Built: The paper towel dispenser is positioned 53" which is too high for either a side or front approach.

Where a clear floor or ground space allows a parallel approach to an element and the side reach is unobstructed, the high side reach shall be 48 inches maximum and the low side reach shall be 15 inches minimum above the finish floor or ground.

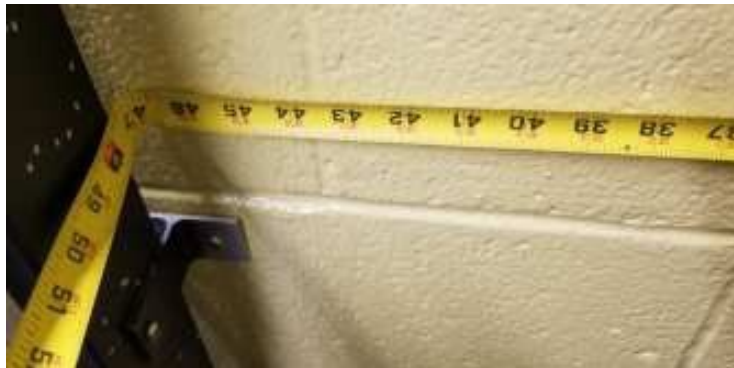
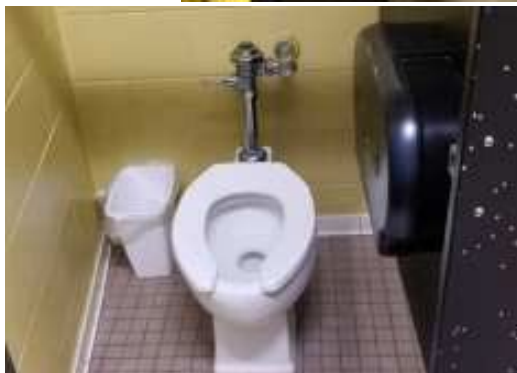
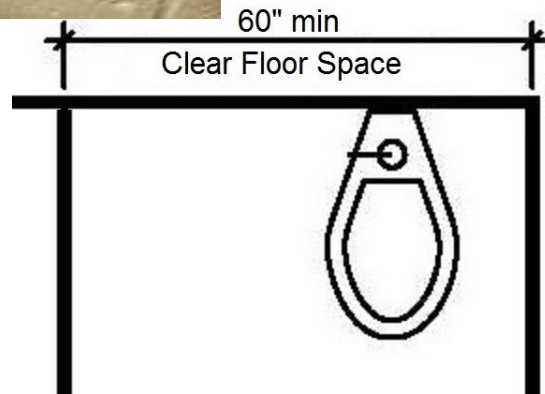
As Built: The toilet compartment is 36" wide which is not wide enough.

Wheelchair accessible compartments shall be 60 inches wide minimum measured perpendicular to the side wall, and 56 inches deep minimum for wall hung water closets and 59 inches deep minimum for floor mounted water closets measured perpendicular to the rear wall.

Demo stall and toilet to right, repair, and patch drainage, install new toilet partitions with new door, grab bars, and coat hook.

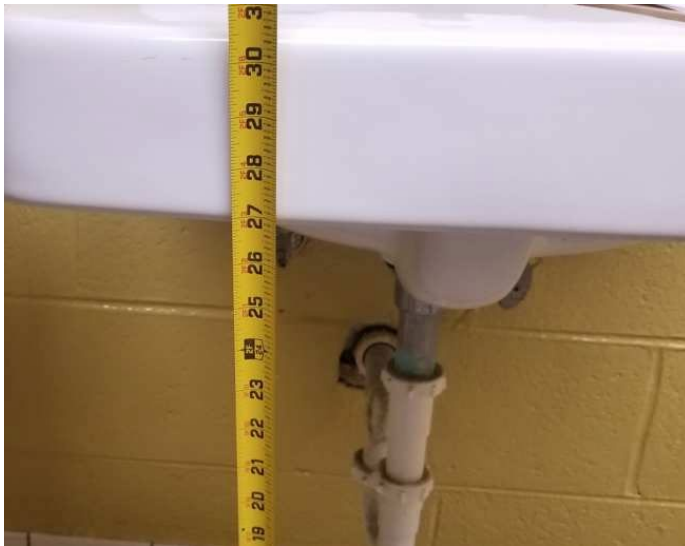
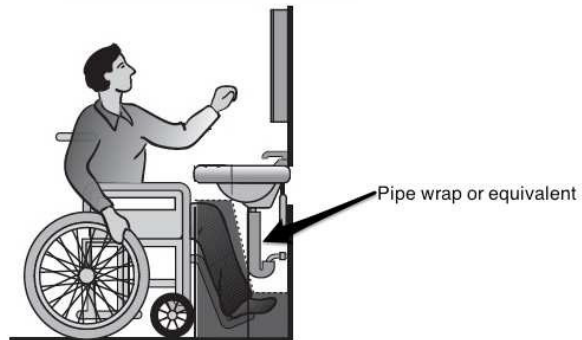
ACCESSIBLE LAVATORY

As Built: The water and drain pipes under the lavatory are not adequately insulated.

Water supply and drain pipes under lavatories and sinks shall be insulated or otherwise configured to protect against contact. There shall be no sharp or abrasive surfaces under lavatories and sinks.

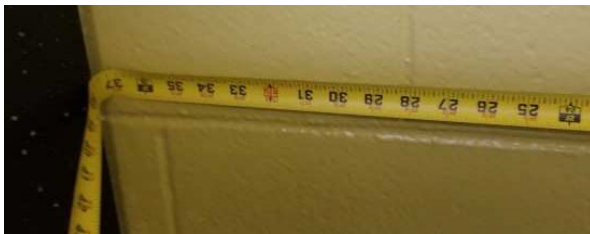
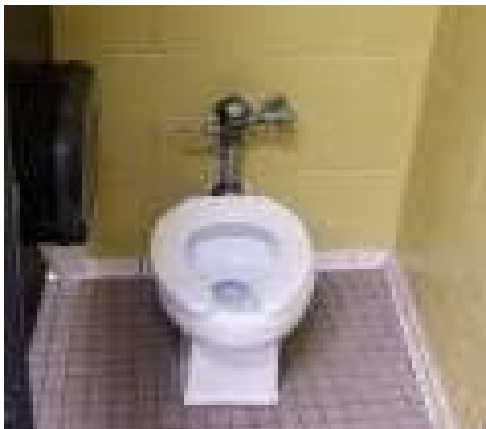
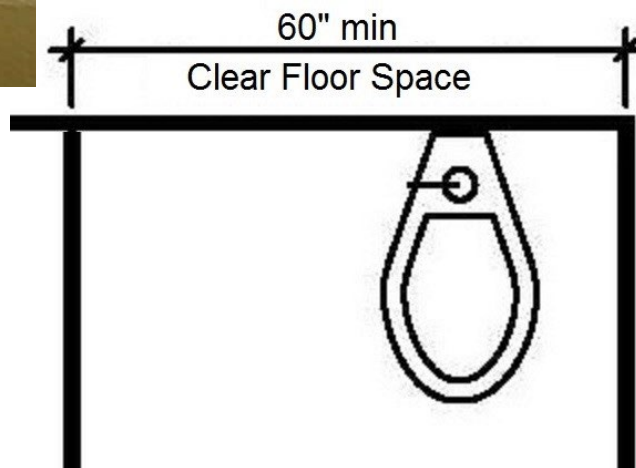
As Built: The toilet compartment is 37" wide which is not wide enough.

Wheelchair accessible compartments shall be 60 inches wide minimum measured perpendicular to the side wall, and 56 inches deep minimum for wall hung water closets and 59 inches deep minimum for floor mounted water closets measured perpendicular to the rear wall.

Demo compartment and toilet on left, patch and repair toilet drain, install new toilet partitions with door, grab bars, and coat hook.

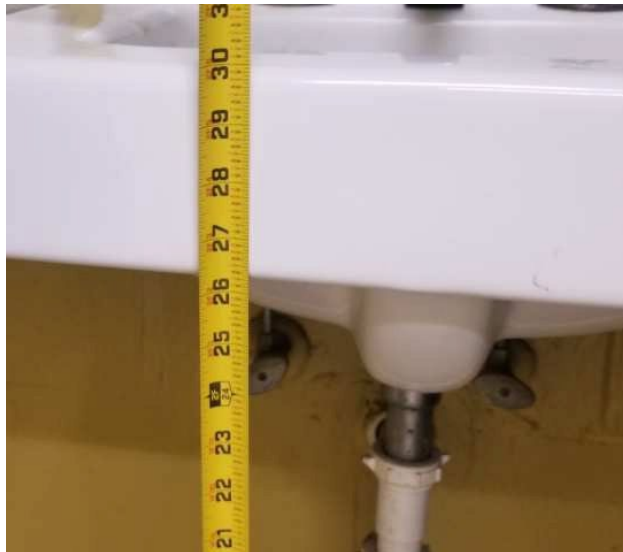
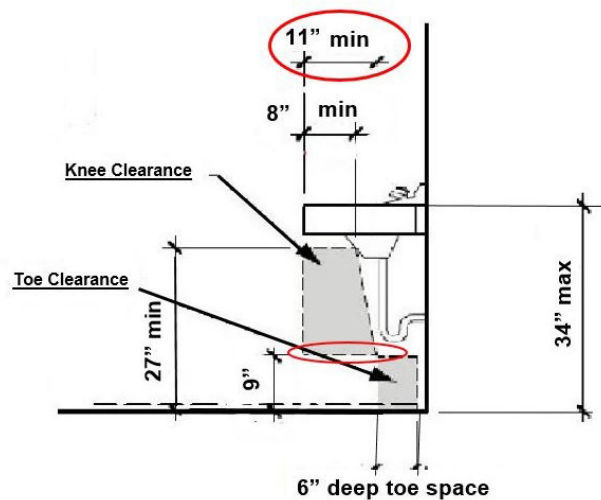
As Built: Compliant knee space has not been provided under the lavatory.

The knee clearance shall be 11 inches minimum in depth at 9 inches above the floor, and 8 inches minimum in depth at 27 inches above the floor. The top of the lavatory rim may be no higher than 34 inches.

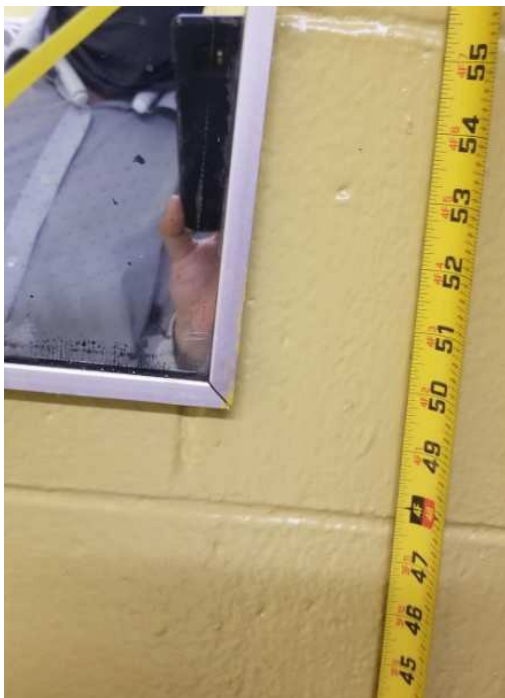
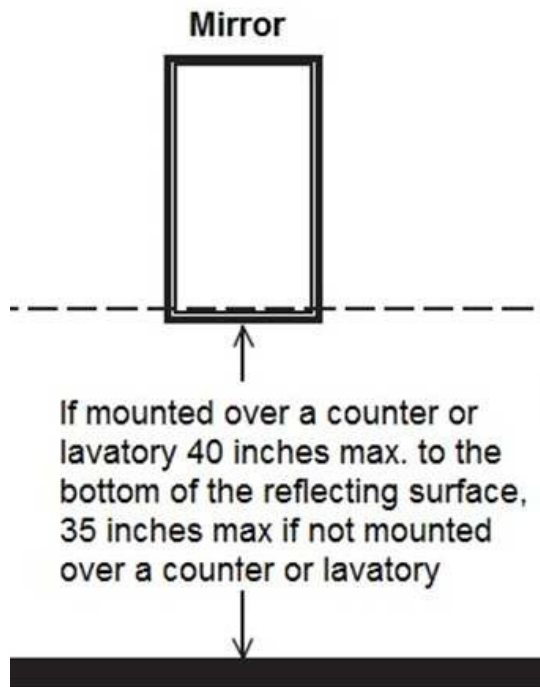
As Built: The mirror is mounted at 50" which is too high.

Mirrors must have the bottom edge of the reflecting surface a maximum of 40 inches above the floor if above a sink or counter. Mirrors not located above lavatories or countertops shall be installed with the bottom edge of the reflecting surface 35 inches maximum above the finish floor or ground.

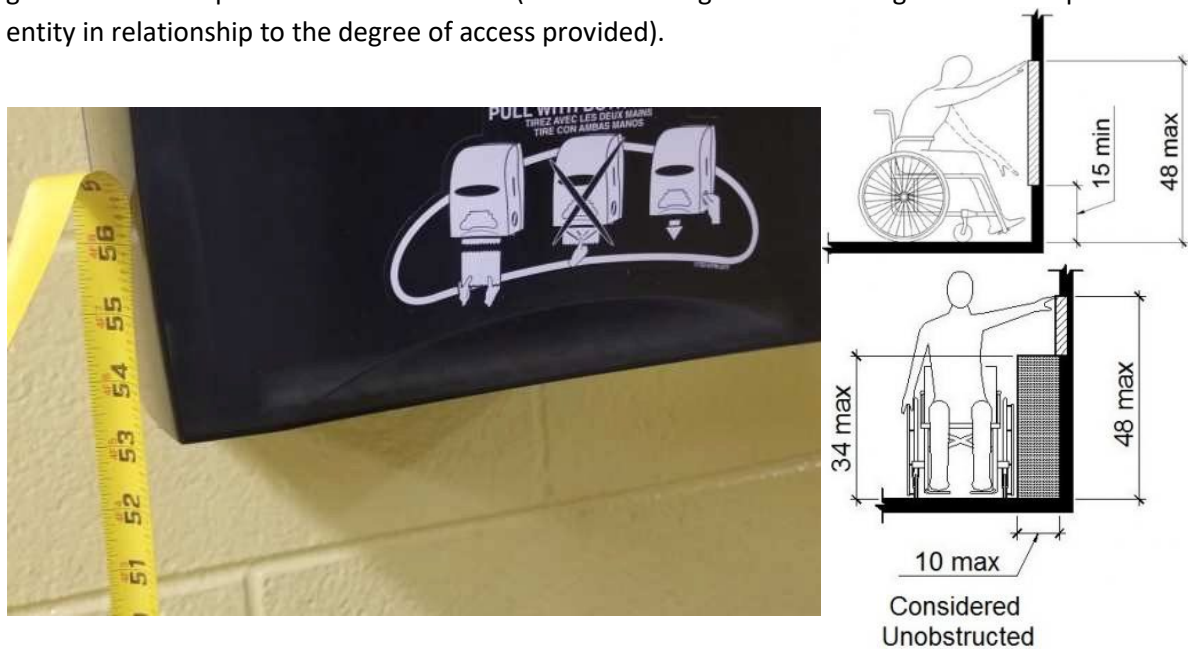
As Built: The paper towel dispenser is positioned at 53" which is not correct for either a side or front approach.

Where a clear floor or ground space allows a parallel or front approach and the side reach is unobstructed, the high side reach shall be 48 inches maximum above the finish floor or ground and the low side reach shall be 15 inches minimum above the finish floor or ground.

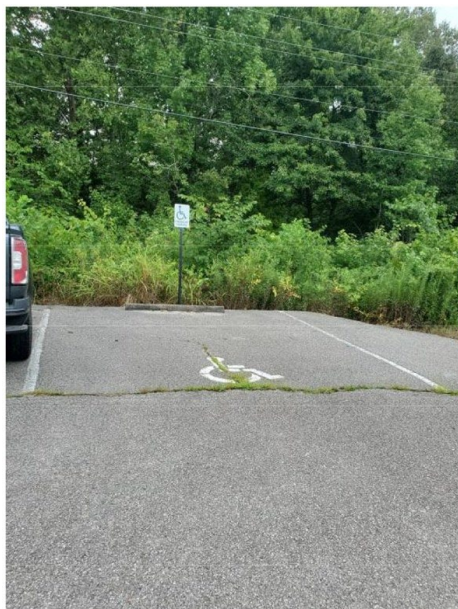
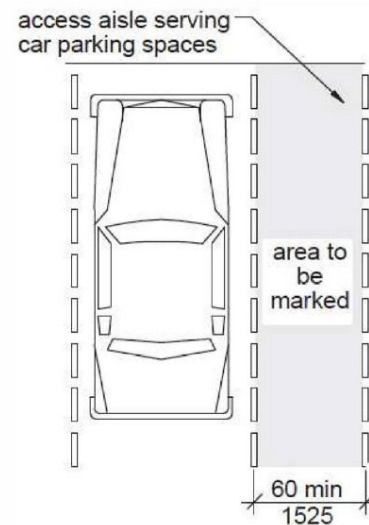
As Built: The access aisle is missing at the accessible parking stall.

Access aisles serving parking spaces shall adjoin an accessible route. Two parking spaces shall be permitted to share a common access aisle.

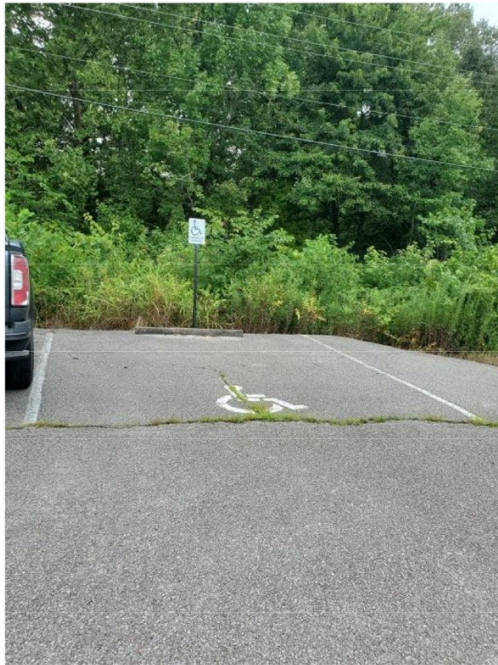
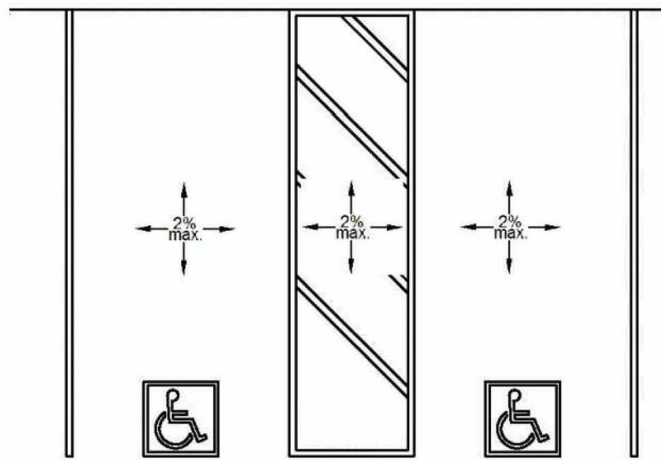
As Built: The running slope (long dimension) of the accessible parking stall is at 6.3%.

The running slope in an accessible parking stall and the access aisle must not exceed 2%.

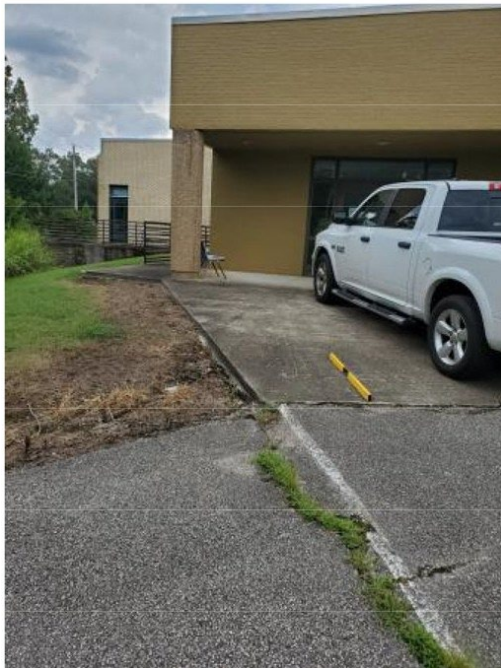
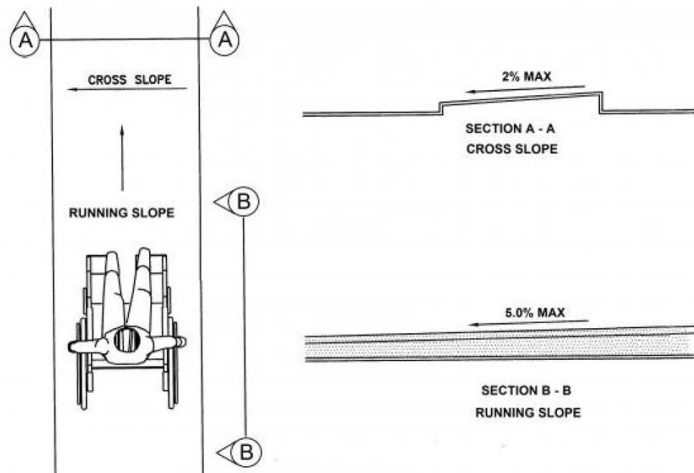
As Built: The accessible route between the building entrance and the accessible parking on the site contains running slopes greater than 5% and has not been constructed as a ramp (i.e. handrails, wheel guides, etc.).

When the slope in the direction of travel of any walk exceeds 1 unit vertical in 20 units horizontal (5-percent slope), it must be constructed as ramp. Surface cross slopes must not exceed one unit vertical in 48 units. Horizontal (2-percent slope).

Replace sidewalk along accessible route to ensure less than 5% running slope and 2% cross slope. If the running slope must exceed 5%, install handrail.

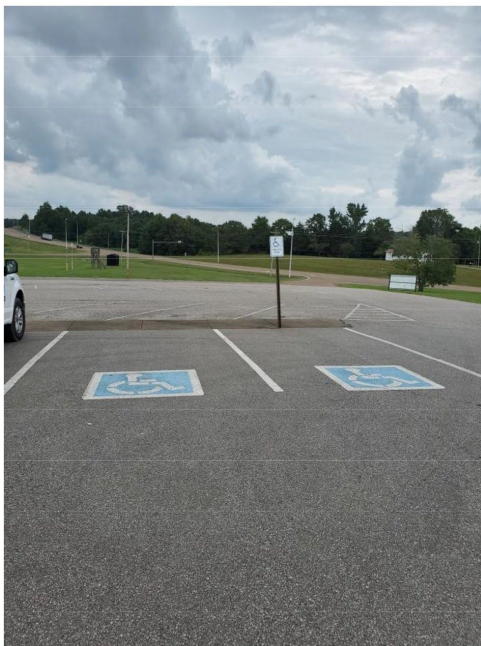
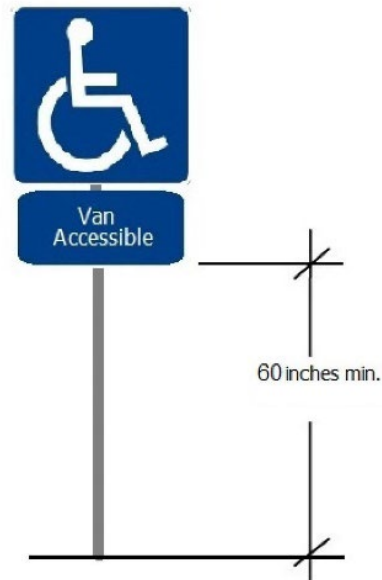
As Built: The required parking signage is missing.

Parking space identification signs shall include the International Symbol of Accessibility (ISA). Signs identifying van parking spaces shall contain the designation "van accessible." All signs shall be 60 inches minimum above the finish floor or ground surface measured to the bottom of the sign.

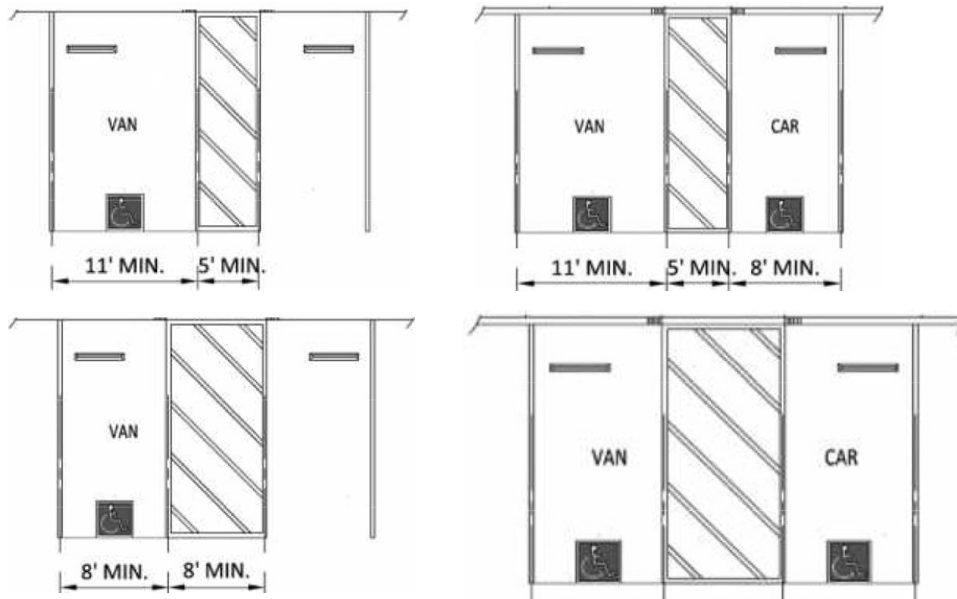
As Built: The accessible parking stall is 10' wide.

Each parking space and access aisle must be marked to meet one of the acceptable layouts in the diagram above. The measurements of parking spaces and access aisles shall be made from the centerline of the markings. Where the parking space is not adjacent to another parking space or access aisle, the measurement shall be permitted to include the full width of the line defining the parking space.

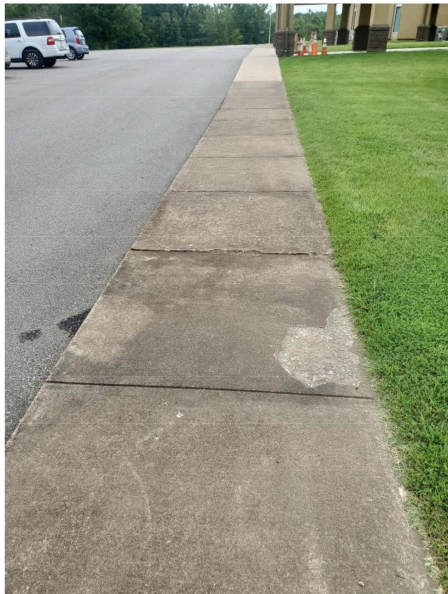
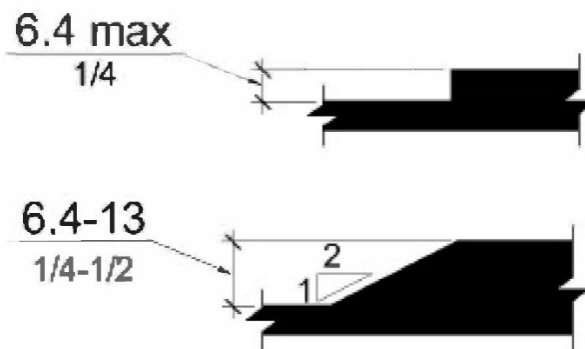
As Built: The surface of the pedestrian access route has vertical discontinuities greater than 1/2 inch or between 1/4 inch and 1/2 inch that are not beveled.

Vertical surface discontinuities shall be 0.5 inch maximum. Vertical surface discontinuities between 0.25 inch and 0.5 inch shall be beveled with a slope not steeper than 50 percent. The bevel shall be applied across the entire vertical surface discontinuity.

Replace 2 panels to flush conditions.

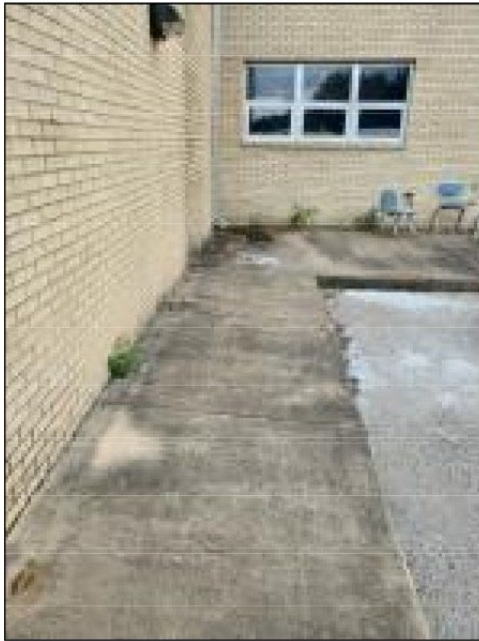
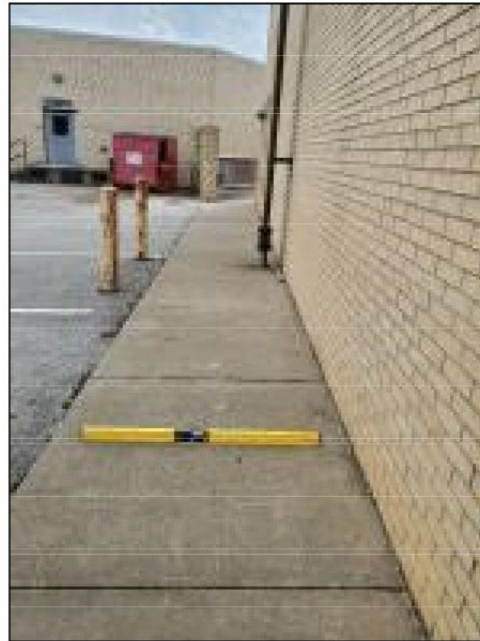
As Built: The cross slope of the pedestrian access route slope varies up to 4.4%.

The cross slope of pedestrian access routes shall be 2 percent maximum.

Replace sidewalks exceeding 2%.

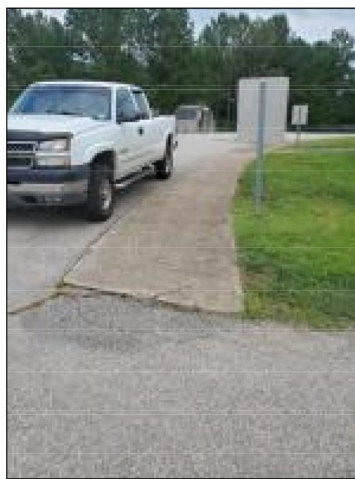
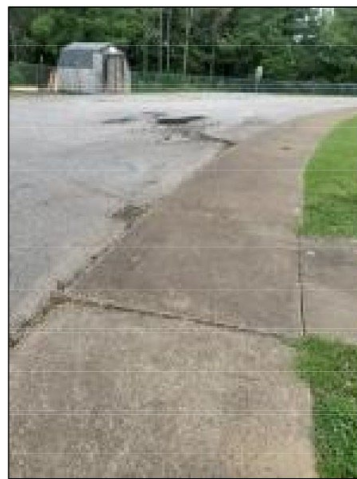
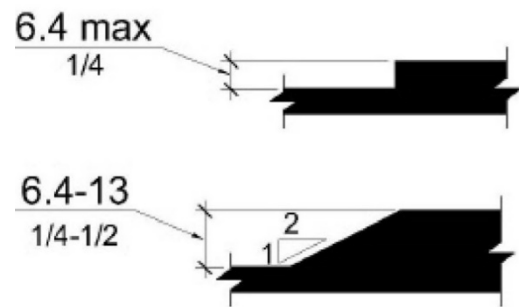
As Built: The surface of the pedestrian access route has vertical discontinuities greater than 1/2 inch or between 1/4 inch and 1/2 inch that are not beveled.

Vertical surface discontinuities shall be 0.5 inch maximum. Vertical surface discontinuities between 0.25 inch and 0.5 inch shall be beveled with a slope not steeper than 50 percent. The bevel shall be applied across the entire vertical surface discontinuity.

Replace panels to provide flush surface.

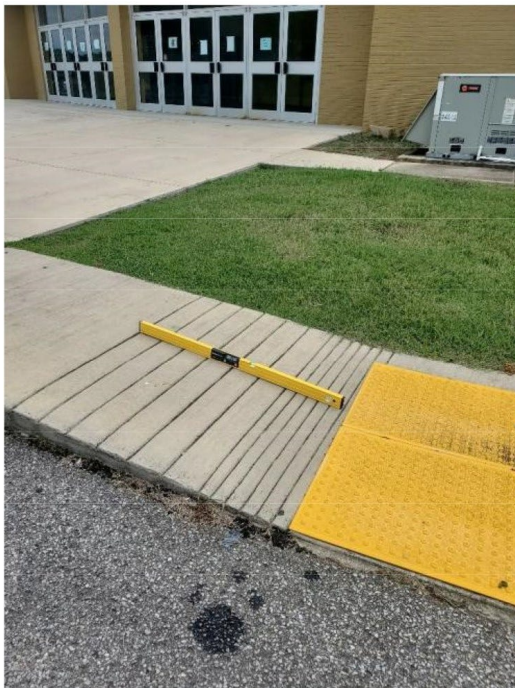
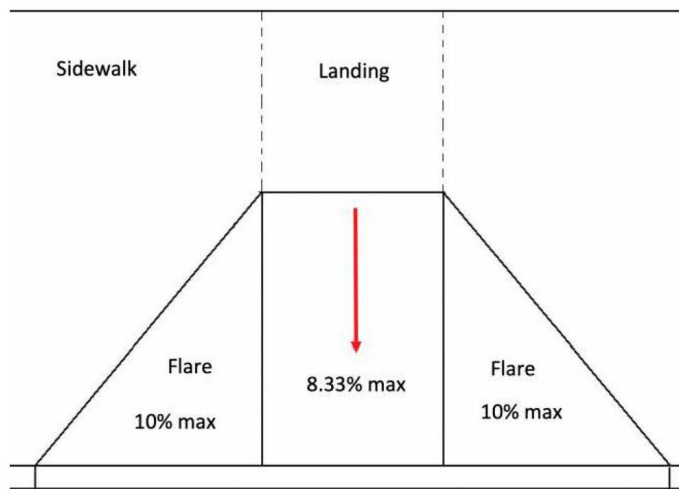
As Built: The curb ramp slopes at 8.8% (Parallel to the direction of travel)

Curb ramps should have the least possible slope but in no case more than 8.3% (1:12).

Replace the ramp.

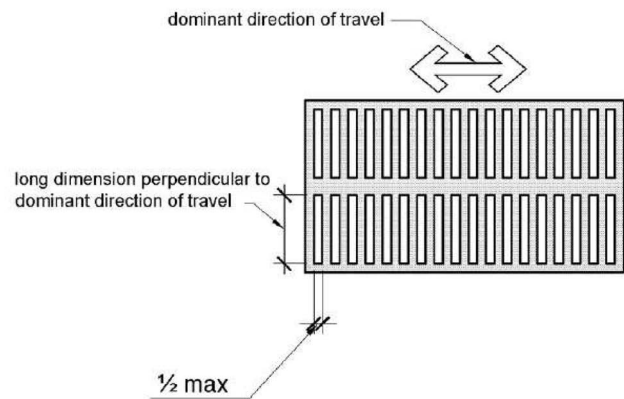
As Built: The concrete expansion joint is spaced greater than a 1/2 inch.

Citation: 2011 PROWAG Section R302.7.3

Provide sealant to create flush condition.

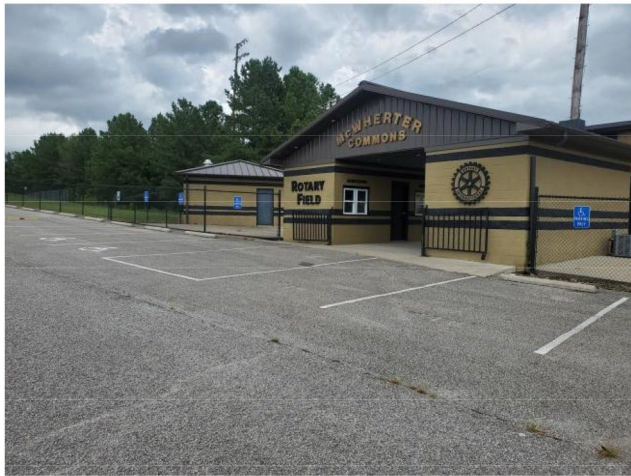
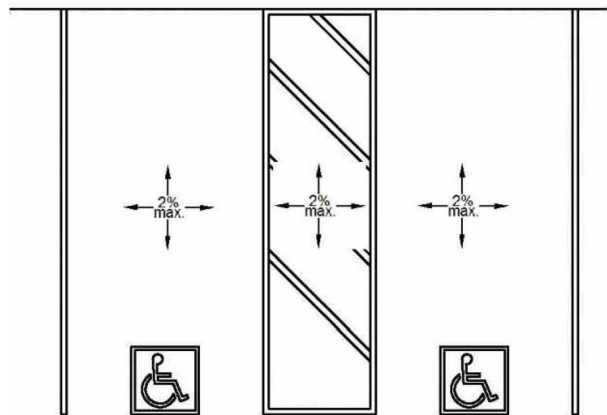
As Built: The cross slope (narrow dimension) of the parking stall varies up to 5.5%

The running and cross slope in an accessible parking stall and the access aisle must not exceed 2%.

Resurfacing lot to correct that drastic of a slope is not feasible. A survey will be required to determine the extent of demolition. Our recommendation would be to demolish 6 spaces southeast of the entrance, pour new concrete handicap space and sidewalk.

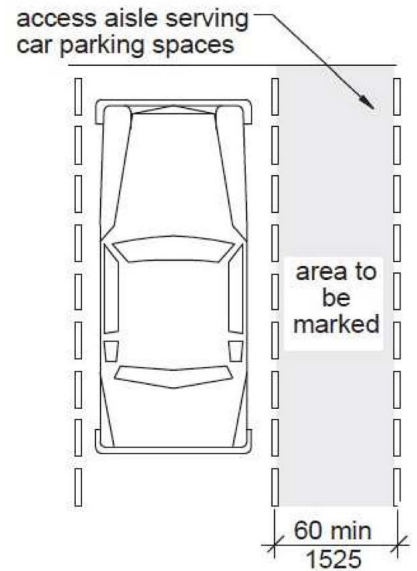
As Built: The access aisle is missing at the accessible parking stall.

Access aisles serving parking spaces shall adjoin an accessible route. Two parking spaces shall be permitted to share a common access aisle.

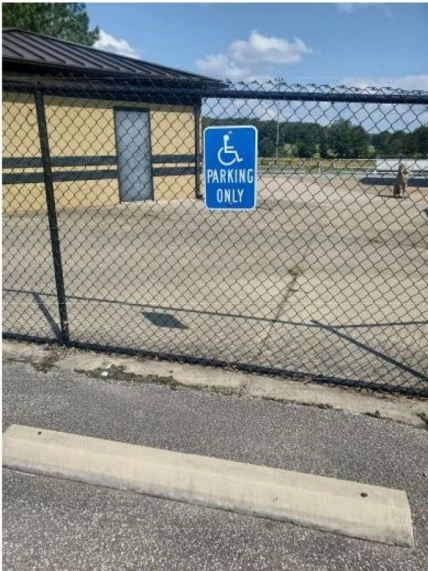
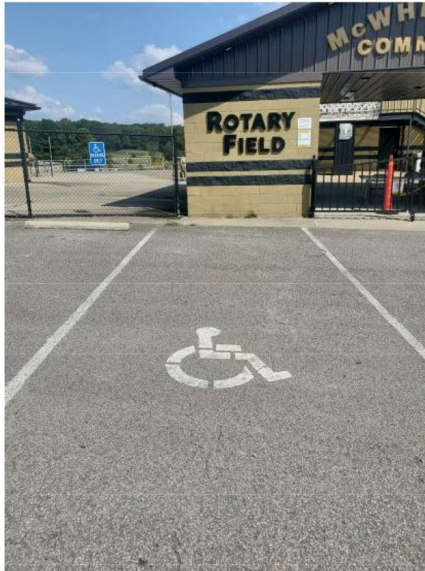
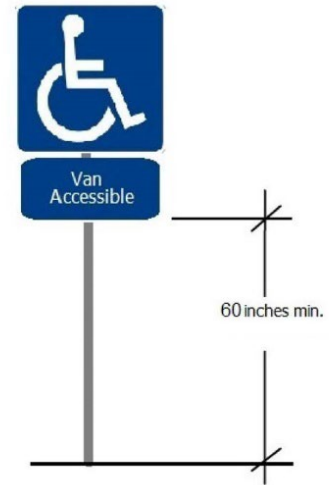
As Built: The required parking signage is missing.

Citation: 2010 ADAS Section 502.6

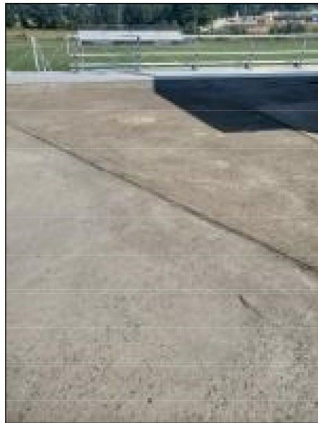
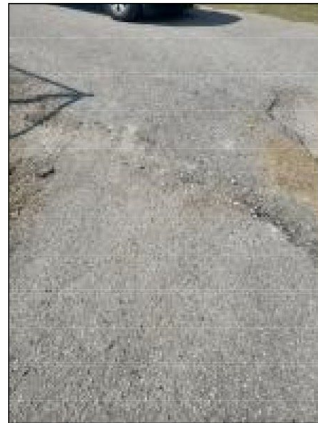
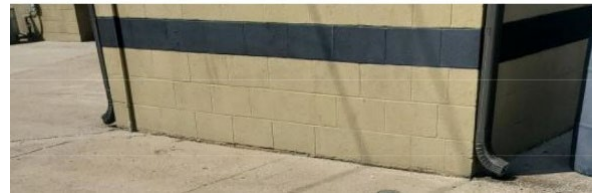
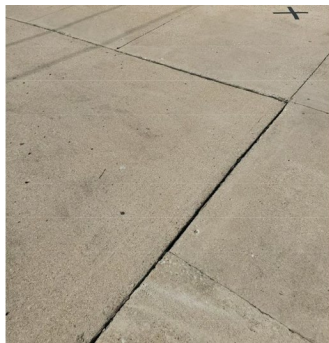
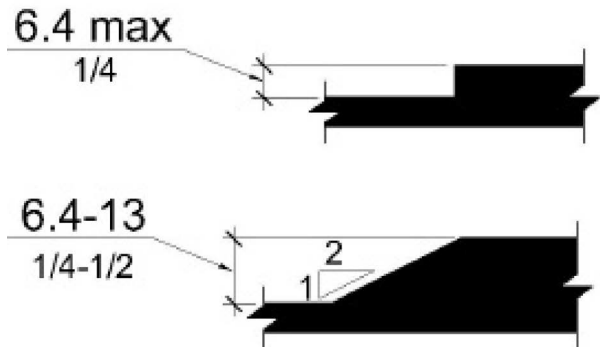
As Built: The surface of the pedestrian access route has vertical discontinuities greater than 1/2 inch or between 1/4 inch and 1/2 inch that are not beveled.

Citation: 2011 PROWAG Section R302.7.2

Recommendation:

Replace approximately 10'x90' of the pedestrian access route.

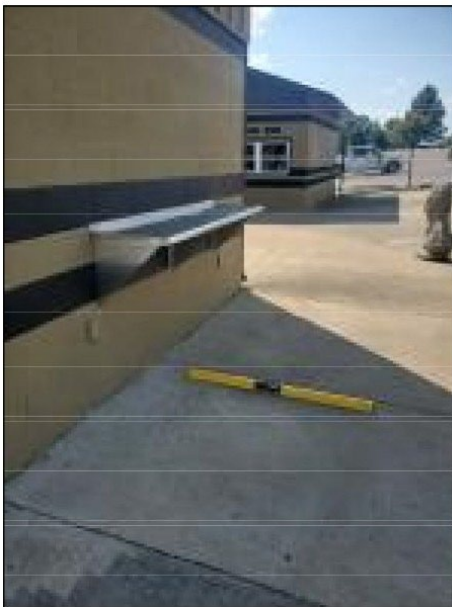
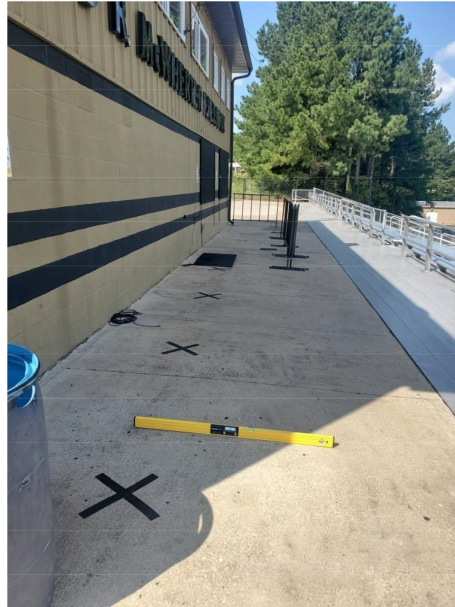
As Built: The cross slope of the pedestrian access route varies up to 4.3% in concession area and condiment counter.

The cross slope of pedestrian access routes shall be 2 percent maximum.

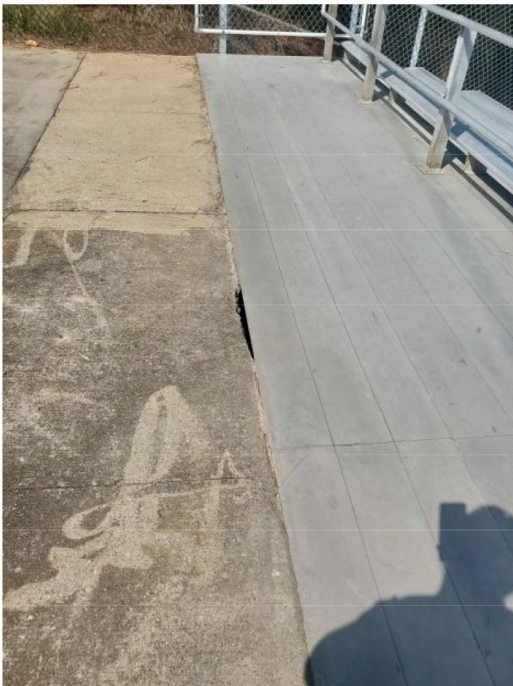
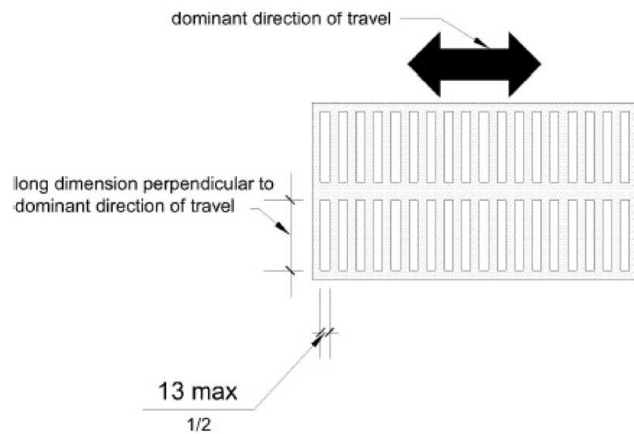
As Built: The surface of the pedestrian access route has openings greater than 1", which exceeds the 1/2 inch max.

Horizontal openings in gratings and joints shall not permit passage of a sphere more than 13 mm (0.5 in) in diameter.

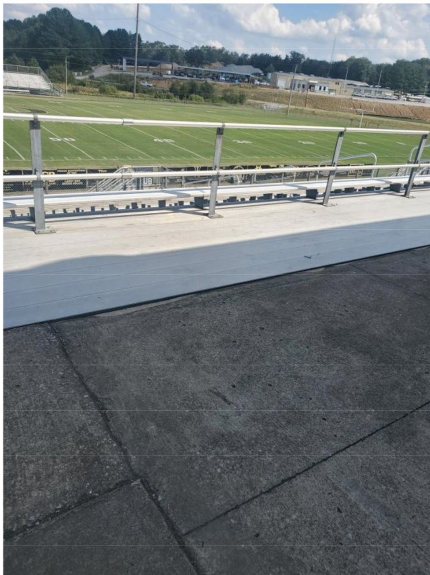
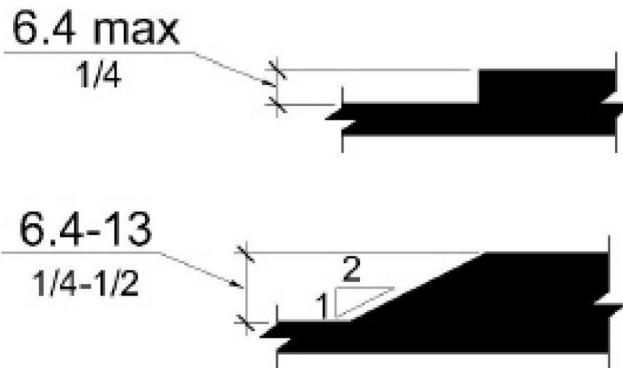
As Built: The entire length of concession stand, concrete is lower than bleacher transition. The surface of the pedestrian access route has vertical discontinuities greater than 1/2 inch or between 1/4 inch and 1/2 inch that are not beveled. Vertical surface discontinuities shall be 0.5 inch maximum. Vertical surface discontinuities between 0.25 inch and 0.5 inch shall be beveled with a slope not steeper than 50 percent. The bevel shall be applied across the entire vertical surface discontinuity.

Citation: 2011 PROWAG Section R302.7.2

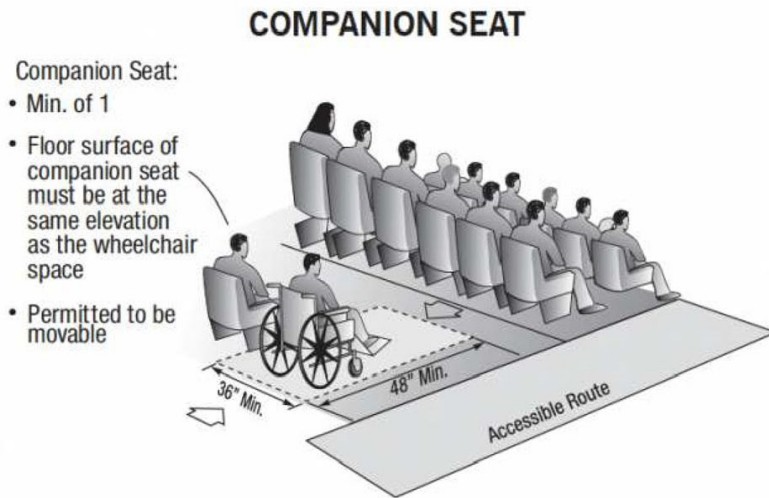
As Built: An accessible wheelchair space is not provided in the team/player seating area.

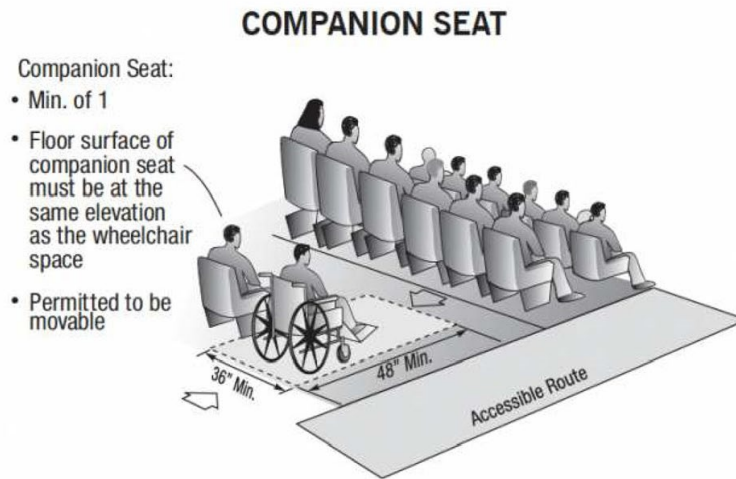
As Built: The wheelchair seating spaces do not have the required companion seats provided next to them.

In row seating, companion seats shall be located to provide shoulder alignment with adjacent wheelchair spaces. The shoulder alignment point of the wheelchair space shall be measured 36 inches from the front of the wheelchair space. The floor surface of the companion seat shall be at the same elevation as the floor surface of the wheelchair space. Companion seats shall be equivalent in size, quality, comfort, and amenities to the seating in the immediate area. Companion seats shall be permitted to be movable.

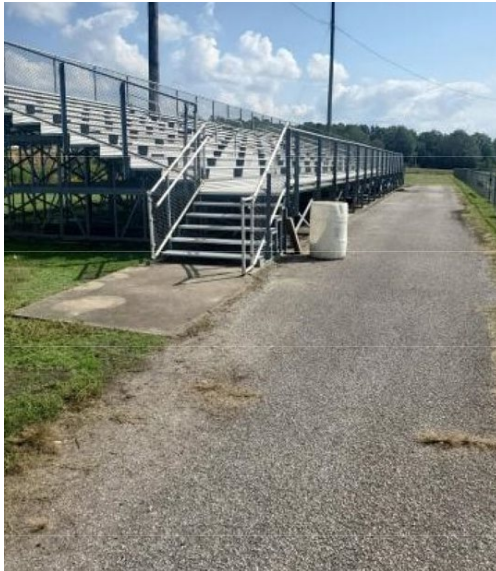
As Built: There are no wheelchair spaces provided on visitor's side. There are paved routes to seating but only stairs to access seating area. Wheelchair spaces shall be provided in assembly areas with fixed seating based on number of seats in figure.

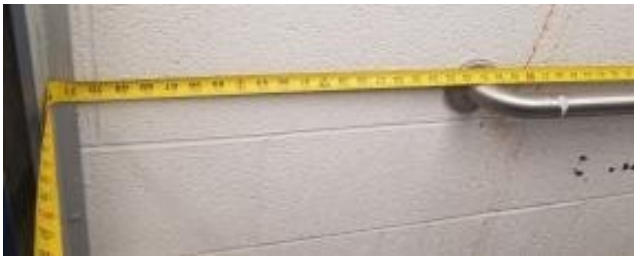
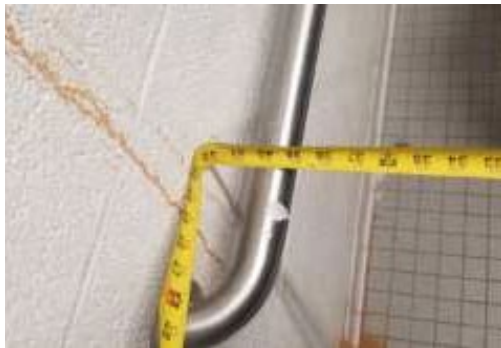
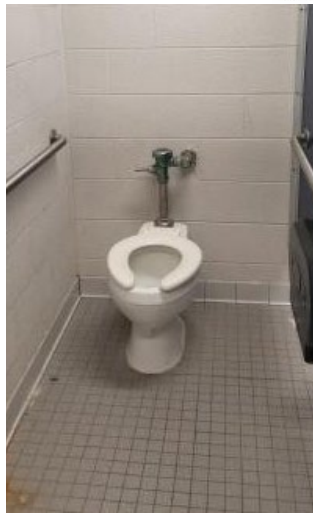
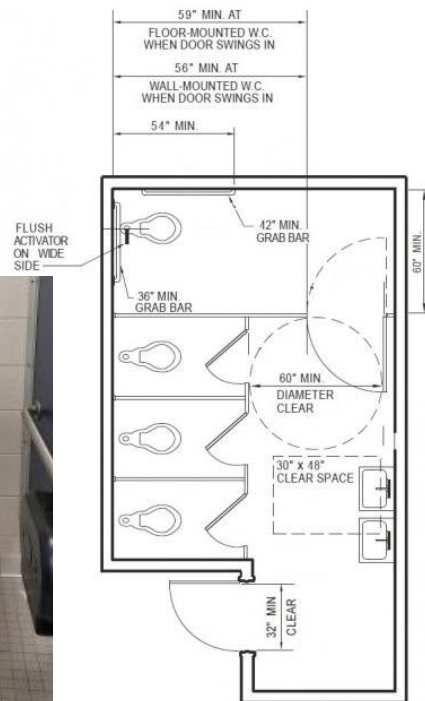
As Built: Compartment size does not comply, flush valve is on the wrong side, missing rear grab bar, side grab does not extend at 54" from wall. The stall does not have the required minimum clear floor space or maneuvering clearances for the toilet, Grab bars are missing and/or incorrectly installed, accessories, such as toilet seat covers, toilet paper holders, and garbage cans are either too high, without clear floor space or both.

Citation: 2010 ADAS Section 603.1
