WEAKLEY COUNTY, TENNESSEE

ADA EVALUATION

Architectural and Site Findings with Recommendations

TLM Associates, Inc

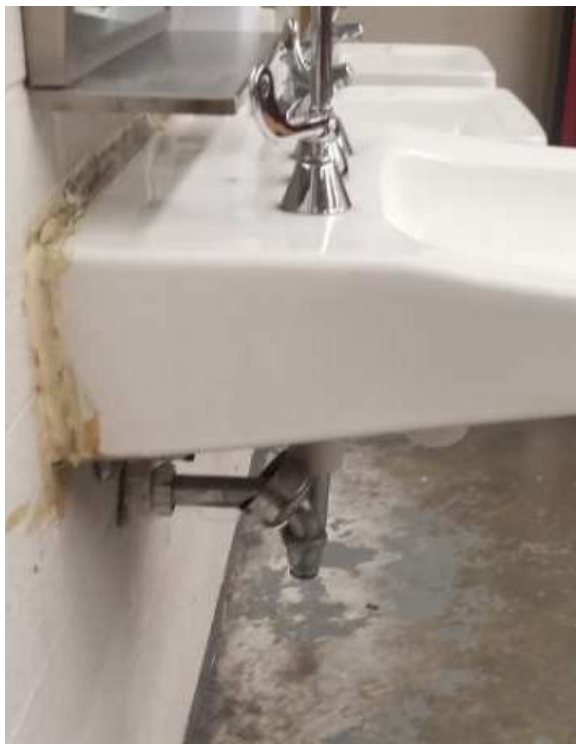
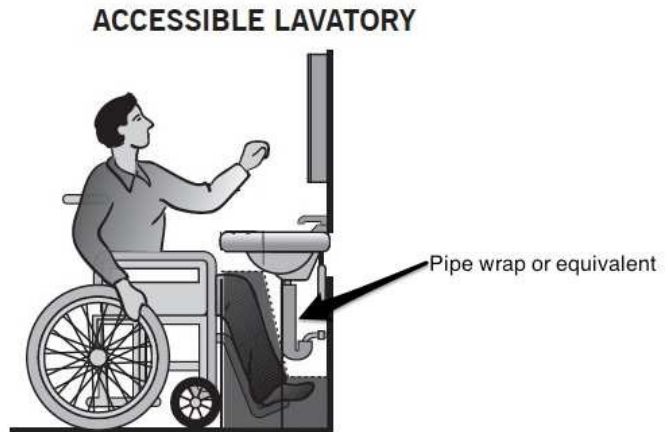
As Built: The water and drainpipes under the lavatory are not adequately insulated.

The water supply and drainpipes under lavatories and sinks shall be insulated or otherwise configured to protect against contact. There shall be no sharp or abrasive surfaces under lavatories and sinks.

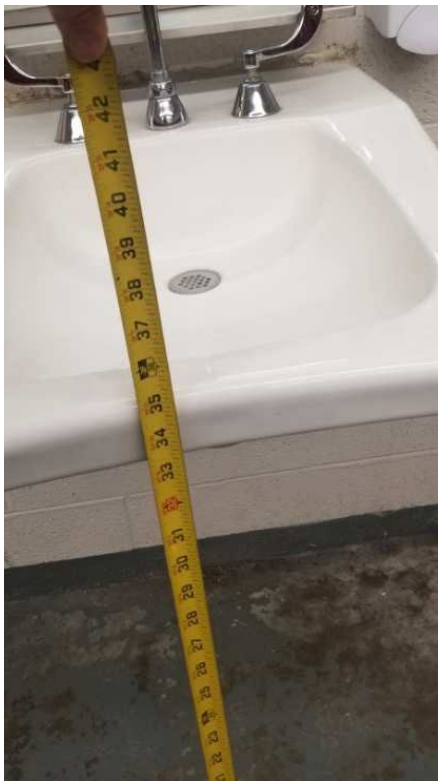
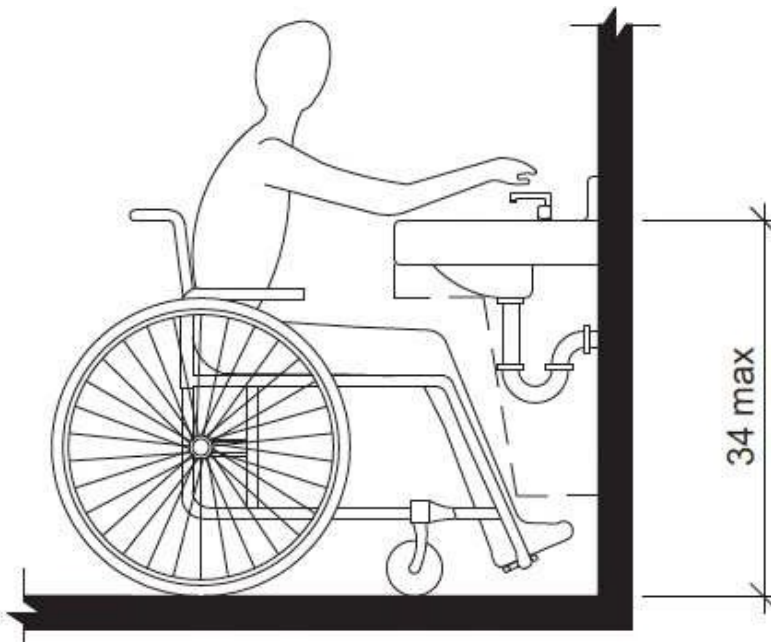
As Built: The top rim of the lavatory is at 35" AFF which is too high.

All lavatories that are designated to be accessible shall be a minimum 17 inches in horizontal depth and mounted with the rim or counter edge no higher than 34 inches above the finished floor.

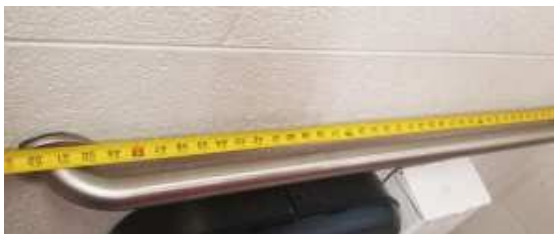
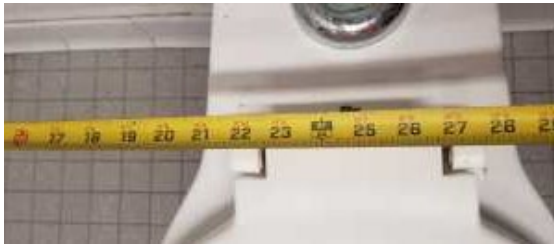
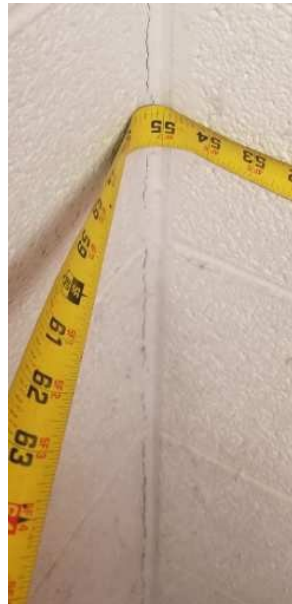
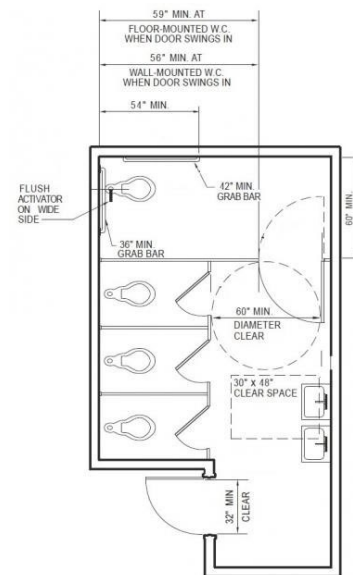
As Built: The compartment stall is not nearly compliant.

The stall does not have the required minimum clear floor space or maneuvering clearances for the toilet, Grab bars are missing and/or incorrectly installed, toilet paper holders, without clear floor space or both. Center of toilet from wall exceeds required 16-18". Coat Hook exceeds 48" max height.

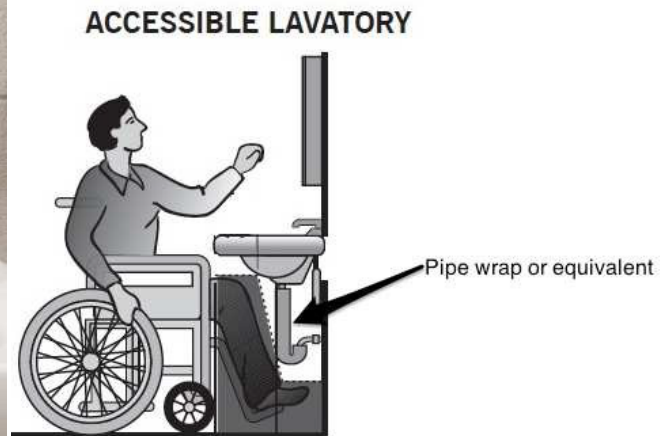
As Built: The water and drain pipes under the lavatory are not adequately insulated.

Water supply and drain pipes under lavatories and sinks shall be insulated or otherwise configured to protect against contact. There shall be no sharp or abrasive surfaces under lavatories and sinks.

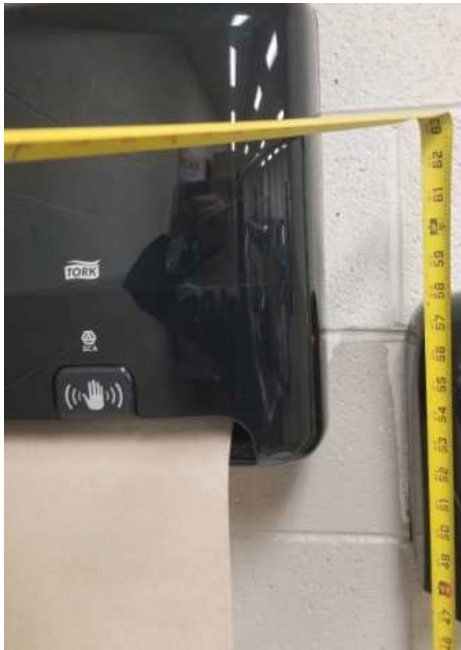
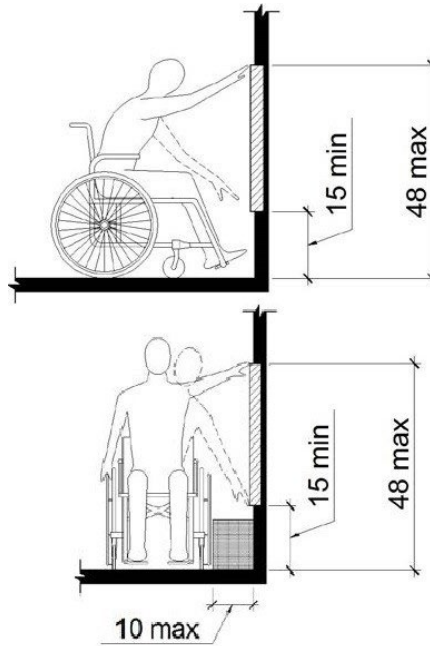
As Built: The paper towel dispenser is positioned at 53" which is too high for either a side or front approach.

Where a clear floor or ground space allows a parallel approach to an element and the side reach is unobstructed, the high side reach shall be 48 inches maximum and the low side reach shall be 15 inches minimum above the finish floor or ground.

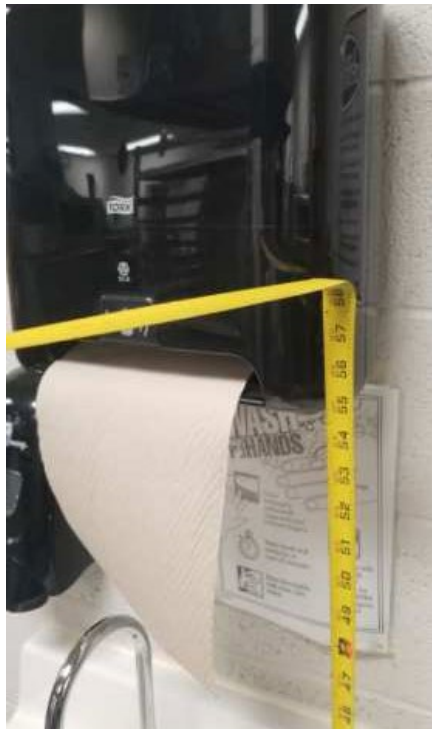
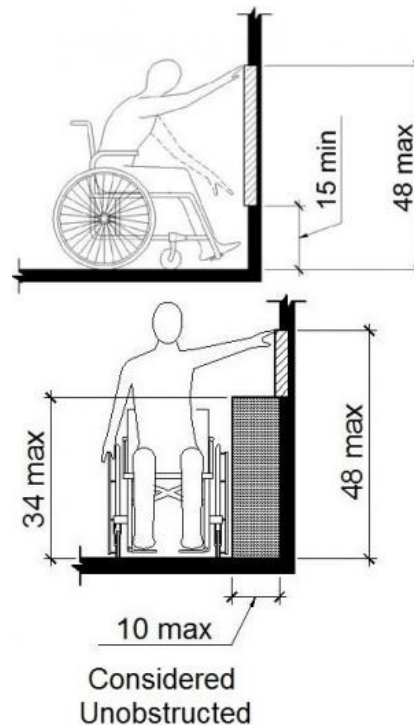
As Built: The paper towel is not positioned correctly for either a side or front approach.

Where a clear floor or ground space allows a parallel or front approach and the side reach is unobstructed, the high side reach shall be 48 inches maximum above the finish floor or ground and the low side reach shall be 15 inches minimum above the finish floor or ground.

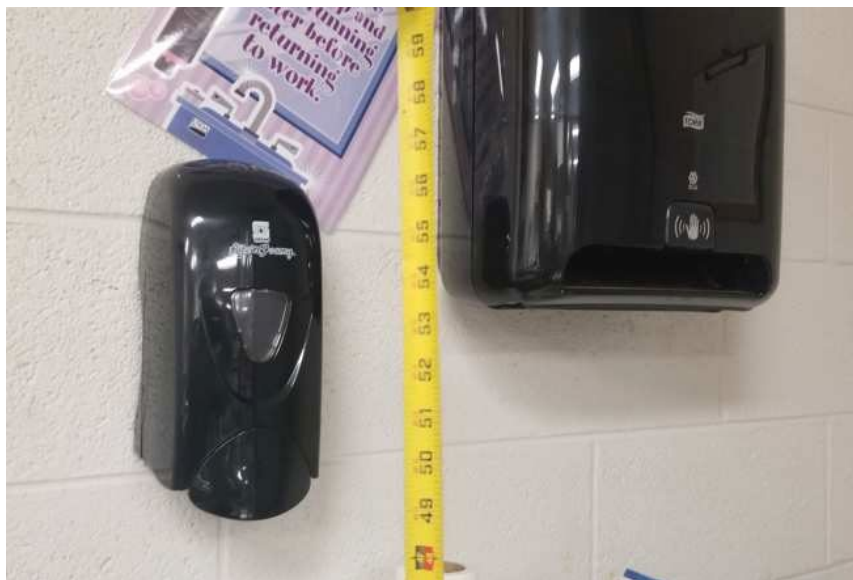
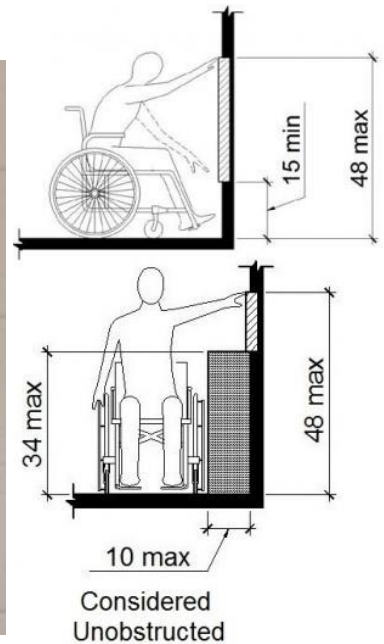
As Built: The paper towel dispenser is at 54" high which is not positioned correctly for either a side or front approach.

Where a clear floor or ground space allows a parallel or front approach and the side reach is unobstructed, the high side reach shall be 48 inches maximum above the finish floor or ground and the low side reach shall be 15 inches minimum above the finish floor or ground.

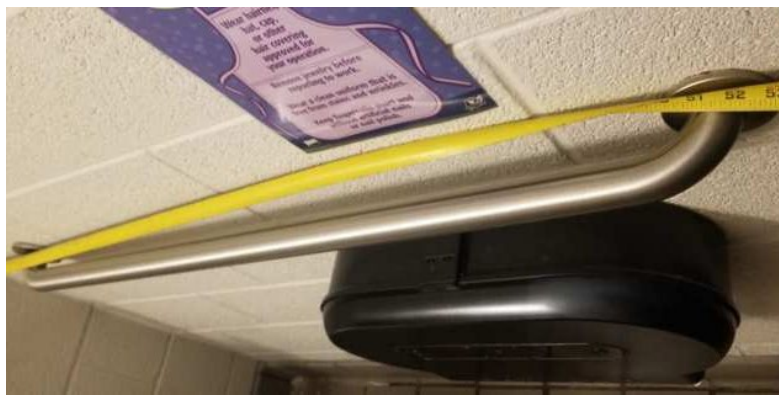
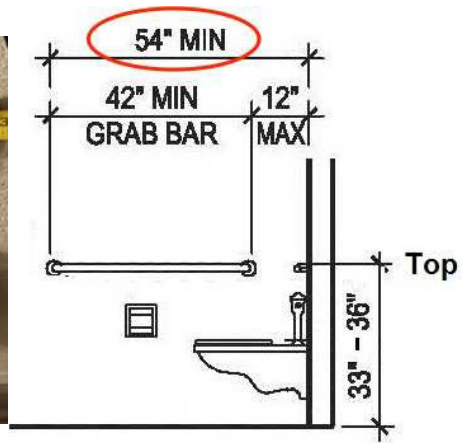
As Built: The side grab bar does not extend far enough from the rear wall.

The side grab bar must extend at least 54 inches minimum beyond the rear wall and start a maximum of 12 inches from the rear wall. A 42-inch grab bar installed the maximum distance from the rear wall (12 inches) will leave the leading end 54 inches from the rear wall.

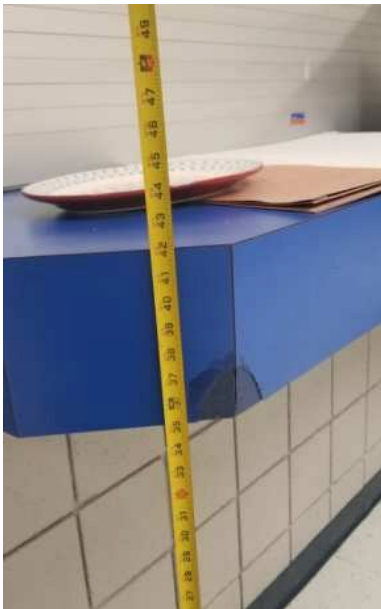
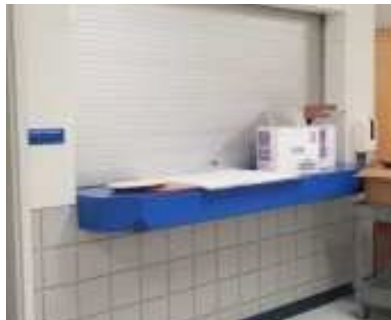
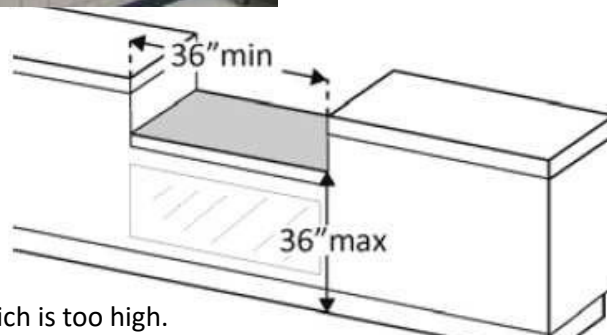
As Built: The transaction counter is 42" AFF which is too high.

A portion of the counter surface that is 36 inches long minimum and 36 inches high maximum above the finish floor shall be provided. Knee and toe space must be provided for a forward approach. A 30 inch by 48-inch clear floor space on an accessible route must be provided for either a forward or parallel approach.

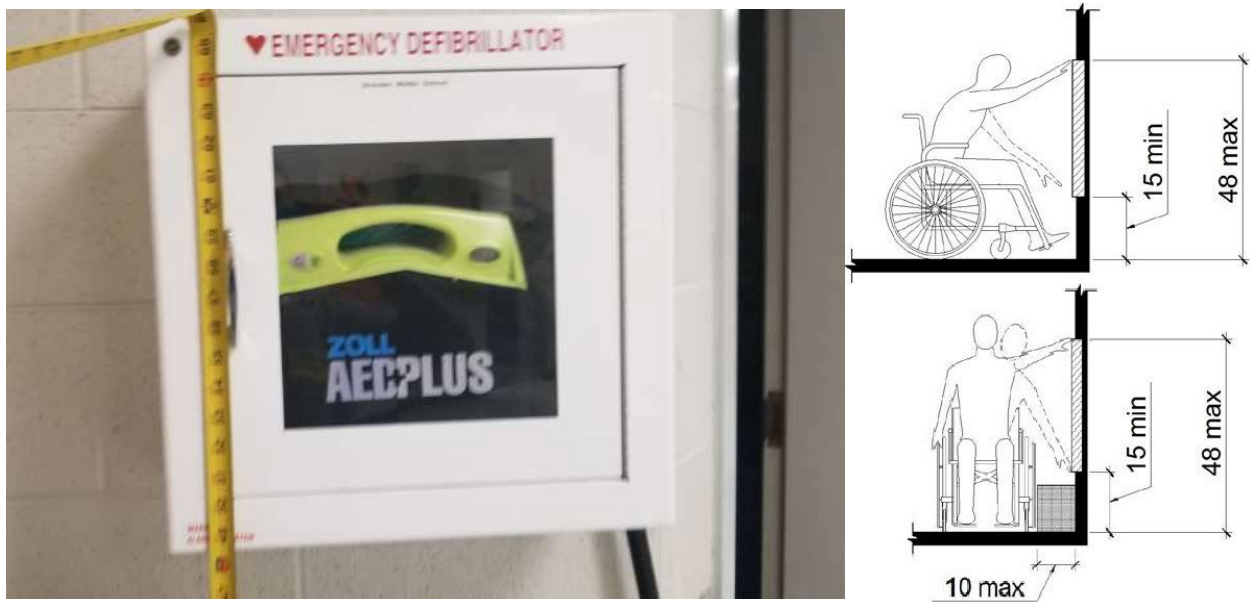
As Built: The Defibrillator is positioned at 56" AFF which is too high for either a side or front approach.

Where a clear floor or ground space allows a parallel approach to an element and the side reach is unobstructed, the high side reach shall be 48 inches maximum and the low side reach shall be 15 inches minimum above the finish floor or ground.

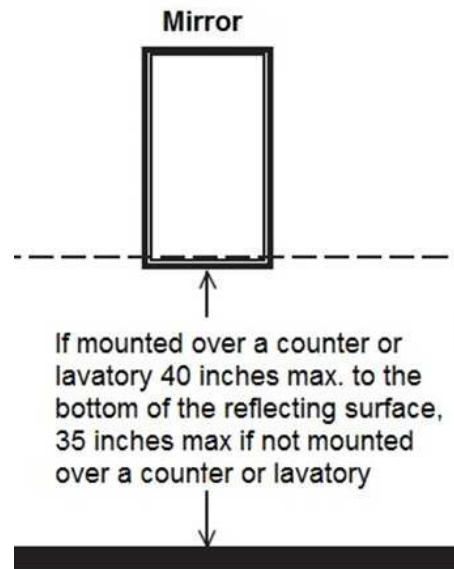
As Built: The mirror is mounted at 52" AFF which is too high.

Mirrors must have the bottom edge of the reflecting surface a maximum of 40 inches above the floor if above a sink or counter. Mirrors not located above lavatories or countertops shall be installed with the bottom edge of the reflecting surface 35 inches maximum above the finish floor or ground.

Citation: 2010 ADAS Section 603.3

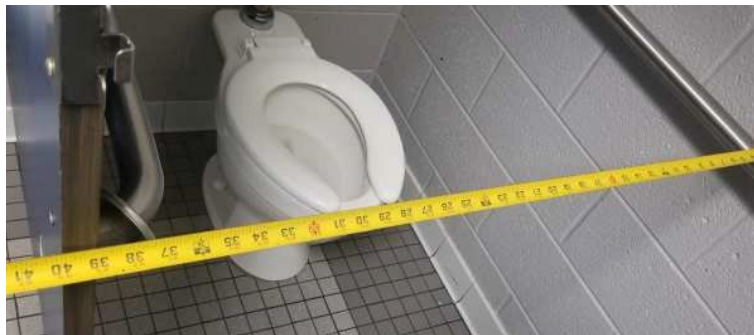
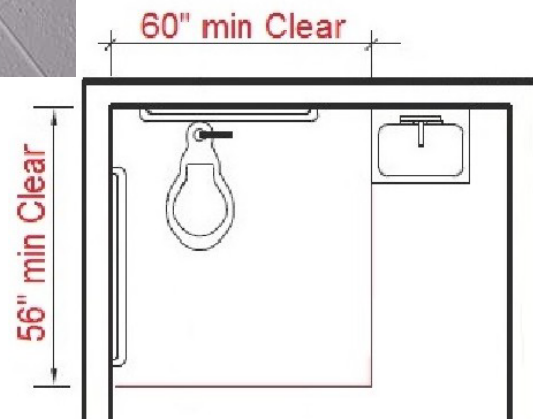
As Built: The clear floor space around the toilet is obstructed by the partition wall. No fixtures are allowed in the clear floor space required for the toilet.

The required clearance around the water closet shall be permitted to overlap the water closet, associated grab bars, dispensers, sanitary napkin disposal units, coat hooks, shelves, accessible routes, clear floor space and clearances required at other fixtures, and the turning space. No other fixtures or obstructions shall be located within the required water closet clearance.

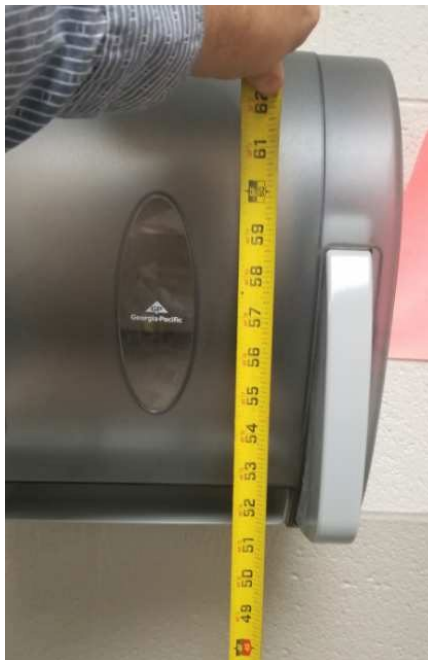
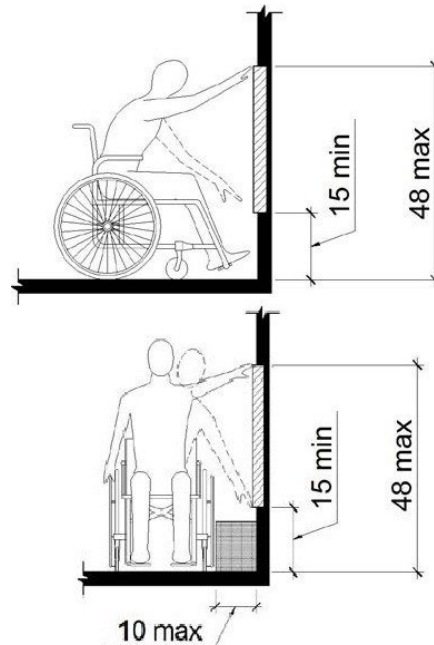
As Built: The paper towel dispenser is positioned at 52" which is too high for either a side or front approach.

Where a clear floor or ground space allows a parallel approach to an element and the side reach is unobstructed, the high side reach shall be 48 inches maximum and the low side reach shall be 15 inches minimum above the finish floor or ground.

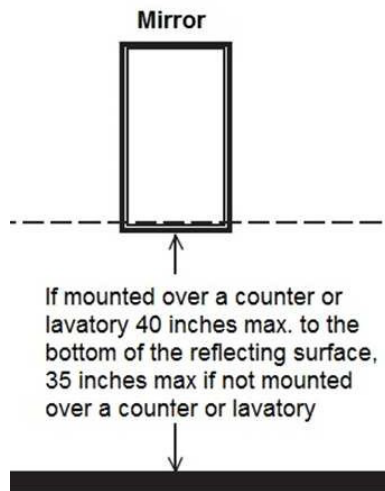
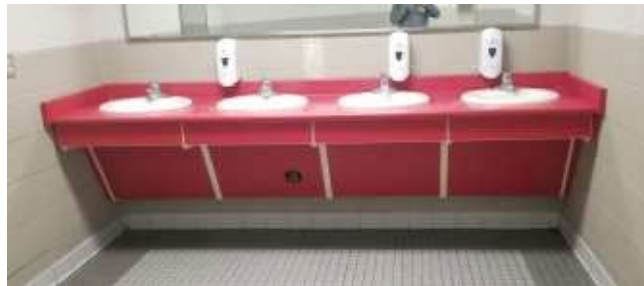
As Built: The mirror is mounted at 51" AFF which is too high.

Mirrors must have the bottom edge of the reflecting surface a maximum of 40 inches above the floor if above a sink or counter. Mirrors not located above lavatories or countertops shall be installed with the bottom edge of the reflecting surface 35 inches maximum above the finish floor or ground.

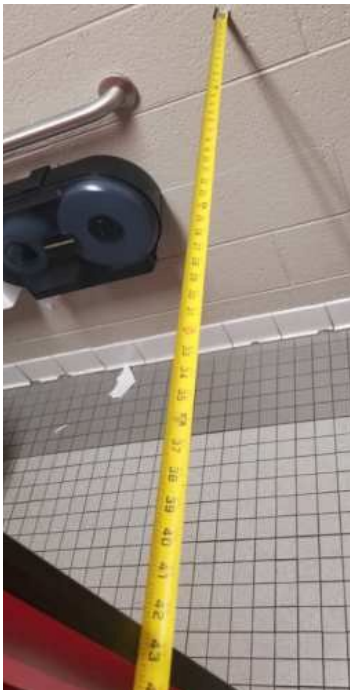
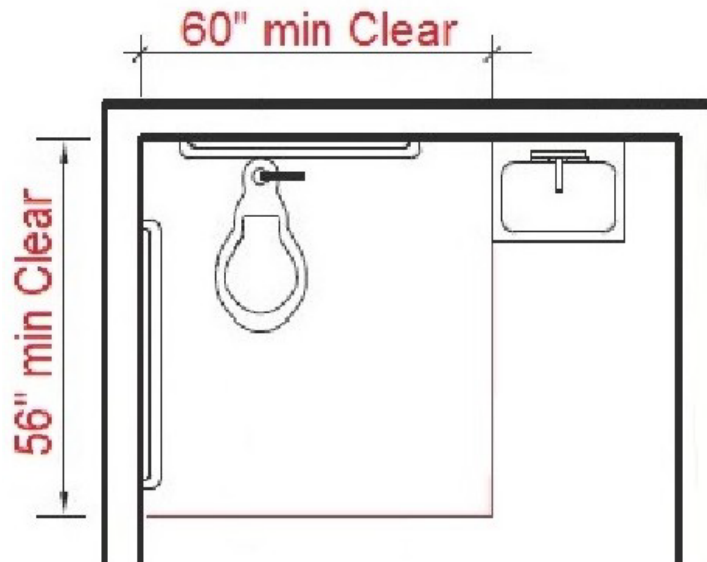
As Built: The clear floor space around the toilet is obstructed by the toilet partition. No fixtures are allowed in the clear floor space required for the toilet.

The required clearance around the water closet shall be permitted to overlap the water closet, associated grab bars, dispensers, sanitary napkin disposal units, coat hooks, shelves, accessible routes, clear floor space and clearances required at other fixtures, and the turning space. No other fixtures or obstructions shall be located within the required water closet clearance.

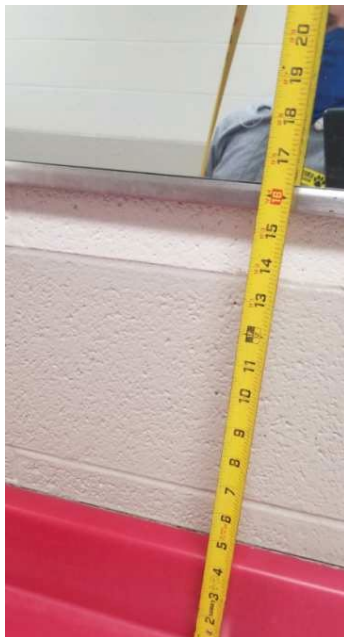
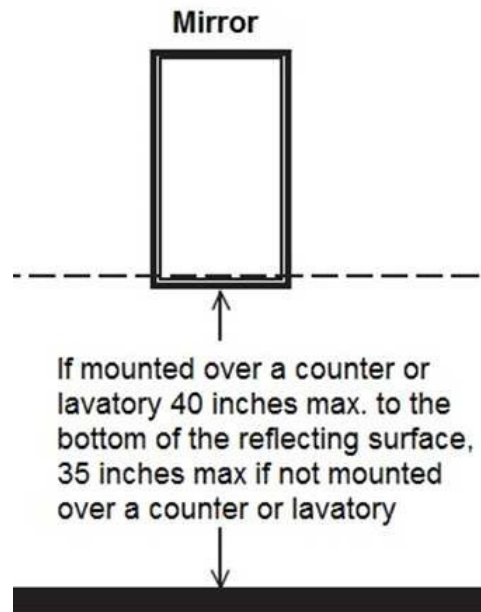
As Built: The mirror is mounted too high.

Mirrors must have the bottom edge of the reflecting surface a maximum of 40 inches above the floor if above a sink or counter. Mirrors not located above lavatories or countertops shall be installed with the bottom edge of the reflecting surface 35 inches maximum above the finish floor or ground.

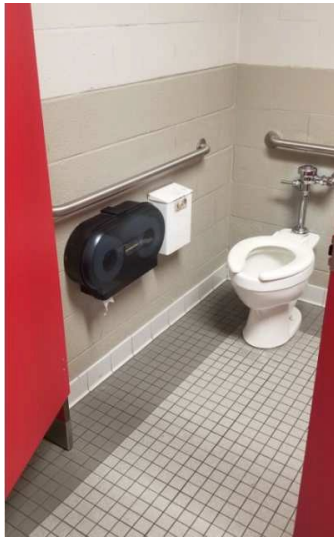
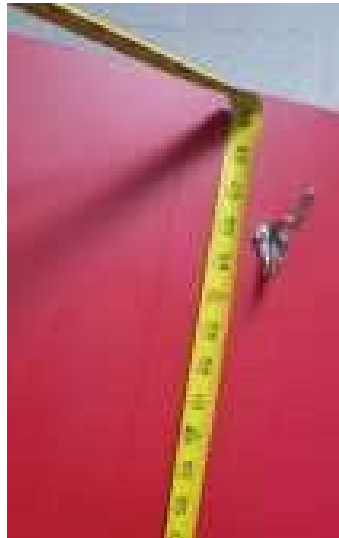
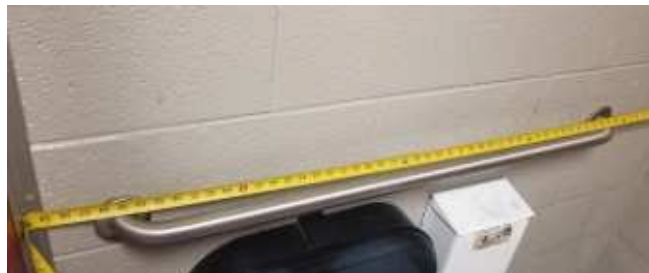
As Built: Compartment door on wrong side, Flush handle on wrong side, side grab bar at 55.5" from wall. The stall does not have the required minimum clear floor space or maneuvering clearances for the toilet. Grab bars are missing and/or incorrectly installed, accessories, such as toilet seat covers, toilet paper holders, and garbage cans are either too high, without clear floor space or both.

Citation: 2010 ADAS Section 603.1

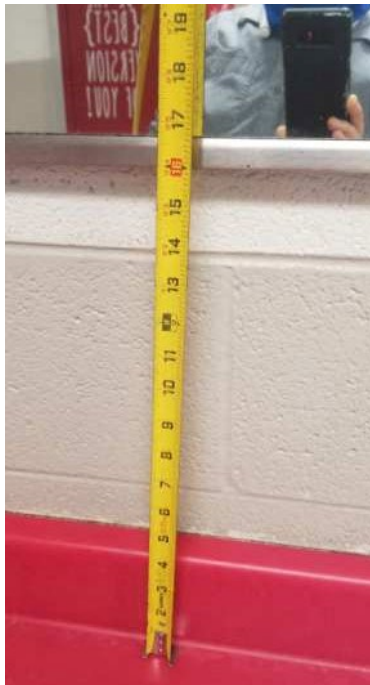
As Built: The mirror is mounted at 51" AFF which is too high.

Mirrors must have the bottom edge of the reflecting surface a maximum of 40 inches above the floor if above a sink or counter. Mirrors not located above lavatories or countertops shall be installed with the bottom edge of the reflecting surface 35 inches maximum above the finish floor or ground.

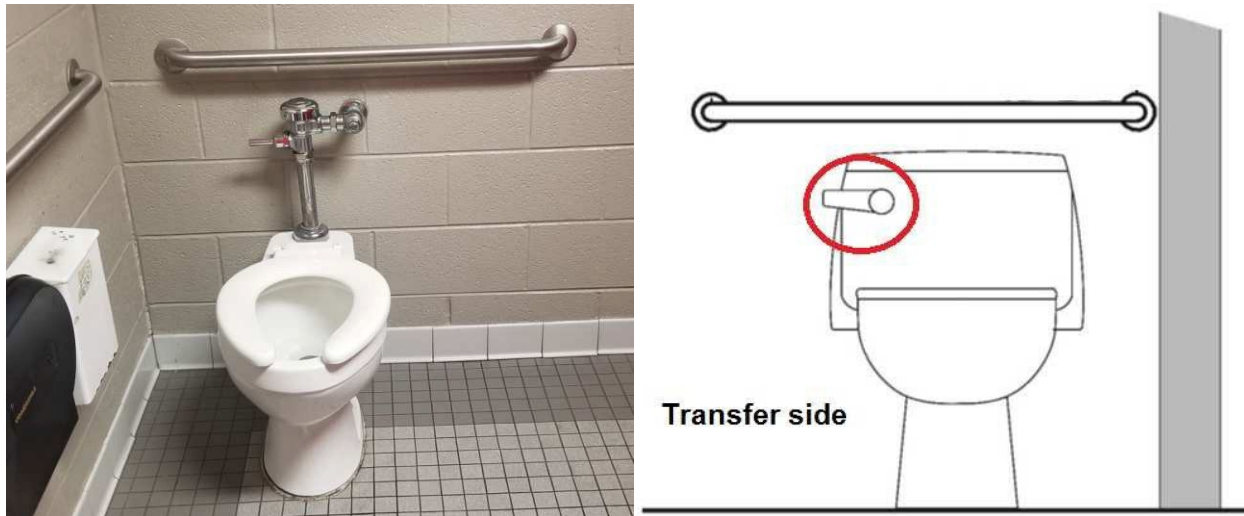
As Built: The flush handle is located on the wrong side of the toilet.

Controls shall be operable with one hand and shall not require tight grasping, pinching or twisting. Controls for the flush valves shall be mounted on the wide side of toilet areas, no more than 48 inches above the floor.

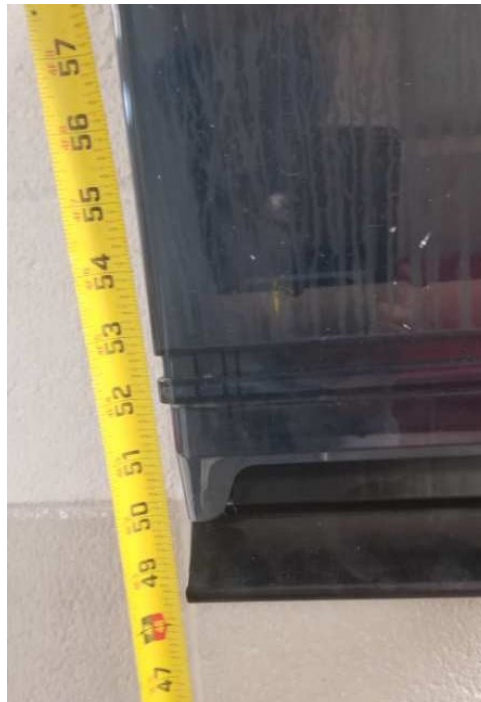
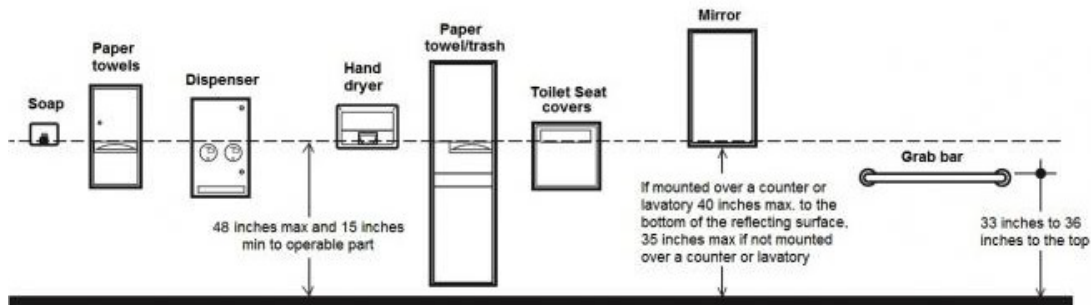
As Built: The paper towel dispenser's operation mechanism is 49" high off the floor. Dispensers must have all operable parts a maximum of 48 inches above the floor.

Citation: 2010 ADAS Section 308.2.1

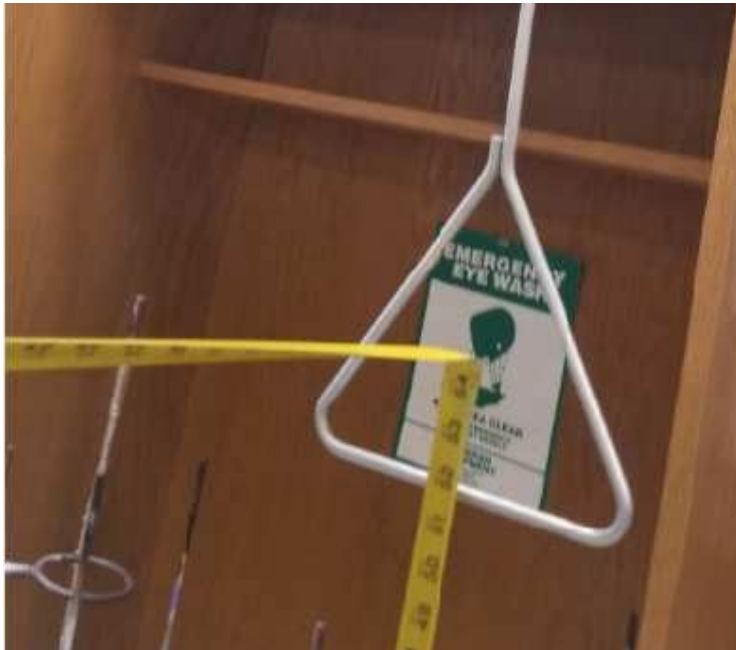
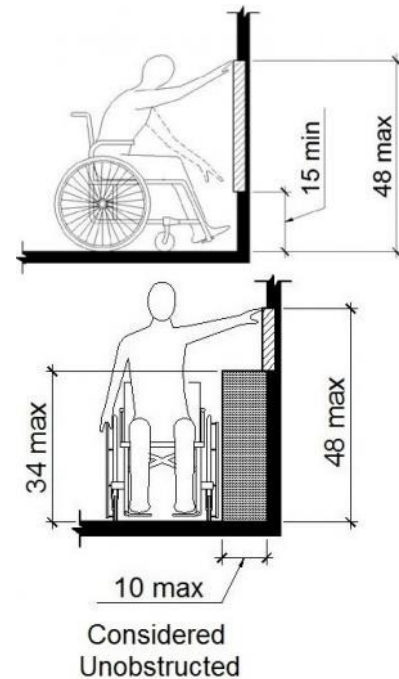
As Built: The emergency shower handle is 52" high, which is not positioned correctly for either a side or front approach.

Where a clear floor or ground space allows a parallel or front approach and the side reach is unobstructed, the high side reach shall be 48 inches maximum above the finish floor or ground and the low side reach shall be 15 inches minimum above the finish floor or ground.

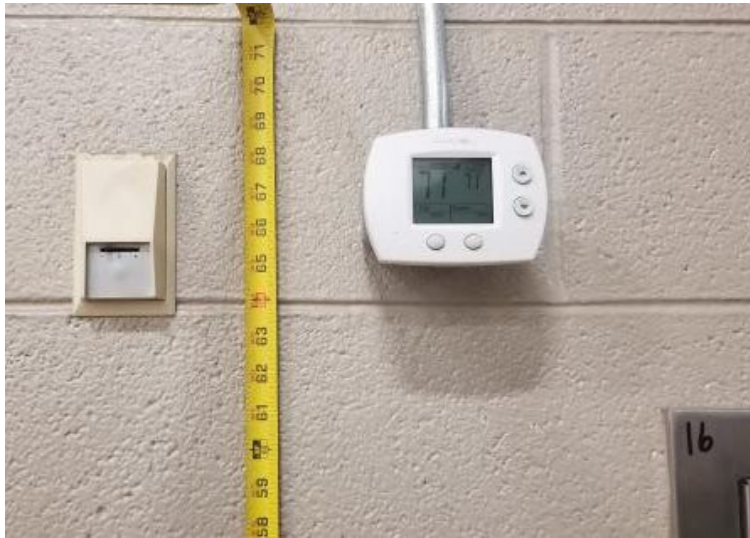
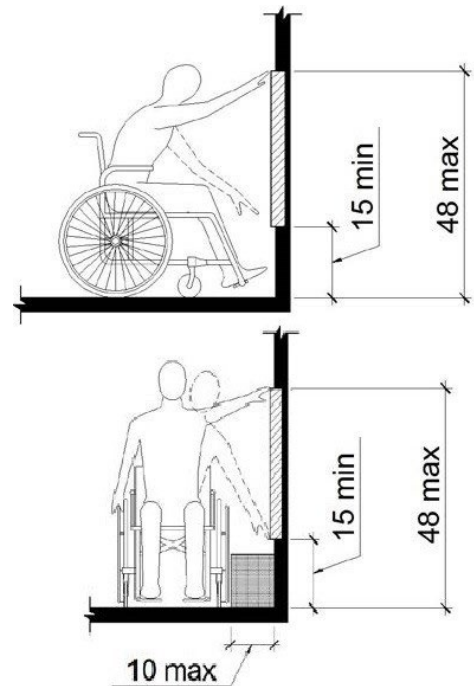
As Built: The thermostat is positioned at 48" AFF which is too high for either a side or front approach.

Where a clear floor or ground space allows a parallel approach to an element and the side reach is unobstructed, the high side reach shall be 48 inches maximum and the low side reach shall be 15 inches minimum above the finish floor or ground.

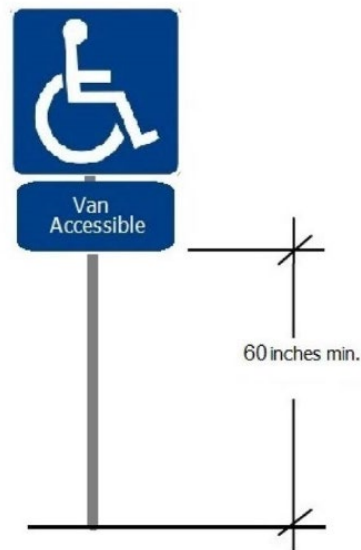
As Built: The parking sign is mounted too low.

Parking space identification signs shall include the International Symbol of Accessibility. Signs identifying van parking spaces shall contain the designation "van accessible."

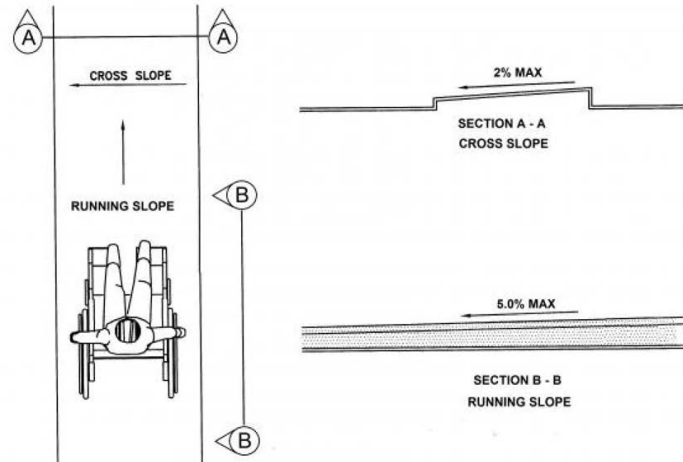
As Built: The accessible route on the site contains running slopes at 8.6% which is greater than the 5% max and has not been constructed as a ramp (i.e. handrails, wheel guides, etc.).

When the slope in the direction of travel of any walk exceeds 1 unit vertical in 20 units horizontal (5-percent slope), it must be constructed as ramp. Surface cross slopes must not exceed one unit vertical in 48 units. Horizontal (2-percent slope).

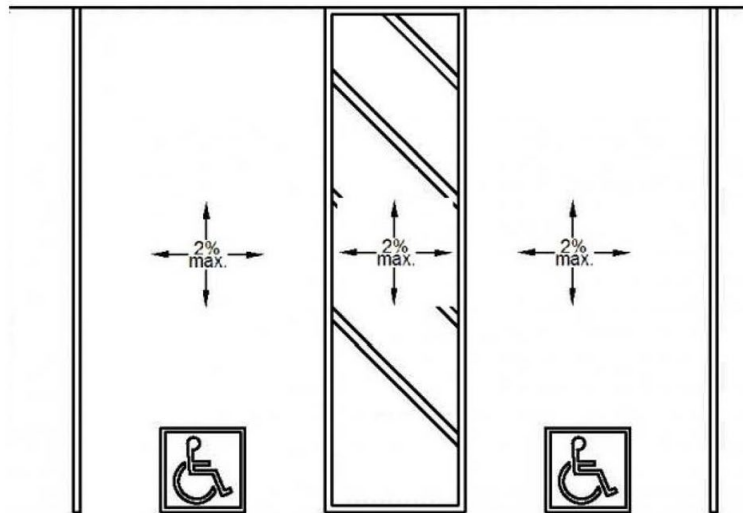
As Built: The cross slopes (narrow dimension) and/or running slopes (long dimension) of the accessible stall exceeds 2%. Both spaces and access aisle exceed 2%, varying up to 4.5%.

The running slope and the cross slope in an accessible parking stall and the access aisle must not exceed 2%.

Replace panels that are over 2%.

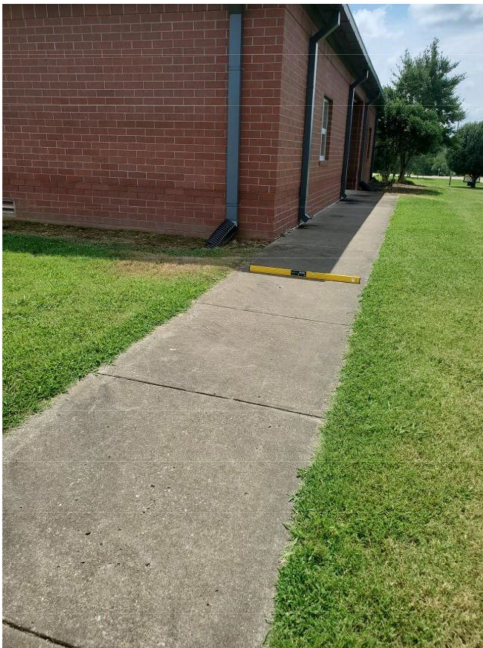
As Built: Six 5' panels of sidewalk approaching entrance exceed 2%, varies up to 2.6%.

Surface cross slopes shall not exceed one unit vertical in 48 units horizontal (2-percent slope). When the slope in the direction of travel of any walk exceeds 1 unit vertical in 20 units horizontal (5-percent slope), it must be constructed as ramp.

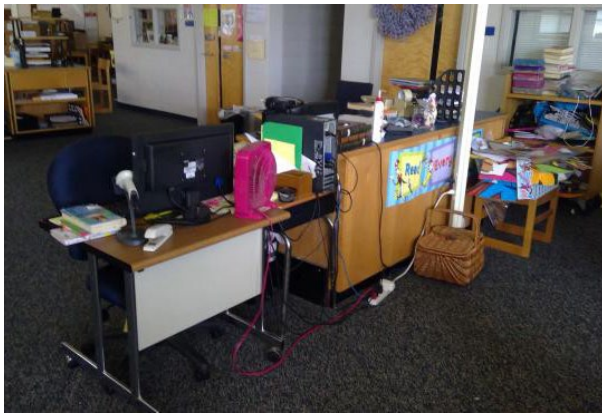
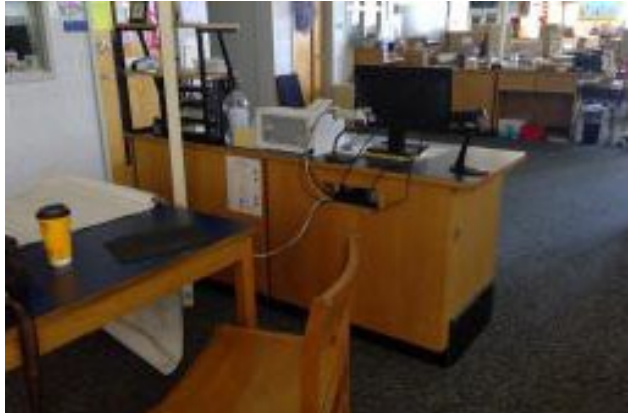
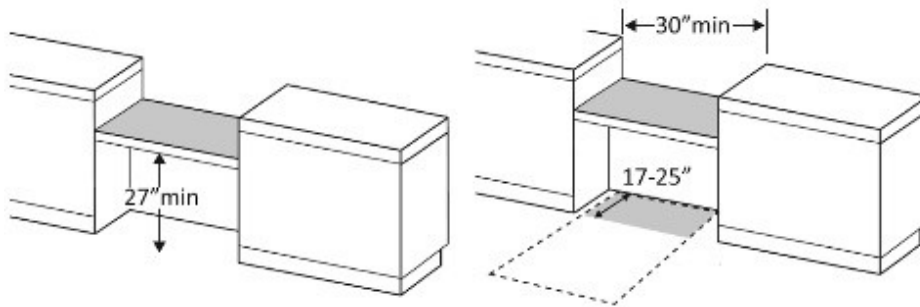
As Built: The transaction counter provides for only a front approach.

Transaction counters shall be 28 to 36 inches high and a minimum of 30 inches wide and must extend the same depth as the sales or service countertop. Knee and toe space must be a minimum of 27 inches tall, 30 inches wide, and 17 inches deep.

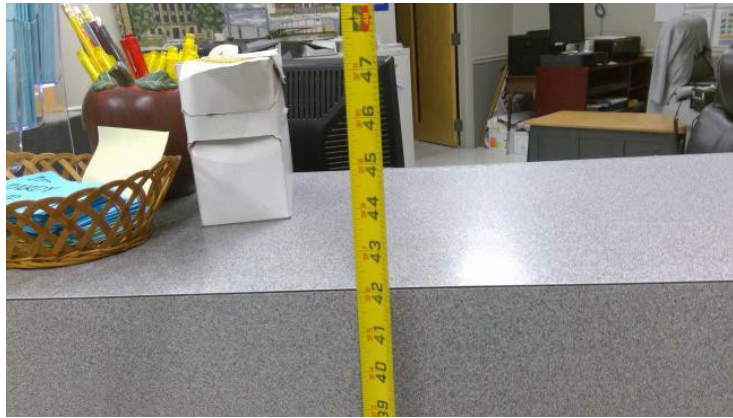
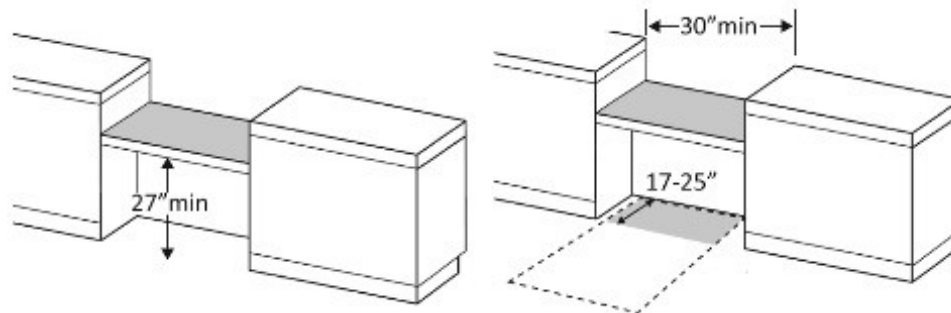
As Built: The transaction counter is 42" to the top of the counter and provides for only a front approach.

Transaction counters shall be 28 to 36 inches high and a minimum of 30 inches wide and must extend the same depth as the sales or service countertop. Knee and toe space must be a minimum of 27 inches tall, 30 inches wide, and 17 inches deep.

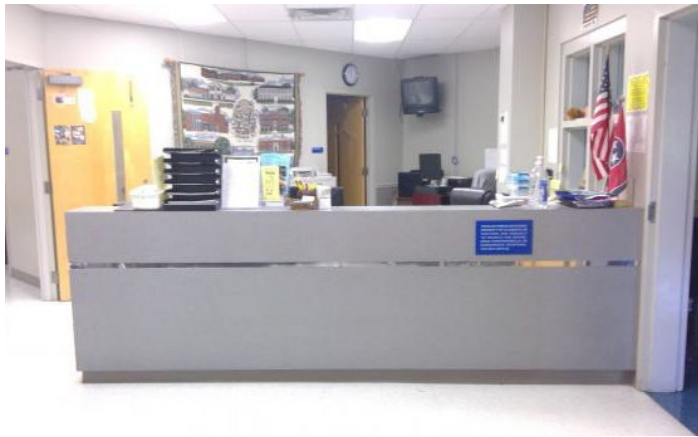
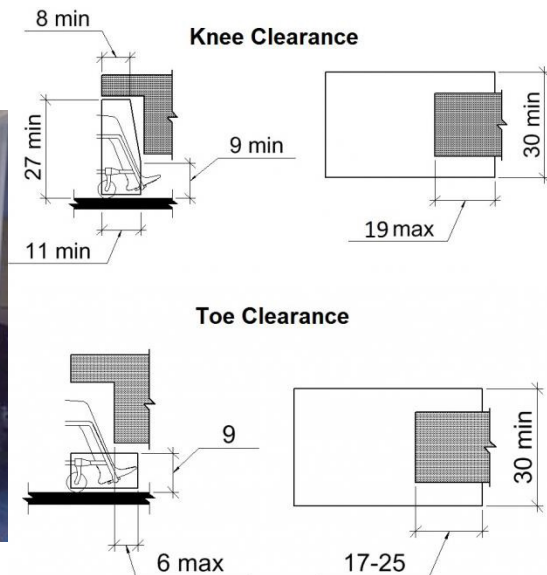
As Built: Compliant knee and/or toe space is not provided.

Space under an element between the finish floor or ground and 9 inches above the finish floor or ground shall be considered toe clearance. Toe clearance shall extend 25 inches maximum and 17 inches minimum under an element. Space extending greater than 6 inches beyond the available knee clearance at 9 inches above the finish floor or ground shall not be considered toe clearance. Toe clearance shall be 30 inches wide minimum.

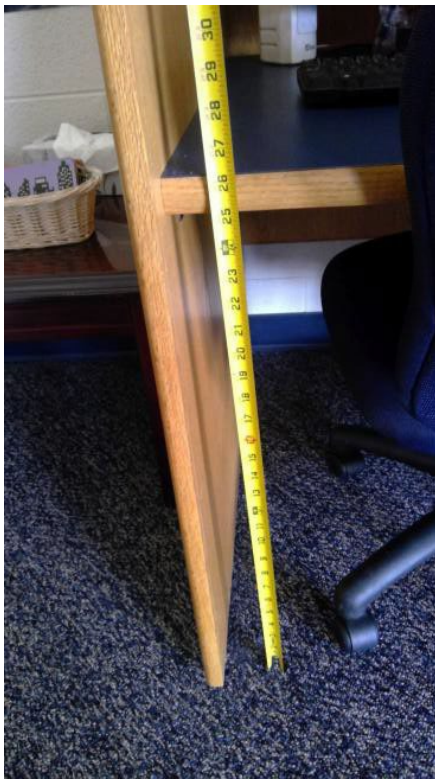
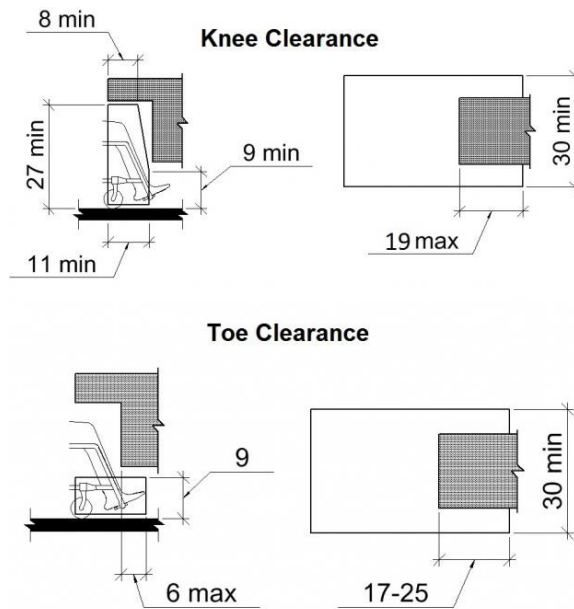
As Built: Compliant knee and/or toe space is not provided.

Space under an element between the finish floor or ground and 9 inches above the finish floor or ground shall be considered toe clearance. Toe clearance shall extend 25 inches maximum and 17 inches minimum under an element. Space extending greater than 6 inches beyond the available knee clearance at 9 inches above the finish floor or ground shall not be considered toe clearance. Toe clearance shall be 30 inches wide minimum.

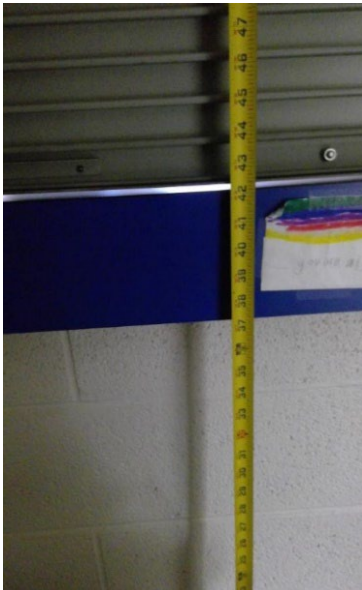
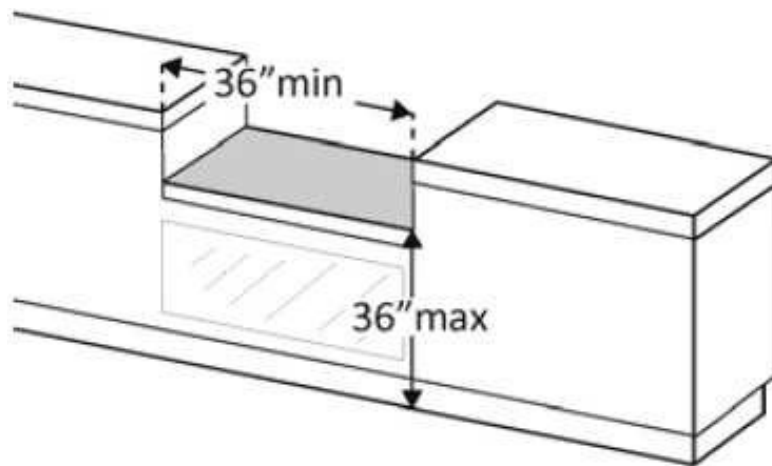
As Built: The transaction counter is too high.

A portion of the counter surface that is 36 inches long minimum and 36 inches high maximum above the finish floor shall be provided. Knee and toe space must be provided for a forward approach. A 30 inch by 48 inch clear floor space on an accessible route must be provided for either a forward or parallel approach.

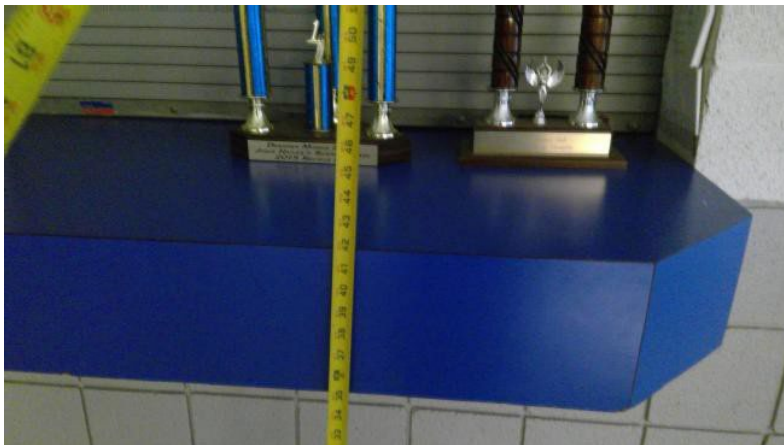
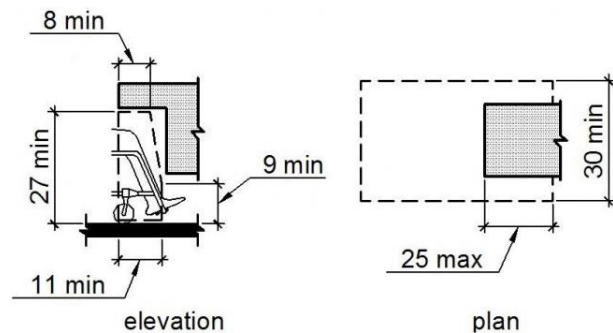
As Built: The knee clearance is not compliant.

The knee clearance shall be 11 inches deep minimum at 9 inches above the finish floor or ground, and 8 inches deep minimum at 27 inches above the finish floor or ground and 30 inches wide minimum.

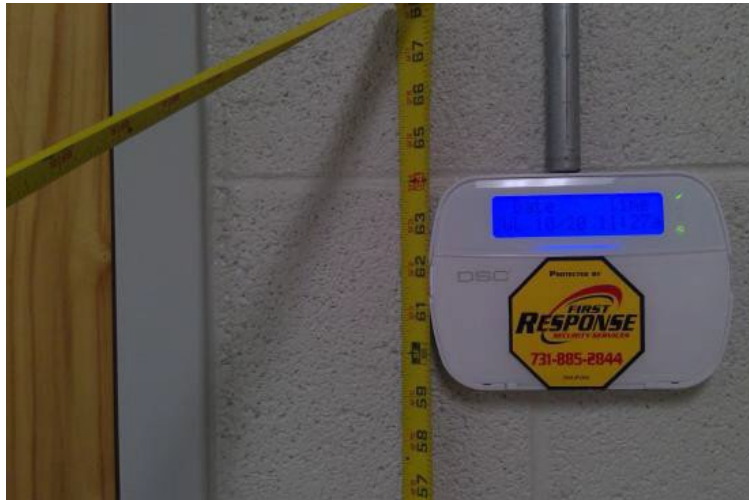
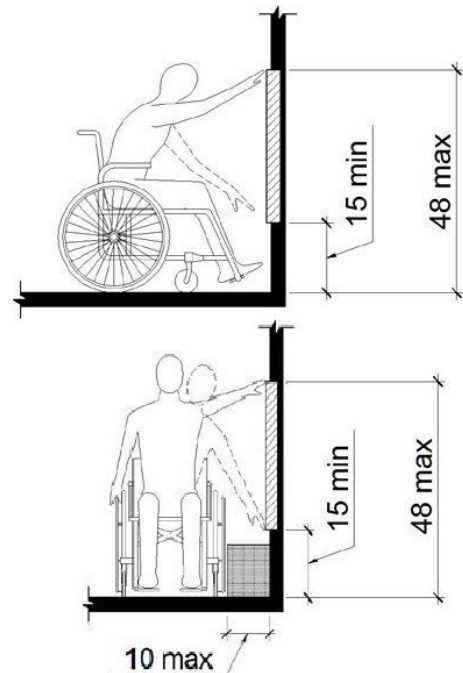
As Built: The alarm keypad is positioned too high for either a side or front approach.

Where a clear floor or ground space allows a parallel approach to an element and the side reach is unobstructed, the high side reach shall be 48 inches maximum and the low side reach shall be 15 inches minimum above the finish floor or ground.

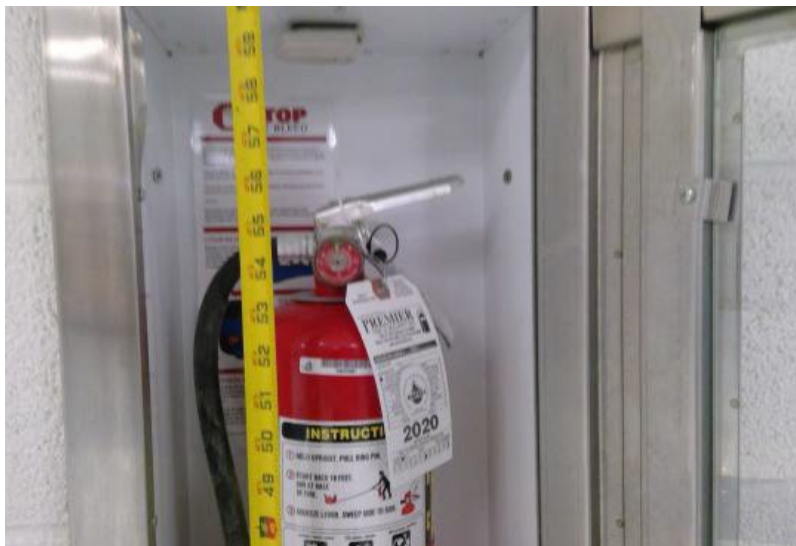
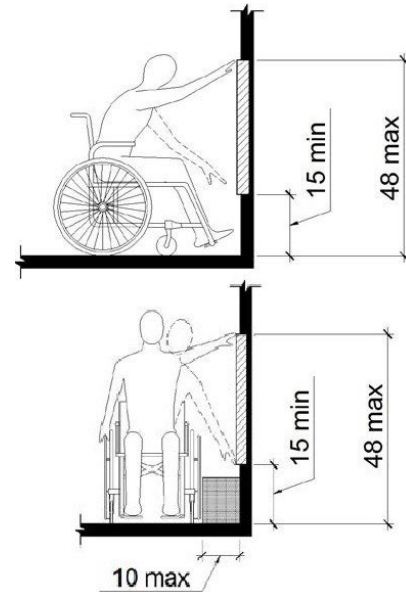
As Built: The Fire extinguisher is positioned at 54" AFF, which is too high for either a side or front approach.

Where a clear floor or ground space allows a parallel approach to an element and the side reach is unobstructed, the high side reach shall be 48 inches maximum and the low side reach shall be 15 inches minimum above the finish floor or ground.
