WEAKLEY COUNTY, TENNESSEE

ADA EVALUATION

Architectural and Site Findings with Recommendations

TLM Associates, Inc

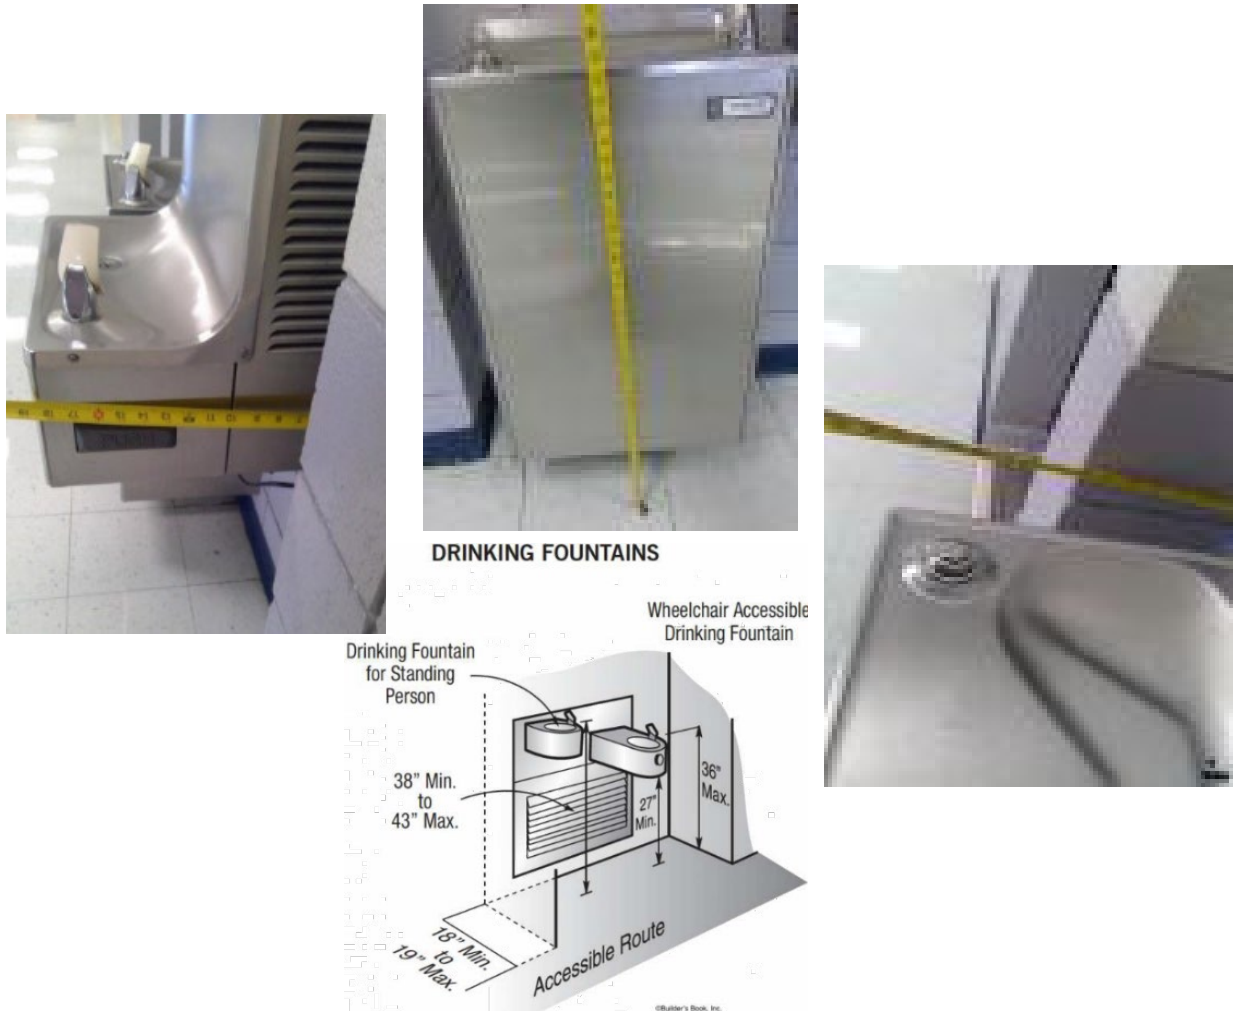
As Built: The drinking fountain 8" deep and at 28" for knee clearance, which is not accessible.

Drinking fountains must be on an accessible route. An accessible route of travel is 36 inches wide minimum and provides a 30 inch by 48 inch clear floor space centered on the unit that allows a forward approach to the drinking fountain.

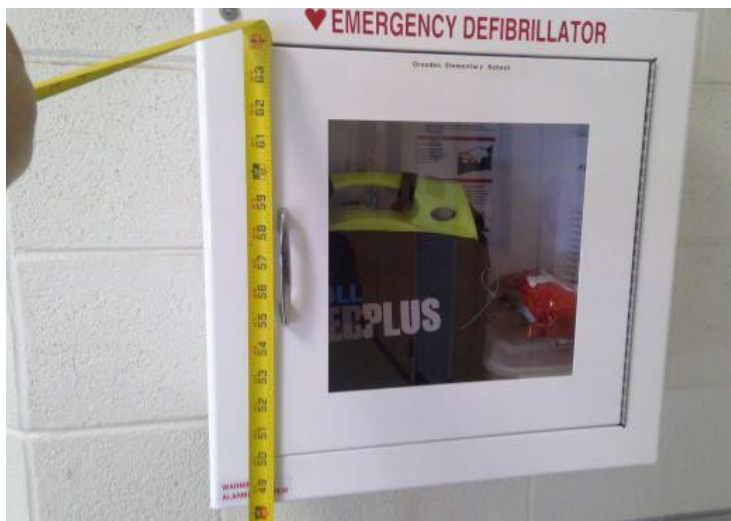
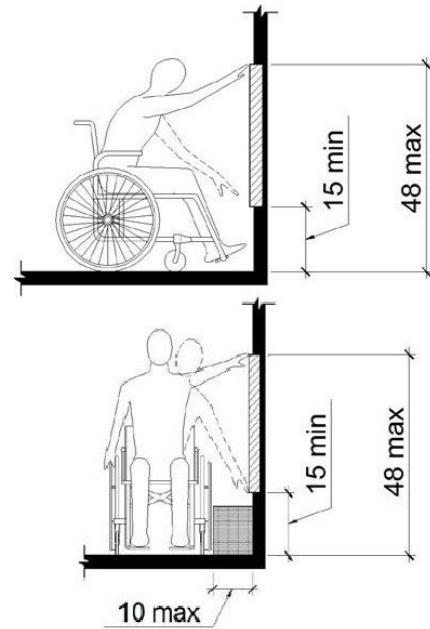
As Built: The Defibrillator is positioned at 55" AFF, which is too high for either a side or front approach.

Where a clear floor or ground space allows a parallel approach to an element and the side reach is unobstructed, the high side reach shall be 48 inches maximum and the low side reach shall be 15 inches minimum above the finish floor or ground.

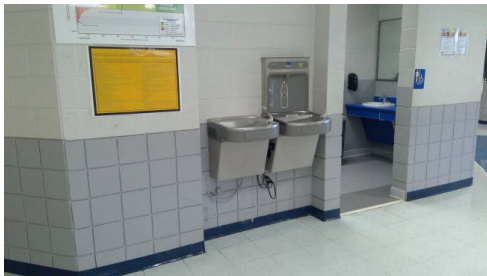
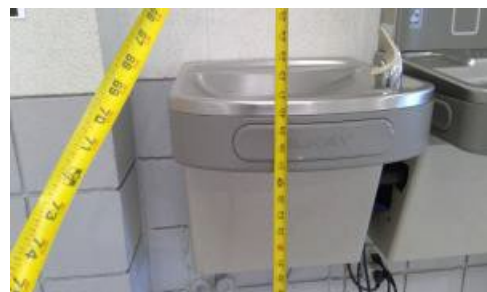
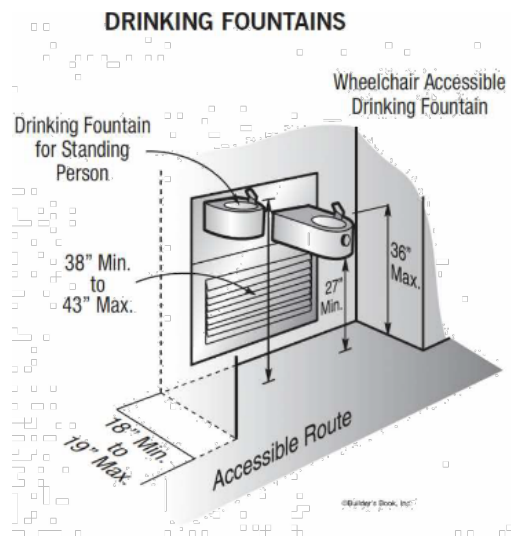
As Built: The drinking fountain alcove is not provided. The fountain is at 40". Drinking fountains must be on an accessible route. An accessible route of travel is 36 inches wide minimum and provides a 30 inch by 48 inch clear floor space centered on the unit that allows a forward approach to the drinking fountain.

At "hi-low" type fountains, the centerline of the 30 inch by 48 inch clear floor space must be centered on the "low" fountain. Spout outlets of drinking fountains for standing persons shall be 38 inches minimum and 43 inches maximum above the finish floor or ground. All drinking fountains shall be located completely within alcoves, positioned completely between wing walls, or otherwise positioned so as not to encroach into pedestrian ways. An alcove must not be less than 32 inches in width and 18 inches in depth. Wing walls must project out from the supporting wall at least as far as the drinking fountain.

Recommendation: Further design required to accommodate required depth alcove.

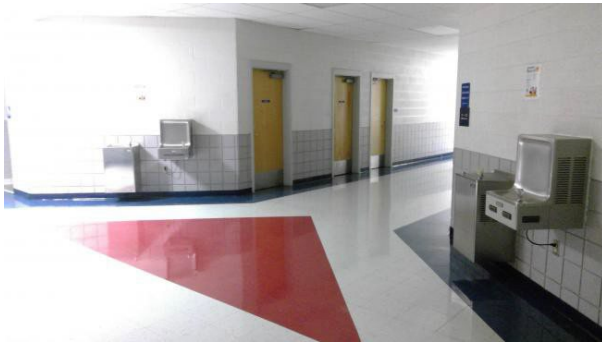
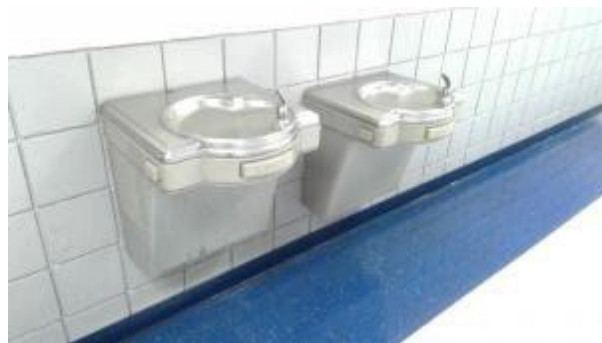
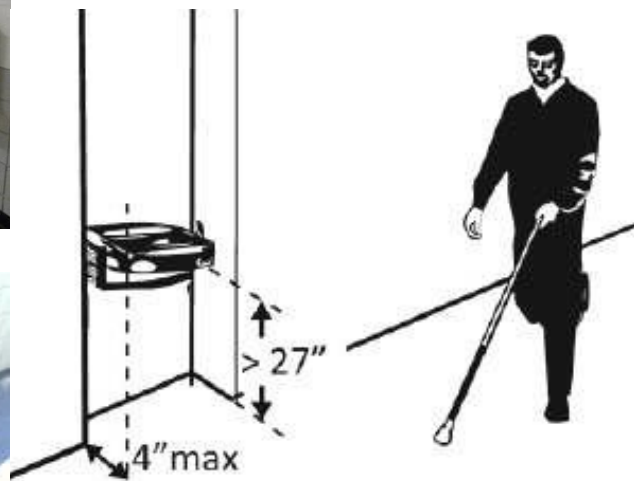
As Built: The drinking fountain projects from the wall into the pedestrian way with its leading edge above 27 inches from the floor.

Objects may protrude no more than 4 inches into walks, halls, corridors, passageways or aisles when located between 27 and 80 inches above the floor. All drinking fountains shall be located completely within alcoves, positioned completely between wing walls, or otherwise positioned so as not to encroach into pedestrian ways. The alcove must not be less than 32 inches in width and 18 inches in depth. Wing walls must project out from the supporting wall at least as far as the drinking fountain.

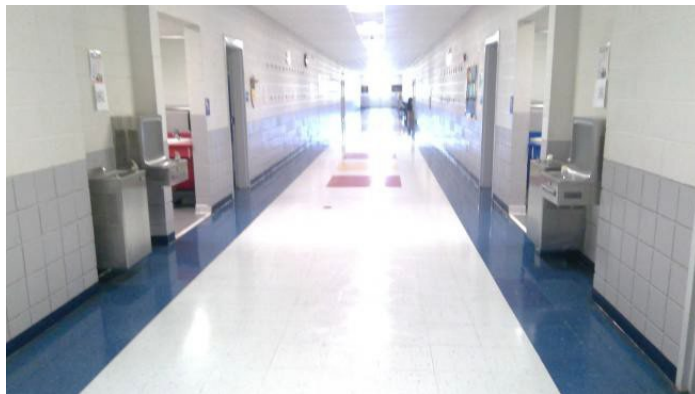
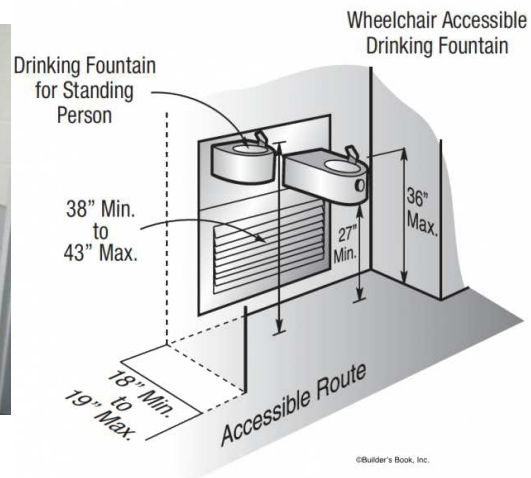
As Built: The drinking fountain is not accessible.

Drinking fountains must be on an accessible route. An accessible route of travel is 36 inches wide minimum and provides a 30 inch by 48 inch clear floor space centered on the unit that allows a forward approach to the drinking fountain.

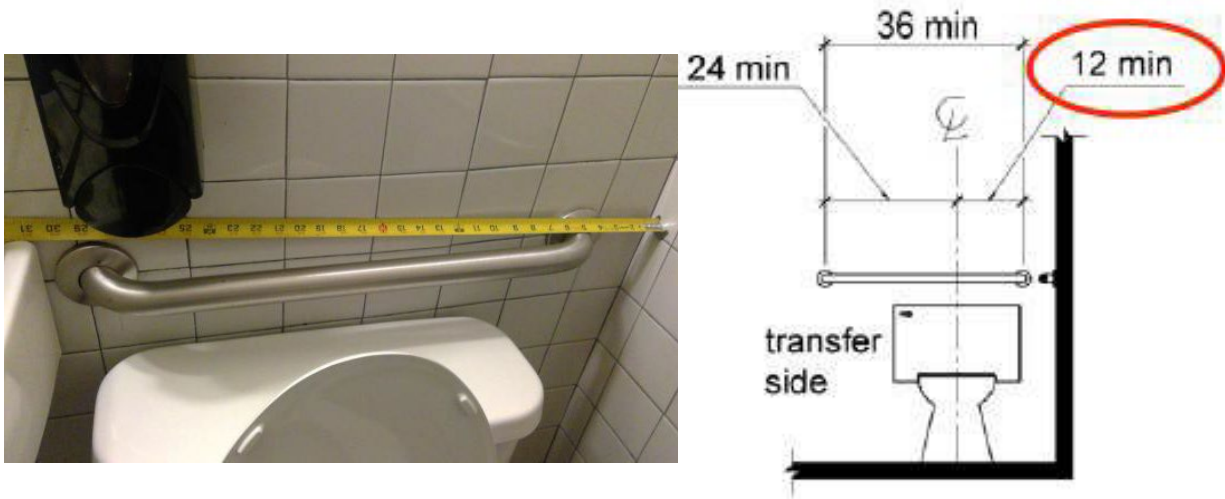
As Built: The rear grab bar does not extend adequately past the centerline of the toilet on the wall side.

The rear grab bar must be a minimum of 36 inches long and extend from the centerline of the toilet 12 inches minimum on one side and 24 inches minimum on the other side.

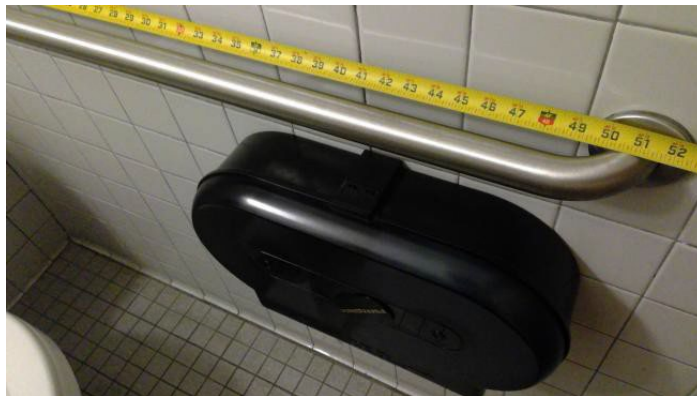
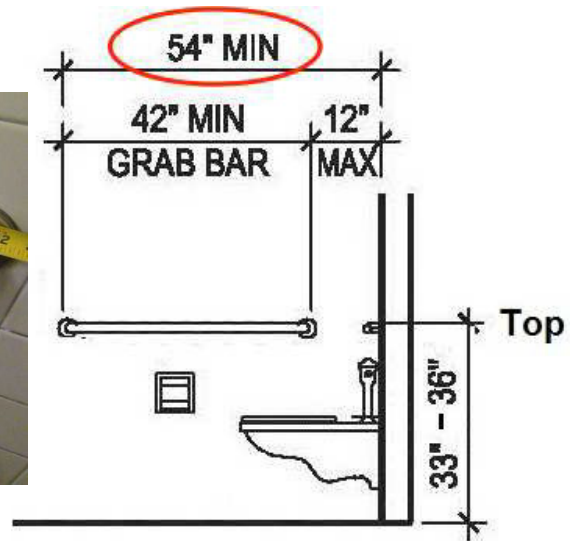
As Built: The side grab bar only extends 52" from the rear wall.

The side grab bar must extend at least 54 inches minimum beyond the rear wall and start a maximum of 12 inches from the rear wall. A 42 inch grab bar installed the maximum distance from the rear wall (12 inches) will leave the leading end 54 inches from the rear wall.

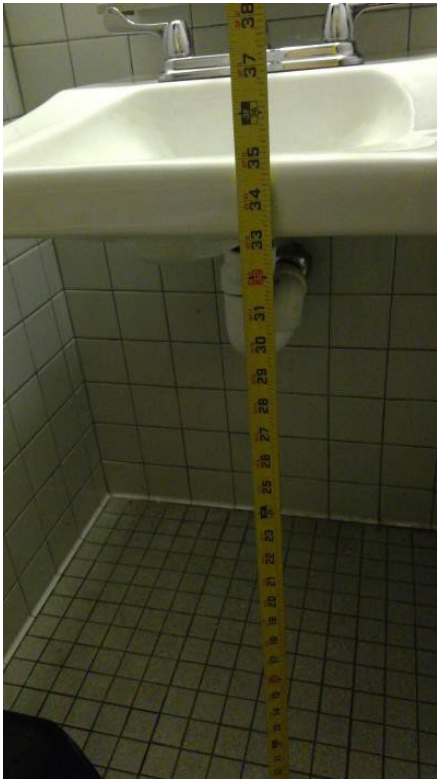
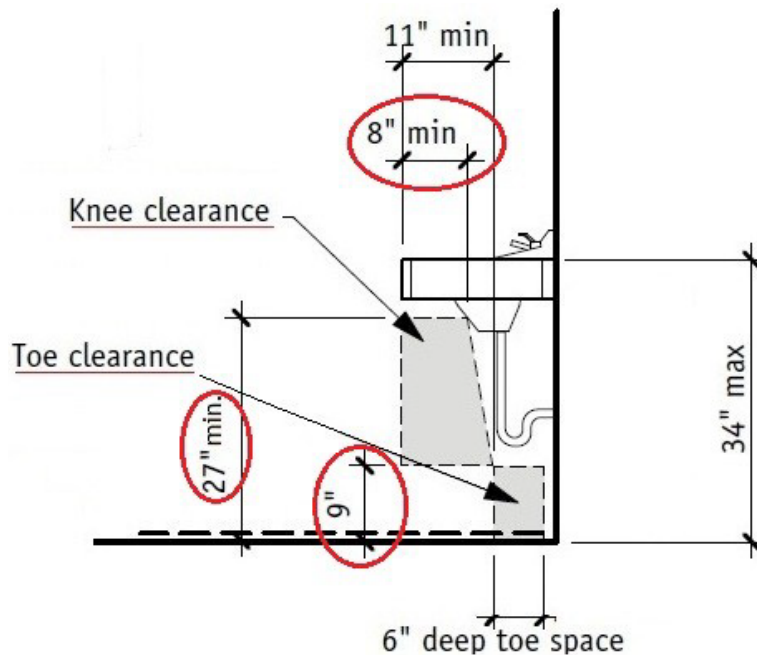
As Built: The apron at the sink projects at 35" AFF, which is too low to the floor.

The vertical clearance measured from the bottom of the apron or the outside bottom edge of the lavatory must be 27 inches at a point located 8 inches back from the front edge.

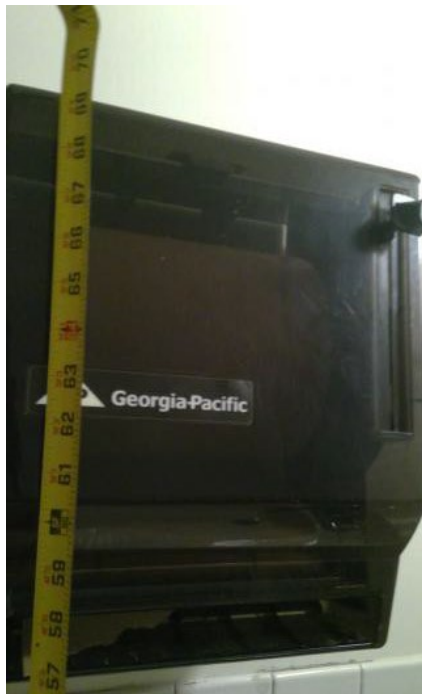
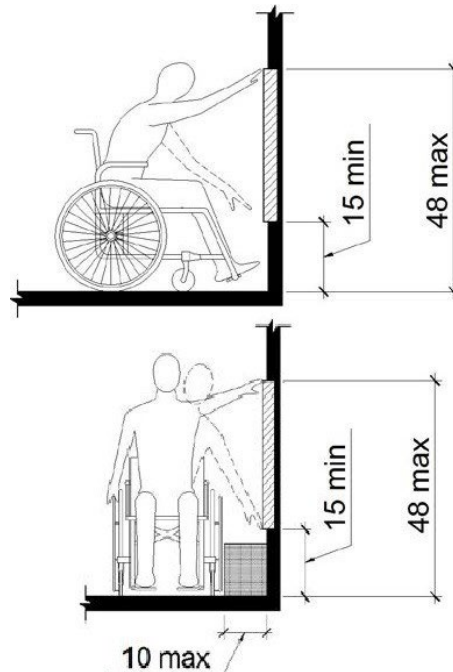
As Built: The Paper towel Dispenser is positioned at 68" AFF which is too high for either a side or front approach.

Where a clear floor or ground space allows a parallel approach to an element and the side reach is unobstructed, the high side reach shall be 48 inches maximum and the low side reach shall be 15 inches minimum above the finish floor or ground.

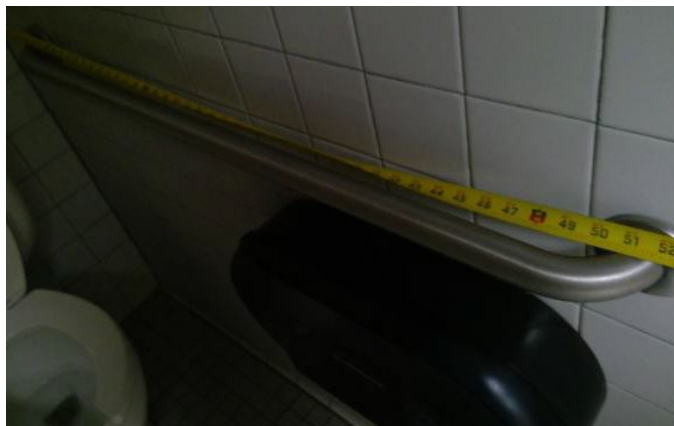
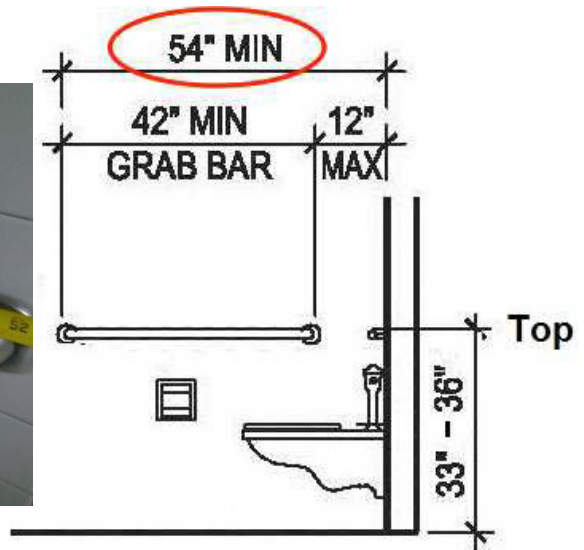
As Built: The side grab bar does not extend far enough from the rear wall.

The side grab bar must extend at least 54 inches minimum beyond the rear wall and start a maximum of 12 inches from the rear wall. A 42 inch grab bar installed the maximum distance from the rear wall (12 inches) will leave the leading end 54 inches from the rear wall.

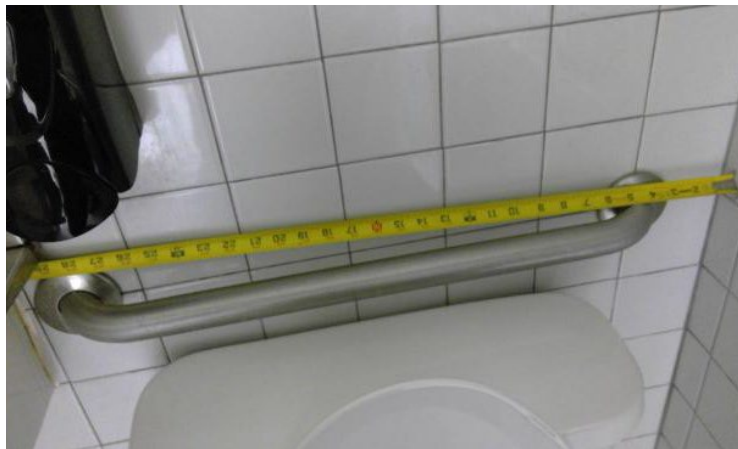
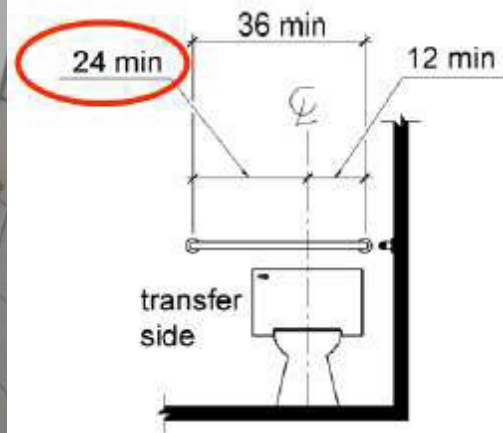
As Built: The rear grab bar does not extend adequately past the toilet on the wide side.

The rear grab bar must be a minimum of 36 inches long and extend from the centerline of the toilet 12 inches minimum on wall side and 24 inches minimum on the wide side.

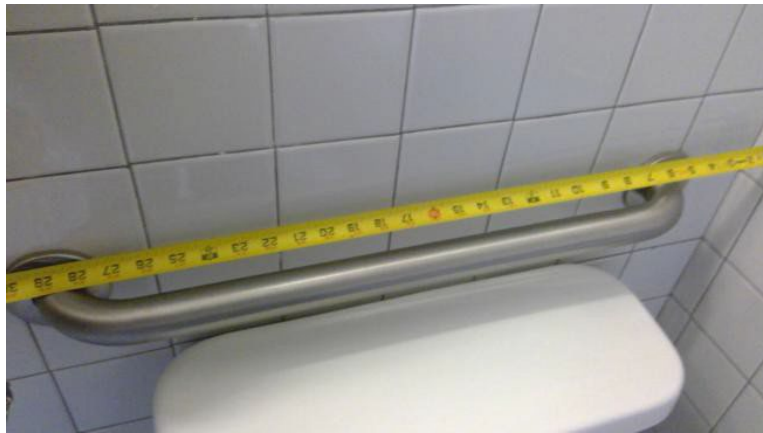
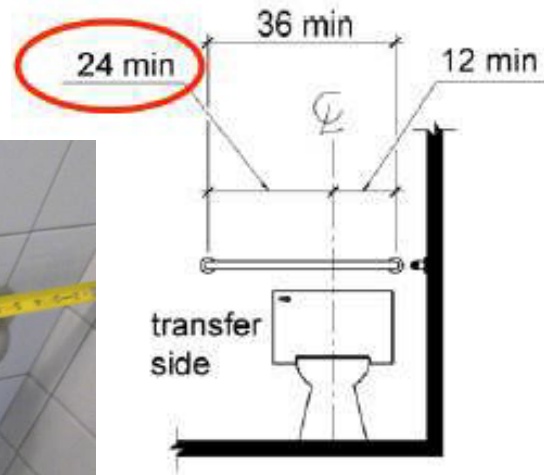
As Built: The rear grab bar does not extend adequately past the toilet on the wide side.

The rear grab bar must be a minimum of 36 inches long and extend from the centerline of the toilet 12 inches minimum on wall side and 24 inches minimum on the wide side.

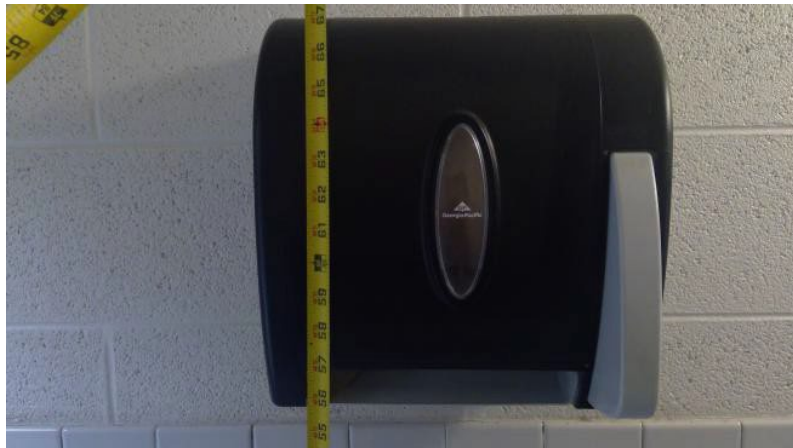
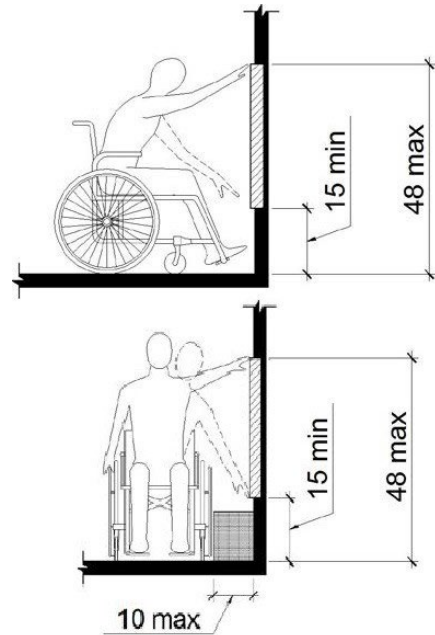
As Built: The Paper Towel is positioned too high for either a side or front approach.

Where a clear floor or ground space allows a parallel approach to an element and the side reach is unobstructed, the high side reach shall be 48 inches maximum and the low side reach shall be 15 inches minimum above the finish floor or ground.

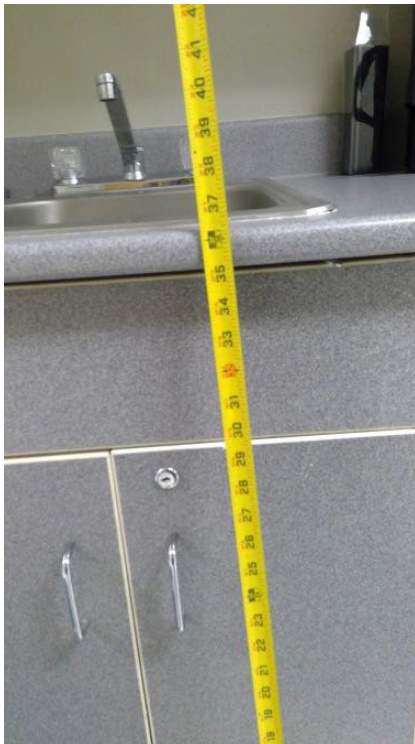
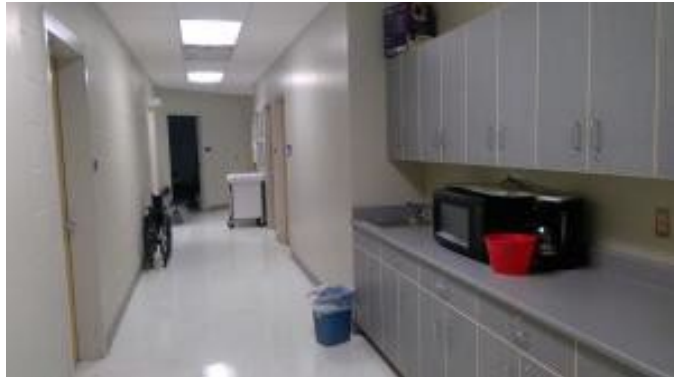
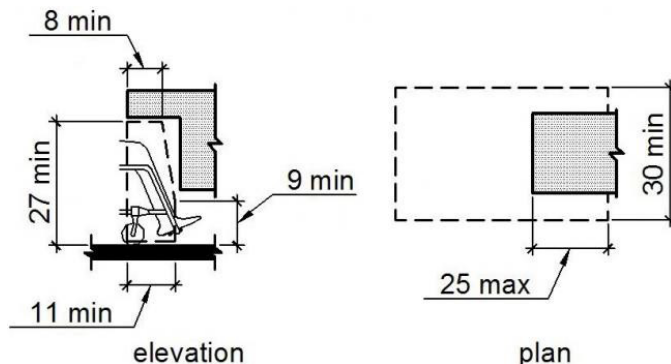
As Built: The top of the sink is 36" AFF, which is too high.

Sinks that are required to be accessible shall be a minimum 17 inches in horizontal depth and mounted with the rim or counter edge no higher than 34 inches above the finished floor.

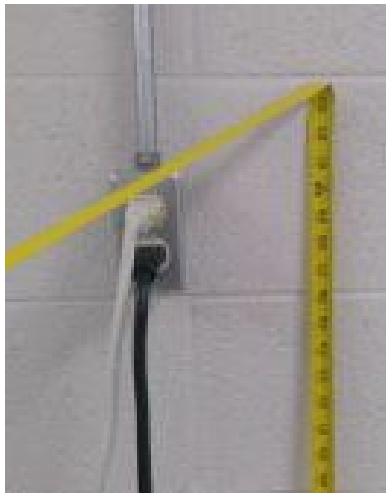
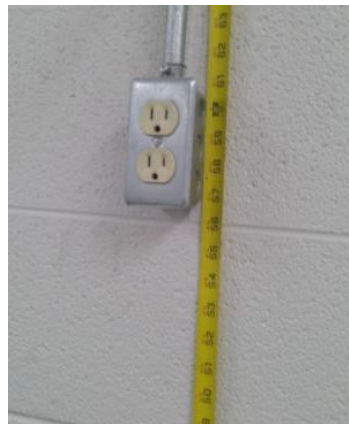
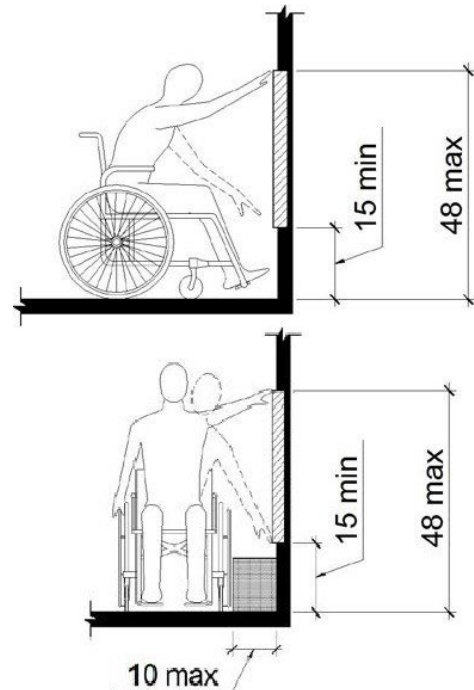
As Built: The receptacles are positioned too high for either a side or front approach.

Where a clear floor or ground space allows a parallel approach to an element and the side reach is unobstructed, the high side reach shall be 48 inches maximum and the low side reach shall be 15 inches minimum above the finish floor or ground.

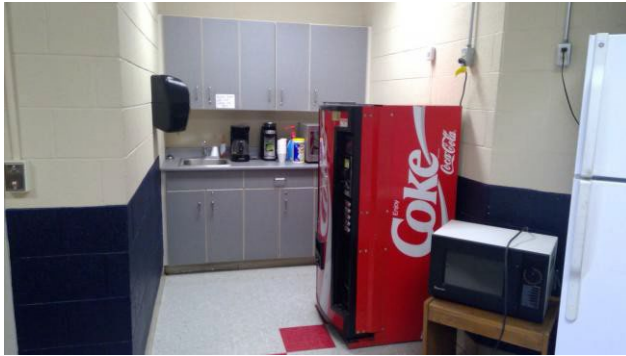
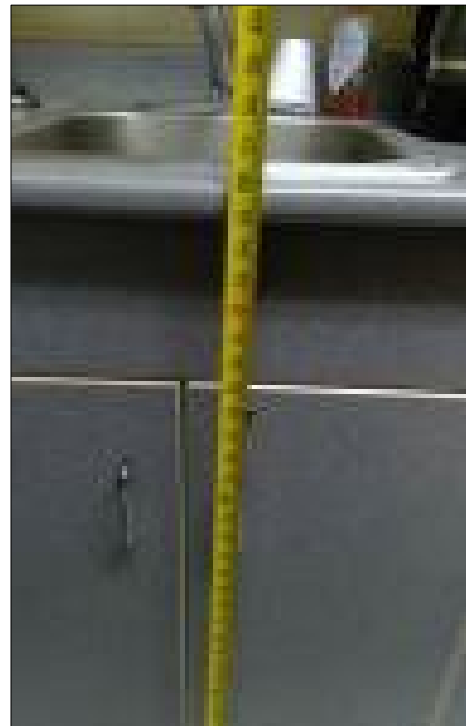
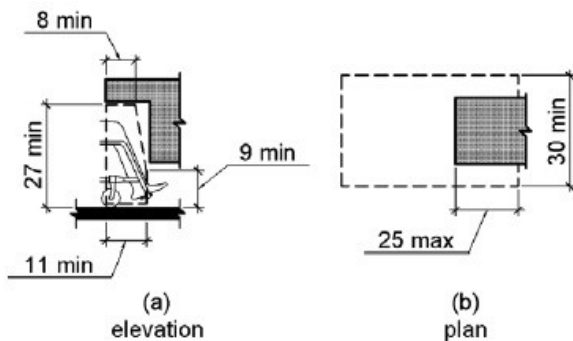
As Built: Knee and toe space has not been provided at the sink.

Kitchen sinks must be provided with a clear floor space positioned for a forward approach including knee and toe clearance

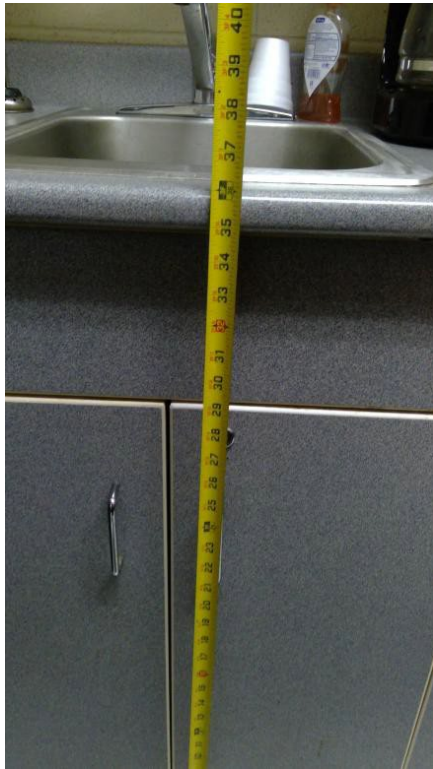
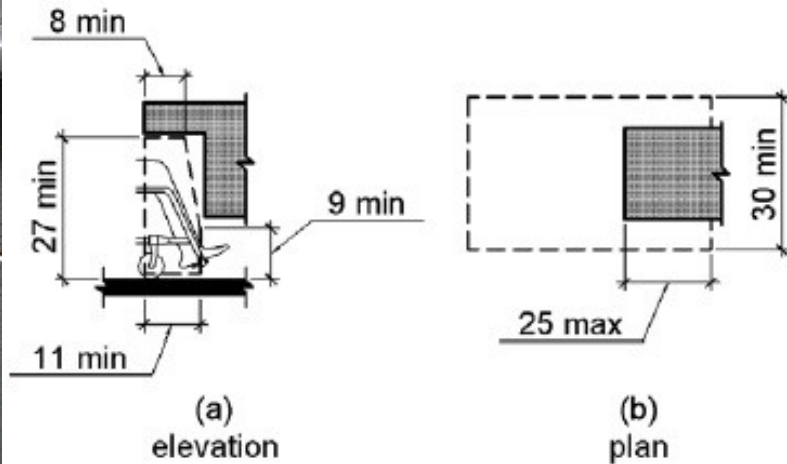
As Built: The top of the sink is too high.

Sinks that are required to be accessible shall be a minimum 17 inches in horizontal depth and mounted with the rim or counter edge no higher than 34 inches above the finished floor.

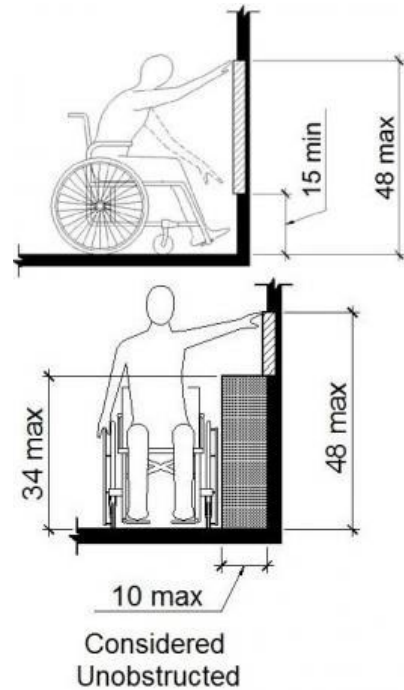
As Built: The paper towel dispenser is not positioned correctly for either a side or front approach.

Where a clear floor or ground space allows a parallel or front approach and the side reach is unobstructed, the high side reach shall be 48 inches maximum above the finish floor or ground and the low side reach shall be 15 inches minimum above the finish floor or ground.

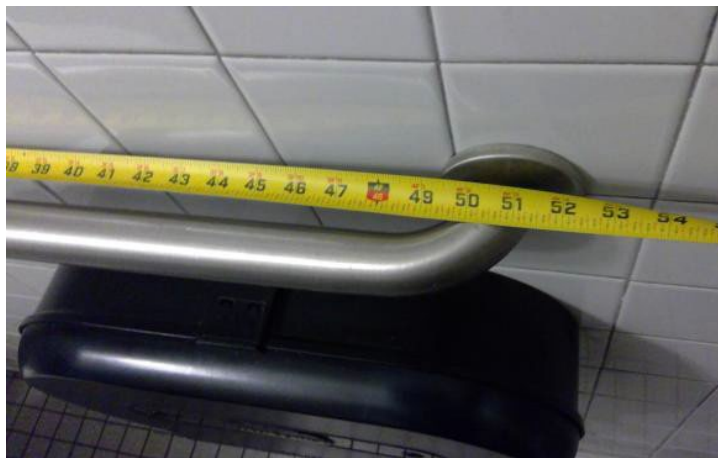
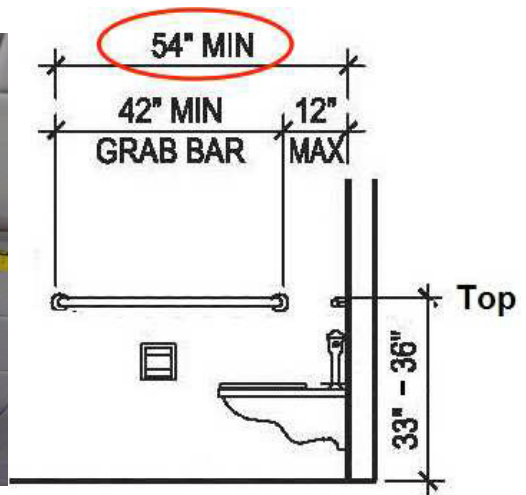
As Built: The side grab bar does not extend far enough from the rear wall.

The side grab bar must extend at least 54 inches minimum beyond the rear wall and start a maximum of 12 inches from the rear wall. A 42 inch grab bar installed the maximum distance from the rear wall (12 inches) will leave the leading end 54 inches from the rear wall. Grab bars shall be installed in a horizontal position, 33 inches minimum and 36 inches maximum above the finish floor measured to the top of the gripping surface.

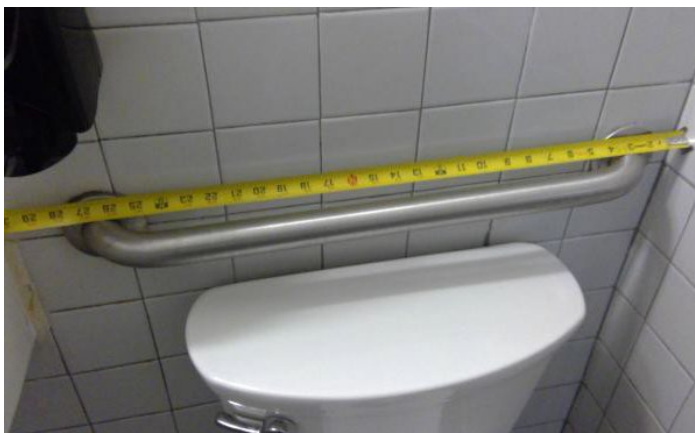
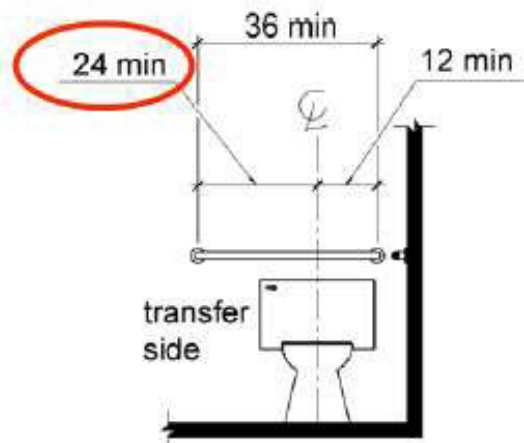
As Built: The rear grab bar does not extend adequately past the toilet on the wide side.

The rear grab bar must be a minimum of 36 inches long and extend from the centerline of the toilet 12 inches minimum on wall side and 24 inches minimum on the wide side.

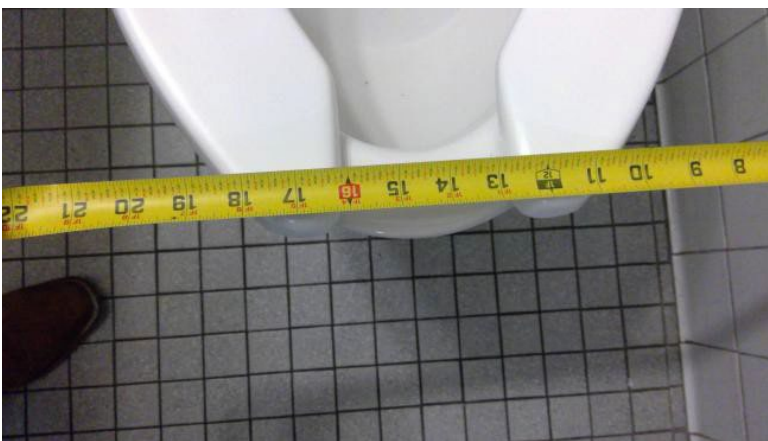
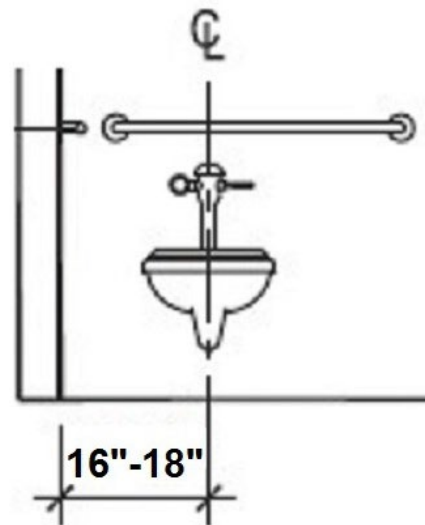
As Built: The toilet is not located within the range allowed from the side wall or partition. The centerline of the toilet must be 16 to 18 inches from the side wall.

Citation: 2010 ADAS Section 604.2

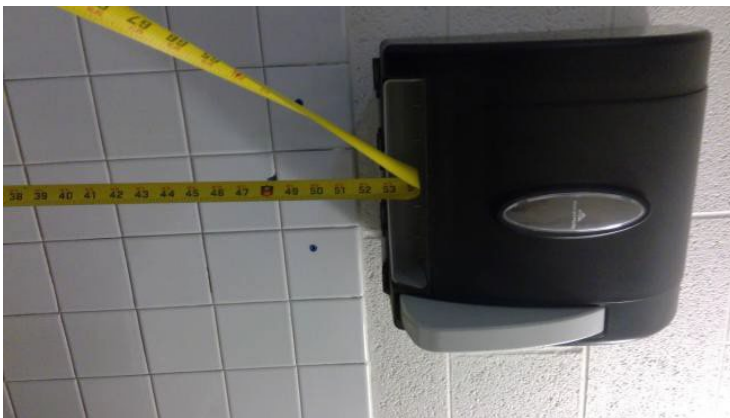
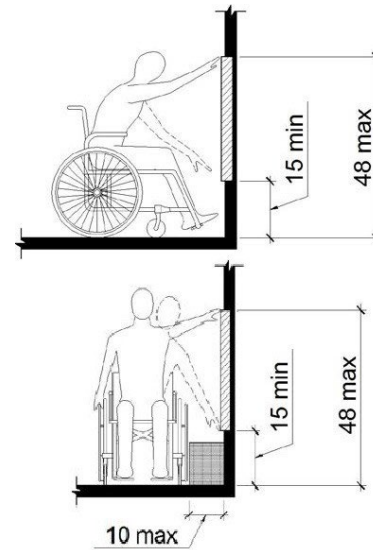
As Built: The paper towel dispenser is positioned too high for either a side or front approach.

Where a clear floor or ground space allows a parallel approach to an element and the side reach is unobstructed, the high side reach shall be 48 inches maximum and the low side reach shall be 15 inches minimum above the finish floor or ground.

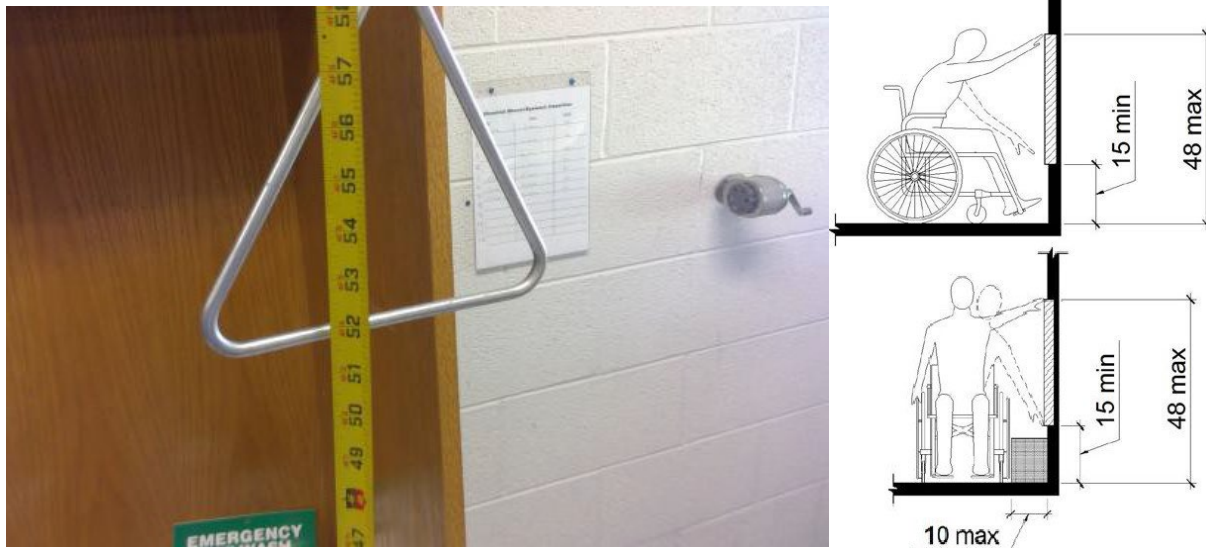
As Built: The Emergency shower handle is positioned at 52", which is too high for either a side or front approach.

Where a clear floor or ground space allows a parallel approach to an element and the side reach is unobstructed, the high side reach shall be 48 inches maximum and the low side reach shall be 15 inches minimum above the finish floor or ground.

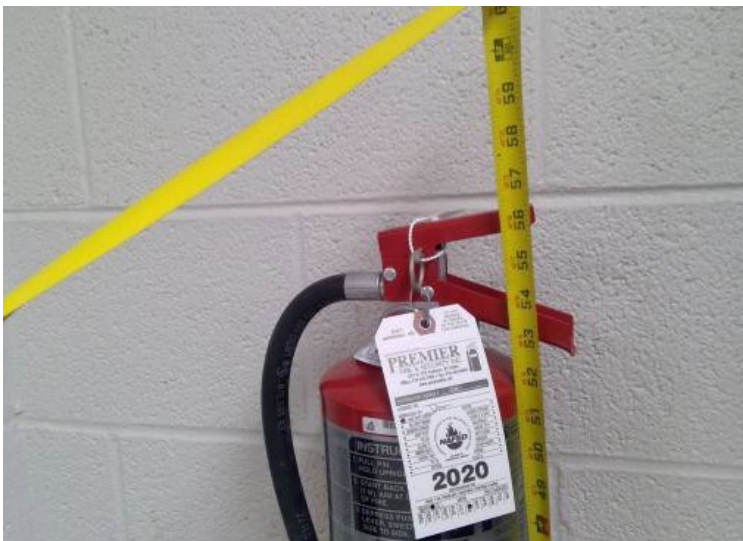
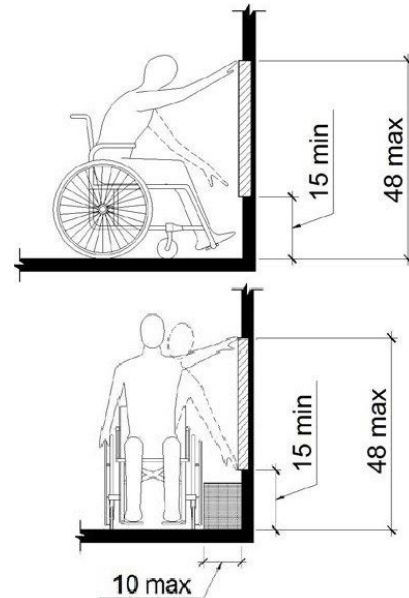
As Built: The fire extinguisher is positioned too high for either a side or front approach.

Where a clear floor or ground space allows a parallel approach to an element and the side reach is unobstructed, the high side reach shall be 48 inches maximum and the low side reach shall be 15 inches minimum above the finish floor or ground.

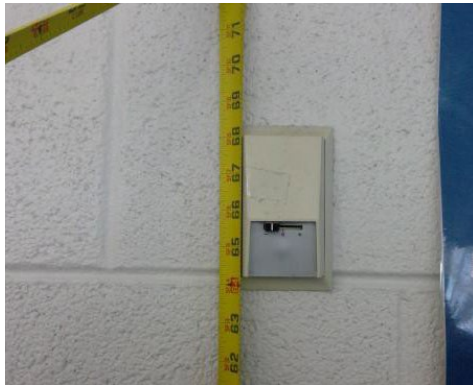
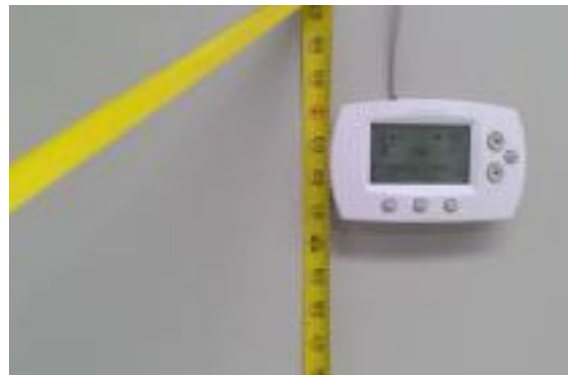
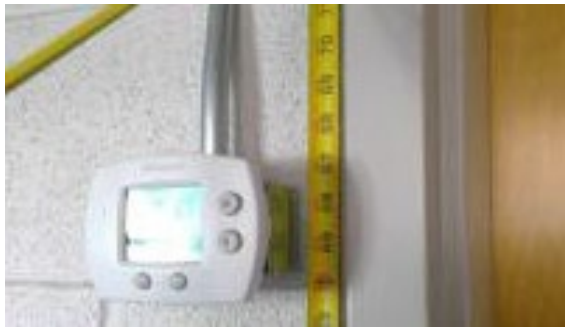
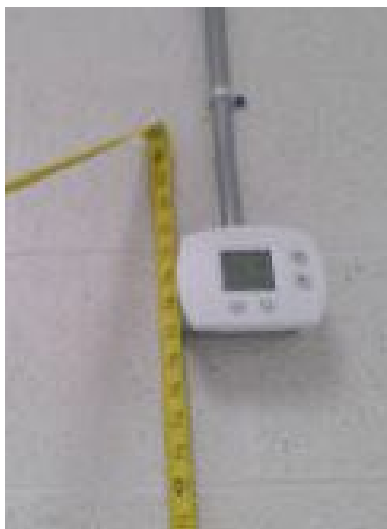
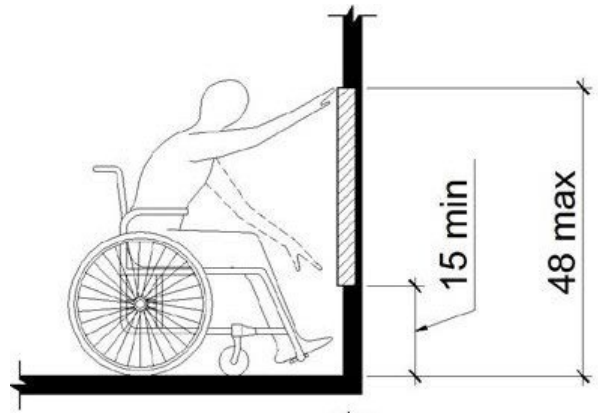
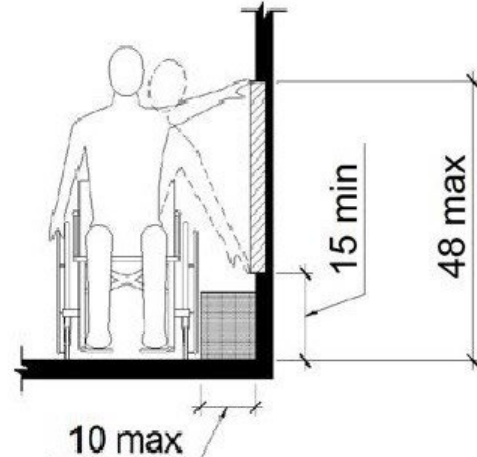
As Built: All thermostats are exceeding 48" in height, which is too high for either a side or front approach.

Where a clear floor or ground space allows a parallel approach to an element and the side reach is unobstructed, the high side reach shall be 48 inches maximum and the low side reach shall be 15 inches minimum above the finish floor or ground.

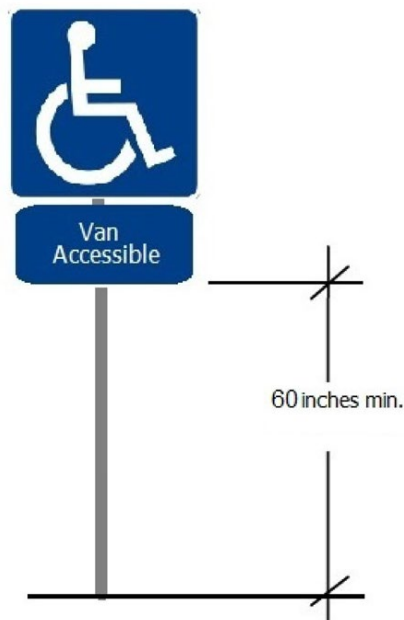
As Built: The parking sign is mounted at 56", which is too low.

Parking space identification signs shall include the International Symbol of Accessibility. Signs identifying van parking spaces shall contain the designation "van accessible."

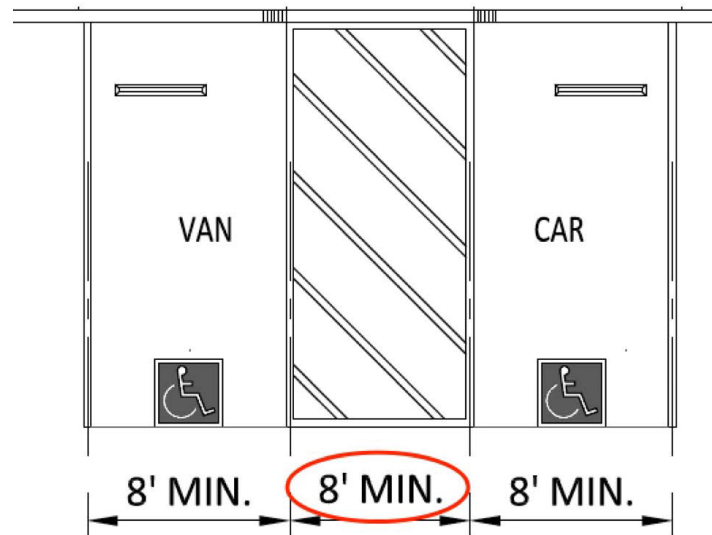
As Built: The access aisle is not a minimum 8 feet to the centerline of the stripe.

The accessible parking stall access aisle must be a minimum of 8 feet wide measured from centerline to centerline. Where parking spaces or access aisles are not adjacent to another parking space or access aisle, measurements shall be permitted to include the full width of the line defining the parking space or access aisle.

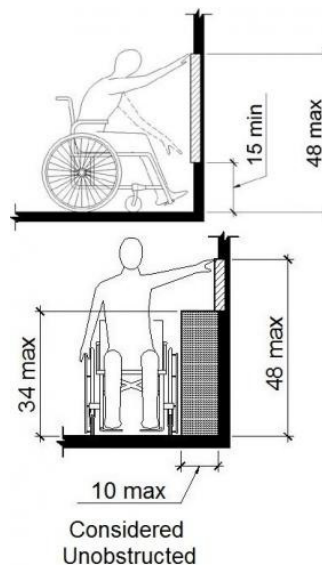
As Built: The push to exit device is not positioned correctly for either a side or front approach.

Where a clear floor or ground space allows a parallel or front approach and the side reach is unobstructed, the high side reach shall be 48 inches maximum above the finish floor or ground and the low side reach shall be 15 inches minimum above the finish floor or ground.

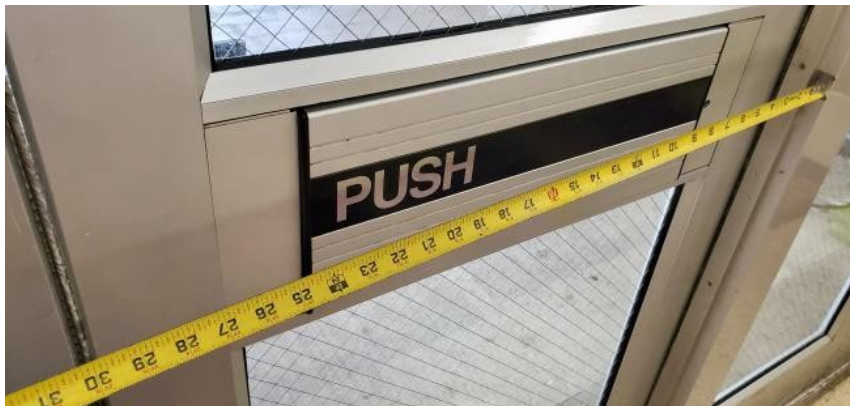
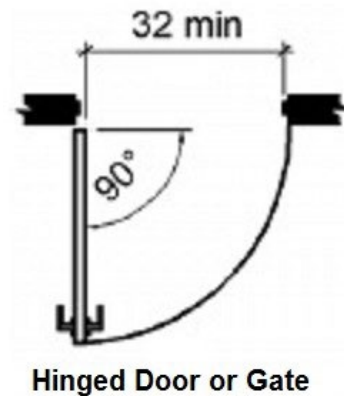
As Built: Neither leaf of the doorway provides at least 32 inches between the face of the door and the opposite stop. At least one of the active leaves of doorways with two leaves shall comply with clear width and maneuvering clearance.

Door openings shall provide a clear width of 32 inches minimum. Clear openings of doorways with swinging doors shall be measured between the face of the door and the stop, with the door open 90 degrees. There shall be no projections into the required clear opening width lower than 34 inches above the finish floor or ground. Projections into the clear opening width between 34 inches and 80 inches above the finish floor or ground shall not exceed 4 inches.

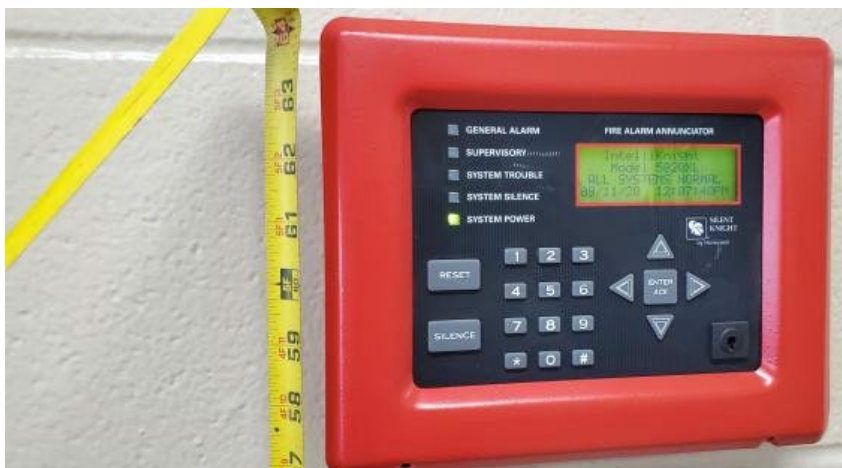
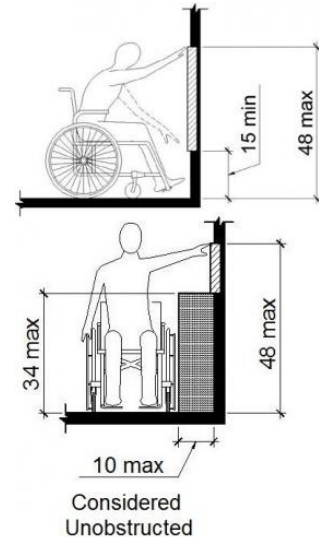
As Built: The fire alarm Annunciator is not positioned correctly for either a side or front approach.

Where a clear floor or ground space allows a parallel or front approach and the side reach is unobstructed, the high side reach shall be 48 inches maximum above the finish floor or ground and the low side reach shall be 15 inches minimum above the finish floor or ground.

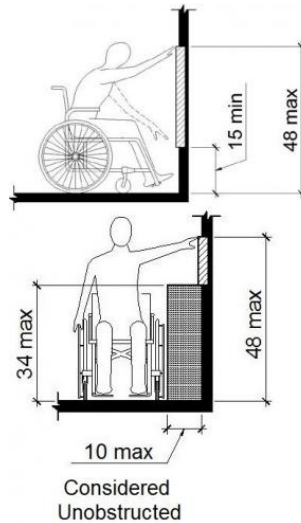
As Built: The thermostat is not positioned correctly for either a side or front approach.

Where a clear floor or ground space allows a parallel or front approach and the side reach is unobstructed, the high side reach shall be 48 inches maximum above the finish floor or ground and the low side reach shall be 15 inches minimum above the finish floor or ground.

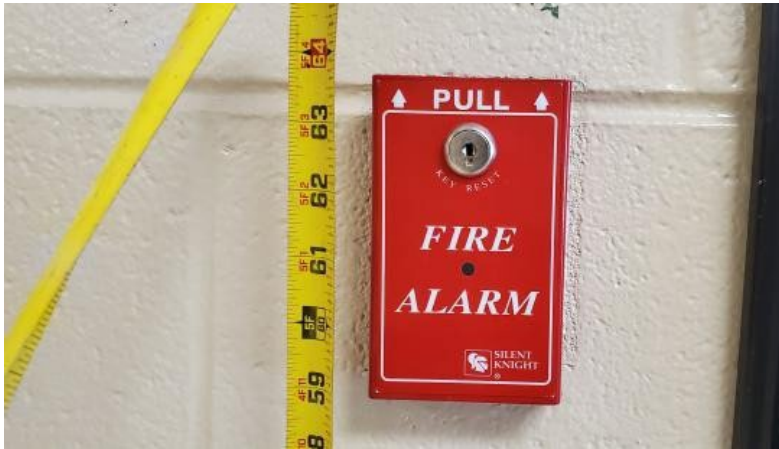
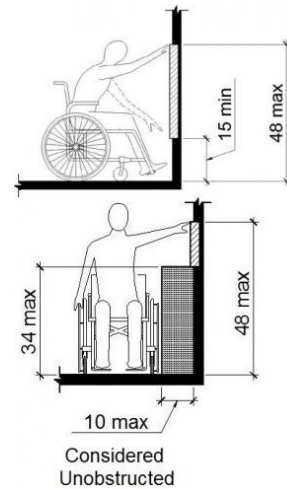
As Built: The fire alarm pull is not positioned correctly for either a side or front approach.

Where a clear floor or ground space allows a parallel or front approach and the side reach is unobstructed, the high side reach shall be 48 inches maximum above the finish floor or ground and the low side reach shall be 15 inches minimum above the finish floor or ground.
