WEAKLEY COUNTY, TENNESSEE

ADA EVALUATION

Architectural and Site Findings with Recommendations

TLM Associates, Inc

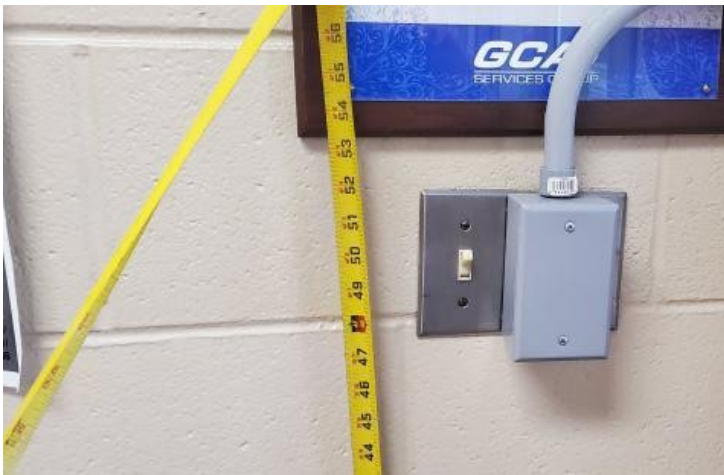
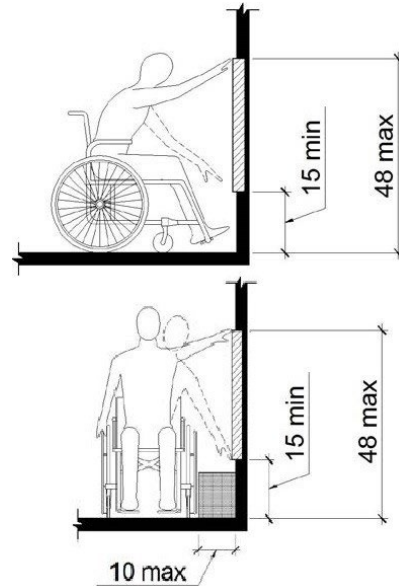
As Built: The receptacle/switch is not positioned correctly for either a side or front approach.

Where a clear floor or ground space allows a parallel or front approach to a switch or receptacle and the side reach is unobstructed, the high side reach shall be 48 inches maximum above the finish floor or ground and the low side reach shall be 15 inches minimum above the finish floor or ground.

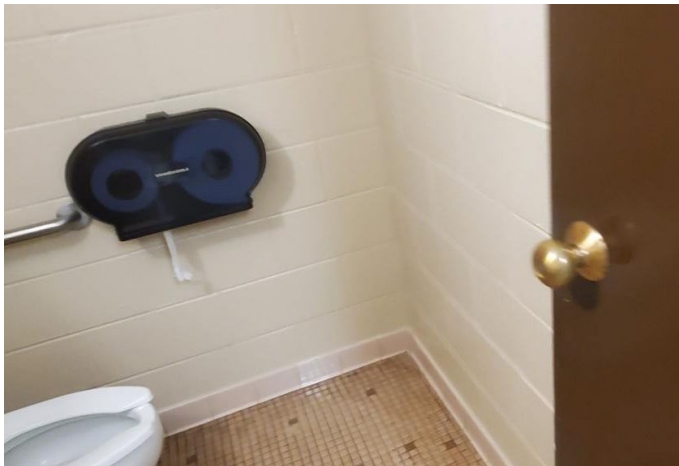
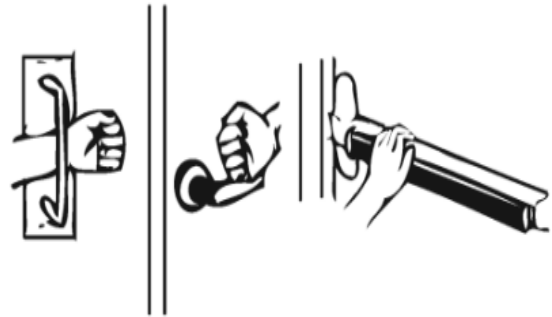
As Built: The door/gate operating hardware is not accessible.

Hand-activated door/gate opening hardware, handles, pulls, latches, locks, and other operating devices on accessible doors shall have a shape that is easy to grasp with one hand and does not require tight grasping, pinching or twisting of the wrist to operate. Hardware shall be 34 inches minimum and 48 inches maximum above the finish floor or ground.

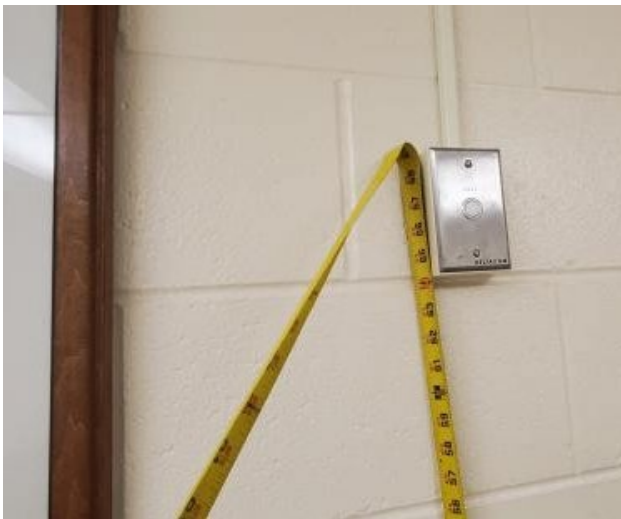
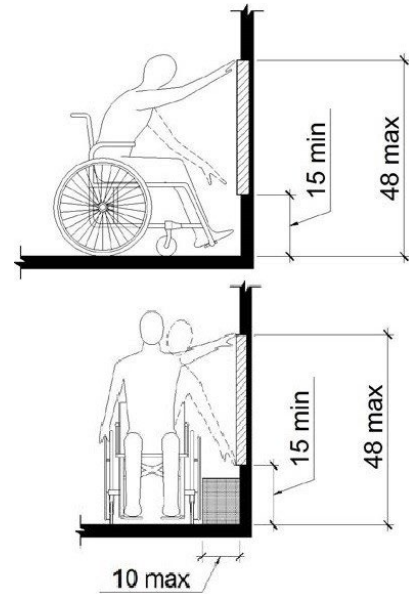
As Built: The intercom buttons are not positioned correctly for either a side or front approach.

Where a clear floor or ground space allows a parallel or front approach to a switch or receptacle and the side reach is unobstructed, the high side reach shall be 48 inches maximum above the finish floor or ground and the low side reach shall be 15 inches minimum above the finish floor or ground.

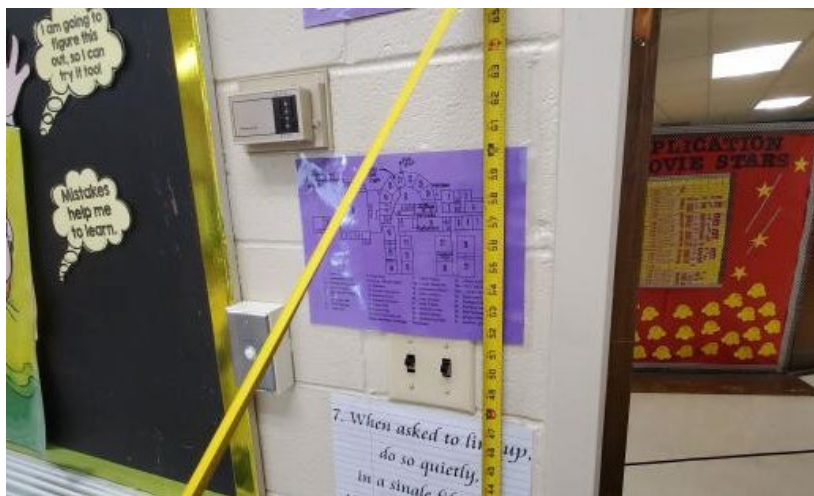
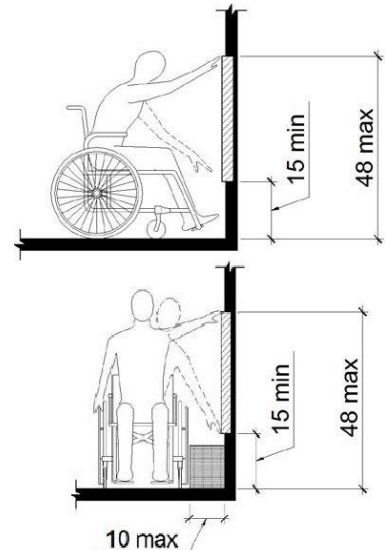
As Built: The thermostats are not positioned correctly for either a side or front approach.

Where a clear floor or ground space allows a parallel or front approach to a switch or receptacle and the side reach is unobstructed, the high side reach shall be 48 inches maximum above the finish floor or ground and the low side reach shall be 15 inches minimum above the finish floor or ground.

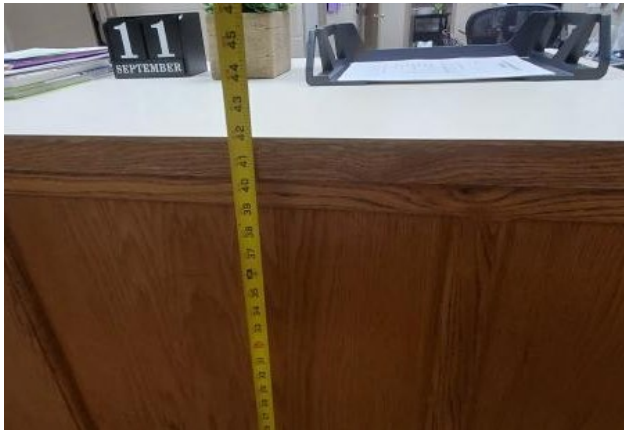
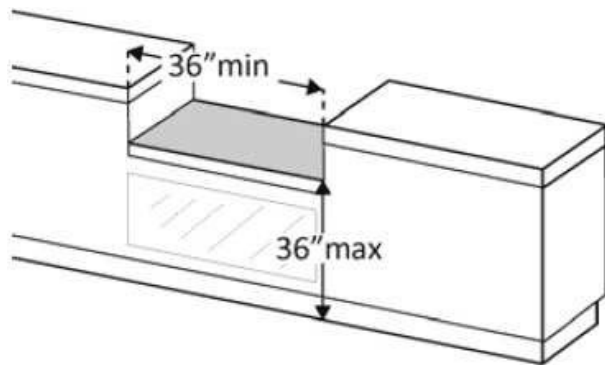
As Built: The counter is too high.

A portion of the counter surface that is 36 inches long minimum and 36 inches high maximum above the finish floor shall be provided. Knee and toe space must be provided for a forward approach. A 30 inch by 48 inch clear floor space on an accessible route must be provided for either a forward or parallel approach.

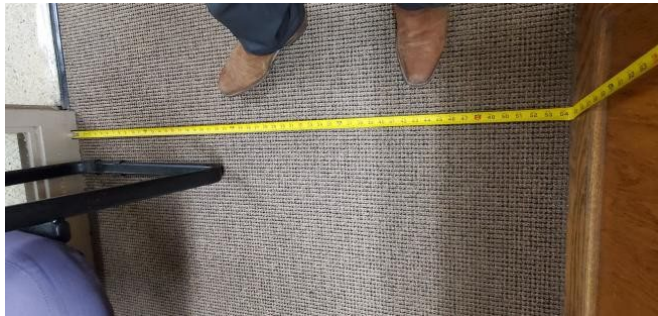
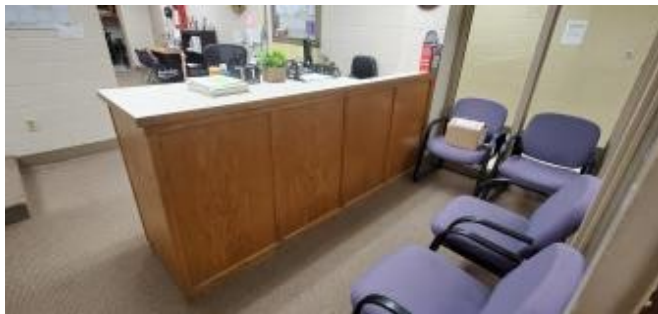
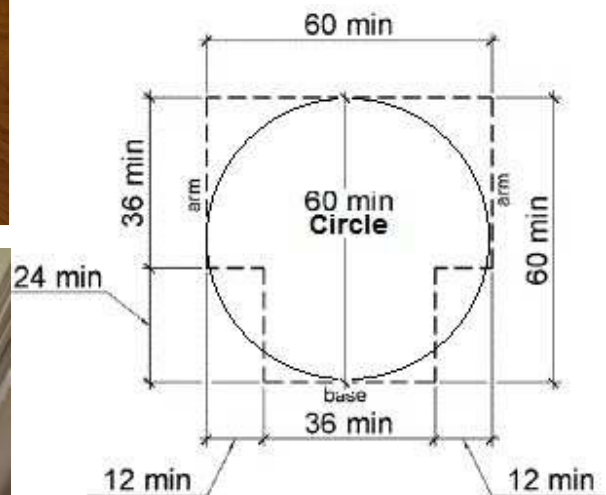
As Built: Compliant turning space has not been provided.

The space required for a wheelchair to make a 180-degree turn is a clear space of 60 inches in diameter or a T-shaped space.

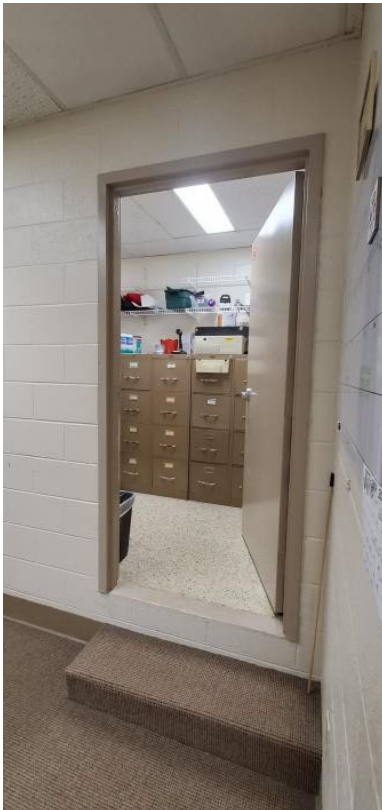
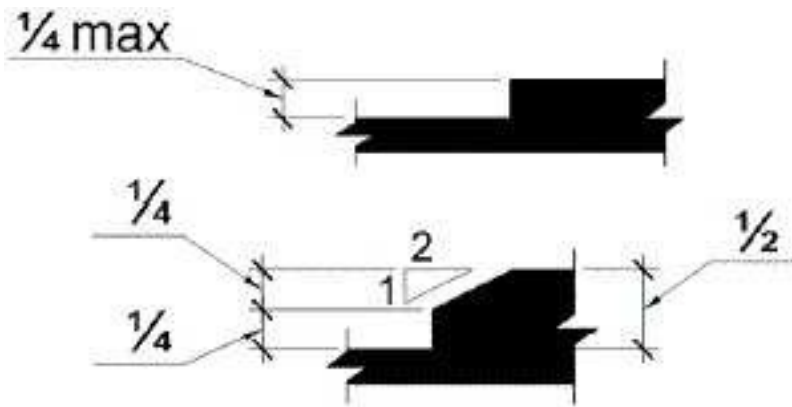
As Built: There is a change in level greater than 1/4 inch.

1/4 inch is the maximum vertical rise. Changes in level between 1/4 inch and 1/2 inch must be beveled at 1:2 or less. Changes in level greater than 1/2 inch must be by way of a ramp.

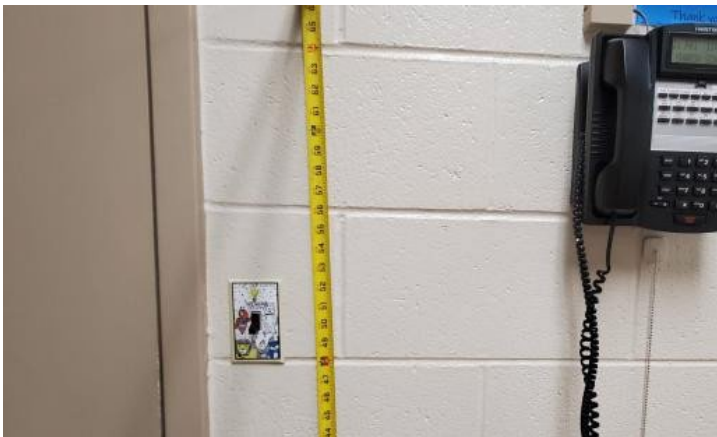
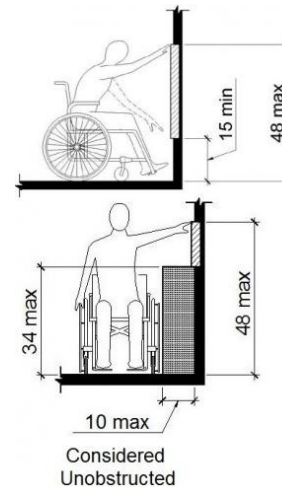
As Built: The 63" is not positioned correctly for either a side or front approach.

Where a clear floor or ground space allows a parallel or front approach and the side reach is unobstructed, the high side reach shall be 48 inches maximum above the finish floor or ground and the low side reach shall be 15 inches minimum above the finish floor or ground.

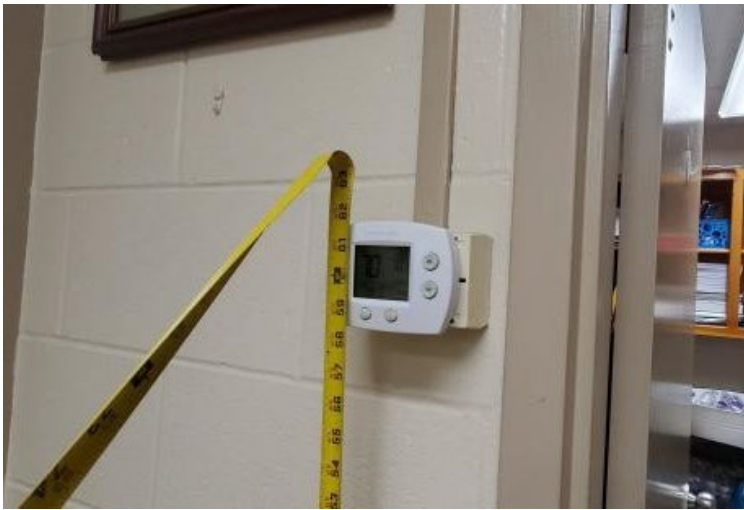
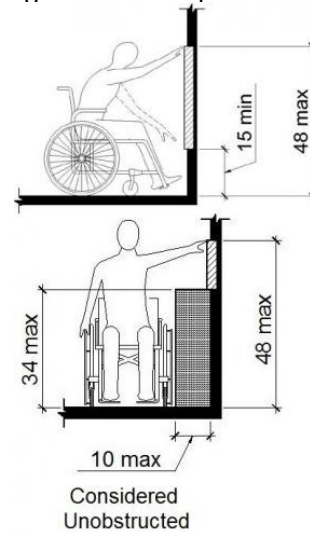
As Built: The thermostat is not positioned correctly for either a side or front approach.

Where a clear floor or ground space allows a parallel or front approach and the side reach is unobstructed, the high side reach shall be 48 inches maximum above the finish floor or ground and the low side reach shall be 15 inches minimum above the finish floor or ground.

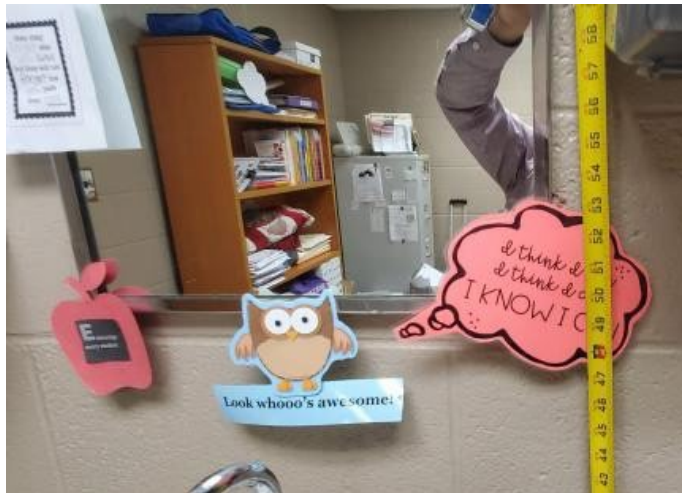
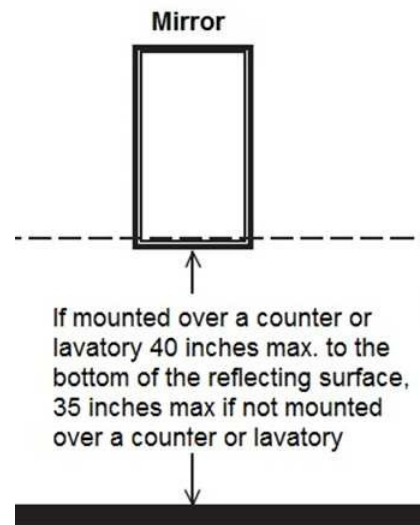
As Built: The mirror is mounted too high.

Mirrors must have the bottom edge of the reflecting surface a maximum of 40 inches above the floor if above a sink or counter. Mirrors not located above lavatories or countertops shall be installed with the bottom edge of the reflecting surface 35 inches maximum above the finish floor or ground.

Citation: 2010 ADAS Section 603.3

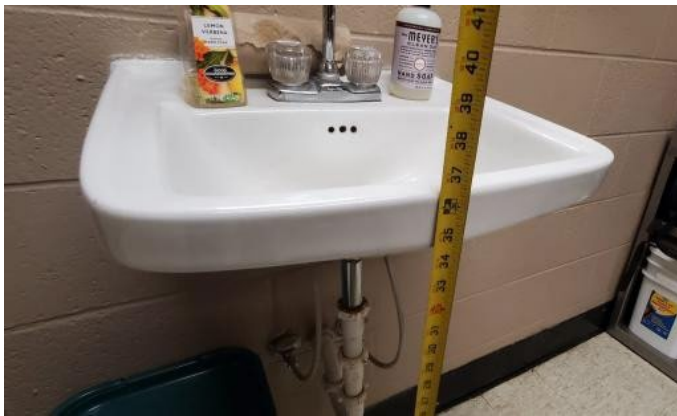
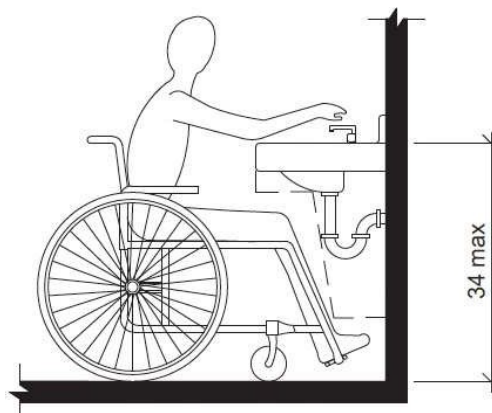
As Built: The top rim of the lavatory is too high.

All lavatories that are designated to be accessible shall be a minimum 17 inches in horizontal depth and mounted with the rim or counter edge no higher than 34 inches above the finished floor.

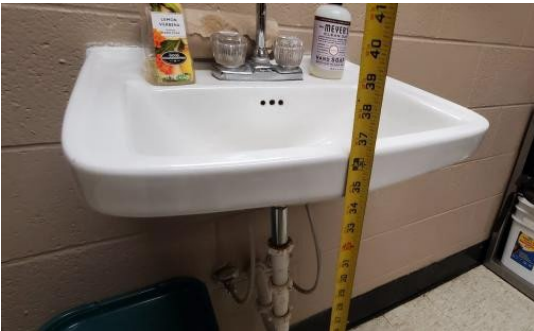
As Built: The faucet controls require twisting of the wrist.

Faucet controls and operating mechanisms shall be operable with one hand and shall not require tight grasping, pinching or twisting of the wrist. The force required to activate controls shall be no greater than 5 lb. Lever-operated, push-type and electronically controlled mechanisms are examples of acceptable designs. Self-closing valves are allowed if the faucet remains open for at least 10 seconds.

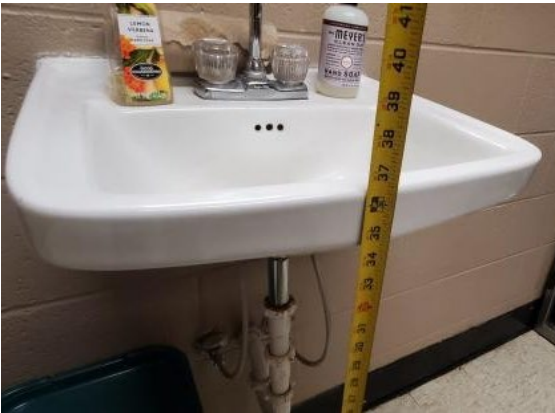
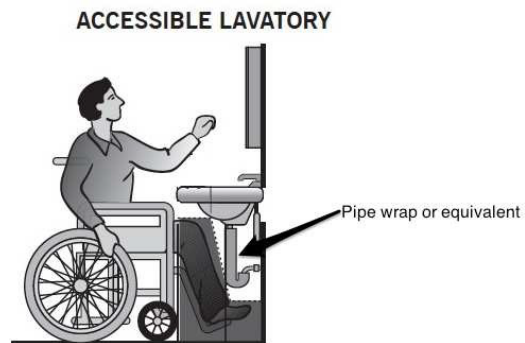
As Built: The water and drainpipe insulation under the lavatory is not installed.

Water supply and drainpipes under lavatories and sinks shall be insulated or otherwise configured to protect against contact. There shall be no sharp or abrasive surfaces under lavatories and sinks.

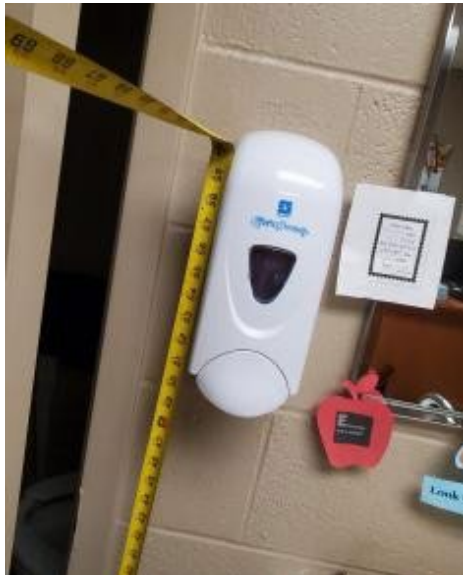
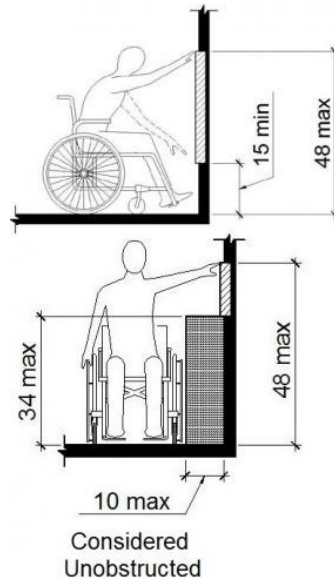
As Built: The hand sanitizer is not positioned correctly for either a side or front approach.

Where a clear floor or ground space allows a parallel or front approach and the side reach is unobstructed, the high side reach shall be 48 inches maximum above the finish floor or ground and the low side reach shall be 15 inches minimum above the finish floor or ground.

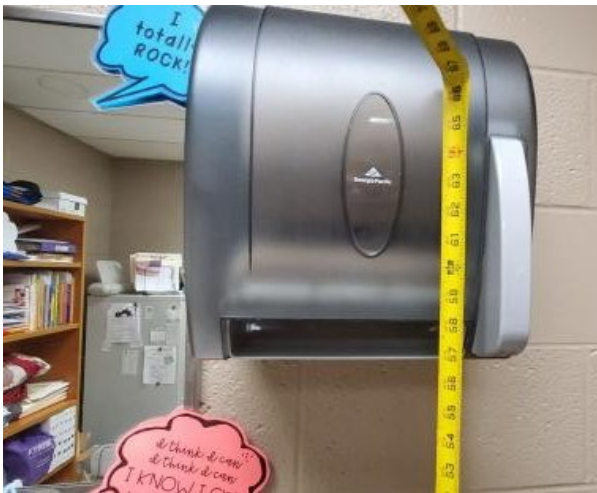
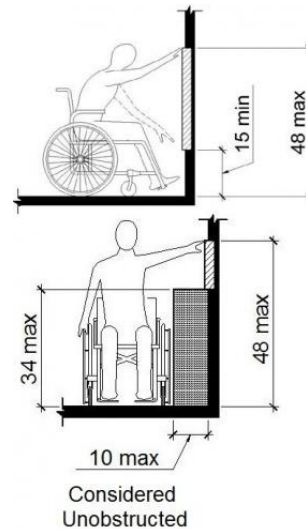
As Built: The paper towel dispenser is not positioned correctly for either a side or front approach.

Where a clear floor or ground space allows a parallel or front approach and the side reach is unobstructed, the high side reach shall be 48 inches maximum above the finish floor or ground and the low side reach shall be 15 inches minimum above the finish floor or ground.

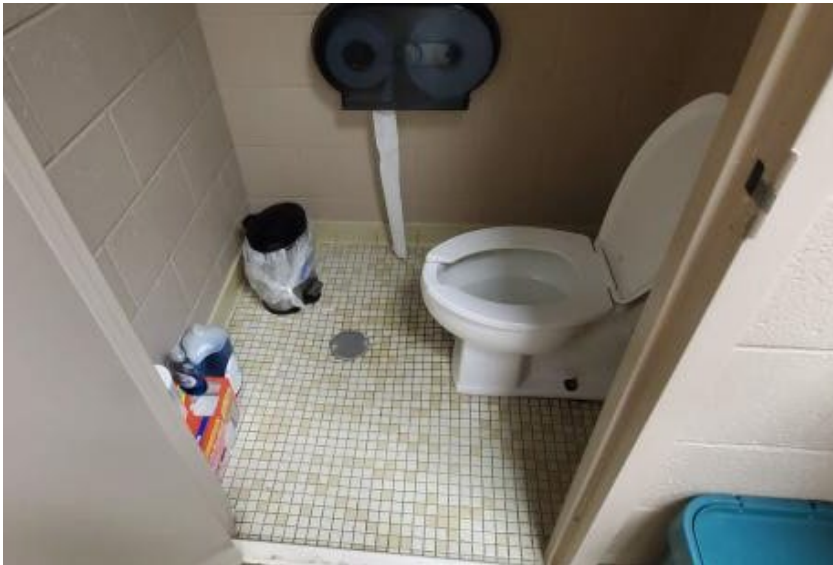
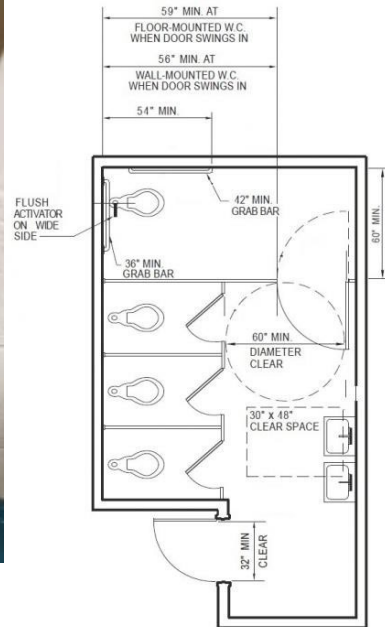
As Built: The toilet compartment does not have the required minimum clear floor space or maneuvering clearances for the toilet. The restroom does not have the required minimum width and depth dimensions. The entry door does not contain the required minimum 60 inches maneuvering space on the pull side. No Grab bars installed.

Citation: 2010 ADAS Section 213.2

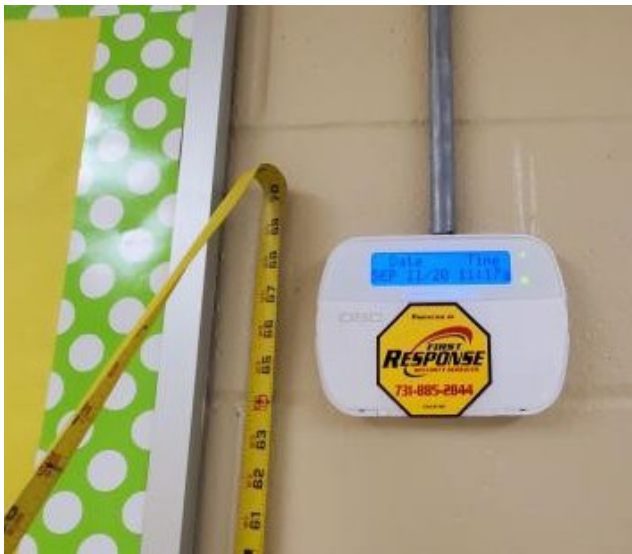
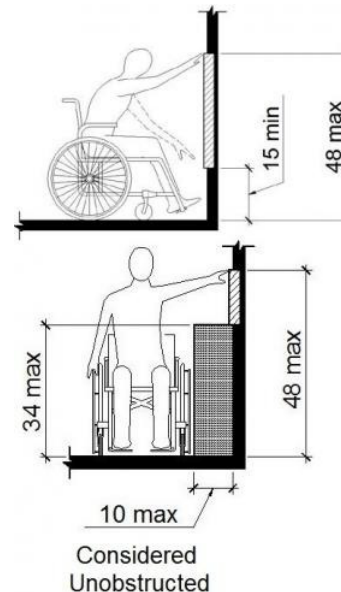
As Built: The alarm pad is not positioned correctly for either a side or front approach.

Where a clear floor or ground space allows a parallel or front approach and the side reach is unobstructed, the high side reach shall be 48 inches maximum above the finish floor or ground and the low side reach shall be 15 inches minimum above the finish floor or ground.

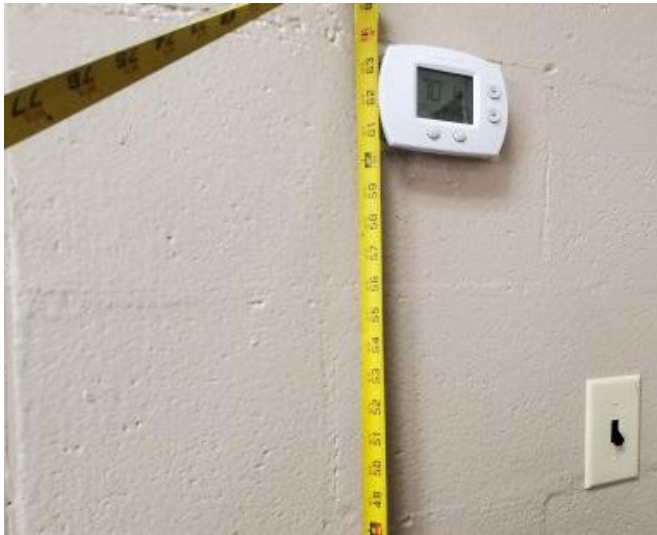
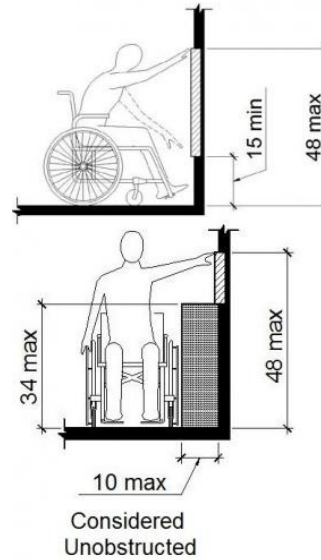
As Built: The thermostat is not positioned correctly for either a side or front approach.

Where a clear floor or ground space allows a parallel or front approach and the side reach is unobstructed, the high side reach shall be 48 inches maximum above the finish floor or ground and the low side reach shall be 15 inches minimum above the finish floor or ground.

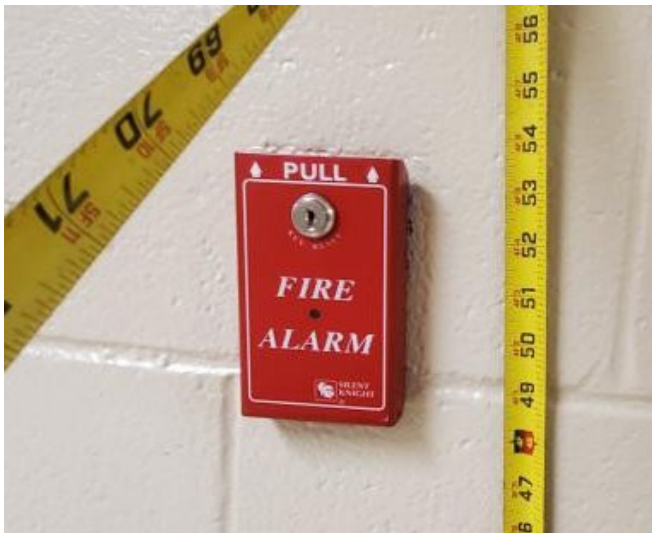
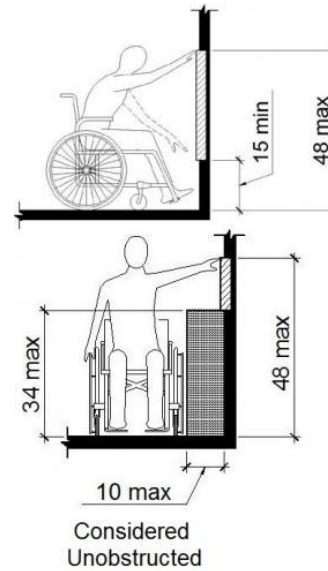
As Built: The fire alarm pull is not positioned correctly for either a side or front approach.

Where a clear floor or ground space allows a parallel or front approach and the side reach is unobstructed, the high side reach shall be 48 inches maximum above the finish floor or ground and the low side reach shall be 15 inches minimum above the finish floor or ground.

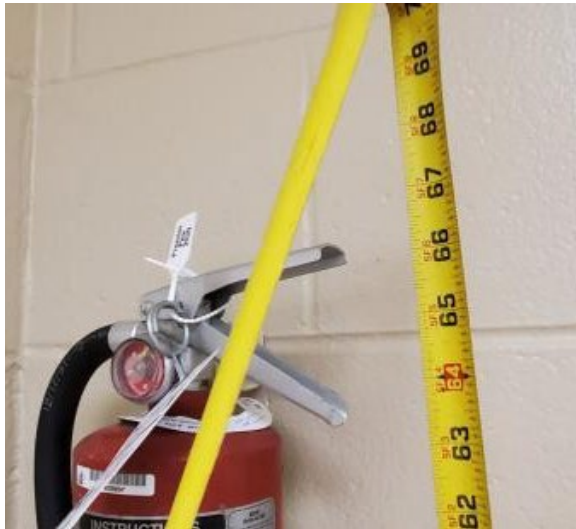
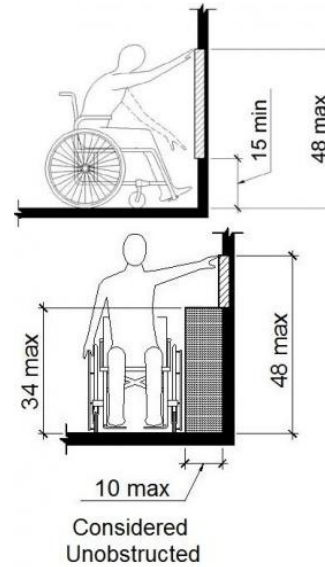
As Built: The fire extinguisher is not positioned correctly for either a side or front approach.

Where a clear floor or ground space allows a parallel or front approach and the side reach is unobstructed, the high side reach shall be 48 inches maximum above the finish floor or ground and the low side reach shall be 15 inches minimum above the finish floor or ground.

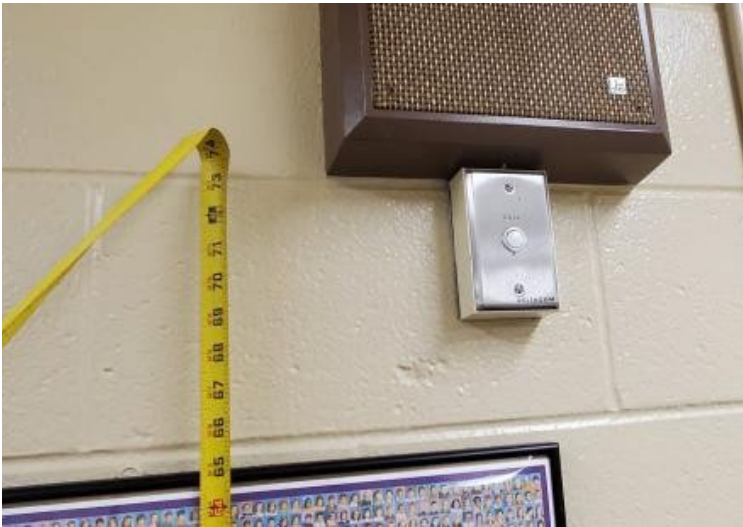
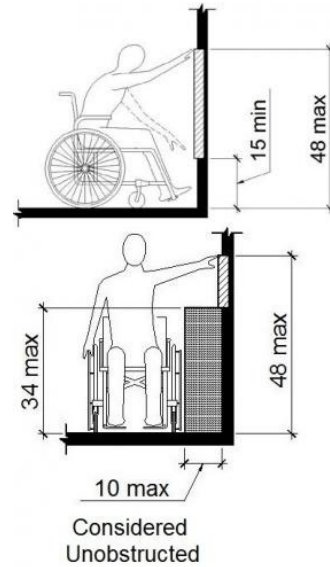
As Built: The 71" is not positioned correctly for either a side or front approach.

Where a clear floor or ground space allows a parallel or front approach and the side reach is unobstructed, the high side reach shall be 48 inches maximum above the finish floor or ground and the low side reach shall be 15 inches minimum above the finish floor or ground.

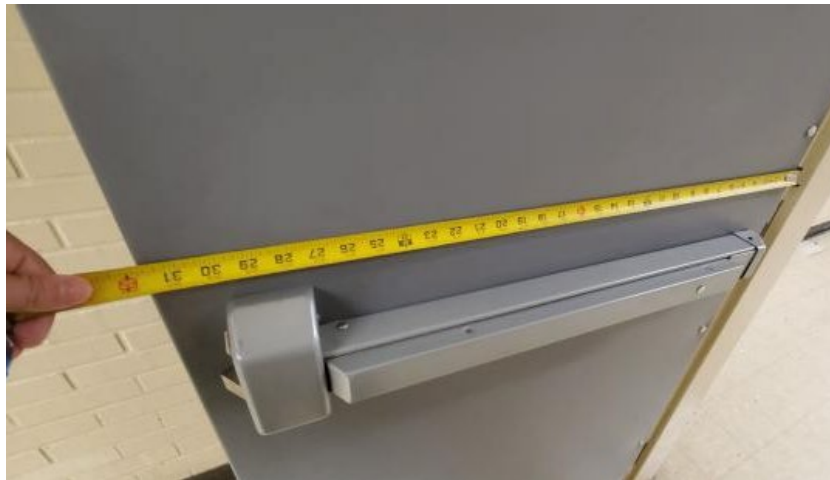
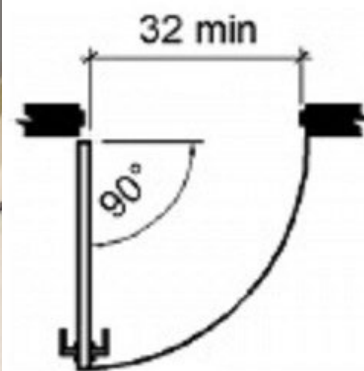
Hinged Door or Gate

As Built: Neither leaf of the doorway provides at least 32 inches between the face of the door and the opposite stop.

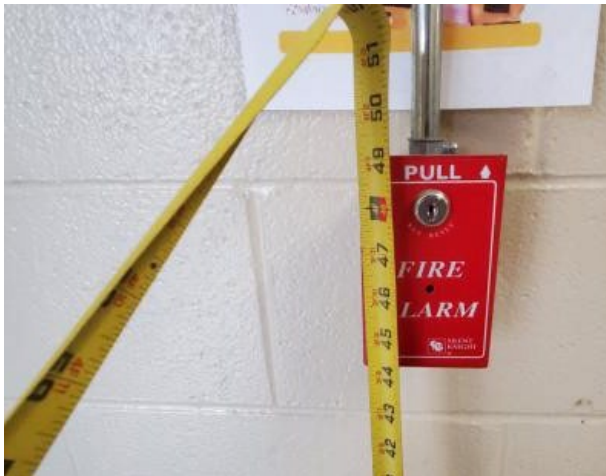
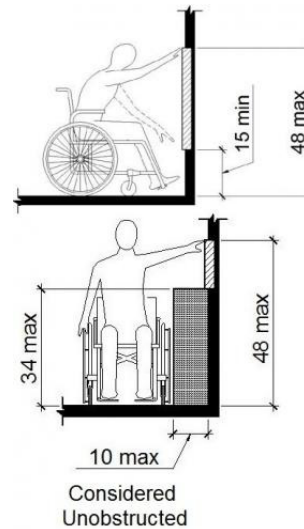
As Built: The fire alarm pull is not positioned correctly for either a side or front approach.

Where a clear floor or ground space allows a parallel or front approach and the side reach is unobstructed, the high side reach shall be 48 inches maximum above the finish floor or ground and the low side reach shall be 15 inches minimum above the finish floor or ground.

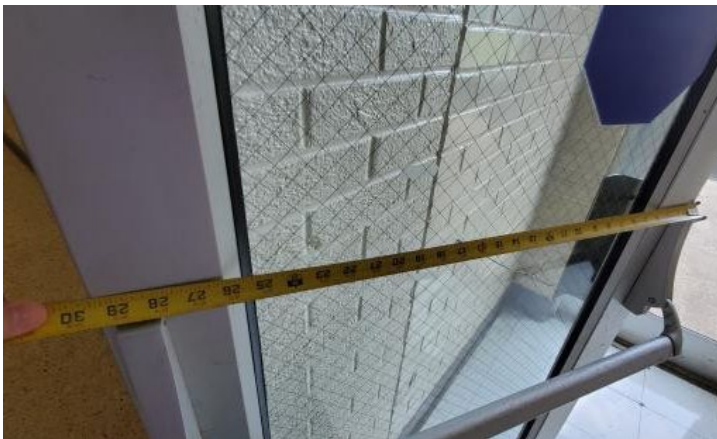
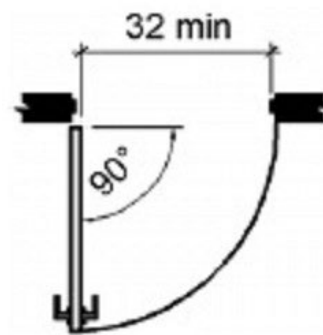
Hinged Door or Gate

As Built: Neither leaf of the doorway provides at least 32 inches between the face of the door and the opposite stop. At least one of the active leaves of doorways with two leaves shall comply with clear width and maneuvering clearance.

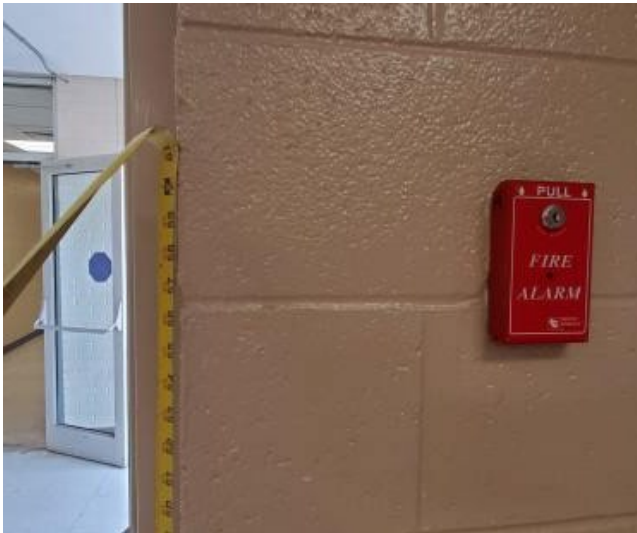
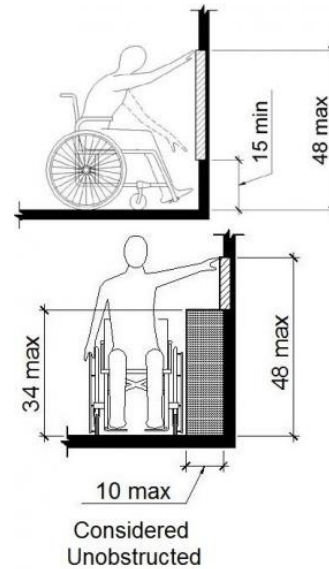
As Built: The fire alarm pull is not positioned correctly for either a side or front approach.

Where a clear floor or ground space allows a parallel or front approach and the side reach is unobstructed, the high side reach shall be 48 inches maximum above the finish floor or ground and the low side reach shall be 15 inches minimum above the finish floor or ground.

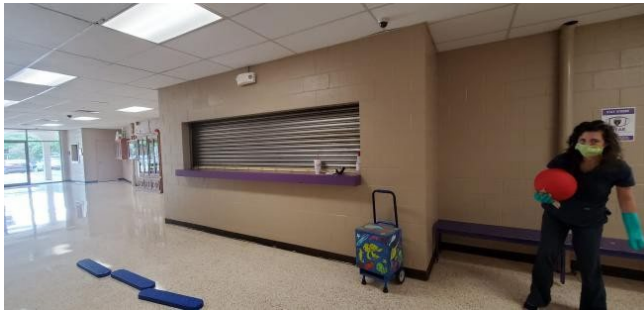
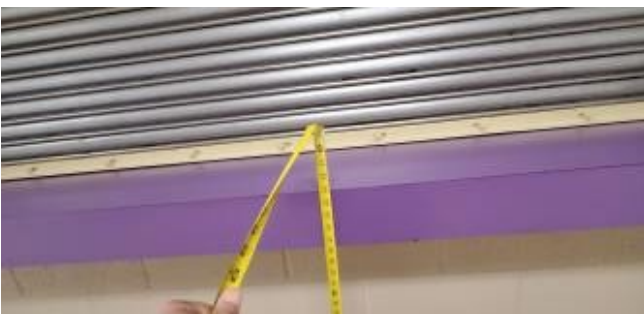
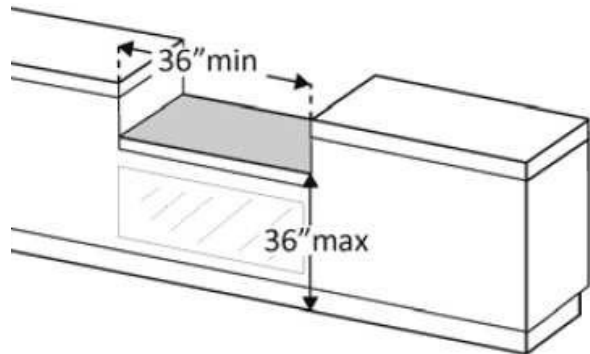
As Built: The counter is too high.

A portion of the counter surface that is 36 inches long minimum and 36 inches high maximum above the finish floor shall be provided. Knee and toe space must be provided for a forward approach. A 30 inch by 48 inch clear floor space on an accessible route must be provided for either a forward or parallel approach.

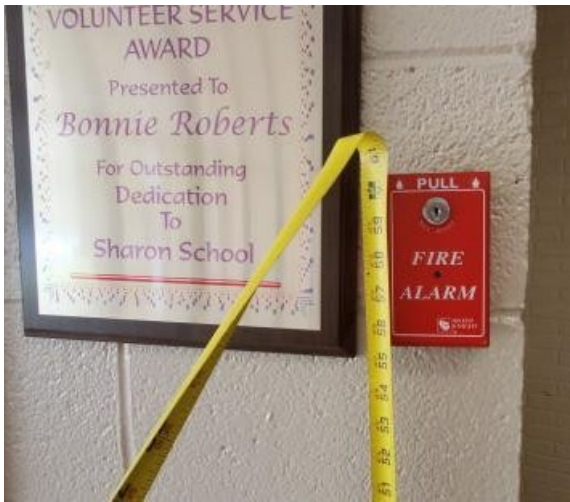
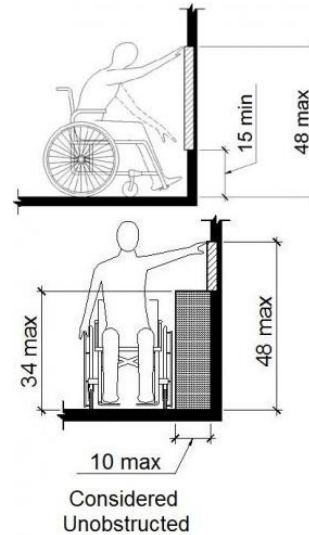
As Built: The fire alarm pull is not positioned correctly for either a side or front approach.

Where a clear floor or ground space allows a parallel or front approach and the side reach is unobstructed, the high side reach shall be 48 inches maximum above the finish floor or ground and the low side reach shall be 15 inches minimum above the finish floor or ground.

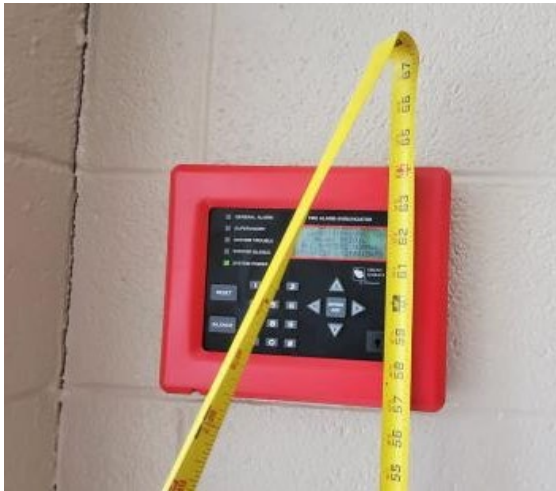
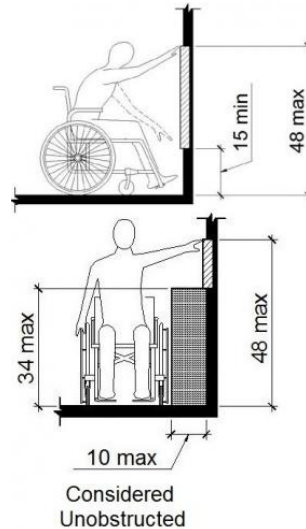
As Built: The fire alarm pull is not positioned correctly for either a side or front approach.

Where a clear floor or ground space allows a parallel or front approach and the side reach is unobstructed, the high side reach shall be 48 inches maximum above the finish floor or ground and the low side reach shall be 15 inches minimum above the finish floor or ground.

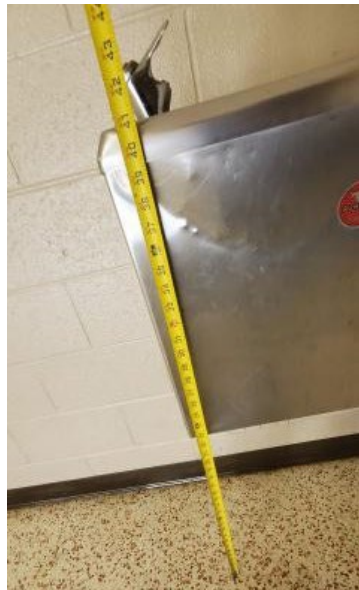
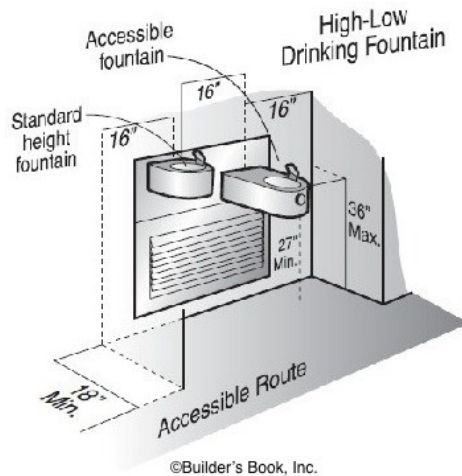
As Built: The drinking fountain is noncompliant.

Spout outlets shall be 36 inches maximum above the finish floor or ground and be located 15 inches minimum from the vertical support and 5 inches maximum from the front edge of the unit, including bumpers. The spout shall provide a flow of water at least 4 inches high minimum and shall be located 5 inches maximum from the front of the unit. The angle of the water stream shall be measured horizontally relative to the front face of the unit. Where spouts are located less than 3 inches of the front of the unit, the angle of the water stream shall be 30 degrees maximum. Where spouts are located between 3 inches and 5 inches maximum from the front of the unit, the angle of the water stream shall be 15 degrees maximum. On an accessible drinking fountain with a round or oval bowl, the spout must be positioned so the flow of water is within 3 inches of the front edge of the fountain.

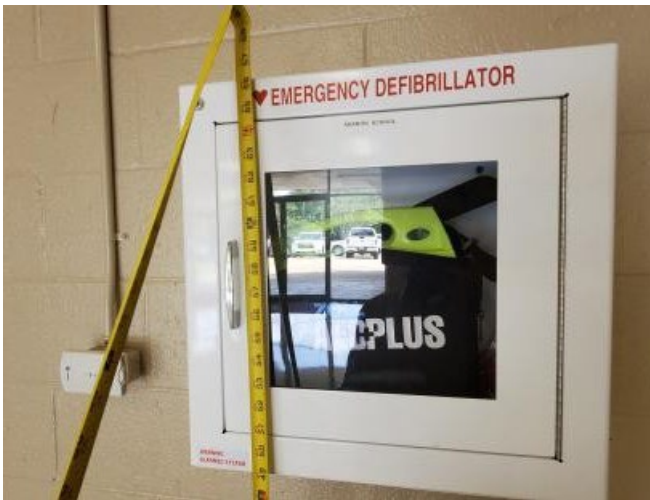
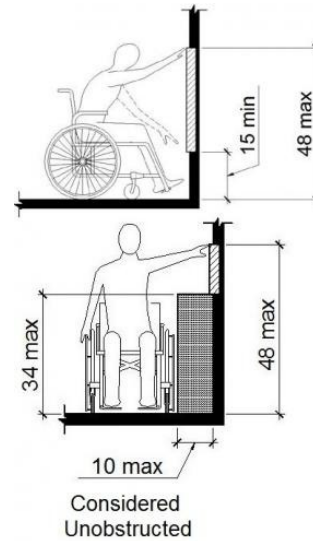
As Built: The Defibrillator is not positioned correctly for either a side or front approach.

Where a clear floor or ground space allows a parallel or front approach and the side reach is unobstructed, the high side reach shall be 48 inches maximum above the finish floor or ground and the low side reach shall be 15 inches minimum above the finish floor or ground.

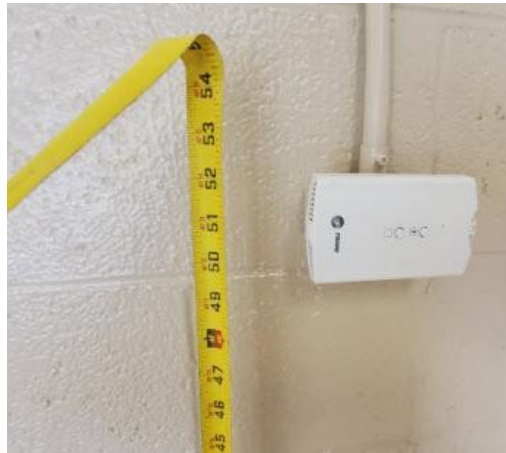
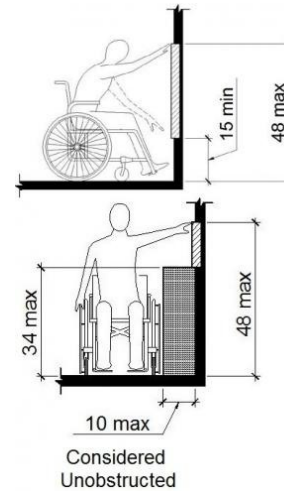
As Built: The thermostat is not positioned correctly for either a side or front approach.

Where a clear floor or ground space allows a parallel or front approach and the side reach is unobstructed, the high side reach shall be 48 inches maximum above the finish floor or ground and the low side reach shall be 15 inches minimum above the finish floor or ground.

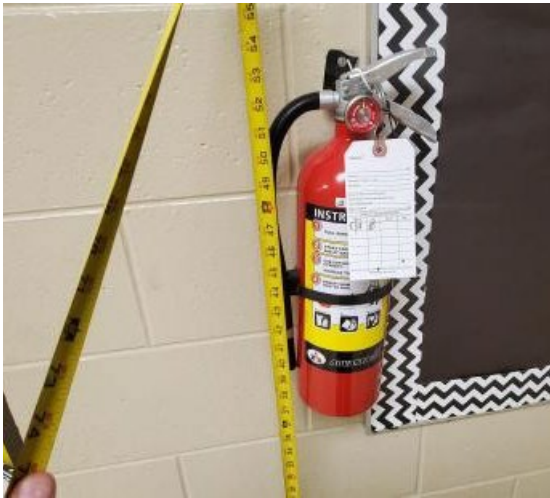
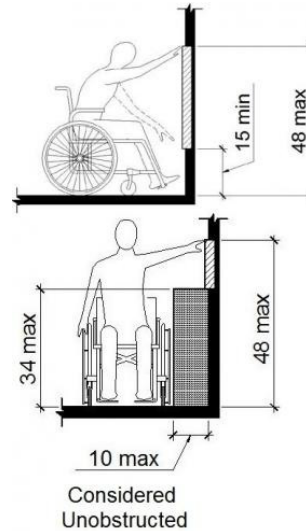
As Built: The fire extinguisher is not positioned correctly for either a side or front approach.

Where a clear floor or ground space allows a parallel or front approach and the side reach is unobstructed, the high side reach shall be 48 inches maximum above the finish floor or ground and the low side reach shall be 15 inches minimum above the finish floor or ground.

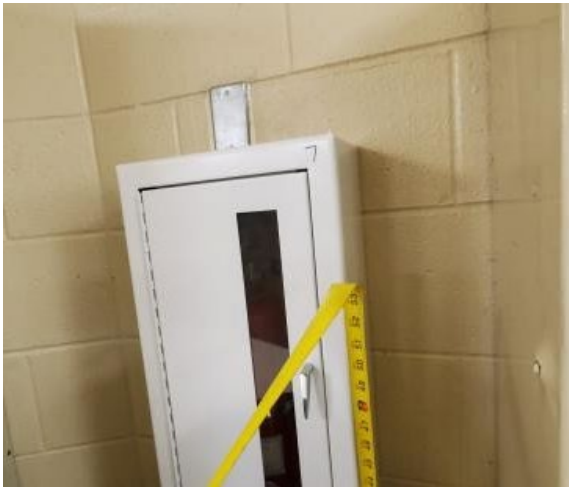
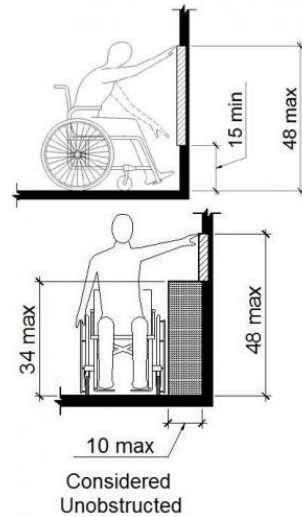
As Built: The fire extinguisher is not positioned correctly for either a side or front approach.

Where a clear floor or ground space allows a parallel or front approach and the side reach is unobstructed, the high side reach shall be 48 inches maximum above the finish floor or ground and the low side reach shall be 15 inches minimum above the finish floor or ground.

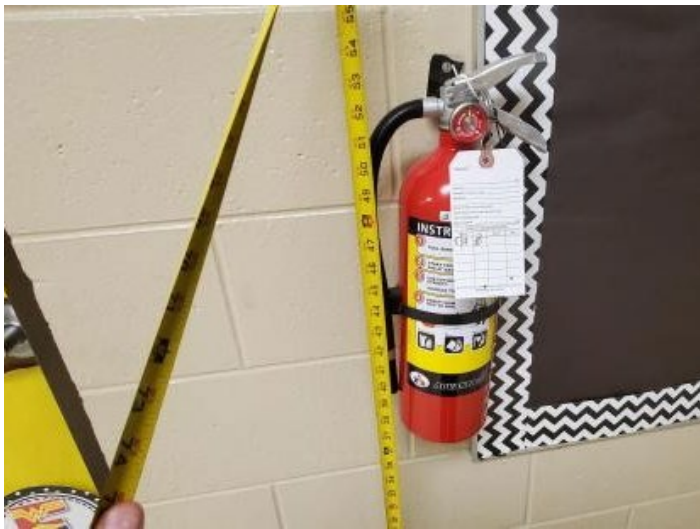
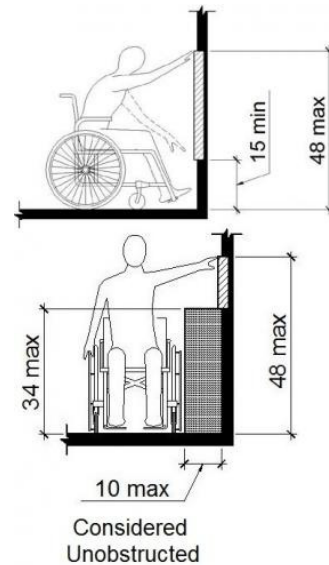
As Built: The fire extinguisher is not positioned correctly for either a side or front approach.

Where a clear floor or ground space allows a parallel or front approach and the side reach is unobstructed, the high side reach shall be 48 inches maximum above the finish floor or ground and the low side reach shall be 15 inches minimum above the finish floor or ground.

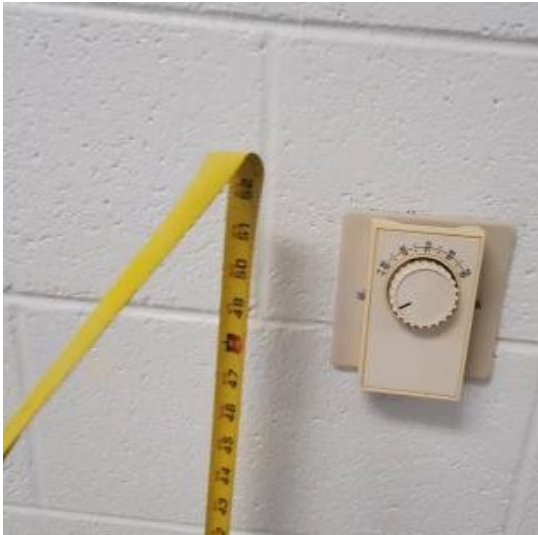
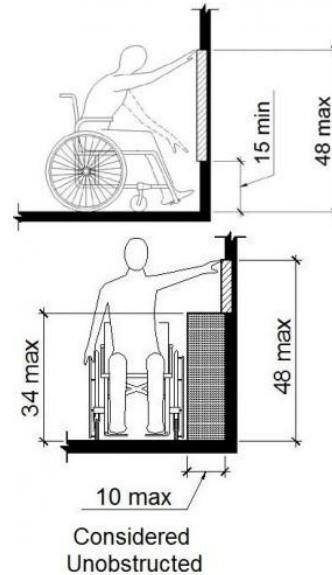
As Built: The thermostat is not positioned correctly for either a side or front approach.

Where a clear floor or ground space allows a parallel or front approach and the side reach is unobstructed, the high side reach shall be 48 inches maximum above the finish floor or ground and the low side reach shall be 15 inches minimum above the finish floor or ground.

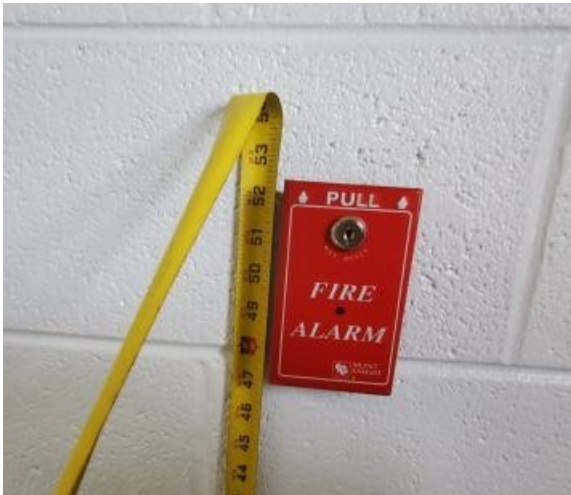
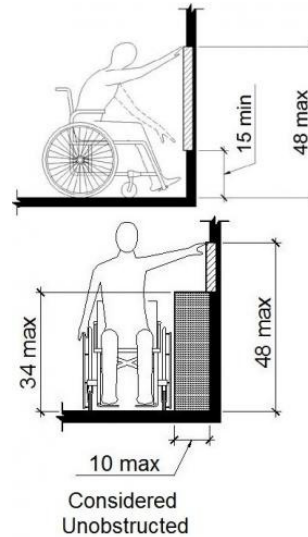
As Built: The fire alarm pull station is not positioned correctly for either a side or front approach.

Where a clear floor or ground space allows a parallel or front approach and the side reach is unobstructed, the high side reach shall be 48 inches maximum above the finish floor or ground and the low side reach shall be 15 inches minimum above the finish floor or ground.

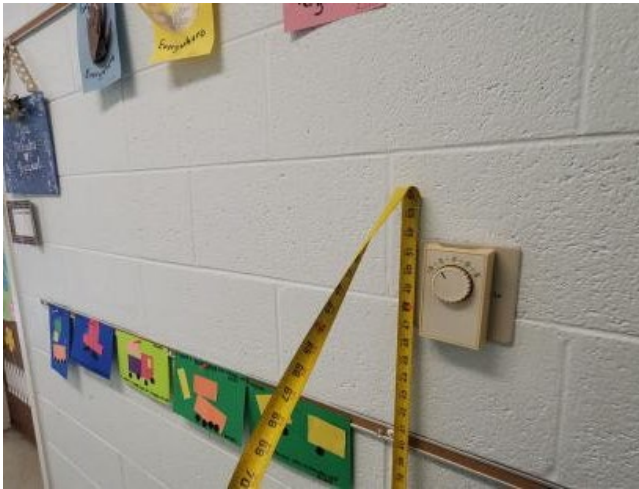
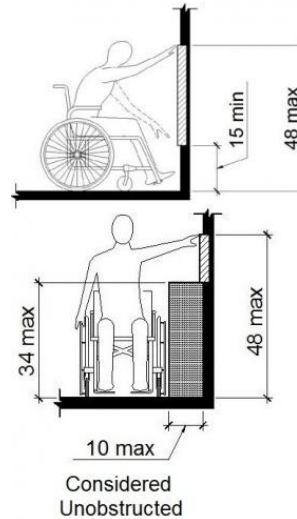
As Built: The thermostat is not positioned correctly for either a side or front approach.

Where a clear floor or ground space allows a parallel or front approach and the side reach is unobstructed, the high side reach shall be 48 inches maximum above the finish floor or ground and the low side reach shall be 15 inches minimum above the finish floor or ground.

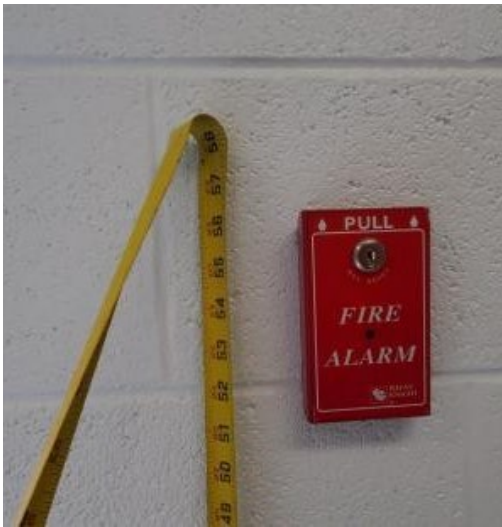
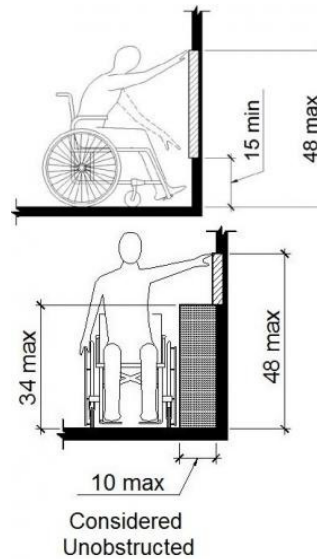
As Built: The fire alarm pull station is not positioned correctly for either a side or front approach.

Where a clear floor or ground space allows a parallel or front approach and the side reach is unobstructed, the high side reach shall be 48 inches maximum above the finish floor or ground and the low side reach shall be 15 inches minimum above the finish floor or ground.
