WEAKLEY COUNTY, TENNESSEE

ADA EVALUATION

Architectural and Site Findings with Recommendations

TLM Associates, Inc

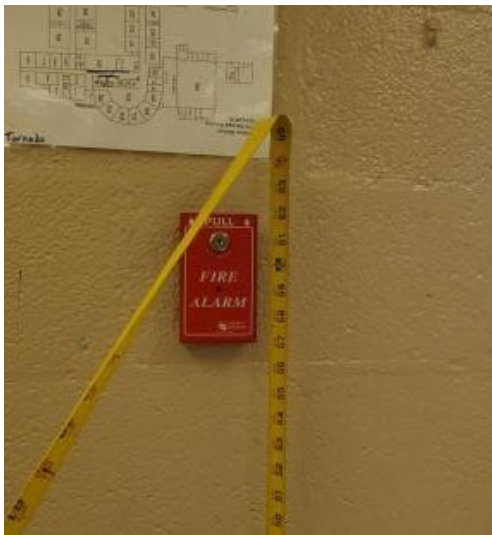
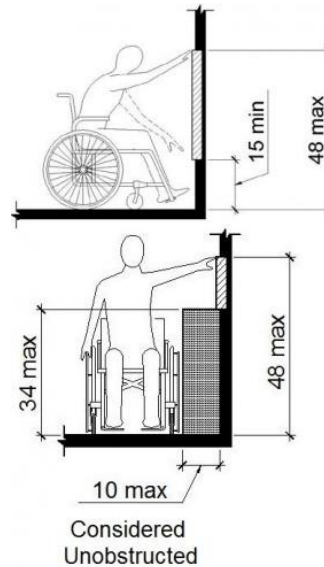
As Built: The fire alarm pull station is not positioned correctly for either a side or front approach.

Where a clear floor or ground space allows a parallel or front approach and the side reach is unobstructed, the high side reach shall be 48 inches maximum above the finish floor or ground and the low side reach shall be 15 inches minimum above the finish floor or ground.

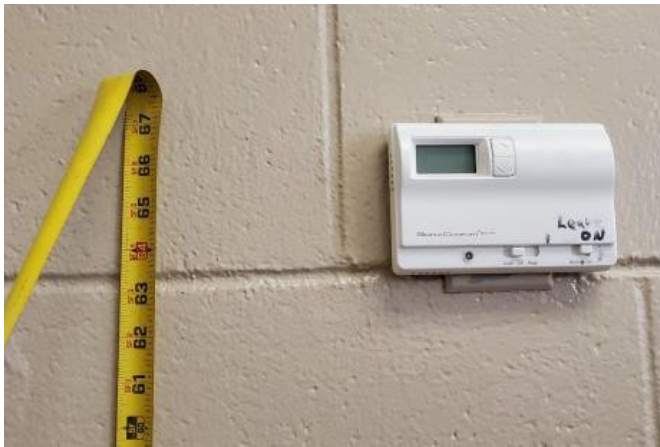
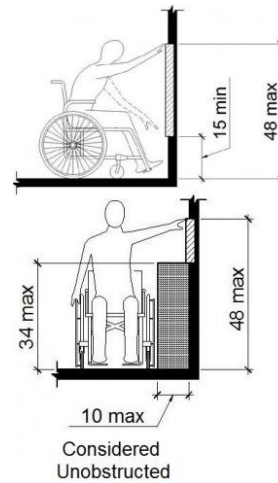
As Built: The thermostat is not positioned correctly for either a side or front approach.

Where a clear floor or ground space allows a parallel or front approach and the side reach is unobstructed, the high side reach shall be 48 inches maximum above the finish floor or ground and the low side reach shall be 15 inches minimum above the finish floor or ground.

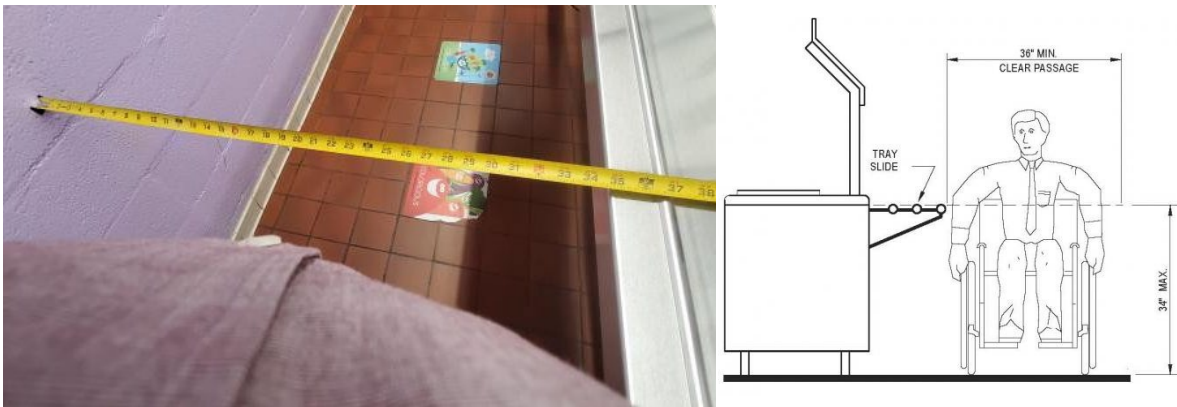
As Built: The food service aisle does not have a minimum 36 inches of clear width because it is obstructed by an element.

Citation: 2010 ADAS Section 403.5.1

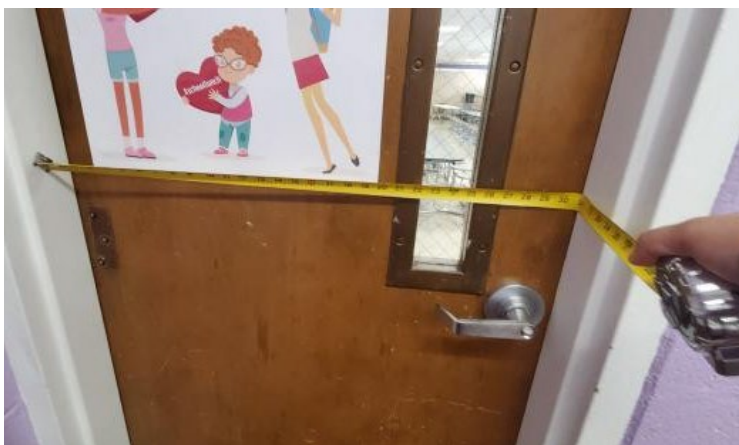
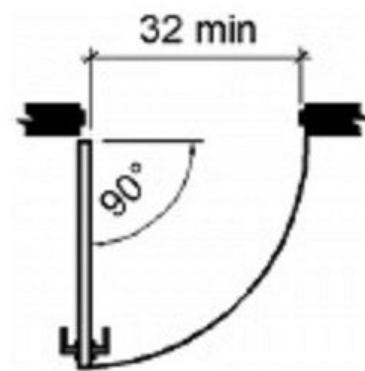
Hinged Door or Gate

As Built: The door opening does not provide at least 32 inches between the face of the door and the opposite stop.

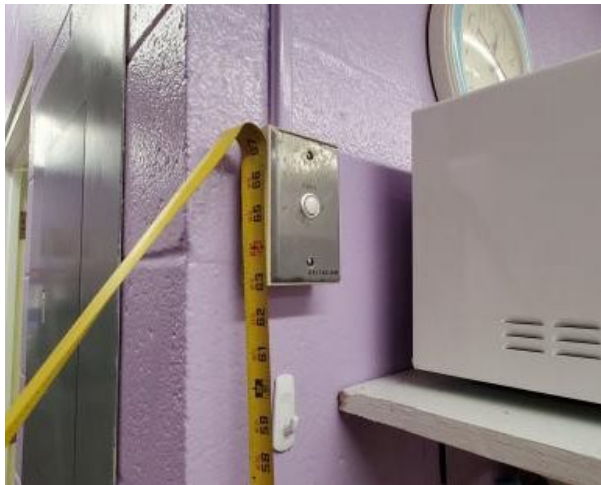
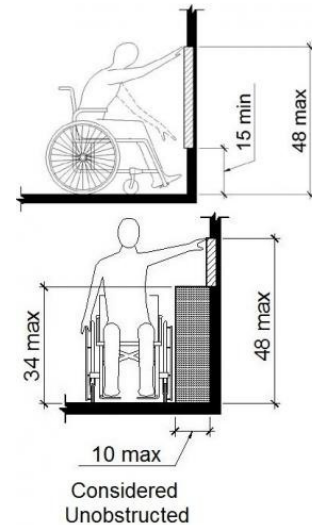
As Built: The Intercom button is not positioned correctly for either a side or front approach.

Where a clear floor or ground space allows a parallel or front approach and the side reach is unobstructed, the high side reach shall be 48 inches maximum above the finish floor or ground and the low side reach shall be 15 inches minimum above the finish floor or ground.

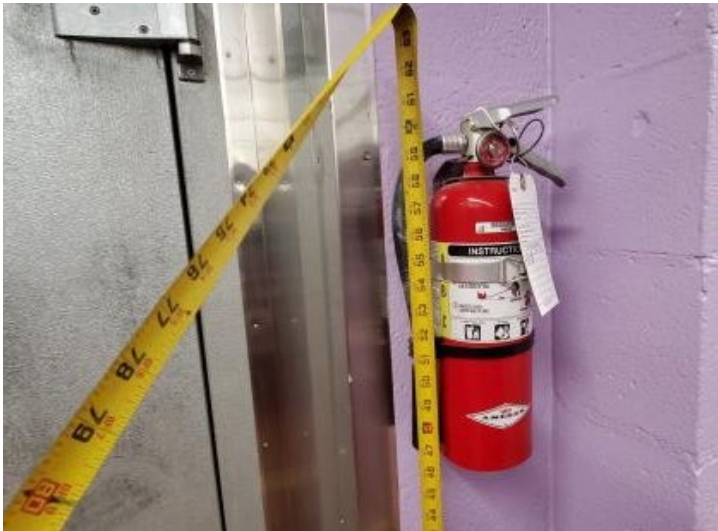
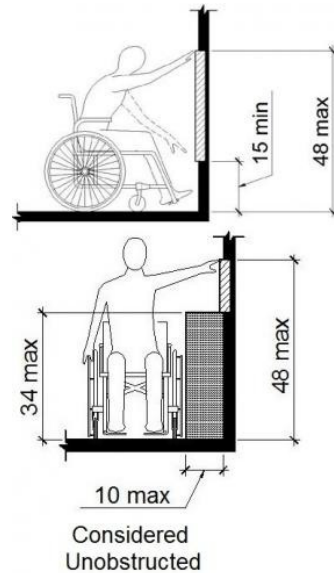
As Built: The fire extinguisher is not positioned correctly for either a side or front approach.

Where a clear floor or ground space allows a parallel or front approach and the side reach is unobstructed, the high side reach shall be 48 inches maximum above the finish floor or ground and the low side reach shall be 15 inches minimum above the finish floor or ground.

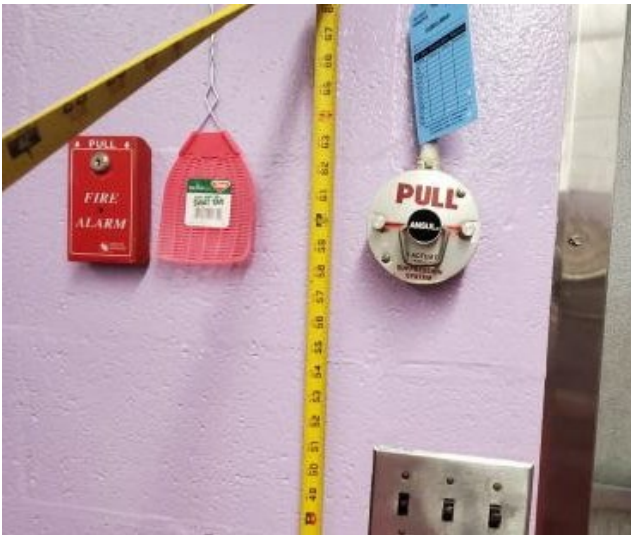
As Built: The Ansul fire pull is not positioned correctly for either a side or front approach.

Where a clear floor or ground space allows a parallel or front approach and the side reach is unobstructed, the high side reach shall be 48 inches maximum above the finish floor or ground and the low side reach shall be 15 inches minimum above the finish floor or ground.

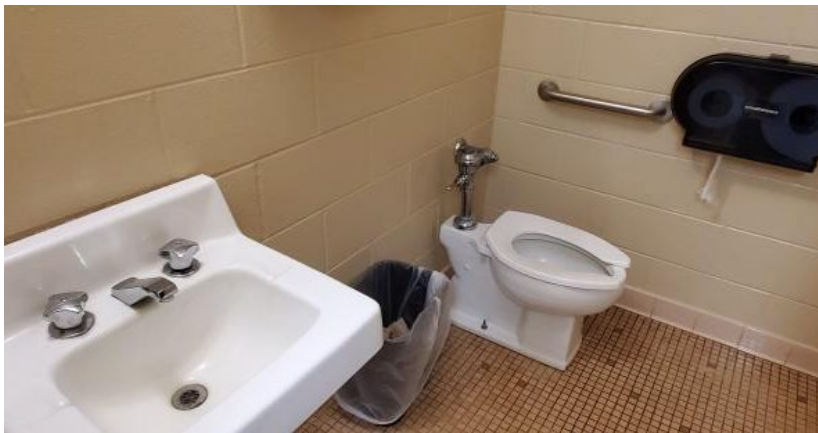
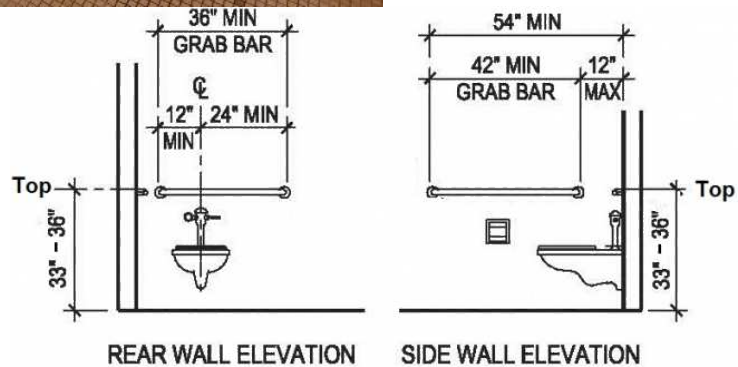
As Built: Accessible toilets must have grab bars installed.

The side grab bar must extend at least 54 inches minimum beyond the rear wall and start a maximum of 12 inches from the rear wall. The rear grab bar must be a minimum of 36 inches long and extend from the centerline of the toilet 12 inches minimum on one side and 24 inches minimum on the other side. Grab bars shall be installed in a horizontal position, 33 inches minimum and 36 inches maximum above the finish floor measured to the top of the gripping surface.

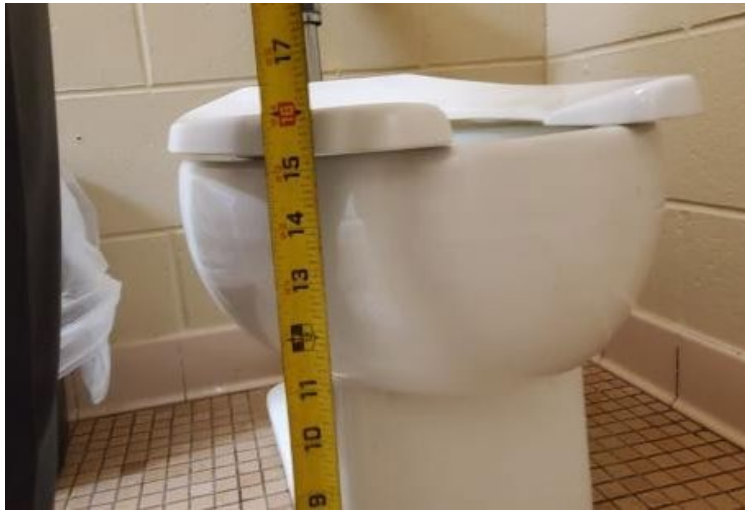
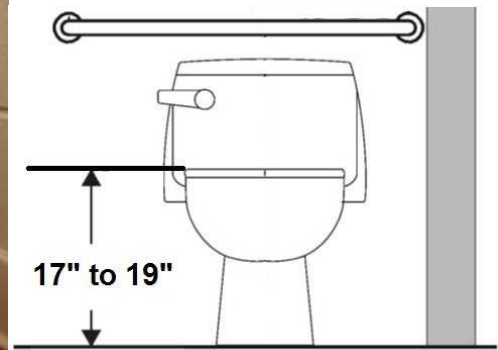
As Built: The toilet seat is not located within the range allowed off the floor.

The height of accessible water closets shall be a minimum of 17 inches and a maximum of 19 inches measured to the top of the toilet seat. The seat itself shall be a maximum of 2 inch high.

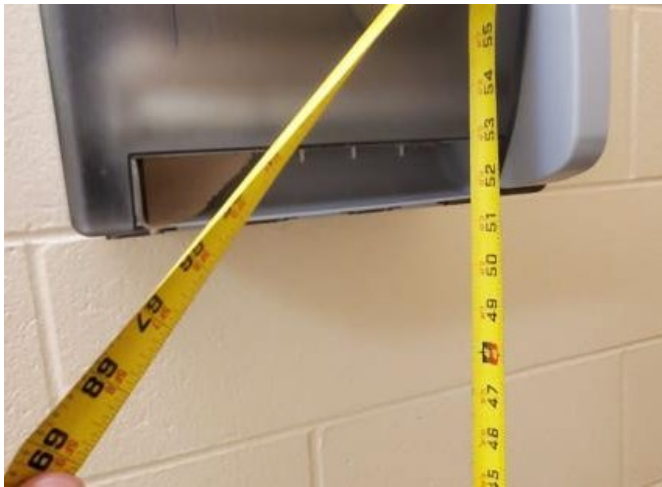
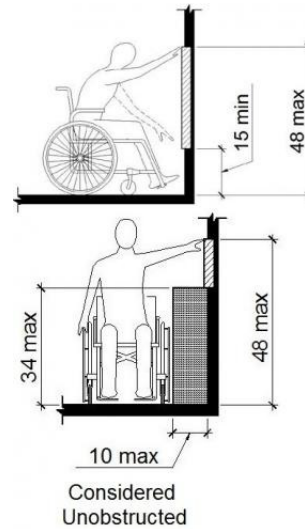
As Built: The paper towel dispenser is not positioned correctly for either a side or front approach.

Where a clear floor or ground space allows a parallel or front approach and the side reach is unobstructed, the high side reach shall be 48 inches maximum above the finish floor or ground and the low side reach shall be 15 inches minimum above the finish floor or ground.

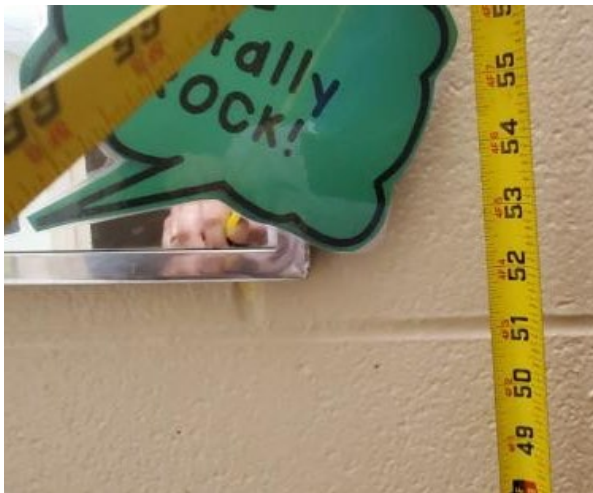
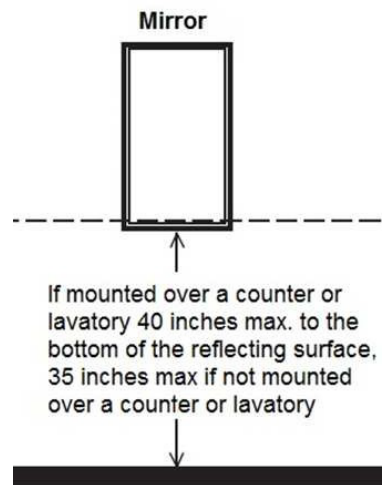
As Built: The mirror is mounted too high.

Mirrors must have the bottom edge of the reflecting surface a maximum of 40 inches above the floor if above a sink or counter. Mirrors not located above lavatories or countertops shall be installed with the bottom edge of the reflecting surface 35 inches maximum above the finish floor or ground.

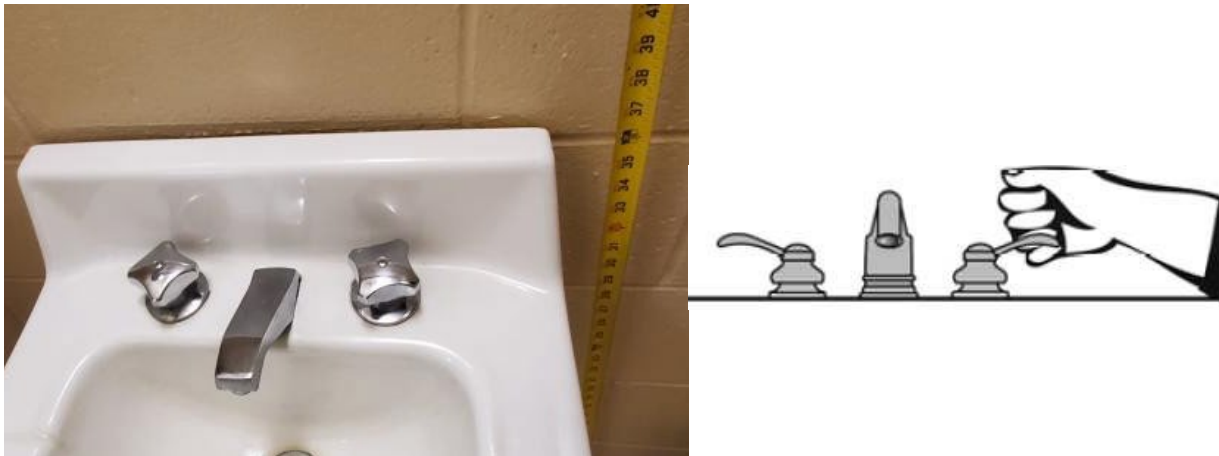
As Built: The faucet controls require twisting of the wrist.

Faucet controls and operating mechanisms shall be operable with one hand and shall not require tight grasping, pinching or twisting of the wrist. The force required to activate controls shall be no greater than 5 lb. Lever-operated, push-type and electronically controlled mechanisms are examples of acceptable designs. Self-closing valves are allowed if the faucet remains open for at least 10 seconds.

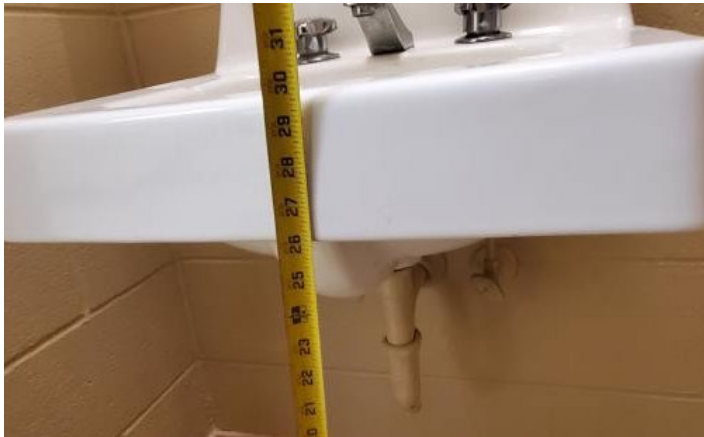
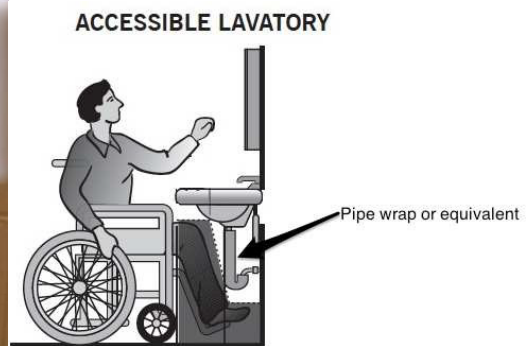
As Built: The water and drainpipes under the lavatory are not adequately insulated.

Water supply and drainpipes under lavatories and sinks shall be insulated or otherwise configured to protect against contact. There shall be no sharp or abrasive surfaces under lavatories and sinks.

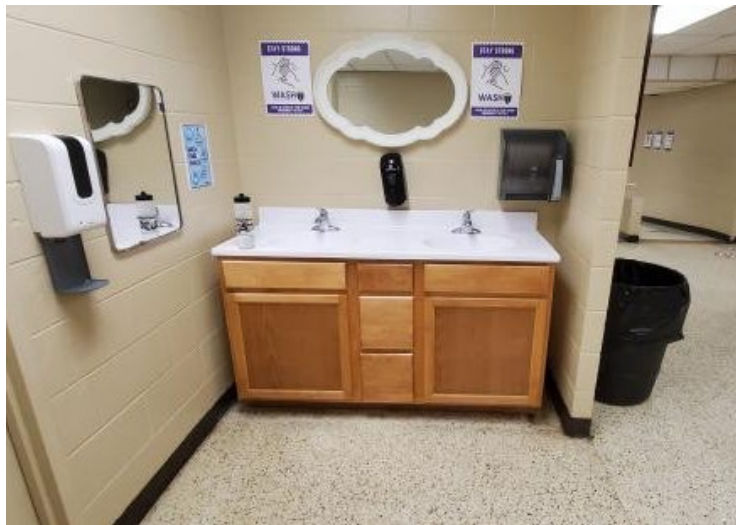
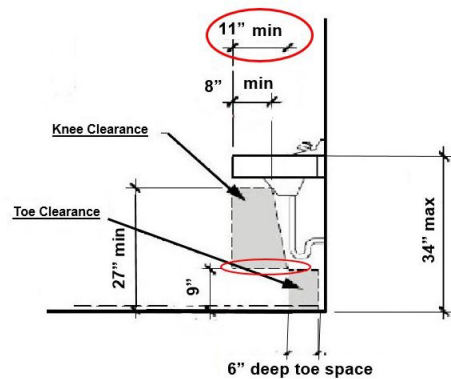
As Built: Compliant knee space has not been provided under the lavatory.

The knee clearance shall be 11 inches minimum in depth at 9 inches above the floor, and 8 inches minimum in depth at 27 inches above the floor. The top of the lavatory rim may be no higher than 34 inches.

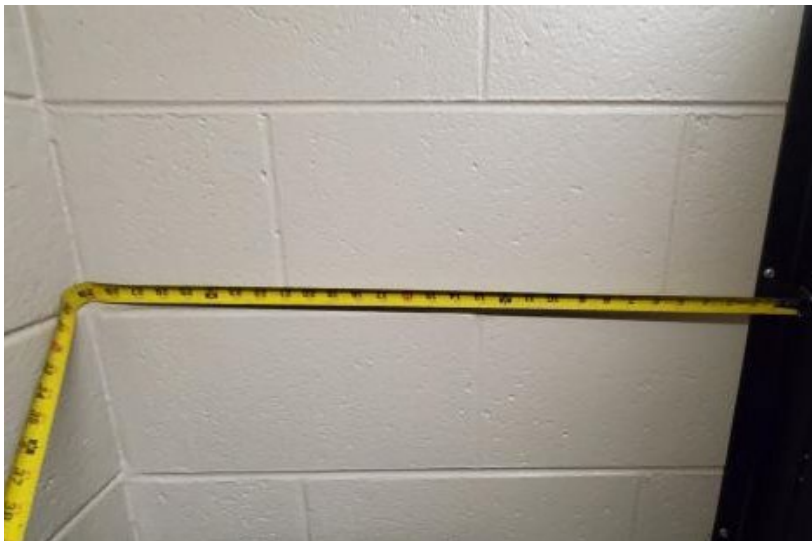
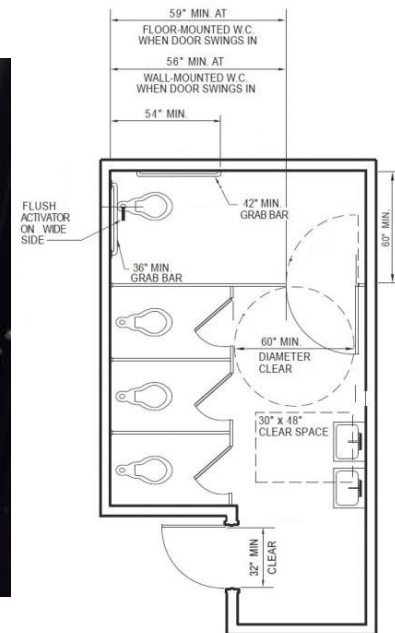
As Built: The toilet compartment does not have the required minimum clear floor space or maneuvering clearances for the toilet.

The restroom does not have the required minimum clear floor space or maneuvering clearances for the lavatory.

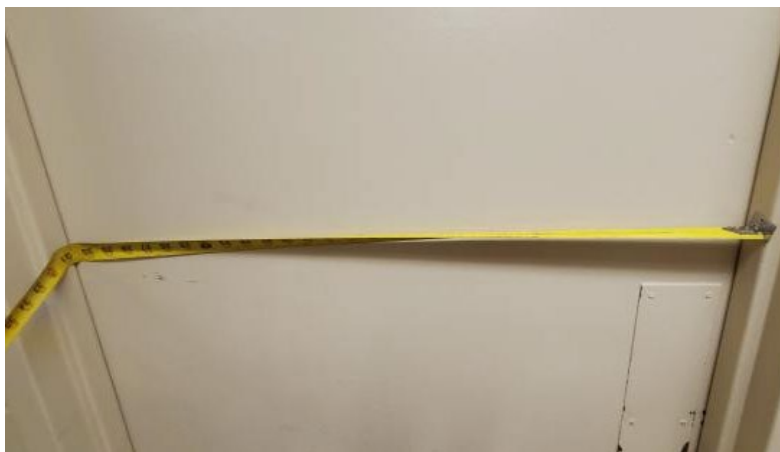
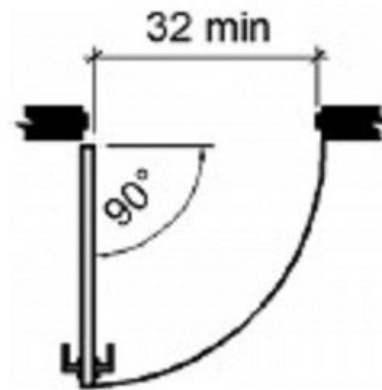
Hinged Door or Gate

As Built: The door opening does not provide at least 32 inches between the face of the door and the opposite stop.

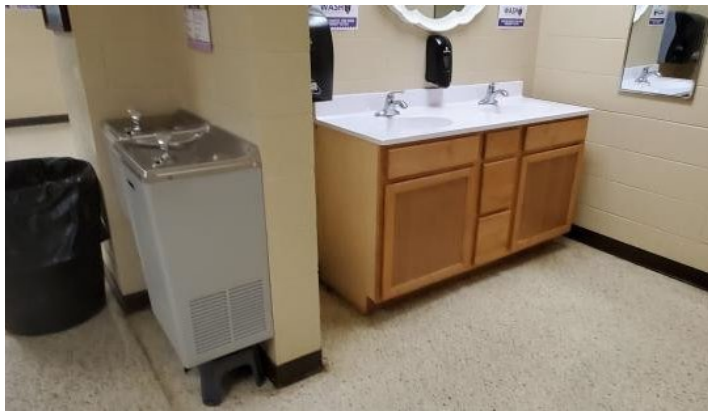
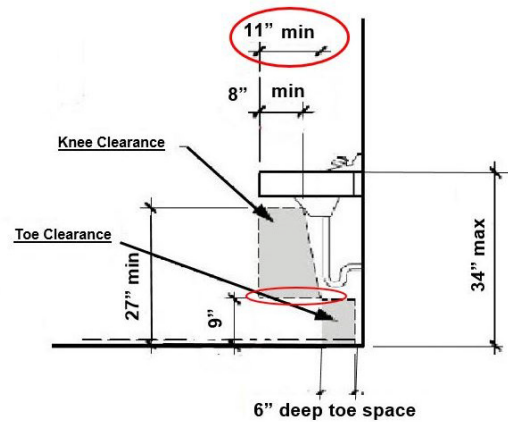
As Built: Compliant knee space has not been provided under the lavatory.

The knee clearance shall be 11 inches minimum in depth at 9 inches above the floor, and 8 inches minimum in depth at 27 inches above the floor. The top of the lavatory rim may be no higher than 34 inches.

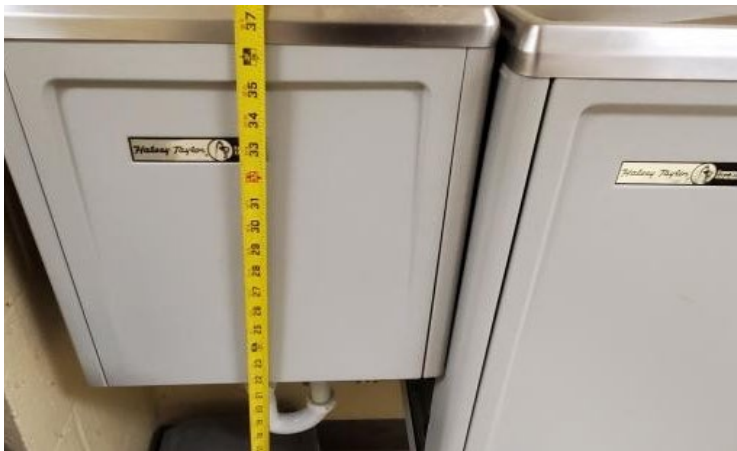
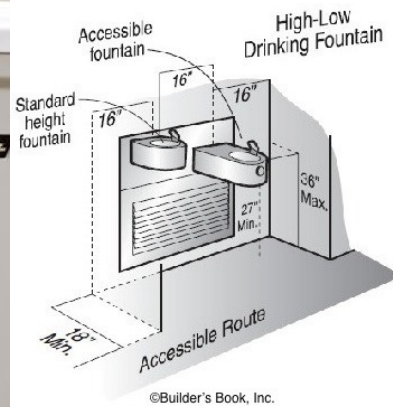
As Built: The drinking fountain is noncompliant.

Spout outlets shall be 36 inches maximum above the finish floor or ground and be located 15 inches minimum from the vertical support and 5 inches maximum from the front edge of the unit, including bumpers. The spout shall provide a flow of water at least 4 inches high minimum and shall be located 5 inches maximum from the front of the unit. The angle of the water stream shall be measured horizontally relative to the front face of the unit. Where spouts are located less than 3 inches of the front of the unit, the angle of the water stream shall be 30 degrees maximum. Where spouts are located between 3 inches and 5 inches maximum from the front of the unit, the angle of the water stream shall be 15 degrees maximum. On an accessible drinking fountain with a round or oval bowl, the spout must be positioned so the flow of water is within 3 inches of the front edge of the fountain.

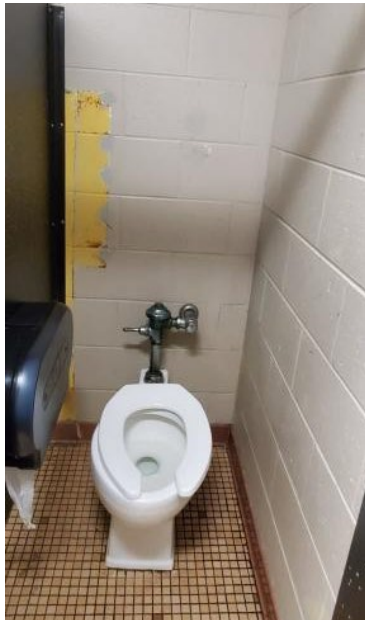
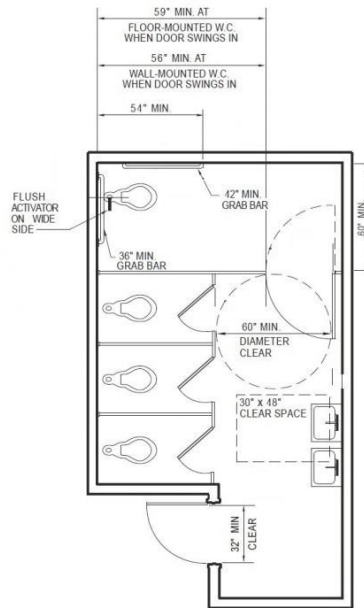
As Built: The toilet compartment does not have the required minimum clear floor space or maneuvering clearances for the toilet.

The restroom does not have the required minimum clear floor space or maneuvering clearances for the lavatory. The entry door does not contain the required minimum 60 inches maneuvering space on the pull side. Grab bars are not installed. Further design required to accommodate compliant toilet compartment.

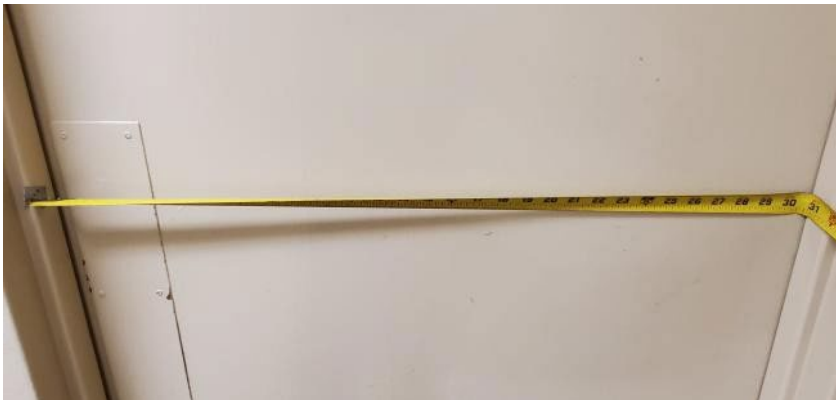
As Built: The door opening does not provide at least 32 inches between the face of the door and the opposite stop.

Door openings shall provide a clear width of 32 inches minimum. Clear openings of doorways with swinging doors shall be measured between the face of the door and the stop, with the door open 90 degrees. There shall be no projections into the required clear opening width lower than 34 inches above the finish floor or ground. Projections into the clear opening width between 34 inches and 80 inches above the finish floor or ground shall not exceed 4 inches.

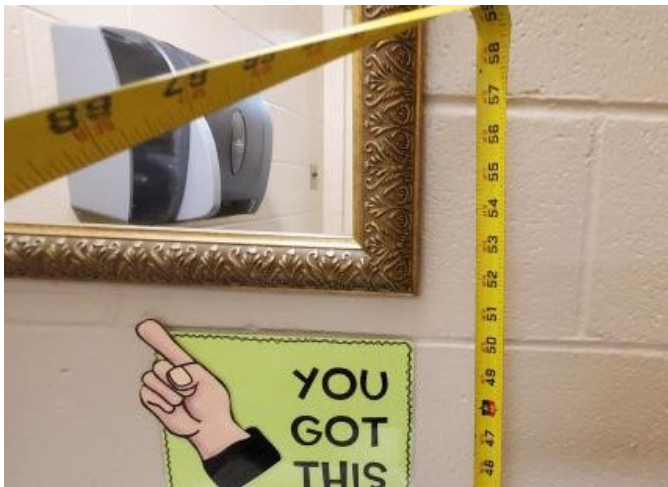
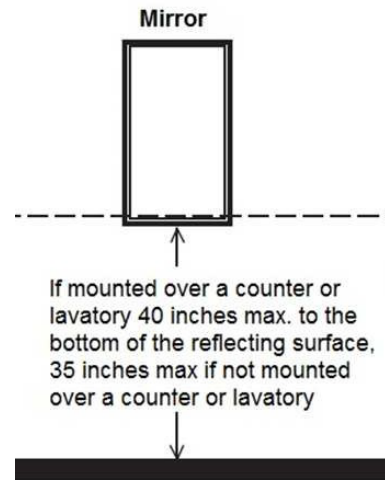
As Built: The mirror is mounted too high.

Mirrors must have the bottom edge of the reflecting surface a maximum of 40 inches above the floor if above a sink or counter. Mirrors not located above lavatories or countertops shall be installed with the bottom edge of the reflecting surface 35 inches maximum above the finish floor or ground.

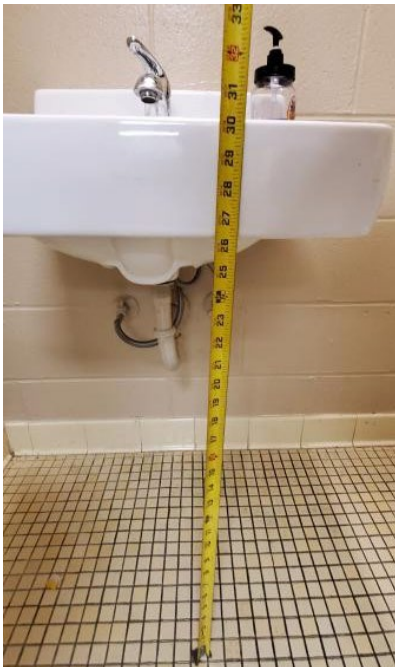
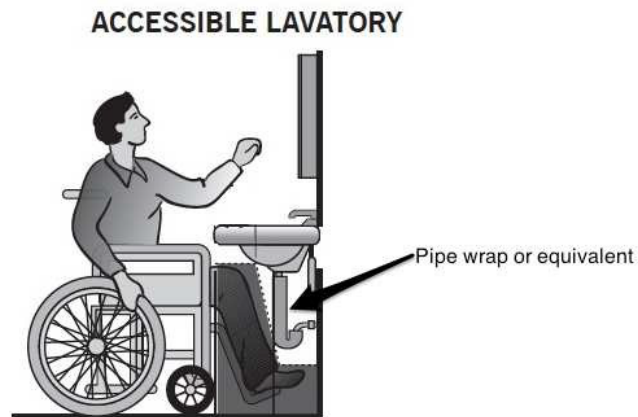
As Built: The water and drainpipes under the lavatory are not adequately insulated.

Water supply and drainpipes under lavatories and sinks shall be insulated or otherwise configured to protect against contact. There shall be no sharp or abrasive surfaces under lavatories and sinks.

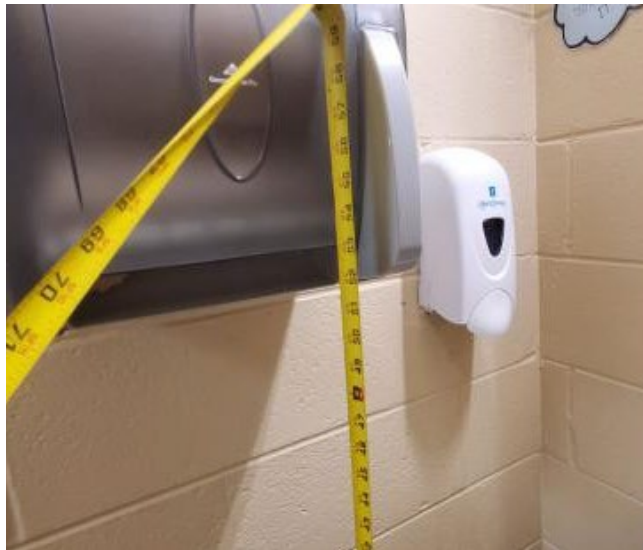
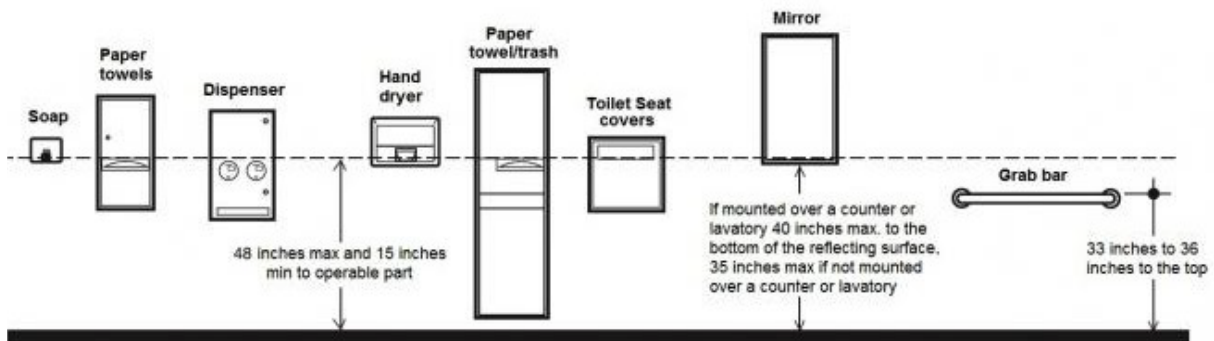
As Built: The paper towel dispenser's operation mechanism is too high off the floor. Dispensers must have all operable parts a maximum of 48 inches above the floor.

Citation: 2010 ADAS Section 308.2.1

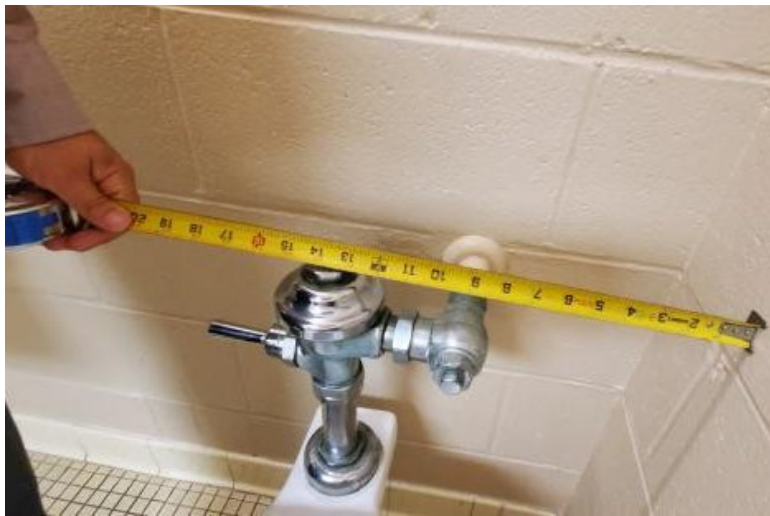
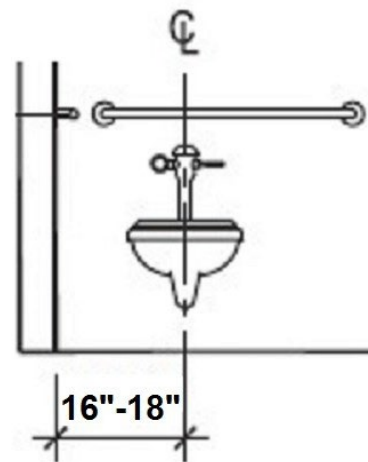
As Built: The toilet is not located within the range allowed from the side wall or partition. The centerline of the toilet must be 16 to 18 inches from the side wall.

Citation: 2010 ADAS Section 604.2

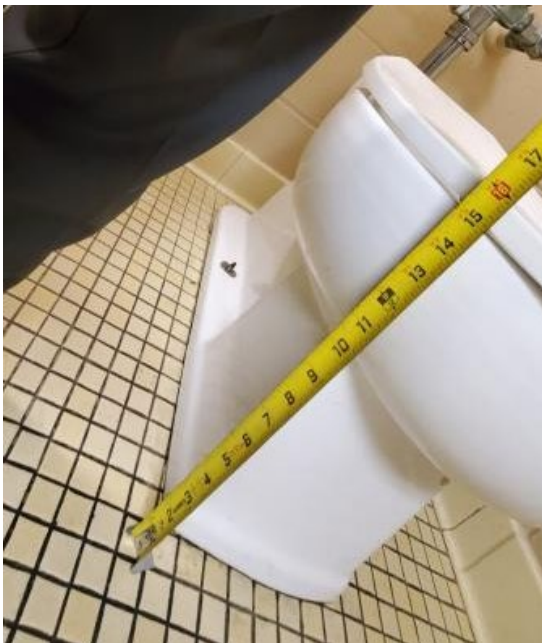
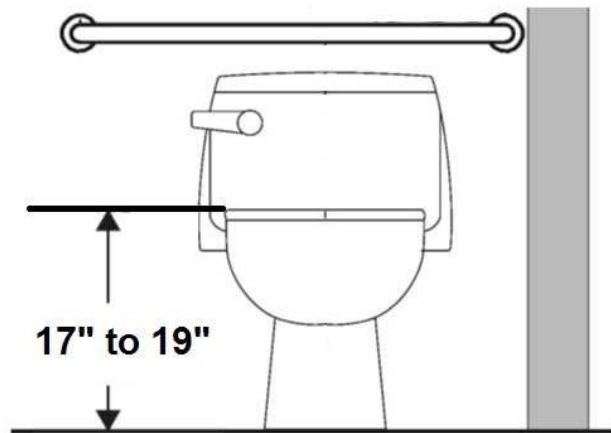
As Built: The toilet seat is not located within the range allowed off the floor.

The height of accessible water closets shall be a minimum of 17 inches and a maximum of 19 inches measured to the top of the toilet seat. The seat itself shall be a maximum of 2 inch high.

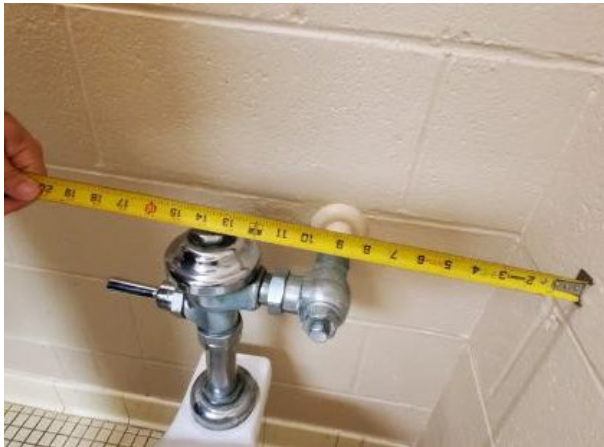
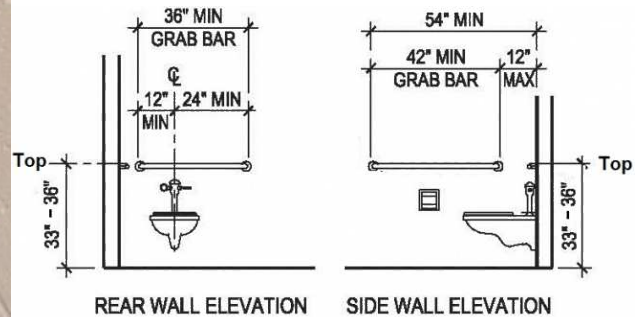
As Built: Accessible toilets must have grab bars installed.

The side grab bar must extend at least 54 inches minimum beyond the rear wall and start a maximum of 12 inches from the rear wall.

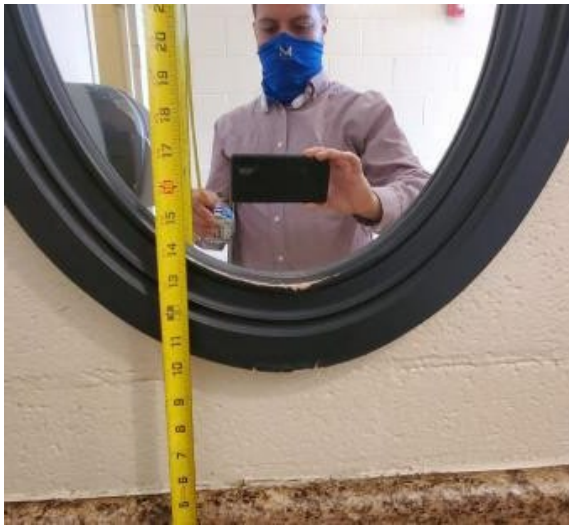
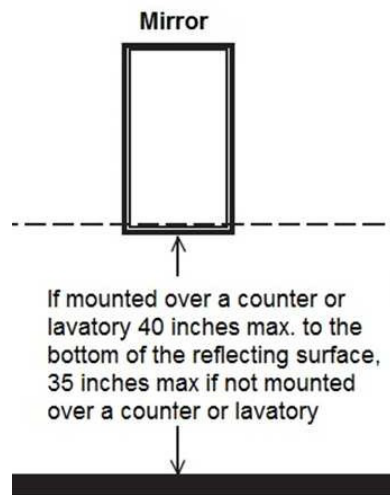
As Built: The mirror is mounted too high.

Mirrors must have the bottom edge of the reflecting surface a maximum of 40 inches above the floor if above a sink or counter. Mirrors not located above lavatories or countertops shall be installed with the bottom edge of the reflecting surface 35 inches maximum above the finish floor or ground.

Recommendation: Redesign toilet room for compliance.

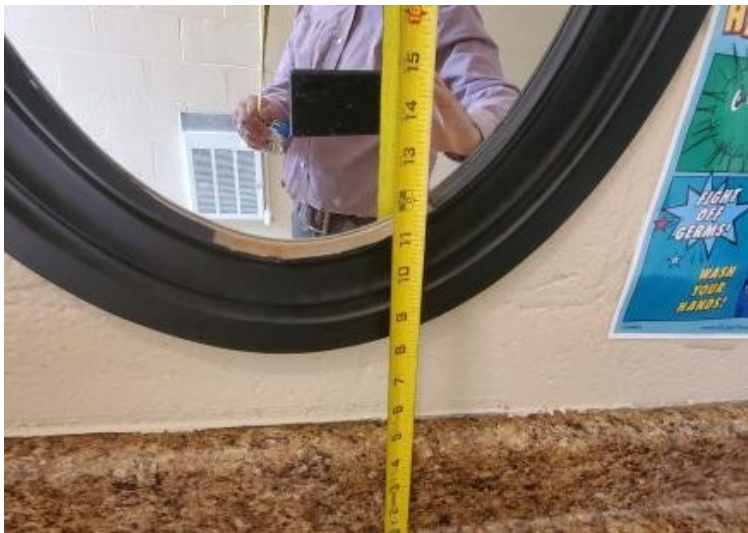
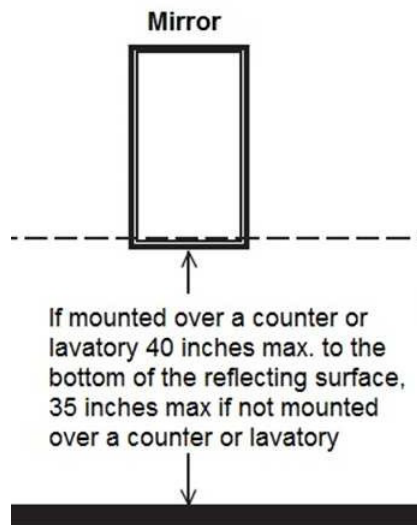
As Built: The mirror is mounted too high.

Mirrors must have the bottom edge of the reflecting surface a maximum of 40 inches above the floor if above a sink or counter. Mirrors not located above lavatories or countertops shall be installed with the bottom edge of the reflecting surface 35 inches maximum above the finish floor or ground.

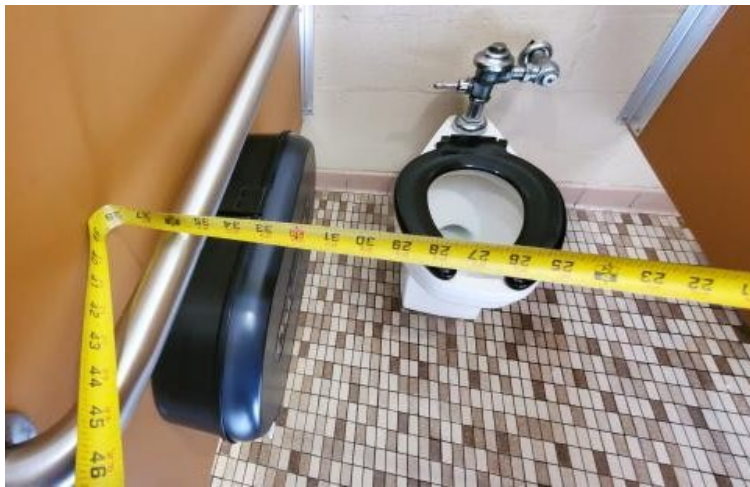
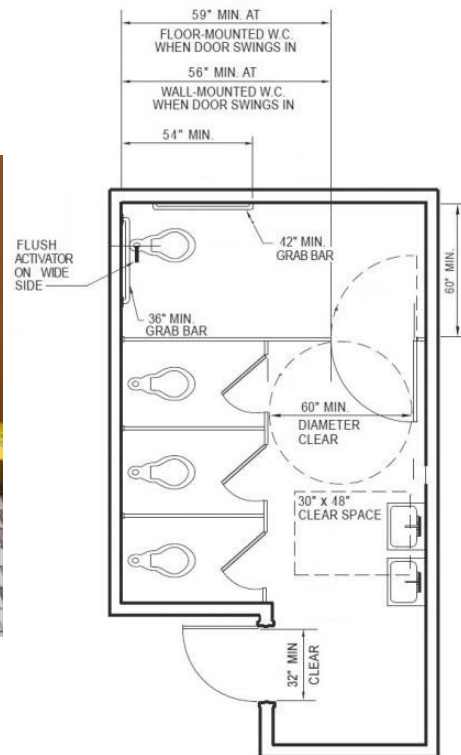
As Built: The toilet compartment does not have the required minimum clear floor space or maneuvering clearances for the toilet.

The restroom does not have the required minimum clear floor width and depth.

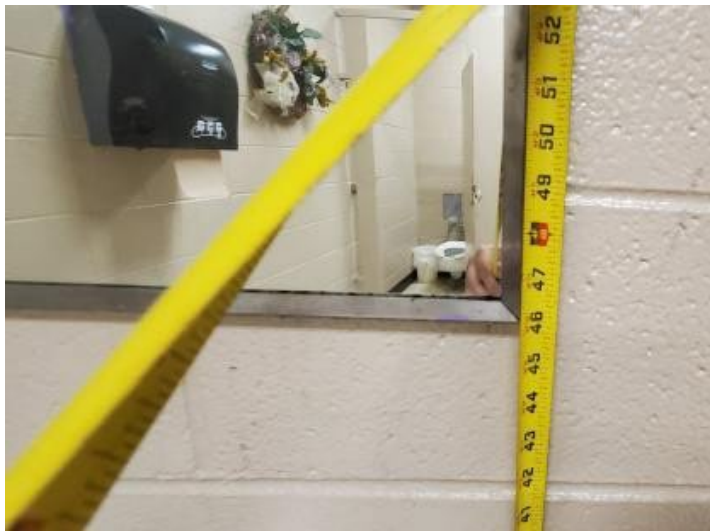
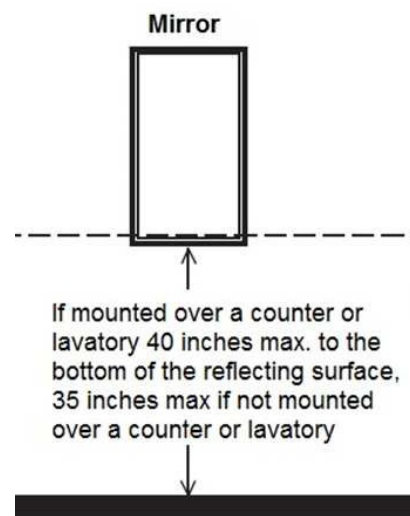
As Built: The mirror is mounted too high.

Mirrors must have the bottom edge of the reflecting surface a maximum of 40 inches above the floor if above a sink or counter. Mirrors not located above lavatories or countertops shall be installed with the bottom edge of the reflecting surface 35 inches maximum above the finish floor or ground.

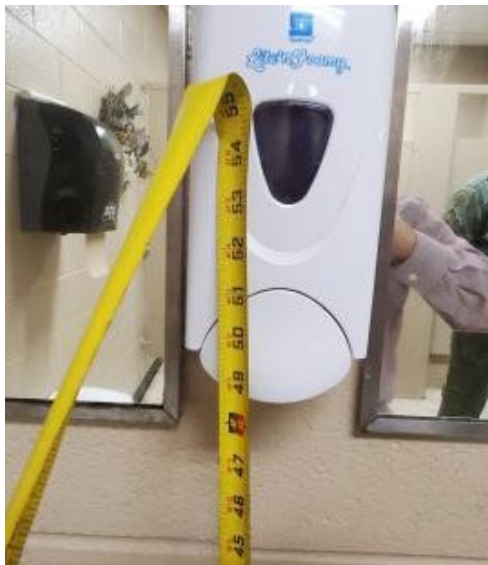
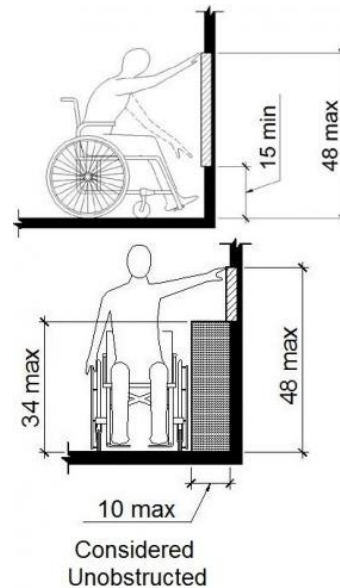
As Built: The soap dispenser is not positioned correctly for either a side or front approach.

Where a clear floor or ground space allows a parallel or front approach and the side reach is unobstructed, the high side reach shall be 48 inches maximum above the finish floor or ground and the low side reach shall be 15 inches minimum above the finish floor or ground.

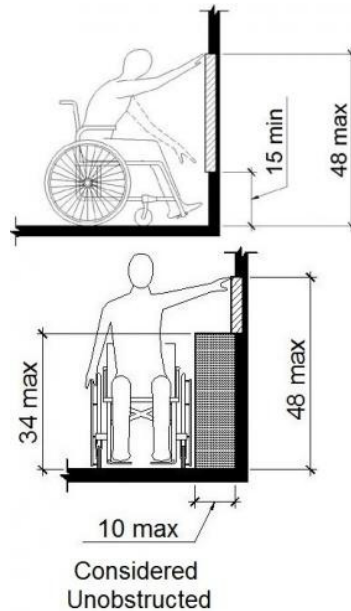
As Built: The paper towel dispenser is not positioned correctly for either a side or front approach.

Where a clear floor or ground space allows a parallel or front approach and the side reach is unobstructed, the high side reach shall be 48 inches maximum above the finish floor or ground and the low side reach shall be 15 inches minimum above the finish floor or ground.

Recommendation: Lower paper towel dispenser for all operable to be 48" max AFF.

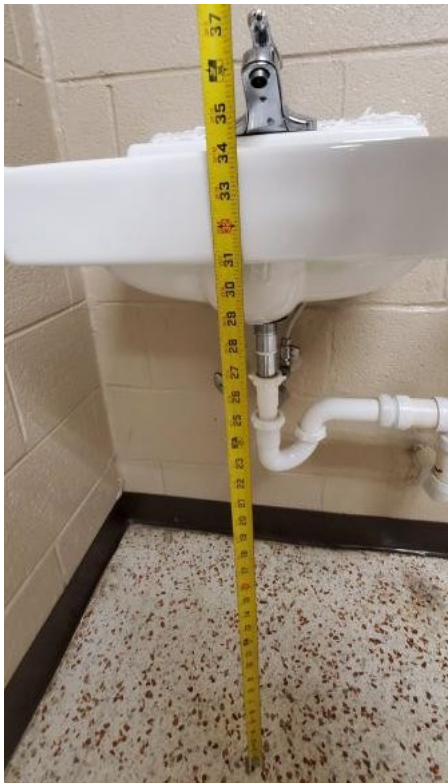
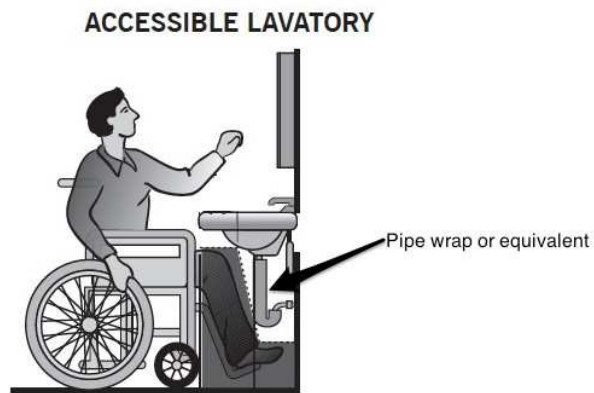
As Built: The water and drainpipes under the lavatory are not adequately insulated.

Water supply and drainpipes under lavatories and sinks shall be insulated or otherwise configured to protect against contact. There shall be no sharp or abrasive surfaces under lavatories and sinks.

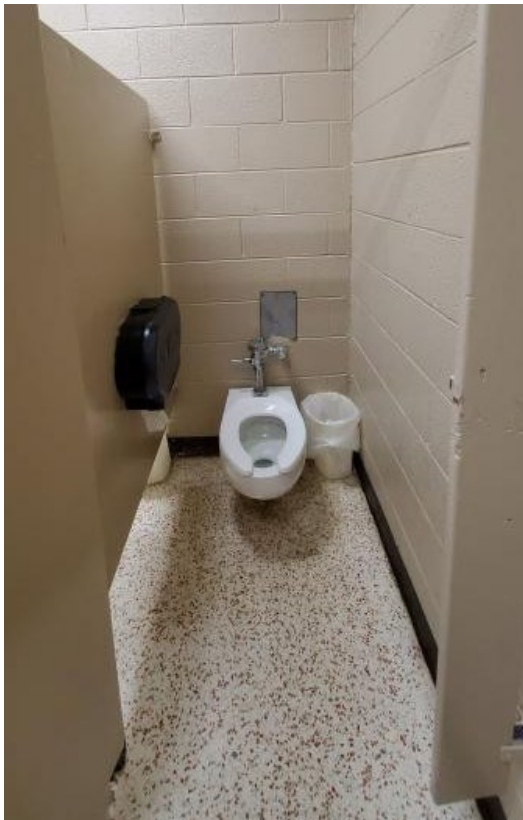
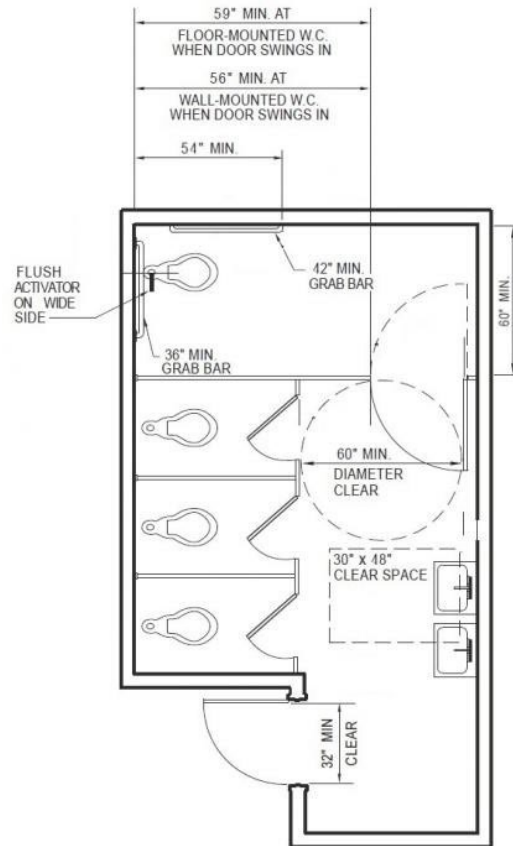
As Built: The toilet compartment does not have the required minimum clear floor space or maneuvering clearances for the toilet.

The restroom does not have the required minimum clear floor width and depth.

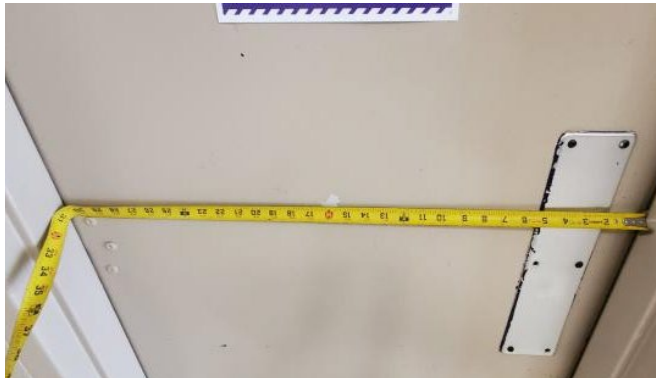
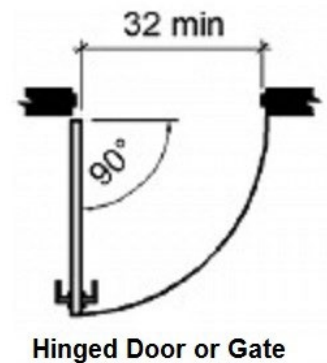
As Built: The door opening does not provide at least 32 inches between the face of the door and the opposite stop.

Door openings shall provide a clear width of 32 inches minimum. Clear openings of doorways with swinging doors shall be measured between the face of the door and the stop, with the door open 90 degrees. There shall be no projections into the required clear opening width lower than 34 inches above the finish floor or ground. Projections into the clear opening width between 34 inches and 80 inches above the finish floor or ground shall not exceed 4 inches.

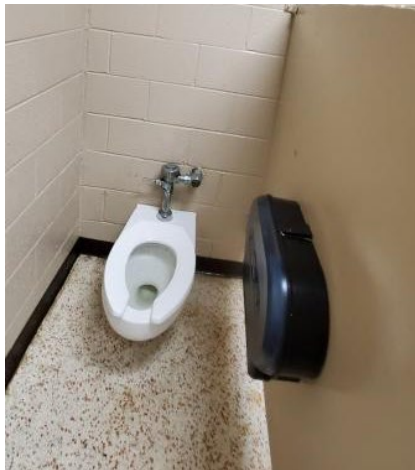
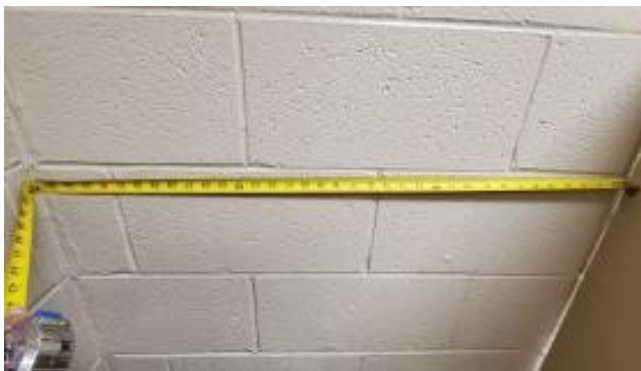
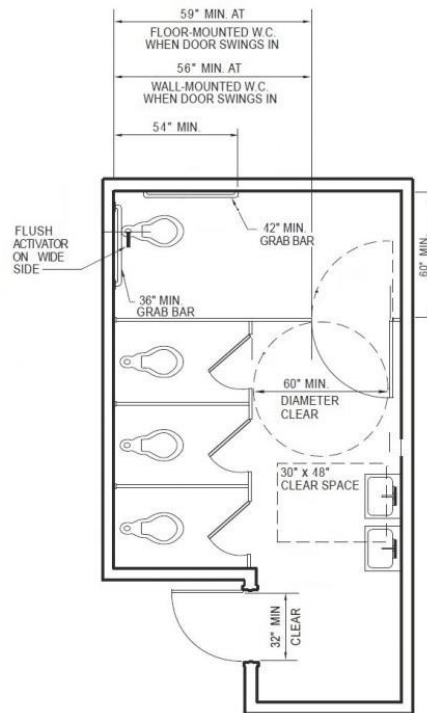
As Built: The toilet compartment does not have the required minimum clear floor space or maneuvering clearances for the toilet.

The restroom does not have the required minimum clear floor width and depth.
