WEAKLEY COUNTY, TENNESSEE

ADA EVALUATION

Architectural and Site Findings with Recommendations

TLM Associates, Inc

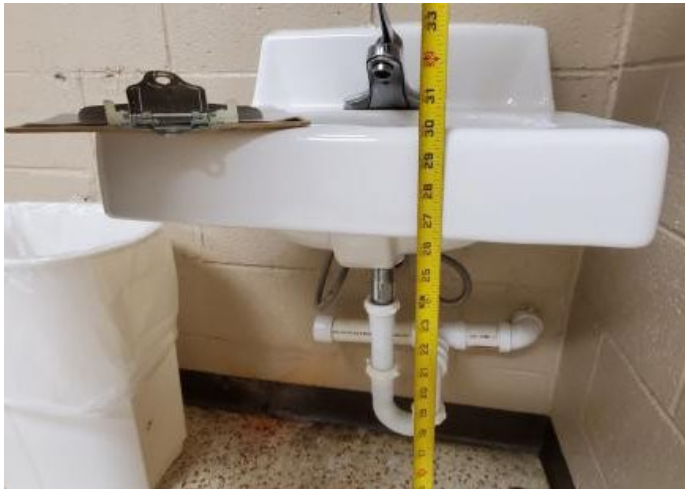
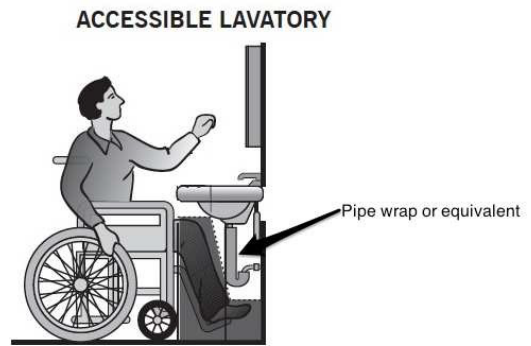
As Built: The water and drainpipes under the lavatory are not adequately insulated.

Water supply and drainpipes under lavatories and sinks shall be insulated or otherwise configured to protect against contact. There shall be no sharp or abrasive surfaces under lavatories and sinks.

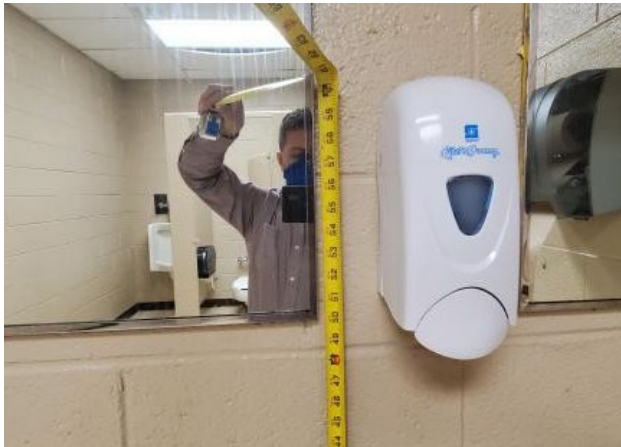
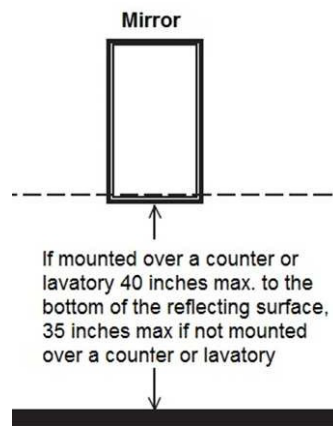
As Built: The mirror is mounted too high.

Mirrors must have the bottom edge of the reflecting surface a maximum of 40 inches above the floor if above a sink or counter. Mirrors not located above lavatories or countertops shall be installed with the bottom edge of the reflecting surface 35 inches maximum above the finish floor or ground.

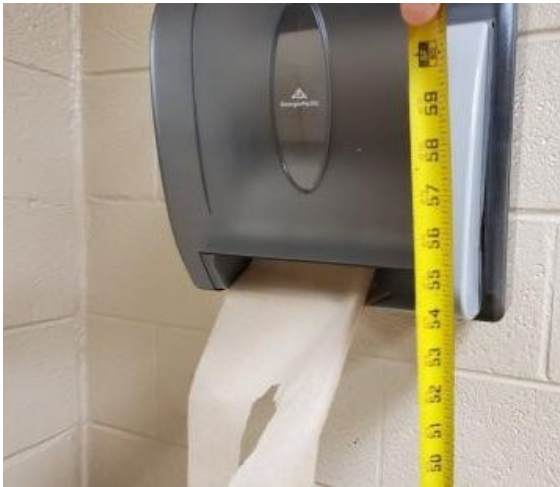
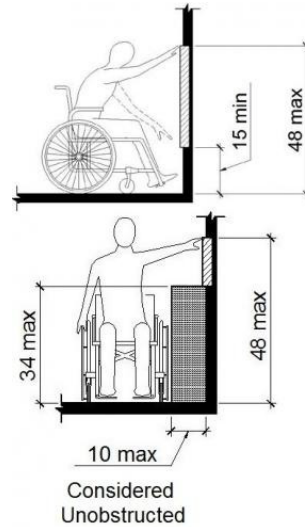
As Built: The paper towel dispenser is not positioned correctly for either a side or front approach.

Where a clear floor or ground space allows a parallel or front approach and the side reach is unobstructed, the high side reach shall be 48 inches maximum above the finish floor or ground and the low side reach shall be 15 inches minimum above the finish floor or ground.

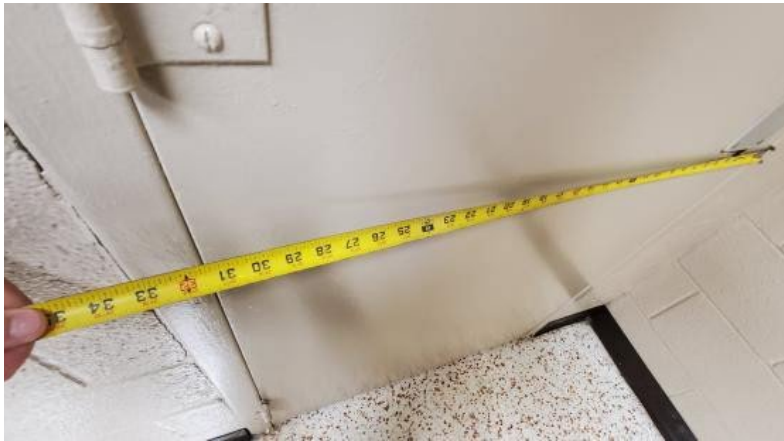
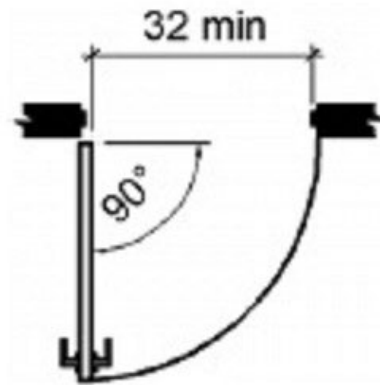
Hinged Door or Gate

As Built: The door opening does not provide at least 32 inches between the face of the door and the opposite stop.

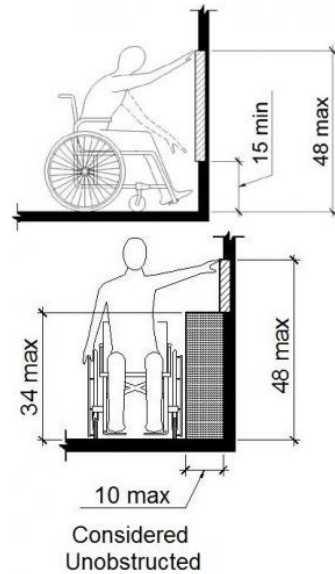
As Built: The soap dispenser is not positioned correctly for either a side or front approach.

Where a clear floor or ground space allows a parallel or front approach and the side reach is unobstructed, the high side reach shall be 48 inches maximum above the finish floor or ground and the low side reach shall be 15 inches minimum above the finish floor or ground.

Recommendation: Lower soap dispenser for push release to be 48" max AFF

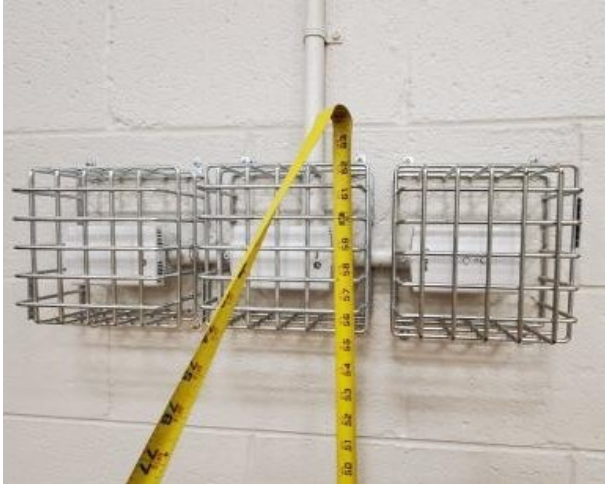
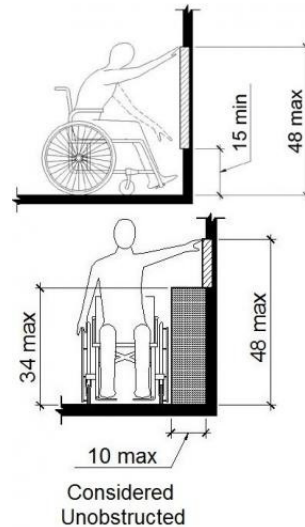
As Built: The thermostat is not positioned correctly for either a side or front approach.

Where a clear floor or ground space allows a parallel or front approach and the side reach is unobstructed, the high side reach shall be 48 inches maximum above the finish floor or ground and the low side reach shall be 15 inches minimum above the finish floor or ground.

Recommendation: Lower thermostats for all operable components to be 48" max AFF

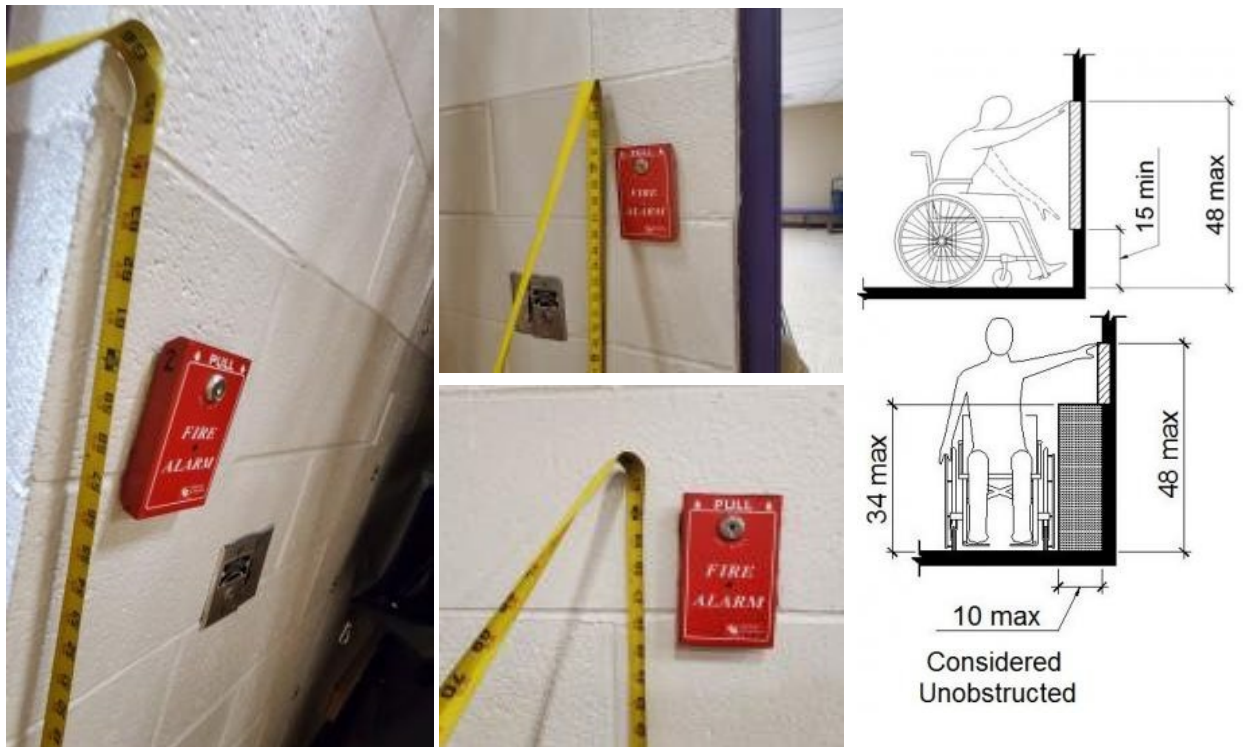
As Built: The fire alarm pull station is not positioned correctly for either a side or front approach. Where a clear floor or ground space allows a parallel or front approach and the side reach is unobstructed, the high side reach shall be 48 inches maximum above the finish floor or ground and the low side reach shall be 15 inches minimum above the finish floor or ground.

Citation: 2010 ADAS Section 308.2.1

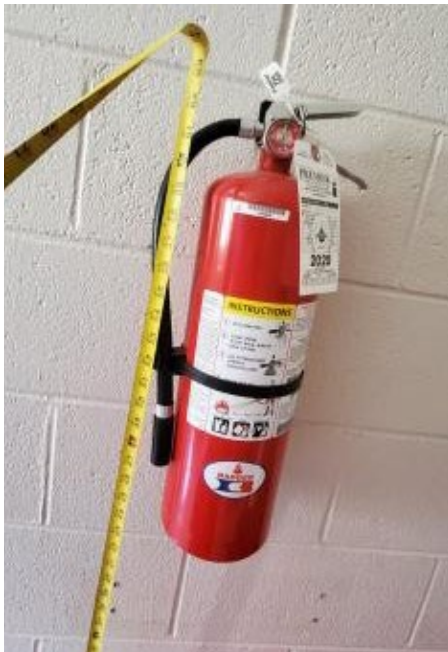
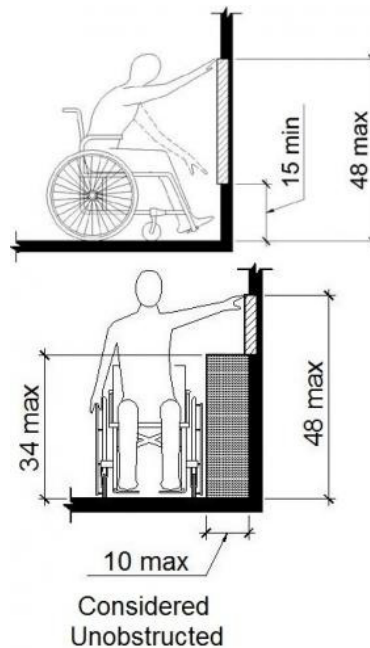
As Built: The fire extinguisher is not positioned correctly for either a side or front approach.

Where a clear floor or ground space allows a parallel or front approach and the side reach is unobstructed, the high side reach shall be 48 inches maximum above the finish floor or ground and the low side reach shall be 15 inches minimum above the finish floor or ground.

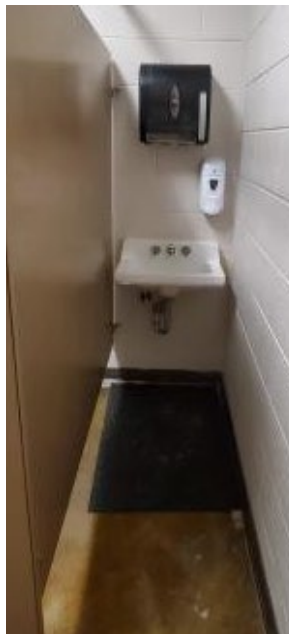
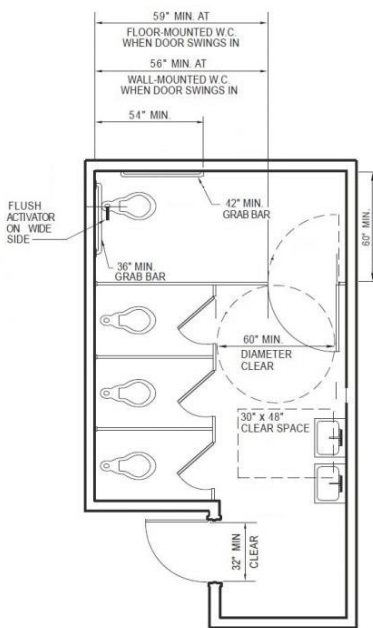
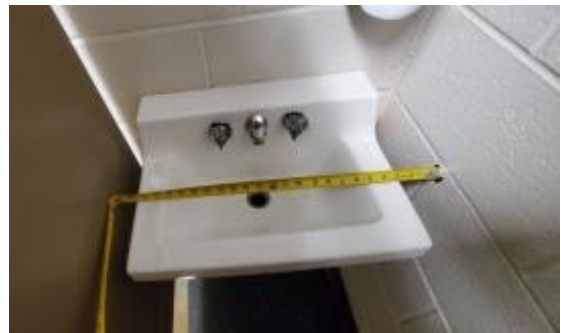
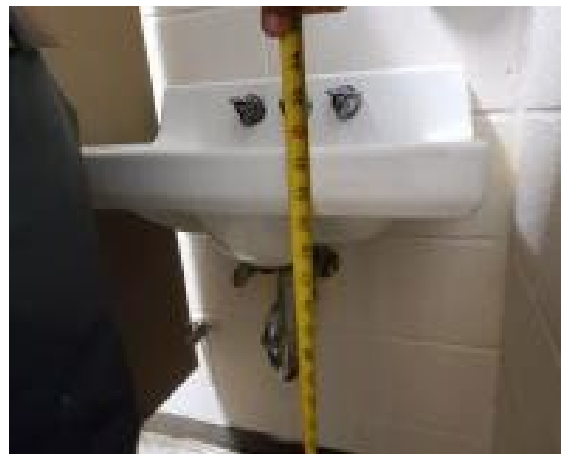
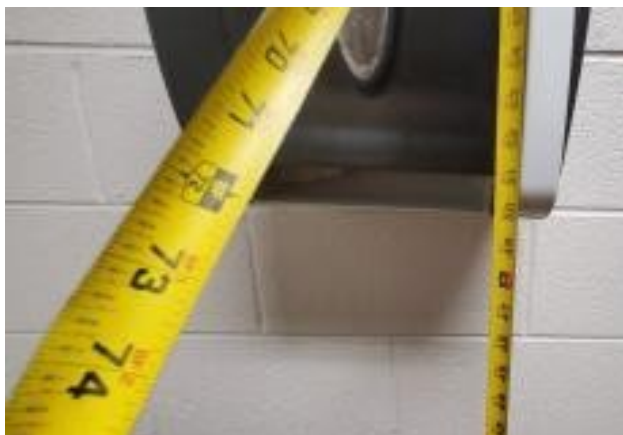
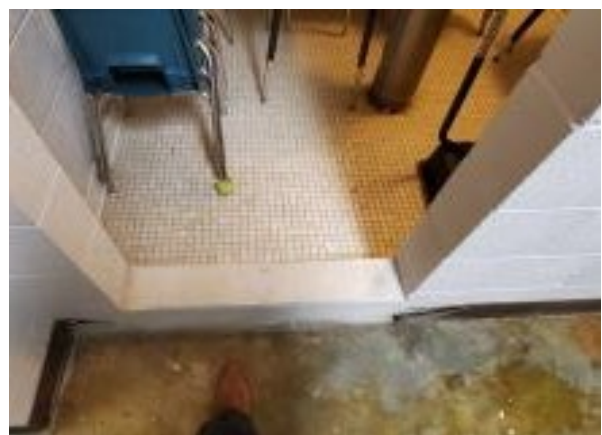
As Built: The toilet compartment does not have the required minimum clear floor space or maneuvering clearances for the toilet. Toilet seat is under 17". The restroom does not have the required minimum clear floor space or maneuvering clearances for the lavatory. Grab bars are incorrectly installed. Missing mirror. Paper towel dispenser. Lavatory missing pipe insulation turn twist type faucet.

Citation: 2010 ADAS Section 213.2

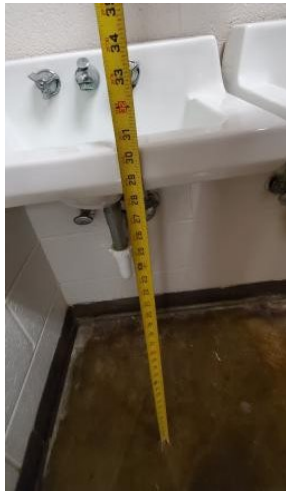
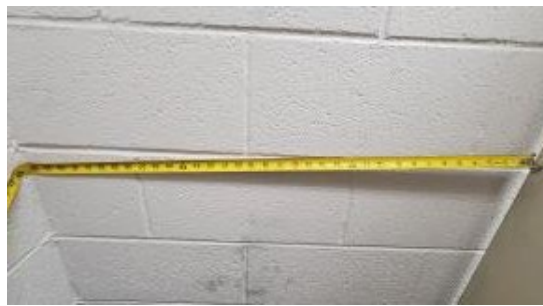
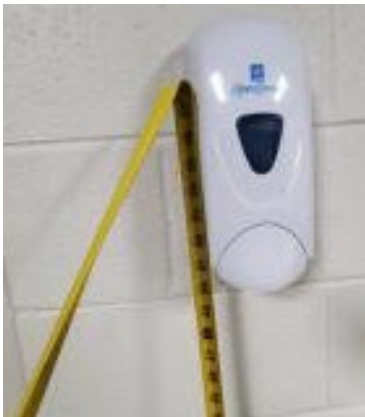
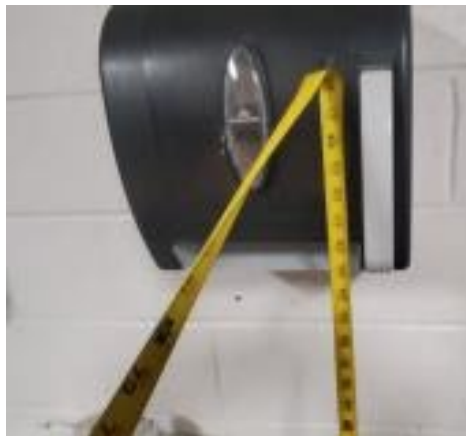
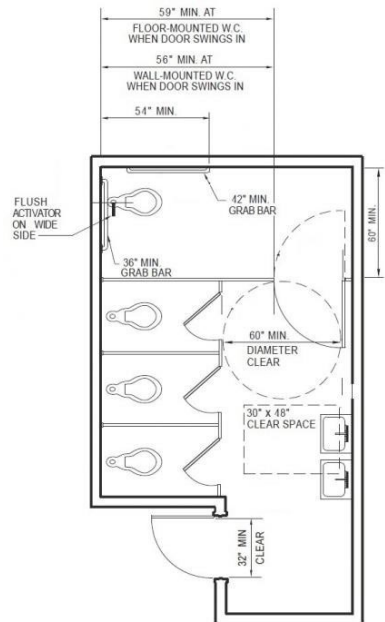
As Built: The toilet compartment does not have the required minimum clear floor space or maneuvering clearances for the toilet. Toilet seat is under 17". The restroom does not have the required minimum clear floor space or maneuvering clearances for the lavatory. Grab bars are incorrectly installed. Missing mirror. Paper towel dispenser. Lavatory missing pipe insulation, too high, turn twist type faucet.

Citation: 2010 ADAS Section 213.2

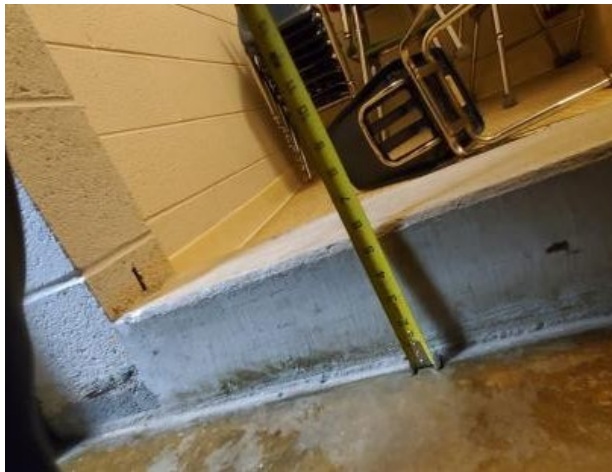
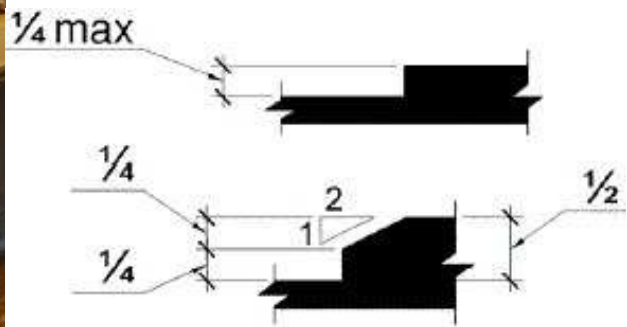
As Built: There is a change in level greater than 1/4 inch.

1/4 inch is the maximum vertical rise. Changes in level between 1/4 inch and 1/2 inch must be beveled at 1:2 or less. Changes in level greater than 1/2 inch must be by way of a ramp.

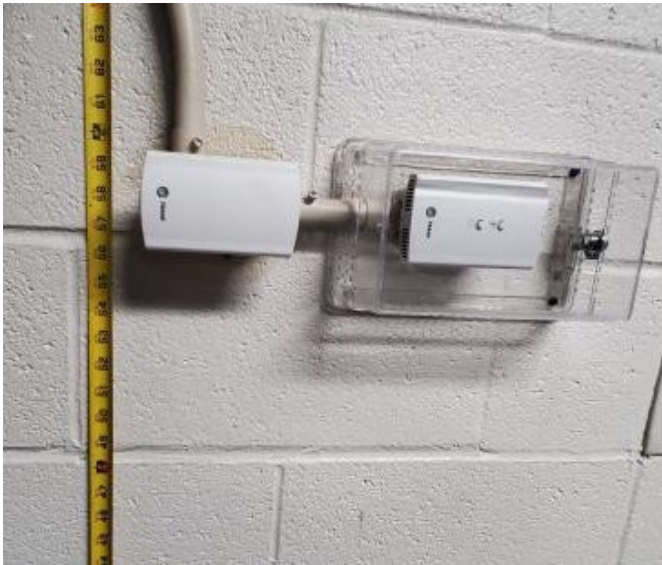
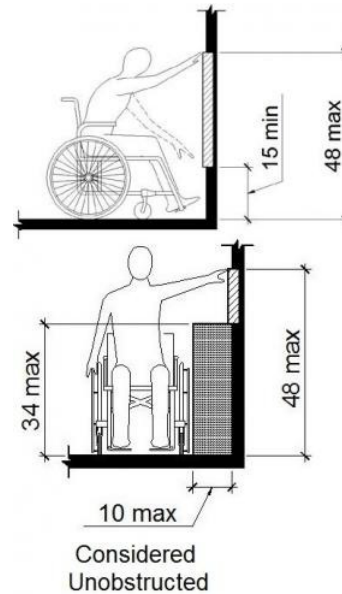
As Built: The thermostat is not positioned correctly for either a side or front approach.

Where a clear floor or ground space allows a parallel or front approach and the side reach is unobstructed, the high side reach shall be 48 inches maximum above the finish floor or ground and the low side reach shall be 15 inches minimum above the finish floor or ground.

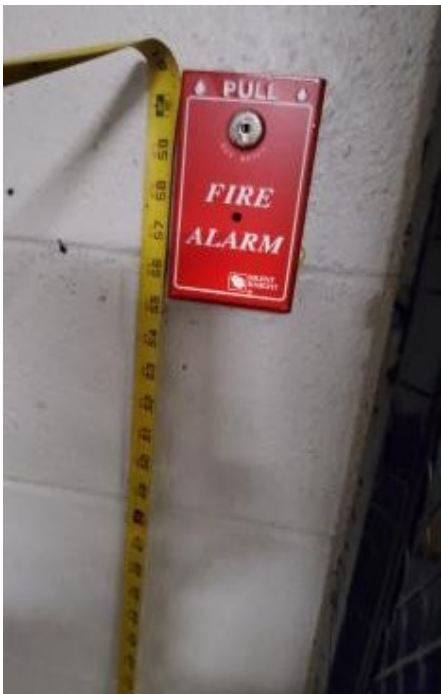
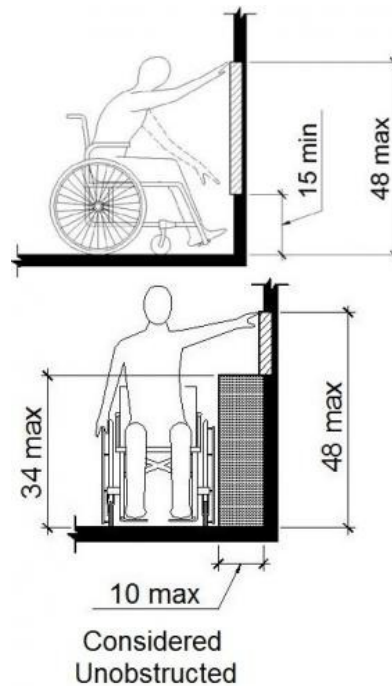
As Built: The fire alarm pull station is not positioned correctly for either a side or front approach.

Where a clear floor or ground space allows a parallel or front approach and the side reach is unobstructed, the high side reach shall be 48 inches maximum above the finish floor or ground and the low side reach shall be 15 inches minimum above the finish floor or ground.

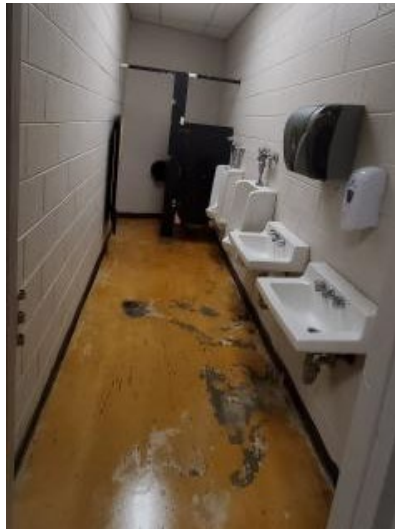
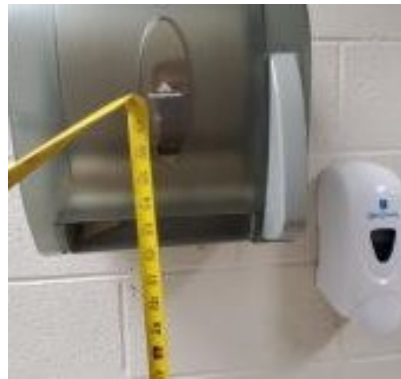
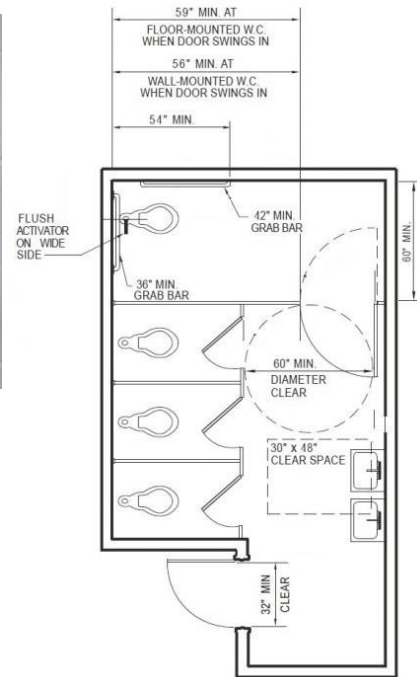
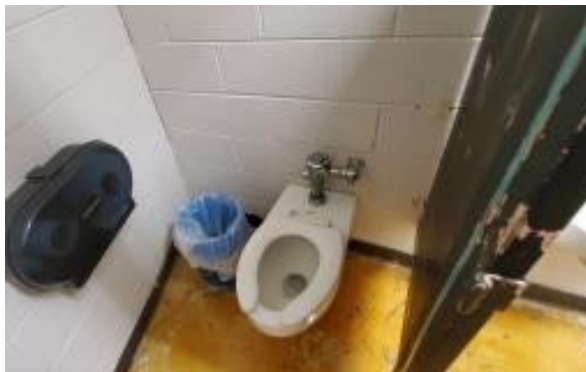
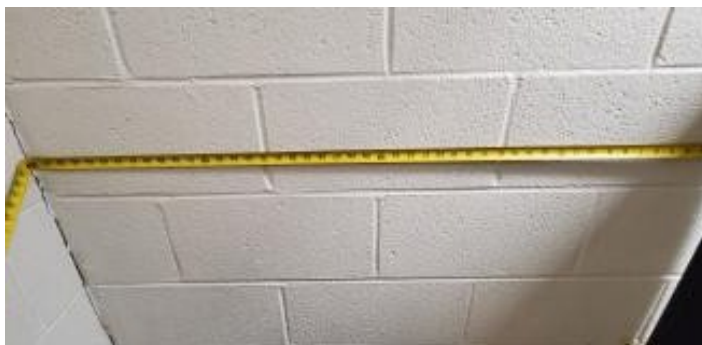
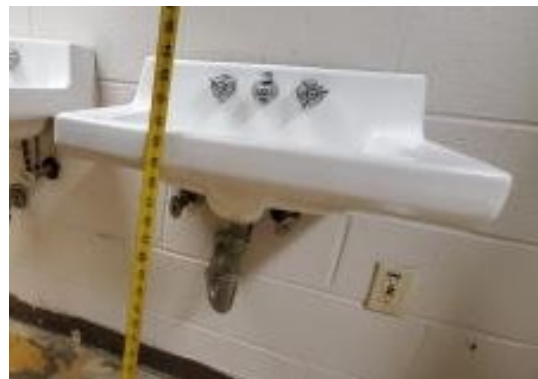
As Built: The toilet compartment does not have the required minimum clear floor space or maneuvering clearances for the toilet. Toilet seat is under 17". Toilet flush handle on wrong side. The restroom does not have the required minimum clear floor space or maneuvering clearances for the lavatory. Grab bars are incorrectly installed. Missing mirror. Paper towel dispenser. Lavatory missing pipe insulation, too high, turn twist type faucet.

Citation: 2010 ADAS Section 213.2

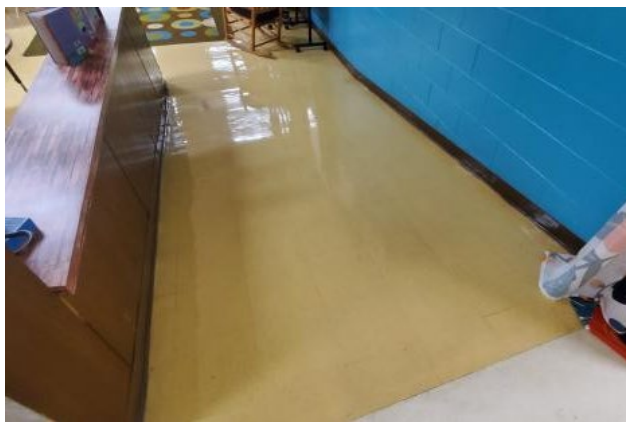
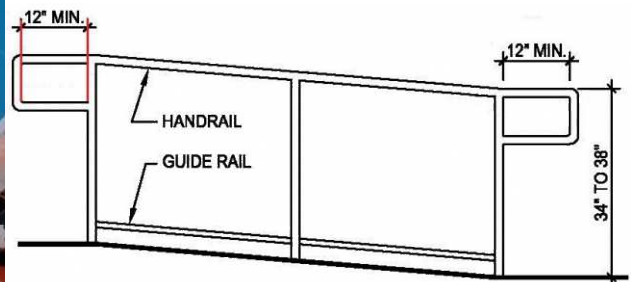
As Built: The ramp does not have compliant handrails.

Handrails are required on both sides of all surfaces that are sloped greater than 5 percent (1:20). Handrails must be between 34 inches and 38 inches above the ramp surface, must extend 12 inches beyond the top and bottom of the ramp and be parallel to the floor or ground surface. The diameter of the handrails must be between 1 1/4 inches and 2 inches in cross-sectional nominal dimension for circular handrails. Handrail gripping surfaces with a non-circular cross section shall have a perimeter dimension of 4 inches minimum and 6 1/4 inches maximum, and a cross-section dimension of 2 1/4 inches maximum. The space between handrails and walls must be 1 1/2 inches minimum.

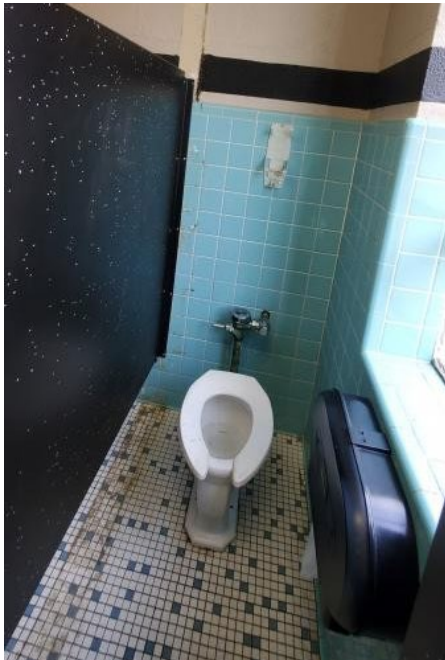
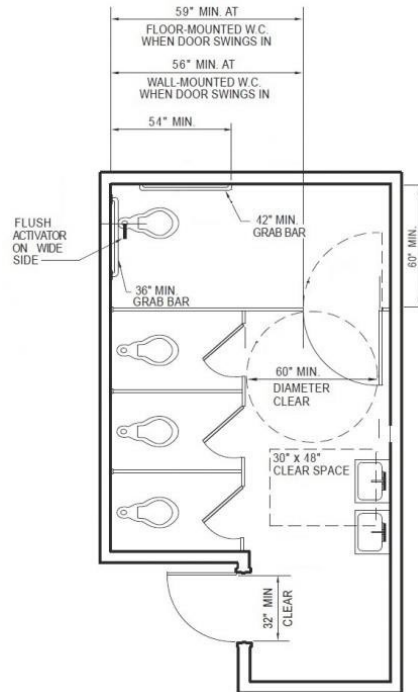
As Built: The toilet compartment does not have the required minimum clear floor space or maneuvering clearances for the toilet. The restroom does not have the required minimum clear floor width and depth. Grab bars are not installed.

Citation: 2010 ADAS Section 213.2

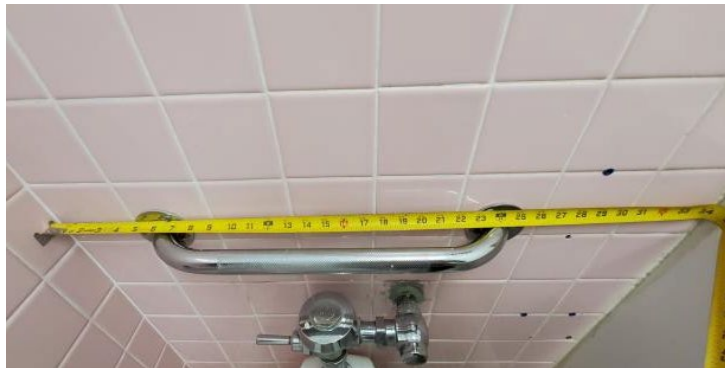
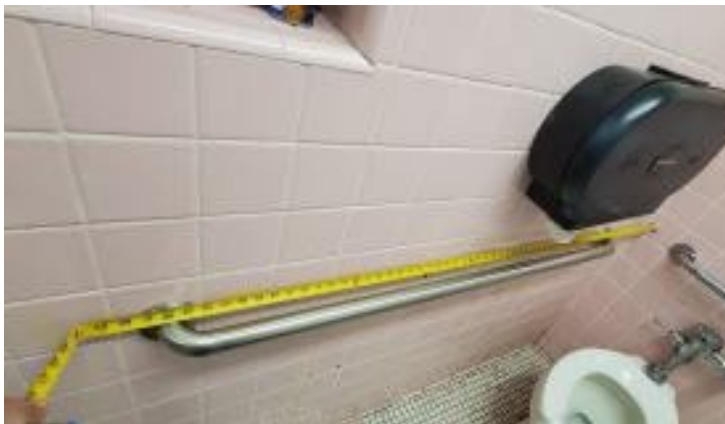
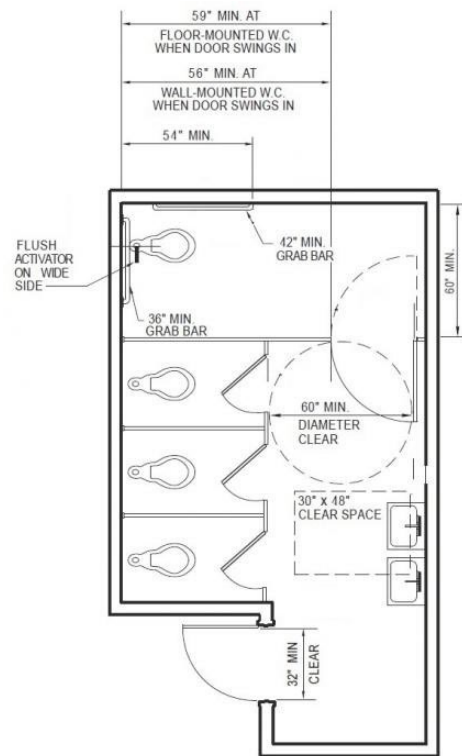
As Built: The toilet compartment does not have the required minimum clear floor space or maneuvering clearances for the toilet. The restroom does not have the required minimum clear floor width and depth. Grab bars are not installed.

Citation: 2010 ADAS Section 213.2

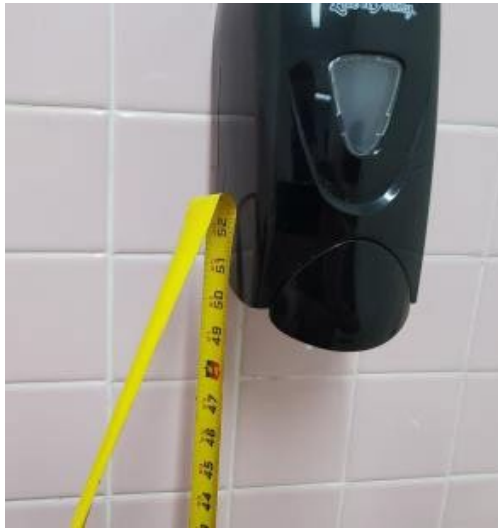
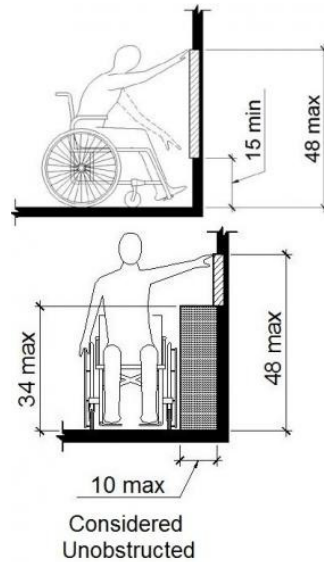
As Built: The soap dispenser is not positioned correctly for either a side or front approach.

Where a clear floor or ground space allows a parallel or front approach and the side reach is unobstructed, the high side reach shall be 48 inches maximum above the finish floor or ground and the low side reach shall be 15 inches minimum above the finish floor or ground.

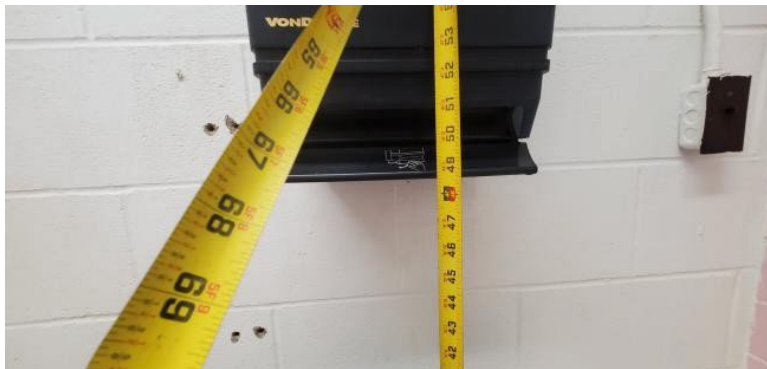
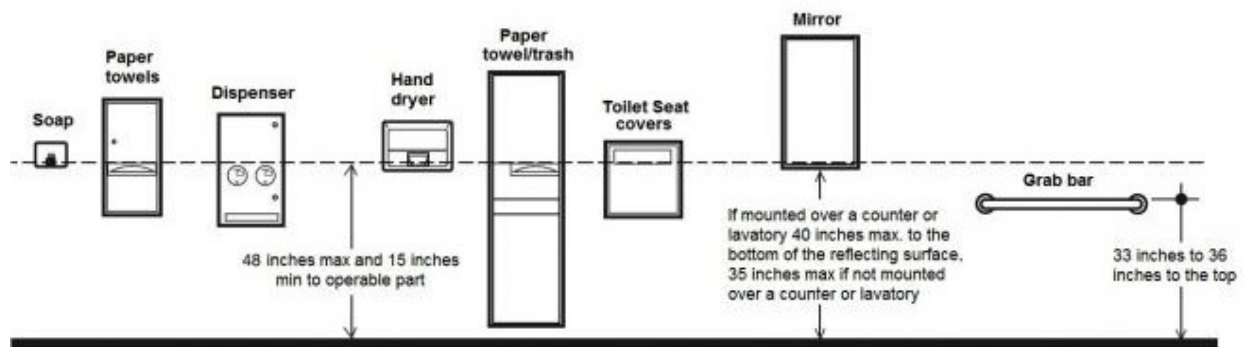
As Built: The paper towel dispenser's operation mechanism is 49" which is too high off the floor. Dispensers must have all operable parts a maximum of 48 inches above the floor.

Citation: 2010 ADAS Section 308.2.1

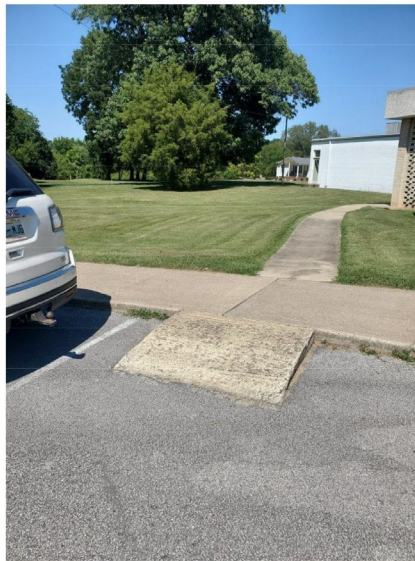
As Built: The running slope of the curb ramp is excessive.

The running slope of the curb ramp shall be 5 percent minimum and 8.3 percent maximum but shall not require the ramp length to exceed 15.0 ft.

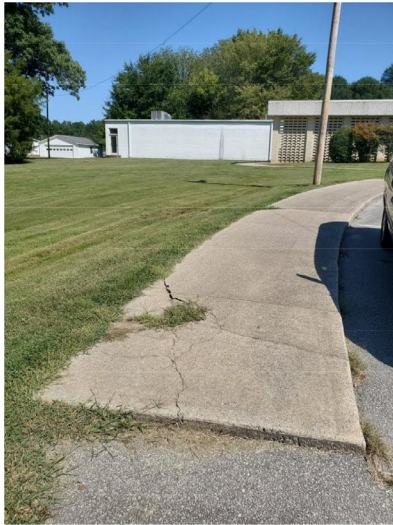
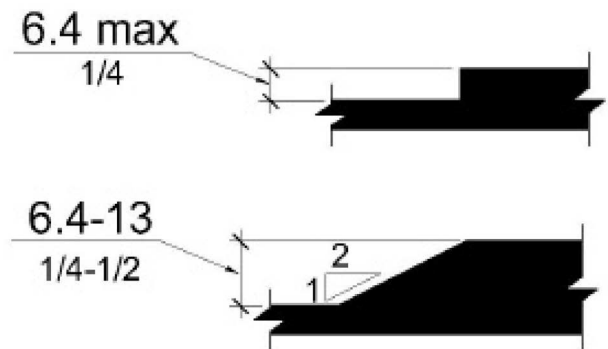
As Built: The surface of the pedestrian access route has vertical discontinuities greater than 1/2 inch or between 1/4 inch and 1/2 inch that are not beveled.

Vertical surface discontinuities shall be 0.5 inch maximum. Vertical surface discontinuities between 0.25 inch and 0.5 inch shall be beveled with a slope not steeper than 50 percent. The bevel shall be applied across the entire vertical surface discontinuity.

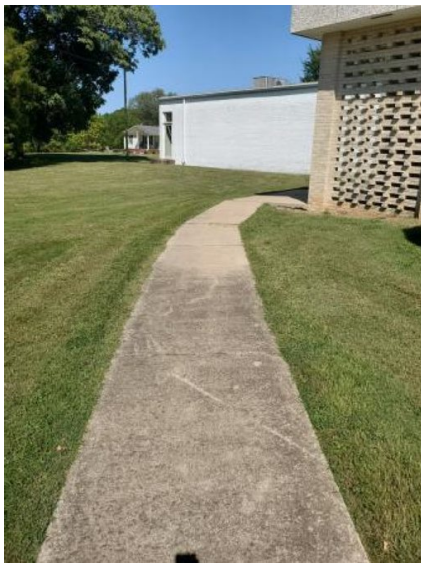
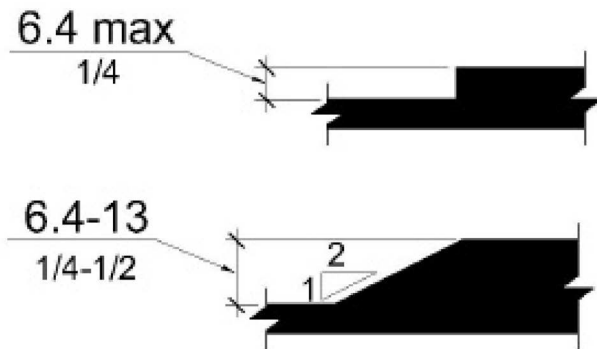
As Built: The cross slope of the pedestrian access route is excessive, varying around 6%.

The cross slope of pedestrian access routes shall be 2 percent maximum.

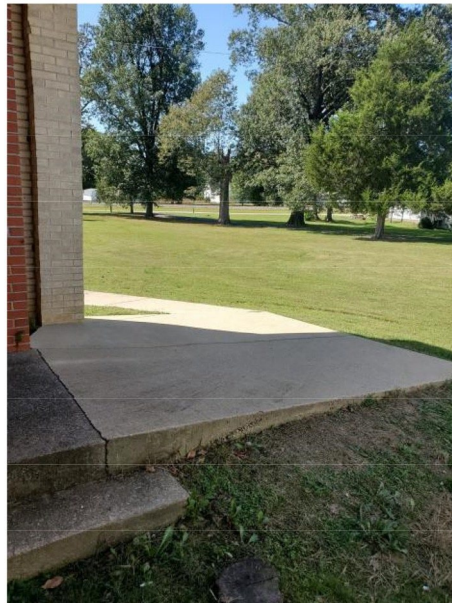
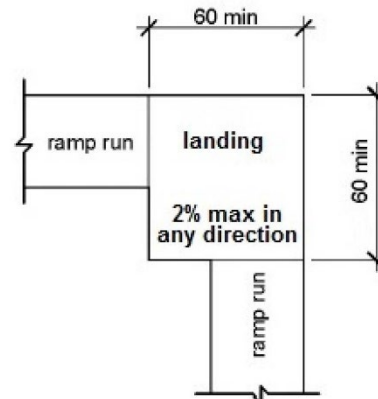
As Built: The cross slope of the pedestrian access route is excessive, varying around 6%.

The cross slope of pedestrian access routes shall be 2 percent maximum.

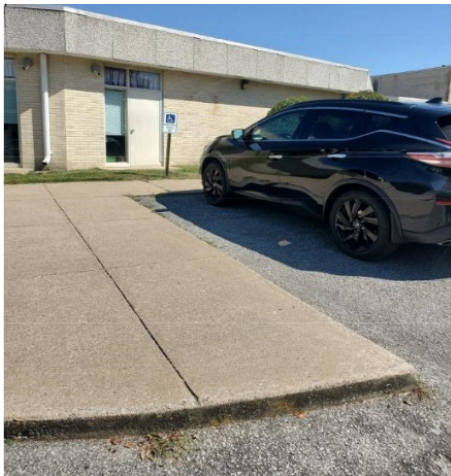
As Built: There are not enough accessible stalls.

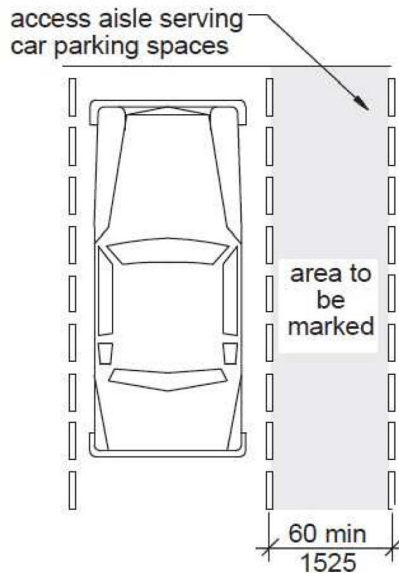
As Built: The access aisle is missing at the accessible parking stall.

Access aisles serving parking spaces shall adjoin an accessible route. Two parking spaces shall be permitted to share a common access aisle.

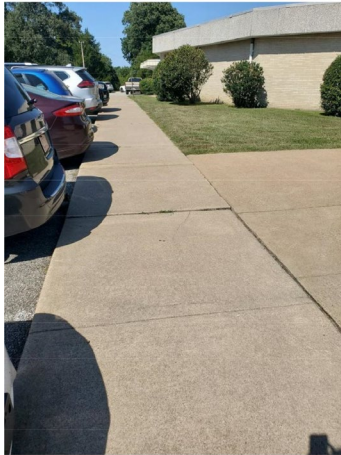
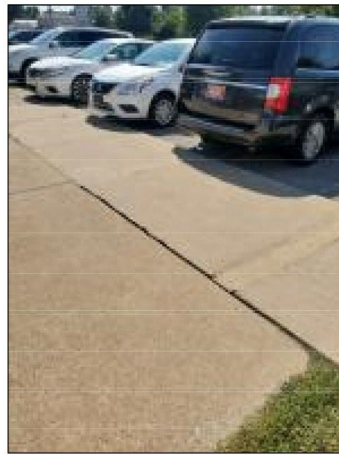
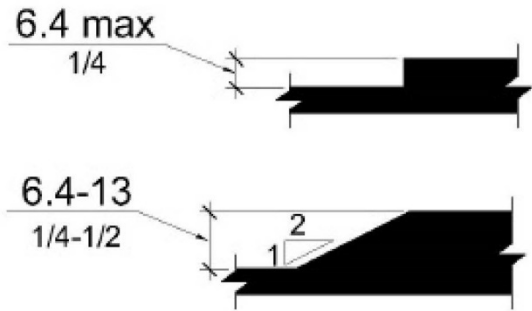
As Built: The surface of the pedestrian access route has vertical discontinuities greater than 1/2 inch or between 1/4 inch and 1/2 inch that are not beveled.

Vertical surface discontinuities shall be 0.5 inch maximum. Vertical surface discontinuities between 0.25 inch and 0.5 inch shall be beveled with a slope not steeper than 50 percent. The bevel shall be applied across the entire vertical surface discontinuity.

Replace approximately 30'x50'.

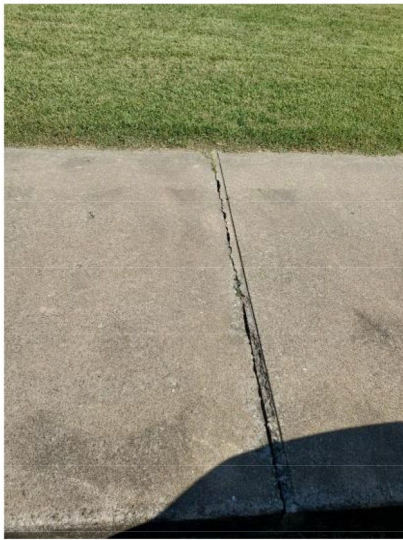
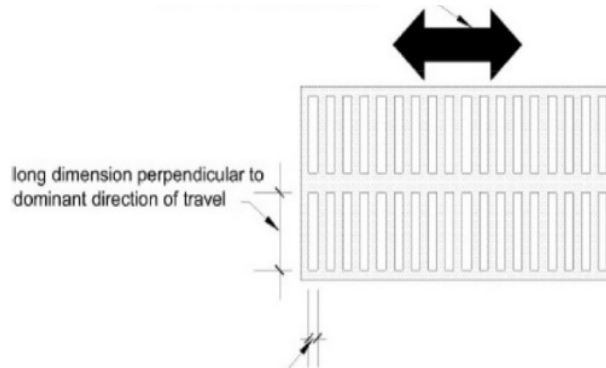
As Built: The surface of the pedestrian access route has openings greater than 1/2 inch.

Horizontal openings in gratings and joints shall not permit passage of a sphere more than 13 mm (0.5 in) in diameter.

Recommendation:

Replace approximately 7'x10' or patch to smooth surface.

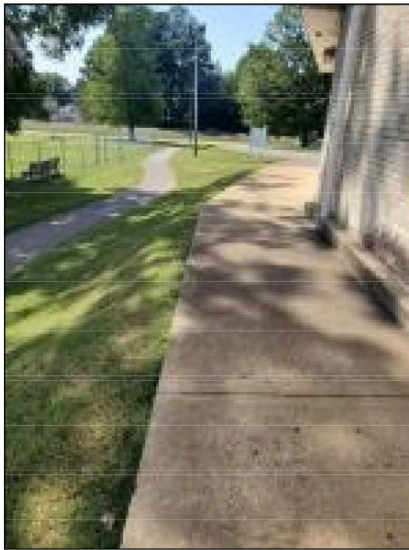
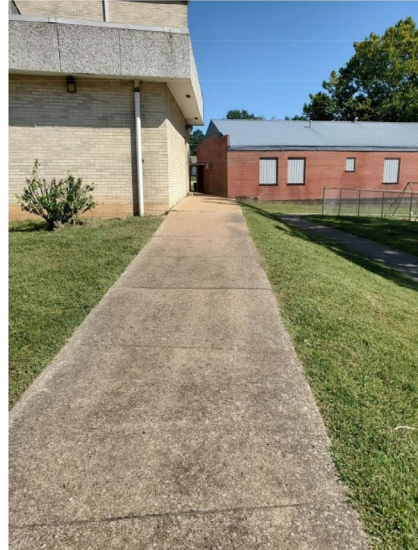
As Built: The cross slope of the pedestrian access route varies up to 6% along a steep adjacent slope, which is excessive.

The cross slope of pedestrian access routes shall be 2 percent maximum.

Recommendation:

Replace sidewalk with compliant slopes and install safety rail along edge.

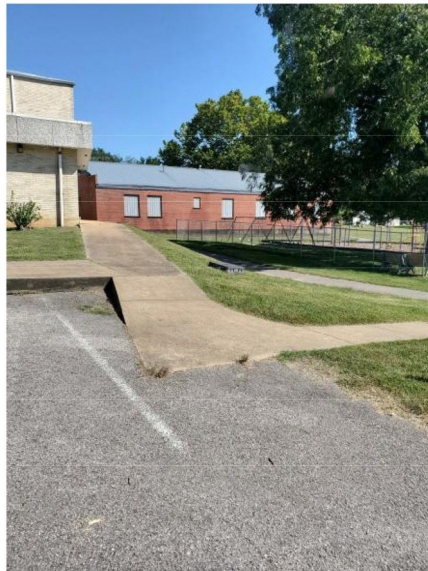
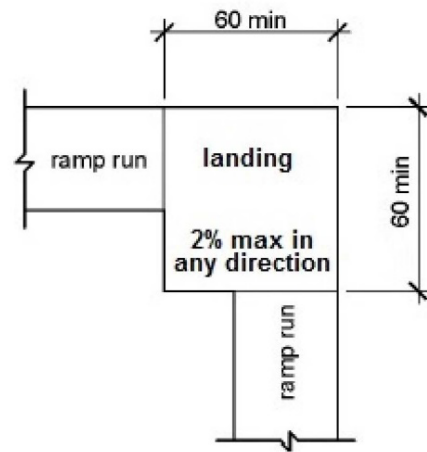
As Built: The landing at the change of direction has excessive slope.

Landings at a change in direction shall have a dimension not less than 60 inches by 60 inches and have a slope of 2% maximum in any direction.

Recommendation:

Replace the ramp.

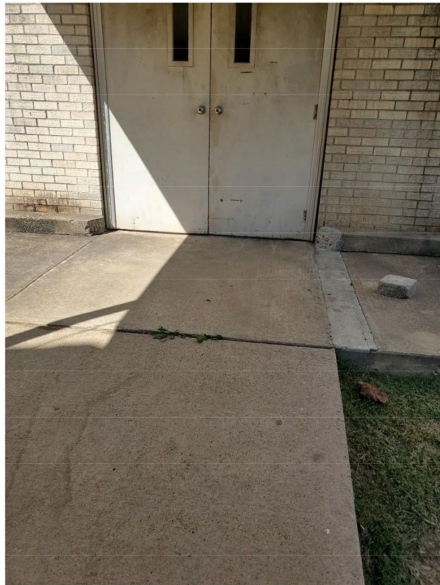
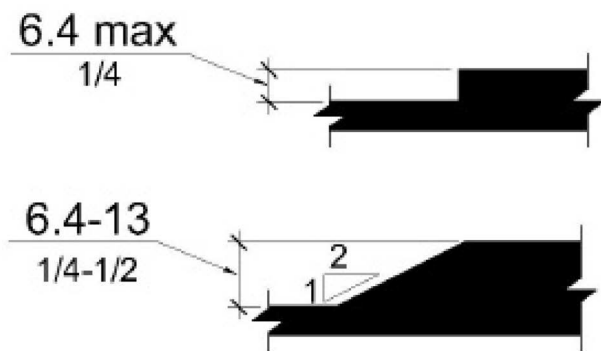
As Built: The surface of the pedestrian access route has vertical discontinuities greater than 1/2 inch or between 1/4 inch and 1/2 inch that are not beveled.

Vertical surface discontinuities shall be 0.5 inch maximum. Vertical surface discontinuities between 0.25 inch and 0.5 inch shall be beveled with a slope not steeper than 50 percent. The bevel shall be applied across the entire vertical surface discontinuity.

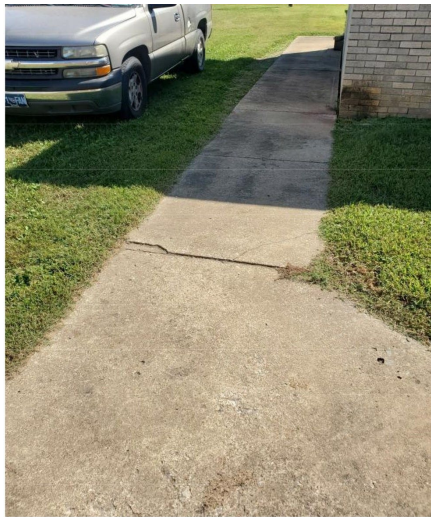
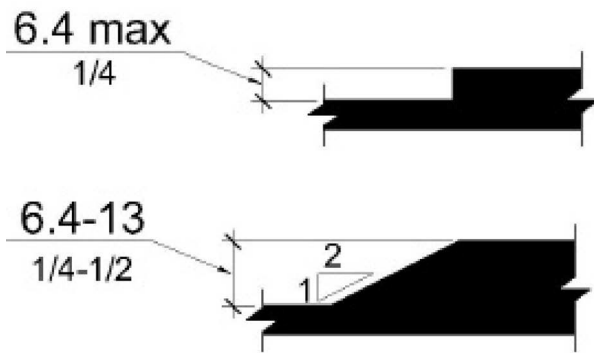
As Built: The surface of the pedestrian access route has vertical discontinuities greater than 1/2 inch or between 1/4 inch and 1/2 inch that are not beveled.

Vertical surface discontinuities shall be 0.5 inch maximum. Vertical surface discontinuities between 0.25 inch and 0.5 inch shall be beveled with a slope not steeper than 50 percent. The bevel shall be applied across the entire vertical surface discontinuity.

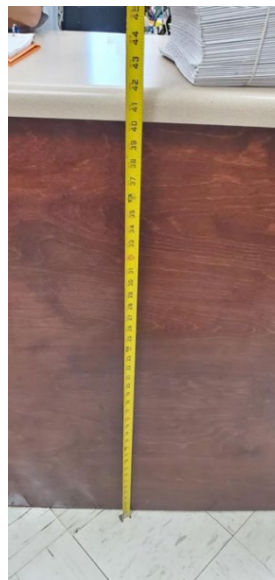
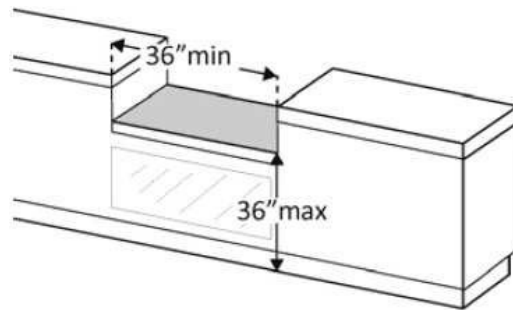
As Built: The counter is too high.

A portion of the counter surface that is 36 inches long minimum and 36 inches high maximum above the finish floor shall be provided. Knee and toe space must be provided for a forward approach. A 30 inch by 48-inch clear floor space on an accessible route must be provided for either a forward or parallel approach.

Recommendation:

Cut out 3' (width) section and replace with new counter at 36" AFF with minimum 17" countertop overhang depth.

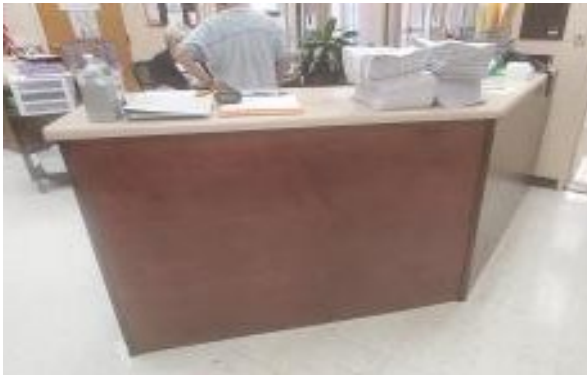
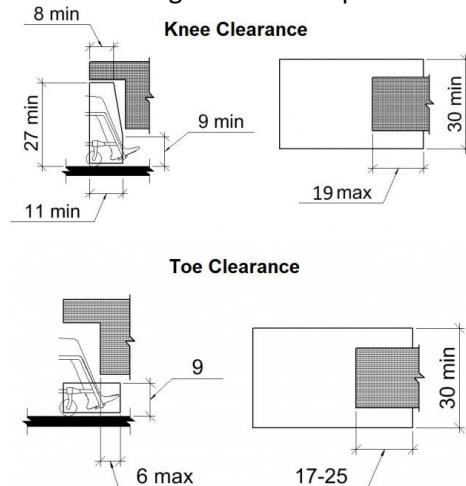
As Built: Compliant knee and/or toe space is not provided.

Space under an element between the finish floor or ground and 9 inches above the finish floor or ground shall be considered toe clearance. Toe clearance shall extend 25 inches maximum and 17 inches minimum under an element. Space extending greater than 6 inches beyond the available knee clearance at 9 inches above the finish floor or ground shall not be considered toe clearance. Toe clearance shall be 30 inches wide minimum.

See Finding #1 for recommendation and budget.

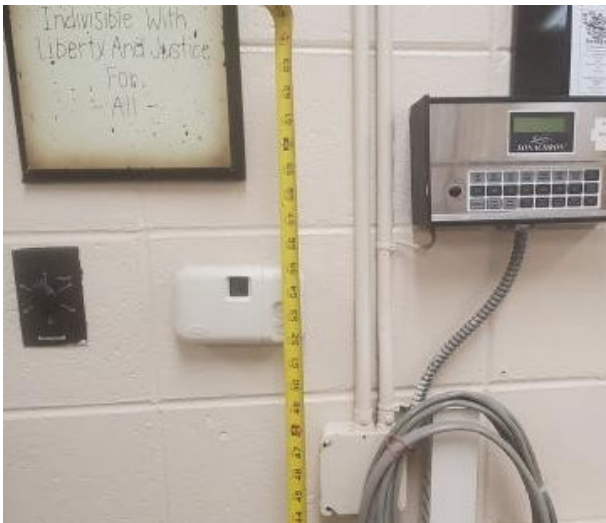
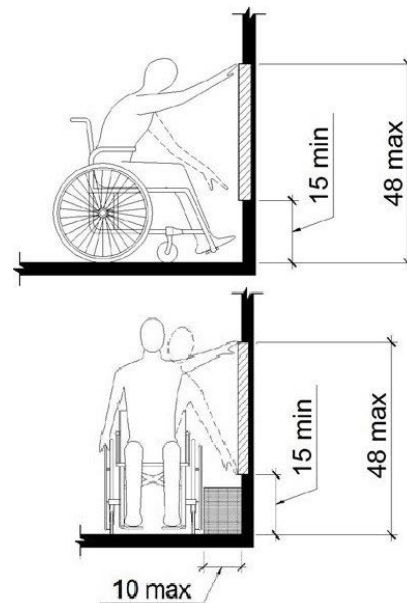
As Built: The thermostat is positioned too high for either a side or front approach.

Where a clear floor or ground space allows a parallel approach to an element and the side reach is unobstructed, the high side reach shall be 48 inches maximum and the low side reach shall be 15 inches minimum above the finish floor or ground.

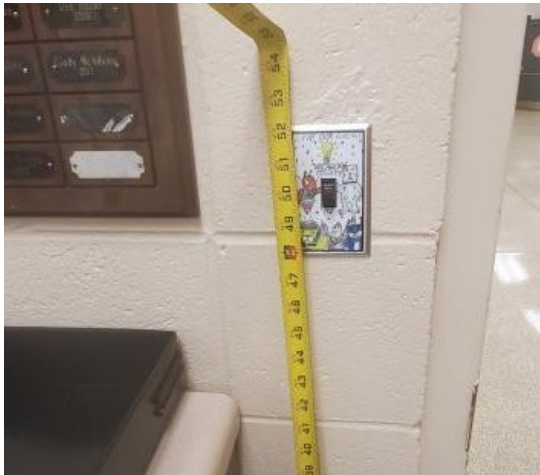
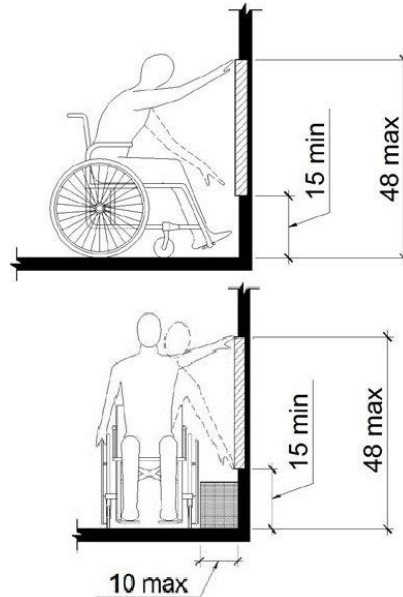
As Built: The receptacle/switch is not positioned correctly for either a side or front approach.

Where a clear floor or ground space allows a parallel or front approach to a switch or receptacle and the side reach is unobstructed, the high side reach shall be 48 inches maximum above the finish floor or ground and the low side reach shall be 15 inches minimum above the finish floor or ground.

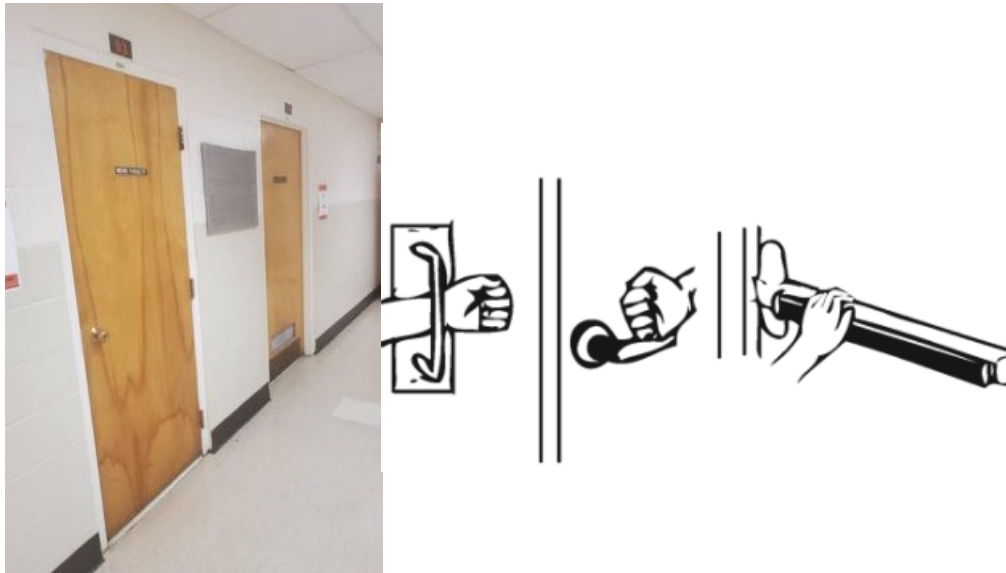
As Built: The door/gate operating hardware is not accessible.

Hand-activated door/gate opening hardware, handles, pulls, latches, locks, and other operating devices on accessible doors shall have a shape that is easy to grasp with one hand and does not require tight grasping, pinching or twisting of the wrist to operate. Hardware shall be 34 inches minimum and 48 inches maximum above the finish floor or ground.
