WEAKLEY COUNTY, TENNESSEE

ADA EVALUATION

Architectural and Site Findings with Recommendations

TLM Associates, Inc

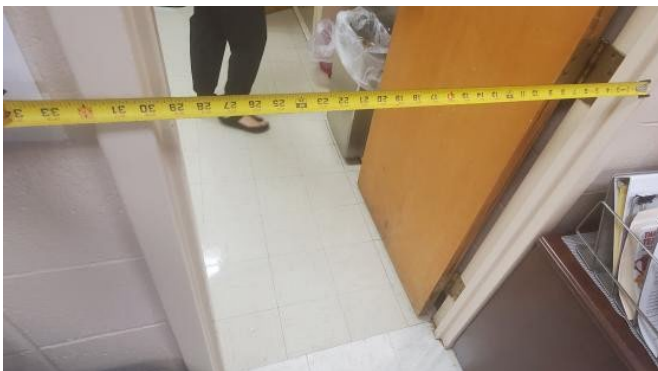
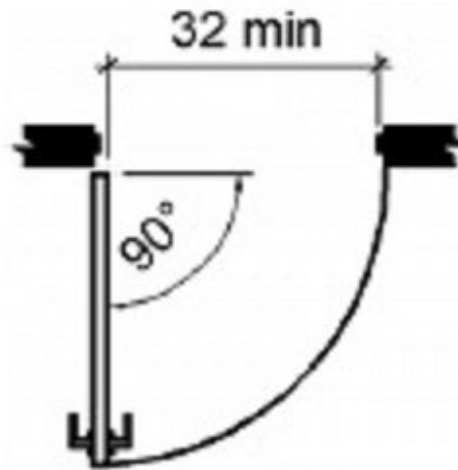
Hinged Door or Gate

As Built: The door opening does not provide at least 32 inches between the face of the door and the opposite stop.

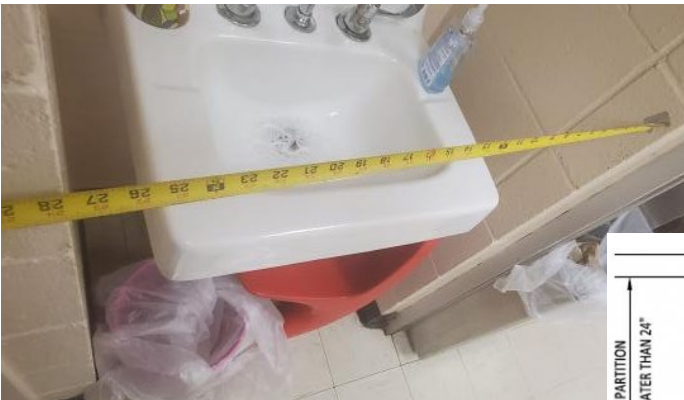
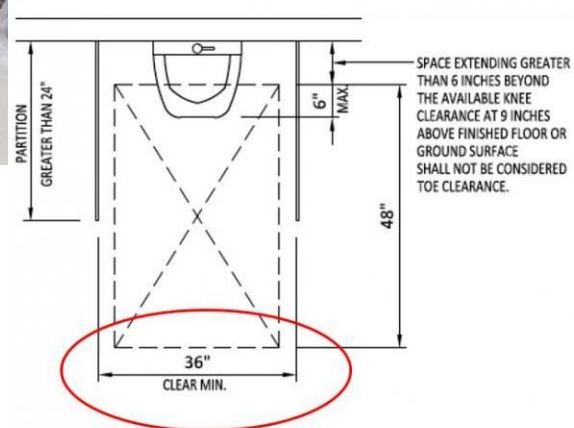
As Built: The lavatory is confined on three sides and is considered to be installed in an alcove.

Lavatories installed in alcoves or with wing walls or partitions that extend greater than 24 inches must provide a clear space in front of the lavatory that is a minimum of 36 inches wide.

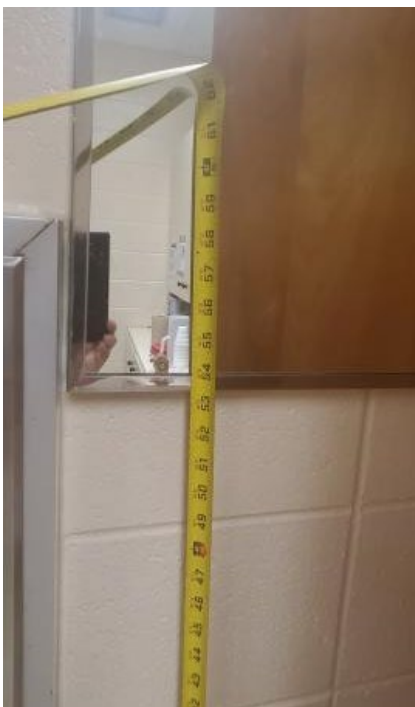
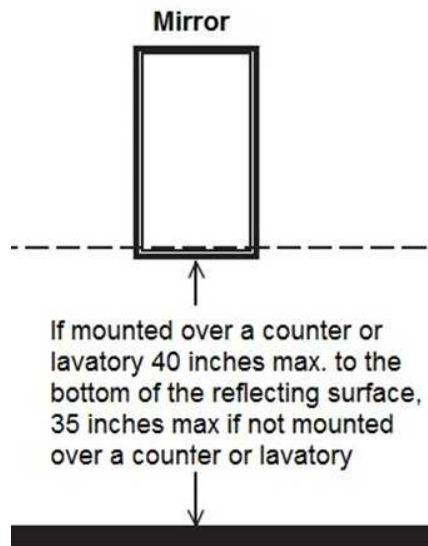
As Built: The mirror is mounted at 54", which is too high.

Mirrors must have the bottom edge of the reflecting surface a maximum of 40 inches above the floor if above a sink or counter. Mirrors not located above lavatories or countertops shall be installed with the bottom edge of the reflecting surface 35 inches maximum above the finish floor or ground.

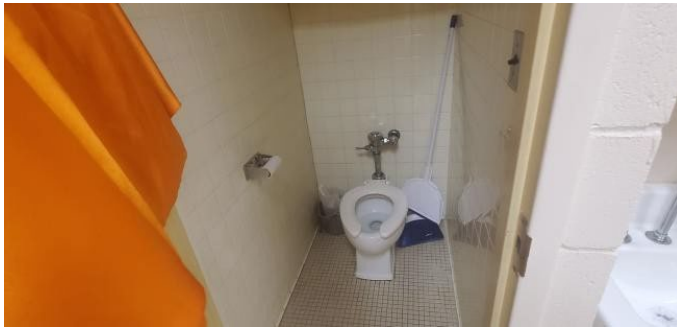
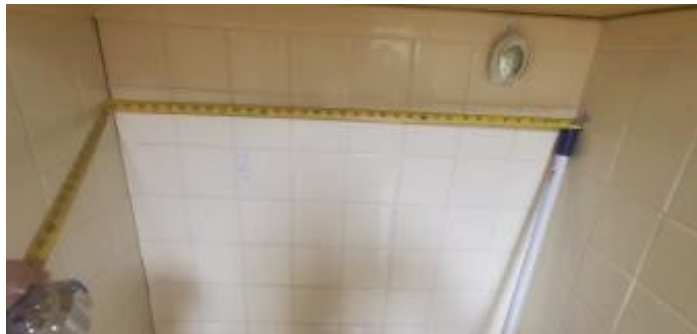
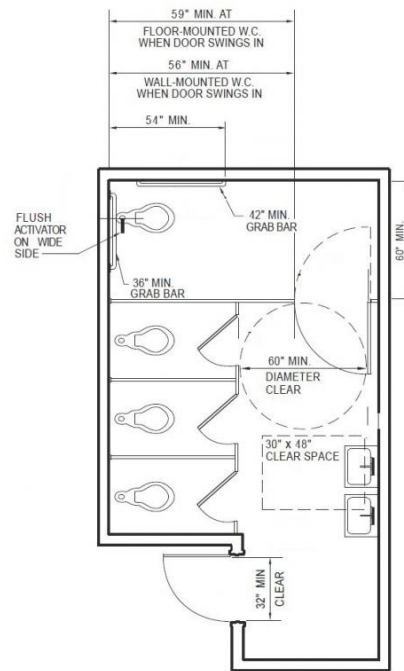
As Built: The restroom is not compliant.

The restroom does not have the required minimum clear floor space or maneuvering clearances for the toilet. Missing grab bars.

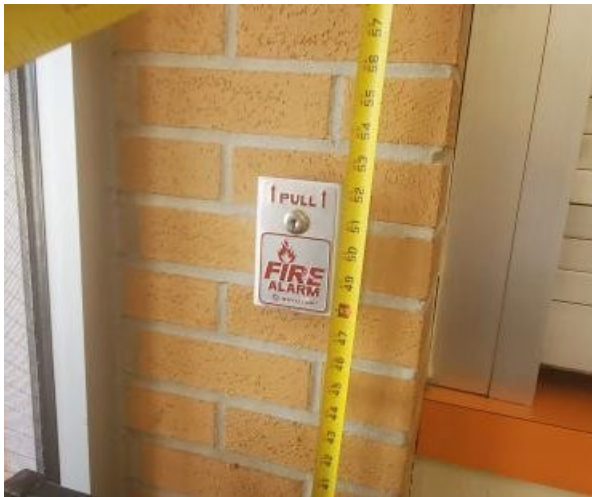
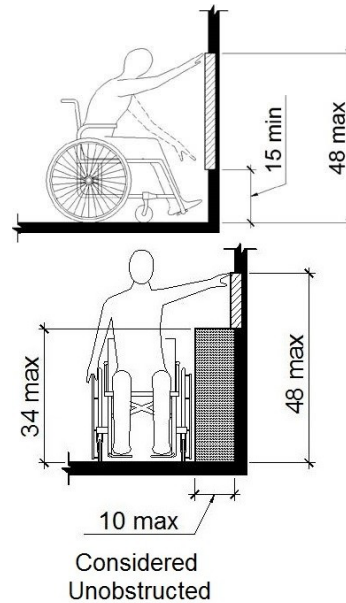
As Built: The fire pull is not positioned correctly for either a side or front approach.

Where a clear floor or ground space allows a parallel or front approach and the side reach is unobstructed, the high side reach shall be 48 inches maximum above the finish floor or ground and the low side reach shall be 15 inches minimum above the finish floor or ground.

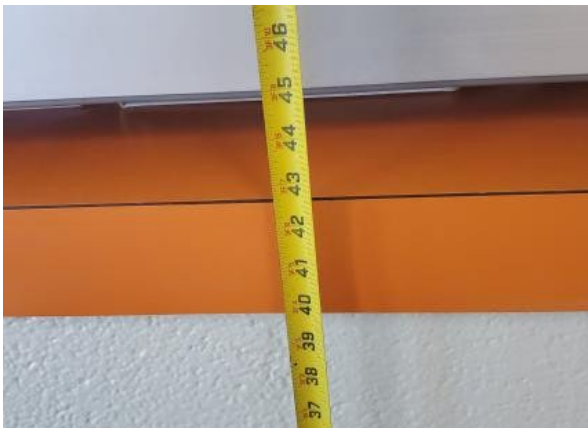
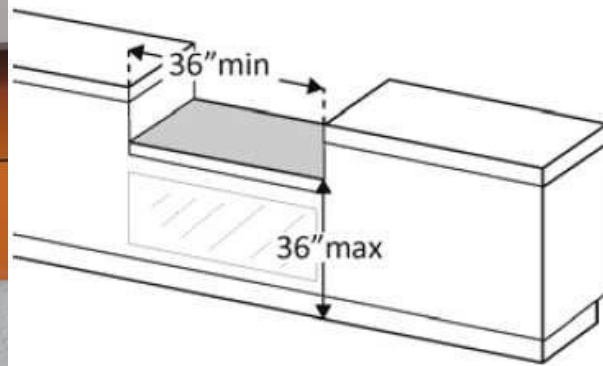
As Built: The counter is 42" which is too high.

A portion of the counter surface that is 36 inches long minimum and 36 inches high maximum above the finish floor shall be provided. Knee and toe space must be provided for a forward approach. A 30 inch by 48 inch clear floor space on an accessible route must be provided for either a forward or parallel approach.

Recommendation:

Cut out 3' (width) section and replace with new counter at 36" AFF with minimum 17" countertop overhang depth.

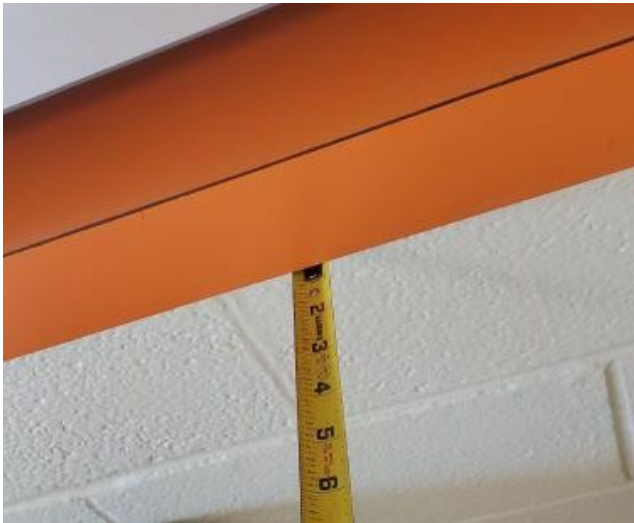
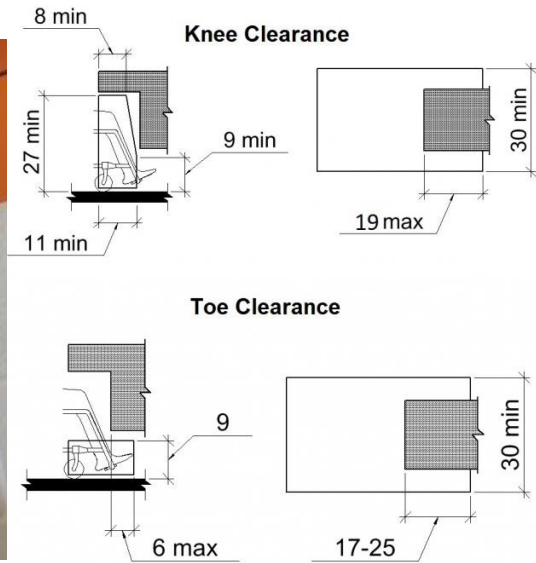
As Built: Compliant knee and/or toe space is not provided.

Space under an element between the finish floor or ground and 9 inches above the finish floor or ground shall be considered toe clearance. Toe clearance shall extend 25 inches maximum and 17 inches minimum under an element. Space extending greater than 6 inches beyond the available knee clearance at 9 inches above the finish floor or ground shall not be considered toe clearance. Toe clearance shall be 30 inches wide minimum.

See recommendation and budget on previous finding.

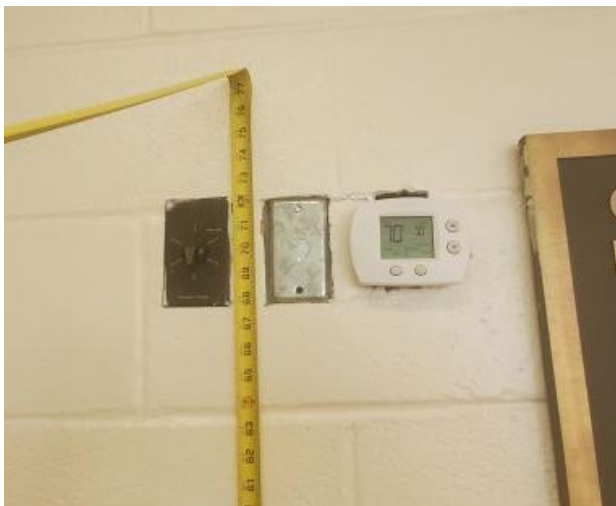
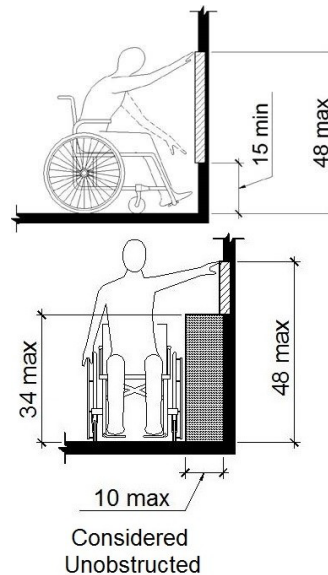
As Built: The thermostat is not positioned correctly for either a side or front approach.

Where a clear floor or ground space allows a parallel or front approach and the side reach is unobstructed, the high side reach shall be 48 inches maximum above the finish floor or ground and the low side reach shall be 15 inches minimum above the finish floor or ground.

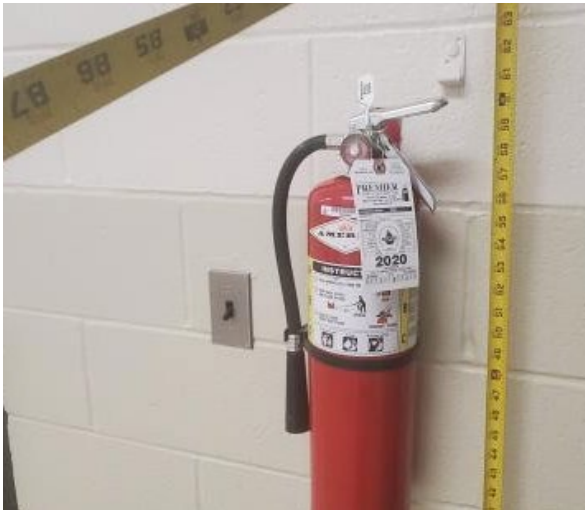
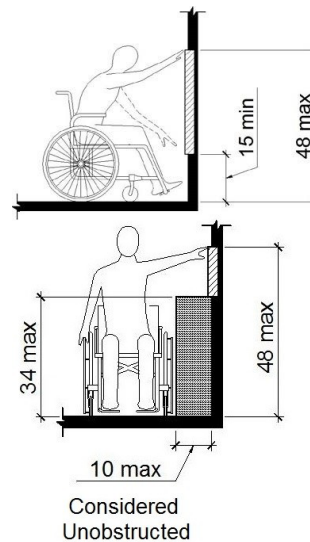
As Built: The fire extinguisher is not positioned correctly for either a side or front approach.

Where a clear floor or ground space allows a parallel or front approach and the side reach is unobstructed, the high side reach shall be 48 inches maximum above the finish floor or ground and the low side reach shall be 15 inches minimum above the finish floor or ground.

Recommendation: Lower fire extinguisher for handle to be 48" max AFF.

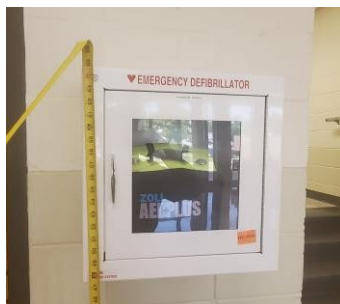
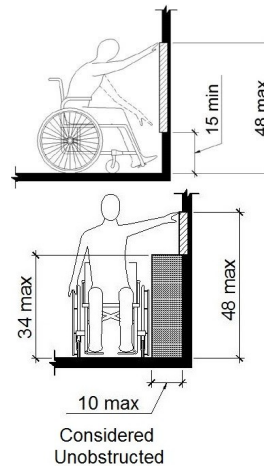
As Built: The defibrillator is not positioned correctly for either a side or front approach.

Where a clear floor or ground space allows a parallel or front approach and the side reach is unobstructed, the high side reach shall be 48 inches maximum above the finish floor or ground and the low side reach shall be 15 inches minimum above the finish floor or ground.

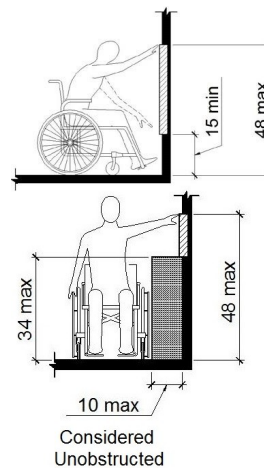
As Built: The fire pull is not positioned correctly for either a side or front approach.

Where a clear floor or ground space allows a parallel or front approach and the side reach is unobstructed, the high side reach shall be 48 inches maximum above the finish floor or ground and the low side reach shall be 15 inches minimum above the finish floor or ground.

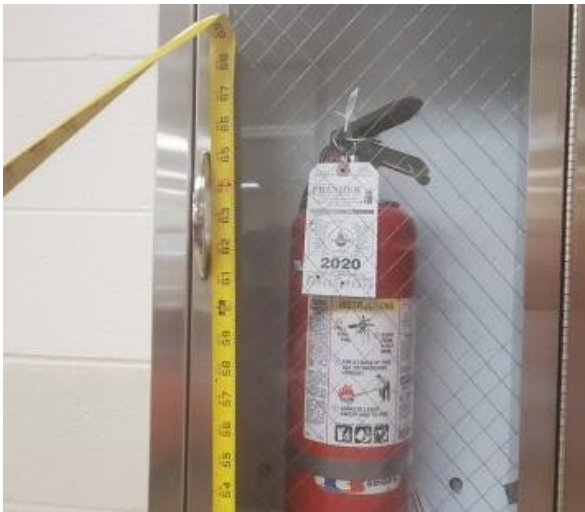
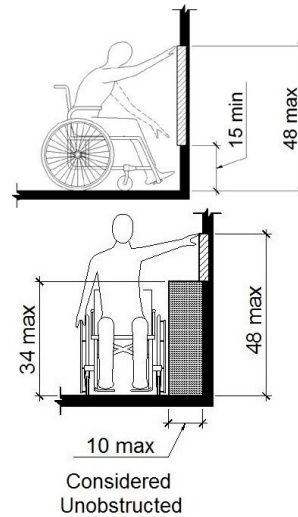
As Built: The fire extinguisher is not positioned correctly for either a side or front approach.

Where a clear floor or ground space allows a parallel or front approach and the side reach is unobstructed, the high side reach shall be 48 inches maximum above the finish floor or ground and the low side reach shall be 15 inches minimum above the finish floor or ground.

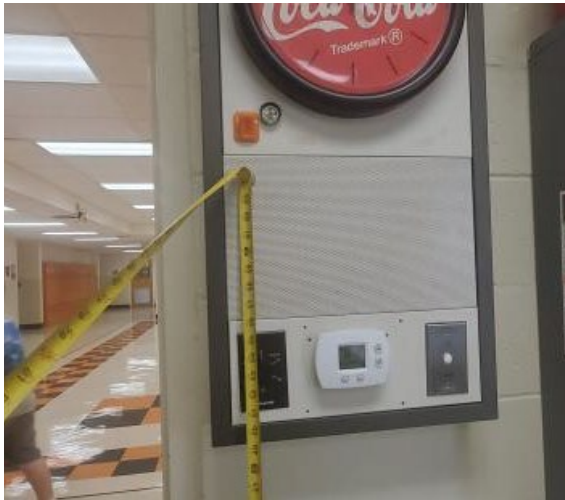
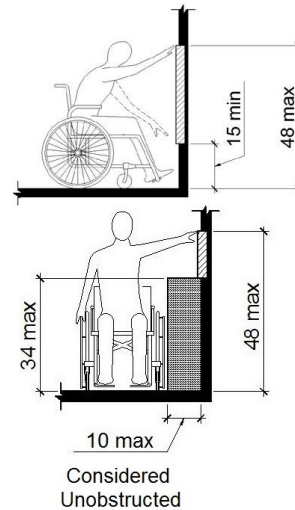
As Built: The thermostat is not positioned correctly for either a side or front approach.

Where a clear floor or ground space allows a parallel or front approach and the side reach is unobstructed, the high side reach shall be 48 inches maximum above the finish floor or ground and the low side reach shall be 15 inches minimum above the finish floor or ground.

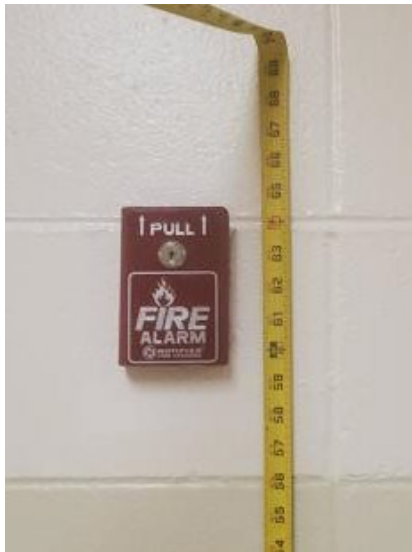
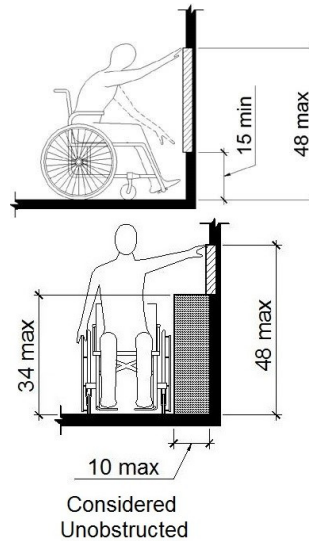
As Built: The fire alarm pull is not positioned correctly for either a side or front approach.

Where a clear floor or ground space allows a parallel or front approach and the side reach is unobstructed, the high side reach shall be 48 inches maximum above the finish floor or ground and the low side reach shall be 15 inches minimum above the finish floor or ground.

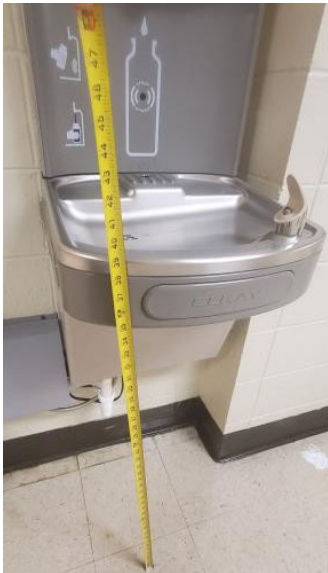
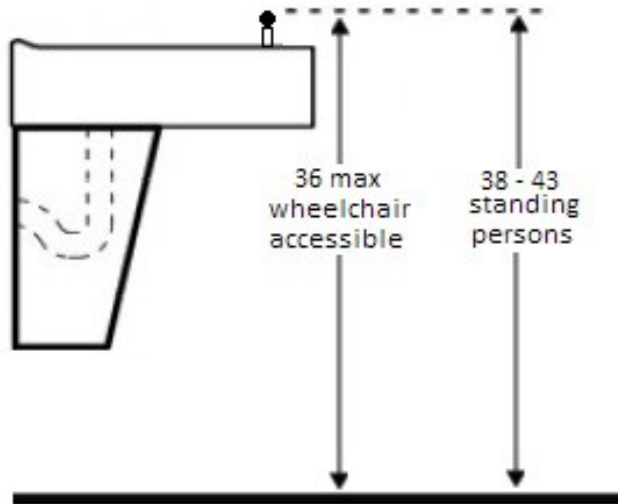
As Built: The total number of drinking fountains are not equally divided between those that are accessible to wheelchair users and those that are available to standing persons.

Where more than two are provided, 50 percent of the total number of drinking fountains provided shall be accessible to wheelchair users and 50 percent available to standing persons.

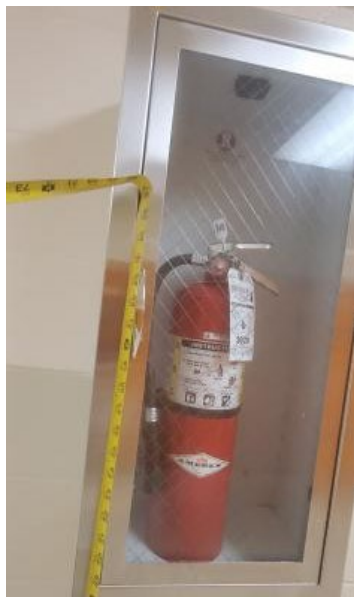
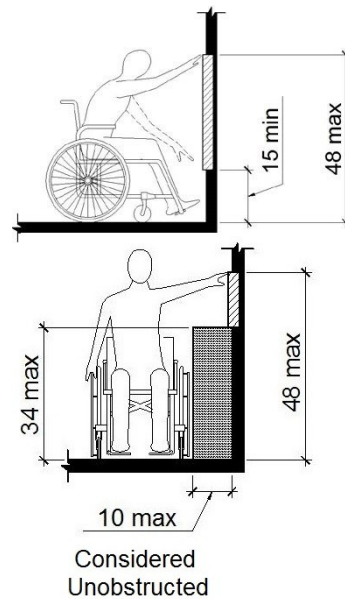
As Built: The fire extinguisher cabinet is not positioned correctly for either a side or front approach.

Where a clear floor or ground space allows a parallel or front approach and the side reach is unobstructed, the high side reach shall be 48 inches maximum above the finish floor or ground and the low side reach shall be 15 inches minimum above the finish floor or ground.

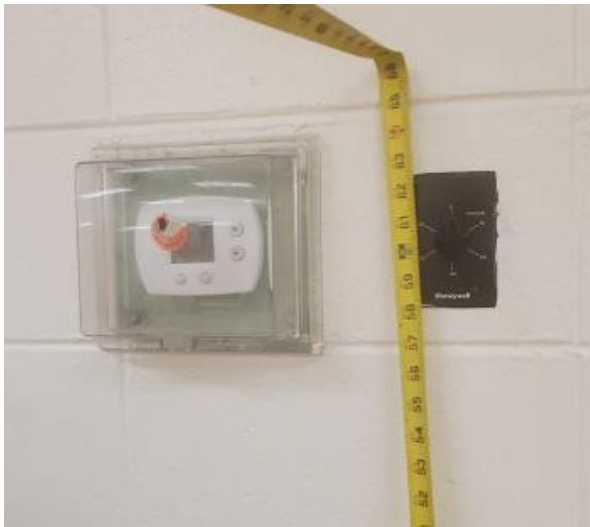
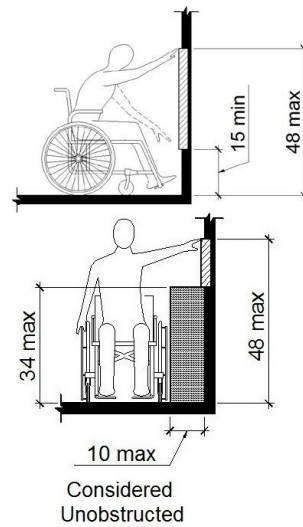
As Built: The thermostat is not positioned correctly for either a side or front approach.

Where a clear floor or ground space allows a parallel or front approach and the side reach is unobstructed, the high side reach shall be 48 inches maximum above the finish floor or ground and the low side reach shall be 15 inches minimum above the finish floor or ground.

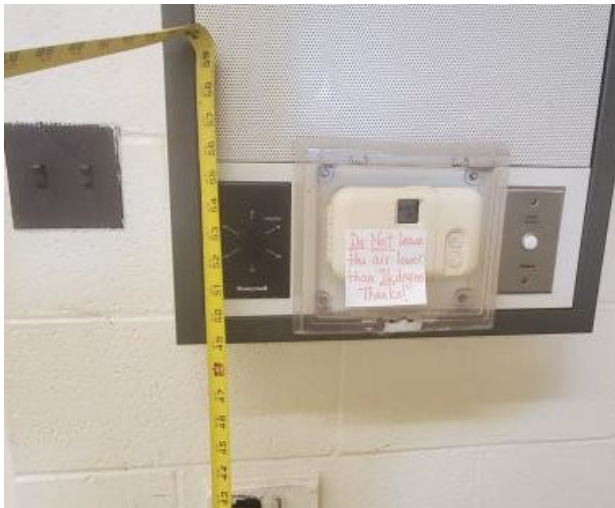
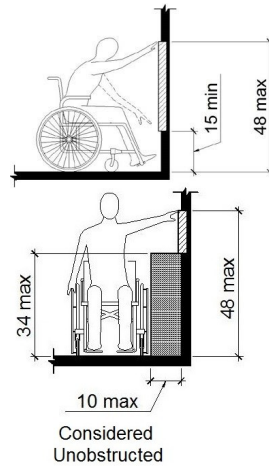
As Built: The thermostat is not positioned correctly for either a side or front approach.

Where a clear floor or ground space allows a parallel or front approach and the side reach is unobstructed, the high side reach shall be 48 inches maximum above the finish floor or ground and the low side reach shall be 15 inches minimum above the finish floor or ground.

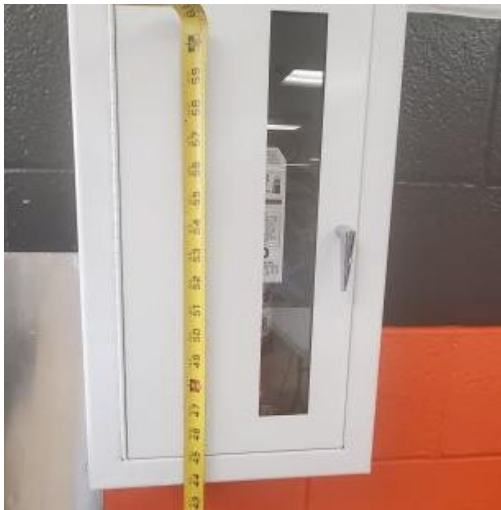
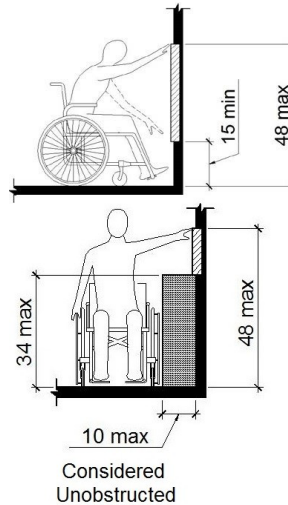
As Built: The fire extinguisher cabinet is not positioned correctly for either a side or front approach.

Where a clear floor or ground space allows a parallel or front approach and the side reach is unobstructed, the high side reach shall be 48 inches maximum above the finish floor or ground and the low side reach shall be 15 inches minimum above the finish floor or ground.

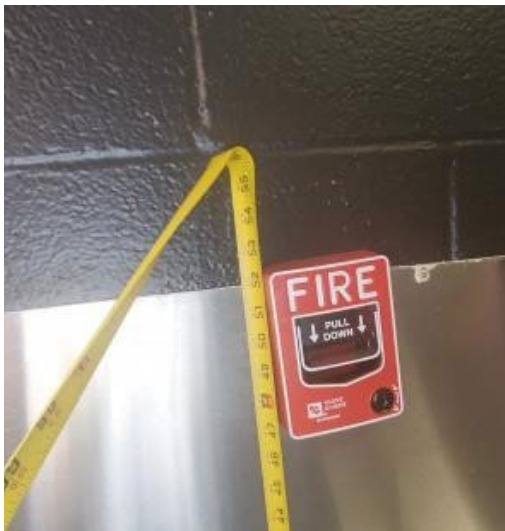
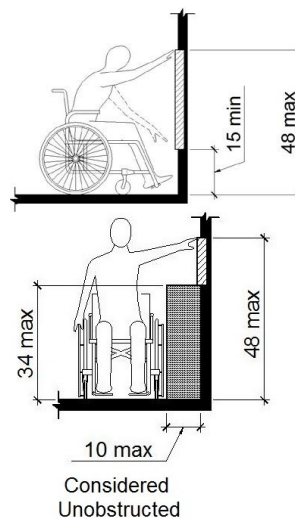
As Built: The fire alarm pull is not positioned correctly for either a side or front approach.

Where a clear floor or ground space allows a parallel or front approach and the side reach is unobstructed, the high side reach shall be 48 inches maximum above the finish floor or ground and the low side reach shall be 15 inches minimum above the finish floor or ground.

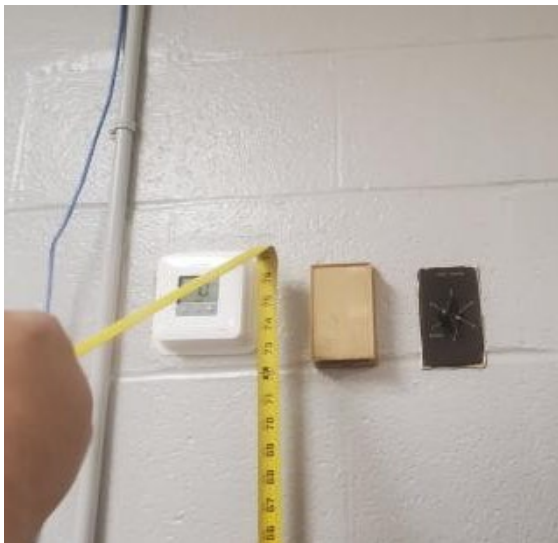
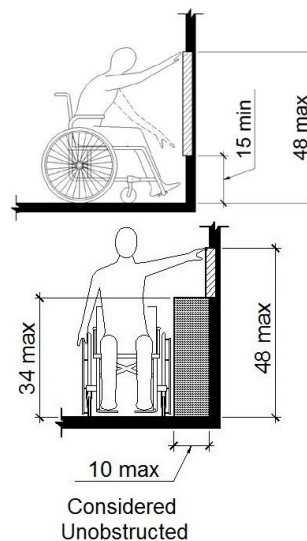
As Built: The thermostat is not positioned correctly for either a side or front approach.

Where a clear floor or ground space allows a parallel or front approach and the side reach is unobstructed, the high side reach shall be 48 inches maximum above the finish floor or ground and the low side reach shall be 15 inches minimum above the finish floor or ground.

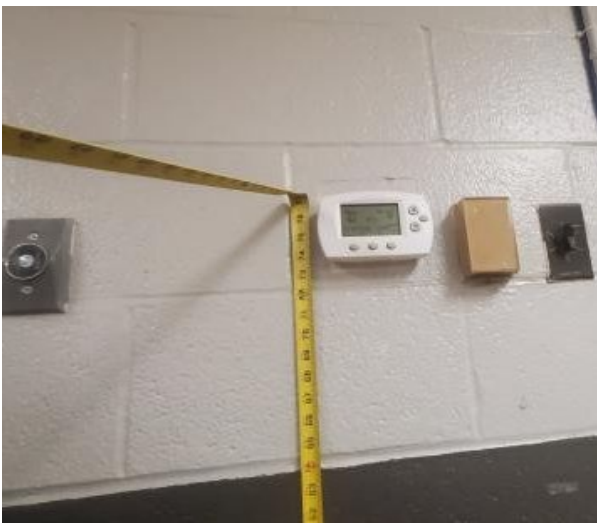
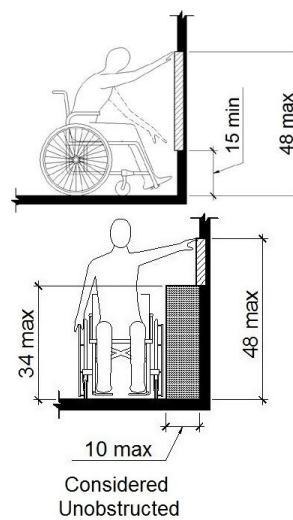
As Built: The thermostat is not positioned correctly for either a side or front approach.

Where a clear floor or ground space allows a parallel or front approach and the side reach is unobstructed, the high side reach shall be 48 inches maximum above the finish floor or ground and the low side reach shall be 15 inches minimum above the finish floor or ground.

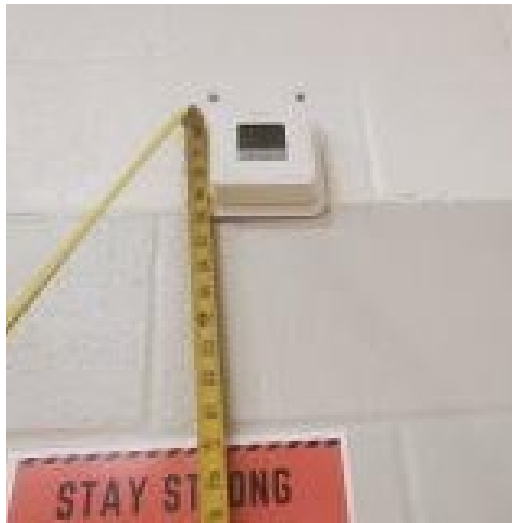
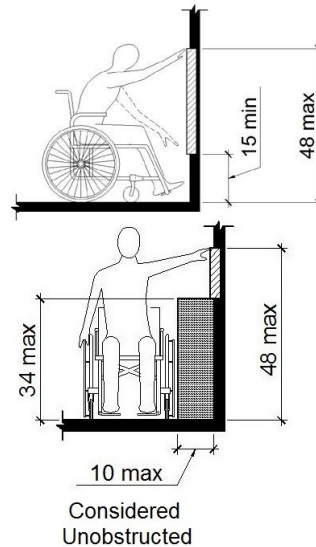
As Built: The thermostats (Qty - 4) in gym are positioned too high for either a side or front approach.

Where a clear floor or ground space allows a parallel approach to an element and the side reach is unobstructed, the high side reach shall be 48 inches maximum and the low side reach shall be 15 inches minimum above the finish floor or ground.

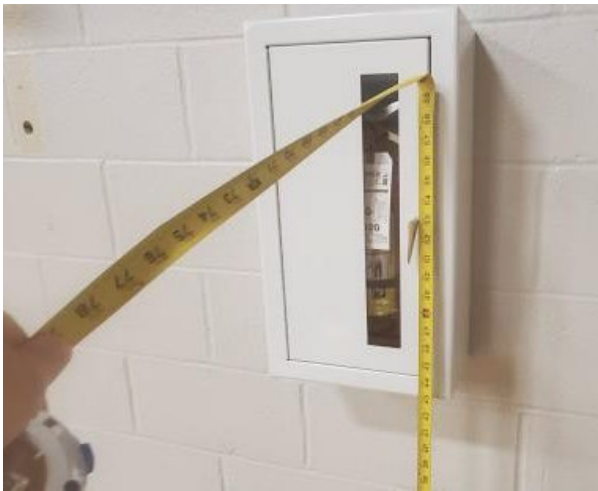
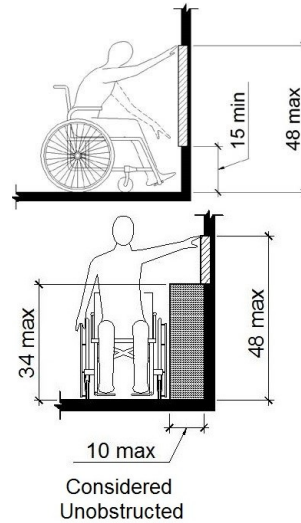
As Built: The fire extinguisher is not positioned correctly for either a side or front approach.

Where a clear floor or ground space allows a parallel or front approach and the side reach is unobstructed, the high side reach shall be 48 inches maximum above the finish floor or ground and the low side reach shall be 15 inches minimum above the finish floor or ground.

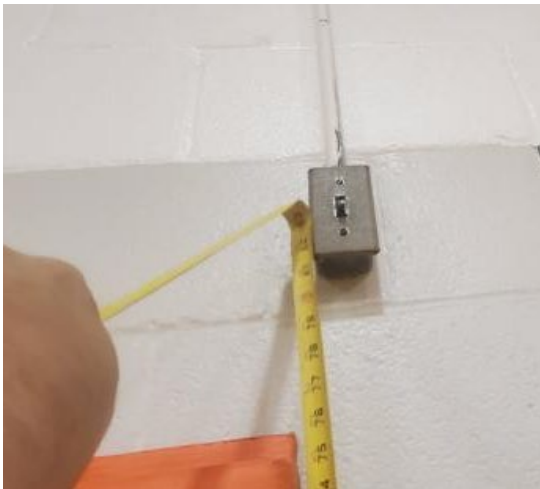
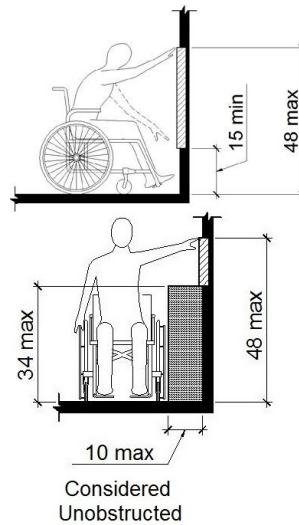
As Built: The receptacle/switch is not positioned correctly for either a side or front approach.

Where a clear floor or ground space allows a parallel or front approach to a switch or receptacle and the side reach is unobstructed, the high side reach shall be 48 inches maximum above the finish floor or ground and the low side reach shall be 15 inches minimum above the finish floor or ground.

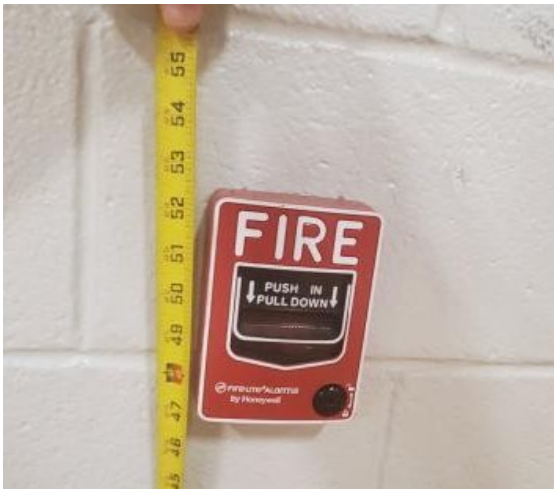
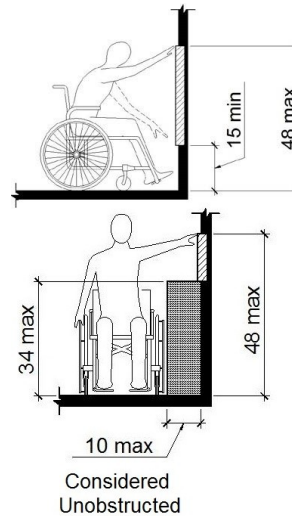
As Built: The fire pull is not positioned correctly for either a side or front approach.

Where a clear floor or ground space allows a parallel or front approach and the side reach is unobstructed, the high side reach shall be 48 inches maximum above the finish floor or ground and the low side reach shall be 15 inches minimum above the finish floor or ground.

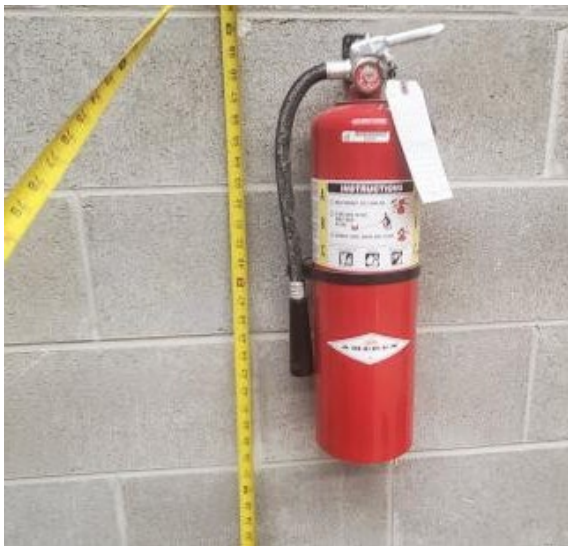
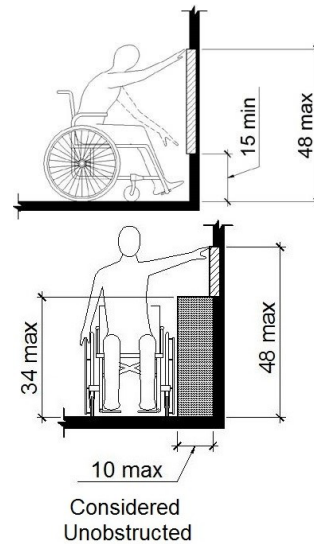
As Built: The fire extinguisher is not positioned correctly for either a side or front approach.

Where a clear floor or ground space allows a parallel or front approach and the side reach is unobstructed, the high side reach shall be 48 inches maximum above the finish floor or ground and the low side reach shall be 15 inches minimum above the finish floor or ground.

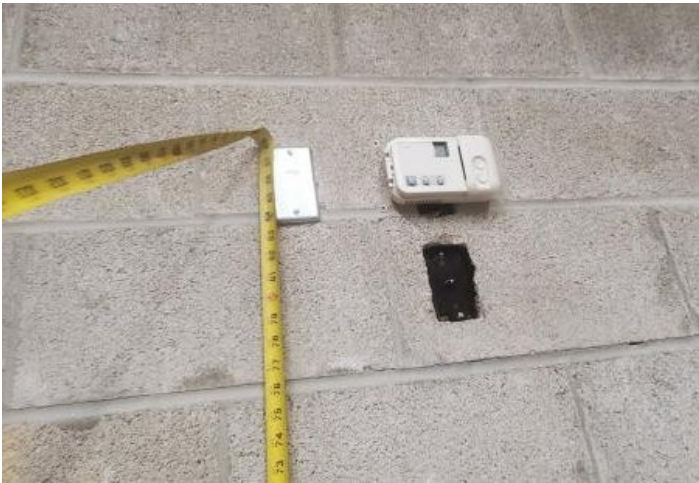
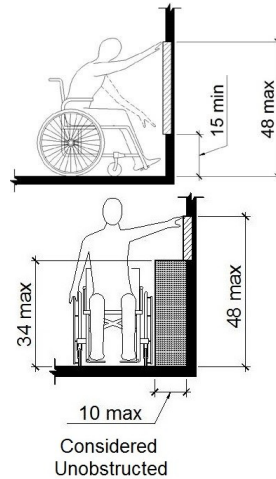
As Built: The thermostat is not positioned correctly for either a side or front approach.

Where a clear floor or ground space allows a parallel or front approach and the side reach is unobstructed, the high side reach shall be 48 inches maximum above the finish floor or ground and the low side reach shall be 15 inches minimum above the finish floor or ground.

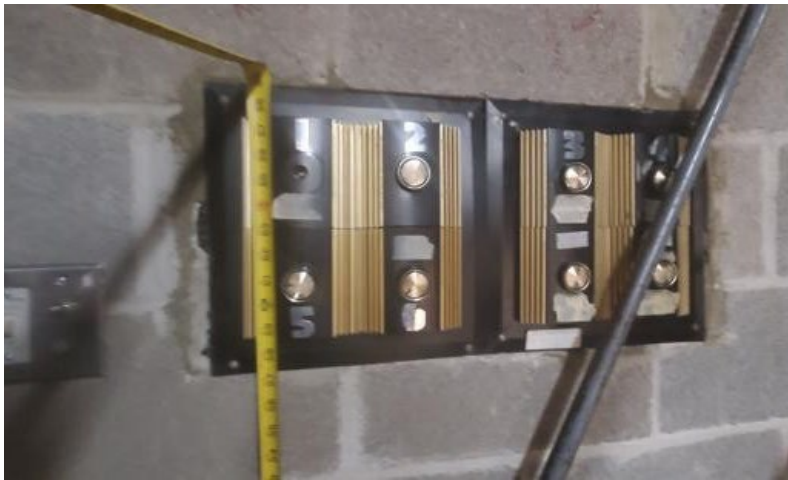
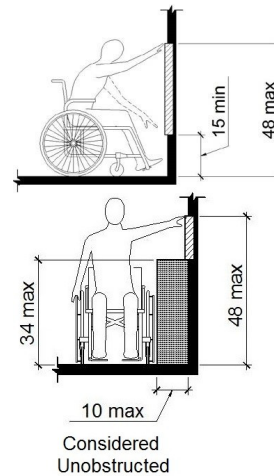
As Built: The stage dimmer switches is not positioned correctly for either a side or front approach.

Where a clear floor or ground space allows a parallel or front approach and the side reach is unobstructed, the high side reach shall be 48 inches maximum above the finish floor or ground and the low side reach shall be 15 inches minimum above the finish floor or ground.

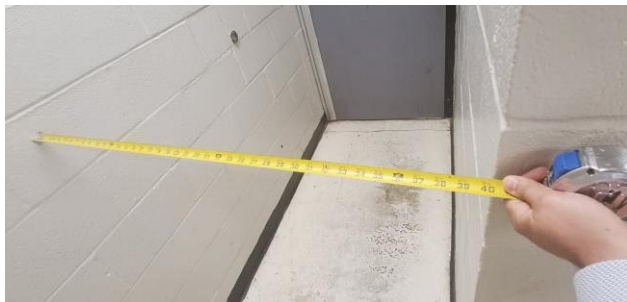
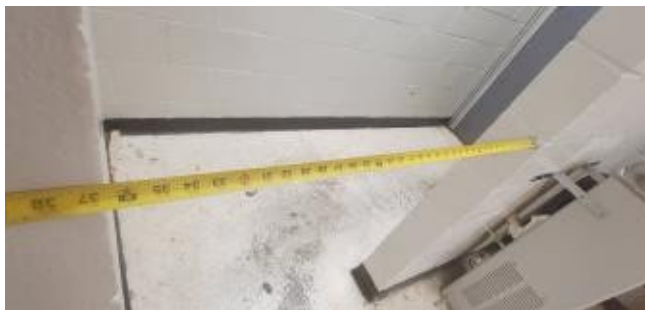
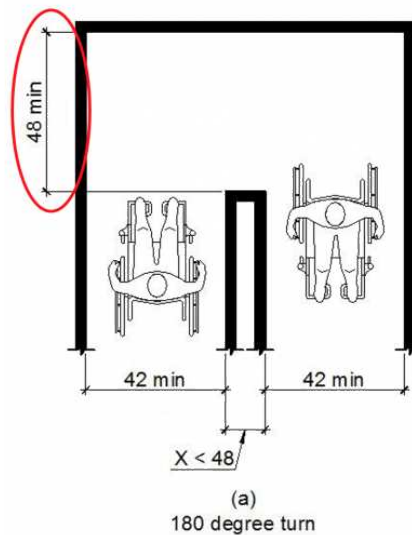
As Built: The queuing line is not a minimum 48 inches at the head of each turn with entry widths of 42 inches minimum.

Where the accessible route makes a 180 degree turn around an element which is less than 48 inches wide, clear width shall be 42 inches minimum approaching the turn, 48 inches minimum at the turn and 42 inches minimum leaving the turn. Where the clear width at the turn is 60 inches minimum a clear width 36 inches minimum approaching the turn and 36 inches minimum at the turn is acceptable.

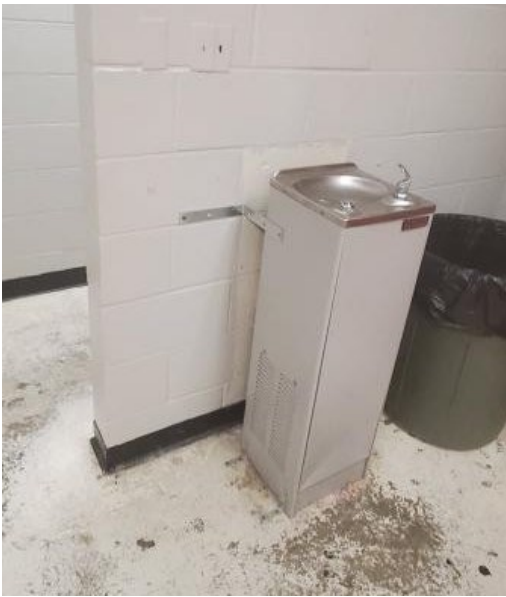
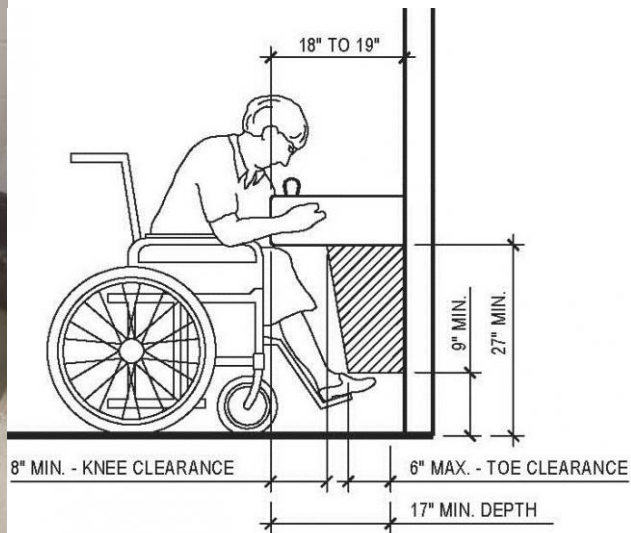
As Built: There is not enough knee clearance under the drinking fountain.

The drinking fountain must have a clear knee space between the bottom of the drinking fountain and the floor not less than 27 inches in height, 30 inches in width, and 8 inches in depth.

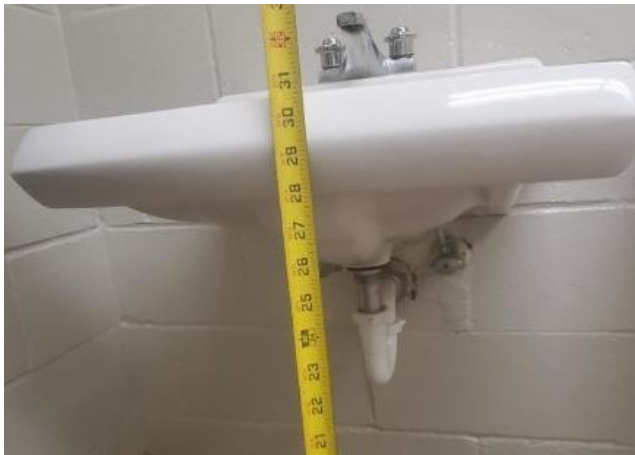
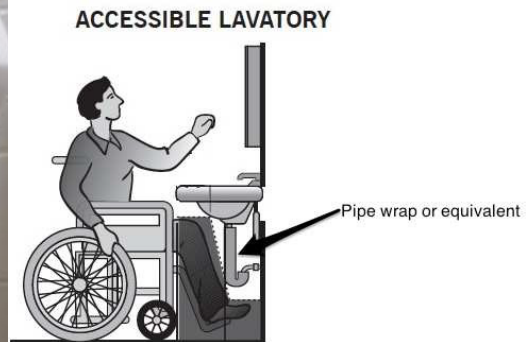
As Built: The water and drainpipes under the lavatory are not adequately insulated.

The water supply and drainpipes under lavatories and sinks shall be insulated or otherwise configured to protect against contact. There shall be no sharp or abrasive surfaces under lavatories and sinks.

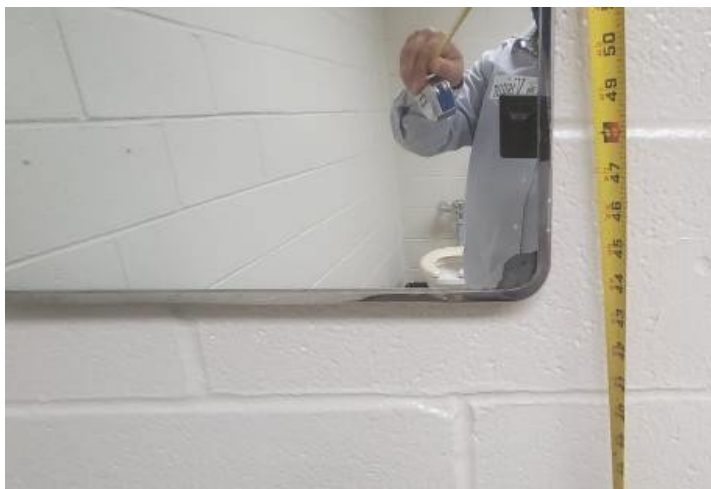
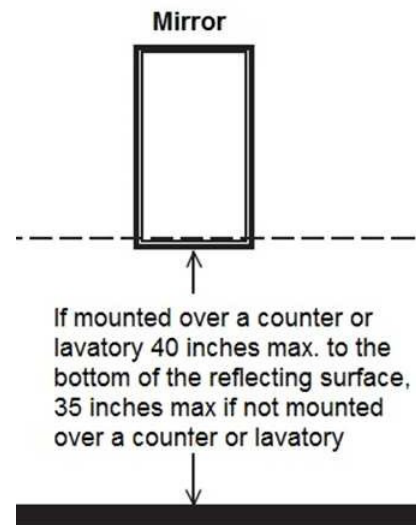
As Built: The mirror is mounted too high.

Mirrors must have the bottom edge of the reflecting surface a maximum of 40 inches above the floor if above a sink or counter. Mirrors not located above lavatories or countertops shall be installed with the bottom edge of the reflecting surface 35 inches maximum above the finish floor or ground.

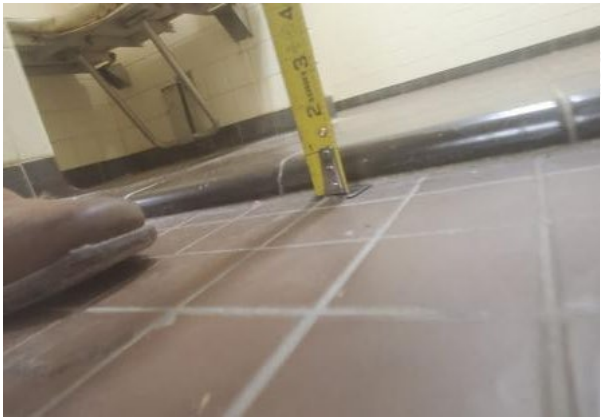
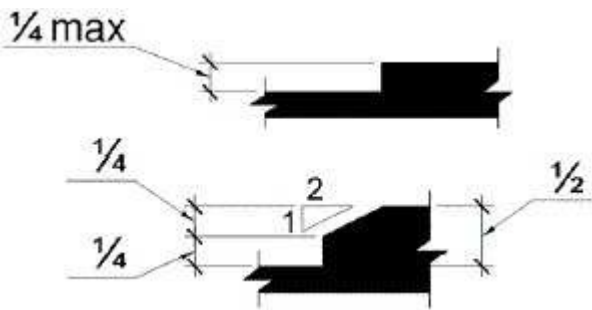
As Built: There is a change in level greater than 1/4 inch.

1/4 inch is the maximum vertical rise. Changes in level between 1/4 inch and 1/2 inch must be beveled at 1:2 or less. Changes in level greater than 1/2 inch must be by way of a ramp.

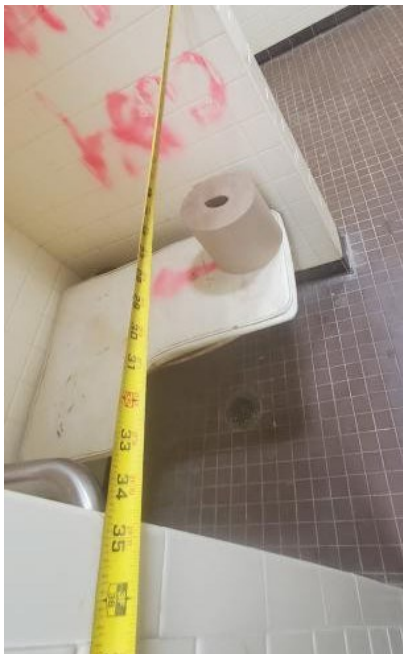
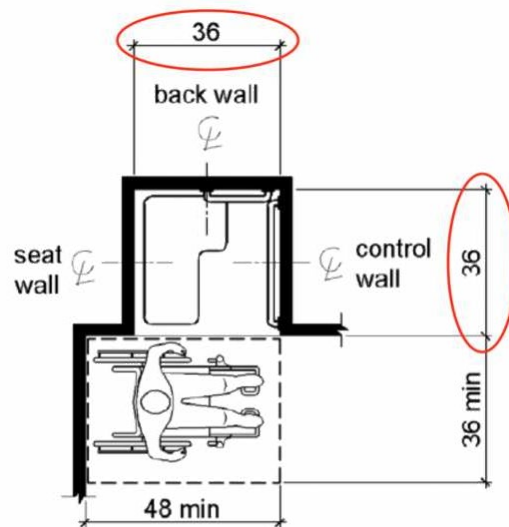
As Built: The transfer shower compartment is not the minimum required size.

See Finding #24 for recommendation.

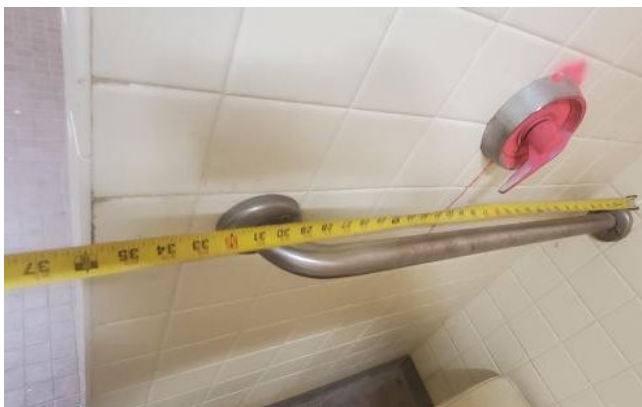
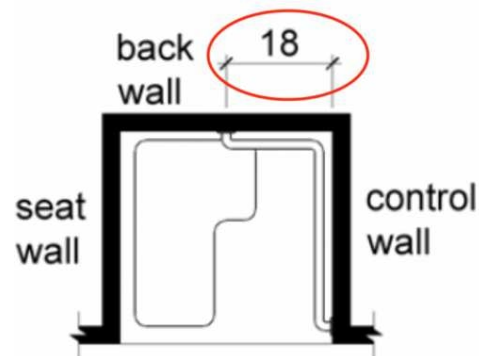
As Built: The grab bar on the back wall is not 18 inches from the control wall.

In transfer type compartments, grab bars shall be provided across the control wall and back wall to a point 18 inches from the control wall.

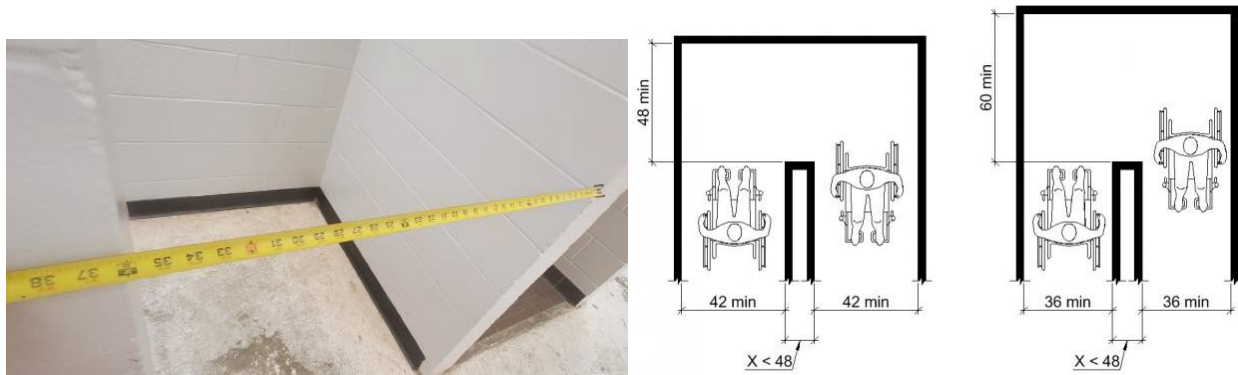
As Built: The route of travel does not meet minimum width requirements around the turn.

Where the accessible route makes a 180 degree turn around an element which is less than 48 inches wide, clear width shall be 42 inches minimum approaching the turn, 48 inches minimum at the turn and 42 inches minimum leaving the turn. Where the clear width at the turn is 60 inches minimum a clear width 36 inches minimum approaching the turn and 36 inches minimum at the turn is acceptable.

Citation: 2010 ADAS Section 403.5.2

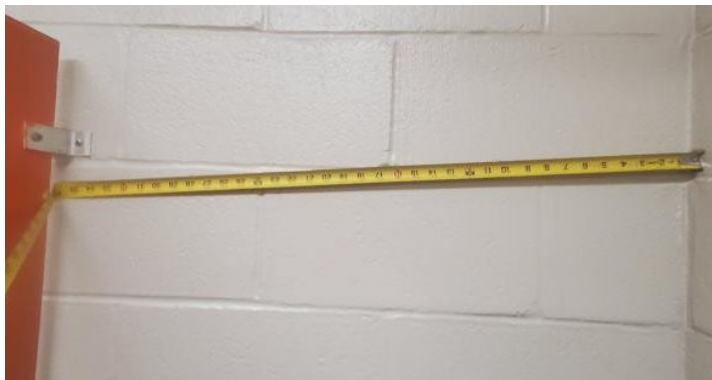
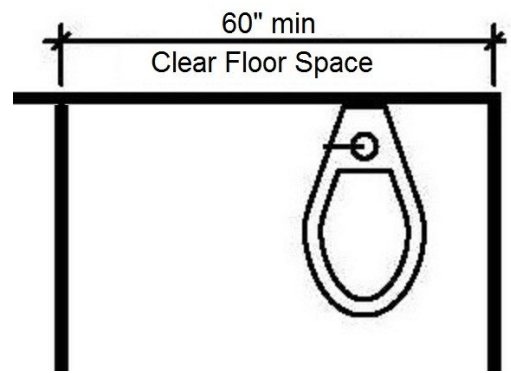
As Built: The toilet compartment is not wide enough.

Wheelchair accessible compartments shall be 60 inches wide minimum measured perpendicular to the side wall, and 56 inches deep minimum for wall hung water closets and 59 inches deep minimum for floor mounted water closets measured perpendicular to the rear wall.

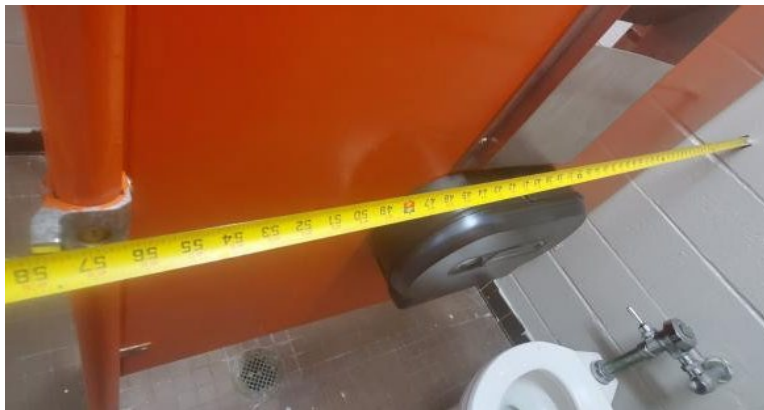
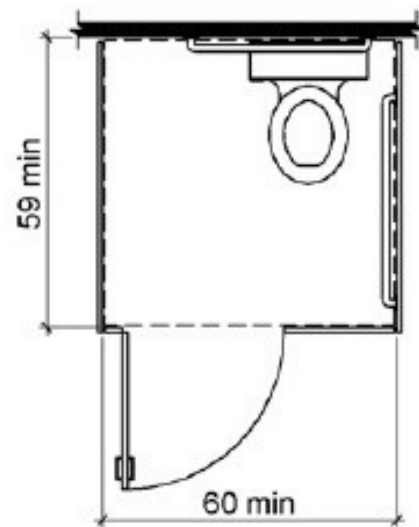
As Built: The toilet stall is not deep enough.

Wheelchair accessible compartments shall be 59 inches deep minimum measured from the back wall for floor mount water closets.
