WEAKLEY COUNTY, TENNESSEE

ADA EVALUATION

Architectural and Site Findings with Recommendations

TLM Associates, Inc

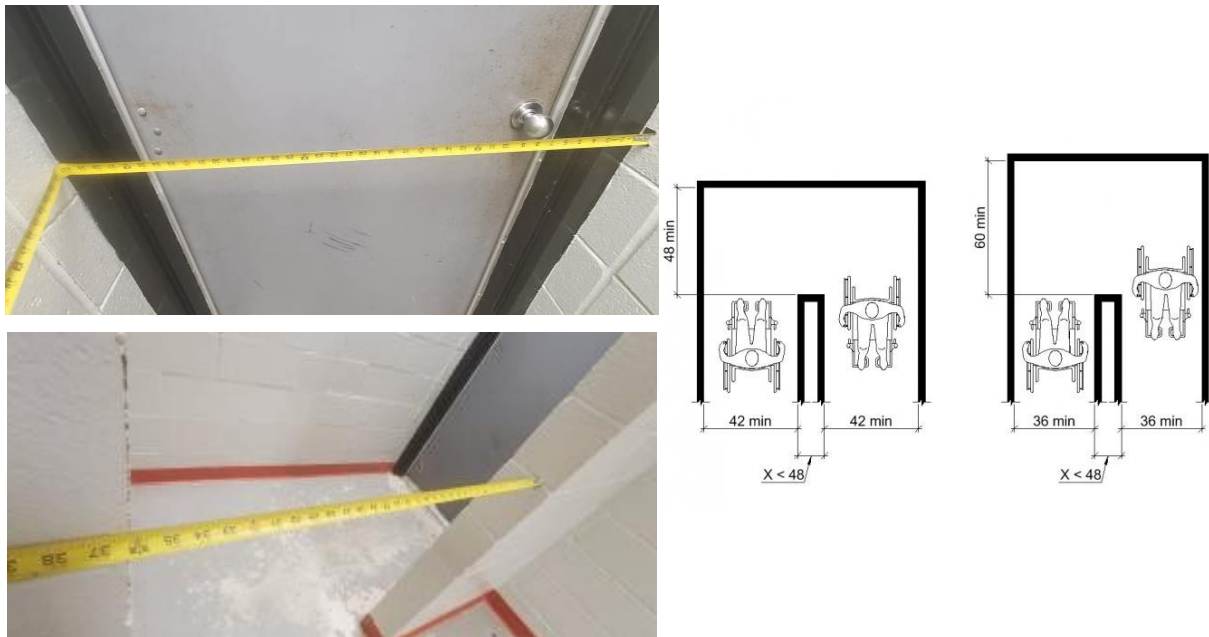
As Built: The route of travel does not meet minimum width requirements around the turn.

Where the accessible route makes a 180 degree turn around an element which is less than 48 inches wide, clear width shall be 42 inches minimum approaching the turn, 48 inches minimum at the turn and 42 inches minimum leaving the turn. Where the clear width at the turn is 60 inches minimum a clear width 36 inches minimum approaching the turn and 36 inches minimum at the turn is acceptable.

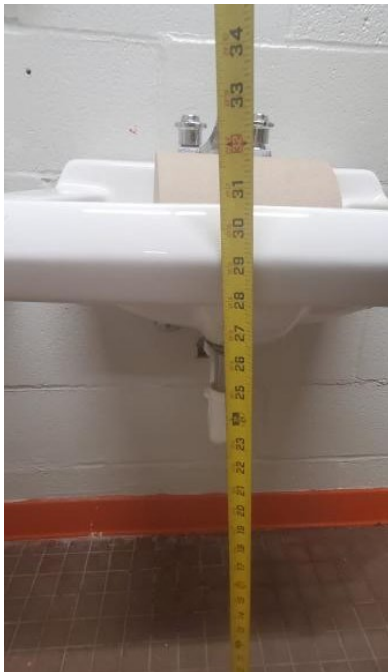
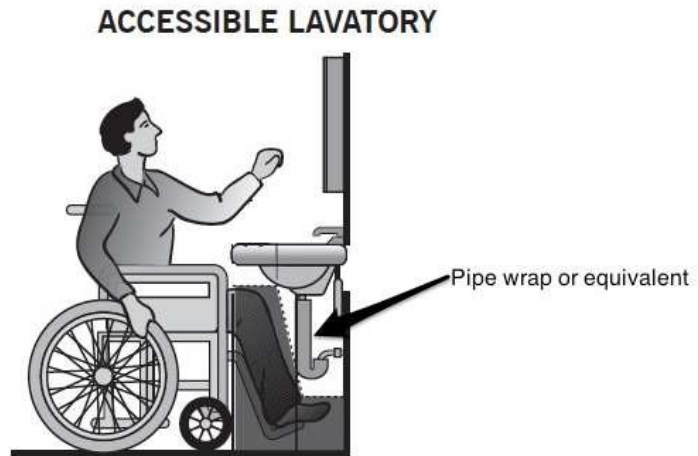
As Built: The water and drain pipes under the lavatory are not adequately insulated.

Water supply and drain pipes under lavatories and sinks shall be insulated or otherwise configured to protect against contact. There shall be no sharp or abrasive surfaces under lavatories and sinks..

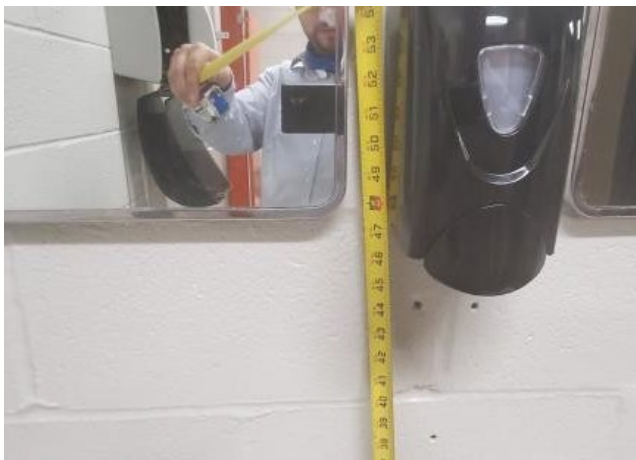
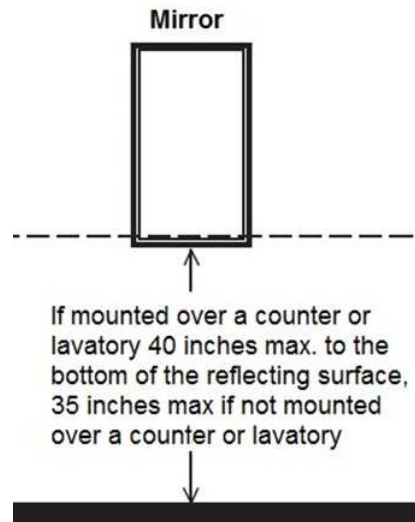
As Built: The mirror is mounted too high.

Mirrors must have the bottom edge of the reflecting surface a maximum of 40 inches above the floor if above a sink or counter. Mirrors not located above lavatories or countertops shall be installed with the bottom edge of the reflecting surface 35 inches maximum above the finish floor or ground.

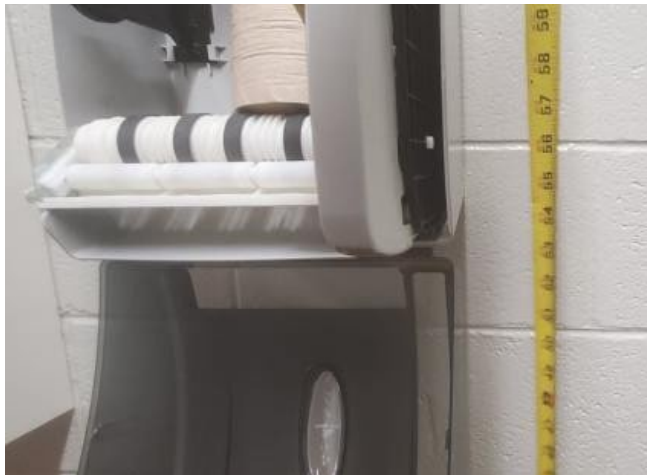
As Built: The paper towel dispenser's operation mechanism is too high off the floor. Dispensers must have all operable parts a maximum of 48 inches above the floor.

Citation: 2010 ADAS Section 308.2.1

Recommendation: Lower paper towel dispenser for all operable components to be 48" max AFF.

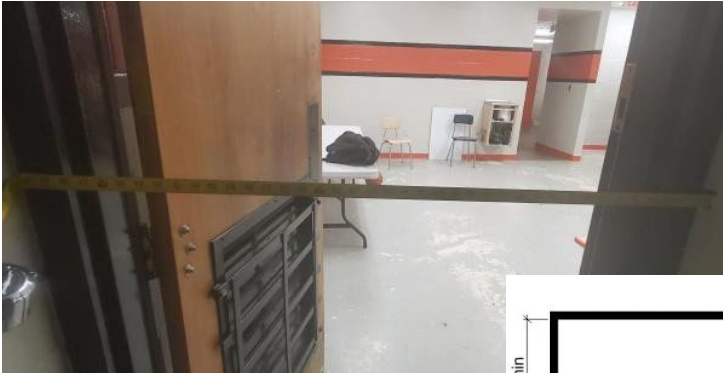
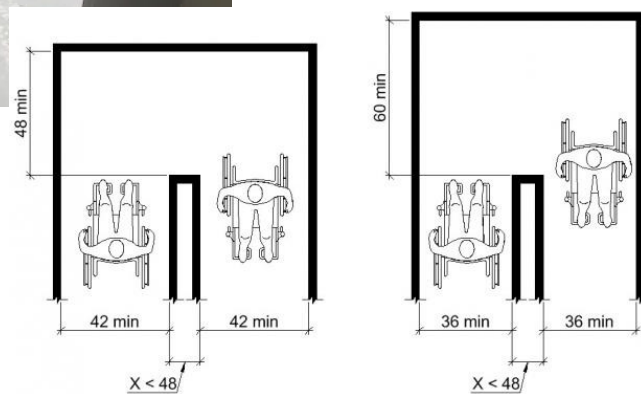
As Built: The route of travel does not meet minimum width requirements around the turn.

Where the accessible route makes a 180 degree turn around an element which is less than 48 inches wide, clear width shall be 42 inches minimum approaching the turn, 48 inches minimum at the turn and 42 inches minimum leaving the turn. Where the clear width at the turn is 60 inches minimum a clear width 36 inches minimum approaching the turn and 36 inches minimum at the turn is acceptable.

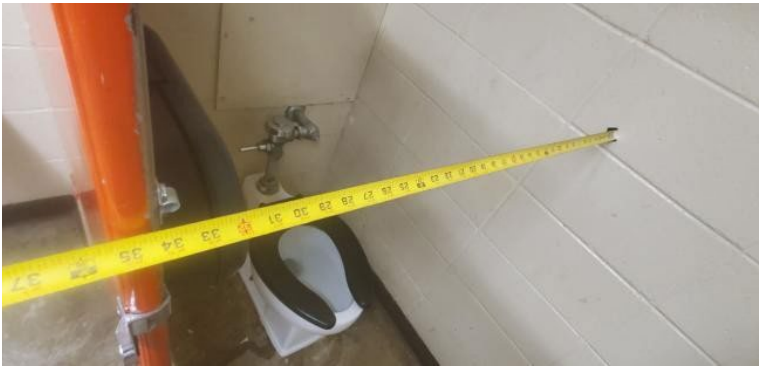
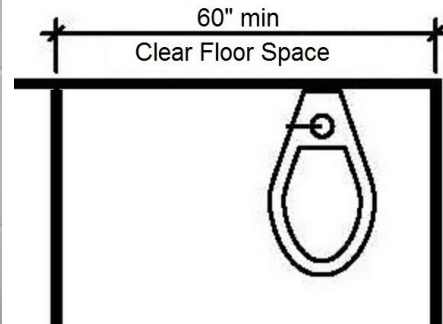
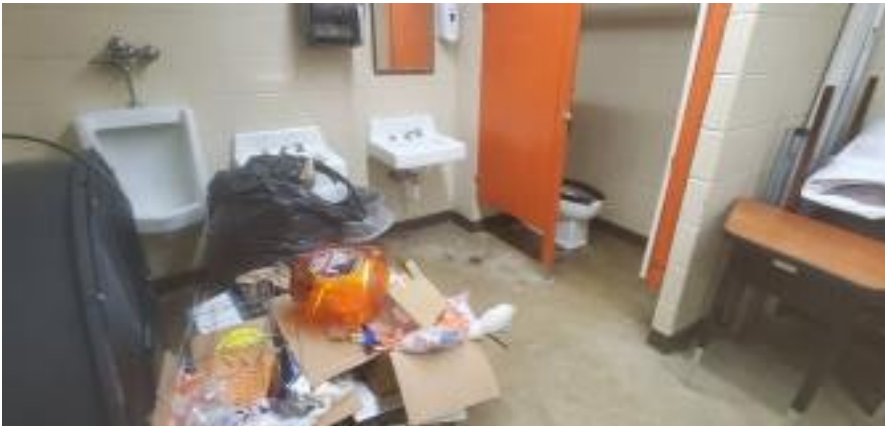
As Built: The toilet compartment is not wide enough.

Wheelchair accessible compartments shall be 60 inches wide minimum measured perpendicular to the side wall, and 56 inches deep minimum for wall hung water closets and 59 inches deep minimum for floor mounted water closets measured perpendicular to the rear wall.

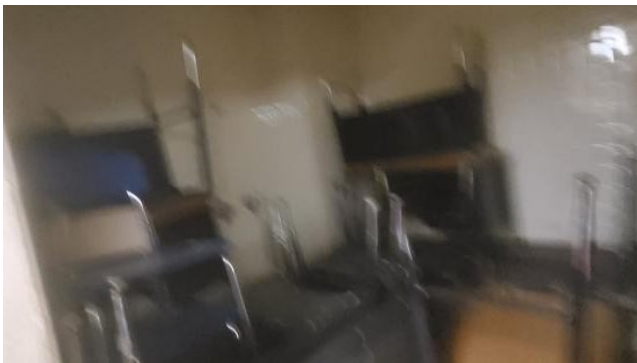
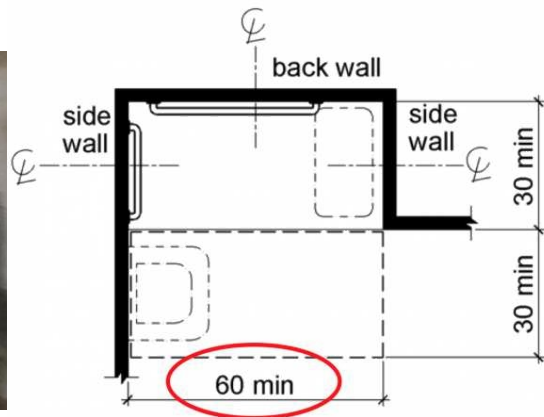
As Built: The shower stall is not 60 inches minimum.

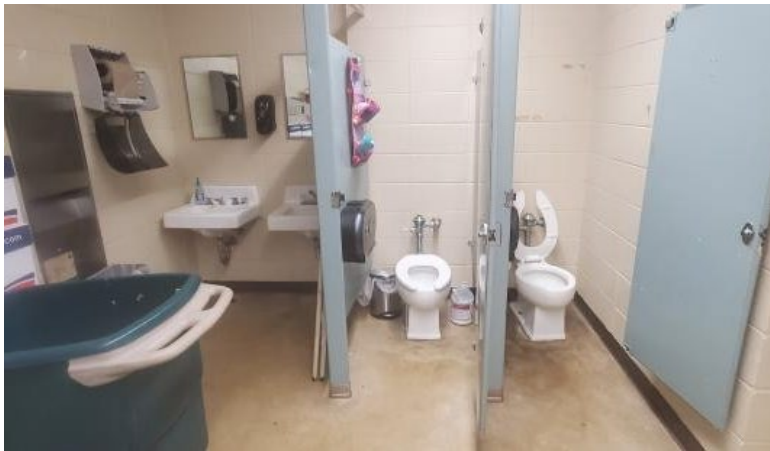
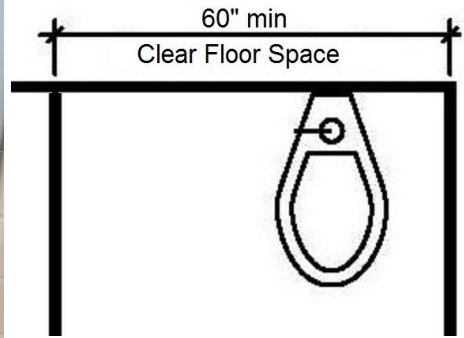
As Built: The toilet compartment is not wide enough.

Wheelchair accessible compartments shall be 60 inches wide minimum measured perpendicular to the side wall, and 56 inches deep minimum for wall hung water closets and 59 inches deep minimum for floor mounted water closets measured perpendicular to the rear wall.

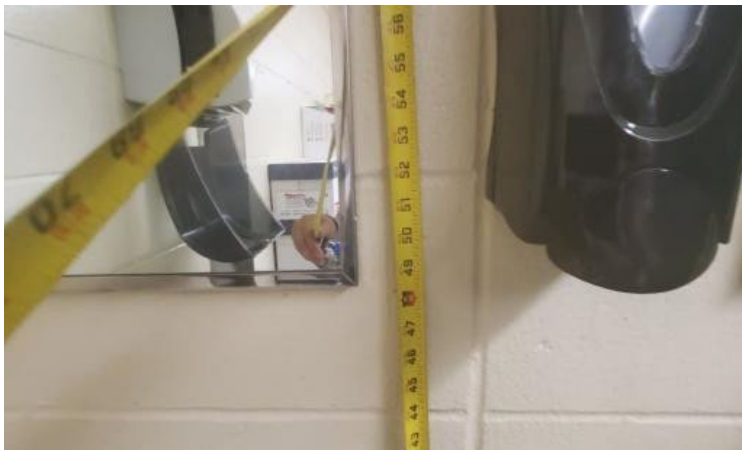
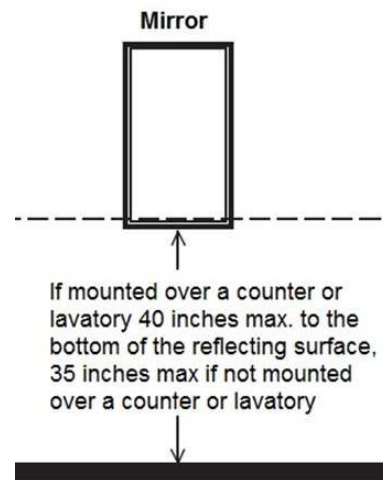
As Built: The mirror is mounted too high.

Mirrors must have the bottom edge of the reflecting surface a maximum of 40 inches above the floor if above a sink or counter. Mirrors not located above lavatories or countertops shall be installed with the bottom edge of the reflecting surface 35 inches maximum above the finish floor or ground.

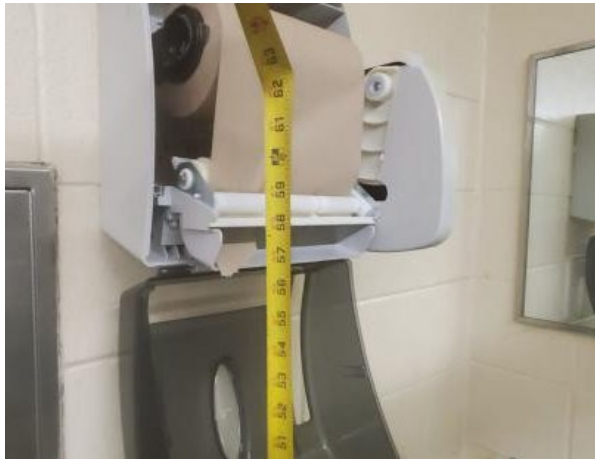
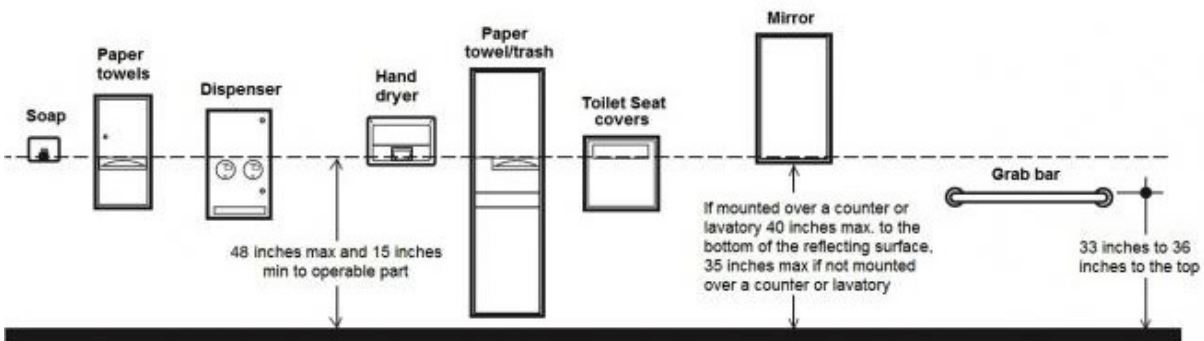
As Built: The paper towel dispenser's operation mechanism is too high off the floor. Dispensers must have all operable parts a maximum of 48 inches above the floor.

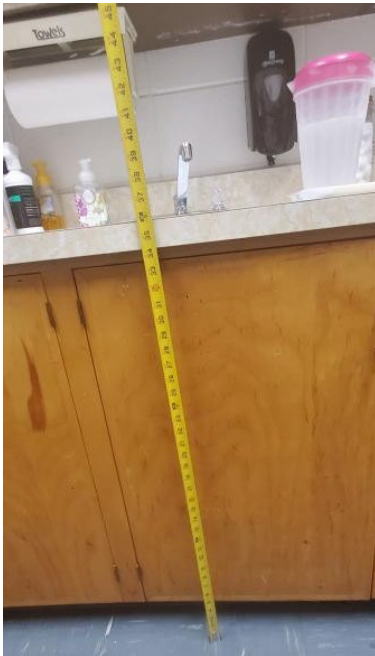
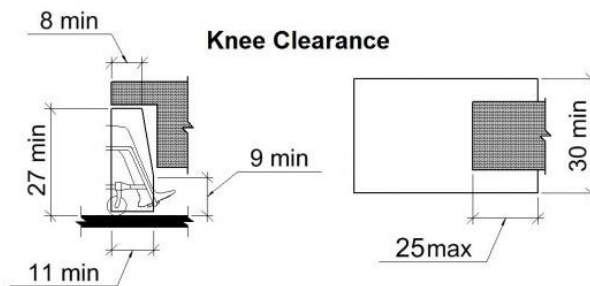
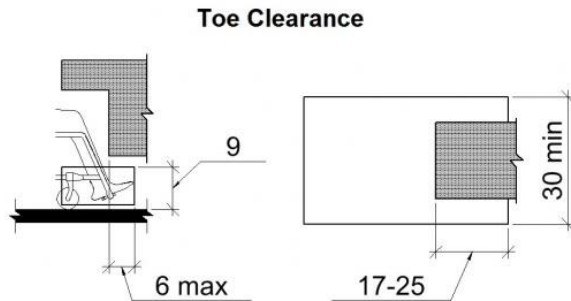
As Built: The top of the sink is too high.

Sinks that are required to be accessible shall be a minimum 17 inches in horizontal depth and mounted with the rim or counter edge no higher than 34 inches above the finished floor.

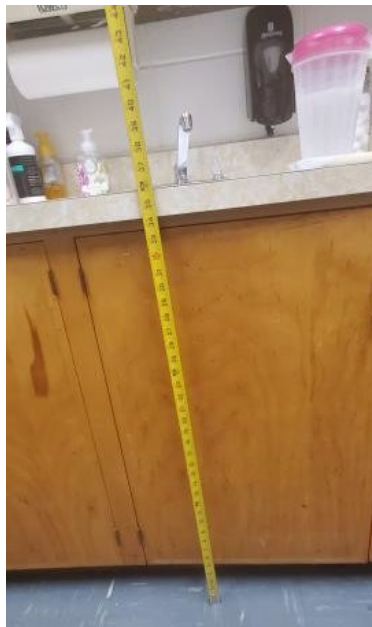
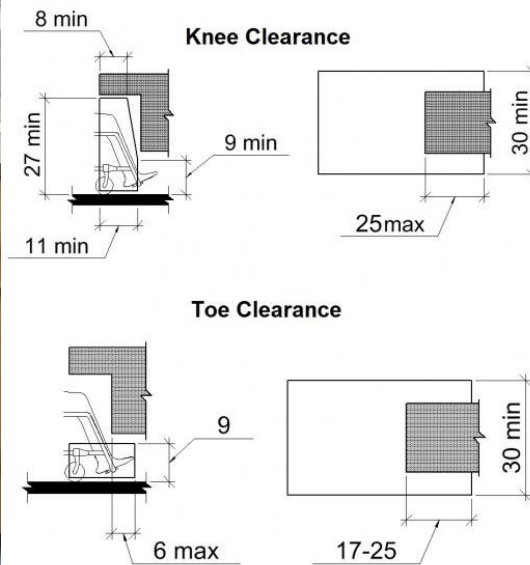
As Built: Knee and toe clearance has not been provided at the sink.

The knee clearance shall be 11 inches deep minimum at 9 inches above the finish floor or ground, and 8 inches deep minimum at 27 inches above the finish floor or ground.

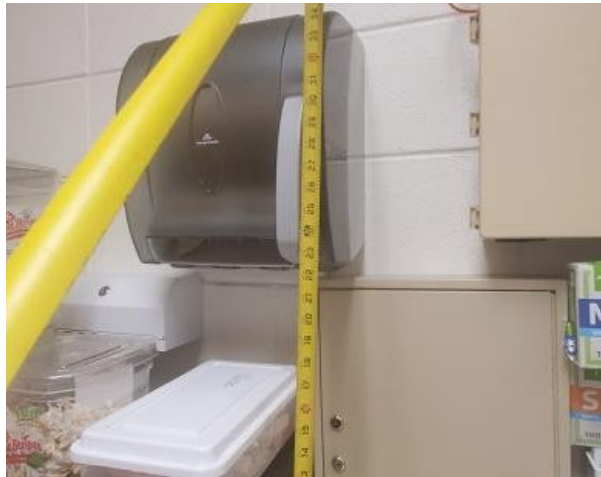
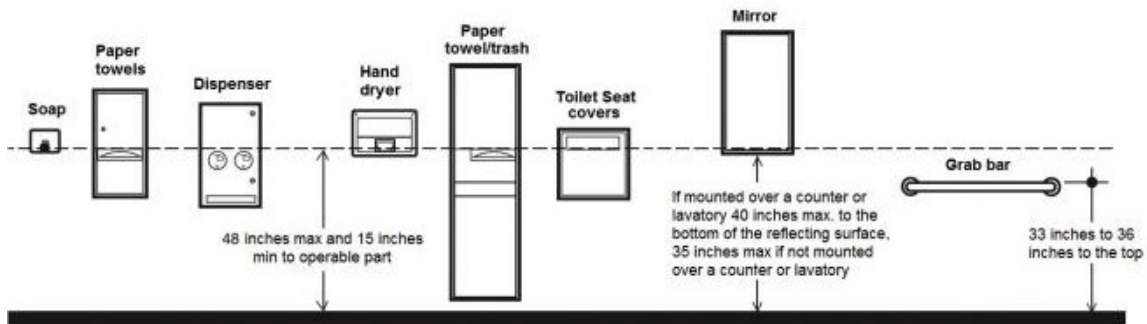
As Built: The paper towel dispenser's operation mechanism is too high off the floor. Dispensers must have all operable parts a maximum of 48 inches above the floor.

Citation: 2010 ADAS Section 606.2

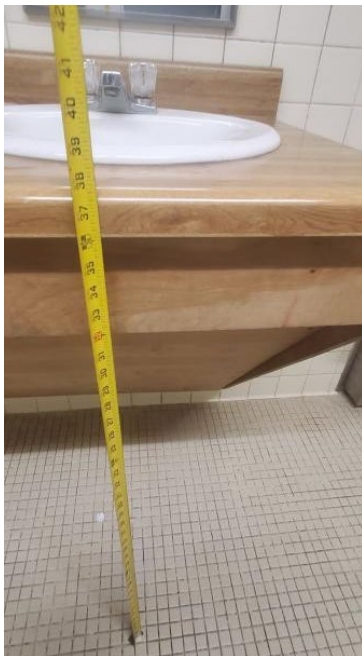
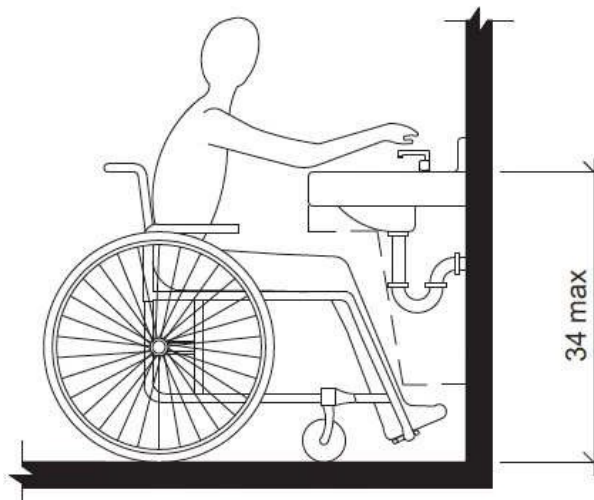
As Built: The top rim of the lavatory is too high.

All lavatories that are designated to be accessible shall be a minimum 17 inches in horizontal depth and mounted with the rim or counter edge no higher than 34 inches above the finished floor.

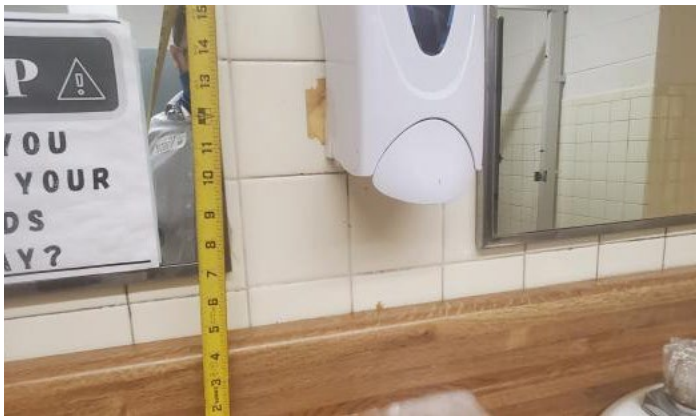
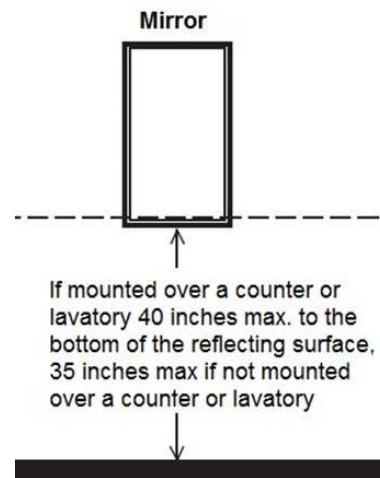
As Built: The mirror is mounted too high.

Mirrors must have the bottom edge of the reflecting surface a maximum of 40 inches above the floor if above a sink or counter. Mirrors not located above lavatories or countertops shall be installed with the bottom edge of the reflecting surface 35 inches maximum above the finish floor or ground.

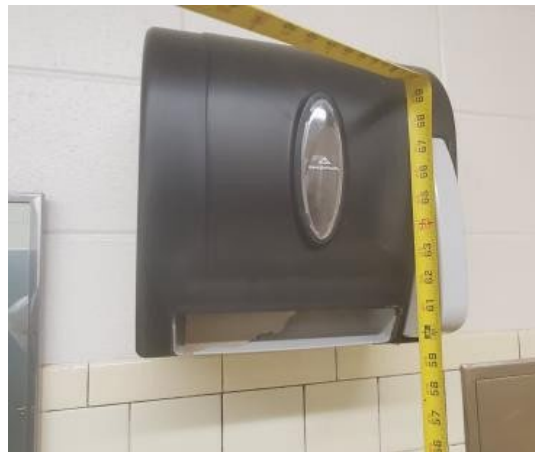
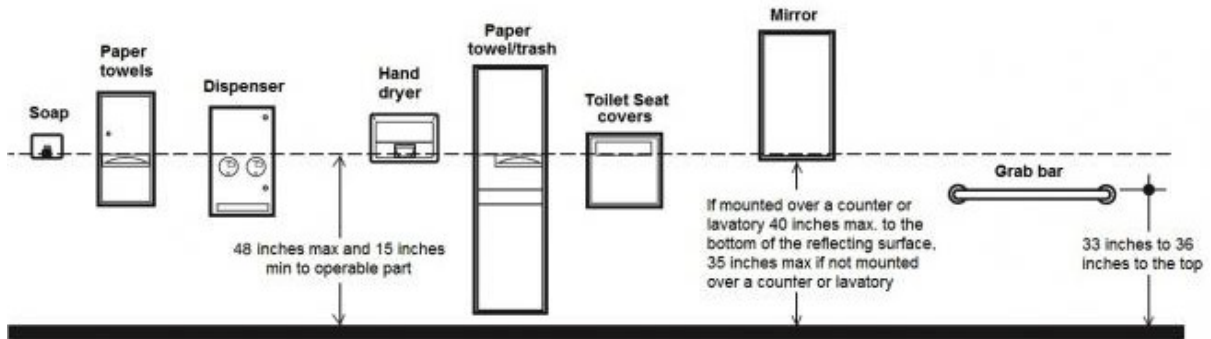
As Built: The paper towel dispenser's operation mechanism is too high off the floor. Dispensers must have all operable parts a maximum of 48 inches above the floor.

Citation: 2010 ADAS Section 308.2.1

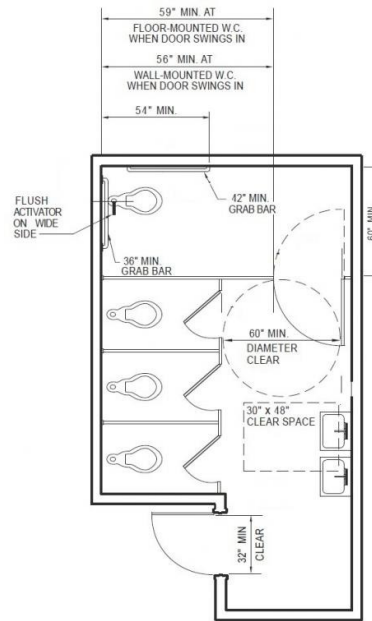
As Built: The toilet compartment does not have the required minimum clear floor space or maneuvering clearances for the toilet. The toilet compartment does not meet required minimum width and depth dimensions. Grab bars are missing. Toilet flush handle is on wrong side.

Citation: 2010 ADAS Section 213.2

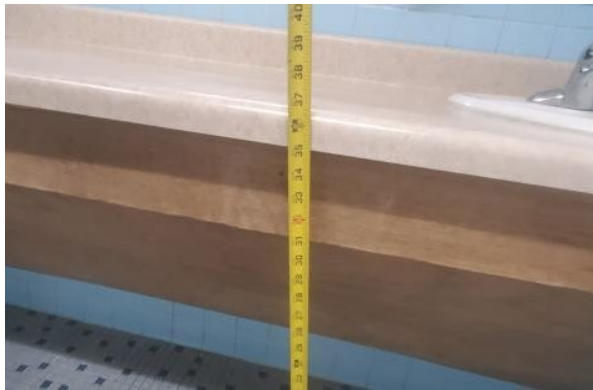
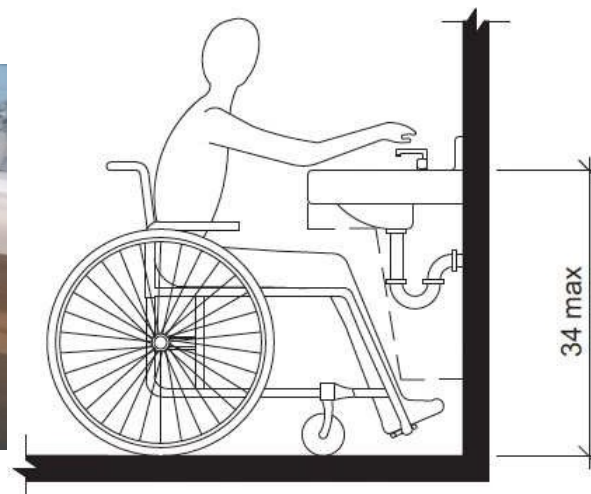
As Built: The top rim of the lavatory is too high.

All lavatories that are designated to be accessible shall be a minimum 17 inches in horizontal depth and mounted with the rim or counter edge no higher than 34 inches above the finished floor.

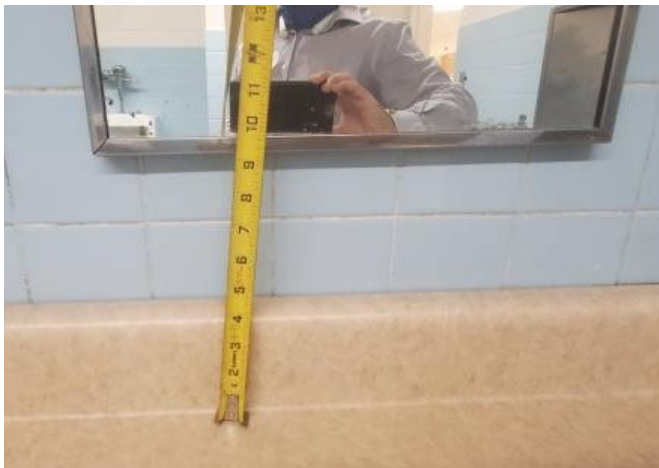
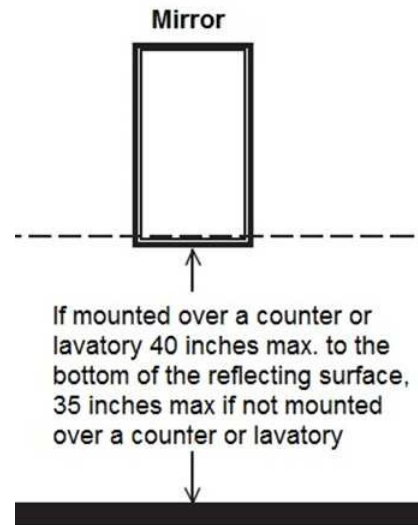
As Built: The mirror is mounted too high.

Mirrors must have the bottom edge of the reflecting surface a maximum of 40 inches above the floor if above a sink or counter. Mirrors not located above lavatories or countertops shall be installed with the bottom edge of the reflecting surface 35 inches maximum above the finish floor or ground.

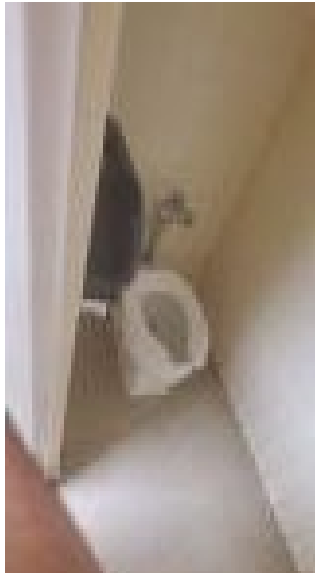
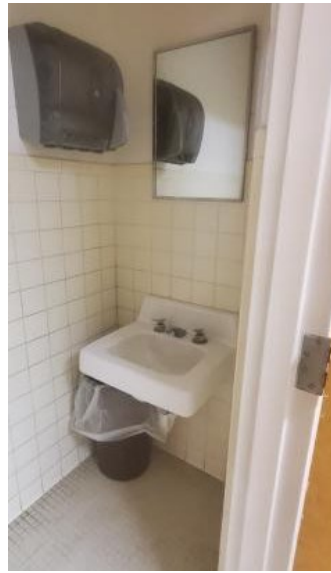
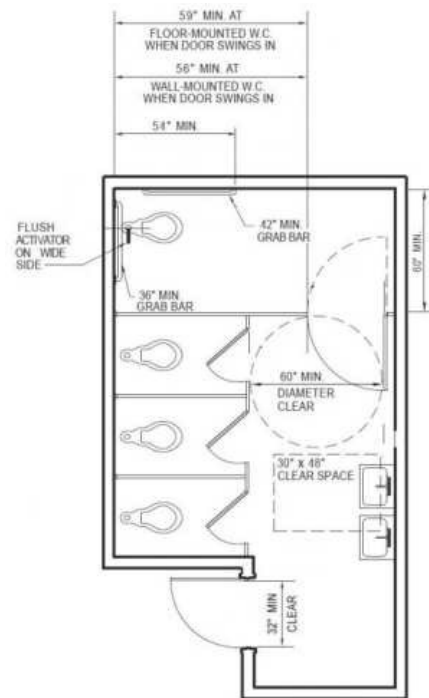
As Built: The restrooms is not nearly compliant.

The restroom does not have the required minimum clear floor space or maneuvering clearances for the toilet. The restroom does not have the required minimum clear floor space or maneuvering clearances for the lavatory. No Grab bars installed. Lavatory clearance not provided. Mirror is too high. Paper towel dispenser is too high.

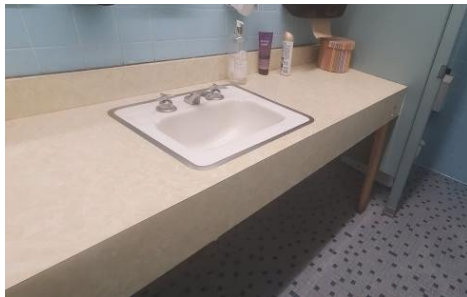
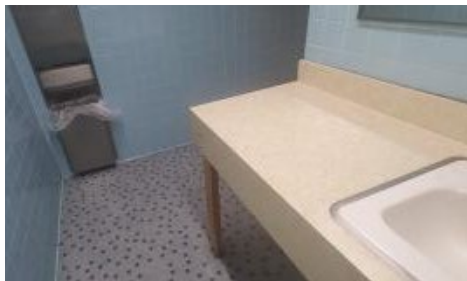
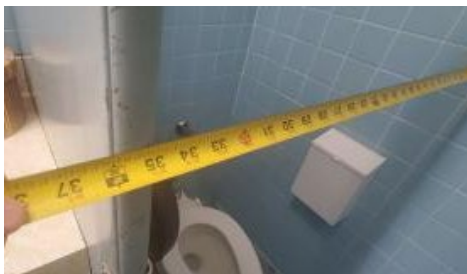
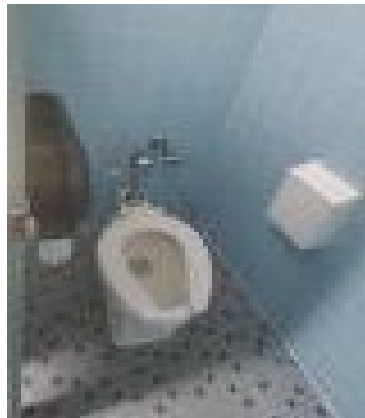
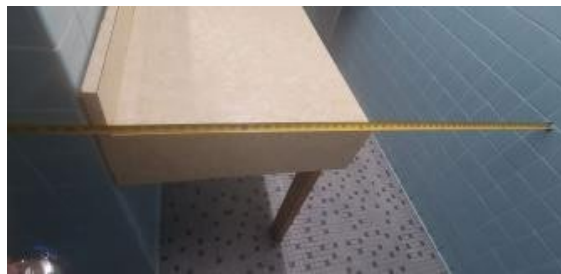
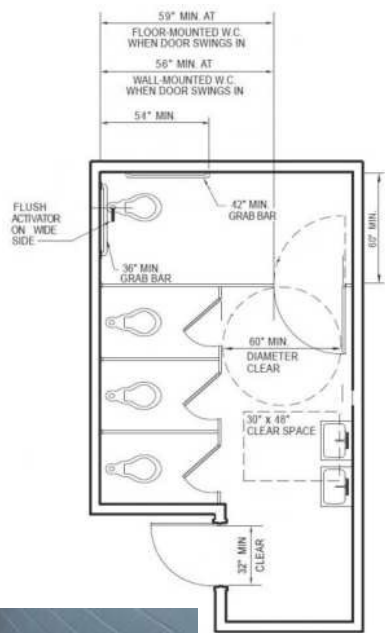
As Built: The restroom is not compliant.

The restroom does not have the required minimum clear floor space or maneuvering clearances for the toilet. The restroom does not have the required minimum clear floor space or maneuvering clearances for the lavatory. No Grab bars installed. Accessories, such as paper towel holders, soap dispenser and mirror are either too high or without clear floor space or both.

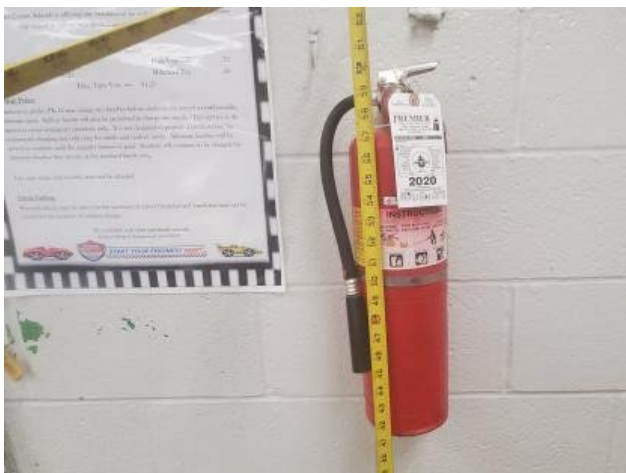
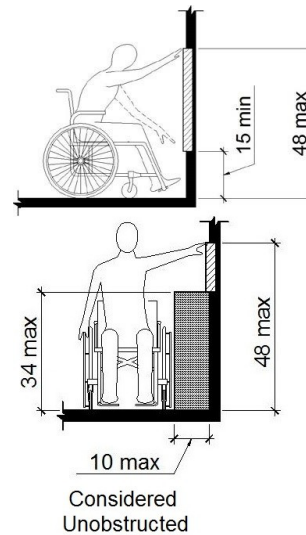
As Built: The fire extinguisher is not positioned correctly for either a side or front approach.

Where a clear floor or ground space allows a parallel or front approach and the side reach is unobstructed, the high side reach shall be 48 inches maximum above the finish floor or ground and the low side reach shall be 15 inches minimum above the finish floor or ground.

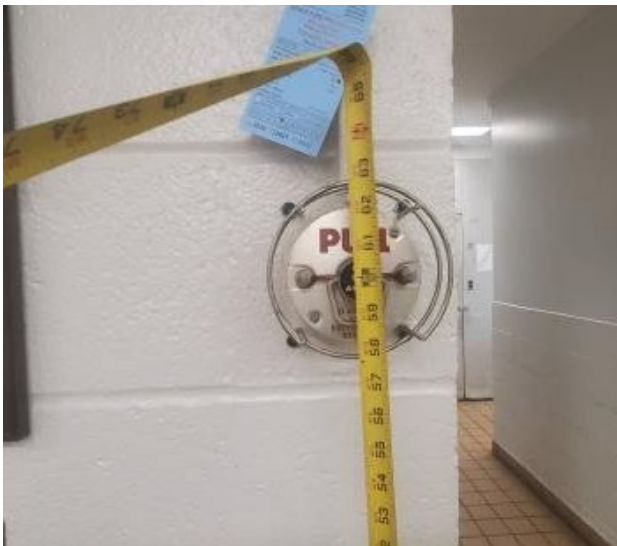
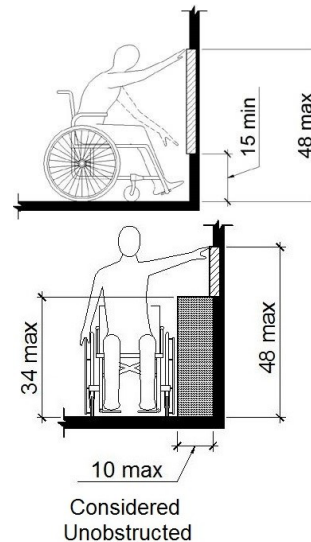
As Built: The fire alarm pull is not positioned correctly for either a side or front approach.

Where a clear floor or ground space allows a parallel or front approach and the side reach is unobstructed, the high side reach shall be 48 inches maximum above the finish floor or ground and the low side reach shall be 15 inches minimum above the finish floor or ground.

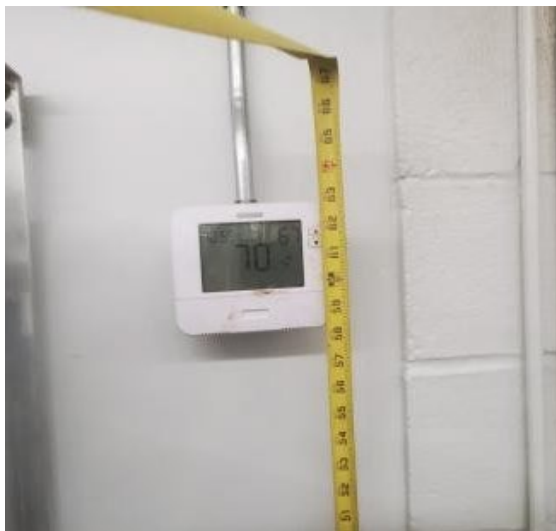
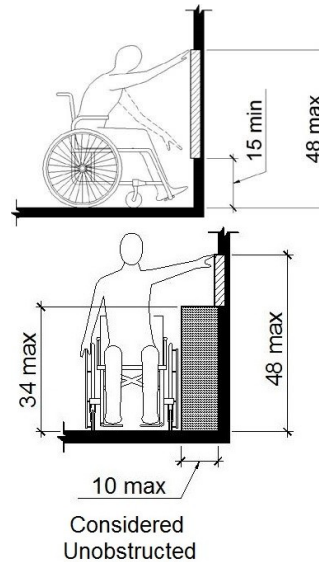
As Built: The thermostat is not positioned correctly for either a side or front approach.

Where a clear floor or ground space allows a parallel or front approach and the side reach is unobstructed, the high side reach shall be 48 inches maximum above the finish floor or ground and the low side reach shall be 15 inches minimum above the finish floor or ground.

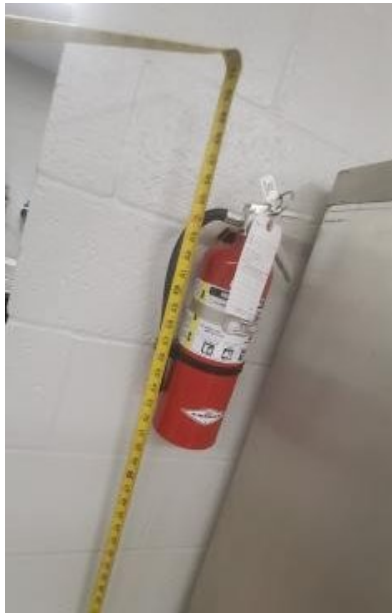
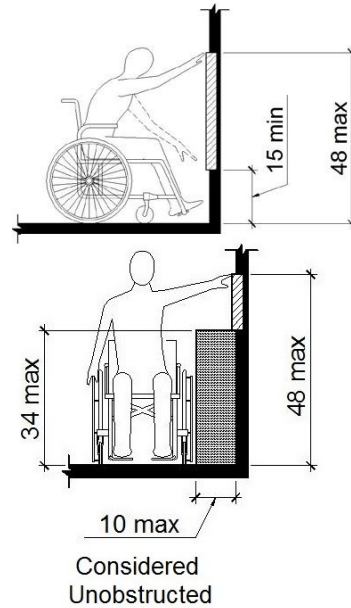
As Built: The fire extinguisher is not positioned correctly for either a side or front approach.

Where a clear floor or ground space allows a parallel or front approach and the side reach is unobstructed, the high side reach shall be 48 inches maximum above the finish floor or ground and the low side reach shall be 15 inches minimum above the finish floor or ground.

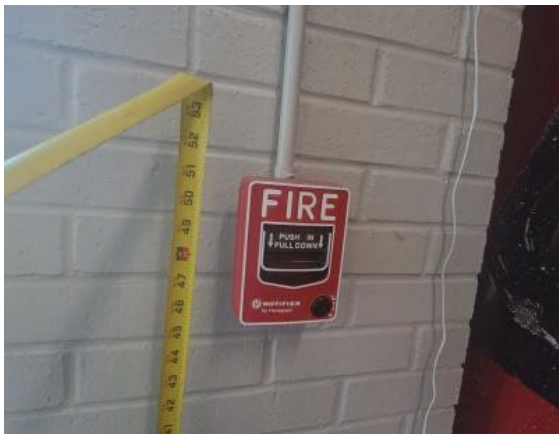
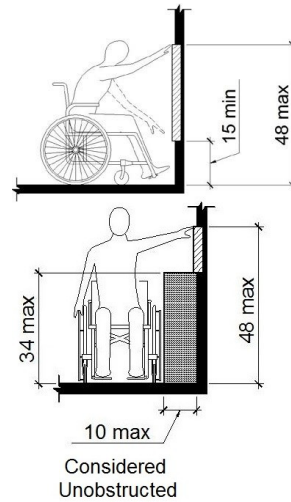
As Built: The fire alarm pull is not positioned correctly for either a side or front approach.

Where a clear floor or ground space allows a parallel or front approach and the side reach is unobstructed, the high side reach shall be 48 inches maximum above the finish floor or ground and the low side reach shall be 15 inches minimum above the finish floor or ground.

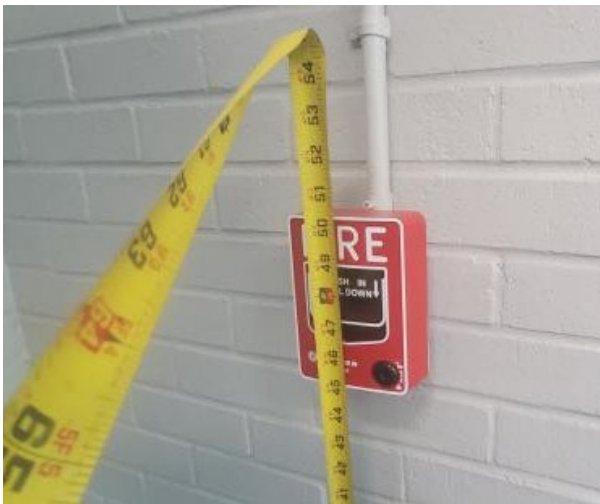
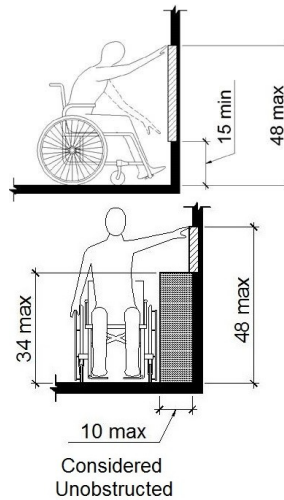
As Built: The fire alarm pull is not positioned correctly for either a side or front approach.

Where a clear floor or ground space allows a parallel or front approach and the side reach is unobstructed, the high side reach shall be 48 inches maximum above the finish floor or ground and the low side reach shall be 15 inches minimum above the finish floor or ground.

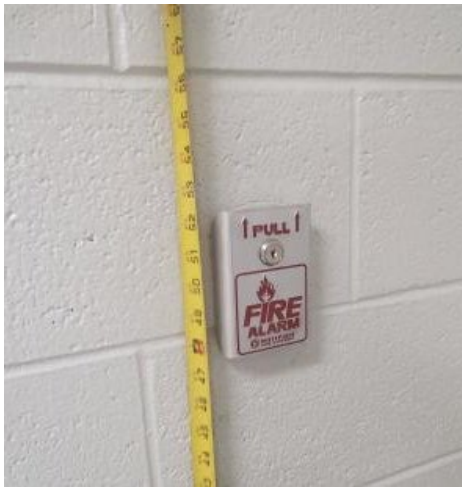
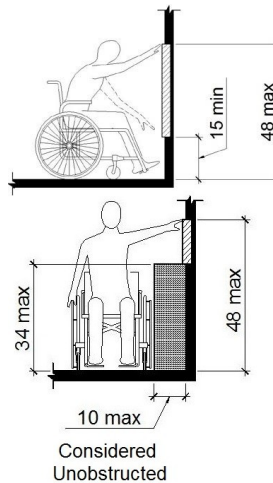
As Built: The fire alarm pull is not positioned correctly for either a side or front approach.

Where a clear floor or ground space allows a parallel or front approach and the side reach is unobstructed, the high side reach shall be 48 inches maximum above the finish floor or ground and the low side reach shall be 15 inches minimum above the finish floor or ground.

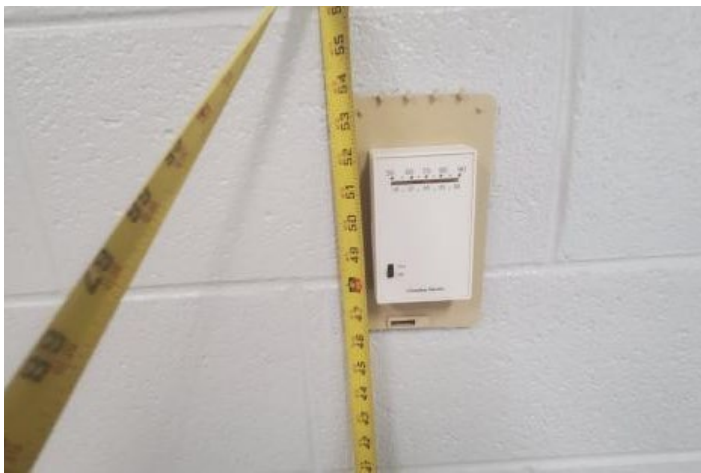
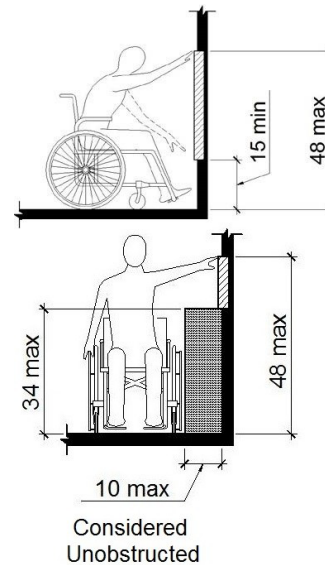
As Built: The thermostat is not positioned correctly for either a side or front approach.

Where a clear floor or ground space allows a parallel or front approach and the side reach is unobstructed, the high side reach shall be 48 inches maximum above the finish floor or ground and the low side reach shall be 15 inches minimum above the finish floor or ground.

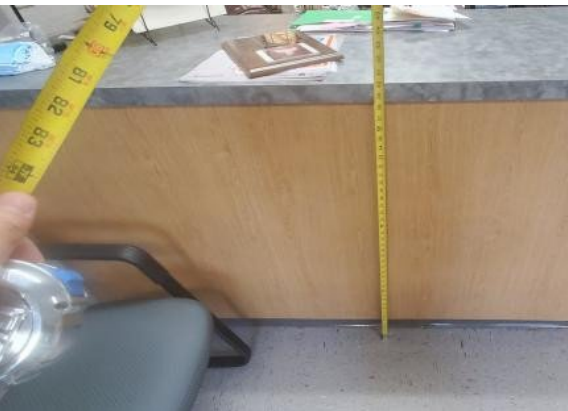
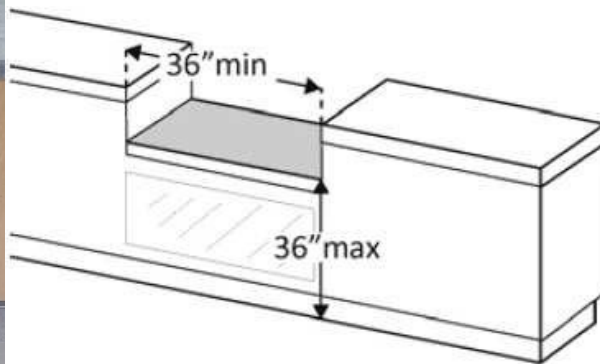
As Built: The counter is too high.

A portion of the counter surface that is 36 inches long minimum and 36 inches high maximum above the finish floor shall be provided. Knee and toe space must be provided for a forward approach. A 30 inch by 48 inch clear floor space on an accessible route must be provided for either a forward or parallel approach.

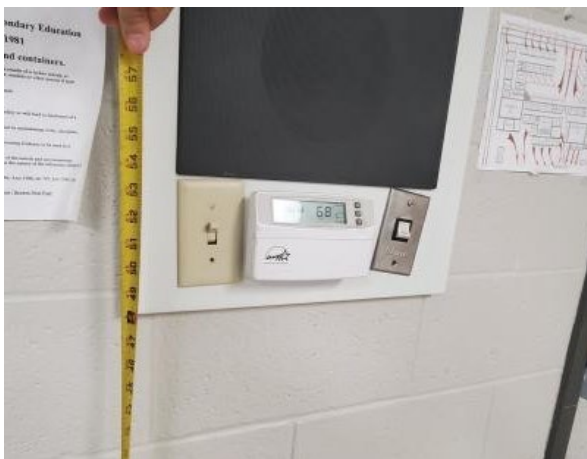
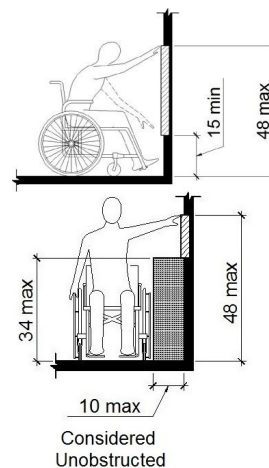
As Built: The thermostat is not positioned correctly for either a side or front approach.

Where a clear floor or ground space allows a parallel or front approach and the side reach is unobstructed, the high side reach shall be 48 inches maximum above the finish floor or ground and the low side reach shall be 15 inches minimum above the finish floor or ground.

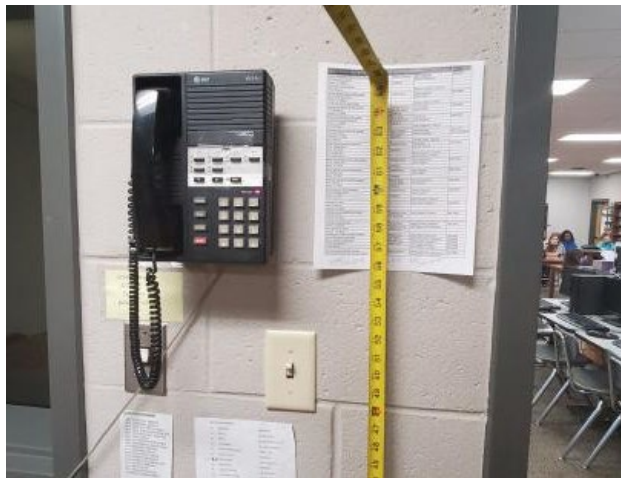
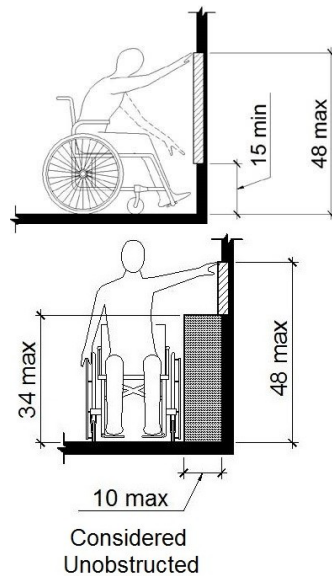
As Built: The telephone is not positioned correctly for either a side or front approach.

Where a clear floor or ground space allows a parallel or front approach and the side reach is unobstructed, the high side reach shall be 48 inches maximum above the finish floor or ground and the low side reach shall be 15 inches minimum above the finish floor or ground.

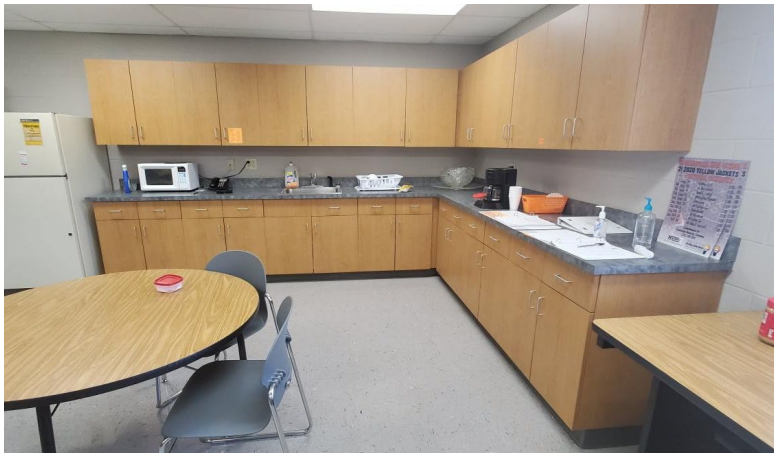
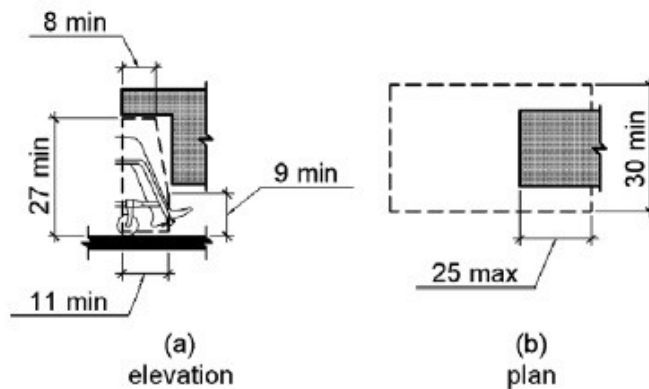
As Built: The top of the sink is too high.

Sinks that are required to be accessible shall be a minimum 17 inches in horizontal depth and mounted with the rim or counter edge no higher than 34 inches above the finished floor.

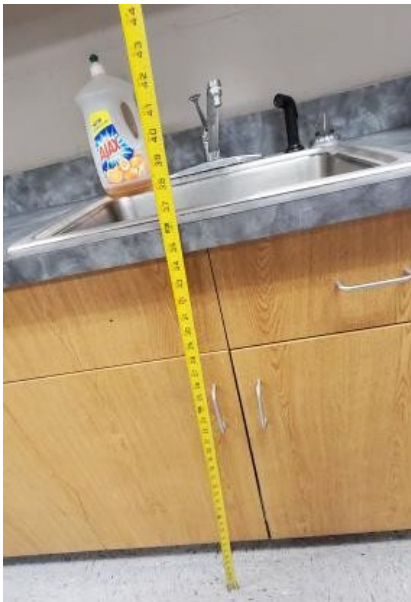
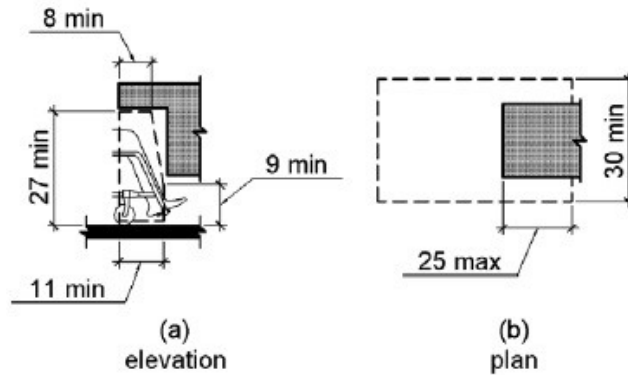
As Built: Knee and toe space has not been provided at the sink.

Kitchen sinks must be provided with a clear floor space positioned for a forward approach including knee and toe clearance.

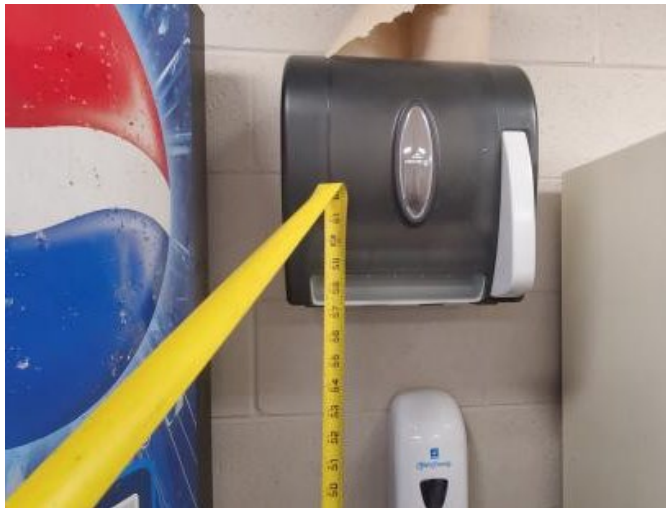
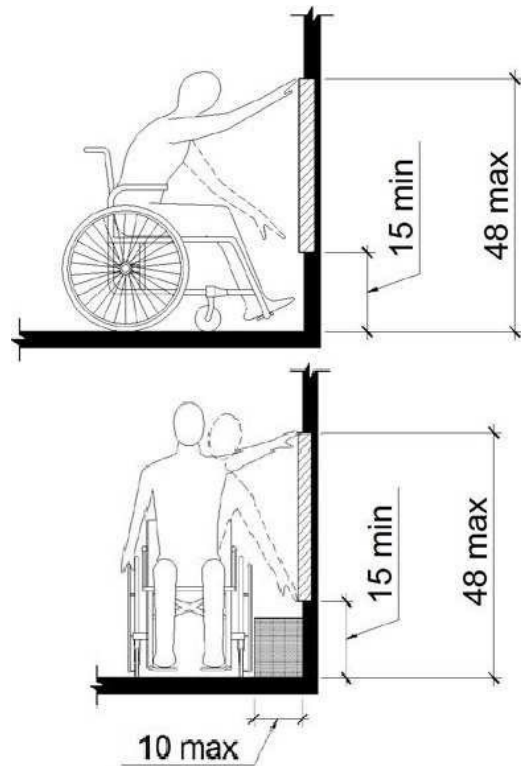
As Built: The paper towel dispenser's operation mechanism is too high off the floor. Dispensers must have all operable parts a maximum of 48 inches above the floor.

Citation: 2010 ADAS Section 308.2.1

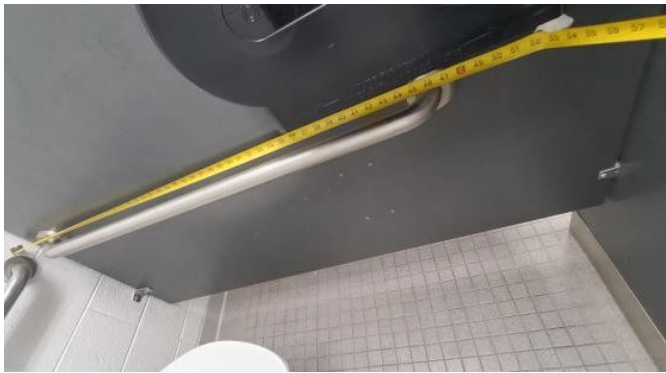
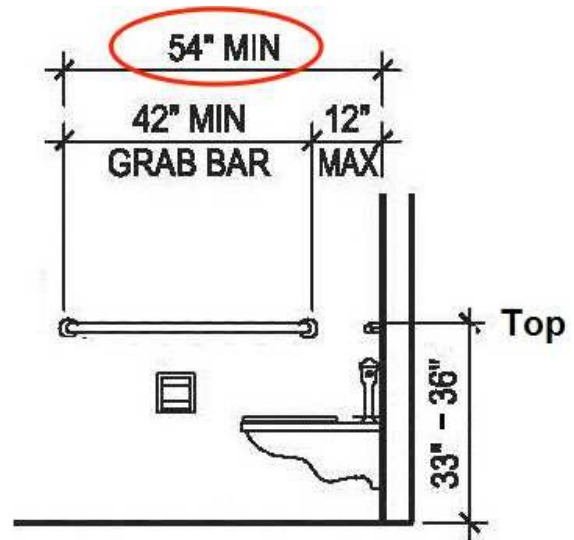
As Built: The side grab bar does not extend far enough from the rear wall.

The side grab bar must extend at least 54 inches minimum beyond the rear wall and start a maximum of 12 inches from the rear wall. A 42 inch grab bar installed the maximum distance from the rear wall (12 inches) will leave the leading end 54 inches from the rear wall.

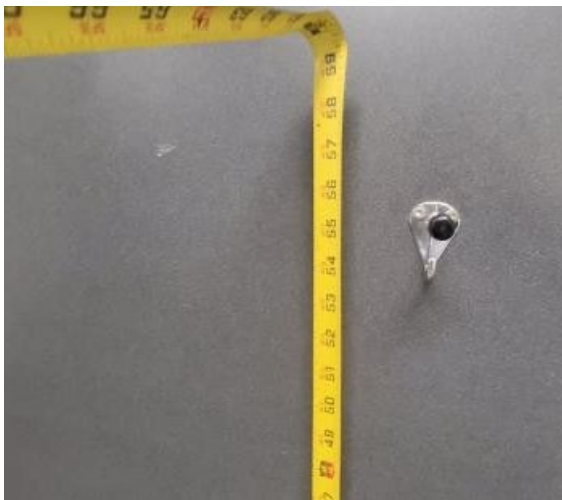
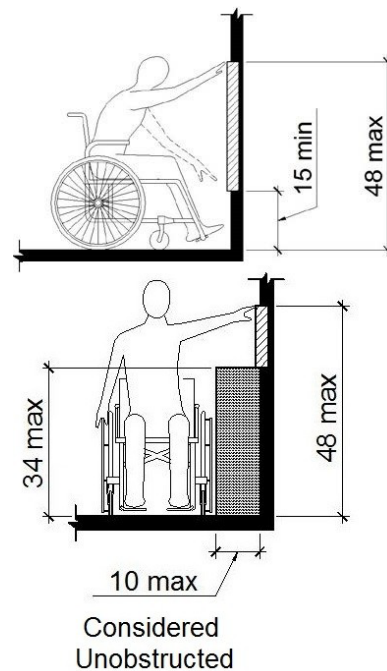
As Built: The coat hook is installed greater than 48 inches above the finished floor.

Where a forward reach is unobstructed, the high forward reach shall be 48 inches maximum above the finished floor.
