WEAKLEY COUNTY, TENNESSEE

ADA EVALUATION

Architectural and Site Findings with Recommendations

TLM Associates, Inc

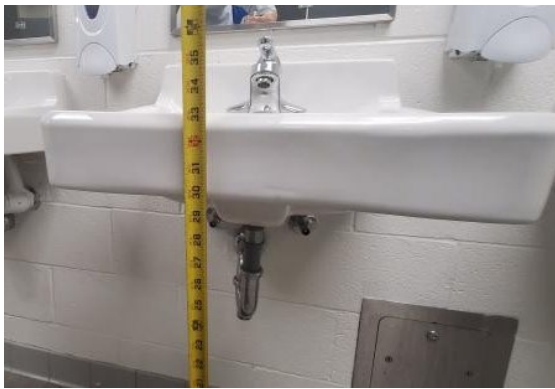
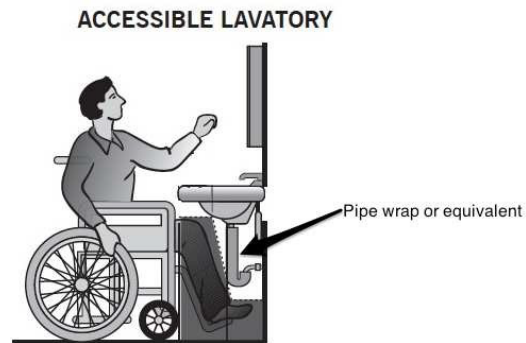
As Built: The water and drainpipes under the lavatory are not insulated.

The water supply and drainpipes under lavatories and sinks shall be insulated or otherwise configured to protect against contact. There shall be no sharp or abrasive surfaces under lavatories and sinks.

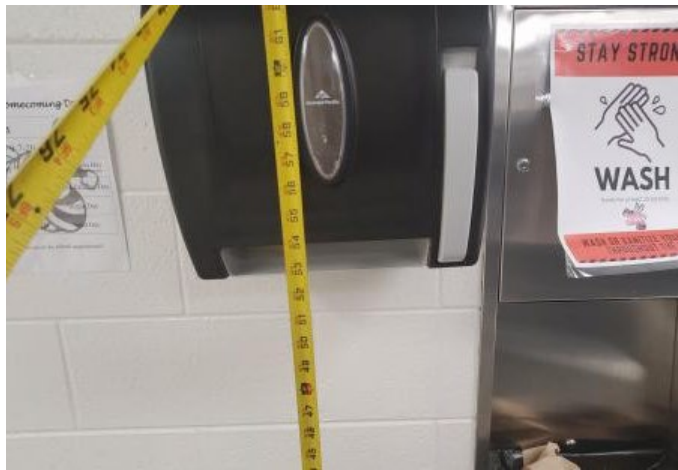
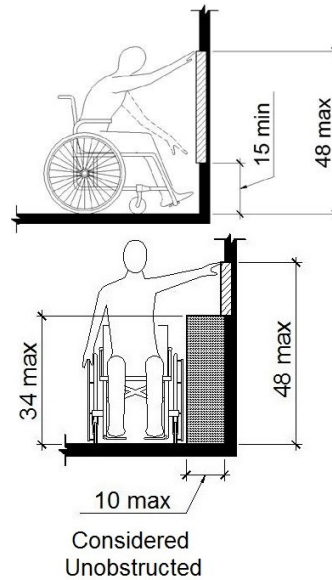
As Built: The paper towel dispenser is not positioned correctly for either a side or front approach.

Where a clear floor or ground space allows a parallel or front approach and the side reach is unobstructed, the high side reach shall be 48 inches maximum above the finish floor or ground and the low side reach shall be 15 inches minimum above the finish floor or ground.

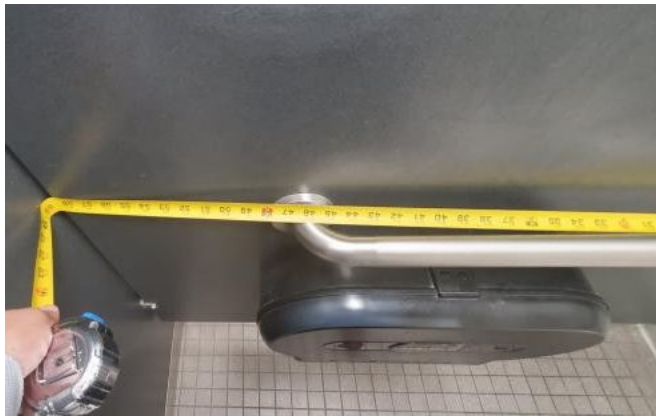
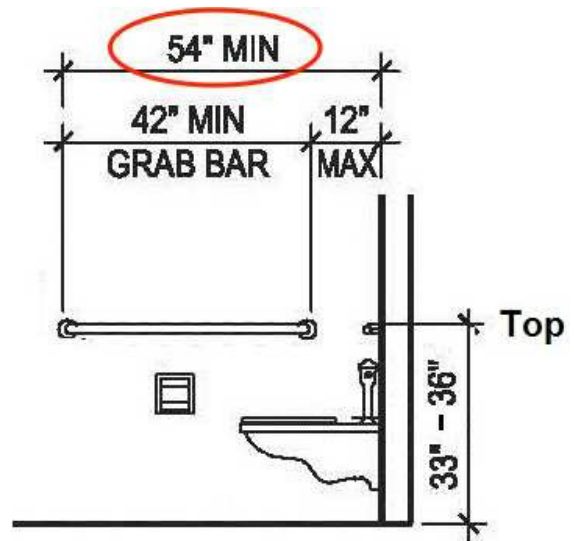
As Built: The side grab bar does not extend far enough from the rear wall.

The side grab bar must extend at least 54 inches minimum beyond the rear wall and start a maximum of 12 inches from the rear wall. A 42 inch grab bar installed the maximum distance from the rear wall (12 inches) will leave the leading end 54 inches from the rear wall.

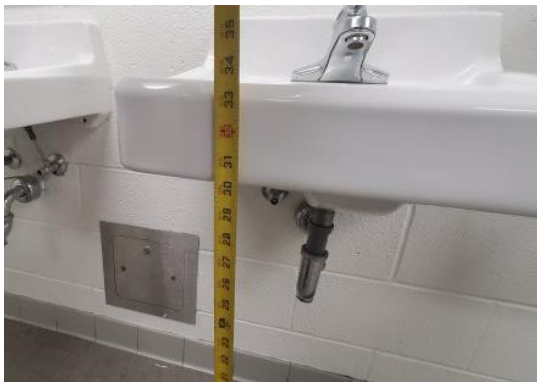
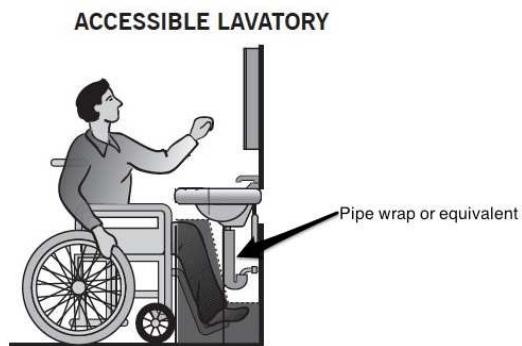
As Built: The water and drainpipes under the lavatory are not installed.

The water supply and drainpipes under lavatories and sinks shall be insulated or otherwise configured to protect against contact. There shall be no sharp or abrasive surfaces under lavatories and sinks.

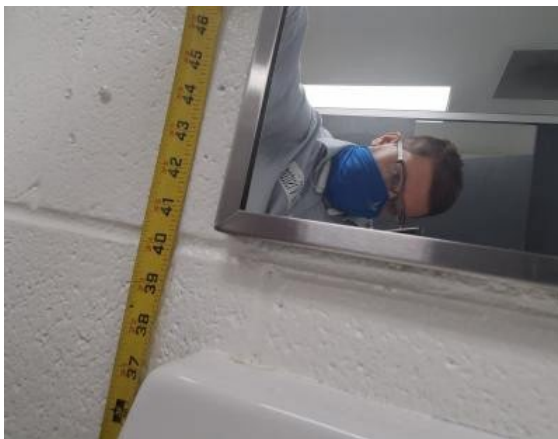
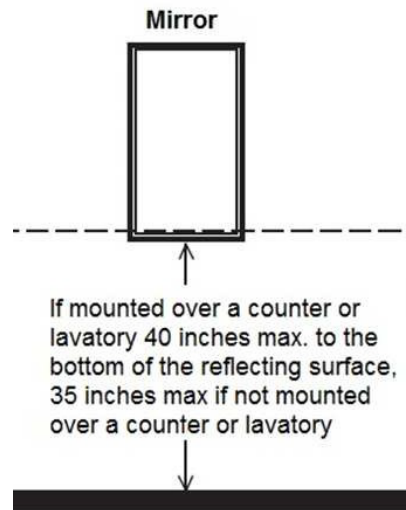
As Built: The mirror is mounted too high.

Mirrors must have the bottom edge of the reflecting surface a maximum of 40 inches above the floor if above a sink or counter. Mirrors not located above lavatories or countertops shall be installed with the bottom edge of the reflecting surface 35 inches maximum above the finish floor or ground.

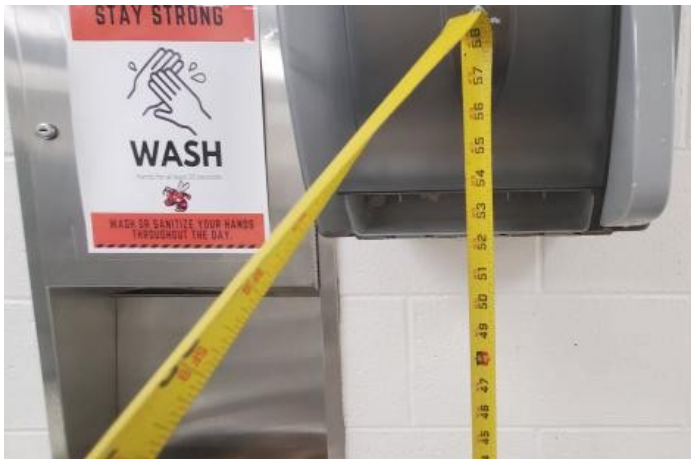
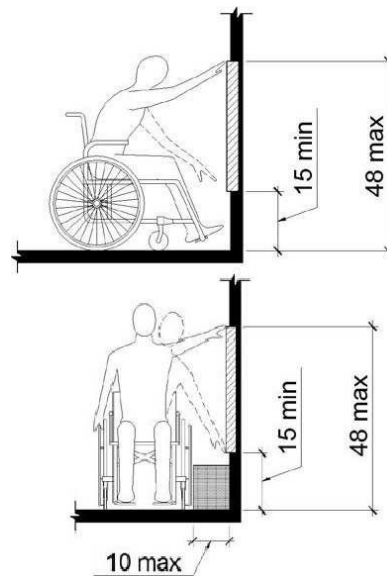
As Built: The paper towel dispenser's operation mechanism is too high off the floor. Dispensers must have all operable parts a maximum of 48 inches above the floor.

Citation: 2010 ADAS Section 308.2.1

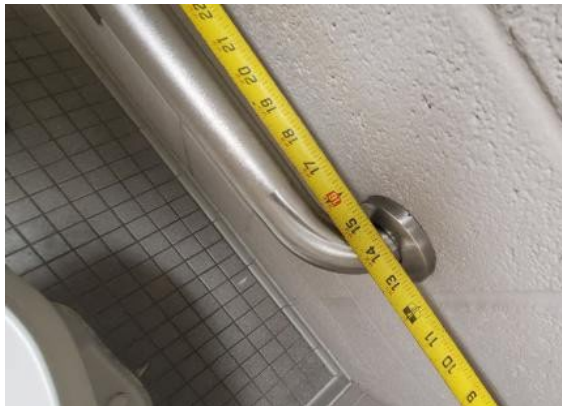
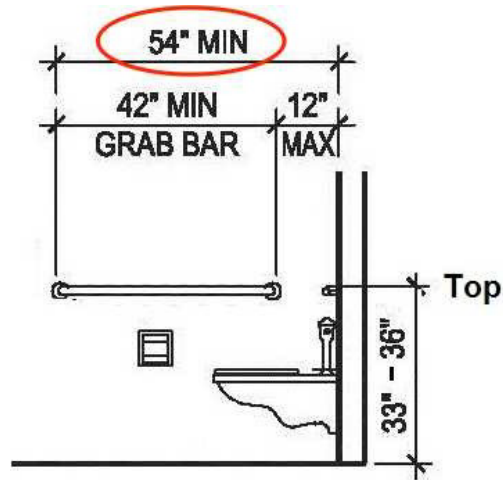
As Built: The side grab bar does not extend far enough from the rear wall.

The side grab bar must extend at least 54 inches minimum beyond the rear wall and start a maximum of 12 inches from the rear wall. A 42 inch grab bar installed the maximum distance from the rear wall (12 inches) will leave the leading end 54 inches from the rear wall.

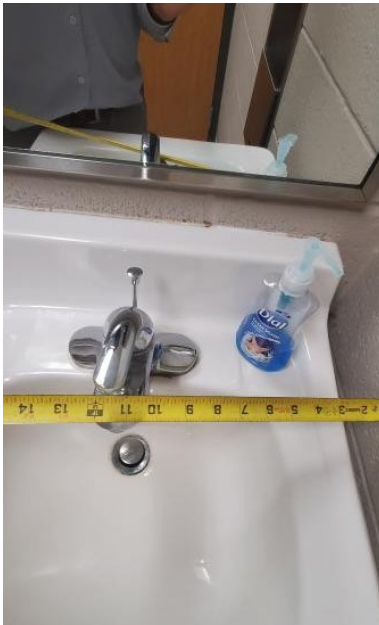
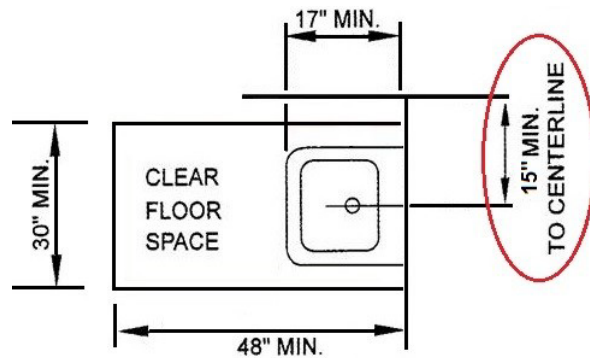
As Built: The lavatory is too close to the side wall.

There must be a minimum of 15 inches from the centerline of the lavatory to the nearest side wall or side partition to allow for an unobstructed 30 inches by 48 inches clear floor space.

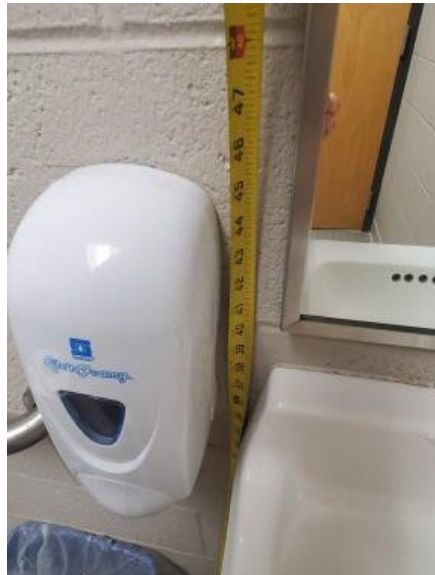
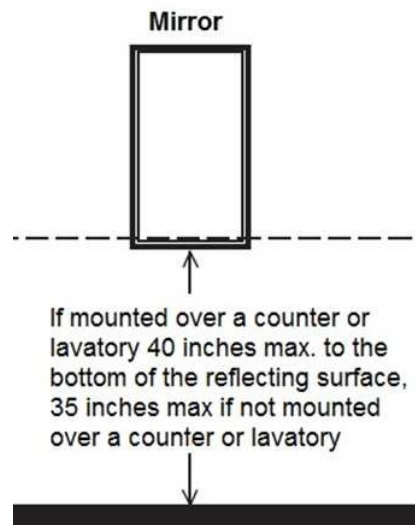
As Built: The mirror is mounted too high.

Mirrors must have the bottom edge of the reflecting surface a maximum of 40 inches above the floor if above a sink or counter. Mirrors not located above lavatories or countertops shall be installed with the bottom edge of the reflecting surface 35 inches maximum above the finish floor or ground.

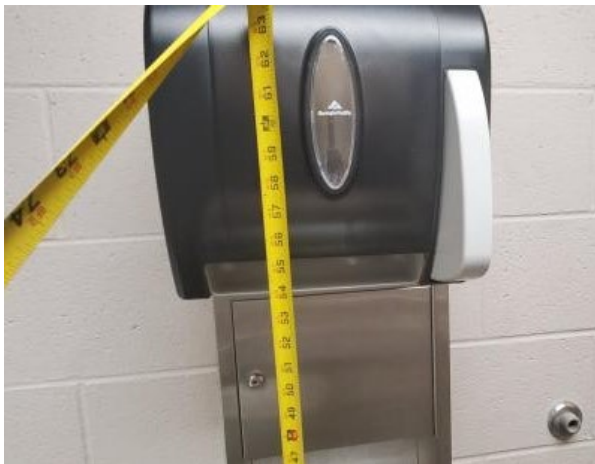
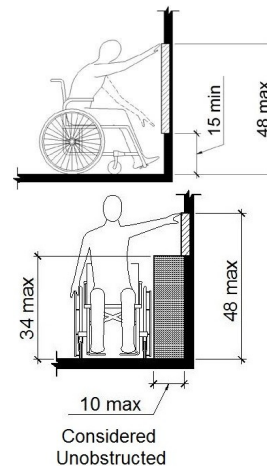
As Built: The paper towel dispenser is not positioned correctly for either a side or front approach.

Where a clear floor or ground space allows a parallel or front approach and the side reach is unobstructed, the high side reach shall be 48 inches maximum above the finish floor or ground and the low side reach shall be 15 inches minimum above the finish floor or ground.

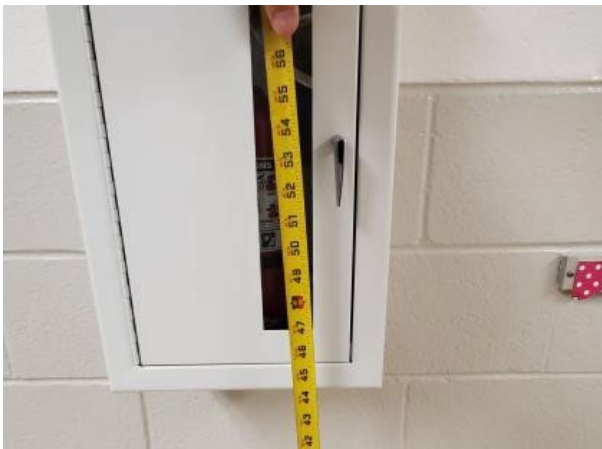
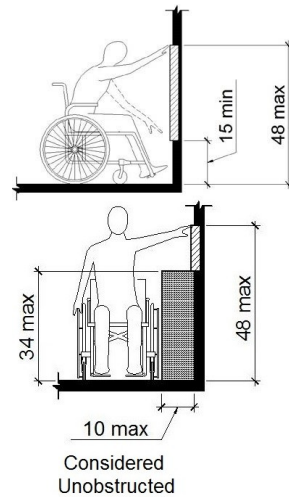
As Built: The fire extinguisher is not positioned correctly for either a side or front approach.

Where a clear floor or ground space allows a parallel or front approach and the side reach is unobstructed, the high side reach shall be 48 inches maximum above the finish floor or ground and the low side reach shall be 15 inches minimum above the finish floor or ground.

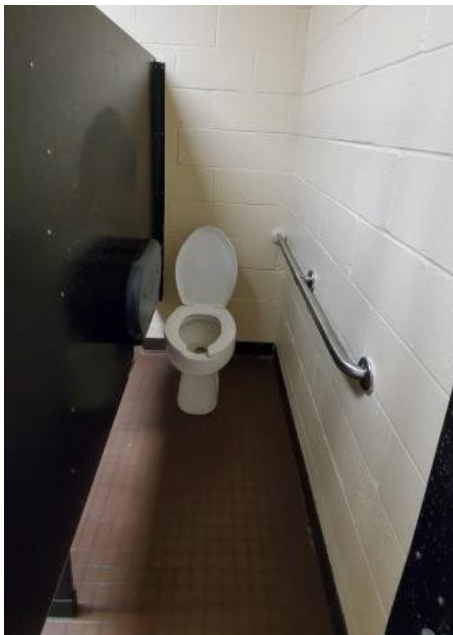
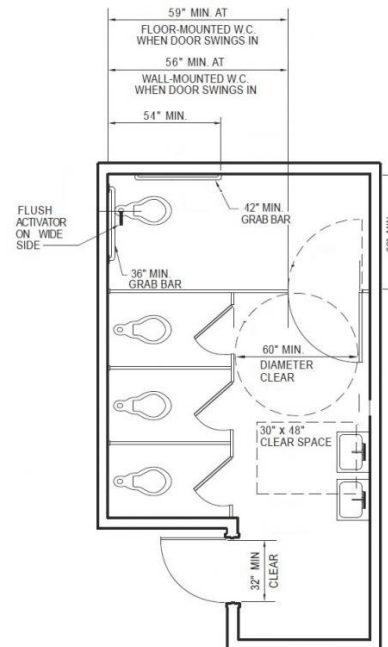
As Built: The toilet compartment does not have the required minimum clear floor space or maneuvering clearances for the toilet. The restroom does not have the required minimum width and depth dimensions. Grab bars are not installed.

Citation: 2010 ADAS Section 213.2

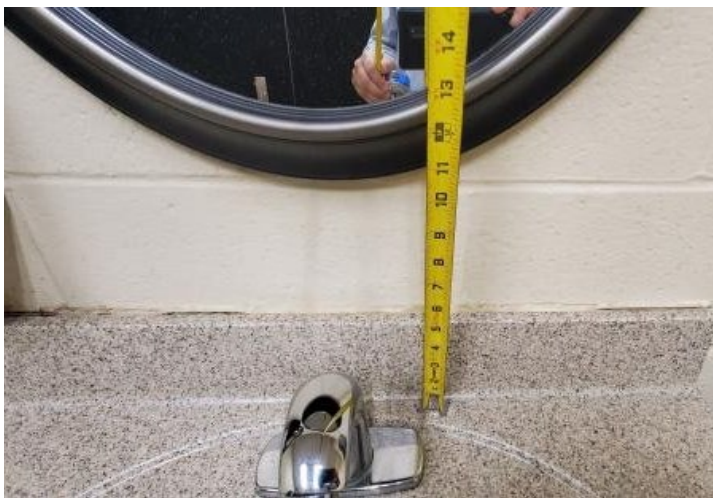
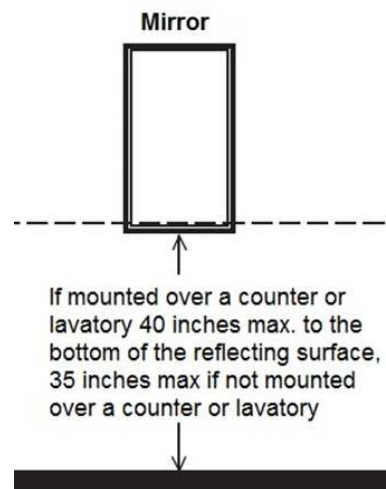
As Built: The mirror is mounted too high.

Mirrors must have the bottom edge of the reflecting surface a maximum of 40 inches above the floor if above a sink or counter. Mirrors not located above lavatories or countertops shall be installed with the bottom edge of the reflecting surface 35 inches maximum above the finish floor or ground.

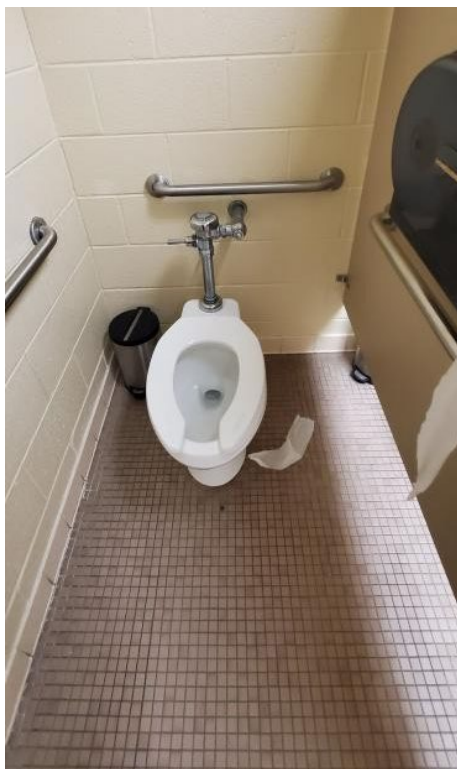
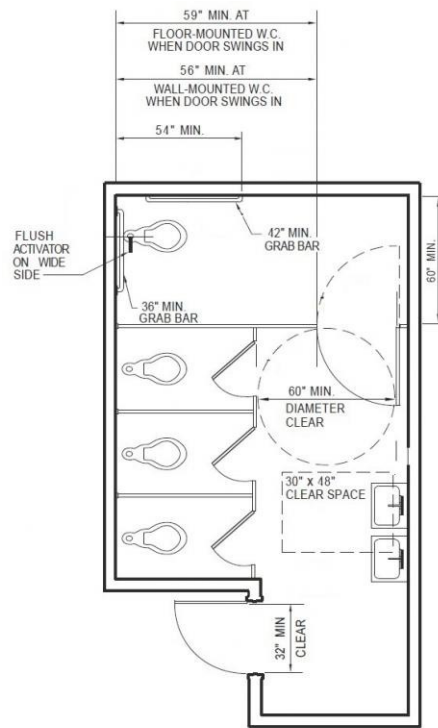
As Built: The toilet compartment does not have the required minimum clear floor space or maneuvering clearances for the toilet. The restroom does not have the required minimum width and depth dimensions. Grab bars are incorrectly installed.

Citation: 2010 ADAS Section 213.2

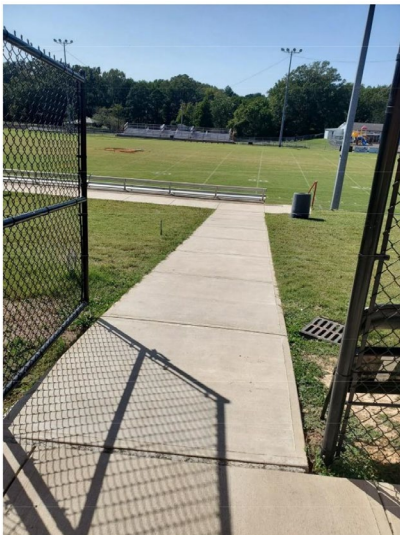
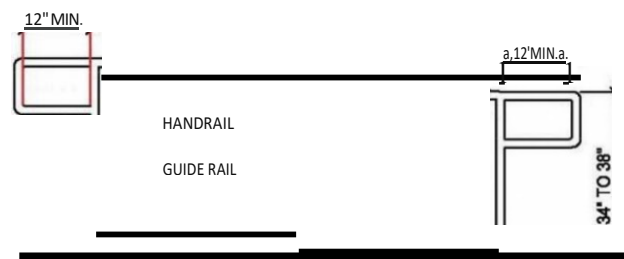
As Built: Ramp slopes 11-12% from parking elevation to bleachers.

Handrails are required on both sides of all surfaces that are sloped greater than 5 percent (1:20). Handrails must be between 34 inches and 38 inches above the ramp surface, must extend beyond the top and bottom of the ramp 12 inches and be parallel to the floor or ground surface. The diameter of the handrails must be between 1 inches and 2 inches in cross-sectional nominal dimension for circular handrails and handrail gripping surfaces with a non-circular cross section shall have a perimeter dimension of 4 inches minimum and 6 inches maximum, and a cross-section dimension of 2 inches maximum. The clear space between handrails and walls must be 1-1/2 inches minimum.

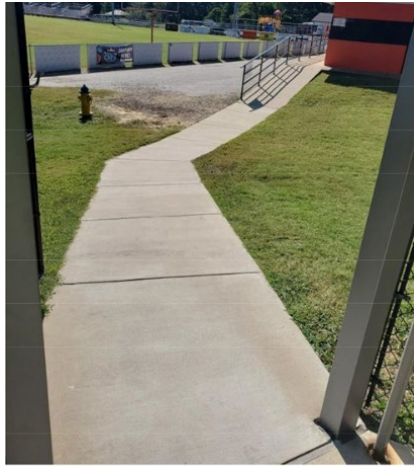
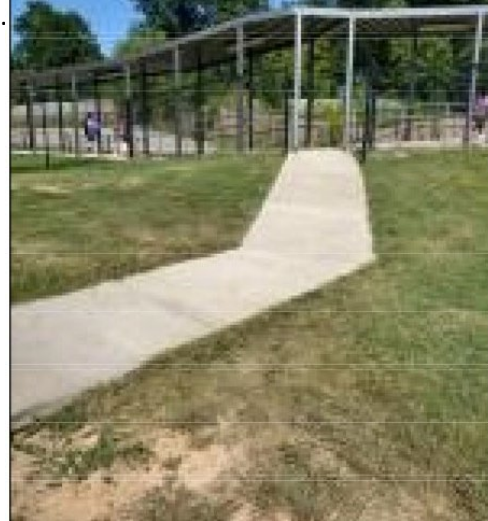
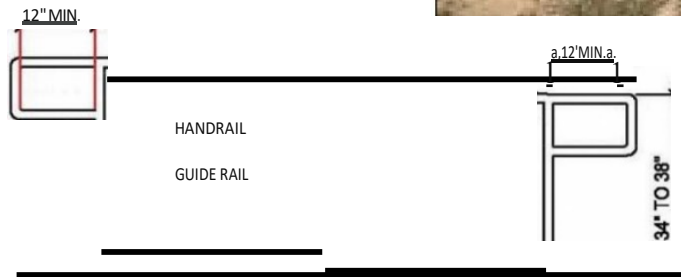
As Built: Ramp slopes 16% from covered walkway between buildings to concessions.

Handrails are required on both sides of all surfaces that are sloped greater than 5 percent (1:20). Handrails must be between 34 inches and 38 inches above the ramp surface, must extend beyond the top and bottom of the ramp 12 inches and be parallel to the floor or ground surface. The diameter of the handrails must be between 1 inches and 2 inches in cross-sectional nominal dimension for circular handrails and handrail gripping surfaces with a non-circular cross section shall have a perimeter dimension of 4 inches minimum and 6 inches maximum, and a cross-section dimension of 2 inches maximum. The clear space between handrails and walls must be 1-1/2 inches minimum.

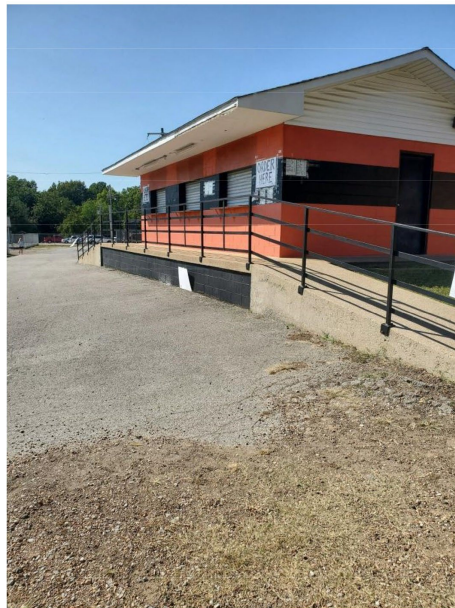
As Built: There are multiple locations where ramps exceed 10% Ramps into concessions/restrooms are 17%, handrail provided on one side. The grade of the pedestrian access route is too steep.

Where pedestrian access routes are not contained within a street or highway right-of-way, the grade of pedestrian access routes shall be 5 percent maximum.

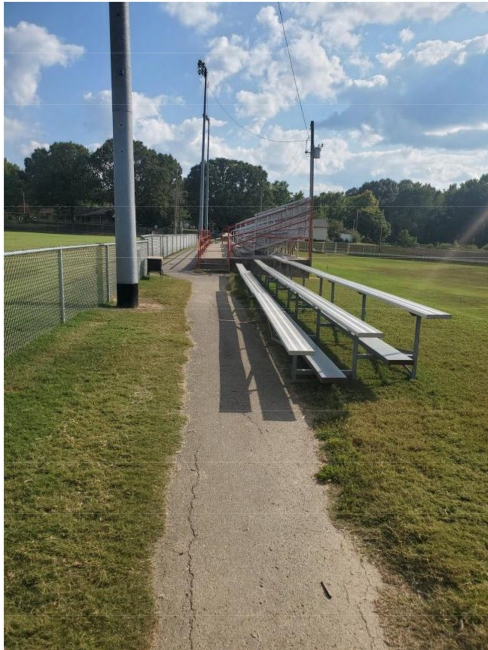
As Built: The paved route provided to visitor’s side has no ramp onto elevated bleachers and no compliant landing/seating for users on lower-level bleachers. Wheelchair spaces shall be provided in assembly areas with fixed seating based on number of available seats in figure.

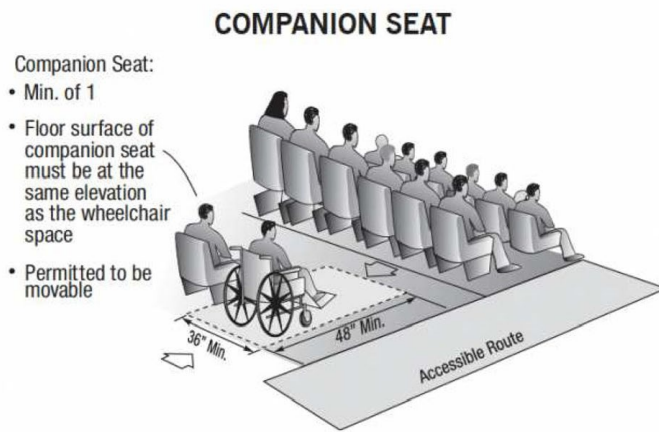
As Built: An accessible wheelchair space is not provided in the team/player seating area.

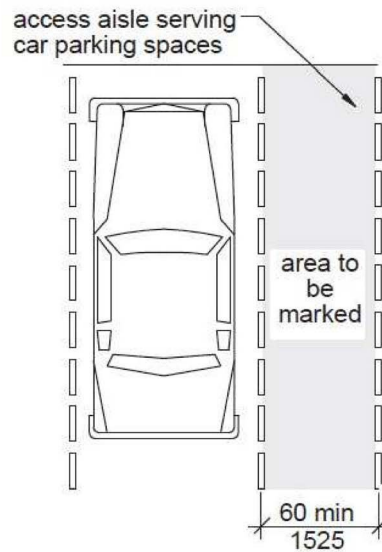
As Built: There are two spaces provided with no access aisles.

Access aisles serving parking spaces shall adjoin an accessible route. Two parking spaces shall be permitted to share a common access aisle.

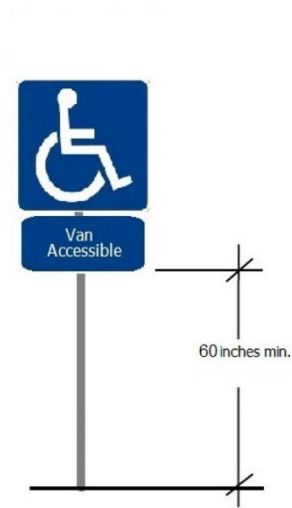
As Built: The parking sign is mounted too low.

Parking space identification signs shall include the International Symbol of Accessibility. Signs identifying van parking spaces shall contain the designation "van accessible."

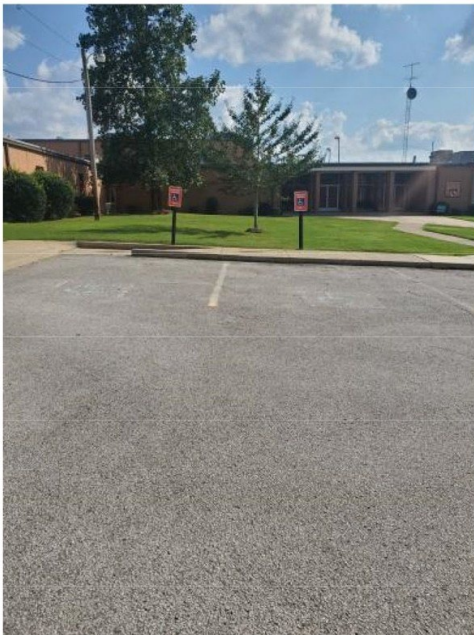
As Built: This lot is associated with a large lot across the street that has no accessible stalls. The lot serves as primary entrance to the Elementary and High School. There are no van accessible parking stalls.

Replace 5'x5'.

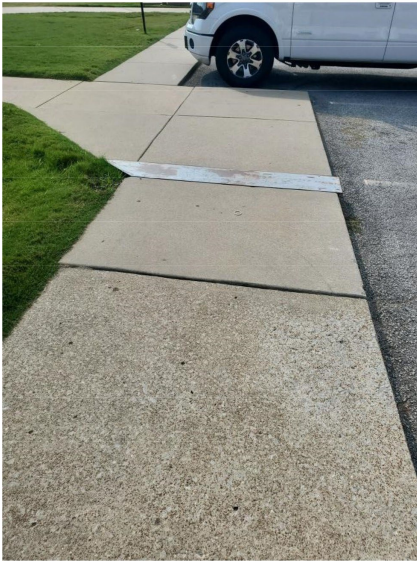
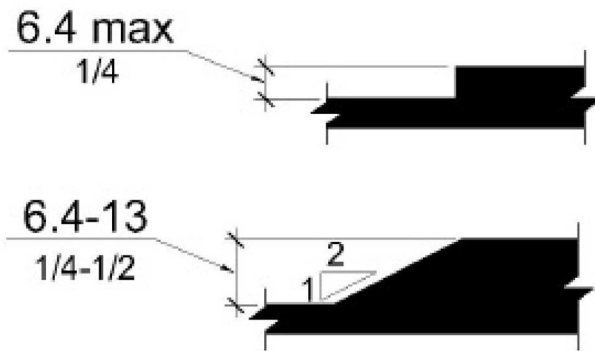
As Built: The surface of the pedestrian access route has vertical discontinuities greater than 1/2 inch or between 1/4 inch and 1/2 inch that are not beveled.

Vertical surface discontinuities shall be 0.5 inch maximum. Vertical surface discontinuities between 0.25 inch and 0.5 inch shall be beveled with a slope not steeper than 50 percent. The bevel shall be applied across the entire vertical surface discontinuity.

Replace the ramp along the curb.

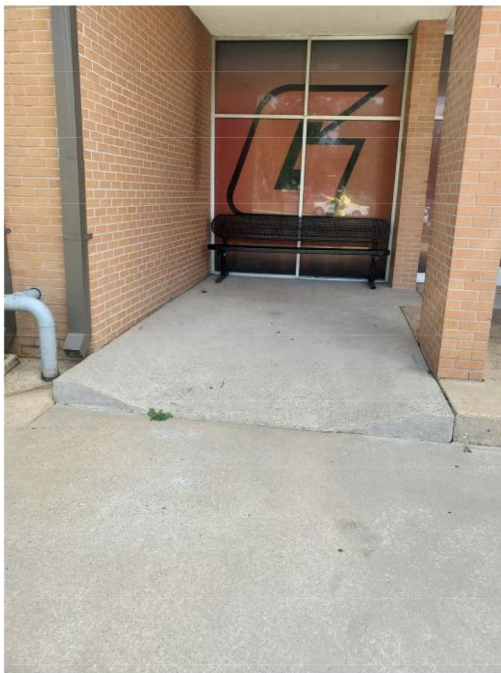
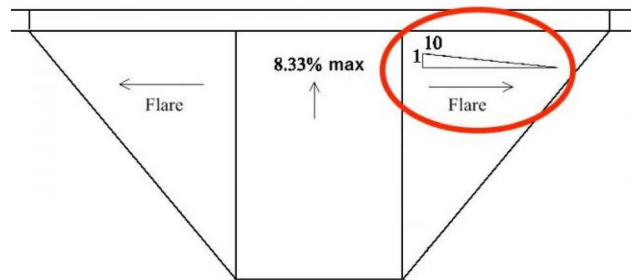
As Built: The curb ramp side flares are at 33%, which is too steep.

The sides of curb ramps (curb ramp flares) where provided, shall not be steeper than 1:10.

Replace the ramp. Ensure slopes are not exceeded on ramp and flares and that a landing is provided at top of ramp that is less than 2%.

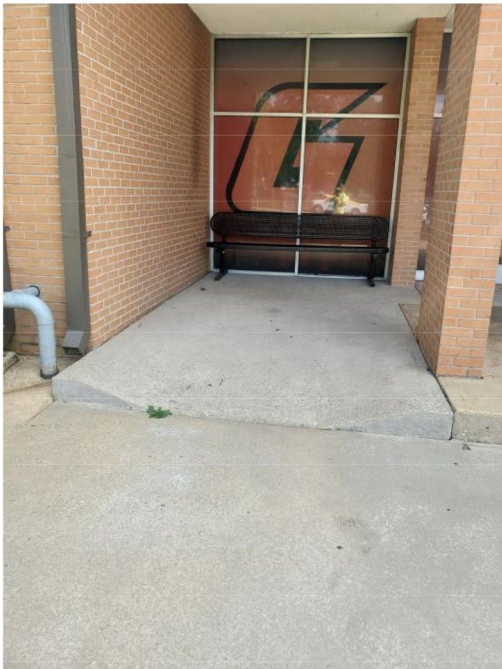
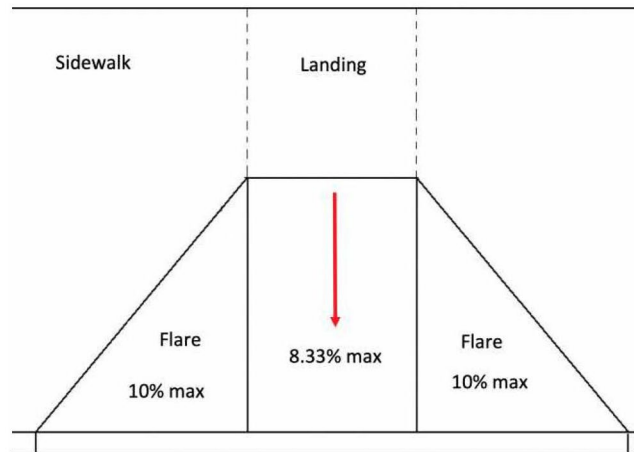
As Built: The curb ramp slope is at 10.8%, which exceeds the maximum running slope (Parallel to the direction of travel) allowable of 8.33%.

Curb ramps should have the least possible slope but in no case more than 8.3% (1:12).

Replace approximately 300 SF of the pedestrian access route.

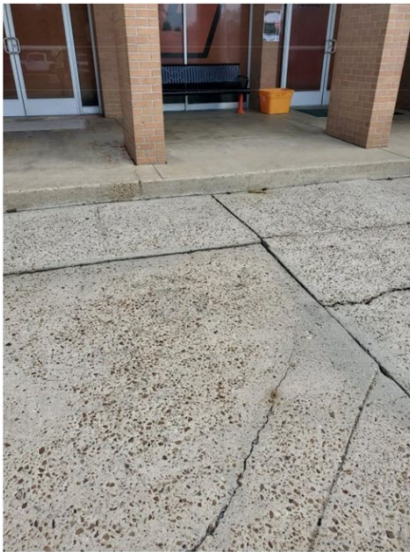
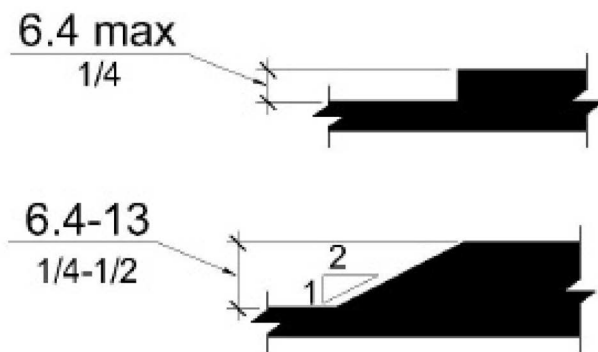
As Built: The surface of the pedestrian access route has vertical discontinuities greater than 1/2 inch or between 1/4 inch and 1/2 inch that are not beveled.

Vertical surface discontinuities shall be 0.5 inch maximum. Vertical surface discontinuities between 0.25 inch and 0.5 inch shall be beveled with a slope not steeper than 50 percent. The bevel shall be applied across the entire vertical surface discontinuity.

Replace panels to stay within 2% and 5% requirements.

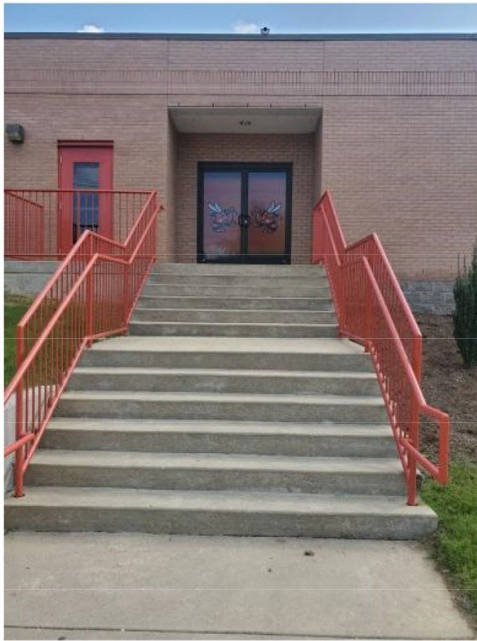
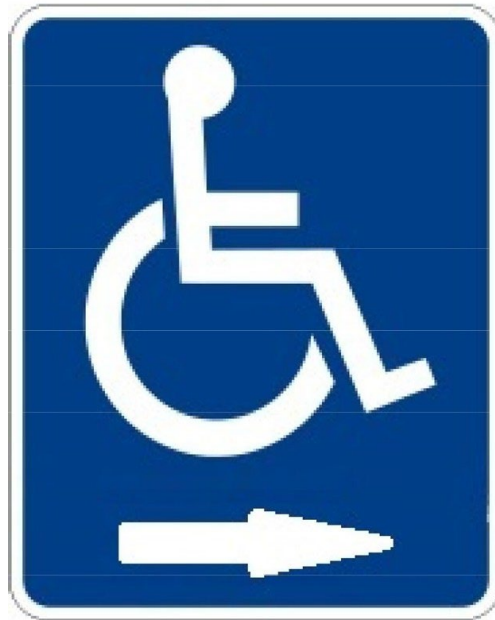
As Built: The entrance is not accessible and is missing signage. An identification sign identifying that this entrance is not accessible and directional signage pointing in the direction to the accessible entrance is required.

When a directional sign is required, it should be located to minimize backtracking. In some cases, this could mean locating a sign at the beginning of a route, not just at the inaccessible entrances to a building.

Replace approximately 70'x5' of the pedestrian access route.

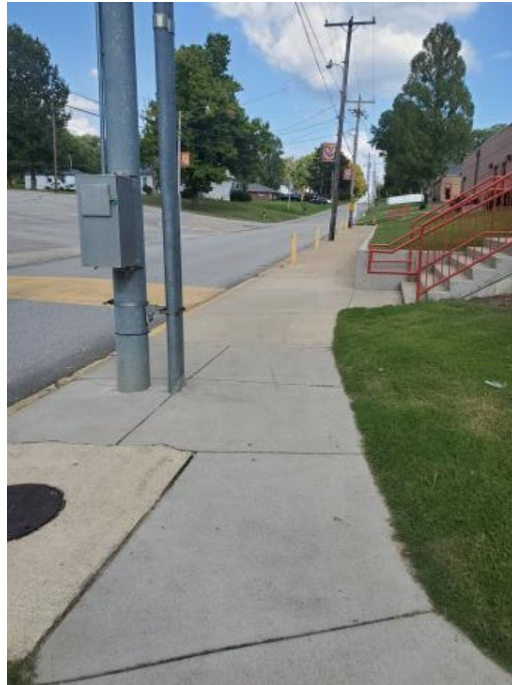
As Built: The cross slope of the pedestrian access route varies 4-5.9%, which is excessive.

The cross slope of pedestrian access routes shall be 2 percent maximum.

Replace approximately 5'x5' of the pedestrian access route.

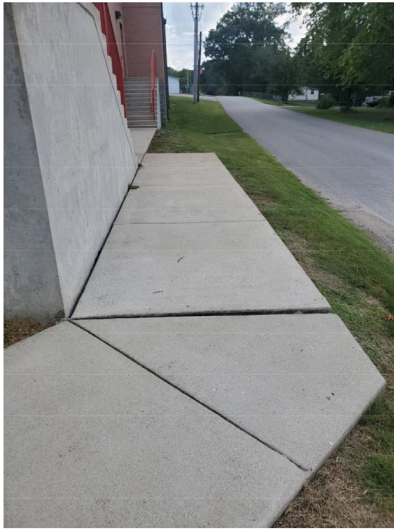
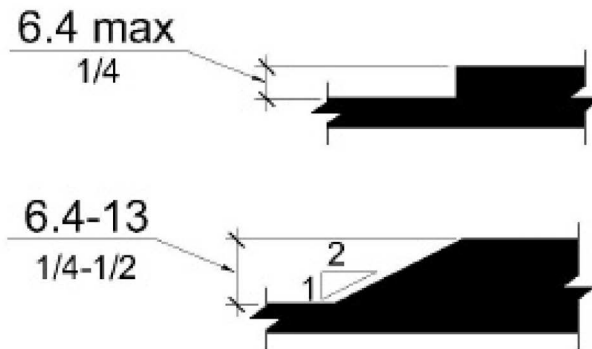
As Built: The surface of the pedestrian access route has vertical discontinuities greater than 1/2 inch or between 1/4 inch and 1/2 inch that are not beveled.

Vertical surface discontinuities shall be 0.5 inch maximum. Vertical surface discontinuities between 0.25 inch and 0.5 inch shall be beveled with a slope not steeper than 50 percent. The bevel shall be applied across the entire vertical surface discontinuity.

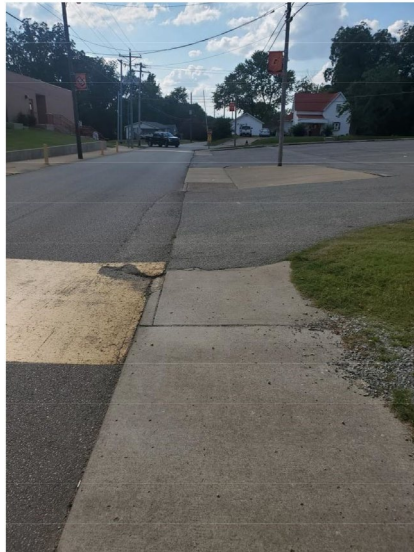
As Built: The cross slope of the pedestrian access route is 8.4%, which is excessive.

The cross slope of pedestrian access routes shall be 2 percent maximum.

Replace sidewalk through driveway to ensure flush condition and less than 2% cross slope.

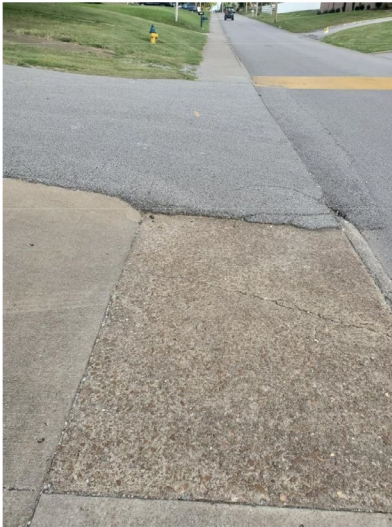
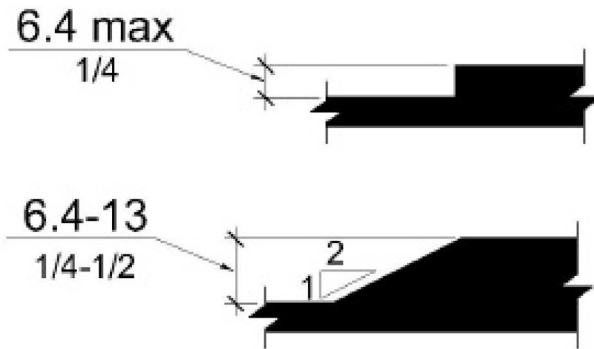
As Built: The surface of the pedestrian access route has vertical discontinuities greater than 1/2 inch or between 1/4 inch and 1/2 inch that are not beveled.

Vertical surface discontinuities shall be 0.5 inch maximum. Vertical surface discontinuities between 0.25 inch and 0.5 inch shall be beveled with a slope not steeper than 50 percent. The bevel shall be applied across the entire vertical surface discontinuity.

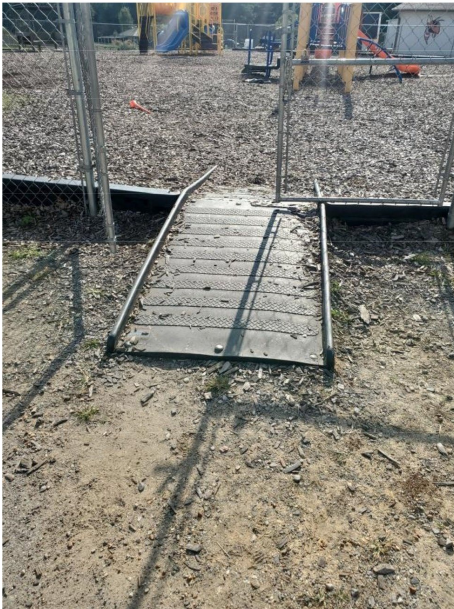
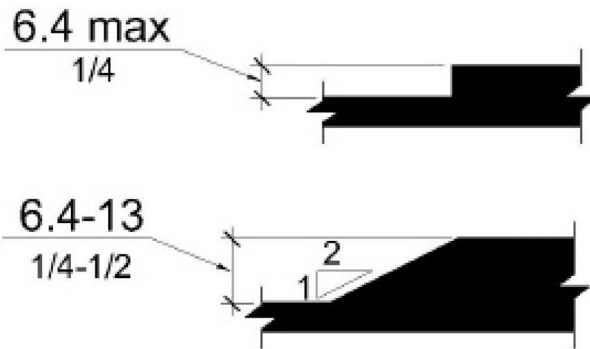
As Built: The surface of the pedestrian access route has vertical discontinuities greater than 1/2 inch or between 1/4 inch and 1/2 inch that are not beveled.

Vertical surface discontinuities shall be 0.5 inch maximum. Vertical surface discontinuities between 0.25 inch and 0.5 inch shall be beveled with a slope not steeper than 50 percent. The bevel shall be applied across the entire vertical surface discontinuity.

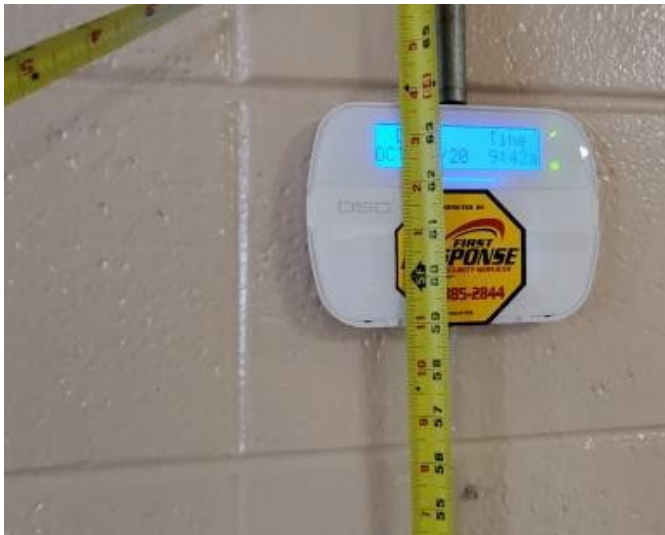
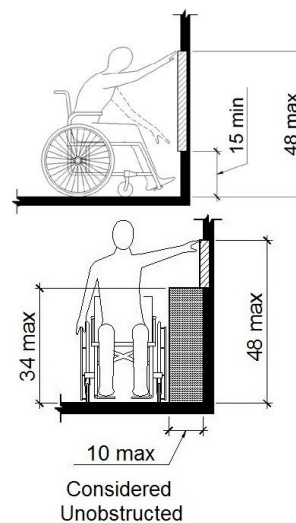
As Built: The alarm pad is not positioned correctly for either a side or front approach.

Where a clear floor or ground space allows a parallel or front approach and the side reach is unobstructed, the high side reach shall be 48 inches maximum above the finish floor or ground and the low side reach shall be 15 inches minimum above the finish floor or ground.

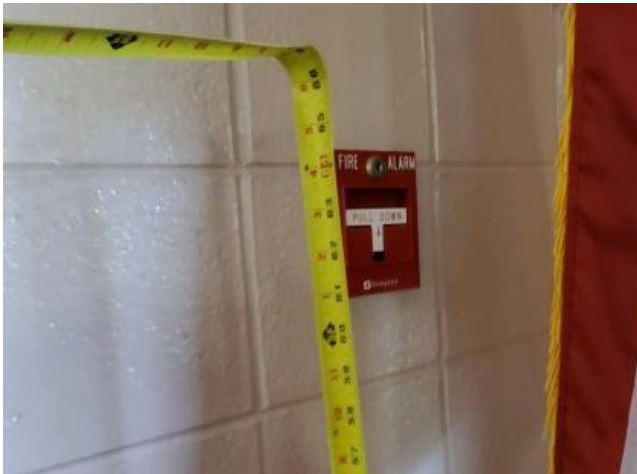
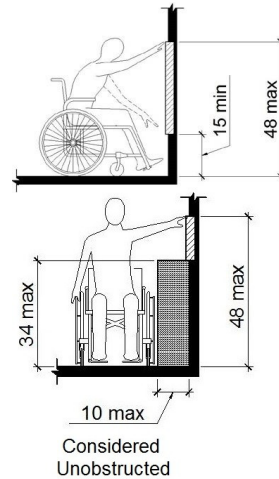
As Built: The alarm pad is not positioned correctly for either a side or front approach.

Where a clear floor or ground space allows a parallel or front approach and the side reach is unobstructed, the high side reach shall be 48 inches maximum above the finish floor or ground and the low side reach shall be 15 inches minimum above the finish floor or ground.

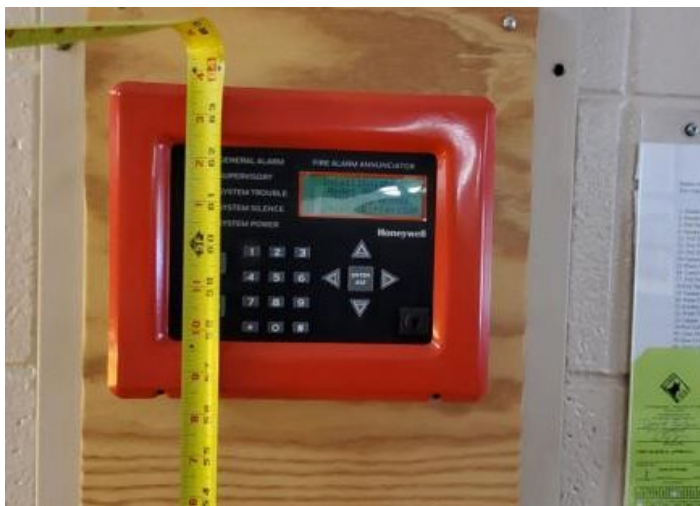
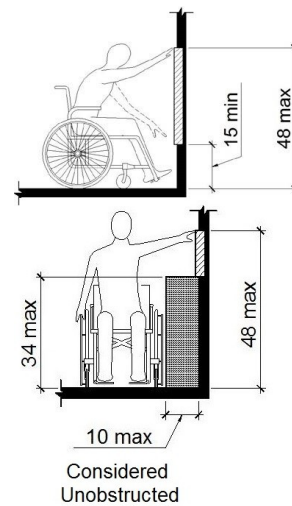
As Built: The fire alarm annunciator pad is not positioned correctly for either a side or front approach.

Where a clear floor or ground space allows a parallel or front approach and the side reach is unobstructed, the high side reach shall be 48 inches maximum above the finish floor or ground and the low side reach shall be 15 inches minimum above the finish floor or ground.

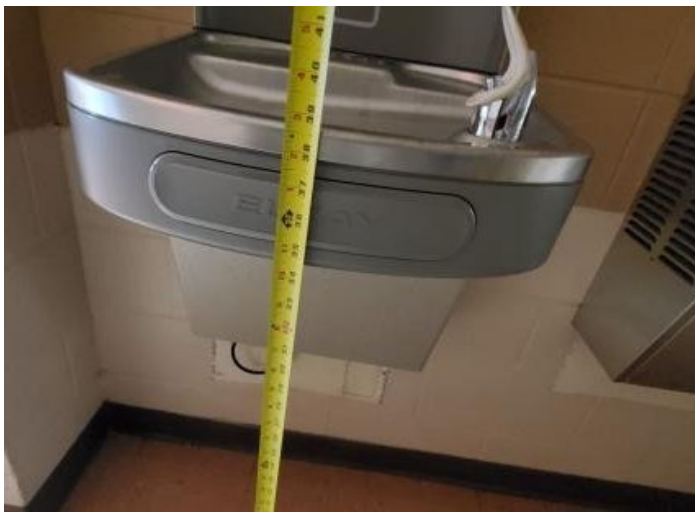
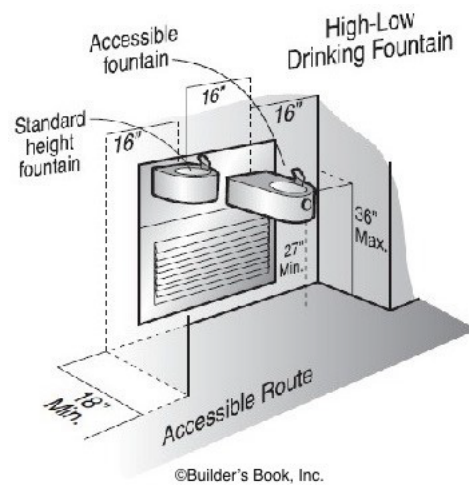
As Built: The drinking fountain is noncompliant.

Spout outlets shall be 36 inches maximum above the finish floor or ground and be located 15 inches minimum from the vertical support and 5 inches maximum from the front edge of the unit, including bumpers. The spout shall provide a flow of water at least 4 inches high minimum and shall be located 5 inches maximum from the front of the unit. The angle of the water stream shall be measured horizontally relative to the front face of the unit. Where spouts are located less than 3 inches of the front of the unit, the angle of the water stream shall be 30 degrees maximum. Where spouts are located between 3 inches and 5 inches maximum from the front of the unit, the angle of the water stream shall be 15 degrees maximum. On an accessible drinking fountain with a round or oval bowl, the spout must be positioned so the flow of water is within 3 inches of the front edge of the fountain.

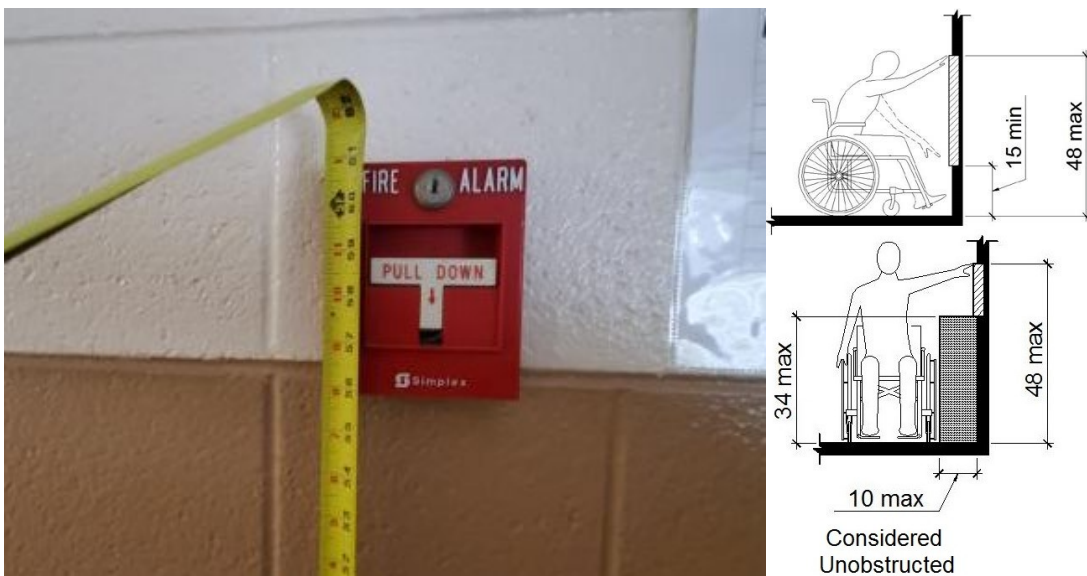
As Built: The fire alarm pull station is not positioned correctly for either a side or front approach.

Where a clear floor or ground space allows a parallel or front approach and the side reach is unobstructed, the high side reach shall be 48 inches maximum above the finish floor or ground and the low side reach shall be 15 inches minimum above the finish floor or ground.

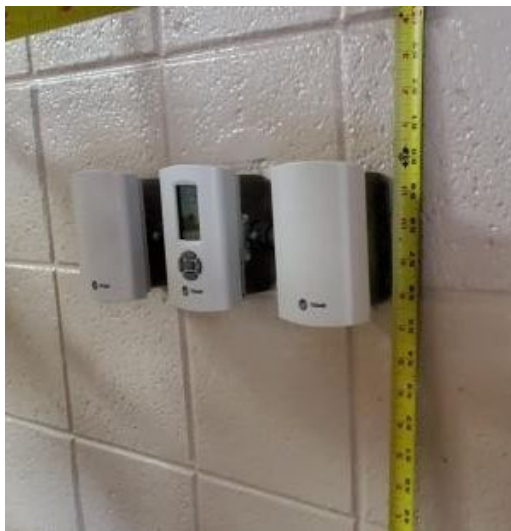
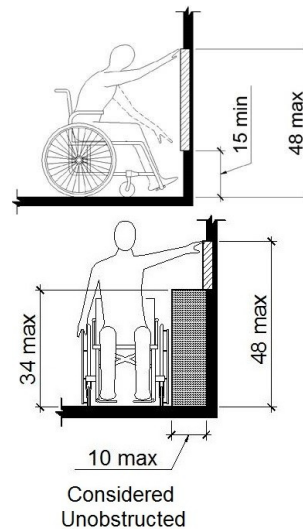
As Built: The thermostat is not positioned correctly for either a side or front approach.

Where a clear floor or ground space allows a parallel or front approach and the side reach is unobstructed, the high side reach shall be 48 inches maximum above the finish floor or ground and the low side reach shall be 15 inches minimum above the finish floor or ground.

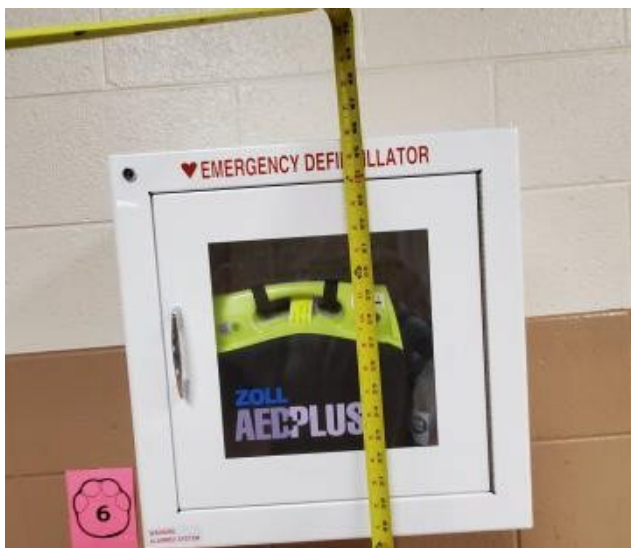
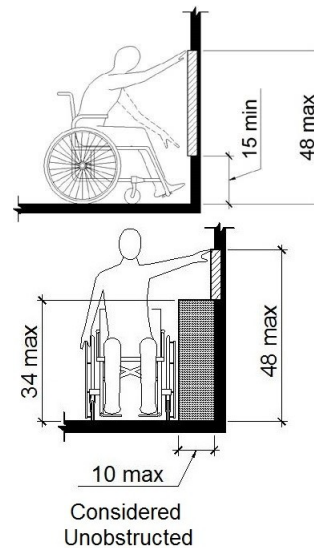
As Built: The defibrillator is not positioned correctly for either a side or front approach.

Where a clear floor or ground space allows a parallel or front approach and the side reach is unobstructed, the high side reach shall be 48 inches maximum above the finish floor or ground and the low side reach shall be 15 inches minimum above the finish floor or ground.

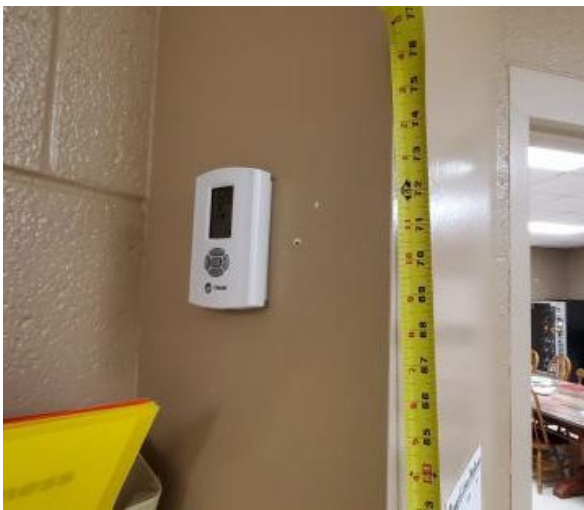
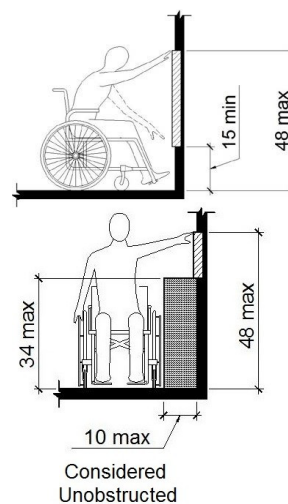
As Built: The thermostat is not positioned correctly for either a side or front approach.

Where a clear floor or ground space allows a parallel or front approach and the side reach is unobstructed, the high side reach shall be 48 inches maximum above the finish floor or ground and the low side reach shall be 15 inches minimum above the finish floor or ground.

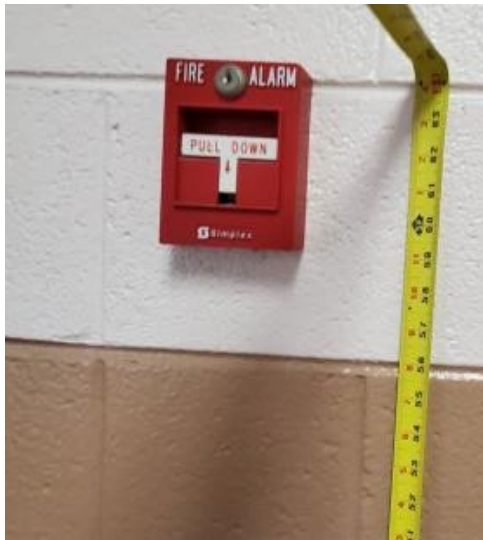
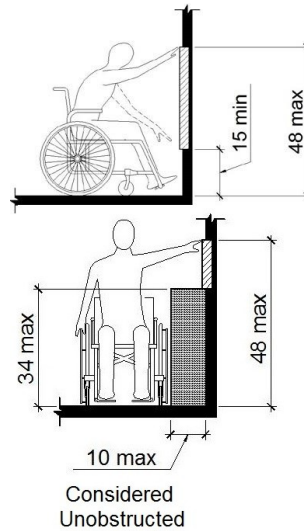
As Built: The fire alarm pull station is not positioned correctly for either a side or front approach.

Where a clear floor or ground space allows a parallel or front approach and the side reach is unobstructed, the high side reach shall be 48 inches maximum above the finish floor or ground and the low side reach shall be 15 inches minimum above the finish floor or ground.
