WEAKLEY COUNTY, TENNESSEE

ADA EVALUATION

Architectural and Site Findings with Recommendations

TLM Associates, Inc

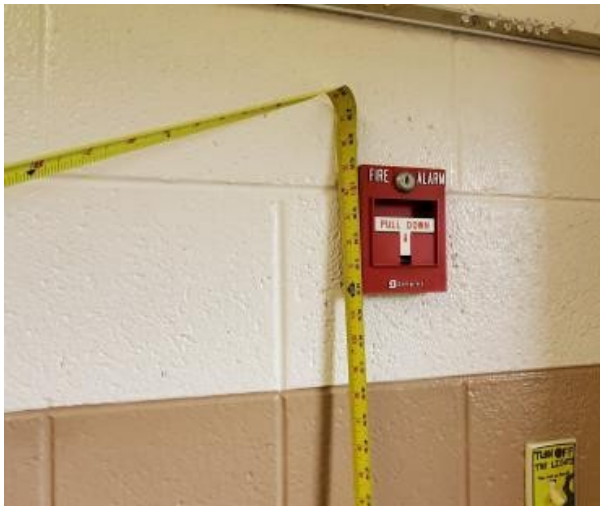
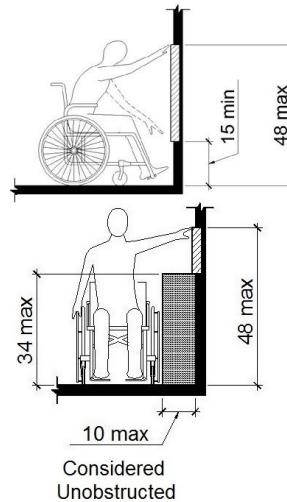
As Built: The fire alarm pull station is not positioned correctly for either a side or front approach.

Where a clear floor or ground space allows a parallel or front approach and the side reach is unobstructed, the high side reach shall be 48 inches maximum above the finish floor or ground and the low side reach shall be 15 inches minimum above the finish floor or ground.

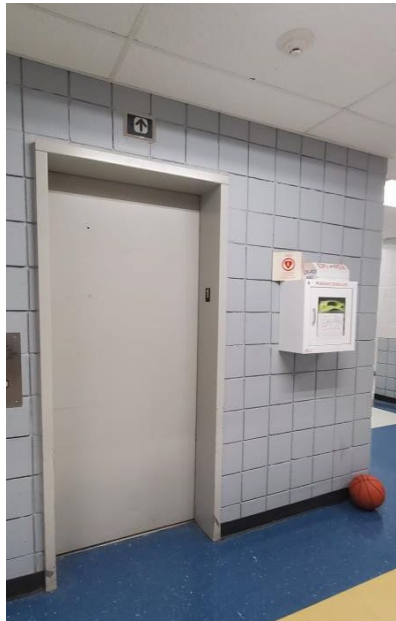
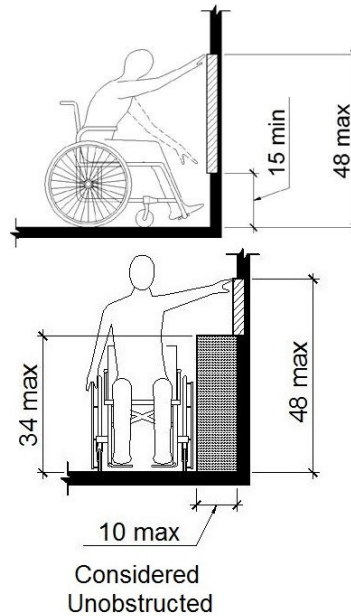
As Built: The defibrillator is not positioned correctly for either a side or front approach.

Where a clear floor or ground space allows a parallel or front approach and the side reach is unobstructed, the high side reach shall be 48 inches maximum above the finish floor or ground and the low side reach shall be 15 inches minimum above the finish floor or ground.

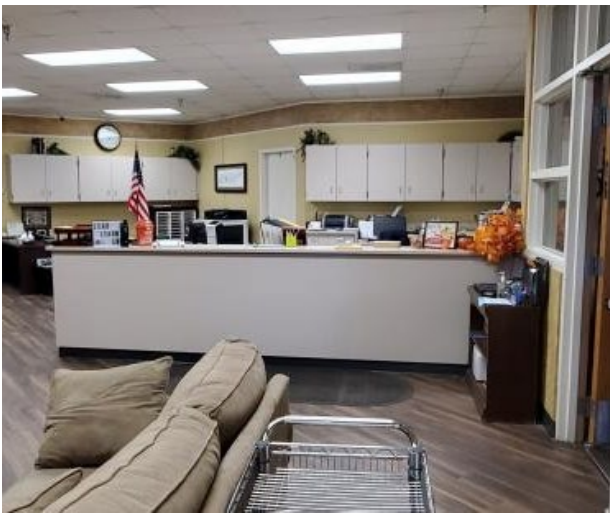
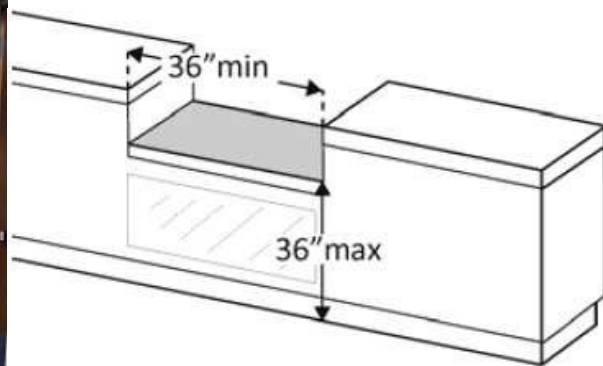
As Built: The counter is too high.

A portion of the counter surface that is 36 inches long minimum and 36 inches high maximum above the finish floor shall be provided. Knee and toe space must be provided for a forward approach. A 30 inch by 48 inch clear floor space on an accessible route must be provided for either a forward or parallel approach.

Cut out 3' (width) section and replace with new counter at 36" AFF.

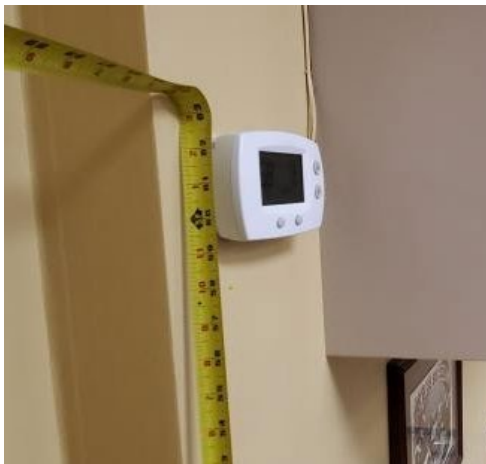
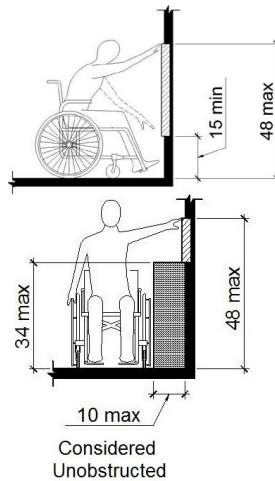
As Built: The thermostat is not positioned correctly for either a side or front approach.

Where a clear floor or ground space allows a parallel or front approach and the side reach is unobstructed, the high side reach shall be 48 inches maximum above the finish floor or ground and the low side reach shall be 15 inches minimum above the finish floor or ground.

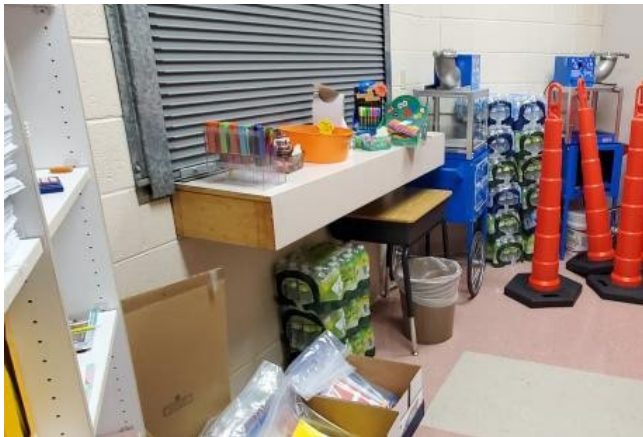
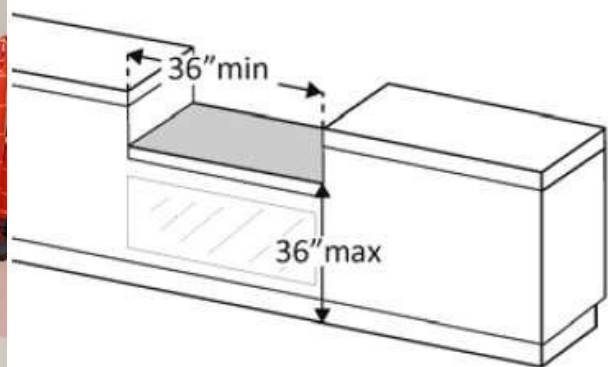
As Built: The counter is too high.

A portion of the counter surface that is 36 inches long minimum and 36 inches high maximum above the finish floor shall be provided. Knee and toe space must be provided for a forward approach. A 30 inch by 48 inch clear floor space on an accessible route must be provided for either a forward or parallel approach.

Cut out 3' (width) section and replace with new counter at 36" AFF.

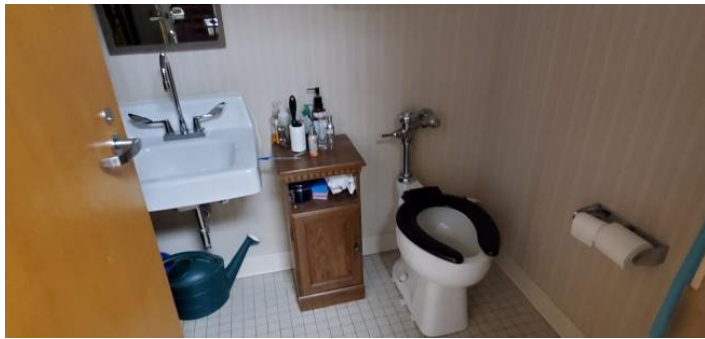
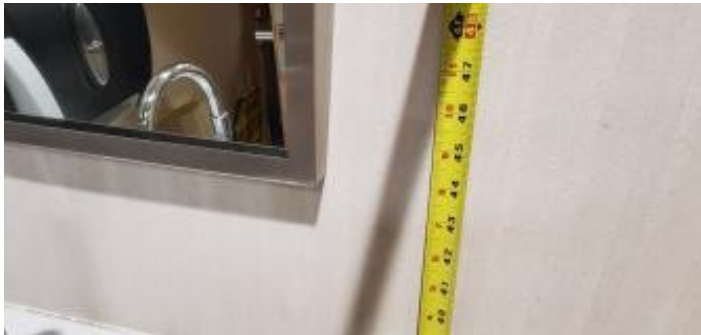
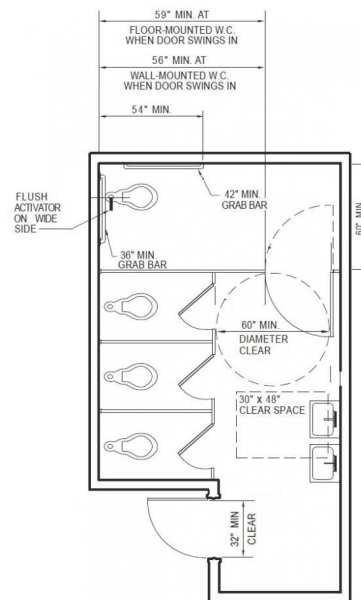
As Built: The restroom does not have the required minimum clear floor space or maneuvering clearances for the toilet. The restroom does not have the required minimum clear floor space or maneuvering clearances for the lavatory. Lavatory does not have pipe insulation. The entry door does not contain the required minimum 60 inches maneuvering space on the pull side. The entry door encroach into the required clear floor space for fixtures. Grab bars are not installed. Mirror are either too high or without clear floor space or both.

Citation: 2010 ADAS Section 213.2

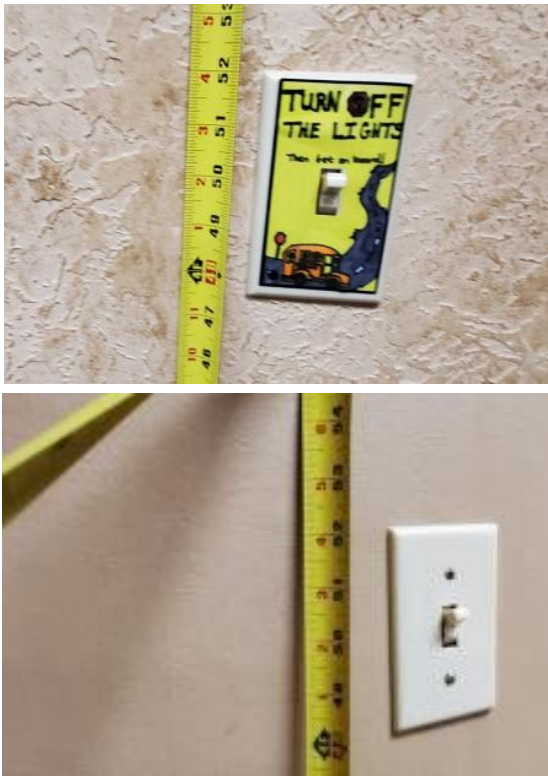
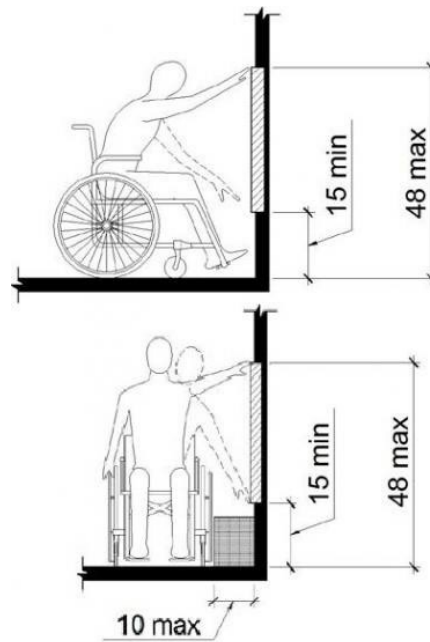
As Built: The receptacle/switch is not positioned correctly for either a side or front approach.

Where a clear floor or ground space allows a parallel or front approach to a switch or receptacle and the side reach is unobstructed, the high side reach shall be 48 inches maximum above the finish floor or ground and the low side reach shall be 15 inches minimum above the finish floor or ground.

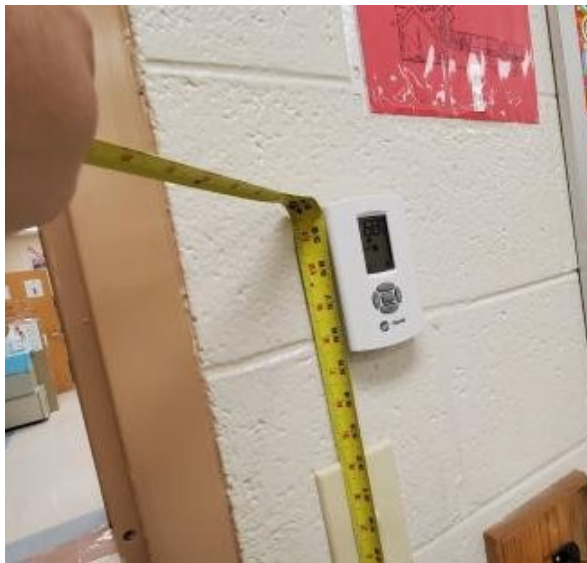
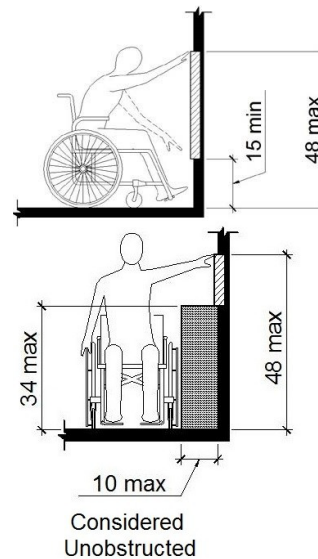
As Built: The thermostat is not positioned correctly for either a side or front approach.

Where a clear floor or ground space allows a parallel or front approach and the side reach is unobstructed, the high side reach shall be 48 inches maximum above the finish floor or ground and the low side reach shall be 15 inches minimum above the finish floor or ground.

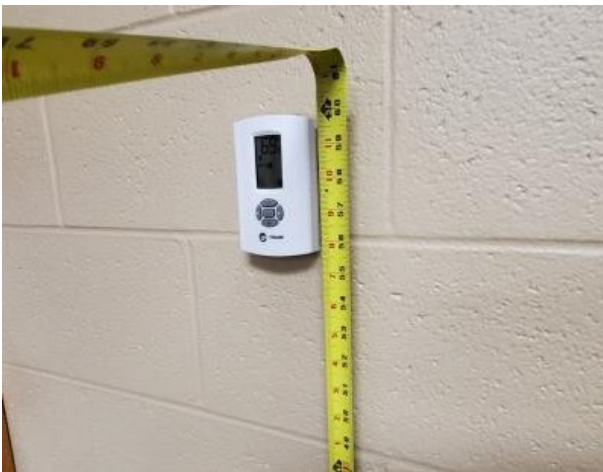
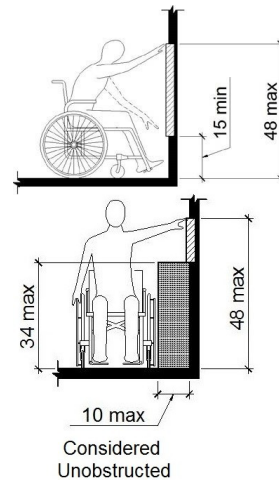
As Built: The thermostat is not positioned correctly for either a side or front approach.

Where a clear floor or ground space allows a parallel or front approach and the side reach is unobstructed, the high side reach shall be 48 inches maximum above the finish floor or ground and the low side reach shall be 15 inches minimum above the finish floor or ground.

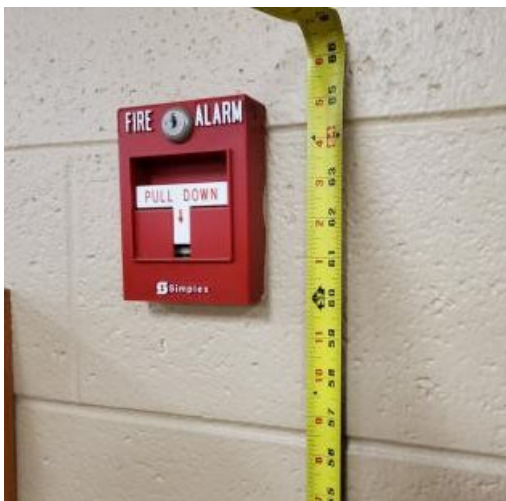
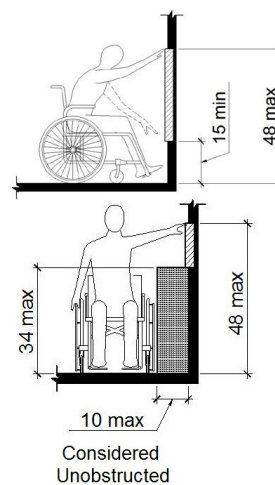
As Built: The fire alarm pad is not positioned correctly for either a side or front approach.

Where a clear floor or ground space allows a parallel or front approach and the side reach is unobstructed, the high side reach shall be 48 inches maximum above the finish floor or ground and the low side reach shall be 15 inches minimum above the finish floor or ground.

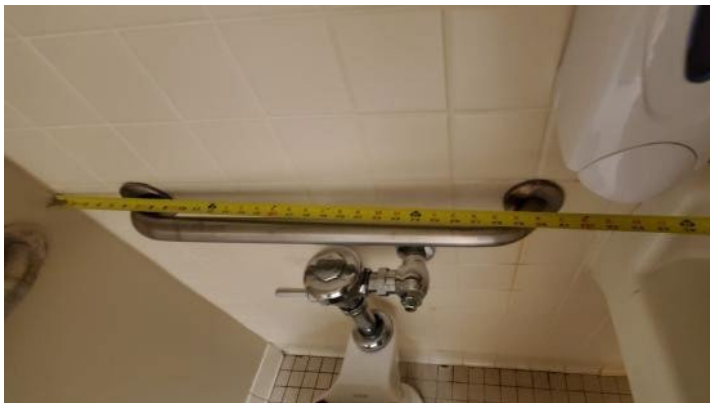
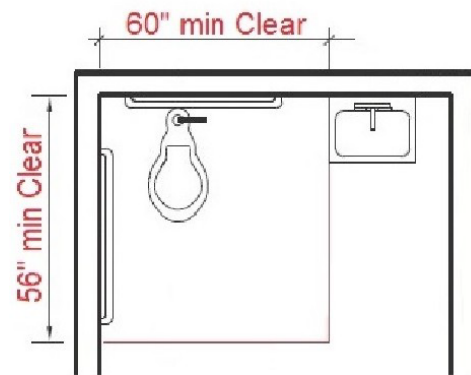
As Built: The lavatory projects into the clear floor space required for the toilet. The clear floor space is 60 inches along the back wall by 56 inches.

The required clearance around the water closet shall be permitted to overlap the water closet, associated grab bars, dispensers, sanitary napkin disposal units, coat hooks, shelves, accessible routes, clear floor space and clearances required at other fixtures, and the turning space. No other fixtures or obstructions shall be located within the required water closet clearance.

See previous recommendation and budget.

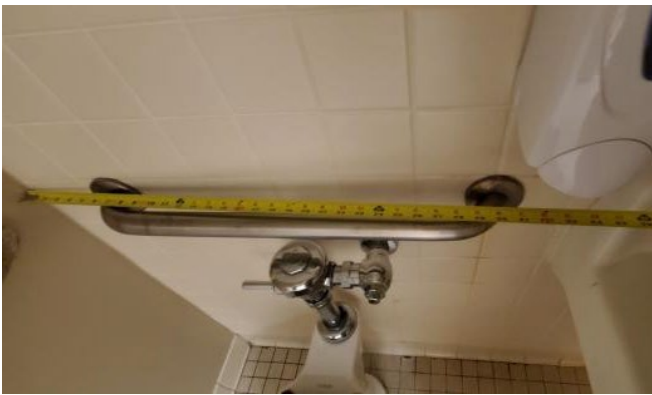
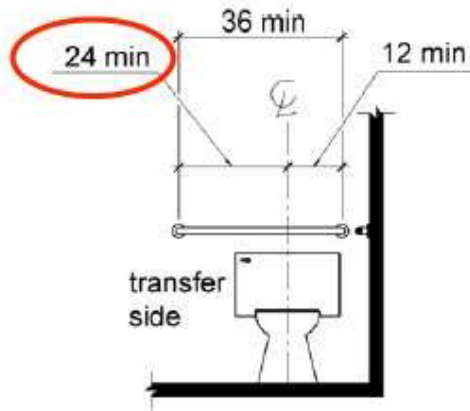
As Built: The rear grab bar does not extend adequately past the toilet on the wide side.

The rear grab bar must be a minimum of 36 inches long and extend from the centerline of the toilet 12 inches minimum on wall side and 24 inches minimum on the wide side.

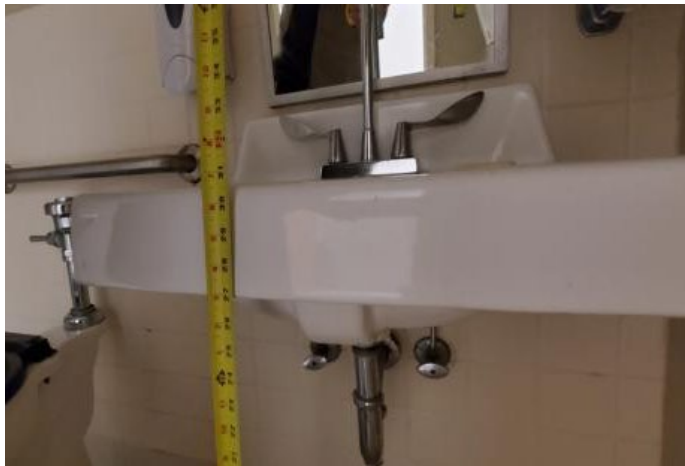
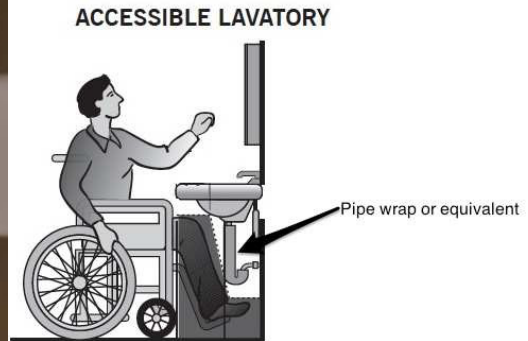
As Built: The water and drainpipes under the lavatory are not adequately insulated.

Water supply and drainpipes under lavatories and sinks shall be insulated or otherwise configured to protect against contact. There shall be no sharp or abrasive surfaces under lavatories and sinks.

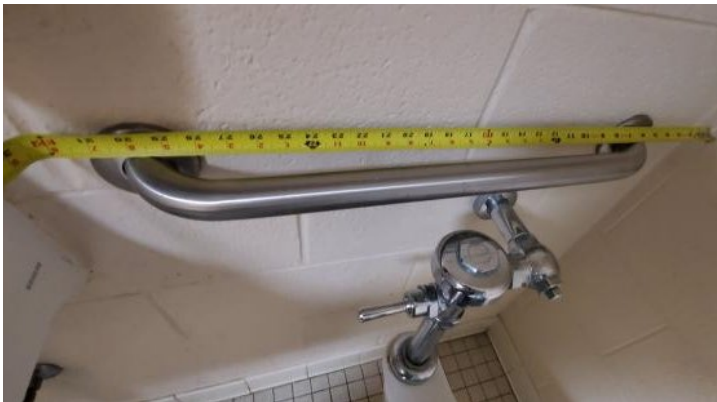
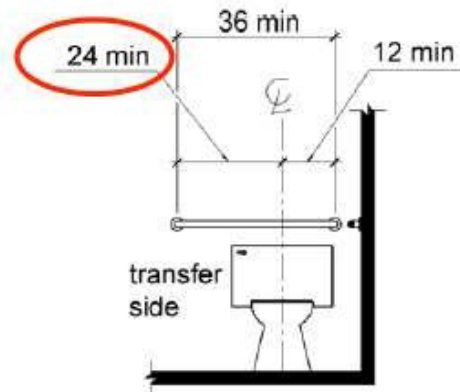
As Built: The rear grab bar does not extend adequately past the toilet on the wide side.

The rear grab bar must be a minimum of 36 inches long and extend from the centerline of the toilet 12 inches minimum on wall side and 24 inches minimum on the wide side.

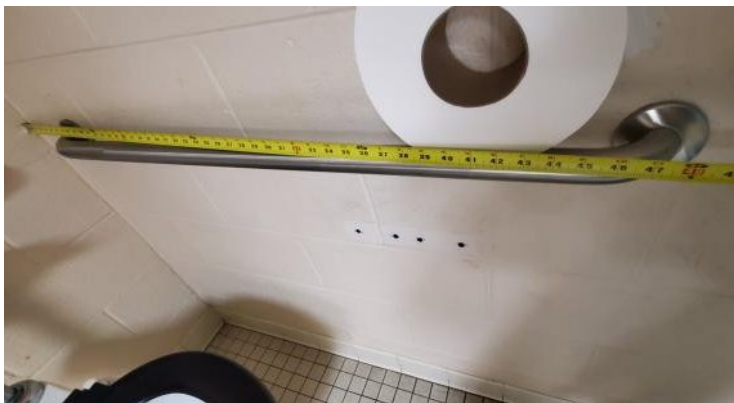
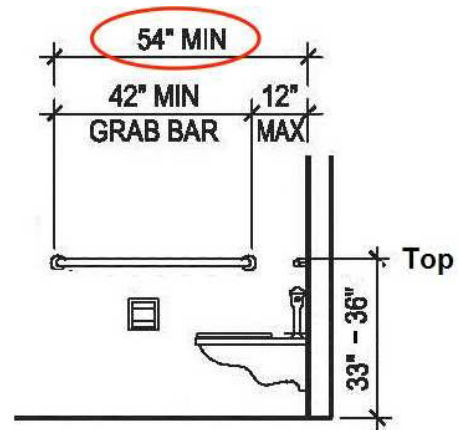
As Built: The side grab bar does not extend far enough from the rear wall.

The side grab bar must extend at least 54 inches minimum beyond the rear wall and start a maximum of 12 inches from the rear wall. A 42 inch grab bar installed the maximum distance from the rear wall (12 inches) will leave the leading end 54 inches from the rear wall.

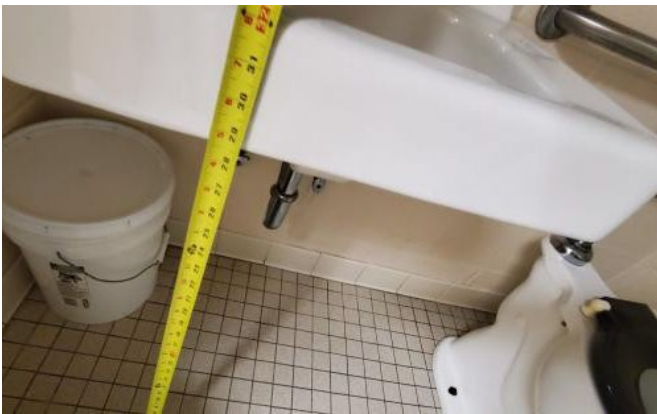
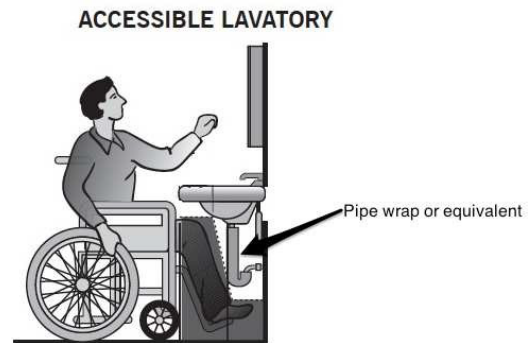
As Built: The water and drainpipes under the lavatory are not adequately insulated.

Water supply and drainpipes under lavatories and sinks shall be insulated or otherwise configured to protect against contact. There shall be no sharp or abrasive surfaces under lavatories and sinks.

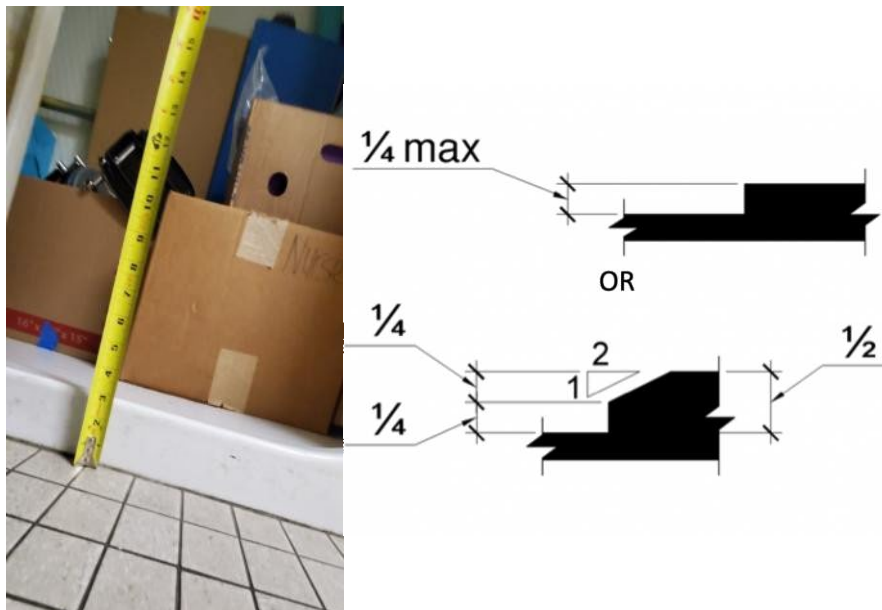
As Built: The threshold for the shower exceeds the maximum height requirement.

Threshold at roll-in shower compartments shall be no higher than 1/2 inch. Changes in level between 1/4 inch and 1/2 inch must be beveled at 1:2 or less. 1/4 inch is the maximum vertical rise.

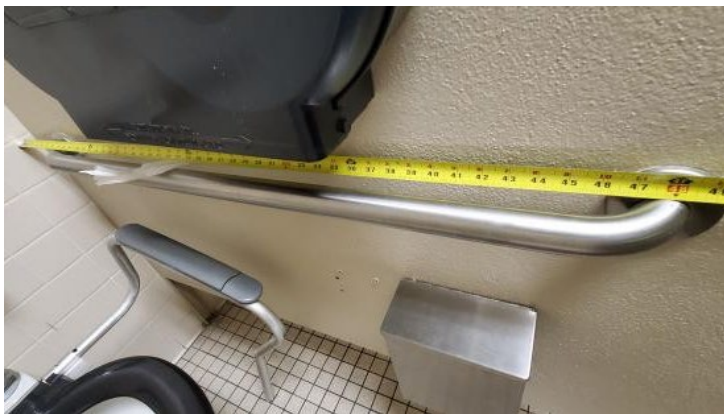
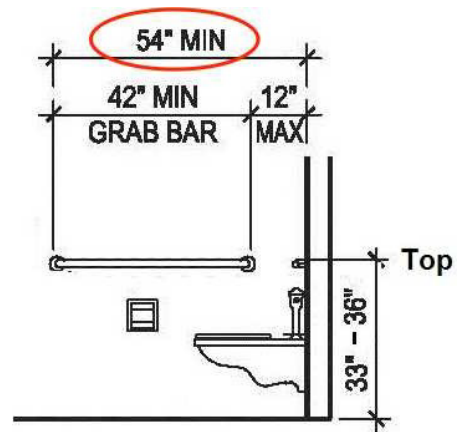
As Built: The side grab bar does not extend far enough from the rear wall.

The side grab bar must extend at least 54 inches minimum beyond the rear wall and start a maximum of 12 inches from the rear wall. A 42 inch grab bar installed the maximum distance from the rear wall (12 inches) will leave the leading end 54 inches from the rear wall.

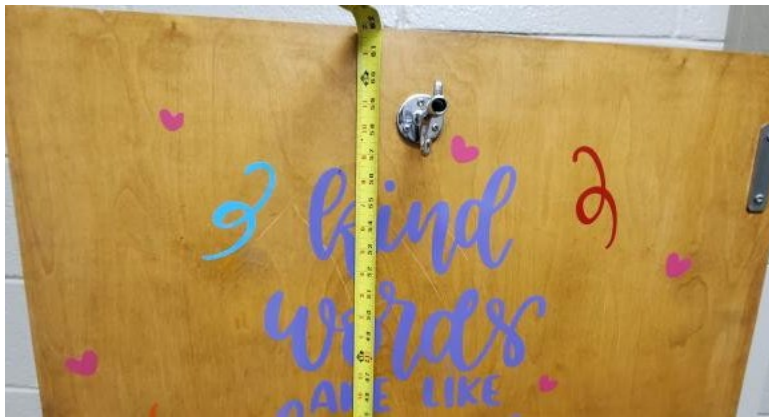
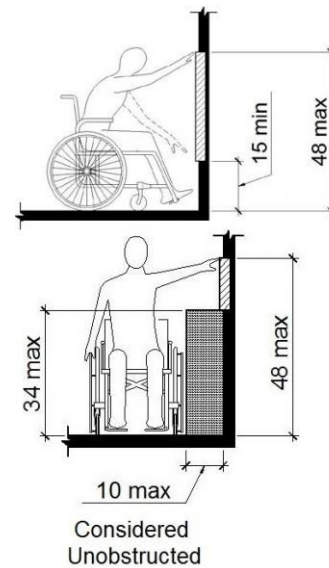
As Built: The coat hook is installed greater than 48 inches above the finished floor.

Where a forward reach is unobstructed, the high forward reach shall be 48 inches maximum above the finished floor.

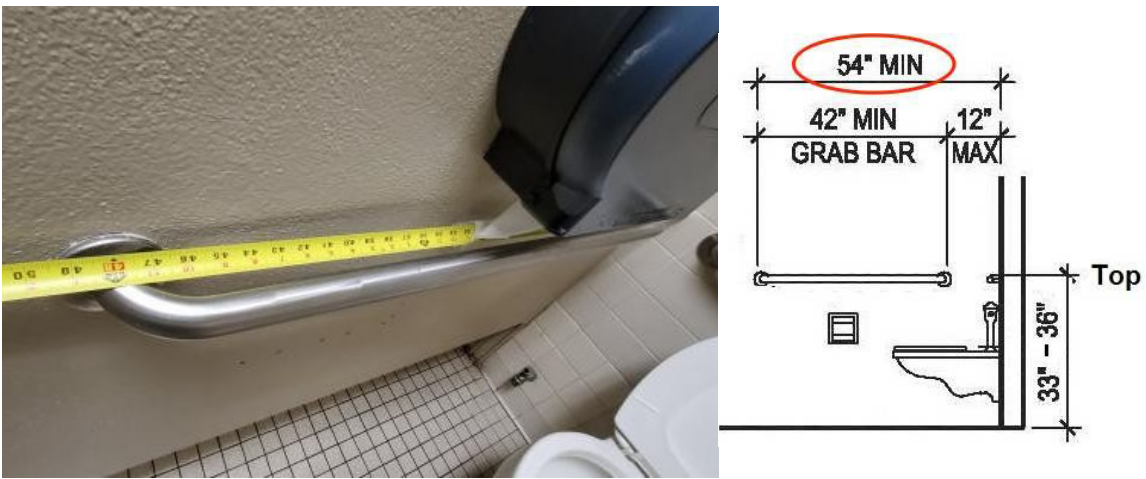
As Built: The side grab bar does not extend far enough from the rear wall.

The side grab bar must extend at least 54 inches minimum beyond the rear wall and start a maximum of 12 inches from the rear wall. A 42 inch grab bar installed the maximum distance from the rear wall (12 inches) will leave the leading end 54 inches from the rear wall.

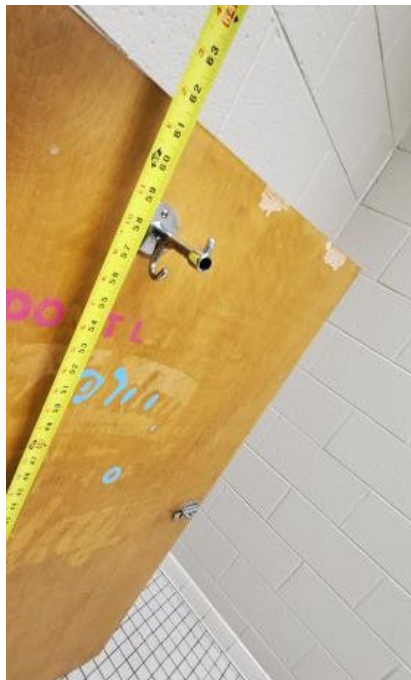
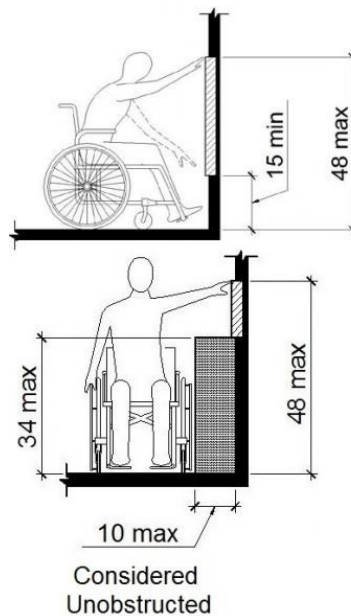
As Built: The coat hook is installed greater than 48 inches above the finished floor.

Where a forward reach is unobstructed, the high forward reach shall be 48 inches maximum above the finished floor.

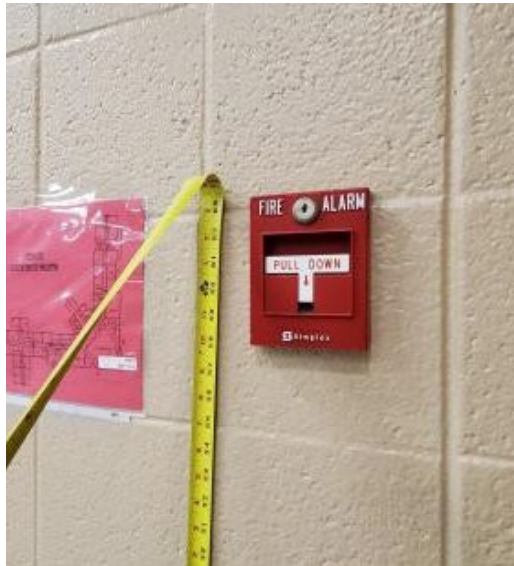
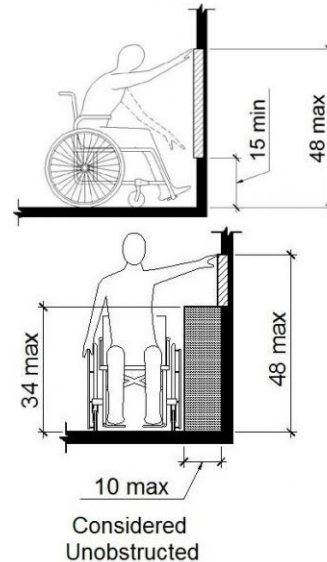
As Built: The fire alarm pull station is not positioned correctly for either a side or front approach.

Where a clear floor or ground space allows a parallel or front approach and the side reach is unobstructed, the high side reach shall be 48 inches maximum above the finish floor or ground and the low side reach shall be 15 inches minimum above the finish floor or ground.

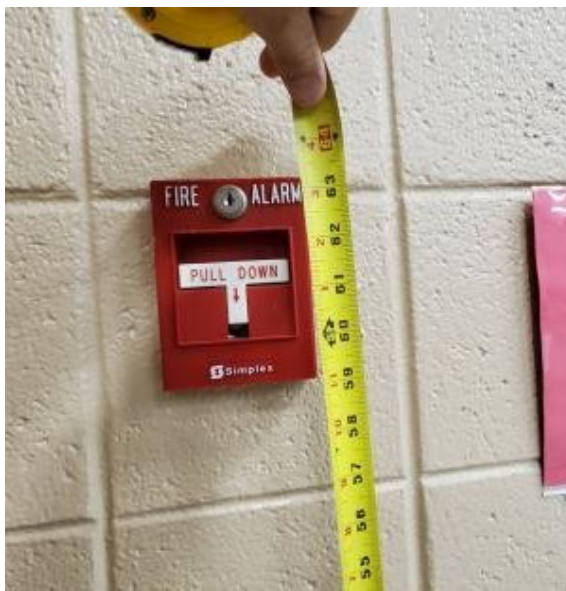
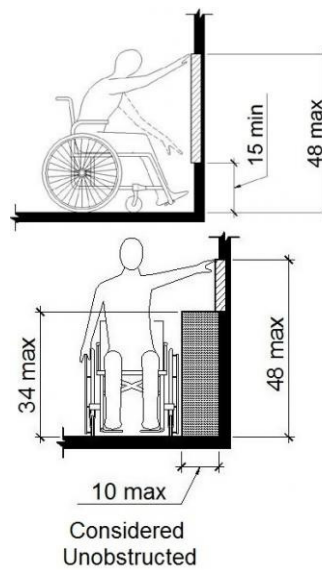
As Built: The fire alarm pull station is not positioned correctly for either a side or front approach.

Where a clear floor or ground space allows a parallel or front approach and the side reach is unobstructed, the high side reach shall be 48 inches maximum above the finish floor or ground and the low side reach shall be 15 inches minimum above the finish floor or ground.

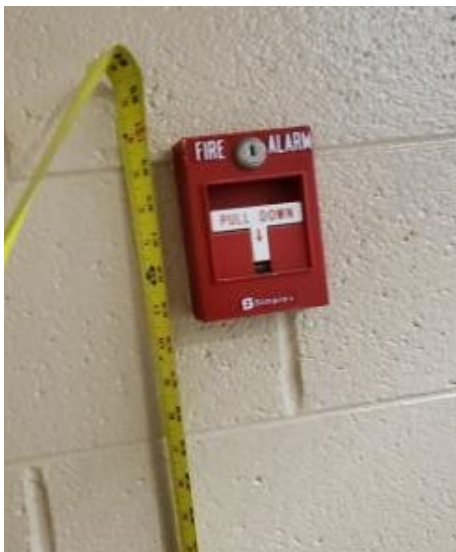
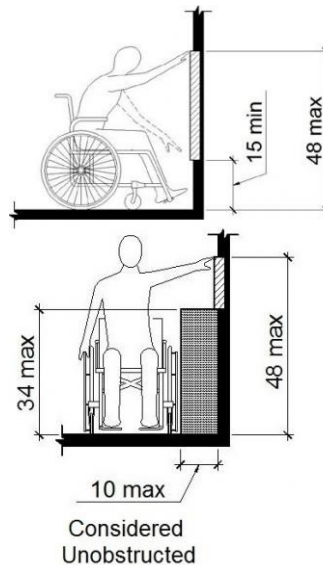
As Built: The fire alarm pull station is not positioned correctly for either a side or front approach.

Where a clear floor or ground space allows a parallel or front approach and the side reach is unobstructed, the high side reach shall be 48 inches maximum above the finish floor or ground and the low side reach shall be 15 inches minimum above the finish floor or ground.

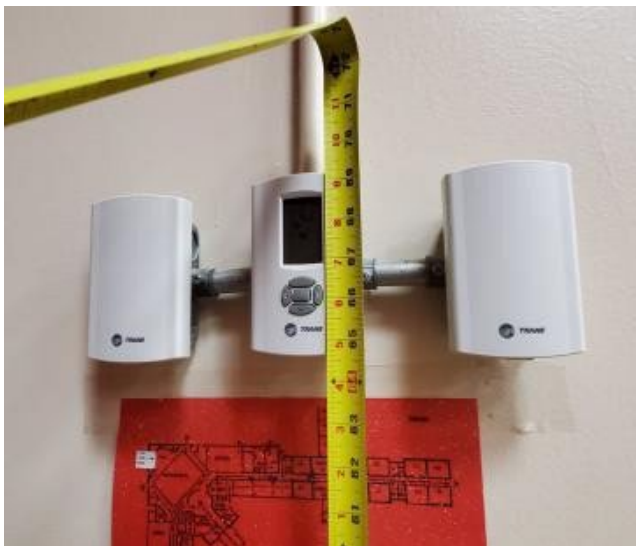
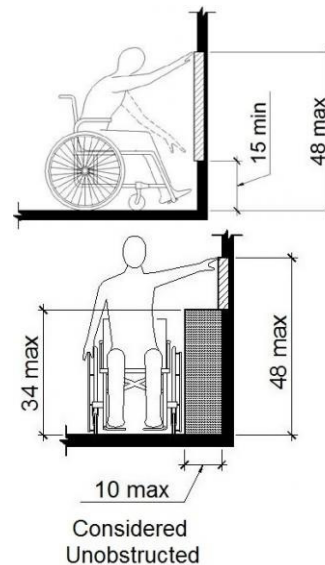
As Built: The thermostat is not positioned correctly for either a side or front approach.

Where a clear floor or ground space allows a parallel or front approach and the side reach is unobstructed, the high side reach shall be 48 inches maximum above the finish floor or ground and the low side reach shall be 15 inches minimum above the finish floor or ground.

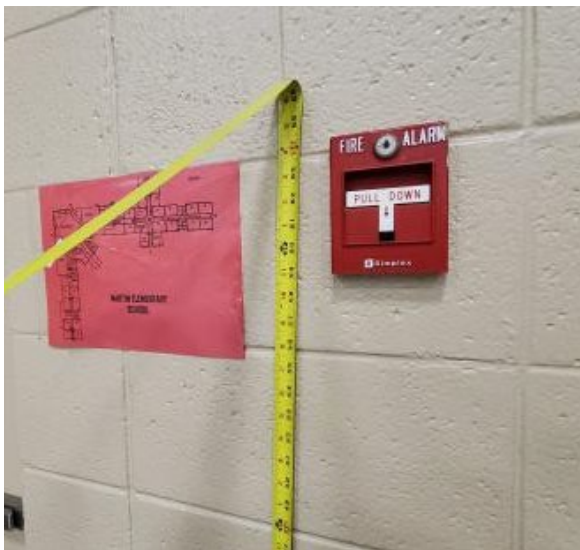
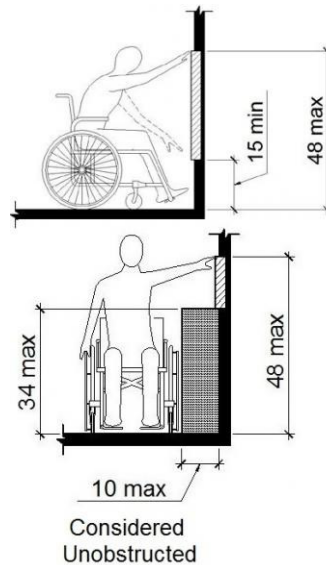
As Built: The fire alarm pull station is not positioned correctly for either a side or front approach.

Where a clear floor or ground space allows a parallel or front approach and the side reach is unobstructed, the high side reach shall be 48 inches maximum above the finish floor or ground and the low side reach shall be 15 inches minimum above the finish floor or ground.

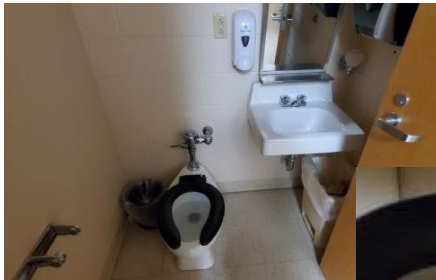
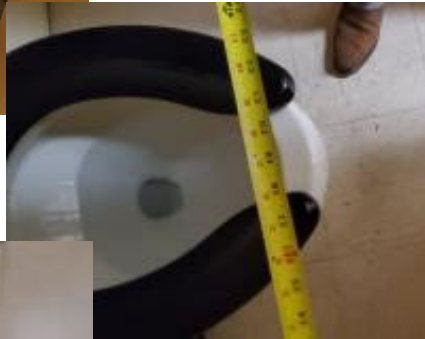
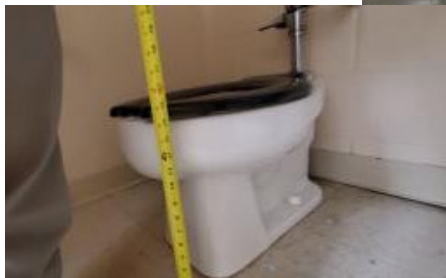
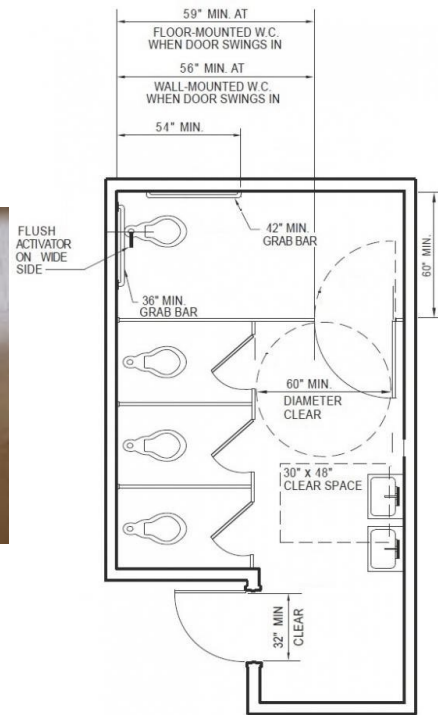
As Built: The restroom does not have the required minimum clear floor space or maneuvering clearances for the toilet. The restroom does not have the required minimum clear floor space or maneuvering clearances for the lavatory. The entry door does not contain the required minimum 60 inches maneuvering space on the pull side. The entry door encroach into the required clear floor space for fixtures. No Grab bars installed. Paper Towel dispenser too high. Toilet seat is not within 16-18 from wall.

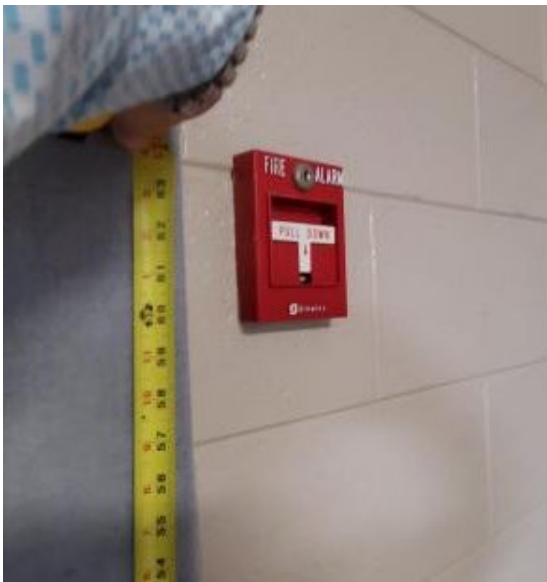
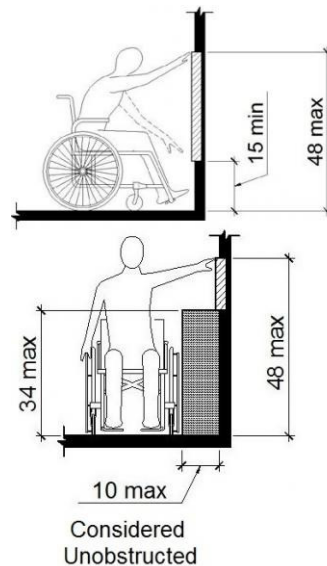
As Built: The fire alarm pull station is not positioned correctly for either a side or front approach.

Where a clear floor or ground space allows a parallel or front approach and the side reach is unobstructed, the high side reach shall be 48 inches maximum above the finish floor or ground and the low side reach shall be 15 inches minimum above the finish floor or ground.

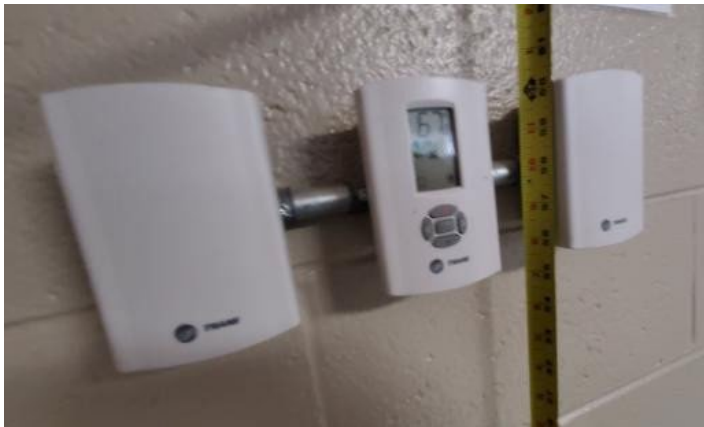
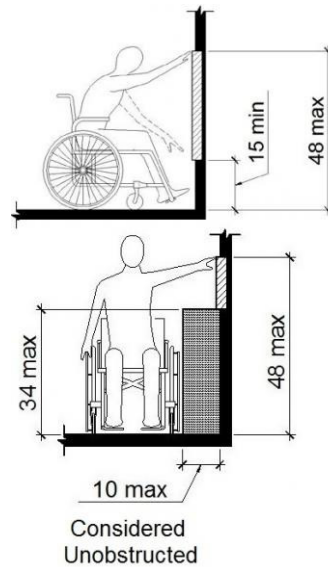
As Built: The thermostat is not positioned correctly for either a side or front approach.

Where a clear floor or ground space allows a parallel or front approach and the side reach is unobstructed, the high side reach shall be 48 inches maximum above the finish floor or ground and the low side reach shall be 15 inches minimum above the finish floor or ground.

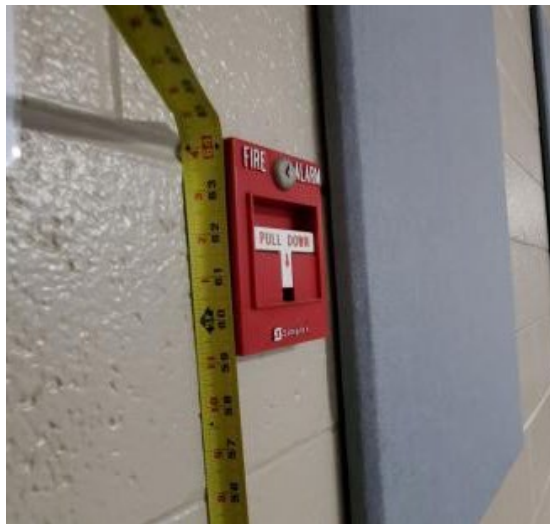
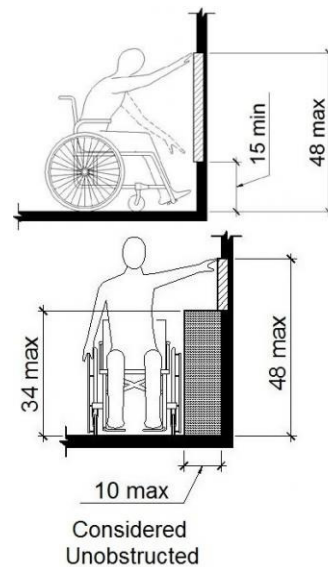
As Built: The fire alarm pull station is not positioned correctly for either a side or front approach.

Where a clear floor or ground space allows a parallel or front approach and the side reach is unobstructed, the high side reach shall be 48 inches maximum above the finish floor or ground and the low side reach shall be 15 inches minimum above the finish floor or ground.

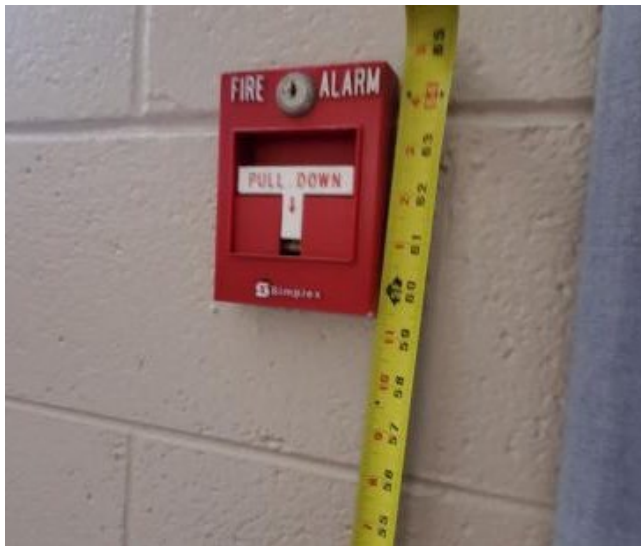
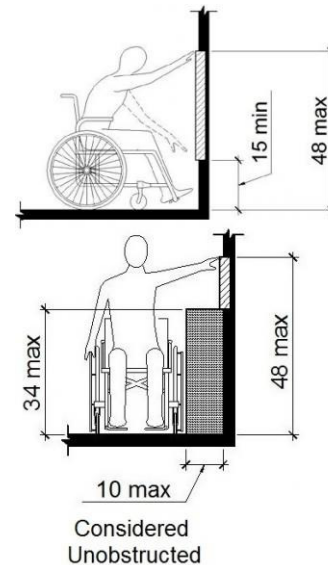
As Built: The fire alarm pull station is not positioned correctly for either a side or front approach.

Where a clear floor or ground space allows a parallel or front approach and the side reach is unobstructed, the high side reach shall be 48 inches maximum above the finish floor or ground and the low side reach shall be 15 inches minimum above the finish floor or ground.

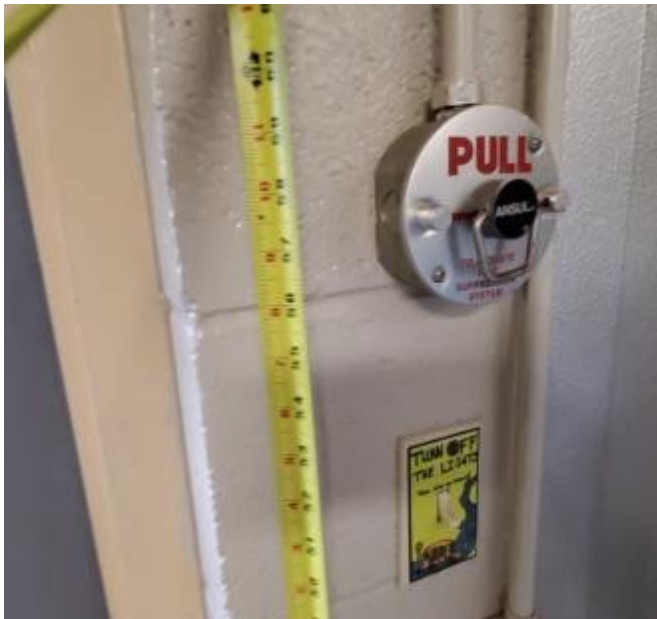
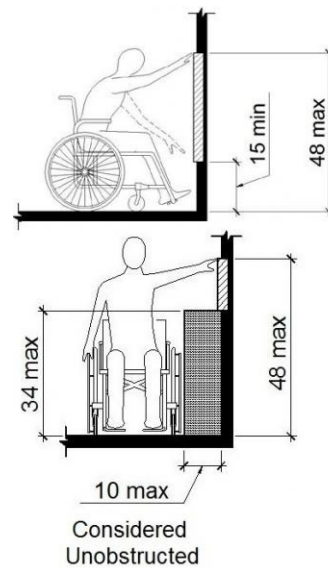
As Built: The Ansul Suppression pull station is not positioned correctly for either a side or front approach.

Where a clear floor or ground space allows a parallel or front approach and the side reach is unobstructed, the high side reach shall be 48 inches maximum above the finish floor or ground and the low side reach shall be 15 inches minimum above the finish floor or ground.

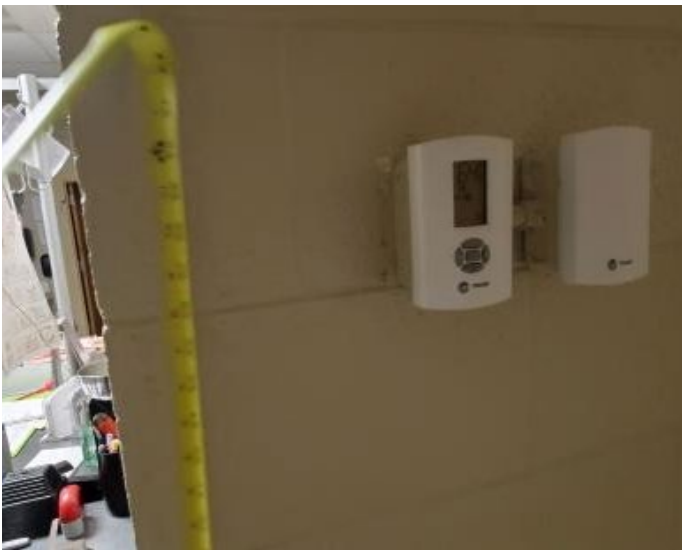
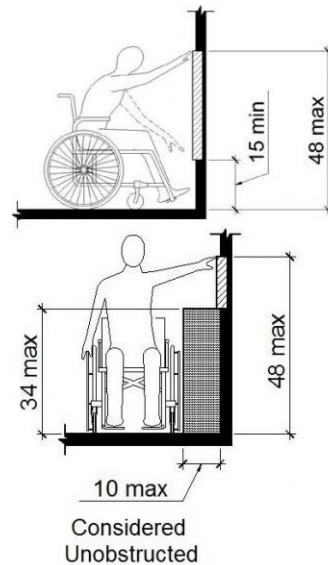
As Built: The thermostat is not positioned correctly for either a side or front approach.

Where a clear floor or ground space allows a parallel or front approach and the side reach is unobstructed, the high side reach shall be 48 inches maximum above the finish floor or ground and the low side reach shall be 15 inches minimum above the finish floor or ground.

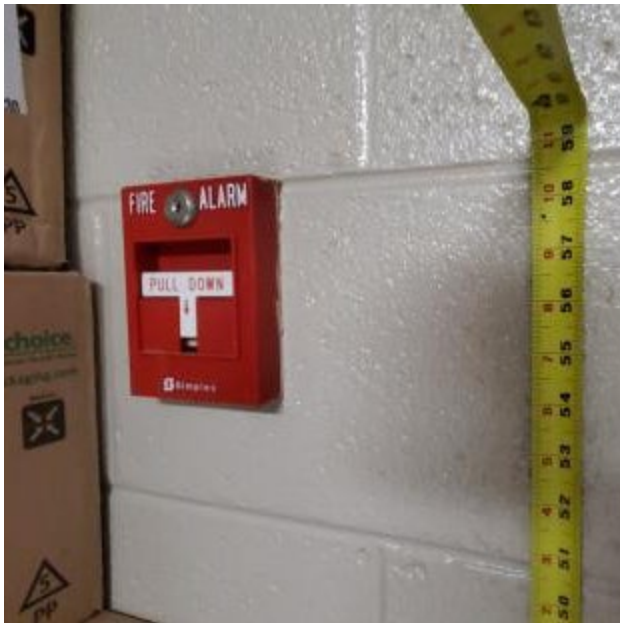
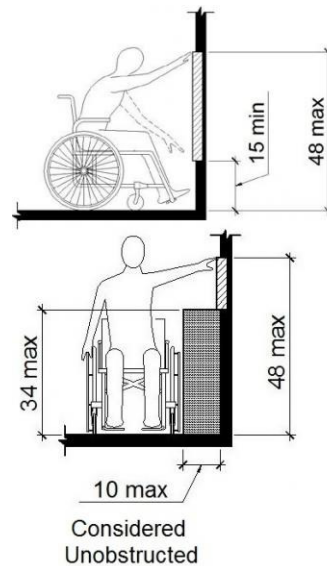
As Built: The fire alarm pull station is not positioned correctly for either a side or front approach.

Where a clear floor or ground space allows a parallel or front approach and the side reach is unobstructed, the high side reach shall be 48 inches maximum above the finish floor or ground and the low side reach shall be 15 inches minimum above the finish floor or ground.

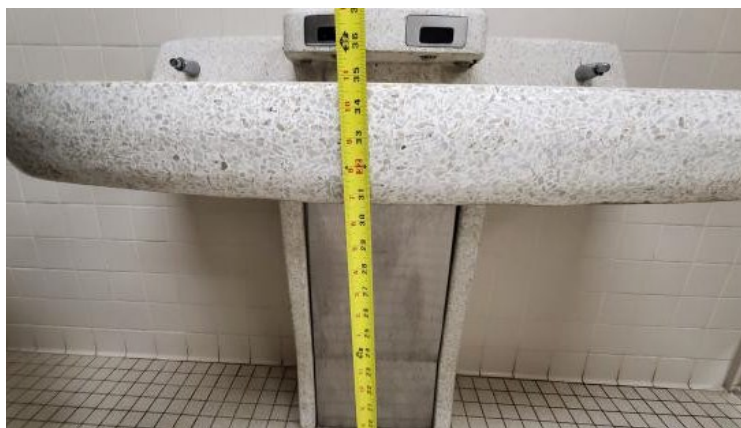
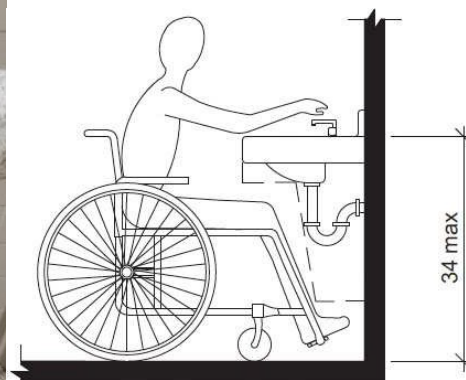
As Built: The top rim of the lavatory is too high.

All lavatories that are designated to be accessible shall be a minimum 17 inches in horizontal depth and mounted with the rim or counter edge no higher than 34 inches above the finished floor.

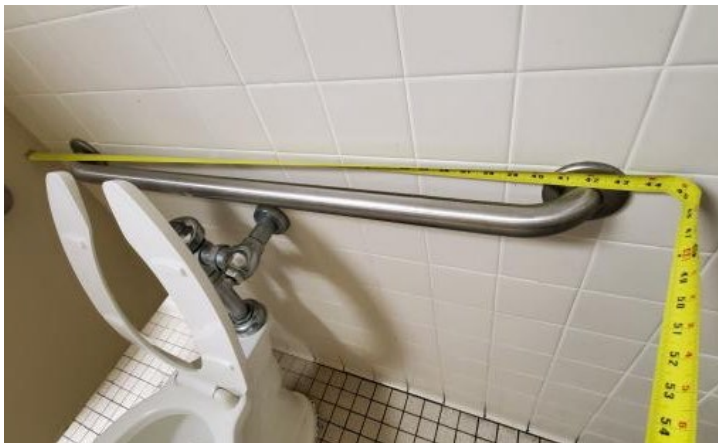
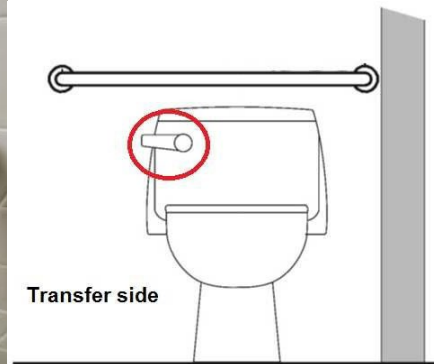
As Built: The flush handle is located on the wrong side of the toilet.

Controls shall be operable with one hand and shall not require tight grasping, pinching or twisting. Controls for the flush valves shall be mounted on the wide side of toilet areas, no more than 48 inches above the floor.

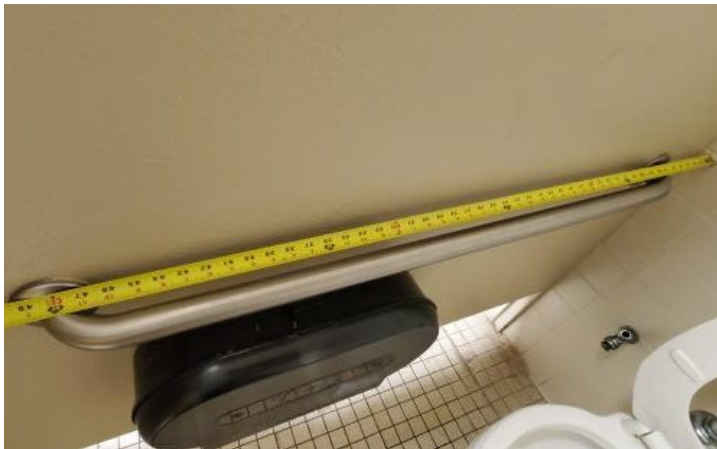
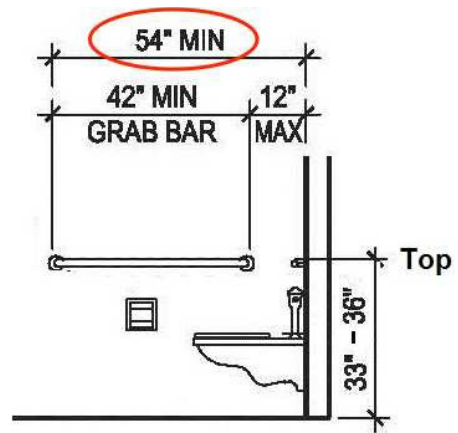
As Built: The side grab bar does not extend far enough from the rear wall.

The side grab bar must extend at least 54 inches minimum beyond the rear wall and start a maximum of 12 inches from the rear wall. A 42 inch grab bar installed the maximum distance from the rear wall (12 inches) will leave the leading end 54 inches from the rear wall.
