WEAKLEY COUNTY, TENNESSEE

ADA EVALUATION

Architectural and Site Findings with Recommendations

TLM Associates, Inc

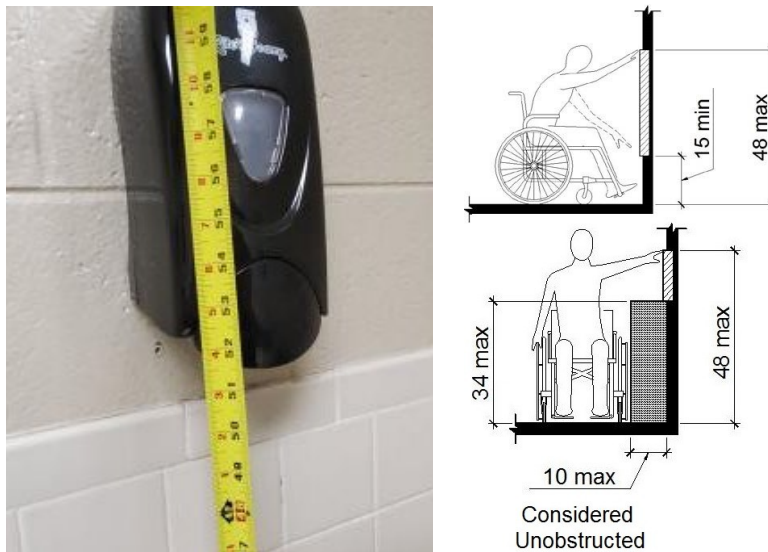
As Built: The soap dispenser is not positioned correctly for either a side or front approach.

Where a clear floor or ground space allows a parallel or front approach and the side reach is unobstructed, the high side reach shall be 48 inches maximum above the finish floor or ground and the low side reach shall be 15 inches minimum above the finish floor or ground.

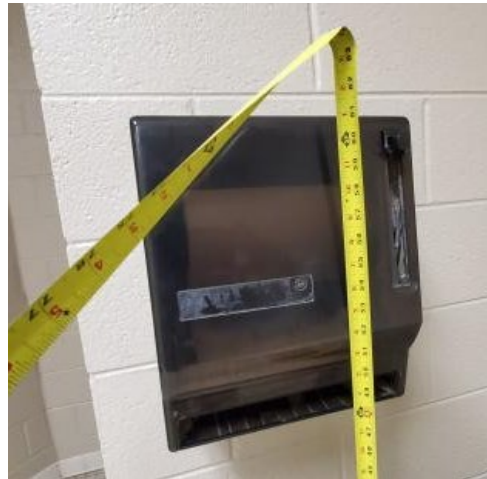
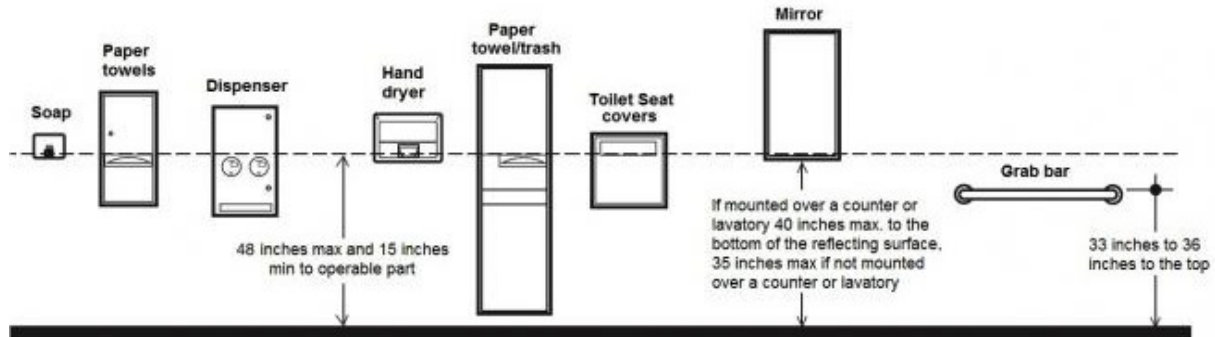
As Built: The paper towel dispenser's operation mechanism is too high off the floor. Dispensers must have all operable parts a maximum of 48 inches above the floor.

Citation: 2010 ADAS Section 308.2.1

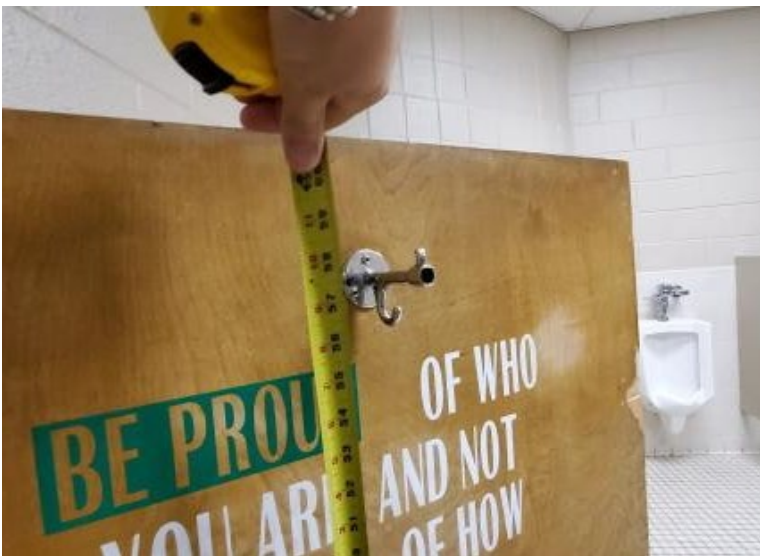
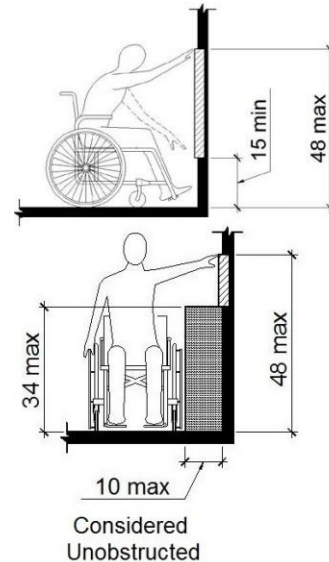
As Built: The coat hook is installed greater than 48 inches above the finished floor.

Where a forward reach is unobstructed, the high forward reach shall be 48 inches maximum above the finished floor.

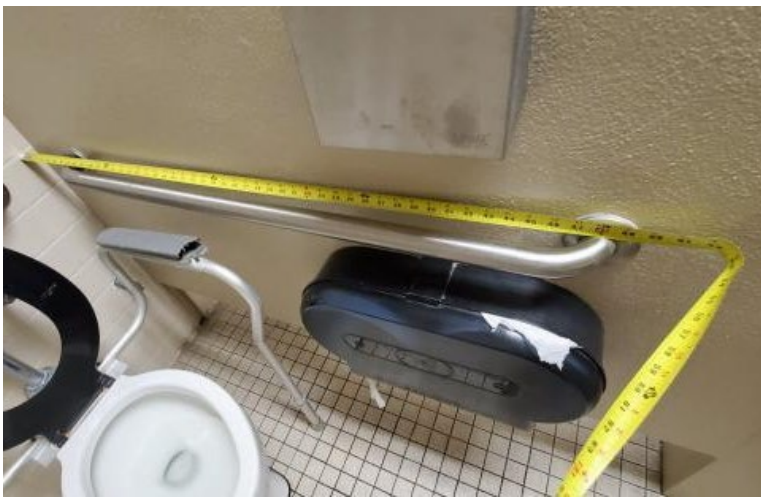
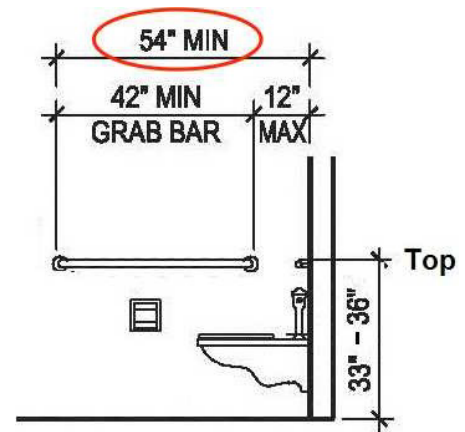
As Built: The side grab bar does not extend far enough from the rear wall.

The side grab bar must extend at least 54 inches minimum beyond the rear wall and start a maximum of 12 inches from the rear wall. A 42 inch grab bar installed the maximum distance from the rear wall (12 inches) will leave the leading end 54 inches from the rear wall.

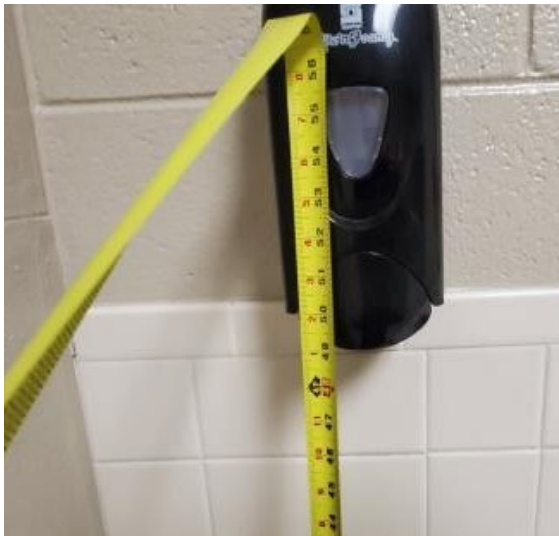
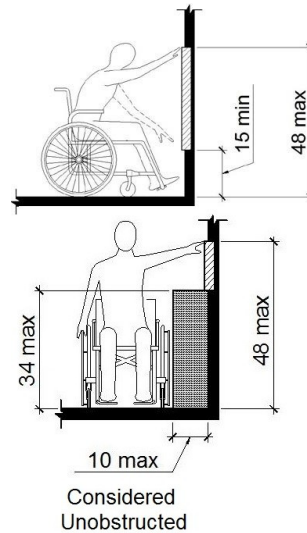
As Built: The soap dispenser is not positioned correctly for either a side or front approach.

Where a clear floor or ground space allows a parallel or front approach and the side reach is unobstructed, the high side reach shall be 48 inches maximum above the finish floor or ground and the low side reach shall be 15 inches minimum above the finish floor or ground.

Recommendation: Lower soap dispenser for all operable components to be 48" max AFF.

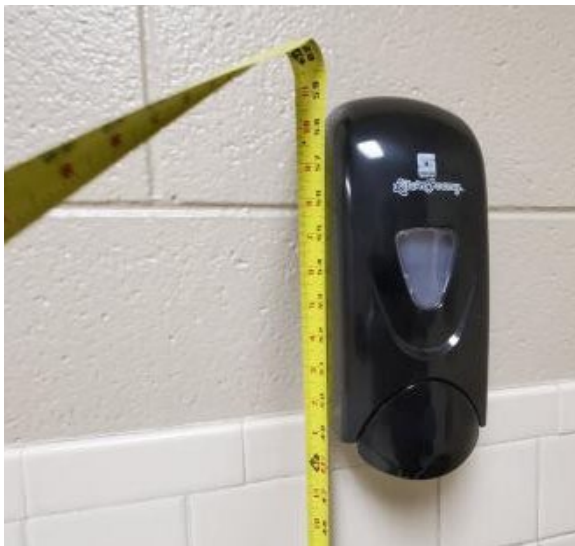
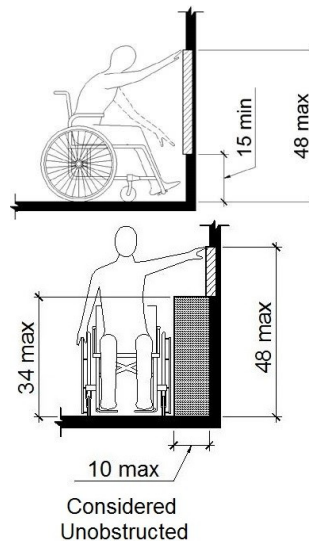
As Built: The soap dispenser is not positioned correctly for either a side or front approach.

Where a clear floor or ground space allows a parallel or front approach and the side reach is unobstructed, the high side reach shall be 48 inches maximum above the finish floor or ground and the low side reach shall be 15 inches minimum above the finish floor or ground.

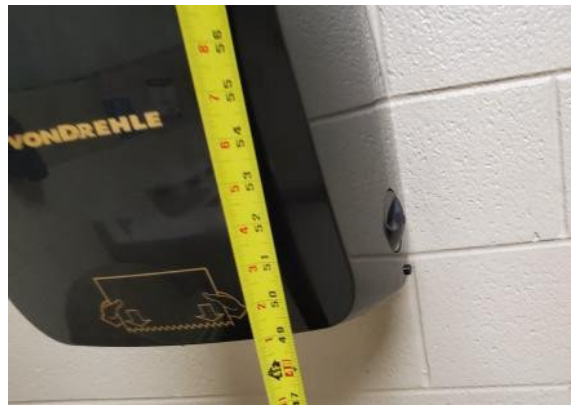
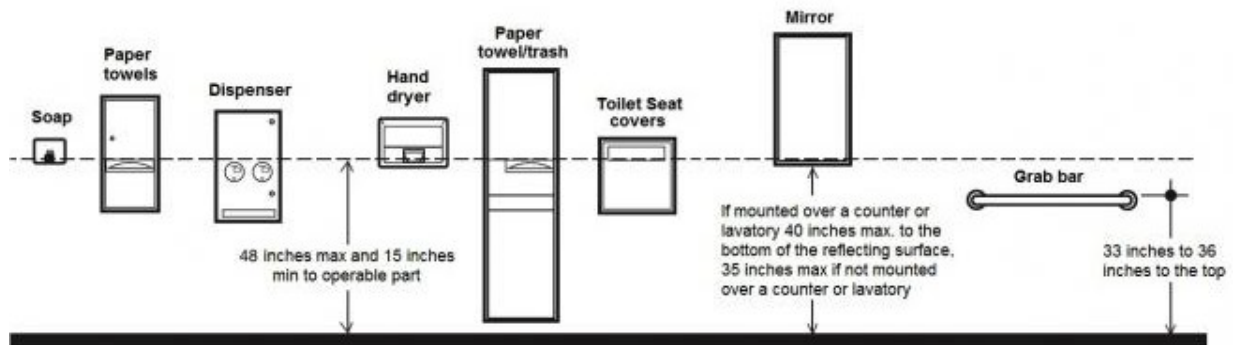
As Built: The paper towel dispenser's operation mechanism is too high off the floor. Dispensers must have all operable parts a maximum of 48 inches above the floor.

Citation: 2010 ADAS Section 308.2.1

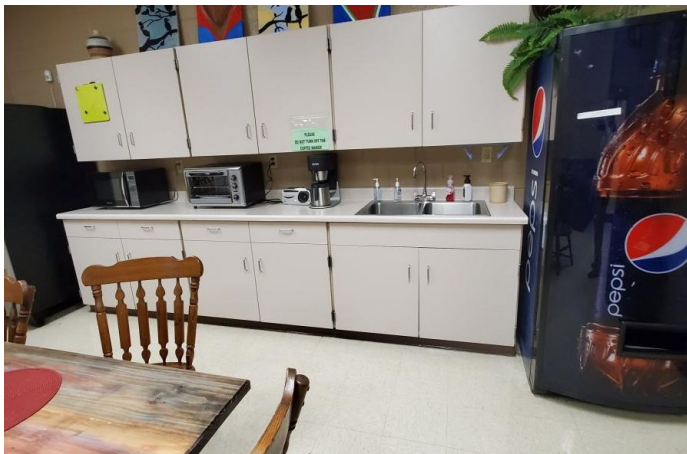
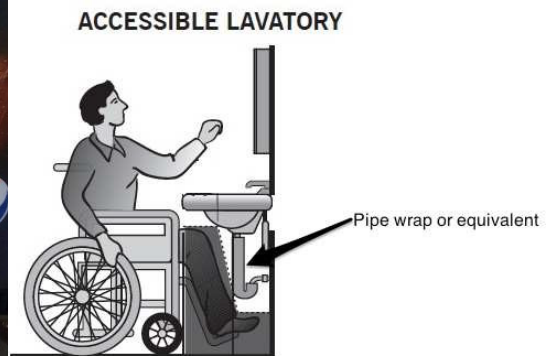
As Built: The top of the sink is too high.

Sinks that are required to be accessible shall be a minimum 17 inches in horizontal depth and mounted with the rim or counter edge no higher than 34 inches above the finished floor.

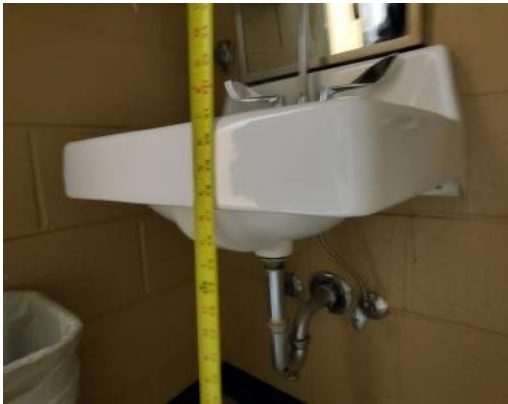
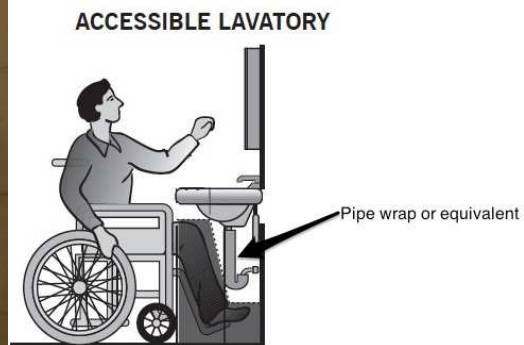
As Built: The water and drainpipes under the lavatory are not adequately insulated.

Water supply and drainpipes under lavatories and sinks shall be insulated or otherwise configured to protect against contact. There shall be no sharp or abrasive surfaces under lavatories and sinks.

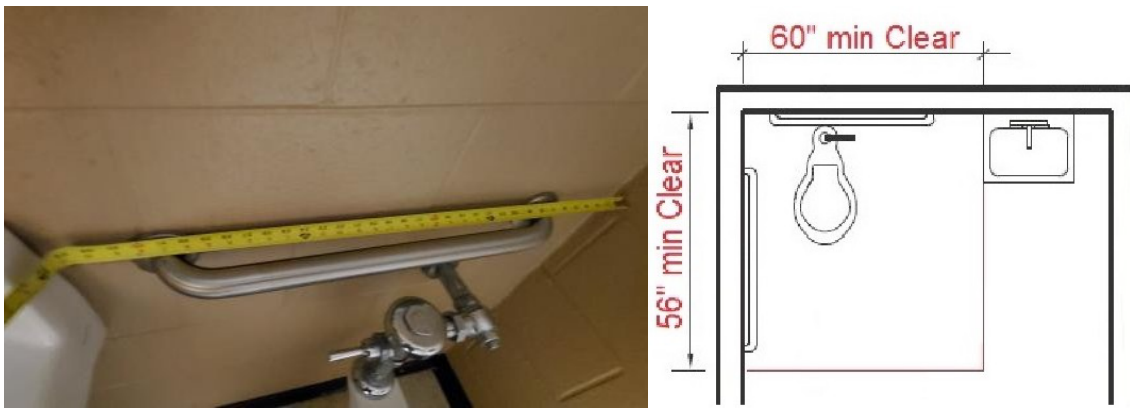
As Built: The lavatory projects into the clear floor space required for the toilet. The clear floor space is 60 inches along the back wall by 56 inches.

The required clearance around the water closet shall be permitted to overlap the water closet, associated grab bars, dispensers, sanitary napkin disposal units, coat hooks, shelves, accessible routes, clear floor space and clearances required at other fixtures, and the turning space. No other fixtures or obstructions shall be located within the required water closet clearance.

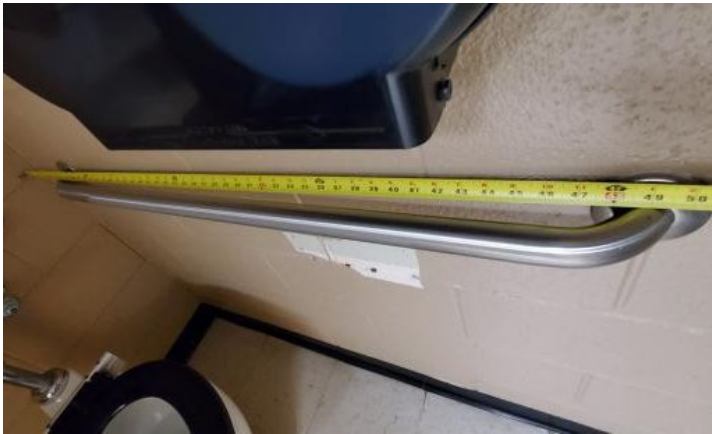
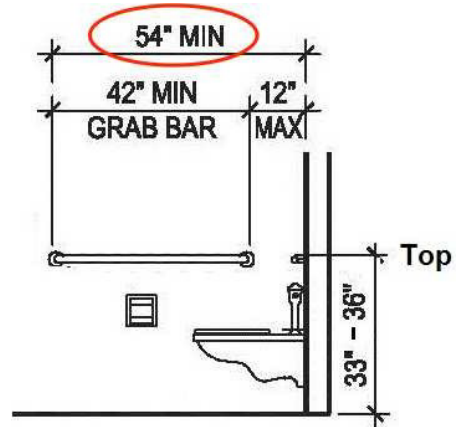
As Built: The side grab bar does not extend far enough from the rear wall.

The side grab bar must extend at least 54 inches minimum beyond the rear wall and start a maximum of 12 inches from the rear wall. A 42 inch grab bar installed the maximum distance from the rear wall (12 inches) will leave the leading end 54 inches from the rear wall.

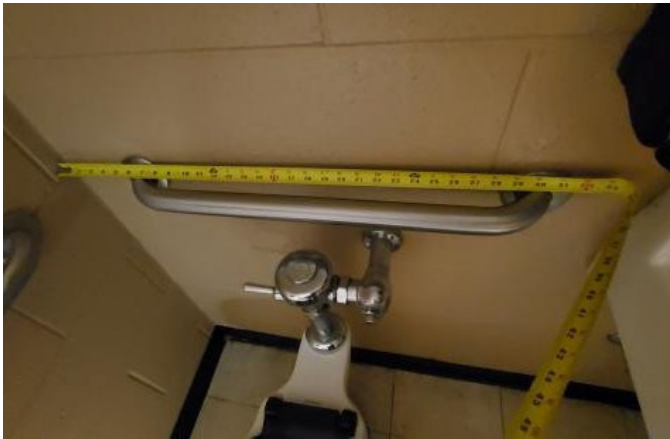
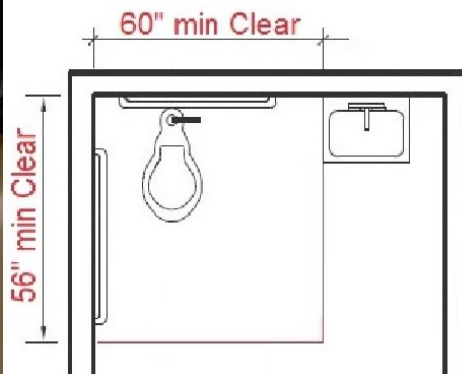
As Built: The lavatory projects into the clear floor space required for the toilet. The clear floor space is 60 inches along the back wall by 56 inches.

The required clearance around the water closet shall be permitted to overlap the water closet, associated grab bars, dispensers, sanitary napkin disposal units, coat hooks, shelves, accessible routes, clear floor space and clearances required at other fixtures, and the turning space. No other fixtures or obstructions shall be located within the required water closet clearance.

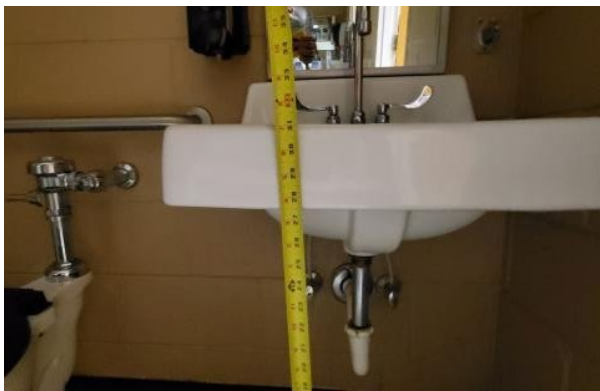
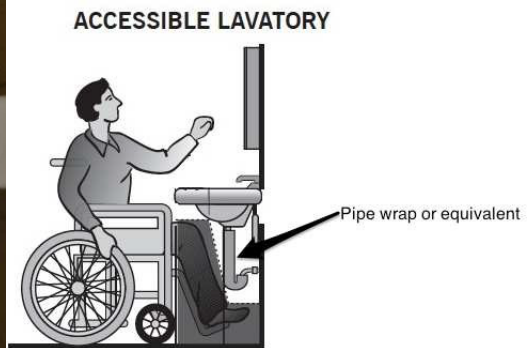
As Built: The water and drainpipes under the lavatory are not adequately insulated.

Water supply and drainpipes under lavatories and sinks shall be insulated or otherwise configured to protect against contact. There shall be no sharp or abrasive surfaces under lavatories and sinks.

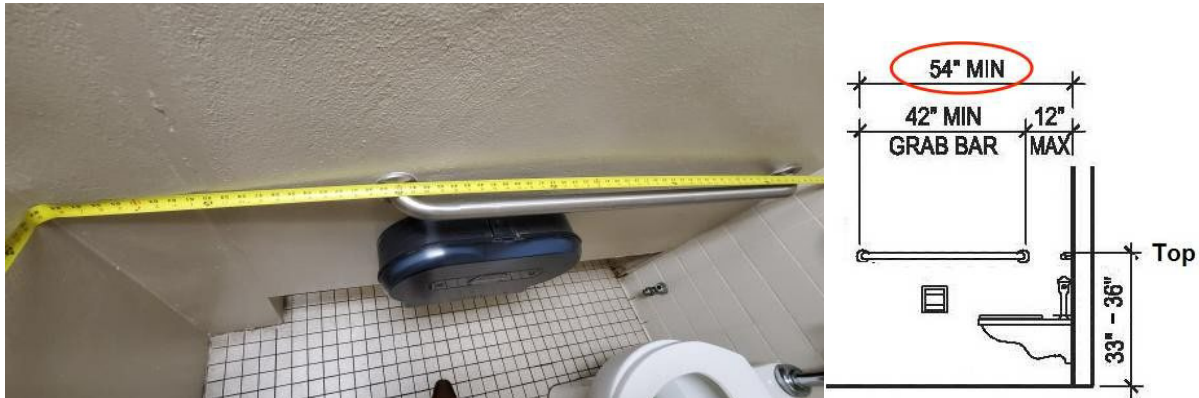
As Built: The side grab bar does not extend far enough from the rear wall.

The side grab bar must extend at least 54 inches minimum beyond the rear wall and start a maximum of 12 inches from the rear wall. A 42 inch grab bar installed the maximum distance from the rear wall (12 inches) will leave the leading end 54 inches from the rear wall.

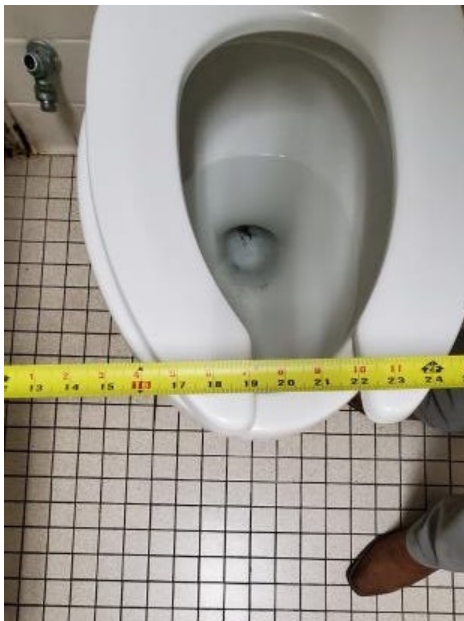
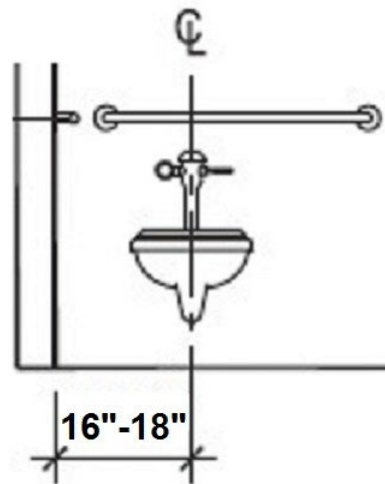
As Built: The toilet is not located within the range allowed from the side wall or partition. The centerline of the toilet must be 16 to 18 inches from the side wall.

Citation: 2010 ADAS Section 604.2

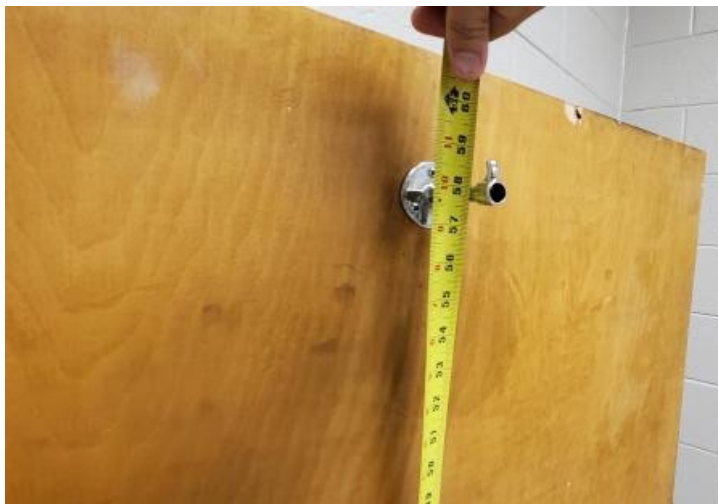
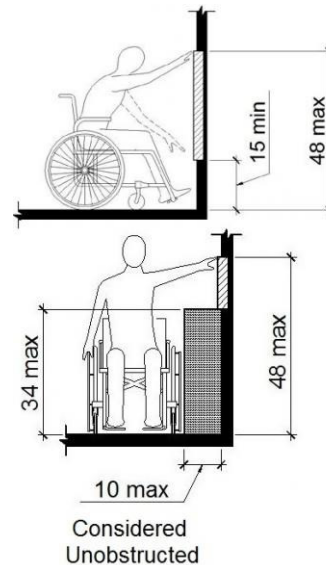
As Built: The coat hook is installed greater than 48 inches above the finished floor.

Where a forward reach is unobstructed, the high forward reach shall be 48 inches maximum above the finished floor.

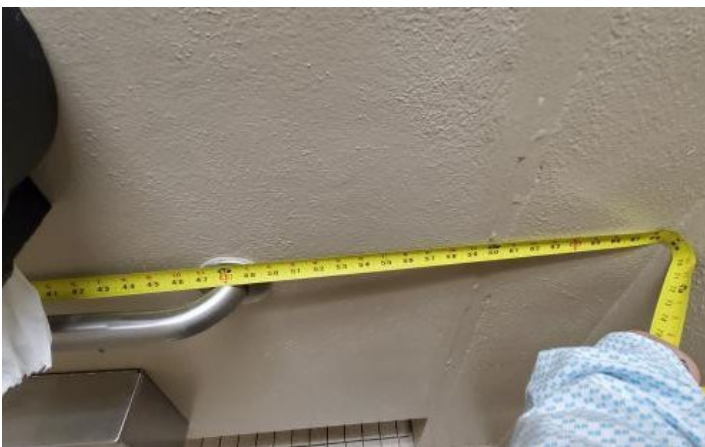
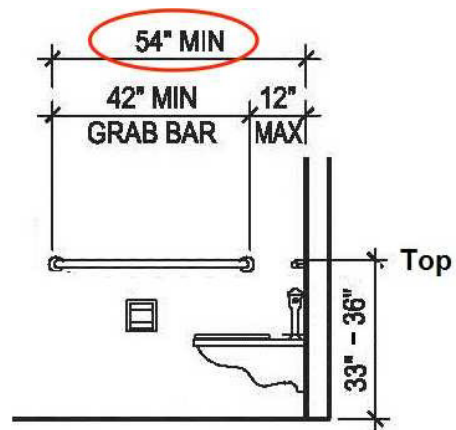
As Built: The side grab bar does not extend far enough from the rear wall.

The side grab bar must extend at least 54 inches minimum beyond the rear wall and start a maximum of 12 inches from the rear wall. A 42 inch grab bar installed the maximum distance from the rear wall (12 inches) will leave the leading end 54 inches from the rear wall.

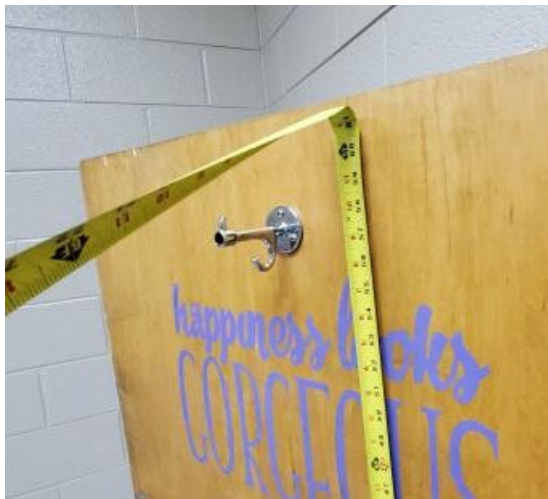
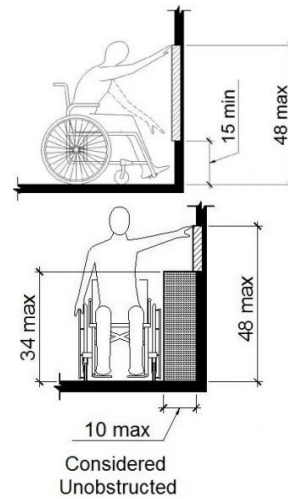
As Built: The coat hook is installed greater than 48 inches above the finished floor.

Where a forward reach is unobstructed, the high forward reach shall be 48 inches maximum above the finished floor.

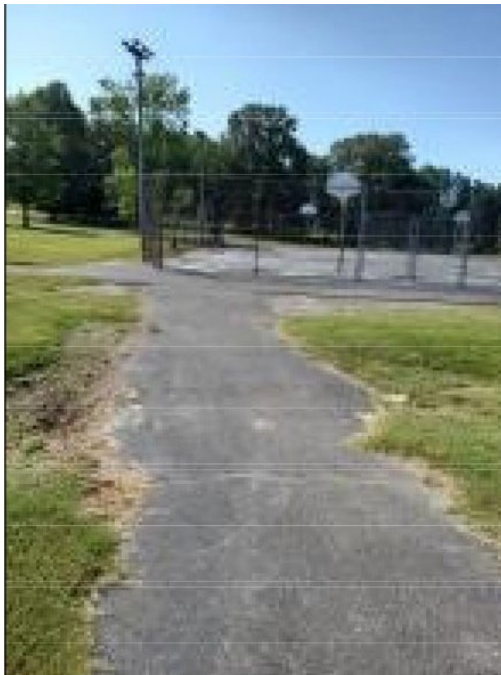
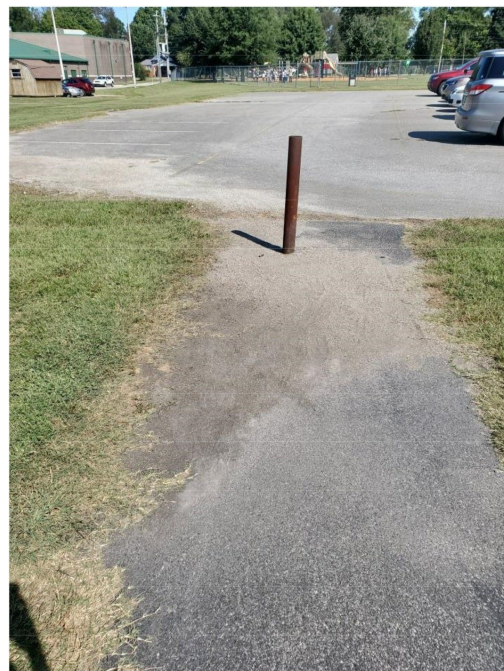
As Built: Slope varies to 4%. Surface is not firm, stable and slip resistant. The cross slope of the pedestrian access route is excessive. The cross slope of pedestrian access routes shall be 2 percent maximum.

Citation: 2011 PROWAG Section R302.6

Replace paved route from school entrance to court entrance approaching 160' at 5' wide.

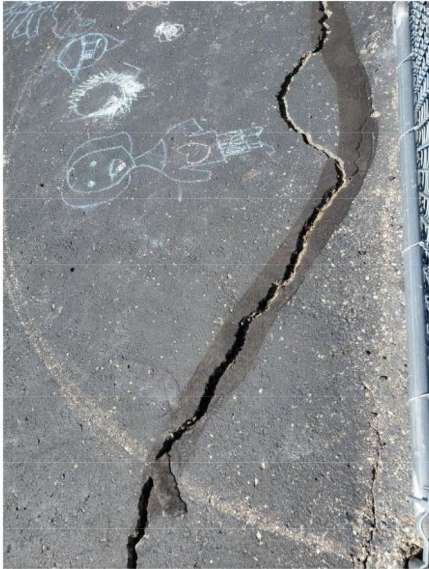
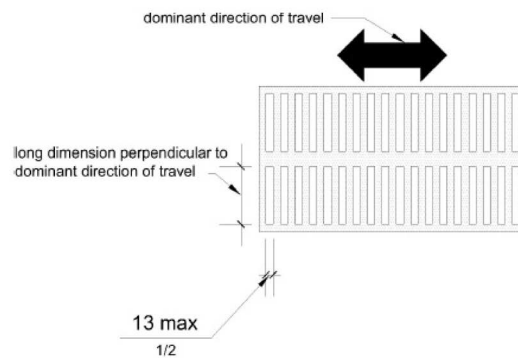
As Built: Multiple cracks exceed 1/2". The surface of the pedestrian access route has openings greater than 1/2 inch.

Horizontal openings in gratings and joints shall not permit passage of a sphere more than 13 mm (0.5 in) in diameter.

Recommendation: Provide sealant to wide cracks.

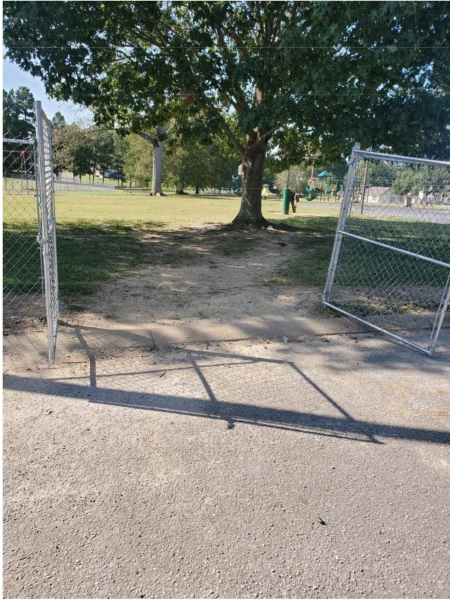
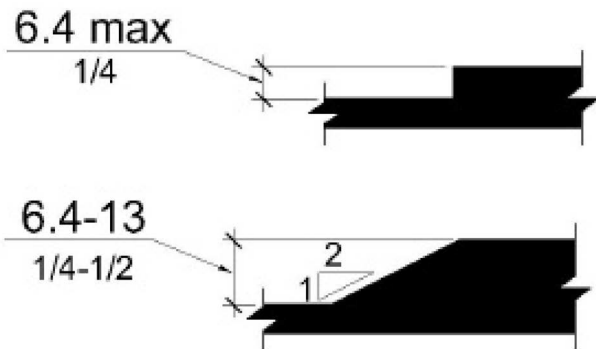
As Built: Sloped curb at gated playground access. The surface of the pedestrian access route has vertical discontinuities greater than 1/2 inch or between 1/4 inch and 1/2 inch that are not beveled.

Vertical surface discontinuities shall be 0.5 inch maximum. Vertical surface discontinuities between 0.25 inch and 0.5 inch shall be beveled with a slope not steeper than 50 percent. The bevel shall be applied across the entire vertical surface discontinuity.

Recommendation: Provide ramp/flush access.

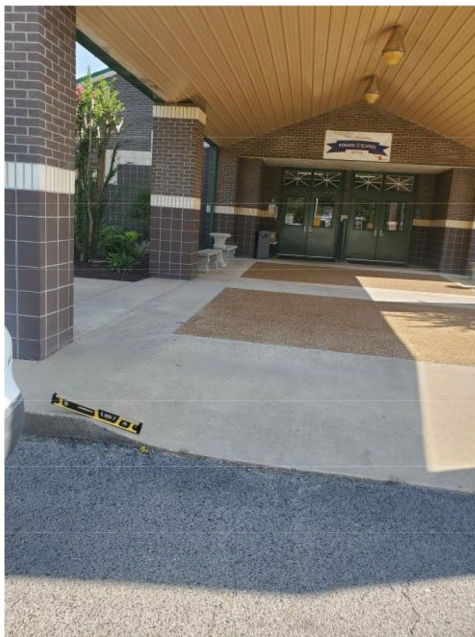
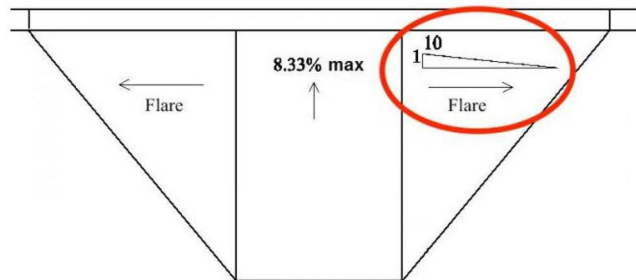
As Built: The ramp varies around 19%. The curb ramp side flares are too steep.

The sides of curb ramps (curb ramp flares) where provided, shall not be steeper than 1:10.

Replace the curb ramp.

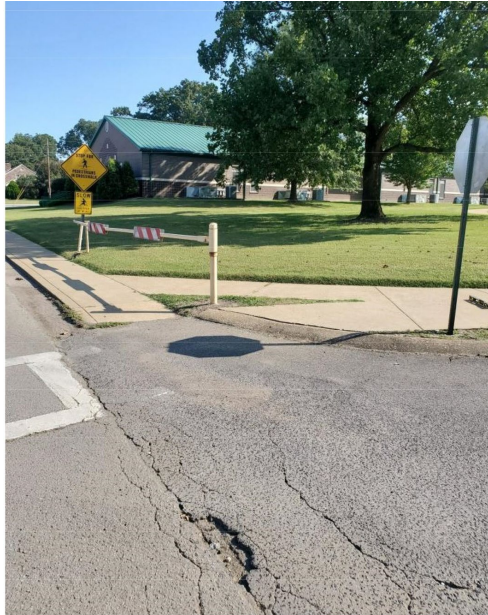
As Built: The only ramped surface is blocked by a gate and is also missing detectable warning. There is no pedestrian access route at the street crossing.

A curb ramp, blended transition, or a combination of curb ramps and blended transitions shall connect the pedestrian access routes at each pedestrian street crossing. The curb ramp (excluding any flared sides) or blended transition shall be contained wholly within the width of the pedestrian street crossing served.

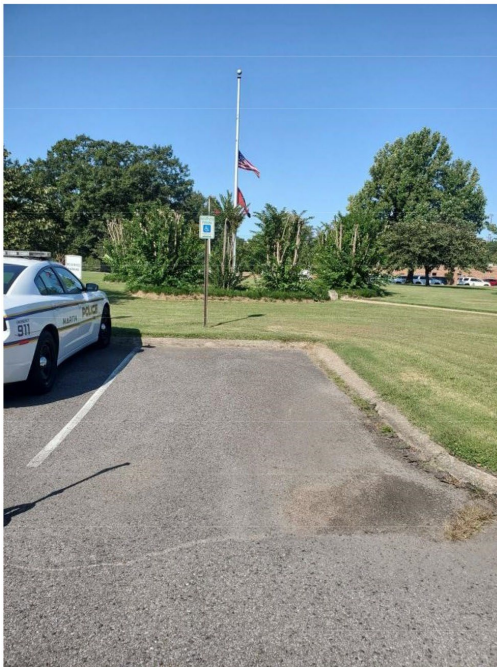
As Built: Approximately 60 spaces in lot. There is one 10' stall with signage. No striping, van sign, or access aisle. There are not enough accessible stalls.

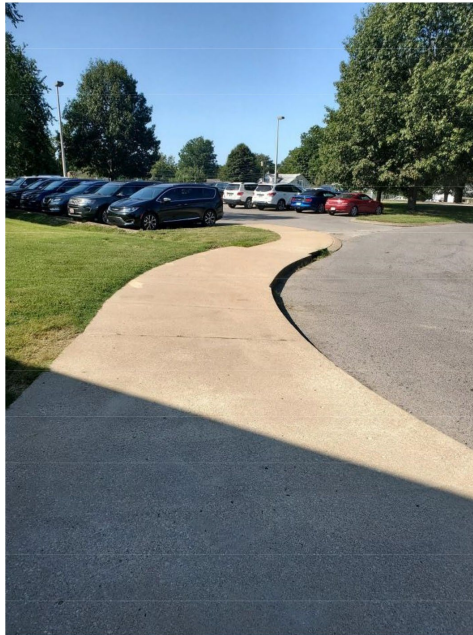
As Built: The cross slope of the pedestrian access route is excessive, varying over 3%, approximately 20'x8'.

The cross slope of pedestrian access routes shall be 2 percent maximum.

Replace sidewalk where the slope exceeds 2%.

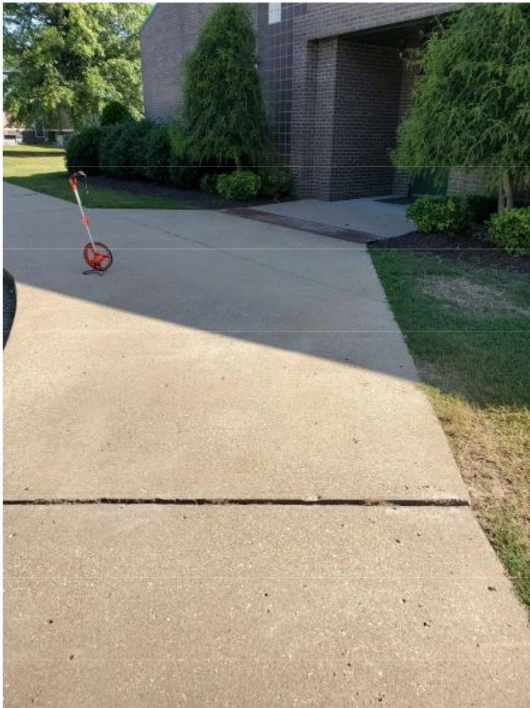
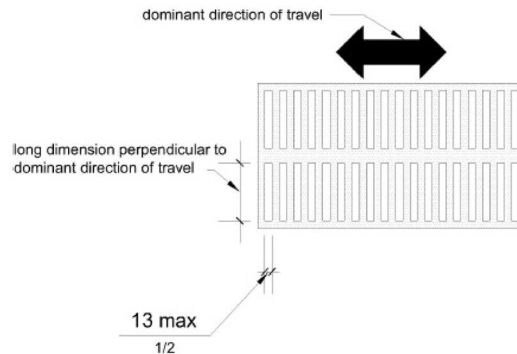
As Built: The surface of the pedestrian access route has openings greater than 1/2 inch.

Horizontal openings in gratings and joints shall not permit passage of a sphere more than 13 mm (0.5 in) in diameter.

Fill sidewalk crack with sealant to provide a flush surface.

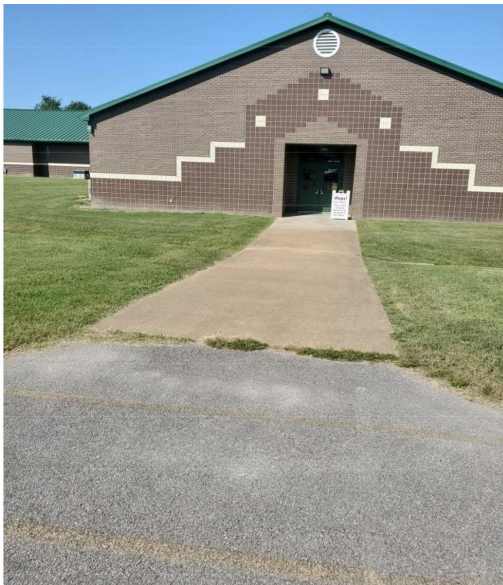
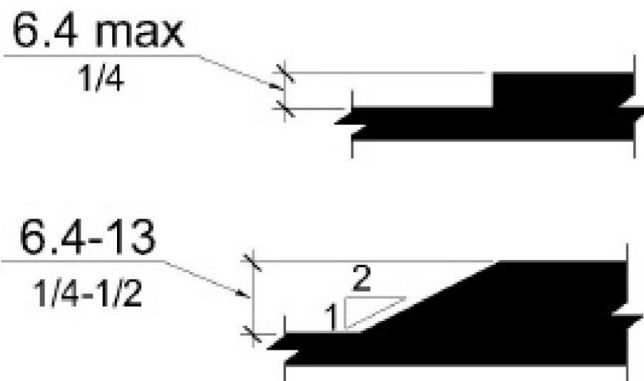
As Built: There is grass mounded up that is over 1" thick. The surface of the pedestrian access route has vertical discontinuities greater than 1/2 inch or between 1/4 inch and 1/2 inch that are not beveled.

Vertical surface discontinuities shall be 0.5 inch maximum. Vertical surface discontinuities between 0.25 inch and 0.5 inch shall be beveled with a slope not steeper than 50 percent. The bevel shall be applied across the entire vertical surface discontinuity.

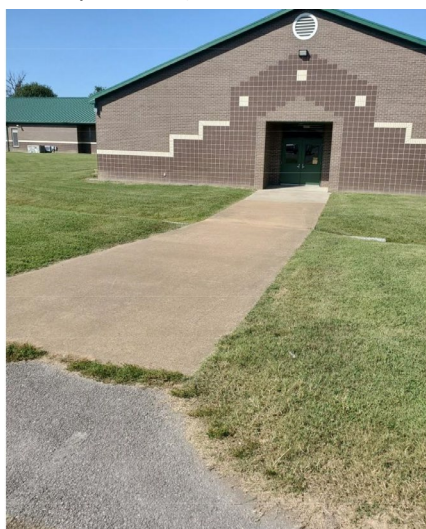
As Built: The grade of the pedestrian access route varies approximately 8% for 40'x10', which is too steep.

Where pedestrian access routes are not contained within a street or highway right-of-way, the grade of pedestrian access routes shall be 5 percent maximum.

Replace 70x10 to remove dip in sidewalk above pipe and keep slope less than 5% or install handrail.

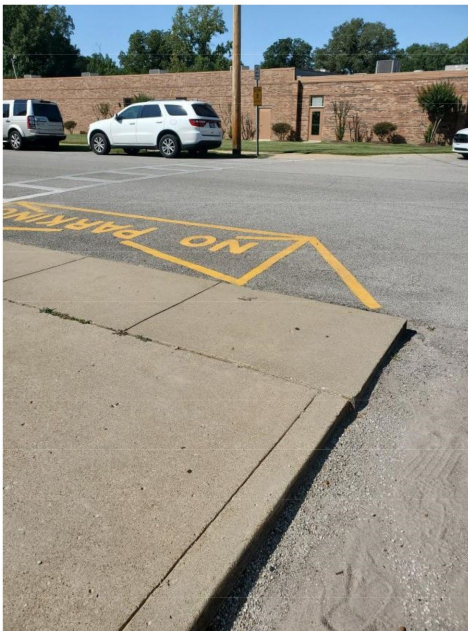
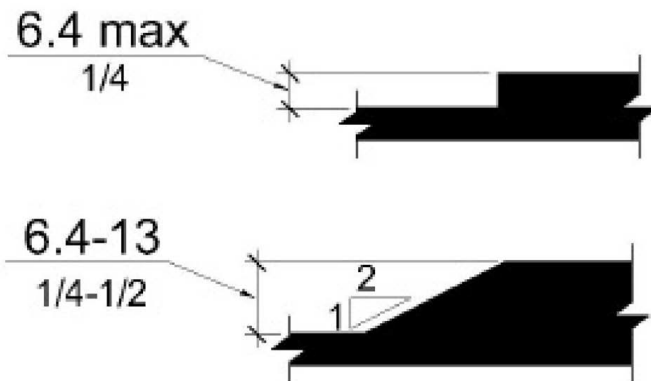
As Built: The surface of the pedestrian access route has vertical discontinuities greater than 1/2 inch or between 1/4 inch and 1/2 inch that are not beveled. Vertical surface discontinuities shall be 0.5 inch maximum. Vertical surface discontinuities between 0.25 inch and 0.5 inch shall be beveled with a slope not steeper than 50 percent. The bevel shall be applied across the entire vertical surface discontinuity.

Citation: 2011 PROWAG Section R302.7.2

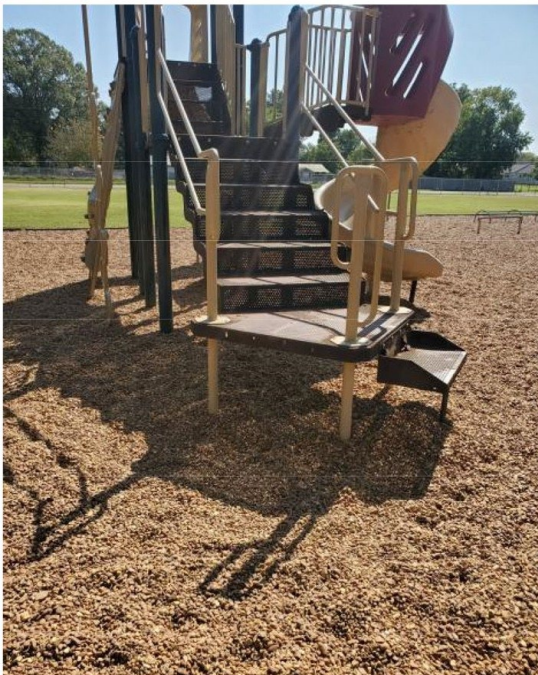
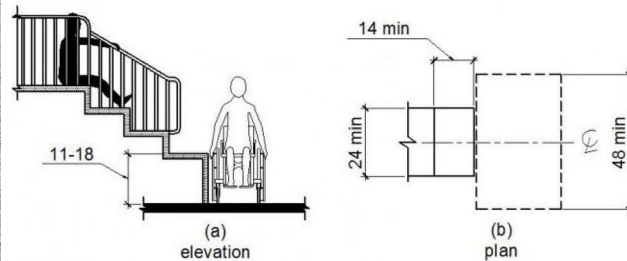
As Built: The transfer platform is 26", which is not within the compliant range above the ground.

The height of transfer platforms shall be 11 inches minimum and 18 inches maximum measured to the top of the surface from the ground or floor surface.

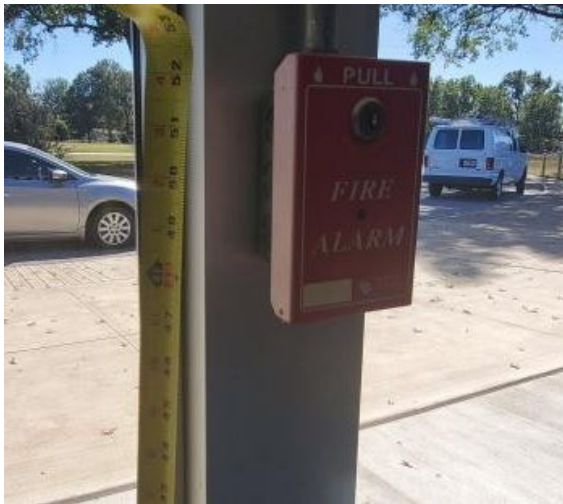
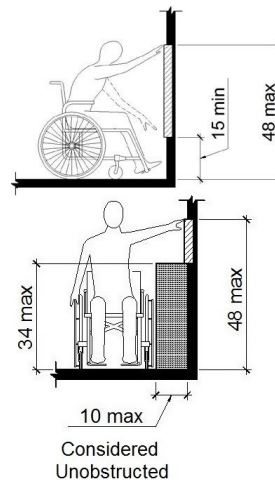
As Built: The Fire Alarm Pull Station is not positioned correctly for either a side or front approach.

Where a clear floor or ground space allows a parallel or front approach and the side reach is unobstructed, the high side reach shall be 48 inches maximum above the finish floor or ground and the low side reach shall be 15 inches minimum above the finish floor or ground.

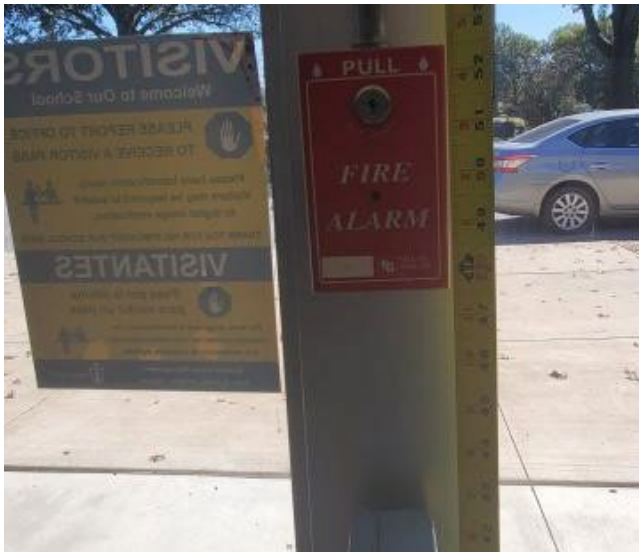
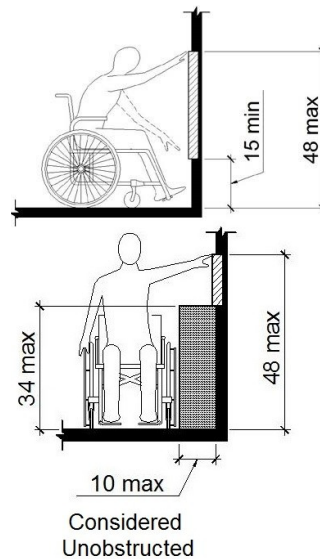
As Built: The Fire Alarm Pull Station is not positioned correctly for either a side or front approach.

Where a clear floor or ground space allows a parallel or front approach and the side reach is unobstructed, the high side reach shall be 48 inches maximum above the finish floor or ground and the low side reach shall be 15 inches minimum above the finish floor or ground.

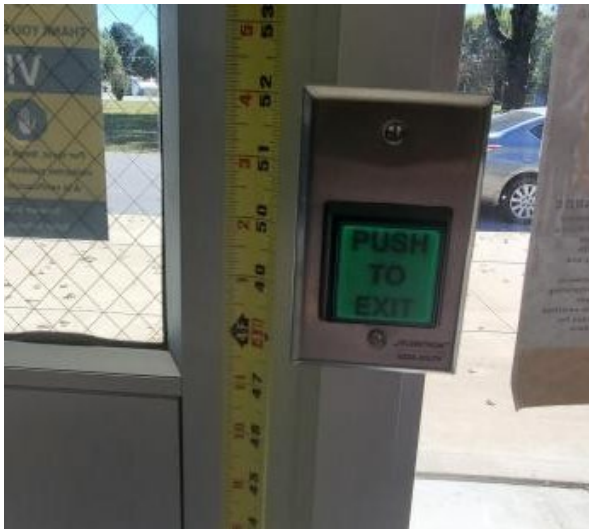
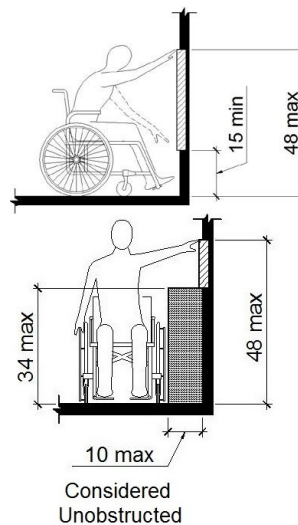
As Built: The Push to Exit Device is not positioned correctly for either a side or front approach.

Where a clear floor or ground space allows a parallel or front approach and the side reach is unobstructed, the high side reach shall be 48 inches maximum above the finish floor or ground and the low side reach shall be 15 inches minimum above the finish floor or ground.

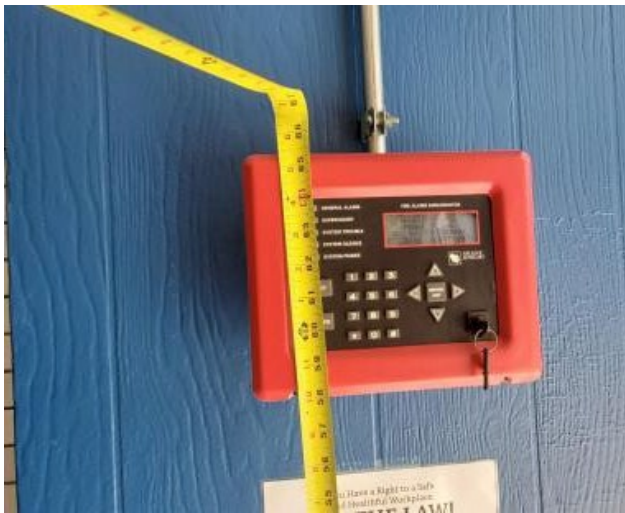
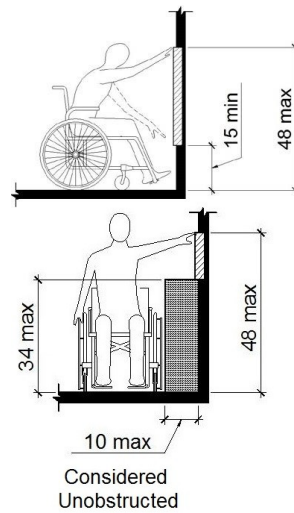
As Built: The Fire Alarm Annunciator is not positioned correctly for either a side or front approach.

Where a clear floor or ground space allows a parallel or front approach and the side reach is unobstructed, the high side reach shall be 48 inches maximum above the finish floor or ground and the low side reach shall be 15 inches minimum above the finish floor or ground.

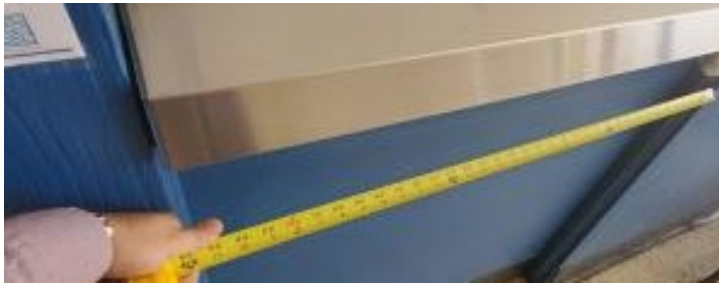
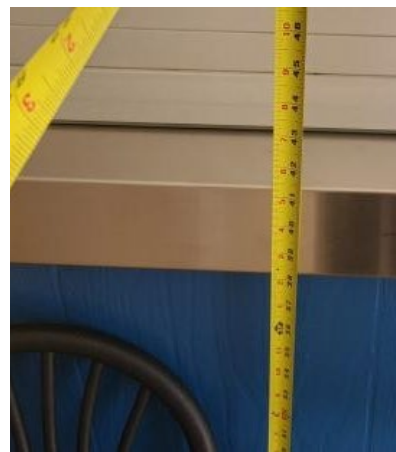
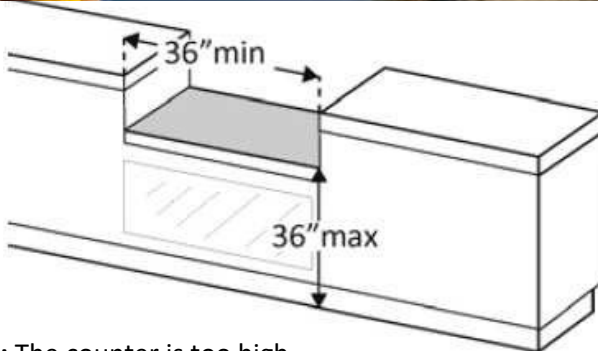
3 (Moderate): Should be completed as soon as possible, but there may be other items that will provide greater access to persons with disabilities. (Includes findings that have a high financial impact on the entity in relationship to the degree of access provided)

As Built: The counter is too high.

A portion of the counter surface that is 36 inches long minimum and 36 inches high maximum above the finish floor shall be provided. Knee and toe space must be provided for a forward approach. A 30 inch by 48 inch clear floor space on an accessible route must be provided for either a forward or parallel approach.

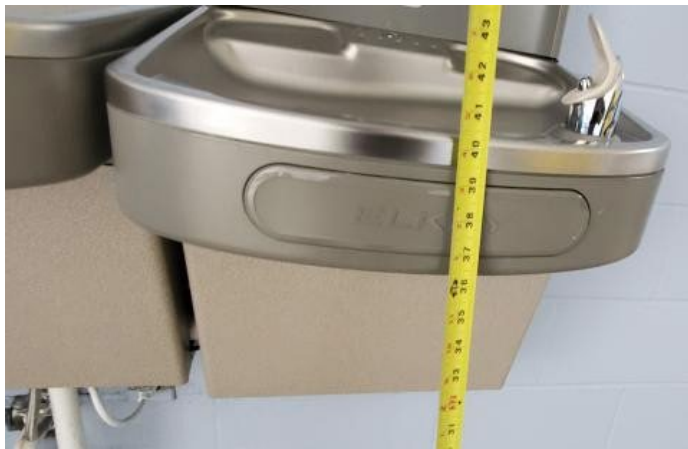
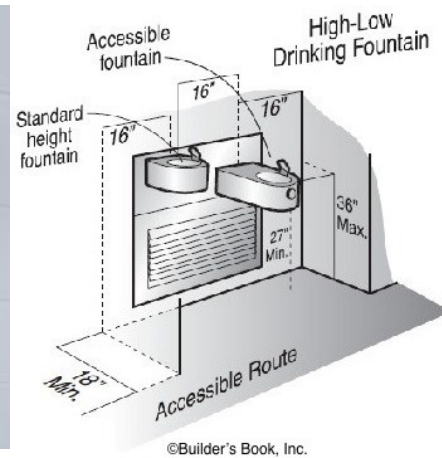
3 (Moderate): Should be completed as soon as possible, but there may be other items that will provide greater access to persons with disabilities. (Includes findings that have a high financial impact on the entity in relationship to the degree of access provided)

As Built: The drinking fountain is noncompliant.

Spout outlets shall be 36 inches maximum above the finish floor or ground and be located 15 inches minimum from the vertical support and 5 inches maximum from the front edge of the unit, including bumpers. The spout shall provide a flow of water at least 4 inches high minimum and shall be located 5 inches maximum from the front of the unit. The angle of the water stream shall be measured horizontally relative to the front face of the unit. Where spouts are located less than 3 inches of the front of the unit, the angle of the water stream shall be 30 degrees maximum. Where spouts are located between 3 inches and 5 inches maximum from the front of the unit, the angle of the water stream shall be 15 degrees maximum. On an accessible drinking fountain with a round or oval bowl, the spout must be positioned so the flow of water is within 3 inches of the front edge of the fountain.

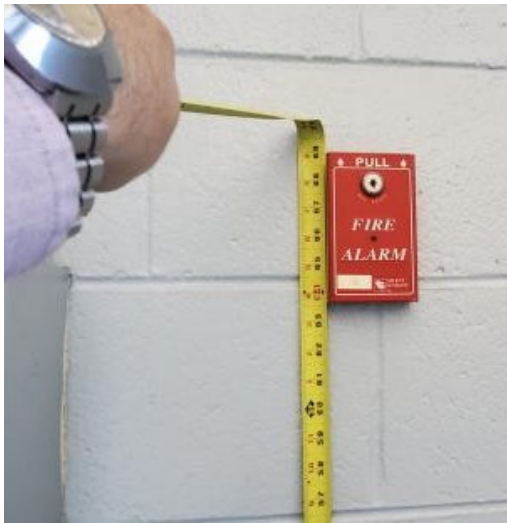
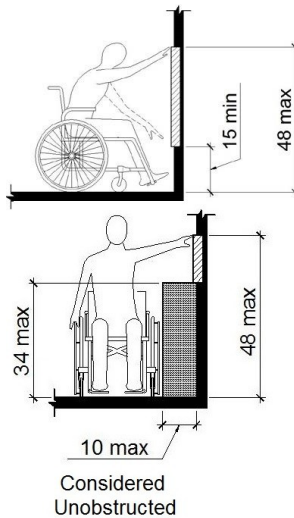
3 (Moderate): Should be completed as soon as possible, but there may be other items that will provide greater access to persons with disabilities. (Includes findings that have a high financial impact on the entity in relationship to the degree of access provided).

As Built: The Fire Alarm Pull Station is not positioned correctly for either a side or front approach.

Where a clear floor or ground space allows a parallel or front approach and the side reach is unobstructed, the high side reach shall be 48 inches maximum above the finish floor or ground and the low side reach shall be 15 inches minimum above the finish floor or ground.

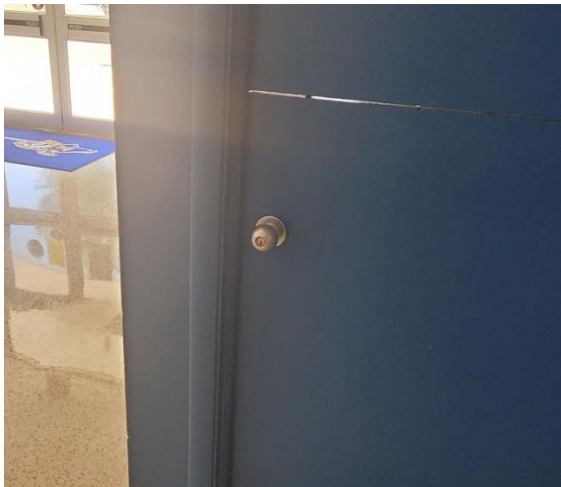
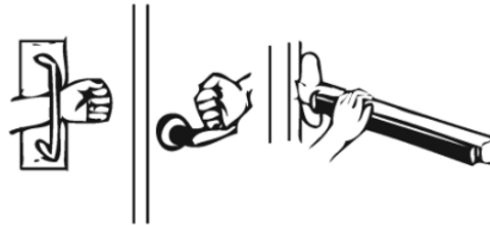
3 (Moderate): Should be completed as soon as possible, but there may be other items that will provide greater access to persons with disabilities. (Includes findings that have a high financial impact on the entity in relationship to the degree of access provided).

As Built: The operating hardware requires tight grasping, pinching or twisting of the wrist to operate.

Hand-activated hardware, handles, pulls, latches, locks, and other operating devices on accessible elements shall have a shape that is easy to grasp with one hand and does not require tight grasping, pinching or twisting of the wrist to operate.
