WEAKLEY COUNTY, TENNESSEE

ADA EVALUATION

Architectural and Site Findings with Recommendations

TLM Associates, Inc

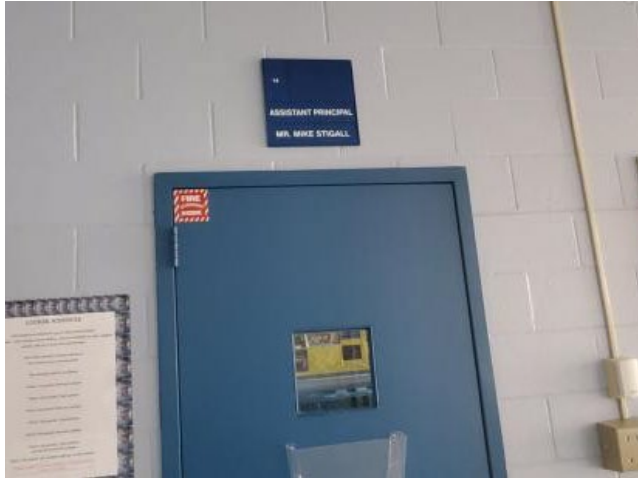
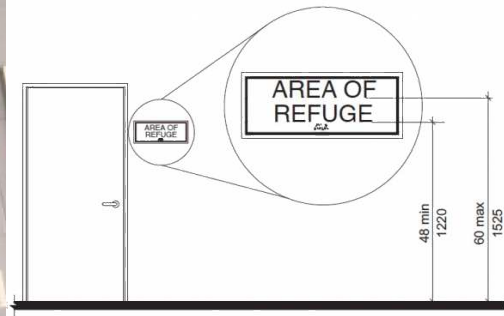
Barrier Priority: 3 (Moderate): Should be completed as soon as possible, but there may be other items that will provide greater access to persons with disabilities. (Includes findings that have a high financial impact on the entity in relationship to the degree of access provided).

As Built: The wall sign is mounted within the required range.

Tactile Characters on signs shall be located 48 inches minimum above the finish floor or ground surface, measured from the baseline of the lowest tactile character and 60 inches maximum above the finish floor or ground surface, measured from the baseline of the highest tactile character. Mounting location shall be determined so that a person may approach within 3 inches of signage without encountering protruding objects and shall be located so that a clear floor space of 18 inches minimum by 18 inches minimum, centered on the tactile Characters, is provided beyond the arc of any door swing between the closed position and 45 degree open position.

Recommendation: Lower all signs to 60" max AFF.

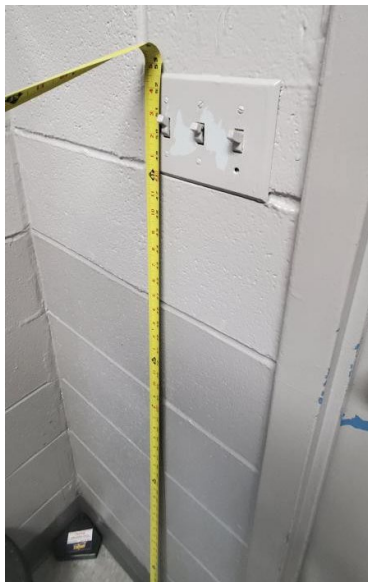
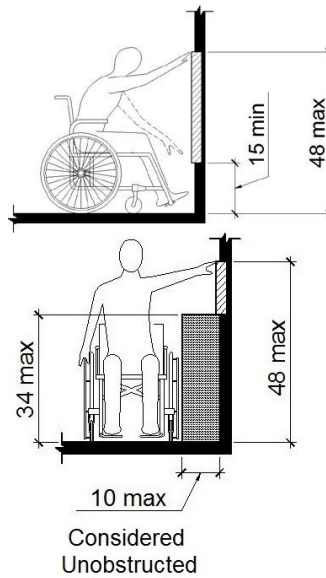
3 (Moderate): Should be completed as soon as possible, but there may be other items that will provide greater access to persons with disabilities. (Includes findings that have a high financial impact on the entity in relationship to the degree of access provided).

As Built: The switches throughout are not positioned correctly for either a side or front approach.

Where a clear floor or ground space allows a parallel or front approach and the side reach is unobstructed, the high side reach shall be 48 inches maximum above the finish floor or ground and the low side reach shall be 15 inches minimum above the finish floor or ground.

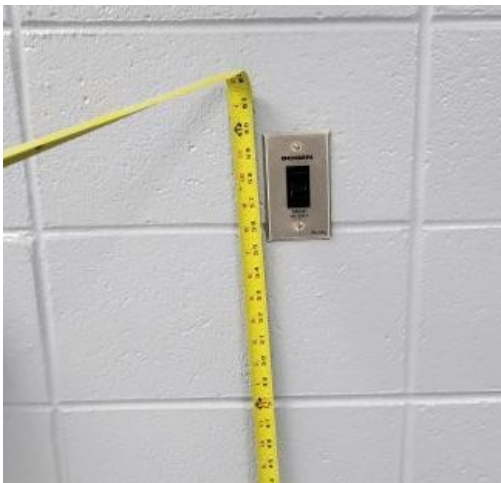
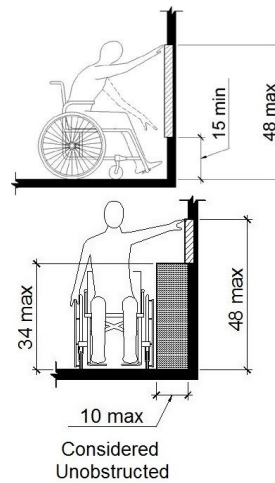
3 (Moderate): Should be completed as soon as possible, but there may be other items that will provide greater access to persons with disabilities. (Includes findings that have a high financial impact on the entity in relationship to the degree of access provided).

As Built: The intercom button is not positioned correctly for either a side or front approach.

Where a clear floor or ground space allows a parallel or front approach and the side reach is unobstructed, the high side reach shall be 48 inches maximum above the finish floor or ground and the low side reach shall be 15 inches minimum above the finish floor or ground.

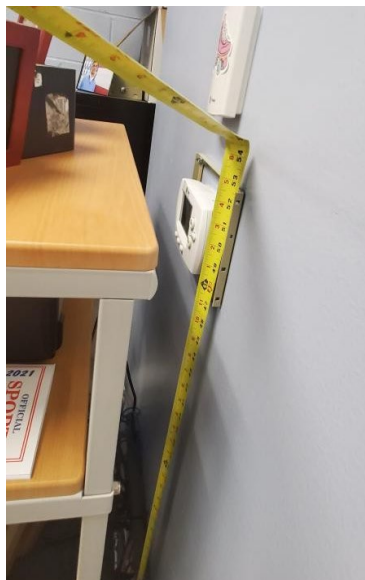
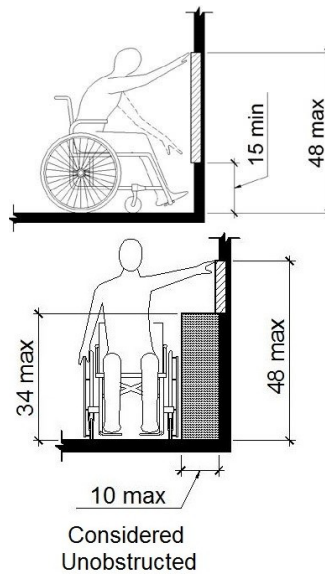
3 (Moderate): Should be completed as soon as possible, but there may be other items that will provide greater access to persons with disabilities. (Includes findings that have a high financial impact on the entity in relationship to the degree of access provided).

As Built: The Thermostats in classrooms are not positioned correctly for either a side or front approach.

Where a clear floor or ground space allows a parallel or front approach and the side reach is unobstructed, the high side reach shall be 48 inches maximum above the finish floor or ground and the low side reach shall be 15 inches minimum above the finish floor or ground.

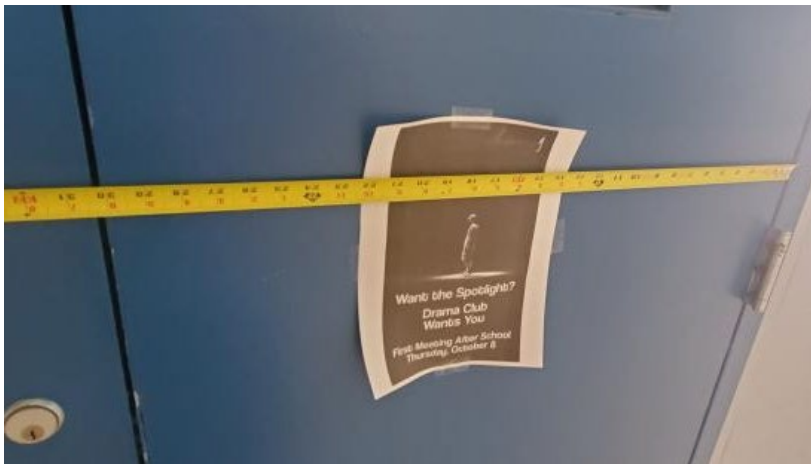
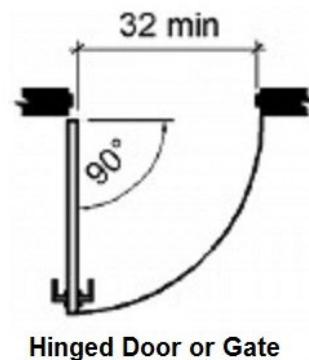
3 (Moderate): Should be completed as soon as possible, but there may be other items that will provide greater access to persons with disabilities. (Includes findings that have a high financial impact on the entity in relationship to the degree of access provided).

As Built: Neither leaf of the doorway provides at least 32 inches between the face of the door and the opposite stop. At least one of the active leaves of doorways with two leaves shall comply with clear width and maneuvering clearance.

Door openings shall provide a clear width of 32 inches minimum. Clear openings of doorways with swinging doors shall be measured between the face of the door and the stop, with the door open 90 degrees. There shall be no projections into the required clear opening width lower than 34 inches above the finish floor or ground. Projections into the clear opening width between 34 inches and 80 inches above the finish floor or ground shall not exceed 4 inches.

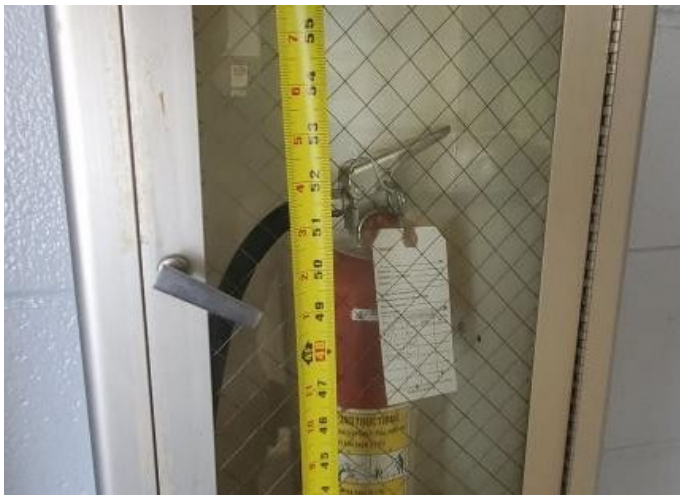
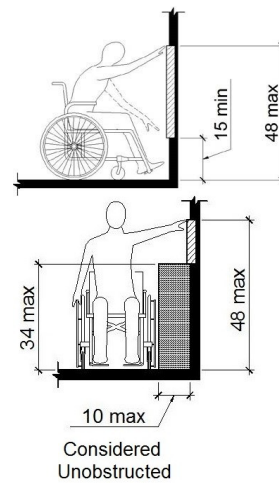
3 (Moderate): Should be completed as soon as possible, but there may be other items that will provide greater access to persons with disabilities. (Includes findings that have a high financial impact on the entity in relationship to the degree of access provided).

As Built: The Fire extinguisher is not positioned correctly for either a side or front approach.

Where a clear floor or ground space allows a parallel or front approach and the side reach is unobstructed, the high side reach shall be 48 inches maximum above the finish floor or ground and the low side reach shall be 15 inches minimum above the finish floor or ground.

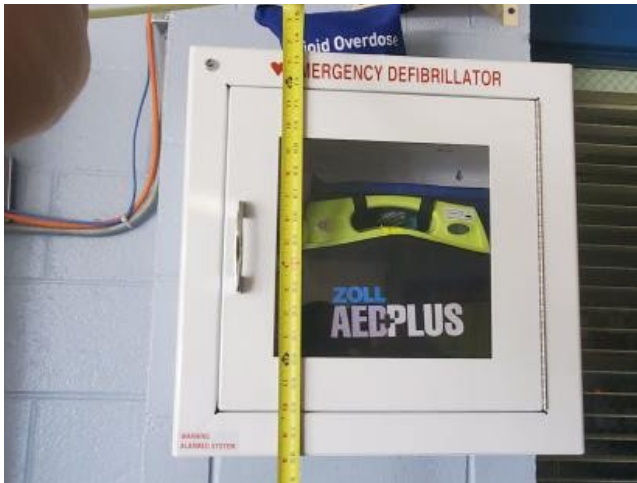
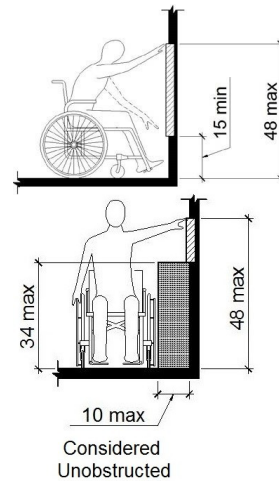
Barrier Priority: 3 (Moderate): Should be completed as soon as possible, but there may be other items that will provide greater access to persons with disabilities. (Includes findings that have a high financial impact on the entity in relationship to the degree of access provided).

As Built: The Defibrillator is not positioned correctly for either a side or front approach.

Where a clear floor or ground space allows a parallel or front approach and the side reach is unobstructed, the high side reach shall be 48 inches maximum above the finish floor or ground and the low side reach shall be 15 inches minimum above the finish floor or ground.

Recommendation: Lower Defibrillator cabinet for handle to be 48" max AFF.

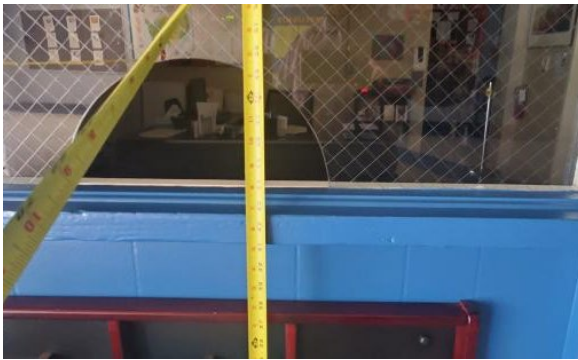
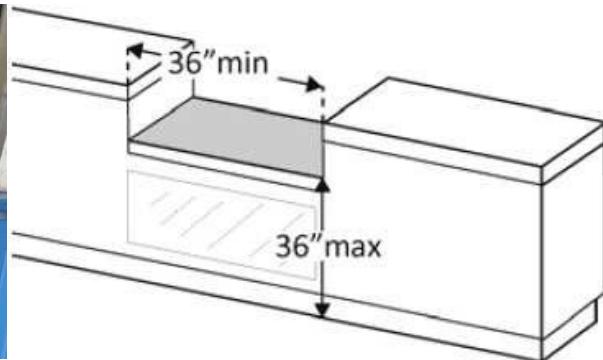
3 (Moderate): Should be completed as soon as possible, but there may be other items that will provide greater access to persons with disabilities. (Includes findings that have a high financial impact on the entity in relationship to the degree of access provided).

As Built: The counter is too high.

A portion of the counter surface that is 36 inches long minimum and 36 inches high maximum above the finish floor shall be provided. Knee and toe space must be provided for a forward approach. A 30 inch by 48 inch clear floor space on an accessible route must be provided for either a forward or parallel approach.

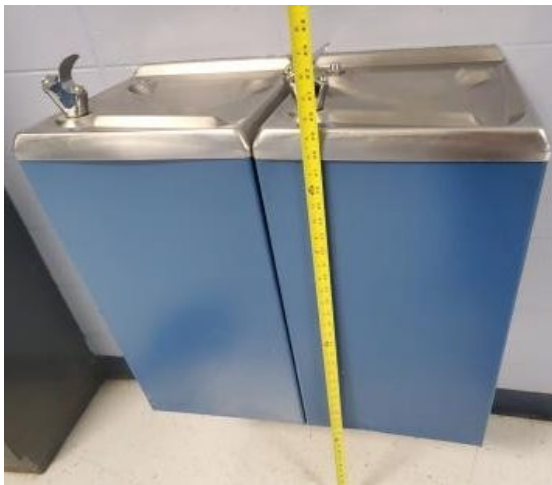
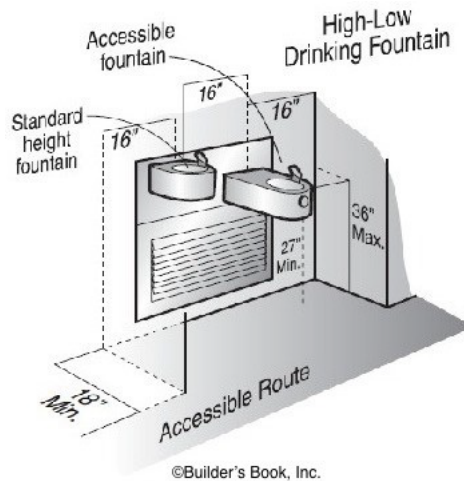
3 (Moderate): Should be completed as soon as possible, but there may be other items that will provide greater access to persons with disabilities. (Includes findings that have a high financial impact on the entity in relationship to the degree of access provided).

As Built: The drinking fountain is noncompliant.

Spout outlets shall be 36 inches maximum above the finish floor or ground and be located 15 inches minimum from the vertical support and 5 inches maximum from the front edge of the unit, including bumpers. The spout shall provide a flow of water at least 4 inches high minimum and shall be located 5 inches maximum from the front of the unit. The angle of the water stream shall be measured horizontally relative to the front face of the unit. Where spouts are located less than 3 inches of the front of the unit, the angle of the water stream shall be 30 degrees maximum. Where spouts are located between 3 inches and 5 inches maximum from the front of the unit, the angle of the water stream shall be 15 degrees maximum. On an accessible drinking fountain with a round or oval bowl, the spout must be positioned so the flow of water is within 3 inches of the front edge of the fountain.

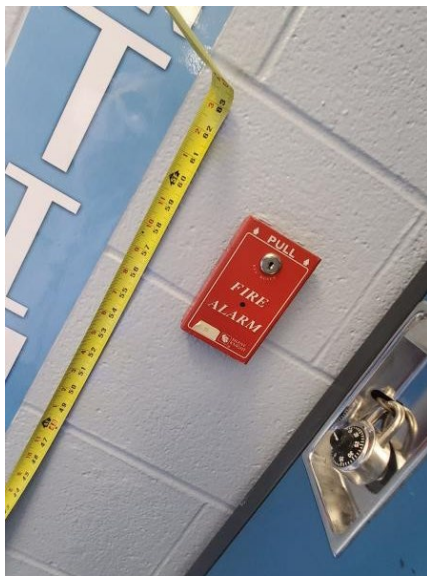
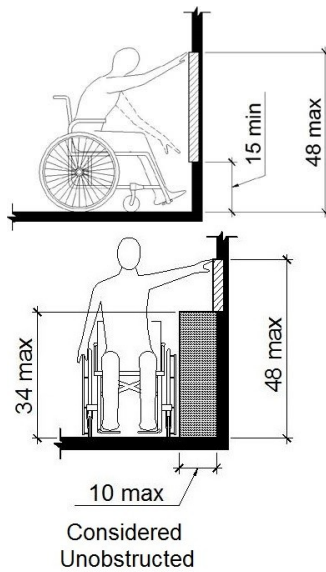
3 (Moderate): Should be completed as soon as possible, but there may be other items that will provide greater access to persons with disabilities. (Includes findings that have a high financial impact on the entity in relationship to the degree of access provided).

As Built: The Fire Alarm Pull Station is not positioned correctly for either a side or front approach.

Where a clear floor or ground space allows a parallel or front approach and the side reach is unobstructed, the high side reach shall be 48 inches maximum above the finish floor or ground and the low side reach shall be 15 inches minimum above the finish floor or ground.

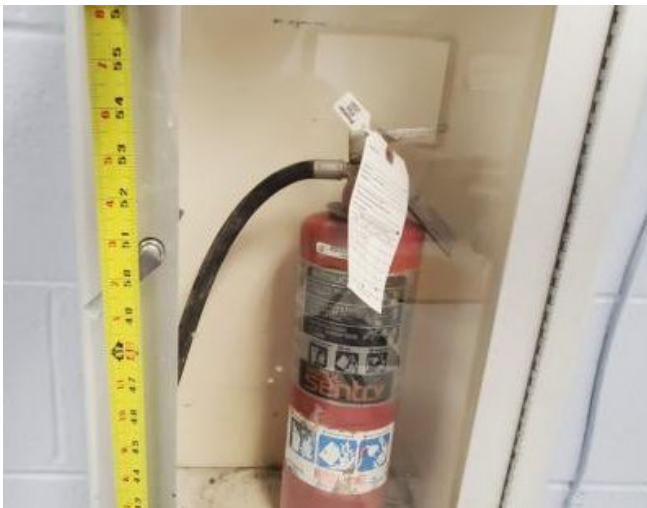
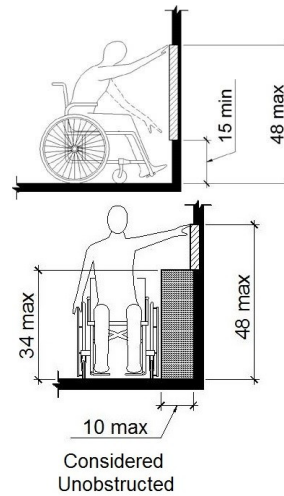
3 (Moderate): Should be completed as soon as possible, but there may be other items that will provide greater access to persons with disabilities. (Includes findings that have a high financial impact on the entity in relationship to the degree of access provided).

As Built: The Fire extinguisher is not positioned correctly for either a side or front approach.

Where a clear floor or ground space allows a parallel or front approach and the side reach is unobstructed, the high side reach shall be 48 inches maximum above the finish floor or ground and the low side reach shall be 15 inches minimum above the finish floor or ground.

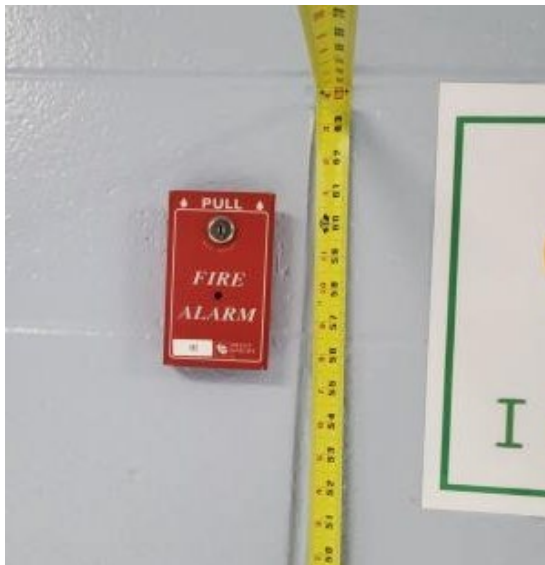
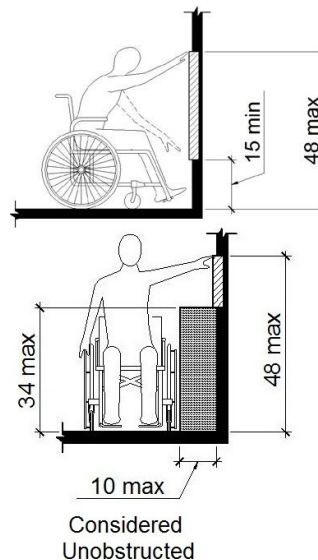
3 (Moderate): Should be completed as soon as possible, but there may be other items that will provide greater access to persons with disabilities. (Includes findings that have a high financial impact on the entity in relationship to the degree of access provided).

As Built: The Fire Alarm Pull Station is not positioned correctly for either a side or front approach.

Where a clear floor or ground space allows a parallel or front approach and the side reach is unobstructed, the high side reach shall be 48 inches maximum above the finish floor or ground and the low side reach shall be 15 inches minimum above the finish floor or ground.

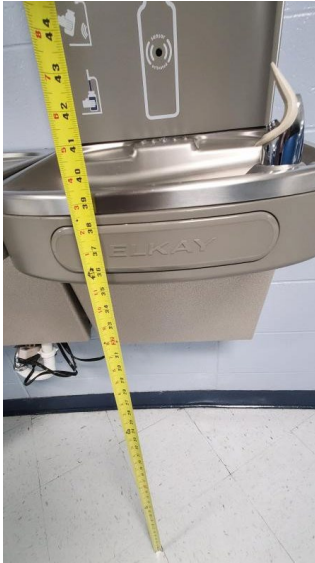
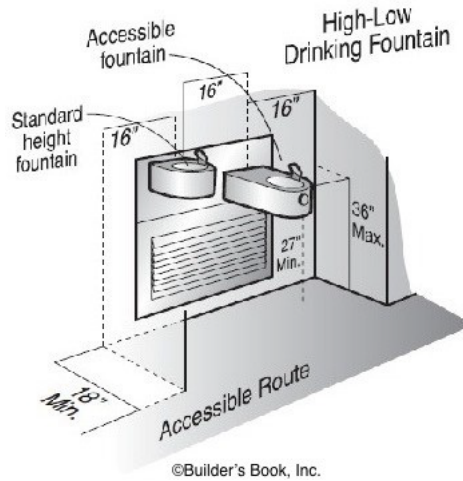
Barrier Priority: 3 (Moderate): Should be completed as soon as possible, but there may be other items that will provide greater access to persons with disabilities. (Includes findings that have a high financial impact on the entity in relationship to the degree of access provided).

As Built: The drinking fountain is noncompliant.

Spout outlets shall be 36 inches maximum above the finish floor or ground and be located 15 inches minimum from the vertical support and 5 inches maximum from the front edge of the unit, including bumpers. The spout shall provide a flow of water at least 4 inches high minimum and shall be located 5 inches maximum from the front of the unit. The angle of the water stream shall be measured horizontally relative to the front face of the unit. Where spouts are located less than 3 inches of the front of the unit, the angle of the water stream shall be 30 degrees maximum. Where spouts are located between 3 inches and 5 inches maximum from the front of the unit, the angle of the water stream shall be 15 degrees maximum. On an accessible drinking fountain with a round or oval bowl, the spout must be positioned so the flow of water is within 3 inches of the front edge of the fountain.

Recommendation: Lower one of the drinking fountains for one of them to be 36" to rim.

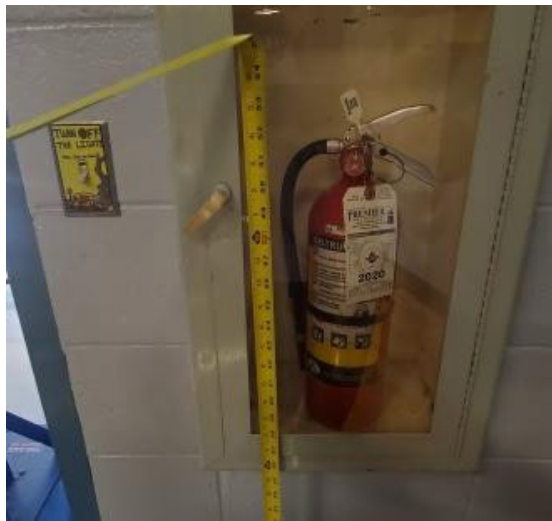
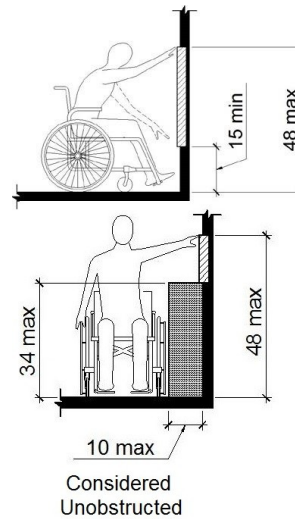
3 (Moderate): Should be completed as soon as possible, but there may be other items that will provide greater access to persons with disabilities. (Includes findings that have a high financial impact on the entity in relationship to the degree of access provided).

As Built: The Fire extinguisher is not positioned correctly for either a side or front approach.

Where a clear floor or ground space allows a parallel or front approach and the side reach is unobstructed, the high side reach shall be 48 inches maximum above the finish floor or ground and the low side reach shall be 15 inches minimum above the finish floor or ground.

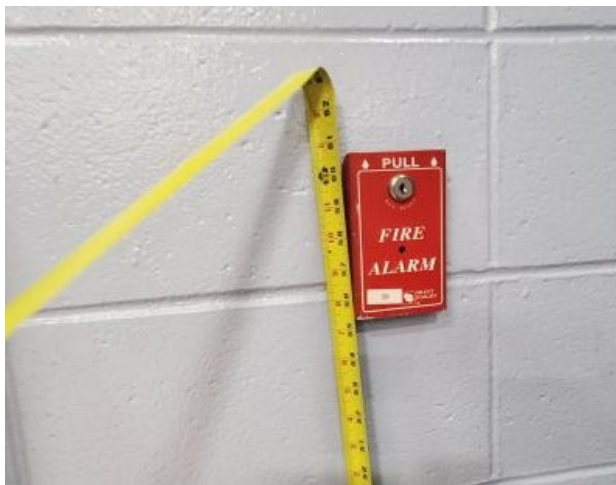
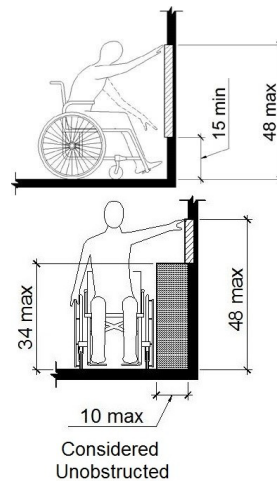
3 (Moderate): Should be completed as soon as possible, but there may be other items that will provide greater access to persons with disabilities. (Includes findings that have a high financial impact on the entity in relationship to the degree of access provided).

As Built: The Fire Alarm Pull Station is not positioned correctly for either a side or front approach.

Where a clear floor or ground space allows a parallel or front approach and the side reach is unobstructed, the high side reach shall be 48 inches maximum above the finish floor or ground and the low side reach shall be 15 inches minimum above the finish floor or ground.

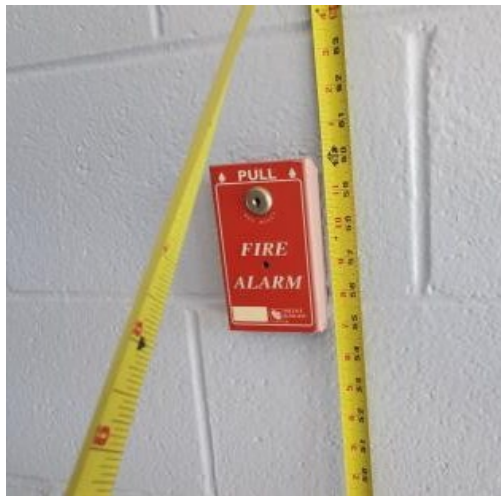
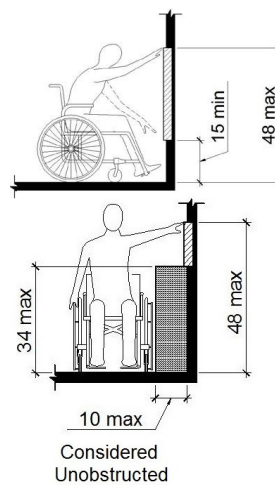
As Built: The Fire Alarm Pull Station is not positioned correctly for either a side or front approach.

Where a clear floor or ground space allows a parallel or front approach and the side reach is unobstructed, the high side reach shall be 48 inches maximum above the finish floor or ground and the low side reach shall be 15 inches minimum above the finish floor or ground.

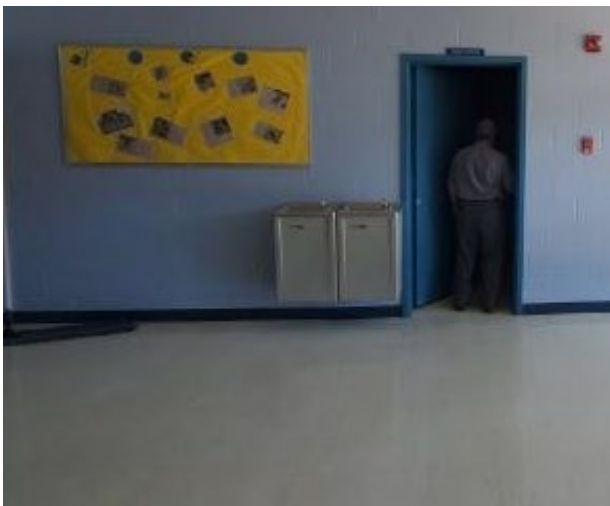
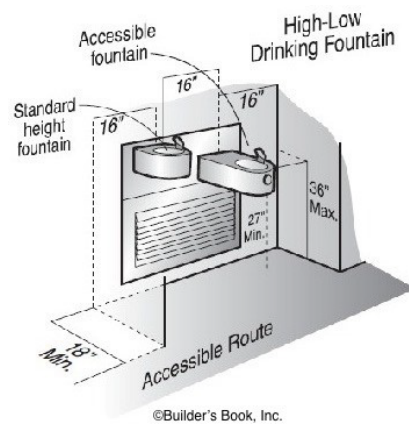
As Built: The drinking fountain is noncompliant.

Spout outlets shall be 36 inches maximum above the finish floor or ground and be located 15 inches minimum from the vertical support and 5 inches maximum from the front edge of the unit, including bumpers. The spout shall provide a flow of water at least 4 inches high minimum and shall be located 5 inches maximum from the front of the unit. The angle of the water stream shall be measured horizontally relative to the front face of the unit. Where spouts are located less than 3 inches of the front of the unit, the angle of the water stream shall be 30 degrees maximum. Where spouts are located between 3 inches and 5 inches maximum from the front of the unit, the angle of the water stream shall be 15 degrees maximum. On an accessible drinking fountain with a round or oval bowl, the spout must be positioned so the flow of water is within 3 inches of the front edge of the fountain.

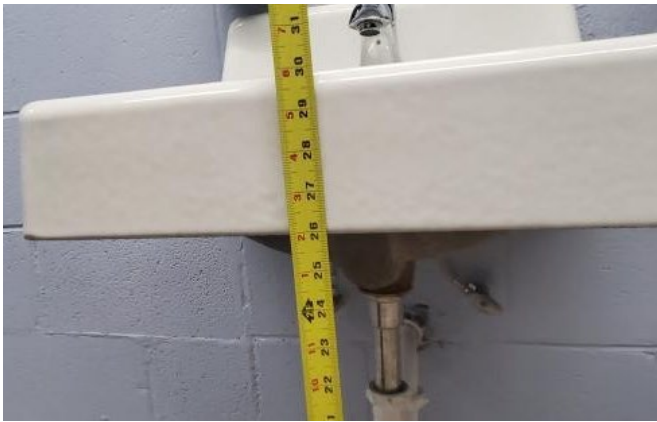
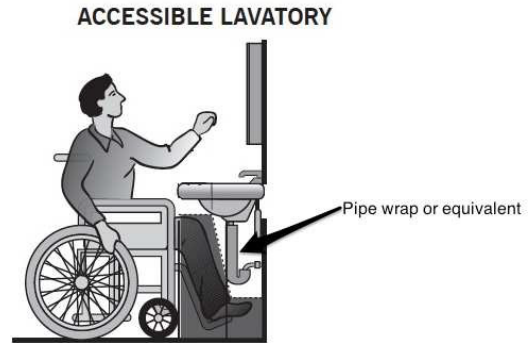
As Built: The water and drainpipes under the lavatory are not adequately insulated.

Water supply and drainpipes under lavatories and sinks shall be insulated or otherwise configured to protect against contact. There shall be no sharp or abrasive surfaces under lavatories and sinks.

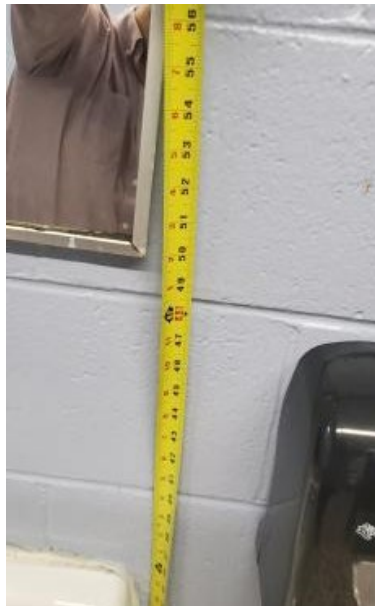
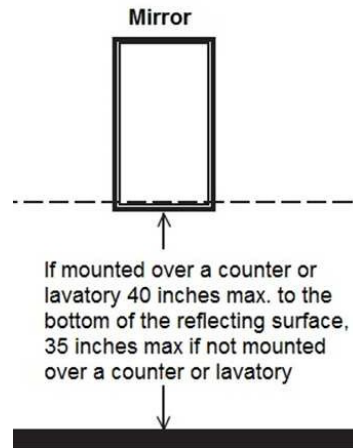
As Built: The mirror is mounted too high.

Mirrors must have the bottom edge of the reflecting surface a maximum of 40 inches above the floor if above a sink or counter. Mirrors not located above lavatories or countertops shall be installed with the bottom edge of the reflecting surface 35 inches maximum above the finish floor or ground.

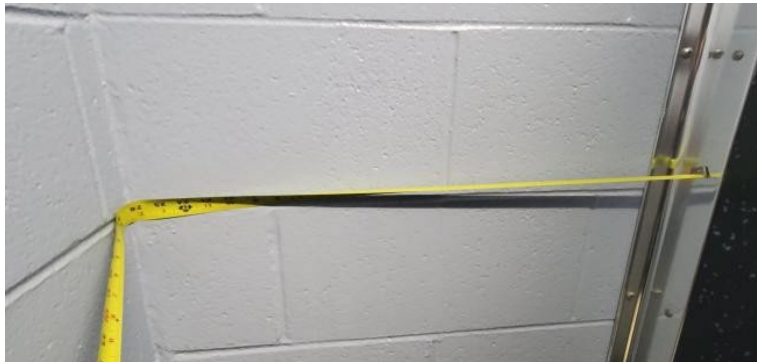
As Built: The toilet compartment does not have the required minimum clear floor space or maneuvering clearances for the toilet. The toilet flush handle is on wrong side. Toilet not within 16-18" from wall. No Grab bars are installed.

Citation: 2010 ADAS Section 213.2

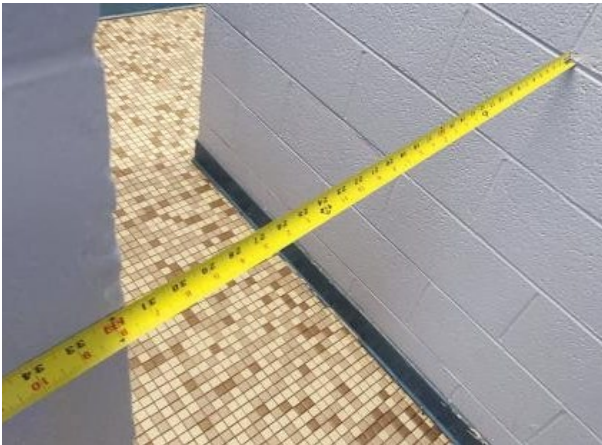
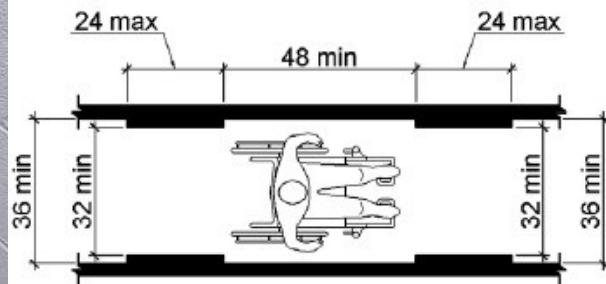
As Built: The route of travel does not provide a minimum width of 36 inches.

The clear width shall be permitted to be reduced to 32 inches minimum for a length of 24 inches maximum provided that reduced width segments are separated by segments that are 48 inches long minimum and 36 inches wide minimum.

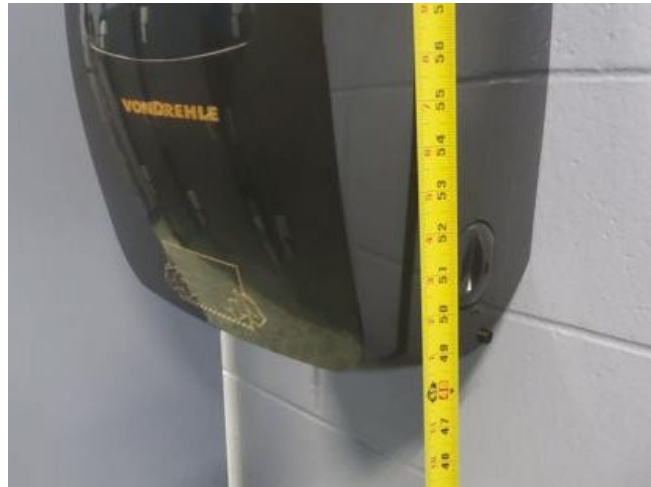
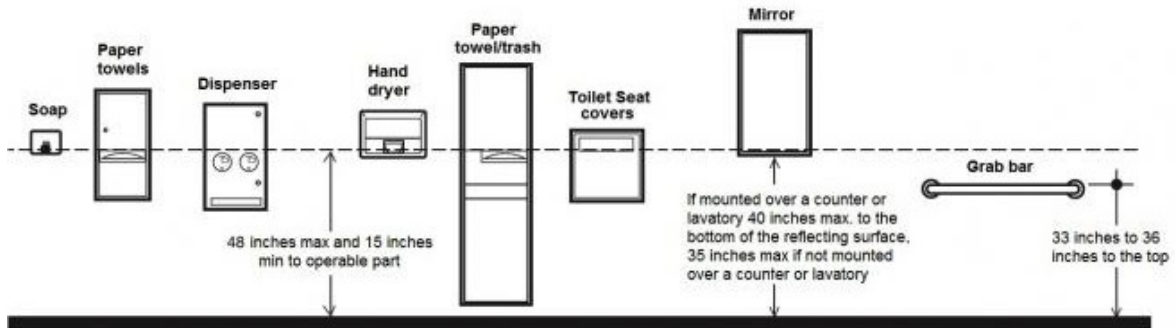
As Built: The paper towel dispenser's operation mechanism is too high off the floor. Dispensers must have all operable parts a maximum of 48 inches above the floor.

Citation: 2010 ADAS Section 308.2.1

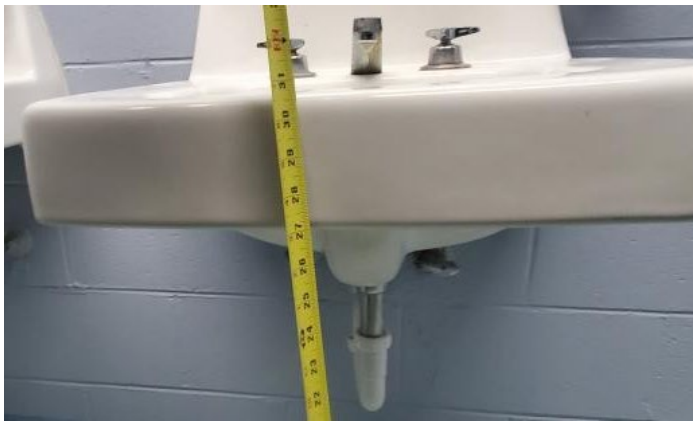
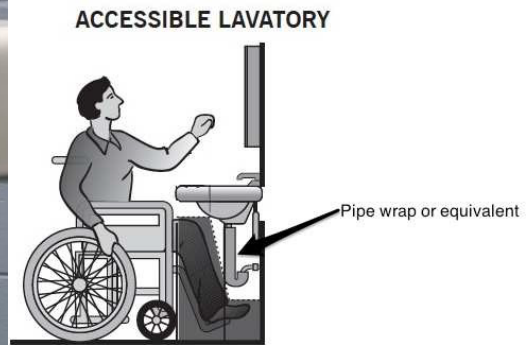
As Built: The water and drainpipes under the lavatory are not adequately insulated.

Water supply and drainpipes under lavatories and sinks shall be insulated or otherwise configured to protect against contact. There shall be no sharp or abrasive surfaces under lavatories and sinks.

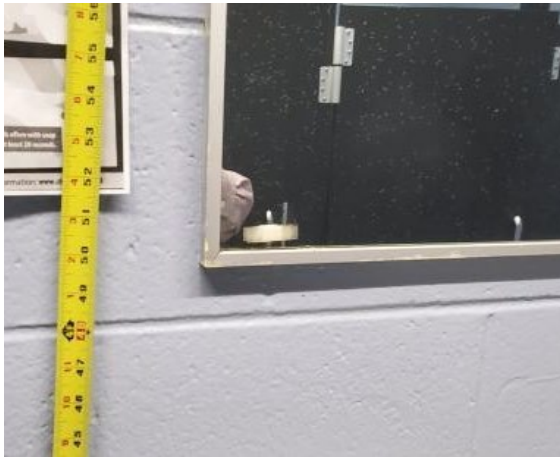
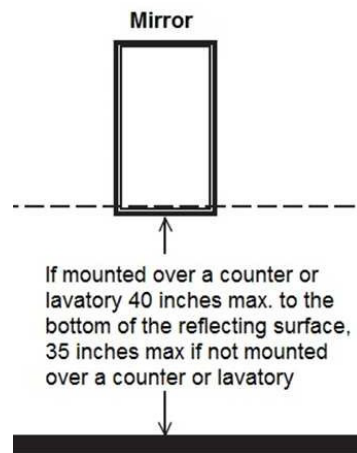
As Built: The mirror is mounted too high.

Mirrors must have the bottom edge of the reflecting surface a maximum of 40 inches above the floor if above a sink or counter. Mirrors not located above lavatories or countertops shall be installed with the bottom edge of the reflecting surface 35 inches maximum above the finish floor or ground.

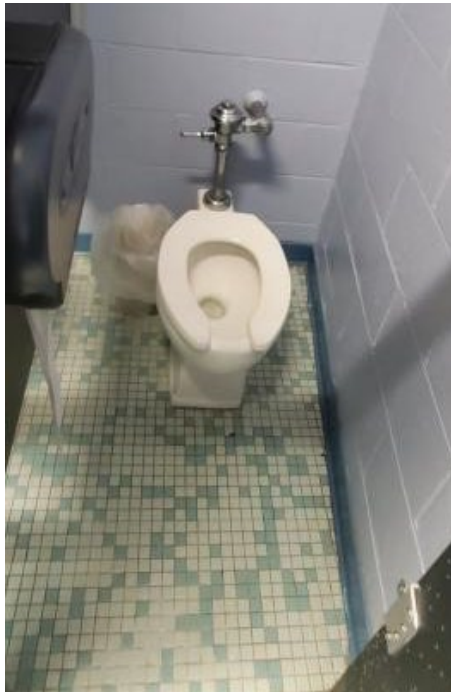
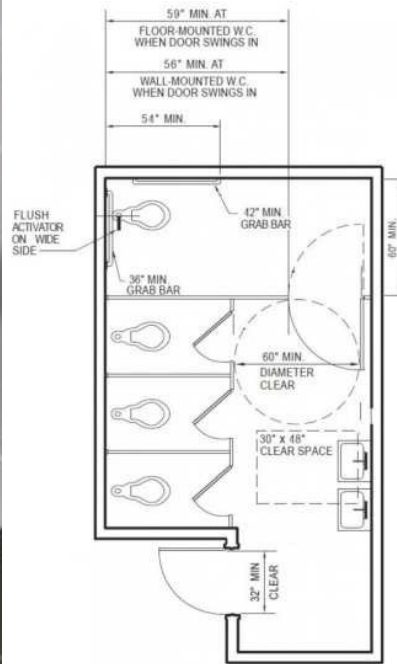
As Built: The toilet compartment does not have the required minimum clear floor space or maneuvering clearances for the toilet. The toilet flush handle is on wrong side. Toilet not within 16-18" from wall. No Grab bars are installed.

Citation: 2010 ADAS Section 213.2

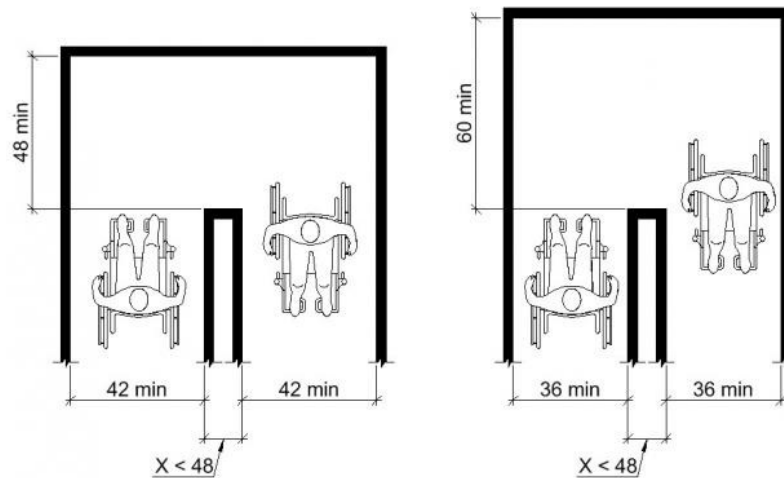
As Built: The route of travel does not meet minimum width requirements around the turn.

Where the accessible route makes a 180 degree turn around an element which is less than 48 inches wide, clear width shall be 42 inches minimum approaching the turn, 48 inches minimum at the turn and 42 inches minimum leaving the turn. Where the clear width at the turn is 60 inches minimum a clear width 36 inches minimum approaching the turn and 36 inches minimum at the turn is acceptable.

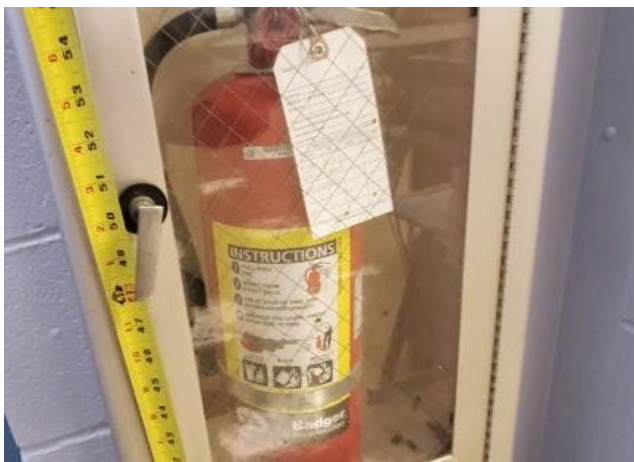
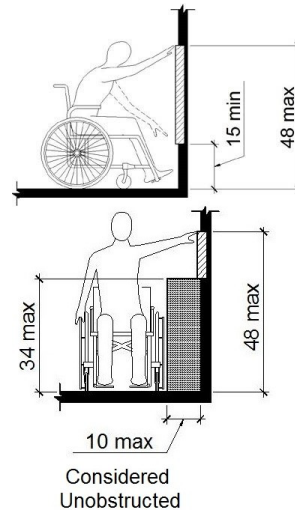
As Built: The Fire extinguisher is not positioned correctly for either a side or front approach.

Where a clear floor or ground space allows a parallel or front approach and the side reach is unobstructed, the high side reach shall be 48 inches maximum above the finish floor or ground and the low side reach shall be 15 inches minimum above the finish floor or ground.

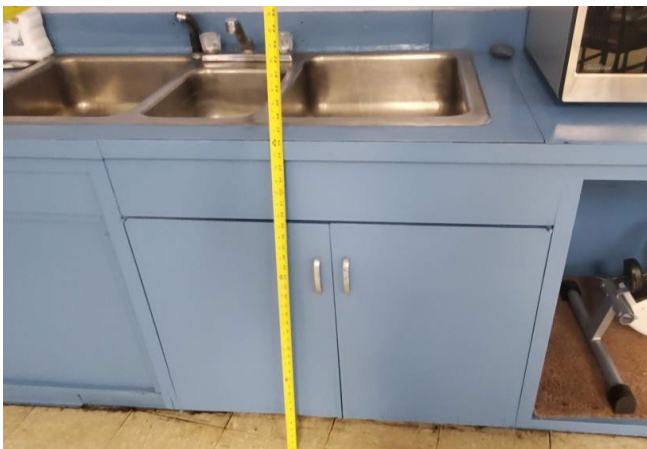
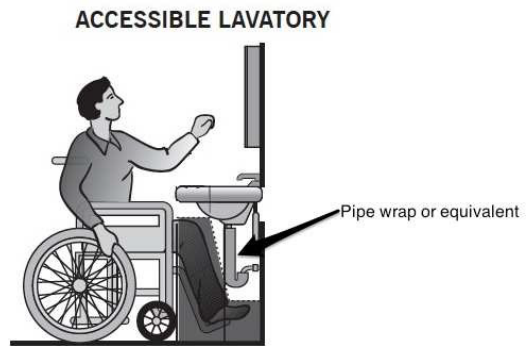
As Built: The top of the sink is too high.

Sinks that are required to be accessible shall be a minimum 17 inches in horizontal depth and mounted with the rim or counter edge no higher than 34 inches above the finished floor.

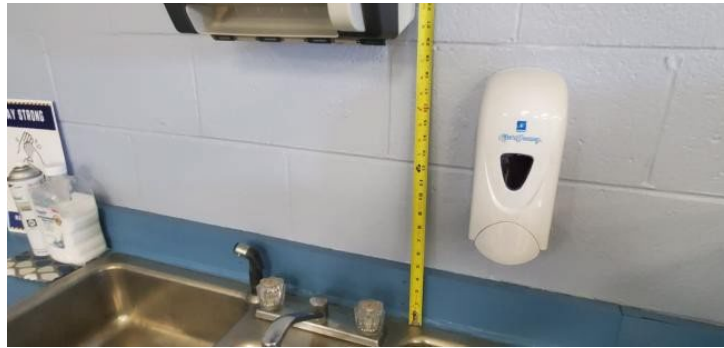
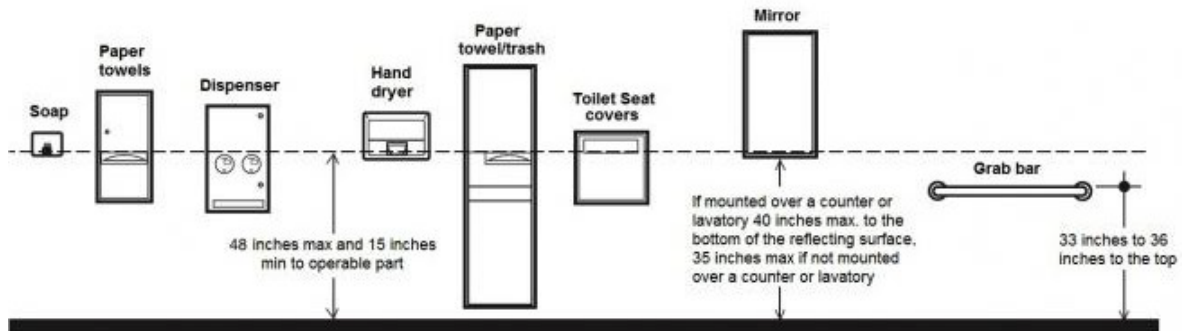
As Built: The paper towel dispenser's operation mechanism is too high off the floor. Dispensers must have all operable parts a maximum of 48 inches above the floor.

Citation: 2010 ADAS Section 308.2.1

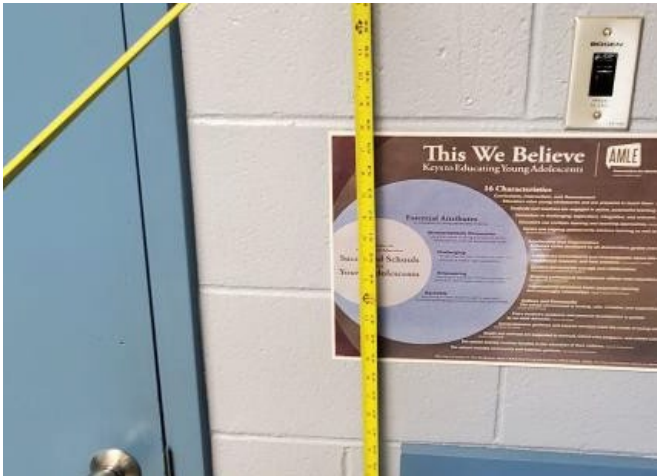
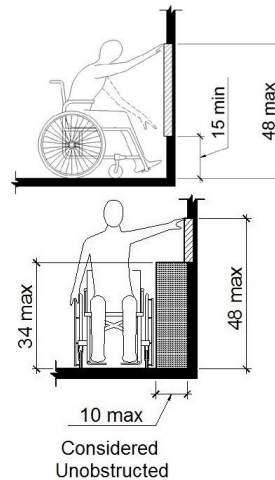
As Built: The Intercom button is not positioned correctly for either a side or front approach.

Where a clear floor or ground space allows a parallel or front approach and the side reach is unobstructed, the high side reach shall be 48 inches maximum above the finish floor or ground and the low side reach shall be 15 inches minimum above the finish floor or ground.

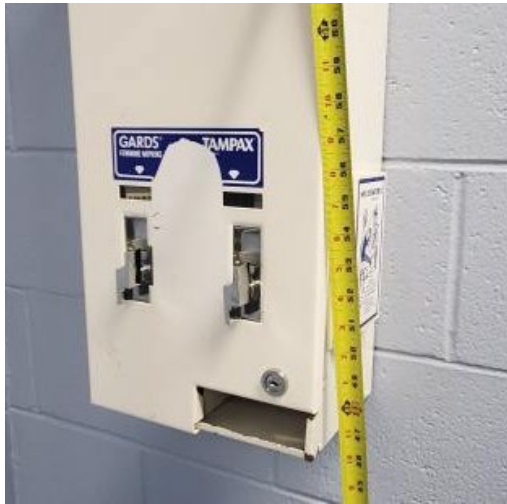
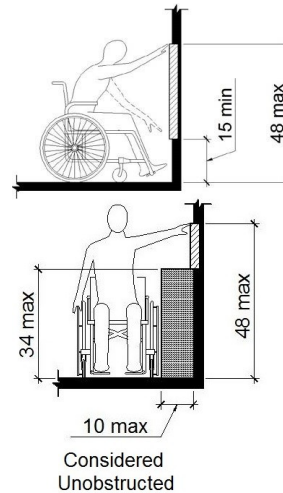
As Built: The hygiene vending cabinet is not positioned correctly for either a side or front approach.

Where a clear floor or ground space allows a parallel or front approach and the side reach is unobstructed, the high side reach shall be 48 inches maximum above the finish floor or ground and the low side reach shall be 15 inches minimum above the finish floor or ground.

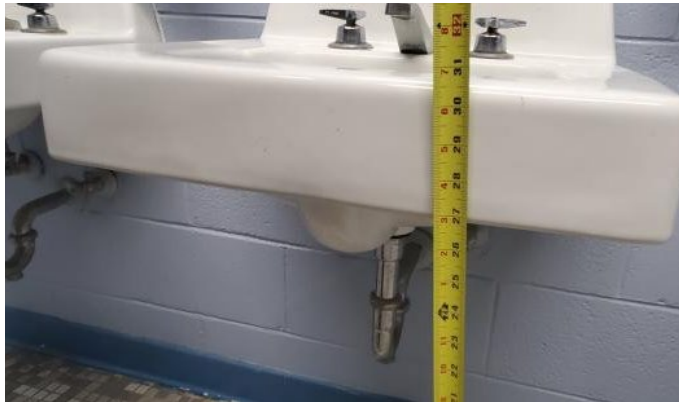
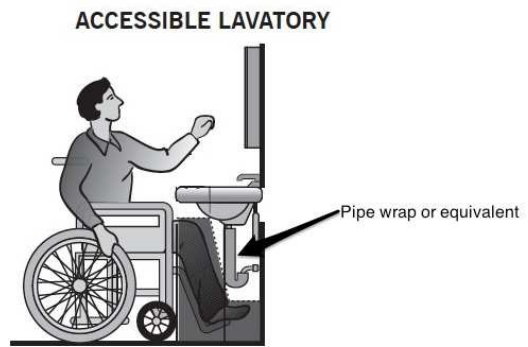
As Built: The water and drainpipes under the lavatory are not adequately insulated.

Water supply and drainpipes under lavatories and sinks shall be insulated or otherwise configured to protect against contact. There shall be no sharp or abrasive surfaces under lavatories and sinks.

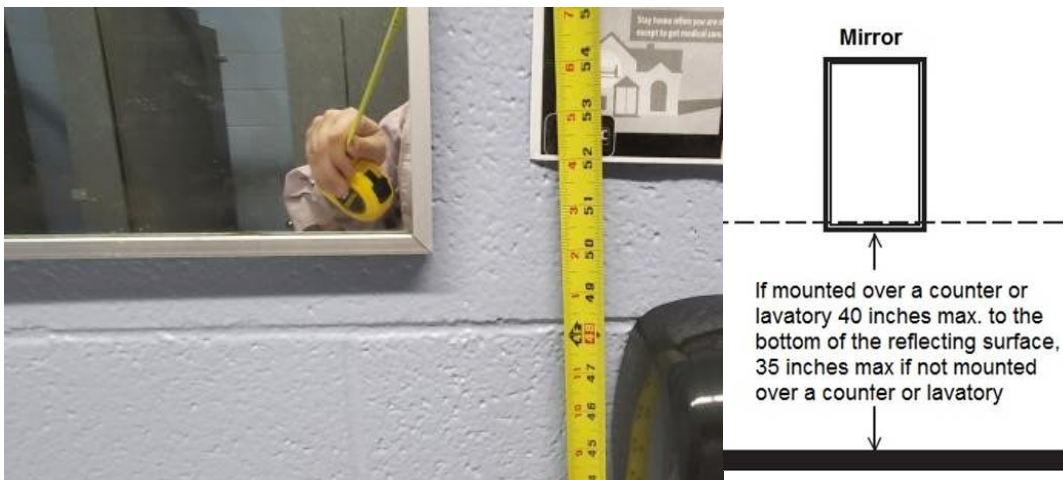
As Built: The mirror is mounted too high.

Mirrors must have the bottom edge of the reflecting surface a maximum of 40 inches above the floor if above a sink or counter. Mirrors not located above lavatories or countertops shall be installed with the bottom edge of the reflecting surface 35 inches maximum above the finish floor or ground.

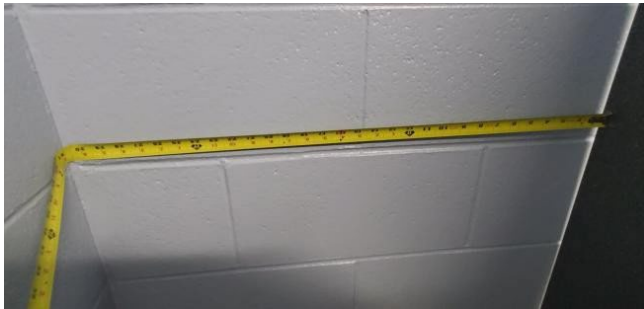
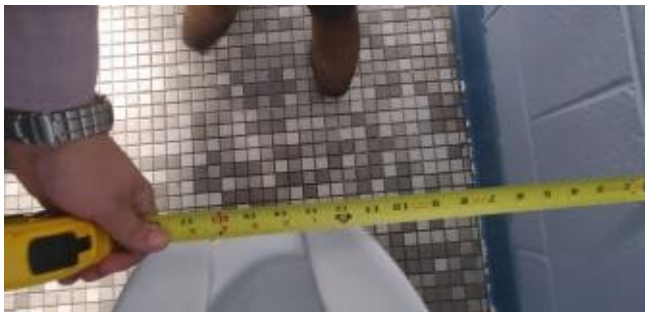
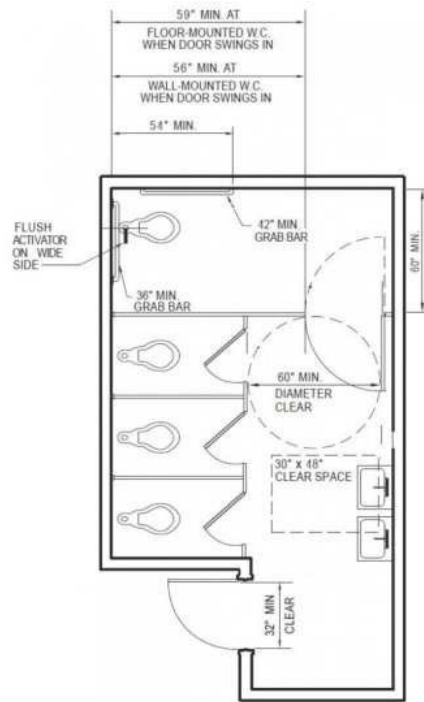
As Built: The toilet compartment does not have the required minimum clear floor space or maneuvering clearances for the toilet. The toilet flush handle is on wrong side. Toilet not within 16-18" from wall. No Grab bars are installed.

Citation: 2010 ADAS Section 213.2

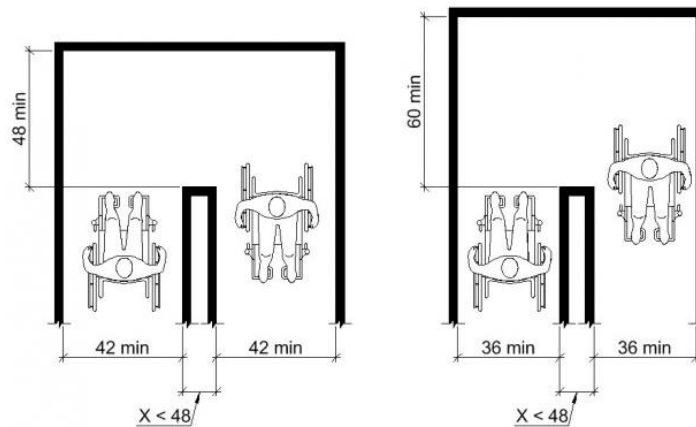
As Built: The route of travel does not meet minimum width requirements around the turn.

Where the accessible route makes a 180 degree turn around an element which is less than 48 inches wide, clear width shall be 42 inches minimum approaching the turn, 48 inches minimum at the turn and 42 inches minimum leaving the turn. Where the clear width at the turn is 60 inches minimum a clear width 36 inches minimum approaching the turn and 36 inches minimum at the turn is acceptable.

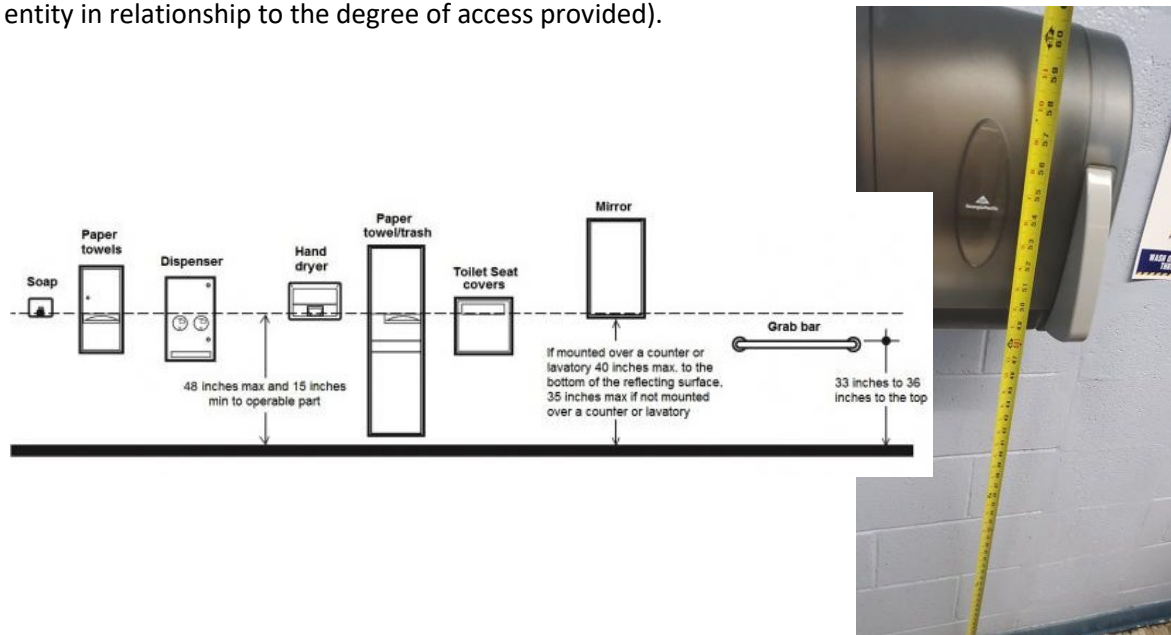
As Built: The paper towel dispenser's operation mechanism is too high off the floor. Dispensers must have all operable parts a maximum of 48 inches above the floor.

Citation: 2010 ADAS Section 308.2.1

Recommendation:
Further design required.

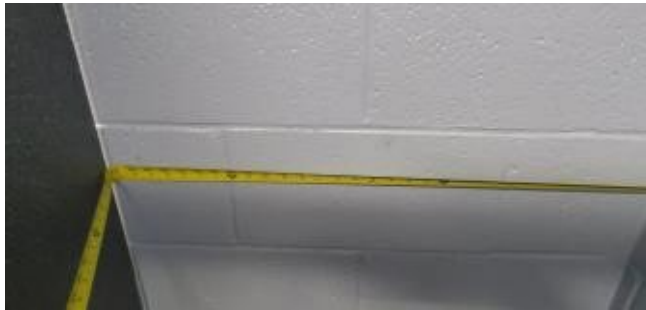
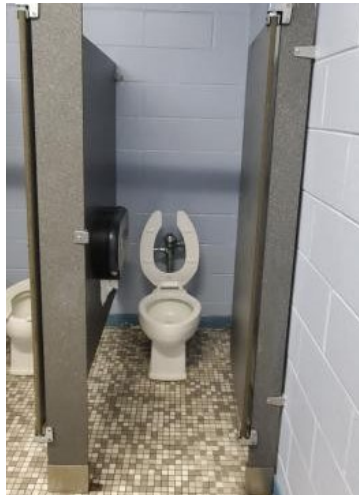
As Built: The toilet compartment does not have the required minimum clear floor space or maneuvering clearances for the toilet. The toilet flush handle is on wrong side. Toilet not within 16-18" from wall. No grab bars are installed.

Citation: 2010 ADAS Section 213.2
