WEAKLEY COUNTY, TENNESSEE

ADA EVALUATION

Architectural and Site Findings with Recommendations

TLM Associates, Inc

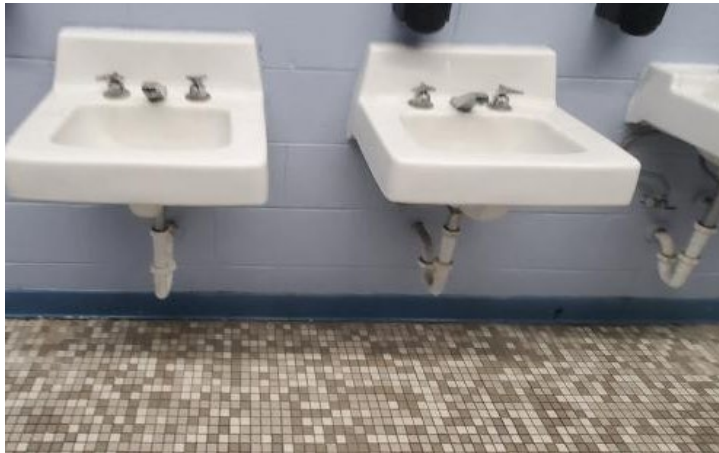
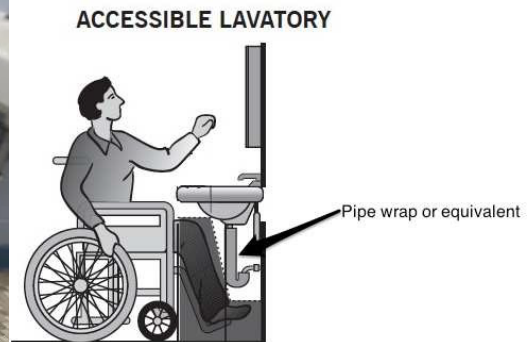
As Built: The water and drainpipes under the lavatory are not adequately insulated.

Water supply and drainpipes under lavatories and sinks shall be insulated or otherwise configured to protect against contact. There shall be no sharp or abrasive surfaces under lavatories and sinks.

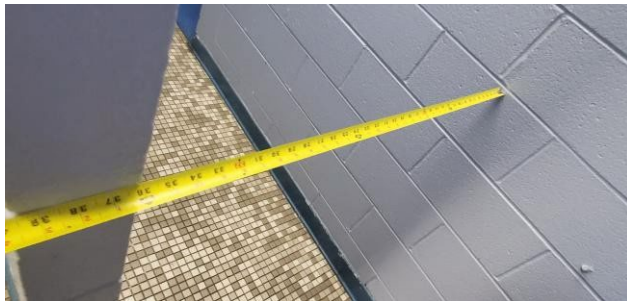
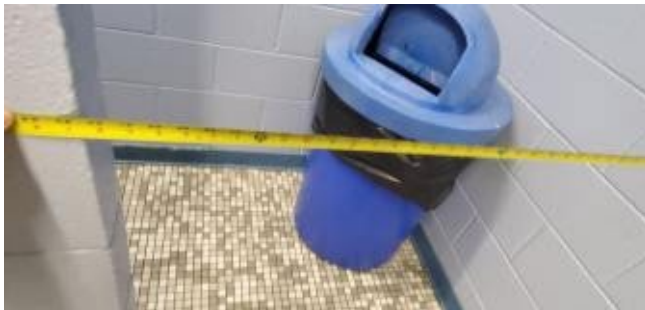
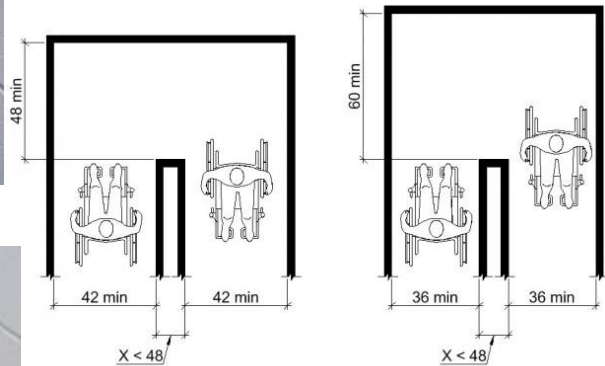
As Built: The route of travel does not meet minimum width requirements around the turn.

Where the accessible route makes a 180 degree turn around an element which is less than 48 inches wide, clear width shall be 42 inches minimum approaching the turn, 48 inches minimum at the turn and 42 inches minimum leaving the turn. Where the clear width at the turn is 60 inches minimum a clear width 36 inches minimum approaching the turn and 36 inches minimum at the turn is acceptable.

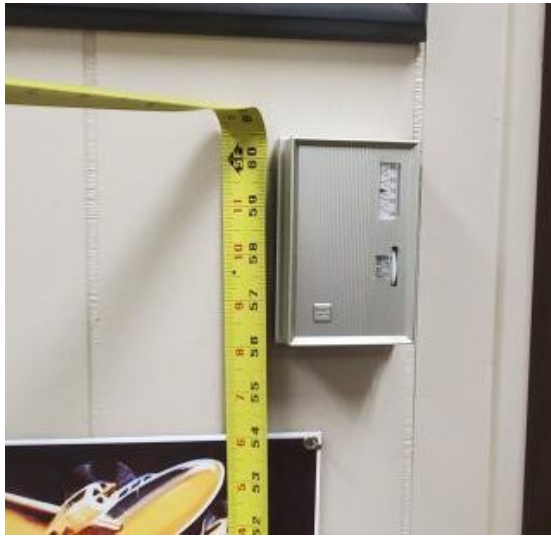
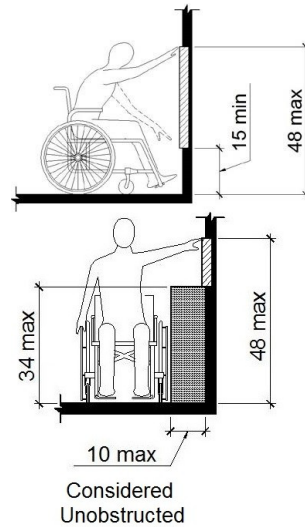
As Built: The Thermostat is not positioned correctly for either a side or front approach.

Where a clear floor or ground space allows a parallel or front approach and the side reach is unobstructed, the high side reach shall be 48 inches maximum above the finish floor or ground and the low side reach shall be 15 inches minimum above the finish floor or ground.

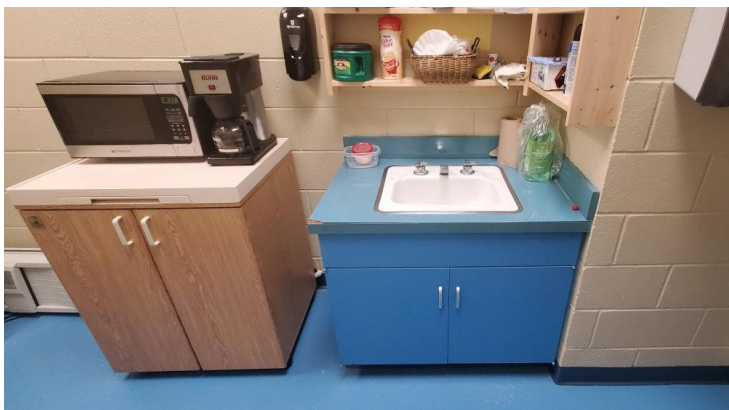
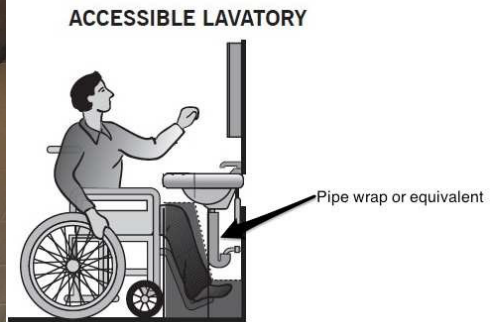
As Built: The top of the sink is too high.

Sinks that are required to be accessible shall be a minimum 17 inches in horizontal depth and mounted with the rim or counter edge no higher than 34 inches above the finished floor.

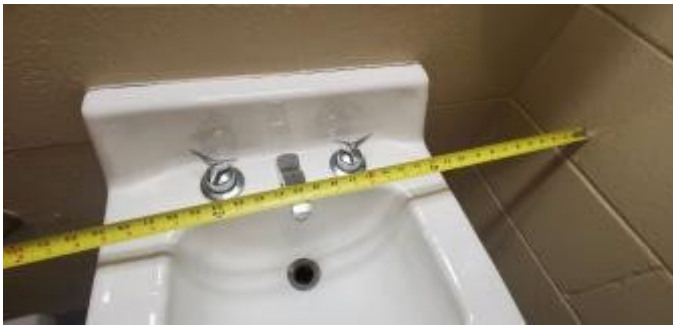
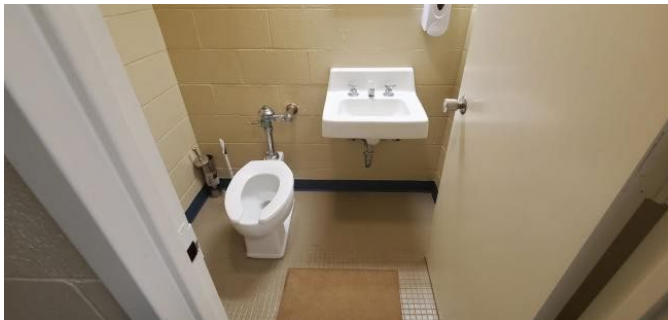
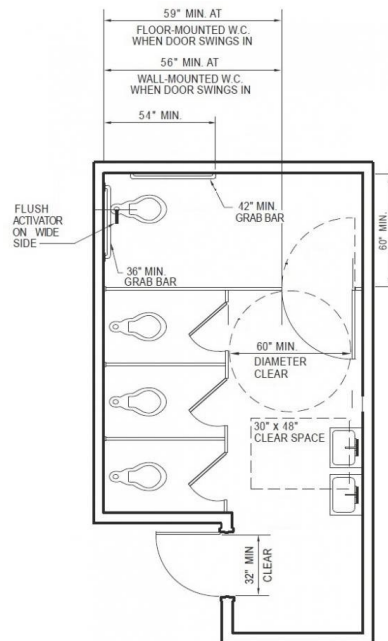
As Built: The restroom does not have the required minimum clear floor space or maneuvering clearances for the toilet. The restroom does not have the required minimum clear floor space or maneuvering clearances for the lavatory. The entry door does not contain the required minimum 60 inches maneuvering space on the pull side. The entry door encroaches into the required clear floor space for fixtures. No grab bars are installed. Mirror reflecting surface is at 49" - reflecting surface to be at 40" max AFF. Center of Toilet not within 16-18" required distance from wall. Toilet flush handle is on wrong side. Lavatory pipes are not insulated.

Citation: 2010 ADAS Section 213.2

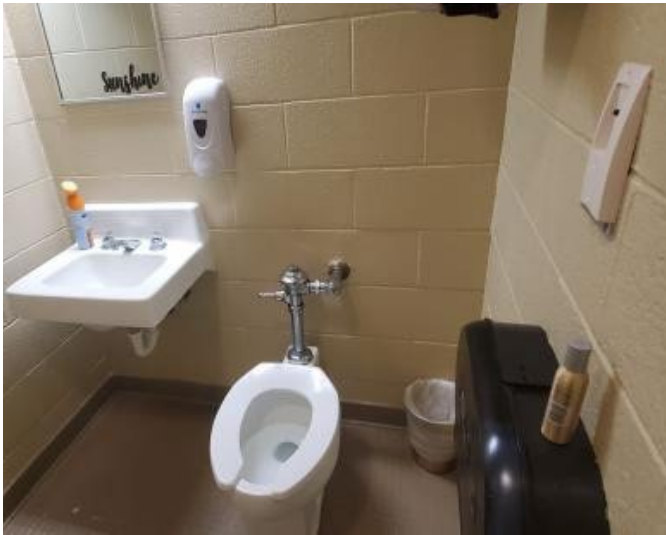
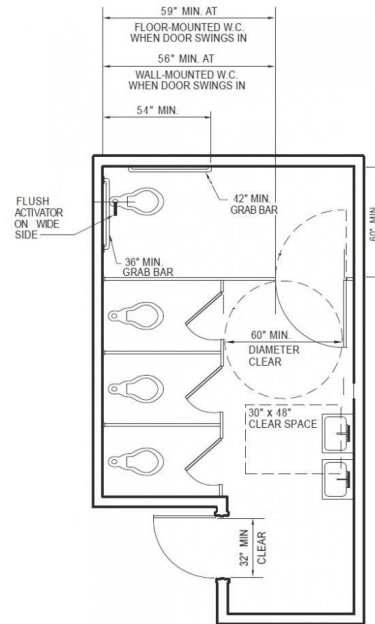
As Built: The restroom does not have the required minimum clear floor space or maneuvering clearances for the toilet. The restroom does not have the required minimum clear floor space or maneuvering clearances for the lavatory. The entry door does not contain the required minimum 60 inches maneuvering space on the pull side. The entry door encroaches into the required clear floor space for fixtures. No Grab bars are installed. Mirror reflecting surface is at 49" - reflecting surface to be at 40" max AFF. Center of Toilet not within 16-18" required distance from wall. Mirror and paper towel dispenser are too high. Lavatory pipes are not insulated.

Citation: 2010 ADAS Section 213.2

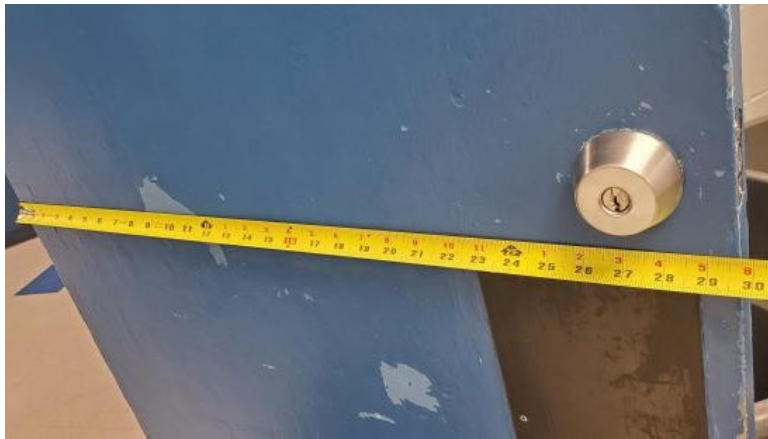
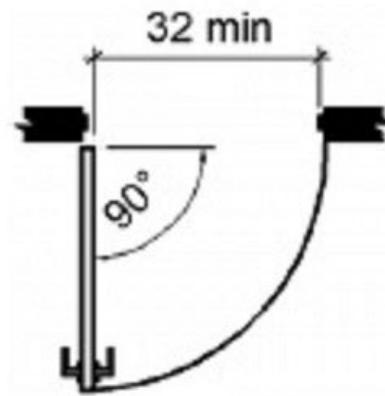
Hinged Door or Gate

As Built: Neither leaf of the doorway provides at least 32 inches between the face of the door and the opposite stop. At least one of the active leaves of doorways with two leaves shall comply with clear width and maneuvering clearance.

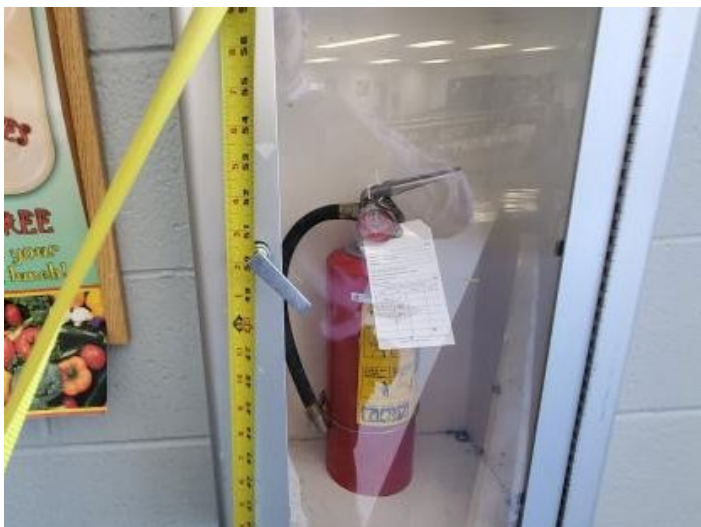
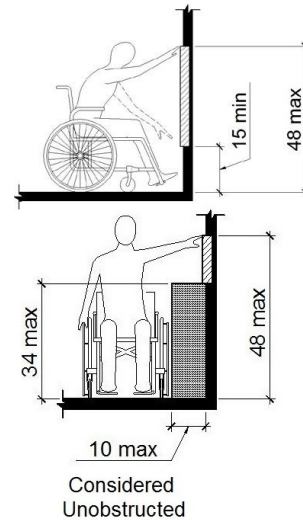
As Built: The Fire extinguisher is not positioned correctly for either a side or front approach.

Where a clear floor or ground space allows a parallel or front approach and the side reach is unobstructed, the high side reach shall be 48 inches maximum above the finish floor or ground and the low side reach shall be 15 inches minimum above the finish floor or ground.

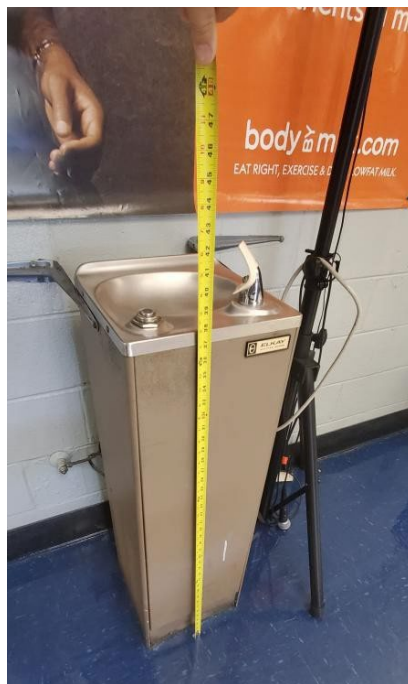
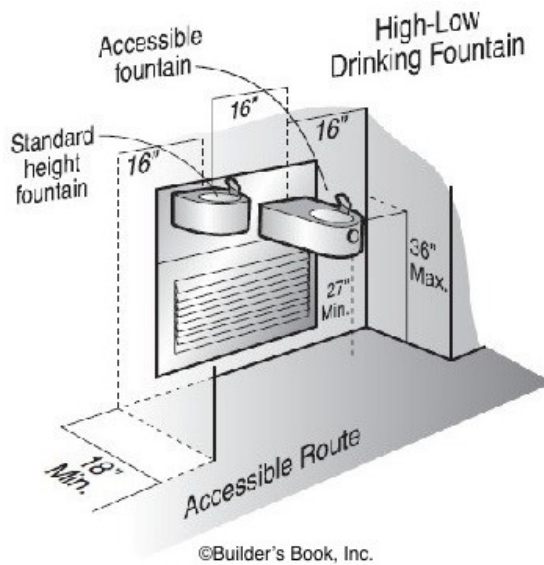
As Built: The drinking fountain is noncompliant.

Spout outlets shall be 36 inches maximum above the finish floor or ground and be located 15 inches minimum from the vertical support and 5 inches maximum from the front edge of the unit, including bumpers. The spout shall provide a flow of water at least 4 inches high minimum and shall be located 5 inches maximum from the front of the unit. The angle of the water stream shall be measured horizontally relative to the front face of the unit. Where spouts are located less than 3 inches of the front of the unit, the angle of the water stream shall be 30 degrees maximum. Where spouts are located between 3 inches and 5 inches maximum from the front of the unit, the angle of the water stream shall be 15 degrees maximum. On an accessible drinking fountain with a round or oval bowl, the spout must be positioned so the flow of water is within 3 inches of the front edge of the fountain.

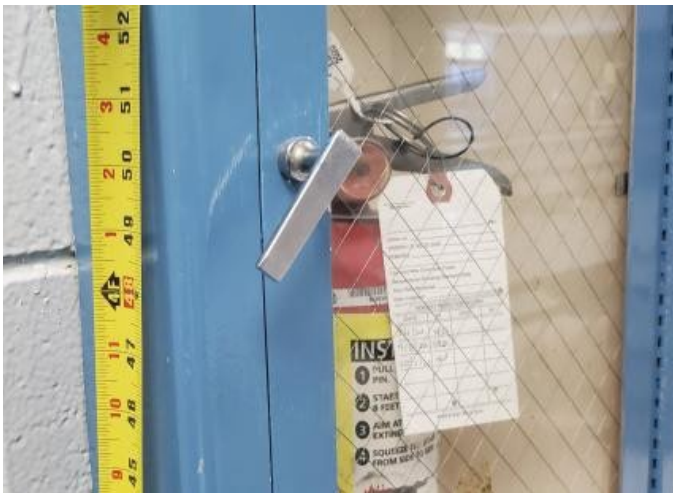
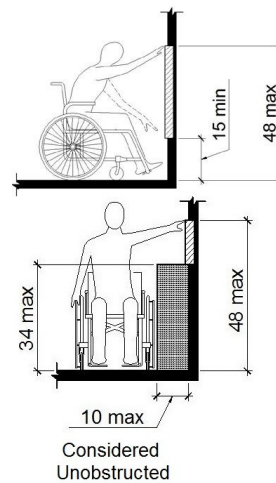
As Built: The Fire extinguisher is not positioned correctly for either a side or front approach.

Where a clear floor or ground space allows a parallel or front approach and the side reach is unobstructed, the high side reach shall be 48 inches maximum above the finish floor or ground and the low side reach shall be 15 inches minimum above the finish floor or ground.

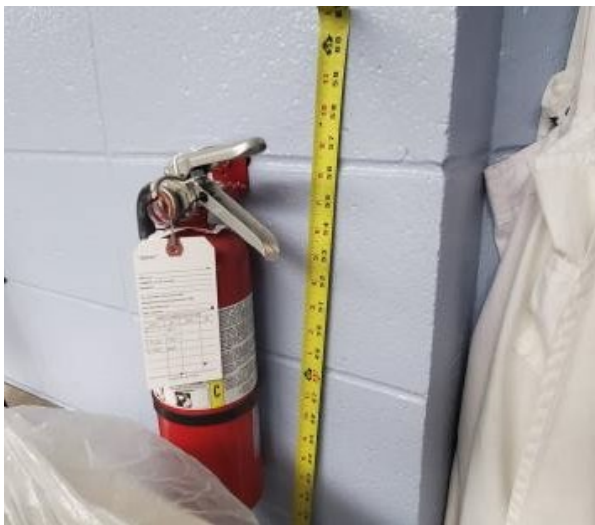
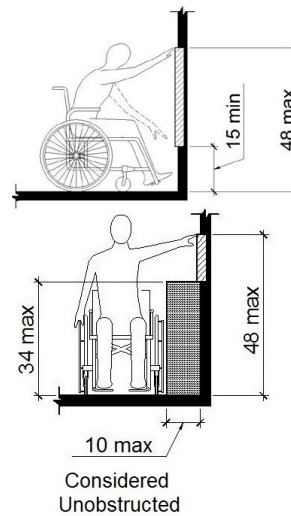
As Built: The Fire extinguisher is not positioned correctly for either a side or front approach.

Where a clear floor or ground space allows a parallel or front approach and the side reach is unobstructed, the high side reach shall be 48 inches maximum above the finish floor or ground and the low side reach shall be 15 inches minimum above the finish floor or ground.

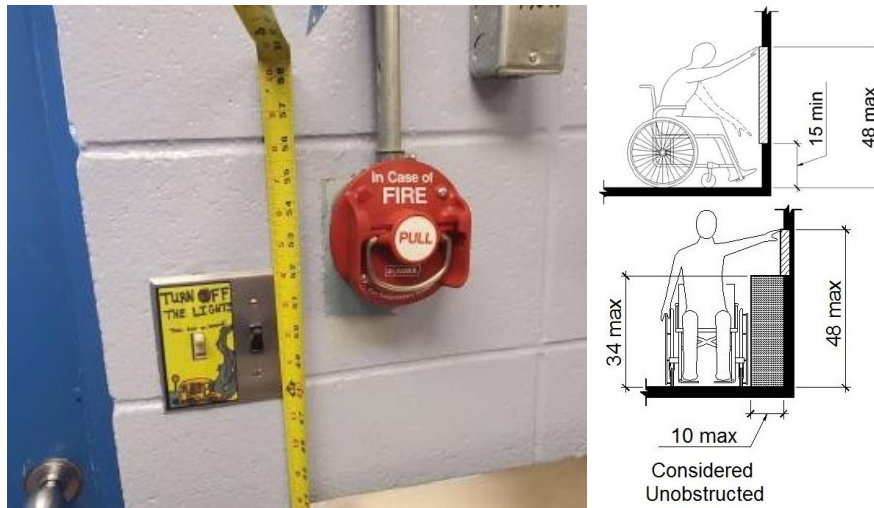
As Built: The Ansul Fire Alarm Pull Station is not positioned correctly for either a side or front approach.

Where a clear floor or ground space allows a parallel or front approach and the side reach is unobstructed, the high side reach shall be 48 inches maximum above the finish floor or ground and the low side reach shall be 15 inches minimum above the finish floor or ground.

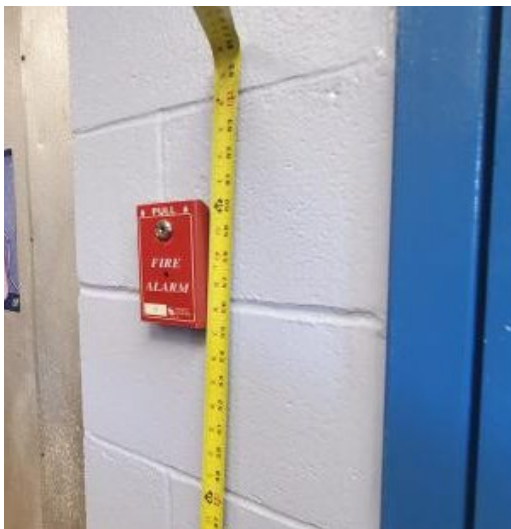
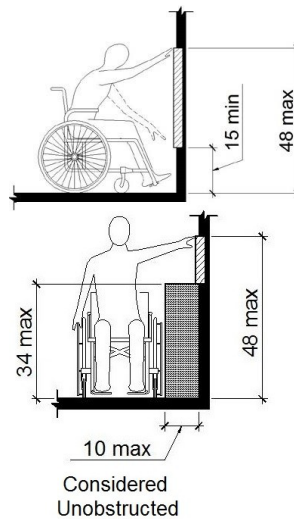
As Built: The Fire Alarm Pull Station is not positioned correctly for either a side or front approach.

Where a clear floor or ground space allows a parallel or front approach and the side reach is unobstructed, the high side reach shall be 48 inches maximum above the finish floor or ground and the low side reach shall be 15 inches minimum above the finish floor or ground.

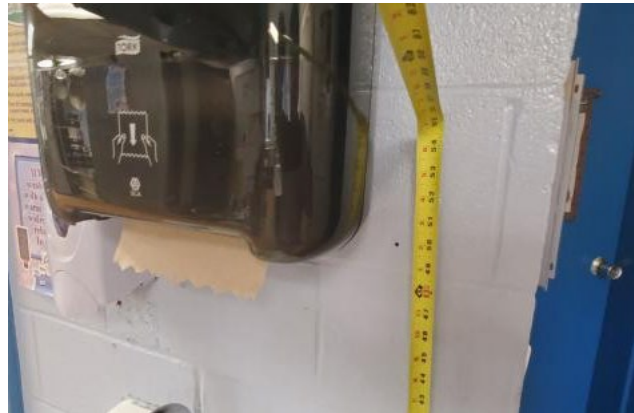
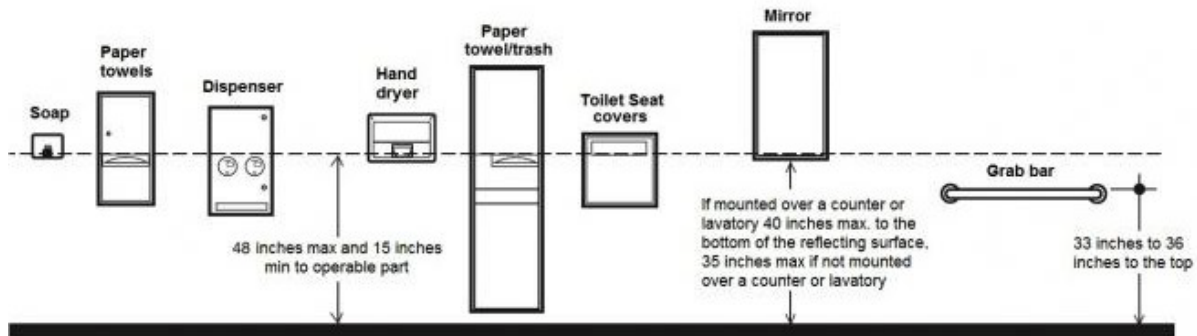
As Built: The paper towel dispenser's operation mechanism is too high off the floor. Dispensers must have all operable parts a maximum of 48 inches above the floor.

Citation: 2010 ADAS Section 308.2.1

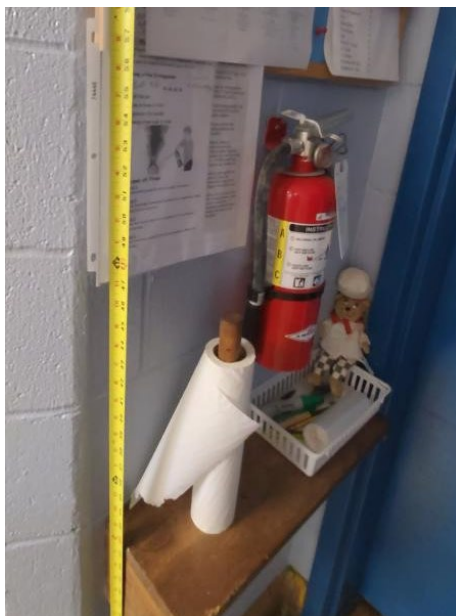
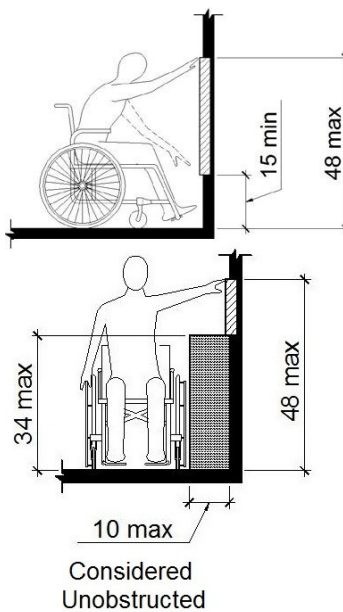
As Built: The Fire extinguisher is not positioned correctly for either a side or front approach.

Where a clear floor or ground space allows a parallel or front approach and the side reach is unobstructed, the high side reach shall be 48 inches maximum above the finish floor or ground and the low side reach shall be 15 inches minimum above the finish floor or ground.

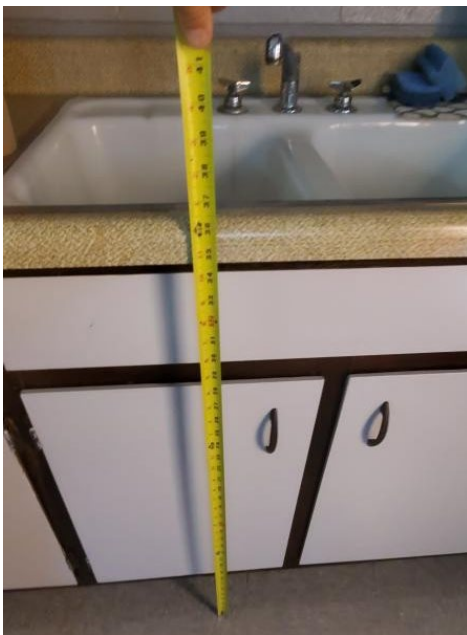
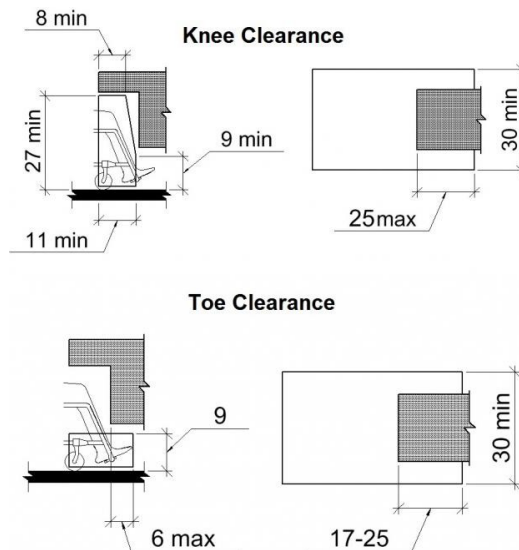
As Built: Knee and toe clearance has not been provided at the sink.

The knee clearance shall be 11 inches deep minimum at 9 inches above the finish floor or ground, and 8 inches deep minimum at 27 inches above the finish floor or ground.

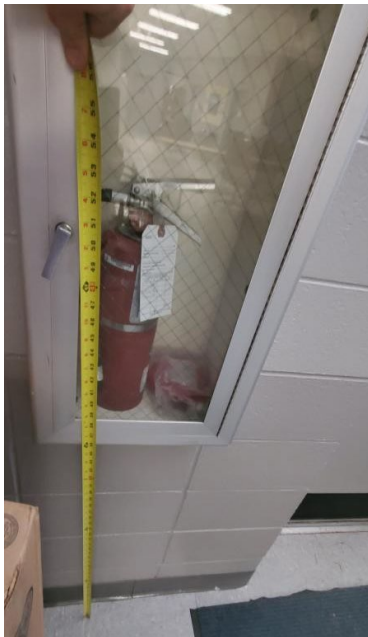
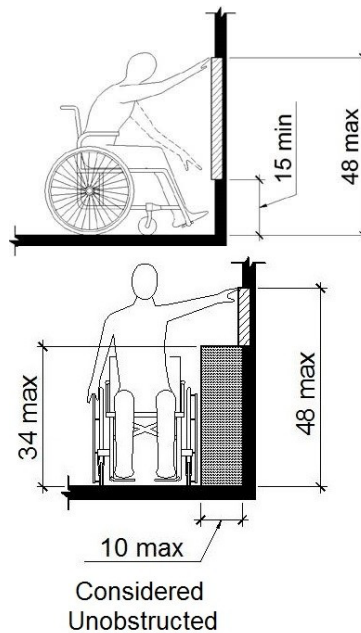
As Built: The Fire extinguisher is not positioned correctly for either a side or front approach.

Where a clear floor or ground space allows a parallel or front approach and the side reach is unobstructed, the high side reach shall be 48 inches maximum above the finish floor or ground and the low side reach shall be 15 inches minimum above the finish floor or ground.

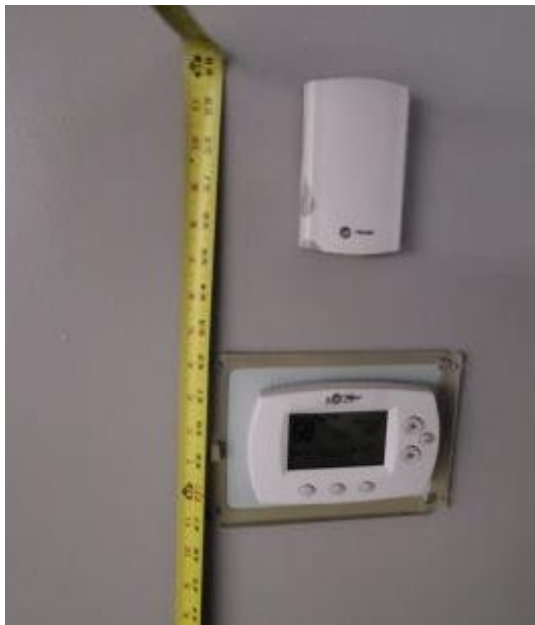
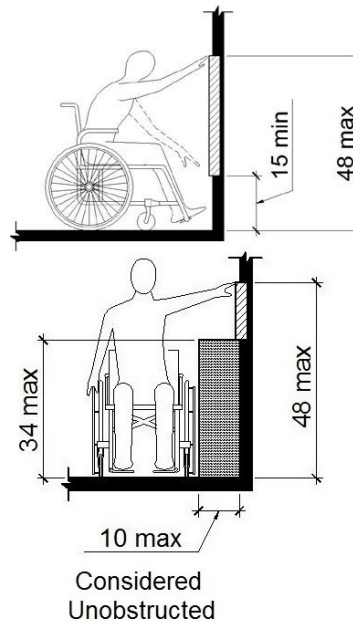
As Built: The Thermostat is not positioned correctly for either a side or front approach.

Where a clear floor or ground space allows a parallel or front approach and the side reach is unobstructed, the high side reach shall be 48 inches maximum above the finish floor or ground and the low side reach shall be 15 inches minimum above the finish floor or ground.

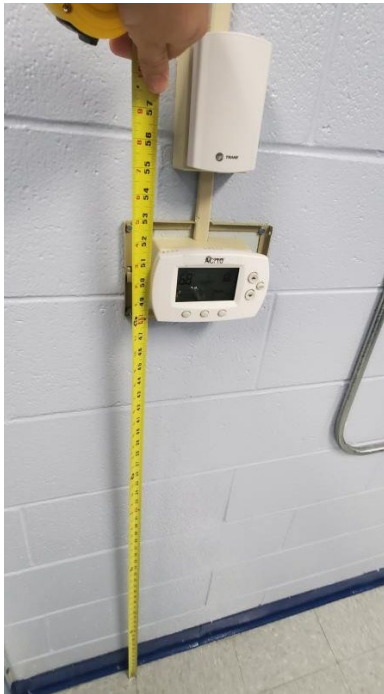
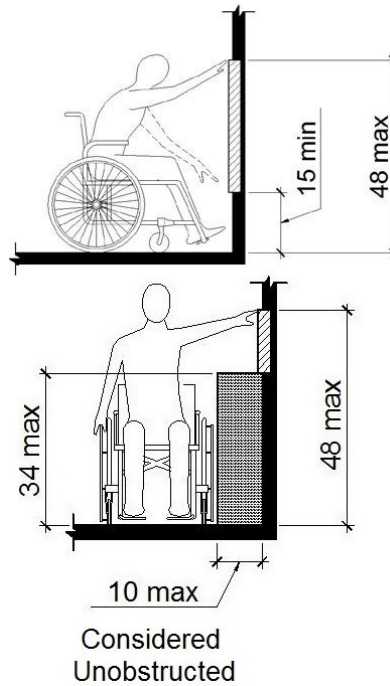
As Built: The Thermostat is not positioned correctly for either a side or front approach.

Where a clear floor or ground space allows a parallel or front approach and the side reach is unobstructed, the high side reach shall be 48 inches maximum above the finish floor or ground and the low side reach shall be 15 inches minimum above the finish floor or ground.

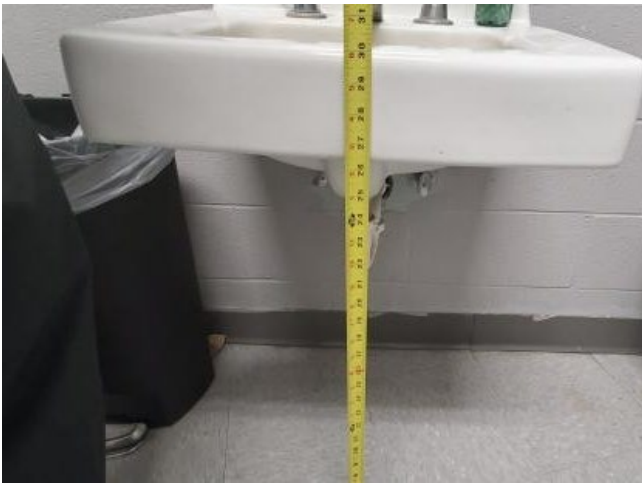
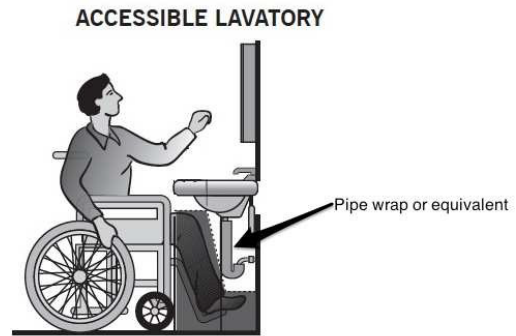
As Built: The water and drainpipes under the lavatory are not insulated.

Water supply and drainpipes under lavatories and sinks shall be insulated or otherwise configured to protect against contact. There shall be no sharp or abrasive surfaces under lavatories and sinks.

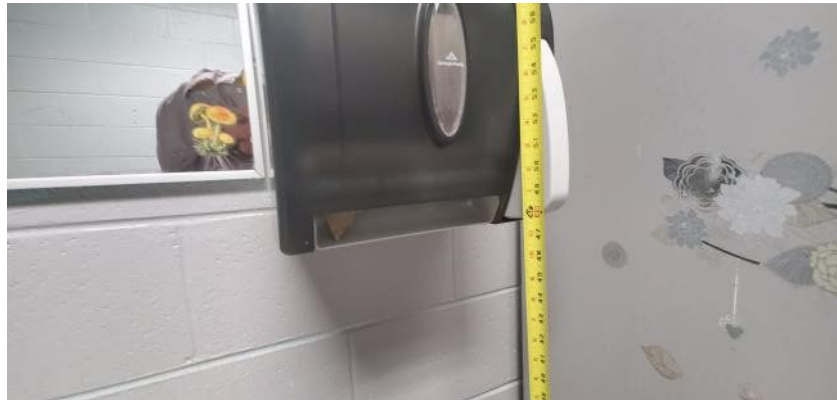
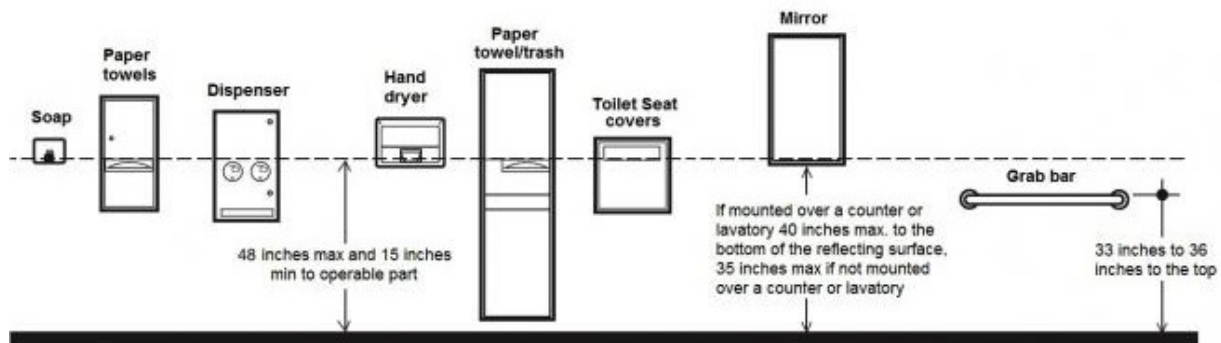
As Built: The paper towel dispenser's operation mechanism is too high off the floor. Dispensers must have all operable parts a maximum of 48 inches above the floor.

Citation: 2010 ADAS Section 308.2.1

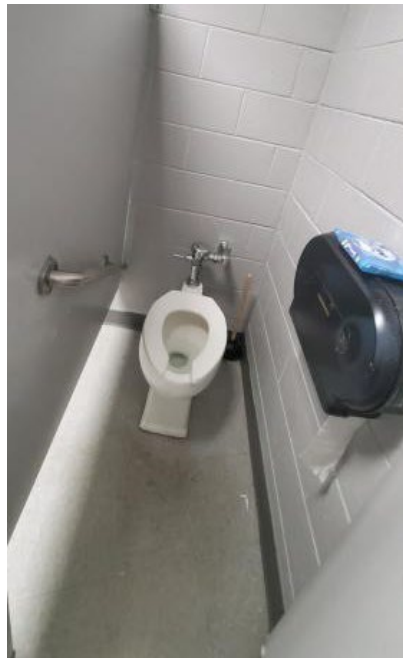
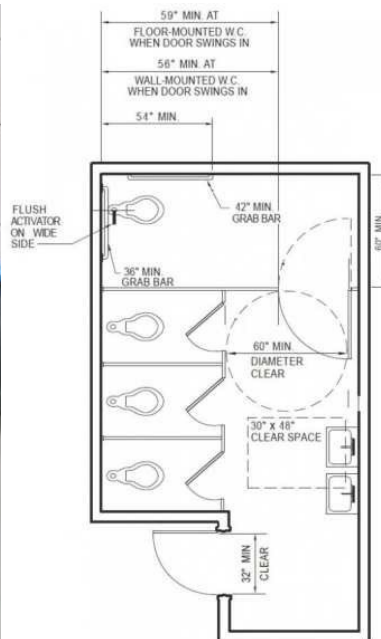
As Built: The toilet compartment does not have the required minimum clear floor space or maneuvering clearances for the toilet. Toilet not within 16-18" from wall. Side grab bar installed incorrectly and rear grab bar missing.

Citation: 2010 ADAS Section 213.2

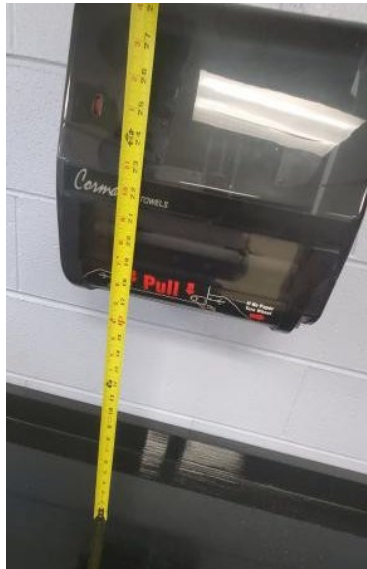
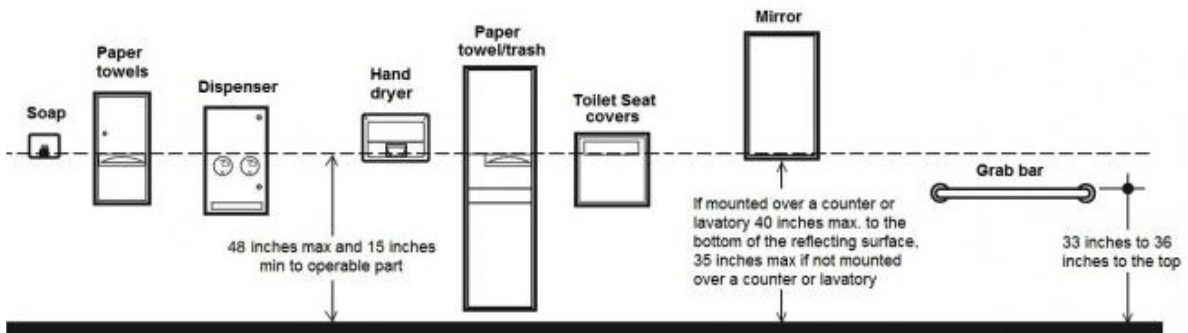
As Built: The paper towel dispenser's operation mechanism is too high off the floor. Dispensers must have all operable parts a maximum of 48 inches above the floor.

Citation: 2010 ADAS Section 308.2.1

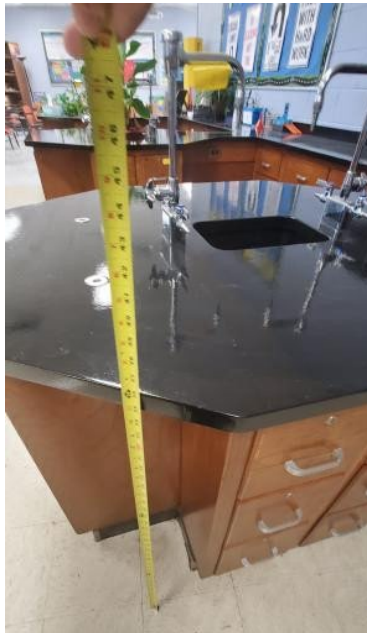
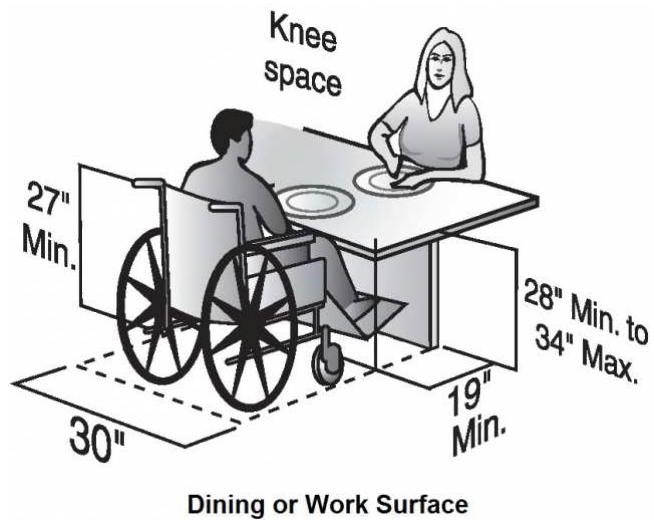
As Built: The top of the table surface is not within a compliant height range.

The tops of tables and counters shall be 28 inches to 34 inches from the floor or ground.

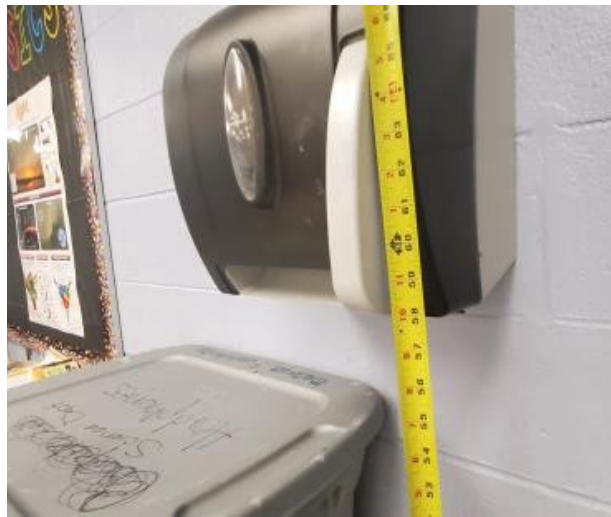
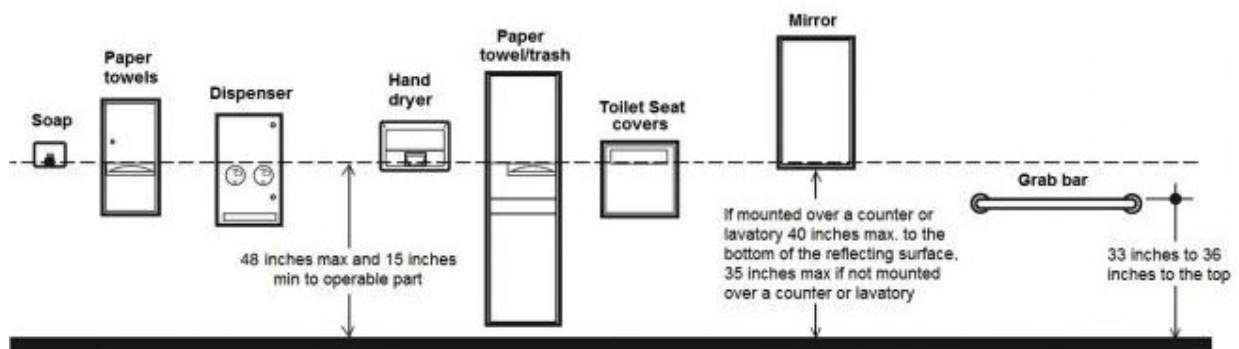
As Built: The paper towel dispenser's operation mechanism is too high off the floor. Dispensers must have all operable parts a maximum of 48 inches above the floor.

Citation: 2010 ADAS Section 308.2.1

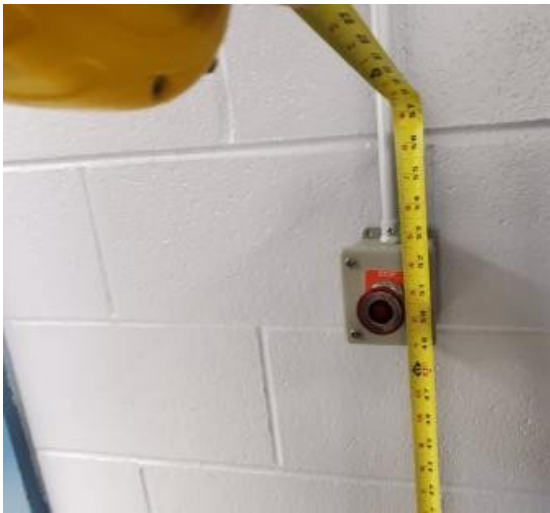
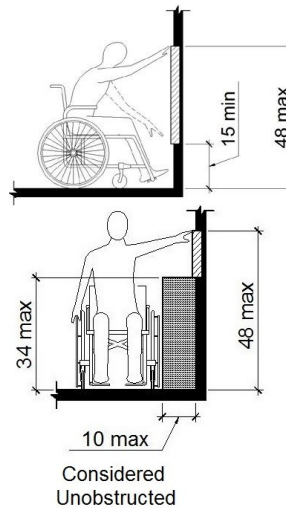
As Built: The Stop button is not positioned correctly for either a side or front approach.

Where a clear floor or ground space allows a parallel or front approach and the side reach is unobstructed, the high side reach shall be 48 inches maximum above the finish floor or ground and the low side reach shall be 15 inches minimum above the finish floor or ground.

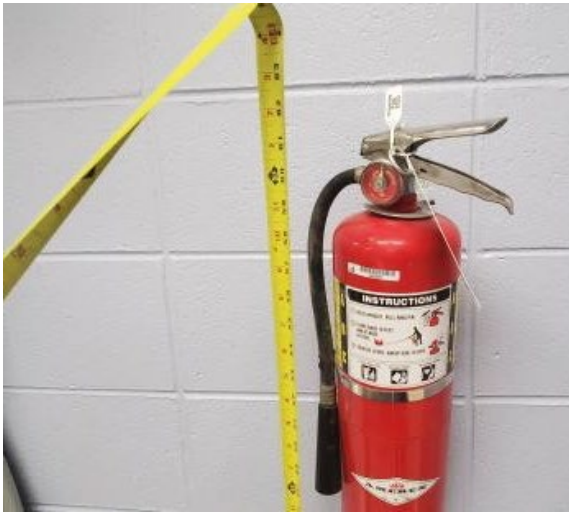
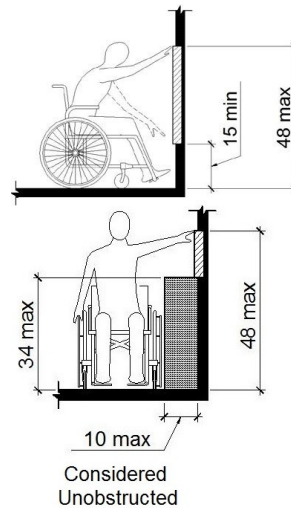
As Built: The Fire extinguisher is not positioned correctly for either a side or front approach.

Where a clear floor or ground space allows a parallel or front approach and the side reach is unobstructed, the high side reach shall be 48 inches maximum above the finish floor or ground and the low side reach shall be 15 inches minimum above the finish floor or ground.

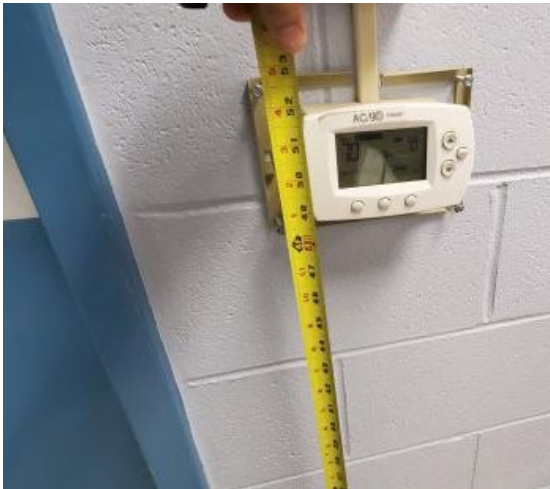
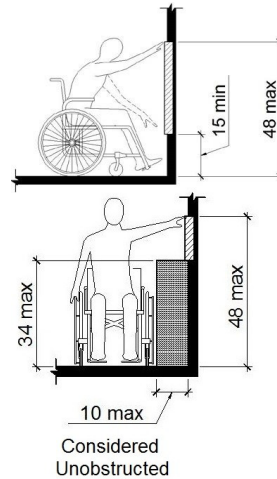
As Built: The Thermostat is not positioned correctly for either a side or front approach.

Where a clear floor or ground space allows a parallel or front approach and the side reach is unobstructed, the high side reach shall be 48 inches maximum above the finish floor or ground and the low side reach shall be 15 inches minimum above the finish floor or ground.

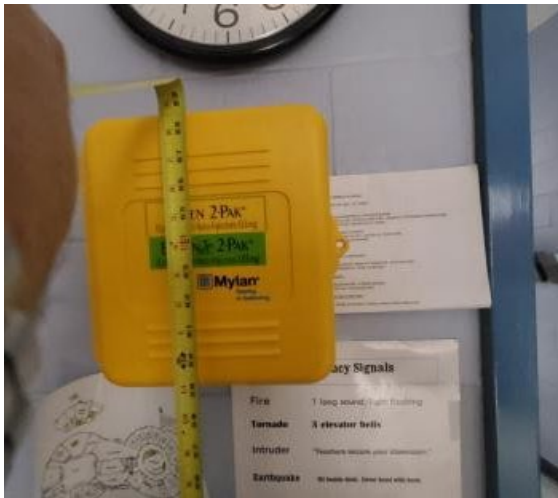
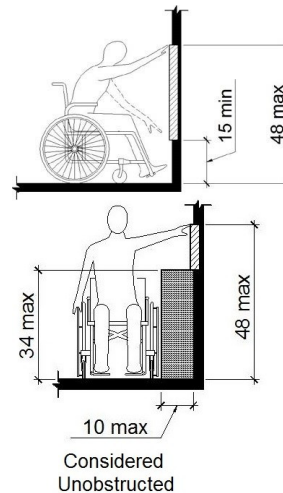
As Built: The EpiPen storage box is not positioned correctly for either a side or front approach.

Where a clear floor or ground space allows a parallel or front approach and the side reach is unobstructed, the high side reach shall be 48 inches maximum above the finish floor or ground and the low side reach shall be 15 inches minimum above the finish floor or ground.

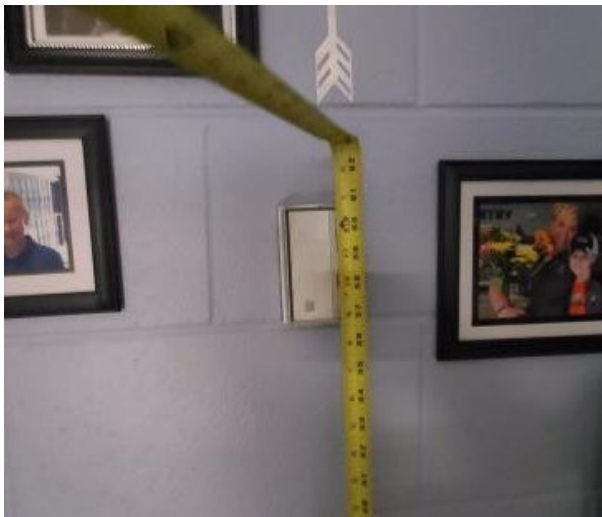
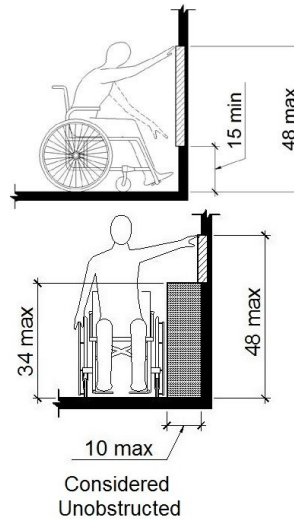
As Built: The thermostat is not positioned correctly for either a side or front approach.

Where a clear floor or ground space allows a parallel or front approach and the side reach is unobstructed, the high side reach shall be 48 inches maximum above the finish floor or ground and the low side reach shall be 15 inches minimum above the finish floor or ground.

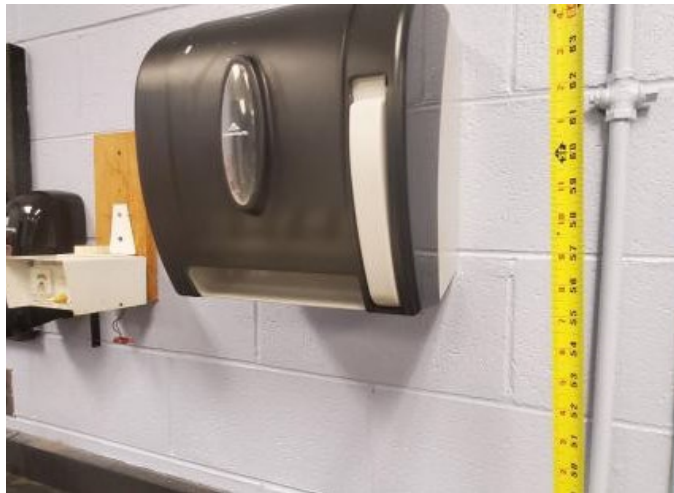
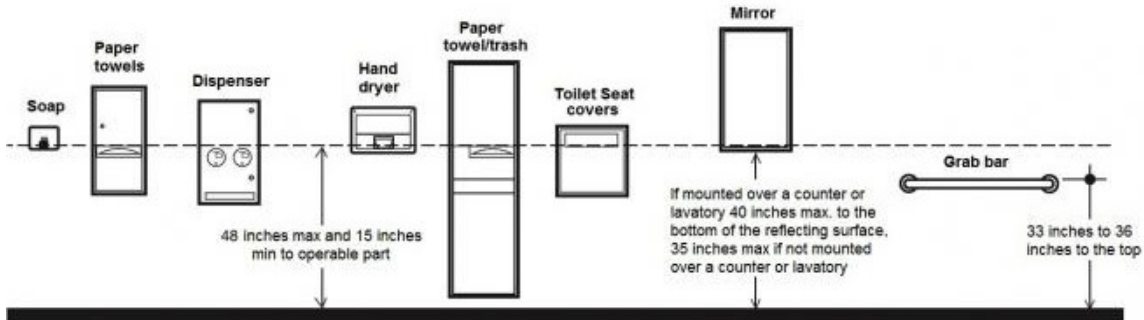
As Built: The paper towel dispenser's operation mechanism is too high off the floor. Dispensers must have all operable parts a maximum of 48 inches above the floor.

Citation: 2010 ADAS Section 308.2.1

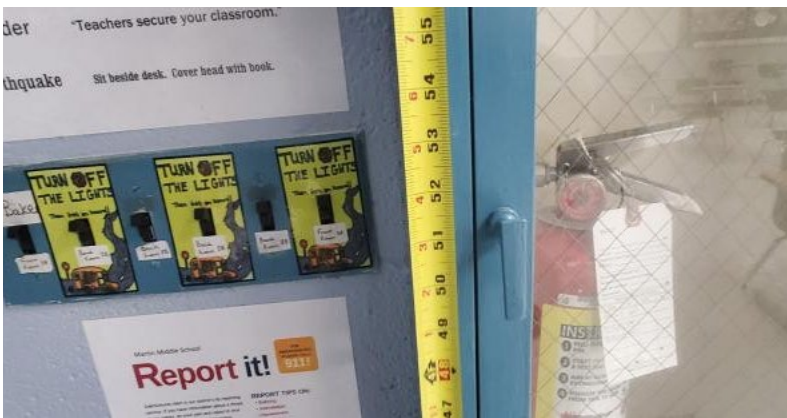
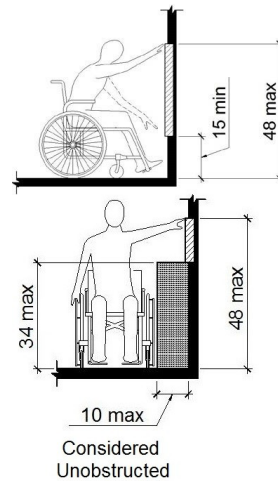
As Built: The fire extinguisher is not positioned correctly for either a side or front approach.

Where a clear floor or ground space allows a parallel or front approach and the side reach is unobstructed, the high side reach shall be 48 inches maximum above the finish floor or ground and the low side reach shall be 15 inches minimum above the finish floor or ground.

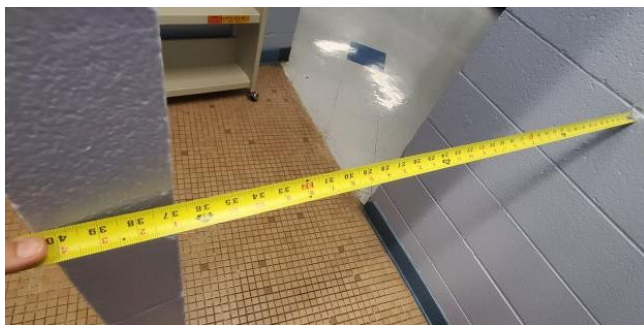
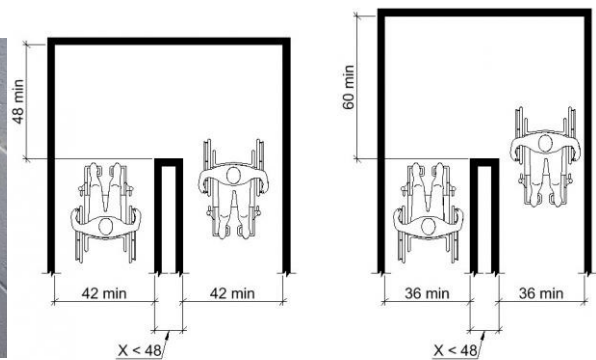
As Built: The route of travel does not meet minimum width requirements around the turn.

Where the accessible route makes a 180 degree turn around an element which is less than 48 inches wide, clear width shall be 42 inches minimum approaching the turn, 48 inches minimum at the turn and 42 inches minimum leaving the turn. Where the clear width at the turn is 60 inches minimum a clear width 36 inches minimum approaching the turn and 36 inches minimum at the turn is acceptable.

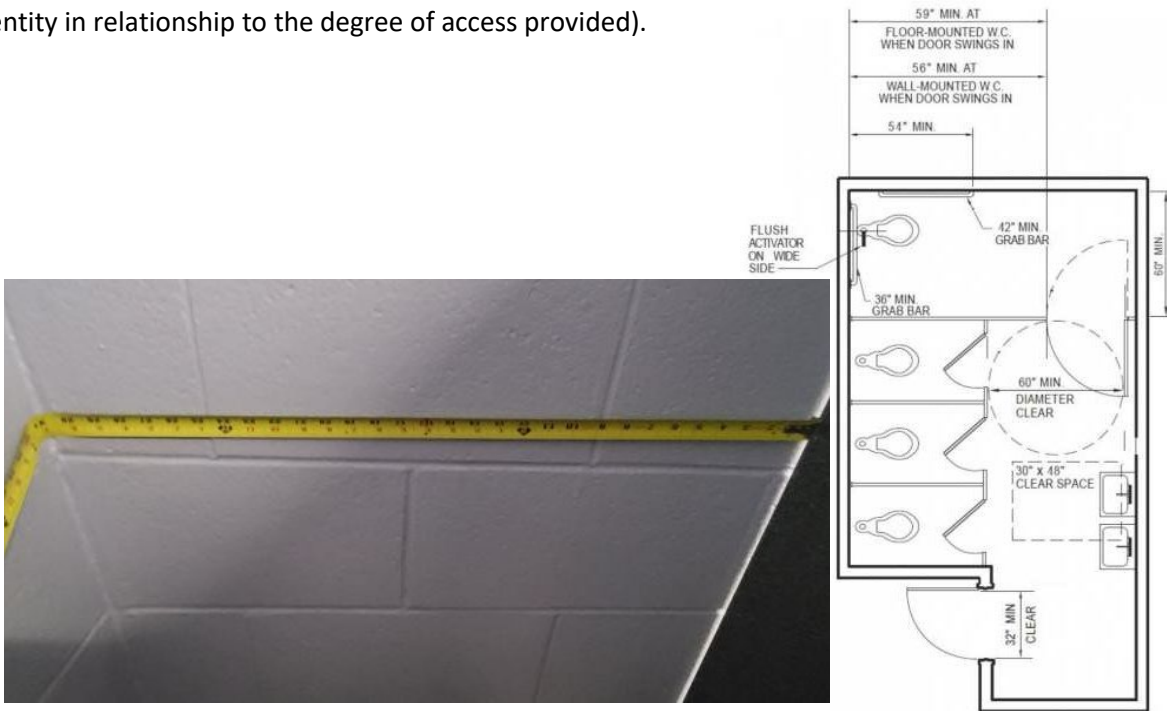
As Built: The toilet compartment does not have the required minimum clear floor space or maneuvering clearances for the toilet. No grab bars are installed.

Citation: 2010 ADAS Section 213.2

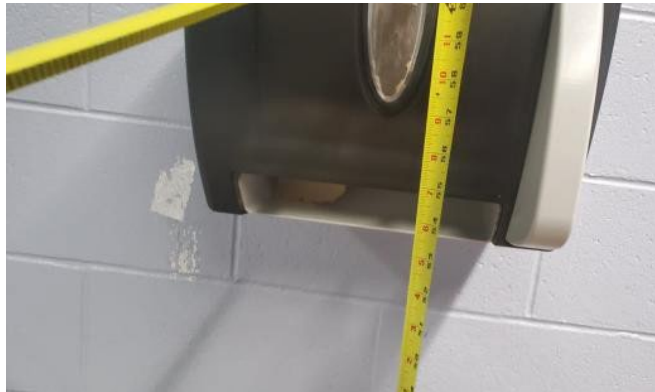
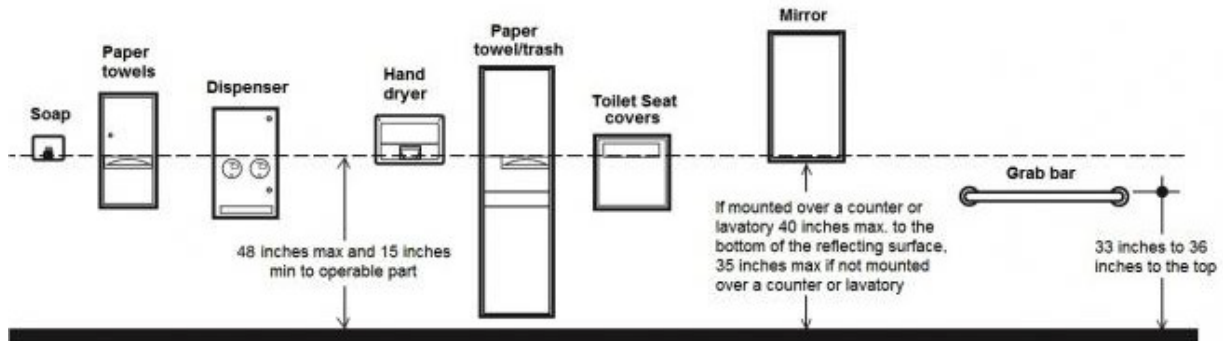
As Built: The paper towel dispenser's operation mechanism is too high off the floor. Dispensers must have all operable parts a maximum of 48 inches above the floor.

Citation: 2010 ADAS Section 308.2.1

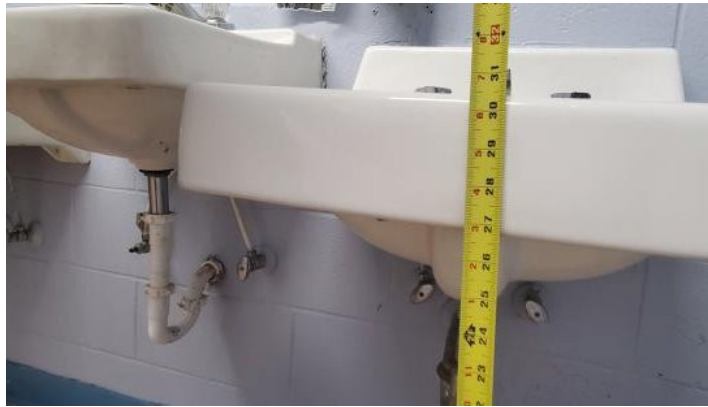
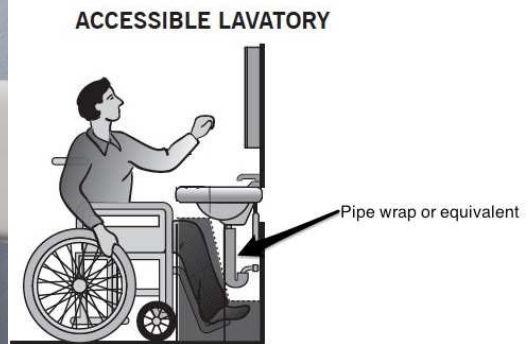
As Built: The water and drainpipes under the lavatory are not adequately insulated.

Water supply and drainpipes under lavatories and sinks shall be insulated or otherwise configured to protect against contact. There shall be no sharp or abrasive surfaces under lavatories and sinks.
