WEAKLEY COUNTY, TENNESSEE

ADA EVALUATION

Architectural and Site Findings with Recommendations

TLM Associates, Inc

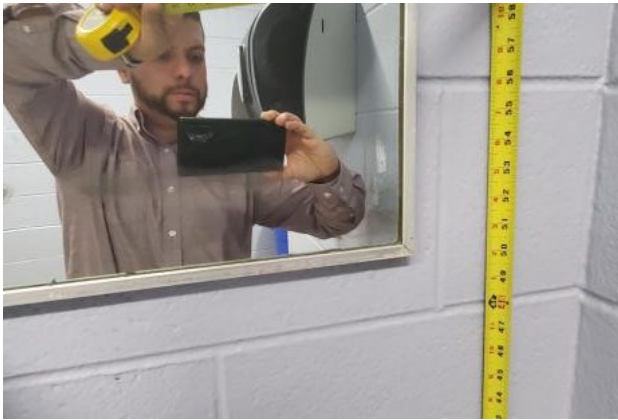
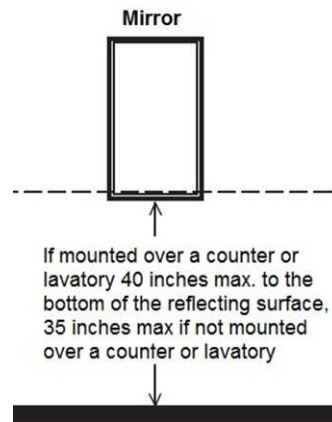
As Built: The mirror is mounted too high.

Mirrors must have the bottom edge of the reflecting surface a maximum of 40 inches above the floor if above a sink or counter. Mirrors not located above lavatories or countertops shall be installed with the bottom edge of the reflecting surface 35 inches maximum above the finish floor or ground.

Recommendation:
Further design required.

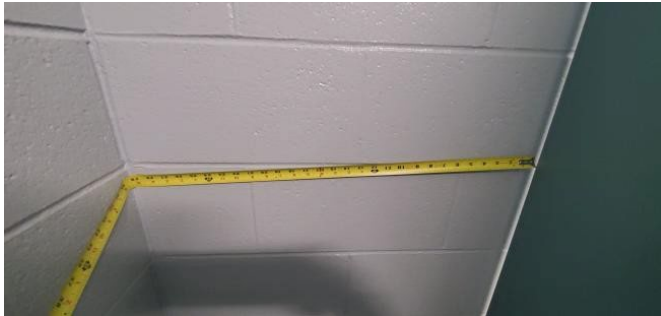
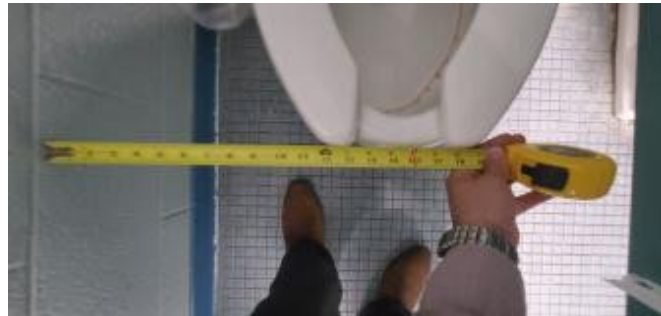
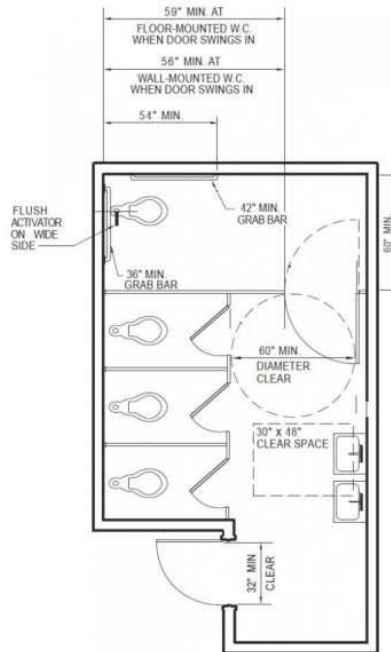
As Built: The toilet compartment does not have the required minimum clear floor space or maneuvering clearances for the toilet. No grab bars are installed. Toilet not centered within 16-18" from wall.

Citation: 2010 ADAS Section 213.2

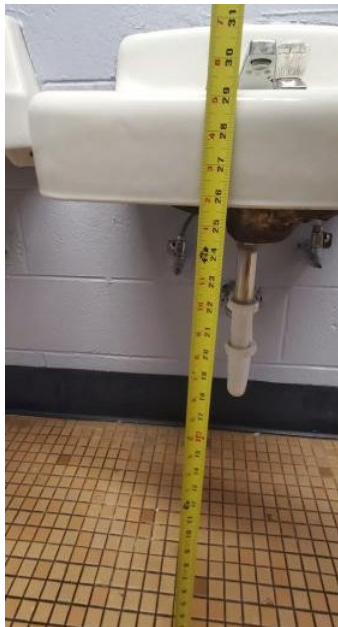
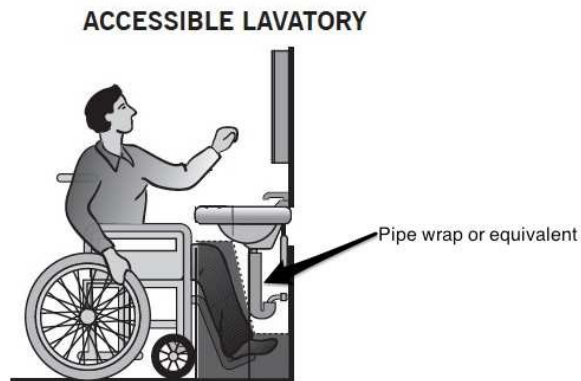
As Built: The water and drainpipes under the lavatory are not adequately insulated.

Water supply and drainpipes under lavatories and sinks shall be insulated or otherwise configured to protect against contact. There shall be no sharp or abrasive surfaces under lavatories and sinks.

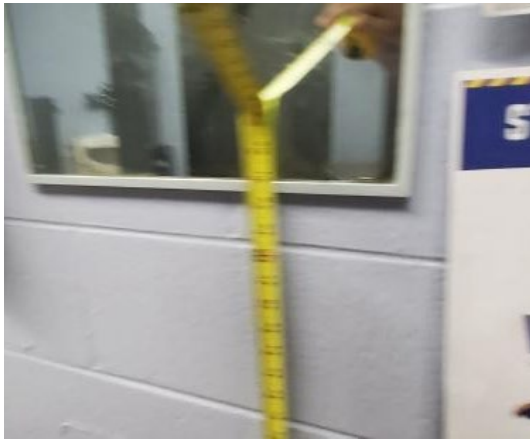
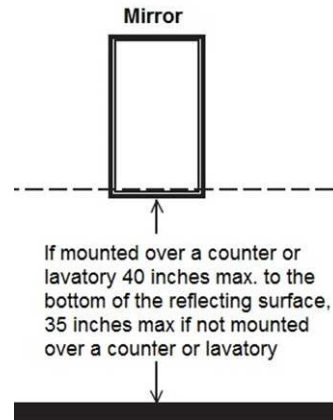
As Built: The mirror is mounted too high.

Mirrors must have the bottom edge of the reflecting surface a maximum of 40 inches above the floor if above a sink or counter. Mirrors not located above lavatories or countertops shall be installed with the bottom edge of the reflecting surface 35 inches maximum above the finish floor or ground.

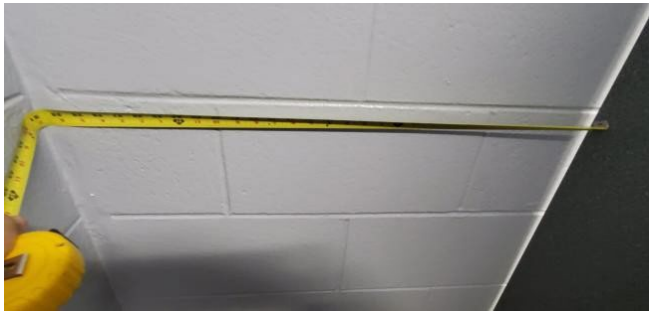
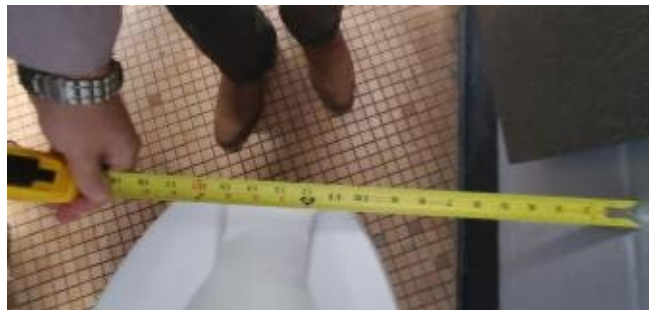
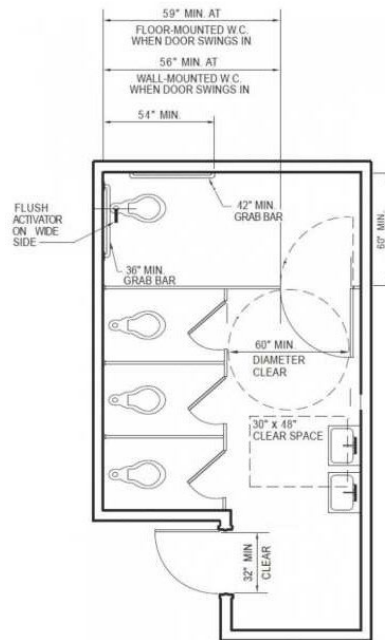
As Built: The toilet compartment does not have the required minimum clear floor space or maneuvering clearances for the toilet. No grab bars are installed.

Citation: 2010 ADAS Section 213.2

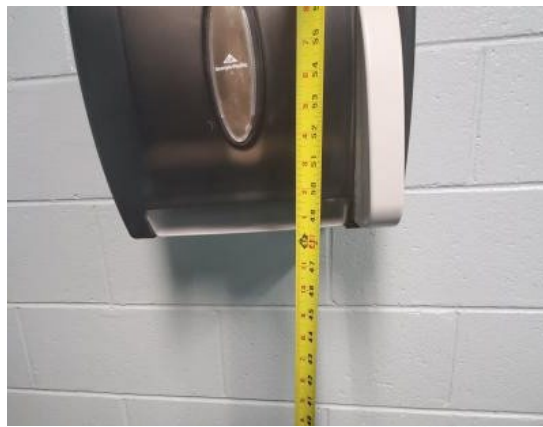
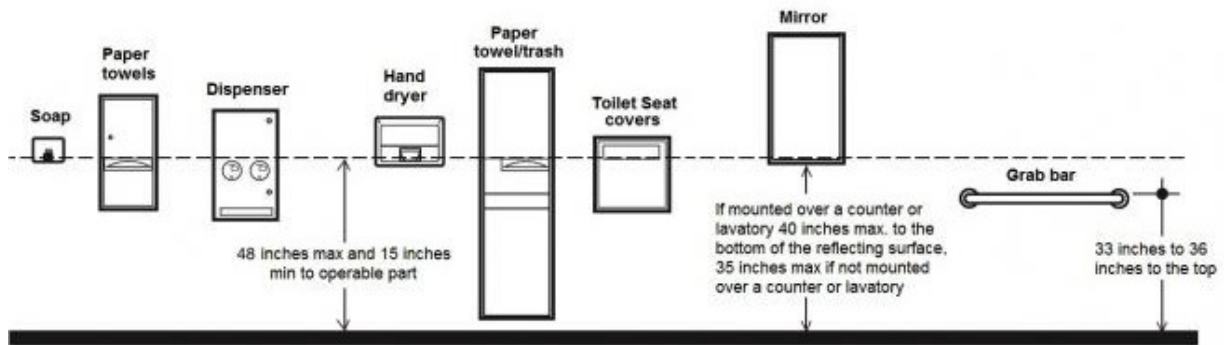
As Built: The paper towel dispenser's operation mechanism is too high off the floor. Dispensers must have all operable parts a maximum of 48 inches above the floor.

Citation: 2010 ADAS Section 308.2.1

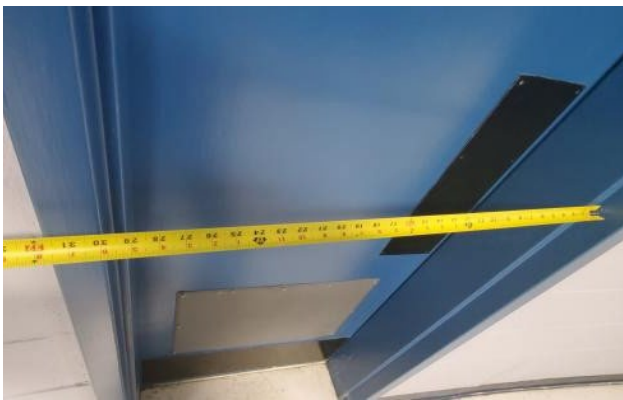
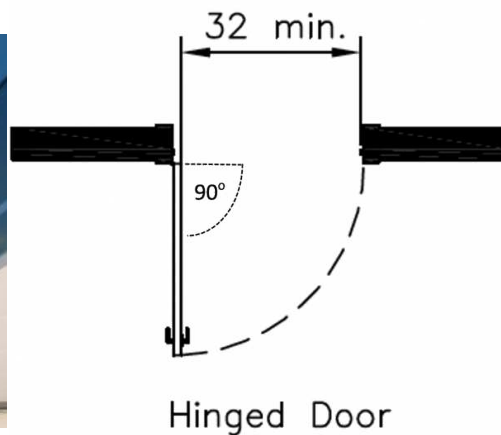
As Built: The door opening does not provide at least 32 inches between the face of the door and the opposite stop.

Door openings shall provide a clear width of 32 inches minimum. Clear openings of doorways with swinging doors shall be measured between the face of the door and the stop, with the door open 90 degrees. There shall be no projections into the required clear opening width lower than 34 inches above the finish floor or ground. Projections into the clear opening width between 34 inches and 80 inches above the finish floor or ground shall not exceed 4 inches.

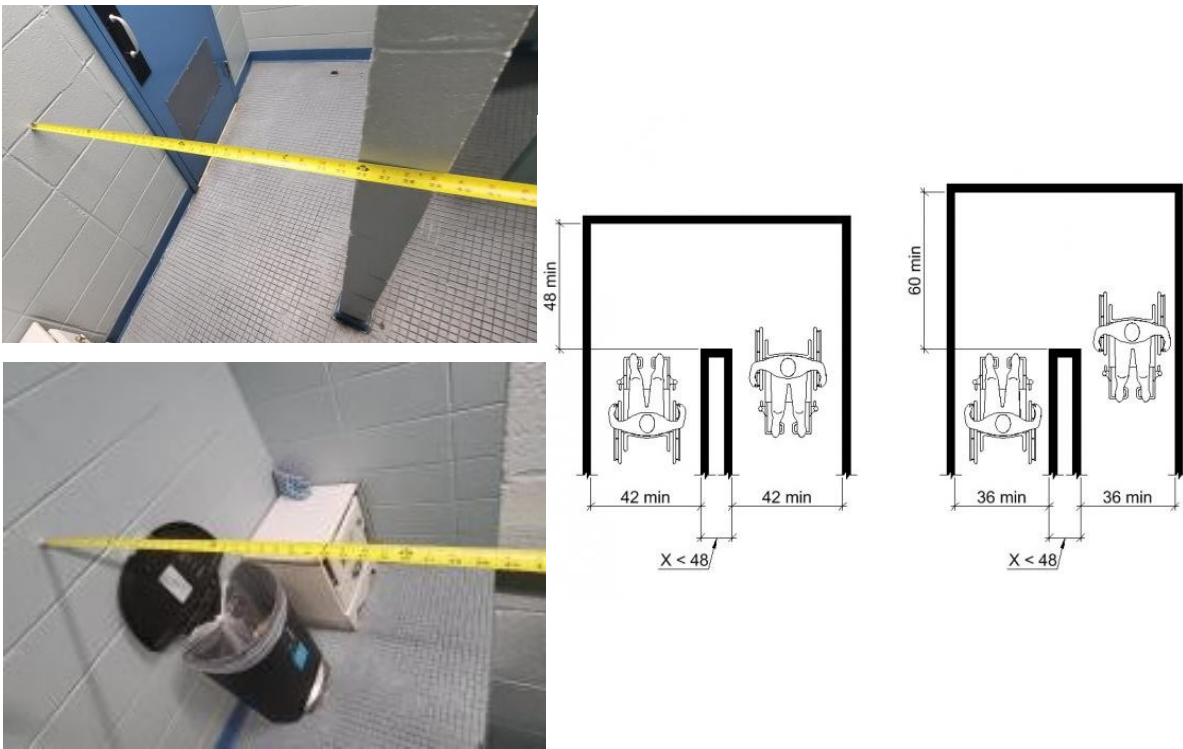
As Built: The route of travel does not meet minimum width requirements around the turn.

Where the accessible route makes a 180 degree turn around an element which is less than 48 inches wide, clear width shall be 42 inches minimum approaching the turn, 48 inches minimum at the turn and 42 inches minimum leaving the turn. Where the clear width at the turn is 60 inches minimum a clear width 36 inches minimum approaching the turn and 36 inches minimum at the turn is acceptable.

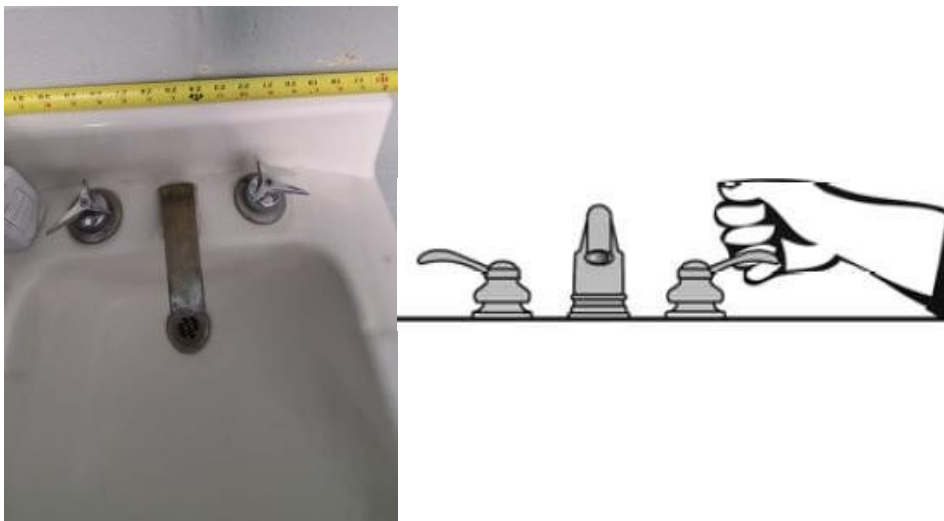
As Built: The faucet controls require twisting of the wrist.

Faucet controls and operating mechanisms shall be operable with one hand and shall not require tight grasping, pinching or twisting of the wrist. The force required to activate controls shall be no greater than 5 lb. Lever-operated, push-type and electronically controlled mechanisms are examples of acceptable designs. Self-closing valves are allowed if the faucet remains open for at least 10 seconds.

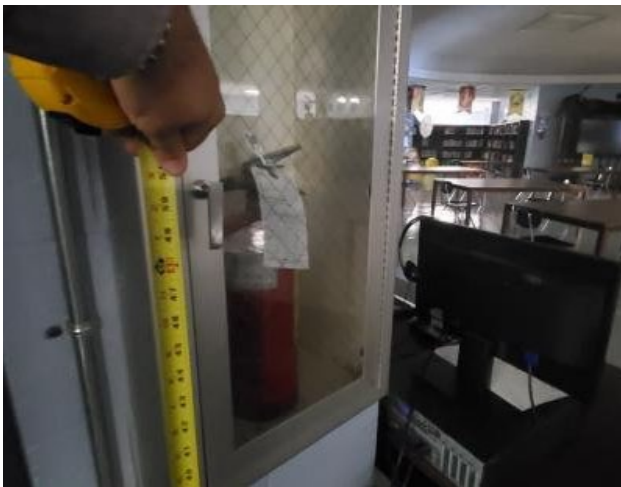
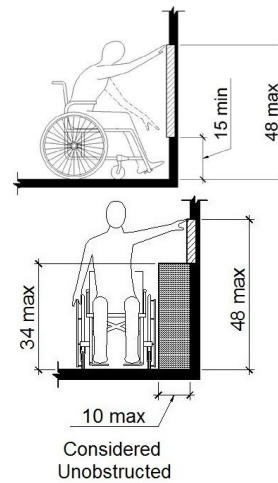
As Built: The Fire extinguisher is not positioned correctly for either a side or front approach.

Where a clear floor or ground space allows a parallel or front approach and the side reach is unobstructed, the high side reach shall be 48 inches maximum above the finish floor or ground and the low side reach shall be 15 inches minimum above the finish floor or ground.

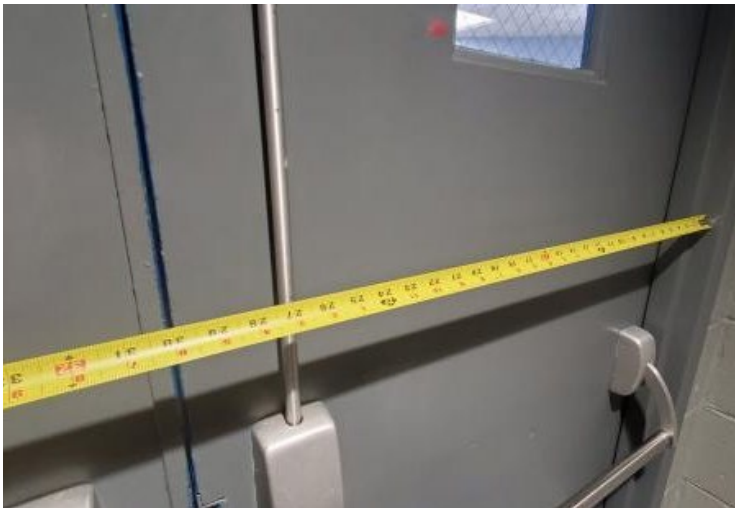
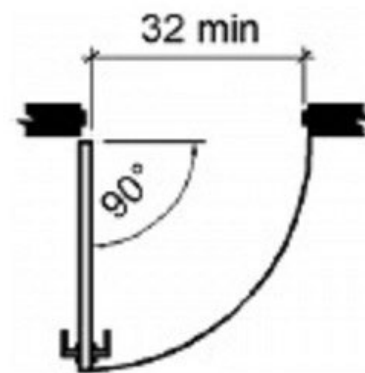
Hinged Door or Gate

As Built: Neither leaf of the doorway provides at least 32 inches between the face of the door and the opposite stop. At least one of the active leaves of doorways with two leaves shall comply with clear width and maneuvering clearance.

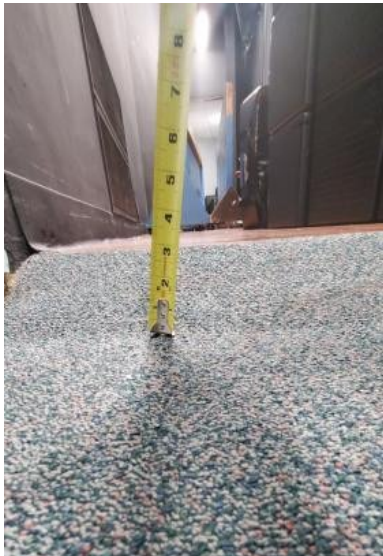
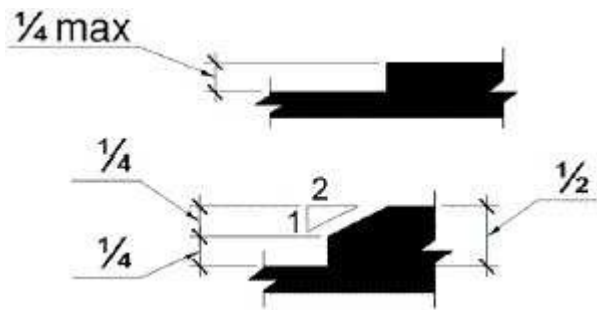
As Built: There is a change in level greater than 1/4 inch.

1/4 inch is the maximum vertical rise. Changes in level between 1/4 inch and 1/2 inch must be beveled at 1:2 or less. Changes in level greater than 1/2 inch must be by way of a ramp.

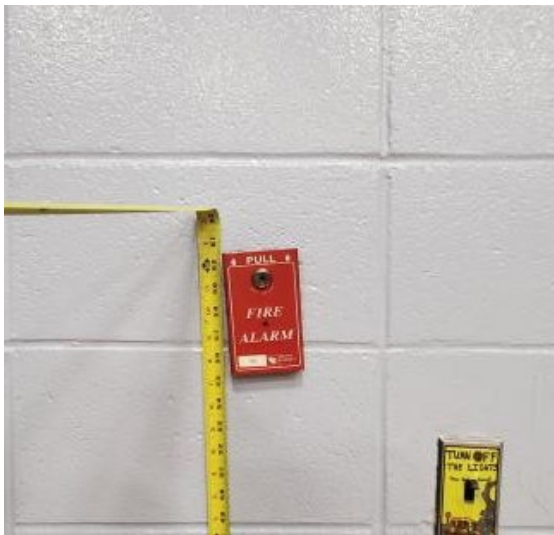
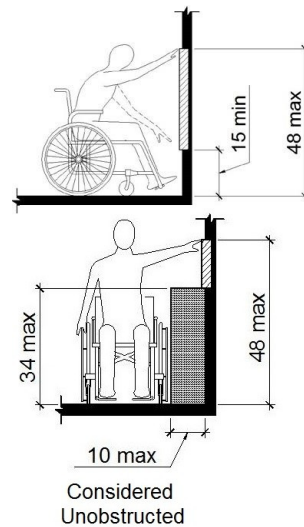
As Built: The Fire Alarm Pull Station is not positioned correctly for either a side or front approach.

Where a clear floor or ground space allows a parallel or front approach and the side reach is unobstructed, the high side reach shall be 48 inches maximum above the finish floor or ground and the low side reach shall be 15 inches minimum above the finish floor or ground.

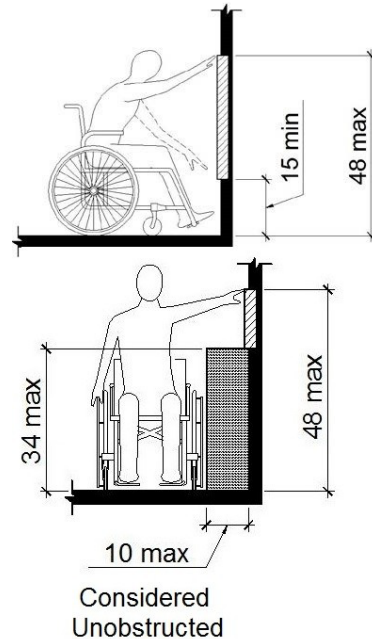
As Built: The thermostat is not positioned correctly for either a side or front approach.

Where a clear floor or ground space allows a parallel or front approach and the side reach is unobstructed, the high side reach shall be 48 inches maximum above the finish floor or ground and the low side reach shall be 15 inches minimum above the finish floor or ground.

Recommendation: Lower the thermostat for all operable components to 48" max AFF.

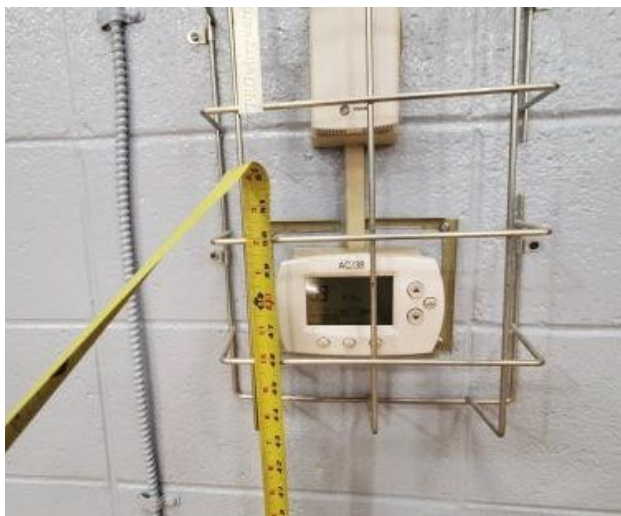
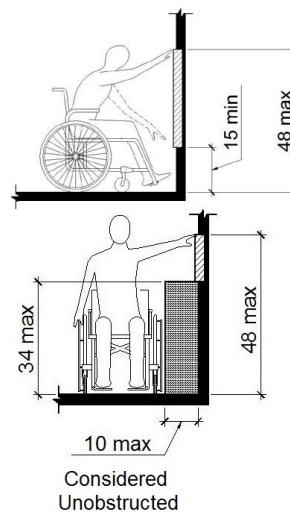
As Built: The Thermostat is not positioned correctly for either a side or front approach.

Where a clear floor or ground space allows a parallel or front approach and the side reach is unobstructed, the high side reach shall be 48 inches maximum above the finish floor or ground and the low side reach shall be 15 inches minimum above the finish floor or ground.

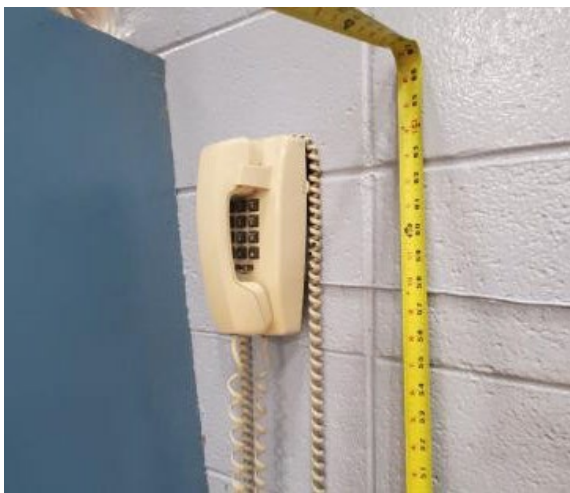
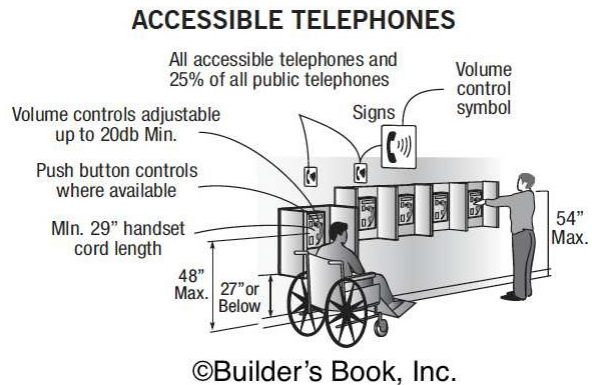
As Built: The telephone is not accessible.

Where coin-operated public pay telephones, coinless public pay telephones, public Closed-Circuit Telephones, public courtesy phones, or other types of public telephones are provided, public telephones shall be wheelchair accessible, have volume controls, TTY and meet the bank requirements if applicable for each type of public telephone provided. For purposes of this section, a bank of telephones shall be considered to be two or more adjacent telephones.

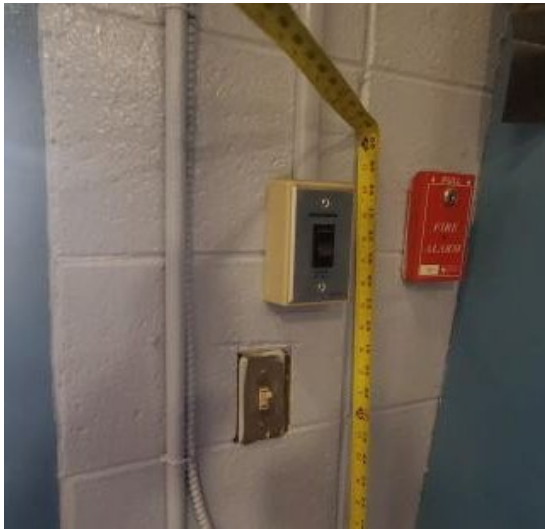
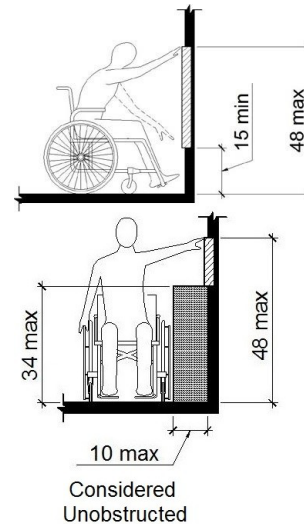
As Built: The Fire Alarm Pull Station is not positioned correctly for either a side or front approach.

Where a clear floor or ground space allows a parallel or front approach and the side reach is unobstructed, the high side reach shall be 48 inches maximum above the finish floor or ground and the low side reach shall be 15 inches minimum above the finish floor or ground.

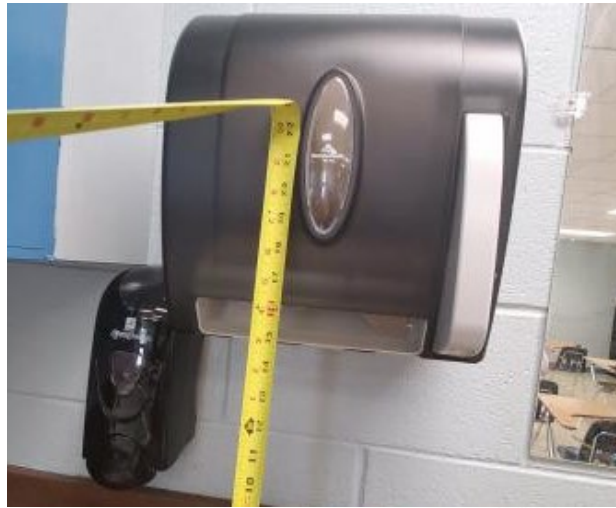
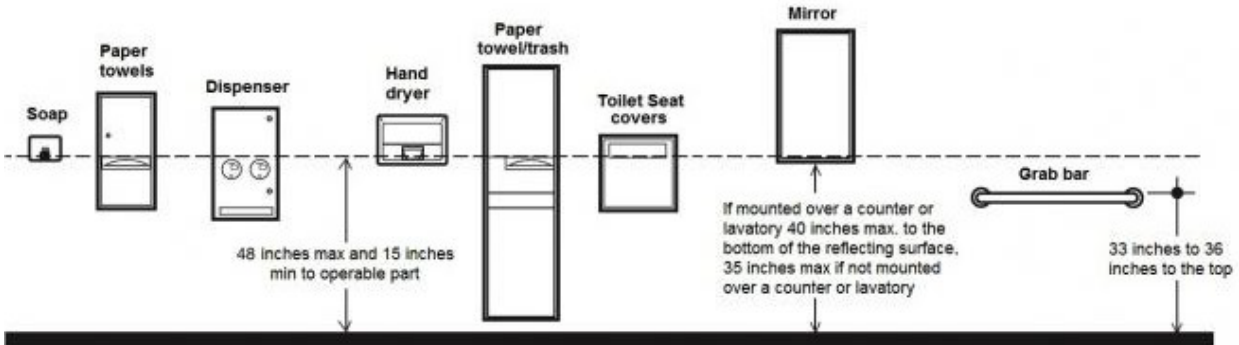
As Built: The paper towel dispenser's operation mechanism is too high off the floor. Dispensers must have all operable parts a maximum of 48 inches above the floor.

Citation: 2010 ADAS Section 308.2.1

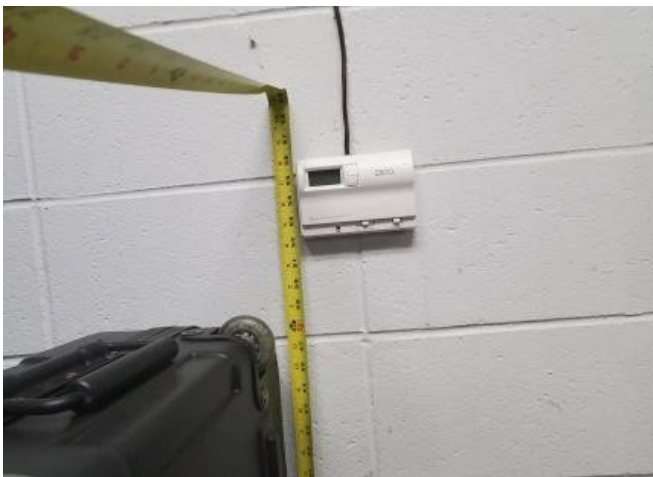
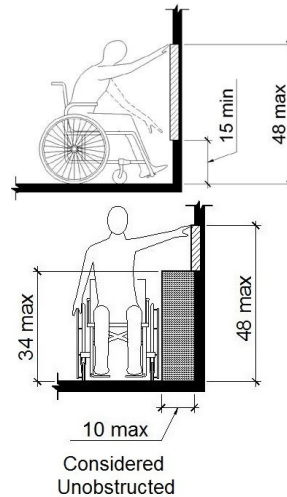
As Built: The Thermostat is not positioned correctly for either a side or front approach.

Where a clear floor or ground space allows a parallel or front approach and the side reach is unobstructed, the high side reach shall be 48 inches maximum above the finish floor or ground and the low side reach shall be 15 inches minimum above the finish floor or ground.

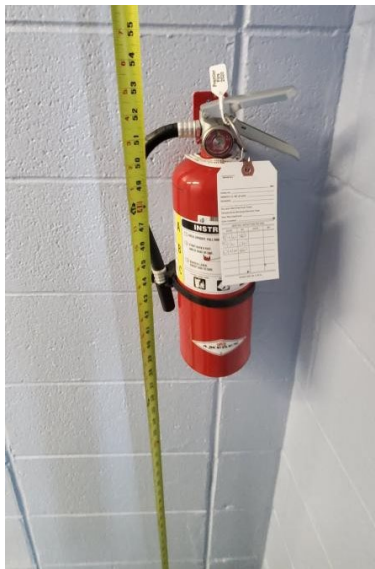
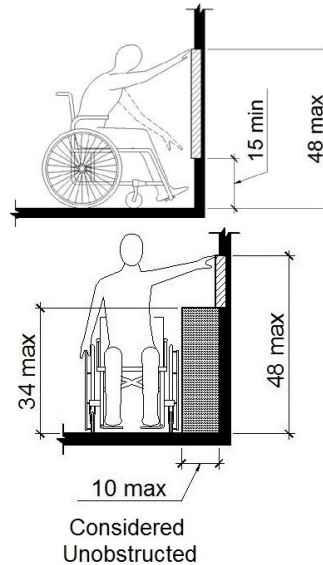
As Built: The Fire extinguisher is not positioned correctly for either a side or front approach.

Where a clear floor or ground space allows a parallel or front approach and the side reach is unobstructed, the high side reach shall be 48 inches maximum above the finish floor or ground and the low side reach shall be 15 inches minimum above the finish floor or ground.

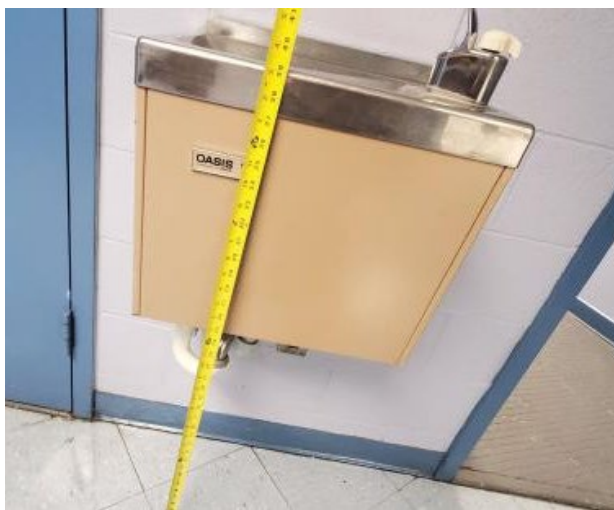
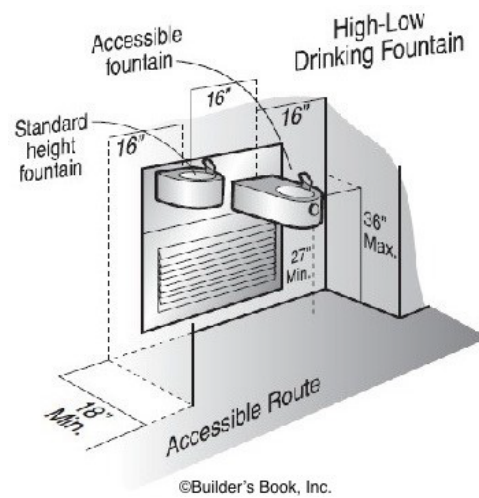
As Built: The drinking fountain is noncompliant.

Spout outlets shall be 36 inches maximum above the finish floor or ground and be located 15 inches minimum from the vertical support and 5 inches maximum from the front edge of the unit, including bumpers. The spout shall provide a flow of water at least 4 inches high minimum and shall be located 5 inches maximum from the front of the unit. The angle of the water stream shall be measured horizontally relative to the front face of the unit. Where spouts are located less than 3 inches of the front of the unit, the angle of the water stream shall be 30 degrees maximum. Where spouts are located between 3 inches and 5 inches maximum from the front of the unit, the angle of the water stream shall be 15 degrees maximum. On an accessible drinking fountain with a round or oval bowl, the spout must be positioned so the flow of water is within 3 inches of the front edge of the fountain.

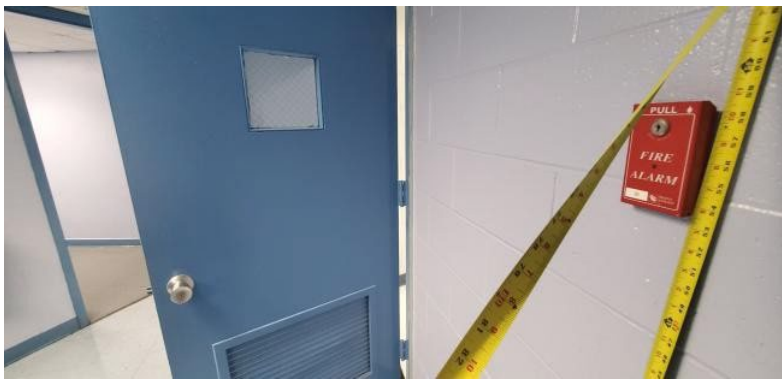
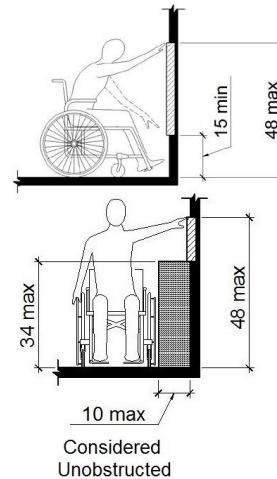
As Built: The Fire Alarm Pull Station is not positioned correctly for either a side or front approach.

Where a clear floor or ground space allows a parallel or front approach and the side reach is unobstructed, the high side reach shall be 48 inches maximum above the finish floor or ground and the low side reach shall be 15 inches minimum above the finish floor or ground.

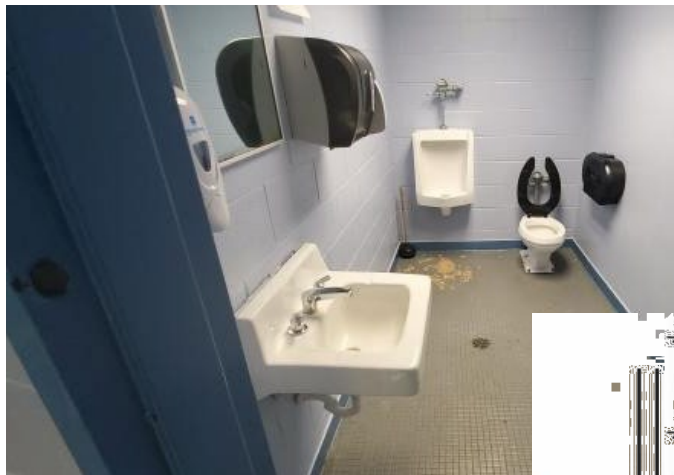
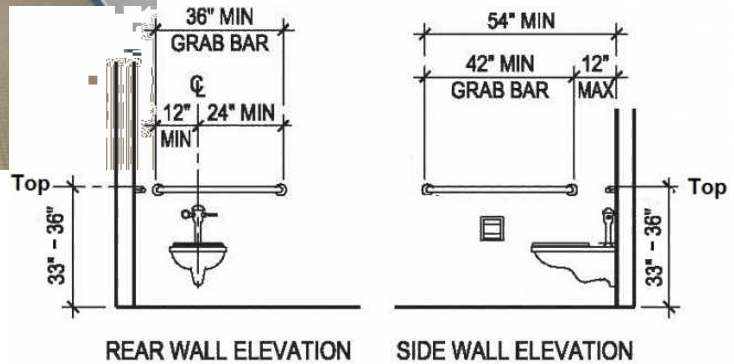
As Built: Accessible toilets must have grab bars installed.

The side grab bar must extend at least 54 inches minimum beyond the rear wall and start a maximum of 12 inches from the rear wall.

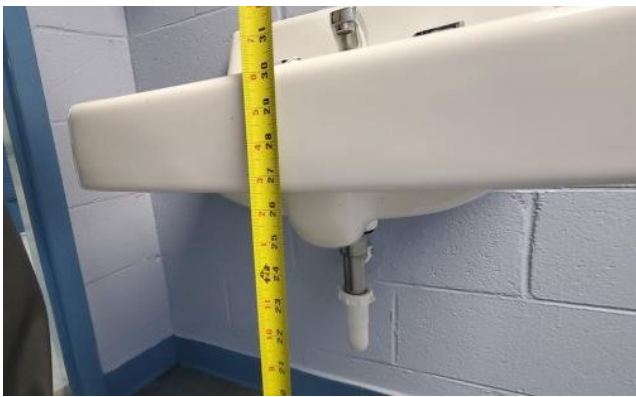
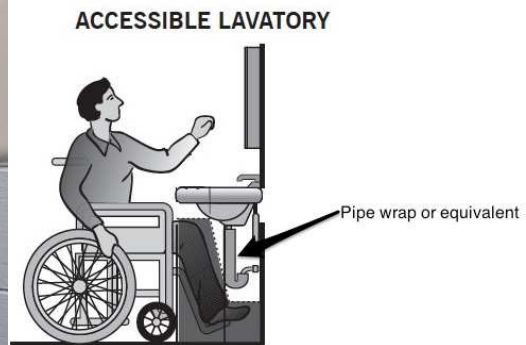
As Built: The water and drainpipes under the lavatory are not adequately insulated.

Water supply and drainpipes under lavatories and sinks shall be insulated or otherwise configured to protect against contact. There shall be no sharp or abrasive surfaces under lavatories and sinks.

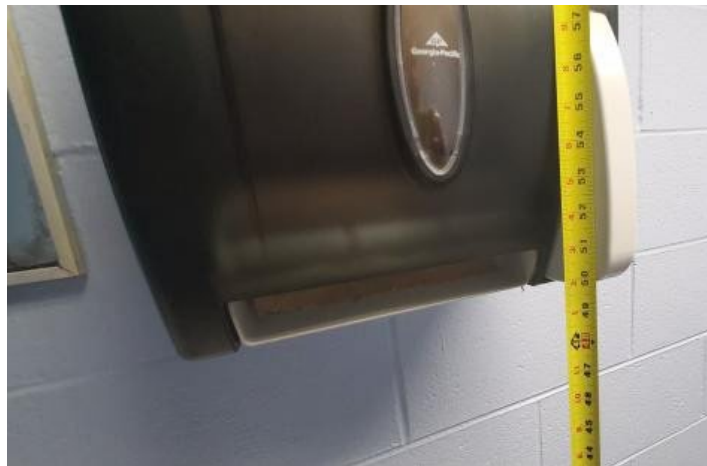
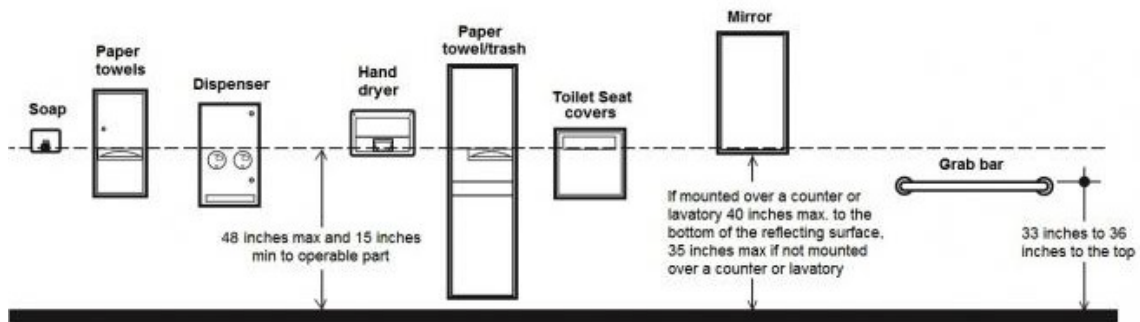
As Built: The paper towel dispenser's operation mechanism is too high off the floor. Dispensers must have all operable parts a maximum of 48 inches above the floor.

Citation: 2010 ADAS Section 308.2.1

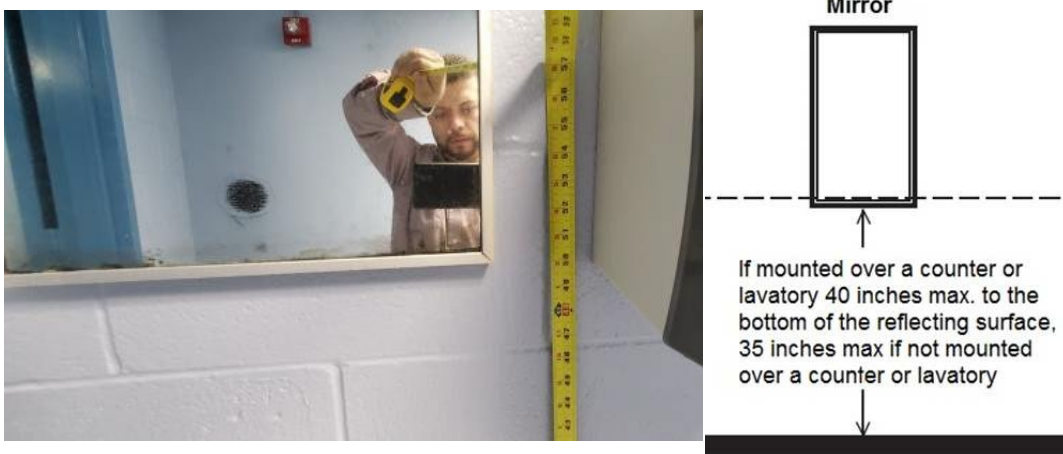
As Built: The mirror is mounted too high.

Mirrors must have the bottom edge of the reflecting surface a maximum of 40 inches above the floor if above a sink or counter. Mirrors not located above lavatories or countertops shall be installed with the bottom edge of the reflecting surface 35 inches maximum above the finish floor or ground.

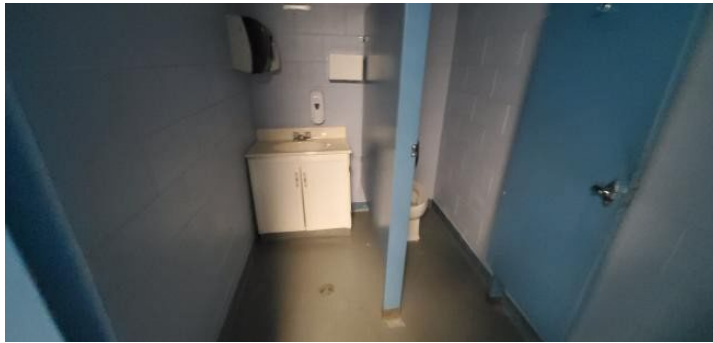
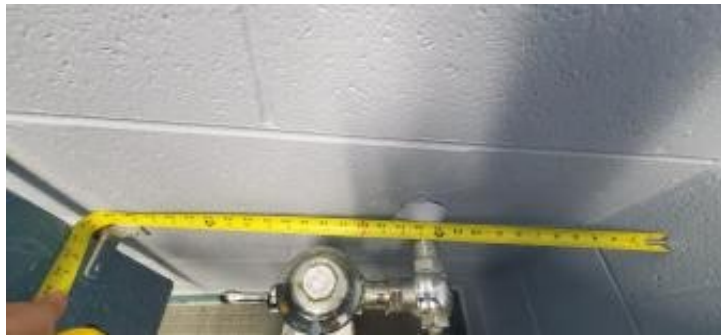
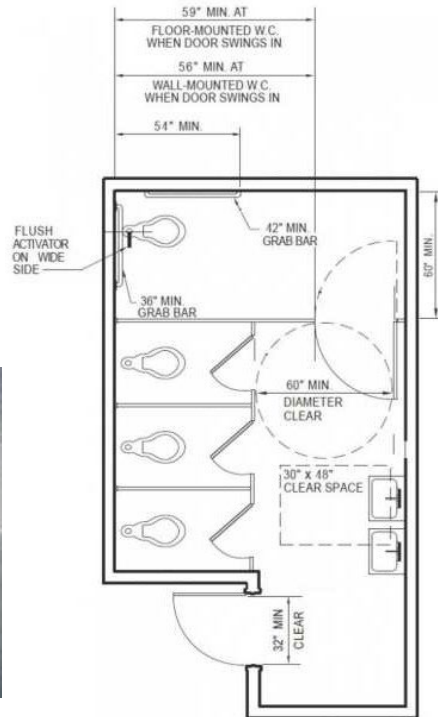
As Built: The toilet compartment does not have the required minimum clear floor space or maneuvering clearances for the toilet. No grab bars are installed.

Citation: 2010 ADAS Section 213.2

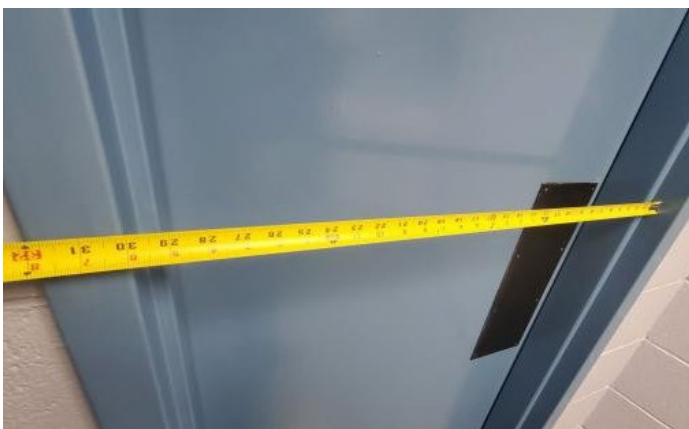
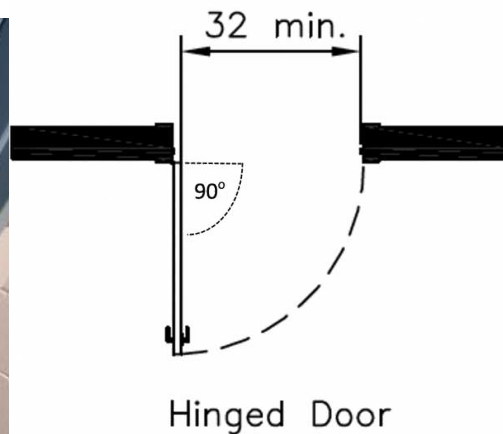
As Built: The door opening does not provide at least 32 inches between the face of the door and the opposite stop.

Door openings shall provide a clear width of 32 inches minimum. Clear openings of doorways with swinging doors shall be measured between the face of the door and the stop, with the door open 90 degrees. There shall be no projections into the required clear opening width lower than 34 inches above the finish floor or ground. Projections into the clear opening width between 34 inches and 80 inches above the finish floor or ground shall not exceed 4 inches.

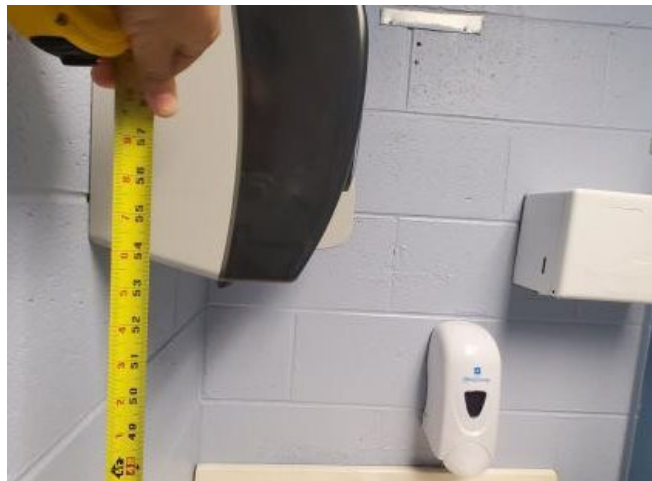
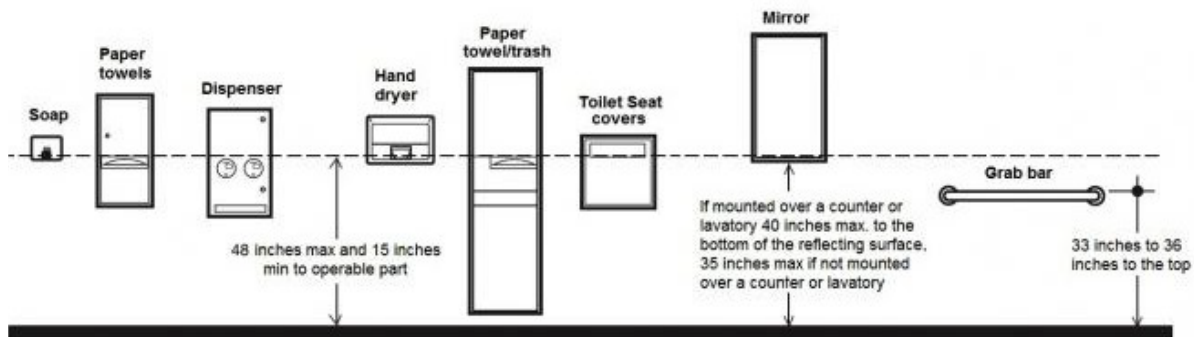
As Built: The paper towel dispenser's operation mechanism is too high off the floor. Dispensers must have all operable parts a maximum of 48 inches above the floor.

Citation: 2010 ADAS Section 308.2.1

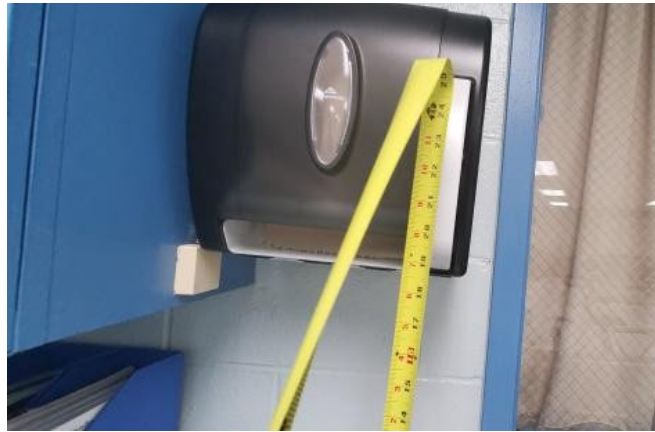
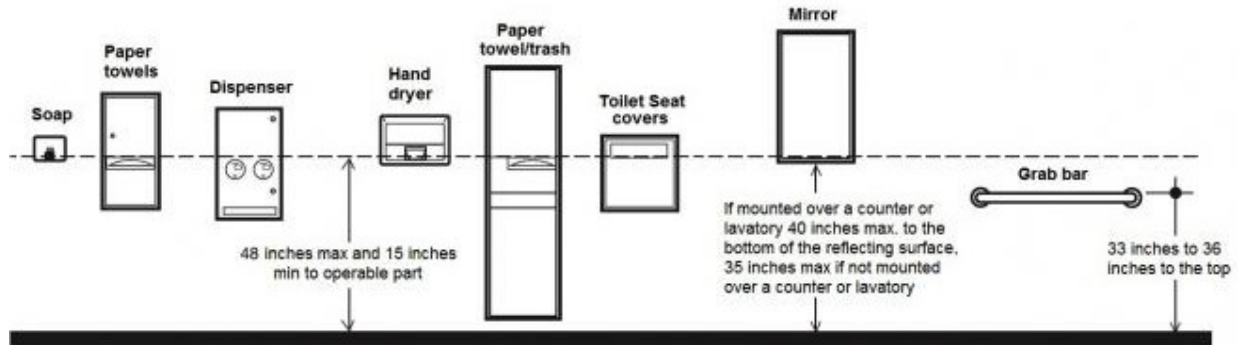
As Built: The paper towel dispenser's operation mechanism is too high off the floor. Dispensers must have all operable parts a maximum of 48 inches above the floor.

Citation: 2010 ADAS Section 308.2.1

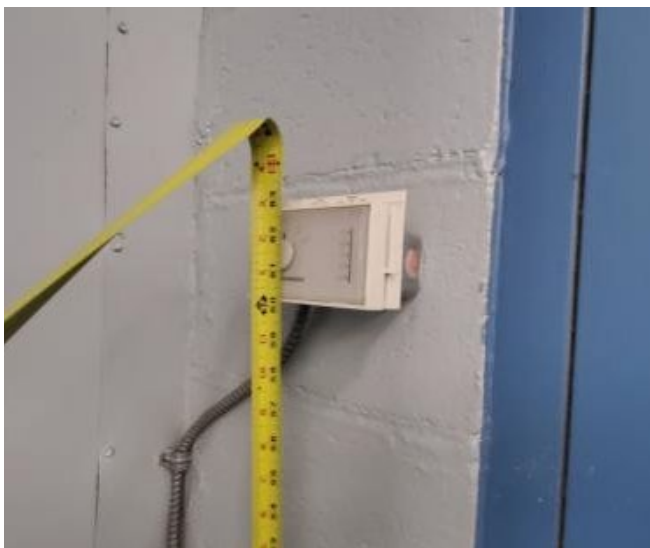
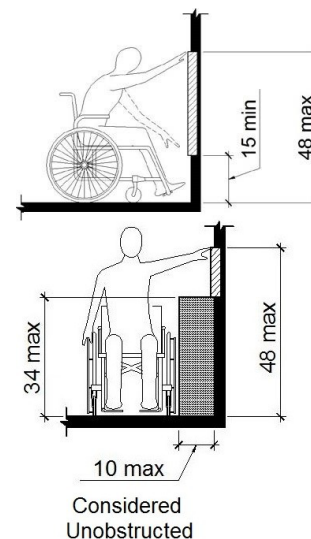
As Built: The Thermostat is not positioned correctly for either a side or front approach.

Where a clear floor or ground space allows a parallel or front approach and the side reach is unobstructed, the high side reach shall be 48 inches maximum above the finish floor or ground and the low side reach shall be 15 inches minimum above the finish floor or ground.

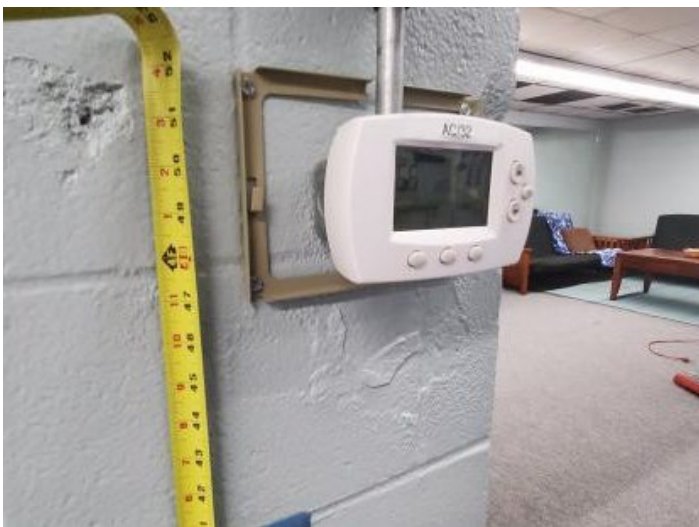
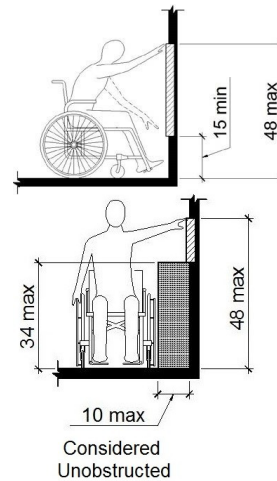
As Built: The Thermostat is not positioned correctly for either a side or front approach.

Where a clear floor or ground space allows a parallel or front approach and the side reach is unobstructed, the high side reach shall be 48 inches maximum above the finish floor or ground and the low side reach shall be 15 inches minimum above the finish floor or ground.

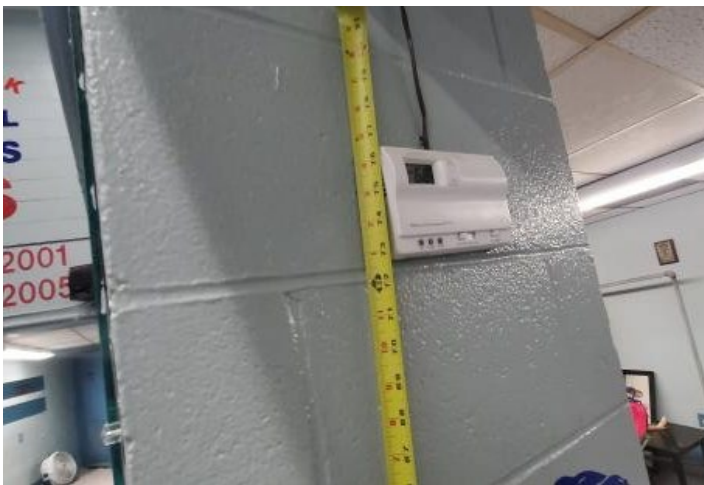
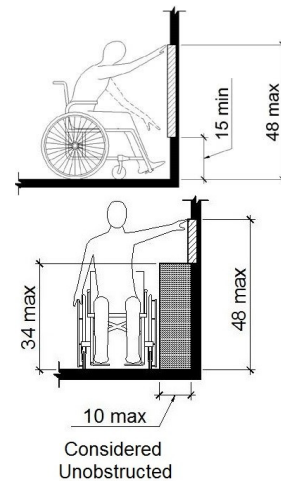
As Built: The Thermostat is not positioned correctly for either a side or front approach.

Where a clear floor or ground space allows a parallel or front approach and the side reach is unobstructed, the high side reach shall be 48 inches maximum above the finish floor or ground and the low side reach shall be 15 inches minimum above the finish floor or ground.

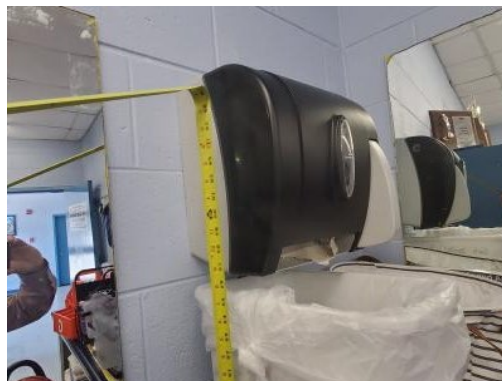
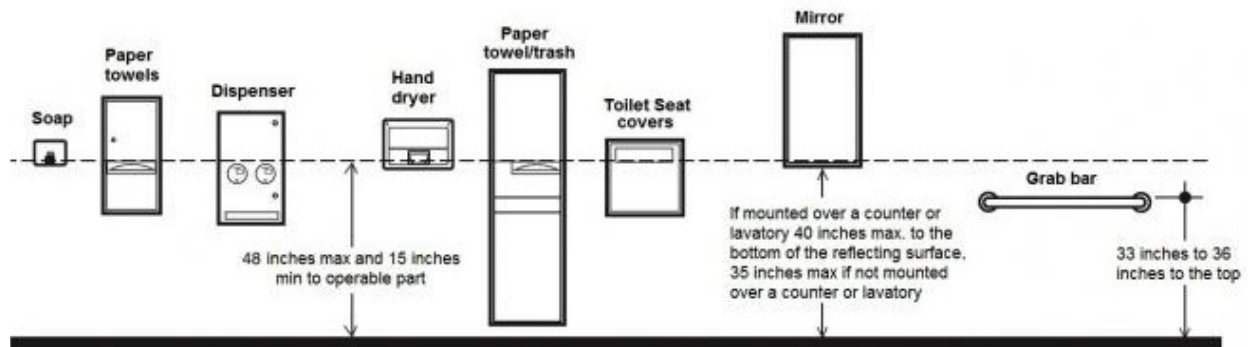
As Built: The paper towel dispenser's operation mechanism is too high off the floor. Dispensers must have all operable parts a maximum of 48 inches above the floor.

Citation: 2010 ADAS Section 308.2.1

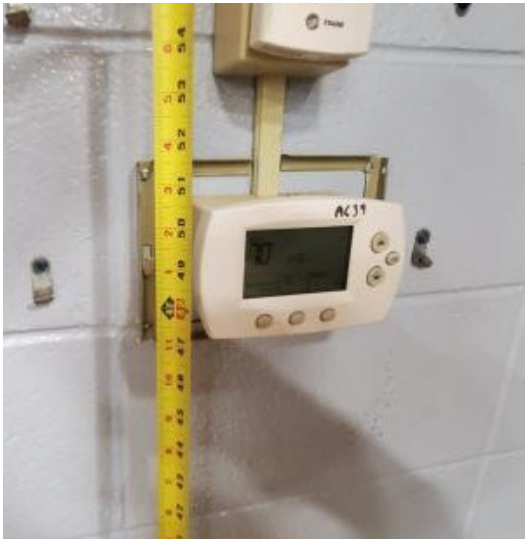
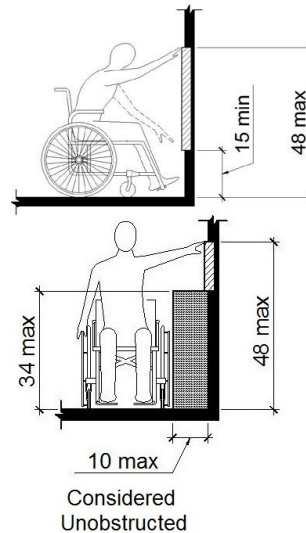
As Built: The Thermostat is not positioned correctly for either a side or front approach.

Where a clear floor or ground space allows a parallel or front approach and the side reach is unobstructed, the high side reach shall be 48 inches maximum above the finish floor or ground and the low side reach shall be 15 inches minimum above the finish floor or ground.

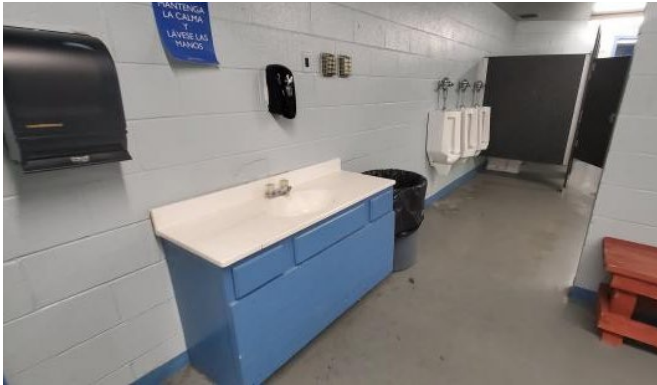
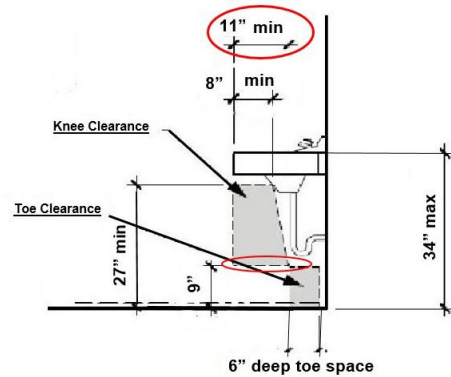
As Built: Compliant knee space has not been provided under the lavatory.

The knee clearance shall be 11 inches minimum in depth at 9 inches above the floor, and 8 inches minimum in depth at 27 inches above the floor. The top of the lavatory rim may be no higher than 34 inches.
