WEAKLEY COUNTY, TENNESSEE

ADA EVALUATION

Architectural and Site Findings with Recommendations

TLM Associates, Inc

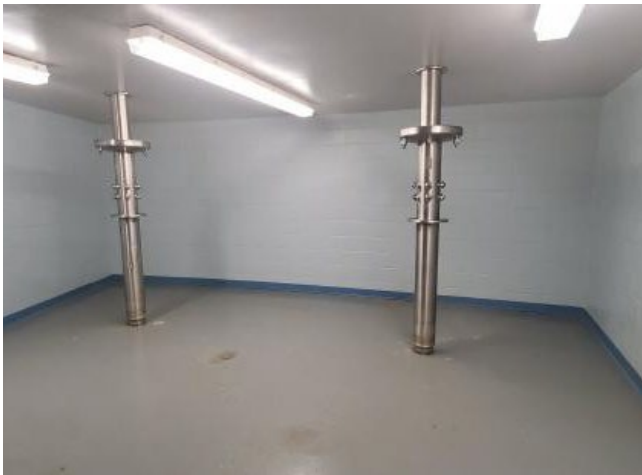
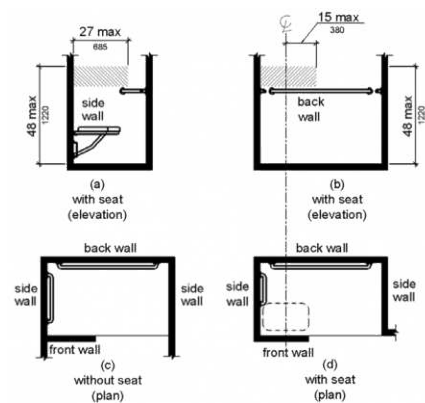
As Built: The operable parts of controls are not located within the allowable height range.

In alternate roll-in type shower compartments, the controls, faucets, and shower spray unit shall be located above the grab bar, but no higher than 48 inches above the shower floor. Where a seat is provided, the controls, faucets, and shower spray unit shall be located on the side wall adjacent to the seat 27 inches maximum from the side wall behind the seat or shall be located on the back wall opposite the seat 15 inches maximum, left or right, of the centerline of the seat. Where a seat is not provided, the controls, faucets, and shower spray unit shall be installed on the side wall farthest from the compartment entry.

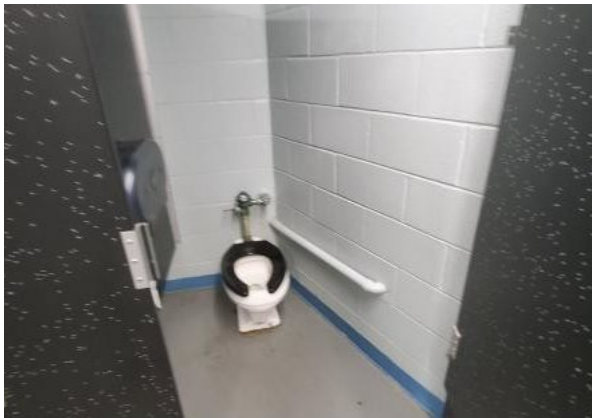
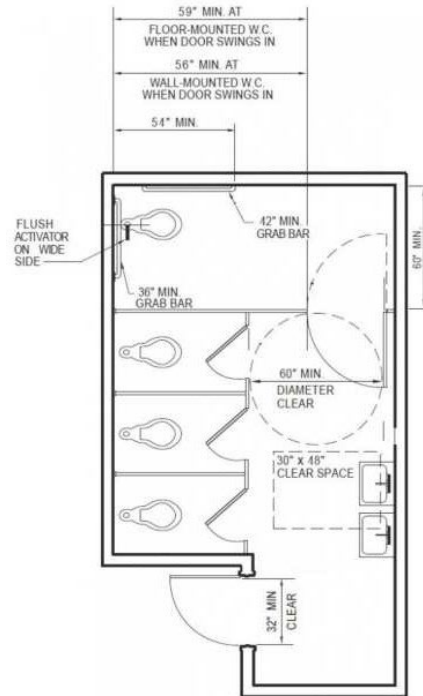
As Built: The toilet compartment does not have the required minimum clear floor space or maneuvering clearances for the toilet.

Citation: 2010 ADAS Section 213.2

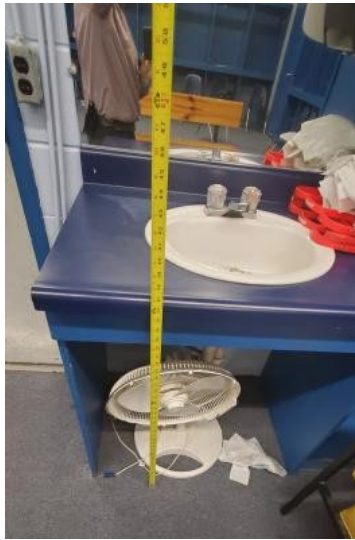
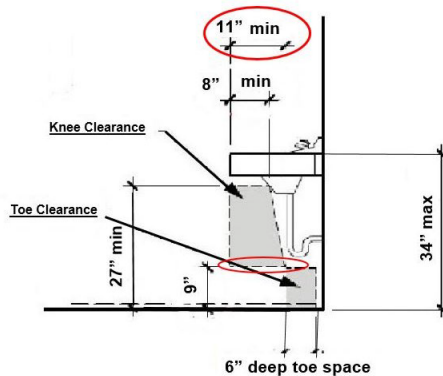
As Built: Compliant knee space has not been provided under the lavatory.

The knee clearance shall be 11 inches minimum in depth at 9 inches above the floor, and 8 inches minimum in depth at 27 inches above the floor. The top of the lavatory rim may be no higher than 34 inches.

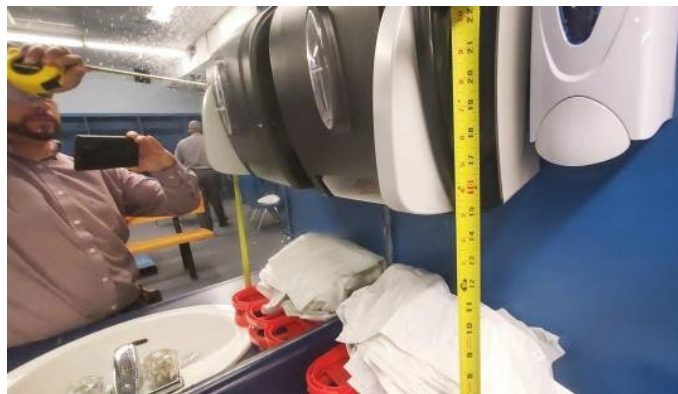
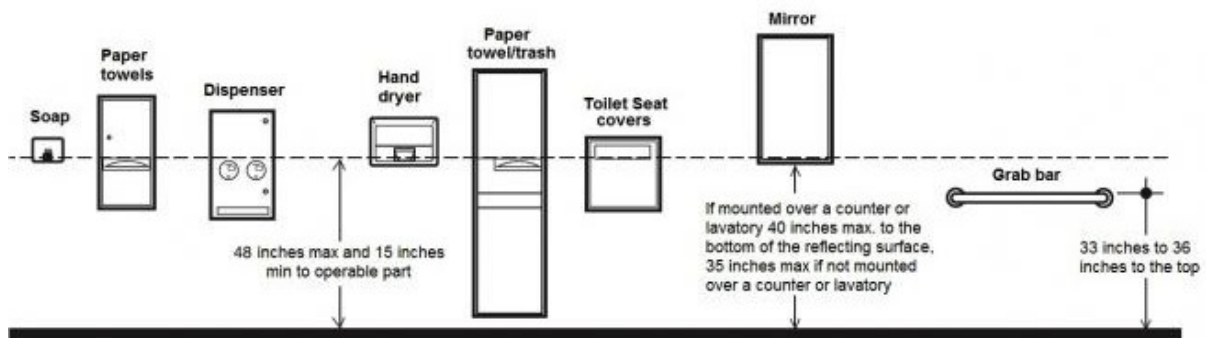
As Built: The paper towel dispenser's operation mechanism is too high off the floor. Dispensers must have all operable parts a maximum of 48 inches above the floor.

Citation: 2010 ADAS Section 308.2.1

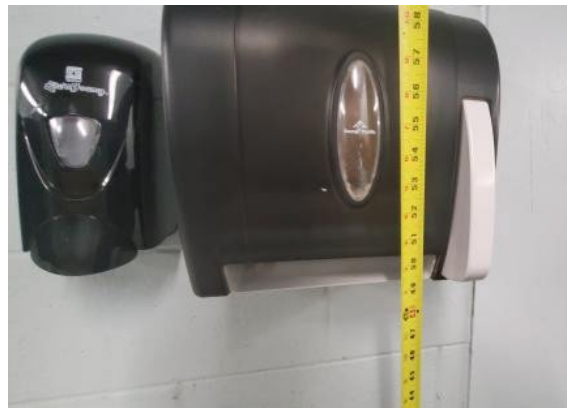
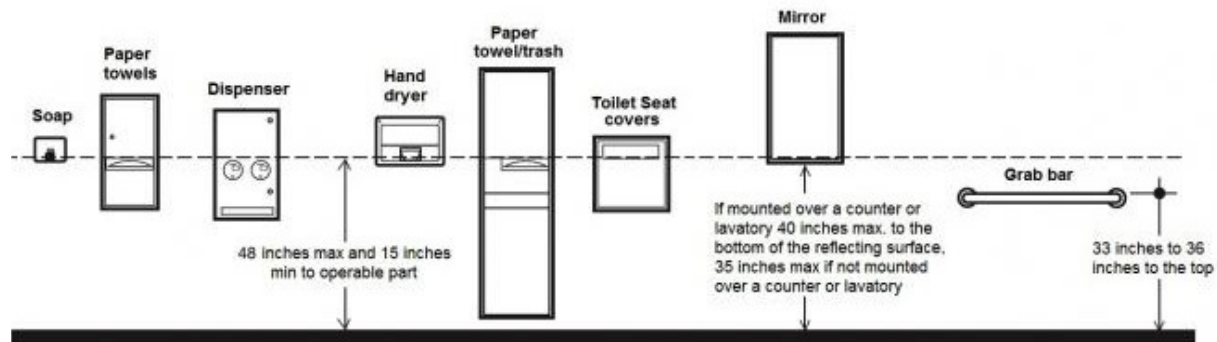
As Built: The paper towel dispenser's operation mechanism is too high off the floor. Dispensers must have all operable parts a maximum of 48 inches above the floor.

Citation: 2010 ADAS Section 308.2.1

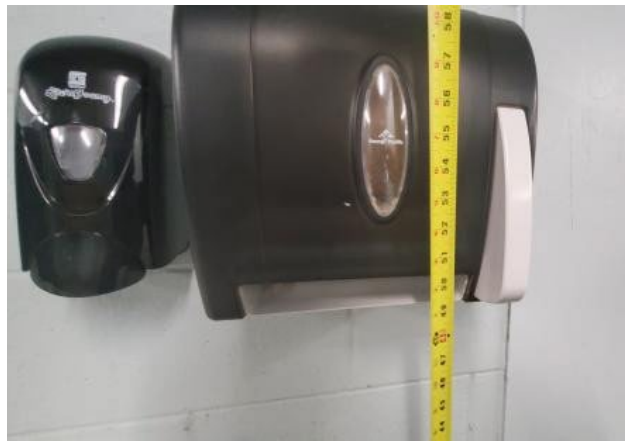
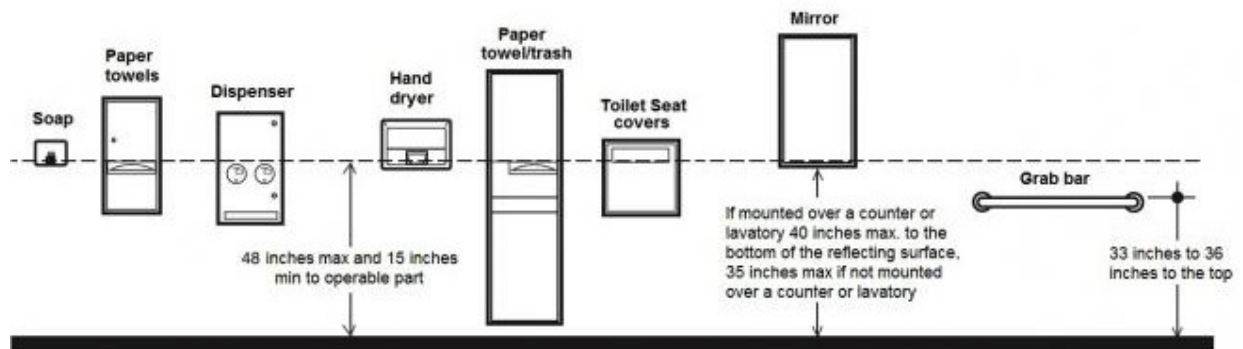
As Built: The soap dispenser's operation mechanism is too high off the floor.

Dispensers must have all operable parts a maximum of 48 inches above the floor.

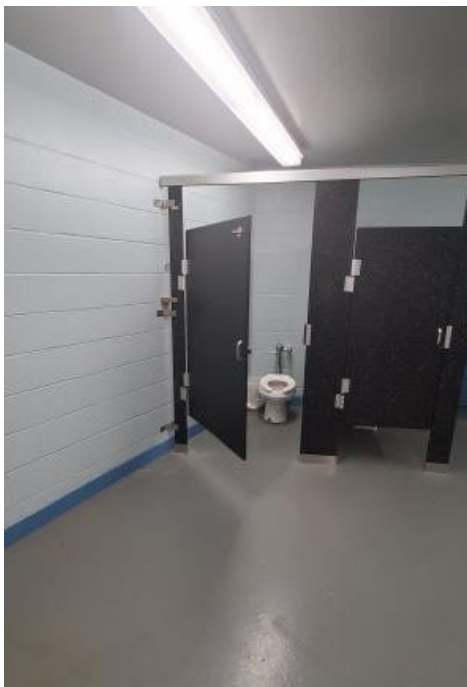
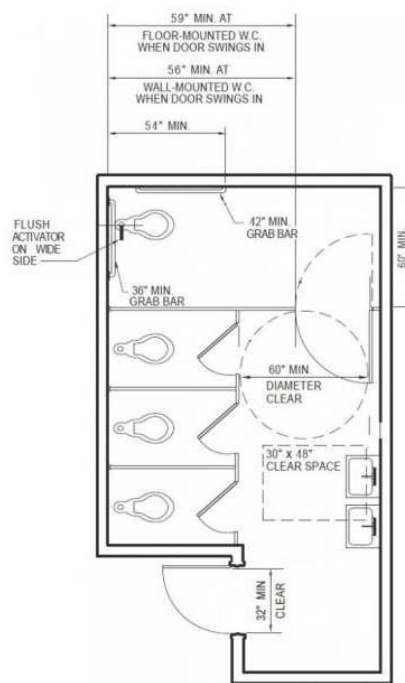
As Built: The toilet compartment does not have the required minimum clear floor space or maneuvering clearances for the toilet. No Grab bars are installed.

Citation: 2010 ADAS Section 213.2

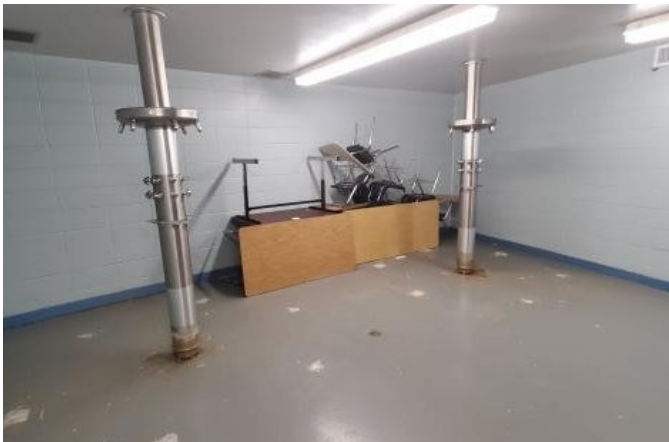
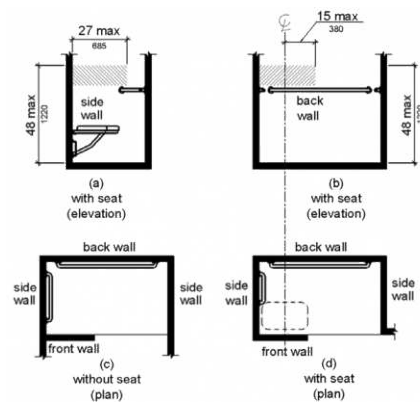
As Built: The operable parts of controls are not located within the allowable height range.

In alternate roll-in type shower compartments, the controls, faucets, and shower spray unit shall be located above the grab bar, but no higher than 48 inches above the shower floor. Where a seat is provided, the controls, faucets, and shower spray unit shall be located on the side wall adjacent to the seat 27 inches maximum from the side wall behind the seat or shall be located on the back wall opposite the seat 15 inches maximum, left or right, of the centerline of the seat. Where a seat is not provided, the controls, faucets, and shower spray unit shall be installed on the side wall farthest from the compartment entry.

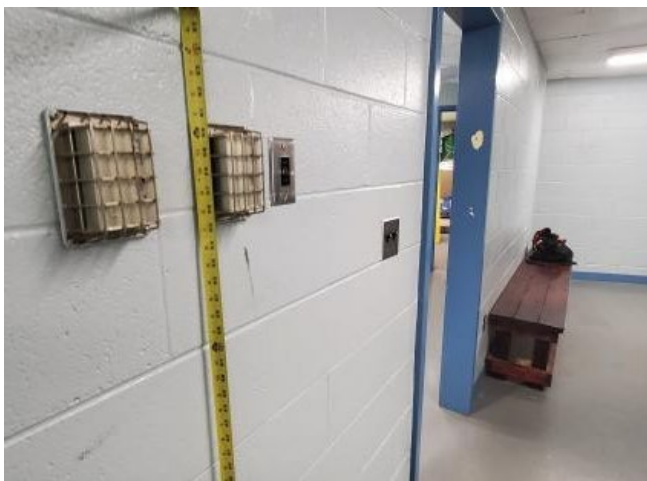
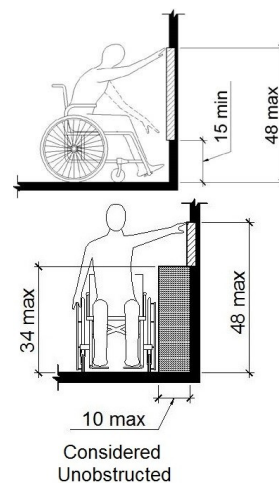
As Built: The Thermostat is not positioned correctly for either a side or front approach.

Where a clear floor or ground space allows a parallel or front approach and the side reach is unobstructed, the high side reach shall be 48 inches maximum above the finish floor or ground and the low side reach shall be 15 inches minimum above the finish floor or ground.

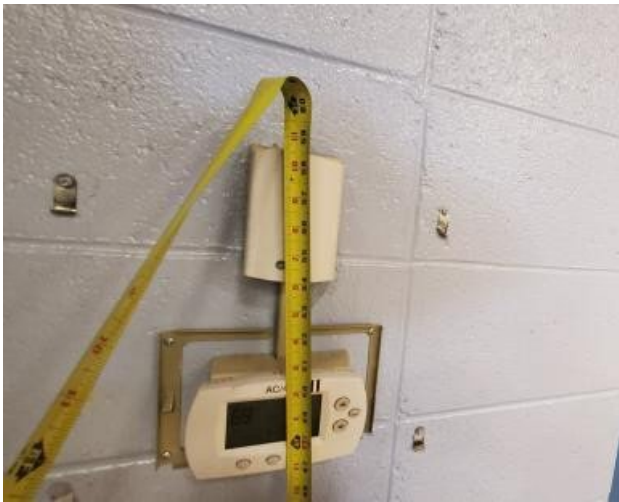
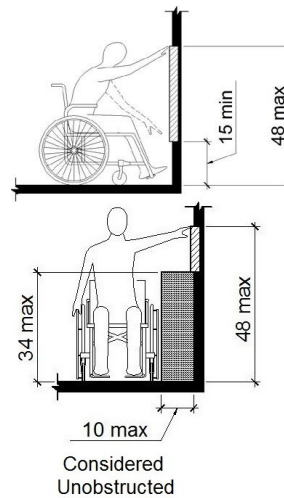
As Built: The Thermostat is not positioned correctly for either a side or front approach.

Where a clear floor or ground space allows a parallel or front approach and the side reach is unobstructed, the high side reach shall be 48 inches maximum above the finish floor or ground and the low side reach shall be 15 inches minimum above the finish floor or ground.

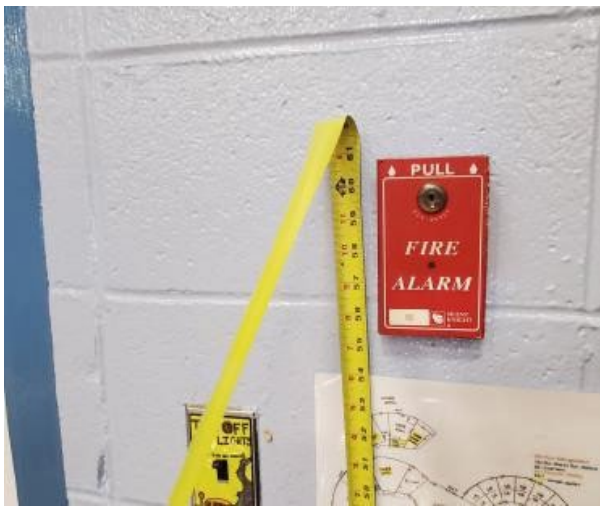
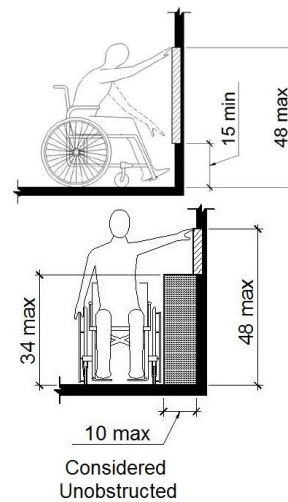
As Built: The Fire Alarm Pull Station is not positioned correctly for either a side or front approach.

Where a clear floor or ground space allows a parallel or front approach and the side reach is unobstructed, the high side reach shall be 48 inches maximum above the finish floor or ground and the low side reach shall be 15 inches minimum above the finish floor or ground.

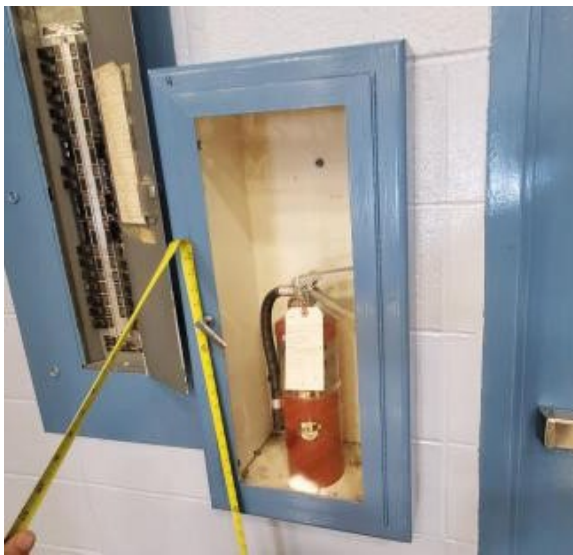
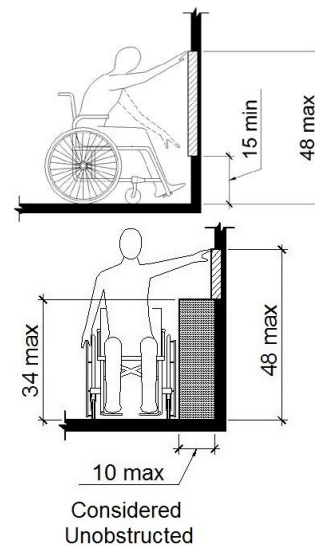
As Built: The Fire extinguisher is not positioned correctly for either a side or front approach.

Where a clear floor or ground space allows a parallel or front approach and the side reach is unobstructed, the high side reach shall be 48 inches maximum above the finish floor or ground and the low side reach shall be 15 inches minimum above the finish floor or ground.

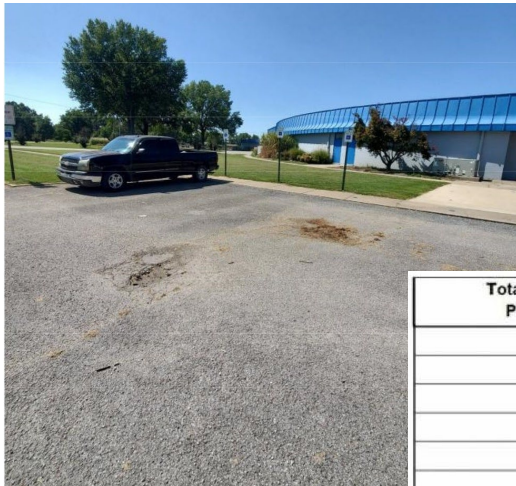
As Built: There are 3 signs, no van sign, no striping, and no access aisle. The required number of van accessible stalls is not provided.

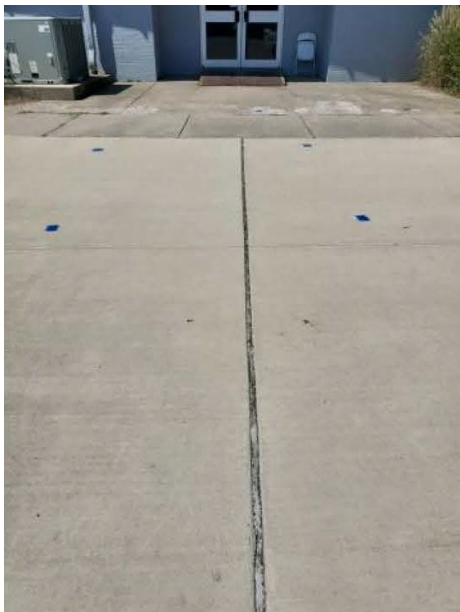
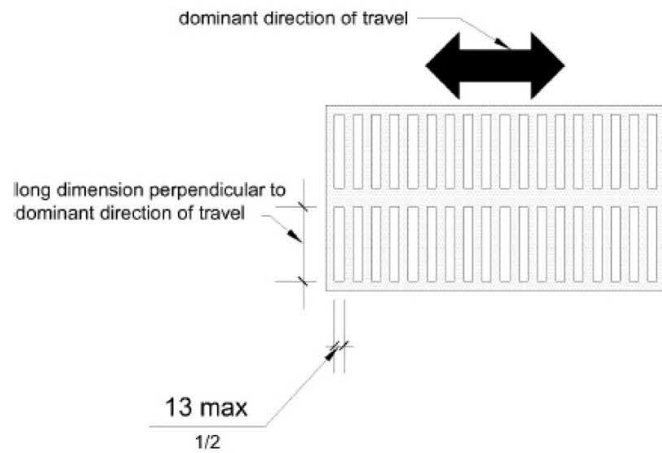
As Built: Expansion sealant has settled creating depression 1" wide. The surface of the pedestrian access route has openings greater than 1/2 inch.

Horizontal openings in gratings and joints shall not permit passage of a sphere more than 13 mm (0.5 in) in diameter.

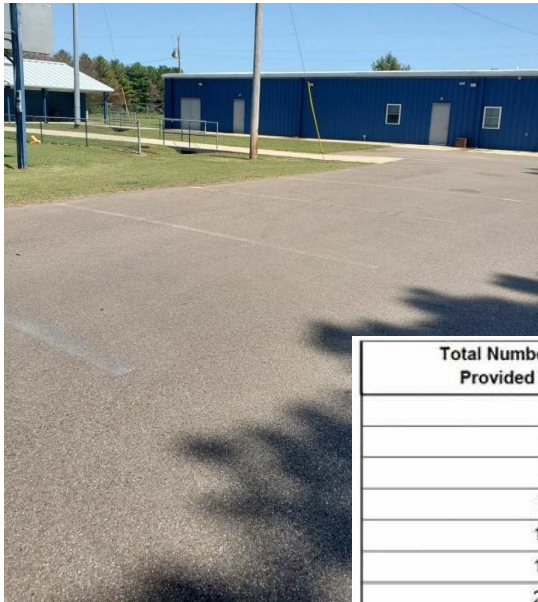
As Built: There is no striping or signage to indicate accessible parking. There are no accessible parking stalls.

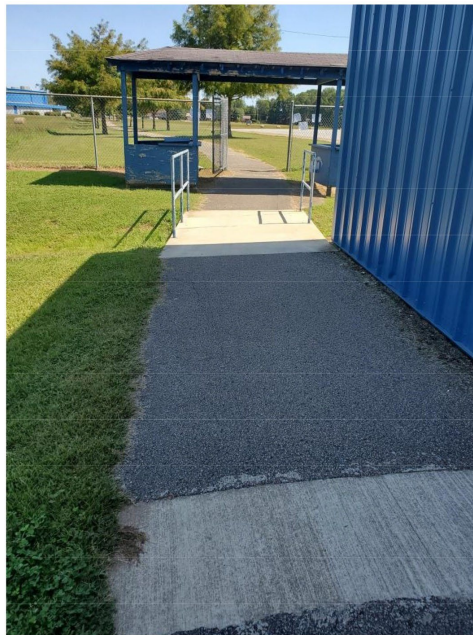
As Built: The cross slopes vary up to 4% on both asphalt and concrete, not on the accessible route from recommended ADA parking. The cross slope of pedestrian access routes shall be 2 percent maximum.

Citation: 2011 PROWAG Section R302.6

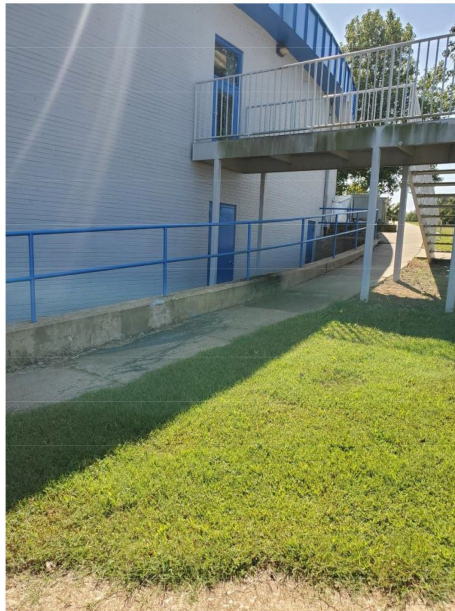
As Built: The grade of the pedestrian access route around 13%, which is too steep.

Where pedestrian access routes are not contained within a street or highway right-of-way, the grade of pedestrian access routes shall be 5 percent maximum.

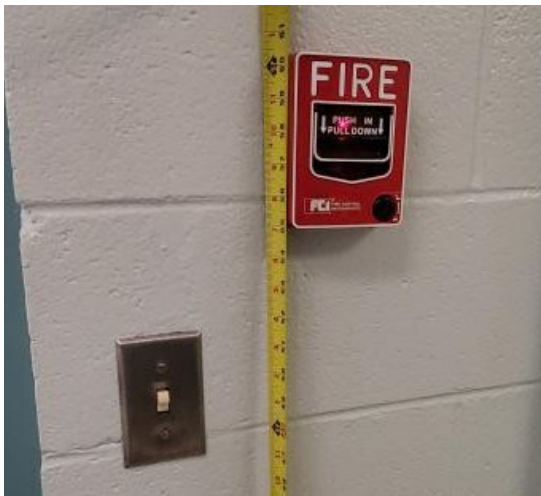
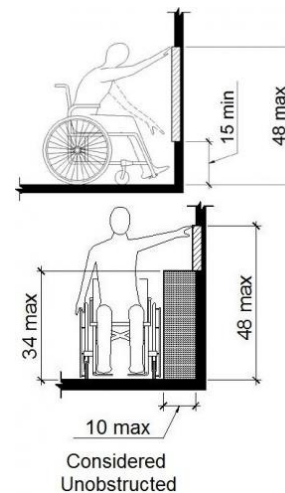
As Built: The Fire Alarm Pull Station is not positioned correctly for either a side or front approach.

Where a clear floor or ground space allows a parallel or front approach and the side reach is unobstructed, the high side reach shall be 48 inches maximum above the finish floor or ground and the low side reach shall be 15 inches minimum above the finish floor or ground.

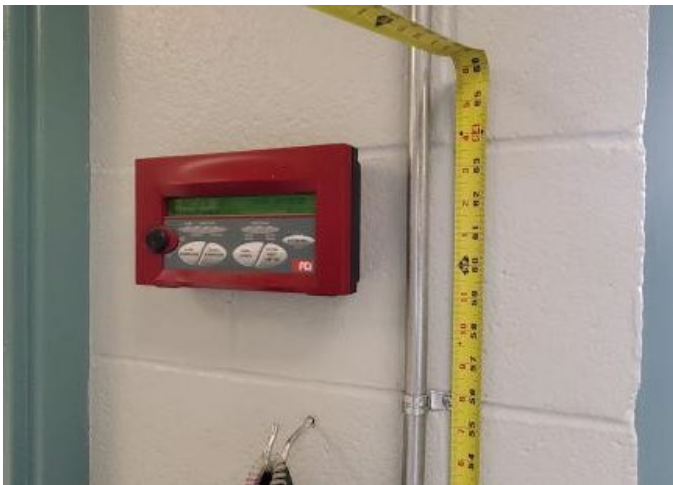
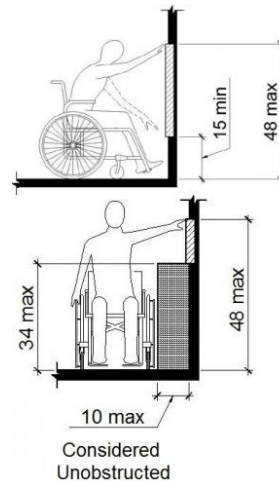
As Built: The Fire Alarm Annunciator is not positioned correctly for either a side or front approach.

Where a clear floor or ground space allows a parallel or front approach and the side reach is unobstructed, the high side reach shall be 48 inches maximum above the finish floor or ground and the low side reach shall be 15 inches minimum above the finish floor or ground.

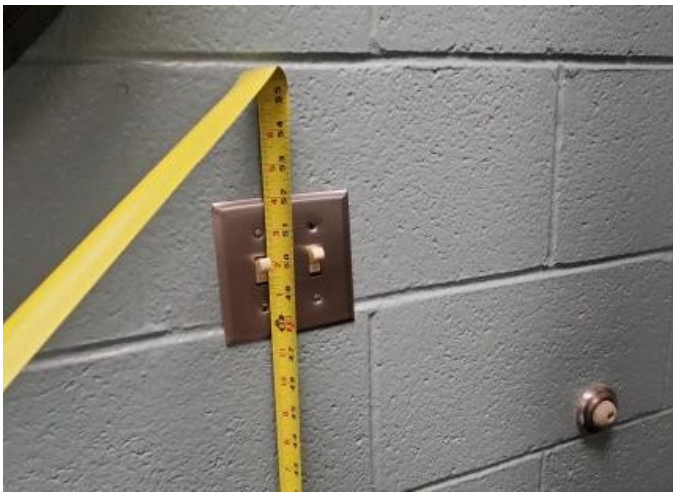
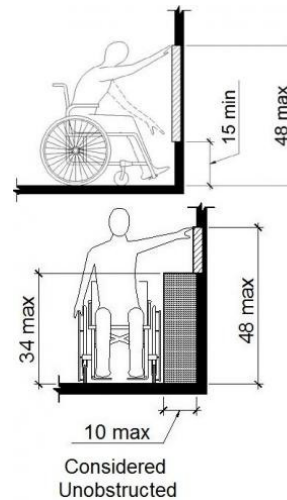
As Built: The light switches are not positioned correctly for either a side or front approach.

Where a clear floor or ground space allows a parallel or front approach and the side reach is unobstructed, the high side reach shall be 48 inches maximum above the finish floor or ground and the low side reach shall be 15 inches minimum above the finish floor or ground.

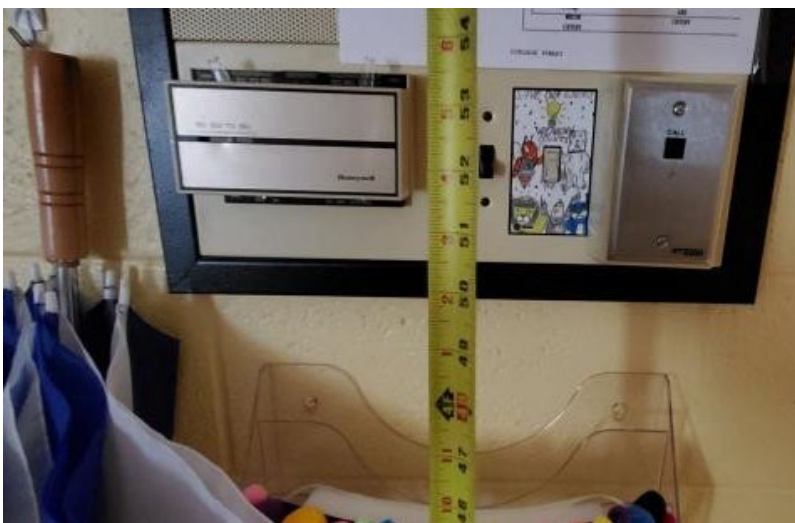
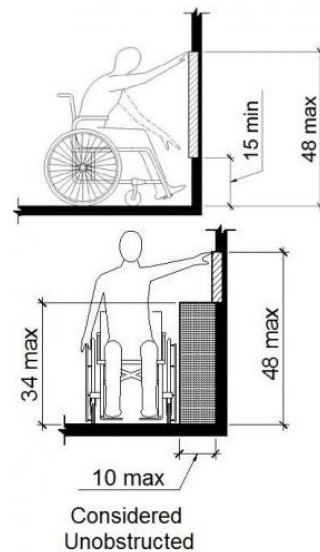
As Built: The thermostats are not positioned correctly for either a side or front approach.

Where a clear floor or ground space allows a parallel or front approach and the side reach is unobstructed, the high side reach shall be 48 inches maximum above the finish floor or ground and the low side reach shall be 15 inches minimum above the finish floor or ground.

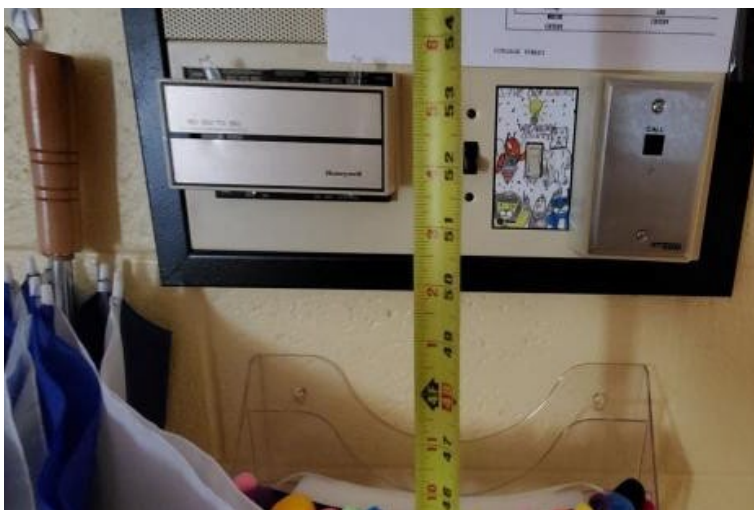
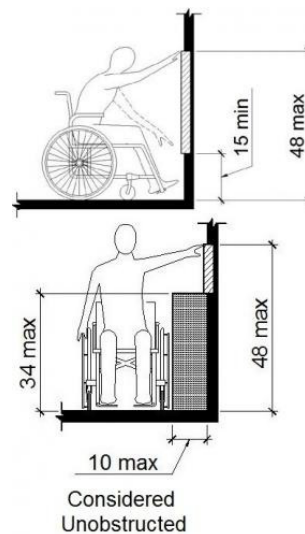
As Built: The call buttons are not positioned correctly for either a side or front approach.

Where a clear floor or ground space allows a parallel or front approach and the side reach is unobstructed, the high side reach shall be 48 inches maximum above the finish floor or ground and the low side reach shall be 15 inches minimum above the finish floor or ground.

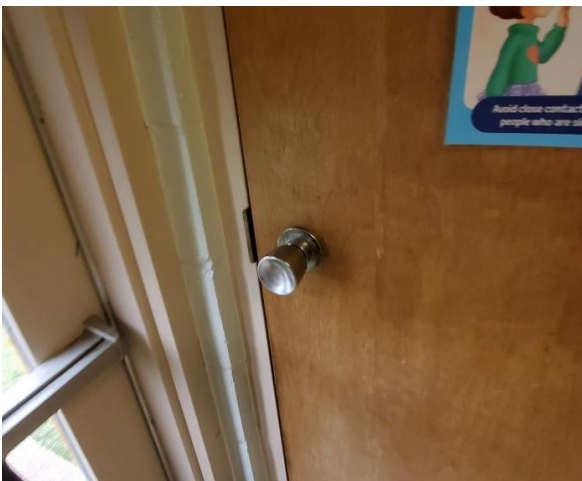
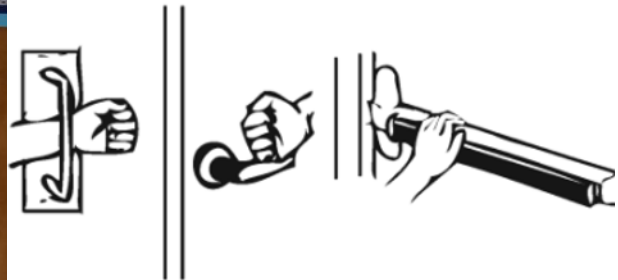
As Built: The door/gate operating hardware is not accessible.

Hand-activated door/gate opening hardware, handles, pulls, latches, locks, and other operating devices on accessible doors shall have a shape that is easy to grasp with one hand and does not require tight grasping, pinching, or twisting of the wrist to operate. Hardware shall be 34 inches minimum and 48 inches maximum above the finish floor or ground.

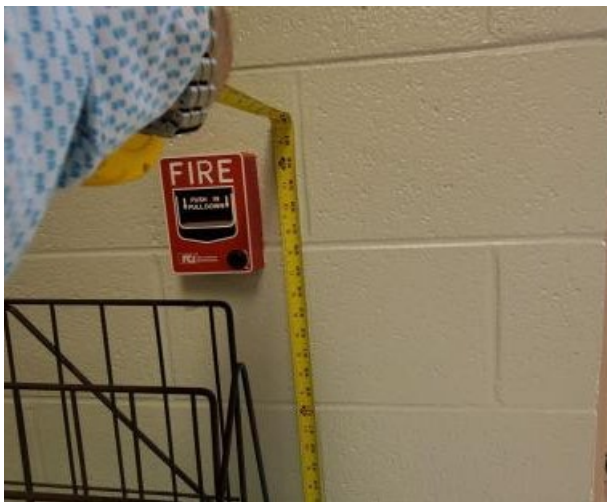
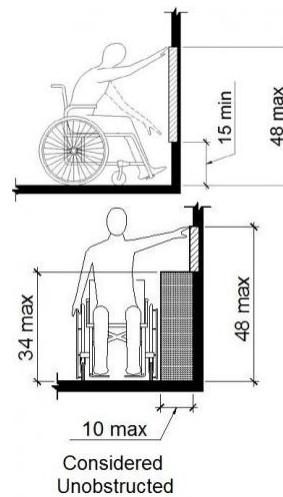
As Built: The Fire Alarm Pull Station is not positioned correctly for either a side or front approach.

Where a clear floor or ground space allows a parallel or front approach and the side reach is unobstructed, the high side reach shall be 48 inches maximum above the finish floor or ground and the low side reach shall be 15 inches minimum above the finish floor or ground.

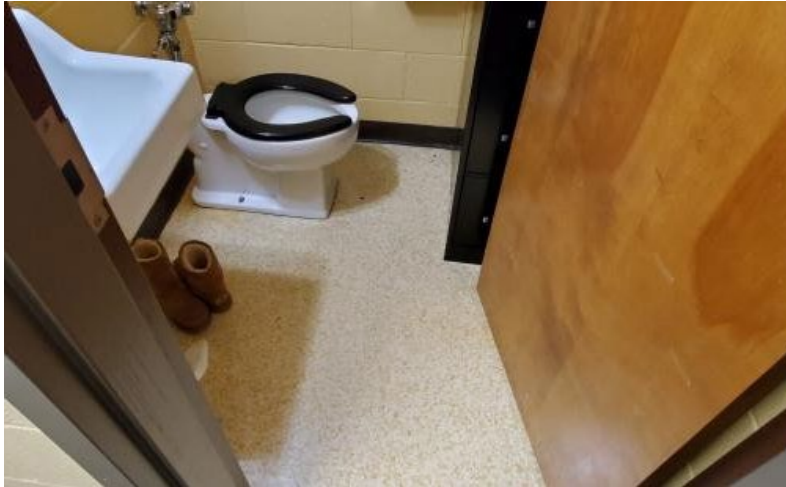
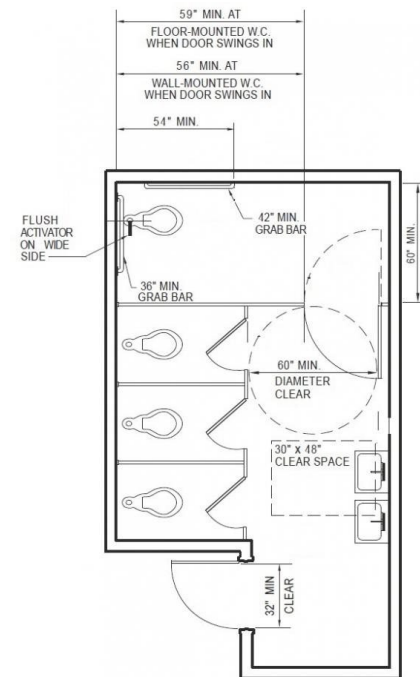
As Built: The restroom is not compliant. The restroom does not have the required minimum clear floor space or maneuvering clearances for the toilet. The restroom does not have the required minimum clear floor space or maneuvering clearances for the lavatory. The entry door does not contain the required minimum 60 inches maneuvering space on the pull side. The entry door encroach into the required clear floor space for fixtures. No grab bars installed. Mirror too high. Lavatory faucet not lever type. Lavatory doesn't have pipe insulation. Toilet Height under 17".

Citation: 2010 ADAS Section 213.2

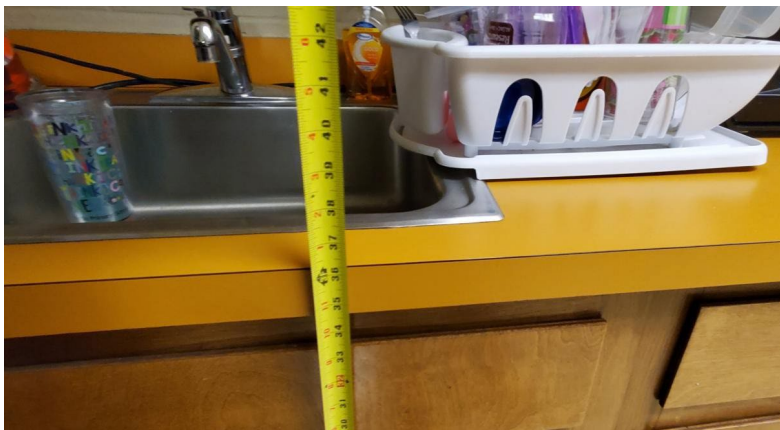
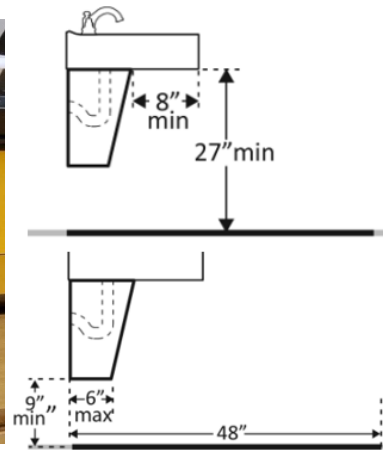
As Built: The top of the sink is too high.

Sinks that are required to be accessible shall be a minimum 17 inches in horizontal depth and mounted with the rim or counter edge no higher than 34 inches above the finished floor.

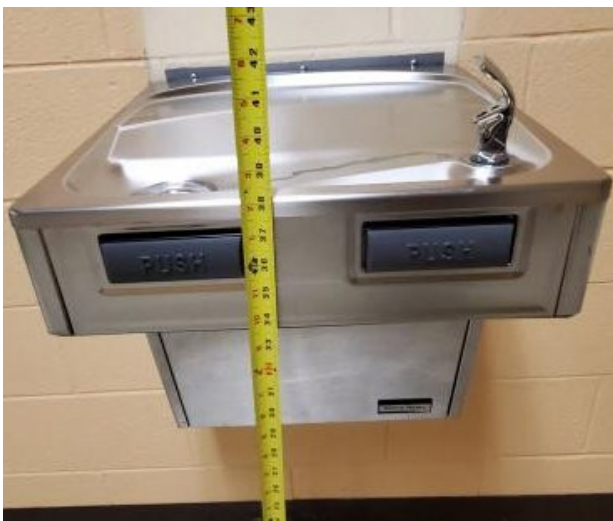
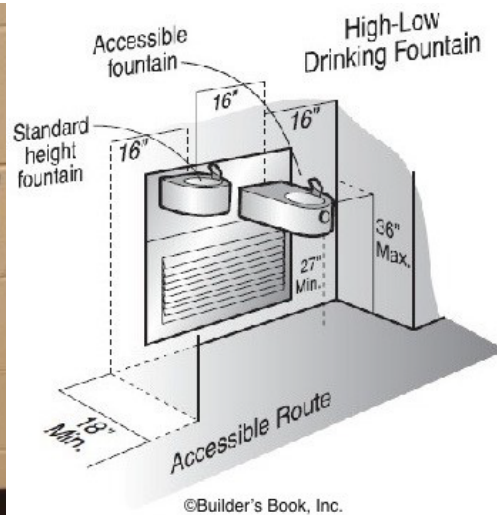
As Built: The drinking fountain is noncompliant.

Spout outlets shall be 36 inches maximum above the finish floor or ground and be located 15 inches minimum from the vertical support and 5 inches maximum from the front edge of the unit, including bumpers. The spout shall provide a flow of water at least 4 inches high minimum and shall be located 5 inches maximum from the front of the unit. The angle of the water stream shall be measured horizontally relative to the front face of the unit. Where spouts are located less than 3 inches of the front of the unit, the angle of the water stream shall be 30 degrees maximum. Where spouts are located between 3 inches and 5 inches maximum from the front of the unit, the angle of the water stream shall be 15 degrees maximum. On an accessible drinking fountain with a round or oval bowl, the spout must be positioned so the flow of water is within 3 inches of the front edge of the fountain.

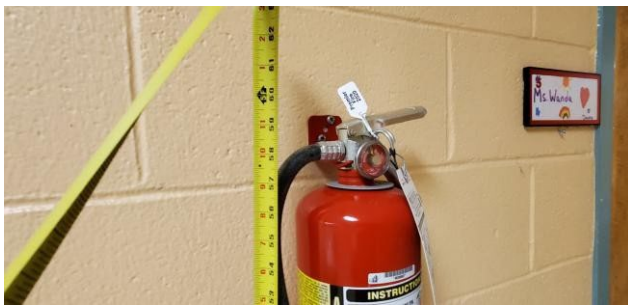
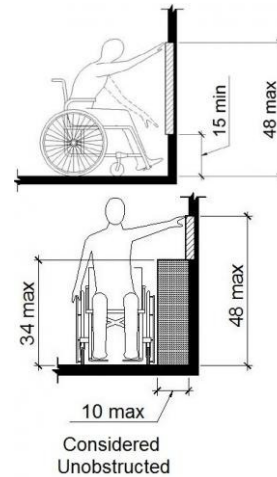
As Built: The fire extinguisher is not positioned correctly for either a side or front approach.

Where a clear floor or ground space allows a parallel or front approach and the side reach is unobstructed, the high side reach shall be 48 inches maximum above the finish floor or ground and the low side reach shall be 15 inches minimum above the finish floor or ground.

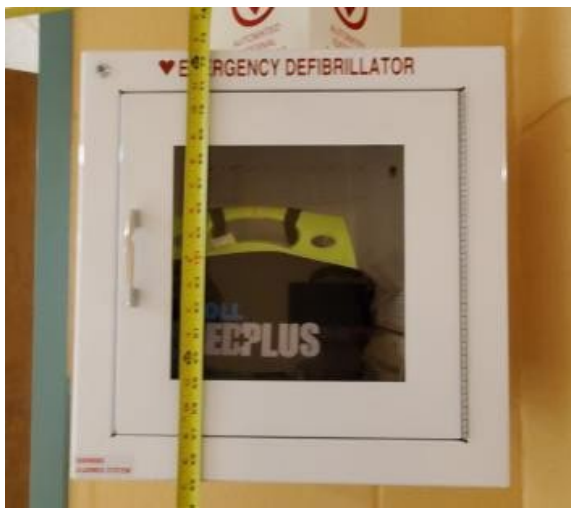
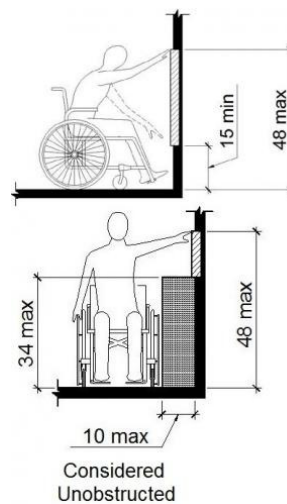
As Built: The defibrillator is not positioned correctly for either a side or front approach.

Where a clear floor or ground space allows a parallel or front approach and the side reach is unobstructed, the high side reach shall be 48 inches maximum above the finish floor or ground and the low side reach shall be 15 inches minimum above the finish floor or ground.

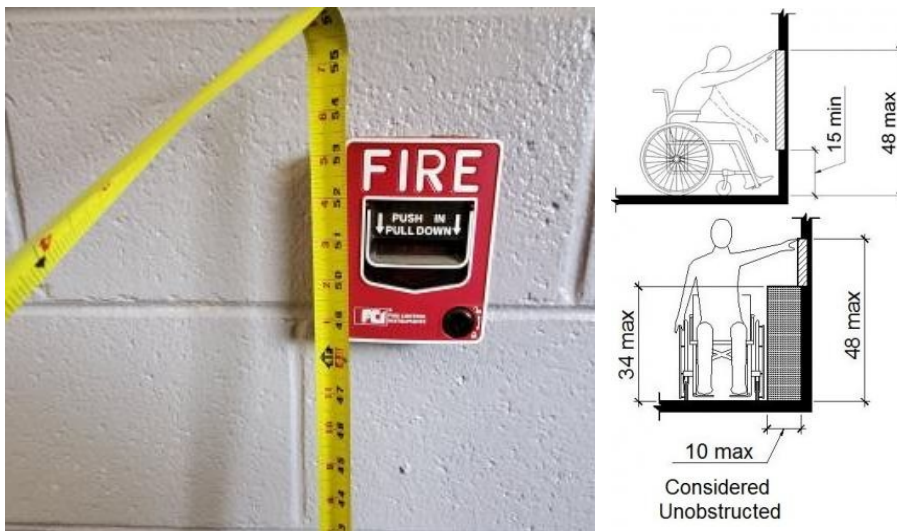
As Built: The Fire Alarm Pull Station is not positioned correctly for either a side or front approach.

Where a clear floor or ground space allows a parallel or front approach and the side reach is unobstructed, the high side reach shall be 48 inches maximum above the finish floor or ground and the low side reach shall be 15 inches minimum above the finish floor or ground.

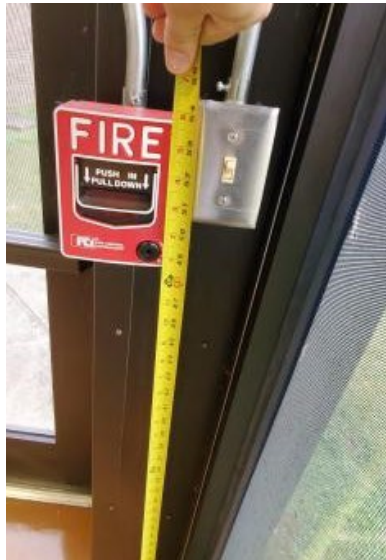
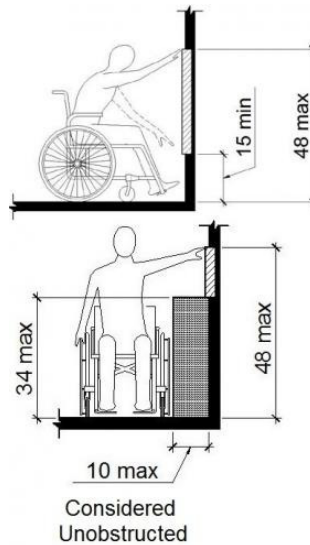
As Built: The Fire Alarm Pull Station is not positioned correctly for either a side or front approach.

Where a clear floor or ground space allows a parallel or front approach and the side reach is unobstructed, the high side reach shall be 48 inches maximum above the finish floor or ground and the low side reach shall be 15 inches minimum above the finish floor or ground.

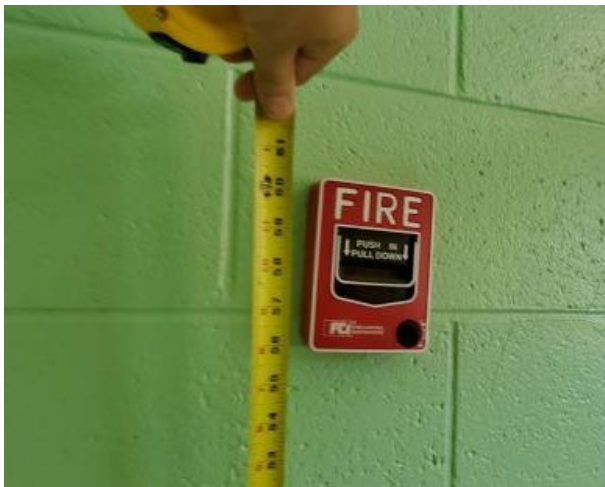
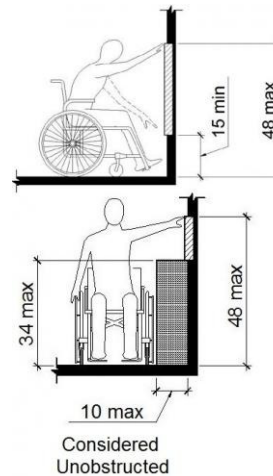
As Built: The Fire Alarm Pull Station is not positioned correctly for either a side or front approach.

Where a clear floor or ground space allows a parallel or front approach and the side reach is unobstructed, the high side reach shall be 48 inches maximum above the finish floor or ground and the low side reach shall be 15 inches minimum above the finish floor or ground.

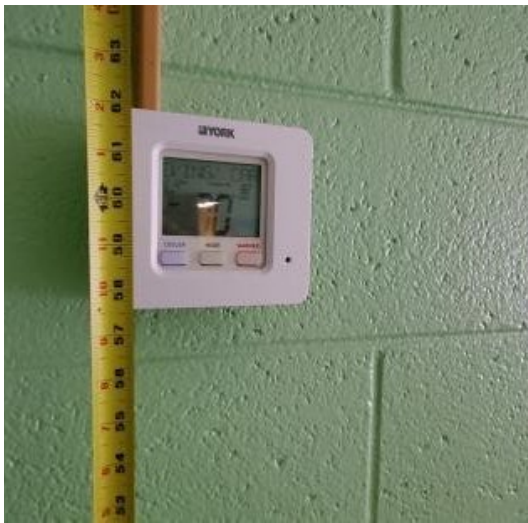
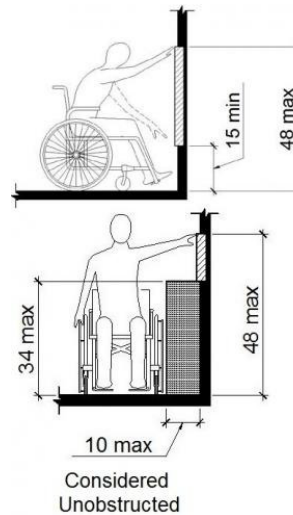
As Built: The thermostat is not positioned correctly for either a side or front approach.

Where a clear floor or ground space allows a parallel or front approach and the side reach is unobstructed, the high side reach shall be 48 inches maximum above the finish floor or ground and the low side reach shall be 15 inches minimum above the finish floor or ground.

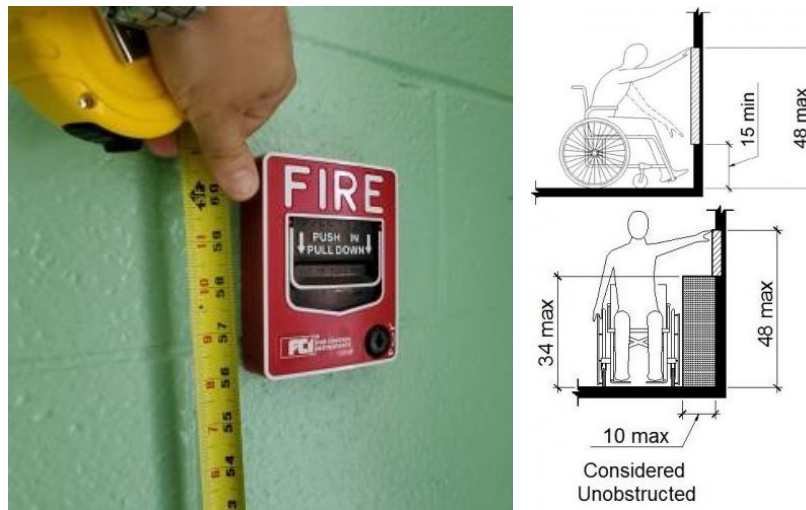
As Built: The Fire Alarm Pull Station is not positioned correctly for either a side or front approach.

Where a clear floor or ground space allows a parallel or front approach and the side reach is unobstructed, the high side reach shall be 48 inches maximum above the finish floor or ground and the low side reach shall be 15 inches minimum above the finish floor or ground.

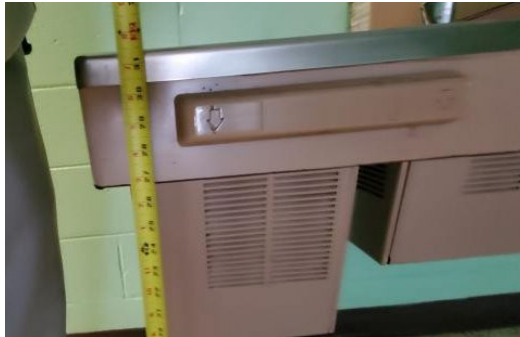
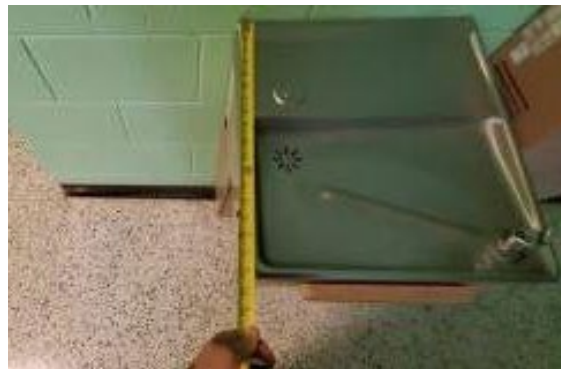
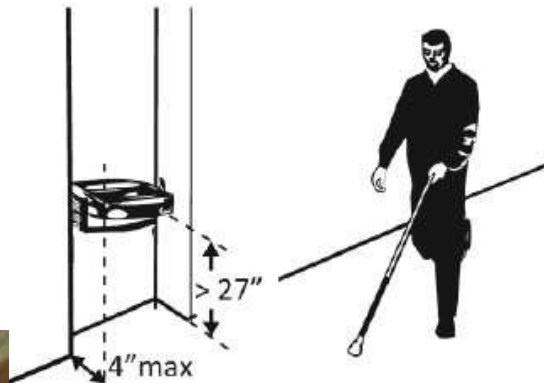
As Built: The drinking fountain projects from the wall into the pedestrian way with its leading edge above 27 inches from the floor.

Objects may protrude no more than 4 inches into walks, halls, corridors, passageways or aisles when located between 27 and 80 inches above the floor. All drinking fountains shall be located completely within alcoves, positioned completely between wing walls, or otherwise positioned so as not to encroach into pedestrian ways. The alcove must not be less than 32 inches in width and 18 inches in depth. Wing walls must project out from the supporting wall at least as far as the drinking fountain.

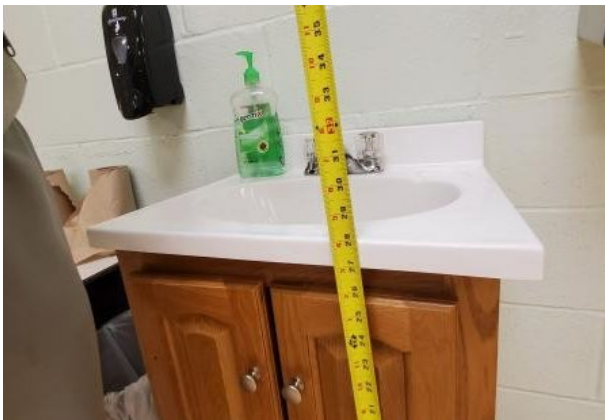
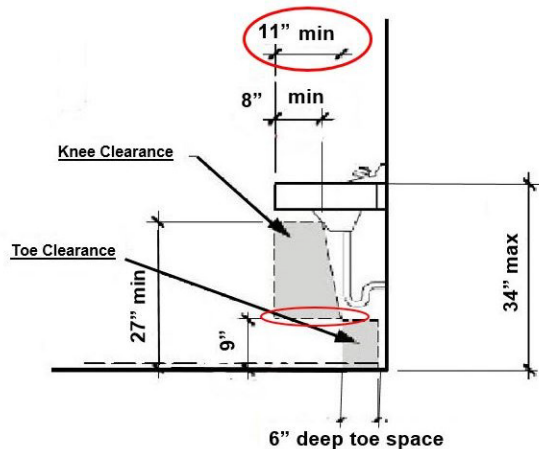
As Built: Compliant knee space has not been provided under the lavatory.

The knee clearance shall be 11 inches minimum in depth at 9 inches above the floor, and 8 inches minimum in depth at 27 inches above the floor. The top of the lavatory rim may be no higher than 34 inches.

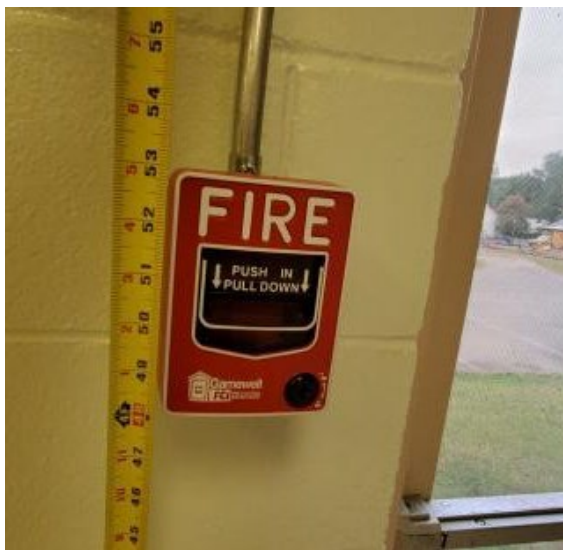
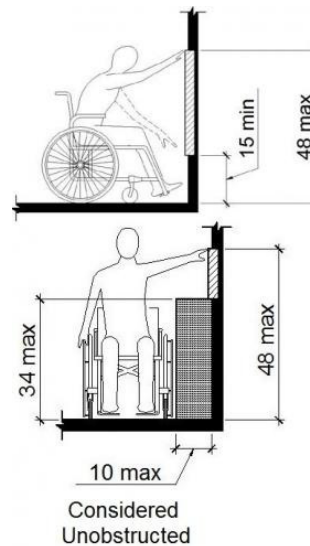
As Built: The Fire Alarm Pull Station is not positioned correctly for either a side or front approach.

Where a clear floor or ground space allows a parallel or front approach and the side reach is unobstructed, the high side reach shall be 48 inches maximum above the finish floor or ground and the low side reach shall be 15 inches minimum above the finish floor or ground.

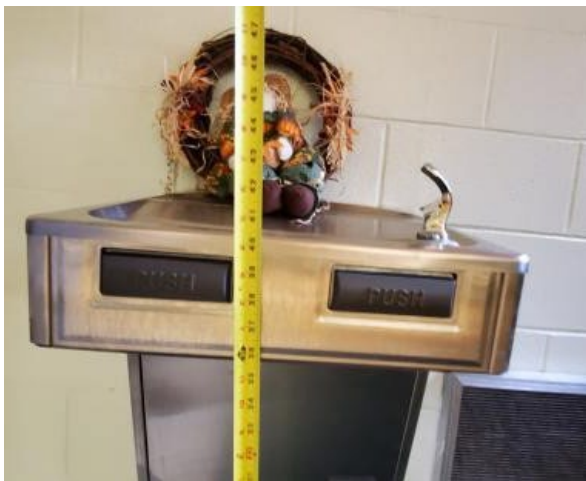
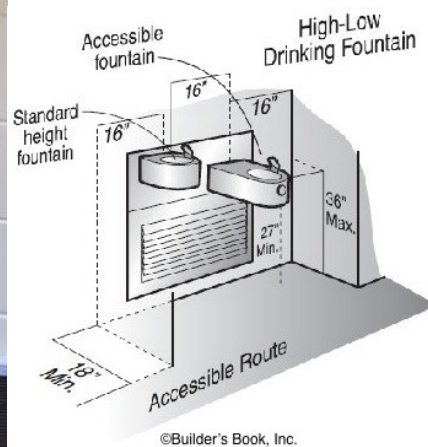
As Built: The drinking fountain is noncompliant.

Spout outlets shall be 36 inches maximum above the finish floor or ground and be located 15 inches minimum from the vertical support and 5 inches maximum from the front edge of the unit, including bumpers. The spout shall provide a flow of water at least 4 inches high minimum and shall be located 5 inches maximum from the front of the unit. The angle of the water stream shall be measured horizontally relative to the front face of the unit. Where spouts are located less than 3 inches of the front of the unit, the angle of the water stream shall be 30 degrees maximum. Where spouts are located between 3 inches and 5 inches maximum from the front of the unit, the angle of the water stream shall be 15 degrees maximum. On an accessible drinking fountain with a round or oval bowl, the spout must be positioned so the flow of water is within 3 inches of the front edge of the fountain.

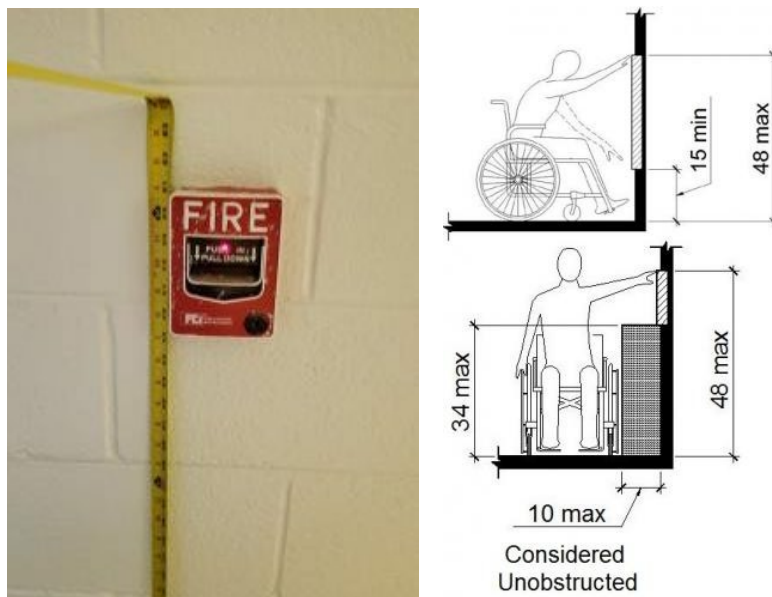
As Built: The Fire Alarm Pull Station is not positioned correctly for either a side or front approach.

Where a clear floor or ground space allows a parallel or front approach and the side reach is unobstructed, the high side reach shall be 48 inches maximum above the finish floor or ground and the low side reach shall be 15 inches minimum above the finish floor or ground.
