WEAKLEY COUNTY, TENNESSEE

ADA EVALUATION

Architectural and Site Findings with Recommendations

TLM Associates, Inc

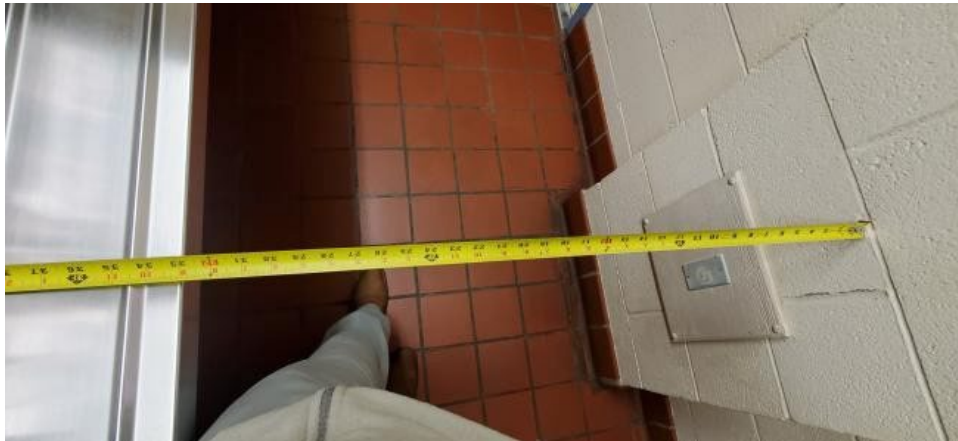
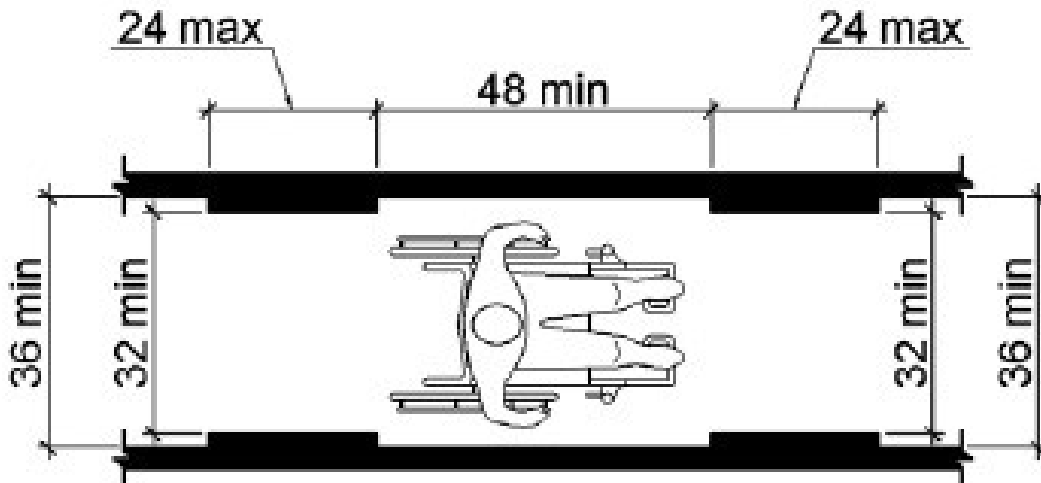
As Built: The route of travel does not provide a minimum width of 36 inches.

The clear width shall be permitted to be reduced to 32 inches minimum for a length of 24 inches maximum provided that reduced width segments are separated by segments that are 48 inches long minimum and 36 inches wide minimum.

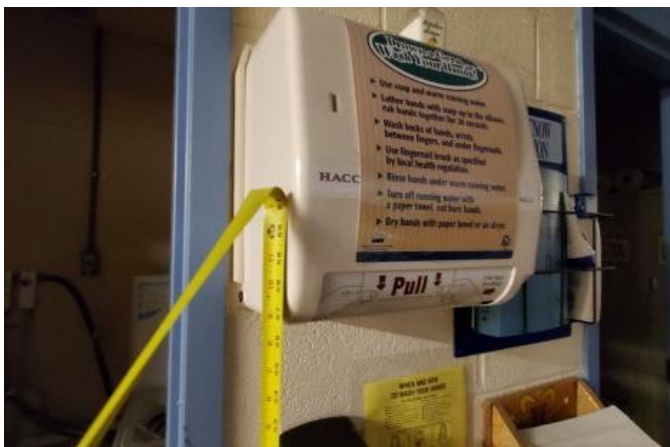
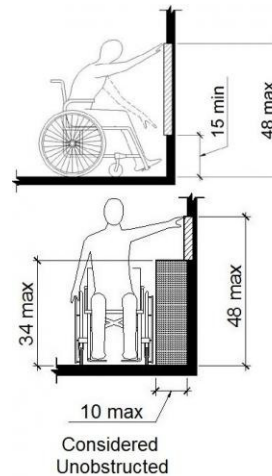
As Built: The paper towel dispenser is not positioned correctly for either a side or front approach.

Where a clear floor or ground space allows a parallel or front approach and the side reach is unobstructed, the high side reach shall be 48 inches maximum above the finish floor or ground and the low side reach shall be 15 inches minimum above the finish floor or ground.

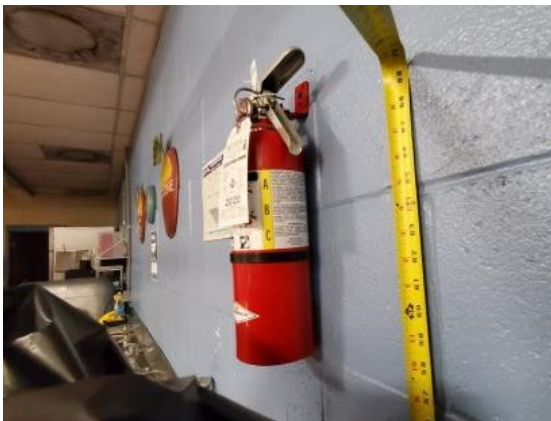
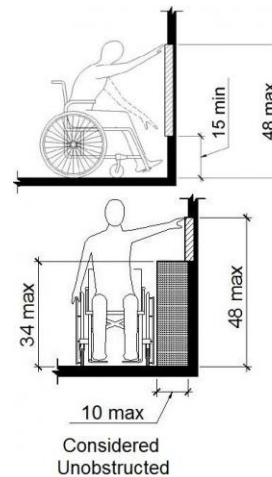
As Built: The fire extinguisher is not positioned correctly for either a side or front approach.

Where a clear floor or ground space allows a parallel or front approach and the side reach is unobstructed, the high side reach shall be 48 inches maximum above the finish floor or ground and the low side reach shall be 15 inches minimum above the finish floor or ground.

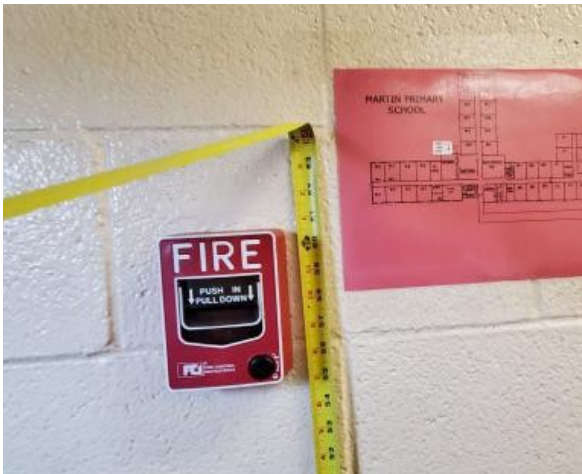
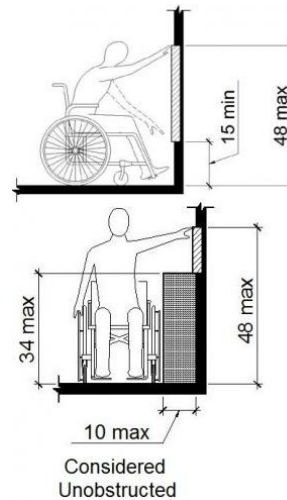
As Built: The Fire Alarm Pull Station is not positioned correctly for either a side or front approach.

Where a clear floor or ground space allows a parallel or front approach and the side reach is unobstructed, the high side reach shall be 48 inches maximum above the finish floor or ground and the low side reach shall be 15 inches minimum above the finish floor or ground.

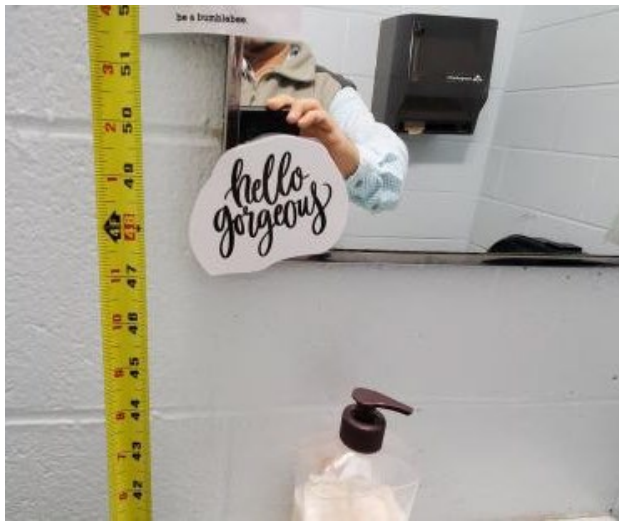
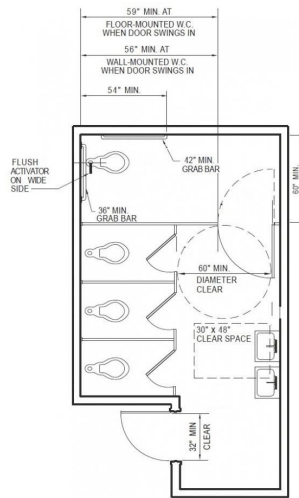
As Built: The restroom is not compliant. The restroom does not have the required minimum clear floor space or maneuvering clearances for the toilet. The restroom does not have the required minimum clear floor space or maneuvering clearances for the lavatory. The entry door does not contain the required minimum 60 inches maneuvering space on the pull side. The entry door encroach into the required clear floor space for fixtures. No grab bars are installed. Soap Dispenser too high. Mirror reflecting surface above 40". Lavatory has doesn't have lever type faucet.

Citation: 2010 ADAS Section 213.2

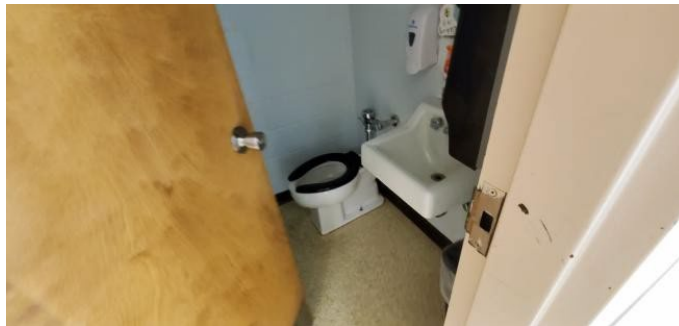
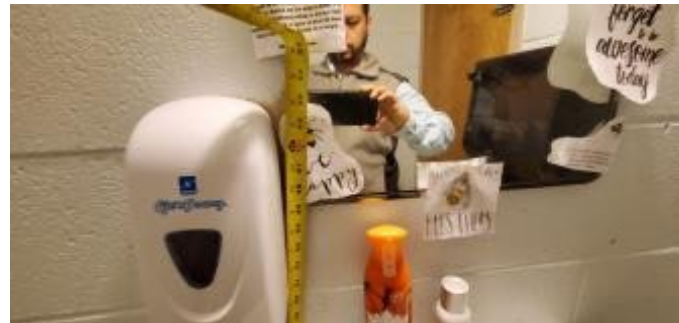
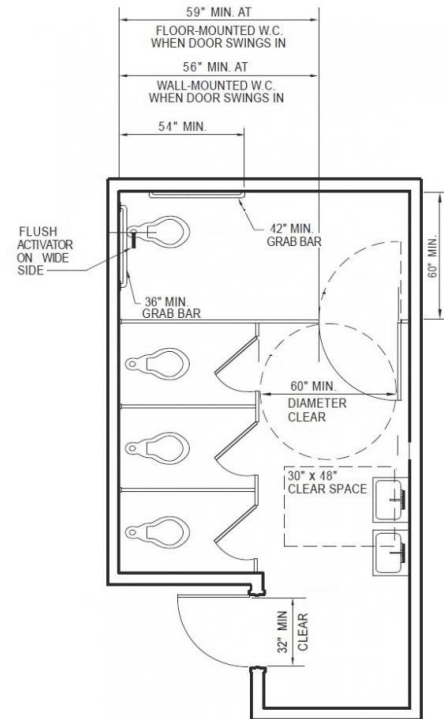
As Built: The restroom is not nearly compliant. The restroom does not have the required minimum clear floor space or maneuvering clearances for the toilet. The restroom does not have the required minimum clear floor space or maneuvering clearances for the lavatory. The entry door does not contain the required minimum 60 inches maneuvering space on the pull side. The entry door encroaches into the required clear floor space for fixtures. No grab bars are installed. Mirror reflecting surface above 40". Lavatory has does not have lever type faucet. Flush handle wrong side.

Citation: 2010 ADAS Section 213.2

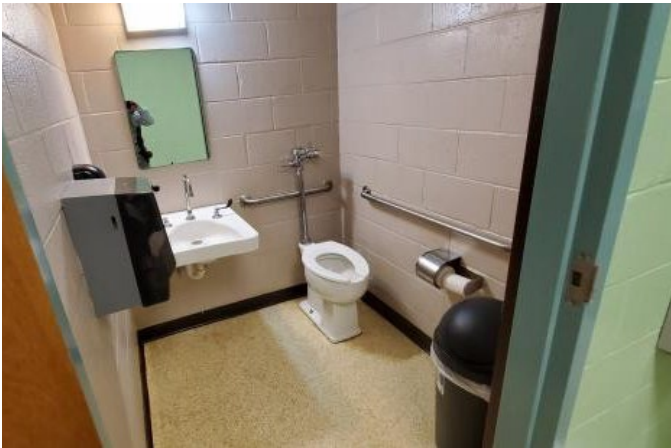
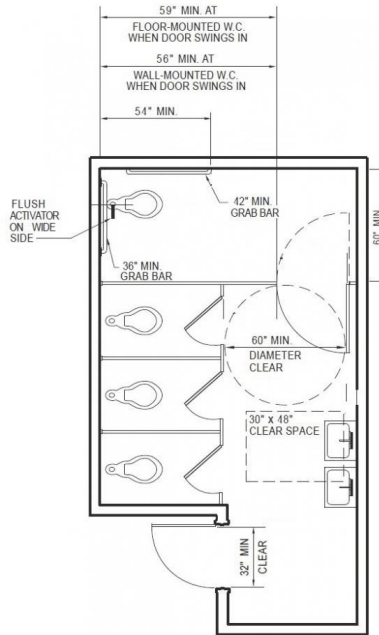
As Built: The restroom is not nearly compliant. The restroom does not have the required minimum clear floor space or maneuvering clearances for the toilet. The restroom does not have the required minimum clear floor space or maneuvering clearances for the lavatory. The entry door does not contain the required minimum 60 inches maneuvering space on the pull side. The entry door encroaches into the required clear floor space for fixtures. Mirror reflecting surface above 40". Lavatory does not have pipe insulation. Toilet less than 16" from wall.

Citation: 2010 ADAS Section 213.2

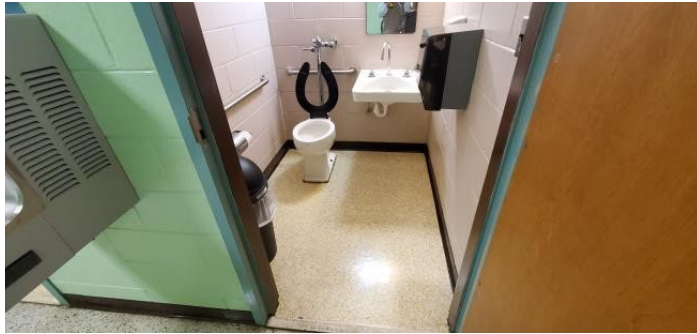
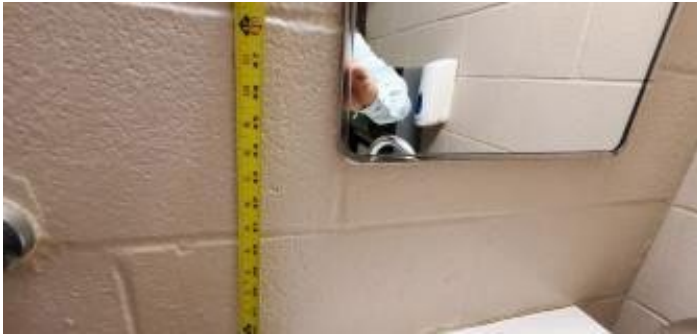
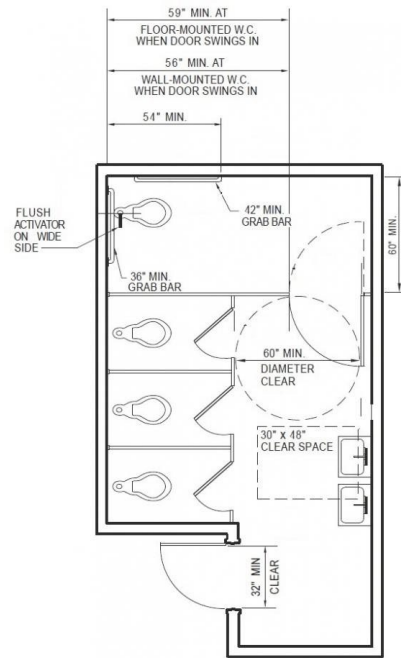
As Built: The restroom is not nearly compliant. The restroom does not have the required minimum clear floor space or maneuvering clearances for the toilet. The restroom does not have the required minimum clear floor space or maneuvering clearances for the lavatory. The entry door does not contain the required minimum 60 inches maneuvering space on the pull side. Rear grab bar incorrect size (lavatory obstructing). Mirror reflecting surface above 40". Lavatory does not have pipe insulation.

Citation: 2010 ADAS Section 213.2

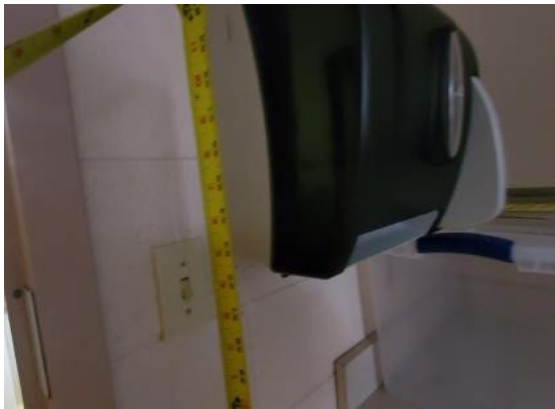
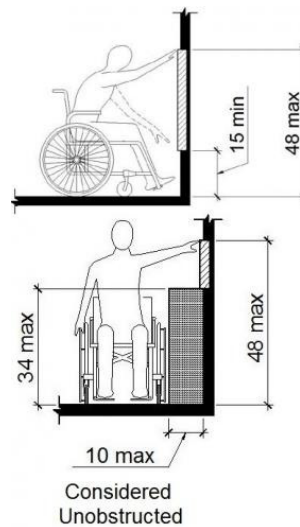
As Built: The paper towel dispenser is not positioned correctly for either a side or front approach.

Where a clear floor or ground space allows a parallel or front approach and the side reach is unobstructed, the high side reach shall be 48 inches maximum above the finish floor or ground and the low side reach shall be 15 inches minimum above the finish floor or ground.

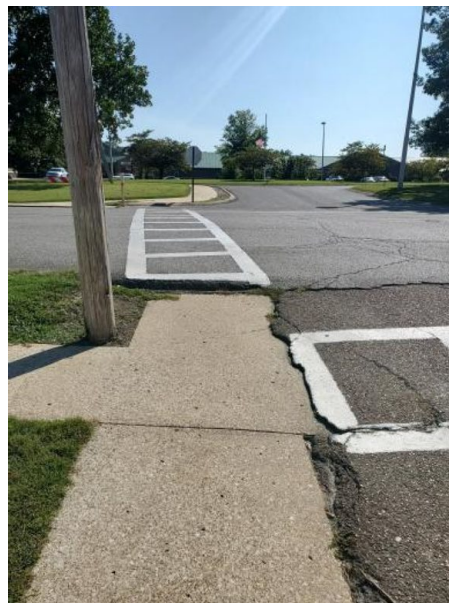
As Built: There is no pedestrian access route at the street crossing.

A curb ramp, blended transition, or a combination of curb ramps and blended transitions shall connect the pedestrian access routes at each pedestrian street crossing. The curb ramp (excluding any flared sides) or blended transition shall be contained wholly within the width of the pedestrian street crossing served.

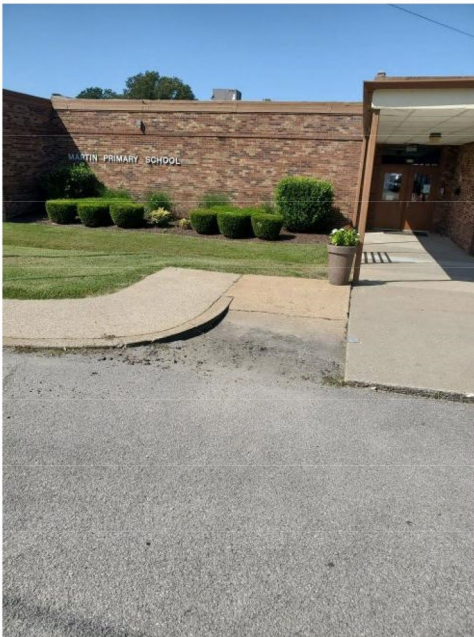
As Built: The curb ramp is holding loose gravel and sediment, and also is cracked.

The accessible route contains loose gravel and/or surfaces that do not provide for a stable, firm slip resistant surface.

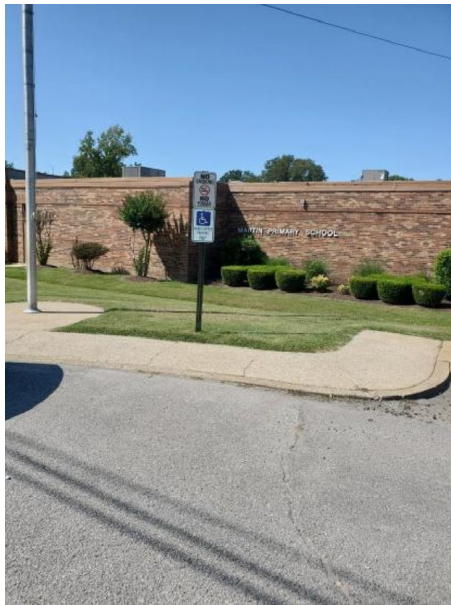
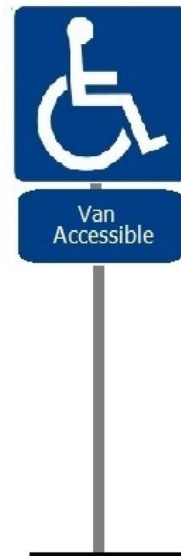
As Built: The van stall is missing a sign identifying it as a van accessible stall.

Parking space identification signs shall include the International Symbol of Accessibility. Signs identifying van parking spaces shall contain the designation "van accessible."

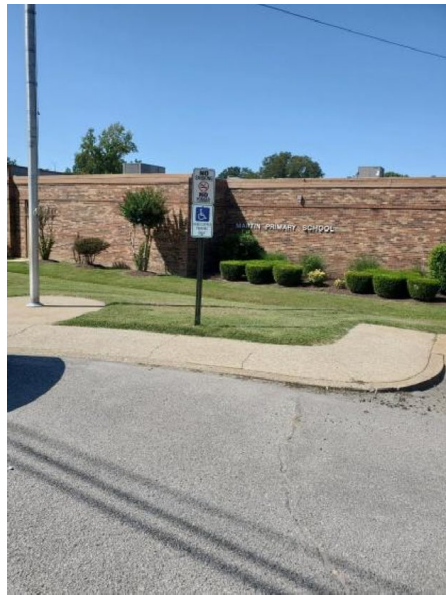
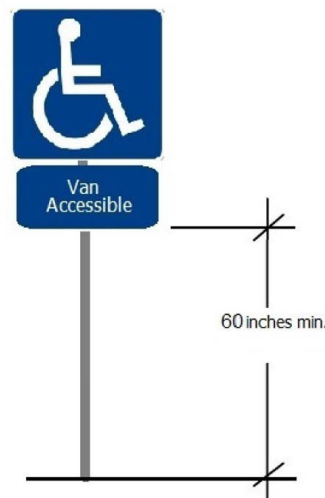
As Built: The parking sign is mounted too low.

Parking space identification signs shall include the International Symbol of Accessibility. Signs identifying van parking spaces shall contain the designation "van accessible." Signs shall be 60 inches minimum above the finish floor or ground surface measured to the bottom of the sign.

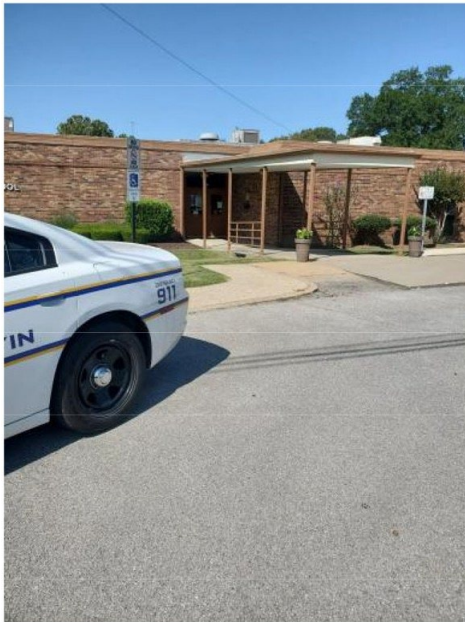
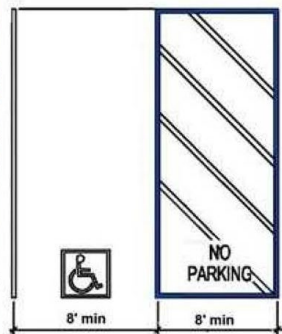
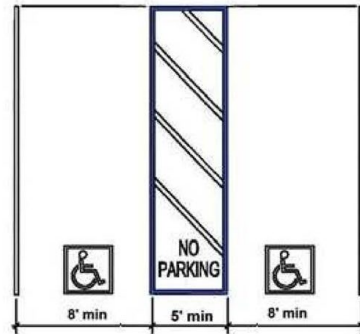
As Built: The access aisle is missing at the accessible parking stall.

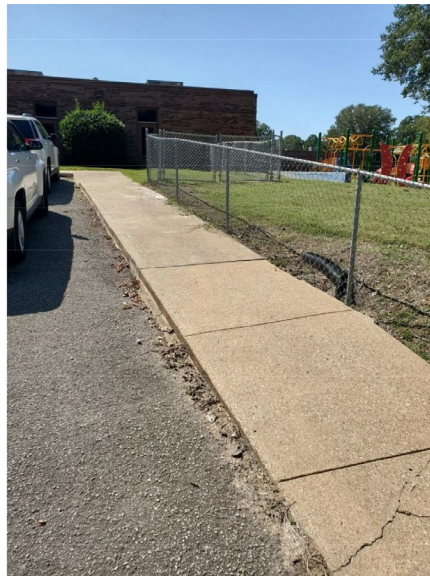
As Built: Sidewalk follows grade of adjacent parking, over 5%, but not along accessible route to an accessible entrance. The grade of the pedestrian access route is too steep. Where pedestrian access routes are not contained within a street or highway right-of-way, the grade of pedestrian access routes shall be 5 percent maximum.

Citation: 2011 PROWAG Section R302.5

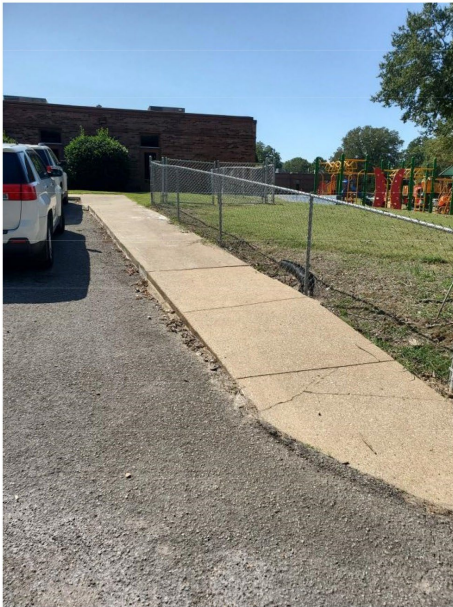
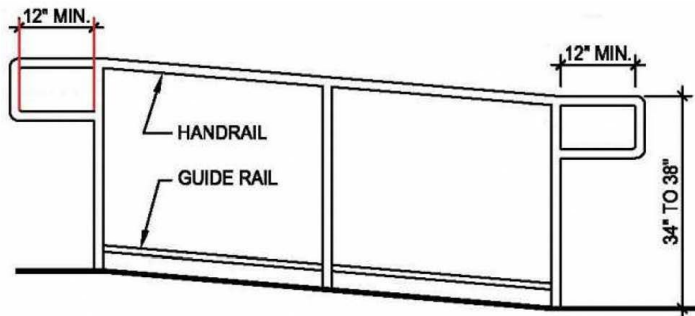
As Built: The ramp does not have compliant handrails.

Handrails are required on both sides of all surfaces that are sloped greater than 5 percent (1:20). Handrails must be between 34 inches and 38 inches above the ramp surface, must extend beyond the top and bottom of the ramp 12 inches and be parallel to the floor or ground surface. The diameter of the handrails must be between 1 inches and 2 inches in cross-sectional nominal dimension for circular handrails and handrail gripping surfaces with a non-circular cross section shall have a perimeter dimension of 4 inches minimum and 6 inches maximum, and a cross-section dimension of 2 inches maximum. The clear space between handrails and walls must 1-1/2 inches minimum.

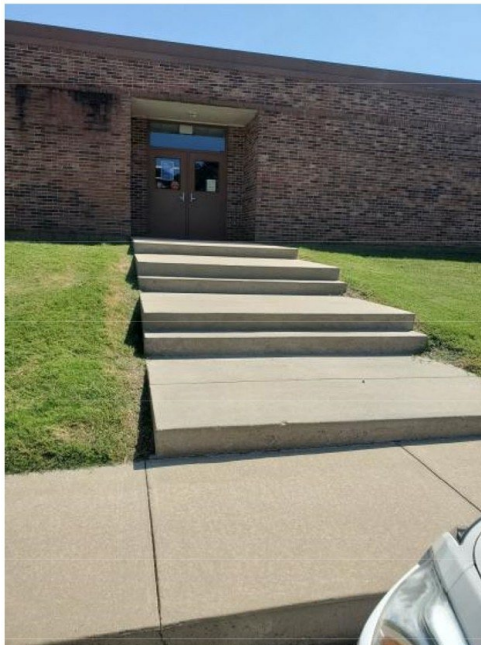
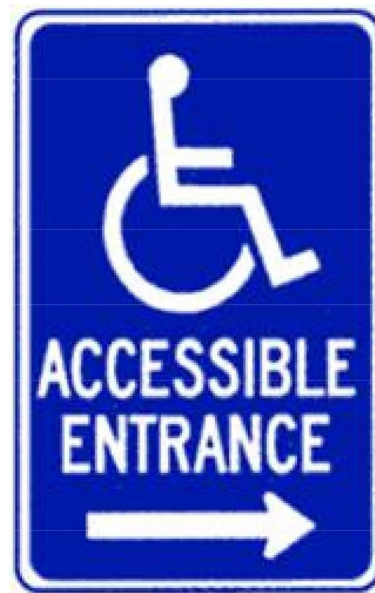
As Built: The entrance is not accessible and is missing signage. An identification sign identifying that this entrance is not accessible and directional signage pointing to the accessible entrance is required.

When a directional sign is required, it should be located to minimize backtracking. In some cases, this could mean locating a sign at the beginning of a route, not just at the inaccessible entrances to a building.

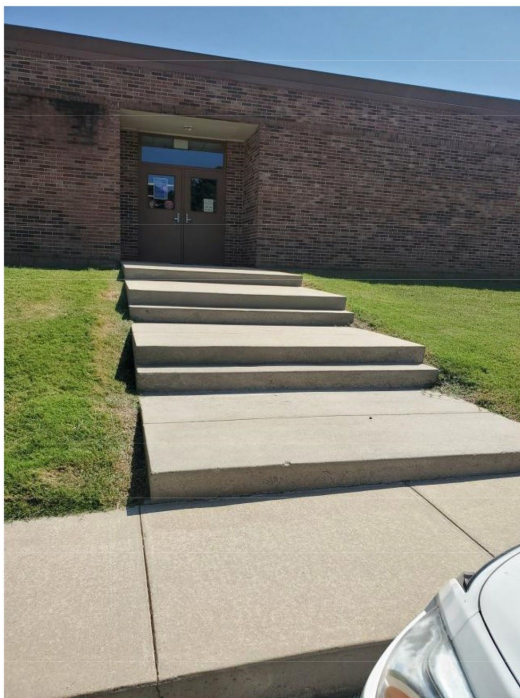
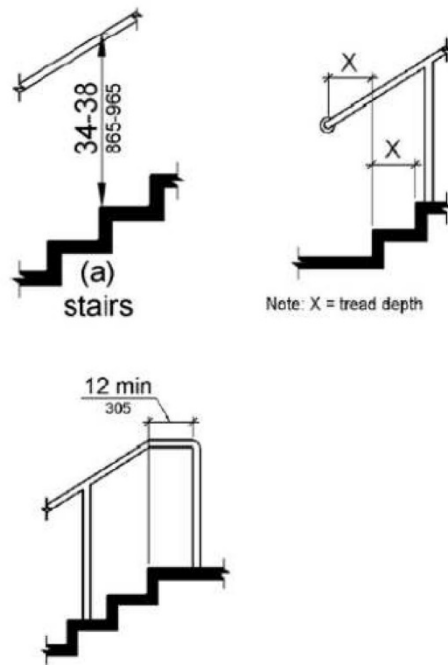
As Built: Stairways must have handrails on both sides.

Handrails and their extensions must be between 34 inches and 38 inches above the stair nosing or ground.

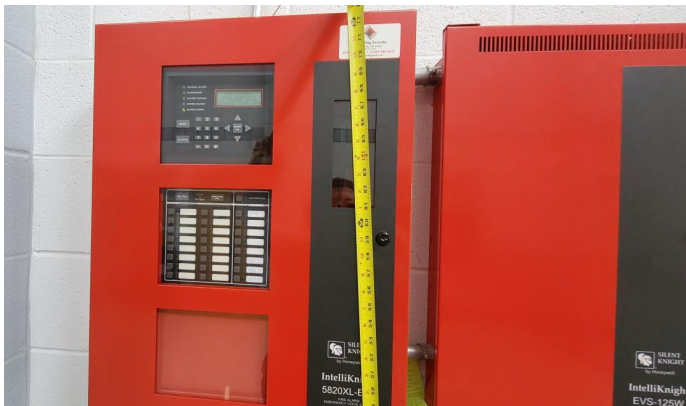
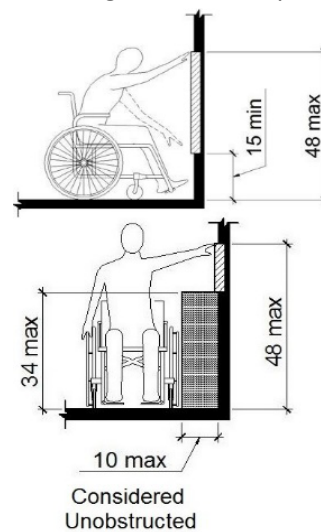
As Built: The Fire Alarm Annunciator is not positioned correctly for either a side or front approach.

Where a clear floor or ground space allows a parallel or front approach and the side reach is unobstructed, the high side reach shall be 48 inches maximum above the finish floor or ground and the low side reach shall be 15 inches minimum above the finish floor or ground.

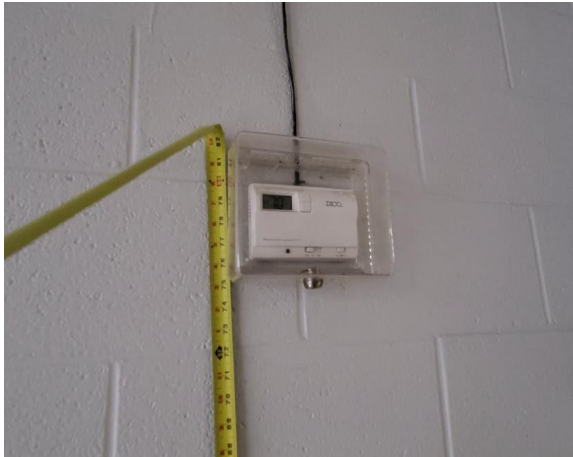
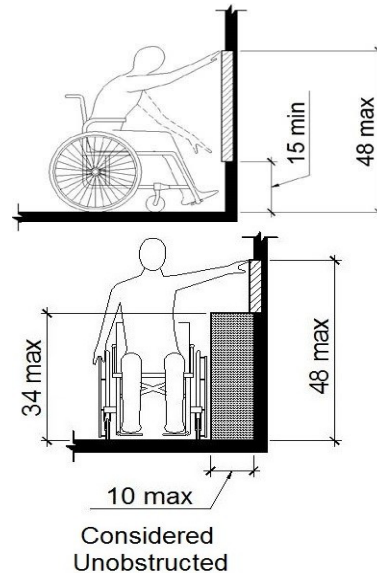
As Built: The thermostat is not positioned correctly for either a side or front approach.

Where a clear floor or ground space allows a parallel or front approach and the side reach is unobstructed, the high side reach shall be 48 inches maximum above the finish floor or ground and the low side reach shall be 15 inches minimum above the finish floor or ground.

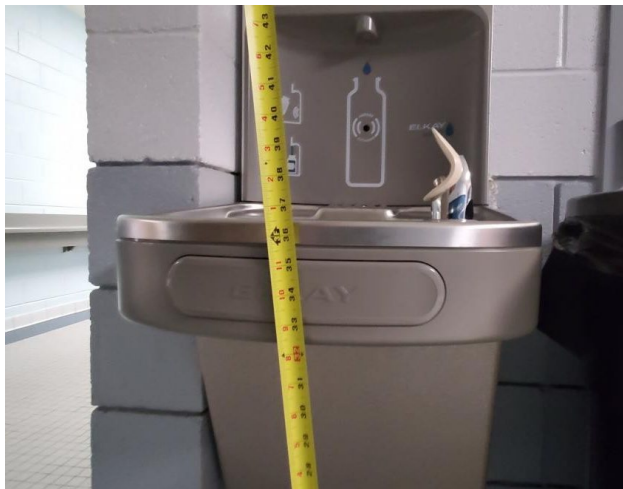
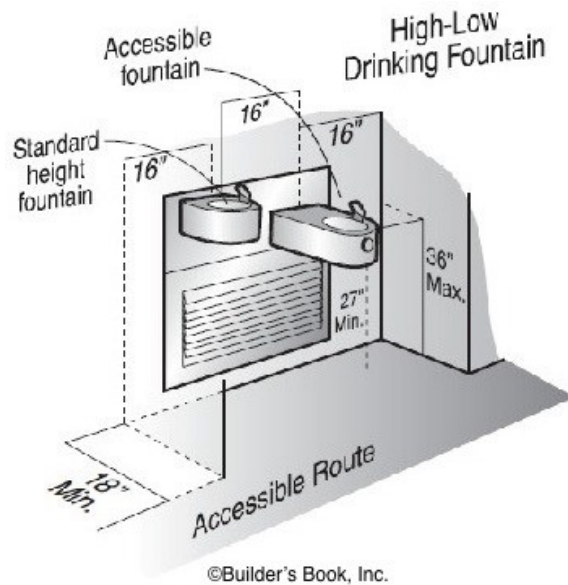
As Built: The drinking fountain is noncompliant.

Spout outlets shall be 36 inches maximum above the finish floor or ground and be located 15 inches minimum from the vertical support and 5 inches maximum from the front edge of the unit, including bumpers. The spout shall provide a flow of water at least 4 inches high minimum and shall be located 5 inches maximum from the front of the unit. The angle of the water stream shall be measured horizontally relative to the front face of the unit. Where spouts are located less than 3 inches of the front of the unit, the angle of the water stream shall be 30 degrees maximum. Where spouts are located between 3 inches and 5 inches maximum from the front of the unit, the angle of the water stream shall be 15 degrees maximum. On an accessible drinking fountain with a round or oval bowl, the spout must be positioned so the flow of water is within 3 inches of the front edge of the fountain.

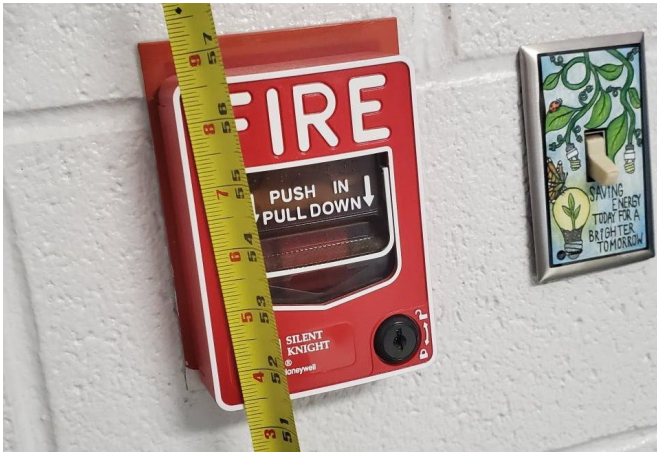
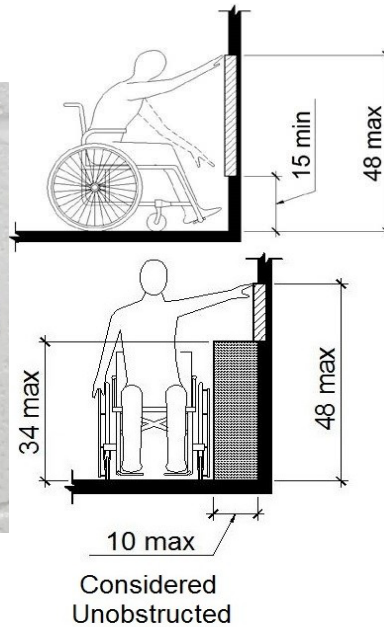
As Built: The fire alarm pull station is not positioned correctly for either a side or front approach.

Where a clear floor or ground space allows a parallel or front approach and the side reach is unobstructed, the high side reach shall be 48 inches maximum above the finish floor or ground and the low side reach shall be 15 inches minimum above the finish floor or ground.

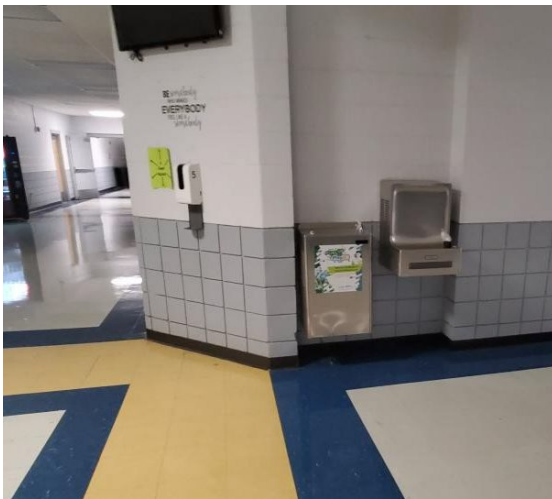
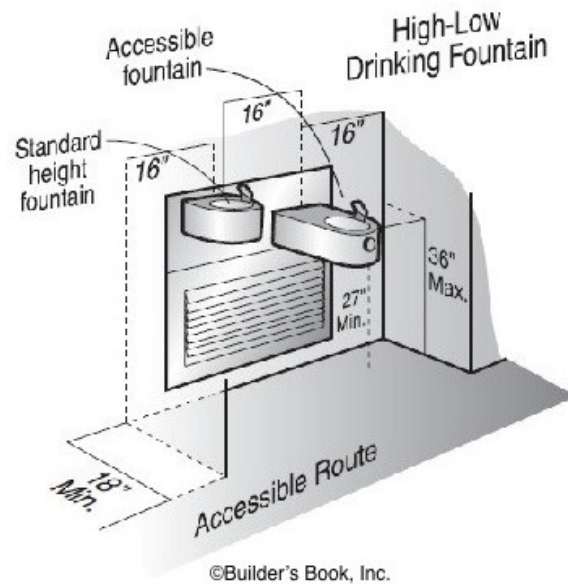
As Built: The drinking fountain is noncompliant.

Spout outlets shall be 36 inches maximum above the finish floor or ground and be located 15 inches minimum from the vertical support and 5 inches maximum from the front edge of the unit, including bumpers. The spout shall provide a flow of water at least 4 inches high minimum and shall be located 5 inches maximum from the front of the unit. The angle of the water stream shall be measured horizontally relative to the front face of the unit. Where spouts are located less than 3 inches of the front of the unit, the angle of the water stream shall be 30 degrees maximum. Where spouts are located between 3 inches and 5 inches maximum from the front of the unit, the angle of the water stream shall be 15 degrees maximum. On an accessible drinking fountain with a round or oval bowl, the spout must be positioned so the flow of water is within 3 inches of the front edge of the fountain.

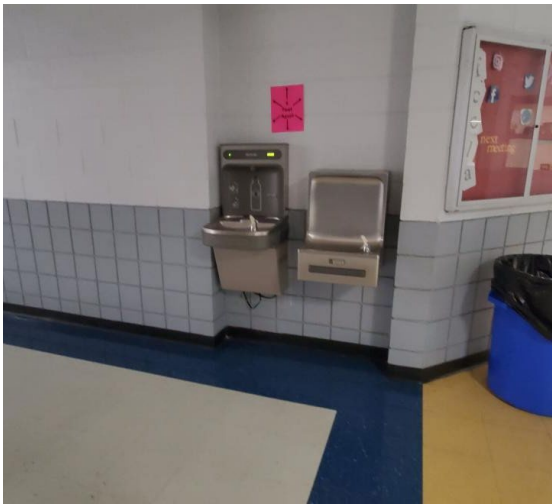
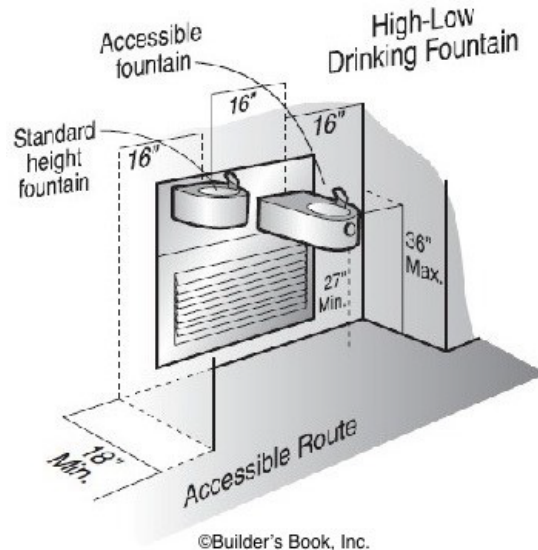
As Built: The drinking fountain is noncompliant.

Spout outlets shall be 36 inches maximum above the finish floor or ground and be located 15 inches minimum from the vertical support and 5 inches maximum from the front edge of the unit, including bumpers. The spout shall provide a flow of water at least 4 inches high minimum and shall be located 5 inches maximum from the front of the unit. The angle of the water stream shall be measured horizontally relative to the front face of the unit. Where spouts are located less than 3 inches of the front of the unit, the angle of the water stream shall be 30 degrees maximum. Where spouts are located between 3 inches and 5 inches maximum from the front of the unit, the angle of the water stream shall be 15 degrees maximum. On an accessible drinking fountain with a round or oval bowl, the spout must be positioned so the flow of water is within 3 inches of the front edge of the fountain.

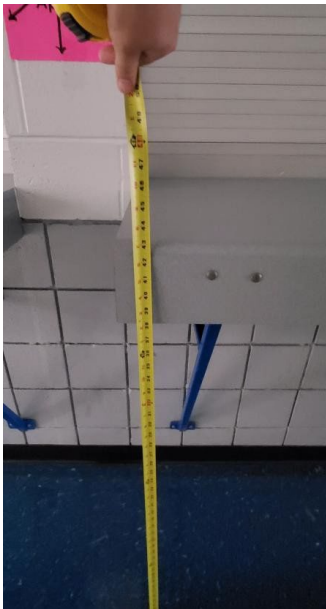
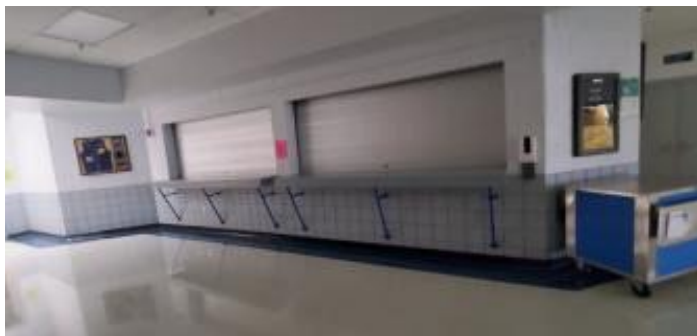
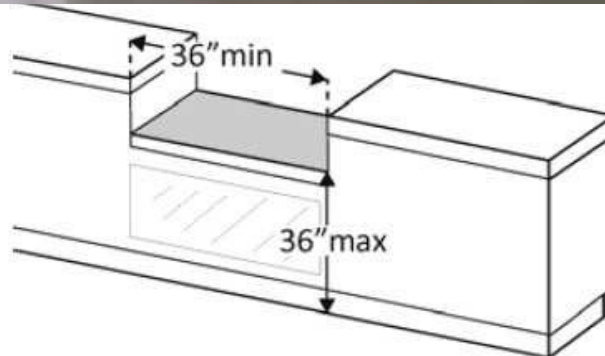
3 (Moderate): Should be completed as soon as possible, but there may be other items that will provide greater access to persons with disabilities. (Includes findings that have a high financial impact on the entity in relationship to the degree of access provided)

As Built: The counter is too high.

A portion of the counter surface that is 36 inches long minimum and 36 inches high maximum above the finish floor shall be provided. Knee and toe space must be provided for a forward approach. A 30 inch by 48-inch clear floor space on an accessible route must be provided for either a forward or parallel approach.

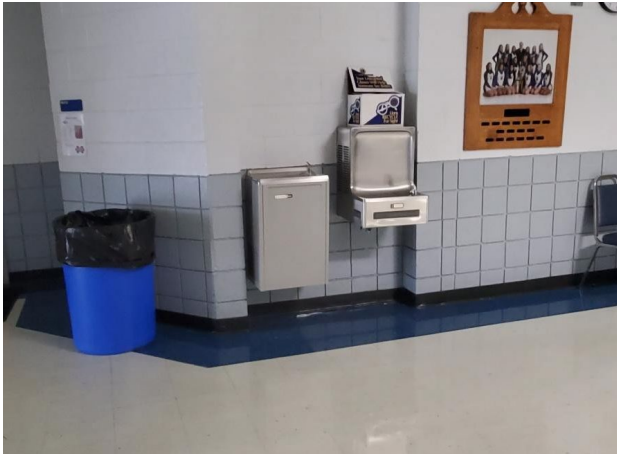
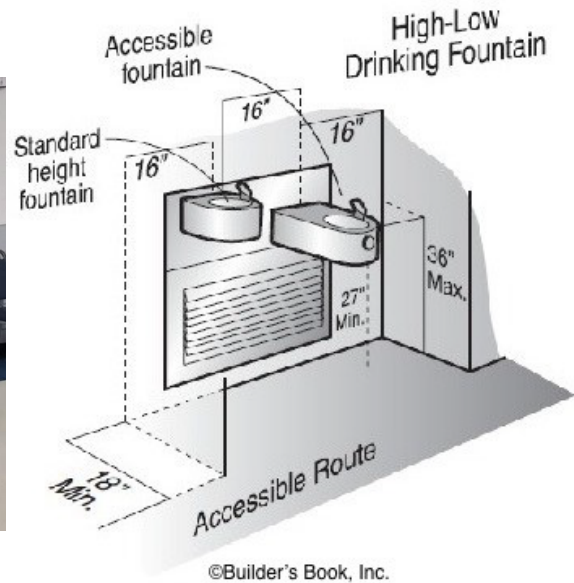
3 (Moderate): Should be completed as soon as possible, but there may be other items that will provide greater access to persons with disabilities. (Includes findings that have a high financial impact on the entity in relationship to the degree of access provided).

As Built: The drinking fountain is noncompliant.

Spout outlets shall be 36 inches maximum above the finish floor or ground and be located 15 inches minimum from the vertical support and 5 inches maximum from the front edge of the unit, including bumpers. The spout shall provide a flow of water at least 4 inches high minimum and shall be located 5 inches maximum from the front of the unit. The angle of the water stream shall be measured horizontally relative to the front face of the unit. Where spouts are located less than 3 inches of the front of the unit, the angle of the water stream shall be 30 degrees maximum. Where spouts are located between 3 inches and 5 inches maximum from the front of the unit, the angle of the water stream shall be 15 degrees maximum. On an accessible drinking fountain with a round or oval bowl, the spout must be positioned so the flow of water is within 3 inches of the front edge of the fountain.

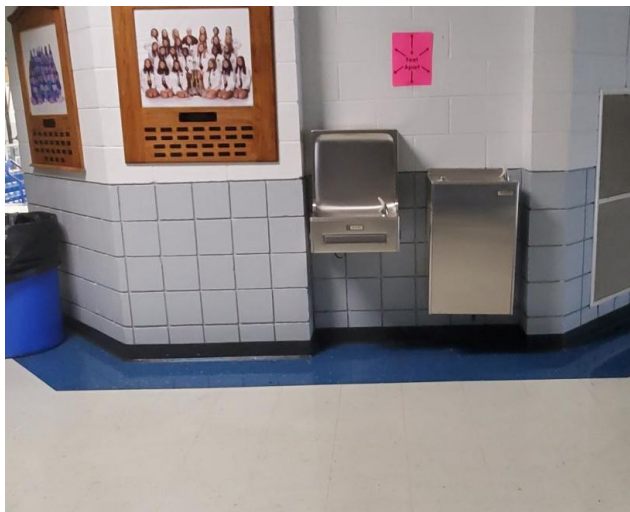
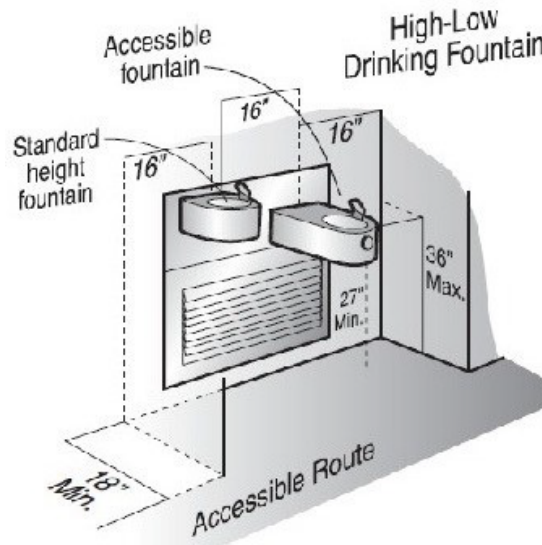
3 (Moderate): Should be completed as soon as possible, but there may be other items that will provide greater access to persons with disabilities. (Includes findings that have a high financial impact on the entity in relationship to the degree of access provided).

As Built: The drinking fountain is noncompliant.

Spout outlets shall be 36 inches maximum above the finish floor or ground and be located 15 inches minimum from the vertical support and 5 inches maximum from the front edge of the unit, including bumpers. The spout shall provide a flow of water at least 4 inches high minimum and shall be located 5 inches maximum from the front of the unit. The angle of the water stream shall be measured horizontally relative to the front face of the unit. Where spouts are located less than 3 inches of the front of the unit, the angle of the water stream shall be 30 degrees maximum. Where spouts are located between 3 inches and 5 inches maximum from the front of the unit, the angle of the water stream shall be 15 degrees maximum. On an accessible drinking fountain with a round or oval bowl, the spout must be positioned so the flow of water is within 3 inches of the front edge of the fountain.

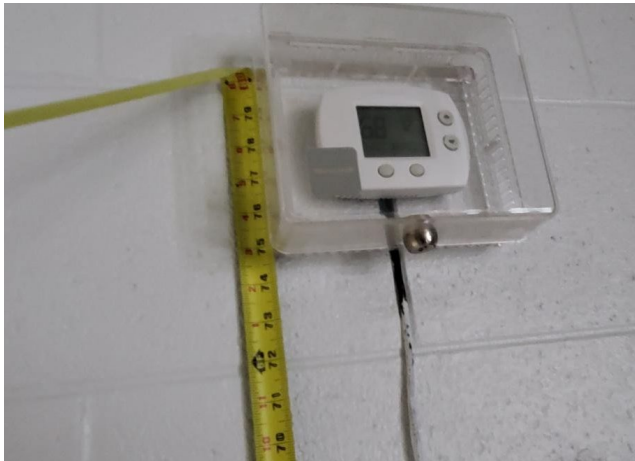
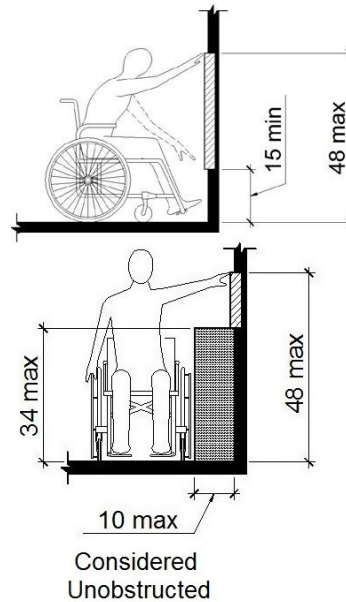
3 (Moderate): Should be completed as soon as possible, but there may be other items that will provide greater access to persons with disabilities. (Includes findings that have a high financial impact on the entity in relationship to the degree of access provided).

As Built: The thermostat is not positioned correctly for either a side or front approach.

Where a clear floor or ground space allows a parallel or front approach and the side reach is unobstructed, the high side reach shall be 48 inches maximum above the finish floor or ground and the low side reach shall be 15 inches minimum above the finish floor or ground.

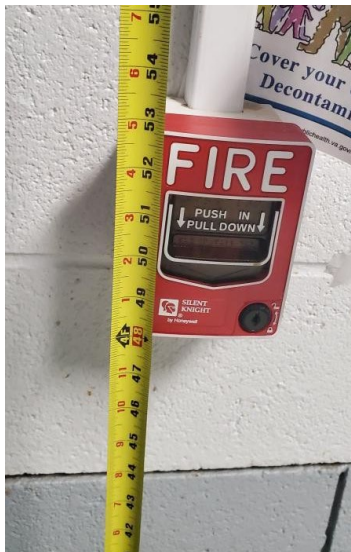
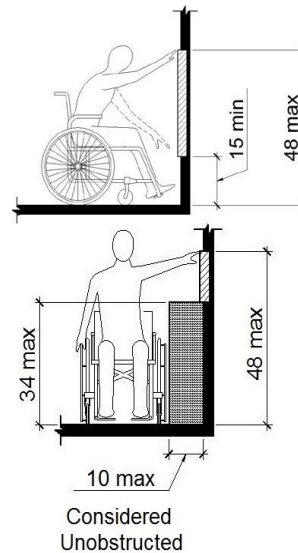
3 (Moderate): Should be completed as soon as possible, but there may be other items that will provide greater access to persons with disabilities. (Includes findings that have a high financial impact on the entity in relationship to the degree of access provided).

As Built: The fire alarm pull station is not positioned correctly for either a side or front approach.

Where a clear floor or ground space allows a parallel or front approach and the side reach is unobstructed, the high side reach shall be 48 inches maximum above the finish floor or ground and the low side reach shall be 15 inches minimum above the finish floor or ground.

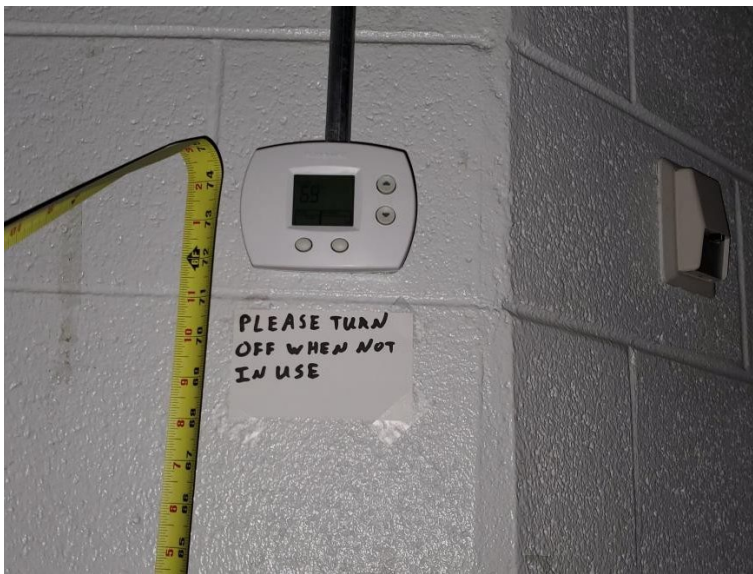
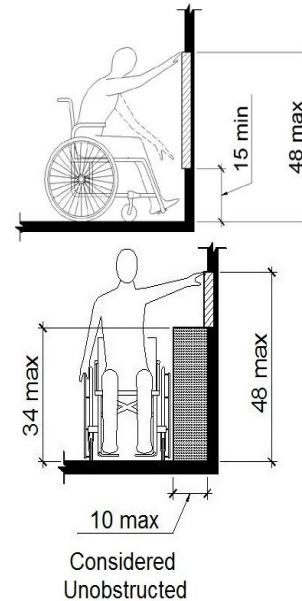
3 (Moderate): Should be completed as soon as possible, but there may be other items that will provide greater access to persons with disabilities. (Includes findings that have a high financial impact on the entity in relationship to the degree of access provided).

As Built: The thermostat is not positioned correctly for either a side or front approach.

Where a clear floor or ground space allows a parallel or front approach and the side reach is unobstructed, the high side reach shall be 48 inches maximum above the finish floor or ground and the low side reach shall be 15 inches minimum above the finish floor or ground.

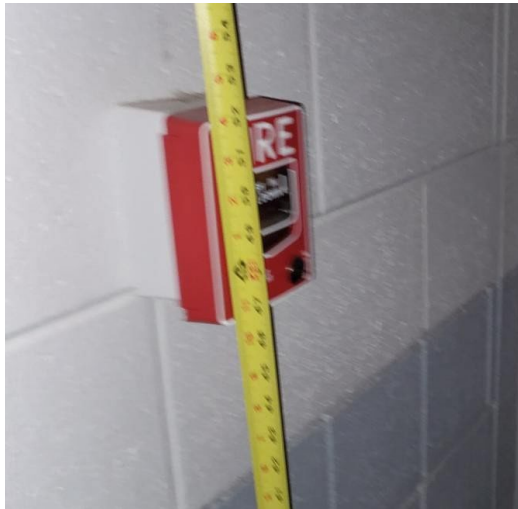
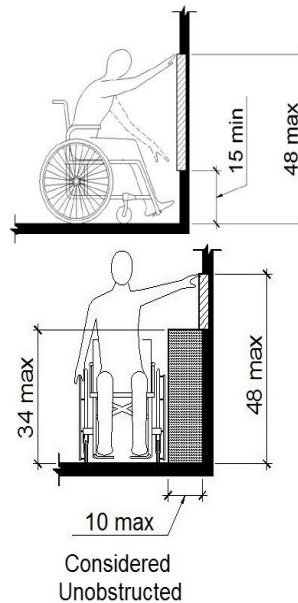
3 (Moderate): Should be completed as soon as possible, but there may be other items that will provide greater access to persons with disabilities. (Includes findings that have a high financial impact on the entity in relationship to the degree of access provided).

As Built: The fire alarm pull station is not positioned correctly for either a side or front approach.

Where a clear floor or ground space allows a parallel or front approach and the side reach is unobstructed, the high side reach shall be 48 inches maximum above the finish floor or ground and the low side reach shall be 15 inches minimum above the finish floor or ground.

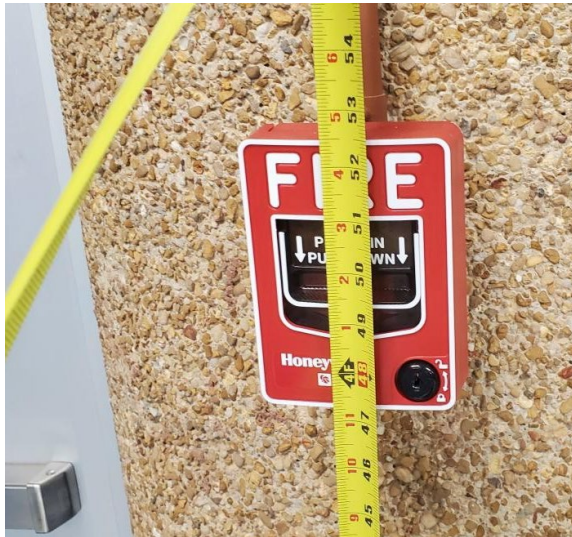
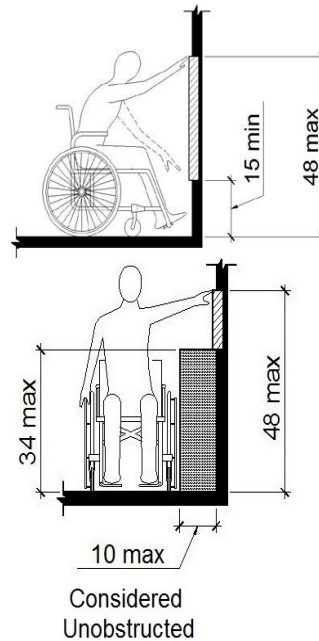
3 (Moderate): Should be completed as soon as possible, but there may be other items that will provide greater access to persons with disabilities. (Includes findings that have a high financial impact on the entity in relationship to the degree of access provided).

As Built: The fire alarm pull station is not positioned correctly for either a side or front approach.

Where a clear floor or ground space allows a parallel or front approach and the side reach is unobstructed, the high side reach shall be 48 inches maximum above the finish floor or ground and the low side reach shall be 15 inches minimum above the finish floor or ground.

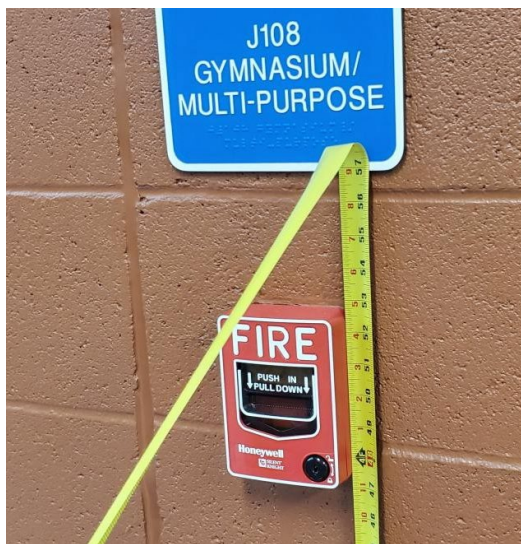
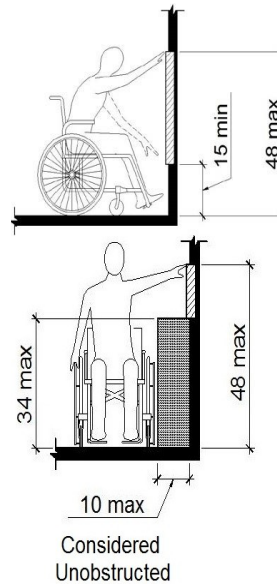
3 (Moderate): Should be completed as soon as possible, but there may be other items that will provide greater access to persons with disabilities. (Includes findings that have a high financial impact on the entity in relationship to the degree of access provided).

As Built: The fire alarm pull station is not positioned correctly for either a side or front approach.

Where a clear floor or ground space allows a parallel or front approach and the side reach is unobstructed, the high side reach shall be 48 inches maximum above the finish floor or ground and the low side reach shall be 15 inches minimum above the finish floor or ground.

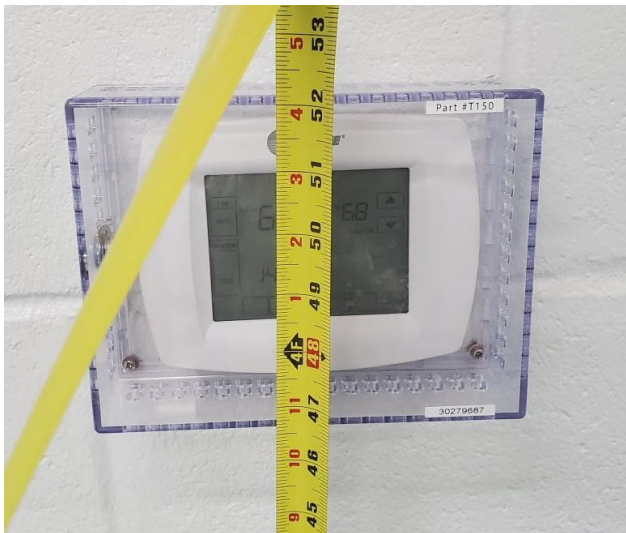
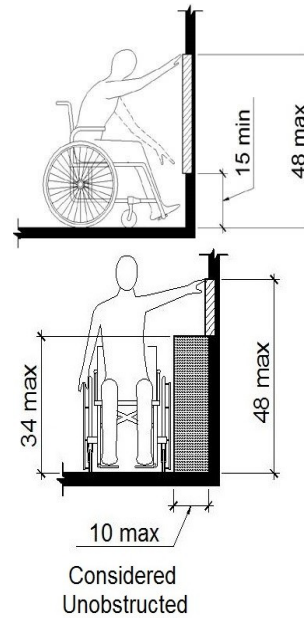
3 (Moderate): Should be completed as soon as possible, but there may be other items that will provide greater access to persons with disabilities. (Includes findings that have a high financial impact on the entity in relationship to the degree of access provided).

As Built: The thermostat is not positioned correctly for either a side or front approach.

Where a clear floor or ground space allows a parallel or front approach and the side reach is unobstructed, the high side reach shall be 48 inches maximum above the finish floor or ground and the low side reach shall be 15 inches minimum above the finish floor or ground.
