WEAKLEY COUNTY, TENNESSEE

ADA EVALUATION

Architectural and Site Findings with Recommendations

TLM Associates, Inc

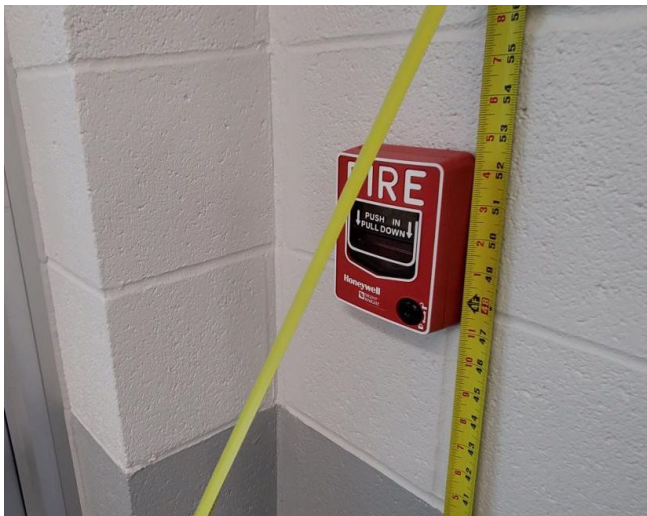
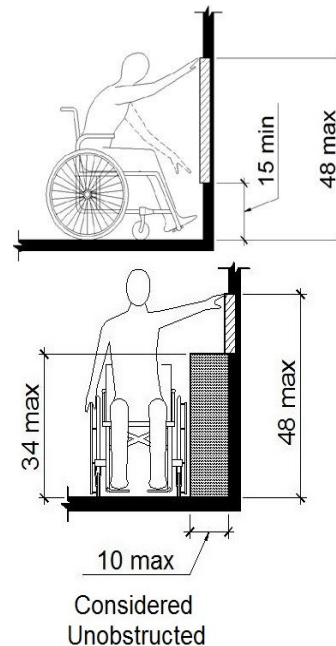
3 (Moderate): Should be completed as soon as possible, but there may be other items that will provide greater access to persons with disabilities. (Includes findings that have a high financial impact on the entity in relationship to the degree of access provided).

As Built: The fire alarm pull station is not positioned correctly for either a side or front approach.

Where a clear floor or ground space allows a parallel or front approach and the side reach is unobstructed, the high side reach shall be 48 inches maximum above the finish floor or ground and the low side reach shall be 15 inches minimum above the finish floor or ground.

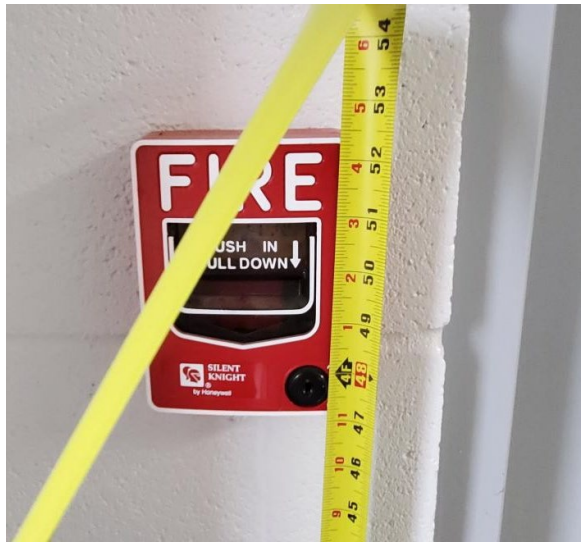
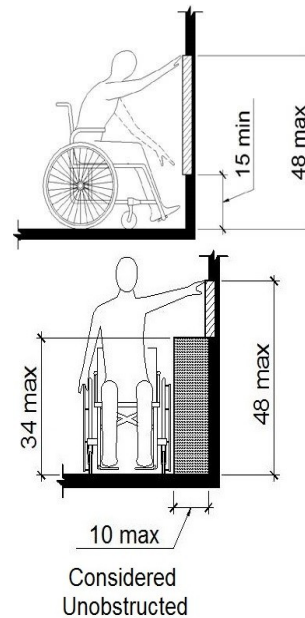
3 (Moderate): Should be completed as soon as possible, but there may be other items that will provide greater access to persons with disabilities. (Includes findings that have a high financial impact on the entity in relationship to the degree of access provided).

As Built: The fire alarm pull station is not positioned correctly for either a side or front approach.

Where a clear floor or ground space allows a parallel or front approach and the side reach is unobstructed, the high side reach shall be 48 inches maximum above the finish floor or ground and the low side reach shall be 15 inches minimum above the finish floor or ground.

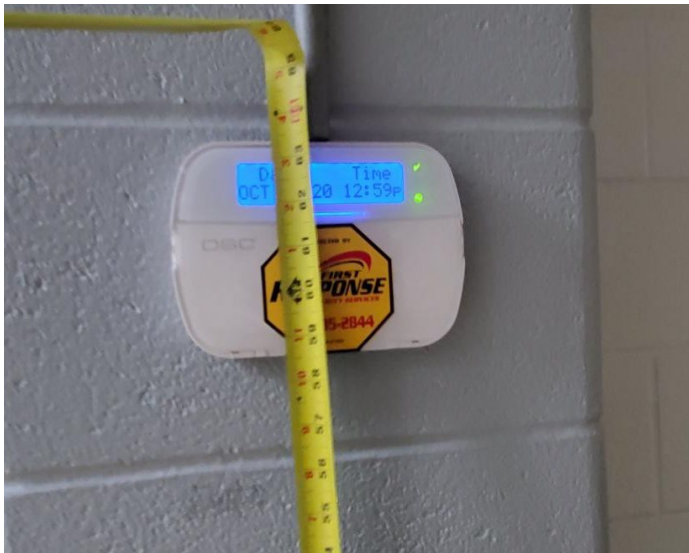
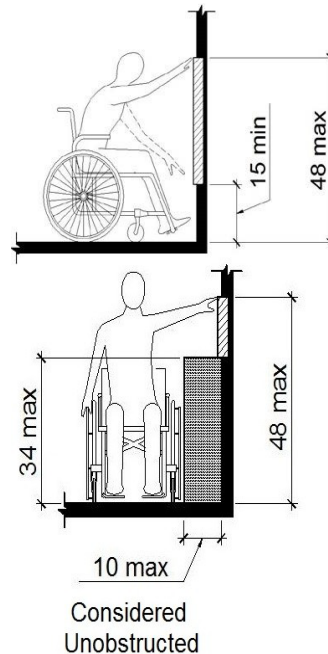
3 (Moderate): Should be completed as soon as possible, but there may be other items that will provide greater access to persons with disabilities. (Includes findings that have a high financial impact on the entity in relationship to the degree of access provided).

As Built: The alarm pad is not positioned correctly for either a side or front approach.

Where a clear floor or ground space allows a parallel or front approach and the side reach is unobstructed, the high side reach shall be 48 inches maximum above the finish floor or ground and the low side reach shall be 15 inches minimum above the finish floor or ground.

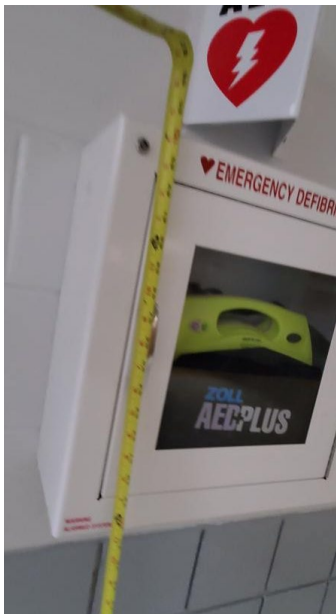
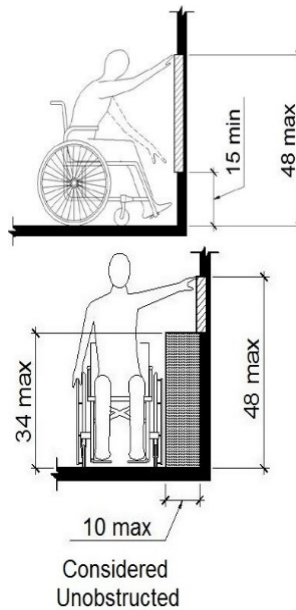
3 (Moderate): Should be completed as soon as possible, but there may be other items that will provide greater access to persons with disabilities. (Includes findings that have a high financial impact on the entity in relationship to the degree of access provided).

As Built: The defibrillator is not positioned correctly for either a side or front approach.

Where a clear floor or ground space allows a parallel or front approach and the side reach is unobstructed, the high side reach shall be 48 inches maximum above the finish floor or ground and the low side reach shall be 15 inches minimum above the finish floor or ground.

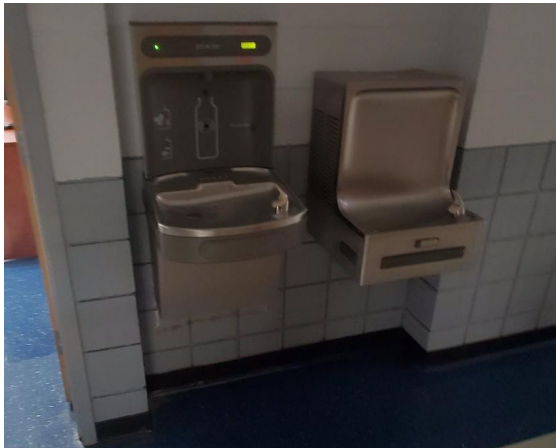
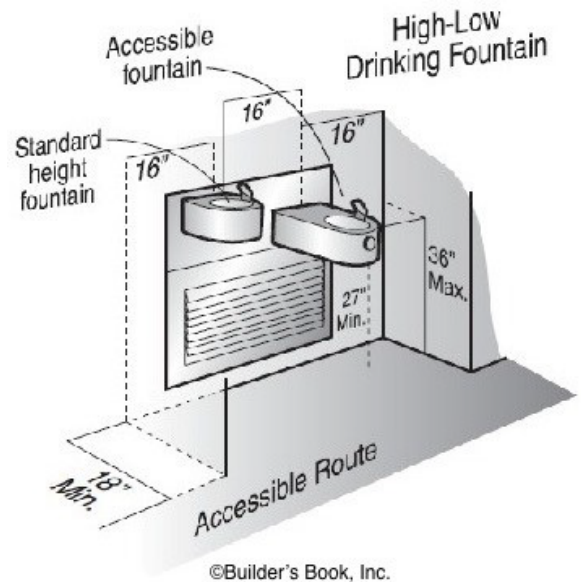
3 (Moderate): Should be completed as soon as possible, but there may be other items that will provide greater access to persons with disabilities. (Includes findings that have a high financial impact on the entity in relationship to the degree of access provided).

As Built: The drinking fountain is noncompliant.

Spout outlets shall be 36 inches maximum above the finish floor or ground and be located 15 inches minimum from the vertical support and 5 inches maximum from the front edge of the unit, including bumpers. The spout shall provide a flow of water at least 4 inches high minimum and shall be located 5 inches maximum from the front of the unit. The angle of the water stream shall be measured horizontally relative to the front face of the unit. Where spouts are located less than 3 inches of the front of the unit, the angle of the water stream shall be 30 degrees maximum. Where spouts are located between 3 inches and 5 inches maximum from the front of the unit, the angle of the water stream shall be 15 degrees maximum. On an accessible drinking fountain with a round or oval bowl, the spout must be positioned so the flow of water is within 3 inches of the front edge of the fountain.

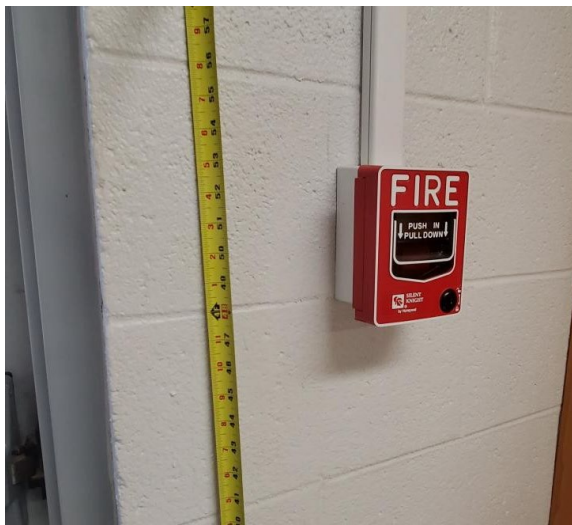
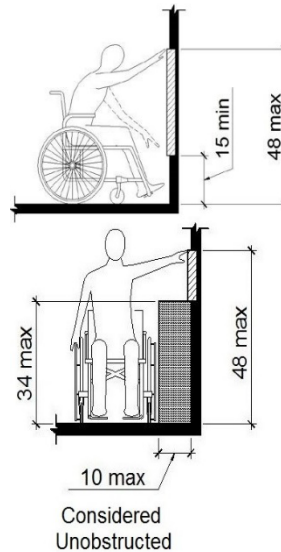
3 (Moderate): Should be completed as soon as possible, but there may be other items that will provide greater access to persons with disabilities. (Includes findings that have a high financial impact on the entity in relationship to the degree of access provided).

As Built: The fire alarm pull station is not positioned correctly for either a side or front approach.

Where a clear floor or ground space allows a parallel or front approach and the side reach is unobstructed, the high side reach shall be 48 inches maximum above the finish floor or ground and the low side reach shall be 15 inches minimum above the finish floor or ground.

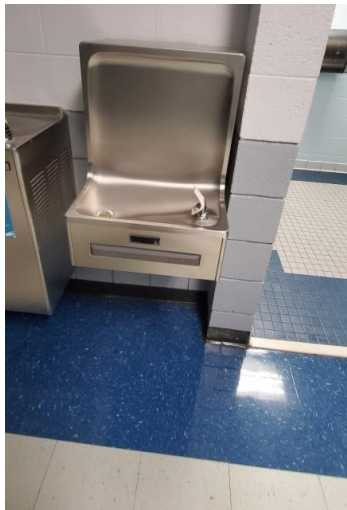
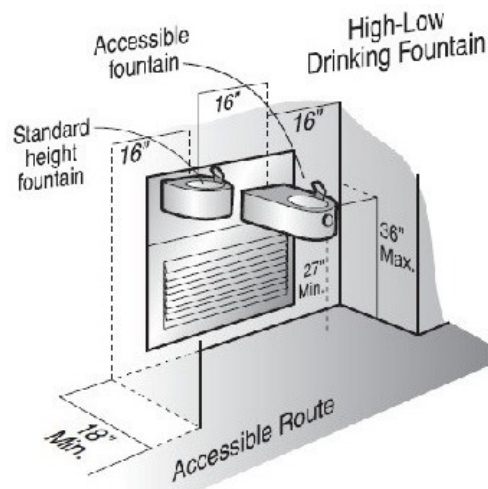
3 (Moderate): Should be completed as soon as possible, but there may be other items that will provide greater access to persons with disabilities. (Includes findings that have a high financial impact on the entity in relationship to the degree of access provided).

As Built: The drinking fountain is noncompliant.

Spout outlets shall be 36 inches maximum above the finish floor or ground and be located 15 inches minimum from the vertical support and 5 inches maximum from the front edge of the unit, including bumpers. The spout shall provide a flow of water at least 4 inches high minimum and shall be located 5 inches maximum from the front of the unit. The angle of the water stream shall be measured horizontally relative to the front face of the unit. Where spouts are located less than 3 inches of the front of the unit, the angle of the water stream shall be 30 degrees maximum. Where spouts are located between 3 inches and 5 inches maximum from the front of the unit, the angle of the water stream shall be 15 degrees maximum. On an accessible drinking fountain with a round or oval bowl, the spout must be positioned so the flow of water is within 3 inches of the front edge of the fountain.

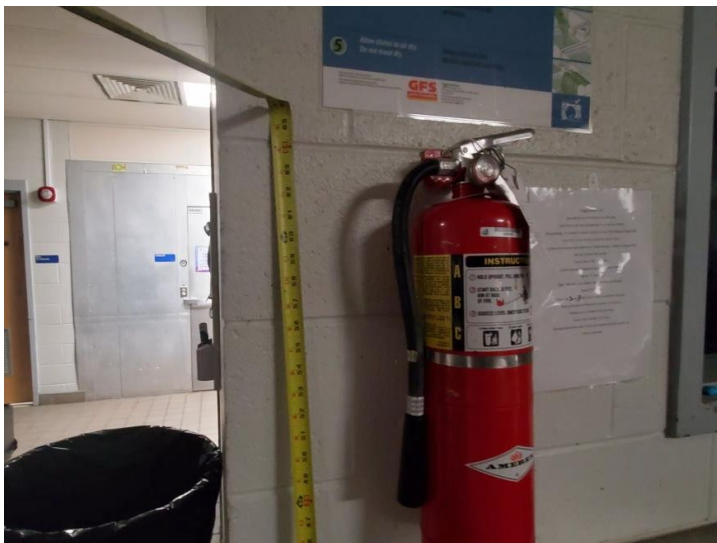
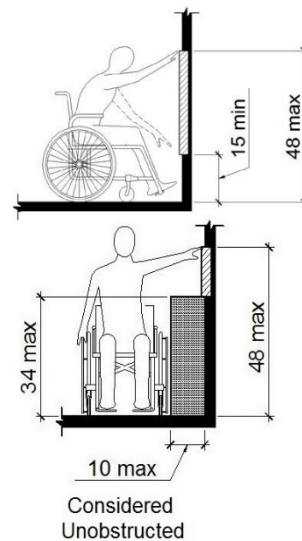
3 (Moderate): Should be completed as soon as possible, but there may be other items that will provide greater access to persons with disabilities. (Includes findings that have a high financial impact on the entity in relationship to the degree of access provided).

As Built: The Fire Extinguisher is not positioned correctly for either a side or front approach.

Where a clear floor or ground space allows a parallel or front approach and the side reach is unobstructed, the high side reach shall be 48 inches maximum above the finish floor or ground and the low side reach shall be 15 inches minimum above the finish floor or ground.

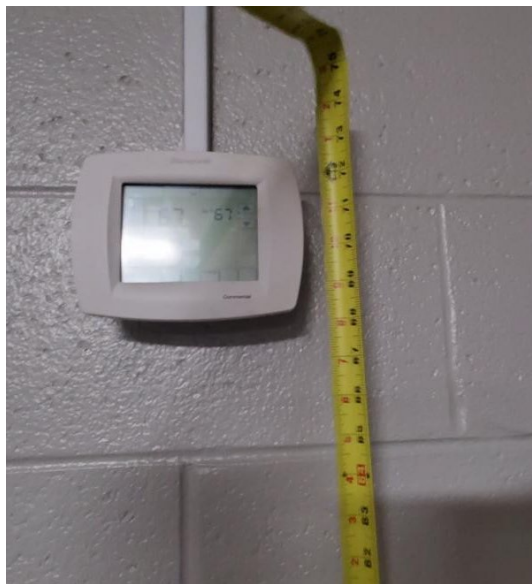
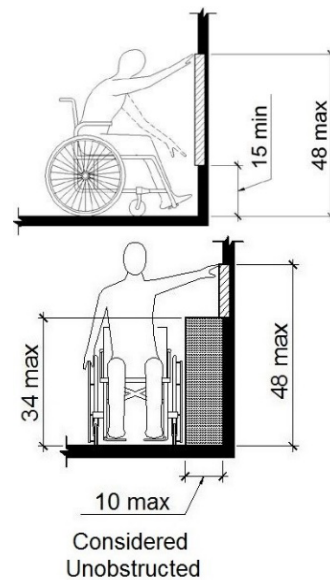
3 (Moderate): Should be completed as soon as possible, but there may be other items that will provide greater access to persons with disabilities. (Includes findings that have a high financial impact on the entity in relationship to the degree of access provided).

As Built: The thermostat is not positioned correctly for either a side or front approach.

Where a clear floor or ground space allows a parallel or front approach and the side reach is unobstructed, the high side reach shall be 48 inches maximum above the finish floor or ground and the low side reach shall be 15 inches minimum above the finish floor or ground.

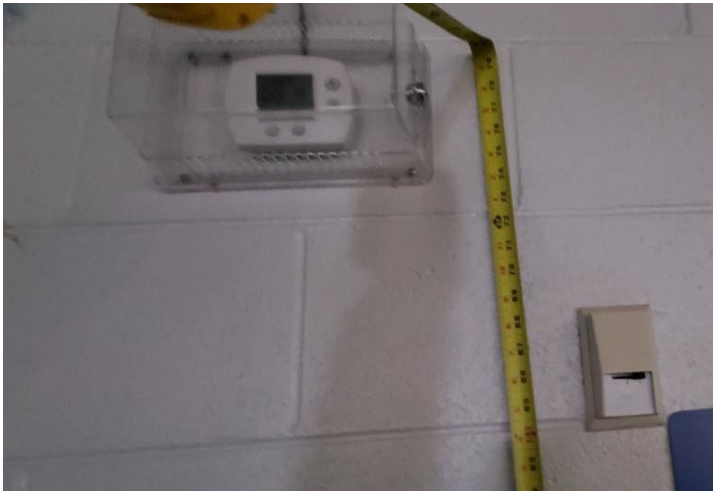
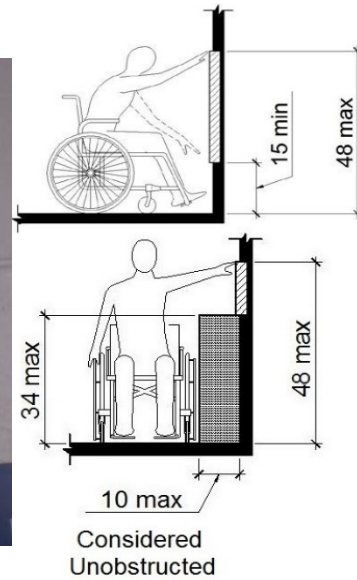
As Built: The thermostat is not positioned correctly for either a side or front approach.

Where a clear floor or ground space allows a parallel or front approach and the side reach is unobstructed, the high side reach shall be 48 inches maximum above the finish floor or ground and the low side reach shall be 15 inches minimum above the finish floor or ground.

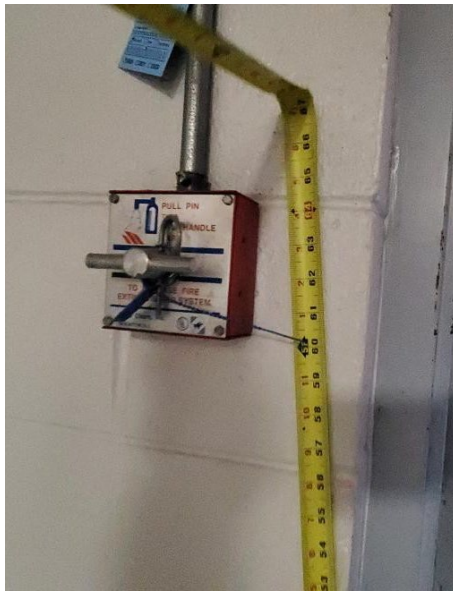
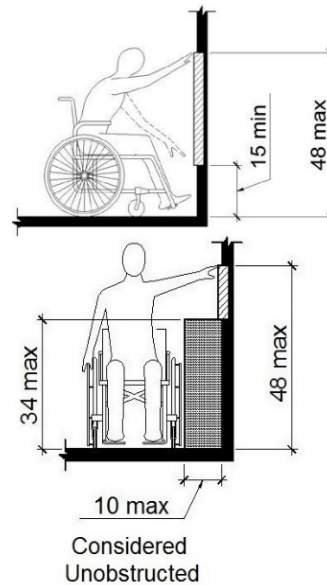
As Built: The Ansul Fire Alarm Pull Station is not positioned correctly for either a side or front approach.

Where a clear floor or ground space allows a parallel or front approach and the side reach is unobstructed, the high side reach shall be 48 inches maximum above the finish floor or ground and the low side reach shall be 15 inches minimum above the finish floor or ground.

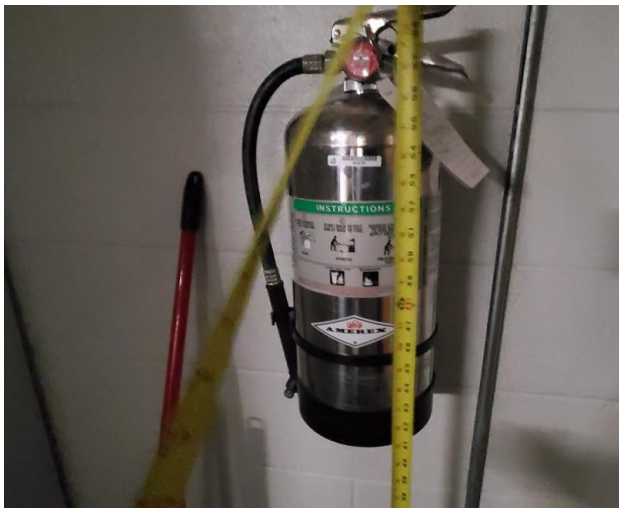
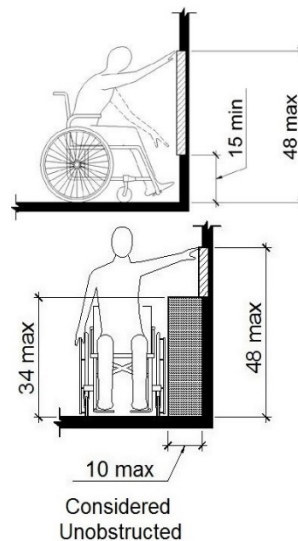
As Built: The Fire Extinguisher is not positioned correctly for either a side or front approach.

Where a clear floor or ground space allows a parallel or front approach and the side reach is unobstructed, the high side reach shall be 48 inches maximum above the finish floor or ground and the low side reach shall be 15 inches minimum above the finish floor or ground.

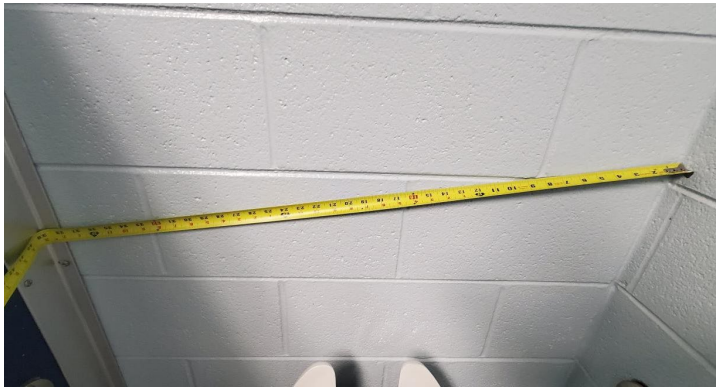
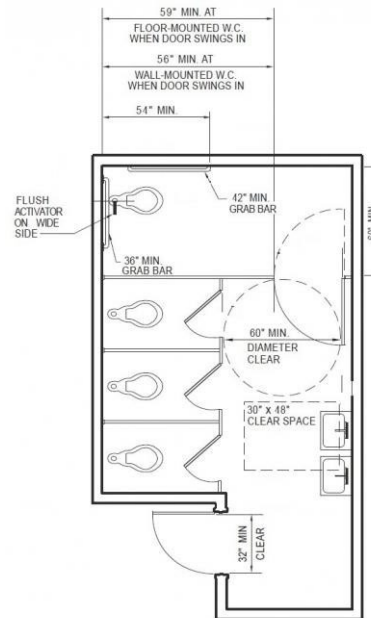
As Built: The toilet compartment does not have the required minimum clear floor space or maneuvering clearances for the toilet. Side grab bar installed incorrectly and rear grab bar missing.

Citation: 2010 ADAS Section 213.2

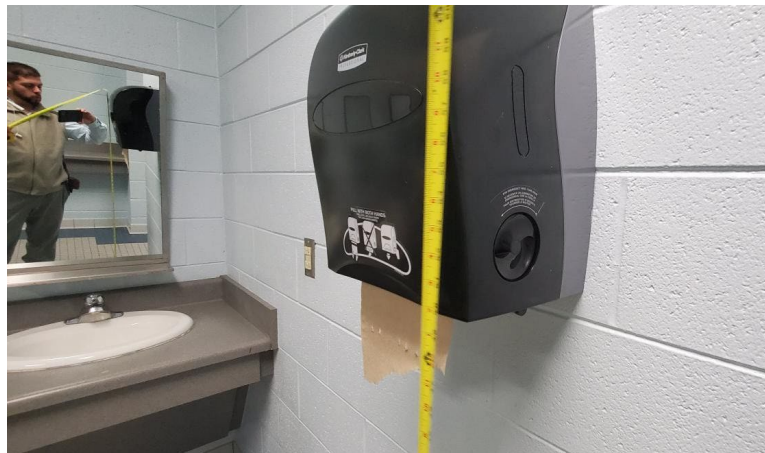
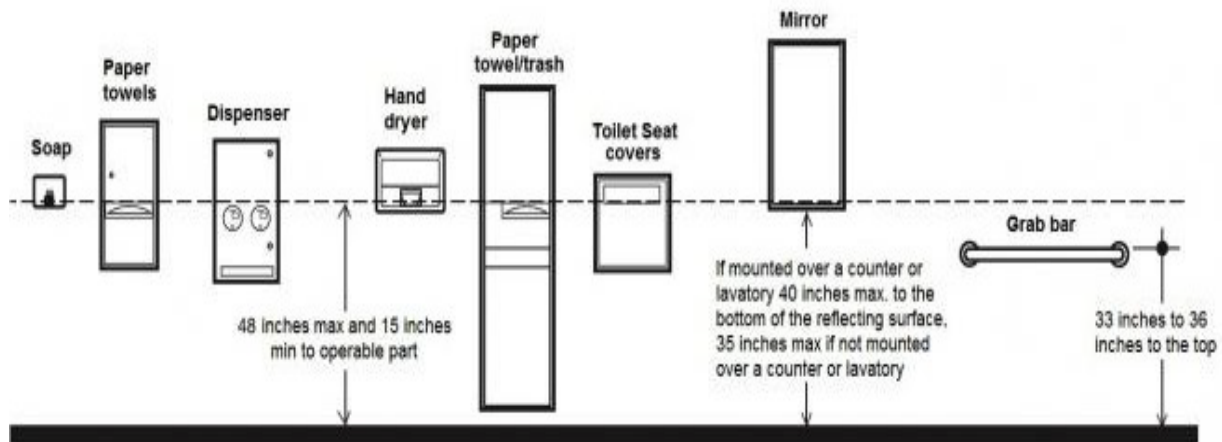
As Built: The paper towel dispenser's operation mechanism is too high off the floor. Dispensers must have all operable parts a maximum of 48 inches above the floor.

Citation: 2010 ADAS Section 308.2.1

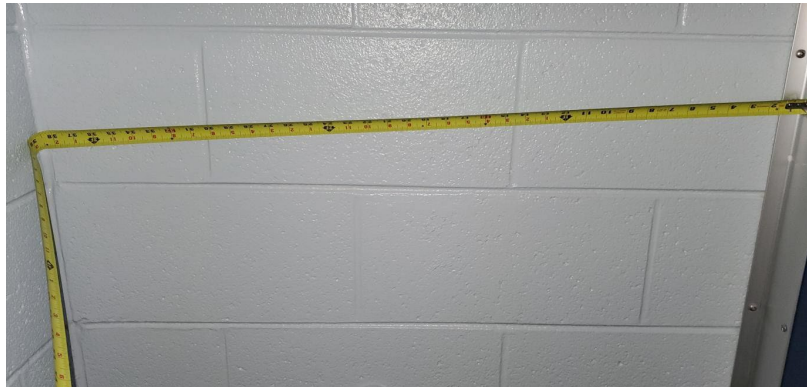
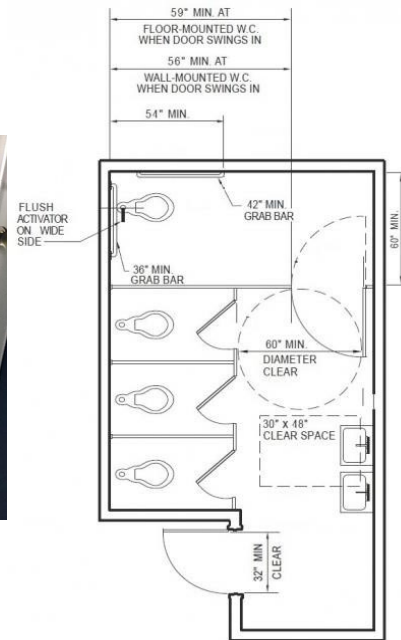
As Built: The toilet compartment does not have the required minimum clear floor space or maneuvering clearances for the toilet. Side grab bar installed incorrectly and rear grab bar missing.

Citation: 2010 ADAS Section 213.2

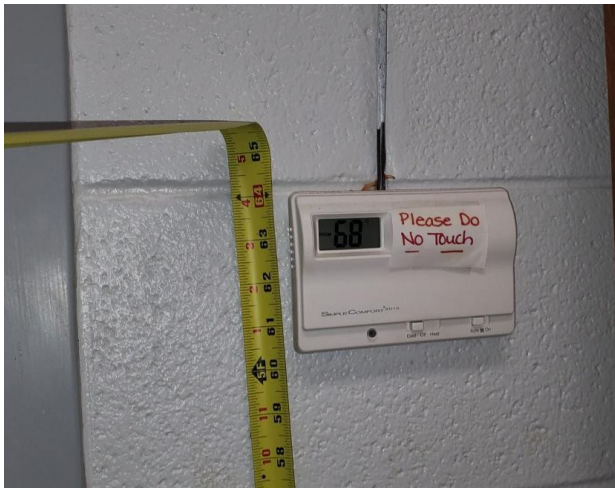
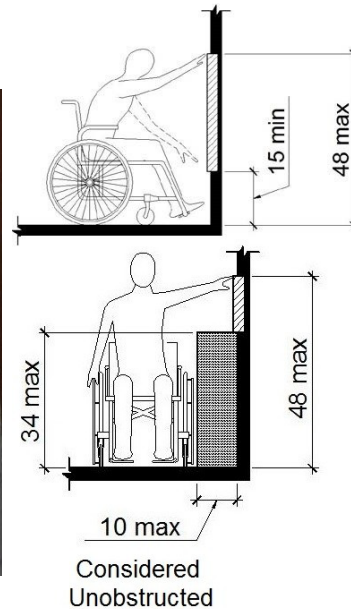
As Built: The thermostat is not positioned correctly for either a side or front approach.

Where a clear floor or ground space allows a parallel or front approach and the side reach is unobstructed, the high side reach shall be 48 inches maximum above the finish floor or ground and the low side reach shall be 15 inches minimum above the finish floor or ground.

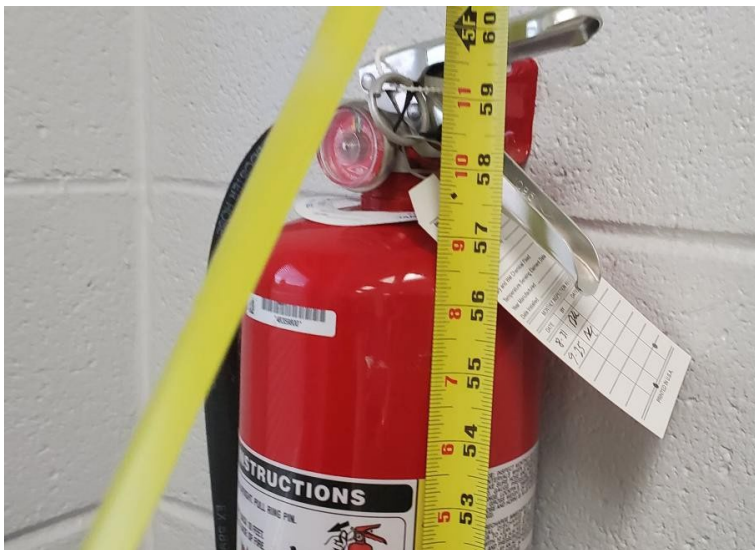
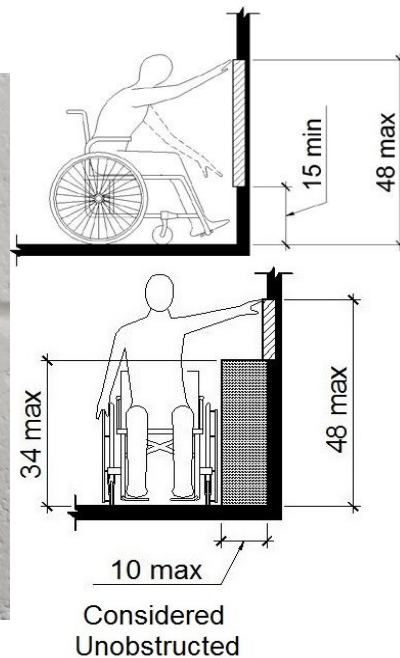
As Built: The fire extinguisher is not positioned correctly for either a side or front approach. Where a clear floor or ground space allows a parallel or front approach and the side reach is unobstructed, the high side reach shall be 48 inches maximum above the finish floor or ground and the low side reach shall be 15 inches minimum above the finish floor or ground.

Citation: 2010 ADAS Section 308.2.1

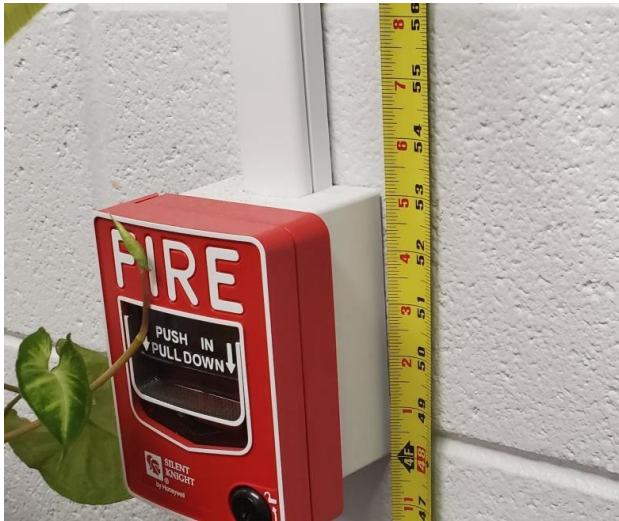
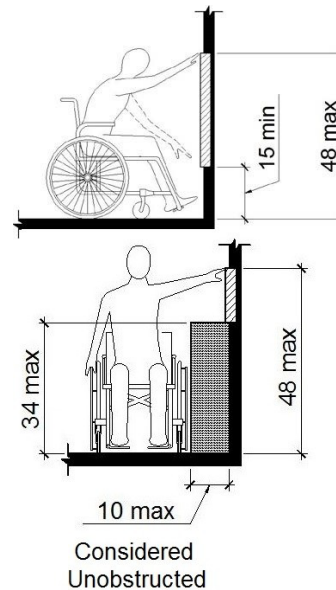
As Built: The fire alarm pull station is not positioned correctly for either a side or front approach.

Where a clear floor or ground space allows a parallel or front approach and the side reach is unobstructed, the high side reach shall be 48 inches maximum above the finish floor or ground and the low side reach shall be 15 inches minimum above the finish floor or ground.

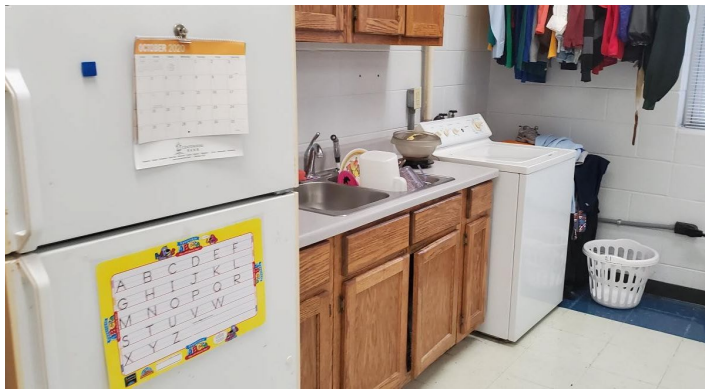
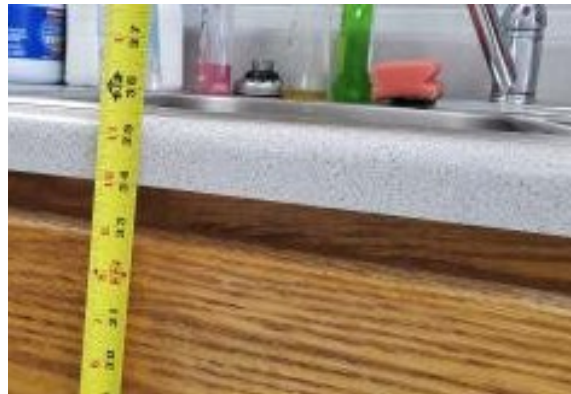
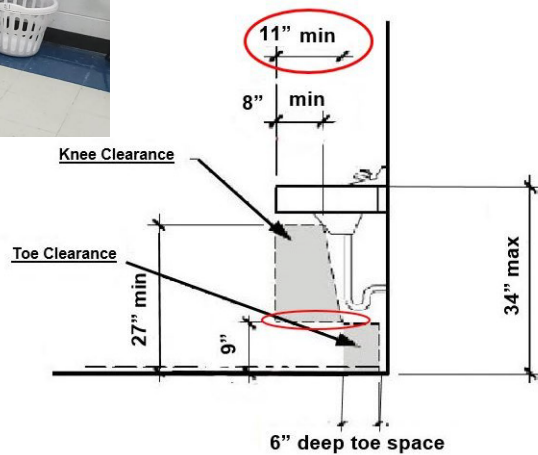
As Built: Compliant knee space has not been provided under the lavatory.

The knee clearance shall be 11 inches minimum in depth at 9 inches above the floor, and 8 inches minimum in depth at 27 inches above the floor. The top of the lavatory rim may be no higher than 34 inches.

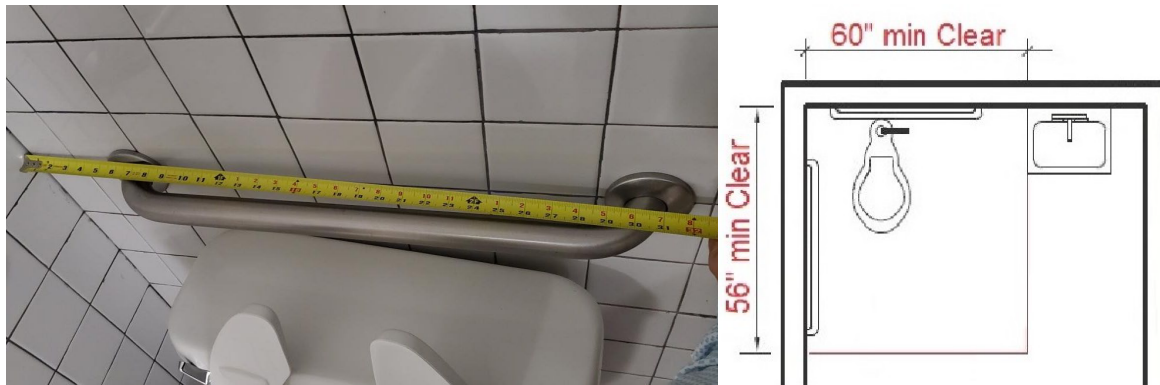
As Built: The lavatory projects into the clear floor space required for the toilet. The clear floor space is 60 inches along the back wall by 56 inches.

The required clearance around the water closet shall be permitted to overlap the water closet, associated grab bars, dispensers, sanitary napkin disposal units, coat hooks, shelves, accessible routes, clear floor space and clearances required at other fixtures, and the turning space. No other fixtures or obstructions shall be located within the required water closet clearance.

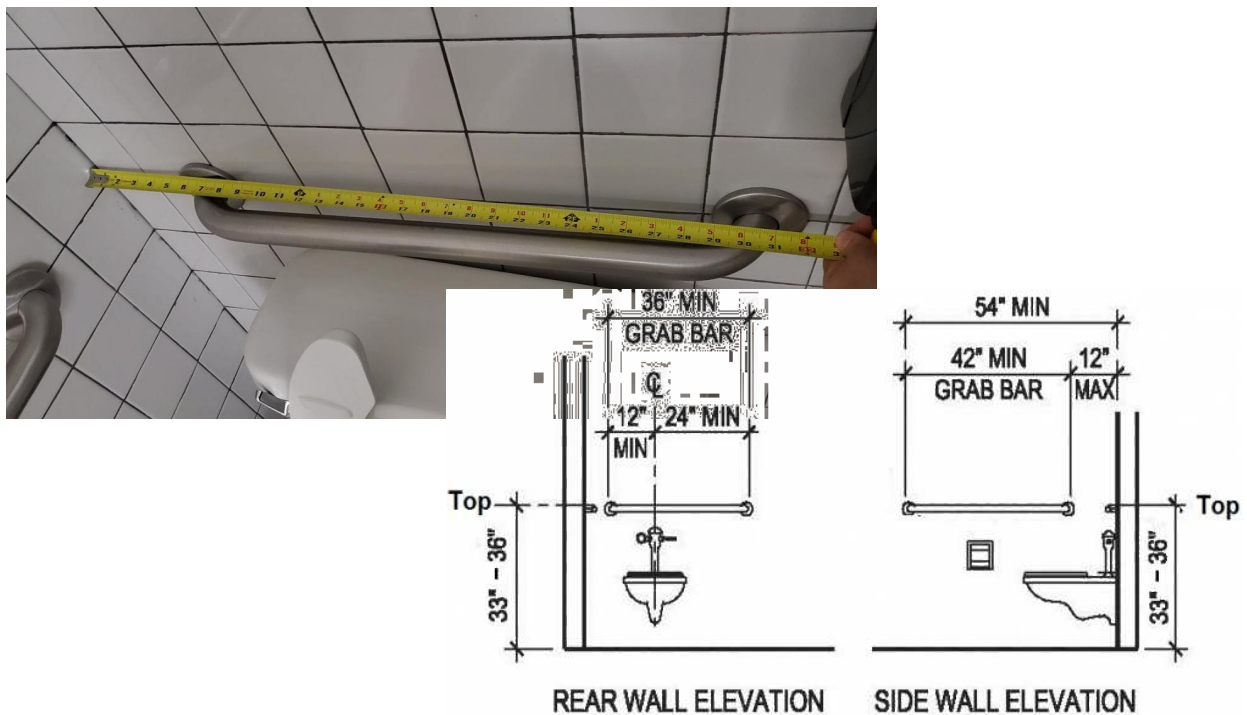
As Built: Grab bar offsets incorrect. Rear grab bar incorrect size.

The side grab bar must extend at least 54 inches minimum beyond the rear wall and start a maximum of 12 inches from the rear wall.

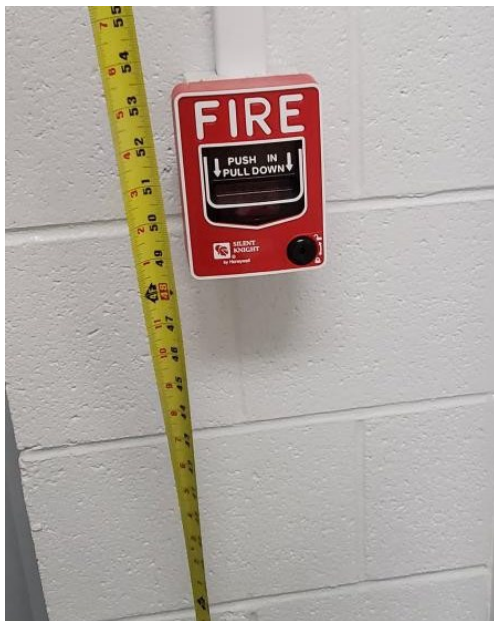
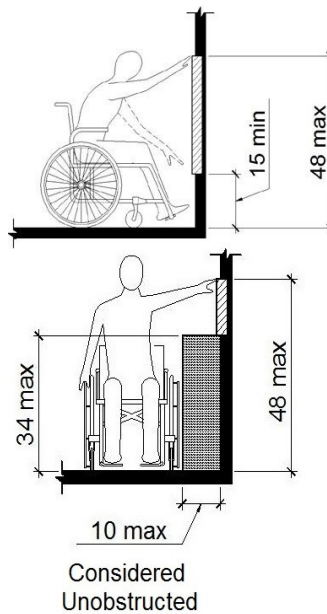
As Built: The fire alarm pull station is not positioned correctly for either a side or front approach.

Where a clear floor or ground space allows a parallel or front approach and the side reach is unobstructed, the high side reach shall be 48 inches maximum above the finish floor or ground and the low side reach shall be 15 inches minimum above the finish floor or ground.

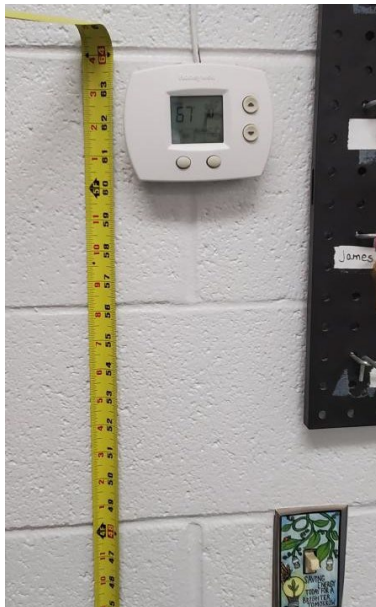
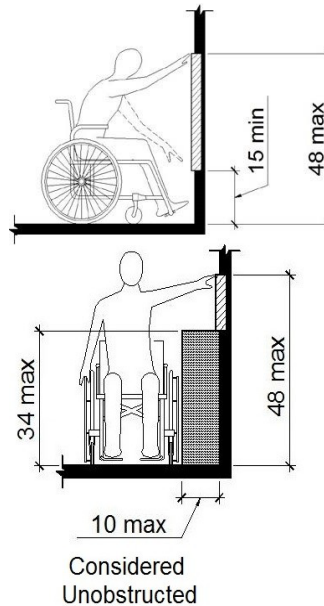
As Built: The thermostat is not positioned correctly for either a side or front approach.

Where a clear floor or ground space allows a parallel or front approach and the side reach is unobstructed, the high side reach shall be 48 inches maximum above the finish floor or ground and the low side reach shall be 15 inches minimum above the finish floor or ground.

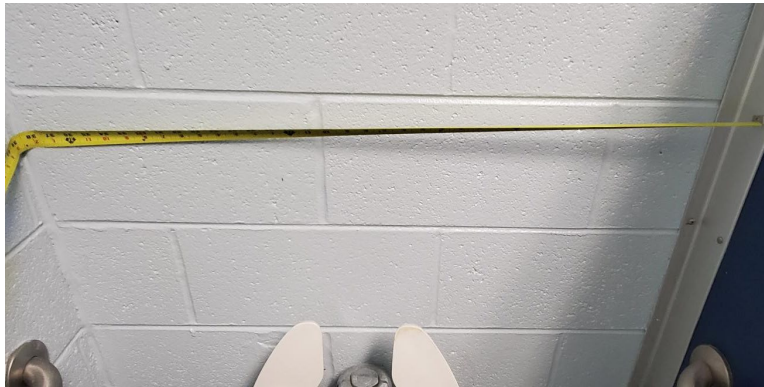
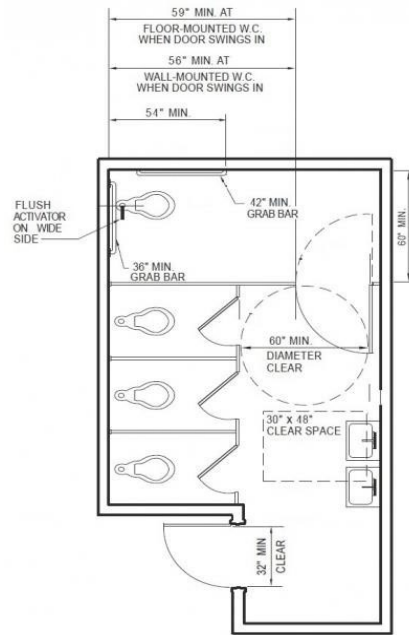
As Built: The toilet compartment does not have the required minimum clear floor space or maneuvering clearances for the toilet. Side grab bar installed incorrectly and rear grab bar missing.

Citation: 2010 ADAS Section 213.2

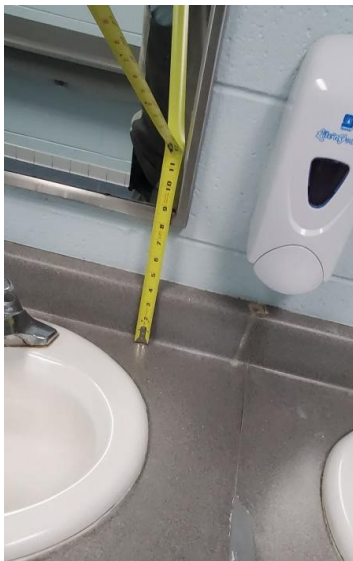
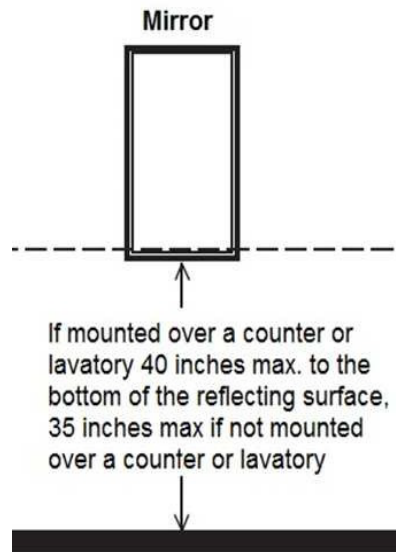
As Built: The mirror is mounted too high.

Mirrors must have the bottom edge of the reflecting surface a maximum of 40 inches above the floor if above a sink or counter. Mirrors not located above lavatories or countertops shall be installed with the bottom edge of the reflecting surface 35 inches maximum above the finish floor or ground.

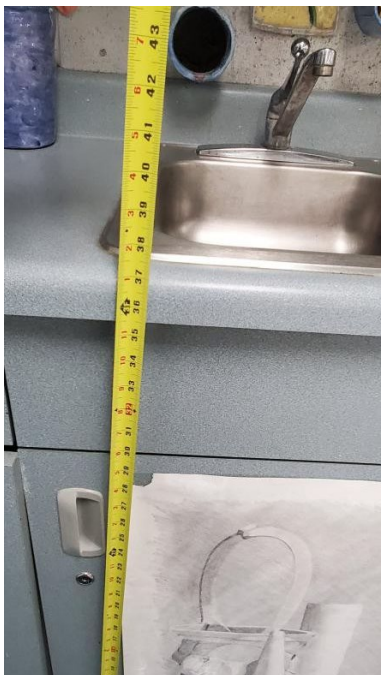
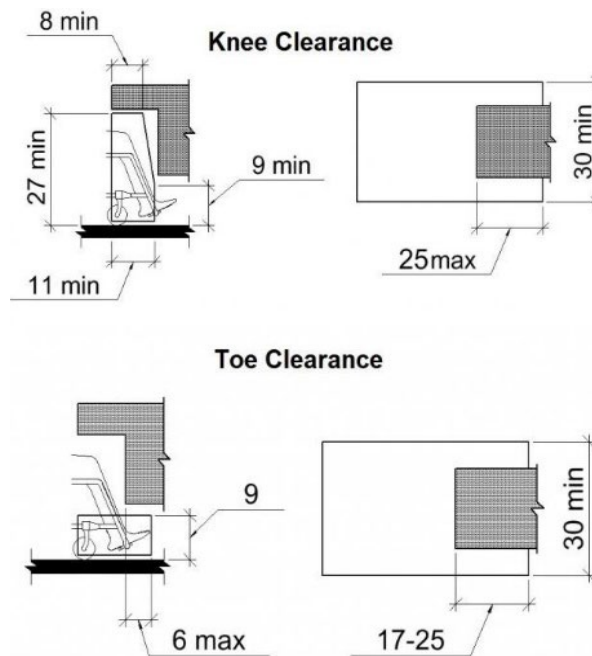
As Built: Knee and toe clearance has not been provided at the sink.

The knee clearance shall be 11 inches deep minimum at 9 inches above the finish floor or ground, and 8 inches deep minimum at 27 inches above the finish floor or ground.

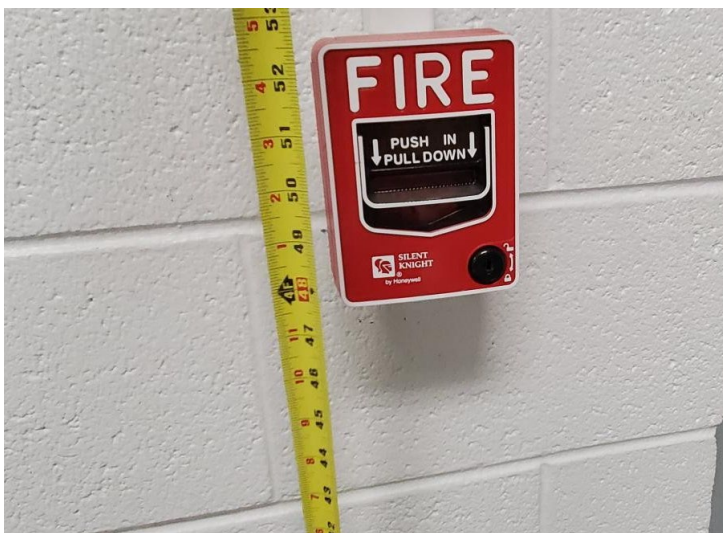
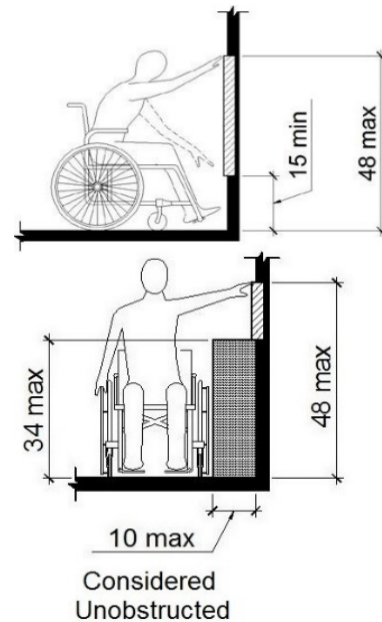
As Built: The fire alarm pull station is not positioned correctly for either a side or front approach.

Where a clear floor or ground space allows a parallel or front approach and the side reach is unobstructed, the high side reach shall be 48 inches maximum above the finish floor or ground and the low side reach shall be 15 inches minimum above the finish floor or ground.

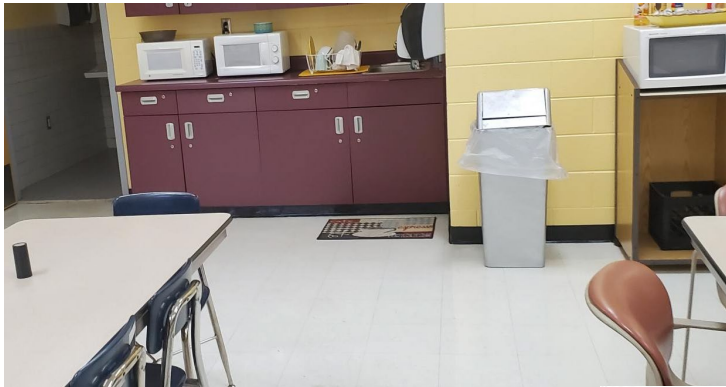
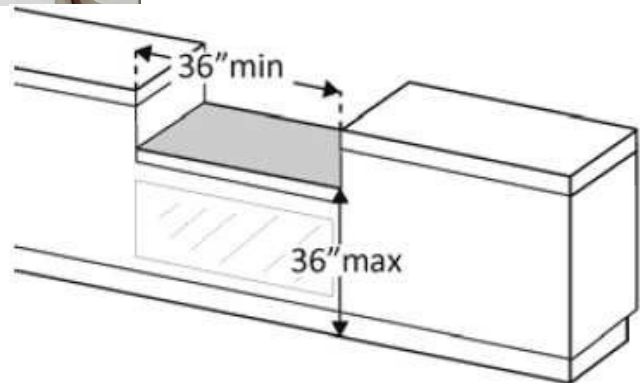
As Built: The top of the sink is too high.

Sinks that are required to be accessible shall be a minimum 17 inches in horizontal depth and mounted with the rim or counter edge no higher than 34 inches above the finished floor.

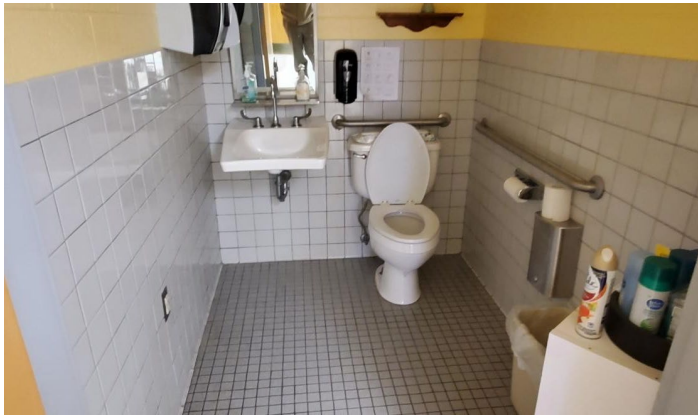
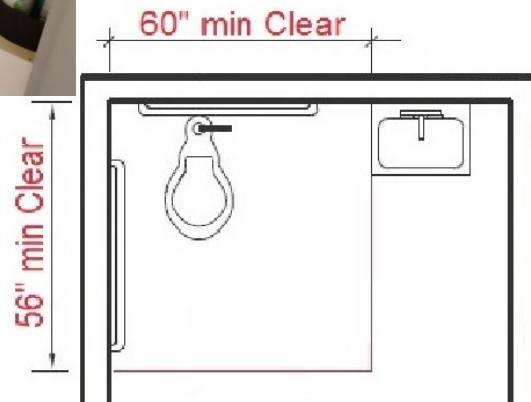
As Built: The lavatory projects into the clear floor space required for the toilet. The clear floor space is 60 inches along the back wall by 56 inches.

The required clearance around the water closet shall be permitted to overlap the water closet, associated grab bars, dispensers, sanitary napkin disposal units, coat hooks, shelves, accessible routes, clear floor space and clearances required at other fixtures, and the turning space. No other fixtures or obstructions shall be located within the required water closet clearance.

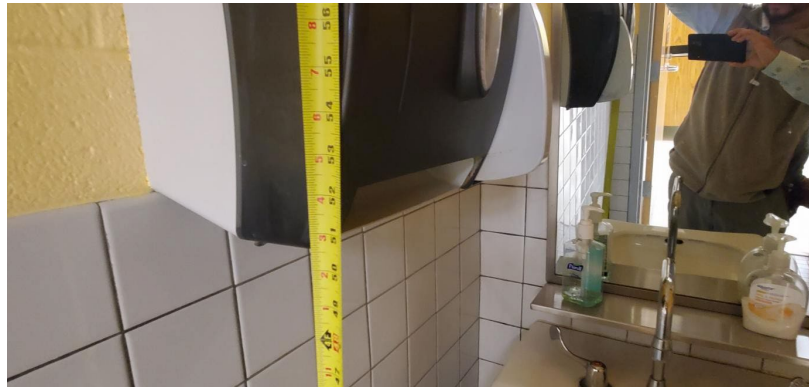
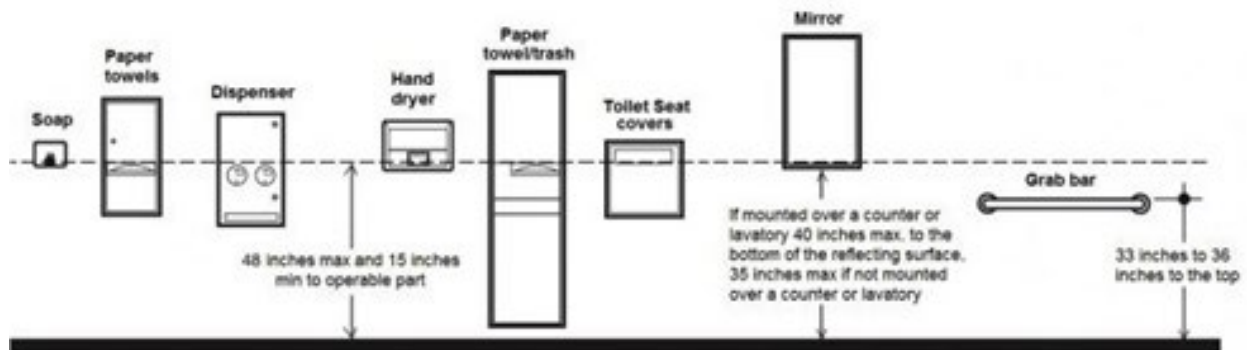
As Built: The paper towel dispenser's operation mechanism is too high off the floor. Dispensers must have all operable parts a maximum of 48 inches above the floor.

Citation: 2010 ADAS Section 308.2.1

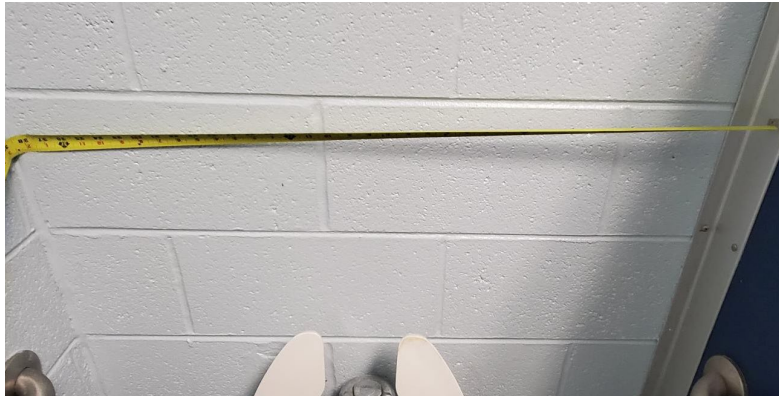
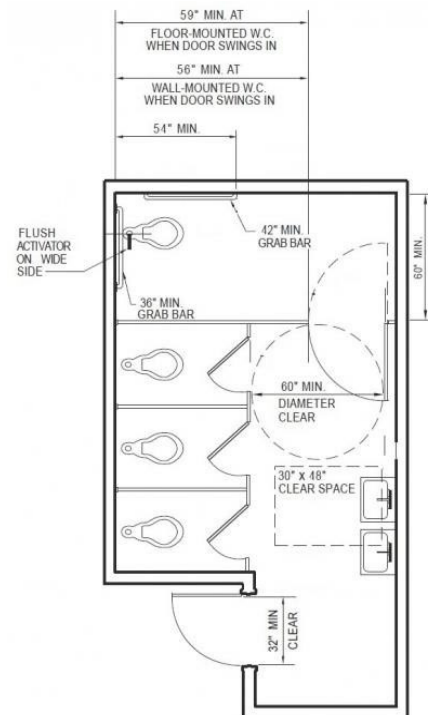
As Built: The toilet compartment does not have the required minimum clear floor space or maneuvering clearances for the toilet. The side grab bar is installed incorrectly and rear grab bar is missing.

Citation: 2010 ADAS Section 213.2

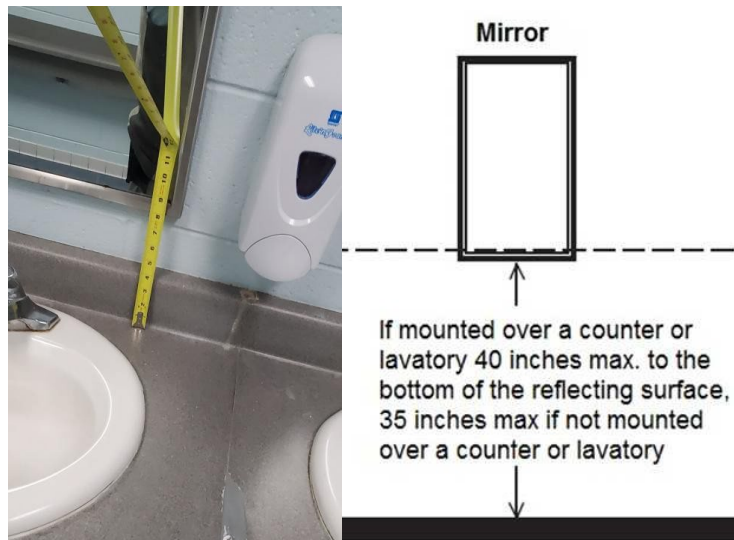
As Built: The mirror is mounted too high.

Mirrors must have the bottom edge of the reflecting surface a maximum of 40 inches above the floor if above a sink or counter. Mirrors not located above lavatories or countertops shall be installed with the bottom edge of the reflecting surface 35 inches maximum above the finish floor or ground.

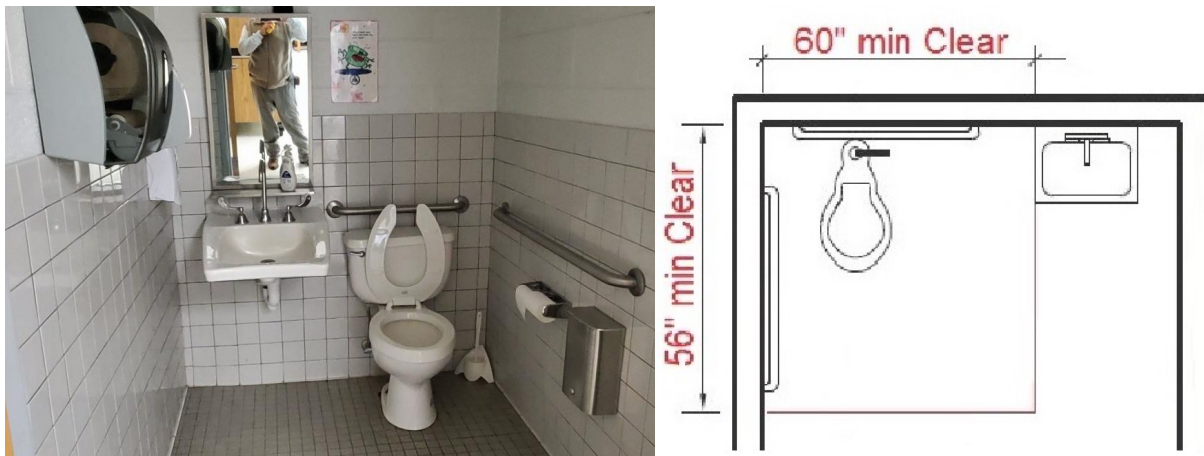
As Built: The lavatory projects into the clear floor space required for the toilet. The clear floor space is 60 inches along the back wall by 56 inches.

The required clearance around the water closet shall be permitted to overlap the water closet, associated grab bars, dispensers, sanitary napkin disposal units, coat hooks, shelves, accessible routes, clear floor space and clearances required at other fixtures, and the turning space. No other fixtures or obstructions shall be located within the required water closet clearance.
