WEAKLEY COUNTY, TENNESSEE

ADA EVALUATION

Architectural and Site Findings with Recommendations

TLM Associates, Inc

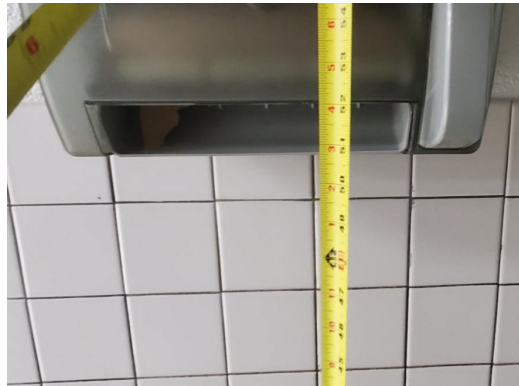
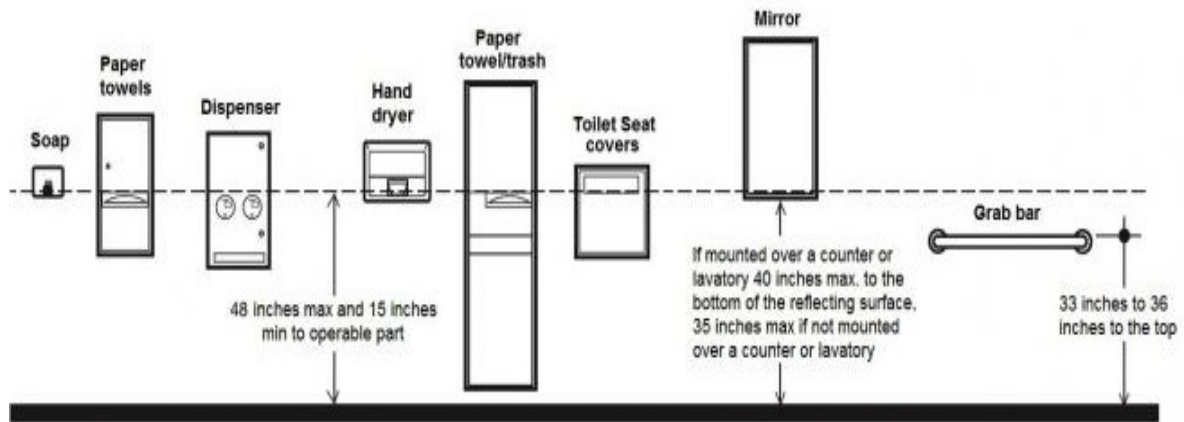
As Built: The paper towel dispenser's operation mechanism is too high off the floor. Dispensers must have all operable parts a maximum of 48 inches above the floor.

Citation: 2010 ADAS Section 308.2.1

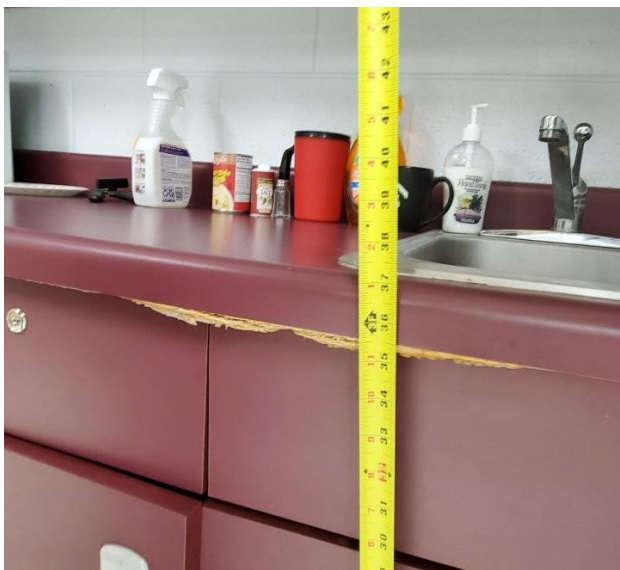
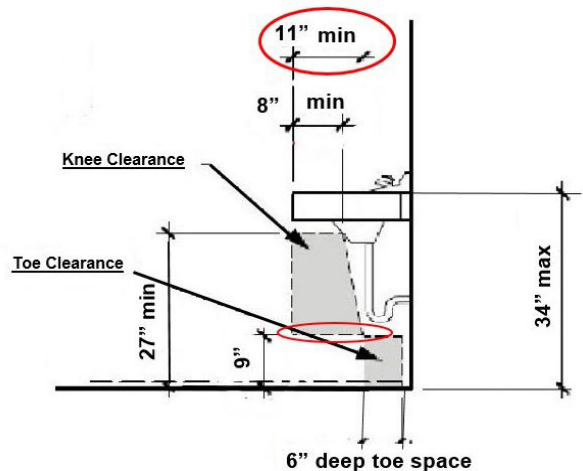
As Built: Compliant knee space has not been provided under the lavatory.

The knee clearance shall be 11 inches minimum in depth at 9 inches above the floor, and 8 inches minimum in depth at 27 inches above the floor. The top of the lavatory rim may be no higher than 34 inches.

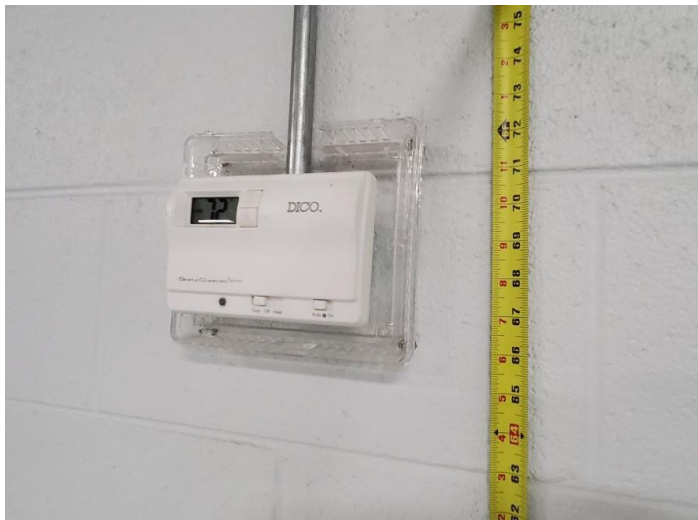
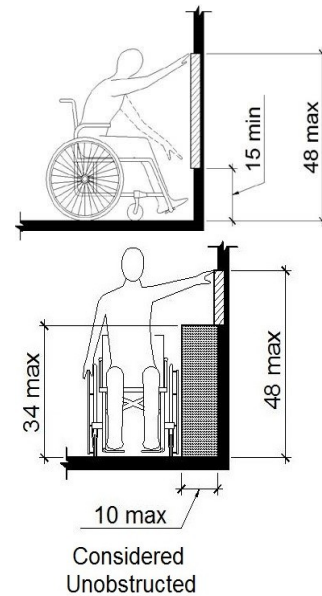
As Built: The thermostat is not positioned correctly for either a side or front approach.

Where a clear floor or ground space allows a parallel or front approach and the side reach is unobstructed, the high side reach shall be 48 inches maximum above the finish floor or ground and the low side reach shall be 15 inches minimum above the finish floor or ground.

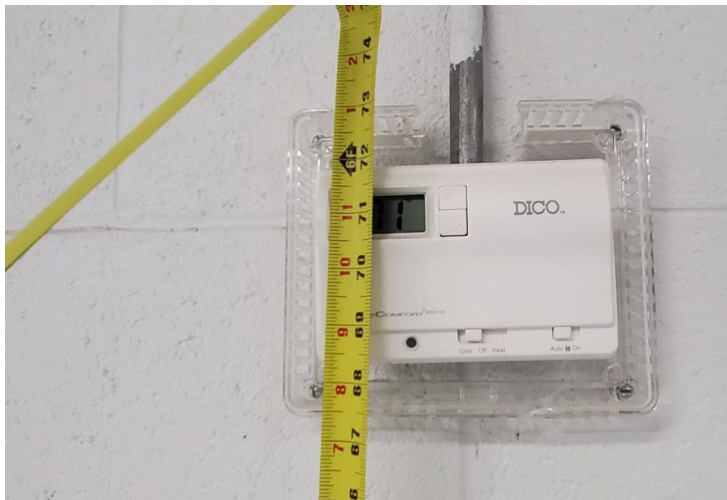
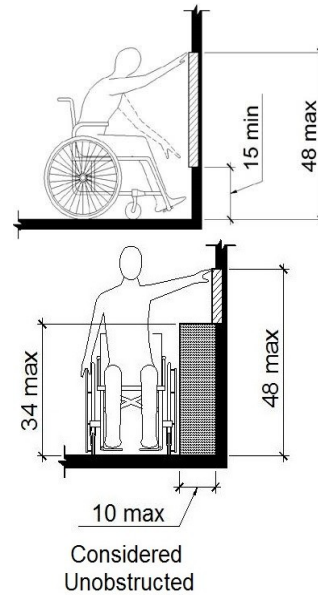
As Built: The thermostat is not positioned correctly for either a side or front approach.

Where a clear floor or ground space allows a parallel or front approach and the side reach is unobstructed, the high side reach shall be 48 inches maximum above the finish floor or ground and the low side reach shall be 15 inches minimum above the finish floor or ground.

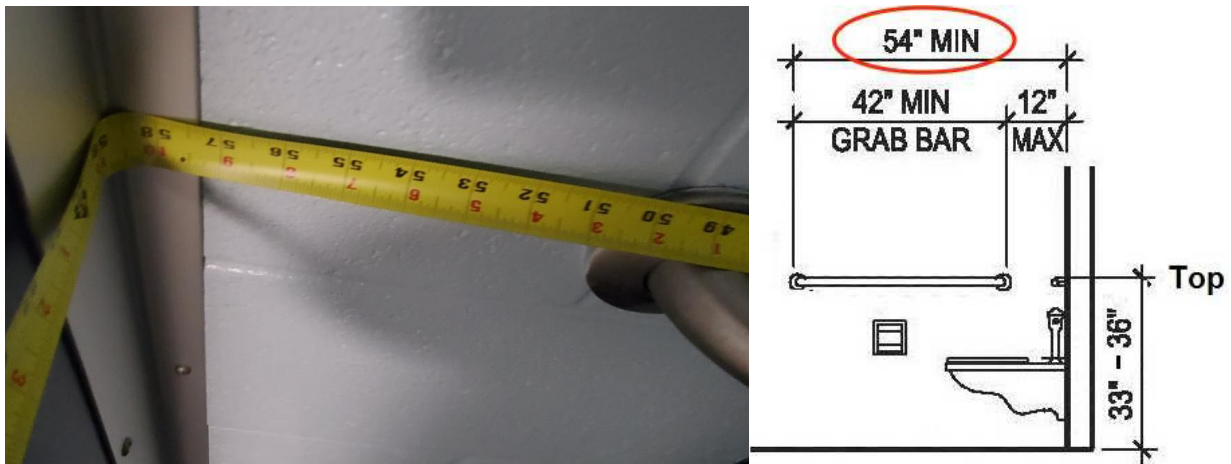
As Built: The side grab bar does not extend far enough from the rear wall.

The side grab bar must extend at least 54 inches minimum beyond the rear wall and start a maximum of 12 inches from the rear wall. A 42 inch grab bar installed the maximum distance from the rear wall (12 inches) will leave the leading end 54 inches from the rear wall.

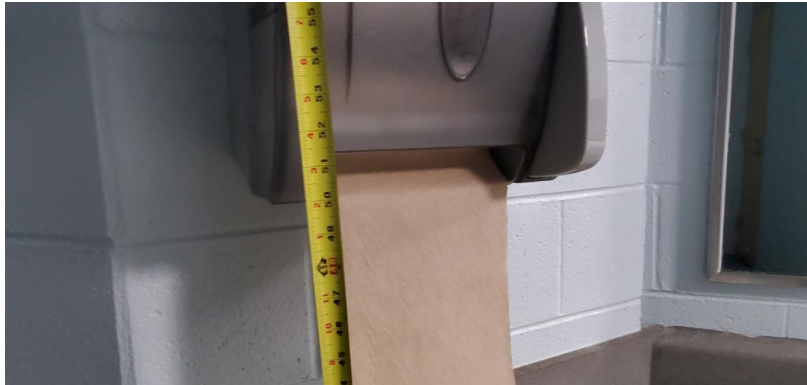
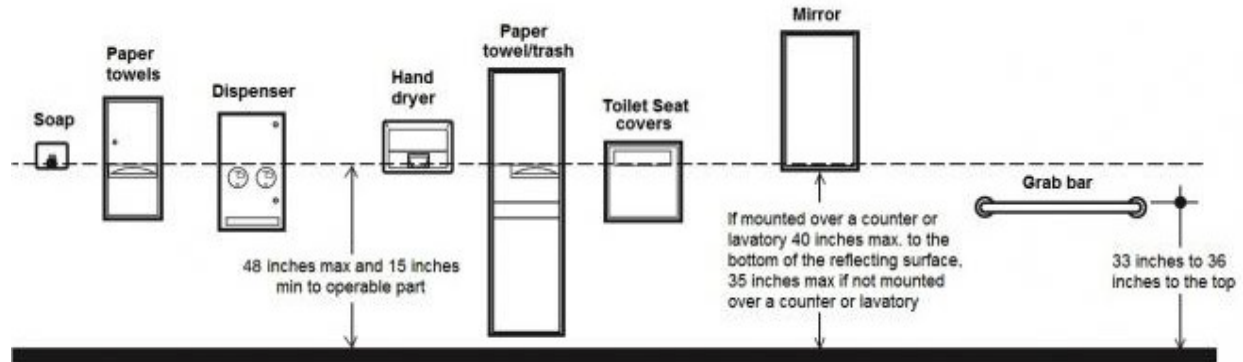
As Built: The paper towel dispenser's operation mechanism is too high off the floor. Dispensers must have all operable parts a maximum of 48 inches above the floor.

Citation: 2010 ADAS Section 308.2.1

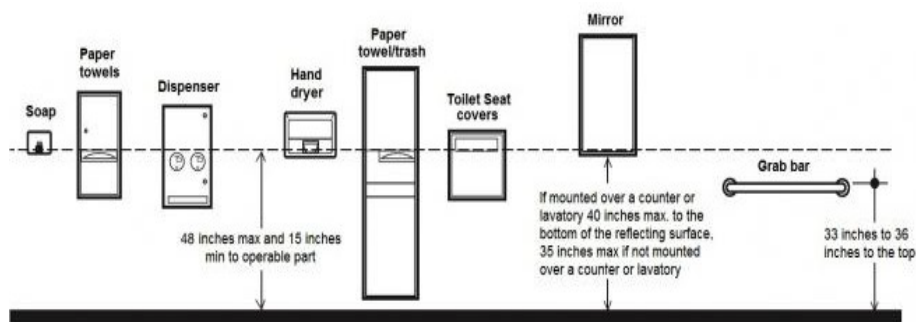
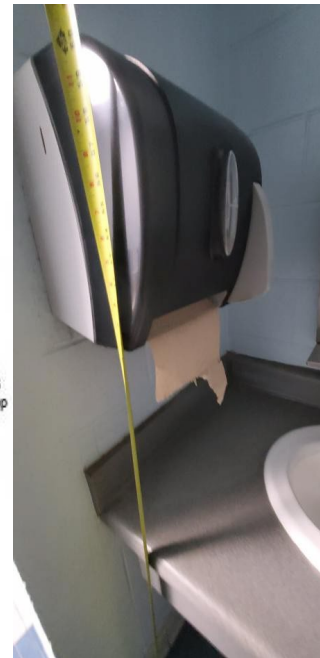
As Built: The paper towel dispenser's operation mechanism is too high off the floor. Dispensers must have all operable parts a maximum of 48 inches above the floor.

Citation: 2010 ADAS Section 308.2.1

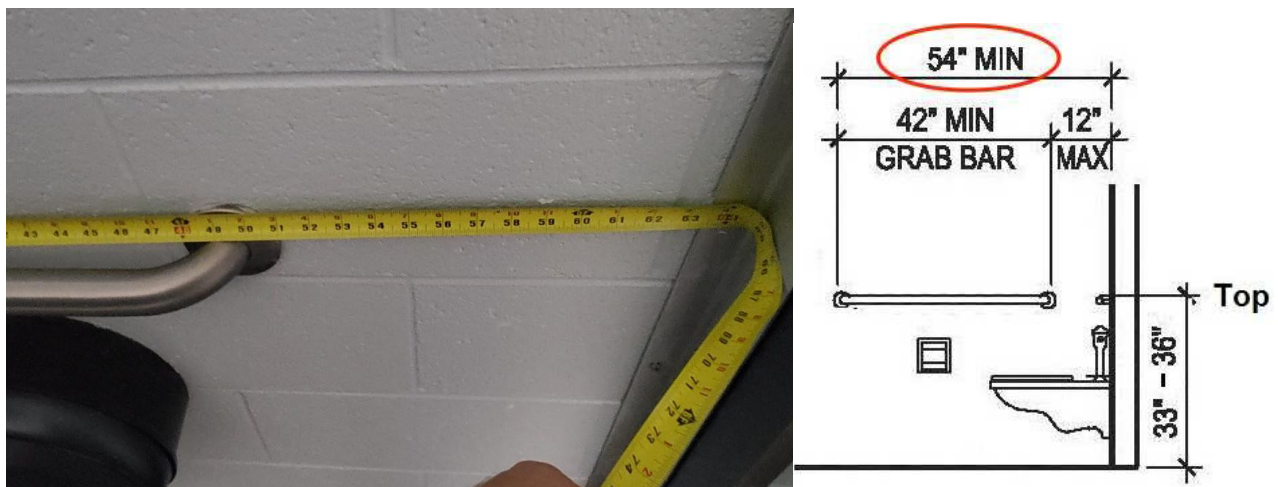
As Built: The side grab bar does not extend far enough from the rear wall.

The side grab bar must extend at least 54 inches minimum beyond the rear wall and start a maximum of 12 inches from the rear wall. A 42 inch grab bar installed the maximum distance from the rear wall (12 inches) will leave the leading end 54 inches from the rear wall.

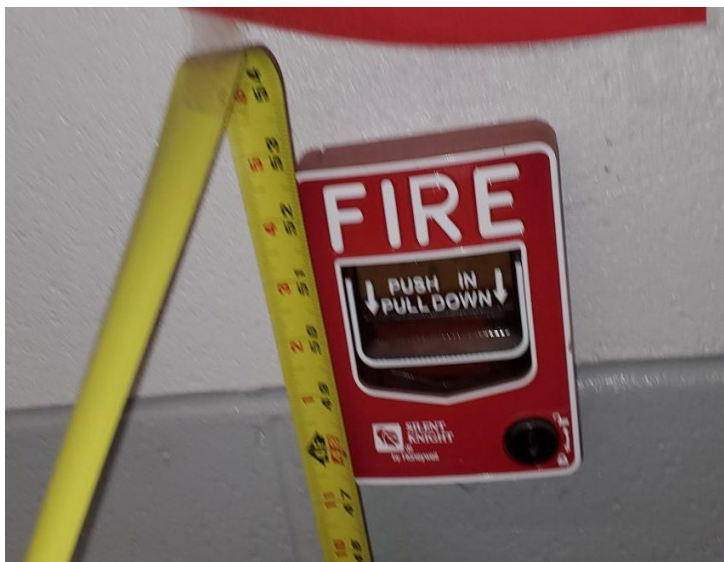
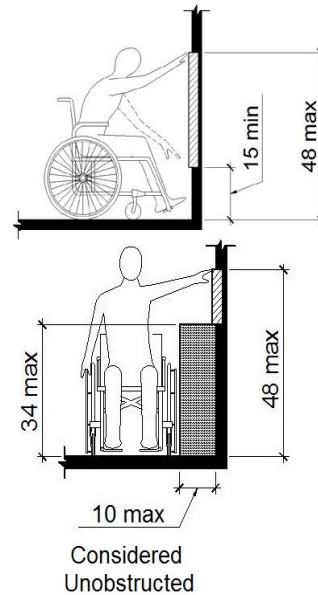
As Built: The fire alarm pull station is not positioned correctly for either a side or front approach.

Where a clear floor or ground space allows a parallel or front approach and the side reach is unobstructed, the high side reach shall be 48 inches maximum above the finish floor or ground and the low side reach shall be 15 inches minimum above the finish floor or ground.

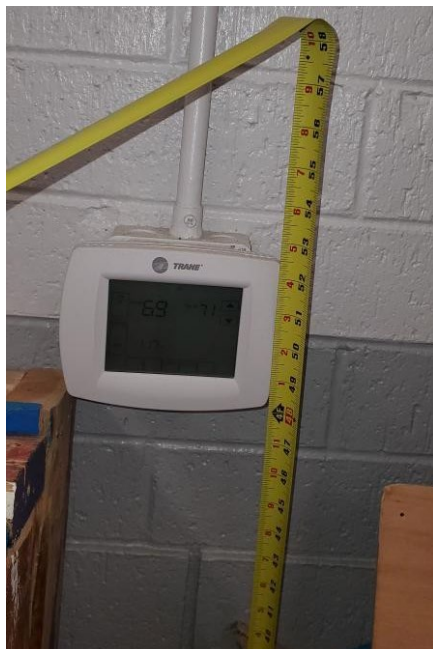
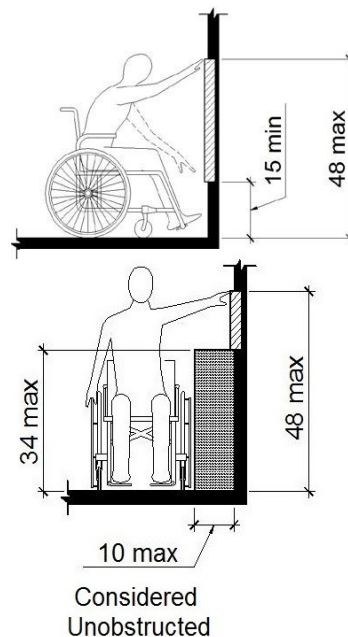
As Built: The thermostat is not positioned correctly for either a side or front approach.

Where a clear floor or ground space allows a parallel or front approach and the side reach is unobstructed, the high side reach shall be 48 inches maximum above the finish floor or ground and the low side reach shall be 15 inches minimum above the finish floor or ground.

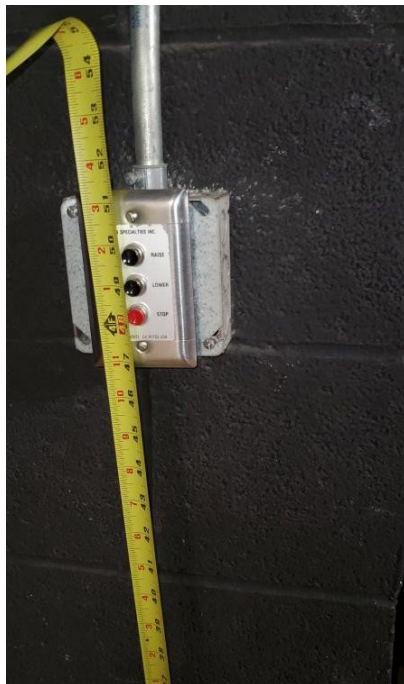
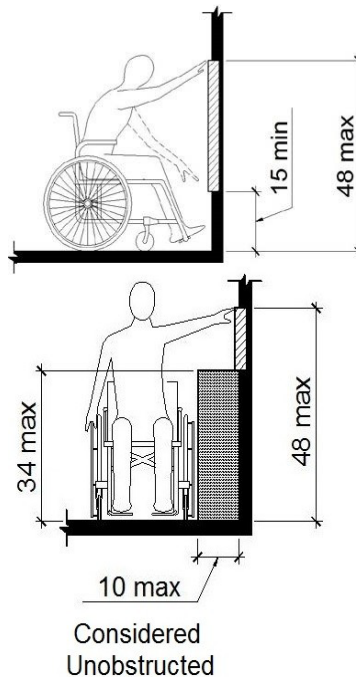
As Built: The curtain buttons is not positioned correctly for either a side or front approach.

Where a clear floor or ground space allows a parallel or front approach and the side reach is unobstructed, the high side reach shall be 48 inches maximum above the finish floor or ground and the low side reach shall be 15 inches minimum above the finish floor or ground.

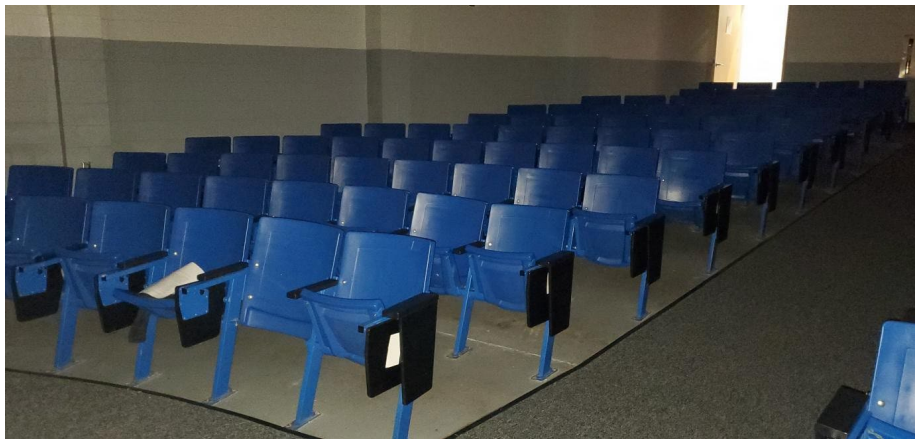
As Built: The wheelchair spaces are not placed among the other seats within the seating area. Wheelchair spaces shall be an integral part of the seating plan.

Citation: 2010 ADAS Section 221.2.2

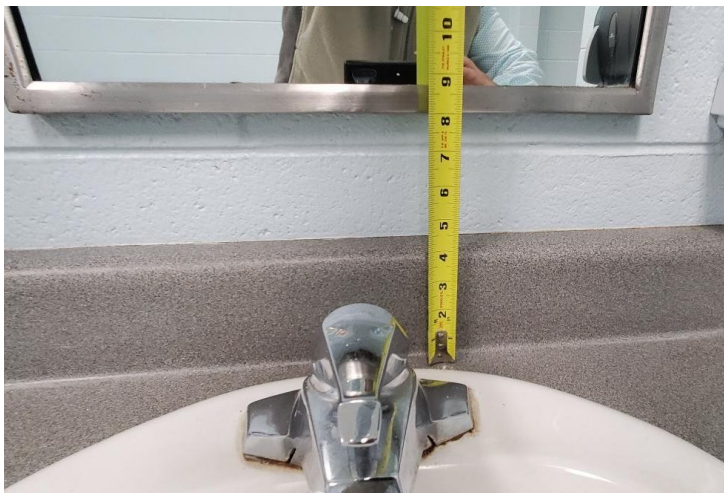
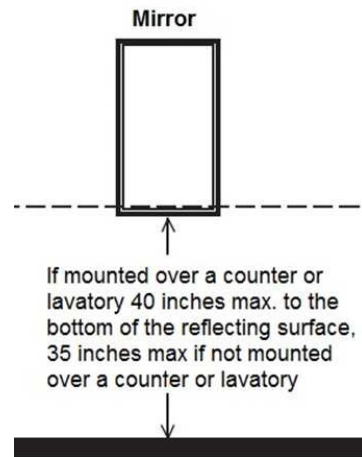
As Built: The mirror is mounted too high.

Mirrors must have the bottom edge of the reflecting surface a maximum of 40 inches above the floor if above a sink or counter. Mirrors not located above lavatories or countertops shall be installed with the bottom edge of the reflecting surface 35 inches maximum above the finish floor or ground.

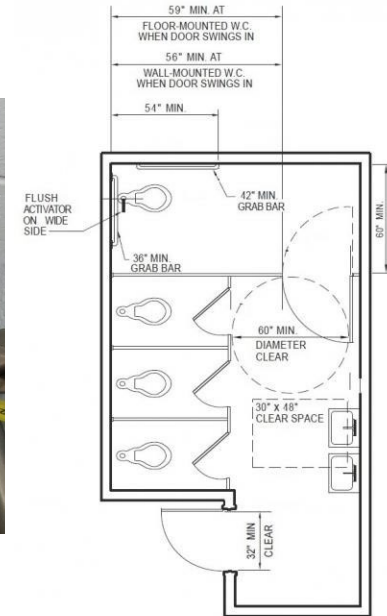
As Built: The toilet compartment does not have the required minimum clear floor space or maneuvering clearances for the toilet. Side grab bar installed incorrectly and rear grab bar missing.

Citation: 2010 ADAS Section 213.2

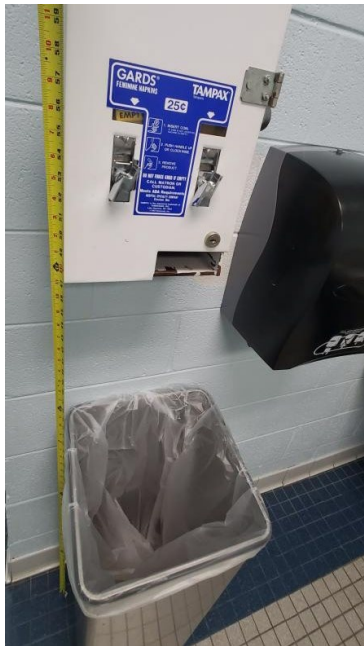
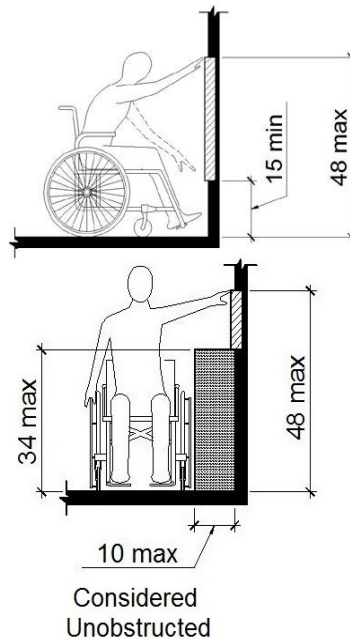
As Built: The hygiene vending machine is not positioned correctly for either a side or front approach.

Where a clear floor or ground space allows a parallel or front approach and the side reach is unobstructed, the high side reach shall be 48 inches maximum above the finish floor or ground and the low side reach shall be 15 inches minimum above the finish floor or ground.

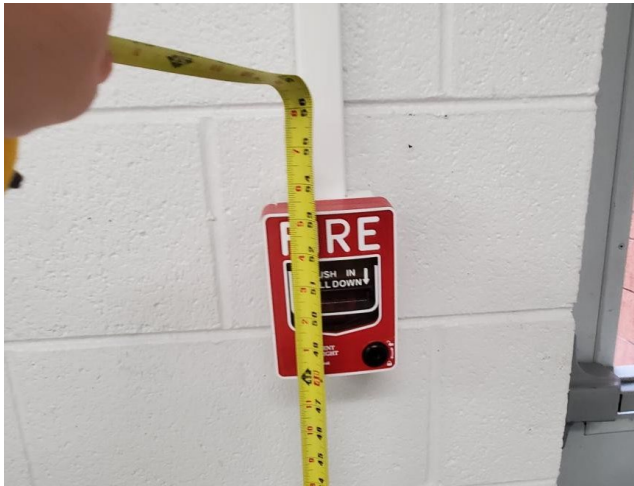
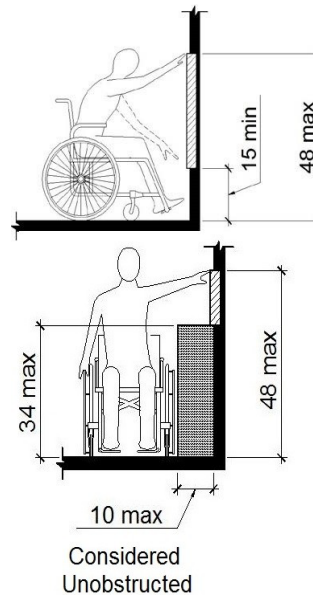
As Built: The fire alarm pull station is not positioned correctly for either a side or front approach.

Where a clear floor or ground space allows a parallel or front approach and the side reach is unobstructed, the high side reach shall be 48 inches maximum above the finish floor or ground and the low side reach shall be 15 inches minimum above the finish floor or ground.

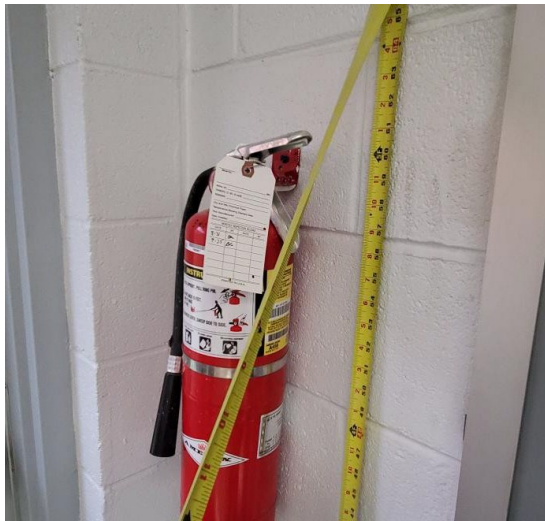
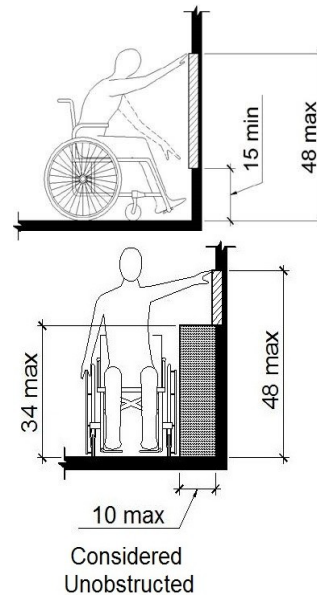
As Built: The Fire Extinguisher is not positioned correctly for either a side or front approach.

Where a clear floor or ground space allows a parallel or front approach and the side reach is unobstructed, the high side reach shall be 48 inches maximum above the finish floor or ground and the low side reach shall be 15 inches minimum above the finish floor or ground.

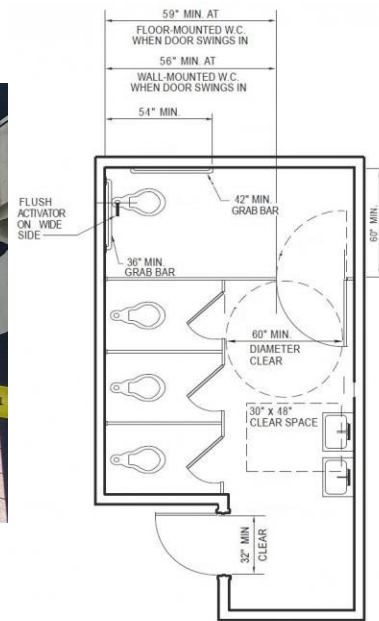
As Built: The toilet compartment does not have the required minimum clear floor space or maneuvering clearances for the toilet. Side grab bar installed incorrectly and rear grab bar missing.

Citation: 2010 ADAS Section 213.2

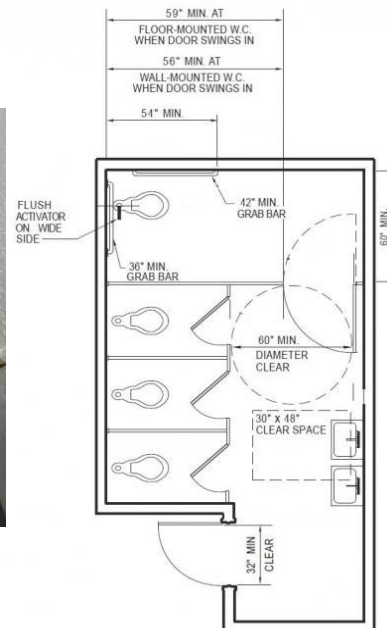
As Built: The toilet compartment does not have the required minimum clear floor space or maneuvering clearances for the toilet. Side grab bar installed incorrectly and rear grab bar missing.

Citation: 2010 ADAS Section 213.2

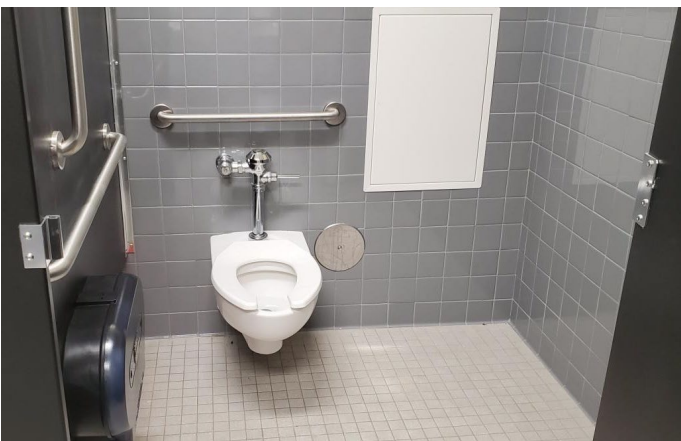
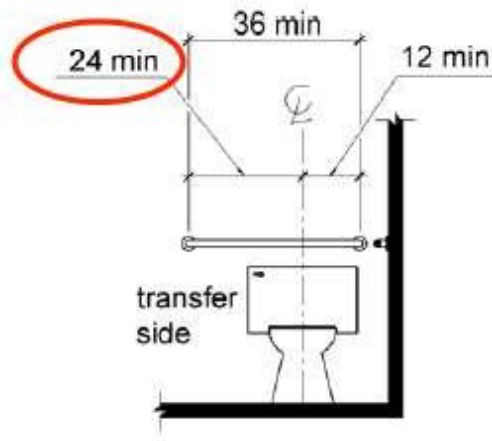
As Built: The rear grab bar does not extend adequately past the toilet on the wide side.

The rear grab bar must be a minimum of 36 inches long and extend from the centerline of the toilet 12 inches minimum on wall side and 24 inches minimum on the wide side.

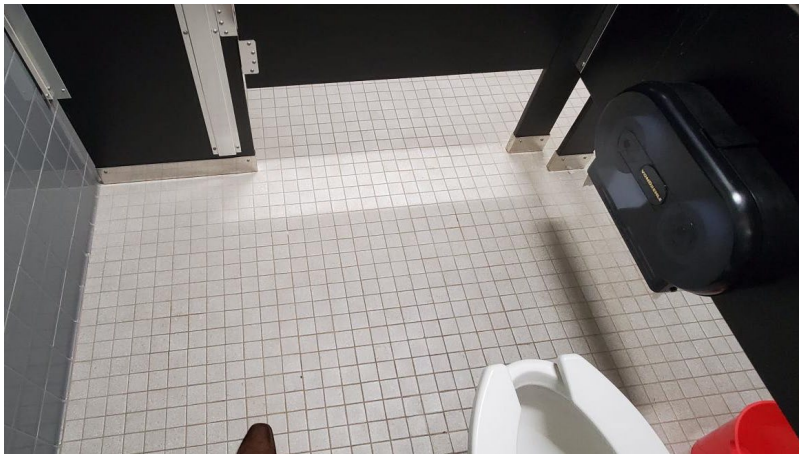
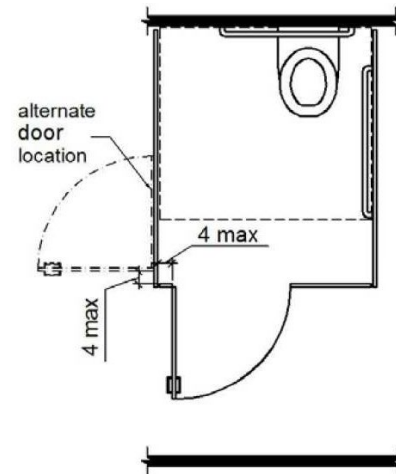
As Built: The door encroaches into the minimum required compartment area.

Toilet compartment doors shall not swing into the minimum required compartment area.

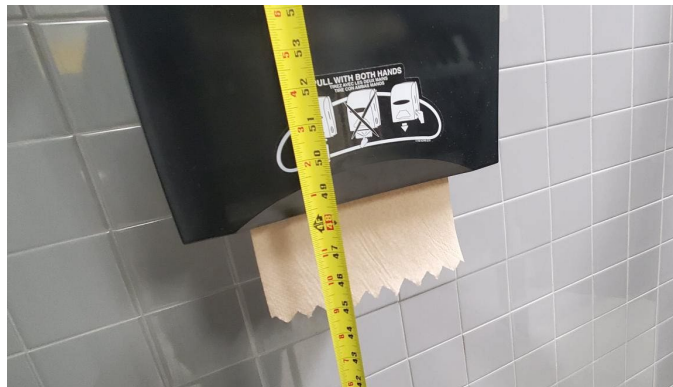
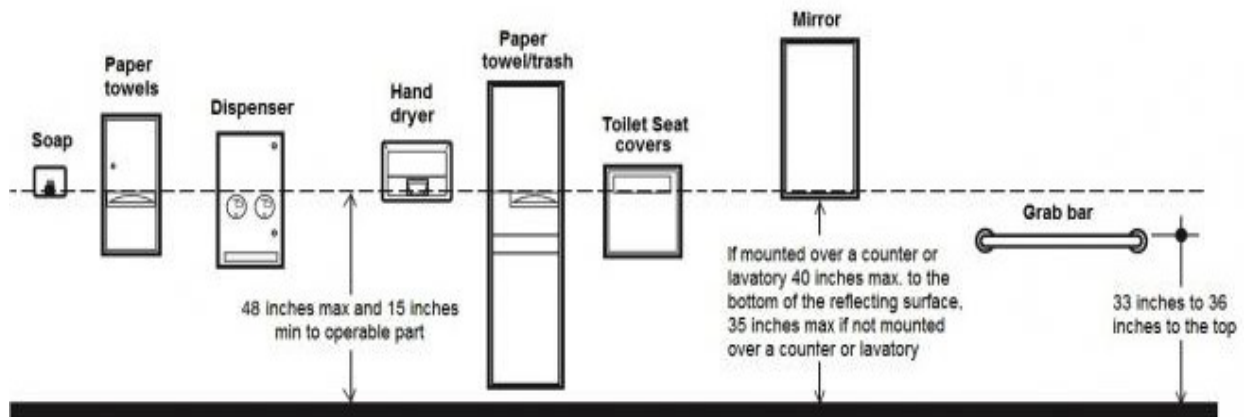
As Built: The paper towel dispenser's operation mechanism is too high off the floor. Dispensers must have all operable parts a maximum of 48 inches above the floor.

Citation: 2010 ADAS Section 308.2.1

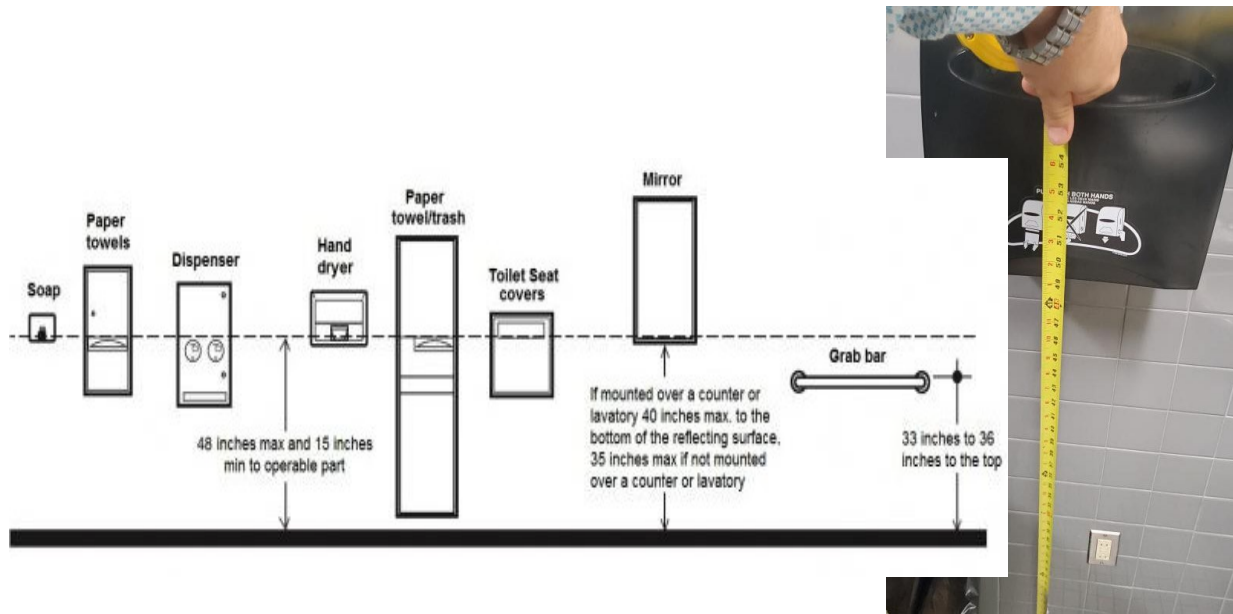
As Built: The paper towel dispenser's operation mechanism is too high off the floor. Dispensers must have all operable parts a maximum of 48 inches above the floor.

Citation: 2010 ADAS Section 308.2.1

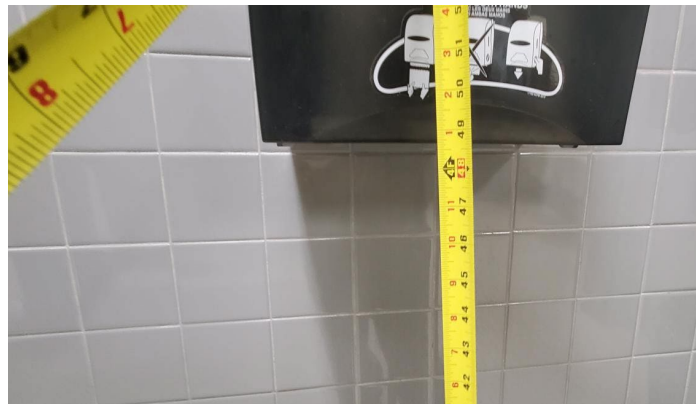
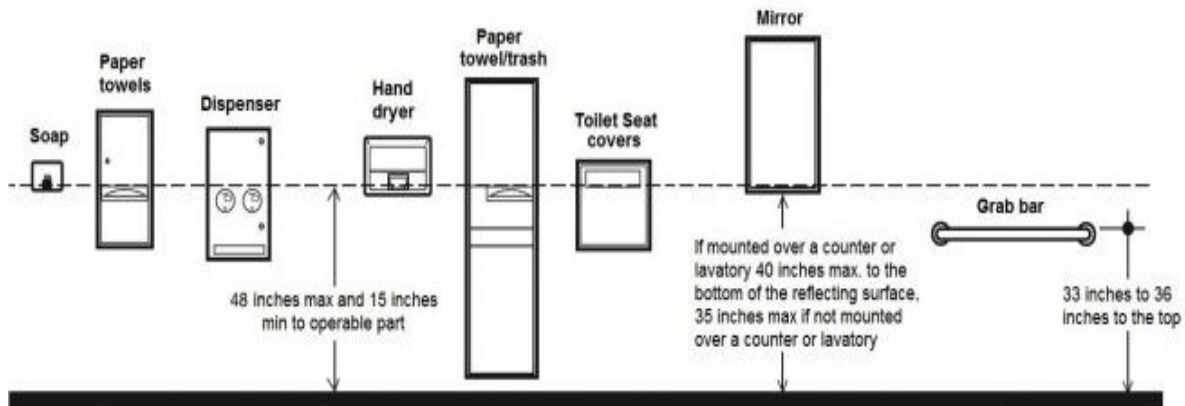
As Built: The paper towel dispenser's operation mechanism is too high off the floor. Dispensers must have all operable parts a maximum of 48 inches above the floor.

Citation: 2010 ADAS Section 308.2.1

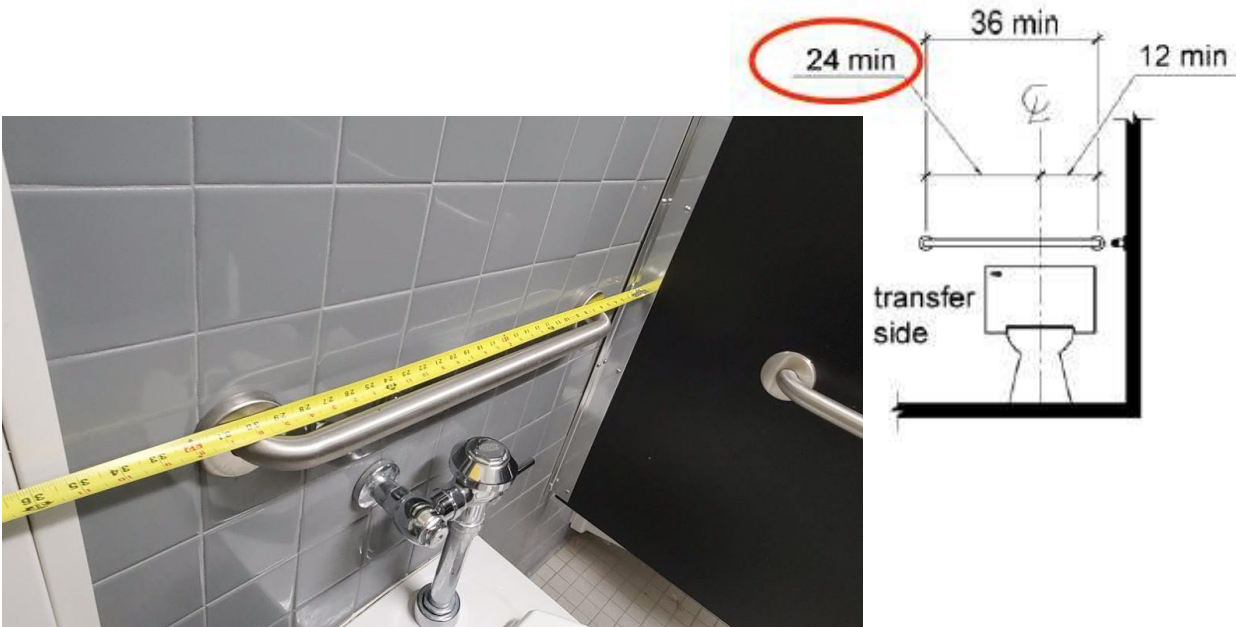
As Built: The rear grab bar does not extend adequately past the toilet on the wide side.

The rear grab bar must be a minimum of 36 inches long and extend from the centerline of the toilet 12 inches minimum on wall side and 24 inches minimum on the wide side.

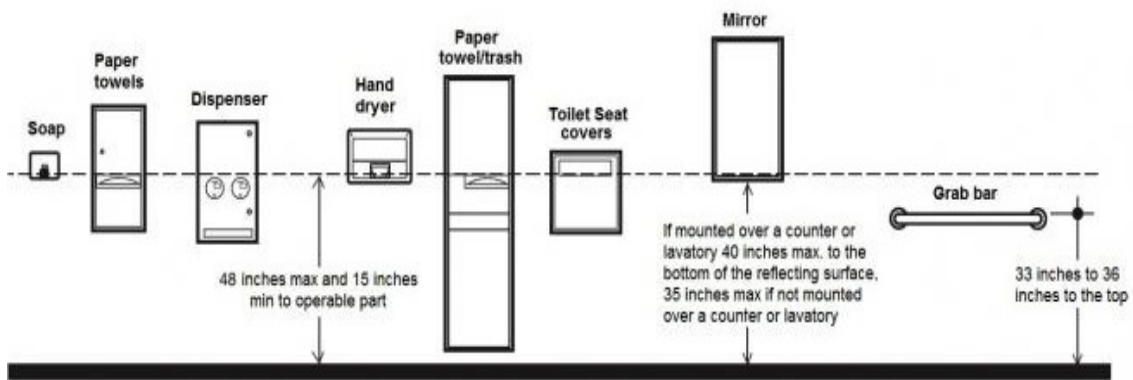
As Built: The paper towel dispenser's operation mechanism is too high off the floor. Dispensers must have all operable parts a maximum of 48 inches above the floor.

Citation: 2010 ADAS Section 308.2.1

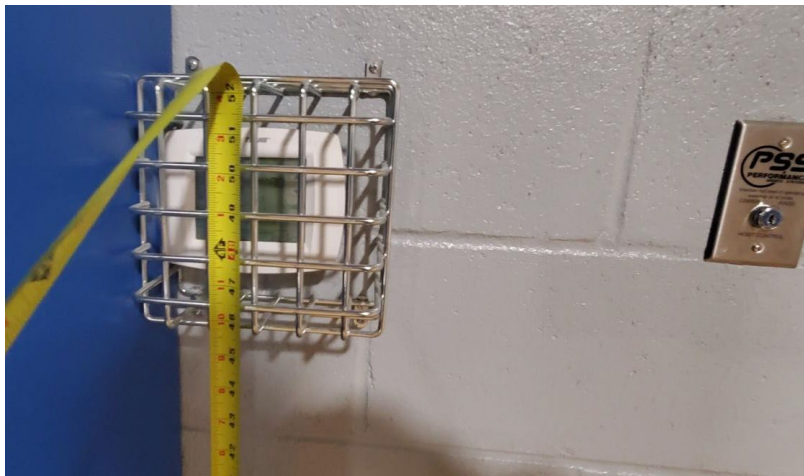
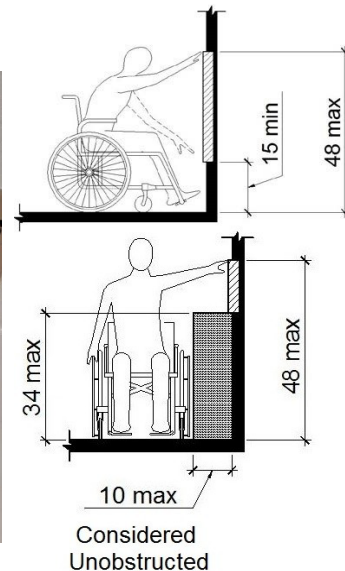
As Built: The thermostat is not positioned correctly for either a side or front approach.

Where a clear floor or ground space allows a parallel or front approach and the side reach is unobstructed, the high side reach shall be 48 inches maximum above the finish floor or ground and the low side reach shall be 15 inches minimum above the finish floor or ground.

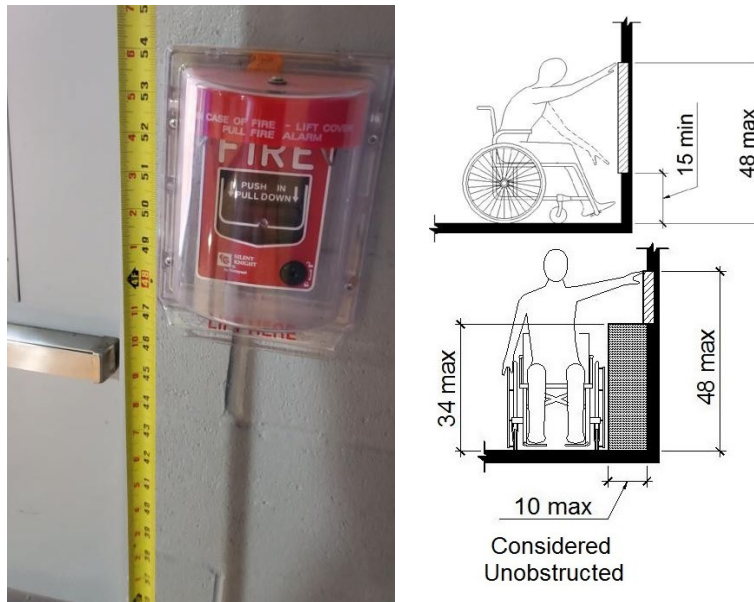
As Built: The fire alarm pull station is not positioned correctly for either a side or front approach.

Where a clear floor or ground space allows a parallel or front approach and the side reach is unobstructed, the high side reach shall be 48 inches maximum above the finish floor or ground and the low side reach shall be 15 inches minimum above the finish floor or ground.

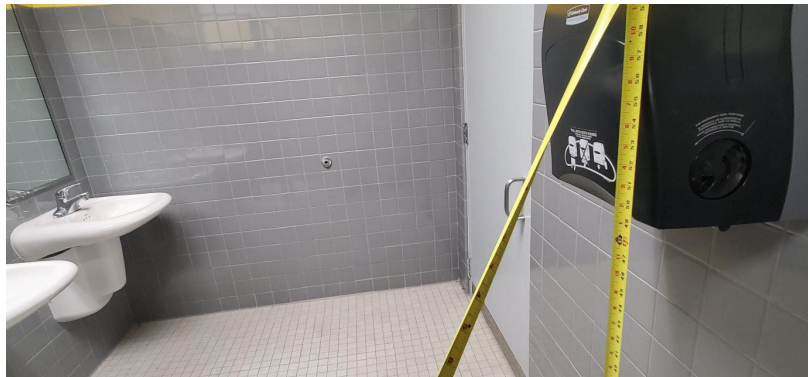
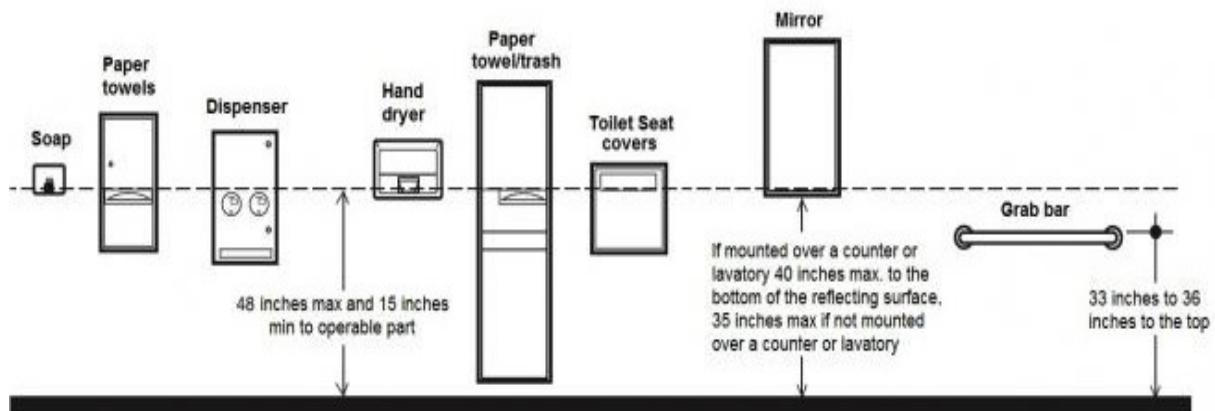
As Built: The paper towel dispenser's operation mechanism is too high off the floor. Dispensers must have all operable parts a maximum of 48 inches above the floor.

Citation: 2010 ADAS Section 308.2.1

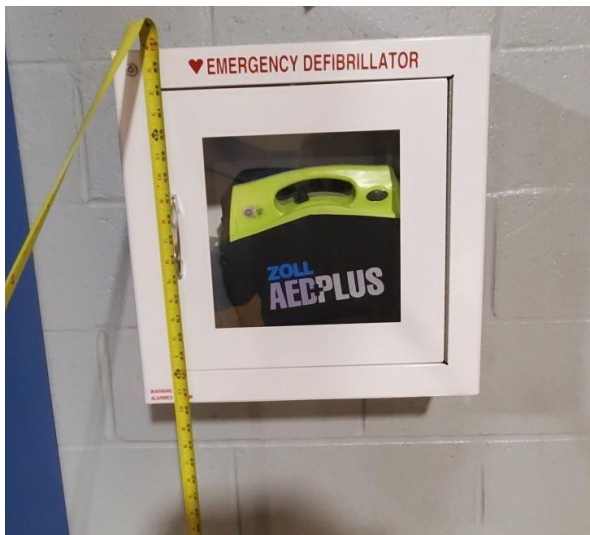
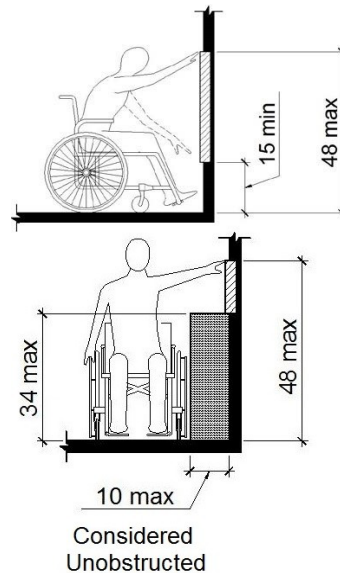
As Built: The defibrillator is not positioned correctly for either a side or front approach.

Where a clear floor or ground space allows a parallel or front approach and the side reach is unobstructed, the high side reach shall be 48 inches maximum above the finish floor or ground and the low side reach shall be 15 inches minimum above the finish floor or ground.

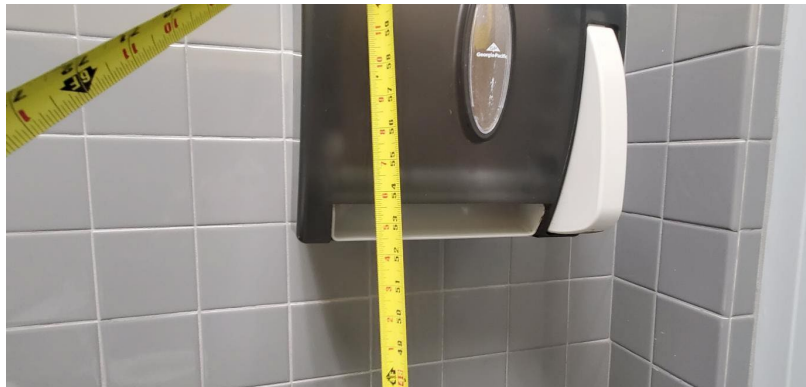
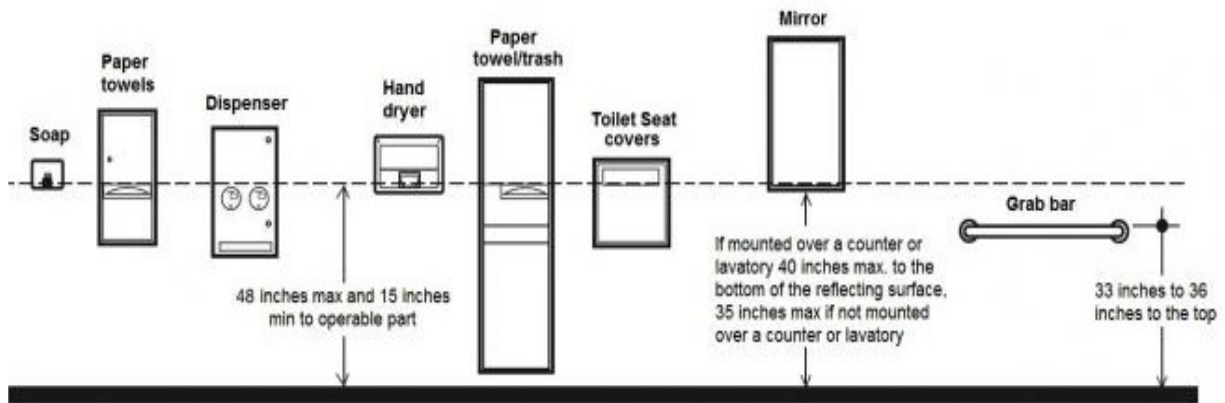
As Built: The paper towel dispenser's operation mechanism is too high off the floor. Dispensers must have all operable parts a maximum of 48 inches above the floor.

Citation: 2010 ADAS Section 308.2.1

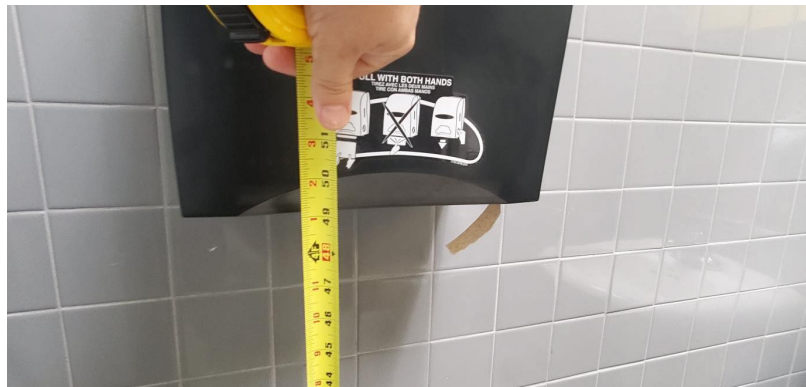
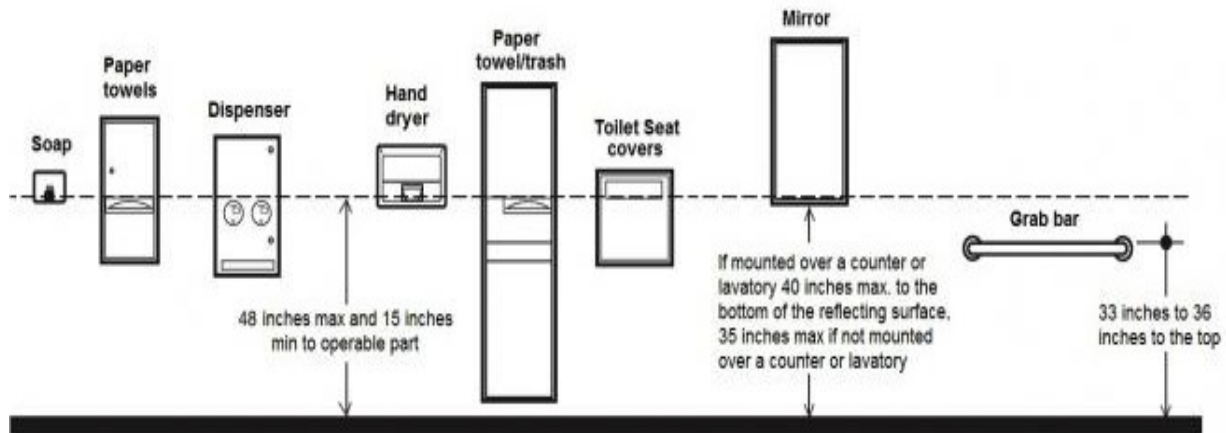
As Built: The paper towel dispenser's operation mechanism is too high off the floor. Dispensers must have all operable parts a maximum of 48 inches above the floor.

Citation: 2010 ADAS Section 308.2.1

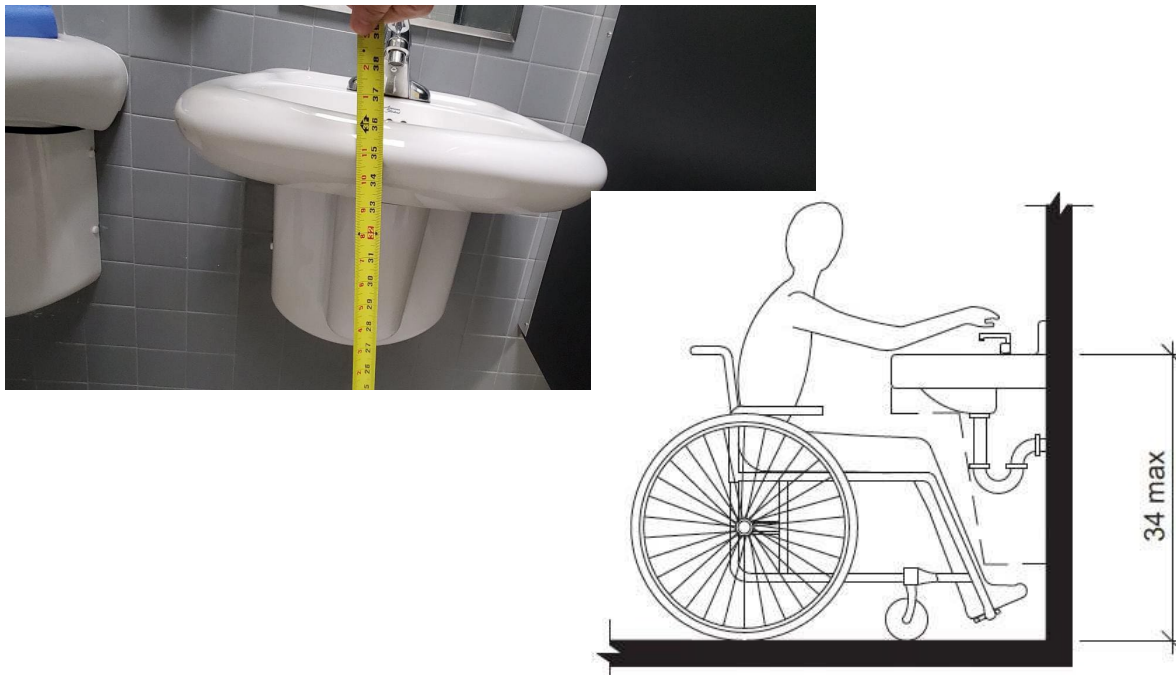
As Built: The top rim of the lavatory is too high.

All lavatories that are designated to be accessible shall be a minimum 17 inches in horizontal depth and mounted with the rim or counter edge no higher than 34 inches above the finished floor.

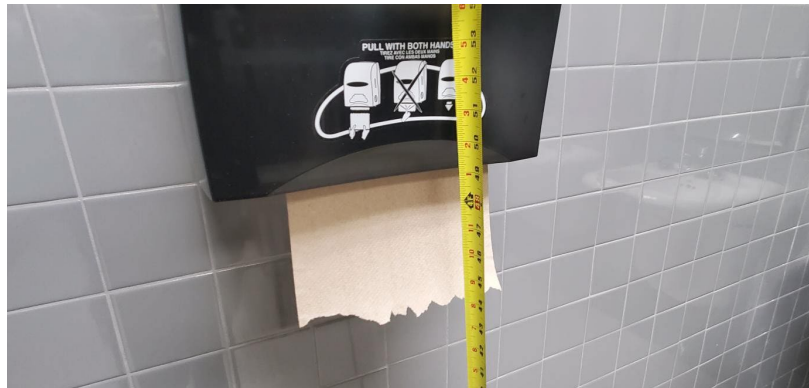
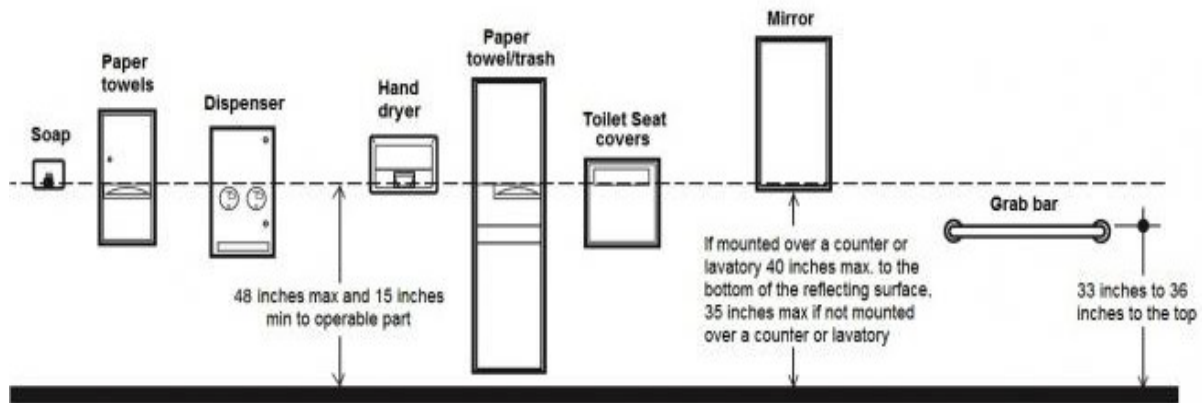
As Built: The paper towel dispenser's operation mechanism is too high off the floor. Dispensers must have all operable parts a maximum of 48 inches above the floor.

Citation: 2010 ADAS Section 308.2.1

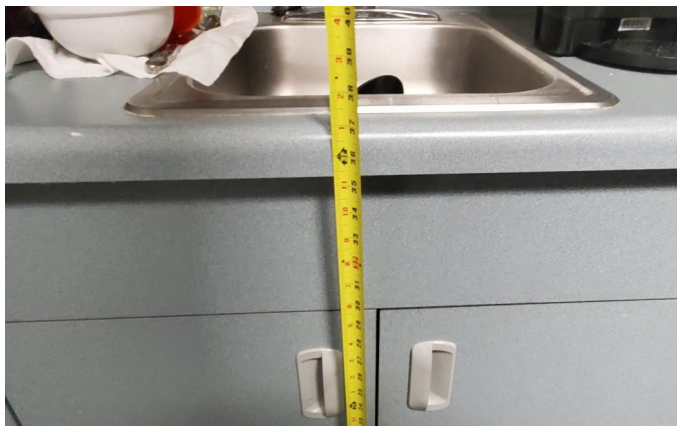
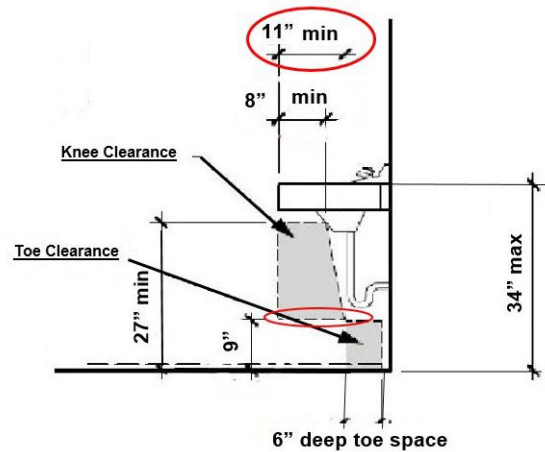
As Built: Compliant knee space has not been provided under the lavatory.

The knee clearance shall be 11 inches minimum in depth at 9 inches above the floor, and 8 inches minimum in depth at 27 inches above the floor. The top of the lavatory rim may be no higher than 34 inches.
