WEAKLEY COUNTY, TENNESSEE

ADA EVALUATION

Architectural and Site Findings with Recommendations

TLM Associates, Inc

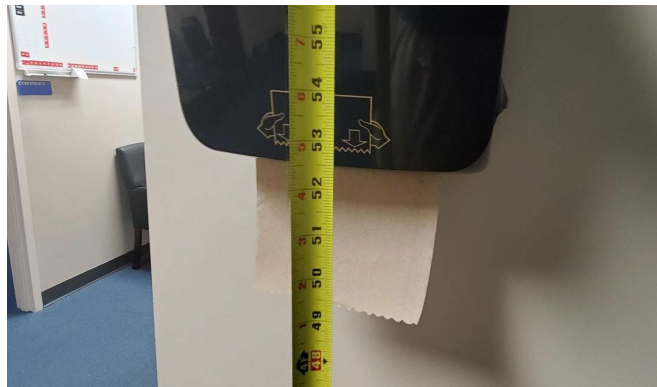
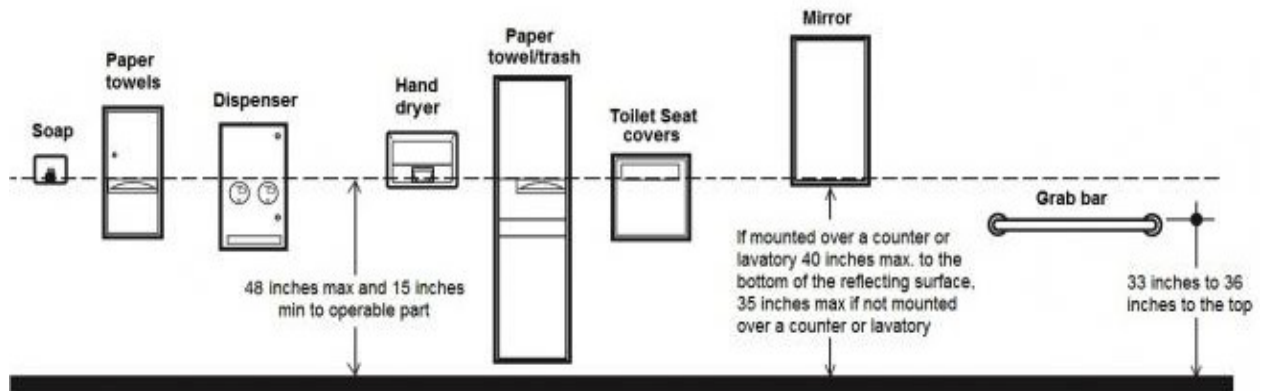
As Built: The paper towel dispenser's operation mechanism is too high off the floor. Dispensers must have all operable parts a maximum of 48 inches above the floor.

Citation: 2010 ADAS Section 308.2.1

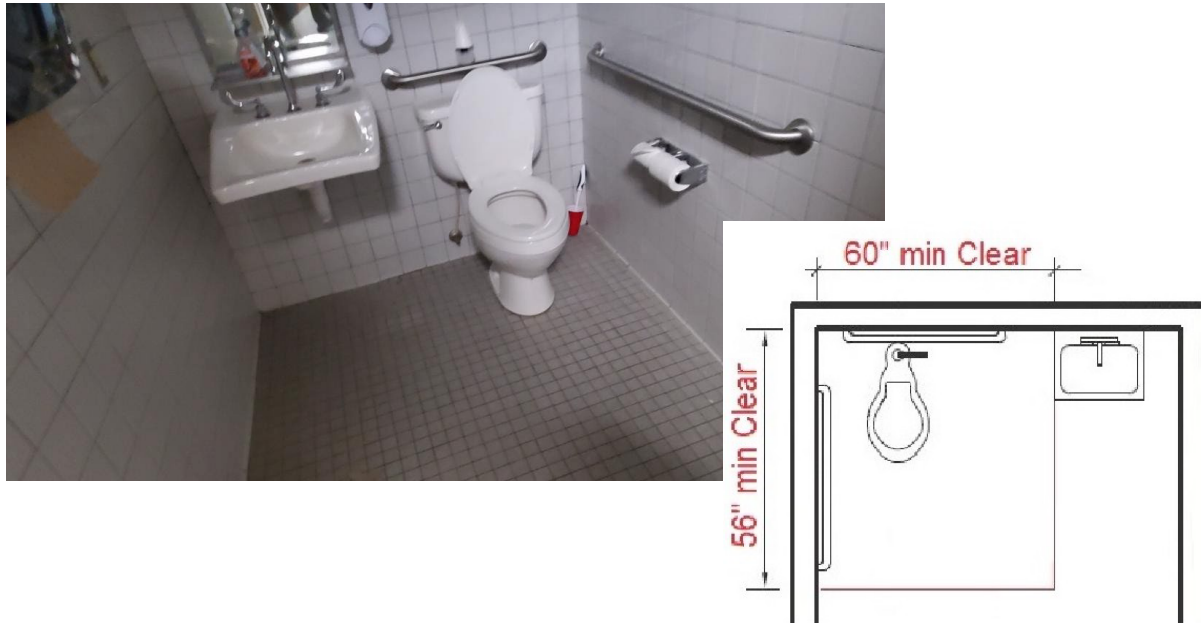
As Built: The lavatory projects into the clear floor space required for the toilet. The clear floor space is 60 inches along the back wall by 56 inches.

The required clearance around the water closet shall be permitted to overlap the water closet, associated grab bars, dispensers, sanitary napkin disposal units, coat hooks, shelves, accessible routes, clear floor space and clearances required at other fixtures, and the turning space. No other fixtures or obstructions shall be located within the required water closet clearance.

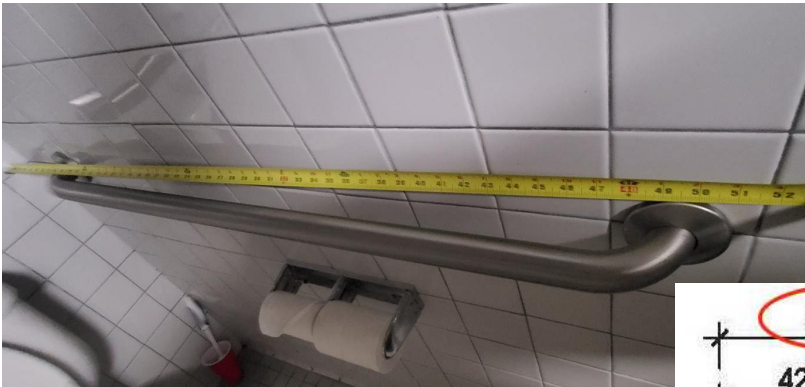
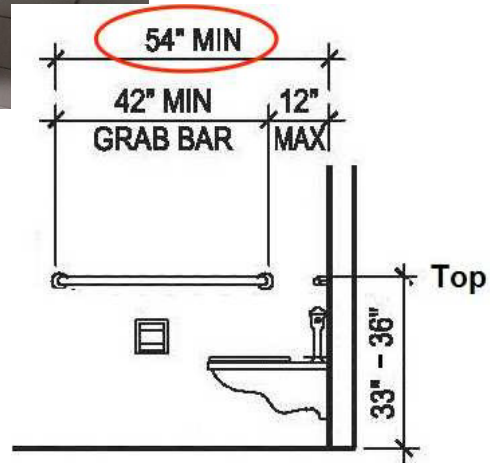
As Built: The side grab bar does not extend far enough from the rear wall.

The side grab bar must extend at least 54 inches minimum beyond the rear wall and start a maximum of 12 inches from the rear wall. A 42 inch grab bar installed the maximum distance from the rear wall (12 inches) will leave the leading end 54 inches from the rear wall.

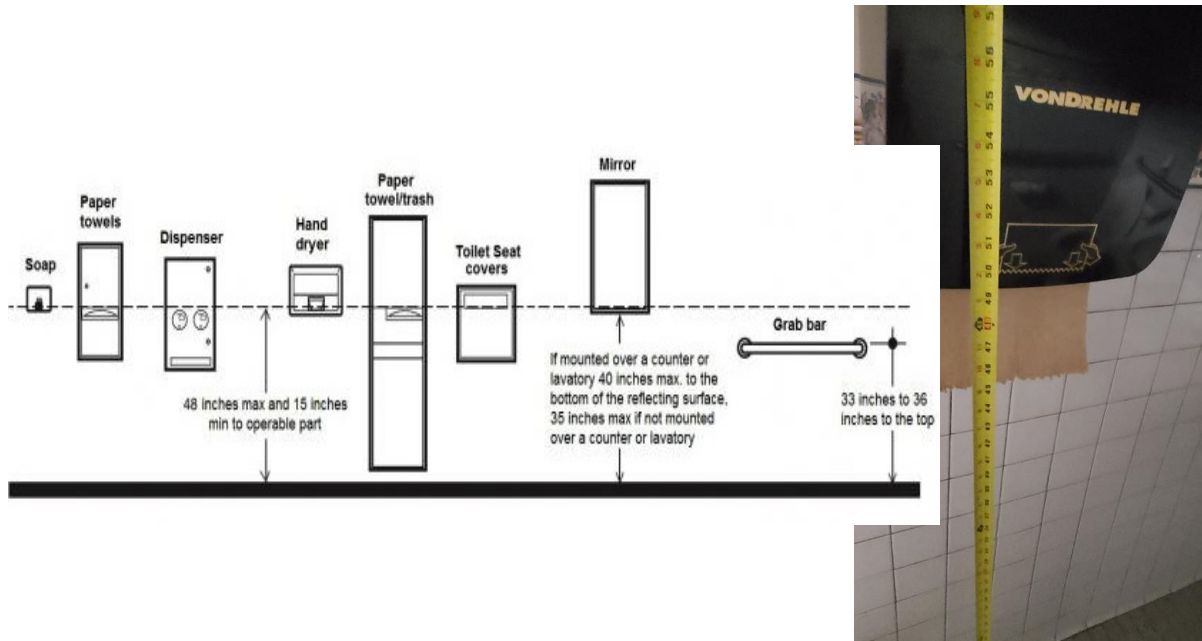
As Built: The paper towel dispenser's operation mechanism is too high off the floor. Dispensers must have all operable parts a maximum of 48 inches above the floor.

Citation: 2010 ADAS Section 308.2.1

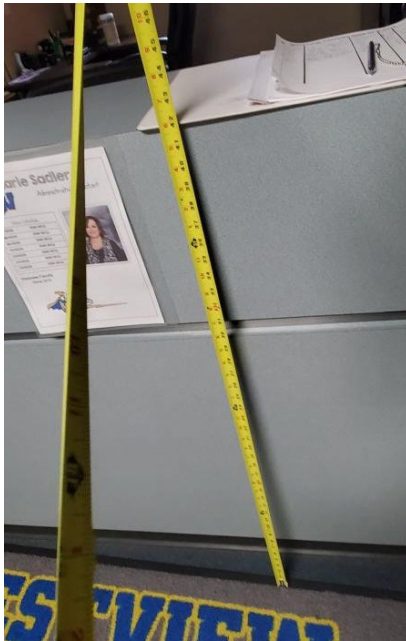
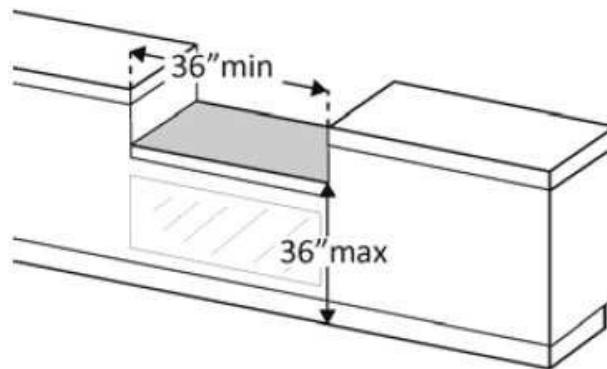
As Built: The counter is too high.

A portion of the counter surface that is 36 inches long minimum and 36 inches high maximum above the finish floor shall be provided. Knee and toe space must be provided for a forward approach. A 30-inch by 48-inch clear floor space on an accessible route must be provided for either a forward or parallel approach.

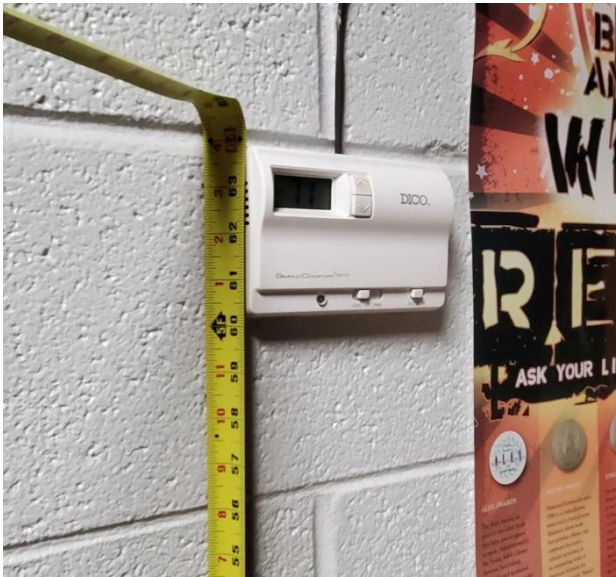
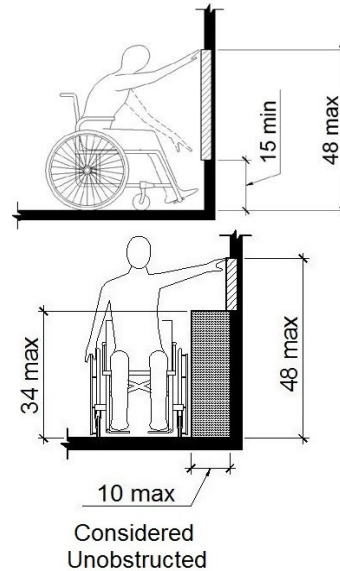
As Built: The thermostat is not positioned correctly for either a side or front approach.

Where a clear floor or ground space allows a parallel or front approach and the side reach is unobstructed, the high side reach shall be 48 inches maximum above the finish floor or ground and the low side reach shall be 15 inches minimum above the finish floor or ground.

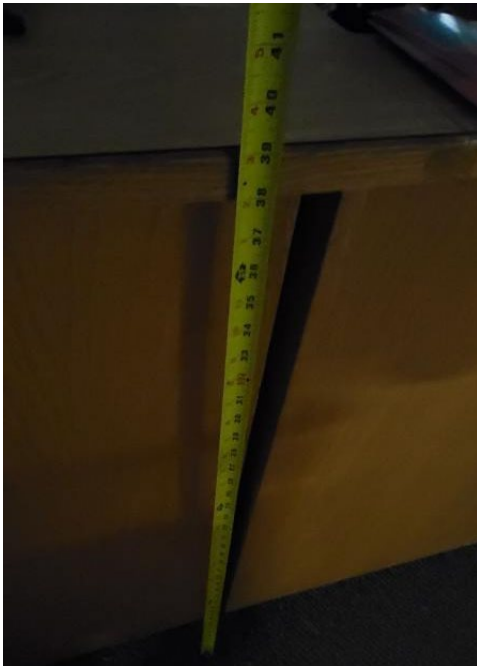
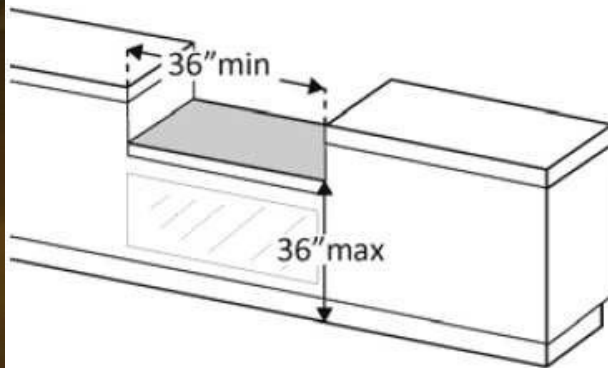
As Built: The counter is too high.

A portion of the counter surface that is 36 inches long minimum and 36 inches high maximum above the finish floor shall be provided. Knee and toe space must be provided for a forward approach. A 30 inch by 48 inch clear floor space on an accessible route must be provided for either a forward or parallel approach.

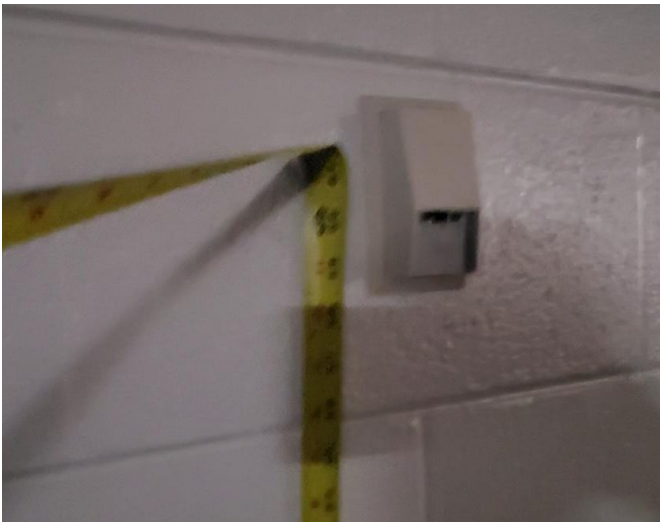
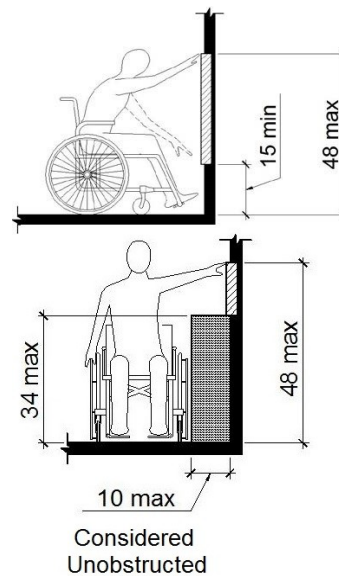
As Built: The thermostat is not positioned correctly for either a side or front approach.

Where a clear floor or ground space allows a parallel or front approach and the side reach is unobstructed, the high side reach shall be 48 inches maximum above the finish floor or ground and the low side reach shall be 15 inches minimum above the finish floor or ground.

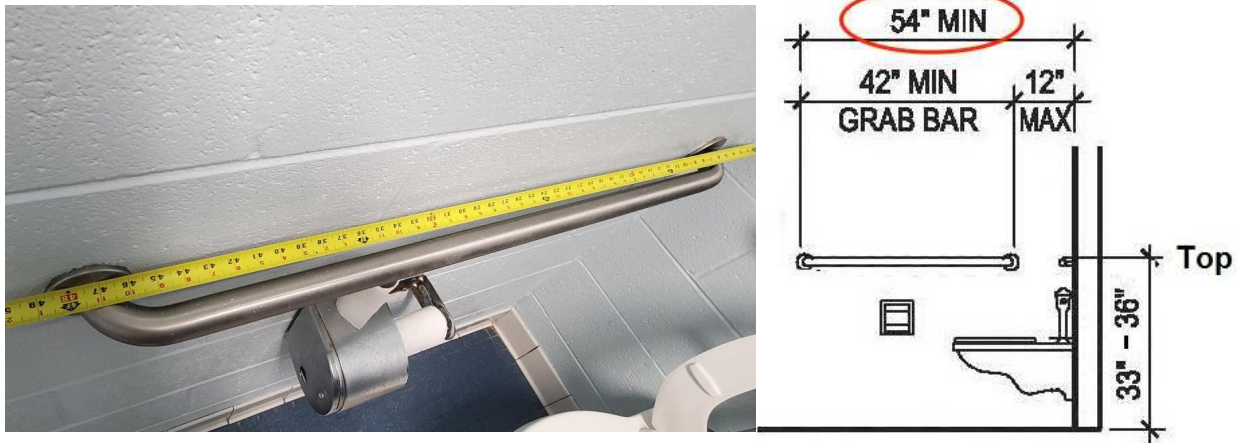
As Built: The side grab bar does not extend far enough from the rear wall.

The side grab bar must extend at least 54 inches minimum beyond the rear wall and start a maximum of 12 inches from the rear wall. A 42 inch grab bar installed the maximum distance from the rear wall (12 inches) will leave the leading end 54 inches from the rear wall.

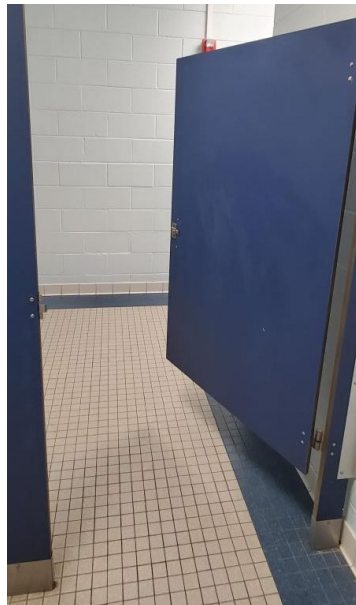
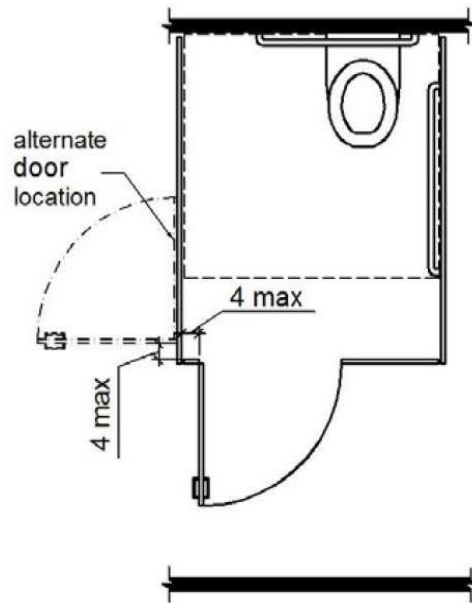
As Built: The door encroaches into the minimum required compartment area.

Toilet compartment doors shall not swing into the minimum required compartment area.

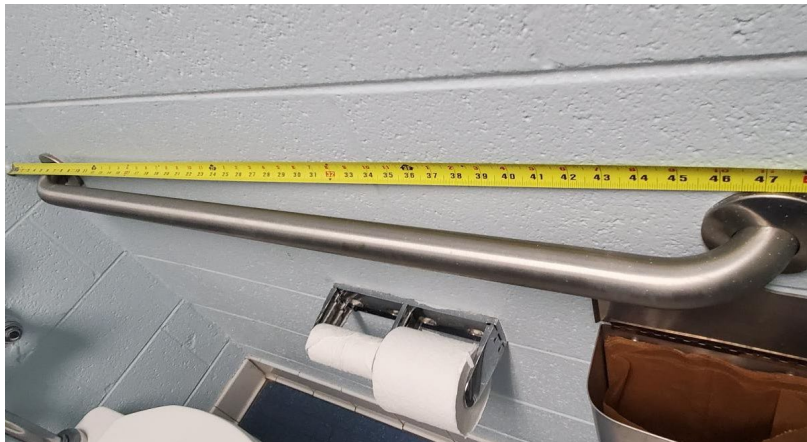
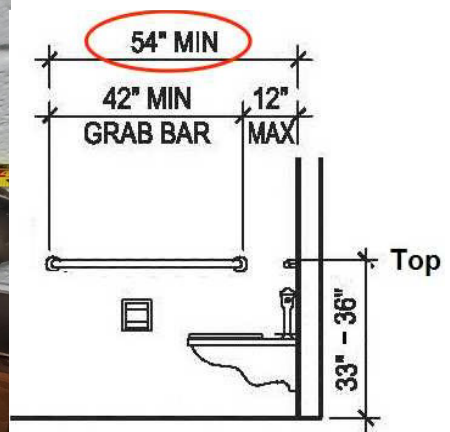
As Built: The side grab bar does not extend far enough from the rear wall.

The side grab bar must extend at least 54 inches minimum beyond the rear wall and start a maximum of 12 inches from the rear wall. A 42 inch grab bar installed the maximum distance from the rear wall (12 inches) will leave the leading end 54 inches from the rear wall.

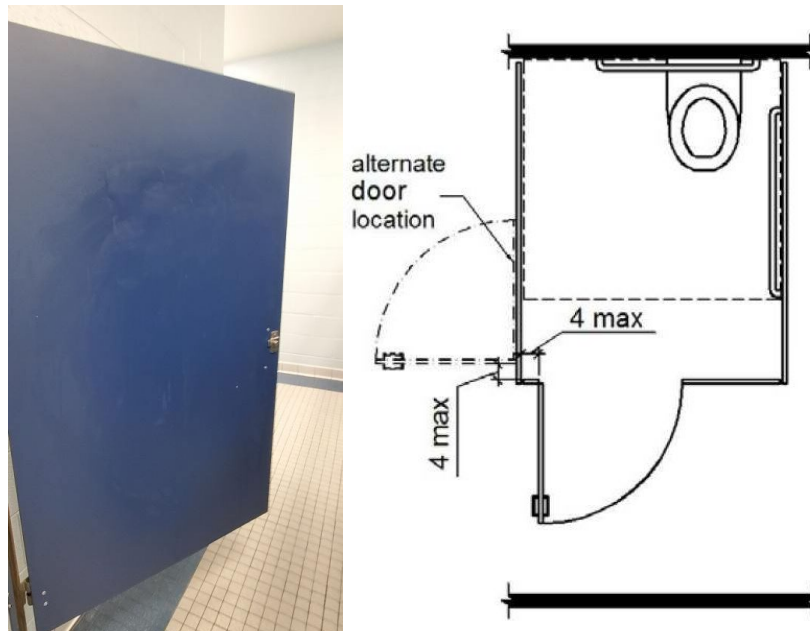
As Built: The door encroaches into the minimum required compartment area.

Toilet compartment doors shall not swing into the minimum required compartment area.

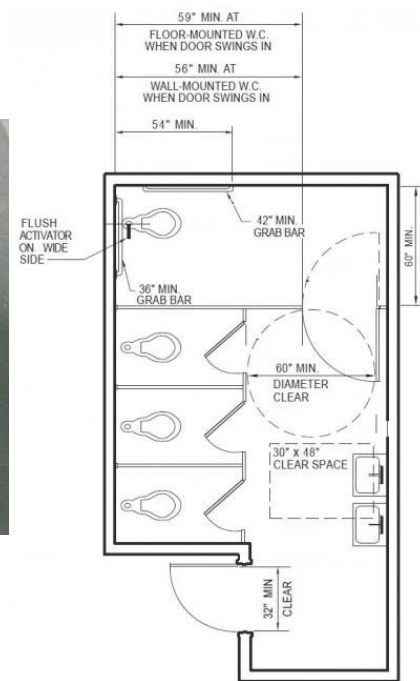
As Built: The toilet compartment does not have the required minimum clear floor space or maneuvering clearances for the toilet. Side grab bar installed incorrectly and rear grab bar missing.

Citation: 2010 ADAS Section 213.2

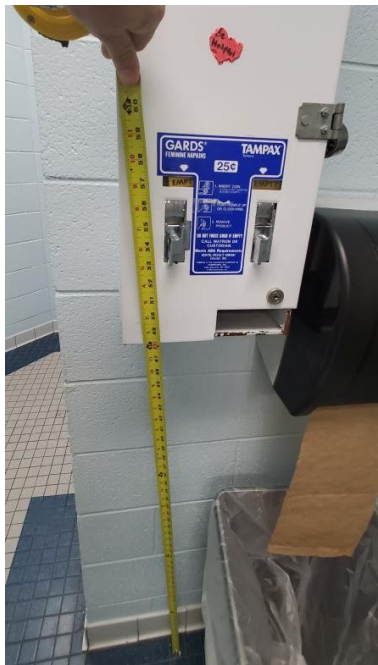
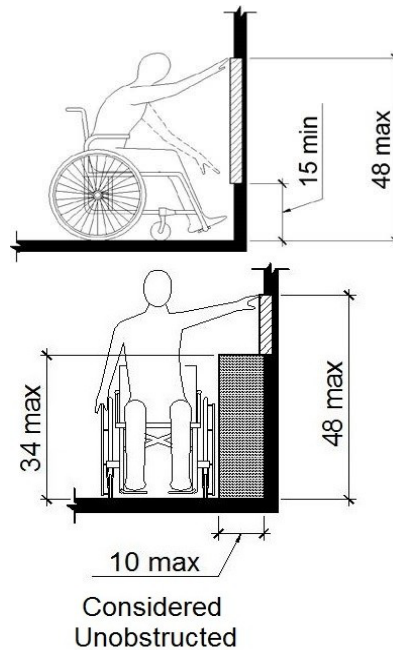
As Built: The hygiene vending machine is not positioned correctly for either a side or front approach.

Where a clear floor or ground space allows a parallel or front approach and the side reach is unobstructed, the high side reach shall be 48 inches maximum above the finish floor or ground and the low side reach shall be 15 inches minimum above the finish floor or ground.

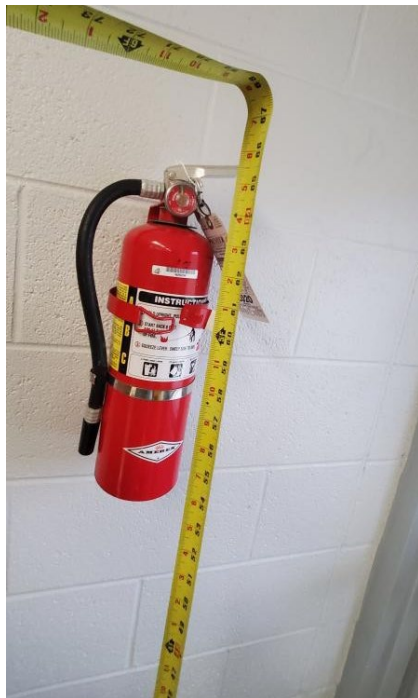
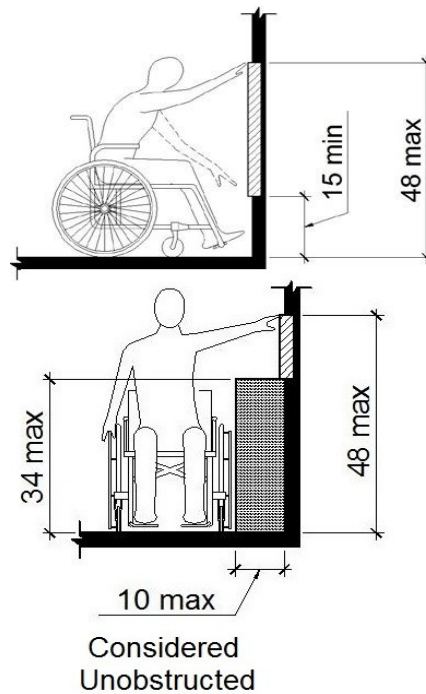
As Built: The Fire Extinguisher is not positioned correctly for either a side or front approach.

Where a clear floor or ground space allows a parallel or front approach and the side reach is unobstructed, the high side reach shall be 48 inches maximum above the finish floor or ground and the low side reach shall be 15 inches minimum above the finish floor or ground.

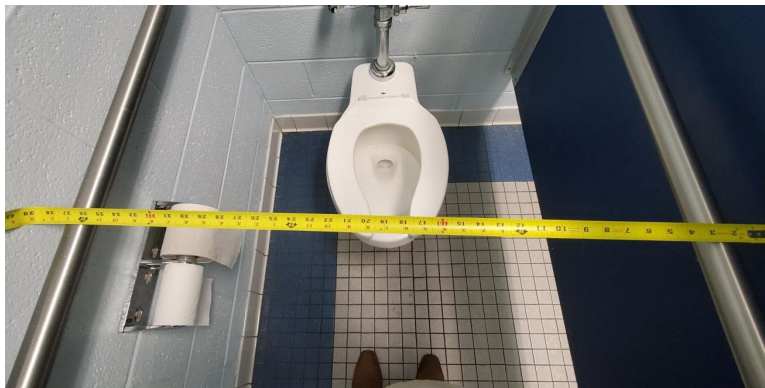
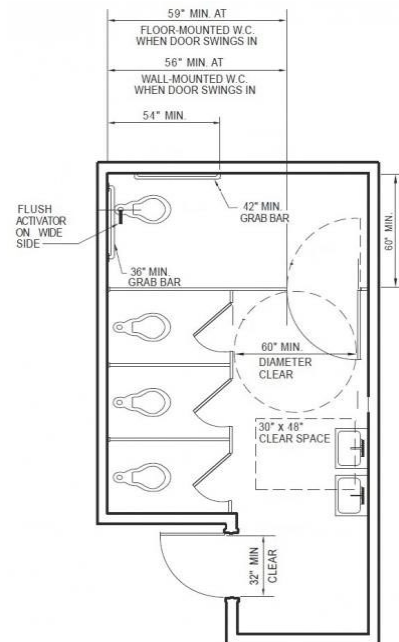
As Built: The toilet compartment does not have the required minimum clear floor space or maneuvering clearances for the toilet. Side grab bar installed incorrectly and rear grab bar missing.

Citation: 2010 ADAS Section 213.2

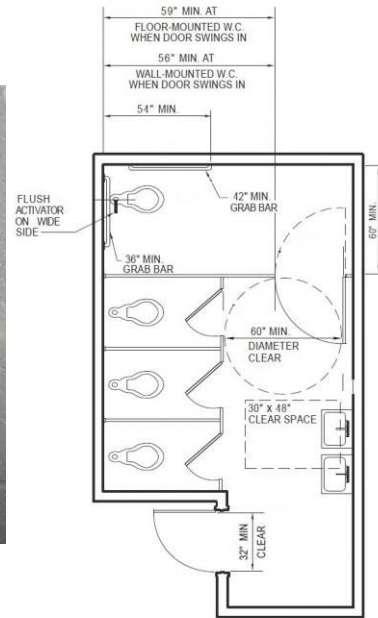
As Built: The toilet compartment does not have the required minimum clear floor space or maneuvering clearances for the toilet. Side grab bar installed incorrectly and rear grab bar missing.

Citation: 2010 ADAS Section 213.2

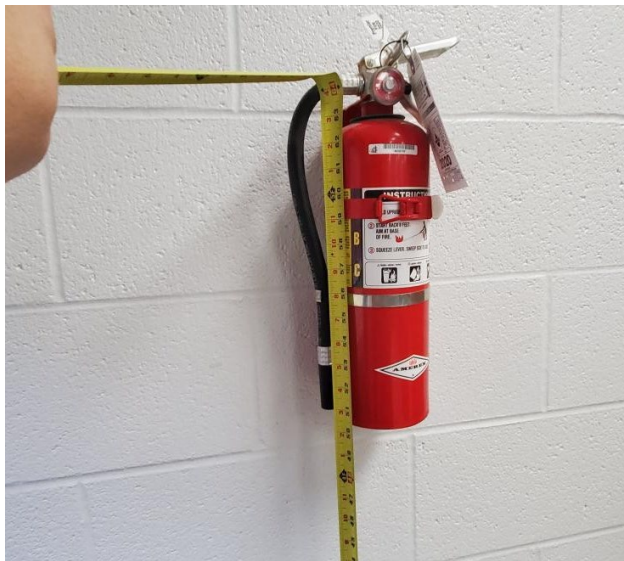
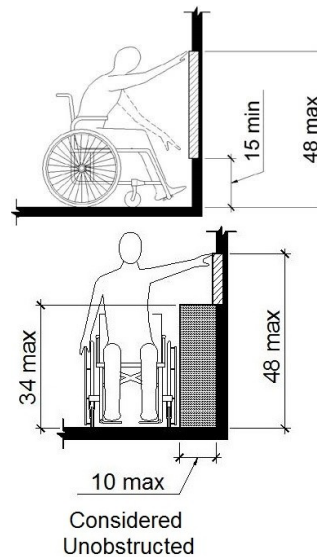
As Built: The Fire Extinguisher is not positioned correctly for either a side or front approach.

Where a clear floor or ground space allows a parallel or front approach and the side reach is unobstructed, the high side reach shall be 48 inches maximum above the finish floor or ground and the low side reach shall be 15 inches minimum above the finish floor or ground.

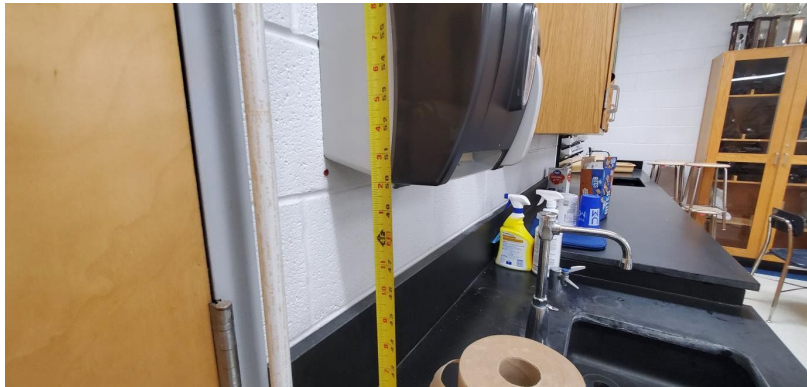
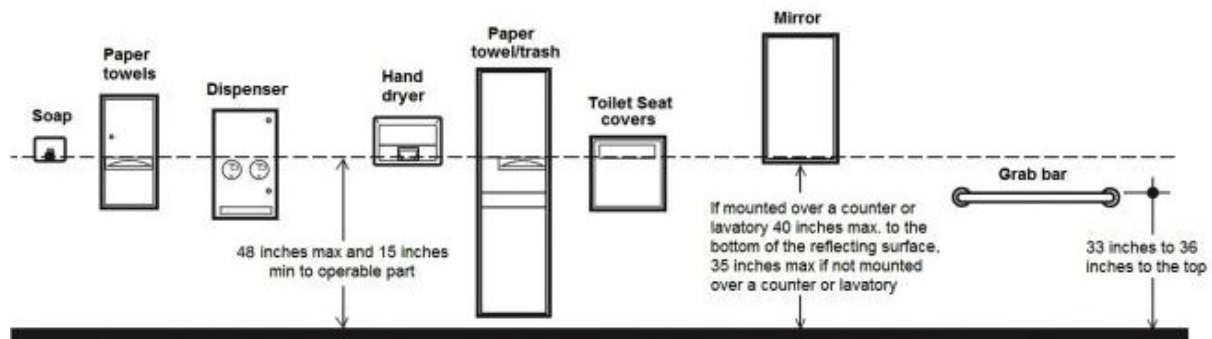
As Built: The paper towel dispenser's operation mechanism is too high off the floor. Dispensers must have all operable parts a maximum of 48 inches above the floor.

Citation: 2010 ADAS Section 308.2.1

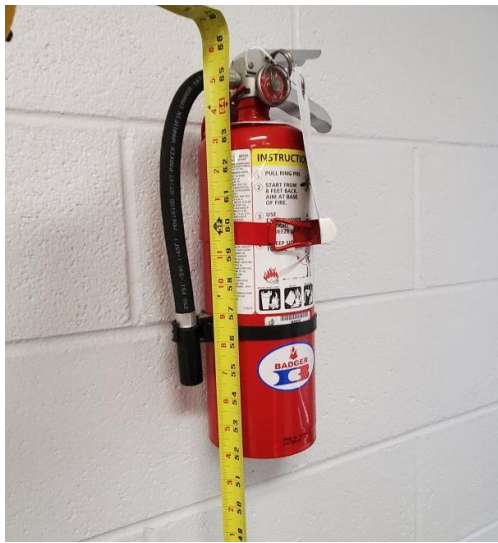
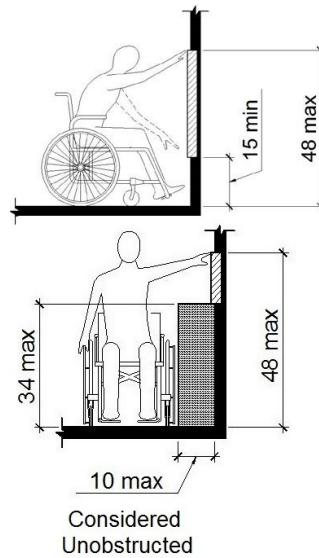
As Built: The Fire Extinguisher is not positioned correctly for either a side or front approach.

Where a clear floor or ground space allows a parallel or front approach and the side reach is unobstructed, the high side reach shall be 48 inches maximum above the finish floor or ground and the low side reach shall be 15 inches minimum above the finish floor or ground.

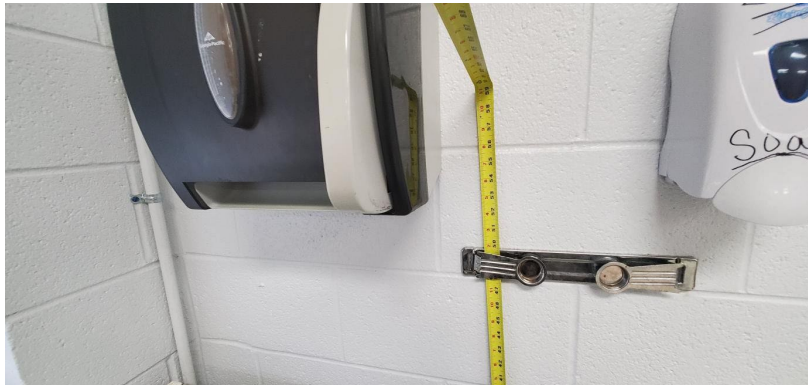
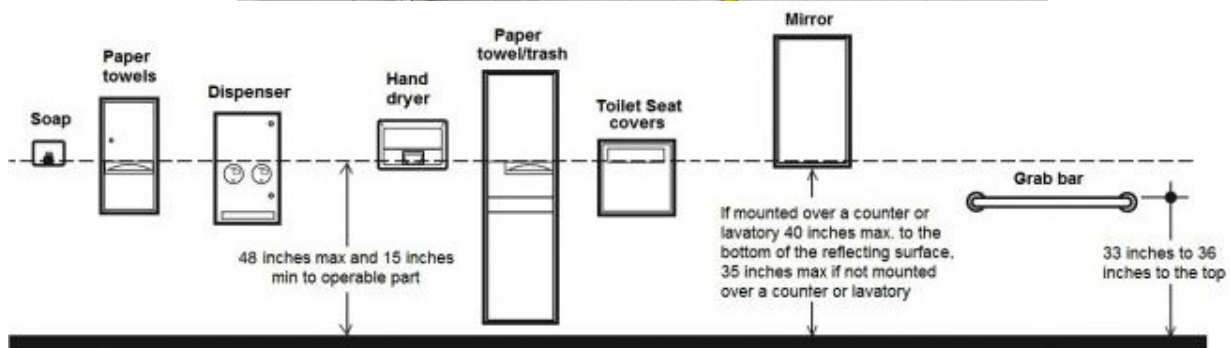
As Built: The paper towel dispenser's operation mechanism is too high off the floor. Dispensers must have all operable parts a maximum of 48 inches above the floor.

Citation: 2010 ADAS Section 308.2.1

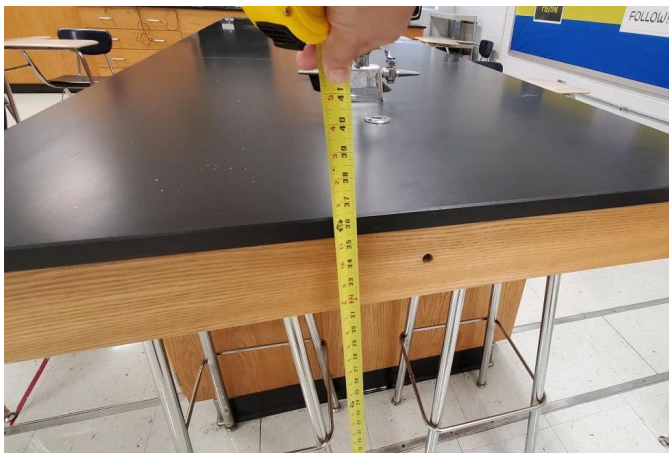
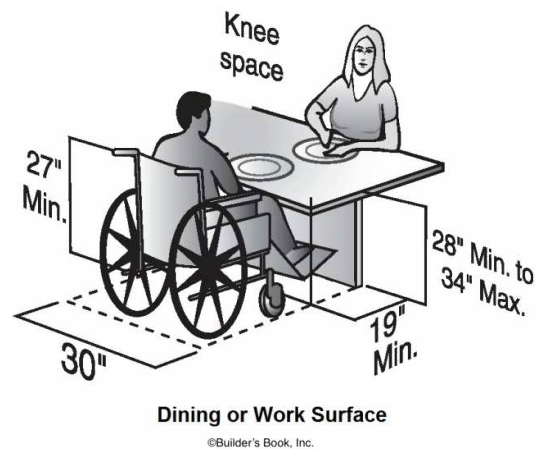
As Built: The work surface is not within the allowable range.

The tops of work surfaces provided for public use or common use shall be 28 inches minimum and 34 inches maximum above the finish floor or ground.

Citation: 2010 ADAS Section 902.3

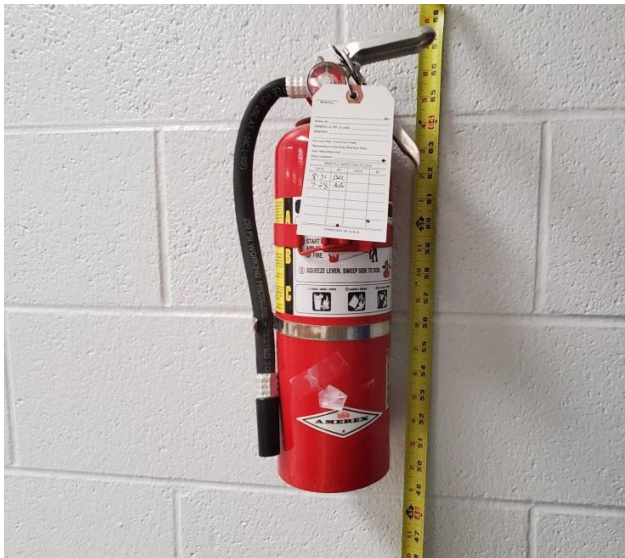
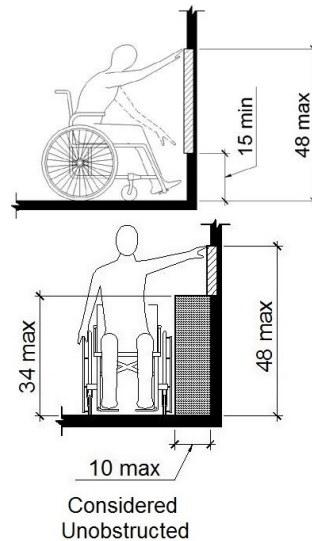
As Built: The Fire Extinguisher is not positioned correctly for either a side or front approach.

Where a clear floor or ground space allows a parallel or front approach and the side reach is unobstructed, the high side reach shall be 48 inches maximum above the finish floor or ground and the low side reach shall be 15 inches minimum above the finish floor or ground.

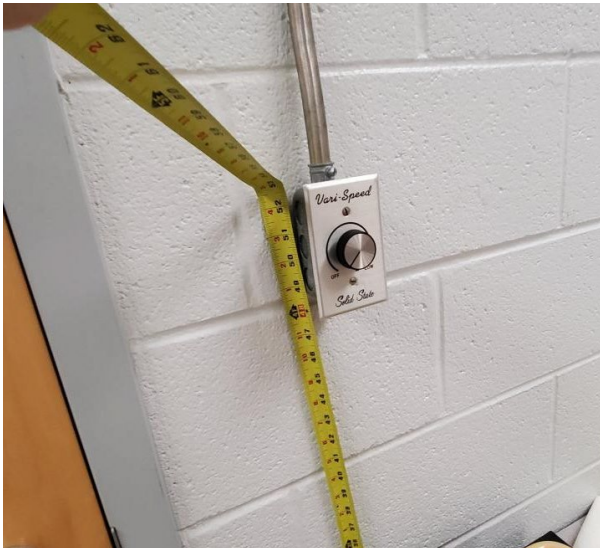
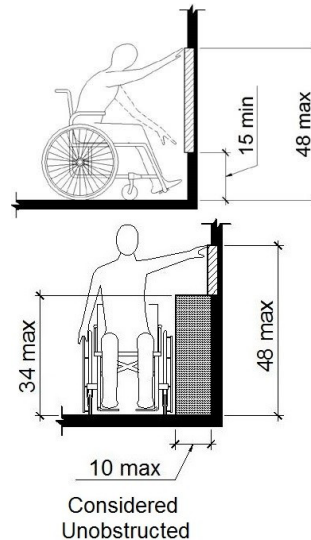
As Built: The thermostat is not positioned correctly for either a side or front approach.

Where a clear floor or ground space allows a parallel or front approach and the side reach is unobstructed, the high side reach shall be 48 inches maximum above the finish floor or ground and the low side reach shall be 15 inches minimum above the finish floor or ground.

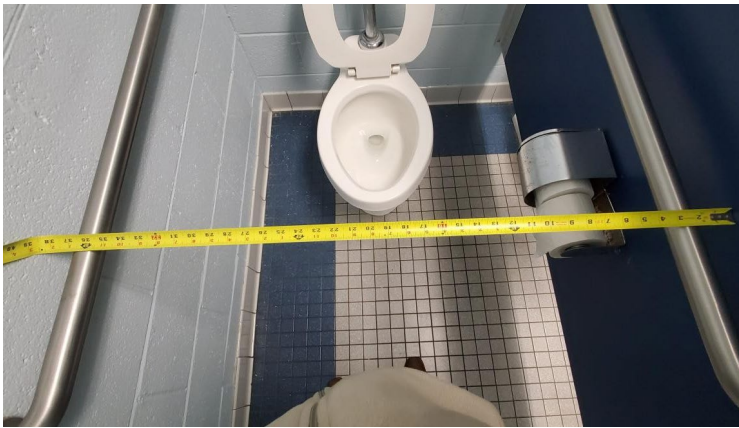
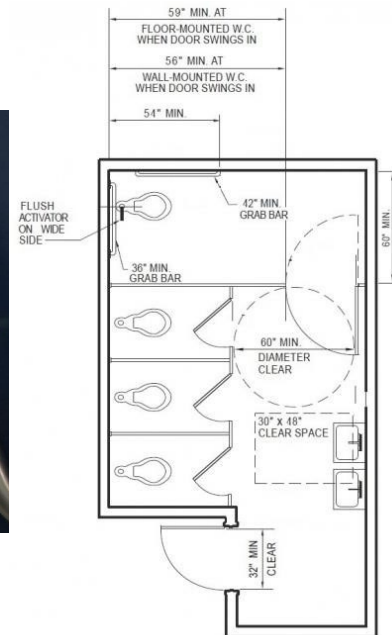
As Built: The toilet compartment does not have the required minimum clear floor space or maneuvering clearances for the toilet. Side grab bar installed incorrectly and rear grab bar missing.

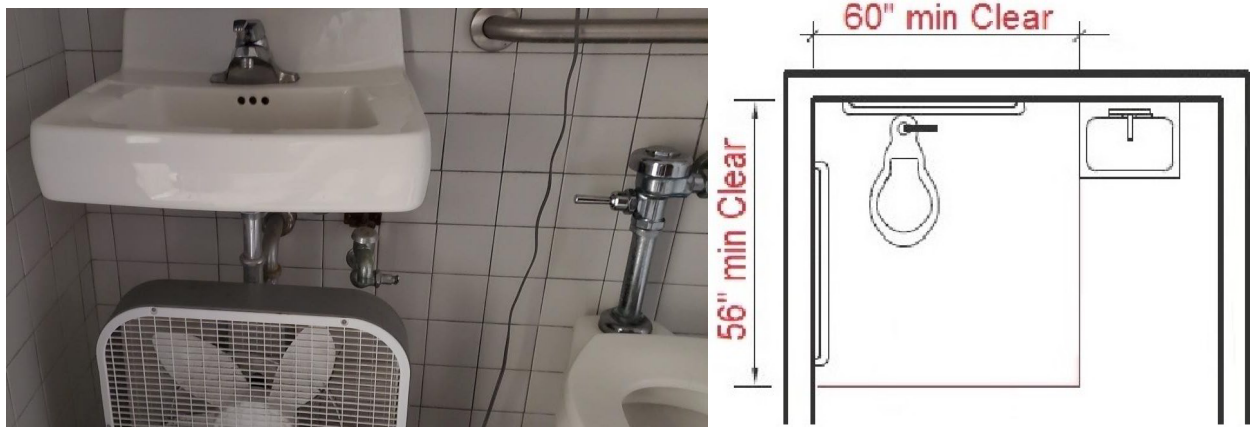
As Built: The lavatory projects into the clear floor space required for the toilet. The clear floor space is 60 inches along the back wall by 56 inches.

The required clearance around the water closet shall be permitted to overlap the water closet, associated grab bars, dispensers, sanitary napkin disposal units, coat hooks, shelves, accessible routes, clear floor space and clearances required at other fixtures, and the turning space. No other fixtures or obstructions shall be located within the required water closet clearance.

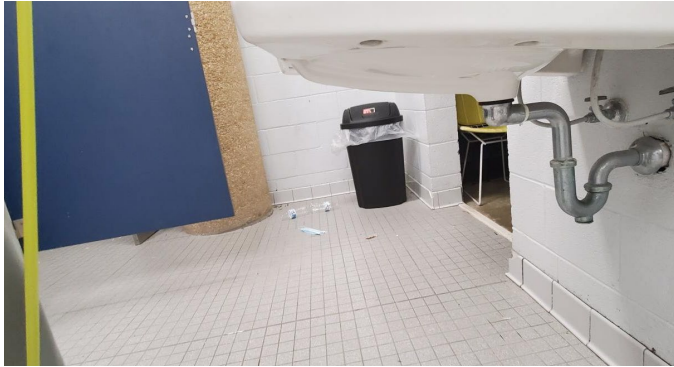
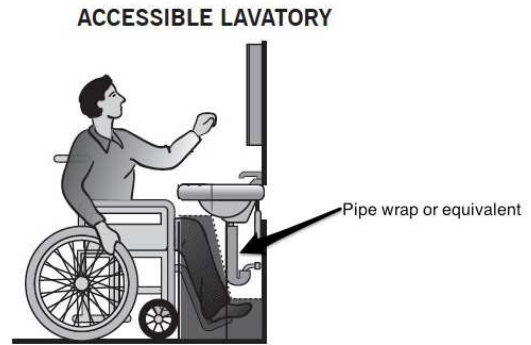
As Built: The water and drainpipes under the lavatory are not adequately insulated.

Water supply and drainpipes under lavatories and sinks shall be insulated or otherwise configured to protect against contact. There shall be no sharp or abrasive surfaces under lavatories and sinks.

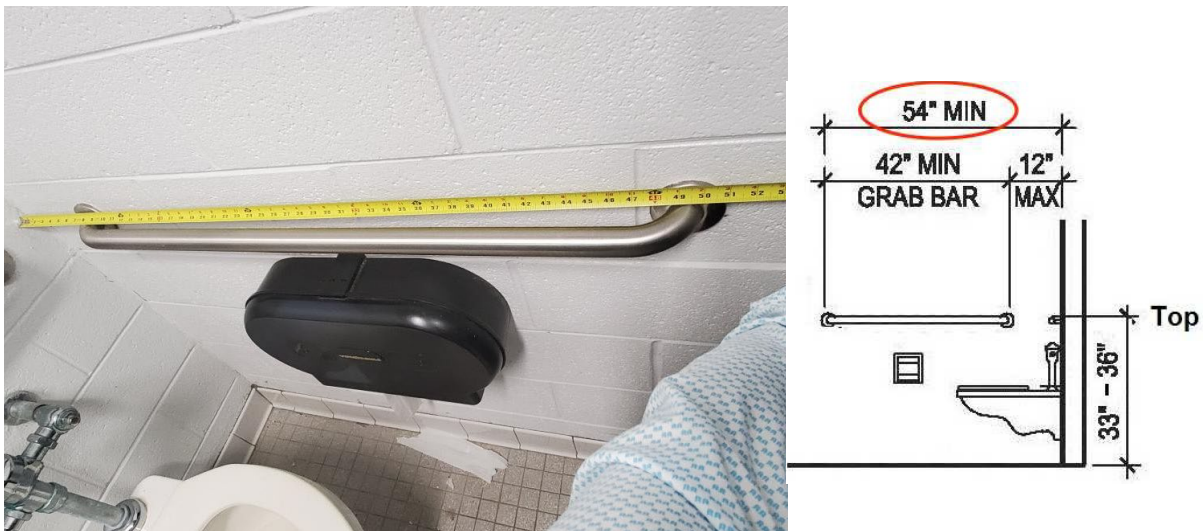
As Built: The side grab bar does not extend far enough from the rear wall.

The side grab bar must extend at least 54 inches minimum beyond the rear wall and start a maximum of 12 inches from the rear wall. A 42 inch grab bar installed the maximum distance from the rear wall (12 inches) will leave the leading end 54 inches from the rear wall.

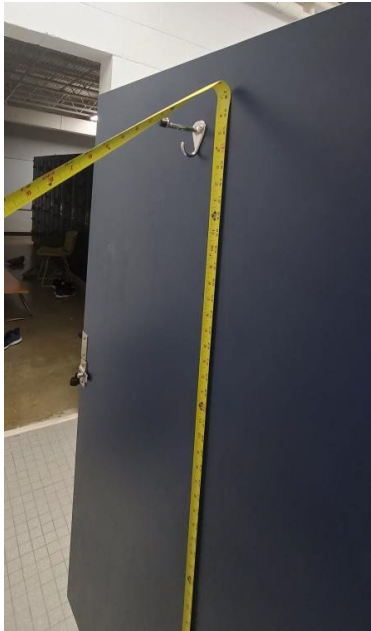
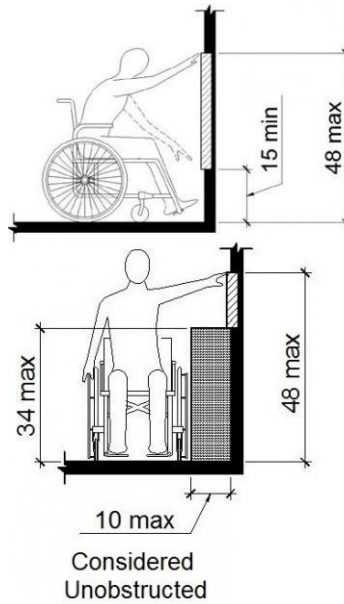
As Built: The coat hook is installed greater than 48 inches above the finished floor.

Where a forward reach is unobstructed, the high forward reach shall be 48 inches maximum above the finished floor.

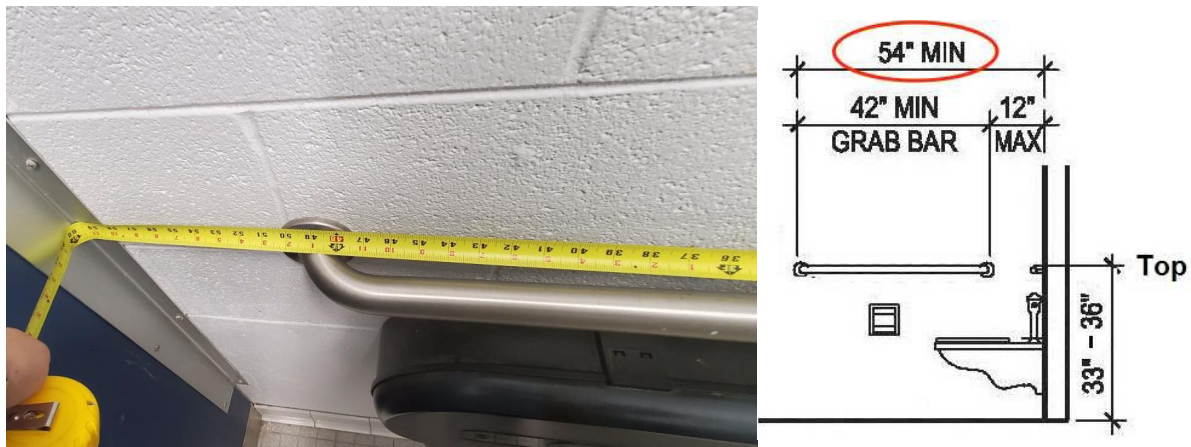
As Built: The side grab bar does not extend far enough from the rear wall.

The side grab bar must extend at least 54 inches minimum beyond the rear wall and start a maximum of 12 inches from the rear wall. A 42 inch grab bar installed the maximum distance from the rear wall (12 inches) will leave the leading end 54 inches from the rear wall.

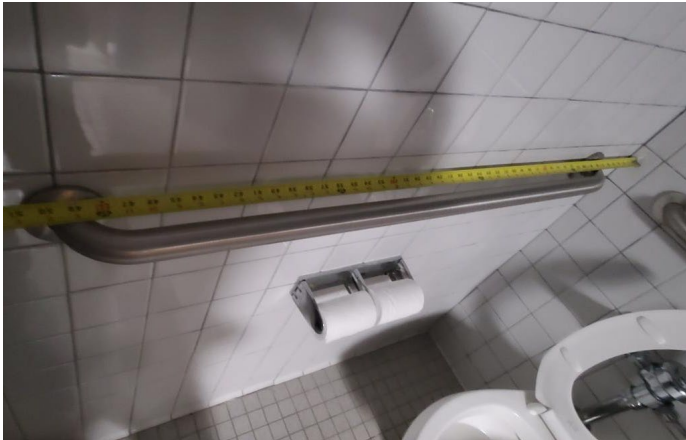
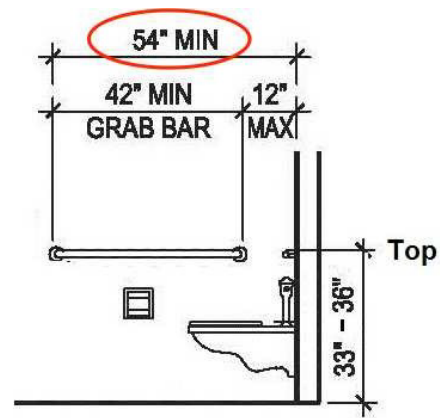
As Built: The side grab bar does not extend far enough from the rear wall.

The side grab bar must extend at least 54 inches minimum beyond the rear wall and start a maximum of 12 inches from the rear wall. A 42 inch grab bar installed the maximum distance from the rear wall (12 inches) will leave the leading end 54 inches from the rear wall.

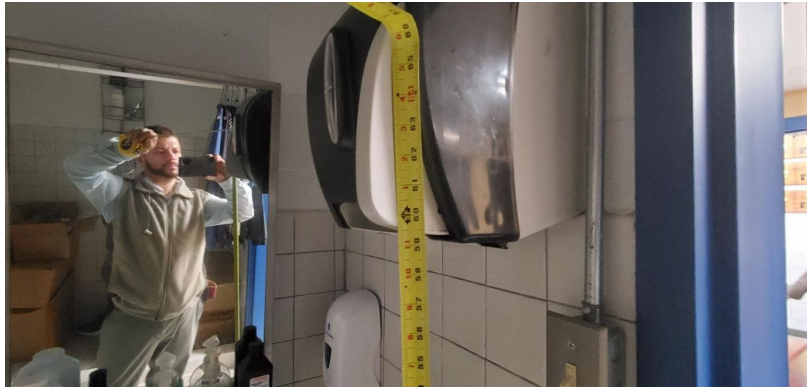
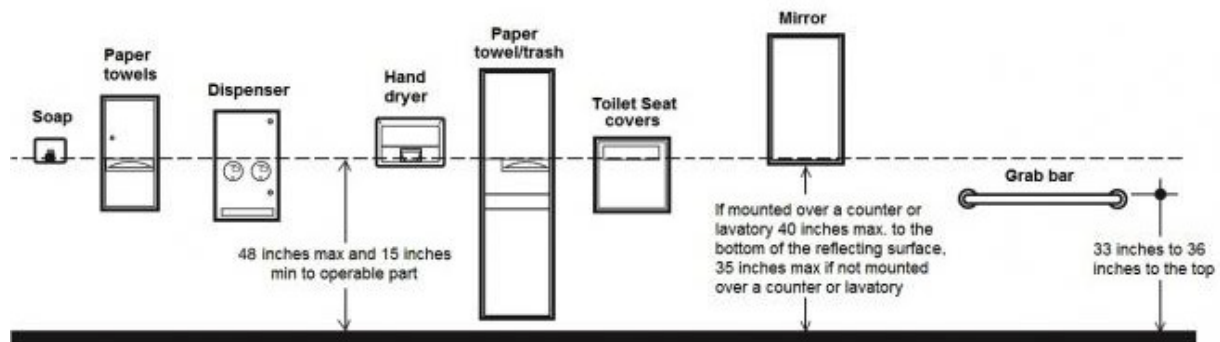
As Built: The paper towel dispenser's operation mechanism is too high off the floor. Dispensers must have all operable parts a maximum of 48 inches above the floor.

Citation: 2010 ADAS Section 308.2.1

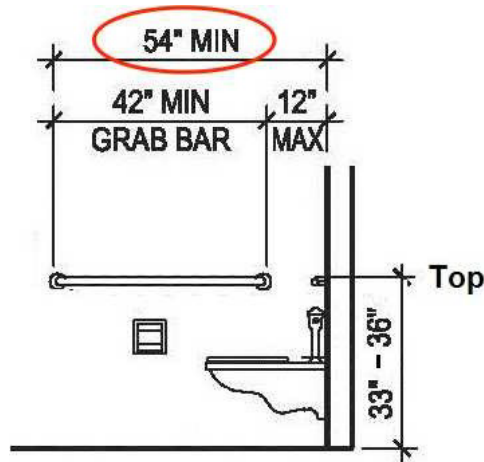
As Built: The side grab bar does not extend far enough from the rear wall.

The side grab bar must extend at least 54 inches minimum beyond the rear wall and start a maximum of 12 inches from the rear wall. A 42 inch grab bar installed the maximum distance from the rear wall (12 inches) will leave the leading end 54 inches from the rear wall.

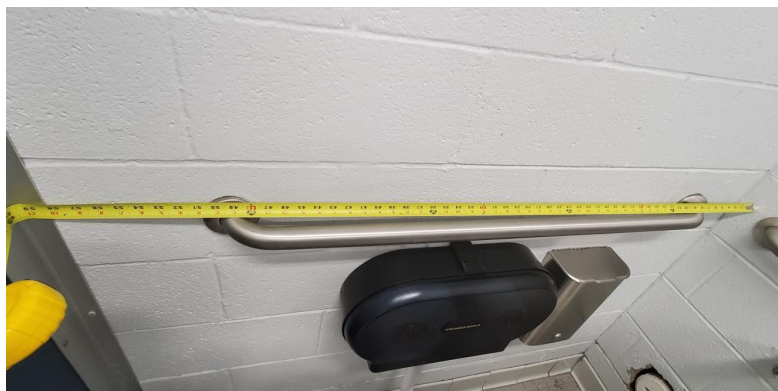
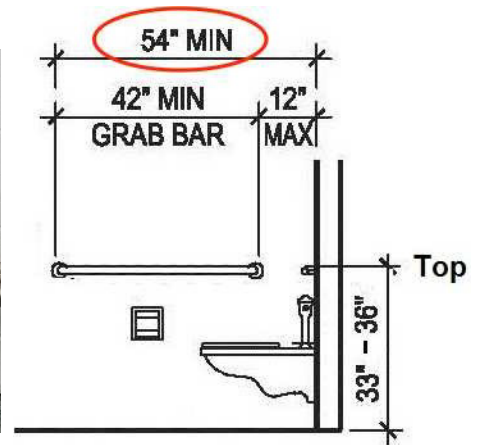
As Built: The side grab bar does not extend far enough from the rear wall.

The side grab bar must extend at least 54 inches minimum beyond the rear wall and start a maximum of 12 inches from the rear wall. A 42 inch grab bar installed the maximum distance from the rear wall (12 inches) will leave the leading end 54 inches from the rear wall.

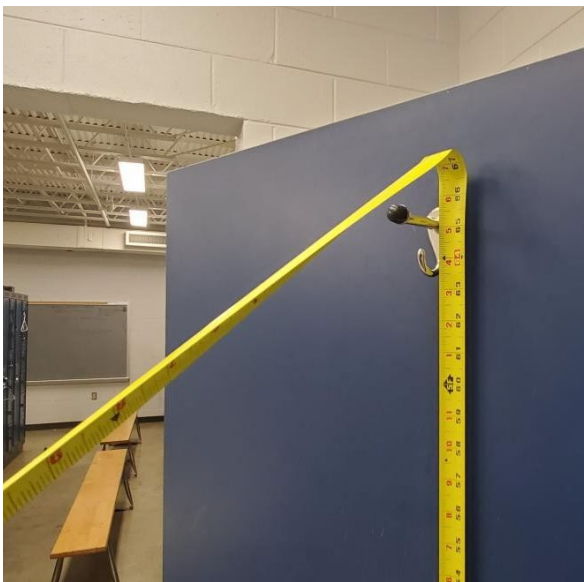
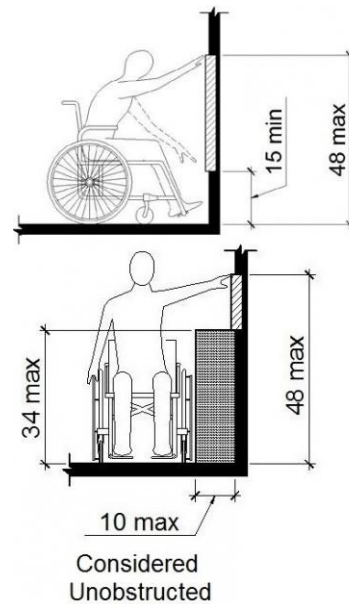
As Built: The coat hook is installed greater than 48 inches above the finished floor.

Where a forward reach is unobstructed, the high forward reach shall be 48 inches maximum above the finished floor.

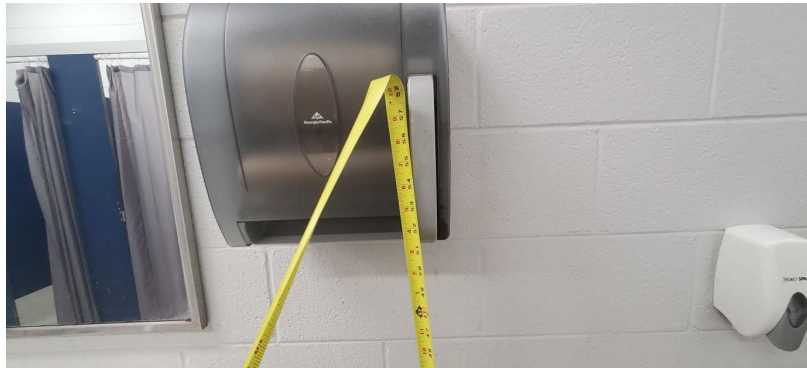
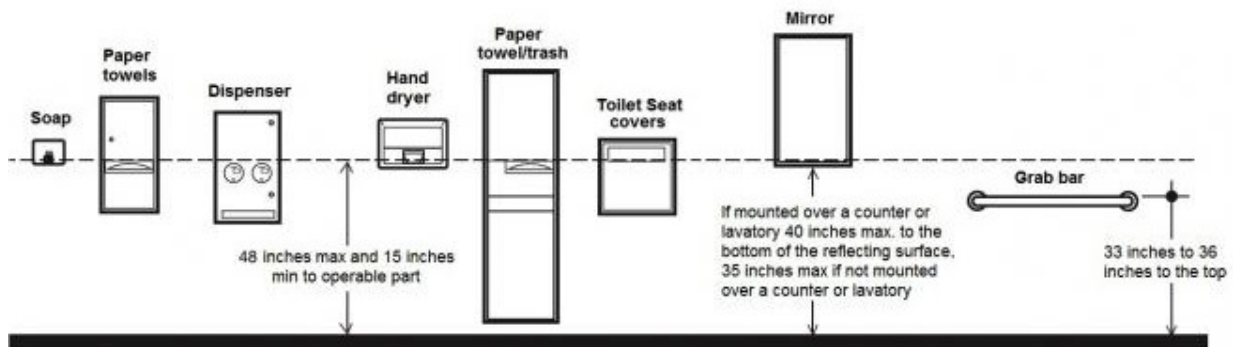
As Built: The paper towel dispenser's operation mechanism is too high off the floor. Dispensers must have all operable parts a maximum of 48 inches above the floor.

Citation: 2010 ADAS Section 308.2.1
