WEAKLEY COUNTY, TENNESSEE

ADA EVALUATION

Architectural and Site Findings with Recommendations

TLM Associates, Inc

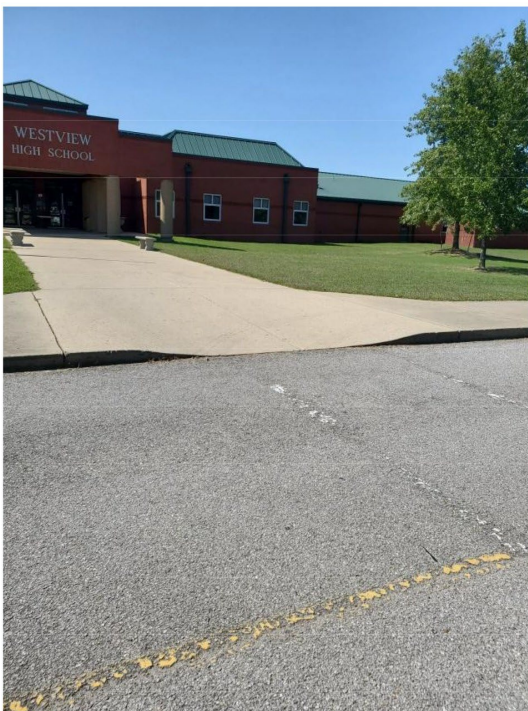
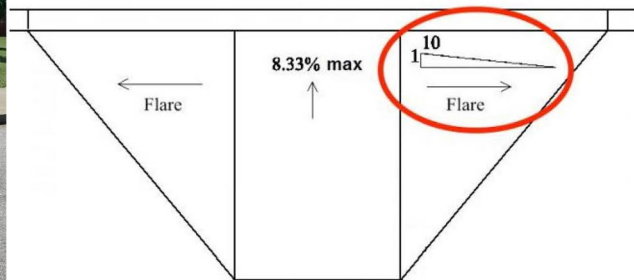
As Built: The curb ramp side flares slope 13-14%, which are too steep.

The sides of curb ramps (curb ramp flares) where provided, shall not be steeper than 1:10.

Replace the curb ramp.

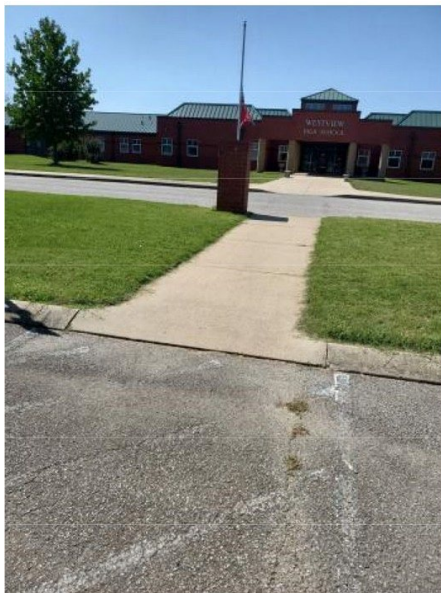
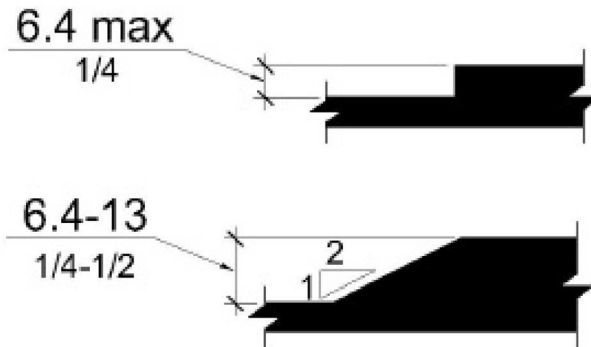
As Built: The surface of the pedestrian access route has vertical discontinuities greater than 1/2 inch or between 1/4 inch and 1/2 inch that are not beveled.

Citation: 2011 PROWAG Section R302.7.2

Bevel transition or replace sidewalk panel.

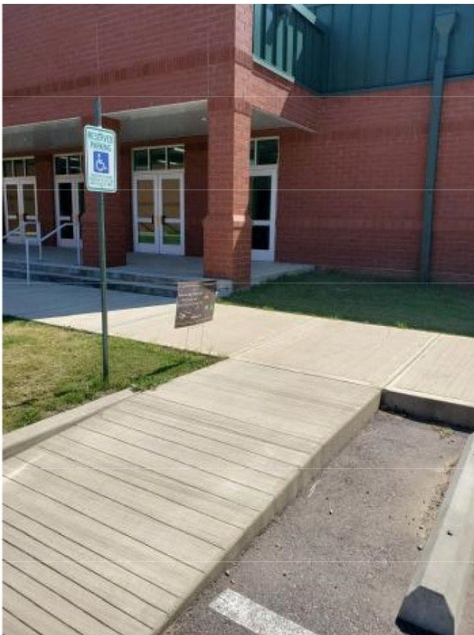
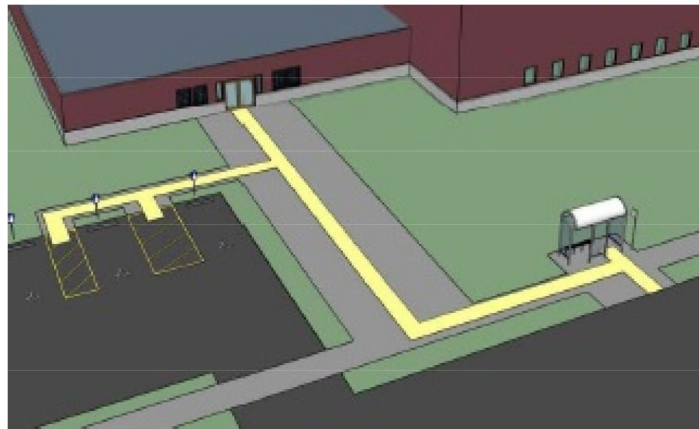
As Built: The current condition is forcing wheelchair users to go past the entrance and back to gain access to the building. The accessible parking space is not located on the shortest accessible route to the building.

Accessible parking spaces serving a particular building or facility entrance shall be located on the shortest accessible route of travel from the parking space to an accessible entrance.

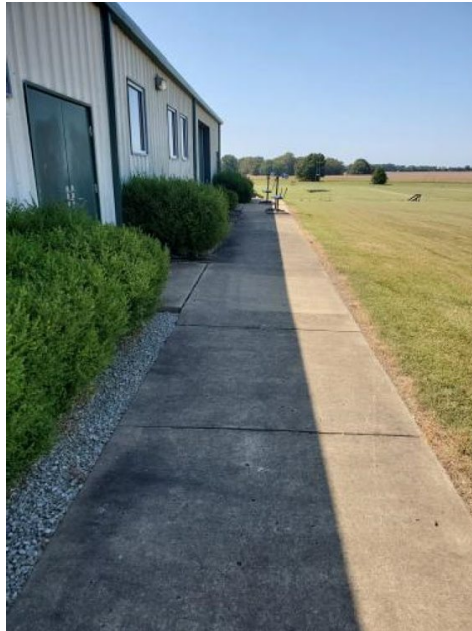
As Built: Replace approximately 6'x 60' total, in sections in front of doors. The cross slope of the pedestrian access route is excessive.

The cross slope of pedestrian access routes shall be 2 percent maximum.

Replace approximately 6'x 60' total, in sections in front of doors.

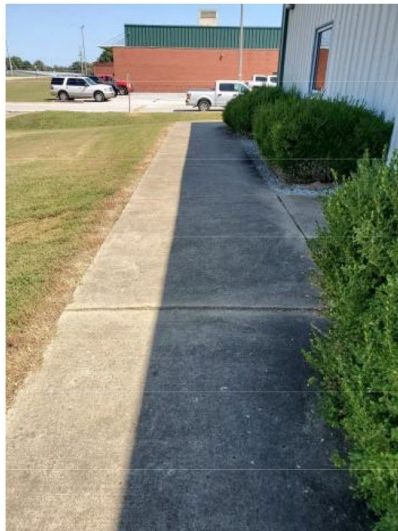
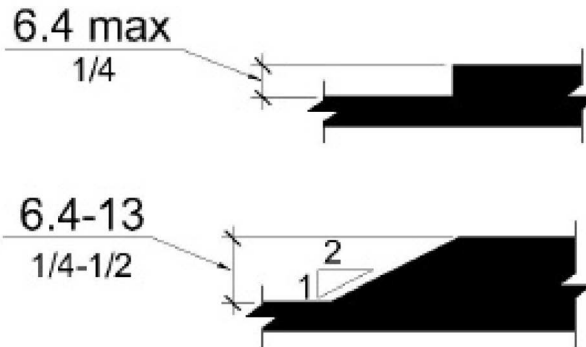
As Built: The surface of the pedestrian access route has vertical discontinuities greater than 1/2 inch or between 1/4 inch and 1/2 inch that are not beveled.

Vertical surface discontinuities shall be 0.5 inch maximum. Vertical surface discontinuities between 0.25 inch and 0.5 inch shall be beveled with a slope not steeper than 50 percent. The bevel shall be applied across the entire vertical surface discontinuity.

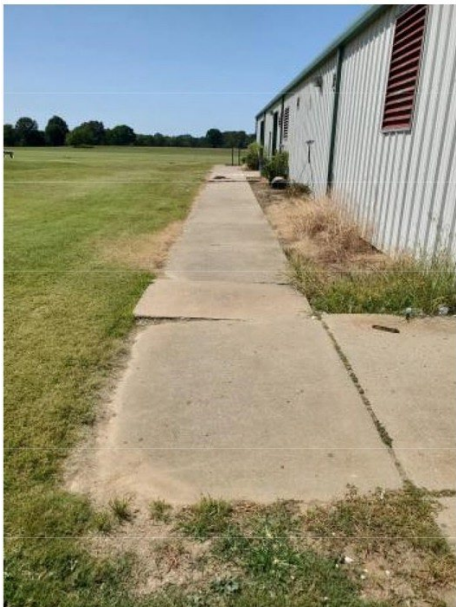
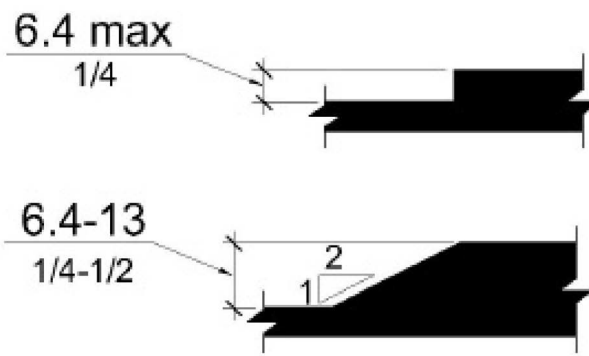
As Built: The surface of the pedestrian access route has vertical discontinuities greater than 1/2 inch or between 1/4 inch and 1/2 inch that are not beveled.

Vertical surface discontinuities shall be 0.5 inch maximum. Vertical surface discontinuities between 0.25 inch and 0.5 inch shall be beveled with a slope not steeper than 50 percent. The bevel shall be applied across the entire vertical surface discontinuity.

Replace 6'x5' sidewalk.

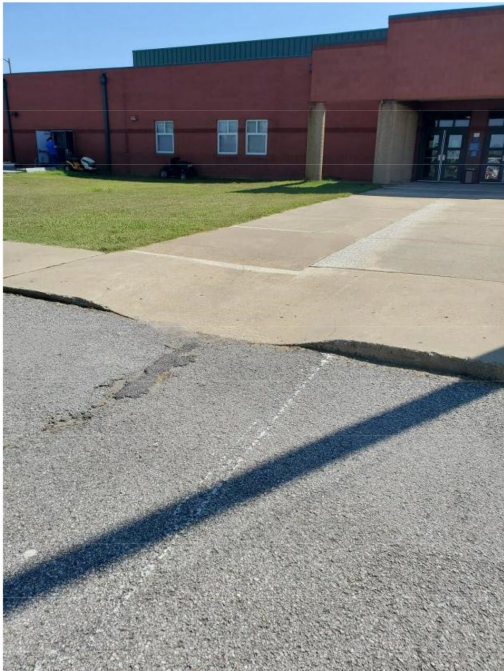
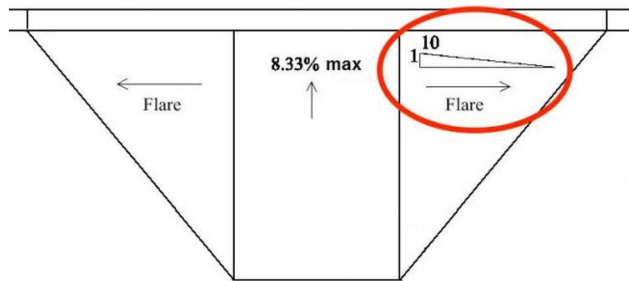
As Built: The curb ramp side flares slope at 19%, which is too steep.

The sides of curb ramps (curb ramp flares) where provided, shall not be steeper than 1:10.

Replace the curb ramp.

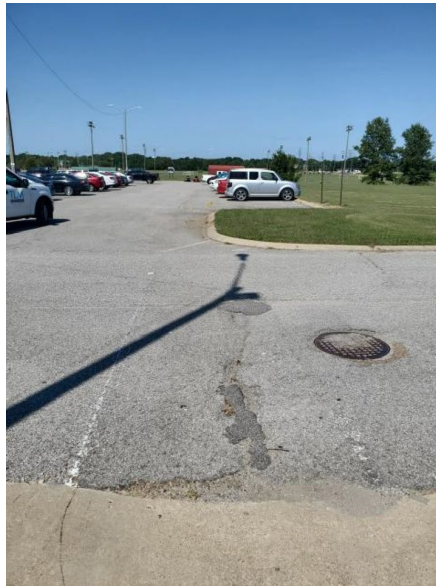
As Built: There is loose gravel, patched, uneven pavement, dilapidated crosswalk striping. The surface of the pedestrian access route is not firm, stable and slip resistant.

The surfaces of pedestrian access routes and elements and spaces along the pedestrian access route that are required to be accessible that connect to pedestrian access routes shall be firm, stable, and slip resistant.

Remove and replace asphalt and re-stripe crosswalk.

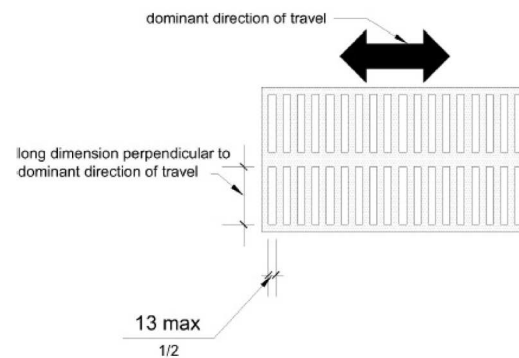
As Built: The surface of the pedestrian access route has openings greater than 1/2 inch.

Horizontal openings in gratings and joints shall not permit passage of a sphere more than 13 mm (0.5 in) in diameter.

Replace 10x5' sidewalk panels.

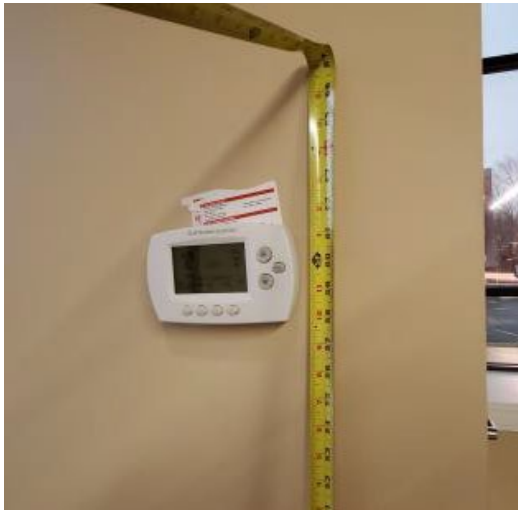
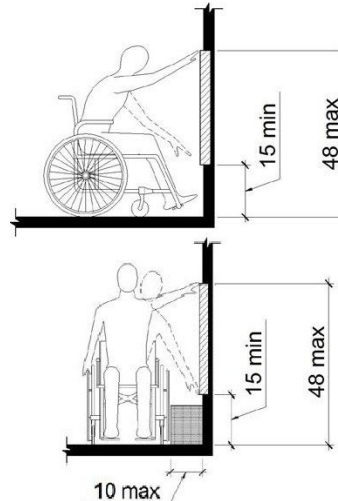
As Built: The Thermostat is positioned too high for either a side or front approach.

Where a clear floor or ground space allows a parallel approach to an element and the side reach is unobstructed, the high side reach shall be 48 inches maximum, and the low side reach shall be 15 inches minimum above the finish floor or ground.

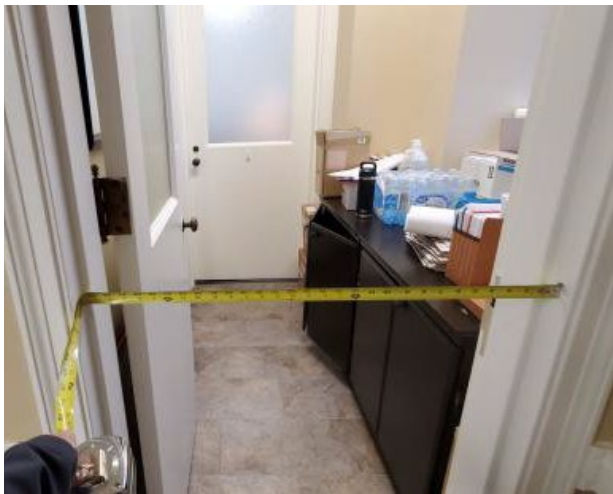
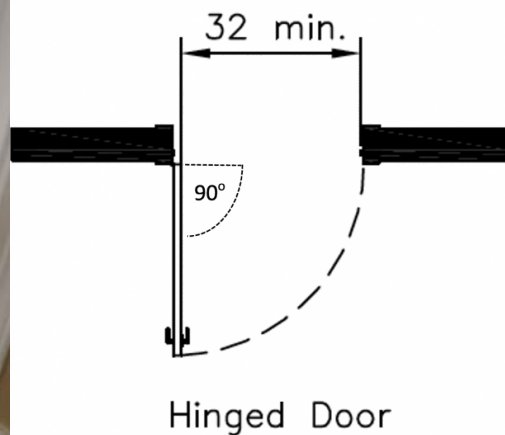
As Built: The door opening does not provide at least 32 inches between the face of the door and the opposite stop.

Door openings shall provide a clear width of 32 inches minimum. Clear openings of doorways with swinging doors shall be measured between the face of the door and the stop, with the door open 90 degrees.

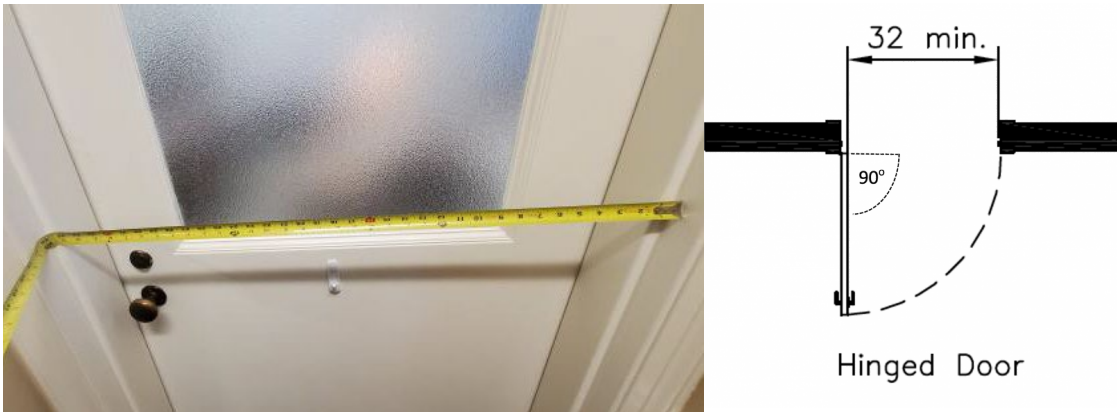
As Built: The door opening does not provide at least 32 inches between the face of the door and the opposite stop.

Door openings shall provide a clear width of 32 inches minimum. Clear openings of doorways with swinging doors shall be measured between the face of the door and the stop, with the door open 90 degrees.

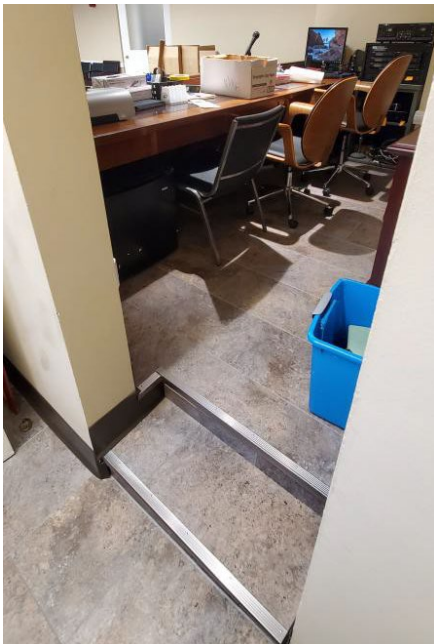
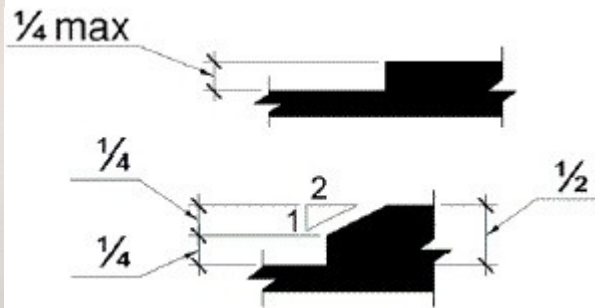
3 (Moderate): Should be completed as soon as possible, but there may be other items that will provide greater access to persons with disabilities. (Includes findings that have a high financial impact on the entity in relationship to the degree of access provided).

As Built: There is a change in level greater than 1/4 inch.

1/4 inch is the maximum vertical rise. Changes in level between 1/4 inch and 1/2 inch must be beveled at 1:2 or less. Changes in level greater than 1/2 inch must be by way of a ramp.

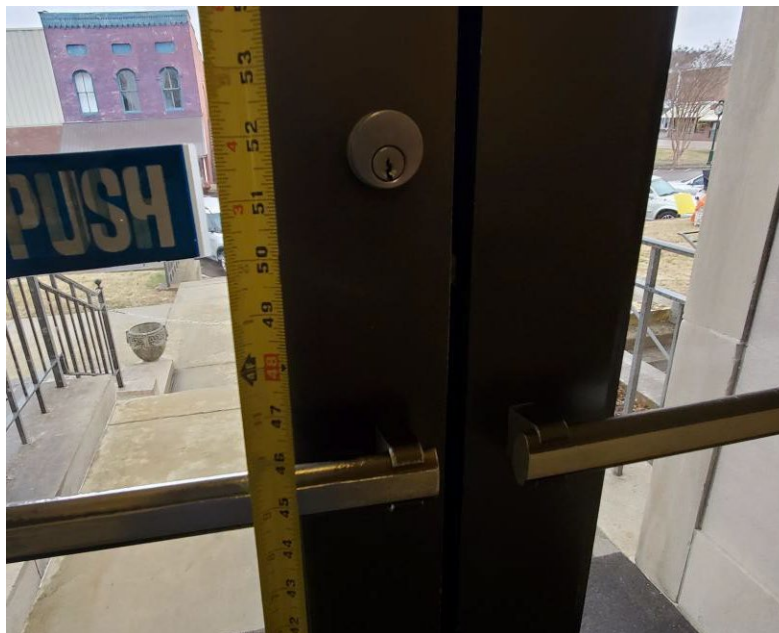
3 (Moderate): Should be completed as soon as possible, but there may be other items that will provide greater access to persons with disabilities. (Includes findings that have a high financial impact on the entity in relationship to the degree of access provided).

As Built: The door operating hardware exceeds maximum height requirements.

Hardware shall be 34 inches minimum and 48 inches maximum above the finish floor or ground.

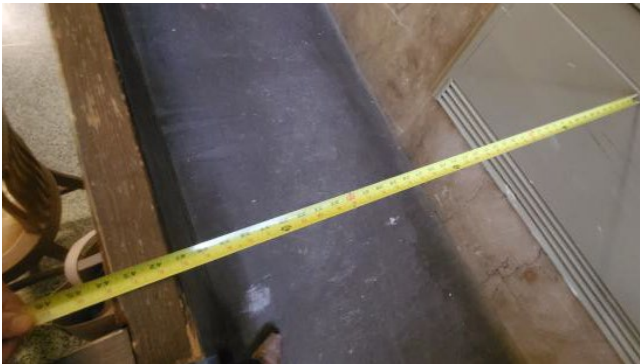
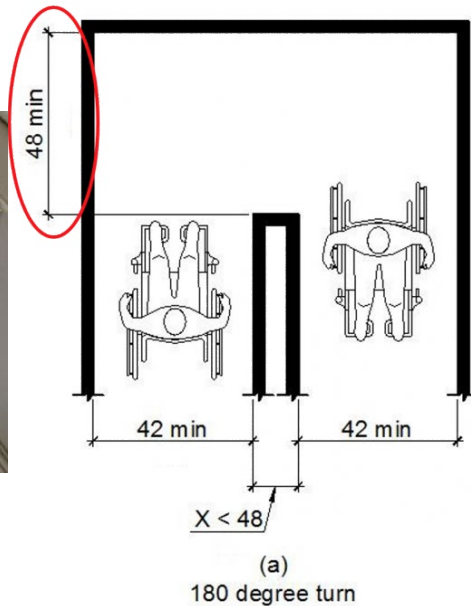
3 (Moderate): Should be completed as soon as possible, but there may be other items that will provide greater access to persons with disabilities. (Includes findings that have a high financial impact on the entity in relationship to the degree of access provided).

As Built: The queuing line is not a minimum 48 inches at the head of each turn with entry widths of 42 inches minimum.

Where the accessible route makes a 180 degree turn around an element which is less than 48 inches wide, clear width shall be 42 inches minimum approaching the turn, 48 inches minimum at the turn and 42 inches minimum leaving the turn. Where the clear width at the turn is 60 inches minimum a clear width 36 inches minimum approaching the turn and 36 inches minimum at the turn is acceptable.

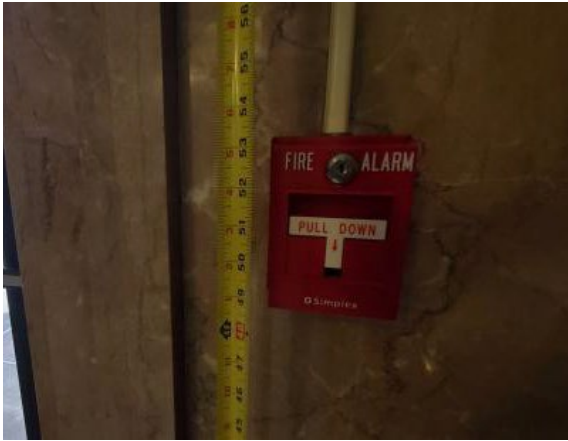
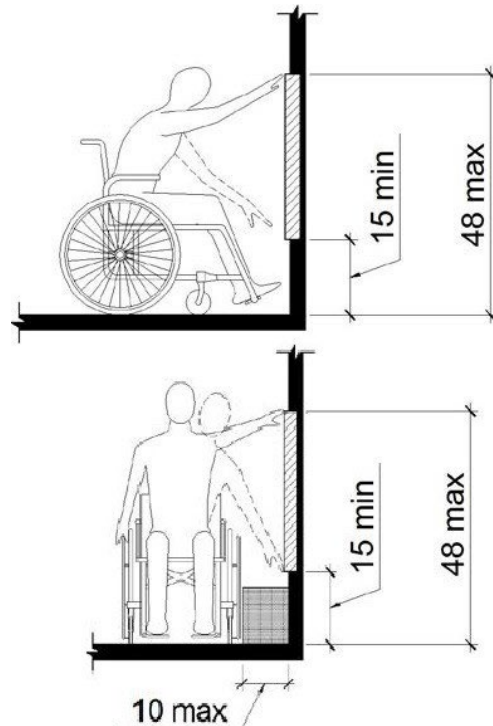
3 (Moderate): Should be completed as soon as possible, but there may be other items that will provide greater access to persons with disabilities. (Includes findings that have a high financial impact on the entity in relationship to the degree of access provided).

As Built: The fire alarm is positioned too high for either a side or front approach.

Where a clear floor or ground space allows a parallel approach to an element and the side reach is unobstructed, the high side reach shall be 48 inches maximum, and the low side reach shall be 15 inches minimum above the finish floor or ground.

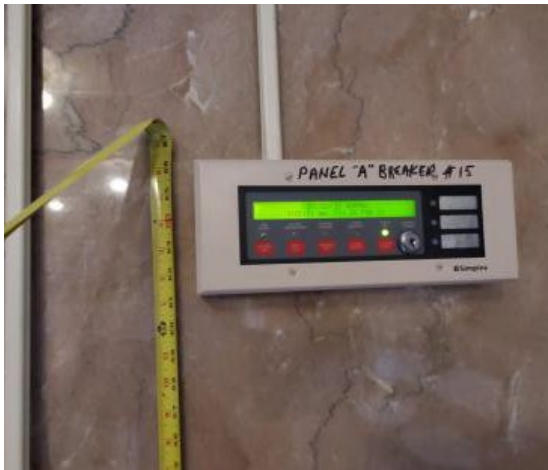
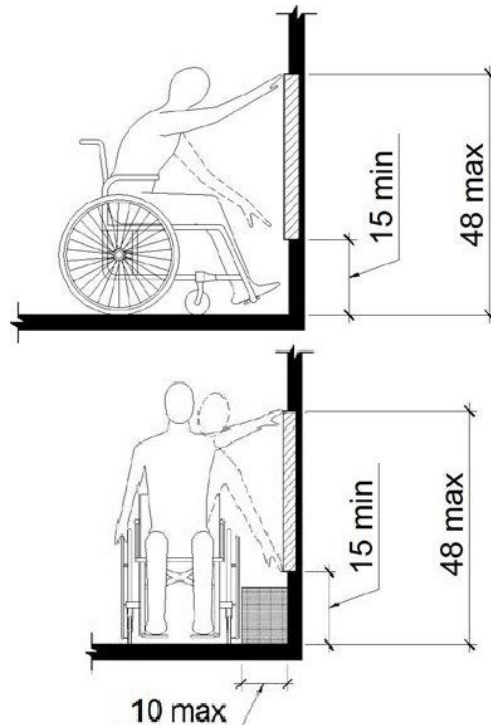
3 (Moderate): Should be completed as soon as possible, but there may be other items that will provide greater access to persons with disabilities. (Includes findings that have a high financial impact on the entity in relationship to the degree of access provided).

As Built: The Fire Alarm Pad is positioned too high for either a side or front approach.

Where a clear floor or ground space allows a parallel approach to an element and the side reach is unobstructed, the high side reach shall be 48 inches maximum and the low side reach shall be 15 inches minimum above the finish floor or ground.

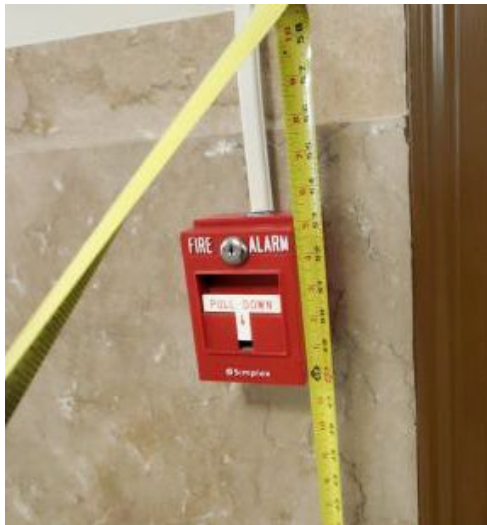
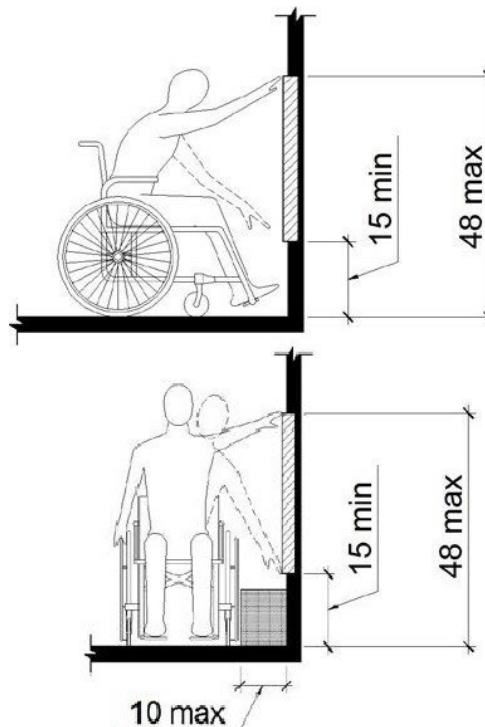
3 (Moderate): Should be completed as soon as possible, but there may be other items that will provide greater access to persons with disabilities. (Includes findings that have a high financial impact on the entity in relationship to the degree of access provided).

As Built: The Fire Alarm Pull is positioned too high for either a side or front approach.

Where a clear floor or ground space allows a parallel approach to an element and the side reach is unobstructed, the high side reach shall be 48 inches maximum, and the low side reach shall be 15 inches minimum above the finish floor or ground.

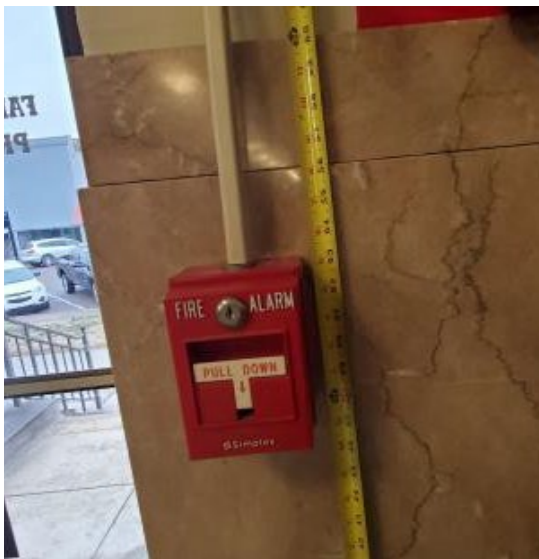
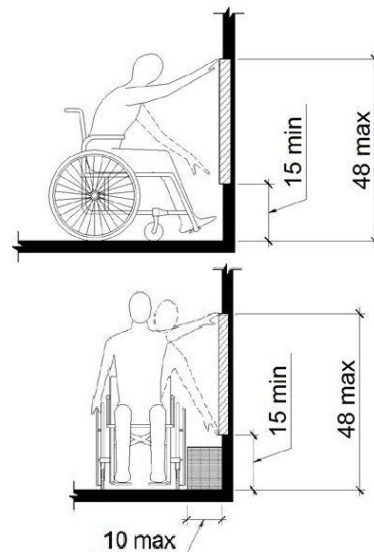
3 (Moderate): Should be completed as soon as possible, but there may be other items that will provide greater access to persons with disabilities. (Includes findings that have a high financial impact on the entity in relationship to the degree of access provided).

As Built: The Fire Alarm Pull is positioned too high for either a side or front approach.

Where a clear floor or ground space allows a parallel approach to an element and the side reach is unobstructed, the high side reach shall be 48 inches maximum, and the low side reach shall be 15 inches minimum above the finish floor or ground.

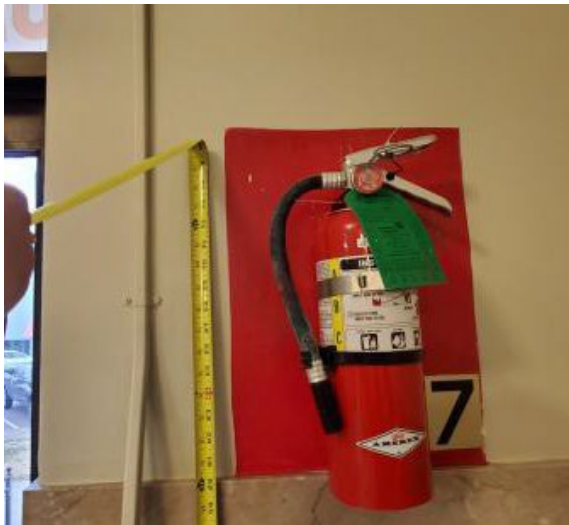
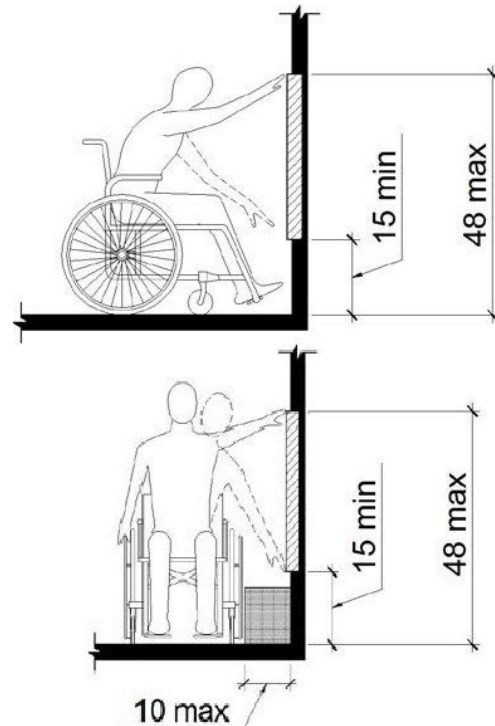
3 (Moderate): Should be completed as soon as possible, but there may be other items that will provide greater access to persons with disabilities. (Includes findings that have a high financial impact on the entity in relationship to the degree of access provided).

As Built: The fire extinguisher is positioned too high for either a side or front approach.

Where a clear floor or ground space allows a parallel approach to an element and the side reach is unobstructed, the high side reach shall be 48 inches maximum, and the low side reach shall be 15 inches minimum above the finish floor or ground.

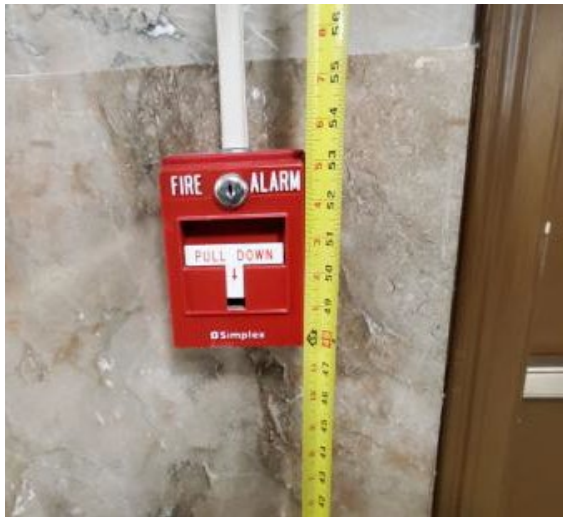
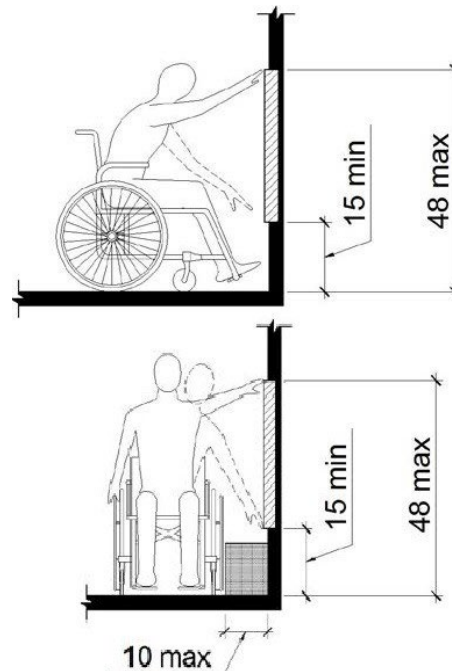
3 (Moderate): Should be completed as soon as possible, but there may be other items that will provide greater access to persons with disabilities. (Includes findings that have a high financial impact on the entity in relationship to the degree of access provided).

As Built: The Fire Alarm Pull is positioned too high for either a side or front approach.

Where a clear floor or ground space allows a parallel approach to an element and the side reach is unobstructed, the high side reach shall be 48 inches maximum, and the low side reach shall be 15 inches minimum above the finish floor or ground.

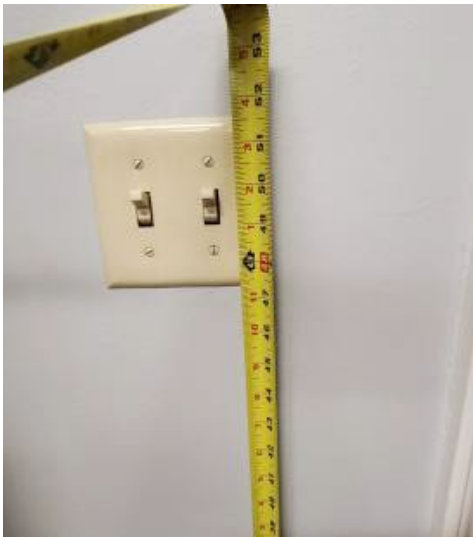
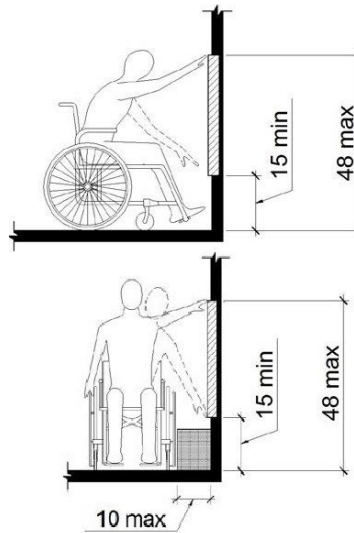
3 (Moderate): Should be completed as soon as possible, but there may be other items that will provide greater access to persons with disabilities. (Includes findings that have a high financial impact on the entity in relationship to the degree of access provided).

As Built: The switches throughout building are positioned too high for either a side or front approach.

Where a clear floor or ground space allows a parallel approach to an element and the side reach is unobstructed, the high side reach shall be 48 inches maximum, and the low side reach shall be 15 inches minimum above the finish floor or ground.

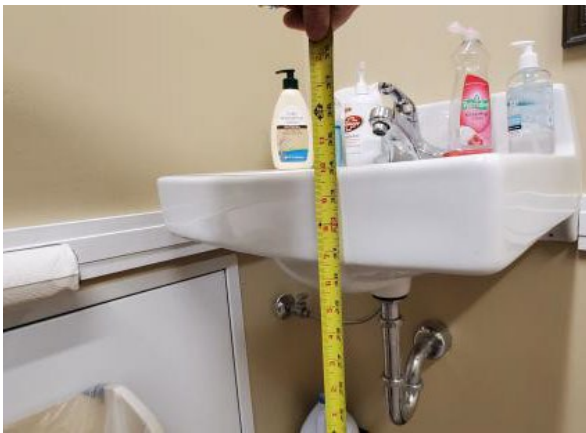
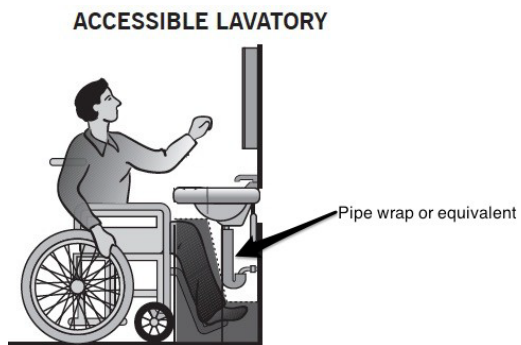
3 (Moderate): Should be completed as soon as possible, but there may be other items that will provide greater access to persons with disabilities. (Includes findings that have a high financial impact on the entity in relationship to the degree of access provided).

As Built: The water and drainpipes under the lavatory are not adequately insulated.

Water supply and drainpipes under lavatories and sinks shall be insulated or otherwise configured to protect against contact. There shall be no sharp or abrasive surfaces under lavatories and sinks.

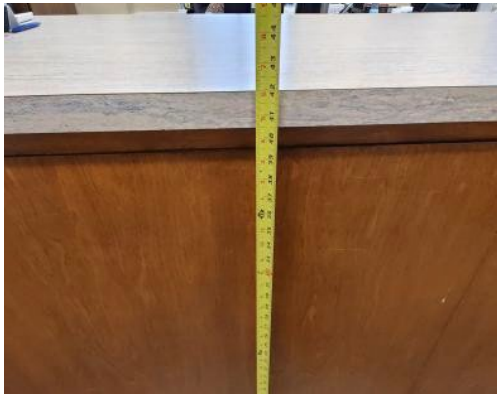
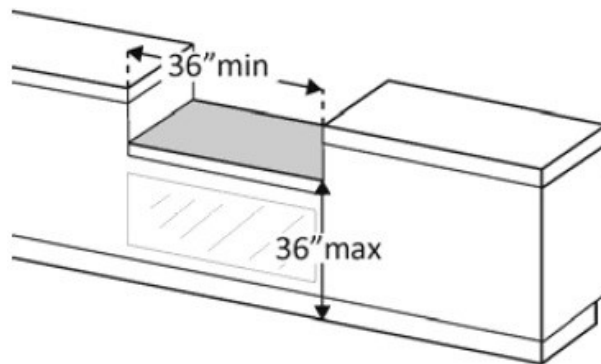
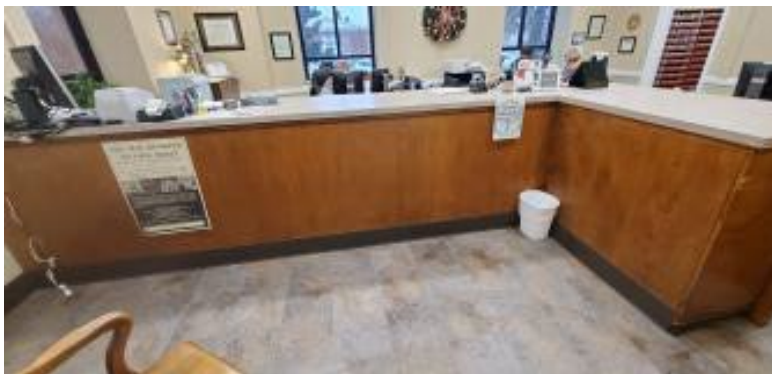
3 (Moderate): Should be completed as soon as possible, but there may be other items that will provide greater access to persons with disabilities. (Includes findings that have a high financial impact on the entity in relationship to the degree of access provided).

As Built: The counter is too high.

A portion of the counter surface that is 36 inches long minimum and 36 inches high maximum above the finish floor shall be provided. Knee and toe space must be provided for a forward approach. A 30 inch by 48 inch clear floor space on an accessible route must be provided for either a forward or parallel approach.

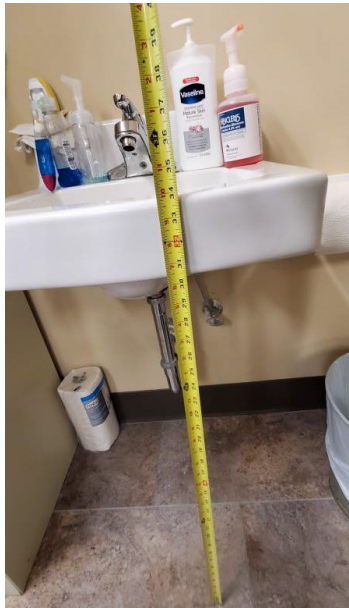
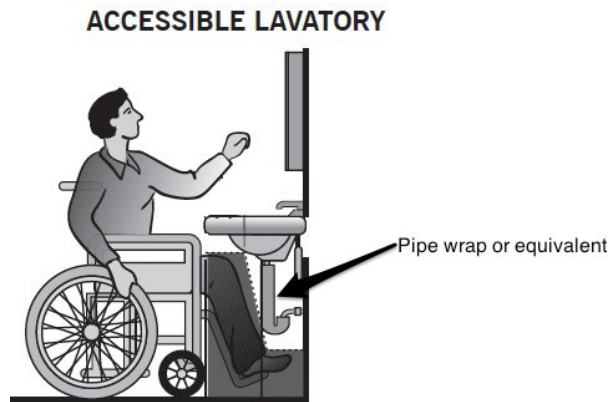
3 (Moderate): Should be completed as soon as possible, but there may be other items that will provide greater access to persons with disabilities. (Includes findings that have a high financial impact on the entity in relationship to the degree of access provided).

As Built: The water and drainpipes under the lavatory are not adequately insulated.

Water supply and drainpipes under lavatories and sinks shall be insulated or otherwise configured to protect against contact. There shall be no sharp or abrasive surfaces under lavatories and sinks.

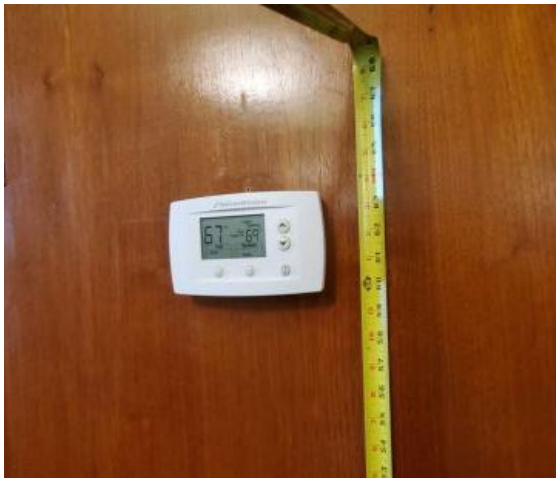
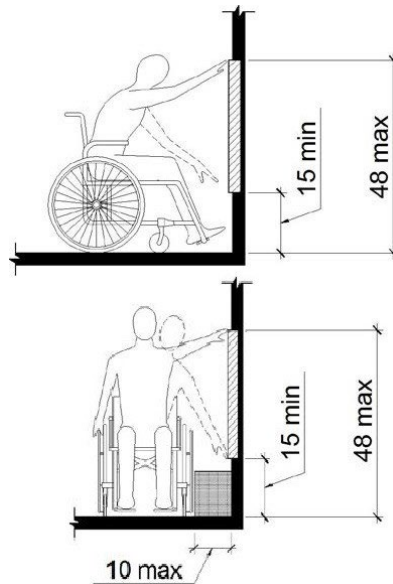
3 (Moderate): Should be completed as soon as possible, but there may be other items that will provide greater access to persons with disabilities. (Includes findings that have a high financial impact on the entity in relationship to the degree of access provided).

As Built: The Thermostat is positioned too high for either a side or front approach.

Where a clear floor or ground space allows a parallel approach to an element and the side reach is unobstructed, the high side reach shall be 48 inches maximum, and the low side reach shall be 15 inches minimum above the finish floor or ground.

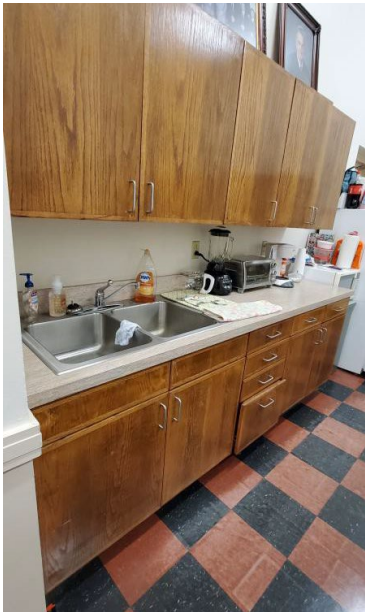
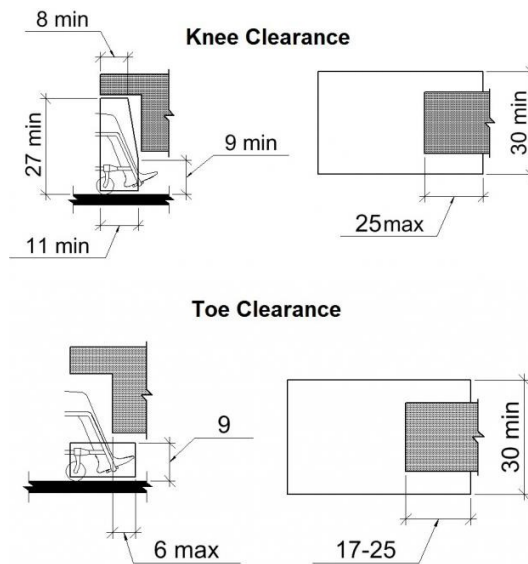
3 (Moderate): Should be completed as soon as possible, but there may be other items that will provide greater access to persons with disabilities. (Includes findings that have a high financial impact on the entity in relationship to the degree of access provided).

As Built: Knee and toe clearance has not been provided at the sink.

The knee clearance shall be 11 inches deep minimum at 9 inches above the finish floor or ground, and 8 inches deep minimum at 27 inches above the finish floor or ground.

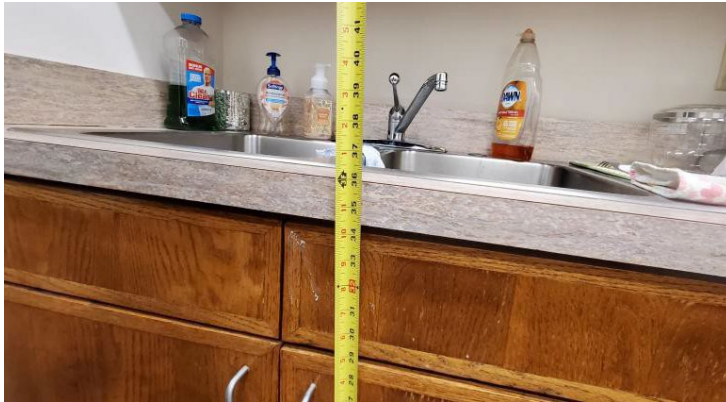
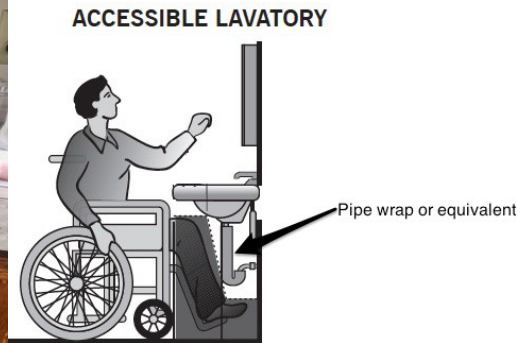
3 (Moderate): Should be completed as soon as possible, but there may be other items that will provide greater access to persons with disabilities. (Includes findings that have a high financial impact on the entity in relationship to the degree of access provided).

As Built: The top of the sink is above the allowable height requirement.

Sinks shall be installed with the front of the higher of the rim or counter surface 34 inches maximum above the finish floor or ground.

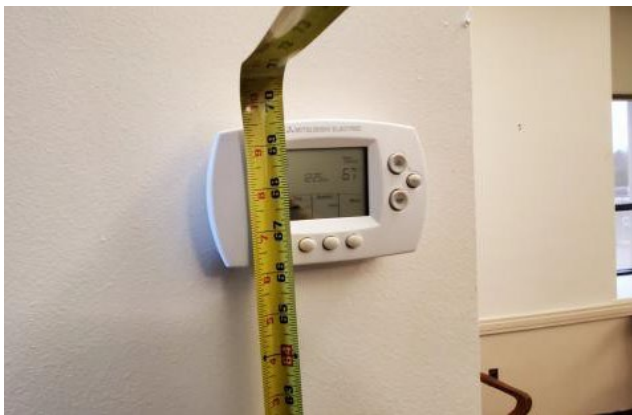
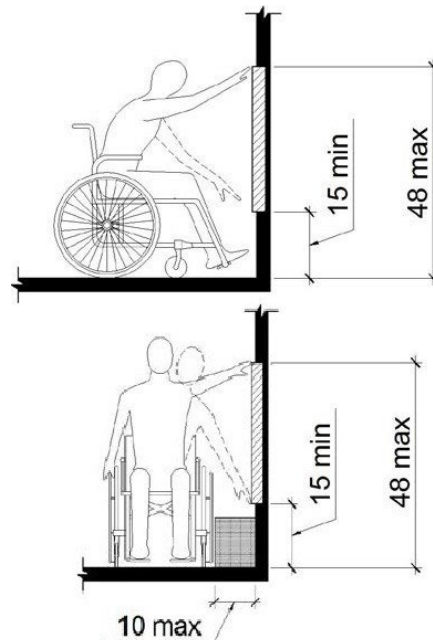
3 (Moderate): Should be completed as soon as possible, but there may be other items that will provide greater access to persons with disabilities. (Includes findings that have a high financial impact on the entity in relationship to the degree of access provided).

As Built: The Thermostat is positioned too high for either a side or front approach.

Where a clear floor or ground space allows a parallel approach to an element and the side reach is unobstructed, the high side reach shall be 48 inches maximum, and the low side reach shall be 15 inches minimum above the finish floor or ground.

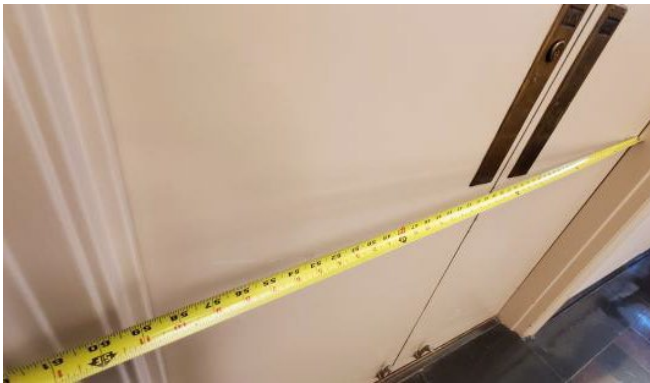
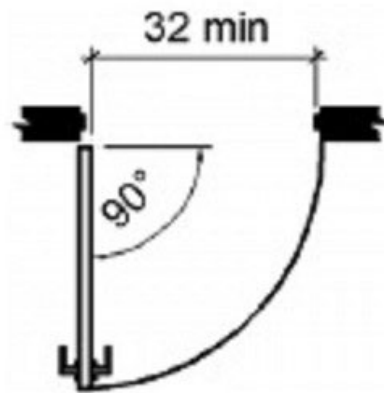
Hinged Door or Gate

2 (Important): Should be completed as soon as possible. (Includes findings that would remove barriers to the greatest number of people to your goods and services).

As Built: Neither leaf of the doorway provides at least 32 inches between the face of the door and the opposite stop.

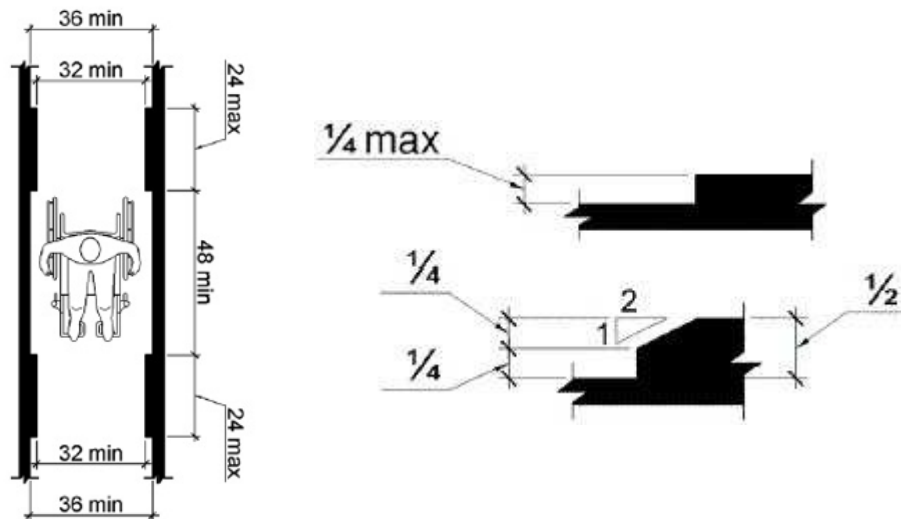
3 (Moderate): Should be completed as soon as possible, but there may be other items that will provide greater access to persons with disabilities. (Includes findings that have a high financial impact on the entity in relationship to the degree of access provided).

As Built: The route of travel does not provide a minimum width of 36 inches. The clear width shall be permitted to be reduced to 32 inches minimum for a length of 24 inches maximum provided that reduced width segments are separated by segments that are 48 inches long minimum and 36 inches wide minimum.

There is a change in level greater than 1/4 inch.
1/4 inch is the maximum vertical rise. Changes in level between 1/4 inch and 1/2 inch must be beveled at 1:2 or less. Changes in level greater than 1/2 inch must be by way of a ramp.

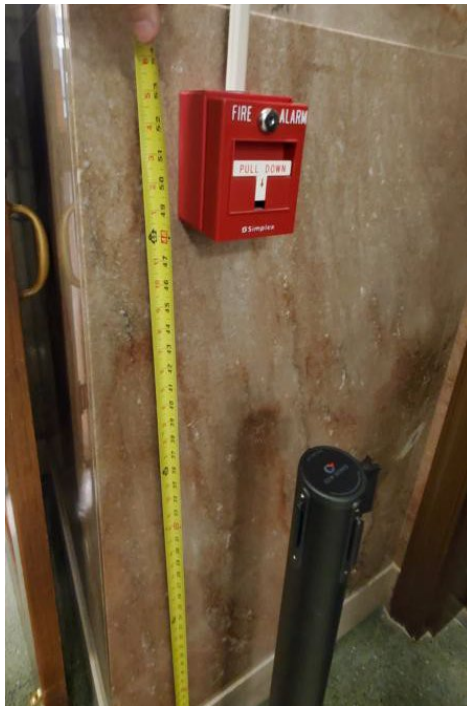
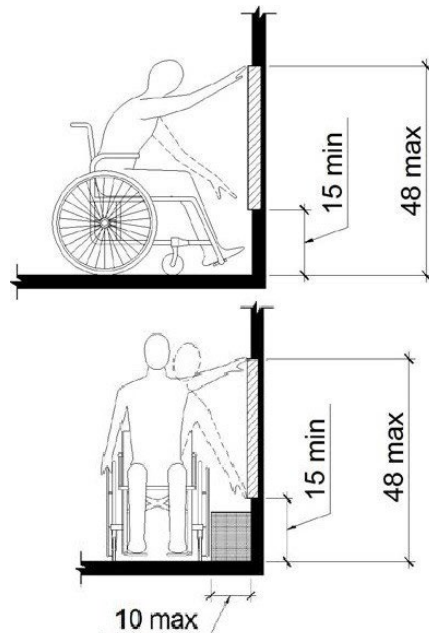
3 (Moderate): Should be completed as soon as possible, but there may be other items that will provide greater access to persons with disabilities. (Includes findings that have a high financial impact on the entity in relationship to the degree of access provided).

As Built: The Fire Alarm Pull is positioned too high for either a side or front approach.

Where a clear floor or ground space allows a parallel approach to an element and the side reach is unobstructed, the high side reach shall be 48 inches maximum, and the low side reach shall be 15 inches minimum above the finish floor or ground.

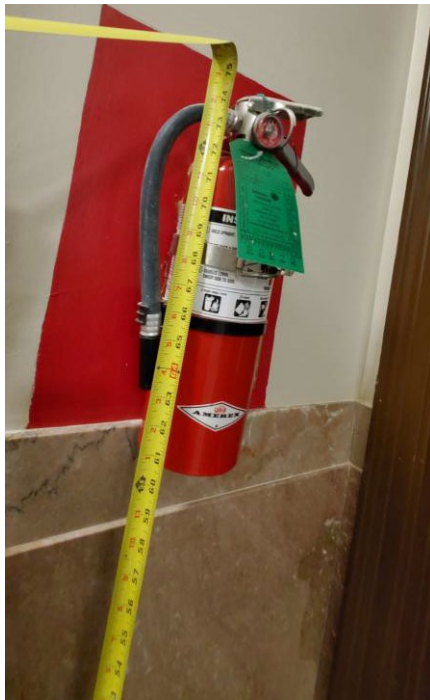
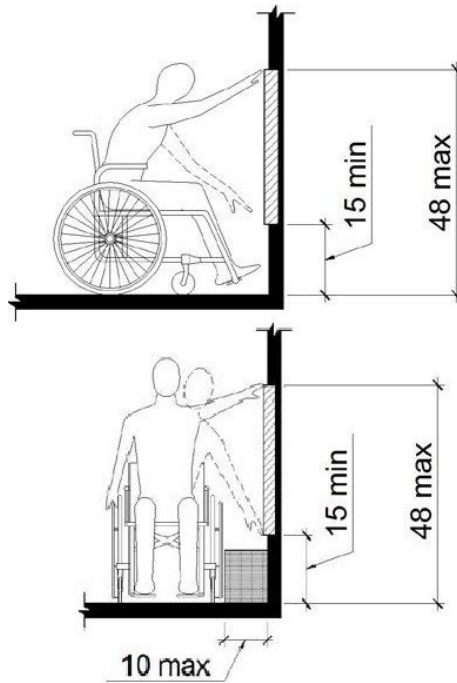
As Built: The fire extinguisher is positioned too high for either a side or front approach.

Where a clear floor or ground space allows a parallel approach to an element and the side reach is unobstructed, the high side reach shall be 48 inches maximum, and the low side reach shall be 15 inches minimum above the finish floor or ground.

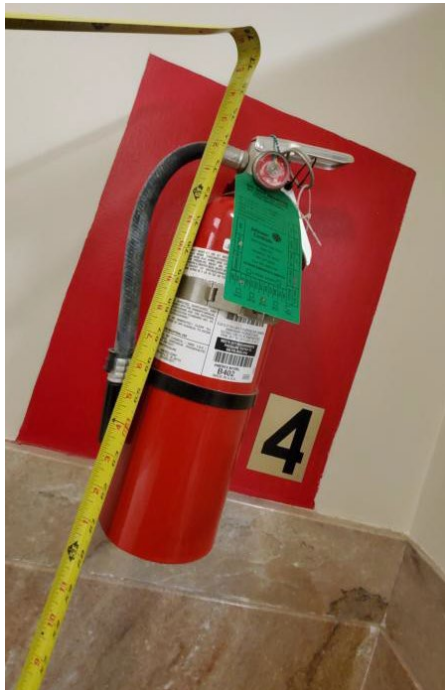
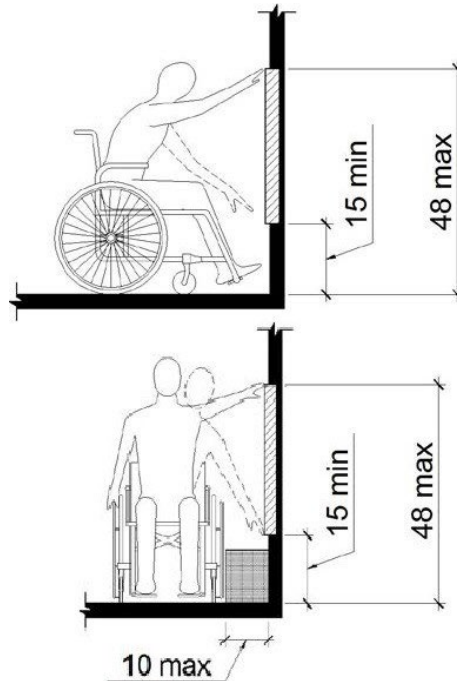
As Built: The fire extinguisher is positioned too high for either a side or front approach.

Where a clear floor or ground space allows a parallel approach to an element and the side reach is unobstructed, the high side reach shall be 48 inches maximum, and the low side reach shall be 15 inches minimum above the finish floor or ground.

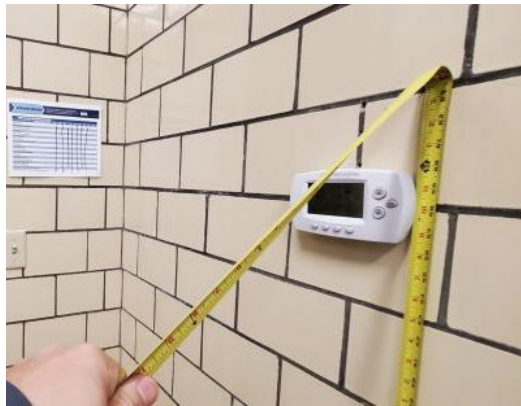
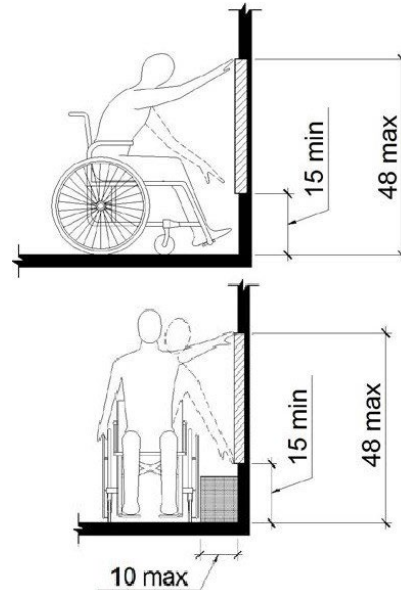
As Built: The Thermostat is positioned too high for either a side or front approach.

Where a clear floor or ground space allows a parallel approach to an element and the side reach is unobstructed, the high side reach shall be 48 inches maximum, and the low side reach shall be 15 inches minimum above the finish floor or ground.

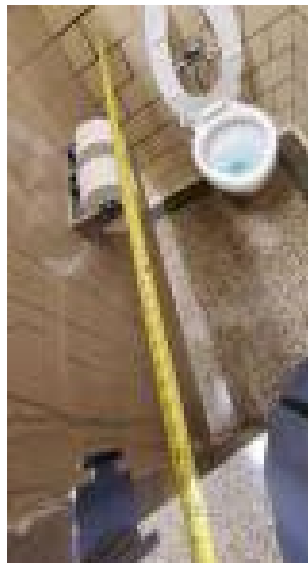
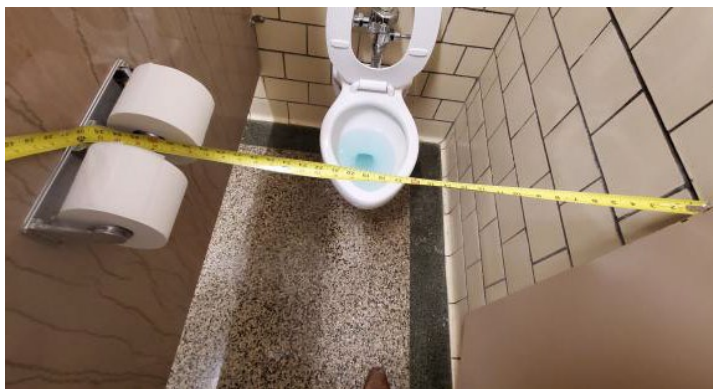
As Built: The stall does not have the required minimum clear floor space or maneuvering clearances for the toilet, grab bars are missing and/or incorrectly installed, flush handle on wrong side.

Citation: 2010 ADAS Section 603.1
