WEAKLEY COUNTY, TENNESSEE

ADA EVALUATION

Architectural and Site Findings with Recommendations

TLM Associates, Inc

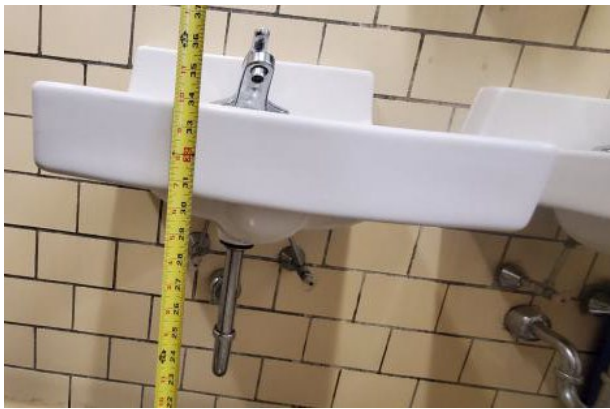
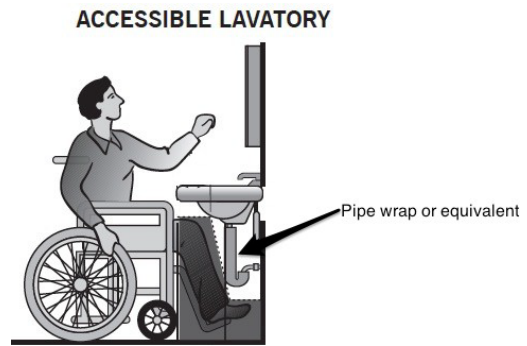
As Built: The water and drainpipes under the lavatory are not adequately insulated.

Water supply and drainpipes under lavatories and sinks shall be insulated or otherwise configured to protect against contact. There shall be no sharp or abrasive surfaces under lavatories and sinks.

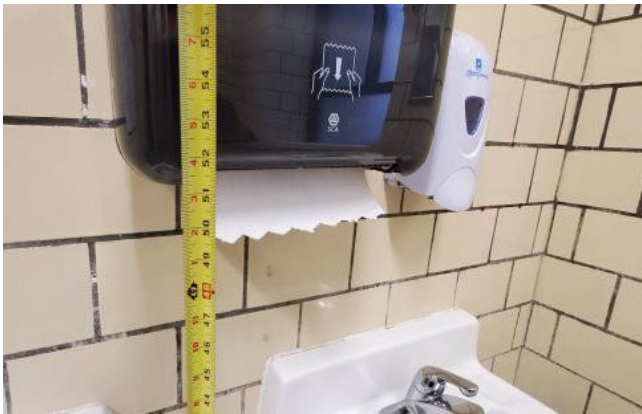
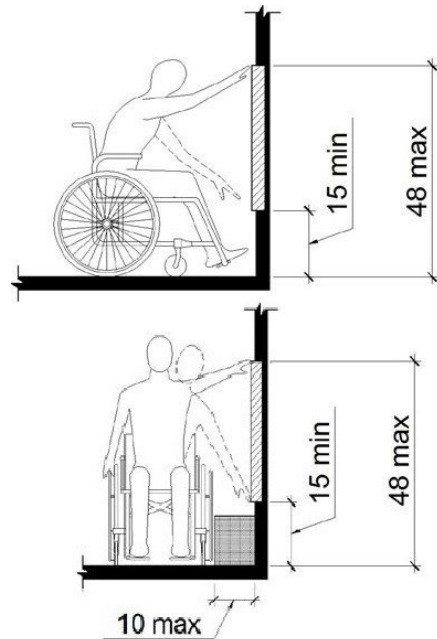
As Built: The paper towel dispenser is positioned too high for either a side or front approach.

Where a clear floor or ground space allows a parallel approach to an element and the side reach is unobstructed, the high side reach shall be 48 inches maximum, and the low side reach shall be 15 inches minimum above the finish floor or ground.

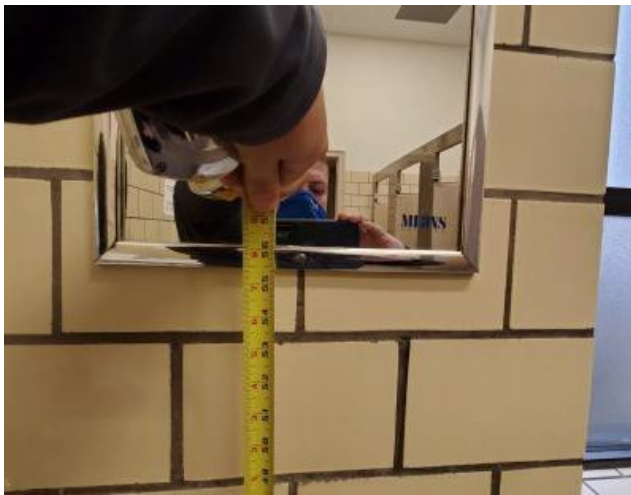
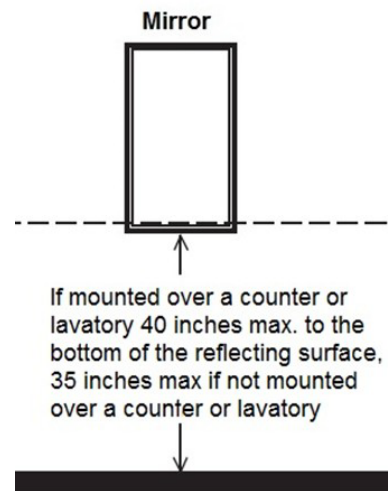
As Built: The mirror is mounted too high.

Mirrors must have the bottom edge of the reflecting surface a maximum of 40 inches above the floor if above a sink or counter. Mirrors not located above lavatories or countertops shall be installed with the bottom edge of the reflecting surface 35 inches maximum above the finish floor or ground.

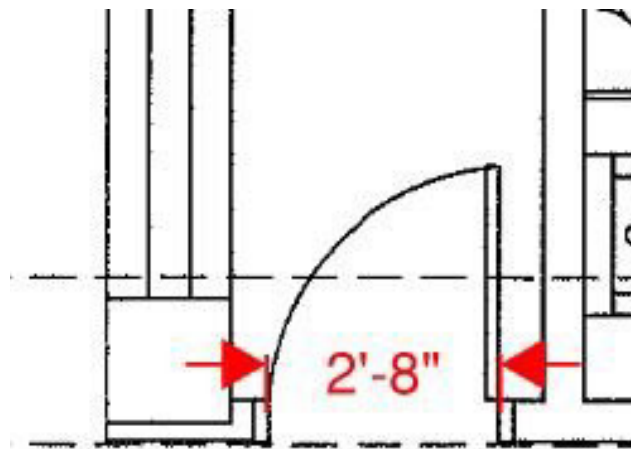
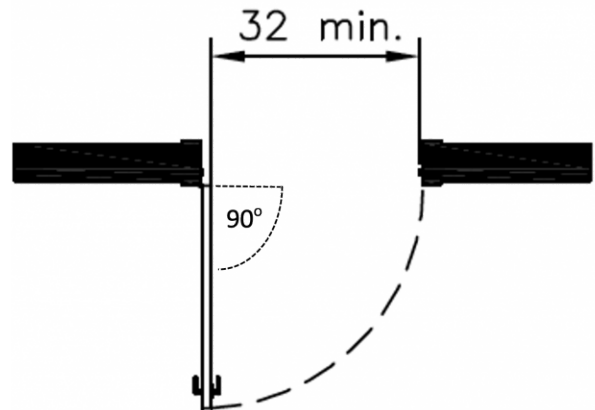
Hinged Door

As Built: The door opening does not provide at least 32 inches between the face of the door and the opposite stop.

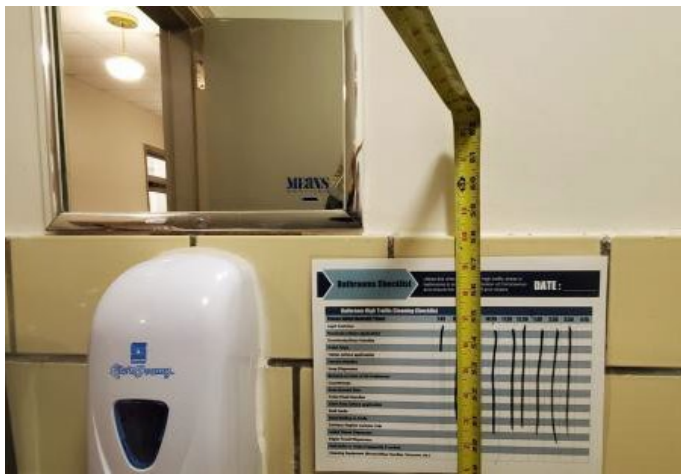
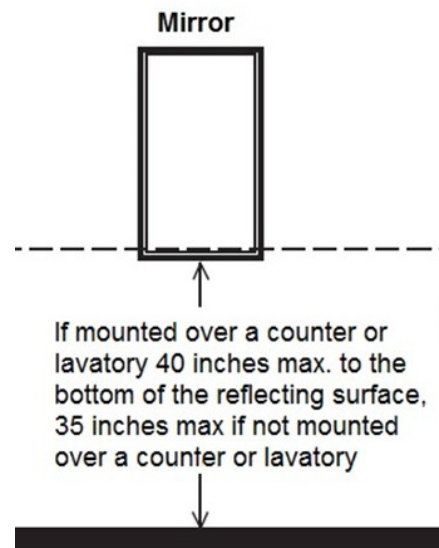
As Built: The mirror is mounted too high.

Mirrors must have the bottom edge of the reflecting surface a maximum of 40 inches above the floor if above a sink or counter. Mirrors not located above lavatories or countertops shall be installed with the bottom edge of the reflecting surface 35 inches maximum above the finish floor or ground.

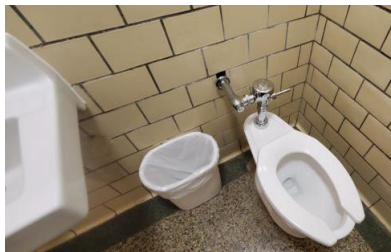
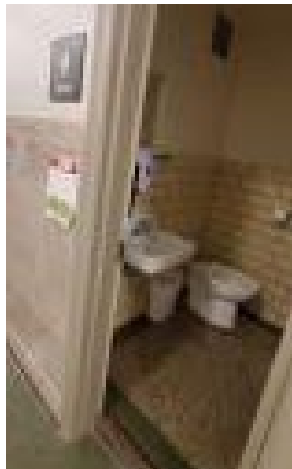
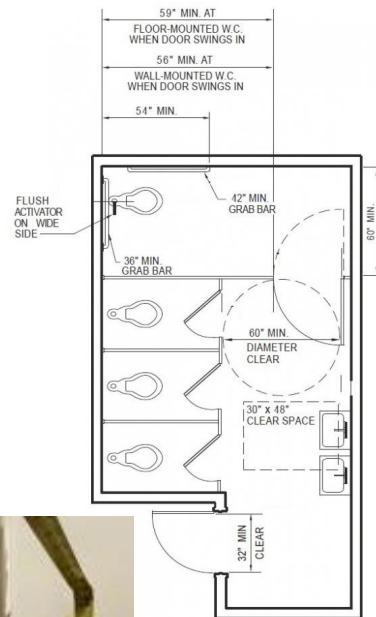
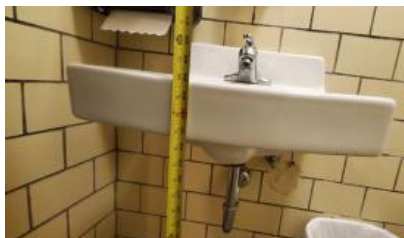
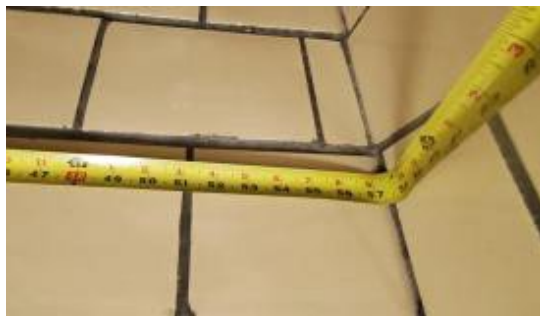
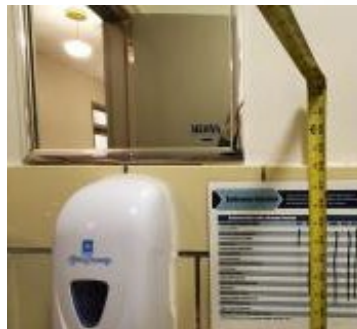
As Built: The restroom does not have the required minimum clear floor or maneuvering clearances for the toilet. The restroom does not have the required minimum clear floor space or maneuvering clearances for the lavatory. The entry door does not contain the required minimum 60 inches maneuvering space on the pull side. The entry door encroaches into the required clear floor space for fixtures. Grab bars are not installed. Mirror is too high. The restroom contains floor level changes greater than a 1/2 inch at the floor drains.

Citation: 2010 ADAS Section 213.2

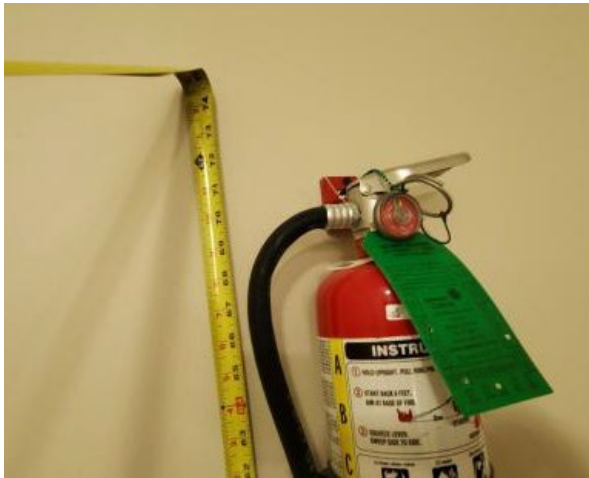
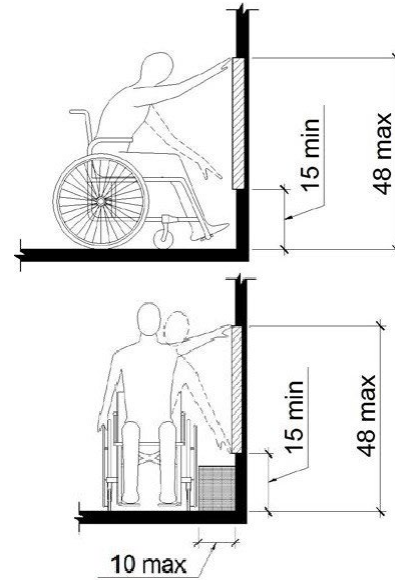
As Built: The fire extinguisher is positioned too high for either a side or front approach.

Where a clear floor or ground space allows a parallel approach to an element and the side reach is unobstructed, the high side reach shall be 48 inches maximum, and the low side reach shall be 15 inches minimum above the finish floor or ground.

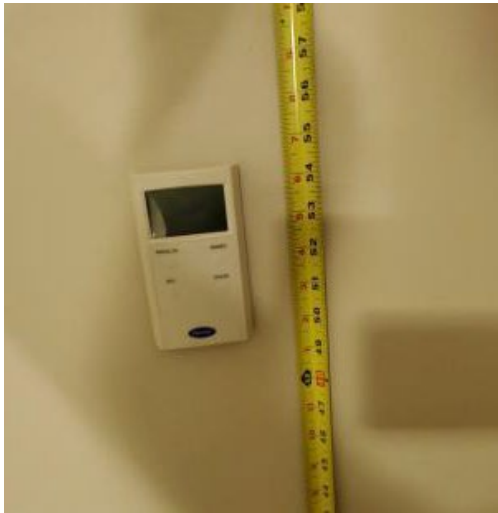
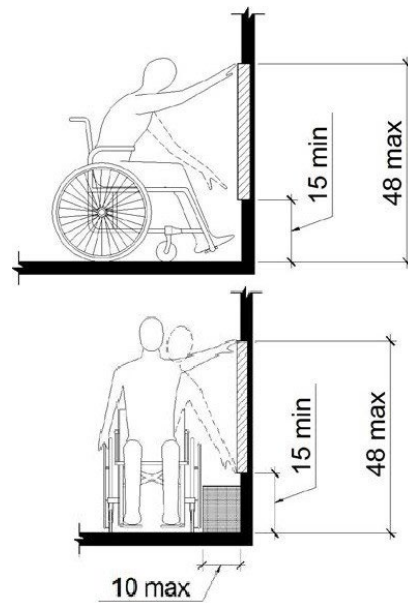
As Built: The Thermostat is positioned too high for either a side or front approach.

Where a clear floor or ground space allows a parallel approach to an element and the side reach is unobstructed, the high side reach shall be 48 inches maximum, and the low side reach shall be 15 inches minimum above the finish floor or ground.

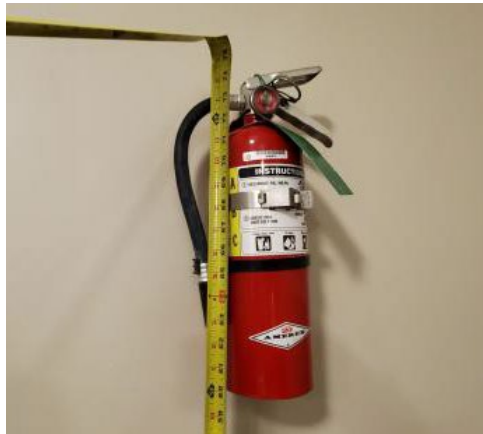
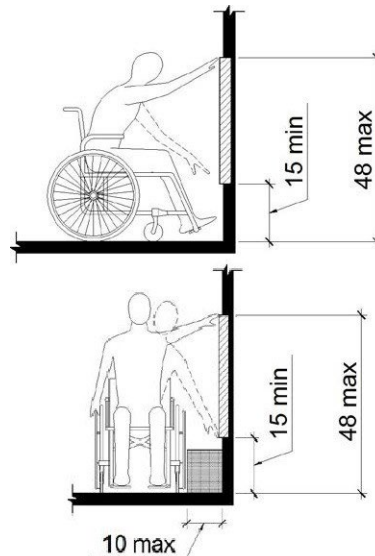
As Built: The fire extinguisher is positioned too high for either a side or front approach.

Where a clear floor or ground space allows a parallel approach to an element and the side reach is unobstructed, the high side reach shall be 48 inches maximum, and the low side reach shall be 15 inches minimum above the finish floor or ground.

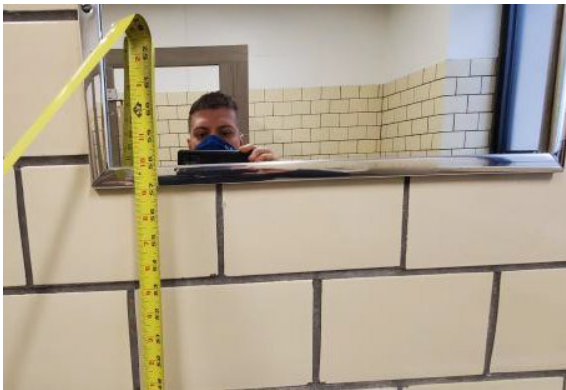
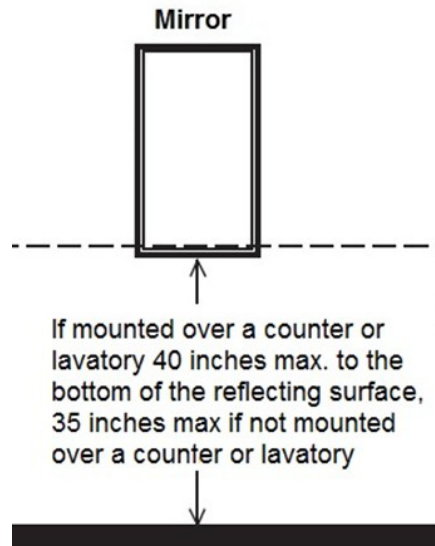
As Built: The mirror is mounted too high.

Mirrors must have the bottom edge of the reflecting surface a maximum of 40 inches above the floor if above a sink or counter. Mirrors not located above lavatories or countertops shall be installed with the bottom edge of the reflecting surface 35 inches maximum above the finish floor or ground.

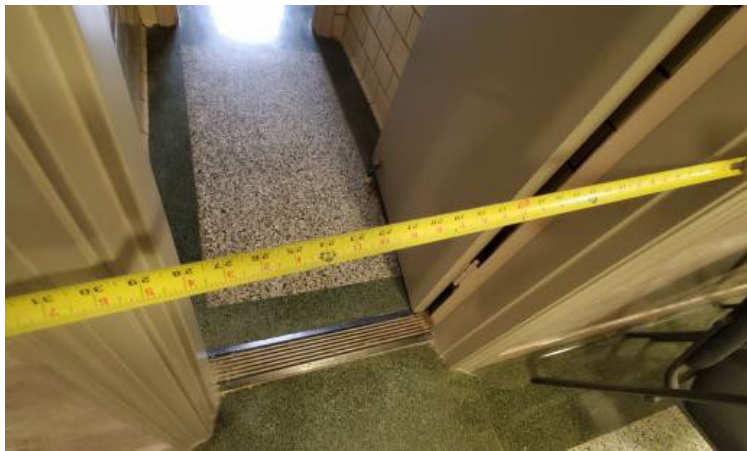
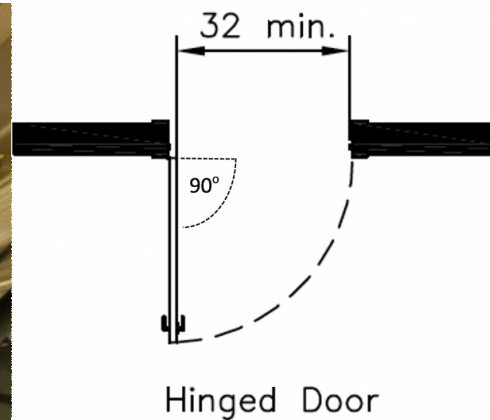
As Built: The door opening does not provide at least 32 inches between the face of the door and the opposite stop.

Door openings shall provide a clear width of 32 inches minimum. Clear openings of doorways with swinging doors shall be measured between the face of the door and the stop, with the door open 90 degrees.

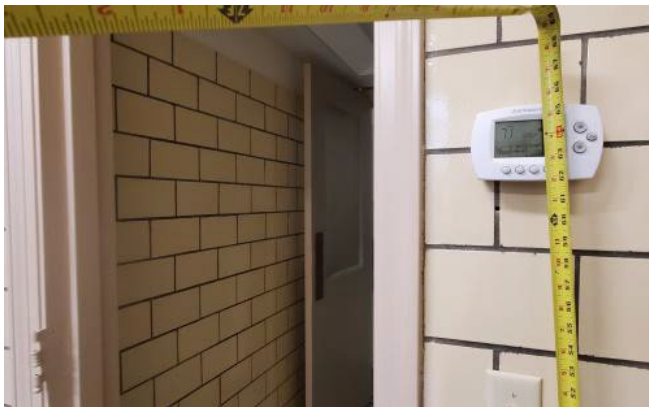
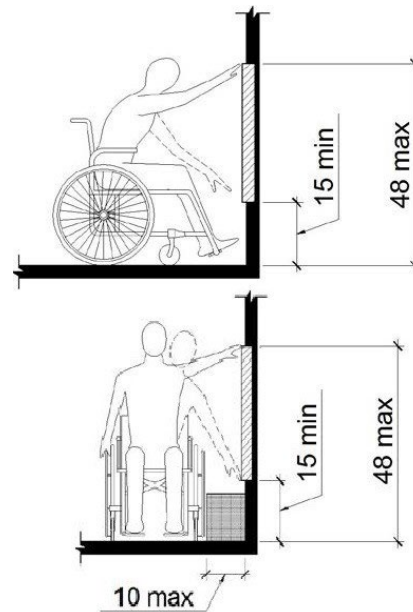
As Built: The Thermostat is positioned too high for either a side or front approach.

Where a clear floor or ground space allows a parallel approach to an element and the side reach is unobstructed, the high side reach shall be 48 inches maximum, and the low side reach shall be 15 inches minimum above the finish floor or ground.

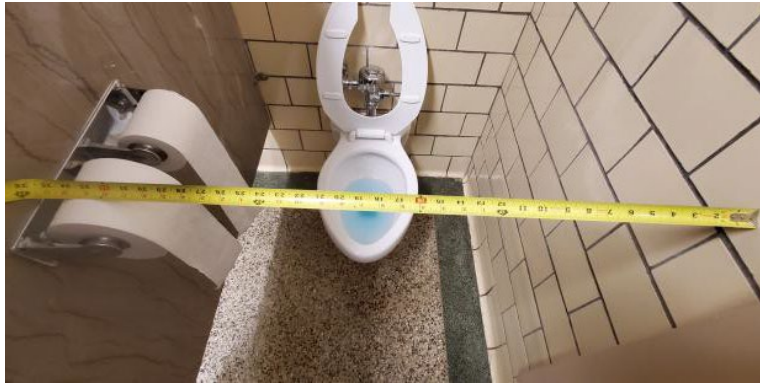
As Built: The stall does not have the required minimum clear floor space or maneuvering clearances for the toilet, grab bars are missing and/or incorrectly installed, flush handle on wrong side.

Citation: 2010 ADAS Section 603.1

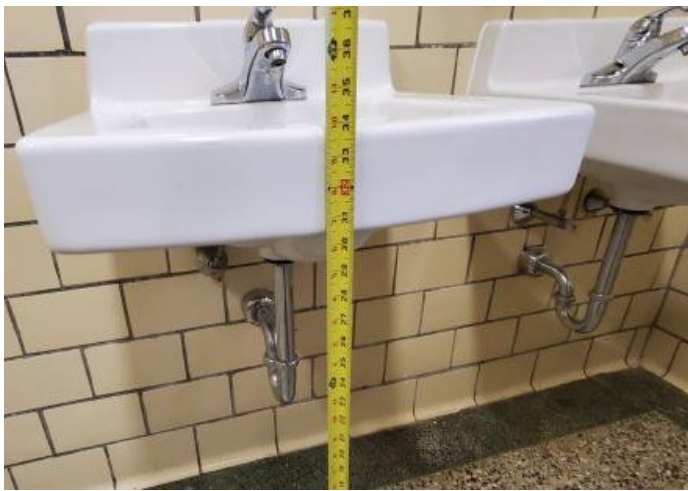
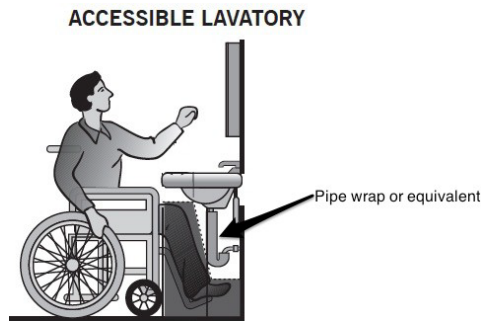
As Built: The water and drainpipes under the lavatory are not adequately insulated.

The water supply and drainpipes under lavatories and sinks shall be insulated or otherwise configured to protect against contact. There shall be no sharp or abrasive surfaces under lavatories and sinks.

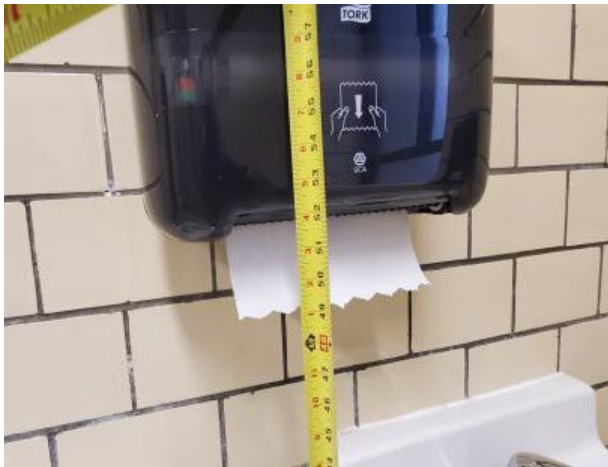
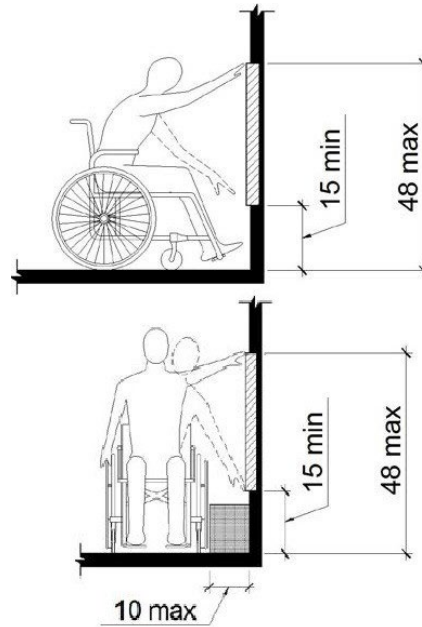
As Built: The paper towel dispenser is positioned too high for either a side or front approach.

Where a clear floor or ground space allows a parallel approach to an element and the side reach is unobstructed, the high side reach shall be 48 inches maximum, and the low side reach shall be 15 inches minimum above the finish floor or ground.

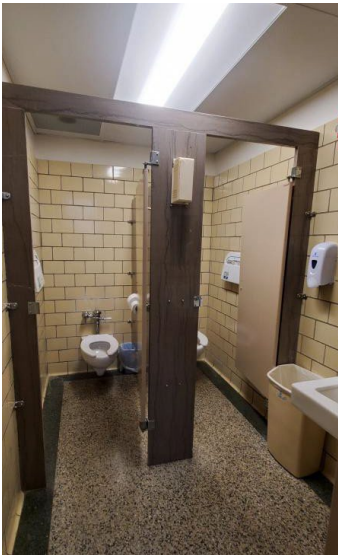
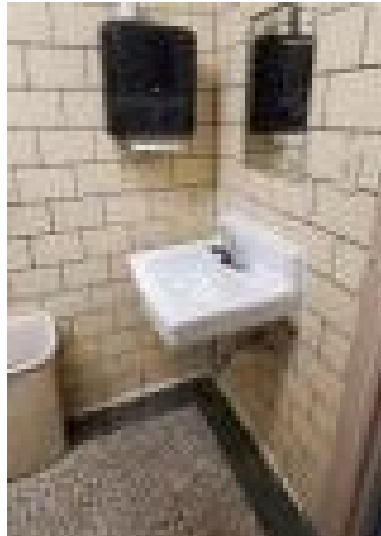
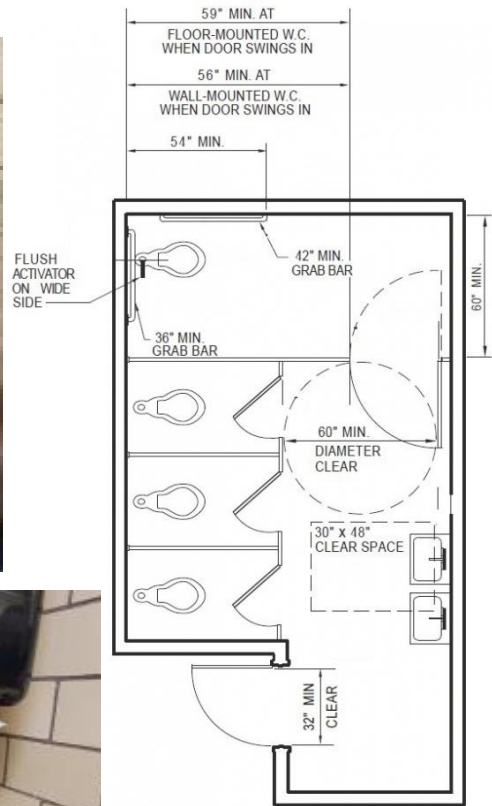
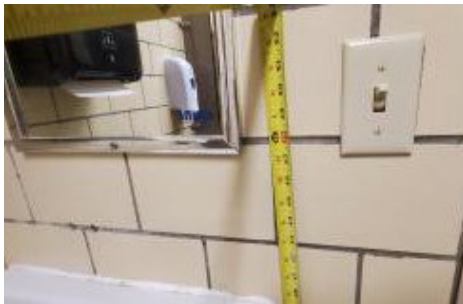
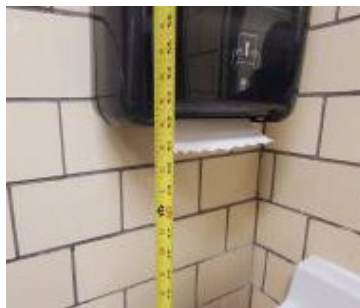
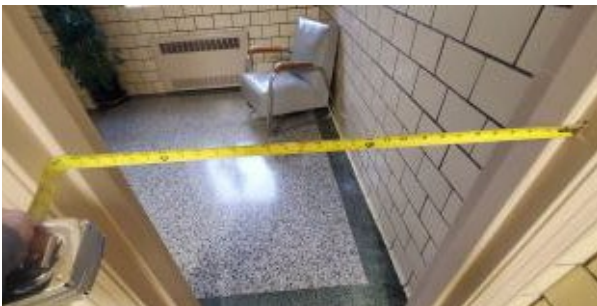
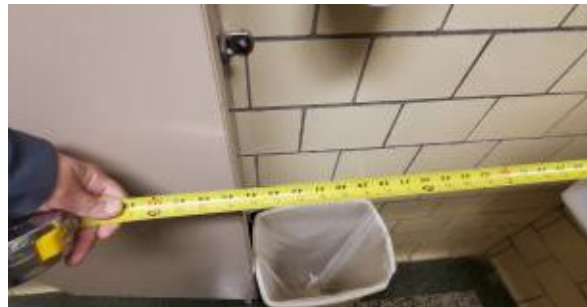
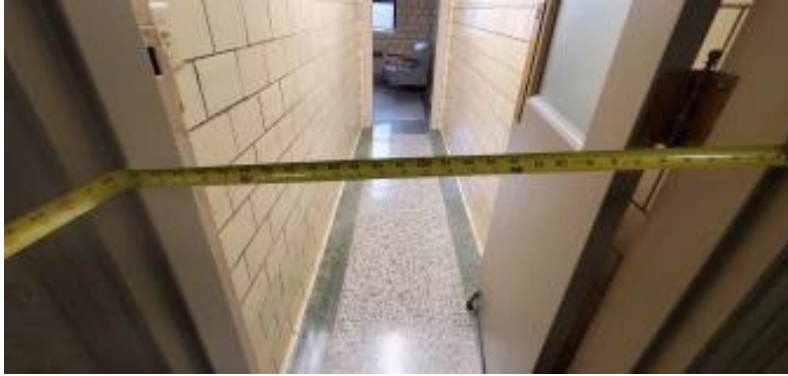
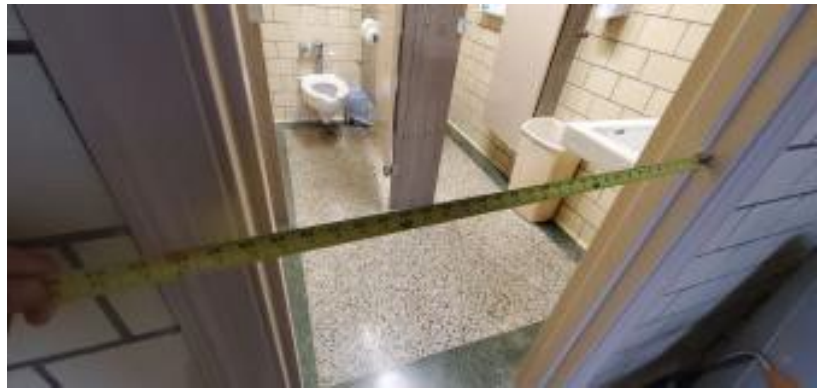
As Built: The compartment stall is not nearly compliant.

The stall does not have the required minimum clear floor space or maneuvering clearances for the toilet, grab bars are missing and/or incorrectly installed, accessories, such as toilet seat covers, mirror and toilet paper towel dispenser too high, without clear floor space or both.

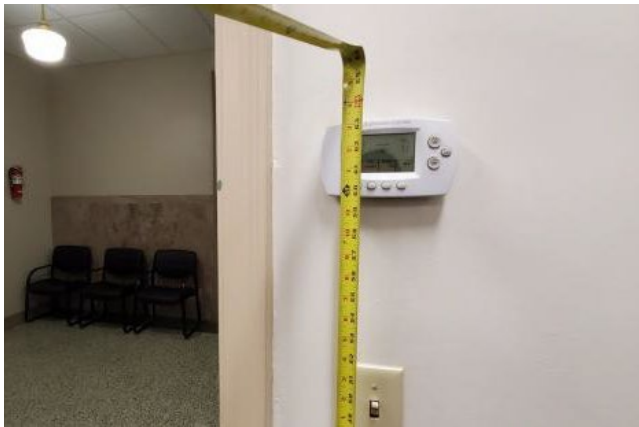
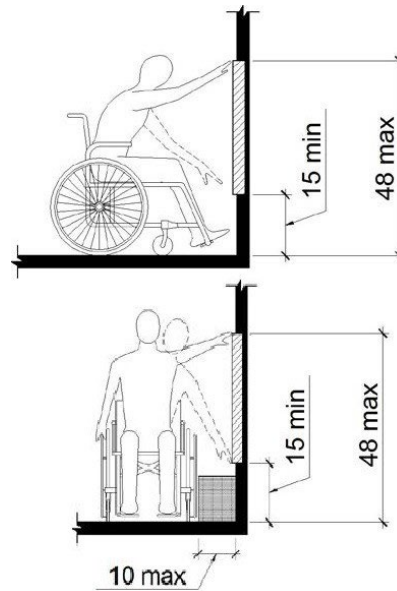
As Built: The Thermostat is positioned too high for either a side or front approach.

Where a clear floor or ground space allows a parallel approach to an element and the side reach is unobstructed, the high side reach shall be 48 inches maximum, and the low side reach shall be 15 inches minimum above the finish floor or ground.

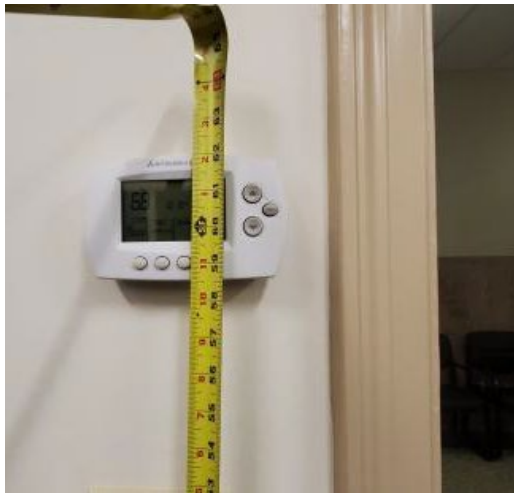
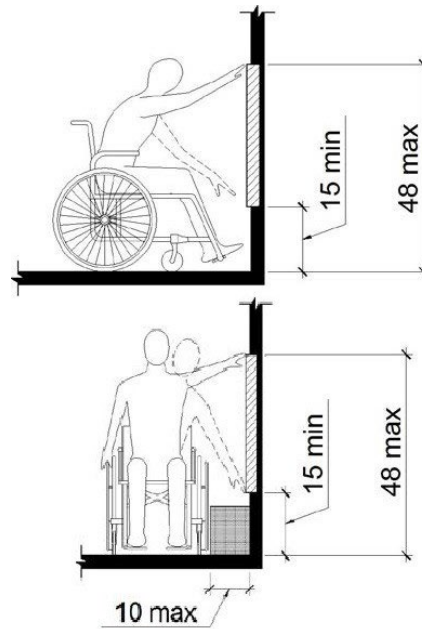
As Built: The Thermostat is positioned too high for either a side or front approach.

Where a clear floor or ground space allows a parallel approach to an element and the side reach is unobstructed, the high side reach shall be 48 inches maximum, and the low side reach shall be 15 inches minimum above the finish floor or ground.

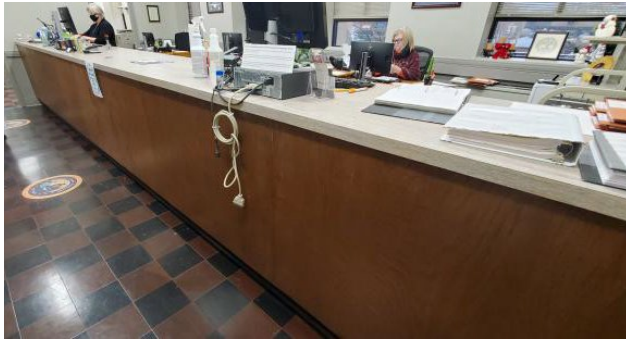
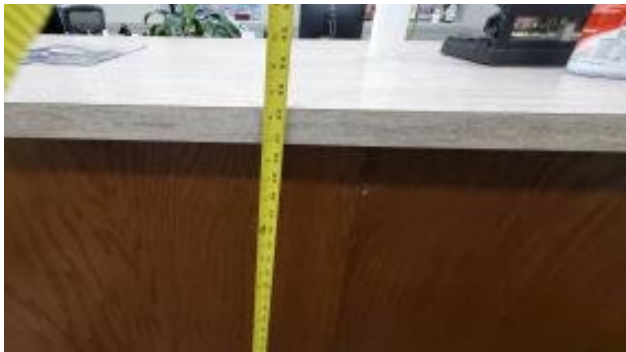
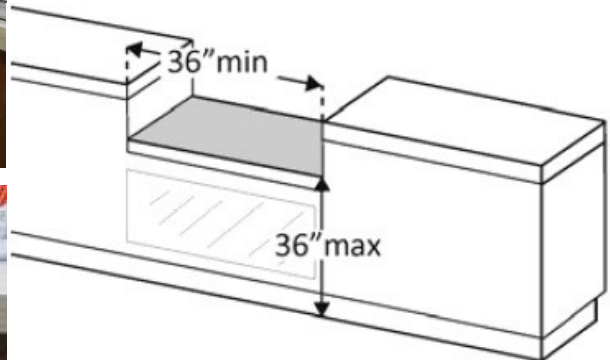
As Built: The counter is too high.

A portion of the counter surface that is 36 inches long minimum and 36 inches high maximum above the finish floor shall be provided. Knee and toe space must be provided for a forward approach. A 30 inch by 48-inch clear floor space on an accessible route must be provided for either a forward or parallel approach.

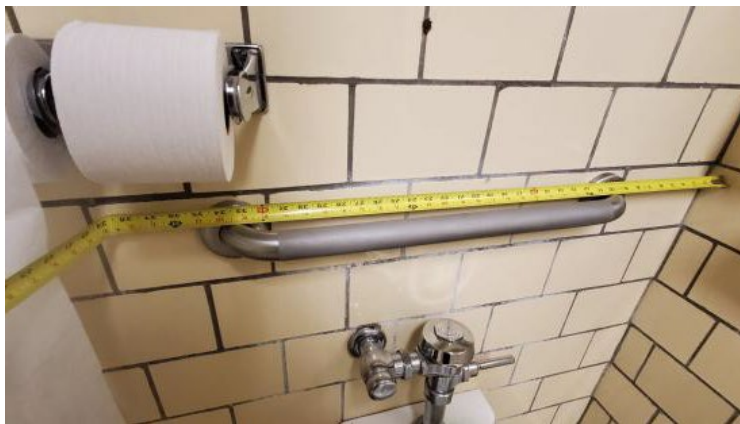
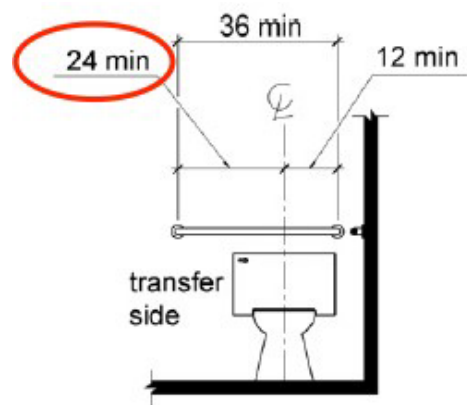
As Built: The rear grab bar does not extend adequately past the toilet on the wide side.

The rear grab bar must be a minimum of 36 inches long and extend from the centerline of the toilet 12 inches minimum on wall side and 24 inches minimum on the wide side.

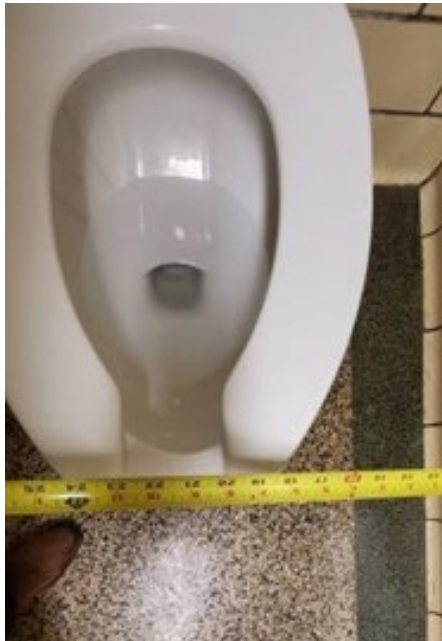
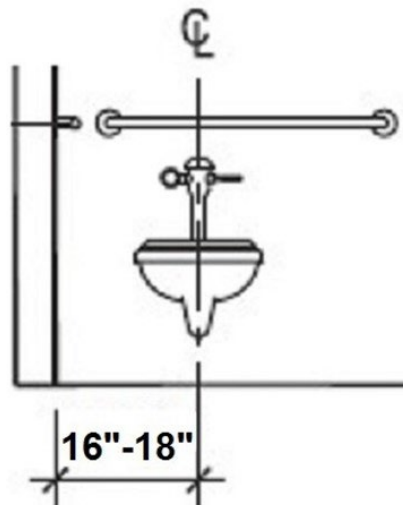
As Built: The toilet is not located within the range allowed from the side wall or partition. The centerline of the toilet must be 16 to 18 inches from the side wall.

Citation: 2010 ADAS Section 604.2

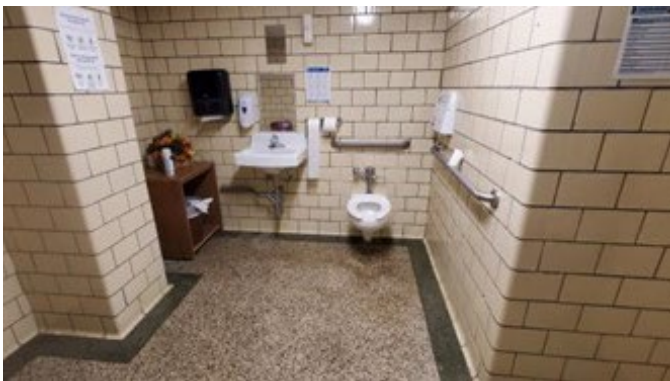
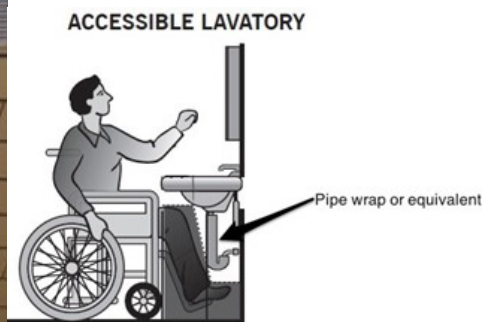
As Built: The water and drainpipes under the lavatory are not adequately insulated.

Water supply and drainpipes under lavatories and sinks shall be insulated or otherwise configured to protect against contact. There shall be no sharp or abrasive surfaces under lavatories and sinks.

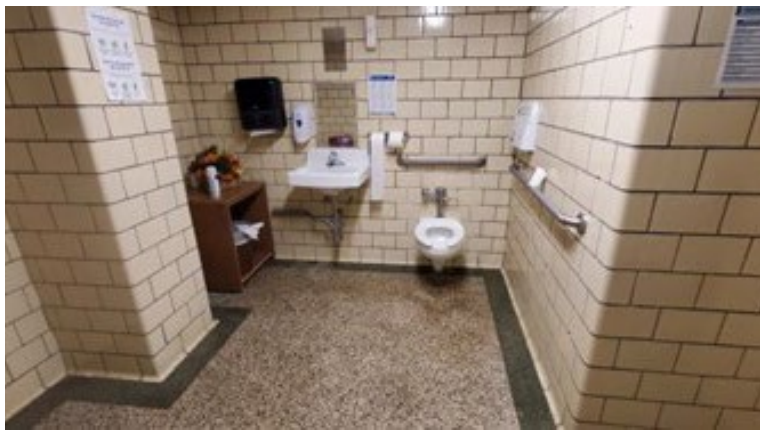
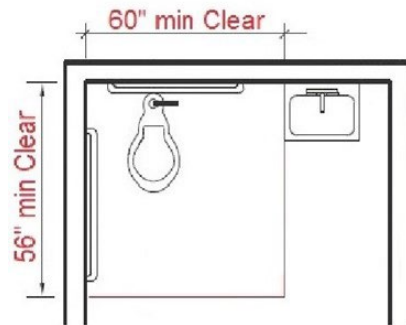
As Built: The lavatory projects into the clear floor space required for the toilet.

The clear floor space is 60 inches along the back wall by 56 inches.

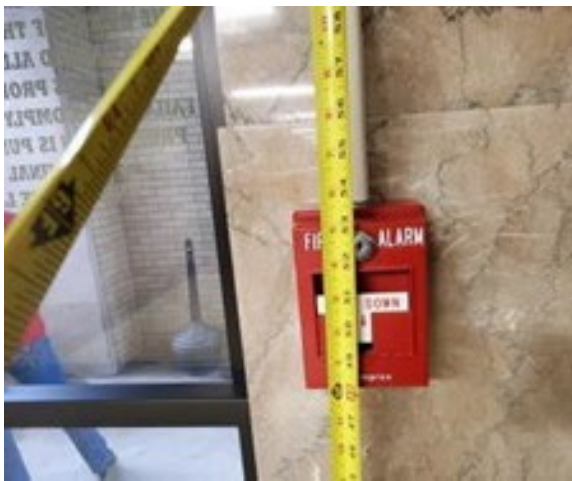
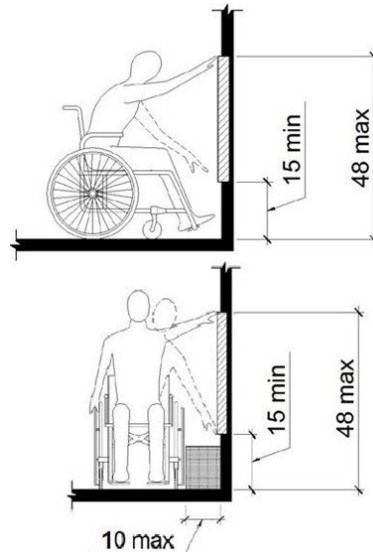
As Built: The Fire Alarm Pull is positioned too high for either a side or front approach.

Where a clear floor or ground space allows a parallel approach to an element and the side reach is unobstructed, the high side reach shall be 48 inches maximum, and the low side reach shall be 15 inches minimum above the finish floor or ground.

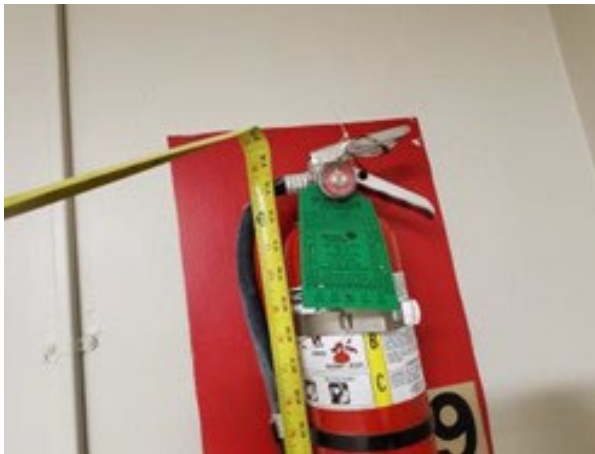
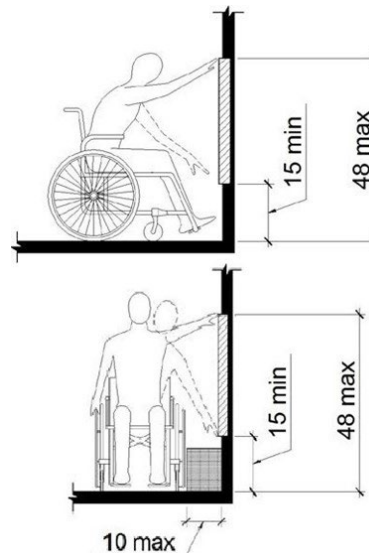
As Built: The fire extinguisher is positioned too high for either a side or front approach.

Where a clear floor or ground space allows a parallel approach to an element and the side reach is unobstructed, the high side reach shall be 48 inches maximum, and the low side reach shall be 15 inches minimum above the finish floor or ground.

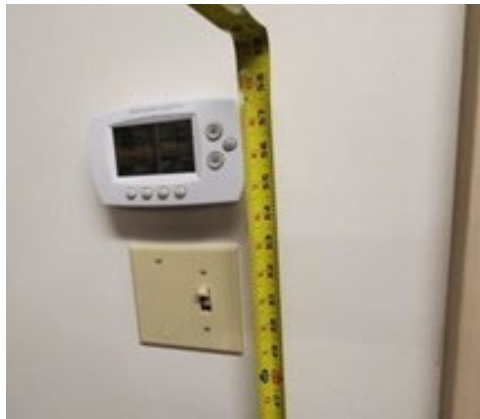
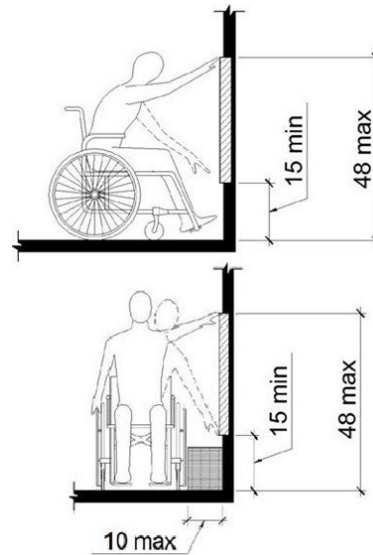
As Built: The Thermostat is positioned too high for either a side or front approach.

Where a clear floor or ground space allows a parallel approach to an element and the side reach is unobstructed, the high side reach shall be 48 inches maximum, and the low side reach shall be 15 inches minimum above the finish floor or ground.

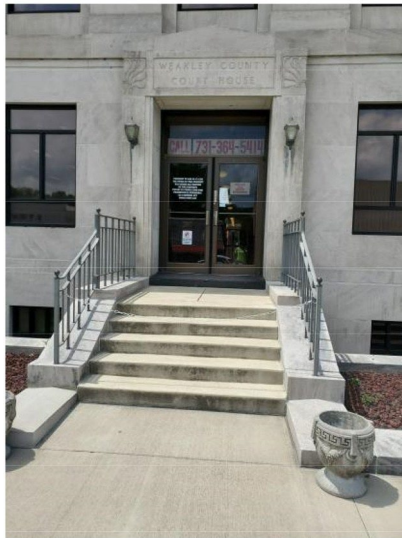
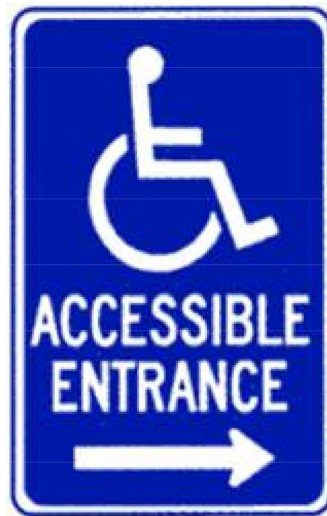
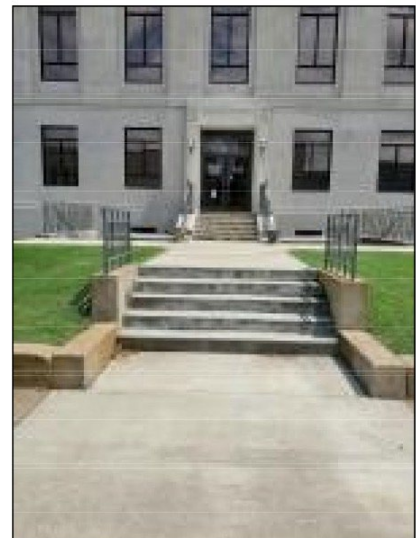
As Built: The entrance is not accessible and is missing signage. An identification sign identifying that this entrance is not accessible and directional signage pointing to the accessible entrance is required.

When a directional sign is required, it should be located to minimize backtracking. In some cases, this could mean locating a sign at the beginning of a route, not just at the inaccessible entrances to a building.

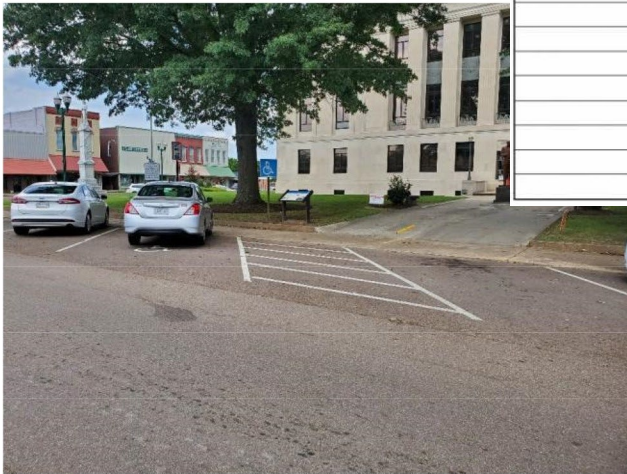
As Built: There are no van accessible parking stalls.

1 in every 6, minimum of one, required accessible stalls must be a van accessible stall.

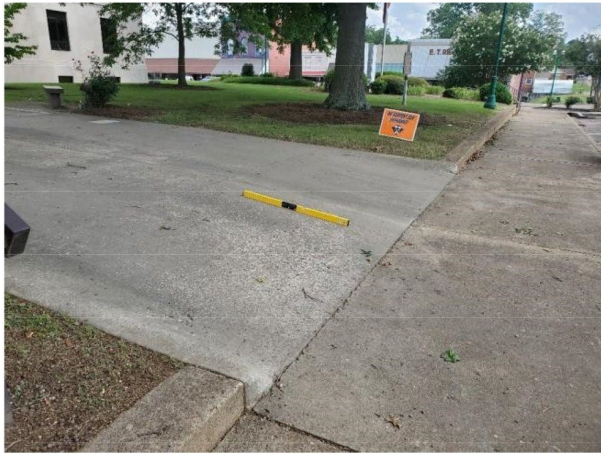
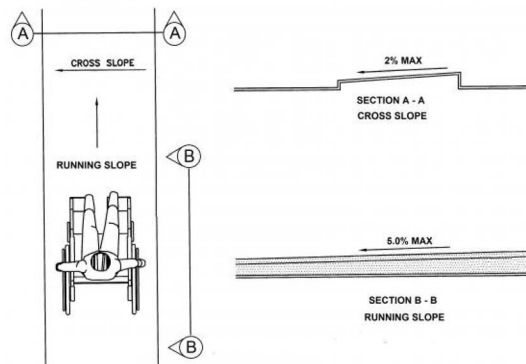
As Built: The accessible route between the building entrance and the accessible parking on the site contains running slopes at 11.2%, which is greater than 5% and has not been constructed as a ramp (i.e. handrails, wheel guides, etc.).

When the slope in the direction of travel of any walk exceeds 1 unit vertical in 20 units horizontal (5-percent slope), it must be constructed as ramp. Surface cross slopes must not exceed one unit vertical in 48 units. Horizontal (2-percent slope).

Replace to provide full width of sidewalk at less than 2%. (3 locations on north & east side).

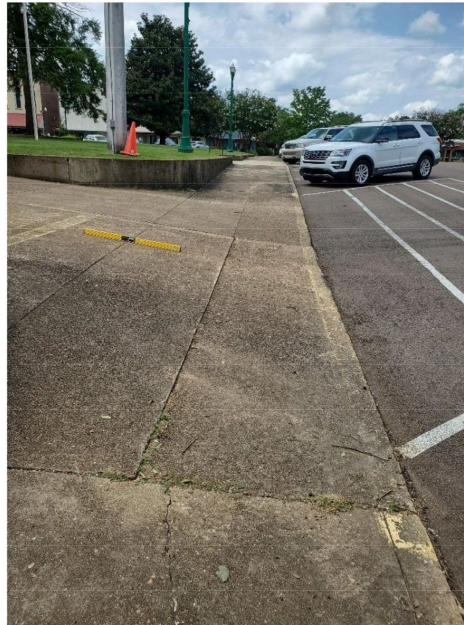
As Built: The cross slope of the pedestrian access route is excessive.

The cross slope of pedestrian access routes shall be 2 percent maximum.

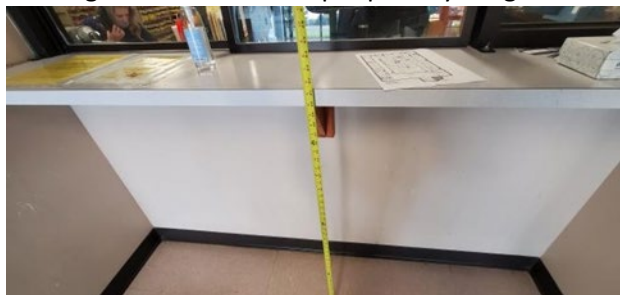
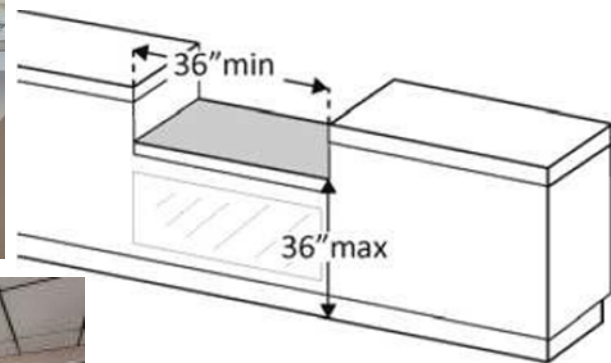
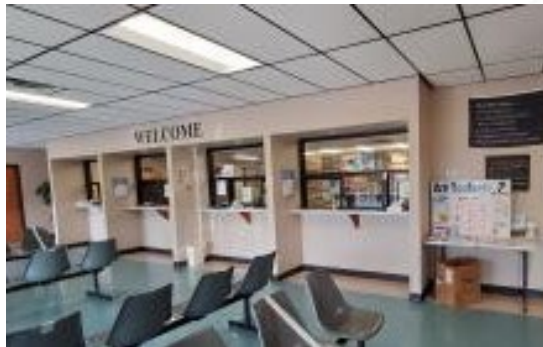
As Built: The counter is 41.5", which is too high. A portion of the counter surface that is 36 inches long minimum and 36 inches high maximum above the finish floor shall be provided. Knee and toe space must be provided for a forward approach. A 30 inch by 48 inch clear floor space on an accessible route must be provided for either a forward or parallel approach.

Citation: 2010 ADAS Section 904.4.2

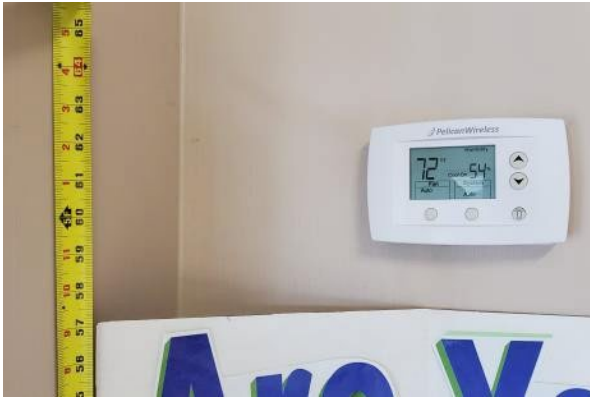
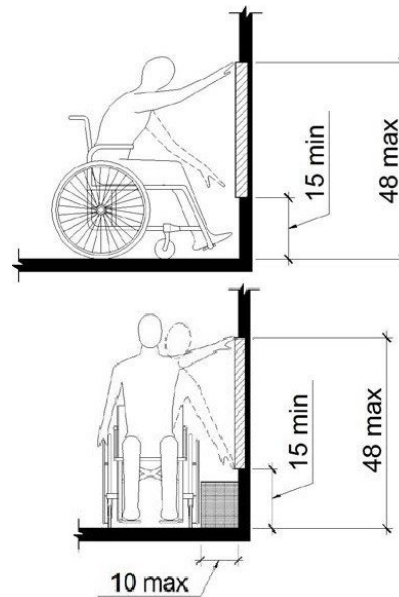
As Built: The thermostat is positioned at 62" which is too high for either a side or front approach.

Where a clear floor or ground space allows a parallel approach to an element and the side reach is unobstructed, the high side reach shall be 48 inches maximum and the low side reach shall be 15 inches minimum above the finish floor or ground.

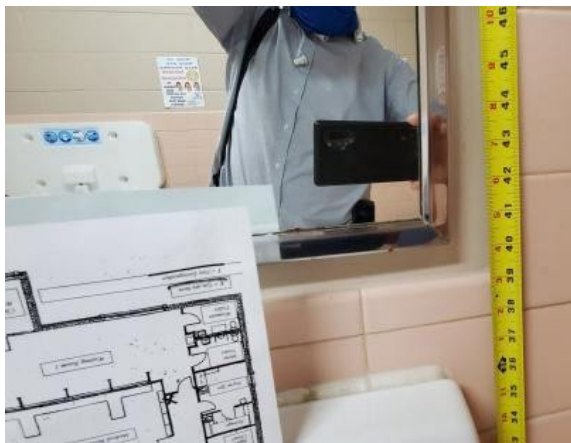
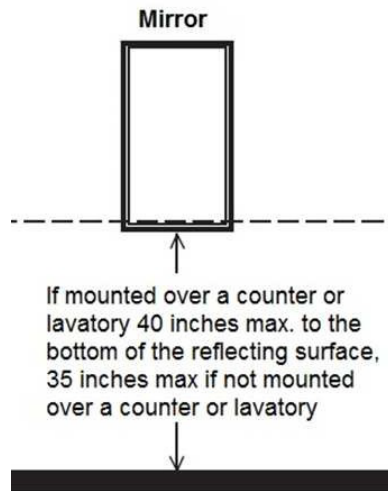
As Built: The mirror is mounted at 41" which is too high.

Mirrors must have the bottom edge of the reflecting surface a maximum of 40 inches above the floor if above a sink or counter. Mirrors not located above lavatories or countertops shall be installed with the bottom edge of the reflecting surface 35 inches maximum above the finish floor or ground.

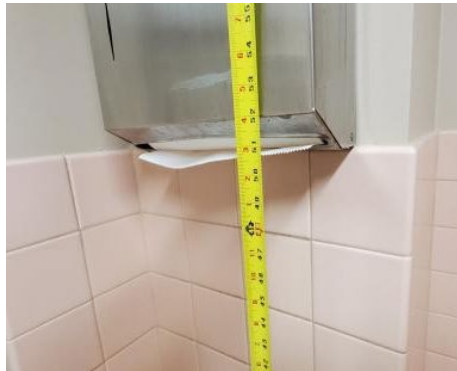
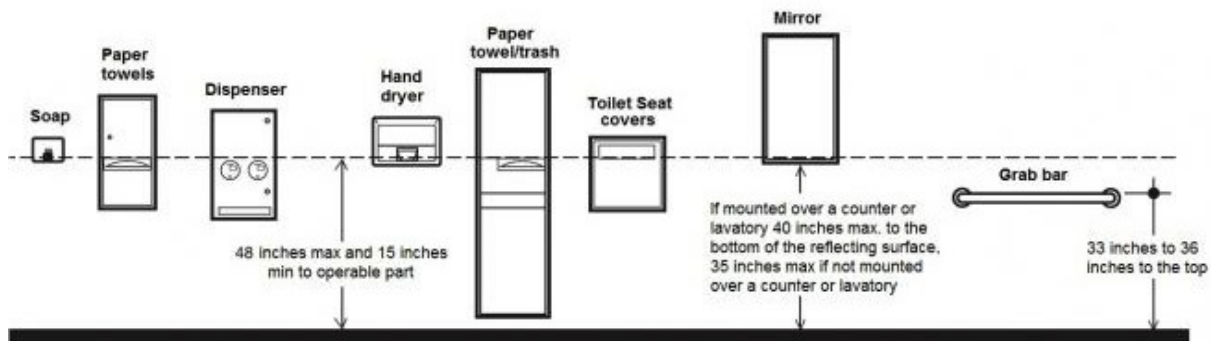
As Built: The paper towel dispenser's operation mechanism is too high off the floor. Dispensers must have all operable parts a maximum of 48 inches above the floor.

Citation: 2010 ADAS Section 308.2.1

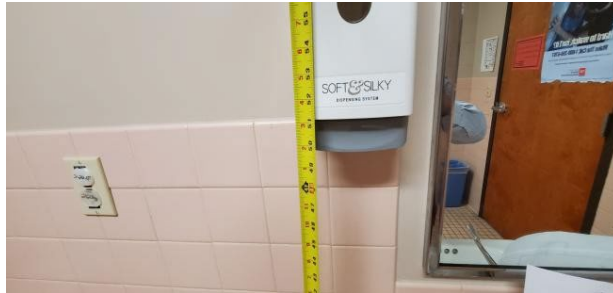
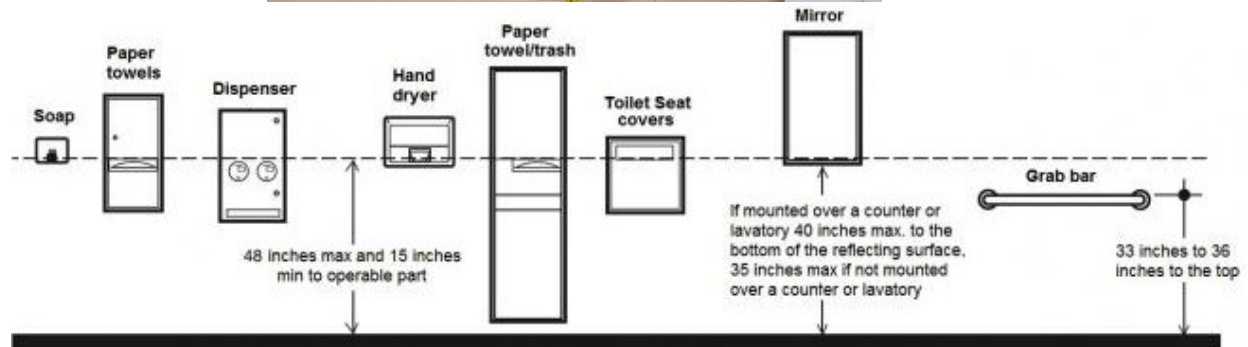
As Built: The soap dispenser's operation mechanism is too high off the floor.

Dispensers must have all operable parts a maximum of 48 inches above the floor.

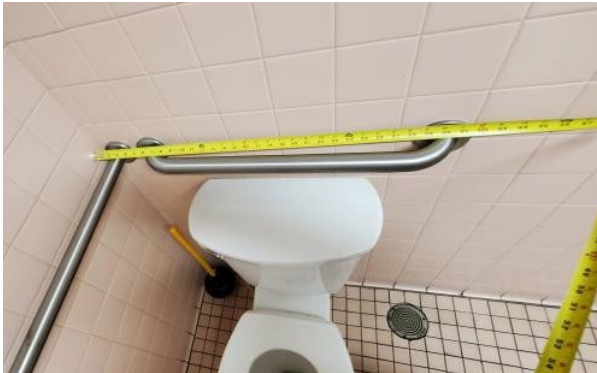
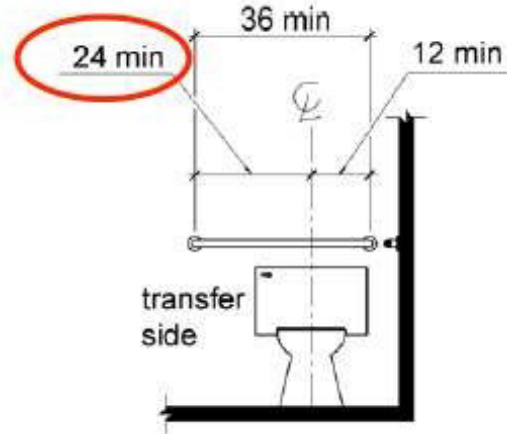
As Built: The rear grab bar does not extend adequately past the toilet on the wide side.

The rear grab bar must be a minimum of 36 inches long and extend from the centerline of the toilet 12 inches minimum on wall side and 24 inches minimum on the wide side.

Install new 3' rear grab bar for grab bar to extend 2' past centerline of toilet on transfer side. Replace tile where current grab bar is installed.
