WEAKLEY COUNTY, TENNESSEE

ADA EVALUATION

Architectural and Site Findings with Recommendations

TLM Associates, Inc

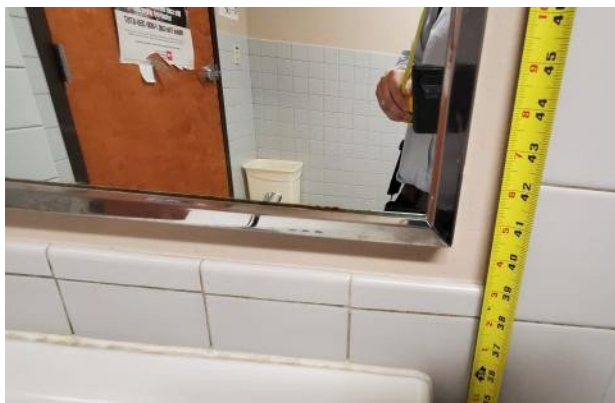
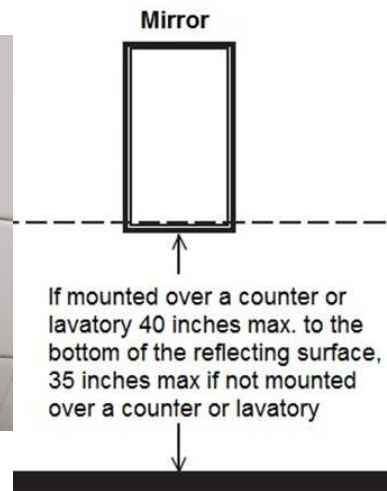
As Built: The mirror is mounted too high.

Mirrors must have the bottom edge of the reflecting surface a maximum of 40 inches above the floor if above a sink or counter. Mirrors not located above lavatories or countertops shall be installed with the bottom edge of the reflecting surface 35 inches maximum above the finish floor or ground.

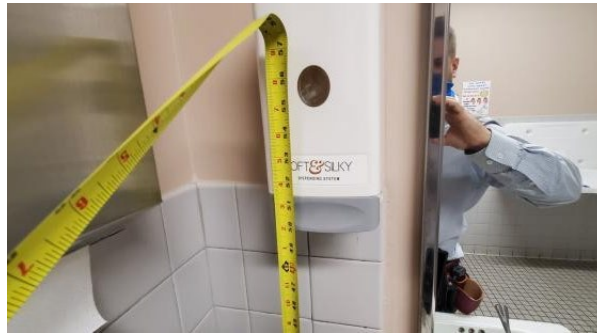
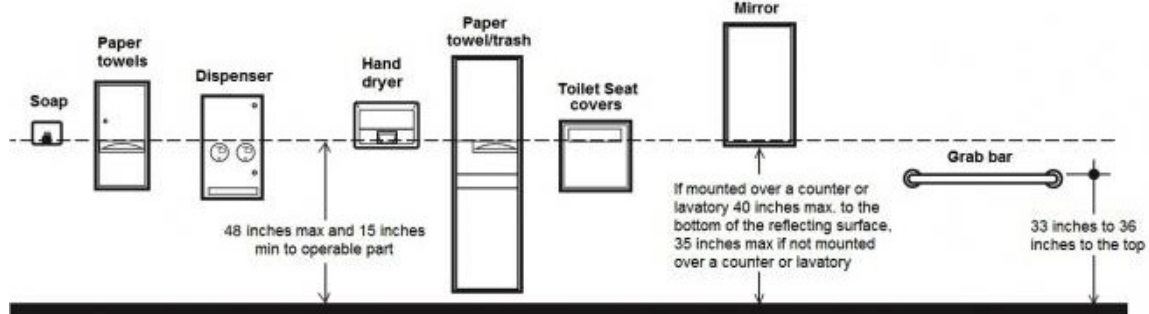
As Built: The soap dispenser's operation mechanism is too high off the floor.

Dispensers must have all operable parts a maximum of 48 inches above the floor.

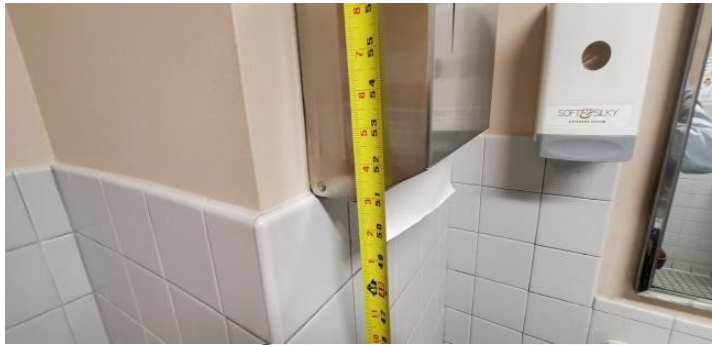
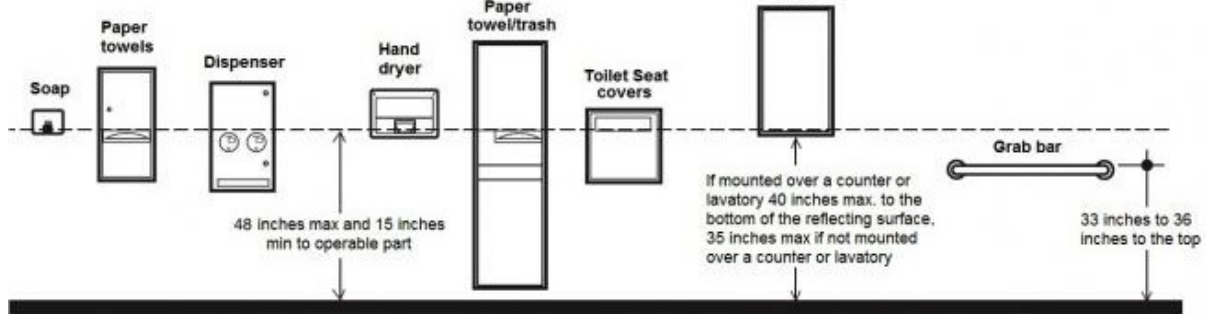
As Built: The paper towel dispenser's operation mechanism is too high off the floor. Dispensers must have all operable parts a maximum of 48 inches above the floor.

Citation: 2010 ADAS Section 308.2.1

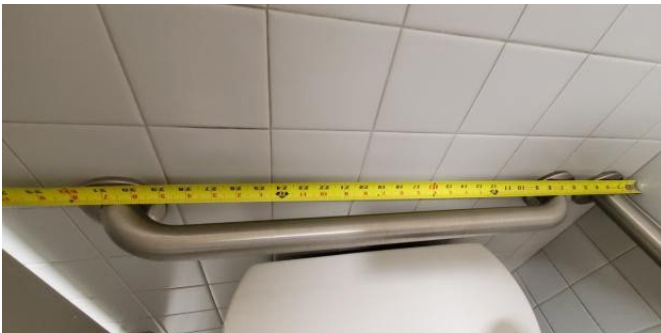
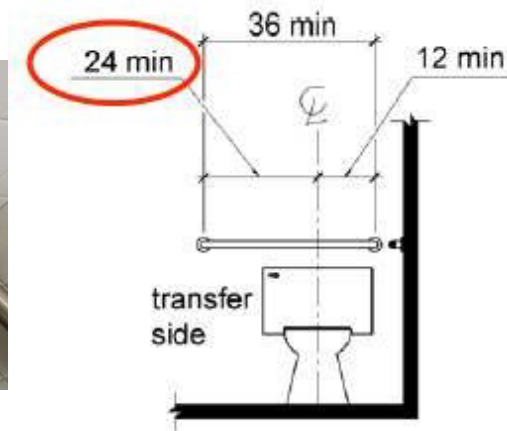
As Built: The rear grab bar does not extend adequately past the toilet on the wide side.

The rear grab bar must be a minimum of 36 inches long and extend from the centerline of the toilet 12 inches minimum on wall side and 24 inches minimum on the wide side.

Install new 3' rear grab bar for 2' to be on transfer side. Replace tile where current grab bar is installed.

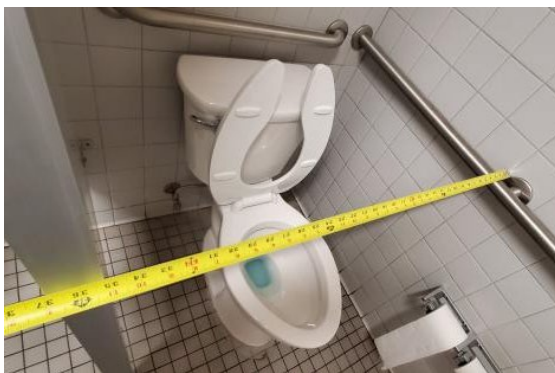
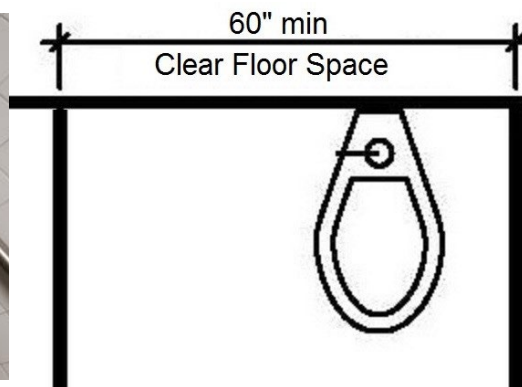
As Built: The toilet compartment is not wide enough.

Wheelchair accessible compartments shall be 60 inches wide minimum measured perpendicular to the side wall, and 56 inches deep minimum for wall hung water closets and 59 inches deep minimum for floor mounted water closets measured perpendicular to the rear wall.

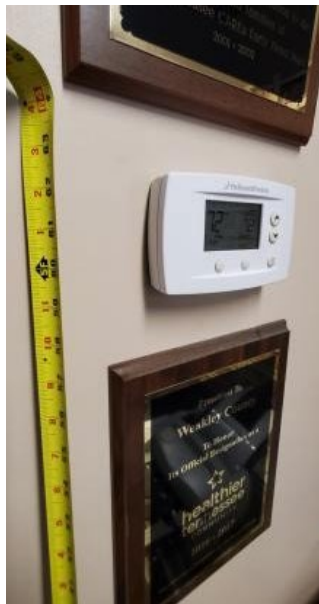
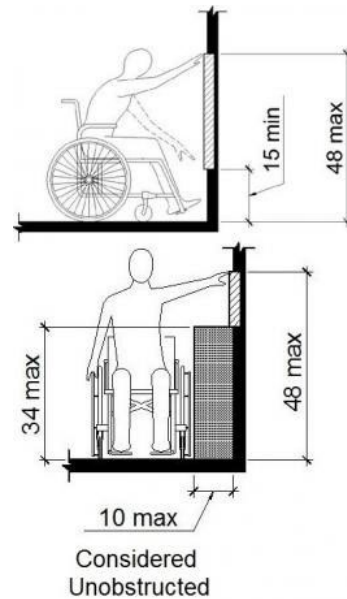
As Built: The thermostat is not positioned correctly for either a side or front approach.

Where a clear floor or ground space allows a parallel or front approach and the side reach is unobstructed, the high side reach shall be 48 inches maximum above the finish floor or ground and the low side reach shall be 15 inches minimum above the finish floor or ground.

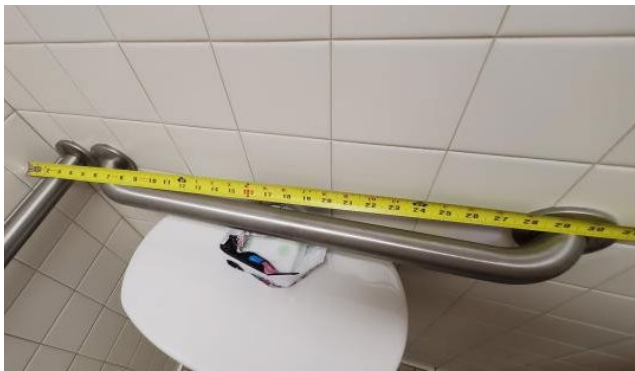
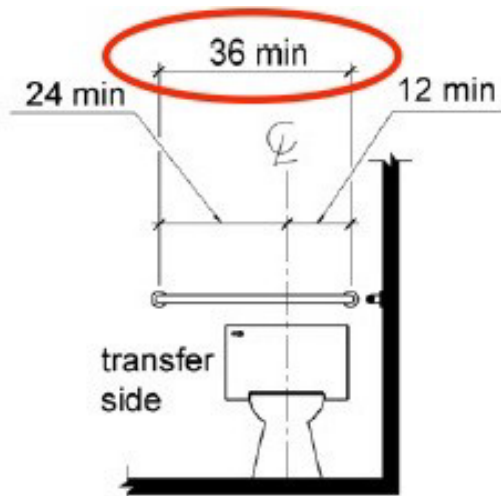
As Built: The rear grab bar is not a minimum 36 inches in length.

Grab bars shall be installed in a horizontal position, 33 inches minimum and 36 inches maximum above the finish floor measured to the top of the gripping surface and the space between the grab bar and the top of the tank (any obstruction) shall be 1-1/2 inches minimum.

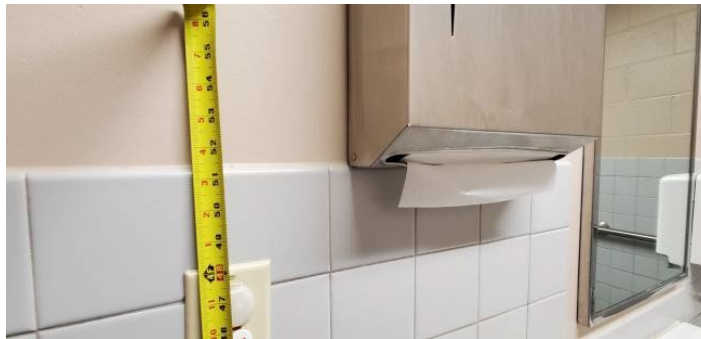
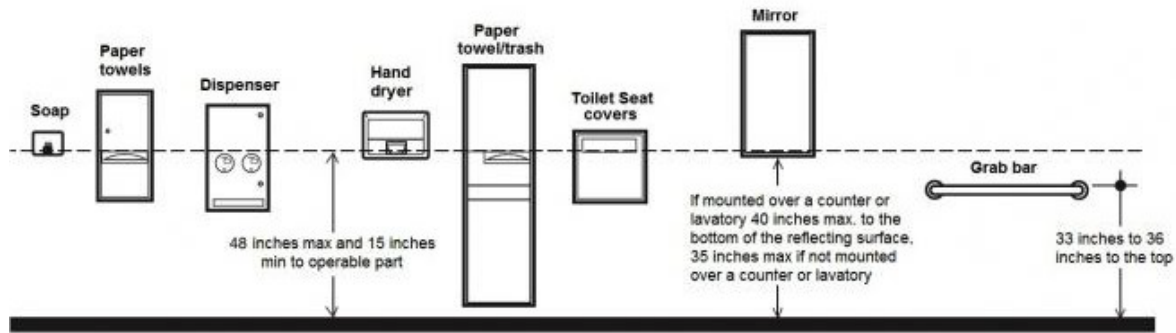
As Built: The paper towel dispenser's operation mechanism is too high off the floor. Dispensers must have all operable parts a maximum of 48 inches above the floor.

Citation: 2010 ADAS Section 308.2.1

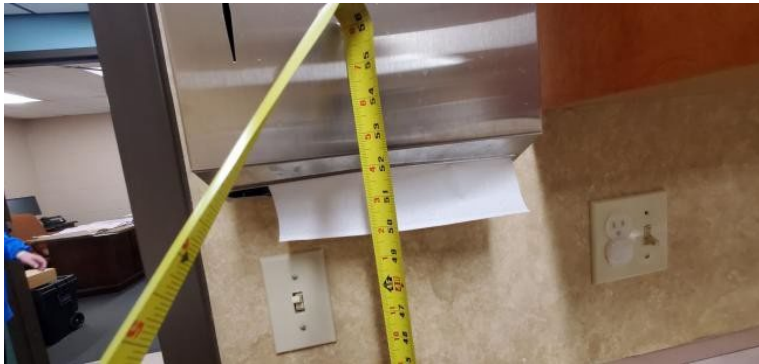
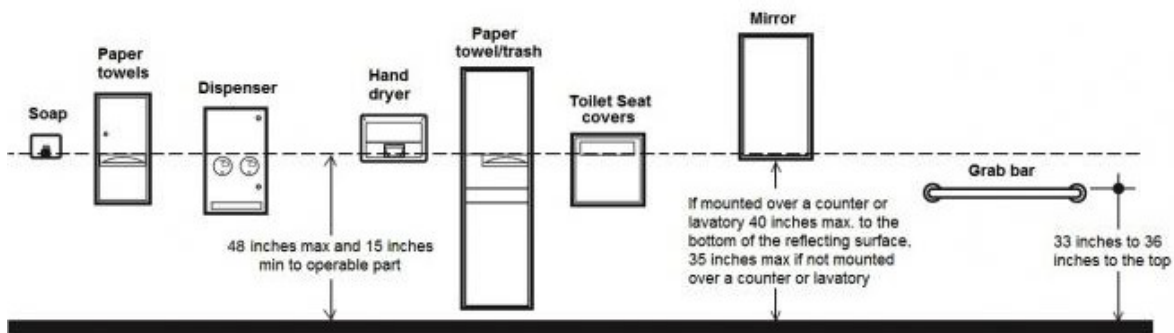
As Built: The paper towel dispenser's operation mechanism is too high off the floor. Dispensers must have all operable parts a maximum of 48 inches above the floor.

Citation: 2010 ADAS Section 308.2.1

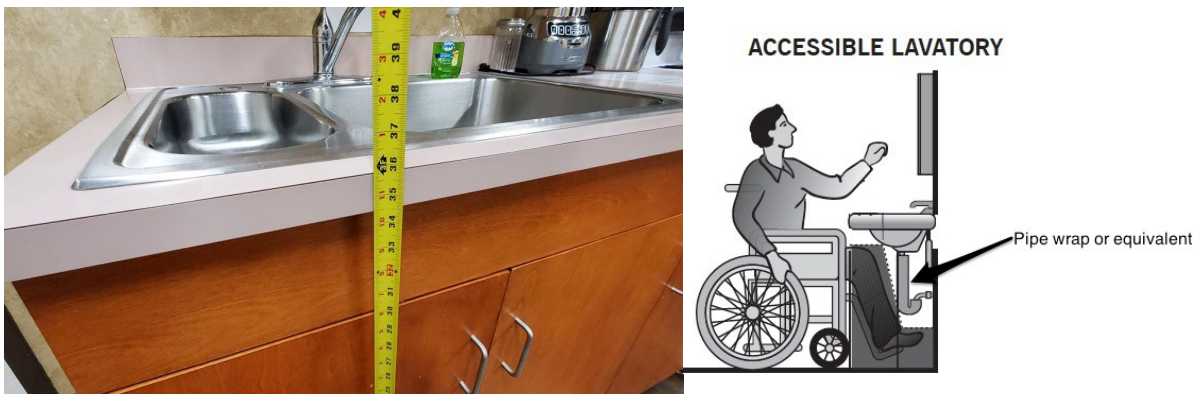
As Built: The top of the sink is too high.

Sinks that are required to be accessible shall be a minimum 17 inches in horizontal depth and mounted with the rim or counter edge no higher than 34 inches above the finished floor.

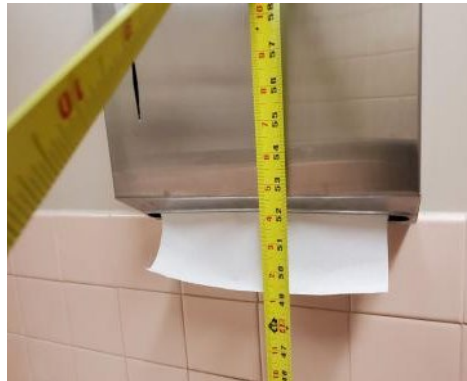
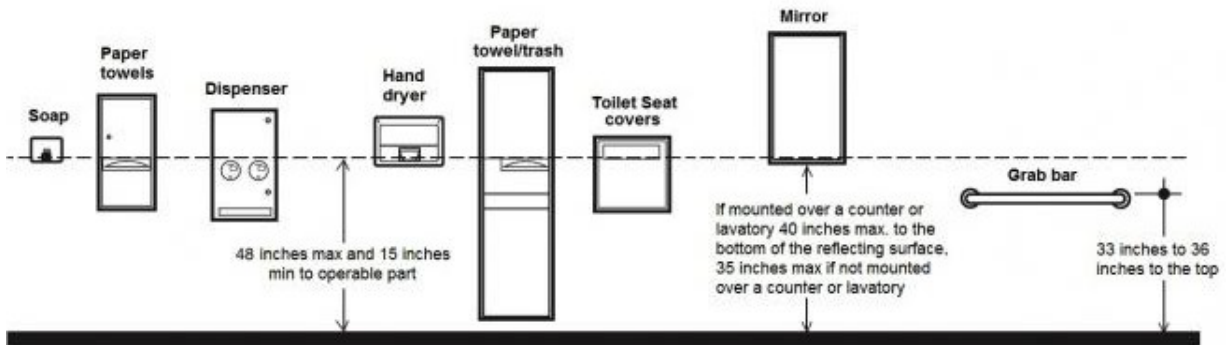
As Built: The paper towel dispenser's operation mechanism is too high off the floor. Dispensers must have all operable parts a maximum of 48 inches above the floor.

Citation: 2010 ADAS Section 308.2.1

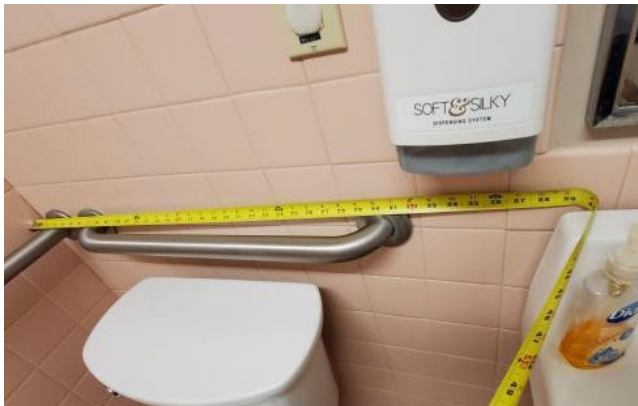
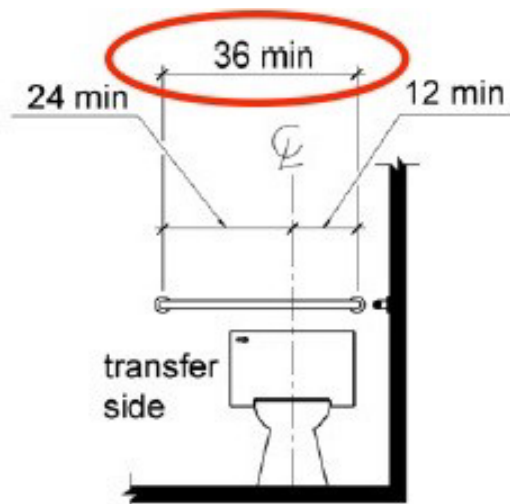
As Built: The rear grab bar is not a minimum 36 inches in length.

Grab bars shall be installed in a horizontal position, 33 inches minimum and 36 inches maximum above the finish floor measured to the top of the gripping surface and the space between the grab bar and the top of the tank (any obstruction) shall be 1-1/2 inches minimum.

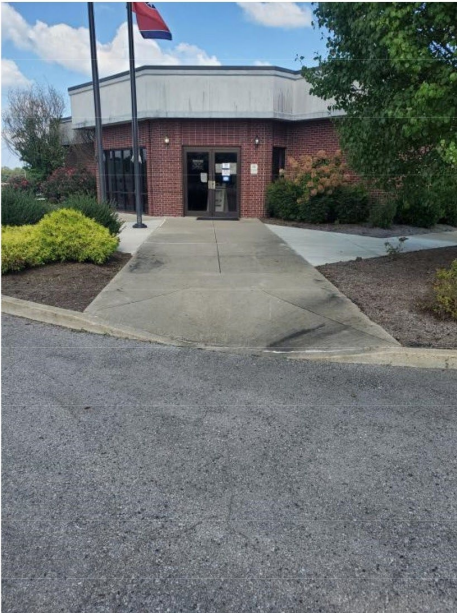
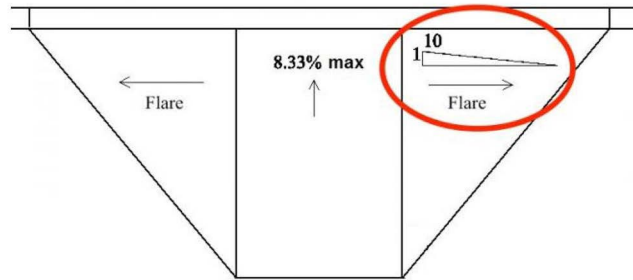
As Built: The curb ramp side flares at 13-15% which is too steep.

The sides of curb ramps (curb ramp flares) where provided, shall not be steeper than 1:10.

Replace the ramp.

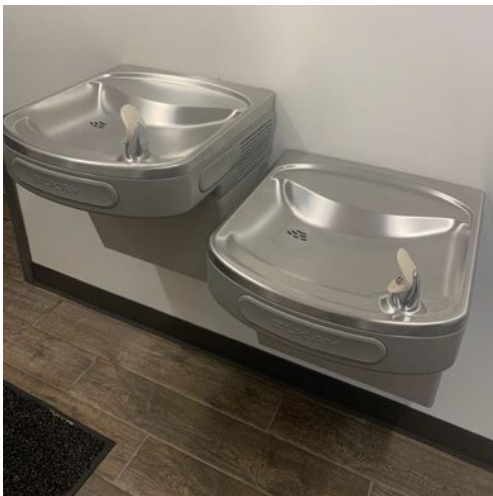
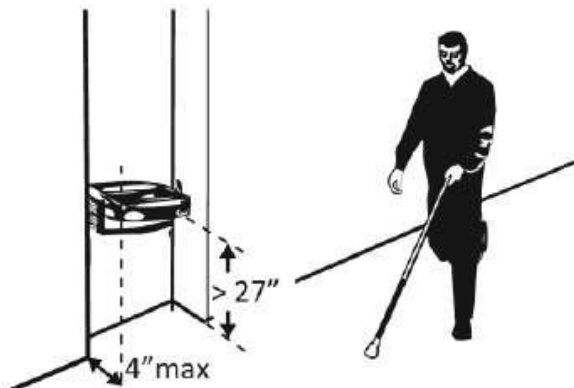
As Built: The protruding object is 17" into walking space.

Objects may protrude no more than 4 inches into walks, halls, corridors, passageways, or aisles when located between 27 and 80 inches above the floor. All drinking fountains shall be located completely within alcoves, positioned completely between wing walls, or otherwise positioned so as not to encroach into pedestrian ways. The alcove must not be less than 32 inches in width and 18 inches in depth. Wing walls must project out from the supporting wall at least as far as the drinking fountain.

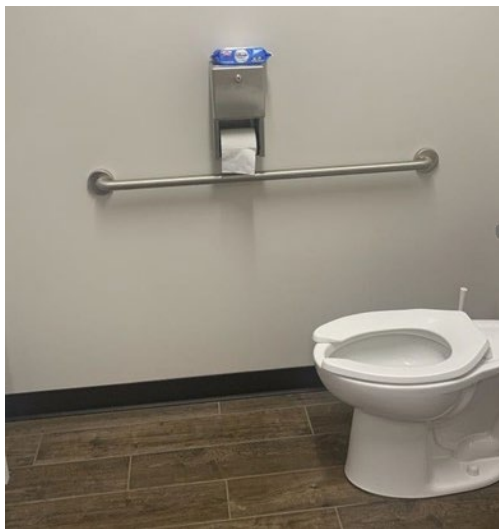
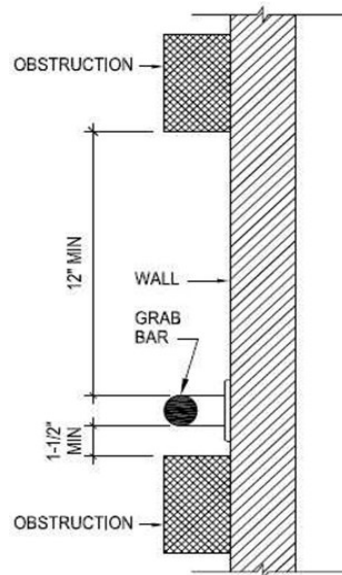
As Built: The toilet paper dispenser is mounted too close to the top of the grab bar, minimizing the gripping surface.

Adjacent elements shall be positioned to provide unobstructed use of grab bars. The space between the grab bar and projecting objects above shall be 12 inches minimum.

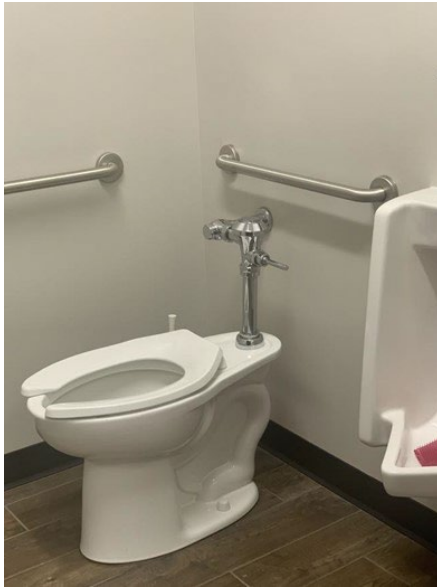
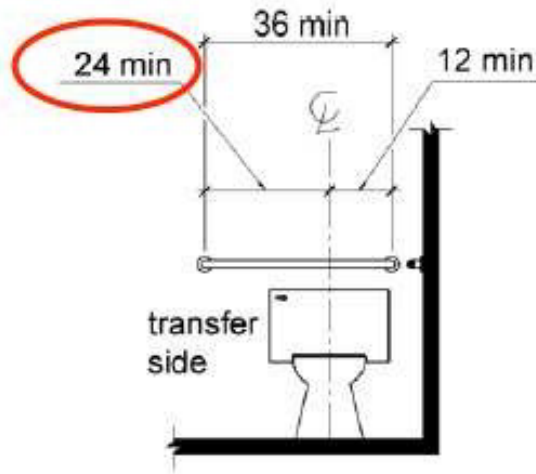
As Built: The rear grab bar does not extend adequately past the toilet on the wide side.

The rear grab bar must be a minimum of 36 inches long and extend from the centerline of the toilet 12 inches minimum on wall side and 24 inches minimum on the wide side.

Install new 3' rear grab bar for 2' to be on transfer side. Replace tile where current grab bar is installed.

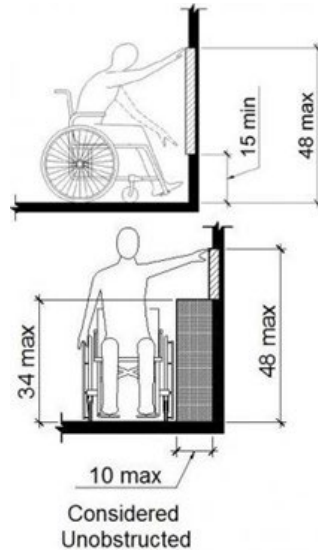
As Built: The receptacle/switch is not positioned correctly for either a side or front approach.

Where a clear floor or ground space allows a parallel or front approach to a switch or receptacle and the side reach is unobstructed, the high side reach shall be 48 inches maximum above the finish floor or ground and the low side reach shall be 15 inches minimum above the finish floor or ground.

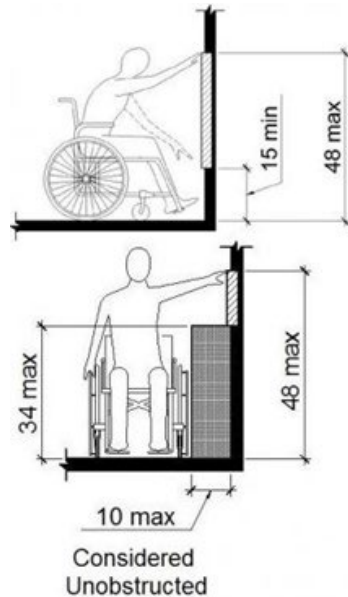
As Built: The receptacle/switch is not positioned correctly for either a side or front approach.

Where a clear floor or ground space allows a parallel or front approach to a switch or receptacle and the side reach is unobstructed, the high side reach shall be 48 inches maximum above the finish floor or ground and the low side reach shall be 15 inches minimum above the finish floor or ground.

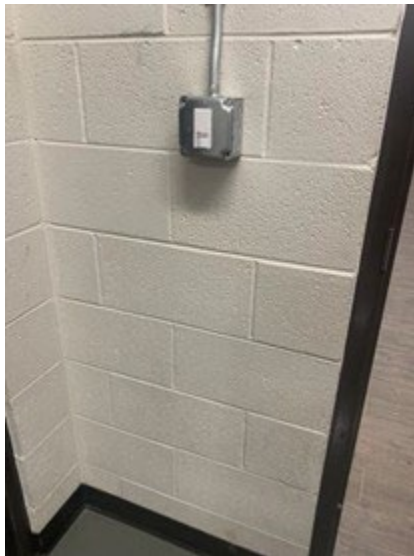
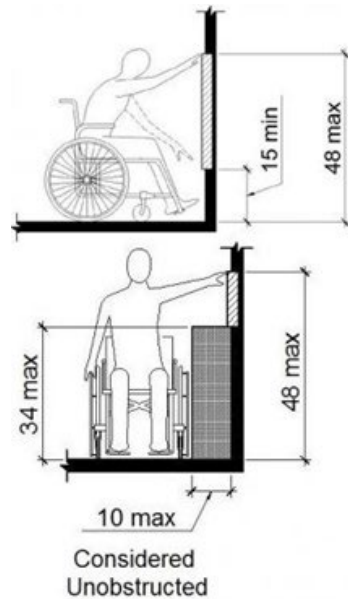
As Built: The receptacle/switch is not positioned correctly for either a side or front approach.

Where a clear floor or ground space allows a parallel or front approach to a switch or receptacle and the side reach is unobstructed, the high side reach shall be 48 inches maximum above the finish floor or ground and the low side reach shall be 15 inches minimum above the finish floor or ground.

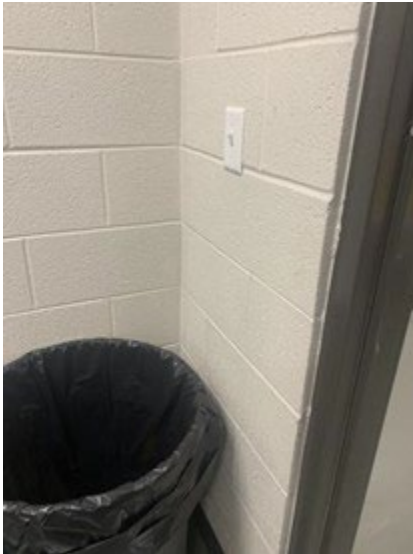
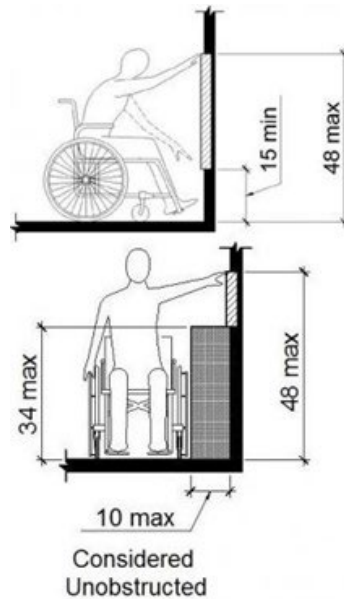
As Built: The receptacle/switch is not positioned correctly for either a side or front approach.

Where a clear floor or ground space allows a parallel or front approach to a switch or receptacle and the side reach is unobstructed, the high side reach shall be 48 inches maximum above the finish floor or ground and the low side reach shall be 15 inches minimum above the finish floor or ground.

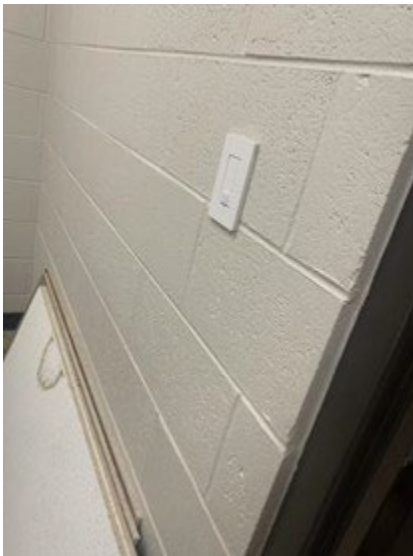
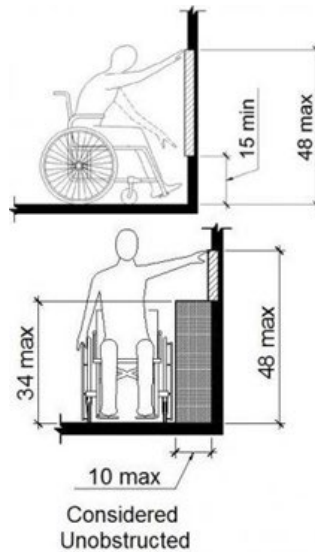
As Built: The receptacle/switch is not positioned correctly for either a side or front approach.

Where a clear floor or ground space allows a parallel or front approach to a switch or receptacle and the side reach is unobstructed, the high side reach shall be 48 inches maximum above the finish floor or ground and the low side reach shall be 15 inches minimum above the finish floor or ground.

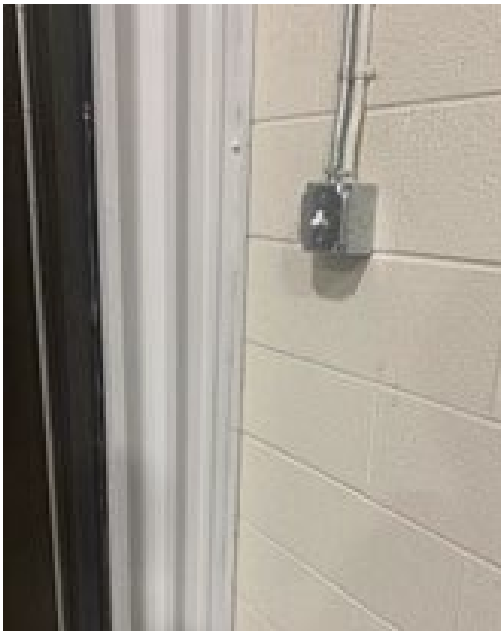
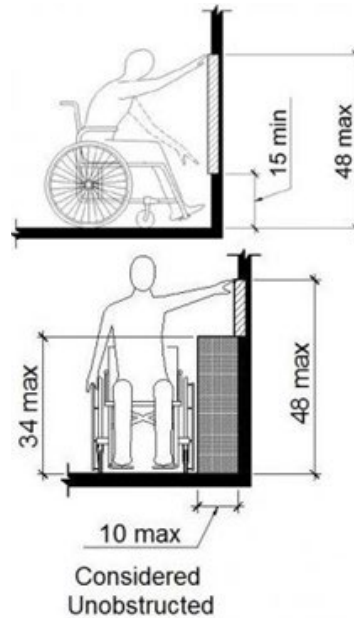
As Built: The receptacle/switch is not positioned correctly for either a side or front approach.

Where a clear floor or ground space allows a parallel or front approach to a switch or receptacle and the side reach is unobstructed, the high side reach shall be 48 inches maximum above the finish floor or ground and the low side reach shall be 15 inches minimum above the finish floor or ground.

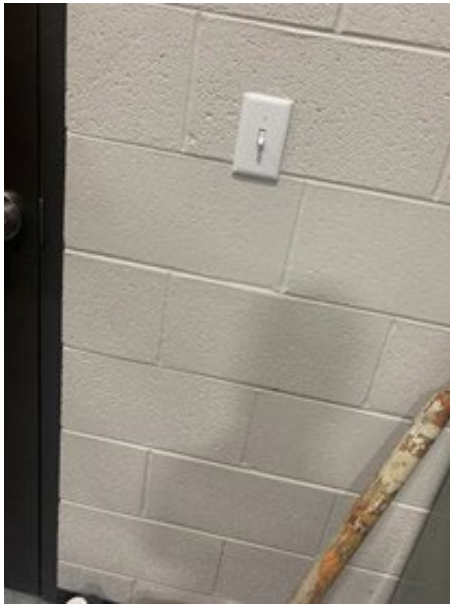
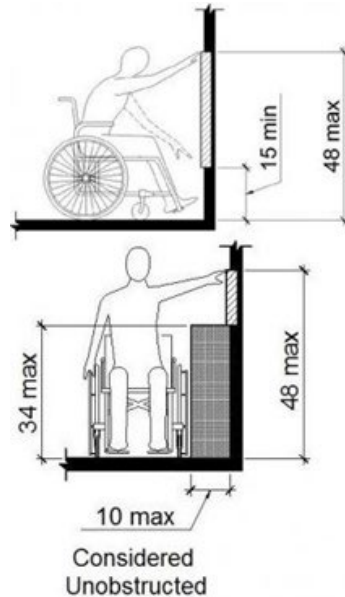
As Built: The receptacle/switch is not positioned correctly for either a side or front approach.

Where a clear floor or ground space allows a parallel or front approach to a switch or receptacle and the side reach is unobstructed, the high side reach shall be 48 inches maximum above the finish floor or ground and the low side reach shall be 15 inches minimum above the finish floor or ground.

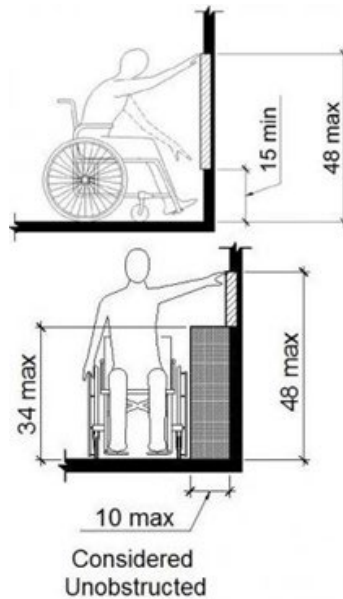
As Built: The receptacle/switch is not positioned correctly for either a side or front approach.

Where a clear floor or ground space allows a parallel or front approach to a switch or receptacle and the side reach is unobstructed, the high side reach shall be 48 inches maximum above the finish floor or ground and the low side reach shall be 15 inches minimum above the finish floor or ground.

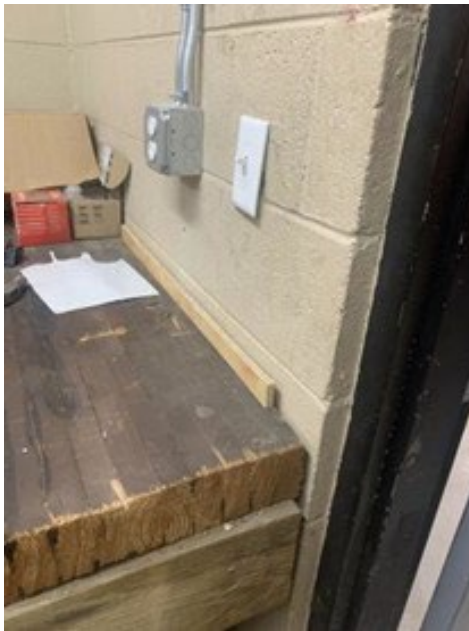
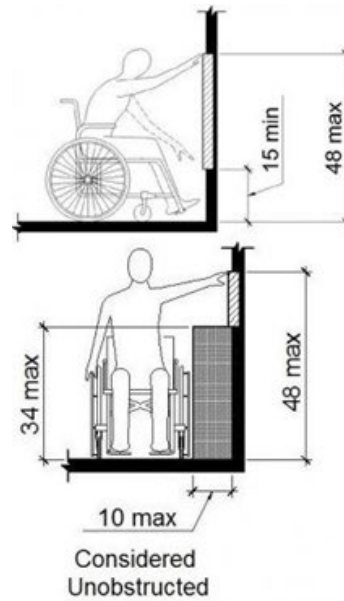
As Built: The receptacle/switch is not positioned correctly for either a side or front approach.

Where a clear floor or ground space allows a parallel or front approach to a switch or receptacle and the side reach is unobstructed, the high side reach shall be 48 inches maximum above the finish floor or ground and the low side reach shall be 15 inches minimum above the finish floor or ground.

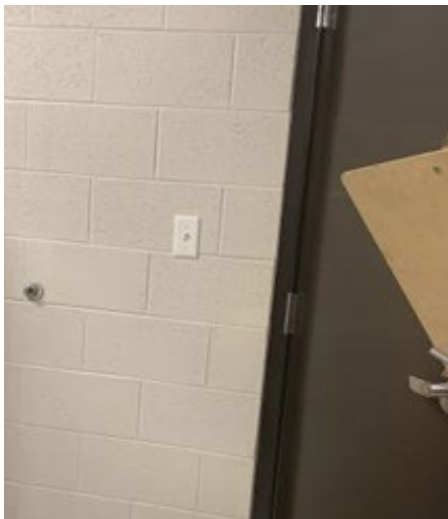
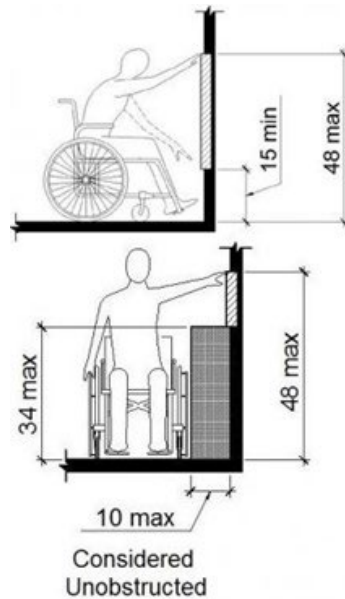
As Built: The receptacle/switch is not positioned correctly for either a side or front approach.

Where a clear floor or ground space allows a parallel or front approach to a switch or receptacle and the side reach is unobstructed, the high side reach shall be 48 inches maximum above the finish floor or ground and the low side reach shall be 15 inches minimum above the finish floor or ground.

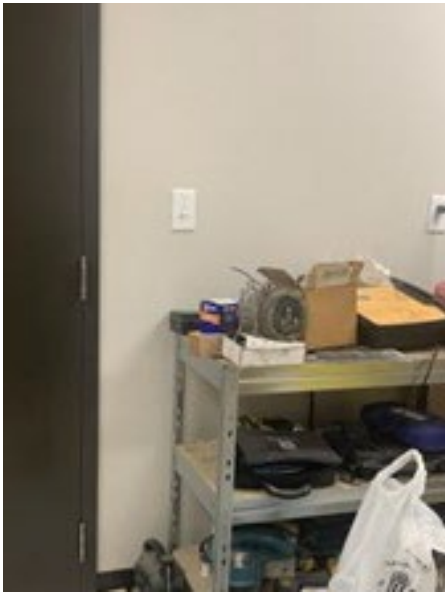
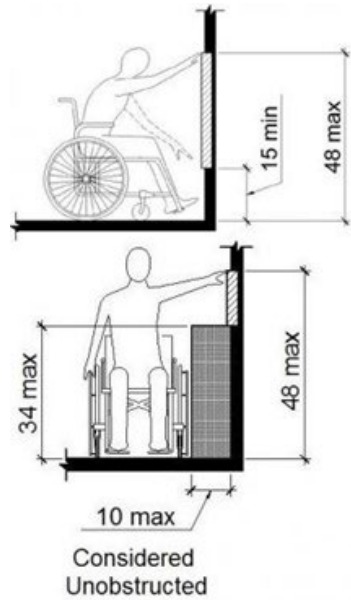
As Built: The receptacle/switch is not positioned correctly for either a side or front approach.

Where a clear floor or ground space allows a parallel or front approach to a switch or receptacle and the side reach is unobstructed, the high side reach shall be 48 inches maximum above the finish floor or ground and the low side reach shall be 15 inches minimum above the finish floor or ground.

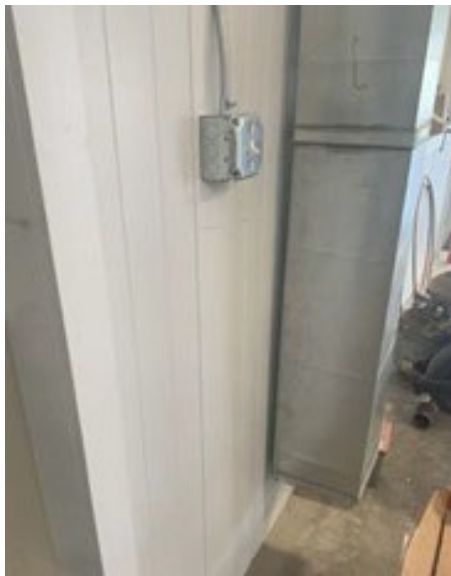
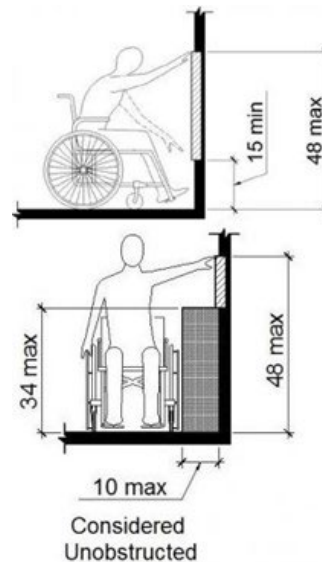
As Built: The receptacle/switch is not positioned correctly for either a side or front approach.

Where a clear floor or ground space allows a parallel or front approach to a switch or receptacle and the side reach is unobstructed, the high side reach shall be 48 inches maximum above the finish floor or ground and the low side reach shall be 15 inches minimum above the finish floor or ground.

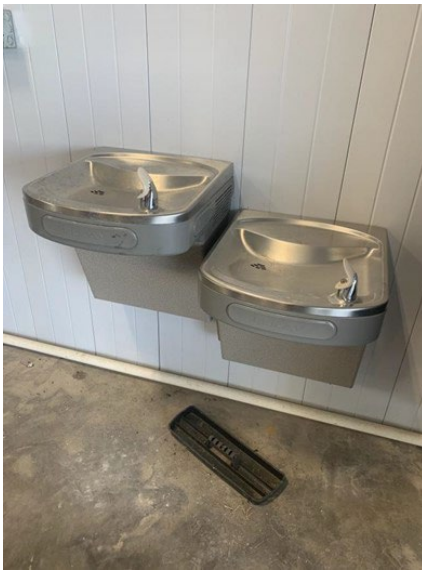
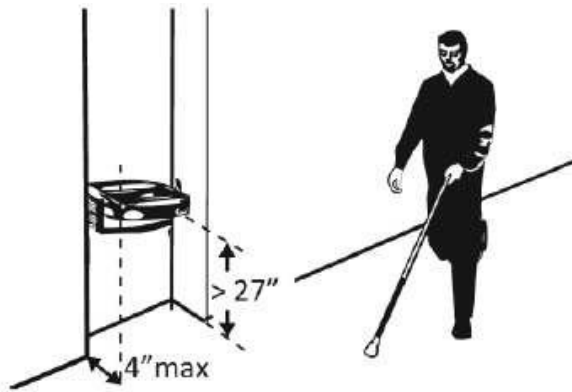
As Built: Fountain protrudes more than 4" into walk space.

Objects may protrude no more than 4 inches into walks, halls, corridors, passageways, or aisles when located between 27 and 80 inches above the floor. All drinking fountains shall be located completely within alcoves, positioned completely between wing walls, or otherwise positioned so as not to encroach into pedestrian ways. The alcove must not be less than 32 inches in width and 18 inches in depth. Wing walls must project out from the supporting wall at least as far as the drinking fountain.

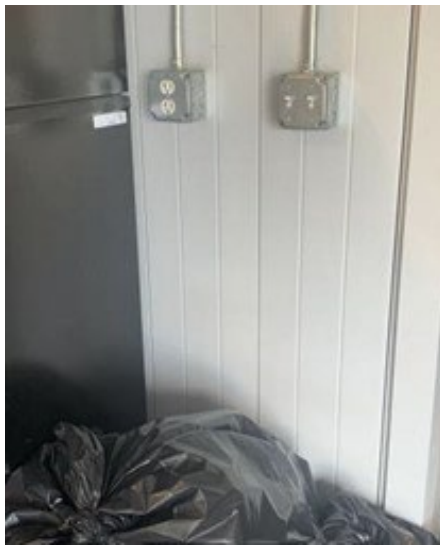
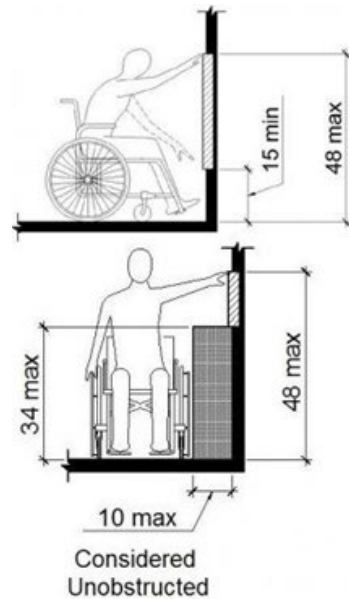
As Built: The receptacle/switch is not positioned correctly for either a side or front approach.

Where a clear floor or ground space allows a parallel or front approach to a switch or receptacle and the side reach is unobstructed, the high side reach shall be 48 inches maximum above the finish floor or ground and the low side reach shall be 15 inches minimum above the finish floor or ground.

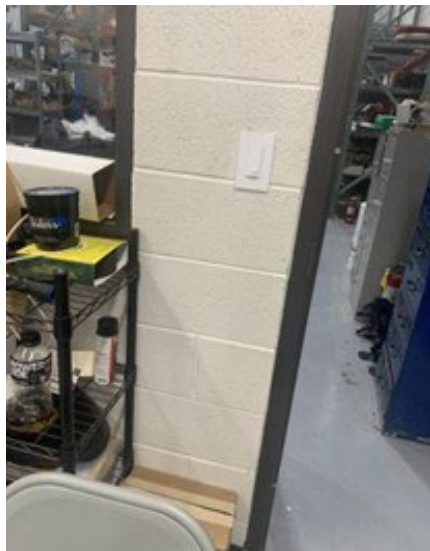
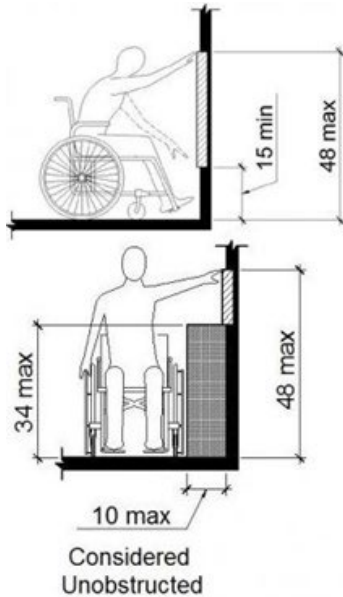
As Built: The receptacle/switch is not positioned correctly for either a side or front approach.

Where a clear floor or ground space allows a parallel or front approach to a switch or receptacle and the side reach is unobstructed, the high side reach shall be 48 inches maximum above the finish floor or ground and the low side reach shall be 15 inches minimum above the finish floor or ground.

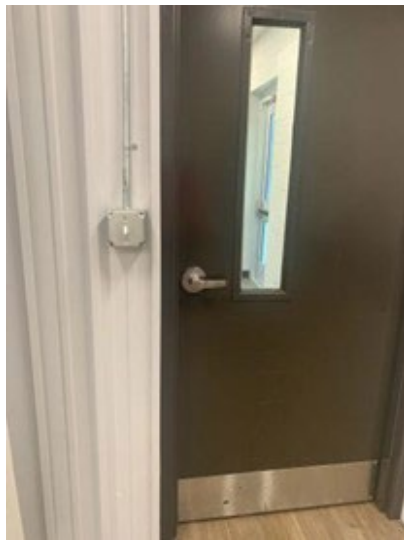
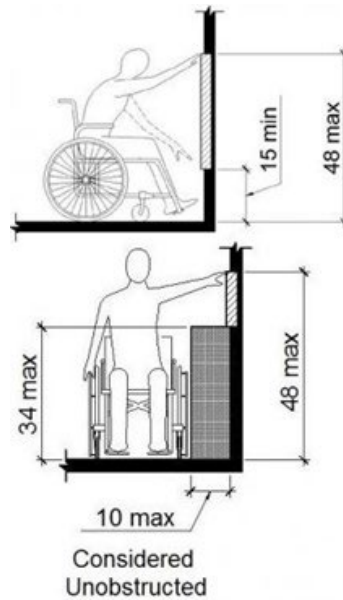
As Built: The receptacle/switch is not positioned correctly for either a side or front approach.

Where a clear floor or ground space allows a parallel or front approach to a switch or receptacle and the side reach is unobstructed, the high side reach shall be 48 inches maximum above the finish floor or ground and the low side reach shall be 15 inches minimum above the finish floor or ground.

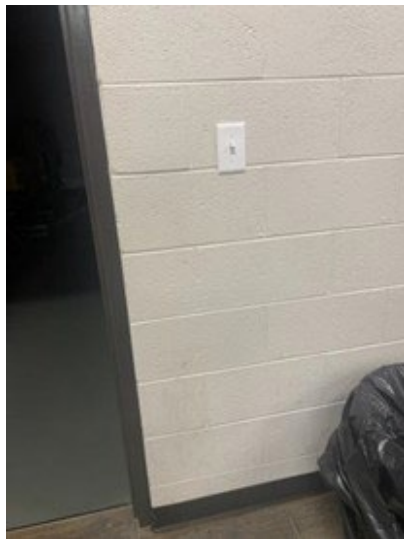
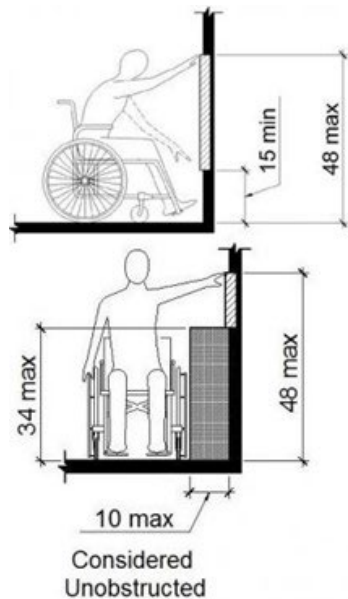
As Built: The receptacle/switch is not positioned correctly for either a side or front approach.

Where a clear floor or ground space allows a parallel or front approach to a switch or receptacle and the side reach is unobstructed, the high side reach shall be 48 inches maximum above the finish floor or ground and the low side reach shall be 15 inches minimum above the finish floor or ground.

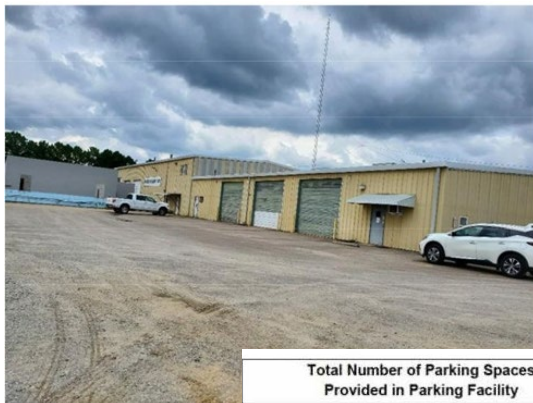
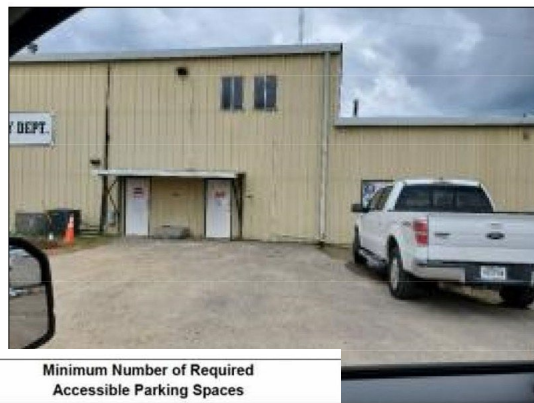
As Built: There are 10 paved spaces with no marked handicap parking or access aisle. There is space for each and an entrance on grade with parking. Remainder of parking is gravel and other entrances are non-accessible. Each lot where parking is provided for the public as clients, guests or employees, shall provide accessible parking and shall be located on the shortest accessible route of travel from adjacent parking to an accessible entrance.

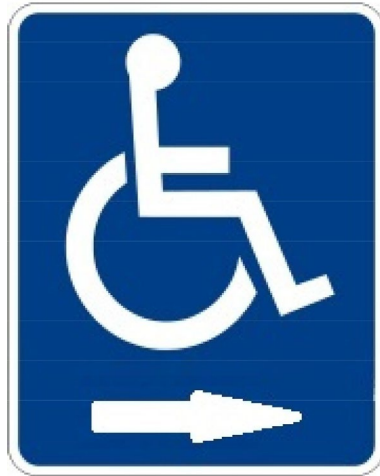
As Built: There is no International Symbol of Accessibility at this entrance.

In existing buildings and facilities where not all entrances are accessible doors that are accessible shall be identified by the International Symbol of Accessibility. Directional signs that indicate the location of the nearest accessible entrance shall be provided at entrances that are not accessible. Directional signs including the International Symbol of Accessibility indicating the accessible route to the nearest accessible entrance shall be provided at junctions when the accessible route diverges from the regular circulation path.

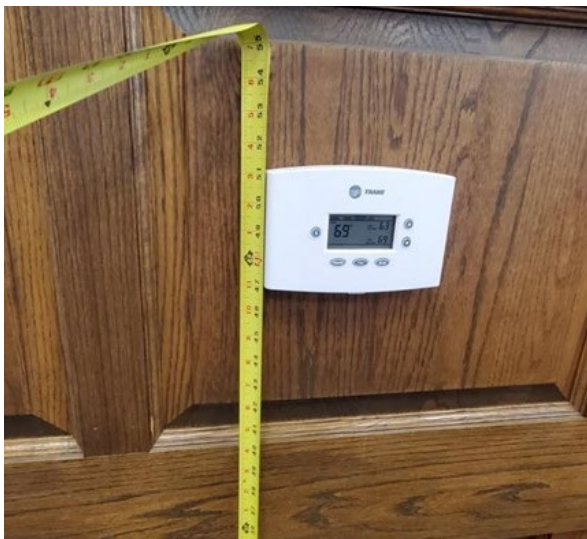
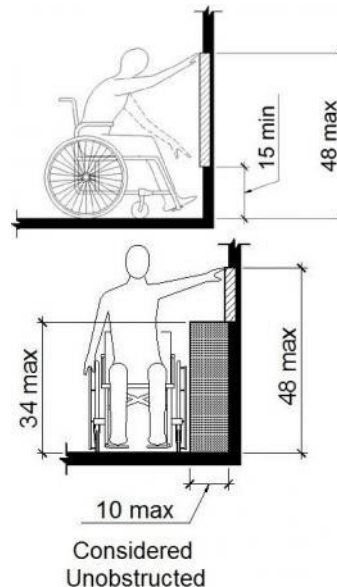
As Built: The thermostat is not positioned correctly for either a side or front approach.

Where a clear floor or ground space allows a parallel or front approach and the side reach is unobstructed, the high side reach shall be 48 inches maximum above the finish floor or ground and the low side reach shall be 15 inches minimum above the finish floor or ground.

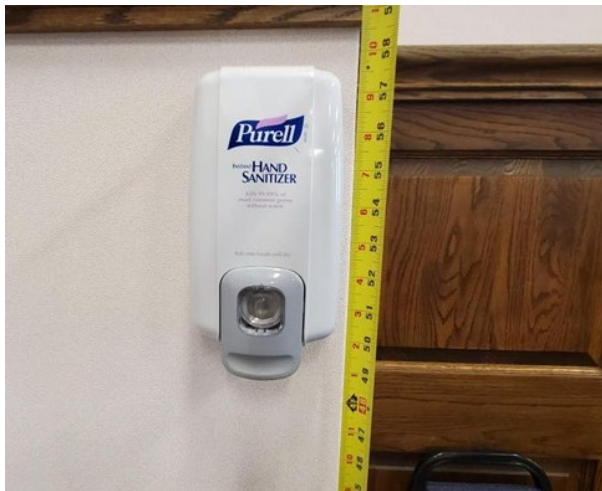
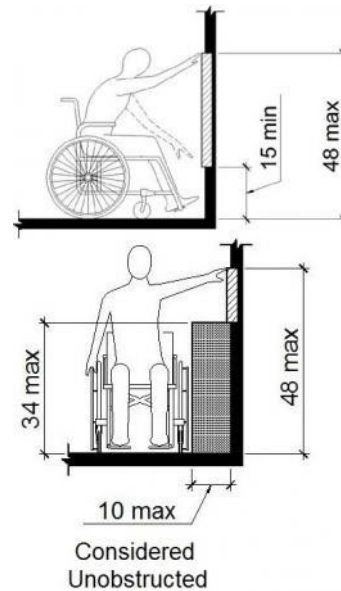
As Built: The hand sanitizer is not positioned correctly for either a side or front approach.

Where a clear floor or ground space allows a parallel or front approach and the side reach is unobstructed, the high side reach shall be 48 inches maximum above the finish floor or ground and the low side reach shall be 15 inches minimum above the finish floor or ground.

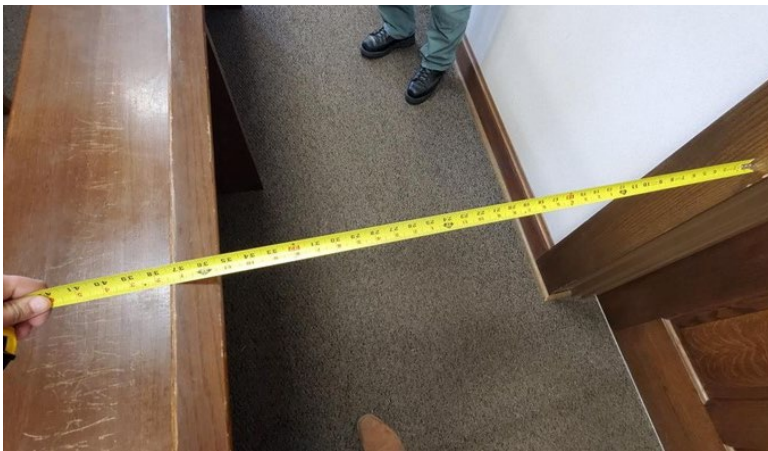
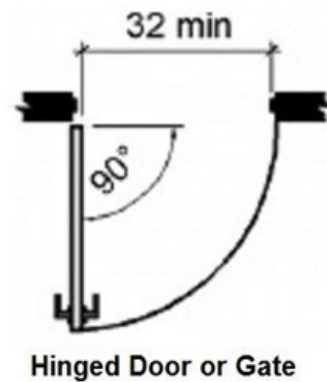
As Built: The door opening has furniture encroaching into wheelchair clear floor space.

Citation: 2010 ADAS Section 404.2.4

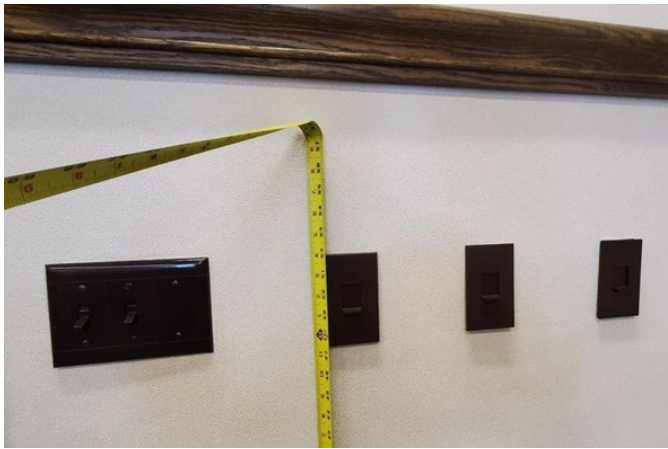
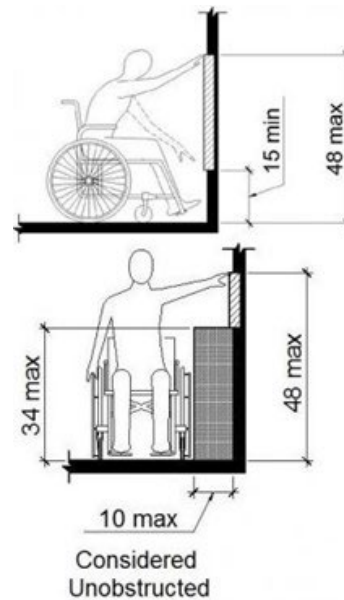
As Built: The receptacle/switch is not positioned correctly for either a side or front approach.

Where a clear floor or ground space allows a parallel or front approach to a switch or receptacle and the side reach is unobstructed, the high side reach shall be 48 inches maximum above the finish floor or ground and the low side reach shall be 15 inches minimum above the finish floor or ground.

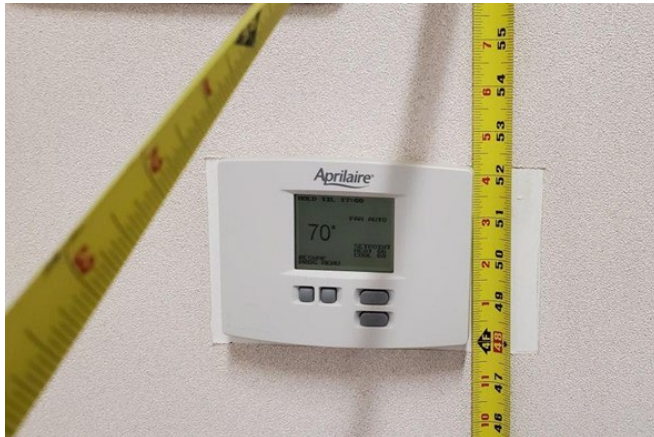
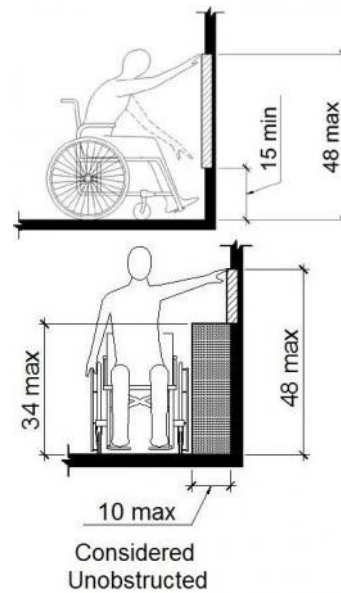
As Built: The thermostat is not positioned correctly for either a side or front approach.

Where a clear floor or ground space allows a parallel or front approach and the side reach is unobstructed, the high side reach shall be 48 inches maximum above the finish floor or ground and the low side reach shall be 15 inches minimum above the finish floor or ground.

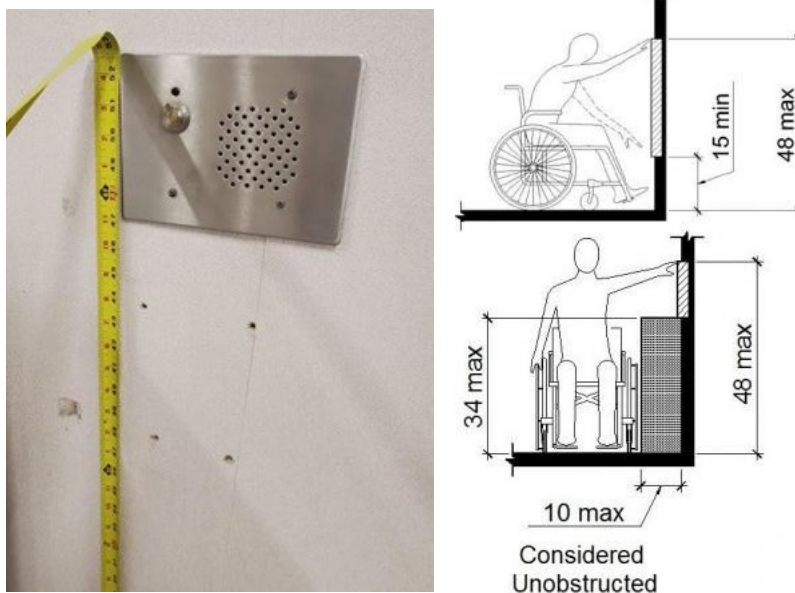
As Built: The Receptionist call button is not positioned correctly for either a side or front approach.

Where a clear floor or ground space allows a parallel or front approach and the side reach is unobstructed, the high side reach shall be 48 inches maximum above the finish floor or ground and the low side reach shall be 15 inches minimum above the finish floor or ground.
