WEAKLEY COUNTY, TENNESSEE

ADA EVALUATION

Architectural and Site Findings with Recommendations

TLM Associates, Inc

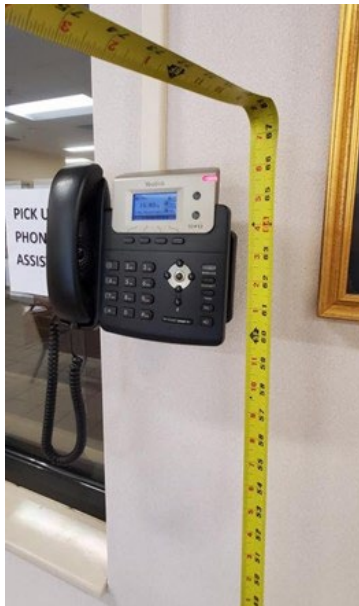
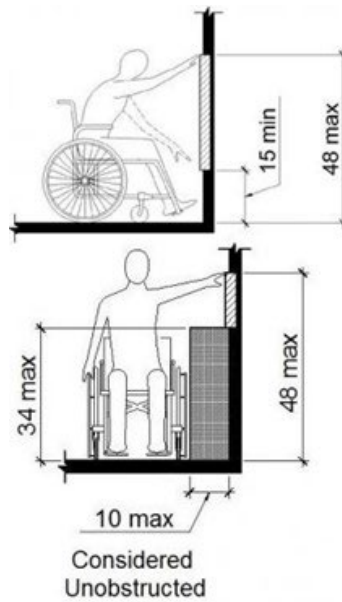
As Built: The telephone is not positioned correctly for either a side or front approach.

Where a clear floor or ground space allows a parallel or front approach and the side reach is unobstructed, the high side reach shall be 48 inches maximum above the finish floor or ground and the low side reach shall be 15 inches minimum above the finish floor or ground.

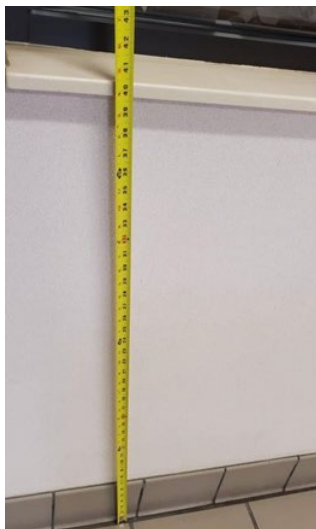
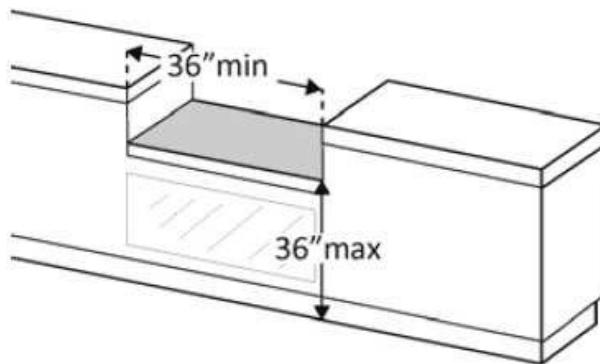
As Built: The transaction counter is too high.

A portion of the counter surface that is 36 inches long minimum and 36 inches high maximum above the finish floor shall be provided. Knee and toe space must be provided for a forward approach. A 30 inch by 48 inch clear floor space on an accessible route must be provided for either a forward or parallel approach.

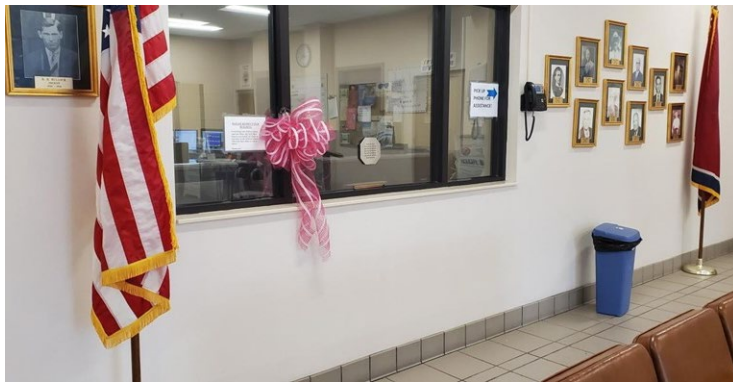
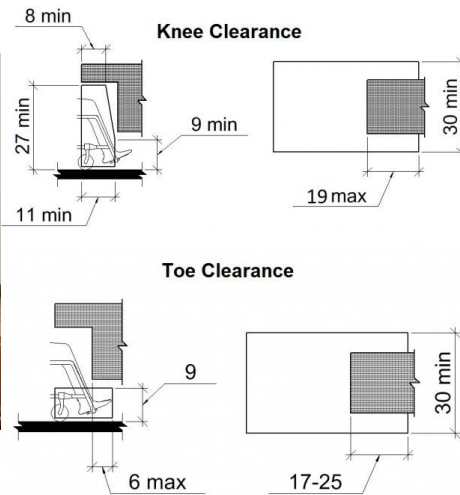
As Built: Compliant knee and/or toe space is not provided.

Space under an element between the finish floor or ground and 9 inches above the finish floor or ground shall be considered toe clearance. Toe clearance shall extend 25 inches maximum and 17 inches minimum under an element. Space extending greater than 6 inches beyond the available knee clearance at 9 inches above the finish floor or ground shall not be considered toe clearance. Toe clearance shall be 30 inches wide minimum.

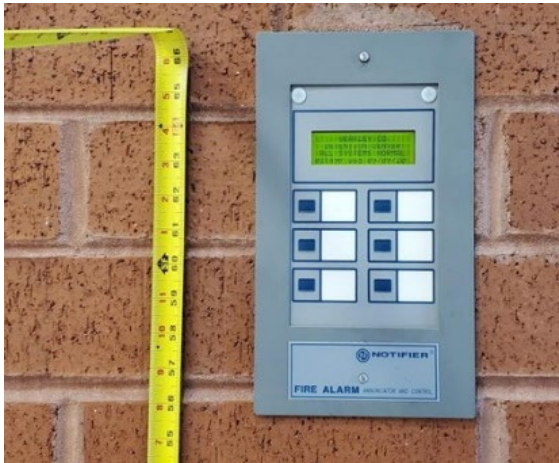
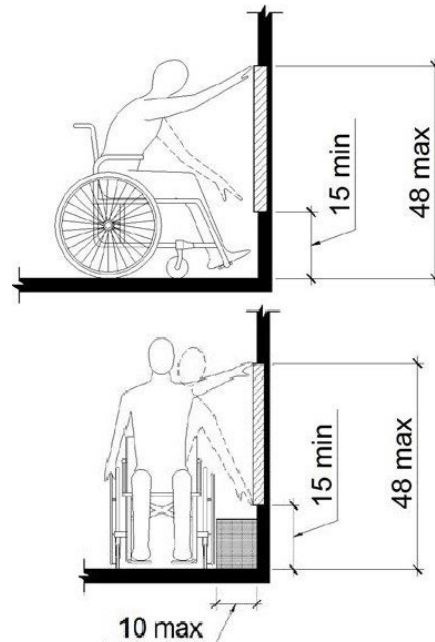
As Built: The Fire Alarm Annunciator is positioned too high for either a side or front approach.

Where a clear floor or ground space allows a parallel approach to an element and the side reach is unobstructed, the high side reach shall be 48 inches maximum, and the low side reach shall be 15 inches minimum above the finish floor or ground.

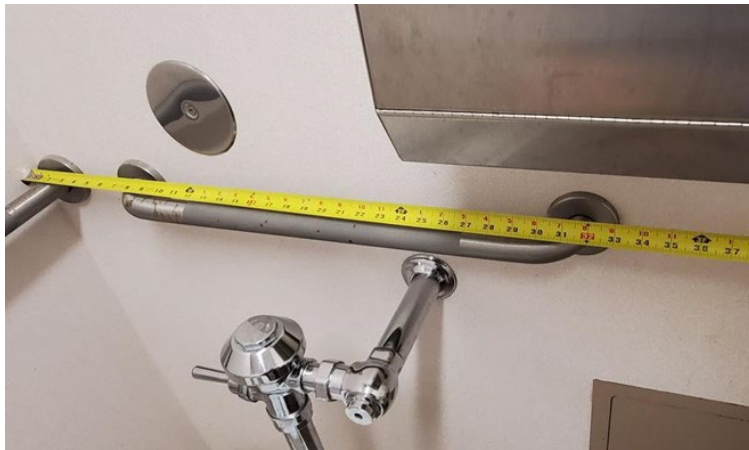
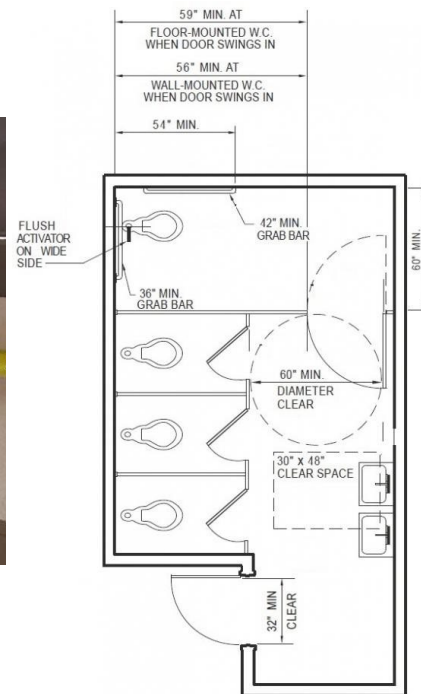
As Built: The restrooms are not nearly compliant. The entry door encroaches into the required clear floor space for fixtures 180 degrees. Rear Grab bar incorrect size to be 36". Lavatory not ADA compliant, wall mount lavs. Toilet Flush handle on wrong side

Citation: 2010 ADAS Section 213.2

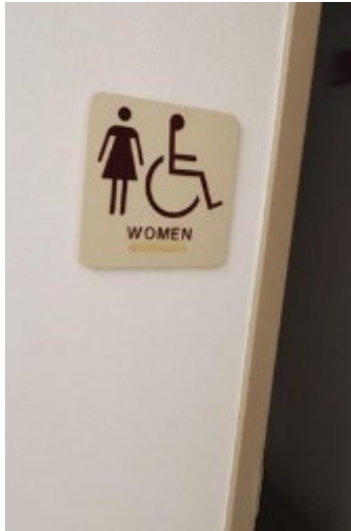
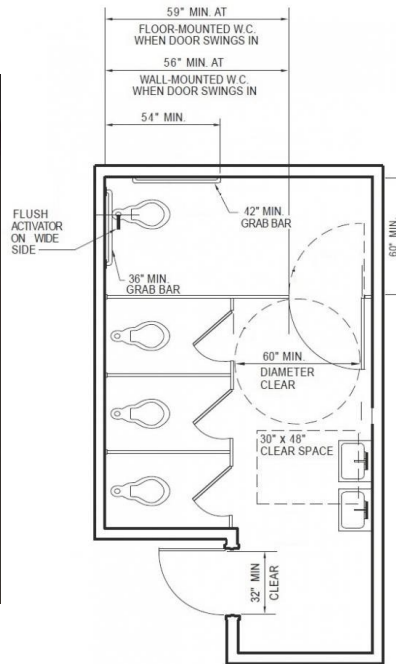
As Built: The restrooms are not nearly compliant. The entry door encroaches into the required clear floor space for fixtures if open at 180 degrees, at 90 degrees it is okay. Rear grab bar not long enough, too small. Mirror exceeds 40" to reflecting surface.

Citation: 2010 ADAS Section 213.2

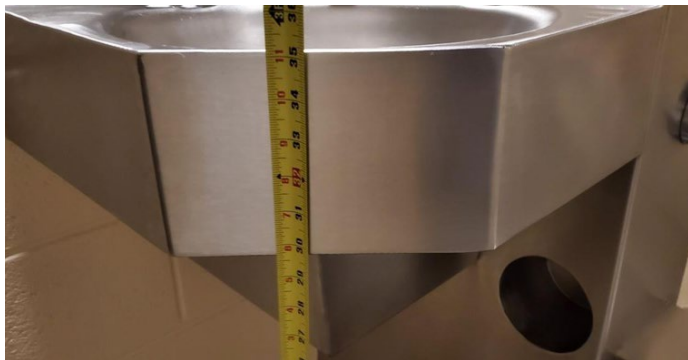
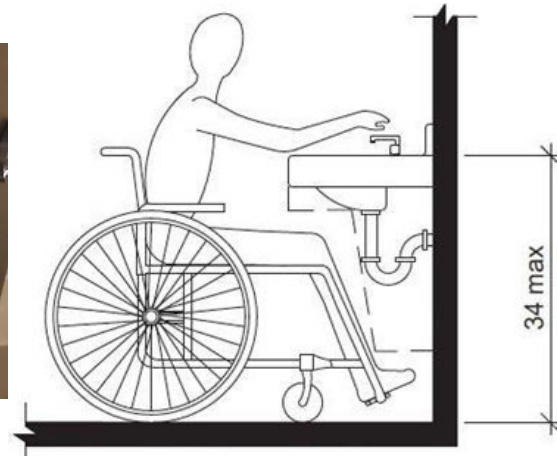
As Built: The top rim of the lavatory is too high.

All lavatories that are designated to be accessible shall be a minimum 17 inches in horizontal depth and mounted with the rim or counter edge no higher than 34 inches above the finished floor.

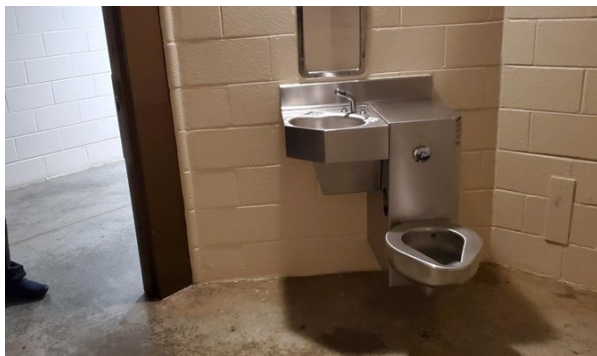
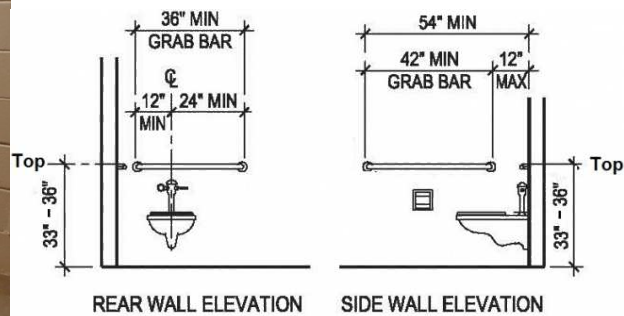
As Built: Accessible toilets must have grab bars installed.

The side grab bar must extend at least 54 inches minimum beyond the rear wall and start a maximum of 12 inches from the rear wall.

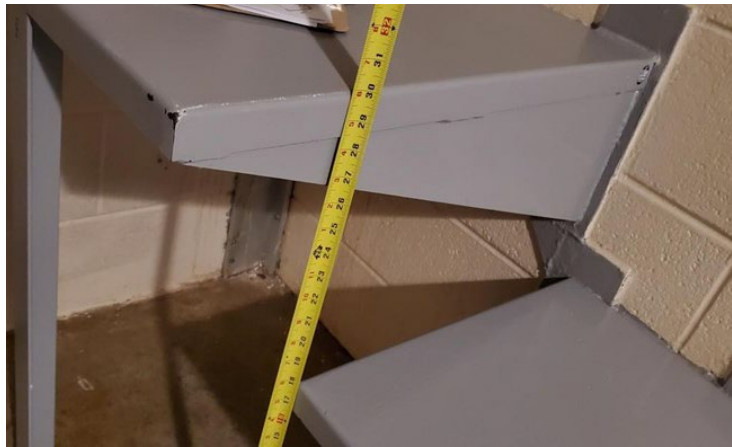
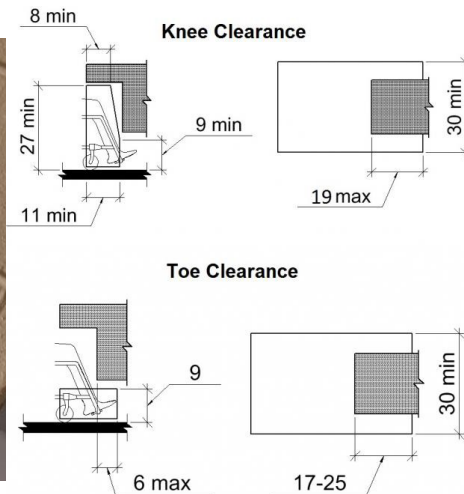
As Built: Compliant knee and/or toe space is not provided.

Space under an element between the finish floor or ground and 9 inches above the finish floor or ground shall be considered toe clearance. Toe clearance shall extend 25 inches maximum and 17 inches minimum under an element. Space extending greater than 6 inches beyond the available knee clearance at 9 inches above the finish floor or ground shall not be considered toe clearance. Toe clearance shall be 30 inches wide minimum.

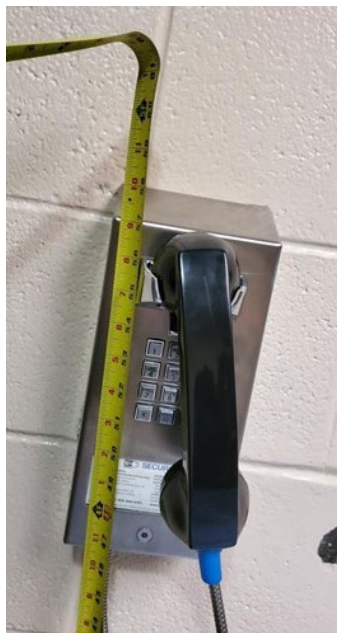
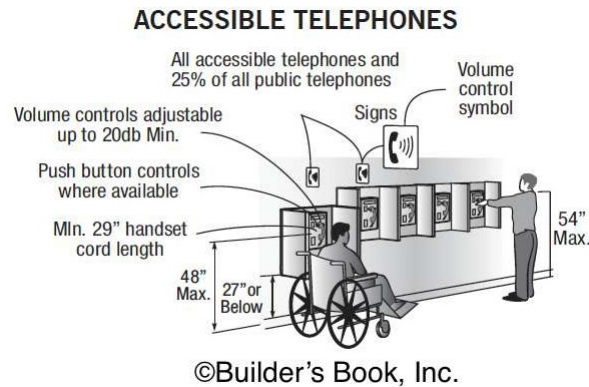
As Built: The telephone is not accessible.

Where coin-operated public pay telephones, coinless public pay telephones, public Closed-Circuit Telephones, public courtesy phones, or other types of public telephones are provided, public telephones shall be wheelchair accessible, have volume controls, TTY and meet the bank requirements if applicable for each type of public telephone provided. For purposes of this section, a bank of telephones shall be considered to be two or more adjacent telephones.

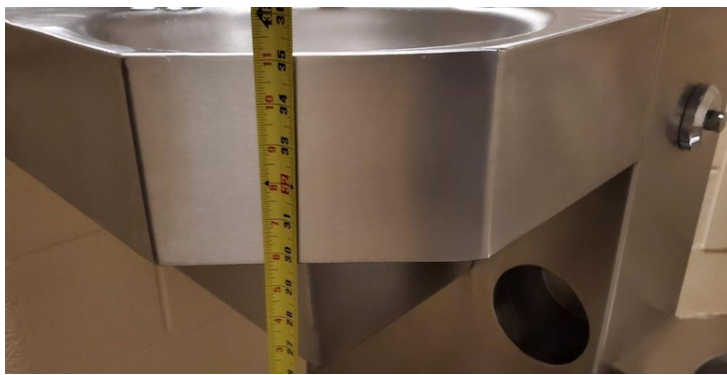
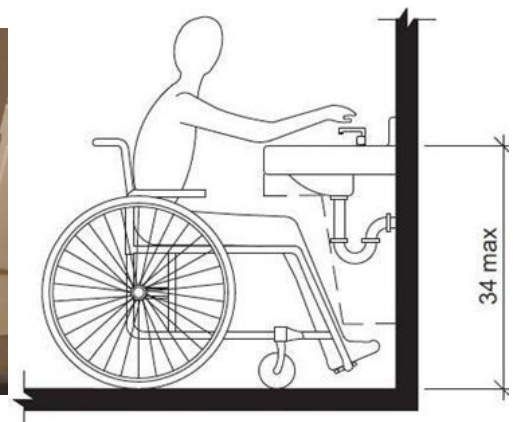
As Built: The top rim of the lavatory is too high.

All lavatories that are designated to be accessible shall be a minimum 17 inches in horizontal depth and mounted with the rim or counter edge no higher than 34 inches above the finished floor.

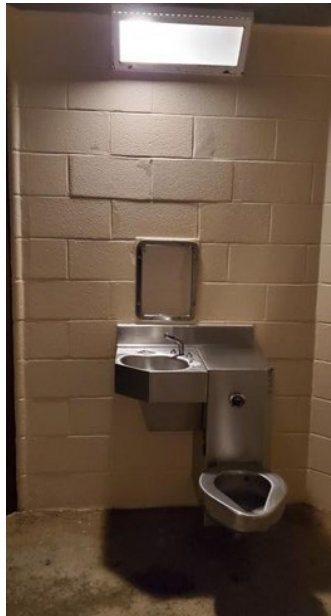
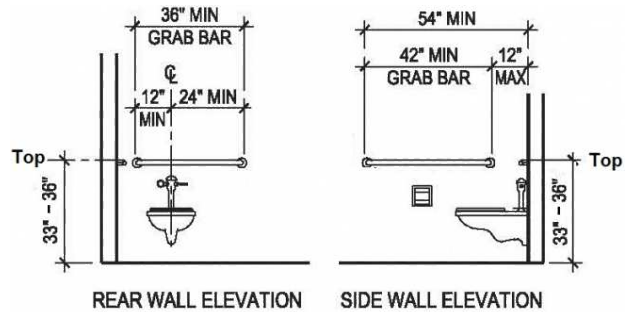
As Built: Accessible toilets must have grab bars installed.

The side grab bar must extend at least 54 inches minimum beyond the rear wall and start a maximum of 12 inches from the rear wall.

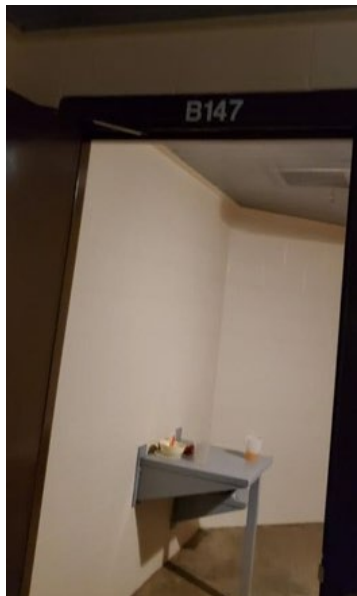
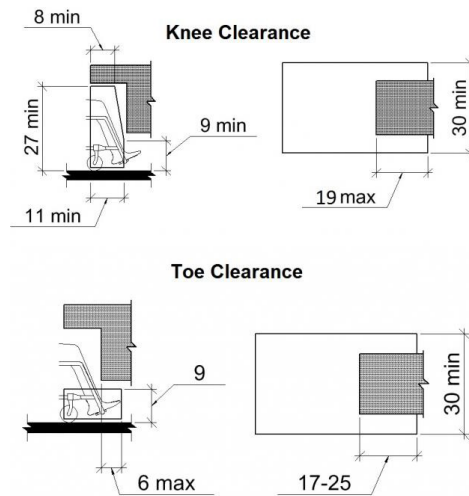
As Built: There are no accessible dining surfaces.

Dining surfaces shall be dispersed throughout the space or facility in each functional area containing dining surfaces. Where dining surfaces are provided for the consumption of food or drink, at least 5 percent of the seating spaces and standing spaces at the dining surfaces shall provide a clear floor space positioned for a forward approach and knee and toe clearance. The tops of dining surfaces shall be 28 inches minimum and 34 inches maximum above the finish floor or ground.

Recommendation: Modify or rebuild a 3' section to provide knee clearance.

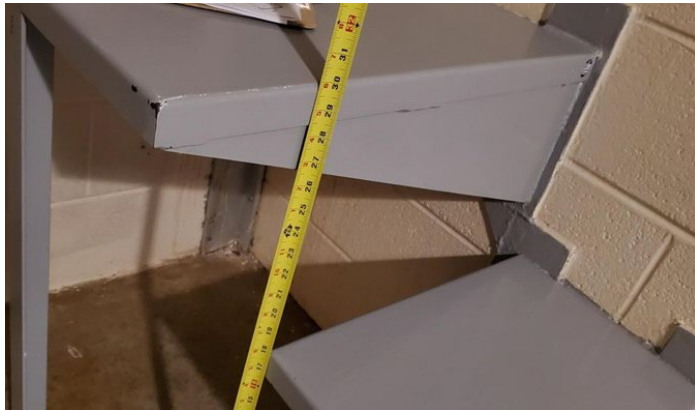
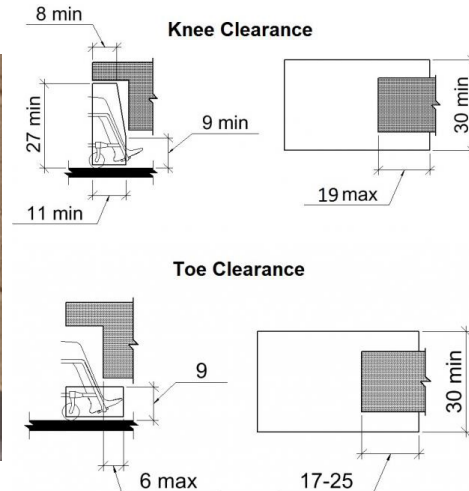
As Built: Compliant knee and/or toe space is not provided.

Space under an element between the finish floor or ground and 9 inches above the finish floor or ground shall be considered toe clearance. Toe clearance shall extend 25 inches maximum and 17 inches minimum under an element. Space extending greater than 6 inches beyond the available knee clearance at 9 inches above the finish floor or ground shall not be considered toe clearance. Toe clearance shall be 30 inches wide minimum.

Recommendation: Lower telephone for all operable components to be 48" max AFF

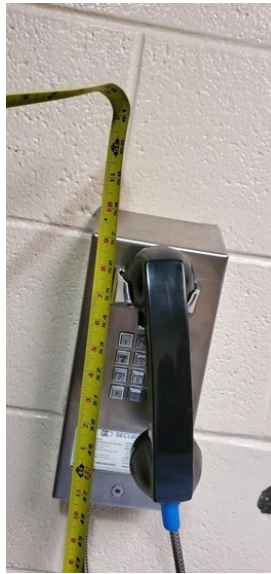
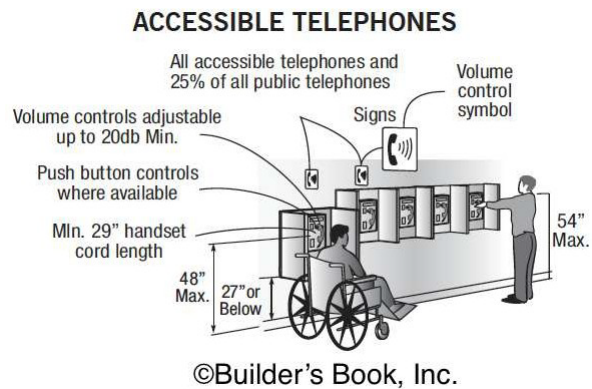
As Built: The telephone is not accessible.

Where coin-operated public pay telephones, coinless public pay telephones, public Closed-Circuit Telephones, public courtesy phones, or other types of public telephones are provided, public telephones shall be wheelchair accessible, have volume controls, TTY and meet the bank requirements if applicable for each type of public telephone provided. For purposes of this section, a bank of telephones shall be considered to be two or more adjacent telephones.

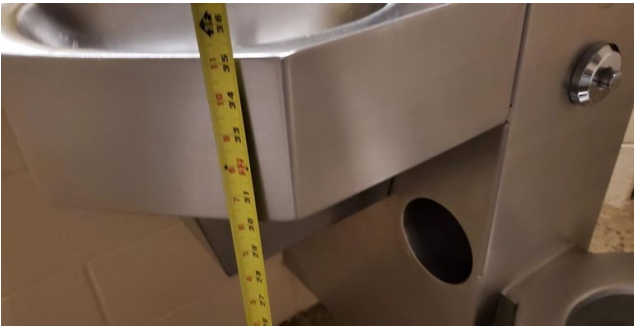
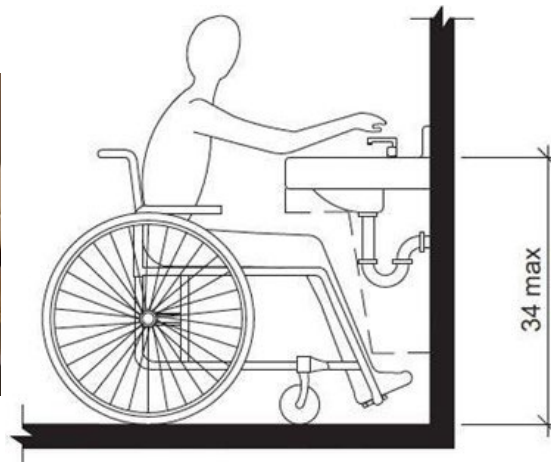
As Built: The top rim of the lavatory is too high.

All lavatories that are designated to be accessible shall be a minimum 17 inches in horizontal depth and mounted with the rim or counter edge no higher than 34 inches above the finished floor.

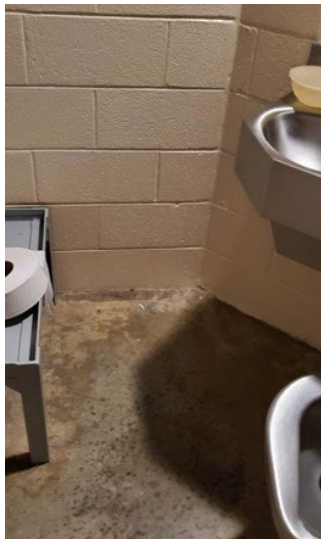
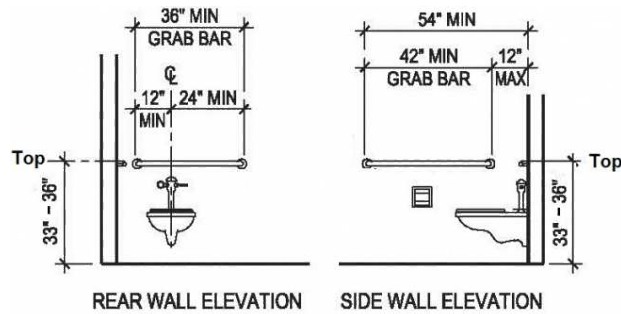
As Built: Accessible toilets must have grab bars installed.

The side grab bar must extend at least 54 inches minimum beyond the rear wall and start a maximum of 12 inches from the rear wall.

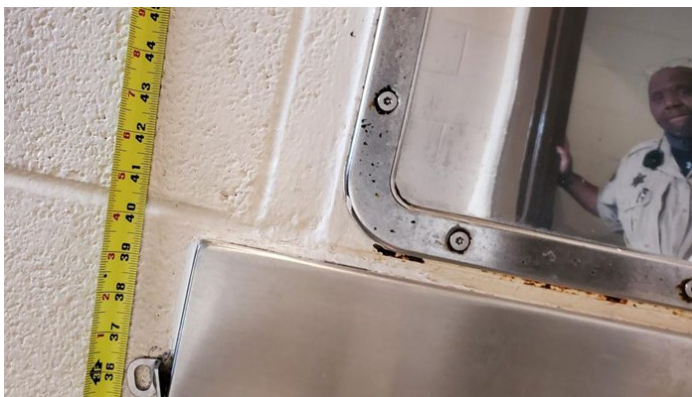
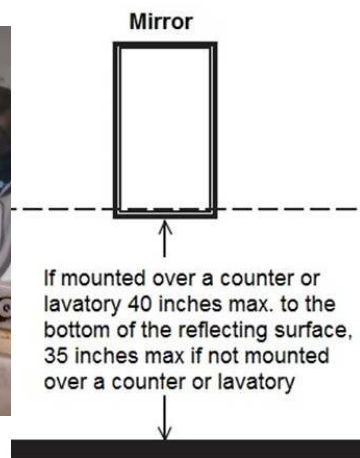
As Built: The mirror is mounted too high.

Mirrors must have the bottom edge of the reflecting surface a maximum of 40 inches above the floor if above a sink or counter. Mirrors not located above lavatories or countertops shall be installed with the bottom edge of the reflecting surface 35 inches maximum above the finish floor or ground.

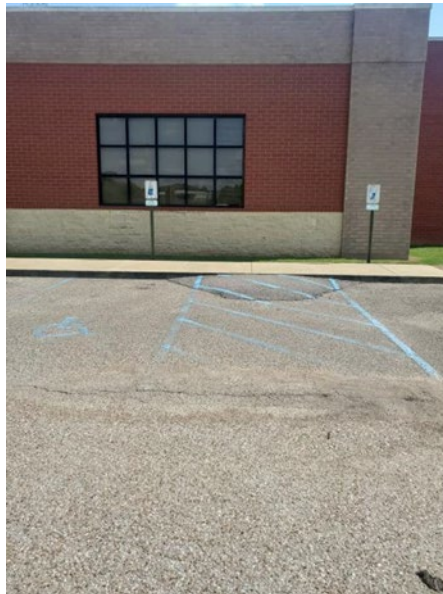
As Built: The ramp projects into a prohibited area.

Ramps shall be located so that they do not project into vehicular traffic lanes, parking spaces, or parking access aisles.

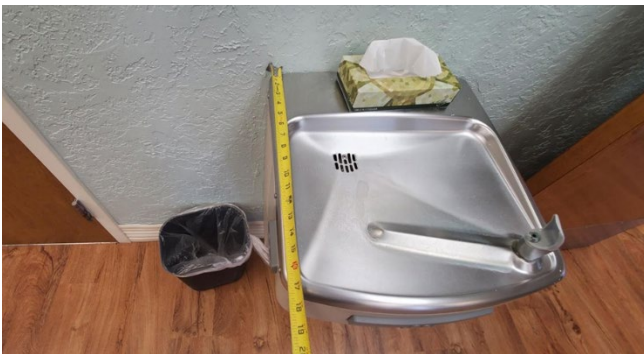
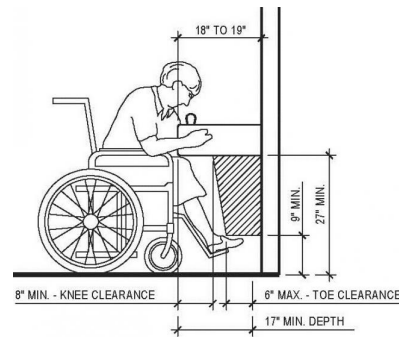
As Built: The drinking fountain projects from the wall into the pedestrian way with its leading edge above 27 inches from the floor.

Objects may protrude no more than 4 inches into walks, halls, corridors, passageways, or aisles when located between 27 and 80 inches above the floor. All drinking fountains shall be located completely within alcoves, positioned completely between wing walls, or otherwise positioned so as not to encroach into pedestrian ways. The alcove must not be less than 32 inches in width and 18 inches in depth. Wing walls must project out from the supporting wall at least as far as the drinking fountain.

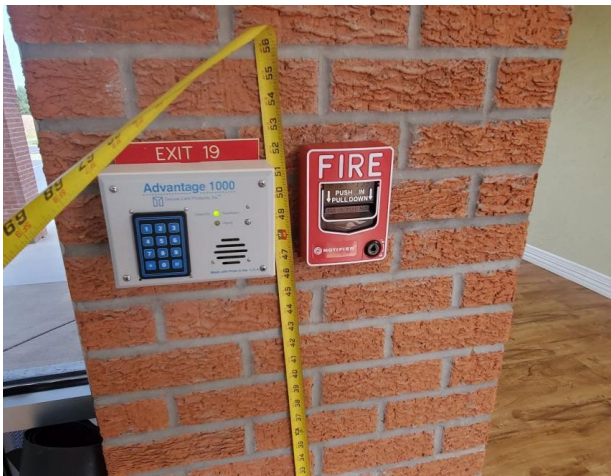
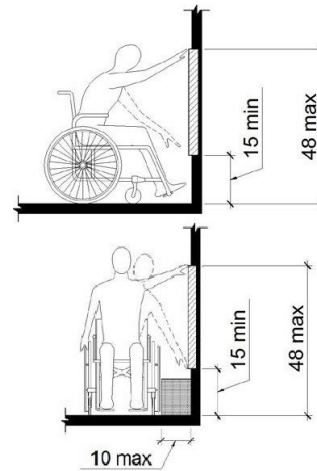
As Built: The fire pull is positioned too high for either a side or front approach.

Where a clear floor or ground space allows a parallel approach to an element and the side reach is unobstructed, the high side reach shall be 48 inches maximum and the low side reach shall be 15 inches minimum above the finish floor or ground.

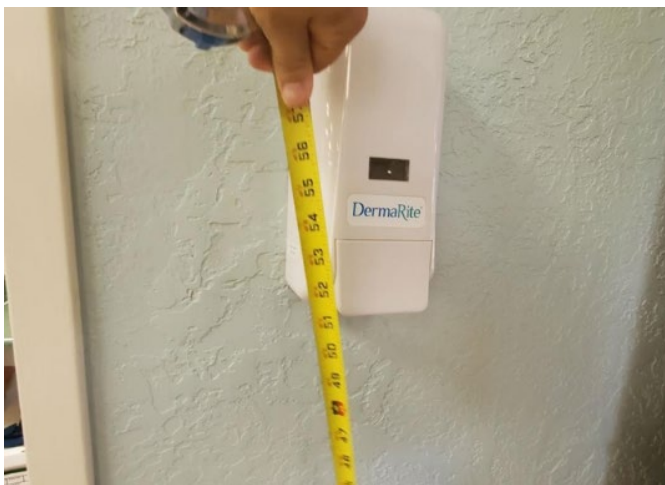
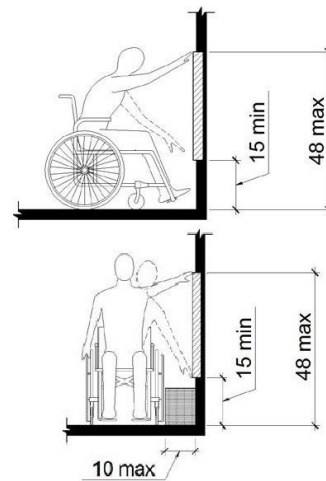
As Built: The sanitizer is not positioned correctly for either a side or front approach.

Where a clear floor or ground space allows a parallel or front approach and the side reach is unobstructed, the high side reach shall be 48 inches maximum above the finish floor or ground and the low side reach shall be 15 inches minimum above the finish floor or ground.

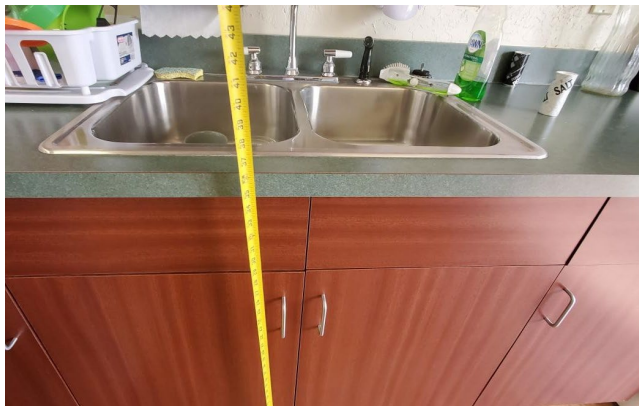
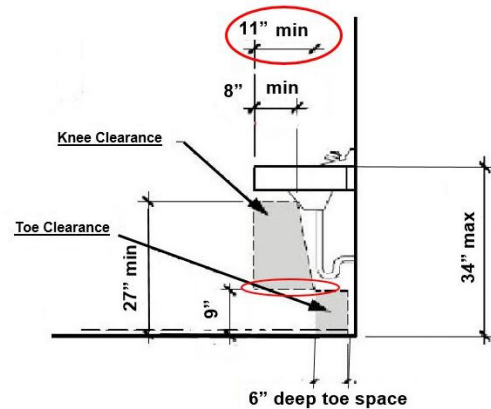
As Built: The top of the sink is too high.

Sinks that are required to be accessible shall be a minimum 17 inches in horizontal depth and mounted with the rim or counter edge no higher than 34 inches above the finished floor. The sanitizer is not positioned correctly for either a side or front approach.

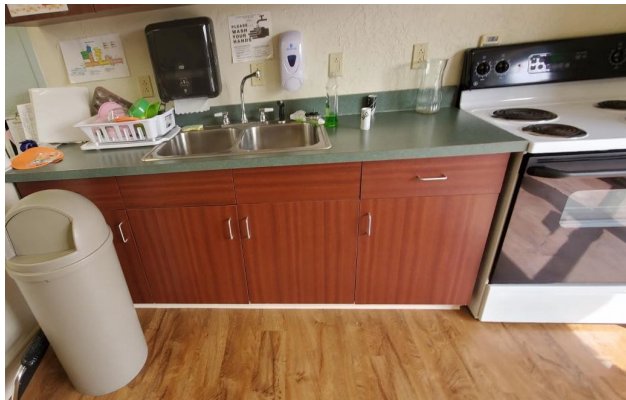
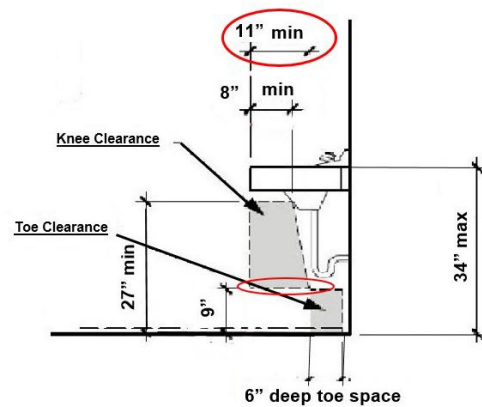
As Built: Knee and toe clearance has not been provided at the sink.

The knee clearance shall be 11 inches deep minimum at 9 inches above the finish floor or ground, and 8 inches deep minimum at 27 inches above the finish floor or ground.

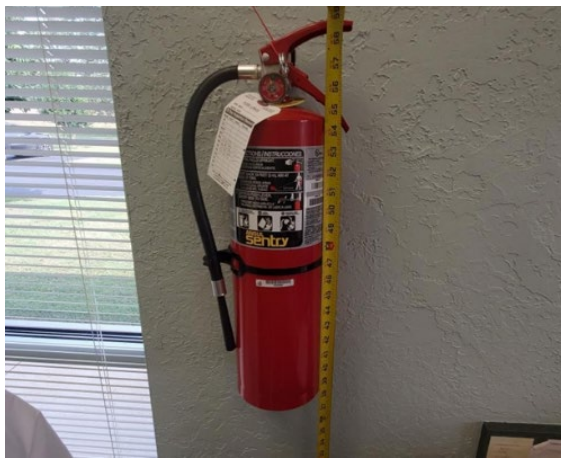
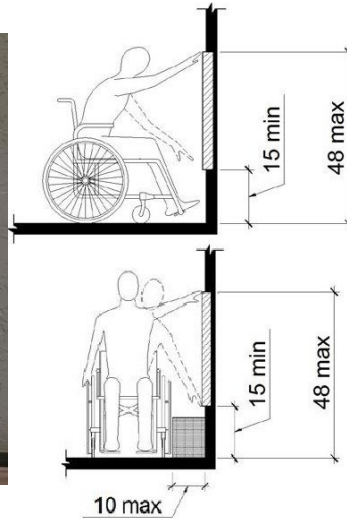
As Built: The fire extinguisher is not positioned correctly for either a side or front approach.

Where a clear floor or ground space allows a parallel or front approach and the side reach is unobstructed, the high side reach shall be 48 inches maximum above the finish floor or ground and the low side reach shall be 15 inches minimum above the finish floor or ground.

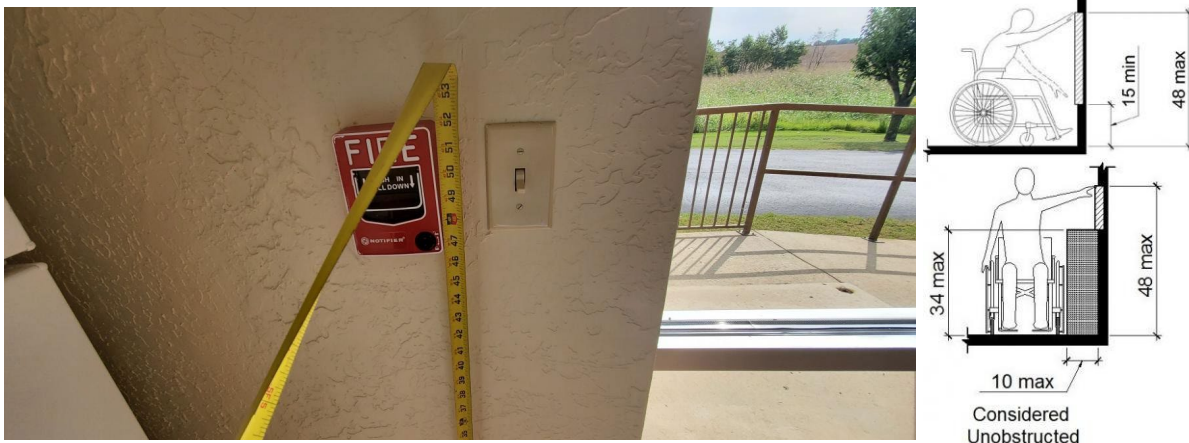
As Built: The fire alarm pull station is positioned too high for either a side or front approach.

Where a clear floor or ground space allows a parallel approach to an element and the side reach is unobstructed, the high side reach shall be 48 inches maximum and the low side reach shall be 15 inches minimum above the finish floor or ground.

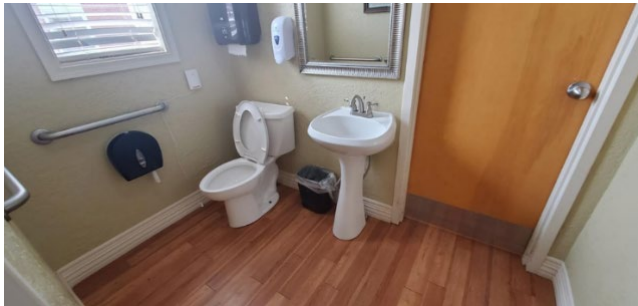
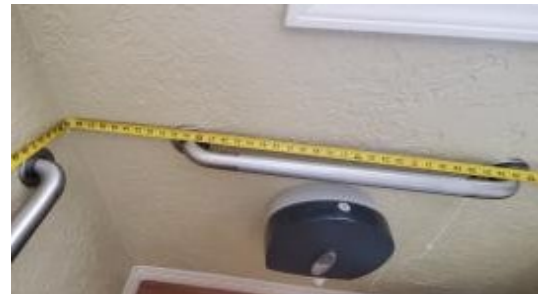
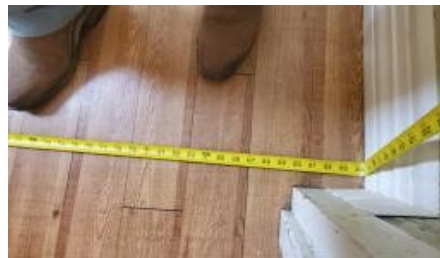
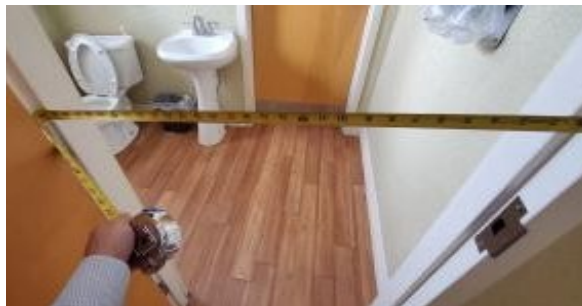
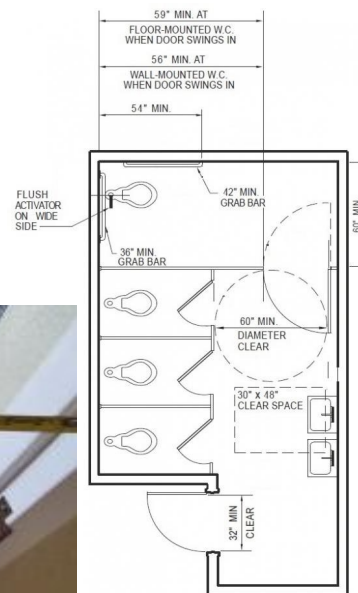
As Built: The restrooms are not nearly compliant. The restroom does not have the required minimum clear floor space or maneuvering clearances for the toilet. The restroom does not have the required minimum clear floor space or maneuvering clearances for the lavatory. Lavatory provided does not have proper knee and toe clearance. The entry door encroaches into the required clear floor space for fixtures. Door opening width is less than 32". Side grab bar is incorrectly installed, and rear grab bar is missing. Accessories, such as toilet seat covers, paper towel holders, garbage cans, hand dryers and mirrors are either too high or without clear floor space or both.

Citation: 2010 ADAS Section 213.2

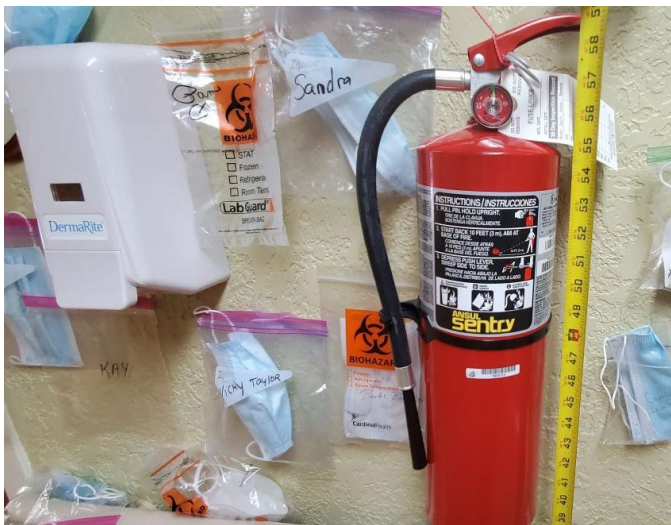
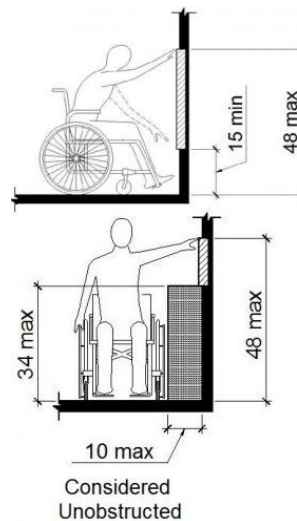
As Built: The fire extinguisher is not positioned correctly for either a side or front approach.

Where a clear floor or ground space allows a parallel or front approach and the side reach is unobstructed, the high side reach shall be 48 inches maximum above the finish floor or ground and the low side reach shall be 15 inches minimum above the finish floor or ground.

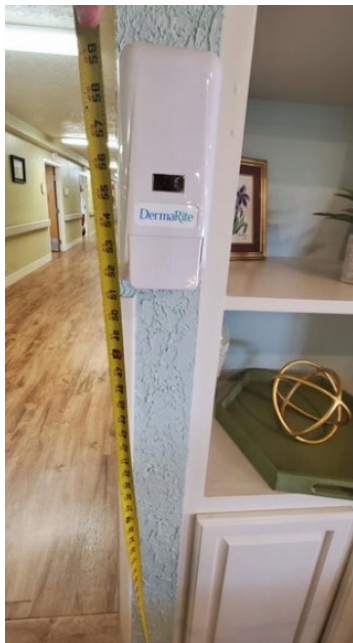
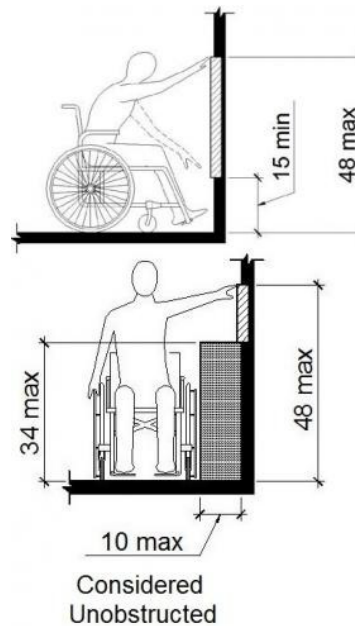
As Built: The hand sanitizer is not positioned correctly for either a side or front approach.

Where a clear floor or ground space allows a parallel or front approach and the side reach is unobstructed, the high side reach shall be 48 inches maximum above the finish floor or ground and the low side reach shall be 15 inches minimum above the finish floor or ground.

Cut out 3' (width) section and replace with new counter at 36" AFF with minimum 17" countertop overhang depth.

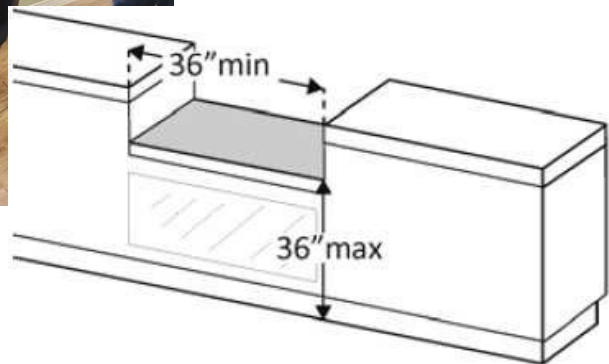
As Built: The counter is too high.

A portion of the counter surface that is 36 inches long minimum and 36 inches high maximum above the finish floor shall be provided. Knee and toe space must be provided for a forward approach. A 30 inch by 48 inch clear floor space on an accessible route must be provided for either a forward or parallel approach.

Refer to Finding 11 for recommendation and budget.

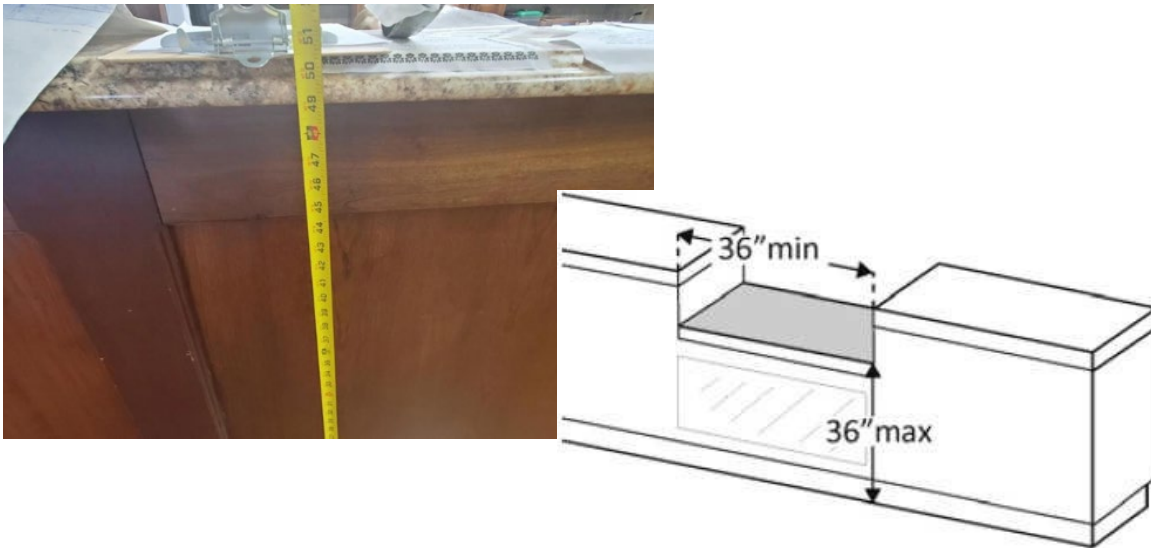
As Built: Compliant knee and/or toe space is not provided.

Space under an element between the finish floor or ground and 9 inches above the finish floor or ground shall be considered toe clearance. Toe clearance shall extend 25 inches maximum and 17 inches minimum under an element. Space extending greater than 6 inches beyond the available knee clearance at 9 inches above the finish floor or ground shall not be considered toe clearance. Toe clearance shall be 30 inches wide minimum.

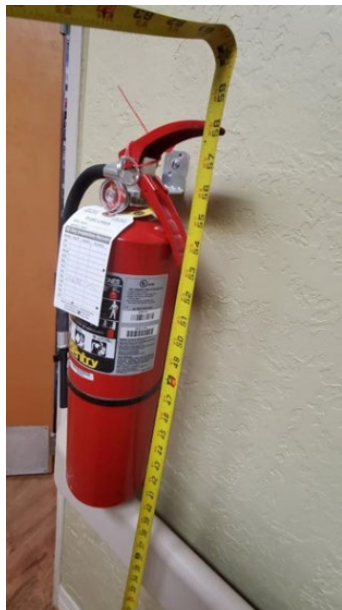
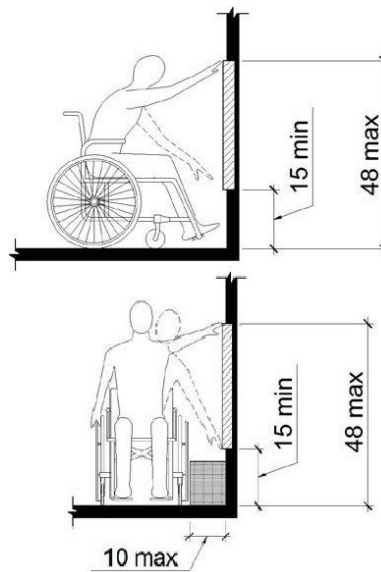
As Built: The Fire Extinguisher is positioned too high for either a side or front approach.

Where a clear floor or ground space allows a parallel approach to an element and the side reach is unobstructed, the high side reach shall be 48 inches maximum and the low side reach shall be 15 inches minimum above the finish floor or ground.

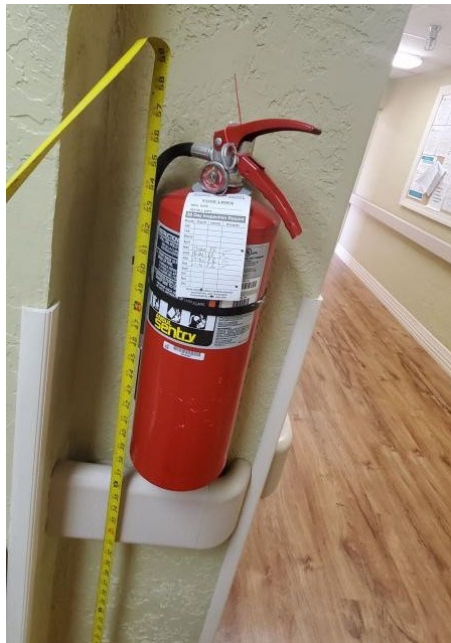
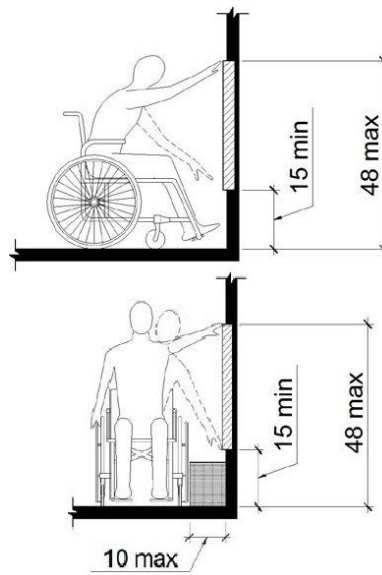
As Built: The Fire Extinguisher is positioned too high for either a side or front approach.

Where a clear floor or ground space allows a parallel approach to an element and the side reach is unobstructed, the high side reach shall be 48 inches maximum and the low side reach shall be 15 inches minimum above the finish floor or ground.

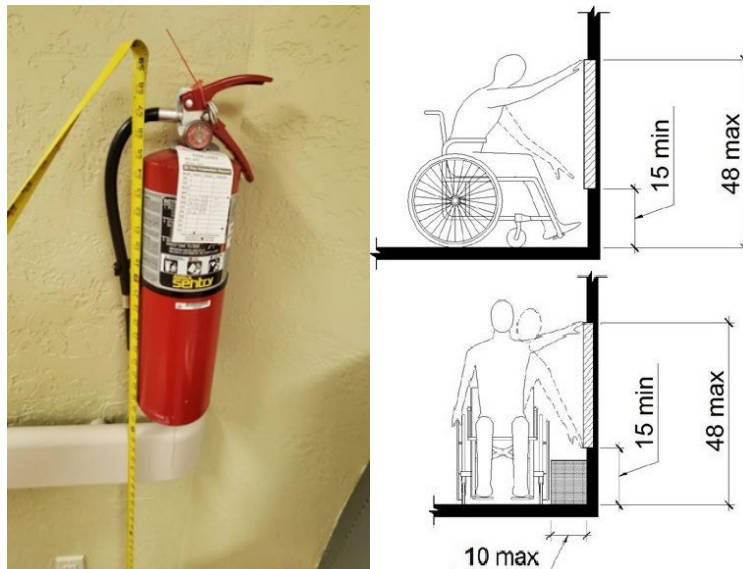
As Built: The Fire Extinguisher is positioned too high for either a side or front approach.

Where a clear floor or ground space allows a parallel approach to an element and the side reach is unobstructed, the high side reach shall be 48 inches maximum and the low side reach shall be 15 inches minimum above the finish floor or ground.

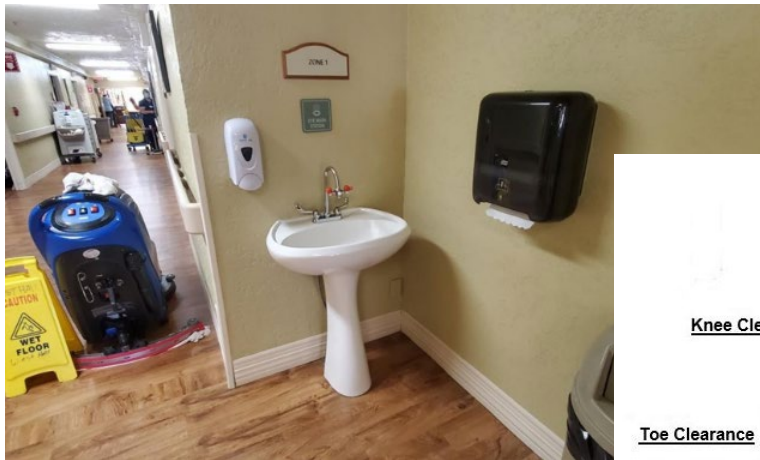
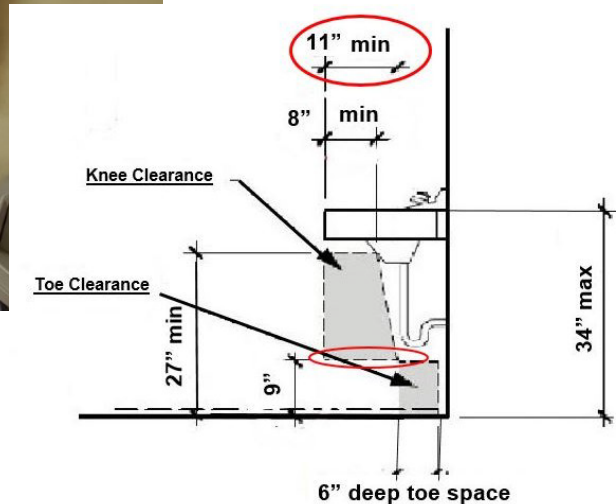
As Built: Compliant knee space has not been provided under the lavatory.

The knee clearance shall be 11 inches minimum in depth at 9 inches above the floor, and 8 inches minimum in depth at 27 inches above the floor. The top of the lavatory rim may be no higher than 34 inches.

Remove pedestal sink, and replace it with wall mounted sink.

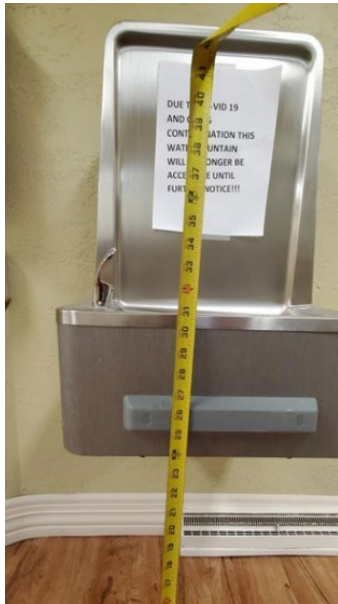
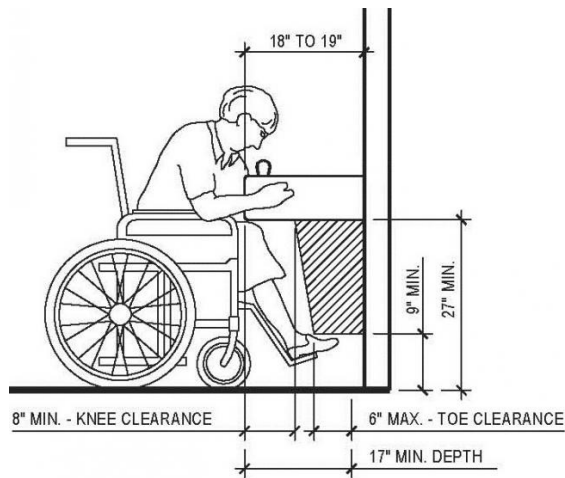
As Built: There is not enough knee clearance under the drinking fountain.

The drinking fountain must have a clear knee space between the bottom of the drinking fountain and the floor not less than 27 inches in height, 30 inches in width, and 8 inches in depth.

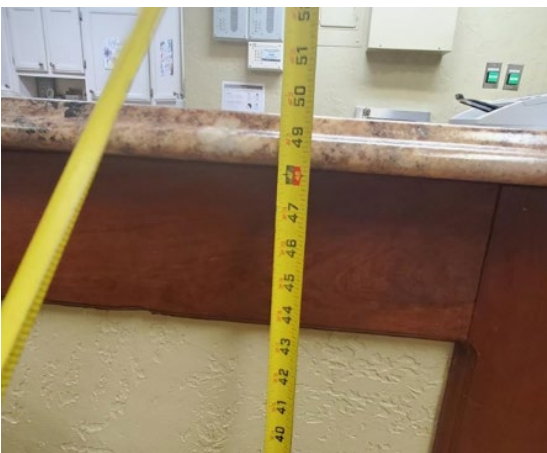
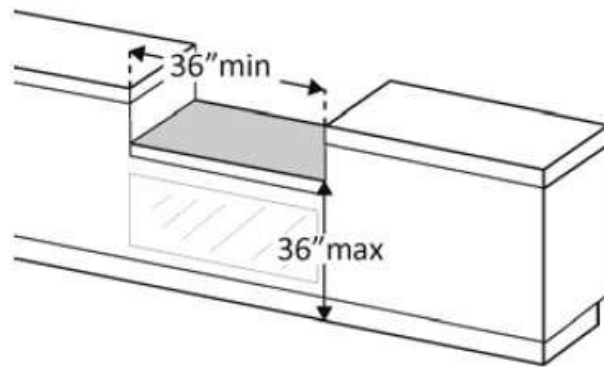
As Built: The counter is too high.

A portion of the counter surface that is 36 inches long minimum and 36 inches high maximum above the finish floor shall be provided. Knee and toe space must be provided for a forward approach. A 30 inch by 48 inch clear floor space on an accessible route must be provided for either a forward or parallel approach.

Cut out 3' (width) section and replace with new counter at 36" AFF with minimum 17" countertop overhang depth.

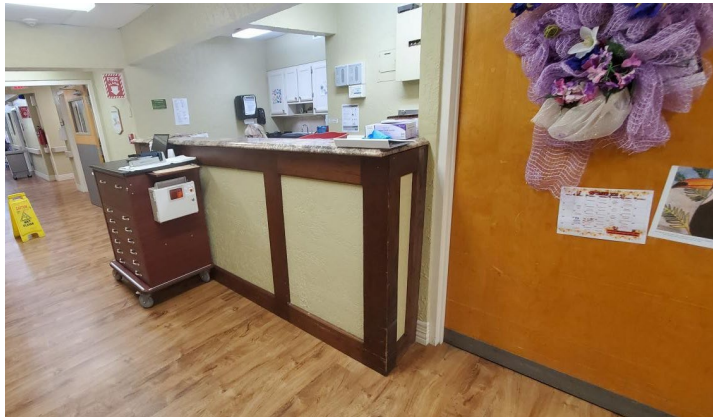
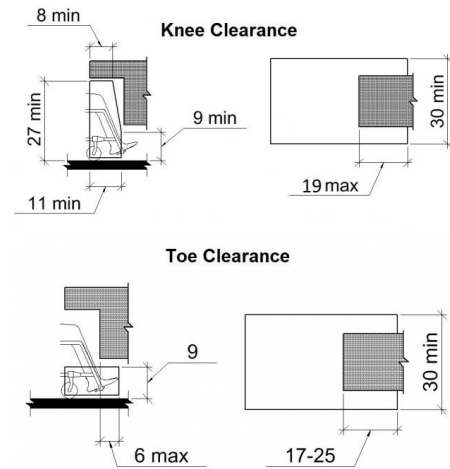
As Built: Compliant knee and/or toe space is not provided.

Space under an element between the finish floor or ground and 9 inches above the finish floor or ground shall be considered toe clearance. Toe clearance shall extend 25 inches maximum and 17 inches minimum under an element. Space extending greater than 6 inches beyond the available knee clearance at 9 inches above the finish floor or ground shall not be considered toe clearance. Toe clearance shall be 30 inches wide minimum.

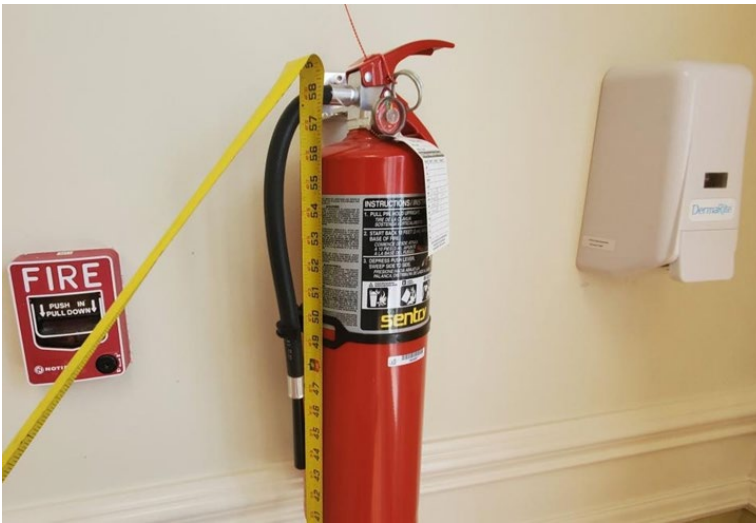
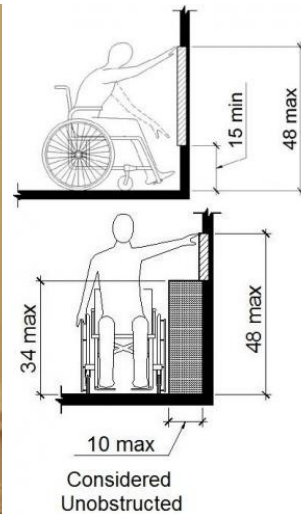
As Built: The fire extinguisher is not positioned correctly for either a side or front approach.

Where a clear floor or ground space allows a parallel or front approach and the side reach is unobstructed, the high side reach shall be 48 inches maximum above the finish floor or ground and the low side reach shall be 15 inches minimum above the finish floor or ground.
