WEAKLEY COUNTY, TENNESSEE

ADA EVALUATION

Architectural and Site Findings with Recommendations

TLM Associates, Inc

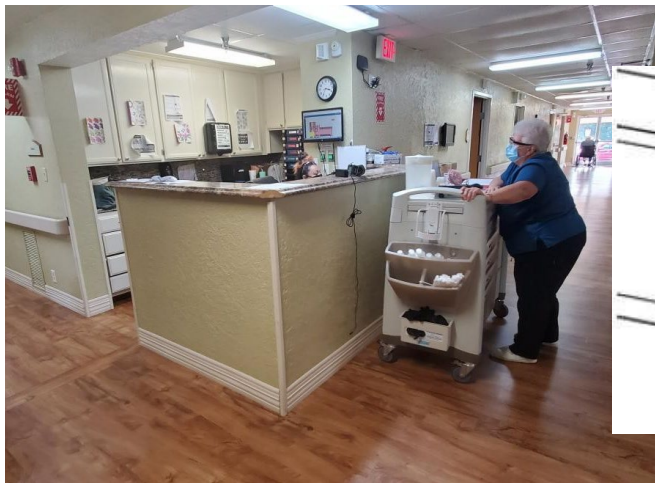
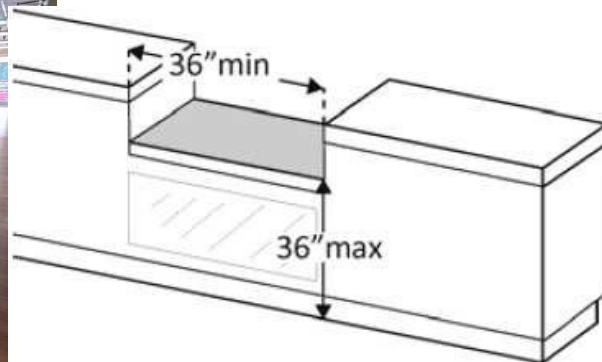
As Built: The counter is too high.

A portion of the counter surface that is 36 inches long minimum and 36 inches high maximum above the finish floor shall be provided. Knee and toe space must be provided for a forward approach. A 30 inch by 48 inch clear floor space on an accessible route must be provided for either a forward or parallel approach.

Cut out 3' (width) section and replace with new counter at 36" AFF with minimum 17" countertop overhang depth.

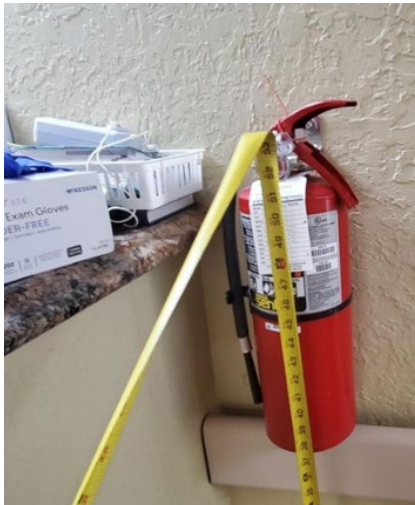
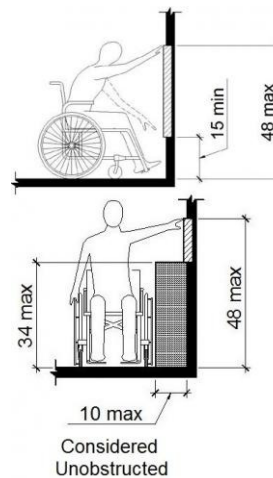
As Built: The fire extinguisher is not positioned correctly for either a side or front approach.

Where a clear floor or ground space allows a parallel or front approach and the side reach is unobstructed, the high side reach shall be 48 inches maximum above the finish floor or ground and the low side reach shall be 15 inches minimum above the finish floor or ground.

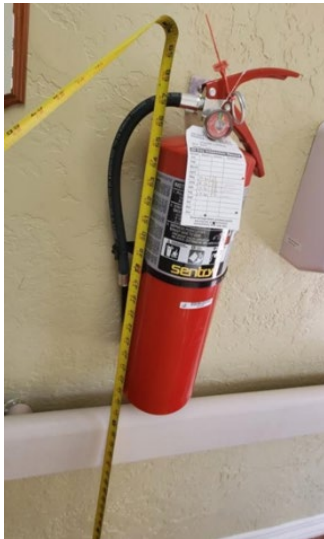
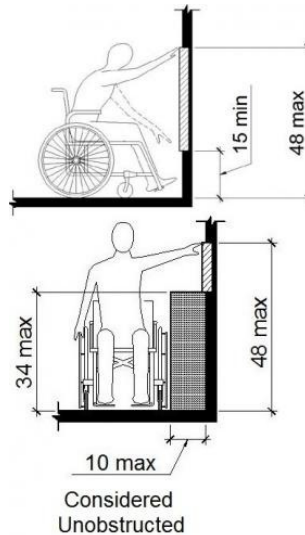
As Built: The fire extinguisher is not positioned correctly for either a side or front approach.

Where a clear floor or ground space allows a parallel or front approach and the side reach is unobstructed, the high side reach shall be 48 inches maximum above the finish floor or ground and the low side reach shall be 15 inches minimum above the finish floor or ground.

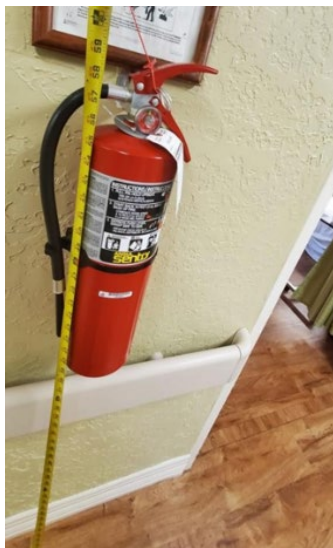
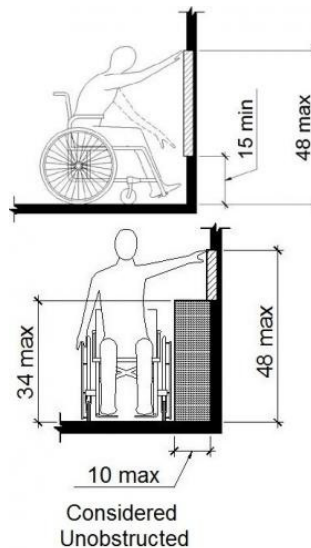
As Built: The fire extinguisher is not positioned correctly for either a side or front approach.

Where a clear floor or ground space allows a parallel or front approach and the side reach is unobstructed, the high side reach shall be 48 inches maximum above the finish floor or ground and the low side reach shall be 15 inches minimum above the finish floor or ground.

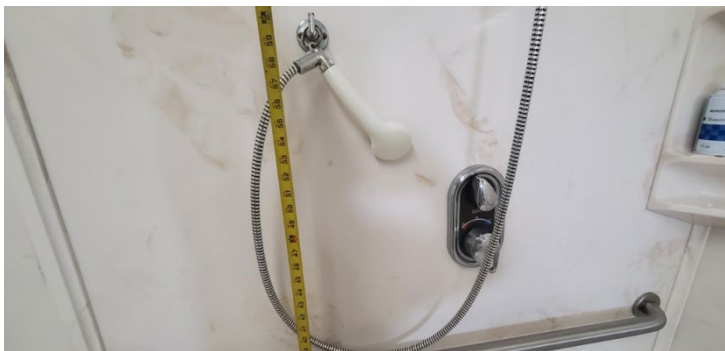
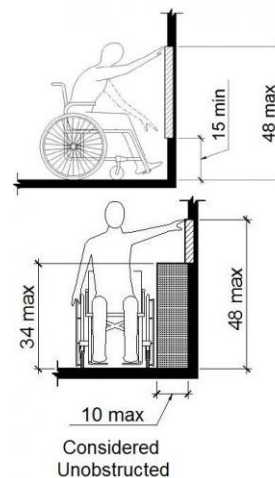
As Built: The handheld sprayer unit is mounted above the required maximum height.

The sprayer unit must have a 59 inches hose and be mounted 48 inches maximum to the top of mounting bracket off the floor. The shower spray unit shall have an on/off control with a non-positive shutoff. If an adjustable-height shower head on a vertical bar is used, the bar shall be installed so as not to obstruct the use of grab bars.

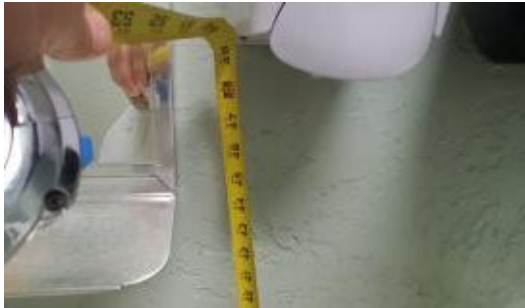
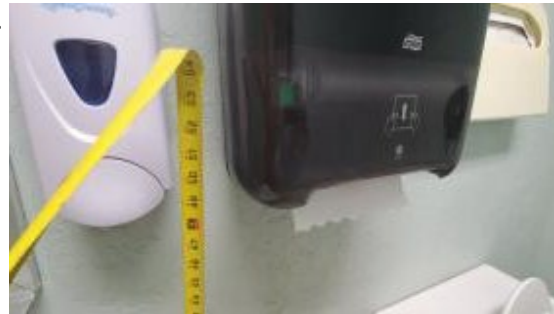
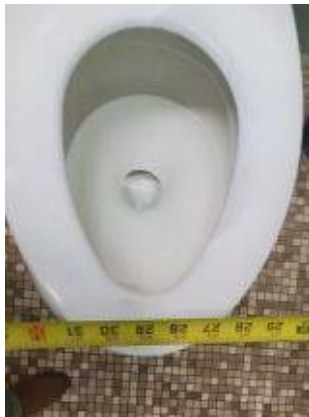
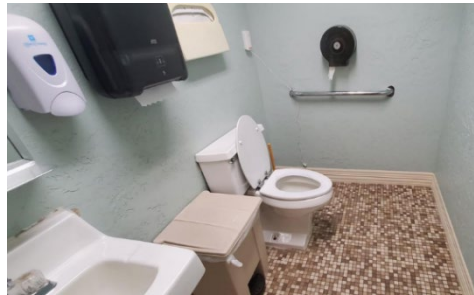
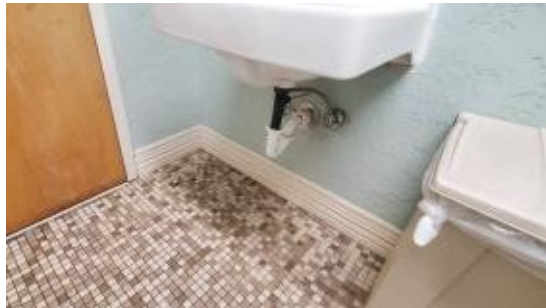
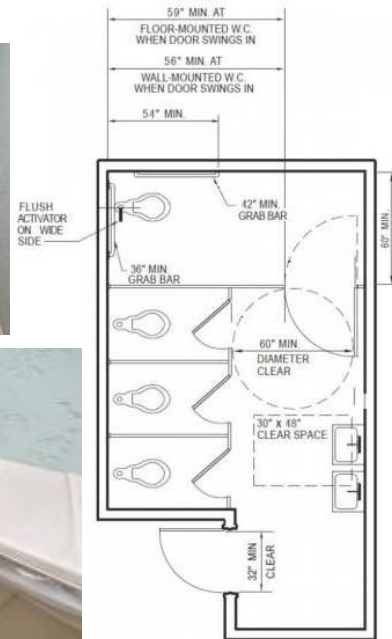
As Built: Multiple accommodations needed for West Restroom. Toilet is missing rear grab bar. Toilet is not centered within 16-18 inches from wall. Toilet tissue dispenser to be below grab bar. Door opening pressure was measured at greater than 5 pounds. Soap dispenser is too high. Mirror reflecting surface is over 40".

Citation: 2010 ADAS Section 213.2

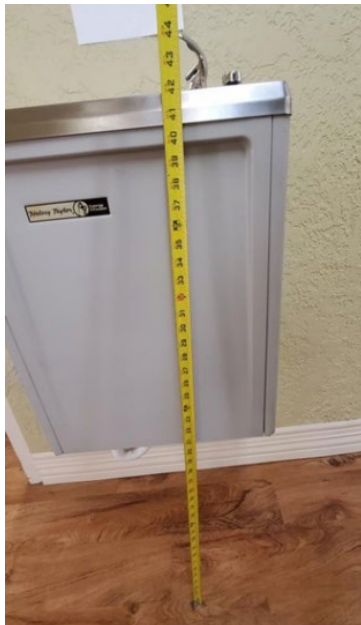
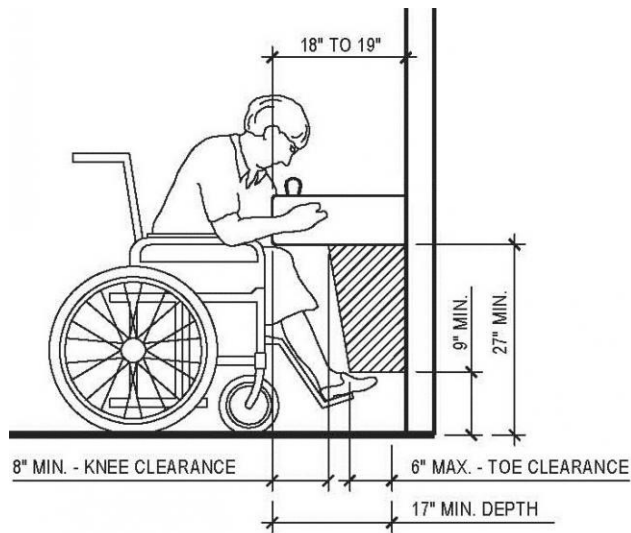
As Built: There is not enough knee clearance under the drinking fountain.

The drinking fountain must have a clear knee space between the bottom of the drinking fountain and the floor not less than 27 inches in height, 30 inches in width, and 8 inches in depth.

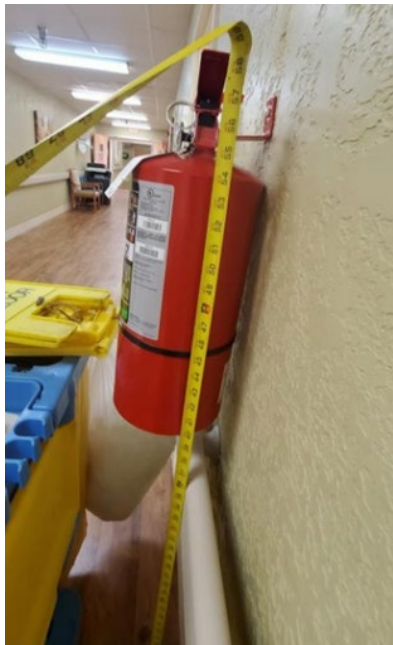
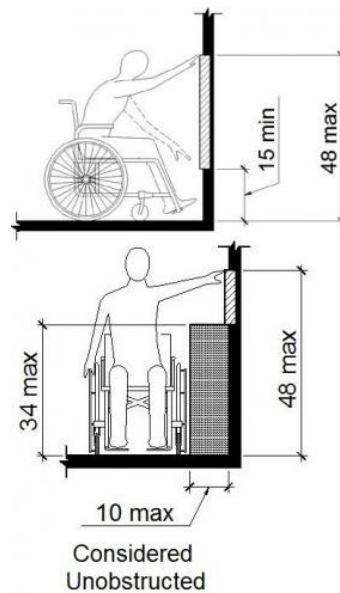
As Built: The fire extinguisher is not positioned correctly for either a side or front approach.

Where a clear floor or ground space allows a parallel or front approach and the side reach is unobstructed, the high side reach shall be 48 inches maximum above the finish floor or ground and the low side reach shall be 15 inches minimum above the finish floor or ground.

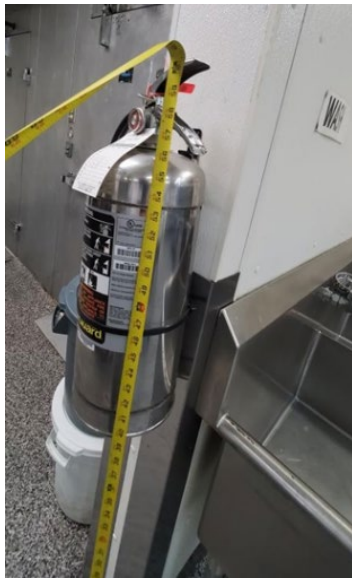
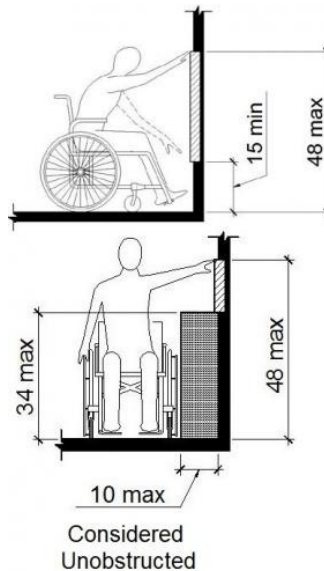
As Built: The fire extinguisher is not positioned correctly for either a side or front approach.

Where a clear floor or ground space allows a parallel or front approach and the side reach is unobstructed, the high side reach shall be 48 inches maximum above the finish floor or ground and the low side reach shall be 15 inches minimum above the finish floor or ground.

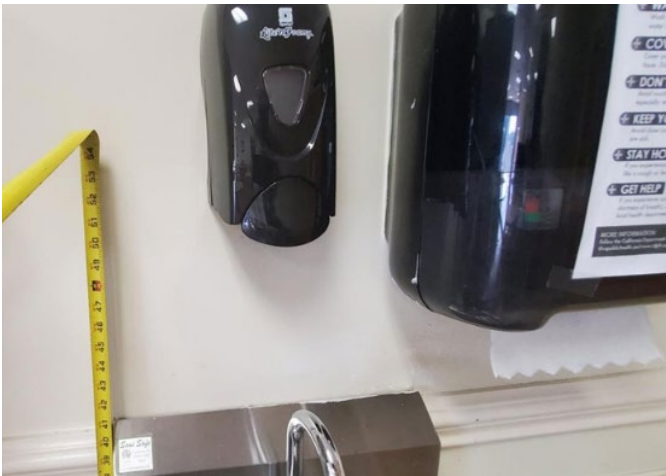
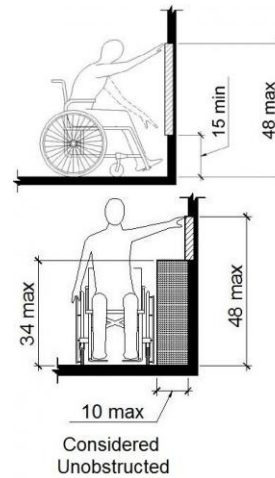
As Built: The soap dispenser is not positioned correctly for either a side or front approach.

Where a clear floor or ground space allows a parallel or front approach and the side reach is unobstructed, the high side reach shall be 48 inches maximum above the finish floor or ground and the low side reach shall be 15 inches minimum above the finish floor or ground.

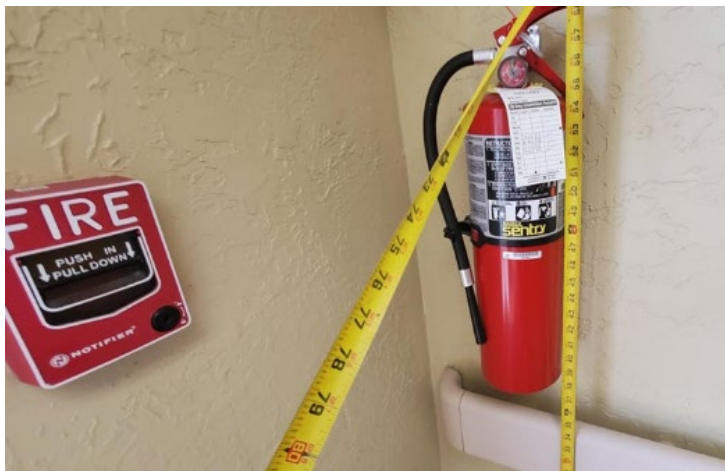
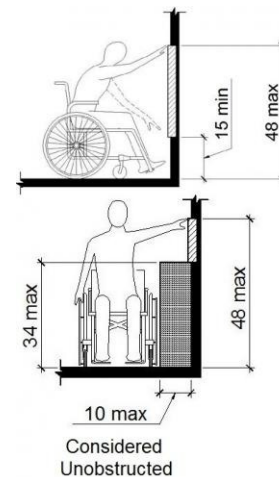
As Built: The fire extinguisher is not positioned correctly for either a side or front approach.

Where a clear floor or ground space allows a parallel or front approach and the side reach is unobstructed, the high side reach shall be 48 inches maximum above the finish floor or ground and the low side reach shall be 15 inches minimum above the finish floor or ground.

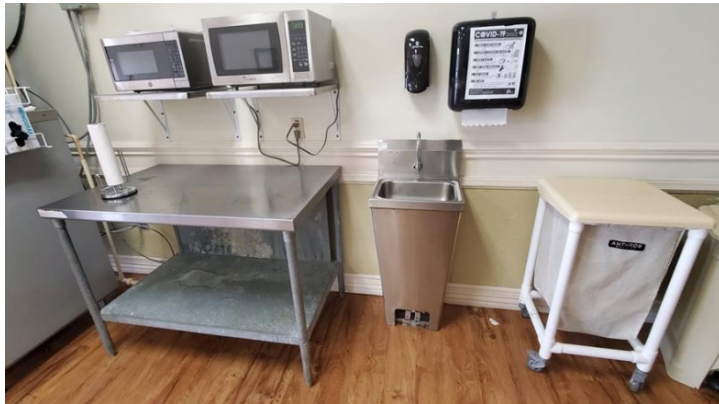
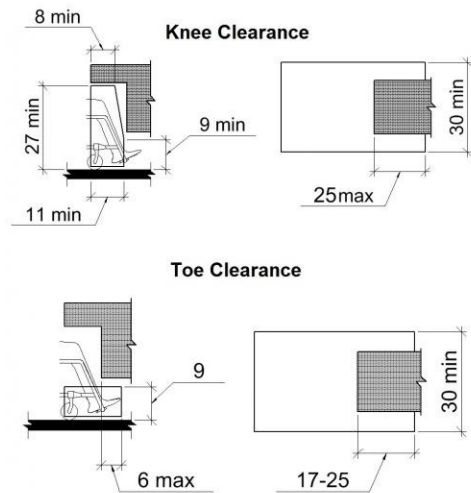
As Built: Knee and toe clearance has not been provided at the sink.

The knee clearance shall be 11 inches deep minimum at 9 inches above the finish floor or ground, and 8 inches deep minimum at 27 inches above the finish floor or ground.

Recommendation: Install new wall mounted sink to have knee and toe clearance.

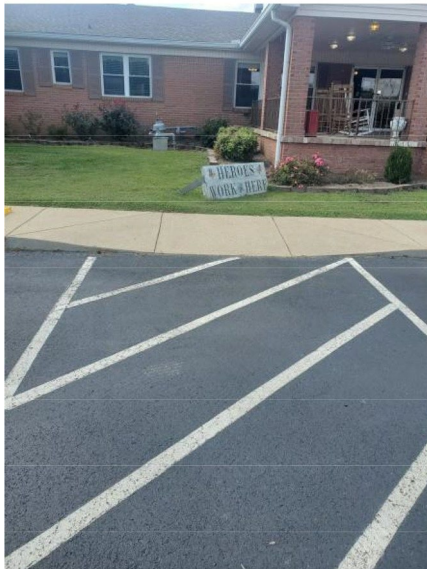
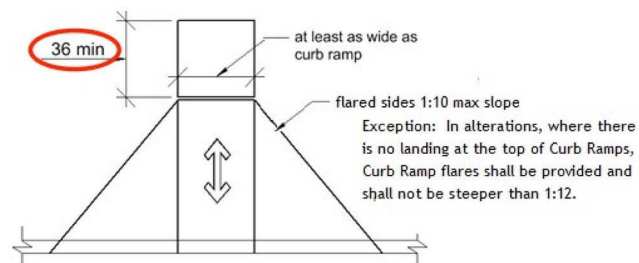
As Built: The top of the curb ramp does not have a level landing.

A level landing 36 inches in deep shall be provided at the upper end of each curb ramp over its full width to permit safe egress from the ramp surface. The landing clear width shall be at least as wide as the Curb Ramp, excluding flared sides, leading to the landing.

Replace ramp and wings.

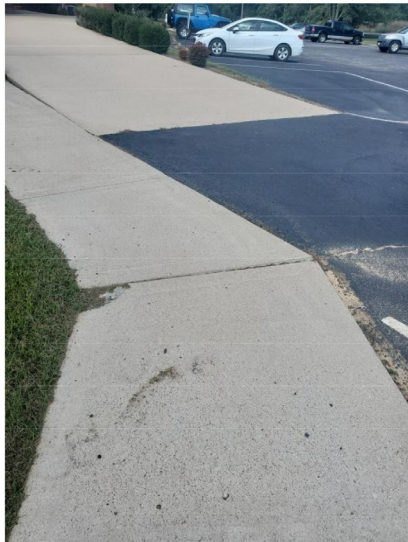
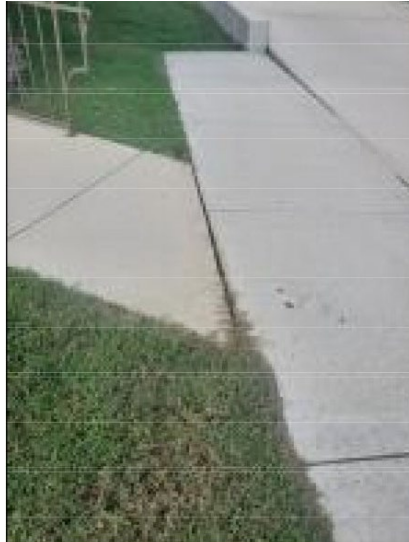
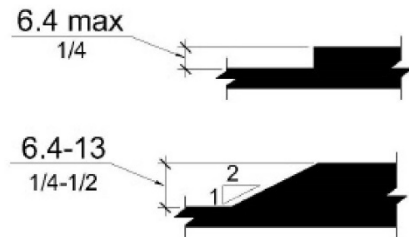
As Built: The surface of the pedestrian access route has vertical discontinuities greater than 1/2 inch or between 1/4 inch and 1/2 inch that are not beveled.

Vertical surface discontinuities shall be 0.5 inch maximum. Vertical surface discontinuities between 0.25 inch and 0.5 inch shall be beveled with a slope not steeper than 50 percent. The bevel shall be applied across the entire vertical surface discontinuity.

Replace the 5'x12' section of the sidewalk.

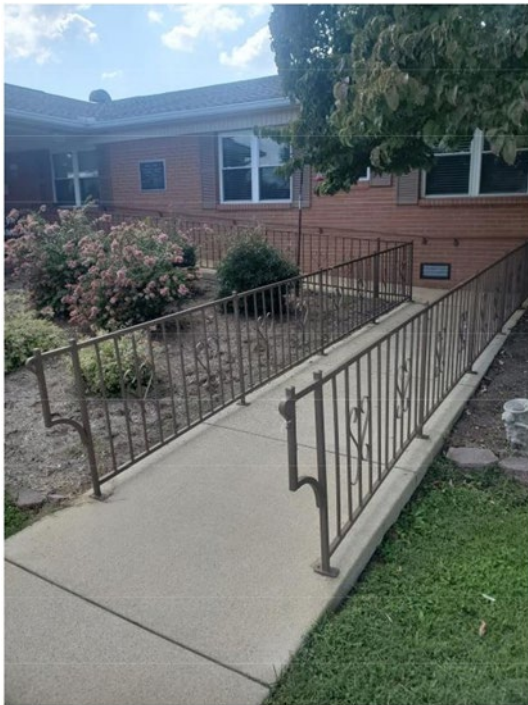
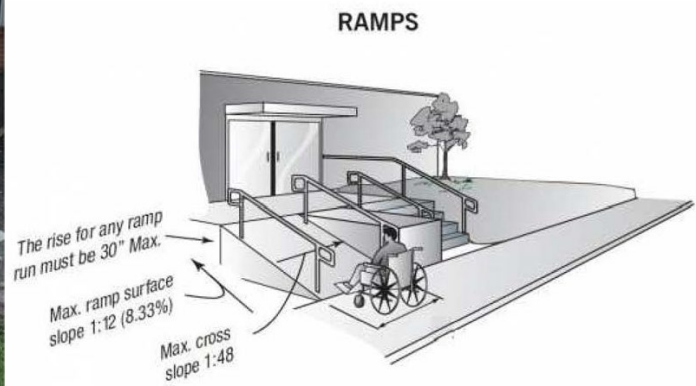
As Built: The ramps slope runs at 9% which exceeds the maximum running slope (direction of travel) allowable of 8.33%. Ramps should have the least possible slope but in no case more than 8.3% (1:12).

Citation: 2010 ADAS Section 405.2

Replace ramp. Enough length provided to ensure entire length less than 8% with proper landing at turn.

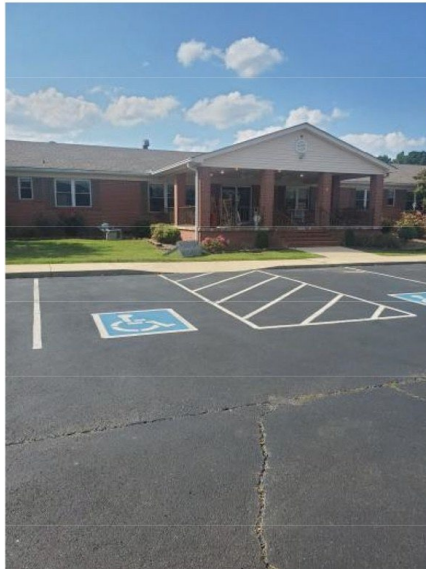
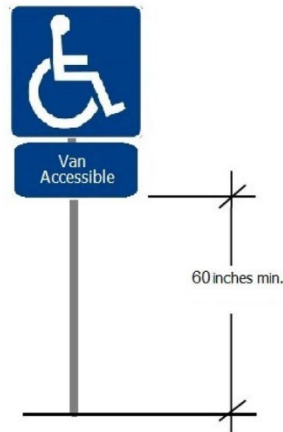
As Built: The required parking signage is missing.

Parking space identification signs shall include the International Symbol of Accessibility (ISA). Signs identifying van parking spaces shall contain the designation "van accessible." All signs shall be 60 inches minimum above the finish floor or ground surface measured to the bottom of the sign.

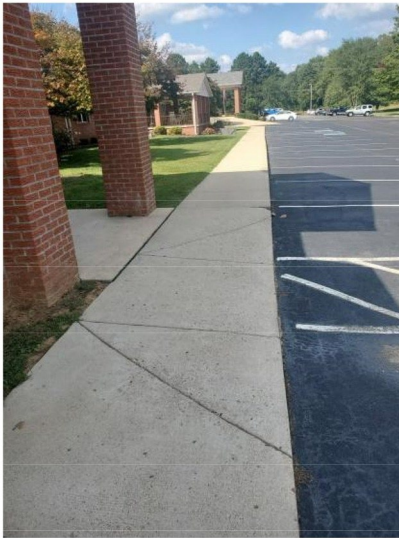
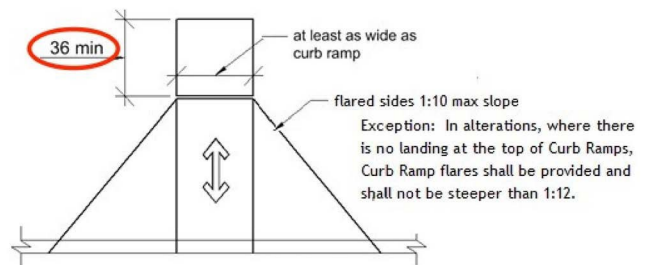
As Built: Relocate and replace curb ramp. The top of the curb ramp does not have a level landing.

A level landing 36 inches in deep shall be provided at the upper end of each curb ramp over its full width to permit safe egress from the ramp surface. The landing clear width shall be at least as wide as the Curb Ramp, excluding flared sides, leading to the landing.

Replace ramp and wings.

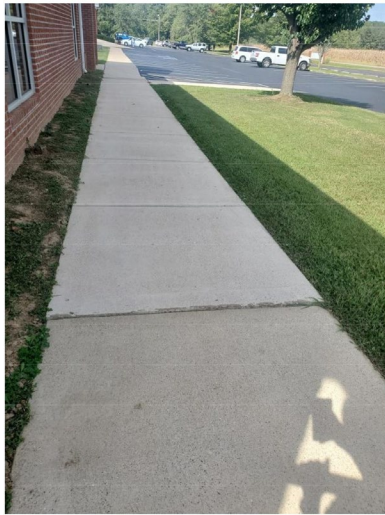
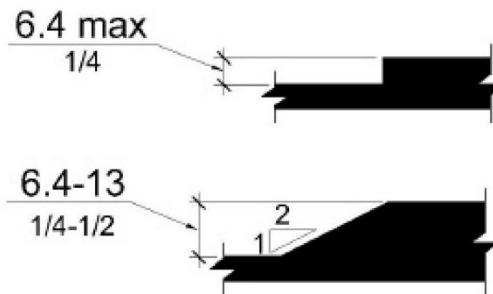
As Built: The surface of the pedestrian access route has vertical discontinuities greater than 1/2 inch or between 1/4 inch and 1/2 inch that are not beveled.

Vertical surface discontinuities shall be 0.5 inch maximum. Vertical surface discontinuities between 0.25 inch and 0.5 inch shall be beveled with a slope not steeper than 50 percent. The bevel shall be applied across the entire vertical surface discontinuity.

Replace 5'x5' section of sidewalk.

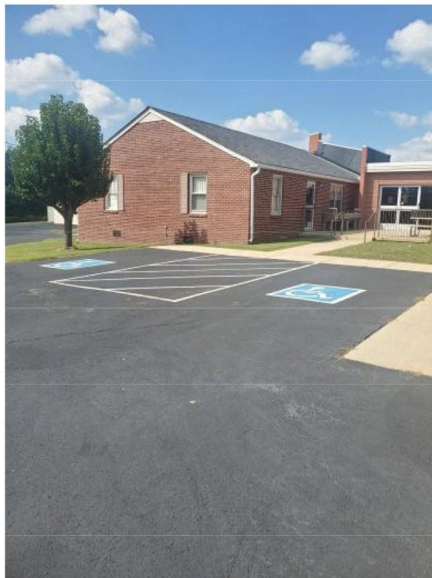
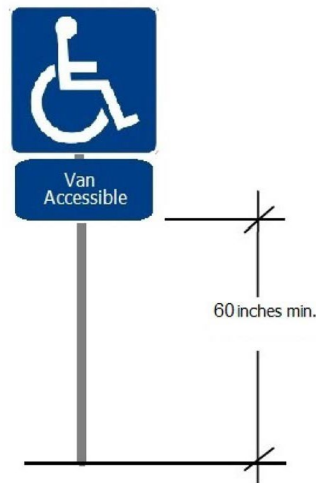
As Built: The required parking signage is missing.

Parking space identification signs shall include the International Symbol of Accessibility (ISA). Signs identifying van parking spaces shall contain the designation "van accessible." All signs shall be 60 inches minimum above the finish floor or ground surface measured to the bottom of the sign.

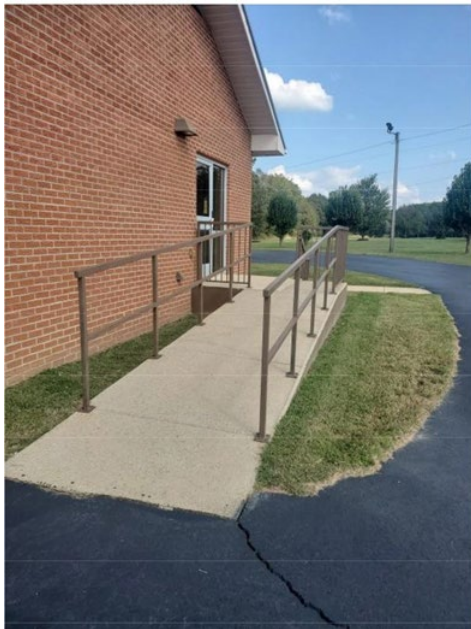
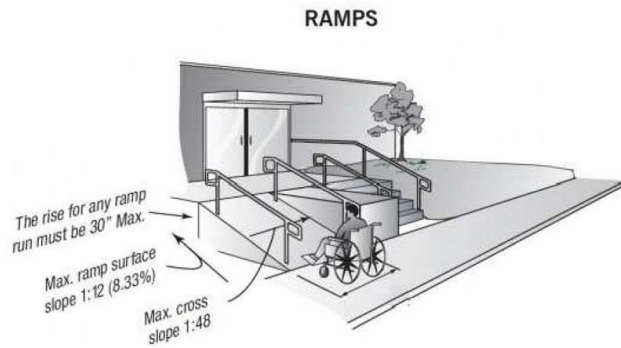
As Built: The ramps slope runs at 9.4%, which exceeds the maximum running slope (direction of travel) allowable of 8.33%. Ramps should have the least possible slope but in no case more than 8.3% (1:12).

Citation: 2010 ADAS Section 405.2

Replace the ramp.

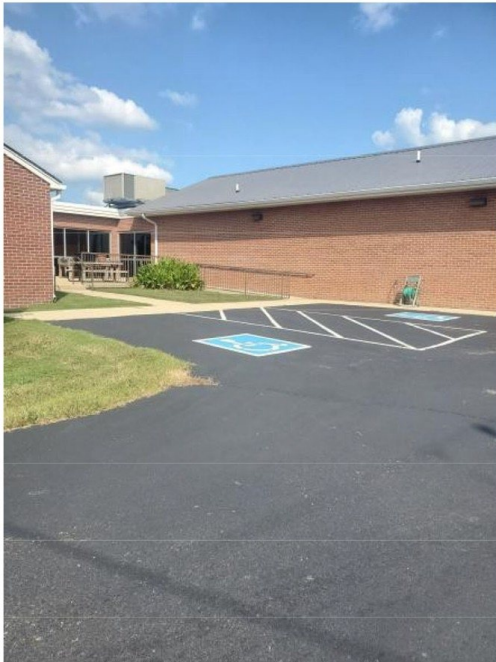
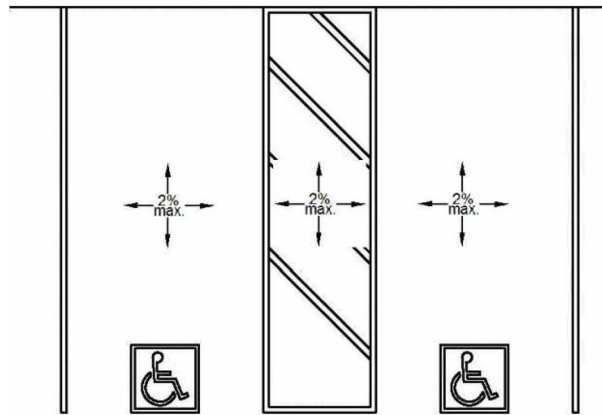
As Built: The running slope (long dimension) of the accessible parking stall varies up to 4.4%, which exceeds the 2% maximum.

The running slope in an accessible parking stall and the access aisle must not exceed 2%.

Remove and replace spaces to less than 2% in all directions.

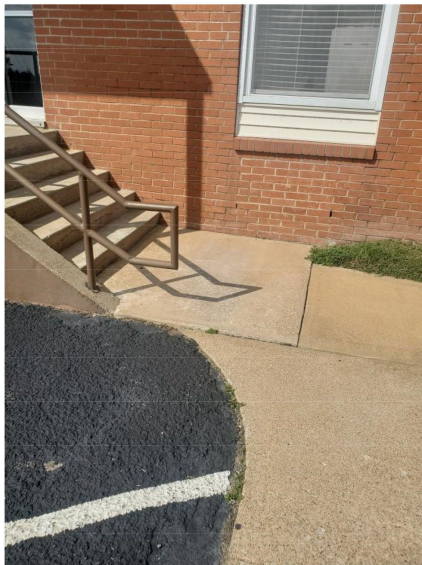
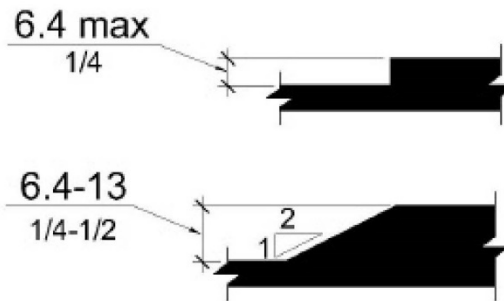
As Built: The surface of the pedestrian access route has vertical discontinuities greater than 1/2 inch or between 1/4 inch and 1/2 inch that are not beveled.

Vertical surface discontinuities shall be 0.5 inch maximum. Vertical surface discontinuities between 0.25 inch and 0.5 inch shall be beveled with a slope not steeper than 50 percent. The bevel shall be applied across the entire vertical surface discontinuity.

Replace approximately 30 SF.

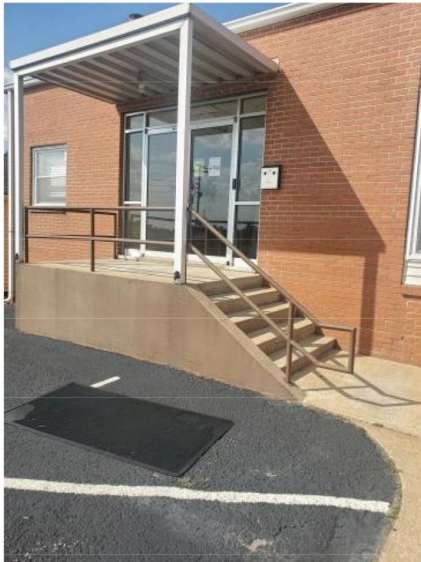
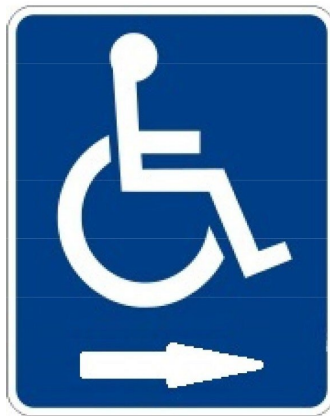
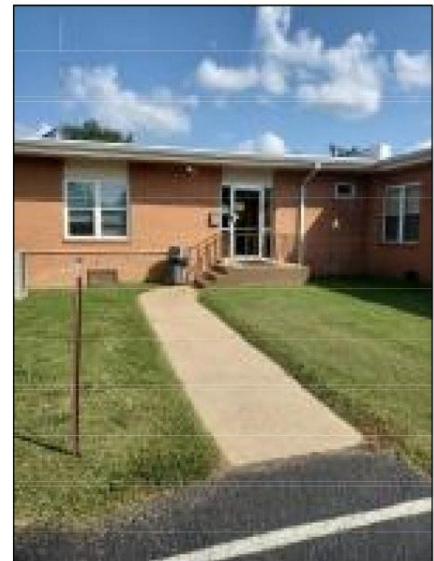
As Built: There is no International Symbol of Accessibility at this entrance.

In existing buildings and facilities where not all entrances are accessible doors that are accessible shall be identified by the International Symbol of Accessibility. Directional signs that indicate the location of the nearest accessible entrance shall be provided at entrances that are not accessible. Directional signs including the International Symbol of Accessibility indicating the accessible route to the nearest accessible entrance shall be provided at junctions when the accessible route diverges from the regular circulation path.

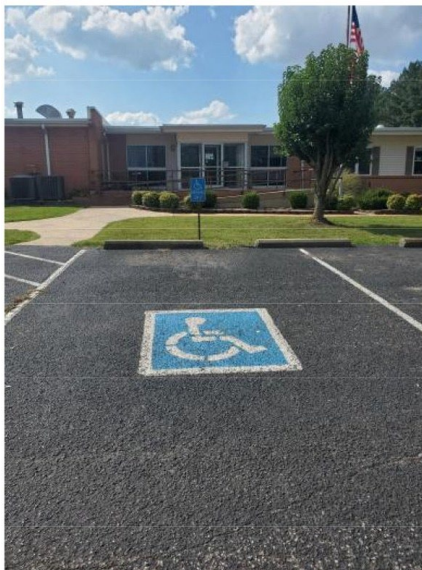
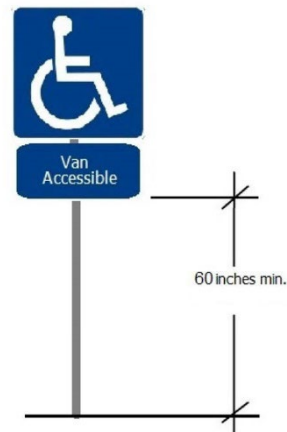
As Built: The parking sign is mounted too low.

Parking space identification signs shall include the International Symbol of Accessibility. Signs identifying van parking spaces shall contain the designation "van accessible." Signs shall be 60 inches minimum above the finish floor or ground surface measured to the bottom of the sign.

Replace signage.

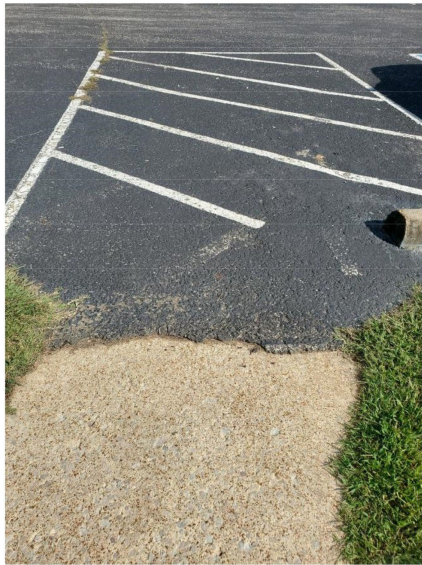
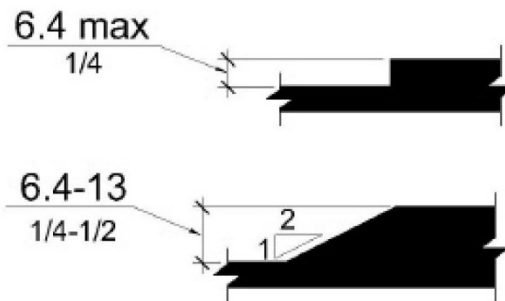
As Built: The surface of the pedestrian access route has vertical discontinuities greater than 1/2 inch or between 1/4 inch and 1/2 inch that are not beveled.

Vertical surface discontinuities shall be 0.5 inch maximum. Vertical surface discontinuities between 0.25 inch and 0.5 inch shall be beveled with a slope not steeper than 50 percent. The bevel shall be applied across the entire vertical surface discontinuity

Replace approximately 30 SF of asphalt surface.

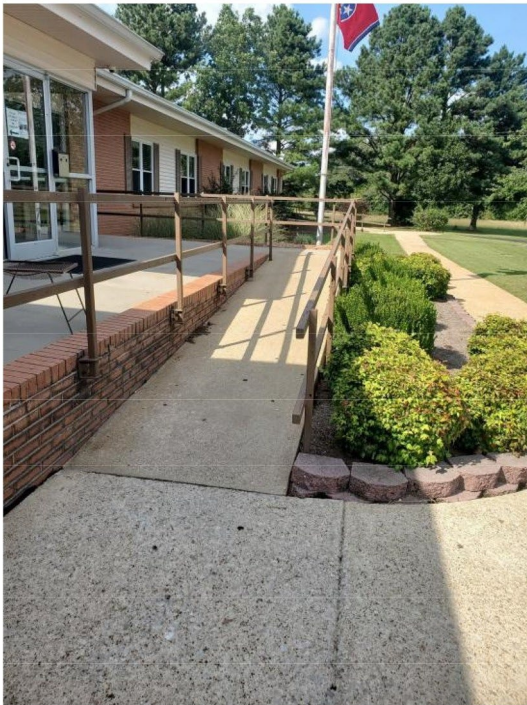
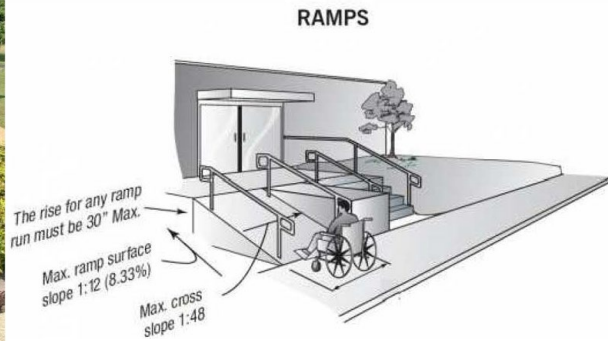
As Built: The ramps slope varies from 8.5-9.4%, which exceeds the maximum running slope (direction of travel) allowable of 8.33%. Ramps should have the least possible slope but in no case more than 8.3% (1:12).

Citation: 2010 ADAS Section 405.2

Replace ramp.

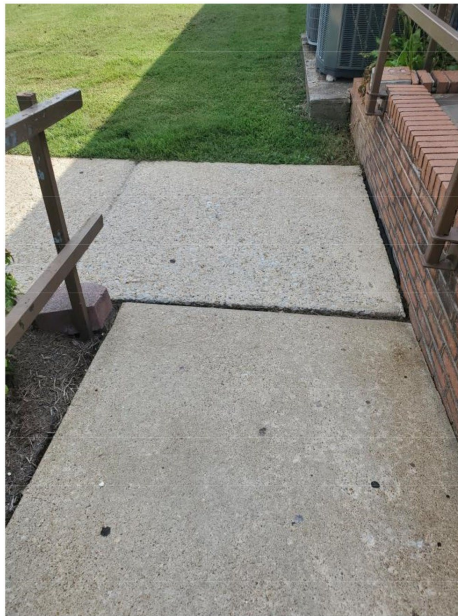
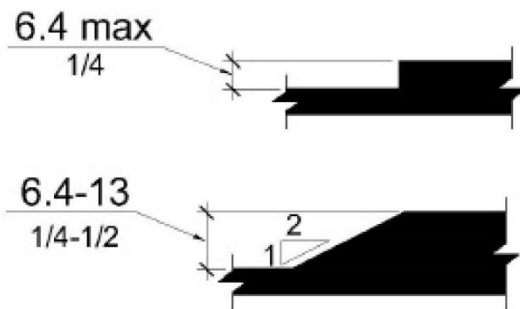
As Built: The surface of the pedestrian access route has vertical discontinuities greater than 1/2 inch or between 1/4 inch and 1/2 inch that are not beveled.

Vertical surface discontinuities shall be 0.5 inch maximum. Vertical surface discontinuities between 0.25 inch and 0.5 inch shall be beveled with a slope not steeper than 50 percent. The bevel shall be applied across the entire vertical surface discontinuity.

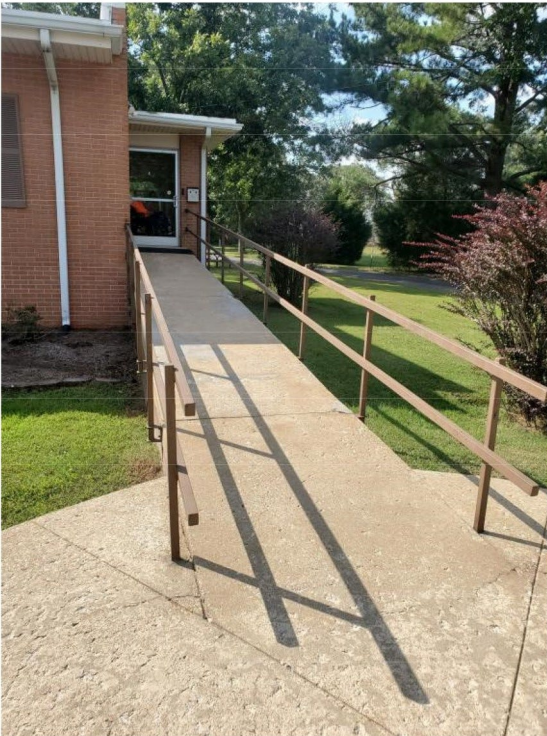
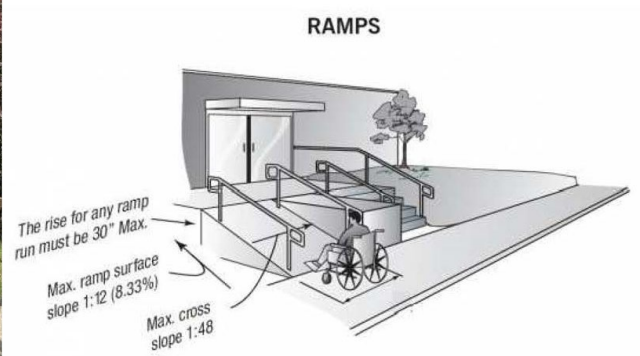
As Built: The ramps slope exceeds the maximum running slope (direction of travel) allowable of 8.33%. Ramps should have the least possible slope but in no case more than 8.3% (1:12).

Citation: 2010 ADAS Section 405.2

Replace ramp.

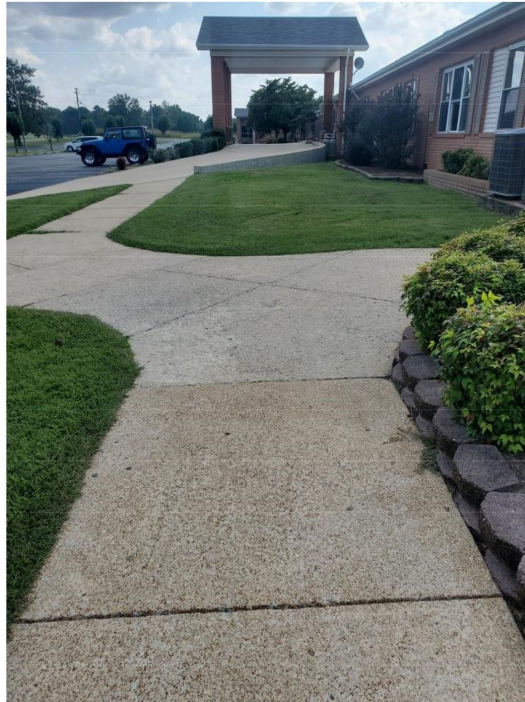
As Built: The cross slope of the pedestrian access route varies up to 7%, which is excessive.

The cross slope of pedestrian access routes shall be 2 percent maximum.

Replace sidewalk.

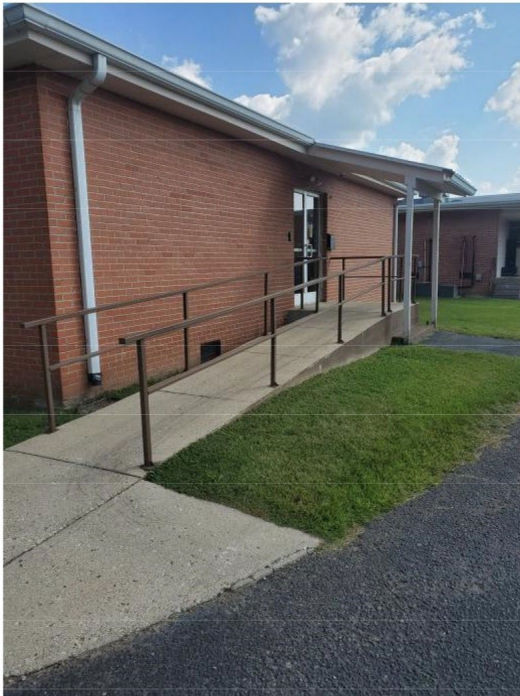
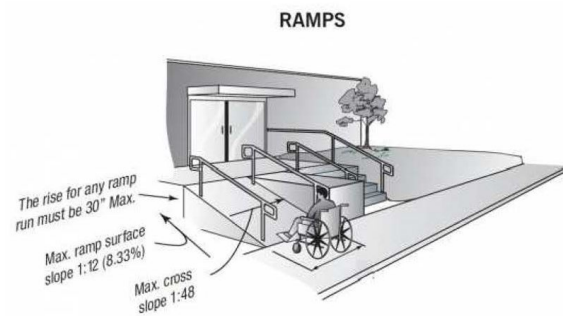
As Built: The ramps slope is at 9.4% which exceeds the maximum running slope (direction of travel) allowable of 8.33%. Ramps should have the least possible slope but in no case more than 8.3% (1:12).

Citation: 2010 ADAS Section 405.2

Replace the ramp.

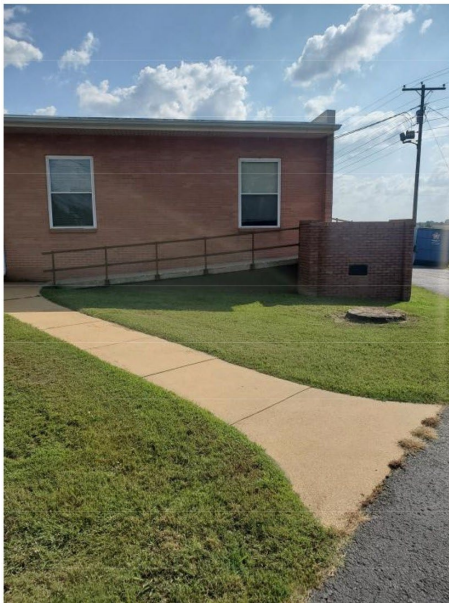
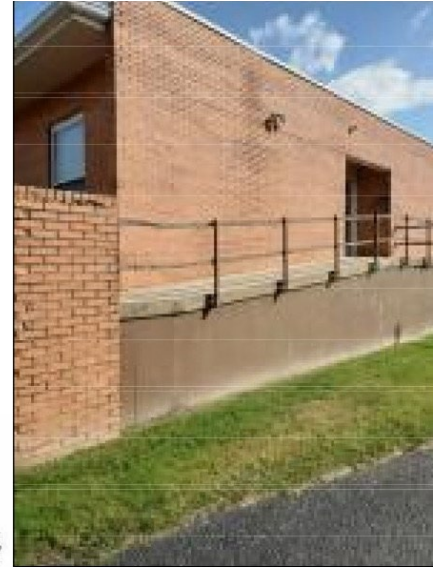
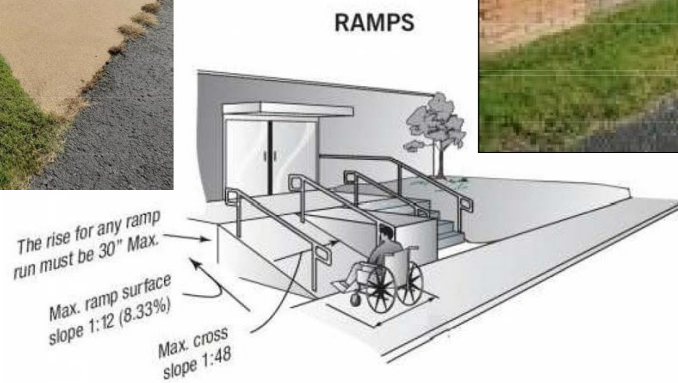
As Built: The ramps slope varies from 9.2-9.6%, which exceeds the maximum running slope (direction of travel) allowable of 8.33%. Ramps should have the least possible slope but in no case more than 8.3% (1:12).

Citation: 2010 ADAS Section 405.2

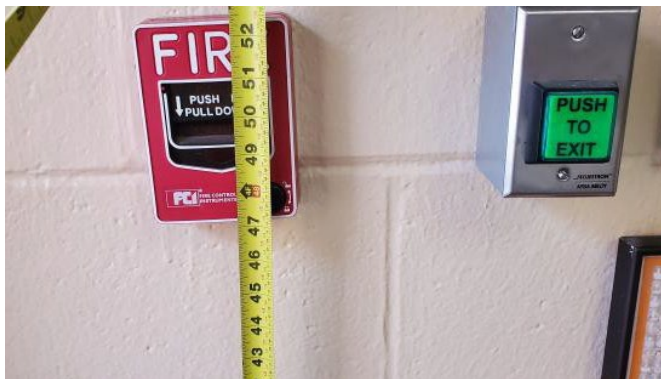
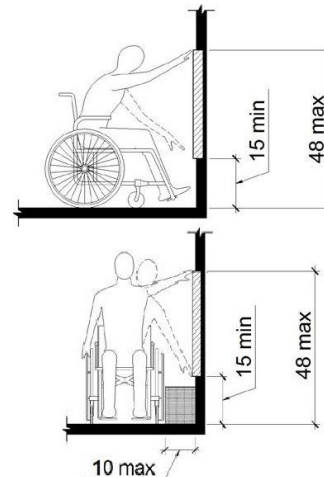
As Built: The fire alarm pull station is positioned too high for either a side or front approach.

Where a clear floor or ground space allows a parallel approach to an element and the side reach is unobstructed, the high side reach shall be 48 inches maximum and the low side reach shall be 15 inches minimum above the finish floor or ground.

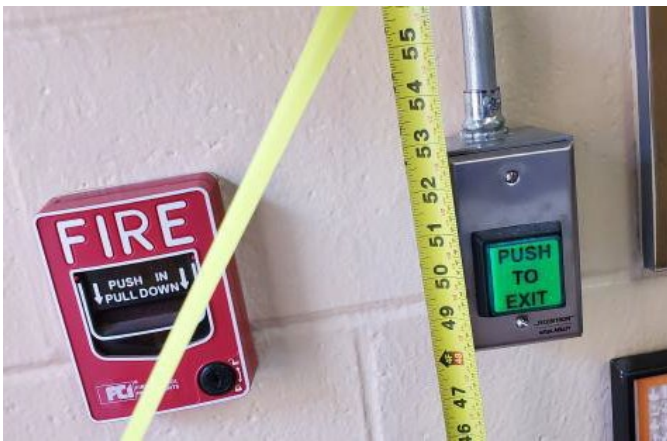
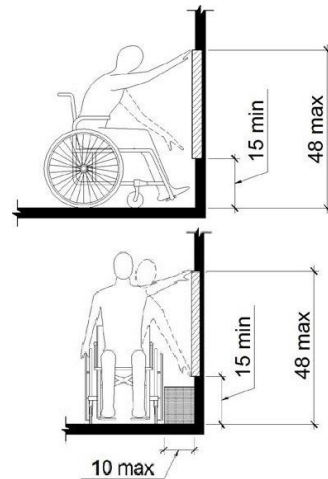
As Built: The push to exit device is not positioned correctly for either a side or front approach.

Where a clear floor or ground space allows a parallel or front approach and the side reach is unobstructed, the high side reach shall be 48 inches maximum above the finish floor or ground and the low side reach shall be 15 inches minimum above the finish floor or ground.

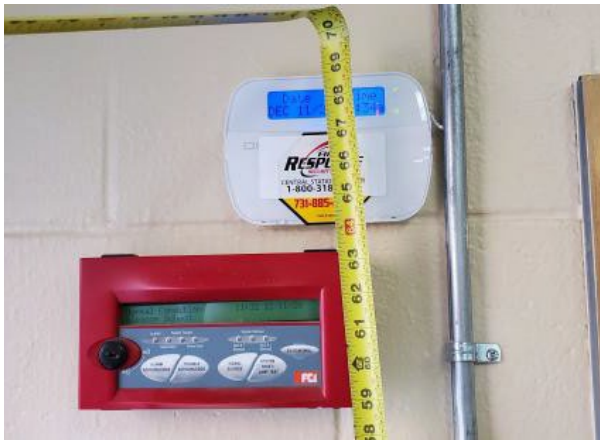
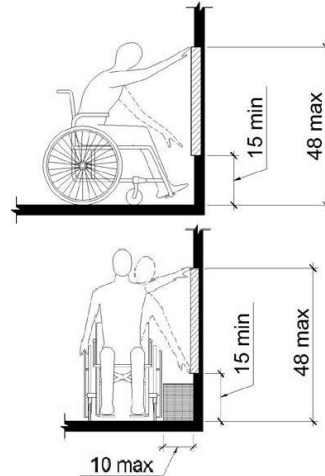
As Built: The fire alarm annunciator is not positioned correctly for either a side or front approach.

Where a clear floor or ground space allows a parallel or front approach and the side reach is unobstructed, the high side reach shall be 48 inches maximum above the finish floor or ground and the low side reach shall be 15 inches minimum above the finish floor or ground.

Recommendation: Lower fire alarm annunciator to 48" max AFF

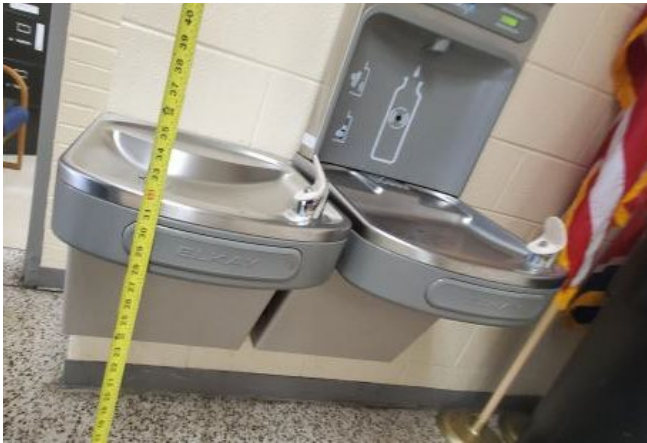
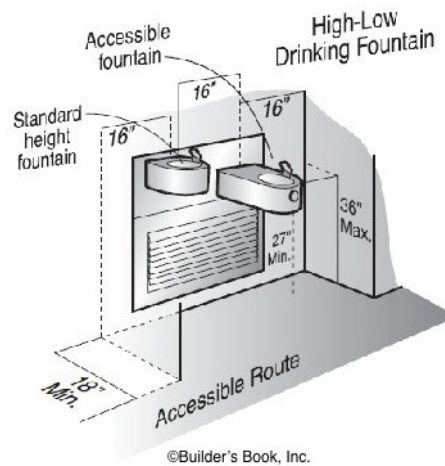
As Built: The drinking fountain is noncompliant.

Spout outlets shall be 36 inches maximum above the finish floor or ground and be located 15 inches minimum from the vertical support and 5 inches maximum from the front edge of the unit, including bumpers. The spout shall provide a flow of water at least 4 inches high minimum and shall be located 5 inches maximum from the front of the unit. The angle of the water stream shall be measured horizontally relative to the front face of the unit. Where spouts are located less than 3 inches of the front of the unit, the angle of the water stream shall be 30 degrees maximum. Where spouts are located between 3 inches and 5 inches maximum from the front of the unit, the angle of the water stream shall be 15 degrees maximum. On an accessible drinking fountain with a round or oval bowl, the spout must be positioned so the flow of water is within 3 inches of the front edge of the fountain.

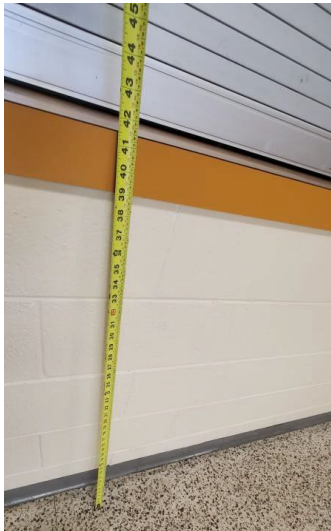
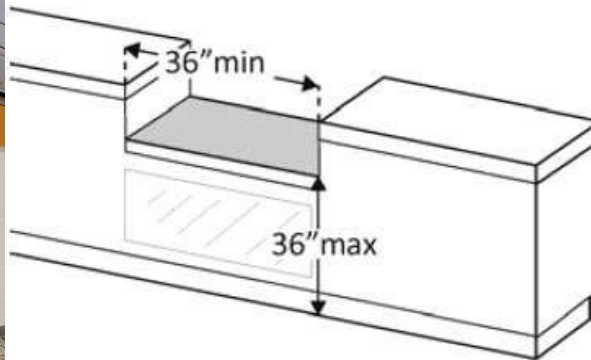
As Built: The counter is too high.

A portion of the counter surface that is 36 inches long minimum and 36 inches high maximum above the finish floor shall be provided. Knee and toe space must be provided for a forward approach. A 30 inch by 48 inch clear floor space on an accessible route must be provided for either a forward or parallel approach.

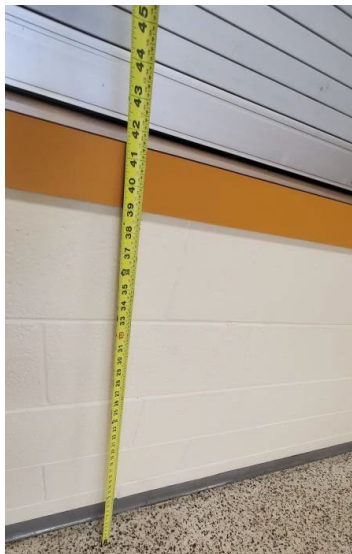
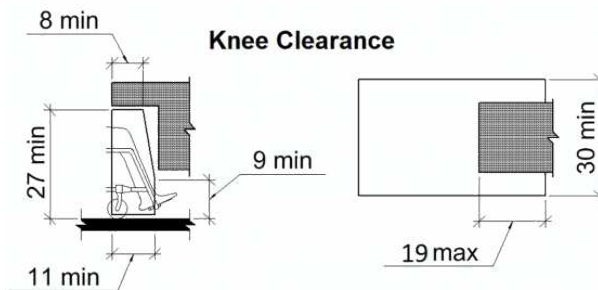
As Built: The knee clearance does not extend a minimum 8 inches under the element at 27 inches above the finished floor and/or 11 inches minimum at 9 inches above the floor.

Space under an element between 9 inches and 27 inches above the finish floor or ground shall be considered knee clearance. Knee clearance shall extend 25 inches maximum under an element at 9 inches above the finish floor or ground. Knee clearance shall be 11 inches deep minimum at 9 inches above the finish floor or ground, and 8 inches deep minimum at 27 inches above the finish floor or ground. Knee clearance shall be 30 inches wide minimum.

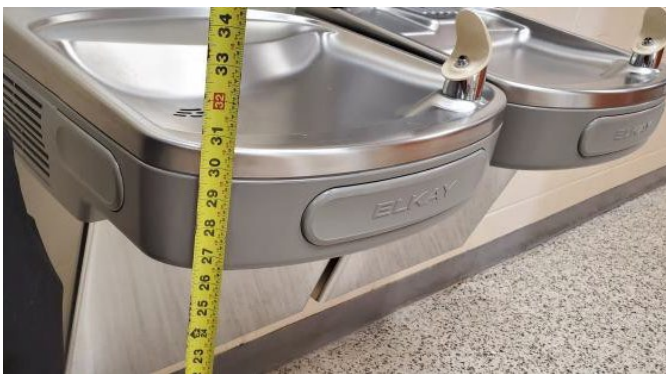
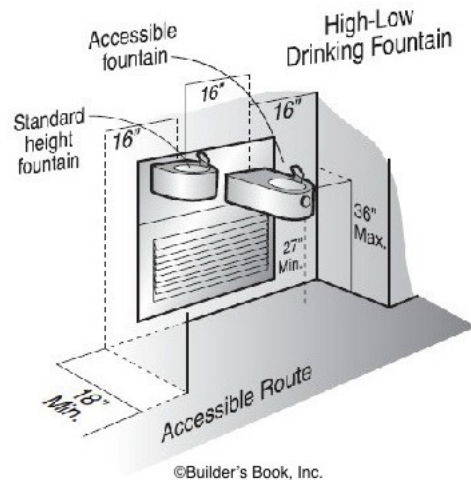
As Built: The drinking fountain is noncompliant.

Spout outlets shall be 36 inches maximum above the finish floor or ground and be located 15 inches minimum from the vertical support and 5 inches maximum from the front edge of the unit, including bumpers. The spout shall provide a flow of water at least 4 inches high minimum and shall be located 5 inches maximum from the front of the unit. The angle of the water stream shall be measured horizontally relative to the front face of the unit. Where spouts are located less than 3 inches of the front of the unit, the angle of the water stream shall be 30 degrees maximum. Where spouts are located between 3 inches and 5 inches maximum from the front of the unit, the angle of the water stream shall be 15 degrees maximum. On an accessible drinking fountain with a round or oval bowl, the spout must be positioned so the flow of water is within 3 inches of the front edge of the fountain.

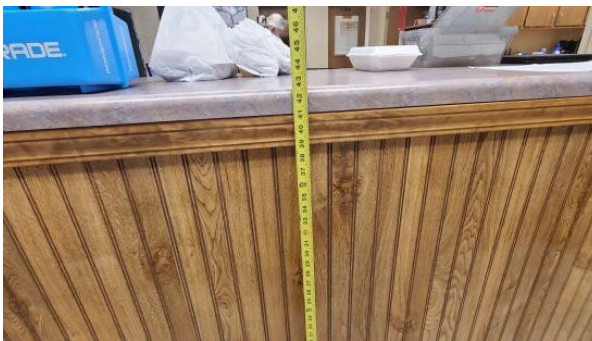
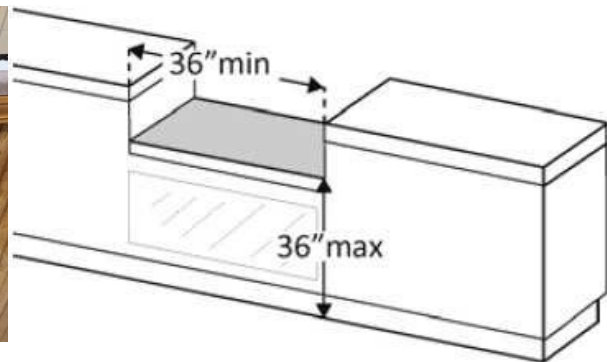
As Built: The counter is too high.

A portion of the counter surface that is 36 inches long minimum and 36 inches high maximum above the finish floor shall be provided. Knee and toe space must be provided for a forward approach. A 30 inch by 48 inch clear floor space on an accessible route must be provided for either a forward or parallel approach.
