WEAKLEY COUNTY, TENNESSEE

ADA EVALUATION

Architectural and Site Findings with Recommendations

TLM Associates, Inc

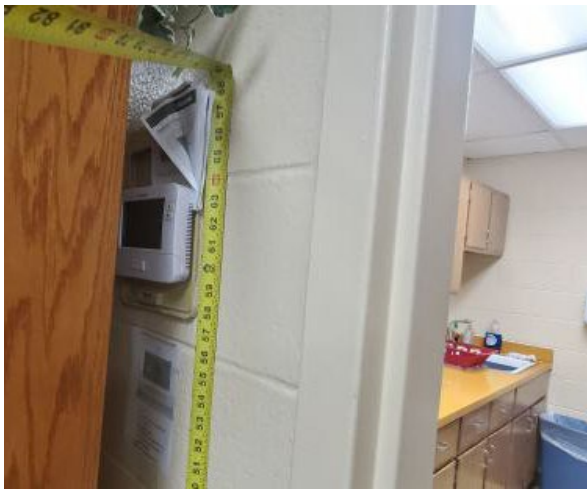
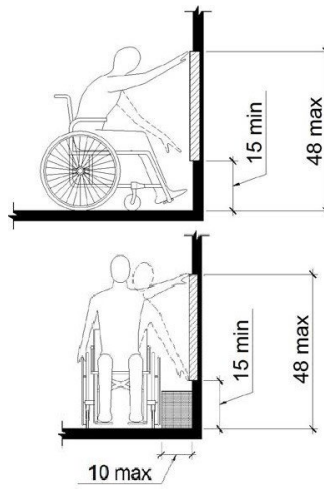
As Built: The Thermostat is positioned too high for either a side or front approach.

Where a clear floor or ground space allows a parallel approach to an element and the side reach is unobstructed, the high side reach shall be 48 inches maximum and the low side reach shall be 15 inches minimum above the finish floor or ground.

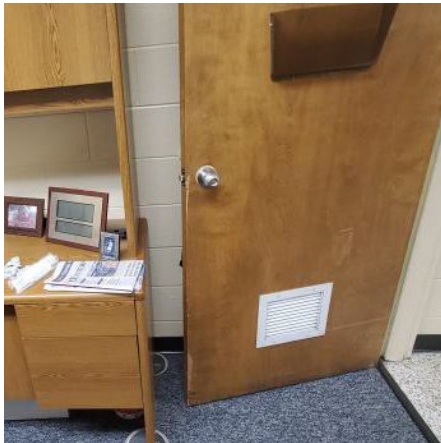
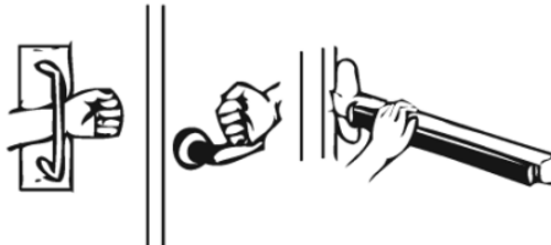
As Built: The door/gate operating hardware is not accessible.

Hand-activated door/gate opening hardware, handles, pulls, latches, locks, and other operating devices on accessible doors shall have a shape that is easy to grasp with one hand and does not require tight grasping, pinching, or twisting of the wrist to operate. Hardware shall be 34 inches minimum and 48 inches maximum above the finish floor or ground.

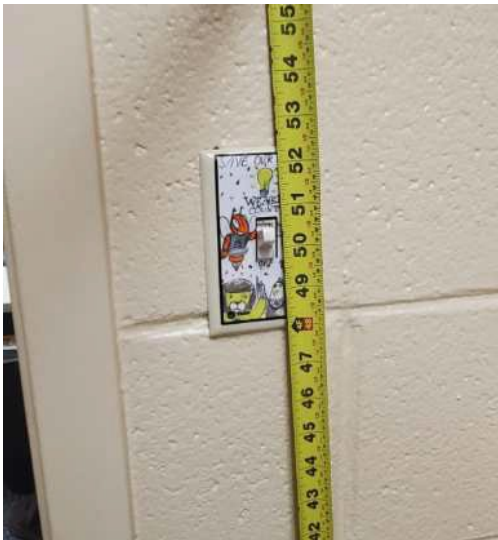
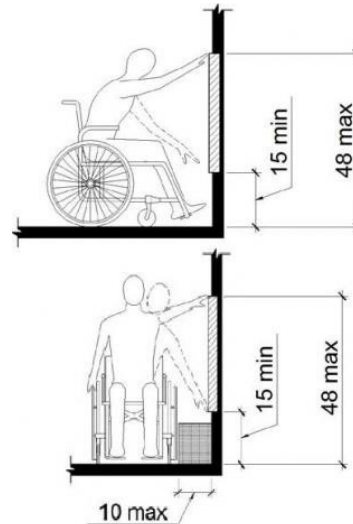
As Built: The receptacle/switch is not positioned correctly for either a side or front approach.

Where a clear floor or ground space allows a parallel or front approach to a switch or receptacle and the side reach is unobstructed, the high side reach shall be 48 inches maximum above the finish floor or ground and the low side reach shall be 15 inches minimum above the finish floor or ground.

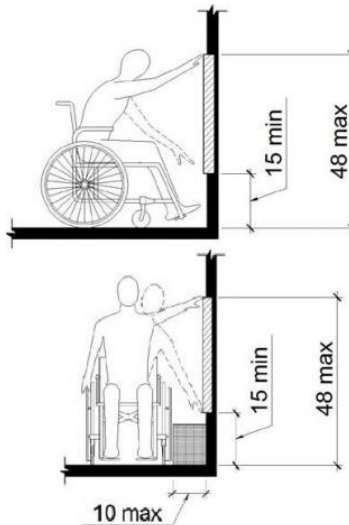
As Built: The Equipment/Light Panel 48" to bottom is not positioned correctly for either a side or front approach.

Where a clear floor or ground space allows a parallel or front approach to a switch or receptacle and the side reach is unobstructed, the high side reach shall be 48 inches maximum above the finish floor or ground and the low side reach shall be 15 inches minimum above the finish floor or ground.

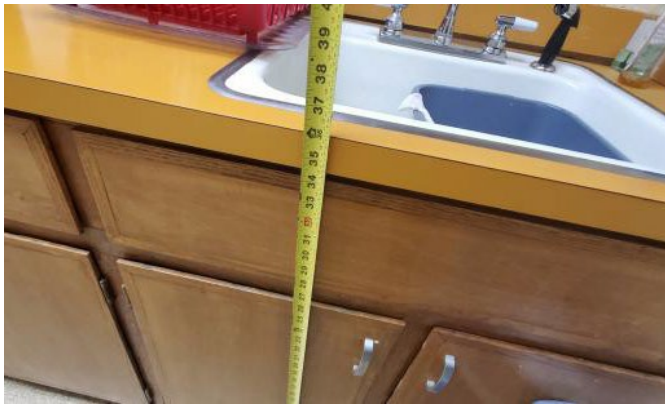
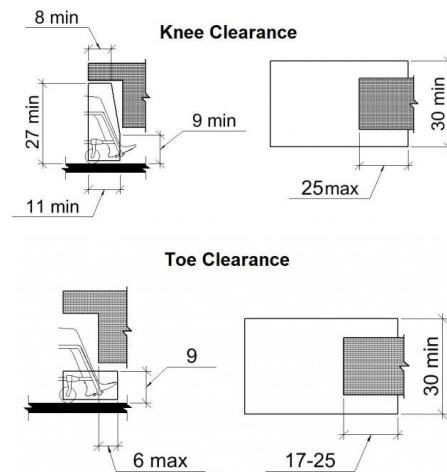
As Built: Knee and toe clearance has not been provided at the sink.

The knee clearance shall be 11 inches deep minimum at 9 inches above the finish floor or ground, and 8 inches deep minimum at 27 inches above the finish floor or ground.

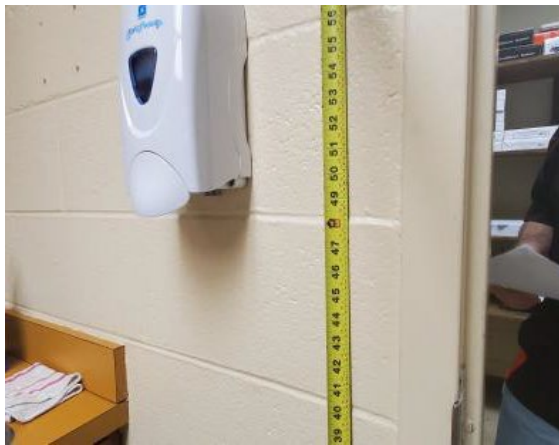
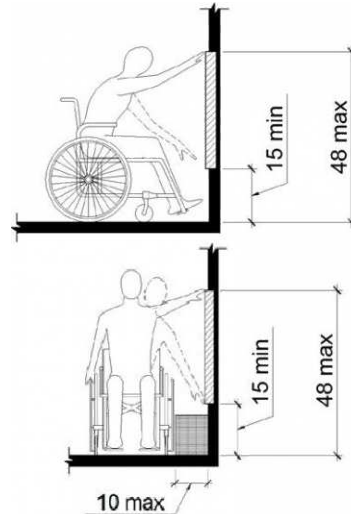
As Built: The hand sanitizer dispenser's operation mechanism is too high off the floor. Dispensers must have all operable parts a maximum of 48 inches above the floor.

Citation: 2010 ADAS Section 308.2.1

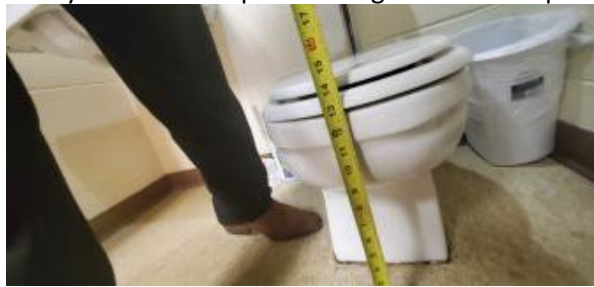
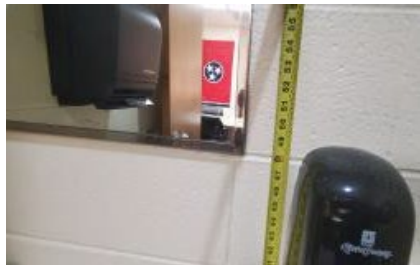
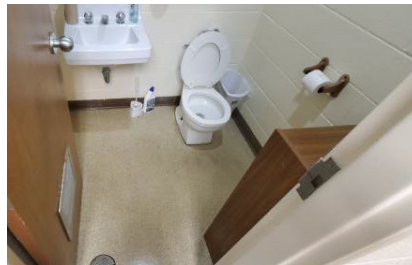
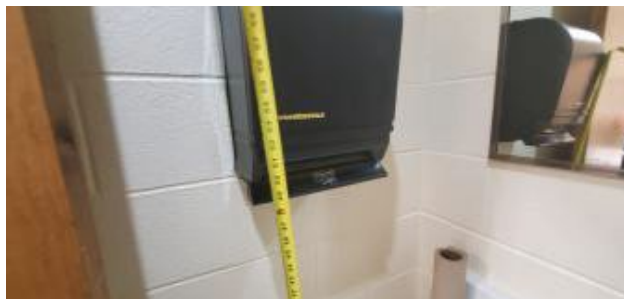
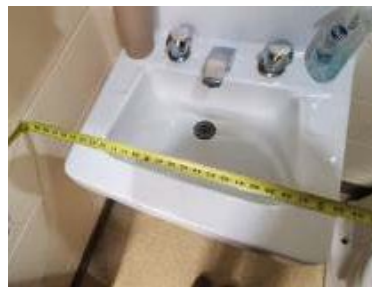
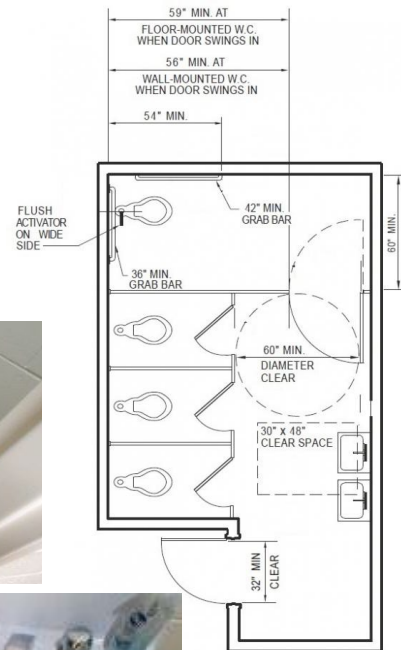
As Built: The restroom does not have the required minimum clear floor space or maneuvering clearances for the toilet. The restroom does not have the required minimum clear floor space or maneuvering clearances for the lavatory. The entry door does not contain the required minimum 60 inches maneuvering space on the pull side. The entry door encroaches into the required clear floor space for fixtures. No Grab bars installed. Toilet seat under 17". Lavatory doesn't have pipe insulation, incorrect faucet type, under 15" from wall. Paper Towel Dispenser 49" to bottom.

Citation: 2010 ADAS Section 213.2

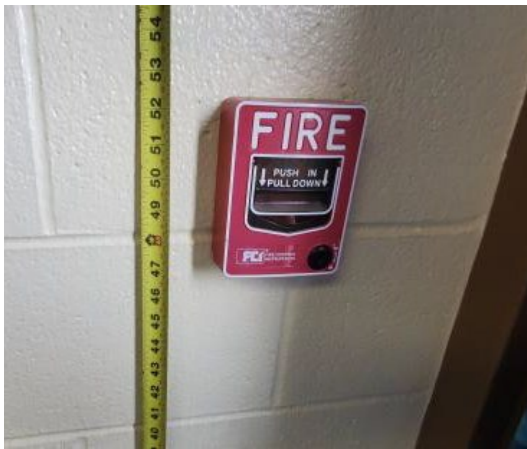
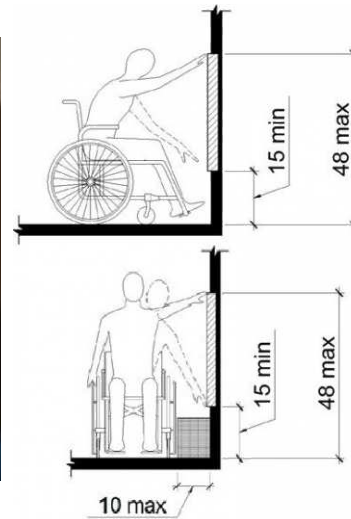
As Built: The fire alarm pull station is positioned too high for either a side or front approach.

Where a clear floor or ground space allows a parallel approach to an element and the side reach is unobstructed, the high side reach shall be 48 inches maximum and the low side reach shall be 15 inches minimum above the finish floor or ground.

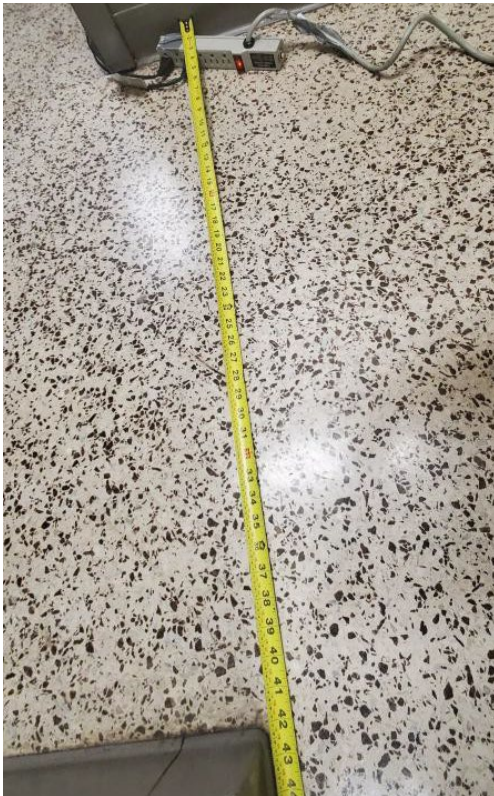
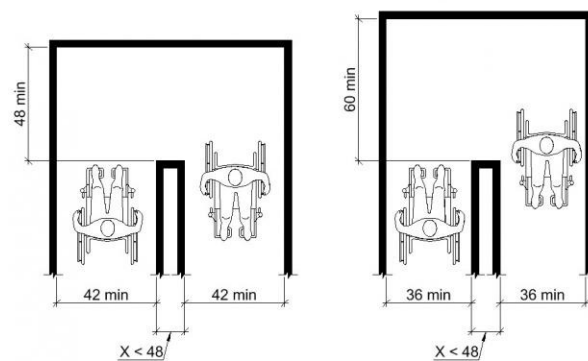
As Built: The route of travel does not meet minimum width requirements around the turn.

Where the accessible route makes a 180 degree turn around an element which is less than 48 inches wide, clear width shall be 42 inches minimum approaching the turn, 48 inches minimum at the turn and 42 inches minimum leaving the turn. Where the clear width at the turn is 60 inches minimum a clear width 36 inches minimum approaching the turn and 36 inches minimum at the turn is acceptable.

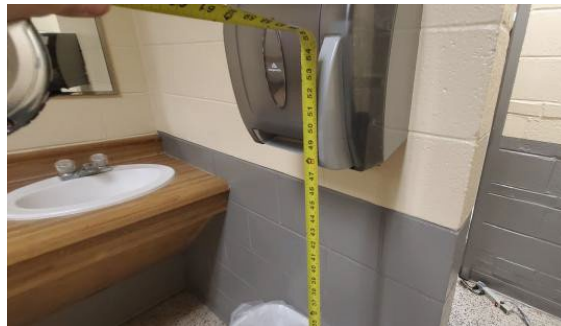
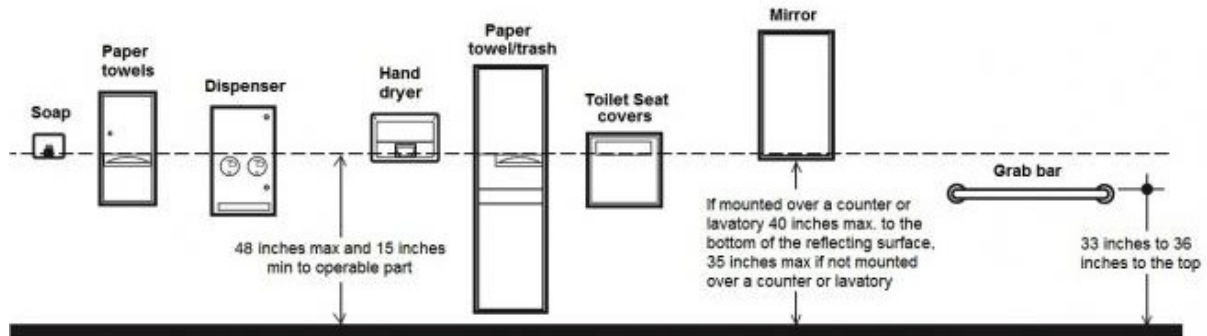
As Built: The paper towel dispenser's operation mechanism is too high off the floor. Dispensers must have all operable parts a maximum of 48 inches above the floor.

Citation: 2010 ADAS Section 308.2.1

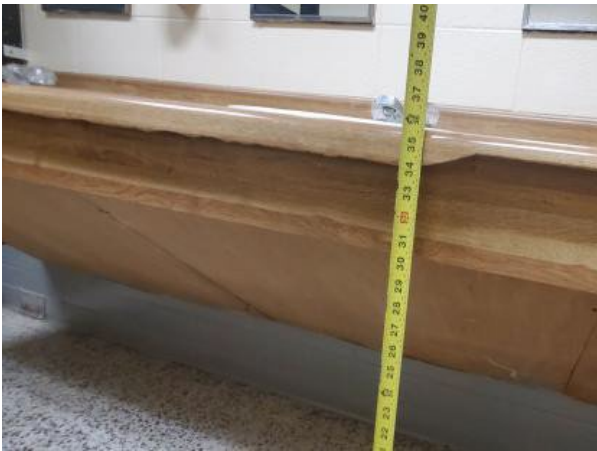
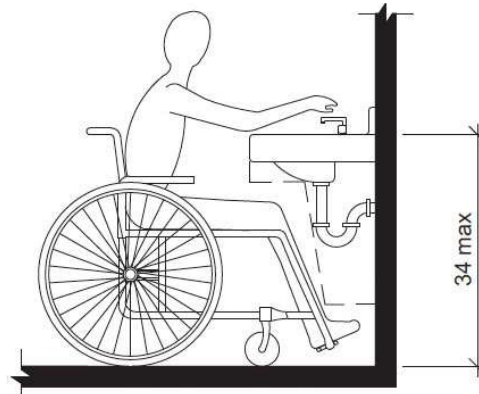
As Built: The top rim of the lavatory is too high.

All lavatories that are designated to be accessible shall be a minimum 17 inches in horizontal depth and mounted with the rim or counter edge no higher than 34 inches above the finished floor.

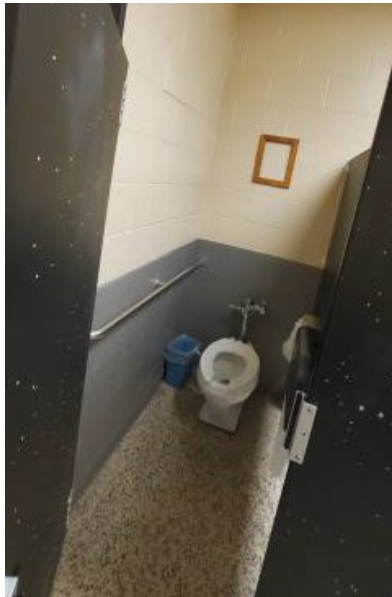
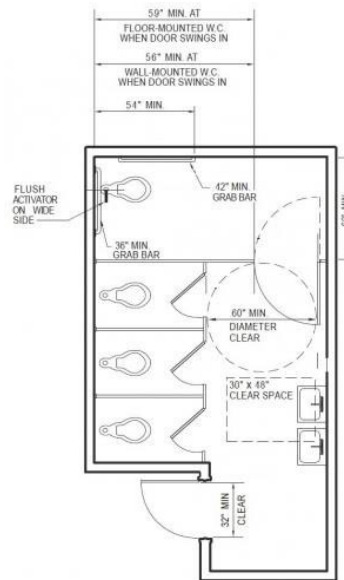
As Built: The compartment stall is not nearly compliant.

The stall does not have the required minimum clear floor space or maneuvering clearances for the toilet, doesn't have required width, rear grab bar is missing and side grab bar incorrectly installed, flush handle on wrong side.

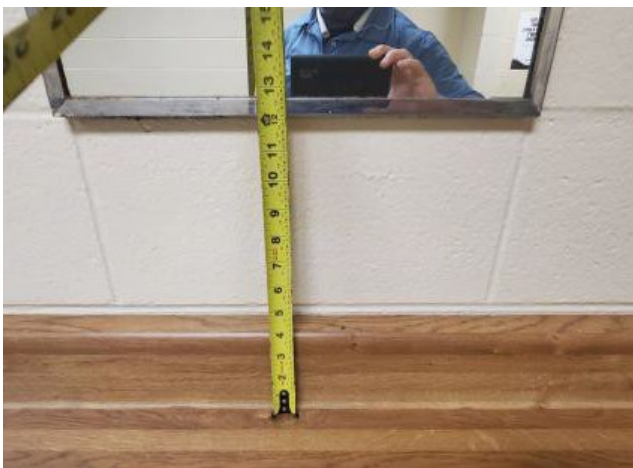
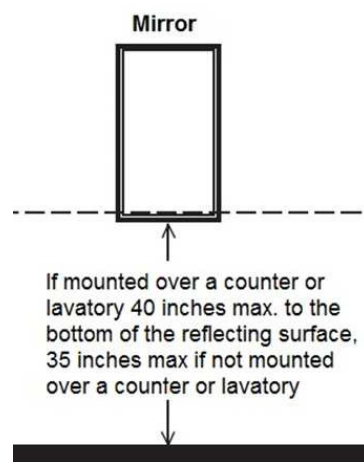
As Built: The mirror is mounted too high.

Mirrors must have the bottom edge of the reflecting surface a maximum of 40 inches above the floor if above a sink or counter. Mirrors not located above lavatories or countertops shall be installed with the bottom edge of the reflecting surface 35 inches maximum above the finish floor or ground.

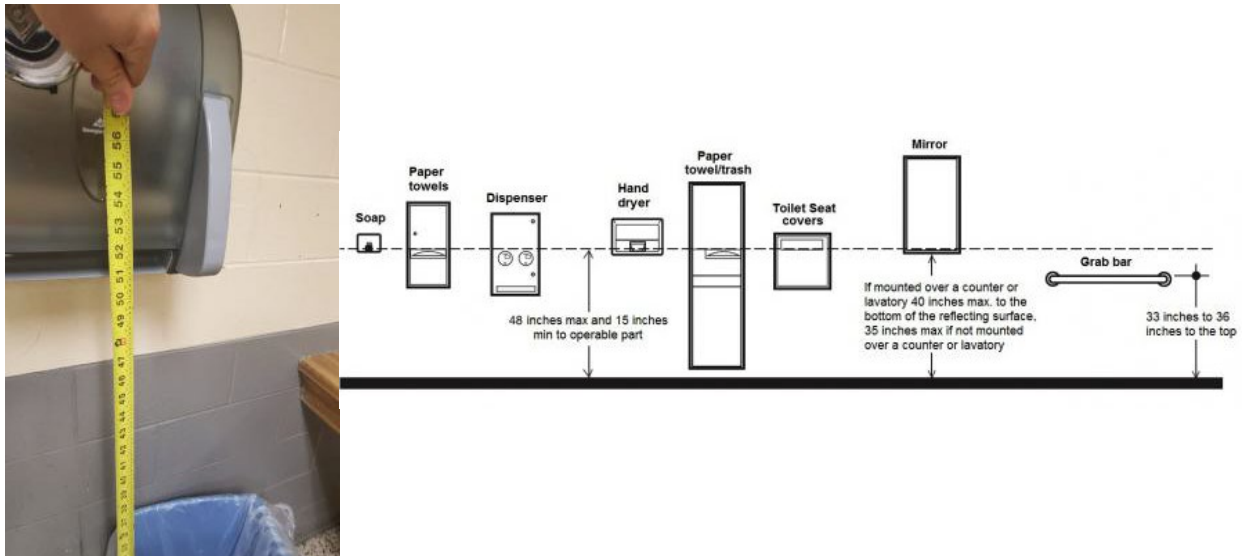
As Built: The paper towel dispenser's operation mechanism is too high off the floor. Dispensers must have all operable parts a maximum of 48 inches above the floor.

Citation: 2010 ADAS Section 308.2.1

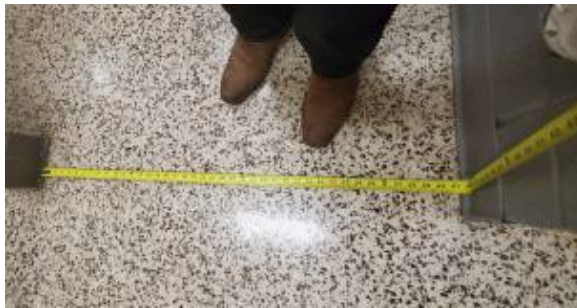
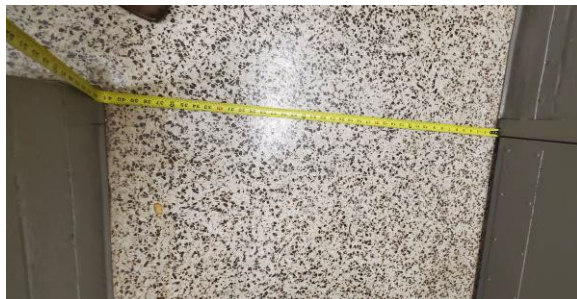
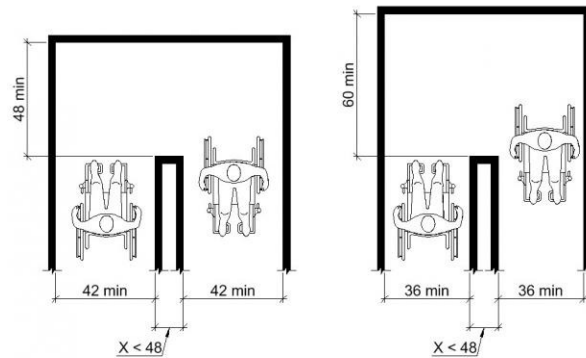
As Built: The route of travel does not meet minimum width requirements around the turn.

Where the accessible route makes a 180 degree turn around an element which is less than 48 inches wide, clear width shall be 42 inches minimum approaching the turn, 48 inches minimum at the turn and 42 inches minimum leaving the turn. Where the clear width at the turn is 60 inches minimum a clear width 36 inches minimum approaching the turn and 36 inches minimum at the turn is acceptable.

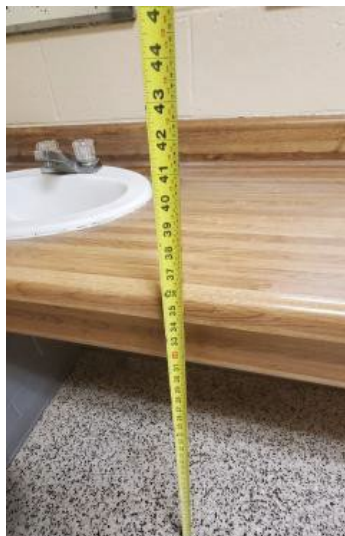
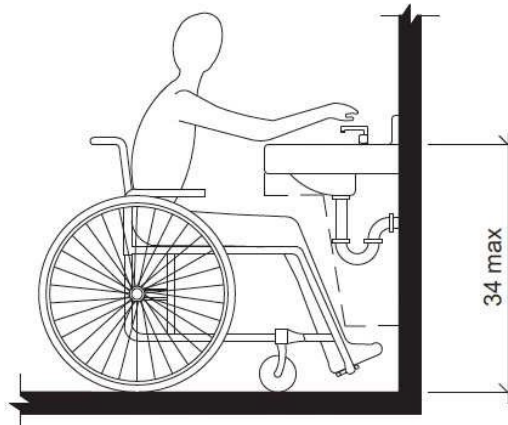
As Built: The top rim of the lavatory is too high.

All lavatories that are designated to be accessible shall be a minimum 17 inches in horizontal depth and mounted with the rim or counter edge no higher than 34 inches above the finished floor.

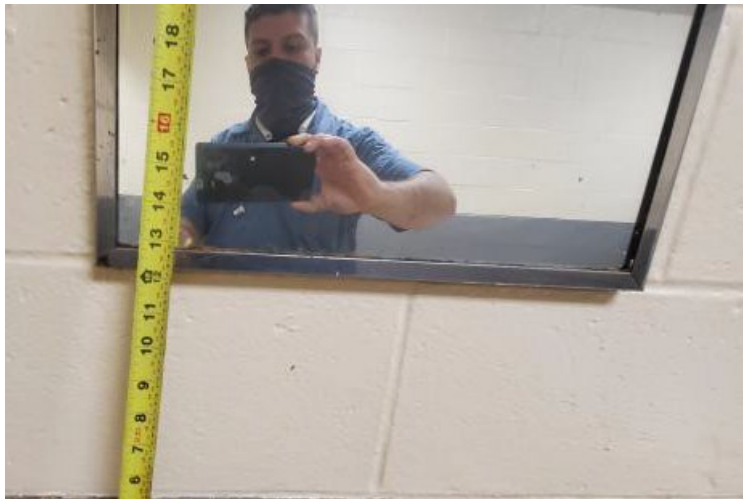
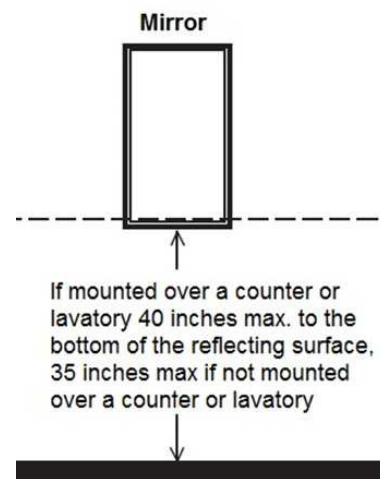
As Built: The mirror is mounted too high.

Mirrors must have the bottom edge of the reflecting surface a maximum of 40 inches above the floor if above a sink or counter. Mirrors not located above lavatories or countertops shall be installed with the bottom edge of the reflecting surface 35 inches maximum above the finish floor or ground.

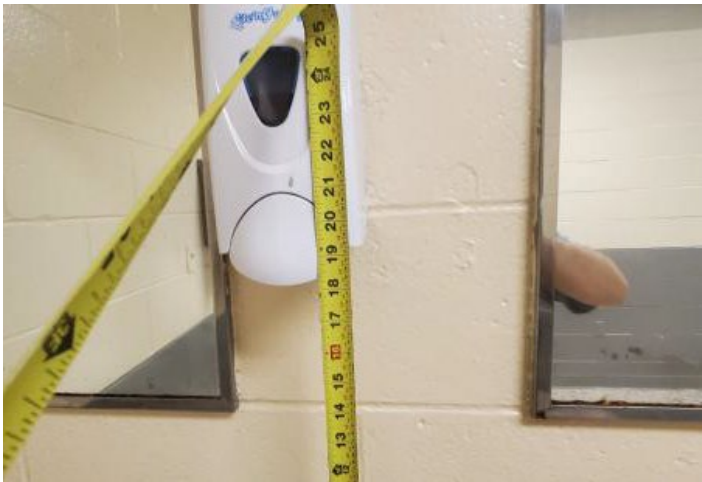
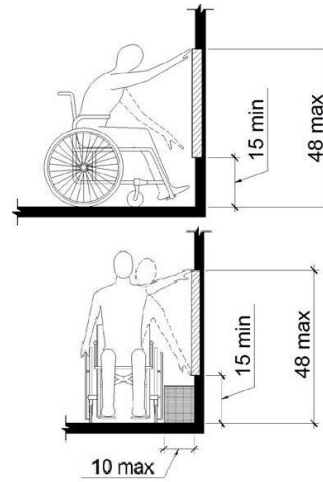
As Built: The soap dispenser's operation mechanism is too high off the floor.

Dispensers must have all operable parts a maximum of 48 inches above the floor.

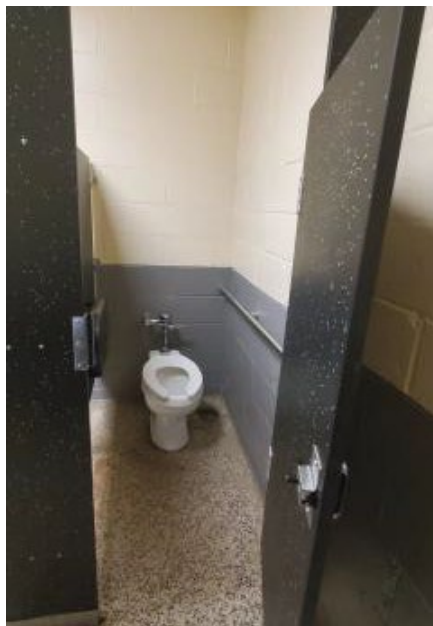
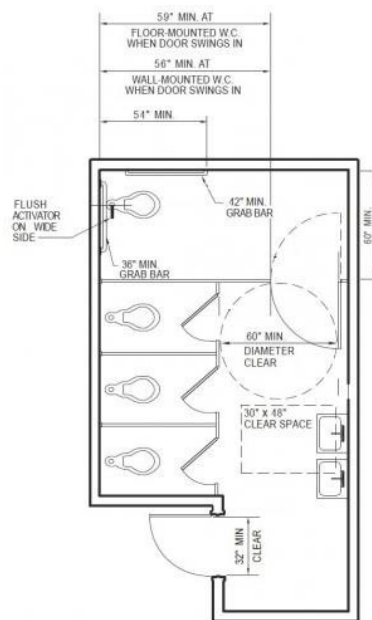
As Built: The compartment stall is not nearly compliant.

The stall does not have the required minimum clear floor space or maneuvering clearances for the toilet, doesn't have required width, rear grab bar is missing and side grab bar incorrectly installed, flush handle on wrong side.

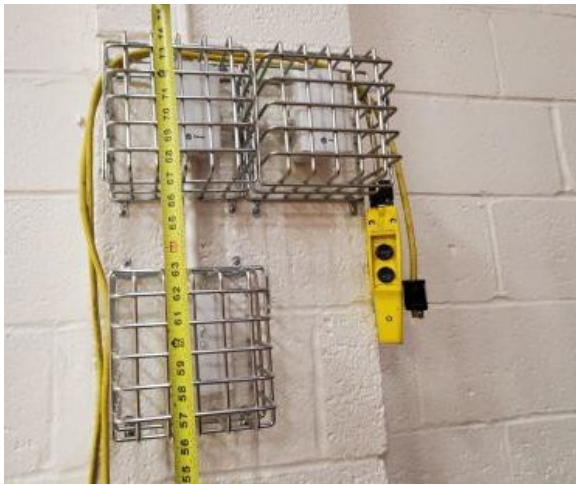
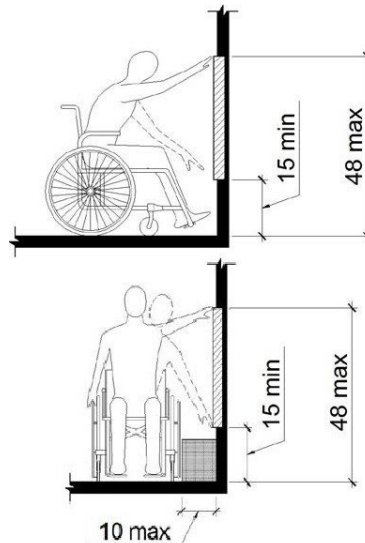
As Built: The Thermostat is positioned too high for either a side or front approach.

Where a clear floor or ground space allows a parallel approach to an element and the side reach is unobstructed, the high side reach shall be 48 inches maximum and the low side reach shall be 15 inches minimum above the finish floor or ground.

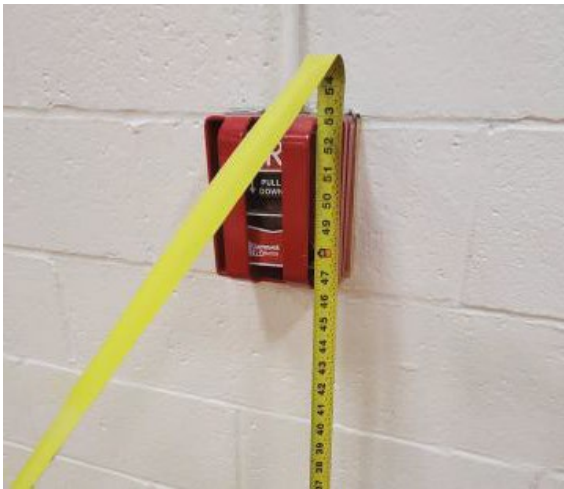
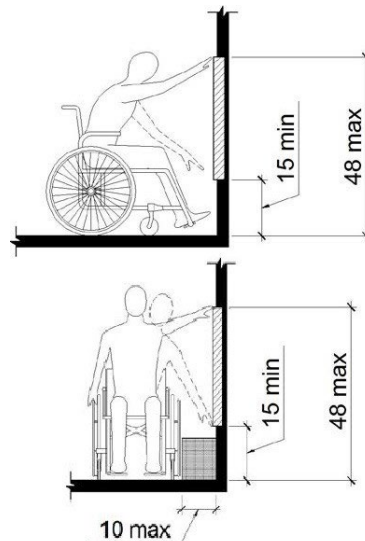
As Built: The fire alarm pull station is positioned too high for either a side or front approach.

Where a clear floor or ground space allows a parallel approach to an element and the side reach is unobstructed, the high side reach shall be 48 inches maximum and the low side reach shall be 15 inches minimum above the finish floor or ground.

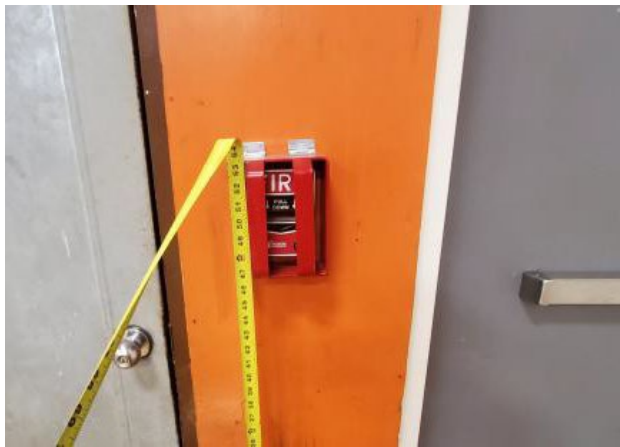
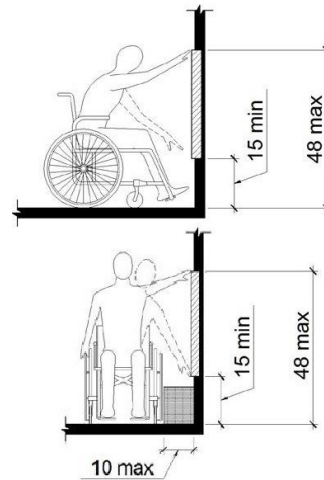
As Built: The fire alarm pull station is positioned too high for either a side or front approach.

Where a clear floor or ground space allows a parallel approach to an element and the side reach is unobstructed, the high side reach shall be 48 inches maximum and the low side reach shall be 15 inches minimum above the finish floor or ground.

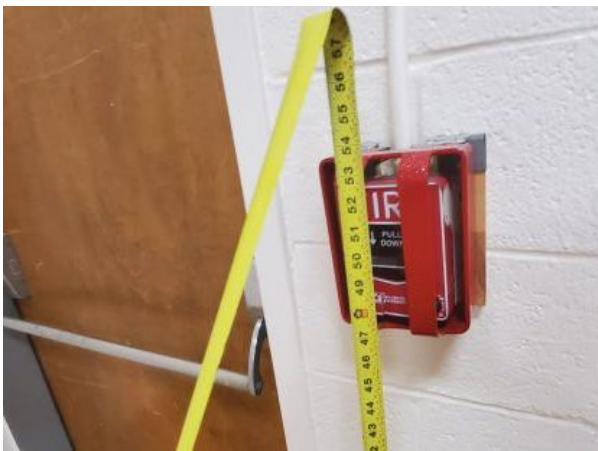
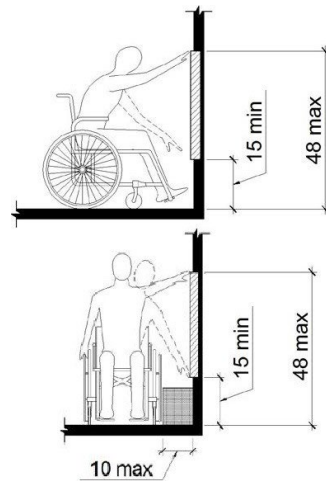
As Built: The fire alarm pull station is positioned too high for either a side or front approach.

Where a clear floor or ground space allows a parallel approach to an element and the side reach is unobstructed, the high side reach shall be 48 inches maximum and the low side reach shall be 15 inches minimum above the finish floor or ground.

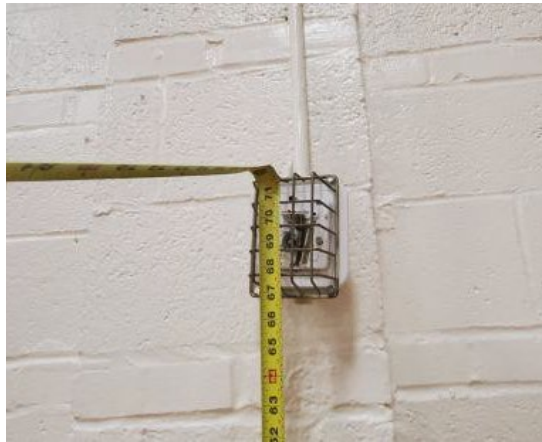
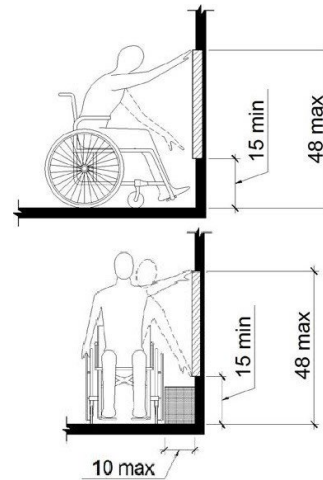
As Built: The Thermostat is positioned too high for either a side or front approach.

Where a clear floor or ground space allows a parallel approach to an element and the side reach is unobstructed, the high side reach shall be 48 inches maximum and the low side reach shall be 15 inches minimum above the finish floor or ground.

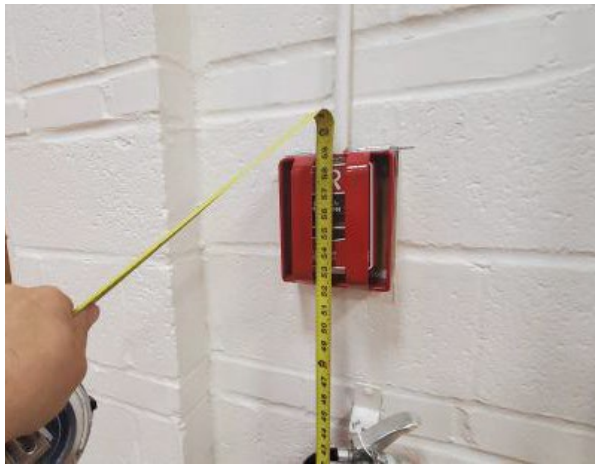
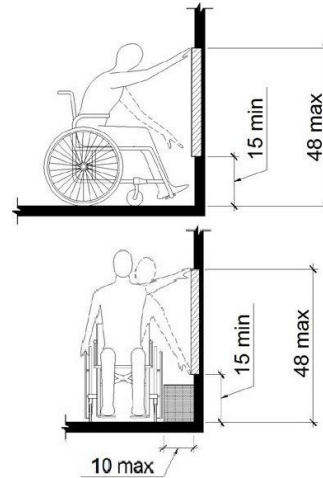
As Built: The fire alarm pull station is positioned too high for either a side or front approach.

Where a clear floor or ground space allows a parallel approach to an element and the side reach is unobstructed, the high side reach shall be 48 inches maximum and the low side reach shall be 15 inches minimum above the finish floor or ground.

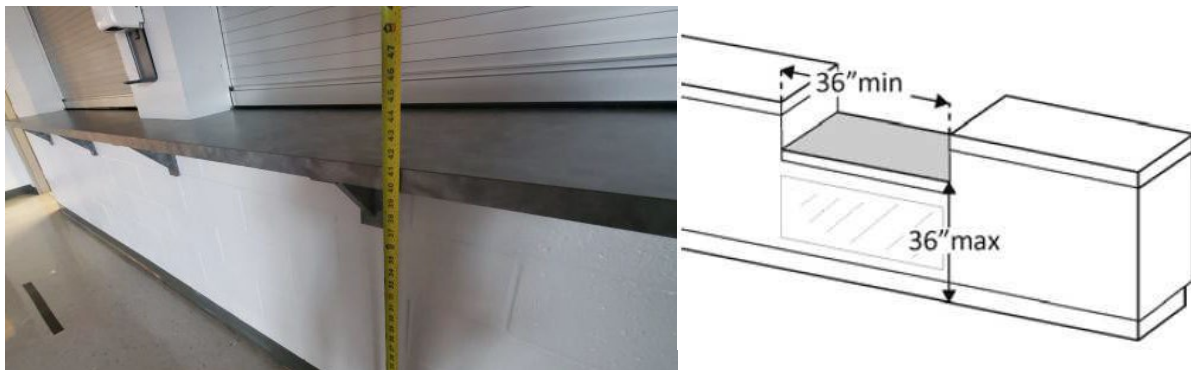
As Built: The counter is too high.

A portion of the counter surface that is 36 inches long minimum and 36 inches high maximum above the finish floor shall be provided. Knee and toe space must be provided for a forward approach. A 30 inch by 48 inch clear floor space on an accessible route must be provided for either a forward or parallel approach.

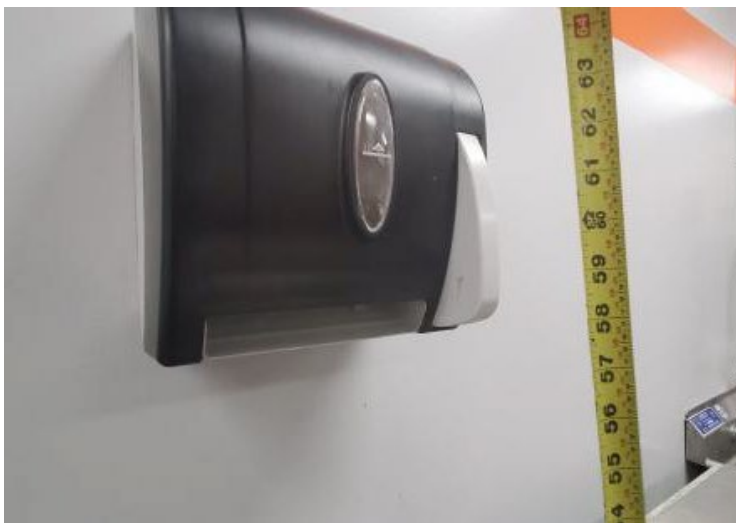
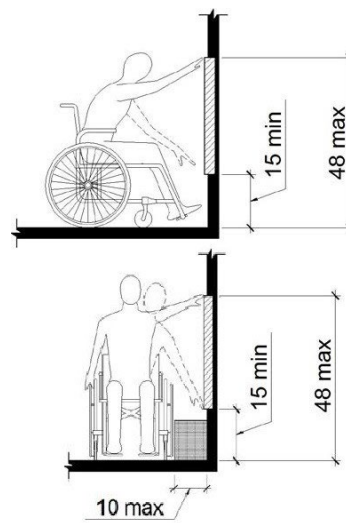
As Built: The paper towel dispenser's operation mechanism is too high off the floor. Dispensers must have all operable parts a maximum of 48 inches above the floor.

Citation: 2010 ADAS Section 308.2.1

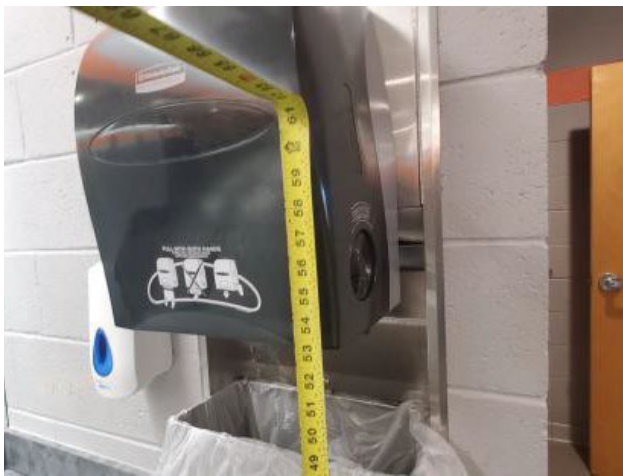
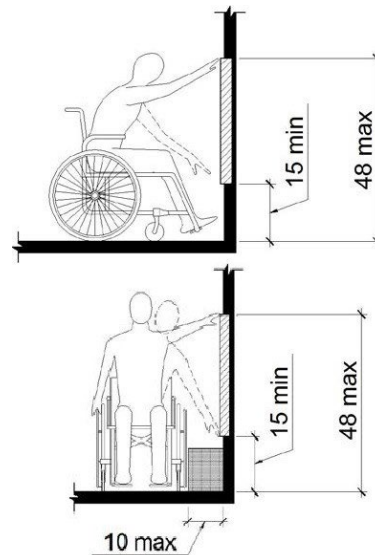
As Built: The paper towel dispenser's operation mechanism is too high off the floor. Dispensers must have all operable parts a maximum of 48 inches above the floor.

Citation: 2010 ADAS Section 308.2.1

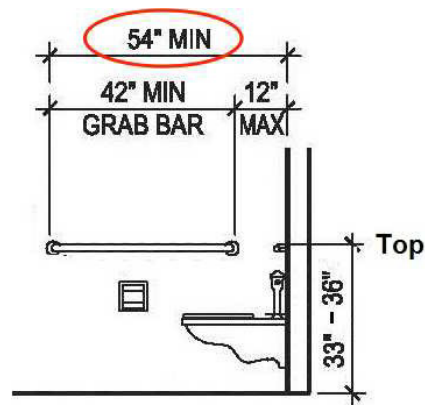
As Built: The side grab bar does not extend far enough from the rear wall.

The side grab bar must extend at least 54 inches minimum beyond the rear wall and start a maximum of 12 inches from the rear wall. A 42 inch grab bar installed the maximum distance from the rear wall (12 inches) will leave the leading end 54 inches from the rear wall.

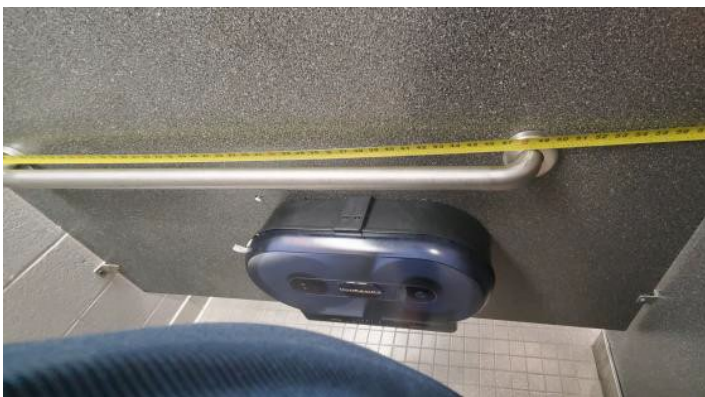
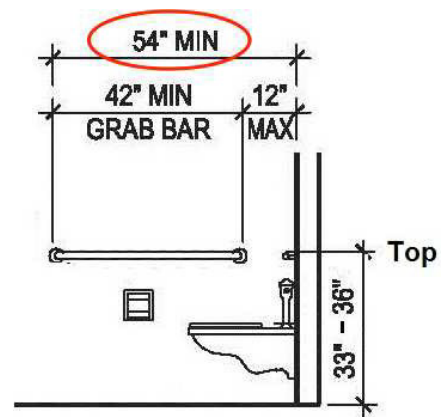
As Built: The side grab bar does not extend far enough from the rear wall.

The side grab bar must extend at least 54 inches minimum beyond the rear wall and start a maximum of 12 inches from the rear wall. A 42 inch grab bar installed the maximum distance from the rear wall (12 inches) will leave the leading end 54 inches from the rear wall.

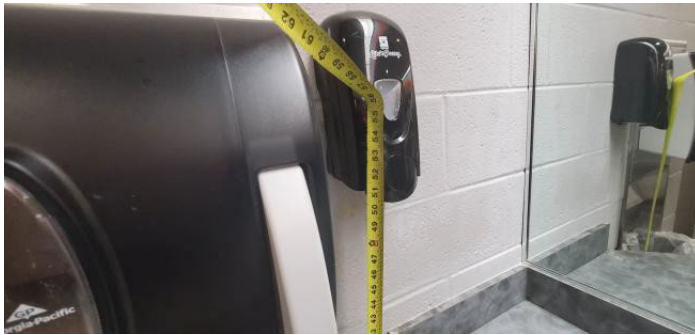
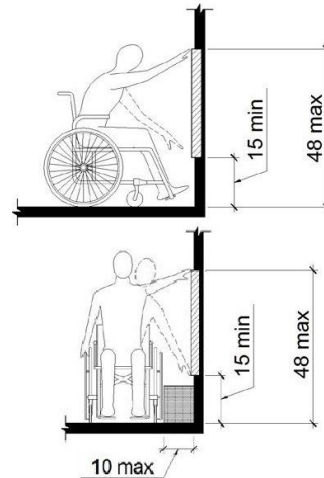
As Built: The soap dispenser's operation mechanism is too high off the floor.

Dispensers must have all operable parts a maximum of 48 inches above the floor.

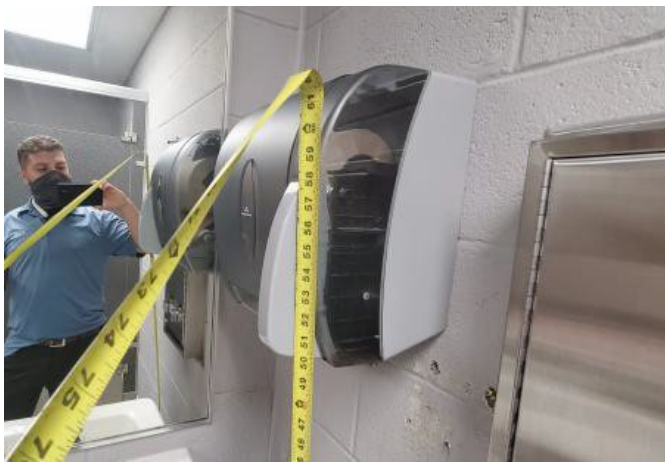
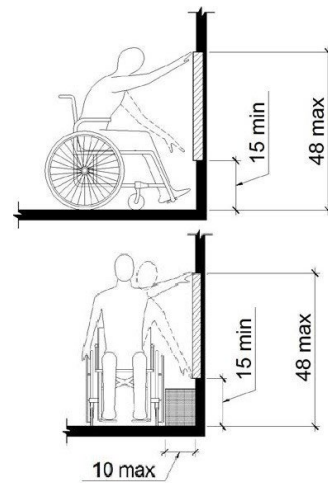
As Built: The paper towel dispenser's operation mechanism is too high off the floor. Dispensers must have all operable parts a maximum of 48 inches above the floor.

Citation: 2010 ADAS Section 308.2.1

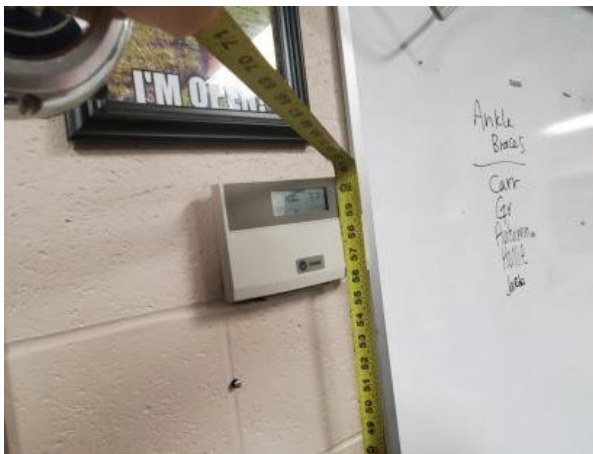
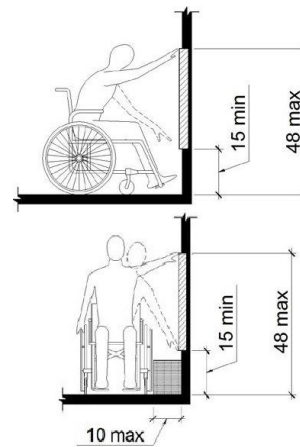
As Built: The Thermostat is positioned too high for either a side or front approach.

Where a clear floor or ground space allows a parallel approach to an element and the side reach is unobstructed, the high side reach shall be 48 inches maximum and the low side reach shall be 15 inches minimum above the finish floor or ground.

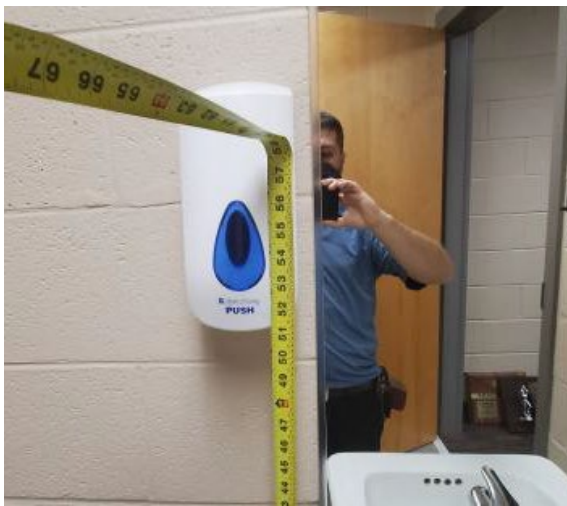
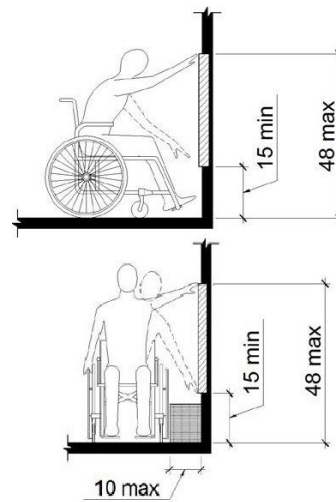
As Built: The soap dispenser's operation mechanism is too high off the floor.

Dispensers must have all operable parts a maximum of 48 inches above the floor.

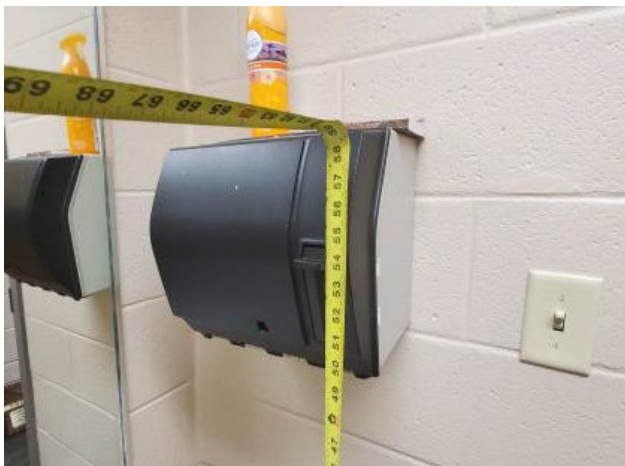
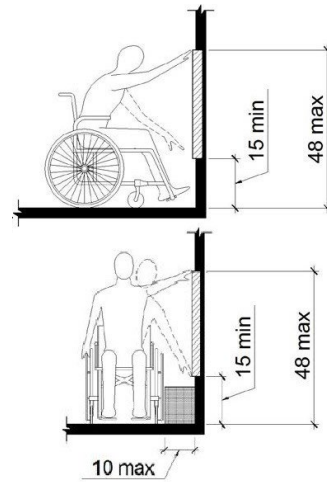
As Built: The paper towel dispenser's operation mechanism is too high off the floor. Dispensers must have all operable parts a maximum of 48 inches above the floor.

Citation: 2010 ADAS Section 308.2.1

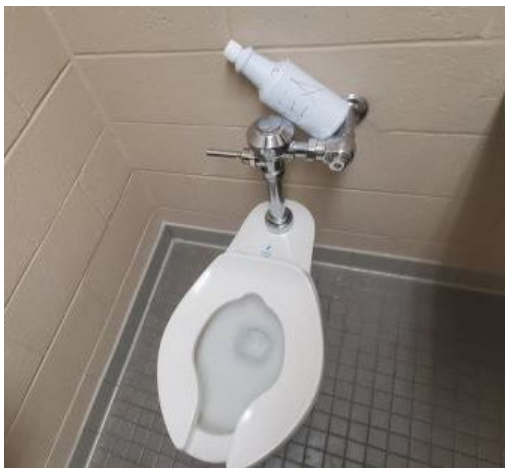
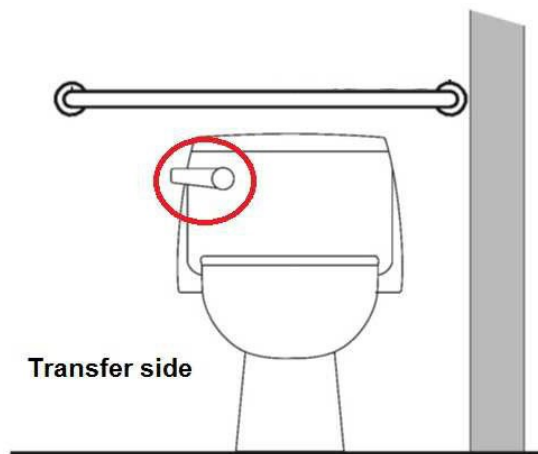
As Built: The flush handle is located on the wrong side of the toilet.

Controls shall be operable with one hand and shall not require tight grasping, pinching or twisting. Controls for the flush valves shall be mounted on the wide side of toilet areas, no more than 48 inches above the floor.

Replace with a compliant toilet.

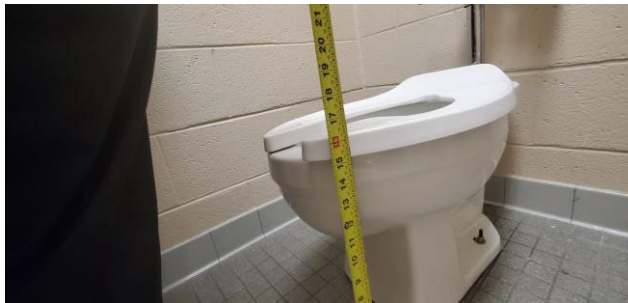
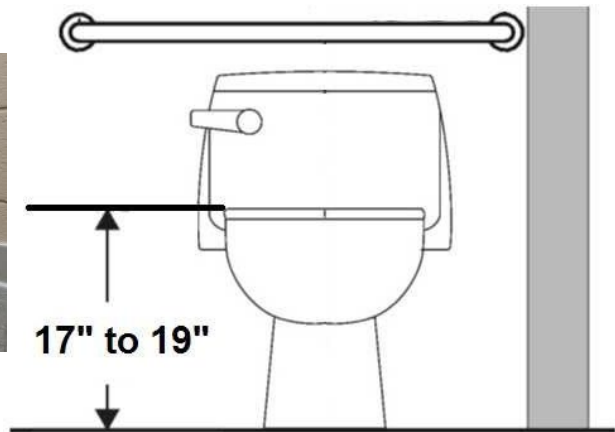
As Built: The toilet seat is not located within the range allowed off the floor.

The height of accessible water closets shall be a minimum of 17 inches and a maximum of 19 inches measured to the top of the toilet seat. The seat itself shall be a maximum of 2 inch high.

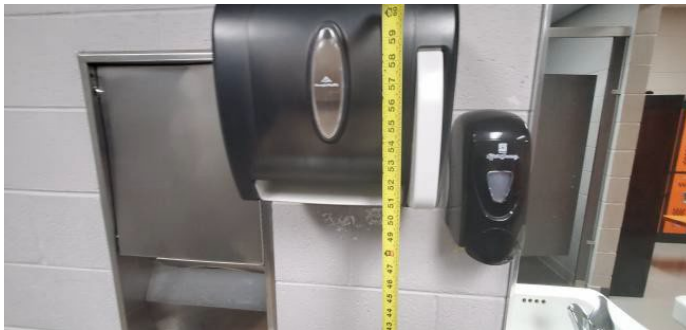
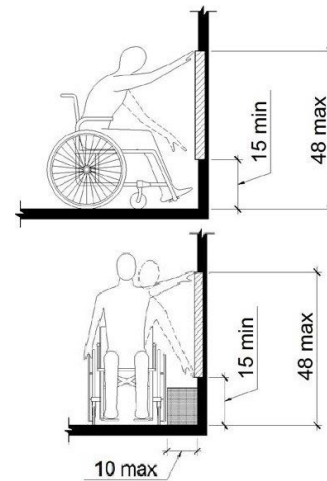
As Built: The paper towel dispenser's operation mechanism is too high off the floor. Dispensers must have all operable parts a maximum of 48 inches above the floor.

Citation: 2010 ADAS Section 308.2.1

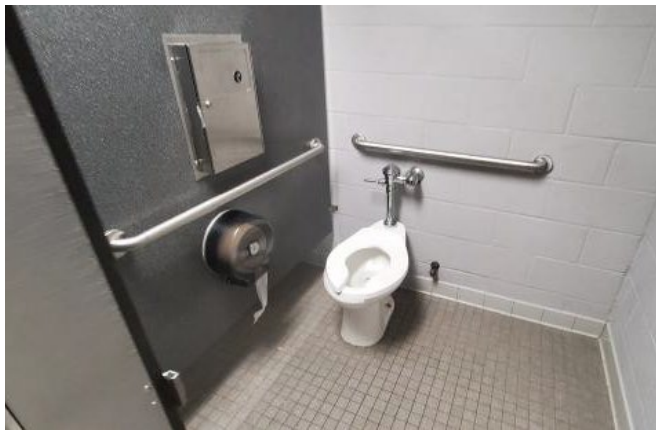
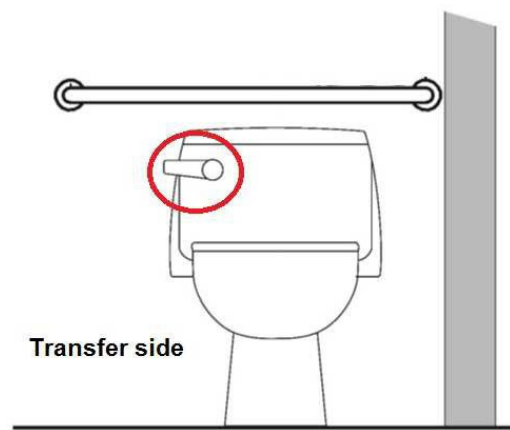
As Built: The flush handle is located on the wrong side of the toilet.

Controls shall be operable with one hand and shall not require tight grasping, pinching, or twisting. Controls for the flush valves shall be mounted on the wide side of toilet areas, no more than 48 inches above the floor.

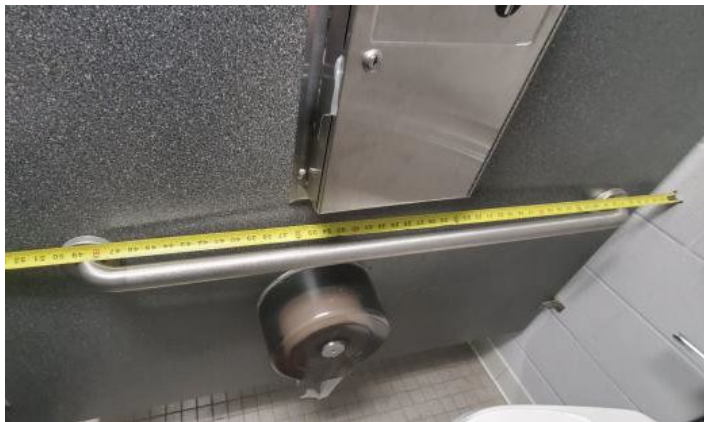
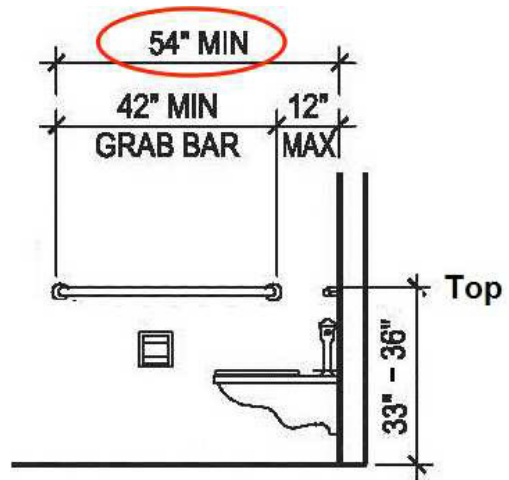
As Built: The side grab bar does not extend far enough from the rear wall.

The side grab bar must extend at least 54 inches minimum beyond the rear wall and start a maximum of 12 inches from the rear wall. A 42 inch grab bar installed the maximum distance from the rear wall (12 inches) will leave the leading end 54 inches from the rear wall.

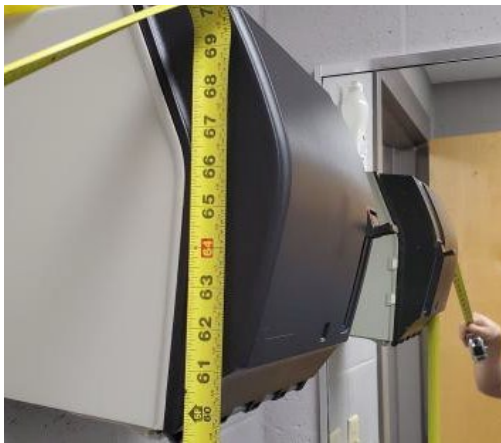
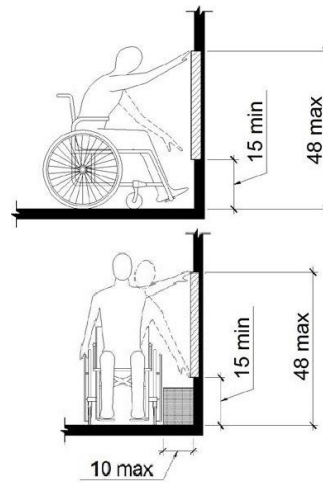
As Built: The paper towel dispenser's operation mechanism is too high off the floor. Dispensers must have all operable parts a maximum of 48 inches above the floor.

Citation: 2010 ADAS Section 308.2.1
