WEAKLEY COUNTY, TENNESSEE

ADA EVALUATION

Architectural and Site Findings with Recommendations

TLM Associates, Inc

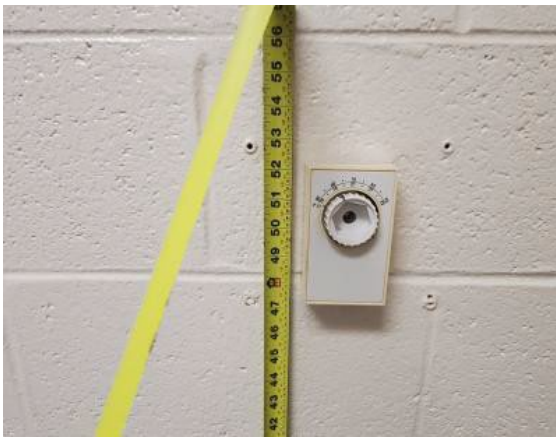
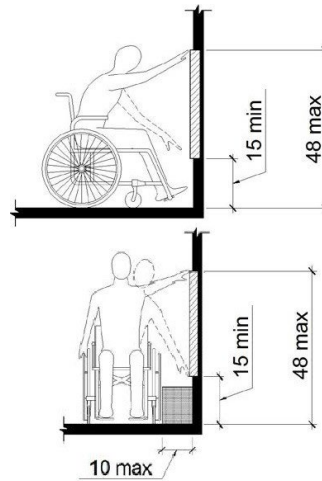
As Built: The Thermostat is positioned at 51" which is too high for either a side or front approach.

Where a clear floor or ground space allows a parallel approach to an element and the side reach is unobstructed, the high side reach shall be 48 inches maximum and the low side reach shall be 15 inches minimum above the finish floor or ground.

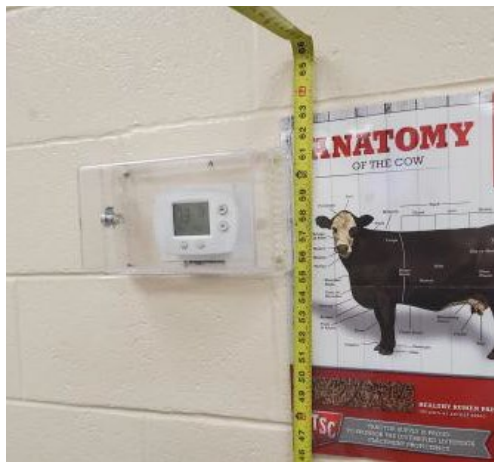
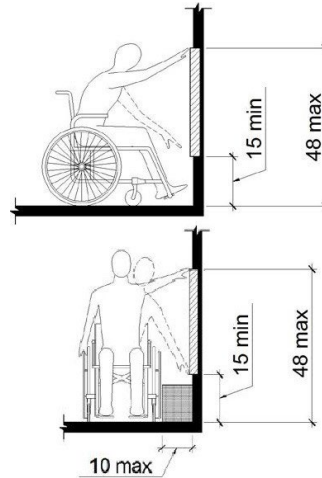
As Built: The Thermostat is positioned at 51" which is too high for either a side or front approach.

Where a clear floor or ground space allows a parallel approach to an element and the side reach is unobstructed, the high side reach shall be 48 inches maximum and the low side reach shall be 15 inches minimum above the finish floor or ground.

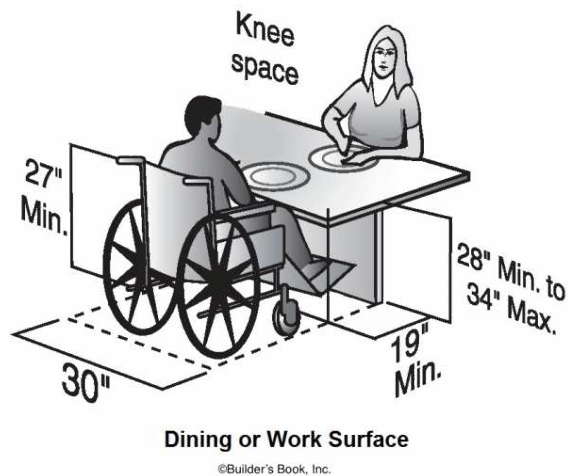
As Built: The work surface is at 36" which is not within the allowable range.

The tops of work surfaces provided for public use or common use shall be 28 inches minimum and 34 inches maximum above the finish floor or ground.

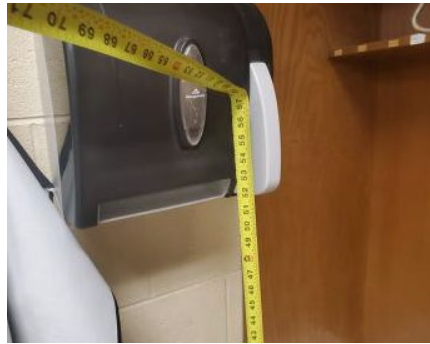
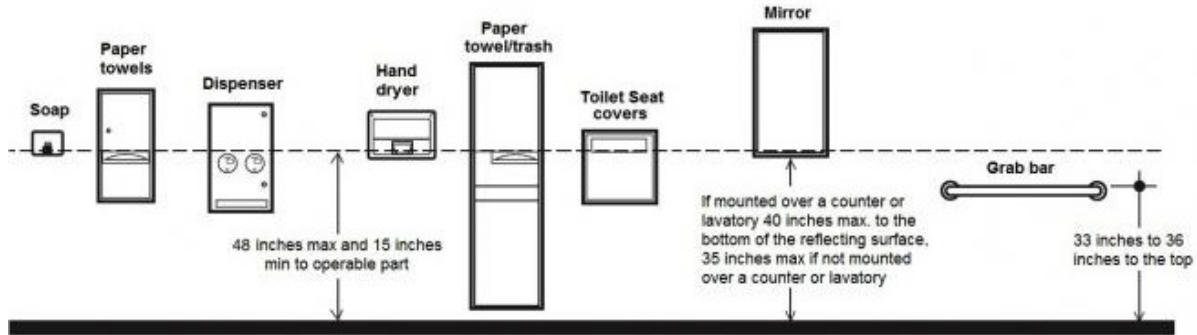
As Built: The paper towel dispenser's operation mechanism is too high off the floor. Dispensers must have all operable parts a maximum of 48 inches above the floor.

Citation: 2010 ADAS Section 308.2.1

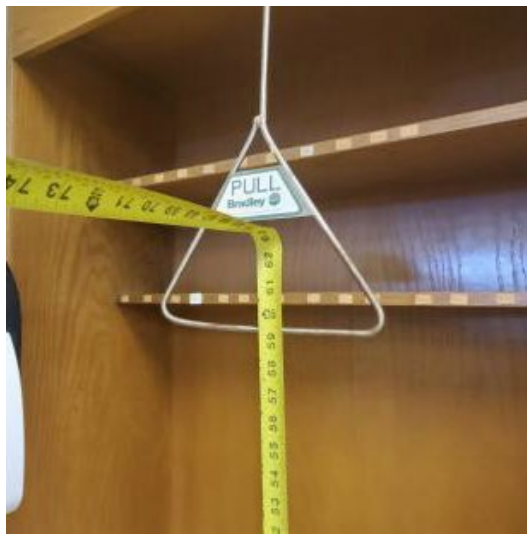
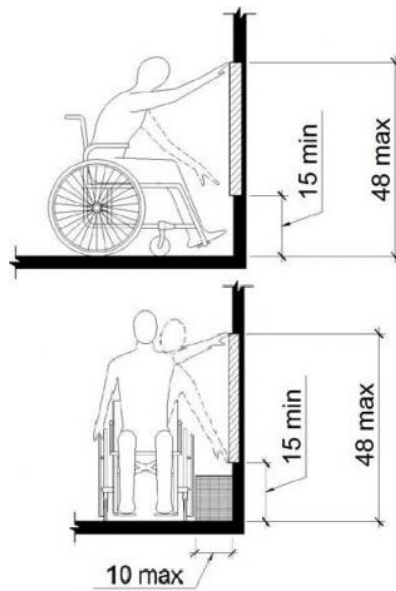
As Built: The shower pull handle is not positioned correctly for either a side or front approach.

Where a clear floor or ground space allows a parallel or front approach to a switch or receptacle and the side reach is unobstructed, the high side reach shall be 48 inches maximum above the finish floor or ground and the low side reach shall be 15 inches minimum above the finish floor or ground.

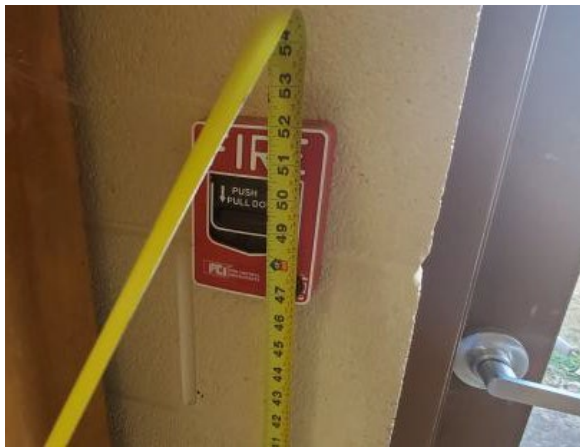
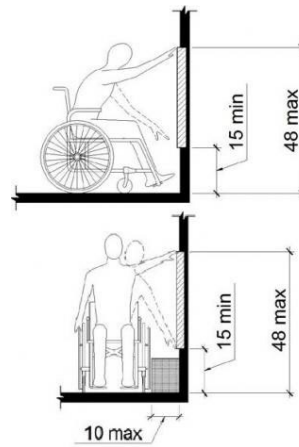
As Built: The fire alarm pull station is positioned at 50" which is too high for either a side or front approach.

Where a clear floor or ground space allows a parallel approach to an element and the side reach is unobstructed, the high side reach shall be 48 inches maximum and the low side reach shall be 15 inches minimum above the finish floor or ground.

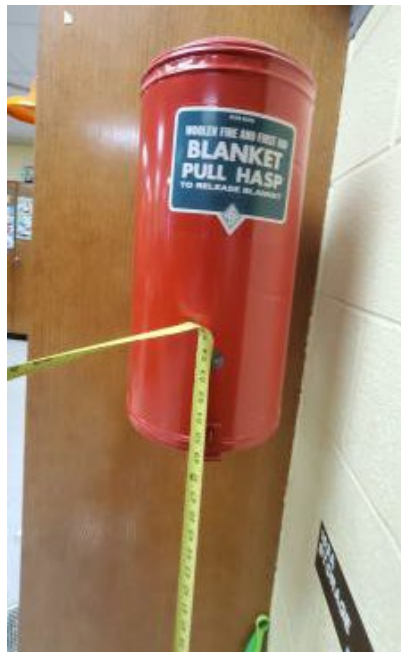
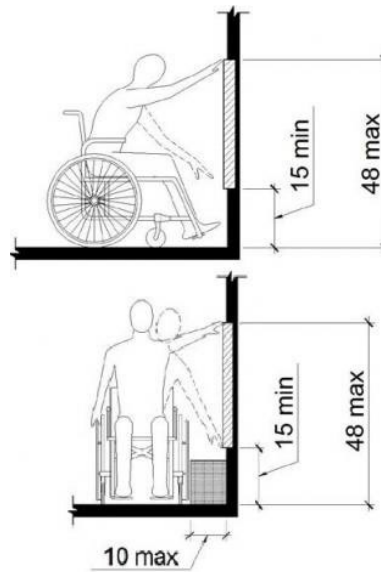
As Built: The Blanket Pull Hasp is at 59" to bottom which is not positioned correctly for either a side or front approach.

Where a clear floor or ground space allows a parallel or front approach to a switch or receptacle and the side reach is unobstructed, the high side reach shall be 48 inches maximum above the finish floor or ground and the low side reach shall be 15 inches minimum above the finish floor or ground.

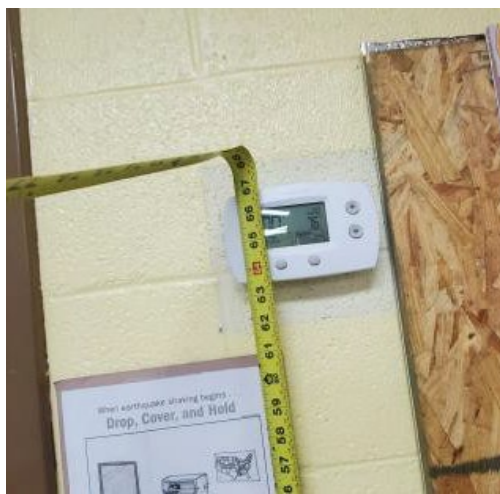
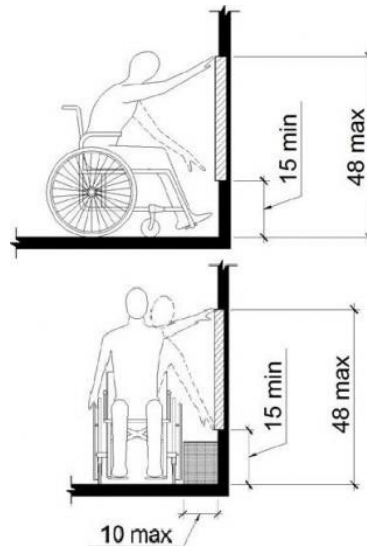
As Built: The Thermostat is positioned at 66" which is too high for either a side or front approach.

Where a clear floor or ground space allows a parallel approach to an element and the side reach is unobstructed, the high side reach shall be 48 inches maximum and the low side reach shall be 15 inches minimum above the finish floor or ground.

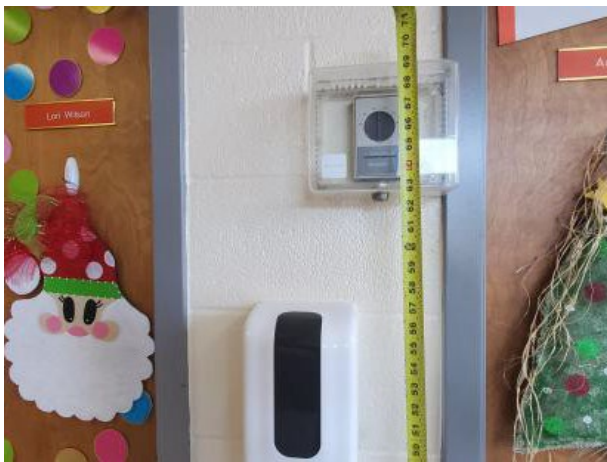
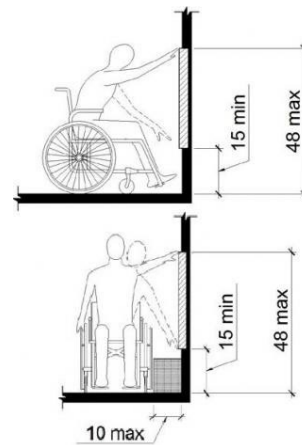
As Built: The Thermostat is positioned at 66" which is too high for either a side or front approach.

Where a clear floor or ground space allows a parallel approach to an element and the side reach is unobstructed, the high side reach shall be 48 inches maximum and the low side reach shall be 15 inches minimum above the finish floor or ground.

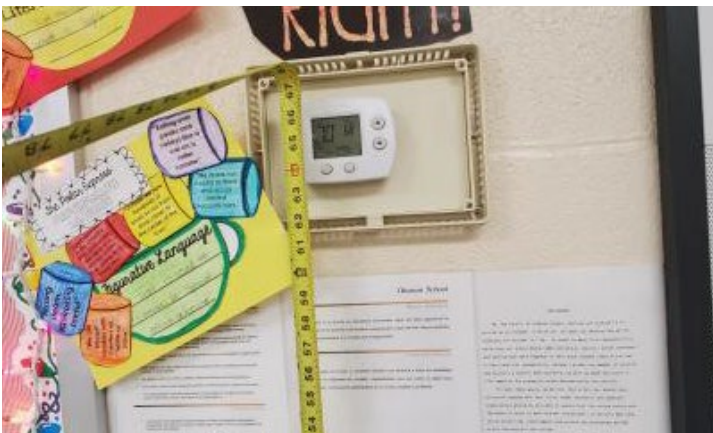
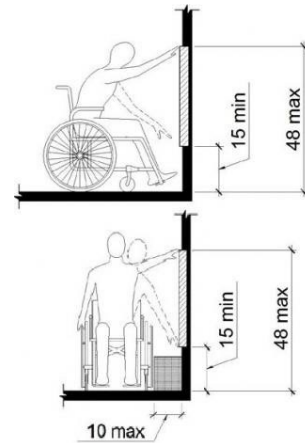
As Built: The Thermostat is positioned at 66" which is too high for either a side or front approach.

Where a clear floor or ground space allows a parallel approach to an element and the side reach is unobstructed, the high side reach shall be 48 inches maximum and the low side reach shall be 15 inches minimum above the finish floor or ground.

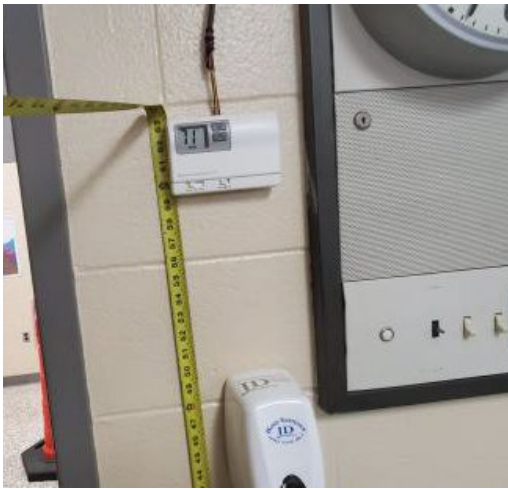
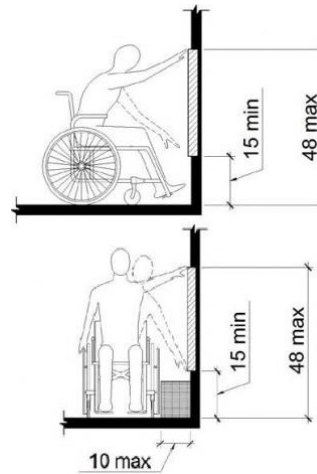
As Built: The Thermostat is positioned at 66" which is too high for either a side or front approach.

Where a clear floor or ground space allows a parallel approach to an element and the side reach is unobstructed, the high side reach shall be 48 inches maximum and the low side reach shall be 15 inches minimum above the finish floor or ground.

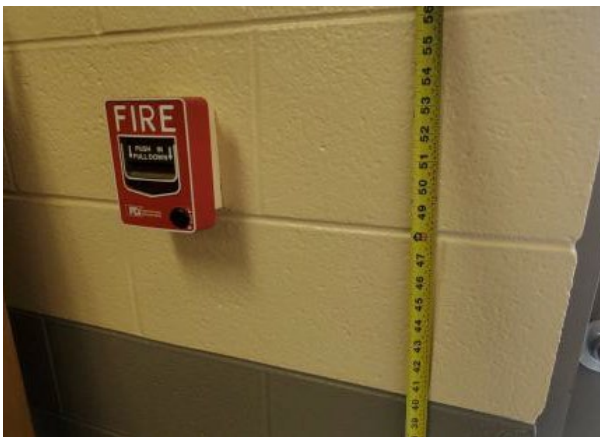
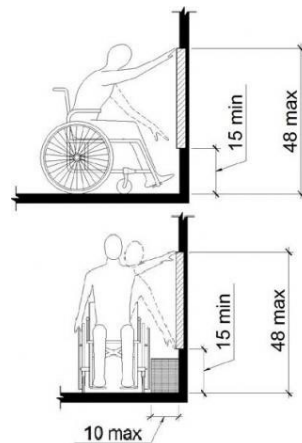
As Built: The fire alarm pull station is positioned at 50" which is too high for either a side or front approach.

Where a clear floor or ground space allows a parallel approach to an element and the side reach is unobstructed, the high side reach shall be 48 inches maximum and the low side reach shall be 15 inches minimum above the finish floor or ground.

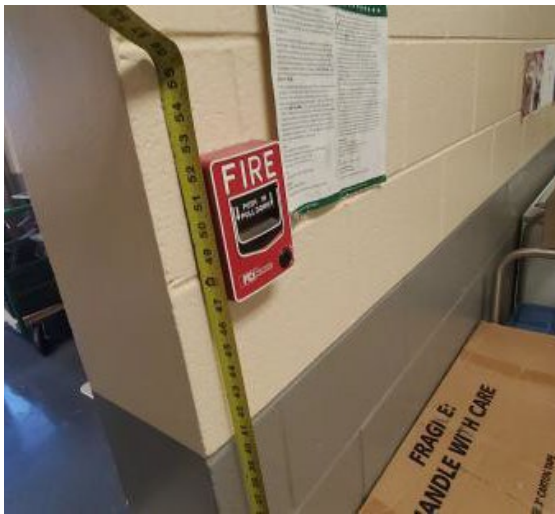
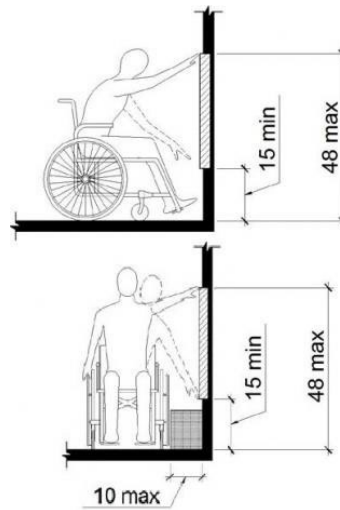
As Built: The fire alarm pull station is positioned at 50" which is too high for either a side or front approach.

Where a clear floor or ground space allows a parallel approach to an element and the side reach is unobstructed, the high side reach shall be 48 inches maximum and the low side reach shall be 15 inches minimum above the finish floor or ground.

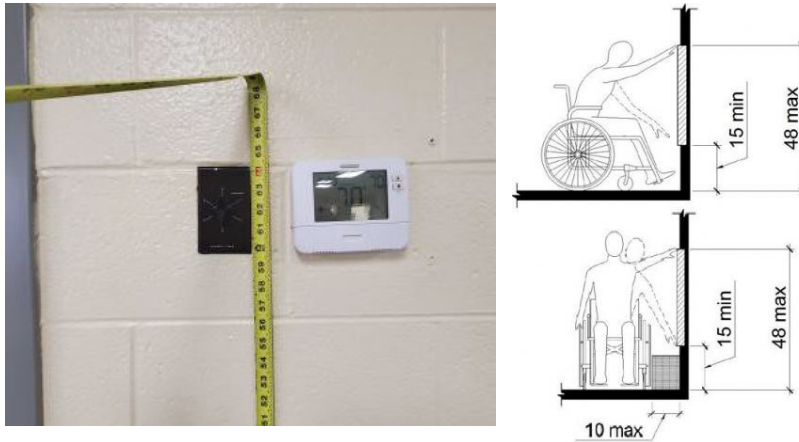
As Built: The Thermostat is positioned at 64" which is too high for either a side or front approach.

Where a clear floor or ground space allows a parallel approach to an element and the side reach is unobstructed, the high side reach shall be 48 inches maximum and the low side reach shall be 15 inches minimum above the finish floor or ground.

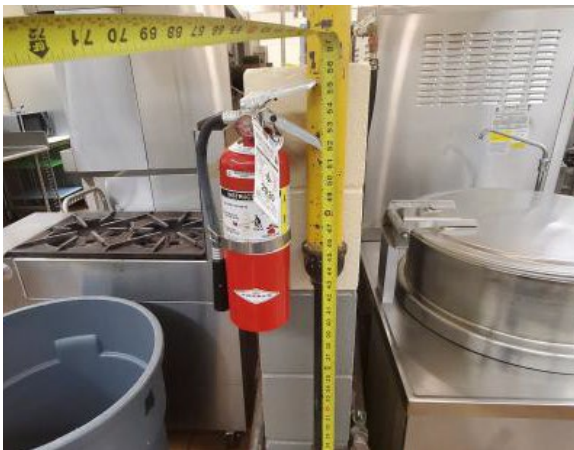
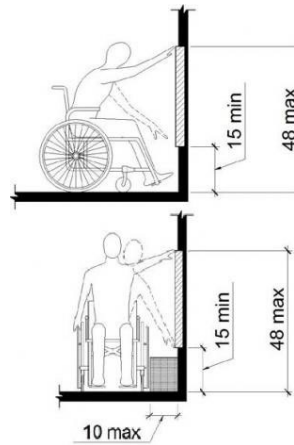
As Built: The Fire Extinguisher is positioned at 54" which is too high for either a side or front approach.

Where a clear floor or ground space allows a parallel approach to an element and the side reach is unobstructed, the high side reach shall be 48 inches maximum and the low side reach shall be 15 inches minimum above the finish floor or ground.

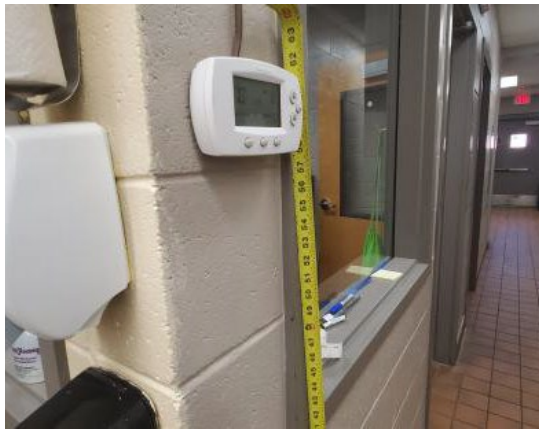
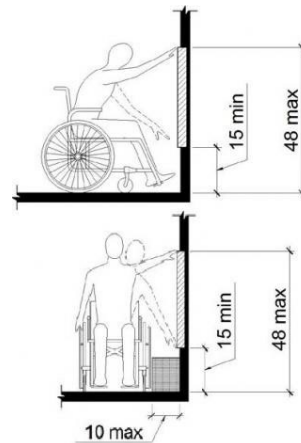
As Built: The Thermostat is positioned at 60" which is too high for either a side or front approach.

Where a clear floor or ground space allows a parallel approach to an element and the side reach is unobstructed, the high side reach shall be 48 inches maximum and the low side reach shall be 15 inches minimum above the finish floor or ground.

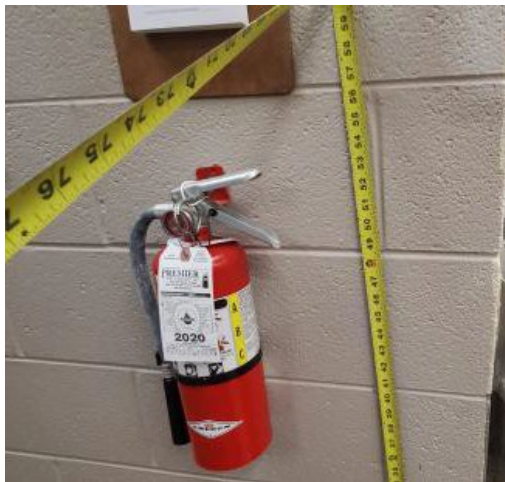
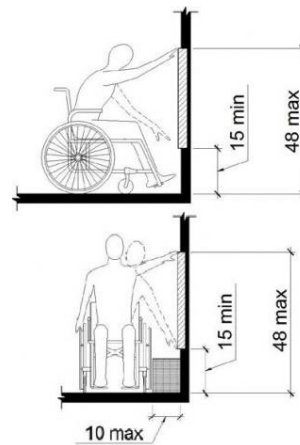
As Built: The Fire Extinguisher is positioned at 52" which is too high for either a side or front approach.

Where a clear floor or ground space allows a parallel approach to an element and the side reach is unobstructed, the high side reach shall be 48 inches maximum and the low side reach shall be 15 inches minimum above the finish floor or ground.

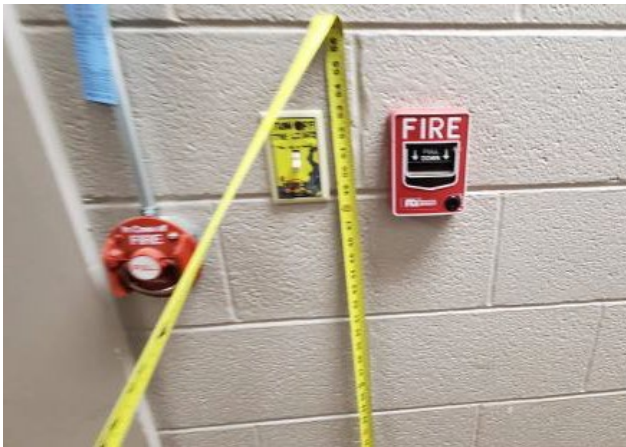
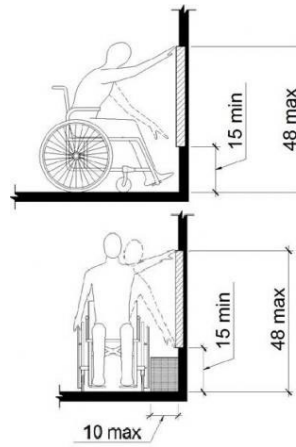
As Built: The fire alarm pull station is positioned at 50" which is too high for either a side or front approach.

Where a clear floor or ground space allows a parallel approach to an element and the side reach is unobstructed, the high side reach shall be 48 inches maximum and the low side reach shall be 15 inches minimum above the finish floor or ground.

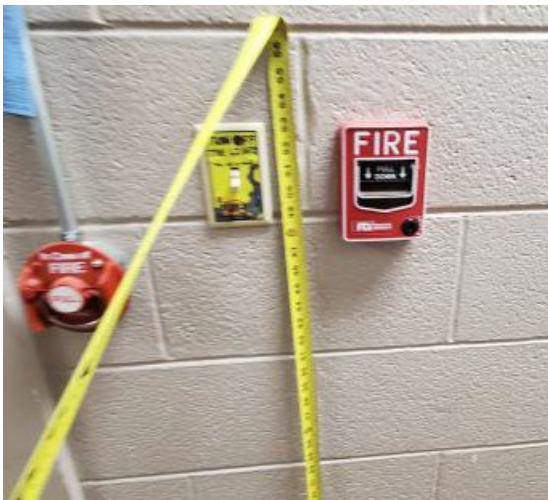
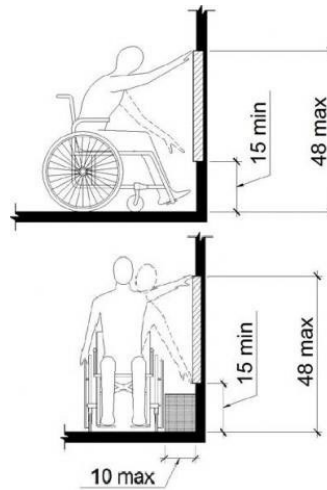
As Built: The fire alarm pull station is positioned at 50" which is too high for either a side or front approach.

Where a clear floor or ground space allows a parallel approach to an element and the side reach is unobstructed, the high side reach shall be 48 inches maximum and the low side reach shall be 15 inches minimum above the finish floor or ground.

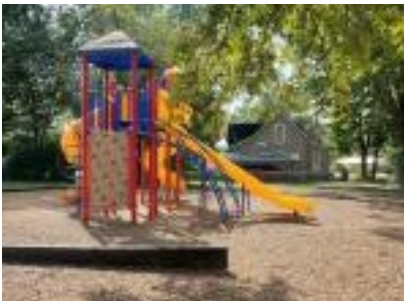
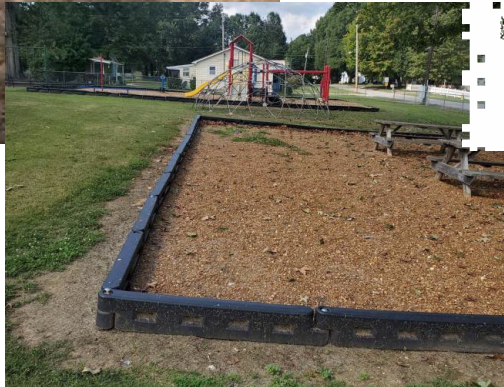
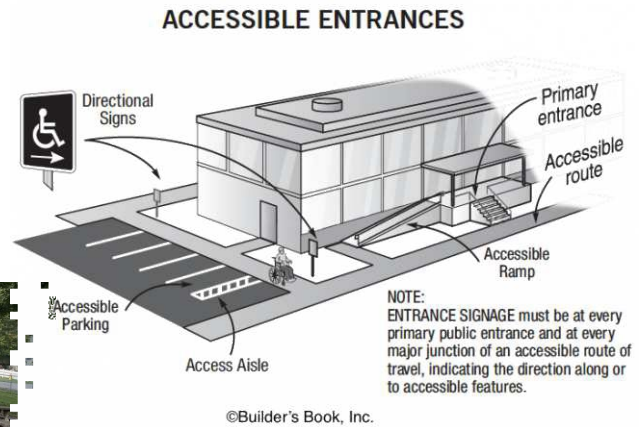
As Built: There is no accessible route to the playground. Each play area (except for one) and picnic table is contained inside an 8" tall border with no ramp or opening. The only play area with border removed for access does not have a transfer platform or ramp.

At least one accessible route shall connect accessible buildings, accessible facilities, accessible elements, and accessible spaces that are on the same site.

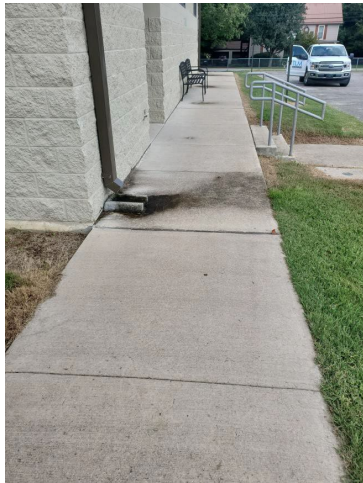
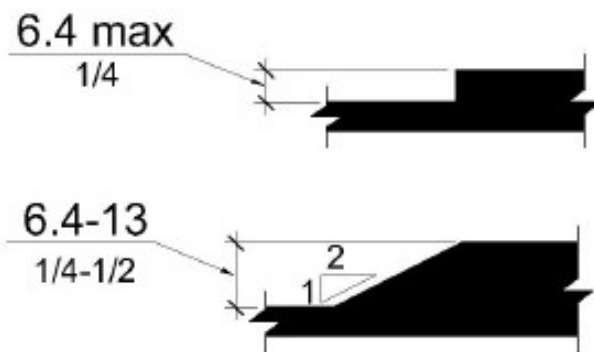
As Built: The surface of the pedestrian access route has vertical discontinuities greater than 1/2 inch or between 1/4 inch and 1/2 inch that are not beveled.

Vertical surface discontinuities shall be 0.5 inch maximum. Vertical surface discontinuities between 0.25 inch and 0.5 inch shall be beveled with a slope not steeper than 50 percent. The bevel shall be applied across the entire vertical surface discontinuity.

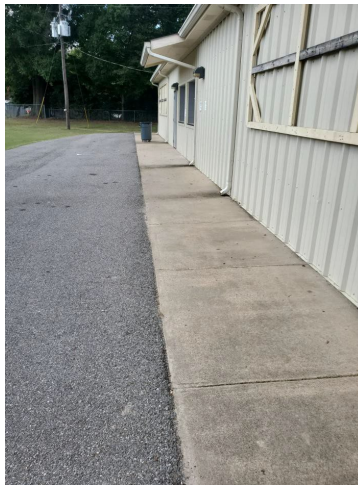
As Built: The cross slope of the pedestrian access route is excessive and varies in front of concession counters up to 3.5%, along entire length of concession side.

The cross slope of pedestrian access routes shall be 2 percent maximum.

Replace approximately 5x10 of pedestrian access route.

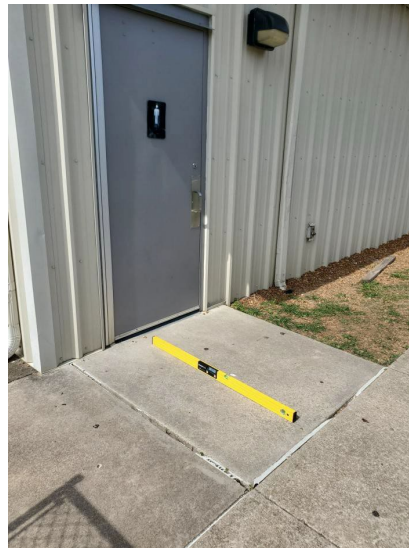
As Built: The cross slope of the pedestrian access route is excessive at 2.4% in front of men's restroom door. Also, expansion joint sealant failed leaving 1" wide gap.

The cross slope of pedestrian access routes shall be 2 percent maximum.

Replace sections of pedestrian access route that are over 2%.

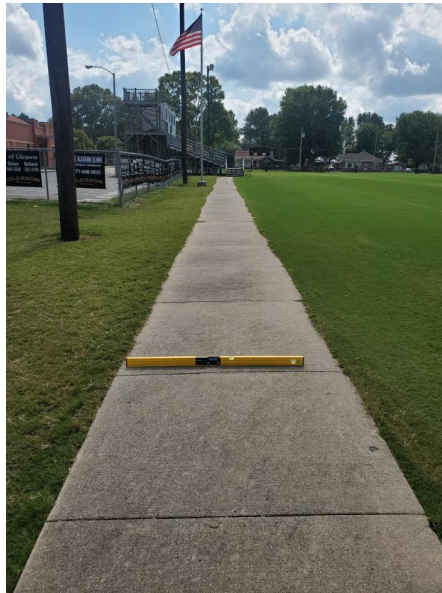
As Built: The cross slope of the pedestrian access route is approximately 20' varies up to 3.3% which is excessive.

The cross slope of pedestrian access routes shall be 2 percent maximum.

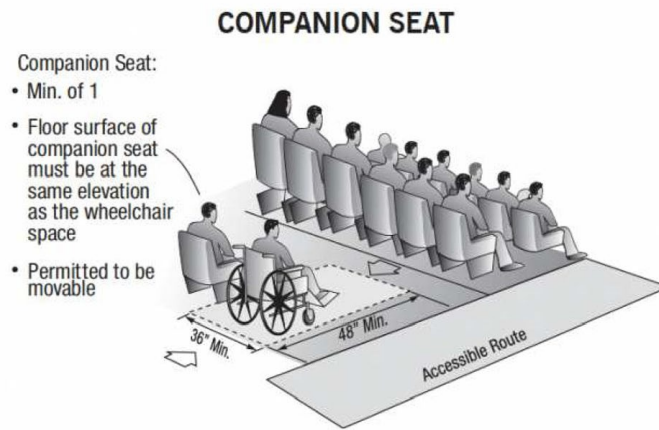
As Built: An accessible wheelchair space is not provided in the team/player seating area.

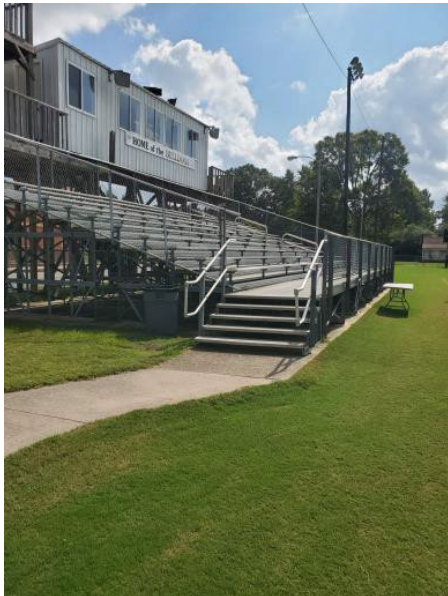
As Built: Based on the number of seats provided in this area, there should be a minimum number of wheelchair seating spaces meeting the figure, as well as accessible route to steps up to home side seating.

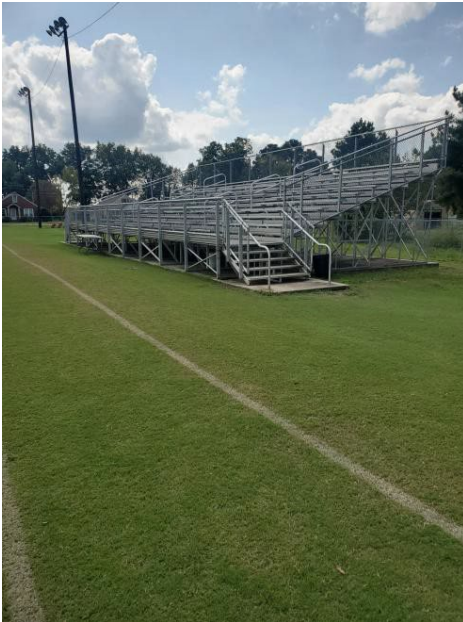
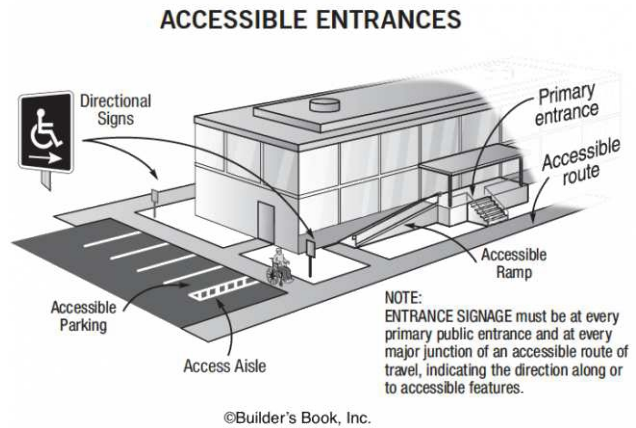
As Built: There is no accessible route to the visitors' seating area.

At least one accessible route shall connect accessible buildings, accessible facilities, accessible elements, and accessible spaces that are on the same site.

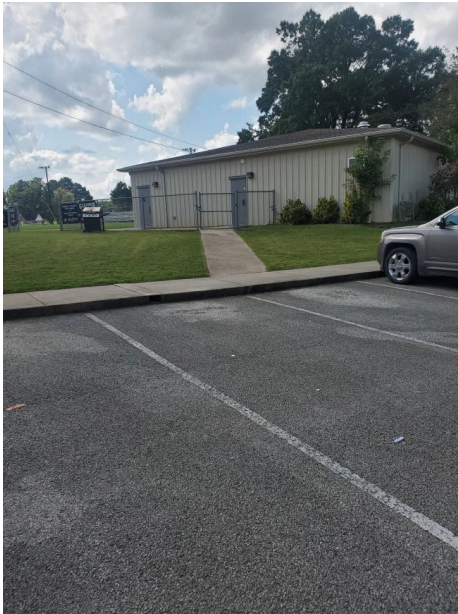
As Built: There are no accessible parking stalls.

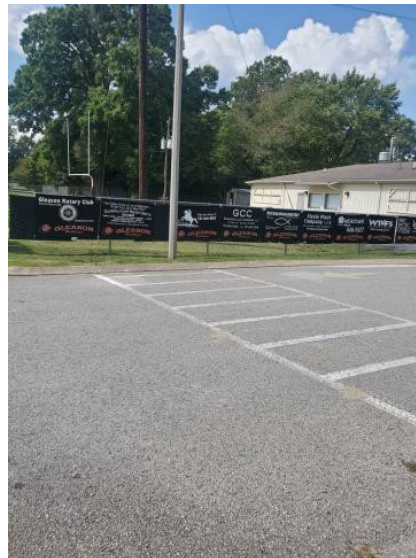
As Built: There is no pedestrian access route at the street crossing.

A curb ramp, blended transition, or a combination of curb ramps and blended transitions shall connect the pedestrian access routes at each pedestrian street crossing. The curb ramp (excluding any flared sides) or blended transition shall be contained wholly within the width of the pedestrian street crossing served.

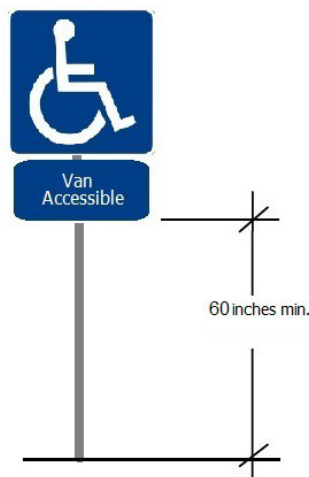
As Built: Two spots are painted, shared access aisle. One spot has no sign.

Parking space identification signs shall include the International Symbol of Accessibility (ISA). Signs identifying van parking spaces shall contain the designation "van accessible." All signs shall be 60 inches minimum above the finish floor or ground surface measured to the bottom of the sign.

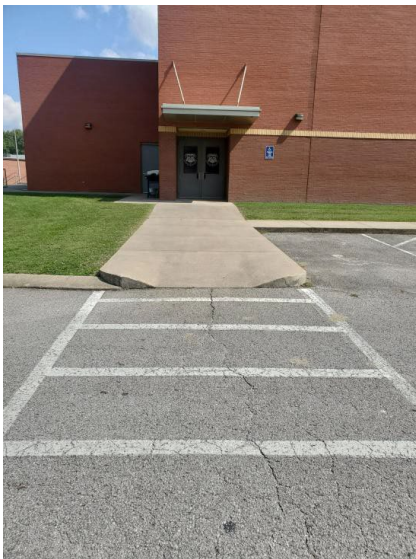
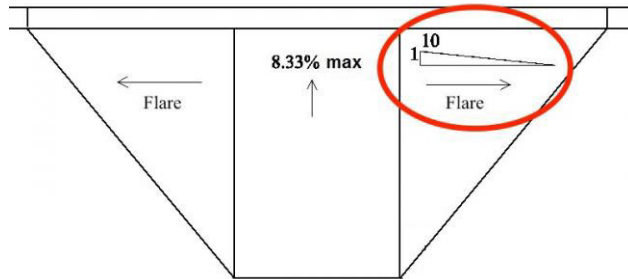
As Built: The curb ramp side flares are too steep, varying up to 33%.

The sides of curb ramps (curb ramp flares) where provided, shall not be steeper than 1:10.

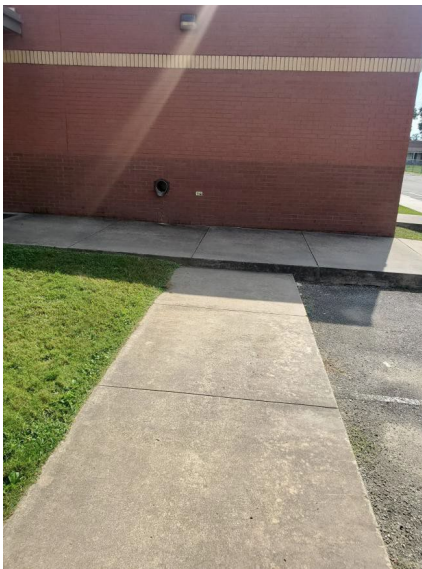
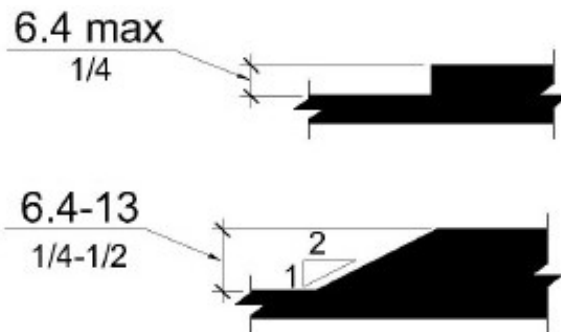
As Built: The surface of the pedestrian access route has vertical discontinuities greater than 1/2 inch or between 1/4 inch and 1/2 inch that are not beveled. There is no ramp option provided at this step. Vertical surface discontinuities shall be 0.5 inch maximum. Vertical surface discontinuities between 0.25 inch and 0.5 inch shall be beveled with a slope not steeper than 50 percent. The bevel shall be applied across the entire vertical surface discontinuity.

Citation: 2011 PROWAG Section R302.7.2

Replace ramp to meet requirements.

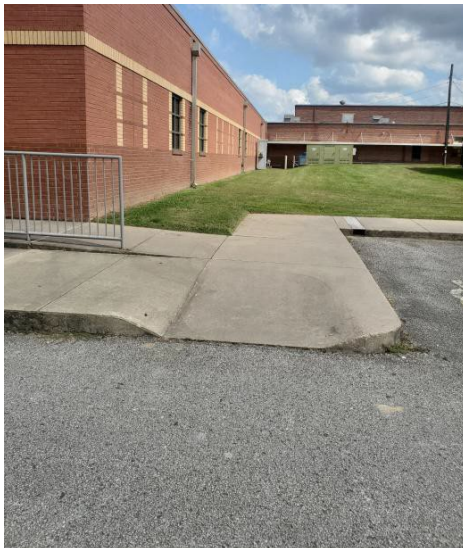
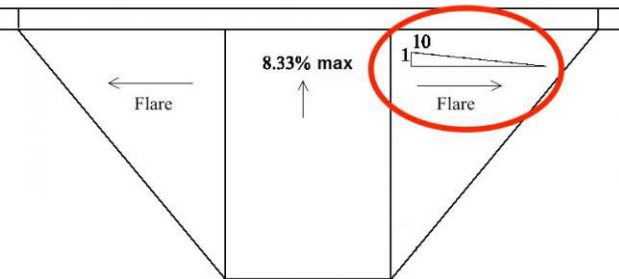
As Built: The curb ramp side flares are too steep, varying up to 33%.

The sides of curb ramps (curb ramp flares) where provided, shall not be steeper than 1:10.

Replace ramp due to excessive slope in ramp and on flares.

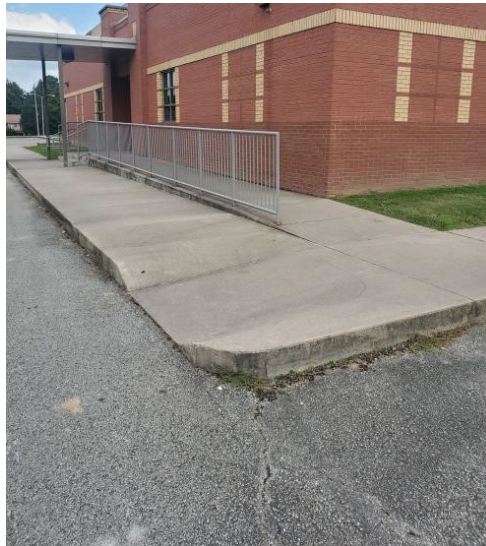
As Built: The curb ramp slope is 9.7% which exceeds the maximum running slope (Parallel to the direction of travel) allowable of 8.33%.

Curb ramps should have the least possible slope but in no case more than 8.3% (1:12).

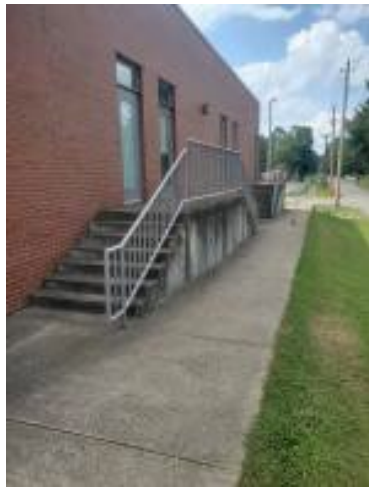
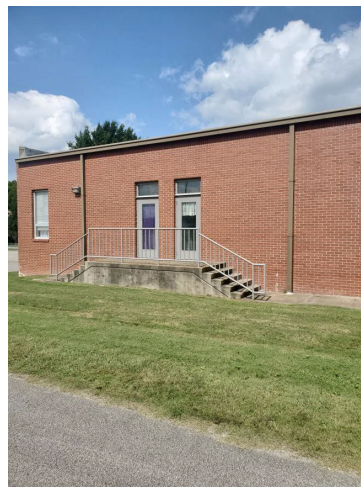
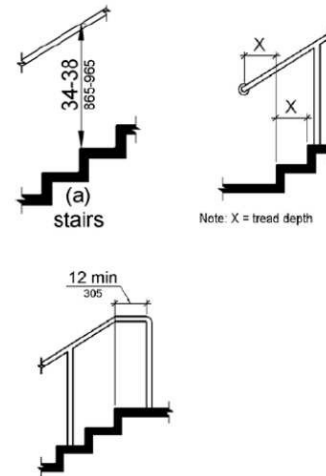
As Built: The stairway only has a handrail on one side. Stairways must have handrails on both sides. Handrails and their extensions must be between 34 inches and 38 inches above the stair nosing or ground. The top handrails shall extend a minimum of 12 inches beyond the top nosing and shall be parallel with the floor or ground surface. At the bottom of a stair flight, handrails shall extend at the slope of the stair flight for a horizontal distance at least equal to one tread depth beyond the last riser nosing. Extension shall return to a wall, guard, or the landing surface, or shall be continuous to the handrail of an adjacent stair flight.

The orientation of at least one handrail, including the extension, shall be in the direction of the run of the stair and perpendicular to the direction of the stair nosing. Handrail gripping surfaces with a circular cross section shall have an outside diameter of 1-1/4 inches minimum and 2 inches maximum. Handrail gripping surfaces with a non-circular cross section shall have a perimeter dimension of 4 inches minimum and 6 1/4 inches maximum, and a cross-section dimension of 2-1/4 inches maximum. The hand grip portion of handrails shall have a smooth surface with no sharp corners. Gripping surfaces (top or sides) shall be uninterrupted by newel posts, other construction elements or obstructions. Any wall or other surface adjacent to the handrail shall be free of sharp or abrasive elements. Handrails projecting from a wall shall have a space of 1-1/2 inches minimum between the wall and the handrail.

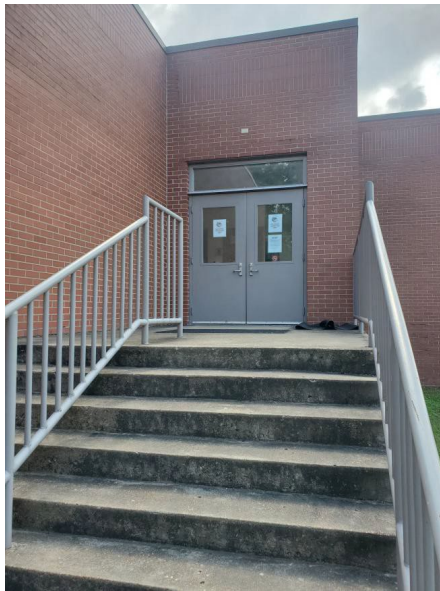
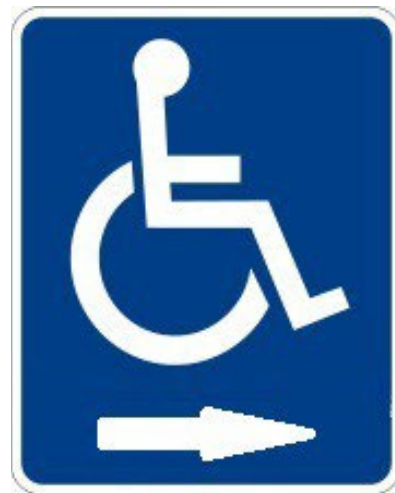
As Built: There is no International Symbol of Accessibility at this entrance.

In existing buildings and facilities where not all entrances are accessible doors that are accessible shall be identified by the International Symbol of Accessibility. Directional signs that indicate the location of the nearest accessible entrance shall be provided at entrances that are not accessible. Directional signs including the International Symbol of Accessibility indicating the accessible route to the nearest accessible entrance shall be provided at junctions when the accessible route diverges from the regular circulation path.

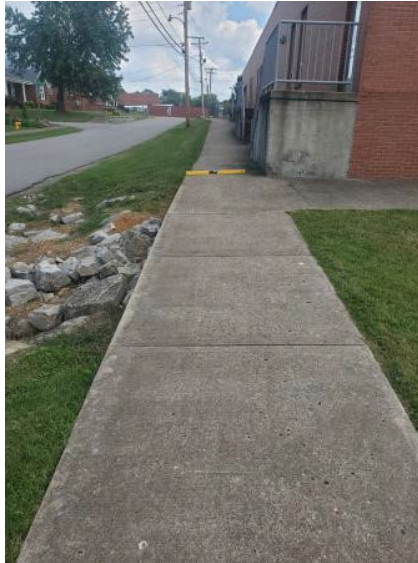
As Built: The cross slope of the pedestrian access route is approximately 60' and varies up to 6.36% which is excessive.

The cross slope of pedestrian access routes shall be 2 percent maximum.

Replace approximately 25'x10' of pedestrian access route.

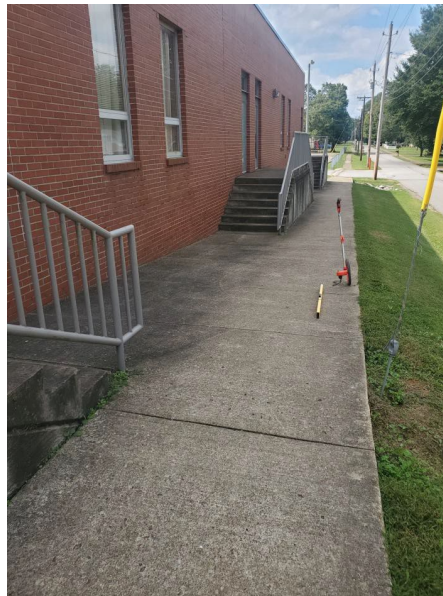
As Built: The grade of the pedestrian access route varies up to 7.1% which is too steep.

Where pedestrian access routes are not contained within a street or highway right-of-way, the grade of pedestrian access routes shall be 5 percent maximum.

Replace sidewalk to provide less than 5%. If over 5%, up to 8.3%, provide handrail.

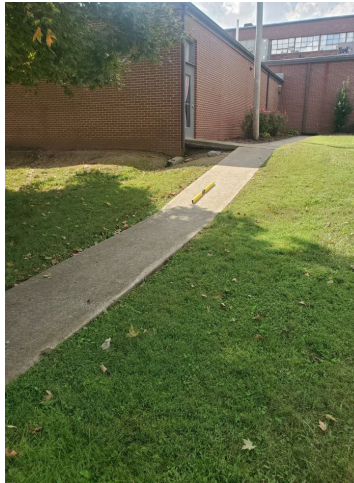
As Built: The grade of the pedestrian access route is too steep.

Where pedestrian access routes are not contained within a street or highway right-of-way, the grade of pedestrian access routes shall be 5 percent maximum.

Replace ramp, include turning landing at less than 2% at bottom of ramp. If over 8.3%, install handrails.

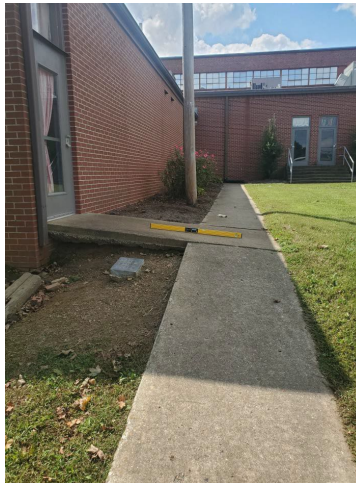
As Built: The grade of the pedestrian access route is 9.3% which is too steep.

Where pedestrian access routes are not contained within a street or highway right-of-way, the grade of pedestrian access routes shall be 5 percent maximum.

Replace sidewalk to flush condition with roadway crossing.

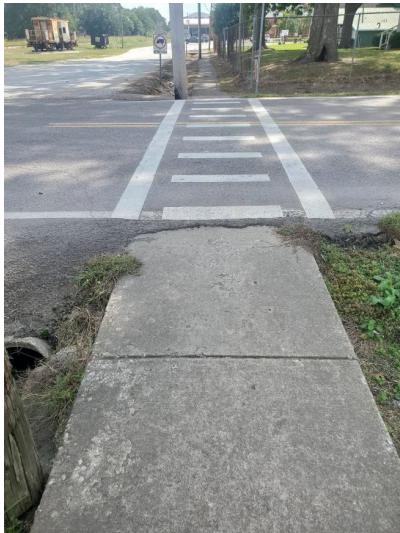
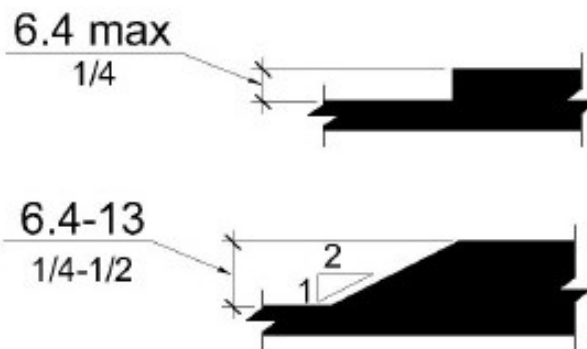
As Built: The surface of the pedestrian access route has vertical discontinuities greater than 1/2 inch or between 1/4 inch and 1/2 inch that are not beveled.

Vertical surface discontinuities shall be 0.5 inch maximum. Vertical surface discontinuities between 0.25 inch and 0.5 inch shall be beveled with a slope not steeper than 50 percent. The bevel shall be applied across the entire vertical surface discontinuity.

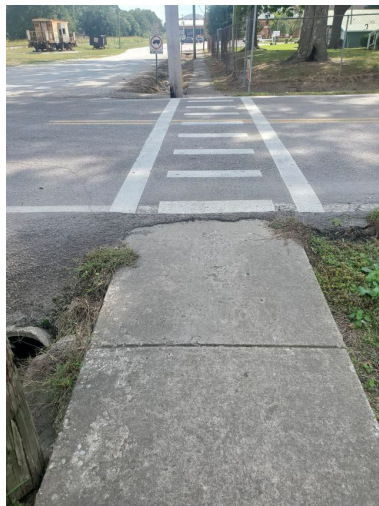
As Built: The detectable warning is missing at the curb ramp.

Curb ramps shall have a detectable warning that extends the full width of the curb ramp, excluding the flared sides, 24 inch minimum in the direction of travel.

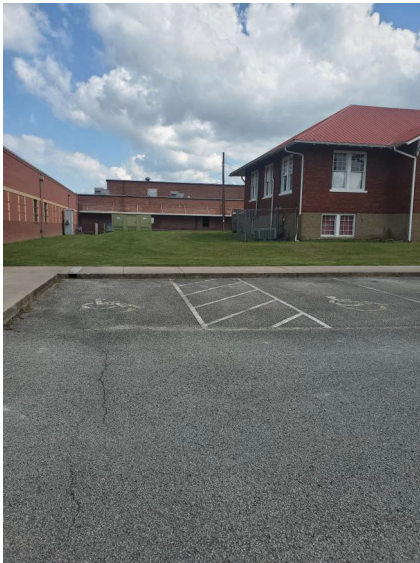
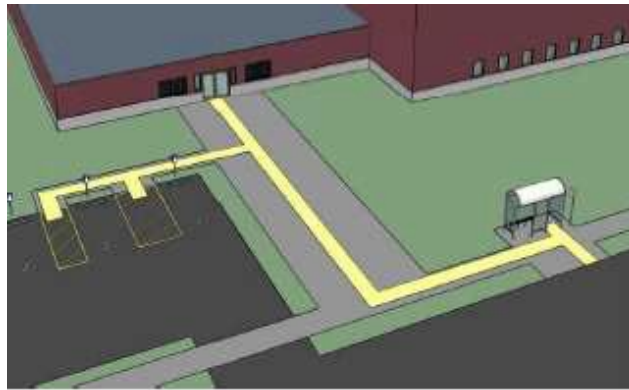
As Built: The accessible parking is not located on an accessible route of travel to the accessible building entrance. There is no curb ramp provided at the access aisle. Users must get into traffic to access nearby ramps.

Accessible parking spaces serving a particular building shall be located on the shortest accessible route of travel from adjacent parking to an accessible entrance. In buildings with multiple accessible entrances with adjacent parking, accessible parking spaces shall be dispersed and located closest to the accessible entrances.

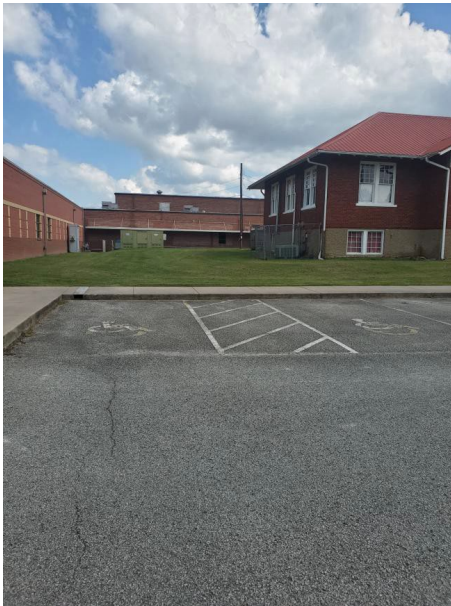
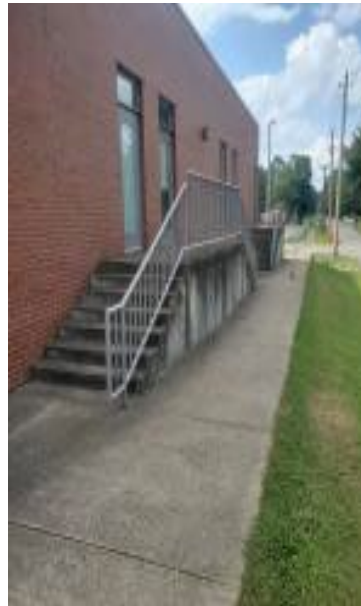
As Built: The required parking signage is missing.

Parking space identification signs shall include the International Symbol of Accessibility (ISA). Signs identifying van parking spaces shall contain the designation "van accessible." All signs shall be 60 inches minimum above the finish floor or ground surface measured to the bottom of the sign.

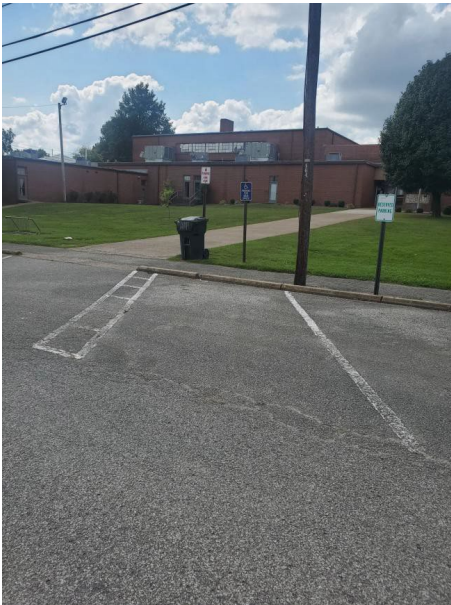
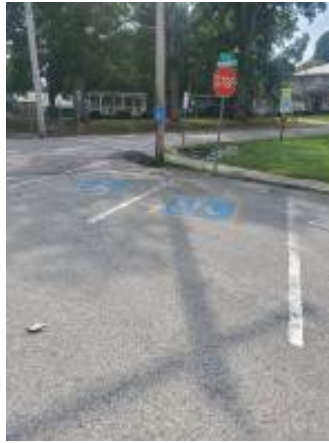
As Built: There are not enough accessible stalls. Two parking spaces marked at end of parking lot do not seem to serve school but the small park across the street. They are not on an access route to the school and are not compliant.

Recommendation: Replace approximately 14'x14' section of access route.

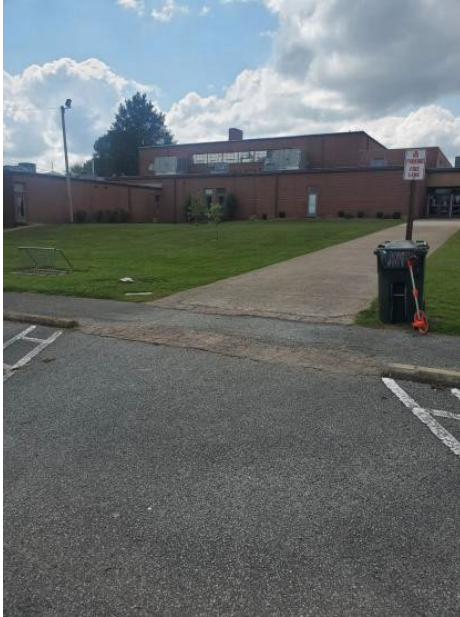
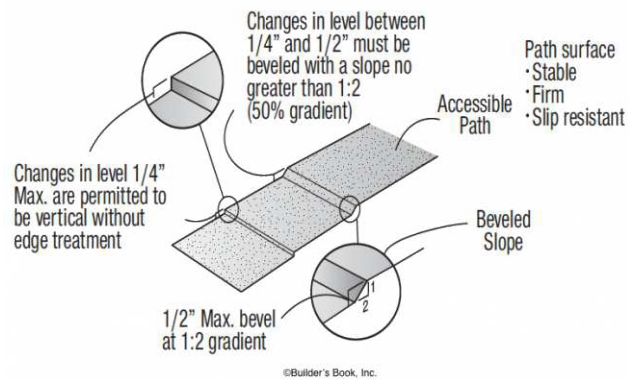
As Built: The accessible route contains loose gravel and/or surfaces that do not provide for a stable, firm slip resistant surface. Approximately 14'x14' contains loose gravel, chipped concrete and asphalt and vertical surface discontinuities over 1/4".

Citation: 2010 ADAS Section 302.1

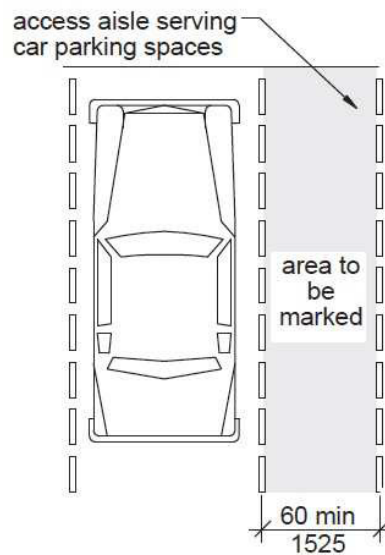
As Built: The access aisle is not a minimum of 5 feet wide.

A accessible parking stall's access aisle must be a minimum of 5 feet wide measured from centerline to centerline.
